Building and Timber Pest Inspection Report

Inspection Date: Wed, 21 Jan 2026

Property Address: 5 Pinetree Ave, Cranebrook NSW 2749,
Australia

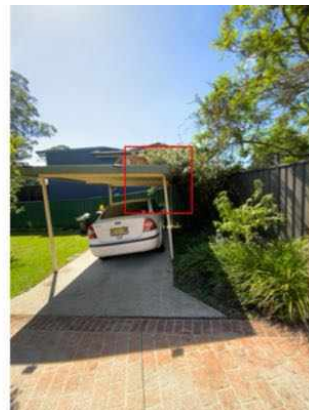
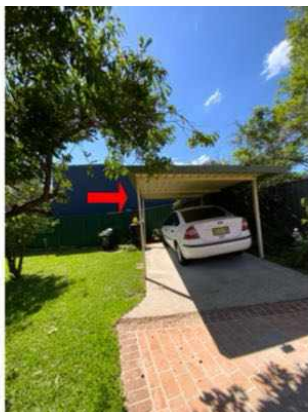
Building: Main Building
Location: Carport
Finding: Carport wobbly
Information: It was noted that the carport is lopsided and wobbly due to the substandard workmanship ,which can be a safety hazard.

A qualified carpenter should be contacted to assess and make good

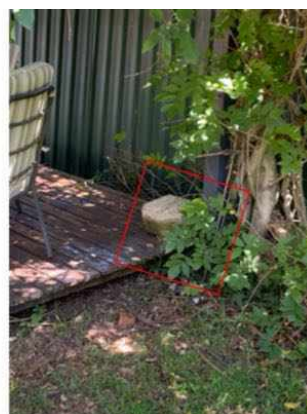
Finding 1.02

Building: Main Building
Location: Pergola
Finding: Structure - Old and non-compliant
Information: This structure, whilst appearing to provide adequate structural support, does not comply with contemporary building practices and current Australian Standards.

Although this is not a requirement in older homes, the client should be aware of the age and non-compliance of the structure when planning any repairs or remodelling.

It is advised that this structure be inspected by a registered builder or structural engineer on a relatively frequent basis to ensure that the structural integrity does not falter over time.

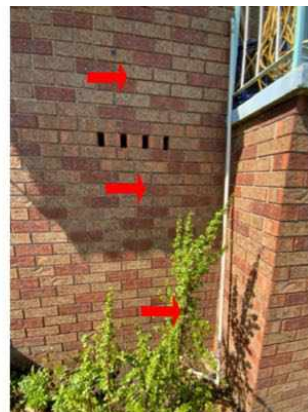
Building:	Main Building
Location:	Exterior walls - rear
Finding:	Subsidence
Information:	It appears that the wall structure has been affected by movement of the foundations, often referred to as sinking or subsidence. Whilst a degree of movement is expected in subfloors over time, especially as environmental conditions change and buildings 'settle' after construction, this degree of subfloor movement requires attention.

General subsidence is usually initiated by changes in soil moisture content. The most critical factor is identifying the specific causes, and identifying if this is a recurring or ongoing problem, or one that has been resolved by previous works in the past.

Subsidence can have complex and varying causes, which will influence the required remedial works. It is advised to begin by consulting a structural engineer to determine the required scope of works. This generally includes some form of underpinning, as well as addressing the underlying cause. Consultation with a geotechnical engineer may also be necessary where changes to soil moisture content is apparent.

A Registered Builder specialising in re-stumping would then generally carry out works as advised by an Engineer.

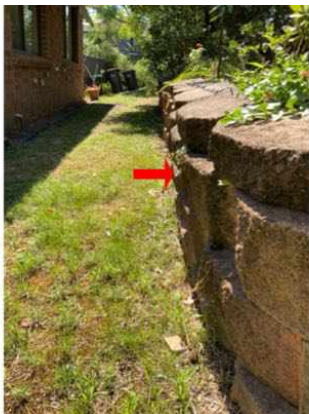
Building: Main Building
 Location: Exterior walls - front
 Finding: Retaining wall - Defective
 Information:

The retaining wall in this area was found to be defective at the time of inspection. Generally, defective retaining walls are caused by poor original design or material use. However, deteriorated retaining walls may also be a result of substandard construction, poor site drainage or unmanaged stormwater flows.

Significant repair and replacement should be expected. Where retaining walls are considered structural walls, a structural engineer / surveyor should be consulted regarding required remedial works. Otherwise, a landscaper or retaining wall installer may be appointed to repair or replace the wall, at the discretion of the client.

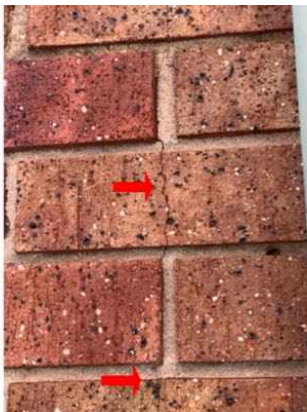
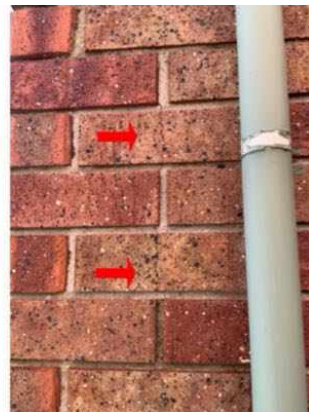
Finding: Brickwork - Cracking [Fine]

Cracking of this nature can generally be repaired with minor filling and should be conducted by a qualified bricklayer.

Always contact a building inspector should cracks widen lengthen or become more numerous.

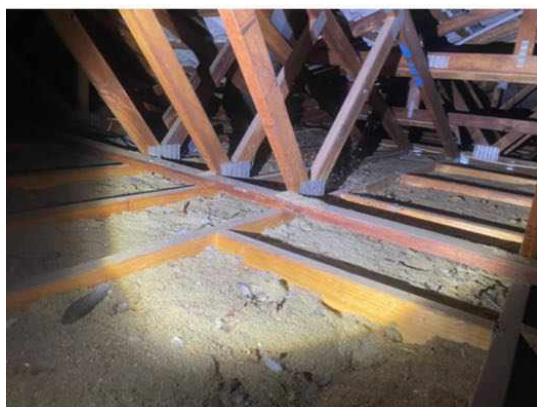
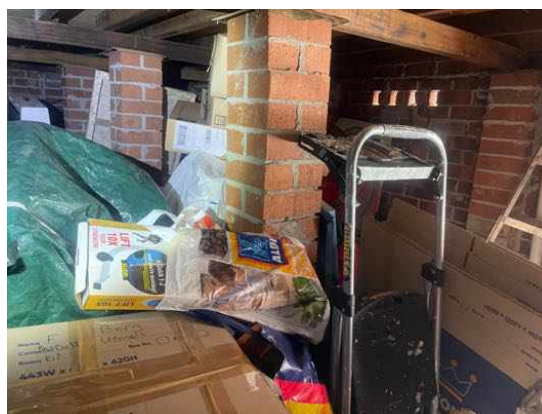
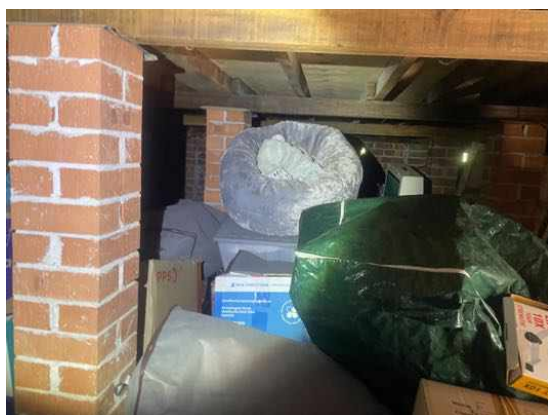
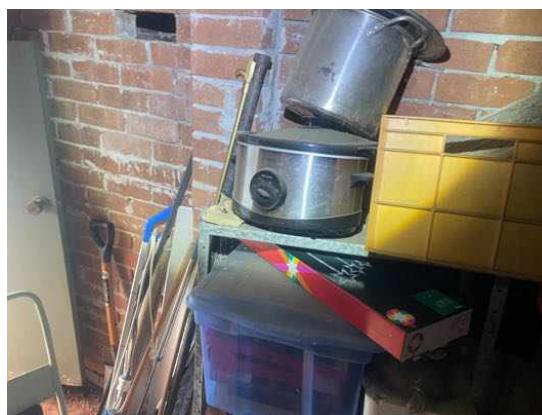
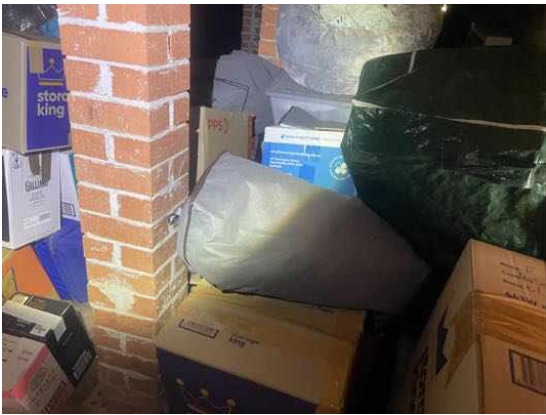
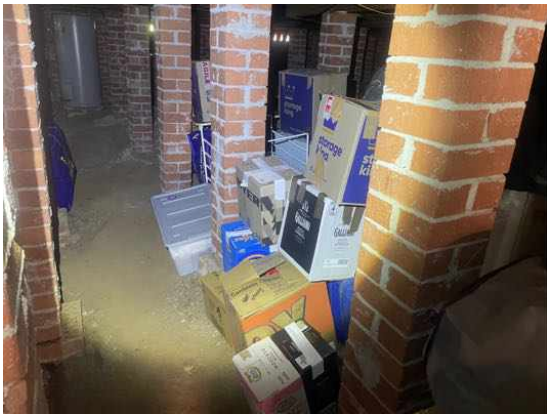
Building: Main Building
Location: All Areas
Finding: Additional Photos - Obstructions and Limitations
Information: These photographs are an indication of the obstructions and limitations which impeded full inspection of the property at the time of inspection. These obstructions can hide an array of defects and should be removed to allow full inspection to be carried out. A re-inspection is recommended once the areas are made accessible.
