## Building Inspection Report

Inspection Date: Mon, 16 Feb 2026

Property Address: 85 Clifford St, Warragul VIC 3820, Australia

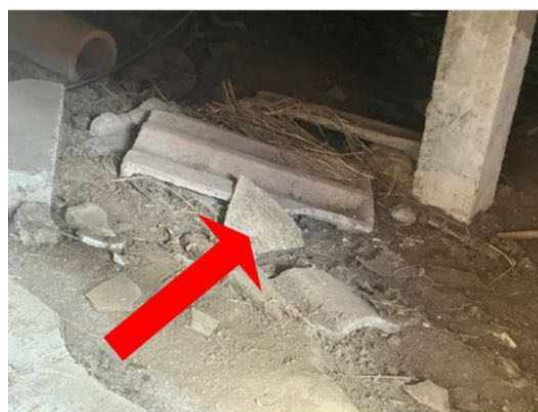
The existence of suspected asbestos debris presents a potential health and safety risk and should not be disturbed. Its presence limits visibility and may conceal additional defects that could not be assessed during this inspection.

It is recommended that a licensed asbestos removal contractor be engaged immediately to undertake a formal assessment, including sampling if required, and to remove all asbestos-containing debris in accordance with relevant health and safety regulations. Once the area has been professionally cleared and deemed safe, a follow-up subfloor inspection should be conducted to assess previously inaccessible areas.

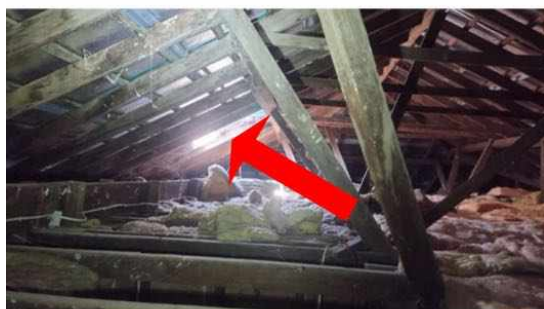
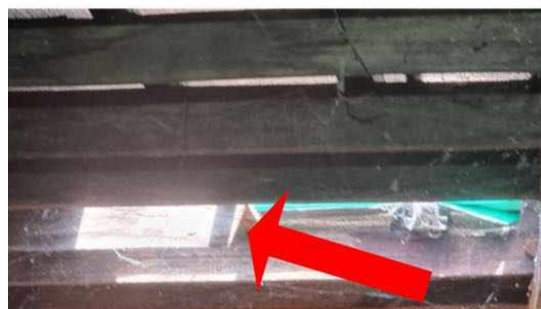
#### Defects 2.01

A compromised rafter may reduce the load-carrying capacity of the roof, increasing the risk of deflection, sagging, or failure under load. Over time, this can lead to roof instability, structural damage, and potential safety hazards.

It is recommended that a registered structural engineer and a qualified carpenter or registered builder assess the roof structure. The cut rafter should be replaced with a properly sized and installed rafter to fully restore structural integrity, ensuring compliance with relevant building standards and safety requirements.

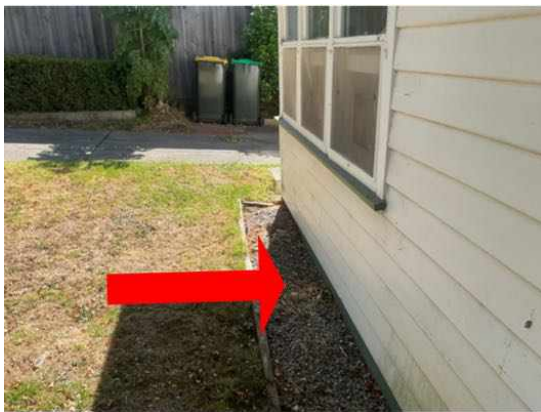
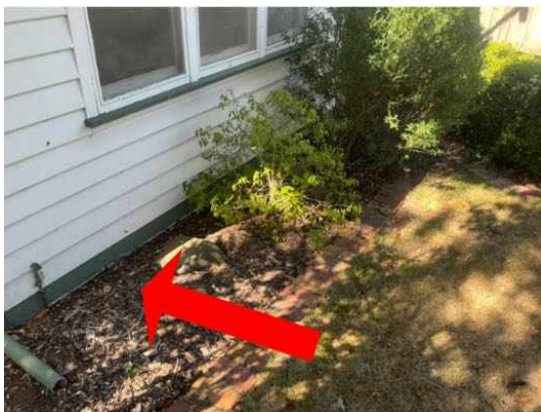
### Defects 3.01

Building:	Main Building
Location:	All External Areas
Finding:	Site drainage - Inadequate
Information:	The site drainage in all yards was found to be inadequate at the time of inspection, creating potential for subsequent water damage to associated building elements.

It is important that water does not lie against the base of walls; surrounding paths and ground levels should be sloped to drain water away from walls. Downpipes should not discharge stormwater onto lower walls or plinths. Stormwater should be carried away by large, regularly cleaned drains. Ground levels may need to be lowered to expose a buried DPC.

Where site drainage is inadequate, installation of an Agricultural (Aggie) Drain may be required. A qualified plumber should be appointed to further inspect the property and perform any remedial works as necessary. Water damage and secondary defects are likely to occur if left unmanaged.

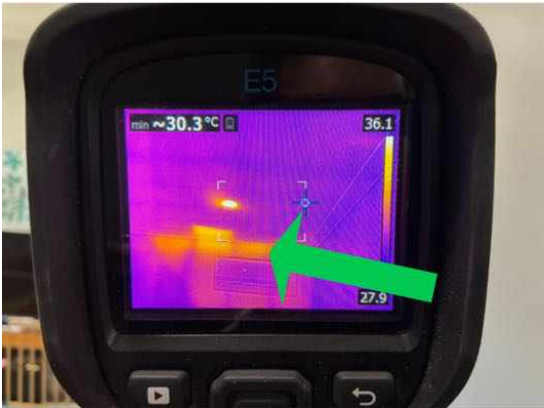
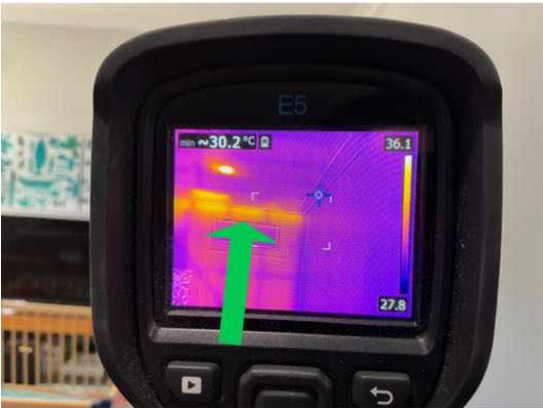
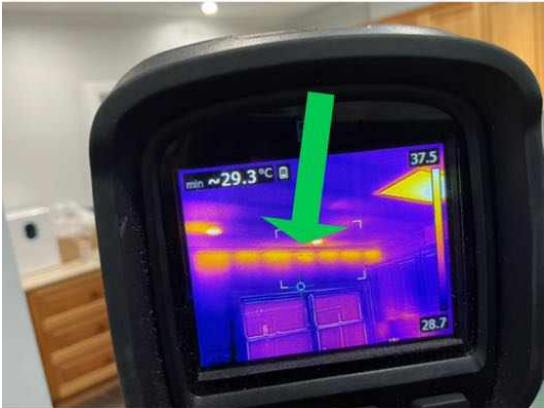
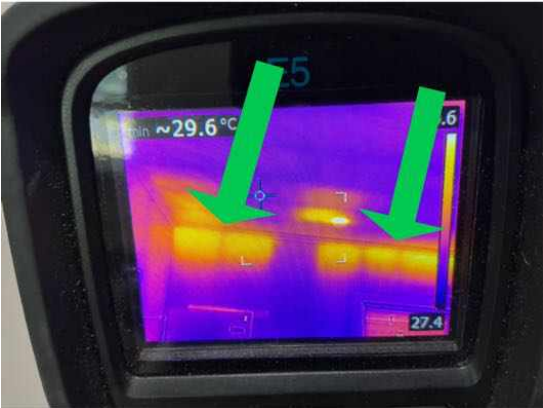
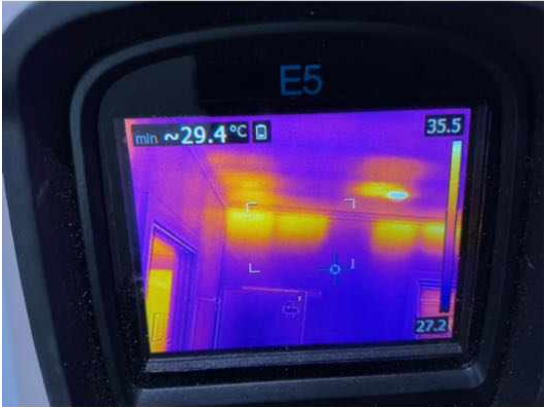
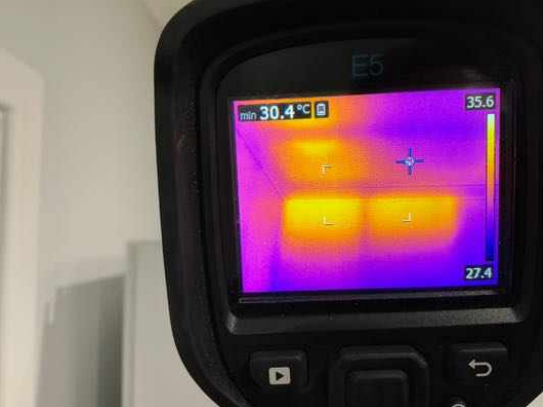
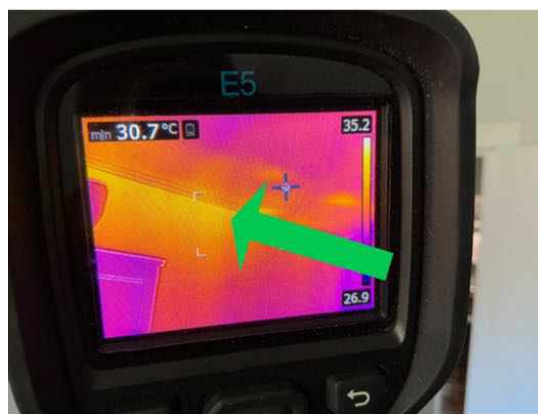
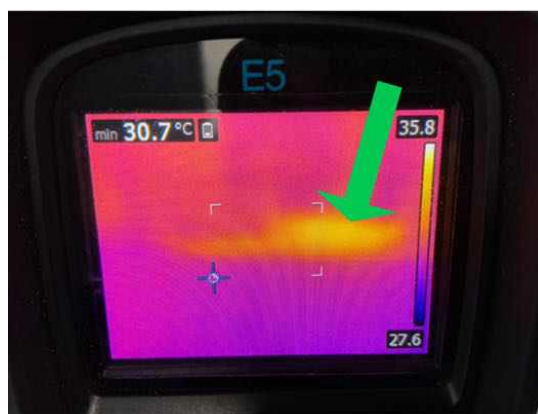
### Defects 3.02

Building:	Main Building
Location:	All Internal Areas
Finding:	Inconsistent Thermal Performance to Ceiling Areas – Suspected Insulation Deficiencies
Information:	Thermal imaging conducted to internal ceiling areas at the time of inspection identified inconsistent heat patterns, which are indicative of variations in thermal performance across the roof space. These patterns are commonly associated with areas of missing, displaced, or insufficient insulation above the ceiling linings.

Inadequate or uneven insulation coverage can reduce the energy efficiency of the

dwelling, contribute to heat loss in cooler periods and heat gain in warmer conditions, and may result in reduced occupant comfort and increased heating and cooling costs. Due to the non-invasive nature of the inspection, the exact extent and condition of insulation could not be confirmed visually in all affected areas.

It is recommended that a qualified insulation contractor inspect the roof space, assess insulation coverage and condition, and top up or reinstate insulation where required to achieve consistent thermal performance throughout the property.

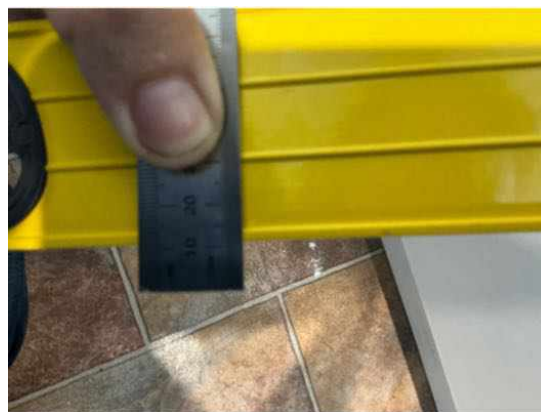
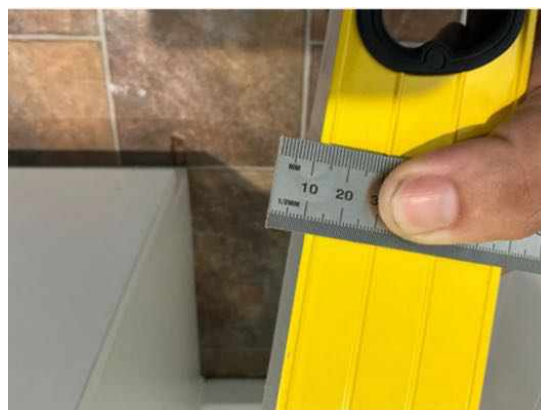
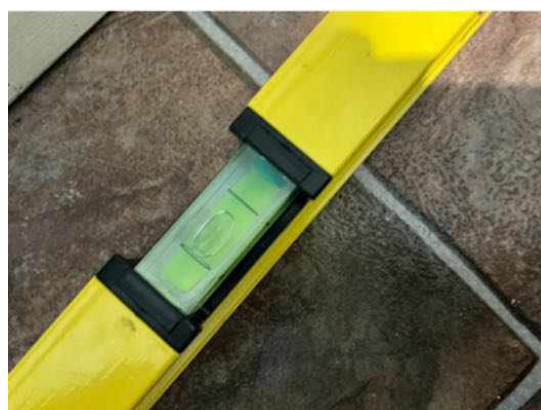
### Defects 3.03

Building: Main Building  
 Location: Bathroom  
 Finding: Uneven Flooring and Localised Floor Level Drop  
 Information:

The timber flooring throughout the dwelling was observed to be uneven, with noticeable undulations and variations in level. Of particular concern, the bathroom floor exhibited a measurable fall of approximately 11 mm over a 1-metre span when checked with a spirit level. This degree of deviation indicates localised settlement beyond normal surface irregularity.

The differential movement is consistent with possible subsidence or settlement of the supporting concrete stumps beneath the subfloor structure. Ongoing stump movement may result in further floor distortion, misalignment of wall and door frames, cracking to finishes, and potential impact on wet area performance if not addressed.

It is recommended that a qualified restumping contractor or registered builder experienced in subfloor rectification be engaged to assess the condition, bearing capacity, and vertical alignment of the existing stumps. Re-levelling, packing, or replacement of affected stumps may be required to restore acceptable floor levels and provide adequate structural support.

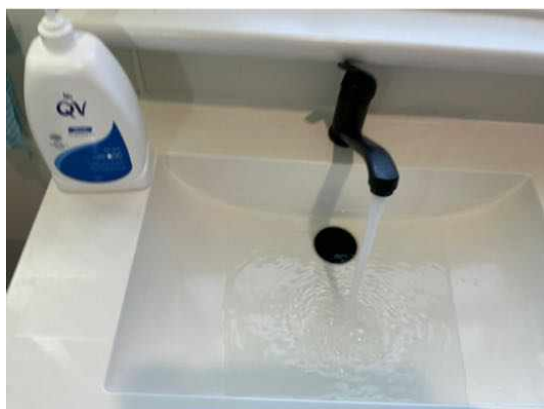
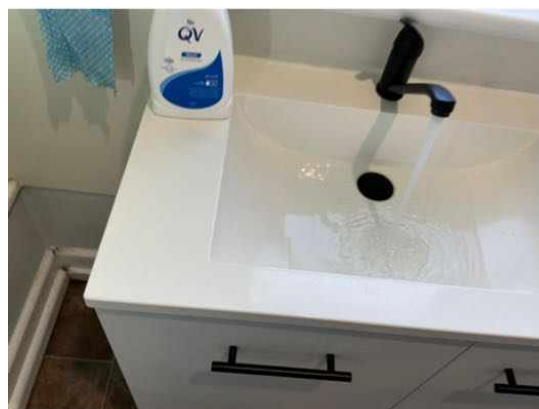
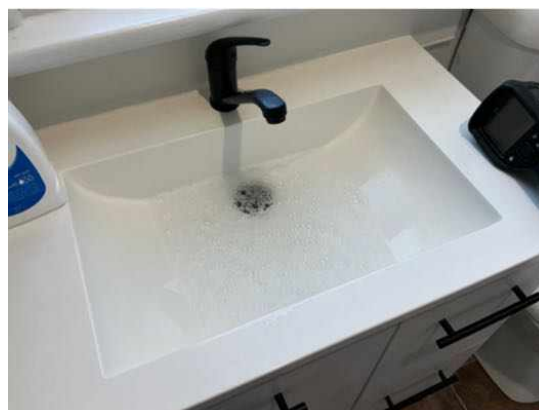
Defects 3.05

The bathroom vanity sink was observed to drain slowly at the time of inspection. Water discharge from the sink was delayed, with minor pooling remaining in the bowl before gradually clearing. This condition is typically indicative of a partial blockage or build-up within the waste pipe or trap assembly.

Restricted drainage may worsen over time and can lead to complete blockage, unpleasant odours, or potential overflow if left unaddressed. Accumulation of hair, soap residue, and general debris within the trap or downstream pipework is a common cause.

It is recommended that a licensed plumber be engaged to inspect and clear the basin waste line, including removal and cleaning of the trap and, if required, mechanical clearing of the associated pipework to restore normal drainage performance.

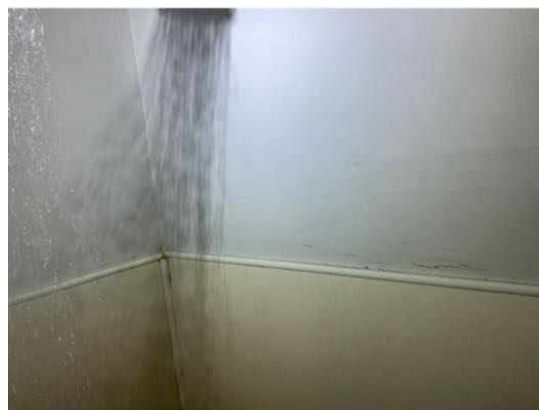
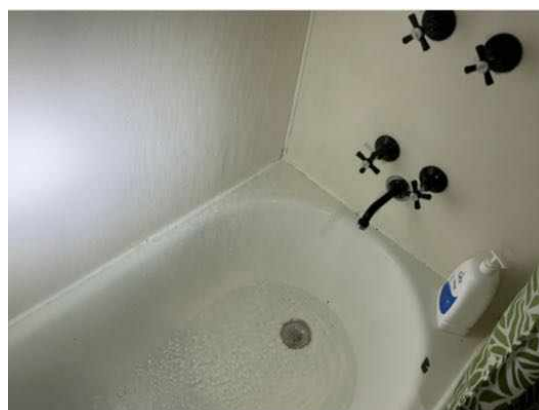
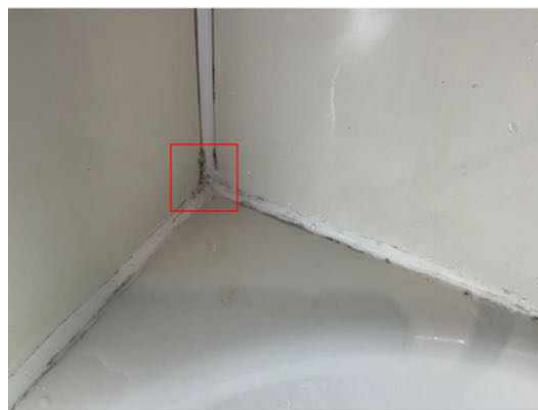
### Defects 3.06

Building: Main Building  
Location: Bathroom  
Finding: Deteriorated and Inconsistent Shower Sealant

The sealant to the internal junctions of the shower recess, including wall-to-wall and wall-to-bathtub corners, was observed to be deteriorated, inconsistently applied, and locally debonded. Minor gaps were noted in sections of the sealant line, and mould growth was visible to some corner areas. The condition is consistent with age-related wear and prolonged exposure to moisture within this older bathroom.

Defective or deteriorated sealant may allow water to penetrate behind wall and floor finishes, potentially affecting the underlying substrate and concealed framing over time. If not rectified, moisture ingress may contribute to concealed damage, mould development within cavities, and deterioration of waterproofing performance.

It is recommended that a licensed plumber or suitably qualified bathroom renovation specialist remove all existing sealant to the shower recess junctions, thoroughly clean and treat affected areas for mould, allow surfaces to dry, and reapply a continuous bead of sanitary-grade mould-resistant silicone sealant in accordance with manufacturer guidelines. Ongoing maintenance of sealant lines should be undertaken to minimise the risk of water ingress into wall and floor cavities.

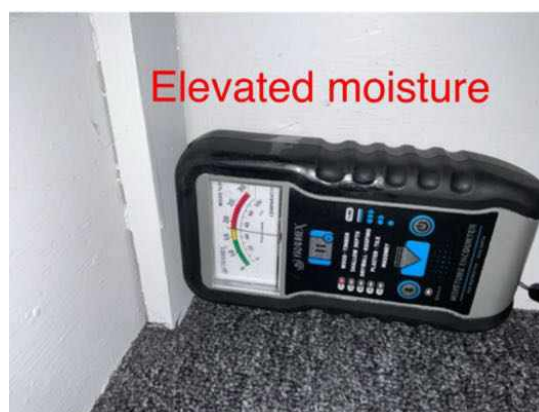
### Defects 3.07

Building:	Main Building
Location:	Bathroom / bedroom 2
Finding:	Elevated Moisture Readings – Wall Behind Shower (Cabinetry Side)
Information:

Following operation of the shower for approximately 30 minutes, moisture testing was undertaken to the wall surface and skirting board located directly behind the shower, accessible from within the adjoining cabinetry/storage area. Slightly elevated moisture readings were detected in this section of wall. The readings were not excessive at the time of inspection; however, they were above typical background levels expected in dry internal areas.

The precise source of the elevated moisture could not be confirmed during this visual and non-invasive inspection. A possible contributing factor may be minor water migration through shower junctions or sealant lines; however, this remains unconfirmed. No finishes were removed and no invasive investigation was carried out, therefore concealed conditions within the wall cavity, including framing and lining materials, could not be assessed.

It is recommended that a licensed plumber undertake further assessment, which may include controlled invasive inspection and testing of the shower recess and associated plumbing to determine whether active leakage or historic moisture ingress is present. Any identified defects to plumbing, sealant, or waterproofing systems should be

rectified accordingly to prevent potential concealed damage.

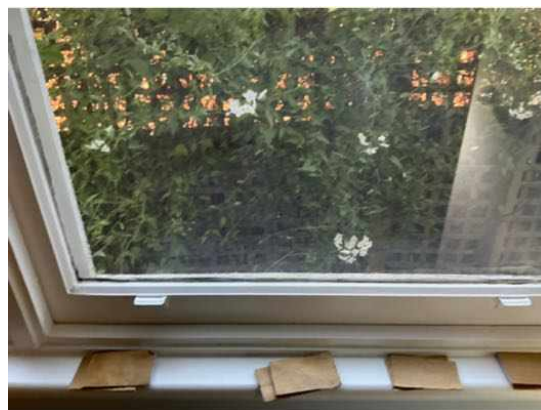
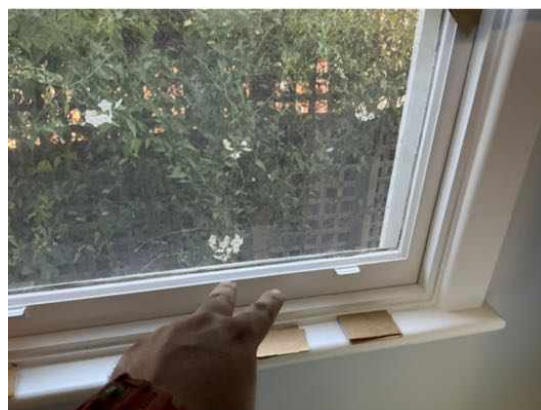
### Defects 3.08

Building: Main Building  
 Location: All Internal Areas  
 Finding: Stiff Window Operation and Inadequate Weather Sealing  
 Information:

Several windows throughout the dwelling were noted to be stiff during operation, requiring additional pressure to open and close. While some windows operated satisfactorily, others did not move freely within their tracks. The condition may be associated with minor frame distortion, settlement, hardware wear, or lack of maintenance.

In addition, a number of windows were observed to be inadequately weather-sealed. Visible gaps were present between the sash and frame in certain locations. The tenant has reportedly inserted cardboard and paper materials into these gaps in an attempt to reduce draughts. This is considered a temporary and unsuitable measure and does not provide an effective or compliant weather seal.

Poorly sealed or difficult-to-operate windows may contribute to air leakage, moisture ingress during adverse weather, and reduced energy efficiency. It is recommended that a qualified carpenter or window specialist inspect the affected windows to assess frame alignment, hardware condition, and sealing components. Adjustment of hardware, planing or re-alignment of sashes, and installation or replacement of appropriate weather seals may be required to restore proper function and weather tightness.

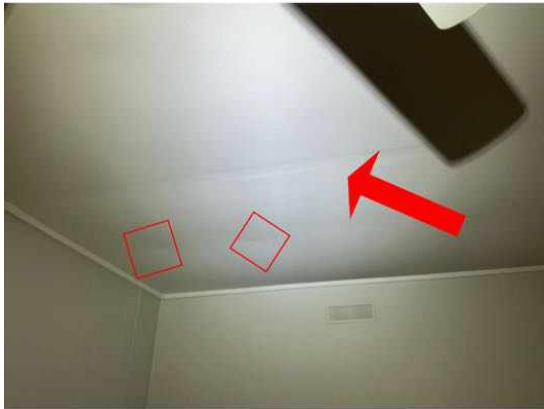
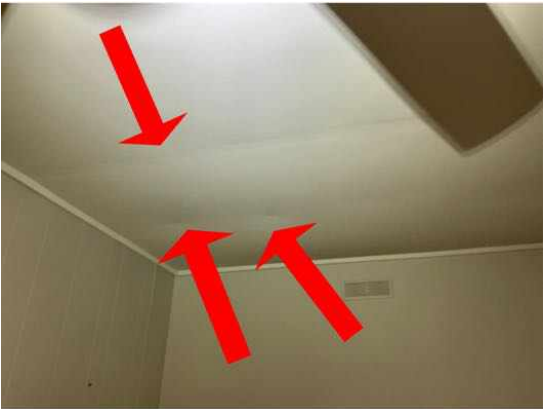
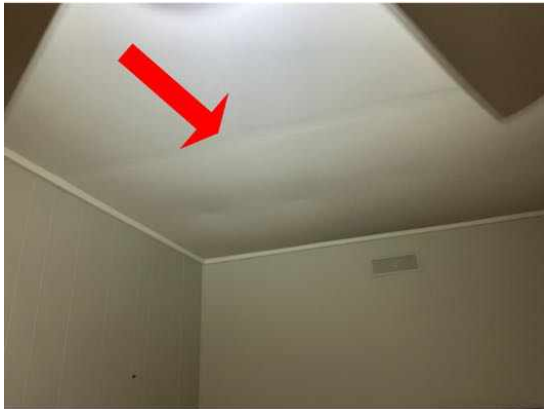
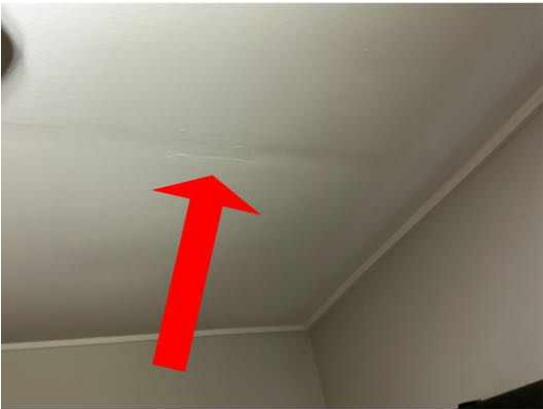
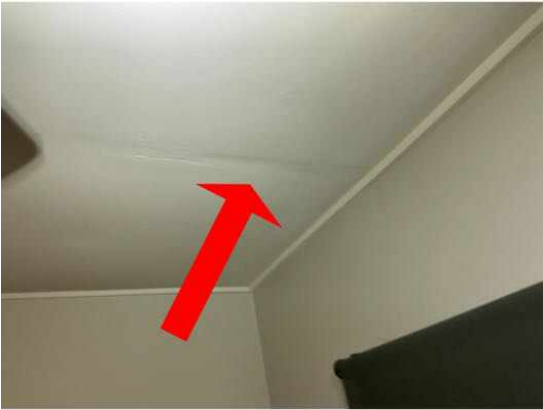
### Defects 3.09

Information: Sections of the ceiling in bedroom 2 were found to be sagging at the time of inspection. Sagging to the fixed ceiling structure generally indicates that the building materials have swollen, due to contact with water, or that fixings (e.g. nails or glue) have become loose and require reattachment.

Where minor sagging is evident, comparatively minor works, such as re-gluing of ceiling sheets, may be required. Such works may be performed by relevant tradespeople, such as plasterers and painters. Where excessive moisture has caused

the roofing structure to swell and sag, the source of the water leak should primarily be identified prior to any remedial works being performed.

In some cases, sagging ceiling linings may also indicate that there are structural issues, causing surfaces to warp, twist or sag. Where sagging appears to be major, appointment of a structural engineer is advised to further inspect the property and identify the source and rectification works required.

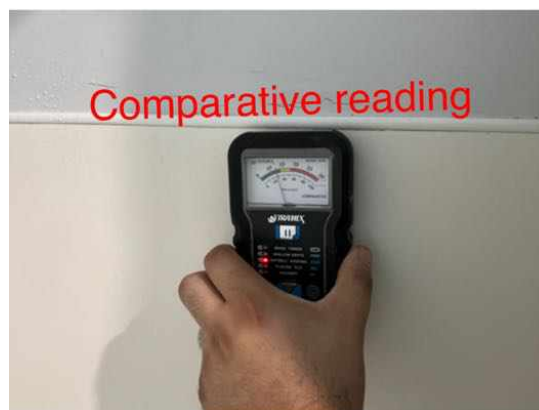
**Defects 3.10**

Building:	Main Building
Location:	Bathroom
Finding:	Shower - Damp
Information:	Damp is evident to the lower 300mm of wall to the shower alcove. This defect is quite common, and is suspected to have been caused by moisture permeating through the grouting in this area, which shows evidence of deterioration. Leaking pipes within the adjoining wall is also a possible cause.

Unmanaged damp in the shower recess is likely to facilitate the formation and development of mould and fungi growth, decaying associated building materials and compromising their structural integrity. It is important to address damp conditions, as the World Health Organisation notes that excess moisture leads - on almost all indoor materials - to growth of microbes such as moulds, fungi and bacteria, which subsequently emit spores and other matter into the indoor air. Exposure to these contaminants is associated with a wide range of respiratory and other health-related problems.

Consultation with a qualified plumber or bathroom specialist is advised immediately to identify the cause of damp and to perform remedial works as required. Where excessive mould growth is present, further inspection by a specialist environmental health inspector should also be considered.

Always ensure that sealant and grout is in good condition to prevent any moisture issues occurring in the future.

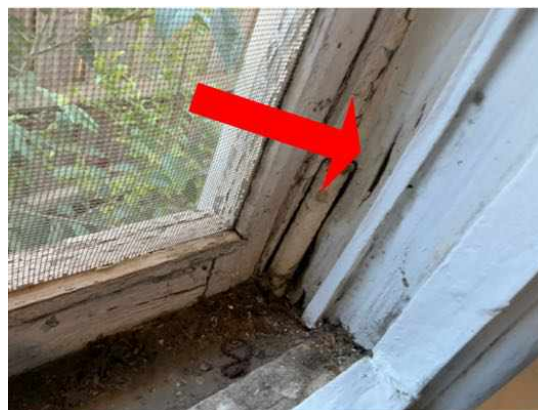
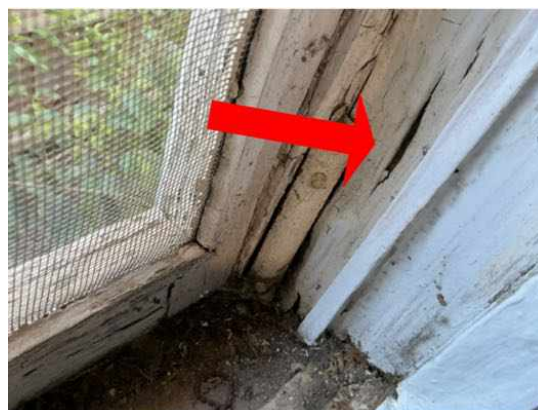
### Defects 3.11

Building:	Main Building
Location:	Bathroom
Finding:	Window - Wood rot
Information:	Wood rot was found to be affecting the bathroom window. Wood rot, also known as Fungal Decay, occurs when timbers and other cellulose building materials are exposed to damp conditions on an ongoing basis.

It is likely that this wood rot has developed as a result of frequent exposure to rain and other weather conditions. It is suspected that failure to maintain the window frames over a prolonged period has resulted in them deteriorating at an accelerated rate, increasing their susceptibility to the development of wood rot. Leaks in roof plumbing or associated pipework may have also contributed to the formation of the wood rot in this area.

Early intervention and regular maintenance will prolong the useful life of these building elements. Prior to any works being performed, any associated pipework or roof plumbing should be inspected by a licensed plumber for faults or leaks.

Repair and/or replacement of affected window frames may be a necessary step in protecting surrounding building elements from such deterioration. Remedial works should be performed by a qualified carpenter or registered builder as soon as possible to prevent any further damage.

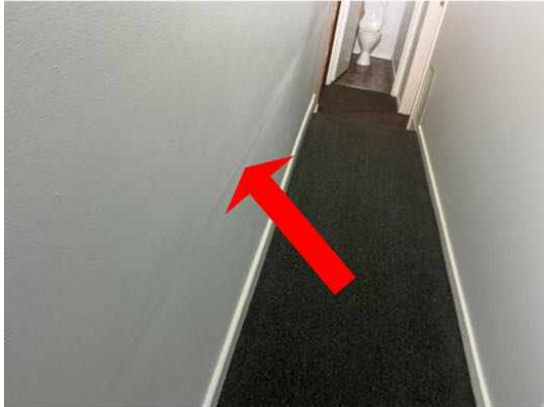
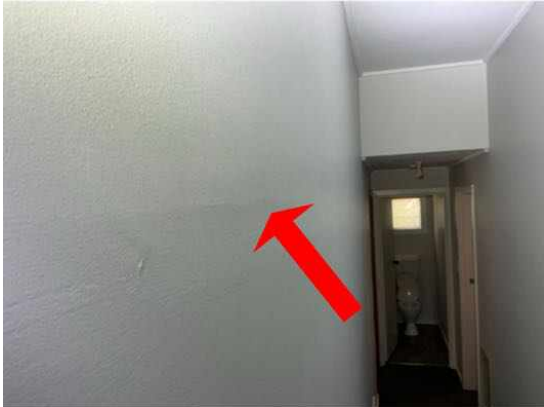
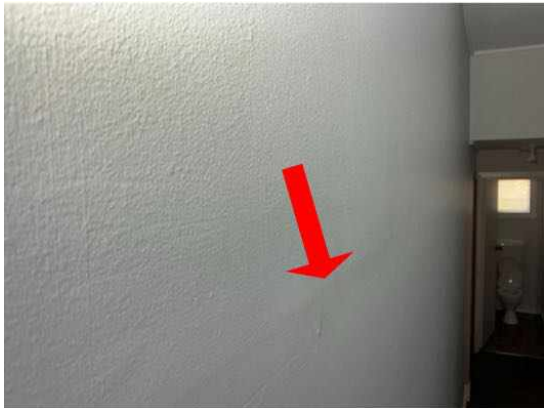
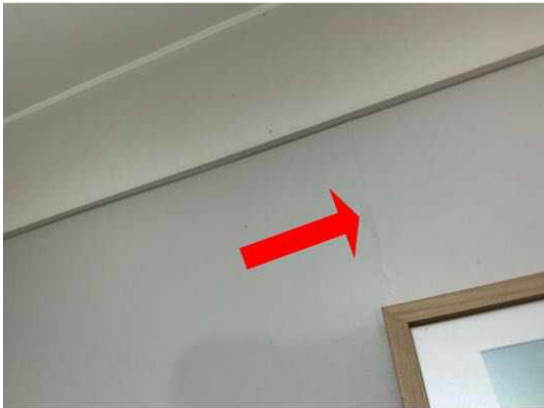
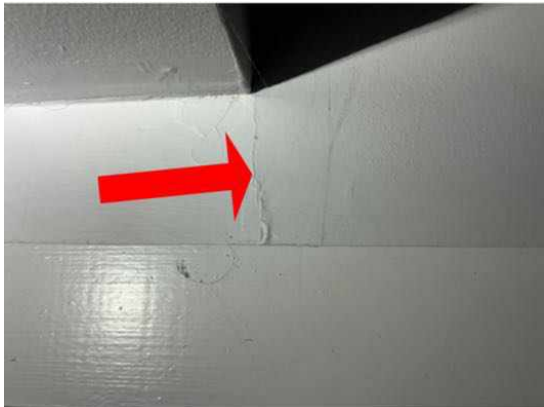
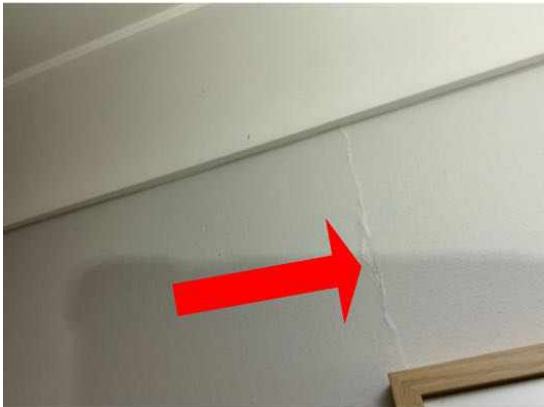
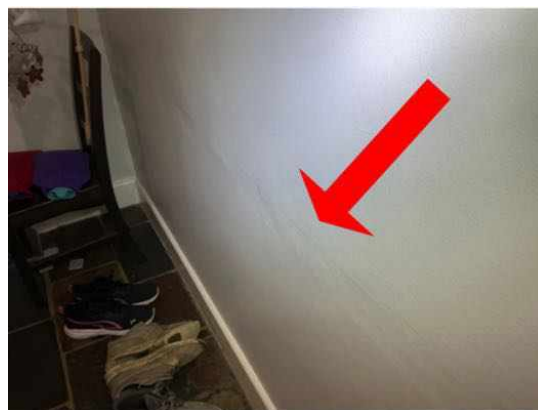
### Defects 3.12

Building:	Main Building
Location:	All Internal Areas
Finding:	Minor Internal Wall Cracking – Movement Related
Information:

Minor cracking was observed to internal wall linings in the hallway and several bedrooms. The cracks were predominantly vertical and horizontal in orientation, with some horizontal cracking occurring along plasterboard joints where slight separation has developed. The cracking observed is considered minor in width and typical of movement-related stress within the structure.

The pattern and location of cracking are consistent with general building movement and possible differential settlement of the supporting stump system. Where subfloor stumps experience minor subsidence or seasonal movement, stress can transfer to wall linings, resulting in joint separation and fine cracking. While the cracks are presently cosmetic in nature, ongoing movement may lead to recurrence if the underlying cause is not addressed.

It is recommended that a registered builder assess the subfloor support system to determine whether stump settlement or uneven bearing conditions are contributing to the movement. Consideration should also be given to improving site drainage and maintaining consistent moisture conditions around the stump footings to minimise seasonal ground movement. Cosmetic repairs, including filling, sanding, and repainting

of affected plaster areas, may be undertaken once the structural movement has been assessed and stabilised.

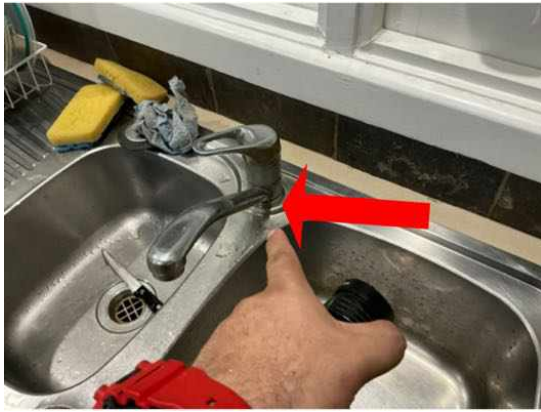
### Defects 3.13

Building:	Main Building
Location:	Kitchen
Finding:	Tap - Water hammer
Information:	The kitchen sink tap shows evidence of water hammer being present. Water hammer, a pressure surge resulting when a fluid is forced to suddenly change direction, is a common defect in plumbing fittings, particularly those that are aged and not frequently maintained. Water hammer is generally caused by factors that create high water pressure in the affected plumbing fixture, usually evidenced by a faint banging noise during operation of the affected tap.

Although water hammer is generally considered to be a minor defect, subsequent damage such as erosion of tap hardware and/or water damage to associated building elements is likely to occur if left unmanaged.

A licensed plumber should be appointed as soon as possible to replace any affected tap hardware and perform any remedial works as necessary. Please be advised that the appointment of a cabinet maker or qualified carpenter may be necessary if water damage to associated building elements has occurred.

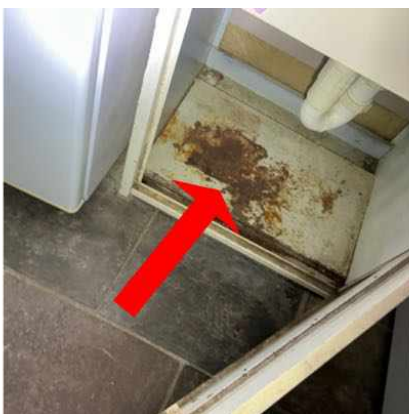
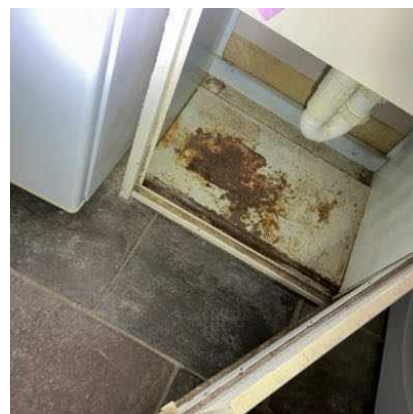
### Defects 3.14

Finding: Rusting to Metal Laundry Vanity Base

Information: The base of the metal laundry vanity unit was observed to be significantly rusted, particularly around the lower edges and beneath the sink area. The corrosion is likely due to prolonged exposure to moisture from splashing, cleaning, or potential leaks from plumbing fixtures above. The rust has visibly affected the surface finish and may continue to deteriorate the structural integrity of the unit if left unaddressed.

Ongoing corrosion to metal fixtures in wet areas can result in sharp edges, staining of surrounding surfaces, and eventual weakening or failure of the unit itself. Additionally, it may be an indicator of poor ventilation or inadequate moisture control within the laundry area, which could contribute to further issues over time.

It is recommended that the metal vanity unit be assessed for replacement or repair, and that moisture sources in the area be identified and addressed. Ensuring proper sealing, drainage, and ventilation will assist in preventing similar deterioration in the future.

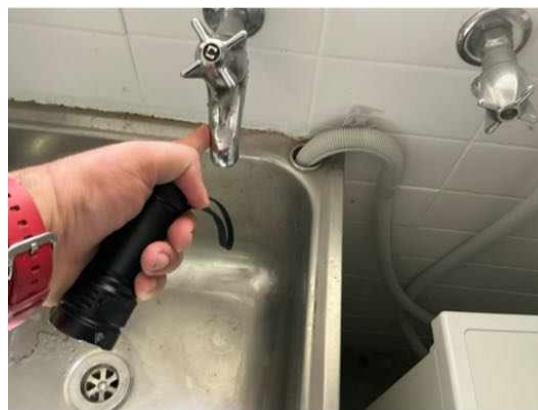
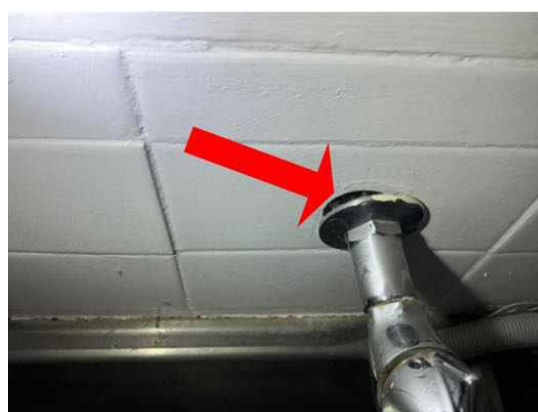
### Defects 3.15

Location: Laundry  
 Finding: Tap - Loose  
 Information: The tap in the laundry room has deteriorated with age, and is consequently loose. This tap being loose creates potential for water leaks and subsequent water damage to the surrounding area.

Where taps or spouts are loose, a qualified plumber should be appointed to re-fix the plumbing fitting.

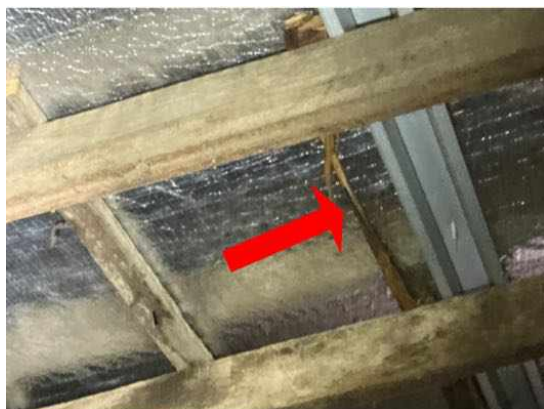
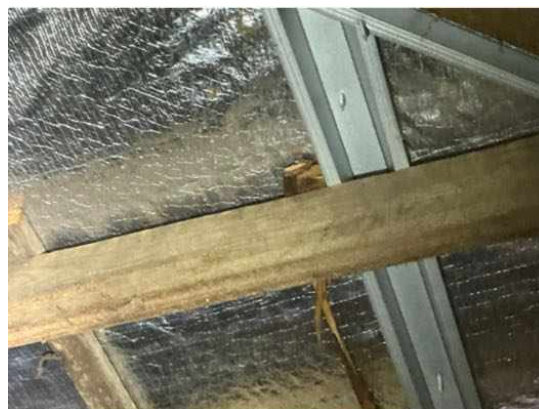
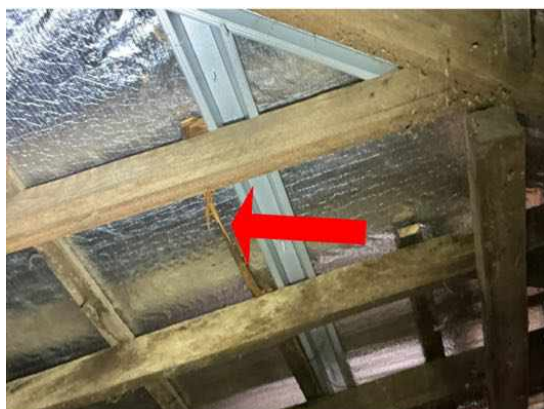
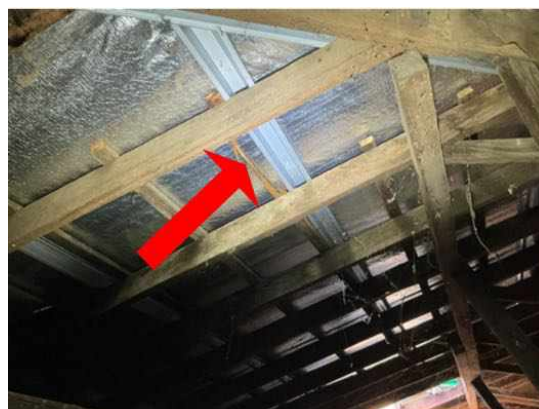
### Defects 3.16

Building: Main Building  
 Location: Roof Void  
 Finding: Damaged Roof Batten – Evidence of Timber Pest Activity  
 Information:

One roof batten within the roof space was observed to be significantly deteriorated and compromised. The timber batten shows damage consistent with previous timber pest (wood borer) activity, likely historic in nature. The affected batten exhibits loss of timber section and reduced structural integrity.

Roof battens provide direct support to the roof covering, and deterioration may affect the stability and fixing of roof tiles or sheeting in the immediate area. While the damage appears aged, any structurally compromised batten should be assessed to

ensure adequate ongoing support to the roof covering.

It is recommended that a qualified carpenter inspect the affected batten and replace it as required. In addition, confirmation from a licensed pest control professional should be considered to verify that no active timber pest infestation remains within the roof structure.

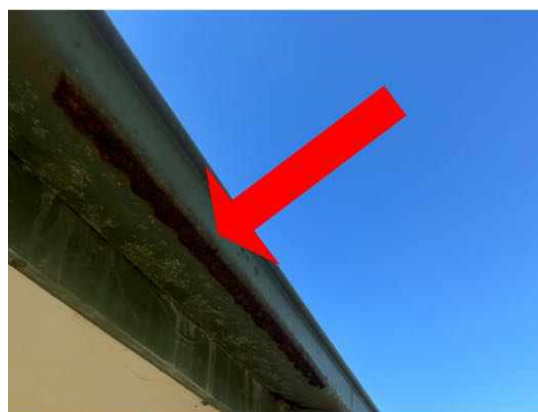
### Defects 3.17

Building: Main Building  
 Location: Front Elevation  
 Finding: Rusted and Leaking Gutters – Front Elevation  
 Information:

The metal gutters along the front elevation were observed to be rusted, with visible corrosion and evidence of leakage at the time of inspection. The extent of deterioration indicates material breakdown beyond normal surface weathering.

Corroded and leaking gutters may result in uncontrolled discharge of roof water, potentially contributing to moisture accumulation around footings, accelerated deterioration of fascia boards, and increased risk of subfloor movement over time.

It is recommended that a licensed roof plumber remove and replace the affected gutter sections at the front elevation. All new guttering should be correctly graded toward downpipes and securely fixed in accordance with current standards to ensure

effective stormwater discharge.

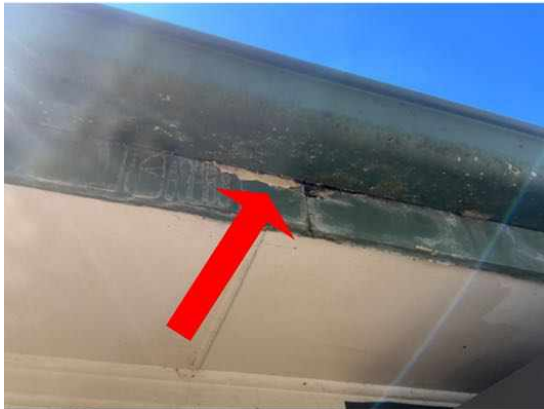
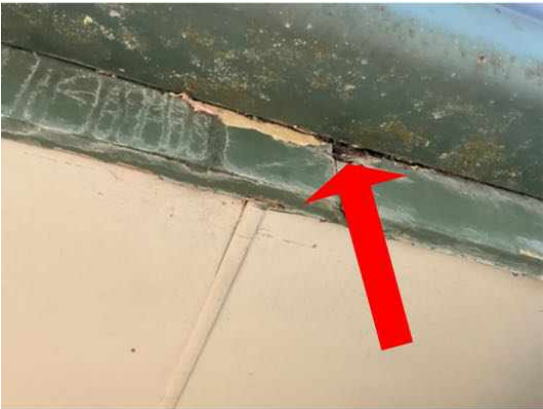
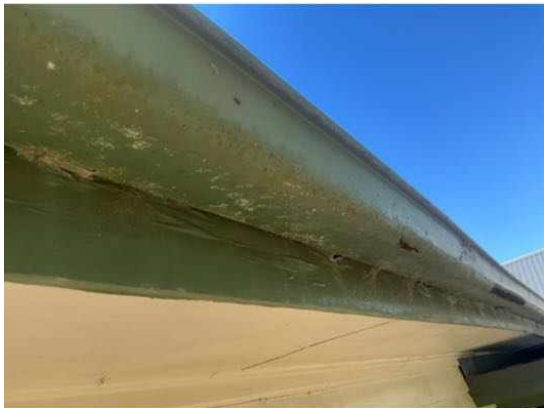
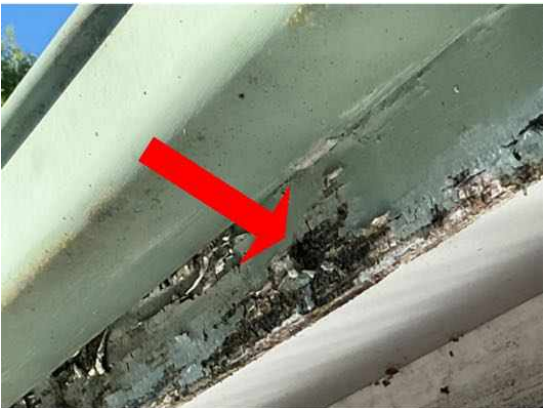
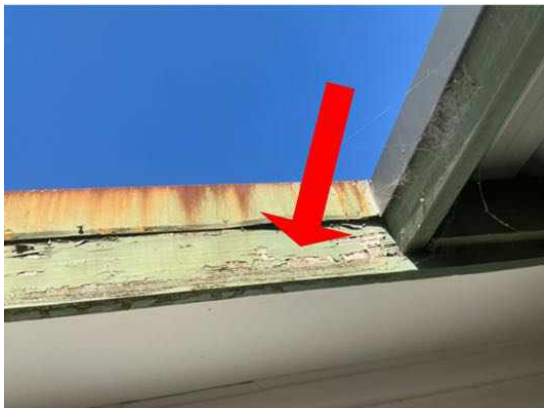
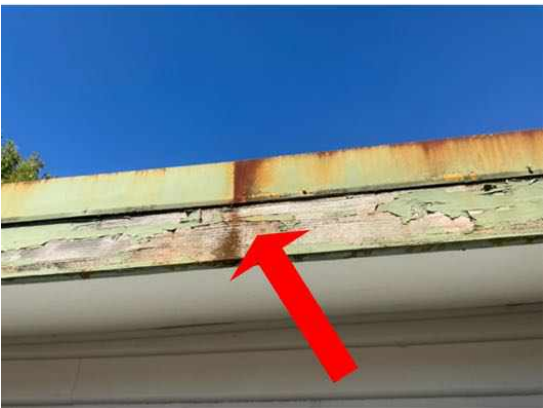
### Defects 3.18

Building:	Main Building
Location:	All External Areas
Finding:	Fascias - Wood rot
Information:	Wood rot was found to be affecting fascias and barges in this area, evidenced by the presence of mould on the surface in some areas. Wood rot, also known as Fungal Decay, occurs when timbers and other cellulose building materials are exposed to damp conditions on an ongoing basis.

It is likely that this wood rot has developed as a result of faults in the roof plumbing, creating excessive moisture in this areas. Frequent exposure to rain and other weather conditions also make fascias and barges susceptible to accelerated deterioration.

Early intervention and regular maintenance will prolong the useful life of these building elements. Prior to any works being performed, the cause of the moisture that has created the visible wood rot should be identified and addressed in a suitable manner.

It is advised that a roof plumber be appointed to inspect all roof plumbing and subsequently identify the cause of the wood rot. Replacement of affected fascias and barges may then be a necessary step in protecting surrounding building elements from such deterioration.

A qualified plumber may be appointed to assess the cause of excessive moisture and to provide advice on any remedial works as required. A qualified carpenter or registered builder may also be required to replace affected building materials.

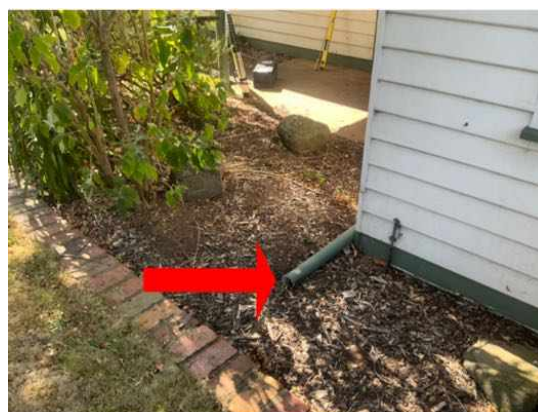
**Defects 3.19**

Building: Main Building  
Location: Front Elevation  
Finding: Entry Porch Gutter Discharging to Ground  
Information:

The gutter servicing the entry porch area was observed to discharge directly into the

Uncontrolled discharge of roof water into the soil near footings may contribute to localised ground saturation, erosion, and potential movement of the foundation system over time. Inconsistent moisture conditions around footings may increase the risk of differential settlement, particularly in reactive soil conditions.

It is recommended that a licensed roof plumber connect the entry porch gutter and associated downpipe to the approved stormwater drainage system. All stormwater discharge points should be directed to a legal point of discharge in accordance with relevant drainage requirements to minimise the risk of foundation movement.

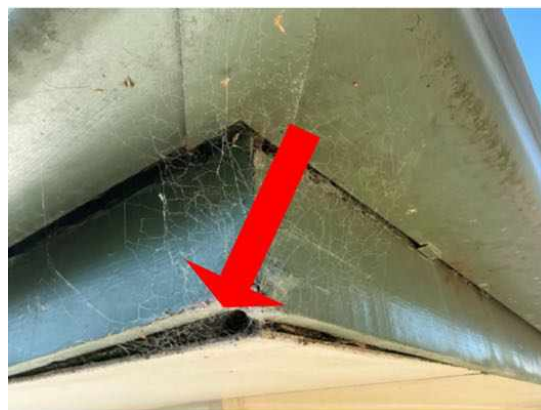
### Defects 3.20

Building:	Main Building
Location:	All External Areas
Finding:	Loose and Partially Detached Eaves – Front Elevation
Information:

Sections of the eaves lining at the front elevation were observed to be loose and slightly detached from their supporting framework. The affected areas appear to have minor separation at fixing points.

Loose eaves may allow entry of vermin, moisture, and wind-driven rain into the roof space and can progressively worsen if not secured. Detachment may also pose a safety risk if panels become further displaced.

It is recommended that a qualified carpenter resecure the affected eaves lining, replace any damaged fixings or framing as required, and ensure the eaves are properly aligned and firmly fixed to prevent further movement.

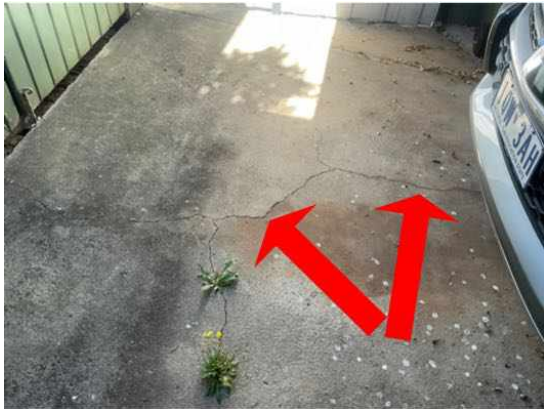
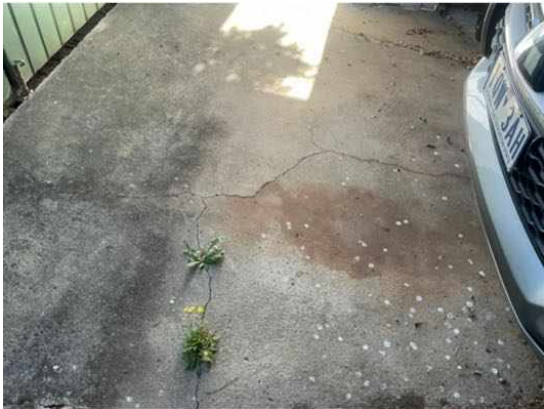
### Defects 3.21

Building:	Main Building
Location:	All External Areas
Finding:	Cracking - External Concrete Paving Damage Category 2 - Distinct (less than 3mm)
Information:	Distinct cracks were identified in external concrete paving. Distinct cracks are generally found in older concrete paving, and may also present as a trip hazard as consequence of an uneven or curved surface.

General age and expected deterioration of the paved areas is a common cause of this type of cracking. However, expansion and contraction of the slab may also have occurred due to environmental factors. Such factors include variable moisture and weather conditions, the presence of trees and their roots having a settling or lifting affect on the soil, or the effect of load bearing, e.g. heavy vehicles over a sustained period of time.

Cracking to this degree may also be due to poor original installation of the concrete. Factors such as poor compaction of the sub surface and/or inadequate reinforcing of the slab may create cracking and other secondary defects.

Repairs are likely to be required to prevent further cracking and to reduce hazards associated with cracking, such as tripping. Monitoring of all cracking should be conducted frequently. Always contact a building inspector should cracks widen, lengthen, or become more numerous.

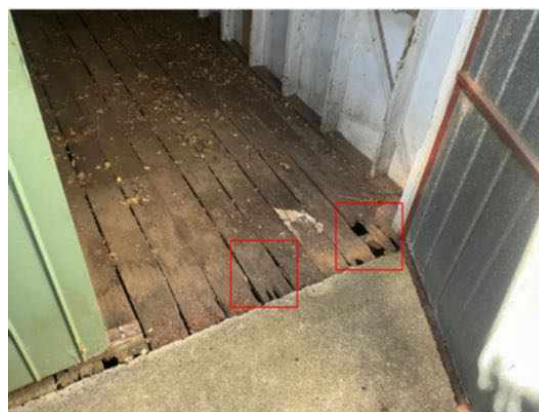
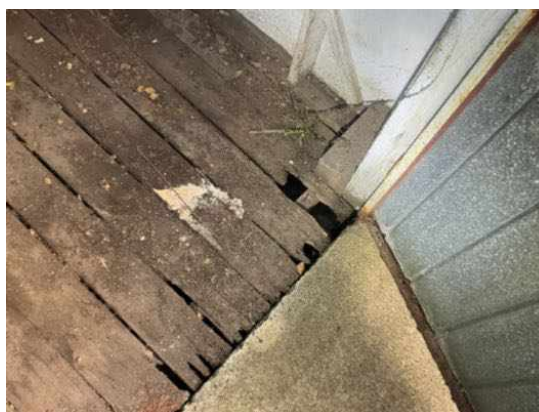
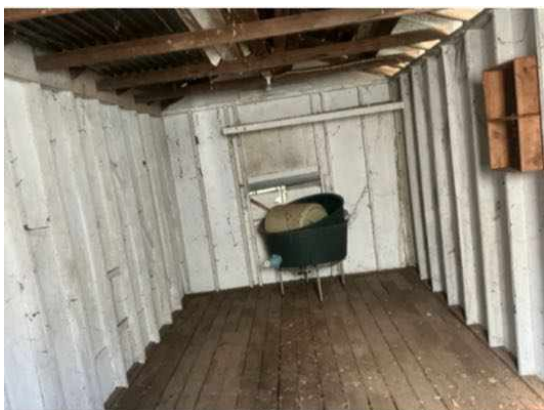
**Defects 3.23**

Location: Shed  
Finding: Severe Timber Decay – Floor Structure to Backyard Shed  
Information:

Significant timber decay was observed to the floor structure within the backyard shed. The affected floorboards and/or supporting floor timbers exhibit advanced deterioration consistent with prolonged moisture exposure and fungal decay. Sections of the timber appear structurally compromised, with visible loss of material and reduced load-bearing capacity.

Deteriorated floor timbers may present a safety hazard due to potential localised failure under load. Continued exposure to moisture may further accelerate decay and spread to adjacent structural elements if not rectified.

It is recommended that a qualified carpenter or registered builder remove and replace all decayed floorboards and any associated supporting timbers within the shed floor system. In conjunction with timber replacement, the source of moisture (e.g., inadequate ground clearance, poor drainage, rising damp, or roof leakage) should be identified and rectified to prevent recurrence of timber decay.

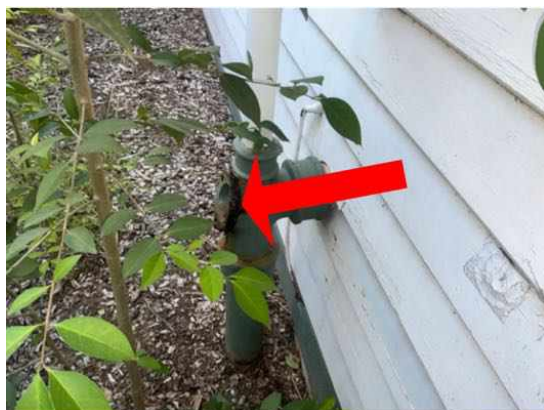
### Defects 3.24

Building: Main Building  
 Location: Yard - Side  
 Finding: Uncapped Drain Inspection Opening at External Wall  
 Information:

An external drain inspection opening was observed at ground level adjacent to the wall (refer photo). The inspection point appears uncapped/open, with visible deterioration/corrosion around the rim and joint area. Vegetation and loose ground material are present around the fitting, increasing the likelihood of debris entering the opening. The drain type (stormwater vs sewer) and the condition of the below-ground pipework could not be confirmed during this visual, non-invasive inspection.

An uncapped inspection opening can allow debris, insects/vermin and tree roots to enter the pipework, increasing the risk of partial or complete blockage. If connected to the sewer, the opening may also allow odours and potentially sewer gases to escape. If connected to stormwater, the opening may surcharge during heavy rainfall events. Either way, discharge or leakage at ground level can contribute to localised soil saturation adjacent to the building, which may adversely affect subfloor conditions and contribute to movement over time.

It is recommended that a licensed plumber/drainage contractor attend to identify the service (sewer/stormwater), confirm the configuration, and reinstate a secure, compliant sealed access cap suitable for the installation. Any deteriorated/corroded sections or failed joints should be repaired or replaced to ensure the opening is serviceable and watertight. Where there is any doubt about the condition of the line (given the open termination and age/deterioration), the plumber should consider CCTV inspection and/or pressure/leak testing to confirm there is no concealed damage, leakage, or root intrusion.

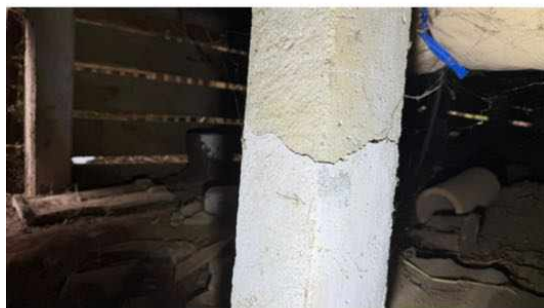
**Defects 3.26**

Building: Main Building  
Location: Subfloor  
Finding: Surface Deterioration to Subfloor Concrete Stump  
Information:

Surface deterioration and paint delamination were observed to the concrete subfloor stump. The applied coating is peeling and flaking, indicating prolonged exposure to moisture within the subfloor environment.

Continued moisture exposure may accelerate surface degradation and contribute to deterioration of surrounding materials and subfloor components over time if not addressed.

It is recommended that the affected stump be cleaned, prepared, and recoated with a suitable masonry-grade protective coating. Subfloor moisture levels and ventilation should also be reviewed to minimise ongoing exposure to damp conditions.
