## Building Inspection Report

Inspection Date: Mon, 16 Feb 2026

Property Address: 85 Clifford St, Warragul VIC 3820, Australia

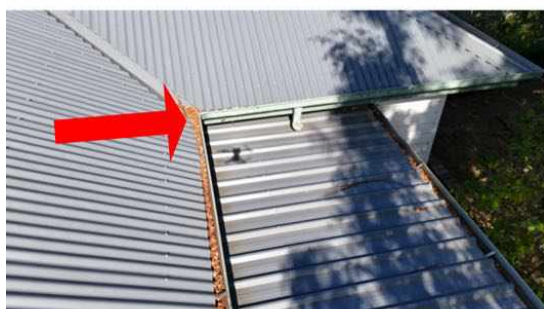
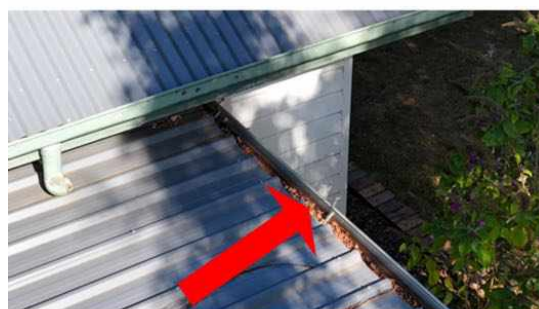
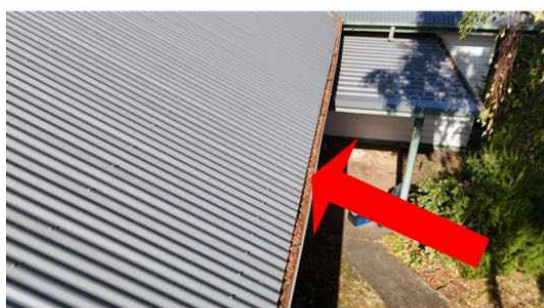
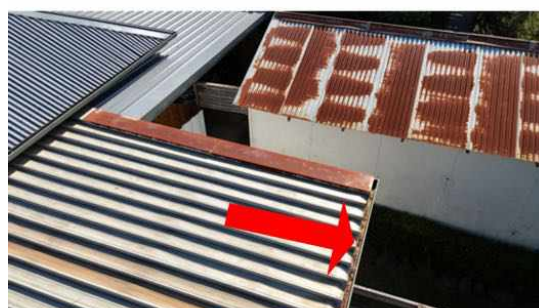
### Defects 3.29

Blocked gutters are likely to lead to high levels of moisture in the affected areas. Such moisture will not only cause rust and decay of the associated building materials, but can also provide conditions that are conducive to termite and timber pest activity. Blockages in gutters should therefore be removed immediately to ensure dry conditions are maintained.

Consult a Licensed Plumber for further specific advice on remedial works that may be required. In the interim, it is highly advised that blocked gutters be removed by the homeowner or a general handyperson as a matter of urgency.

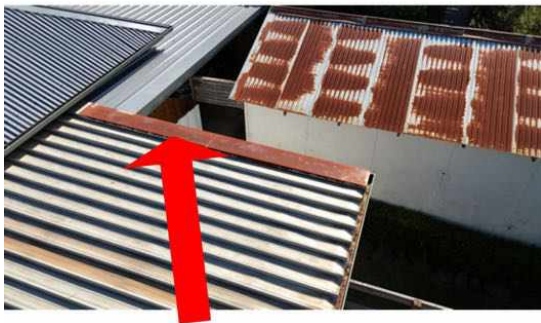
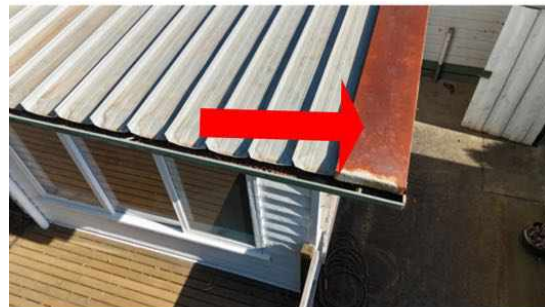
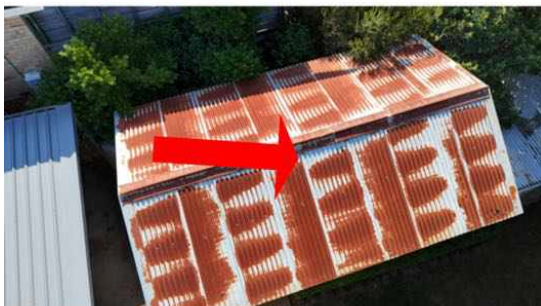
### Defects 3.30

Building: Main Building  
Location: Roof Exterior  
Finding: Advanced Corrosion – Roof Capping (Family Room) and Backyard Shed Roofing  
Information:

Significant rusting and advanced surface corrosion were observed to the roof capping above the family room at the rear of the dwelling. In addition, the roof sheeting to the backyard shed exhibits extensive corrosion and material deterioration. The affected metal components show clear signs of prolonged weather exposure and breakdown of protective coatings.

Advanced corrosion to roof capping and roof sheeting can lead to reduced material thickness, perforation, water ingress, and progressive structural deterioration if not addressed. Ongoing rust development may result in leakage and further damage to underlying structural elements.

It is recommended that a licensed roof plumber assess the extent of corrosion to both the roof capping and shed roofing. Immediate rust treatment, including removal of loose corrosion, application of appropriate rust converter, priming, and protective coating, should be undertaken where feasible. Severely deteriorated or perforated sections should be replaced to ensure ongoing weatherproofing and structural performance.

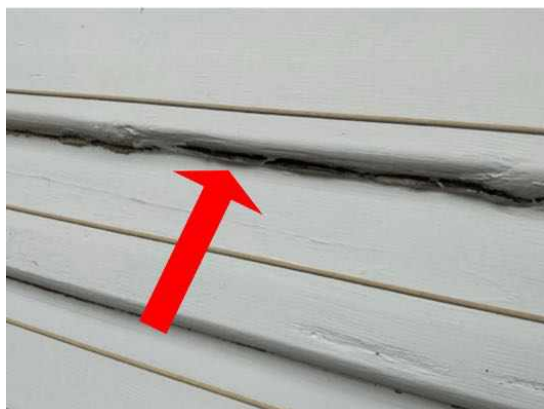
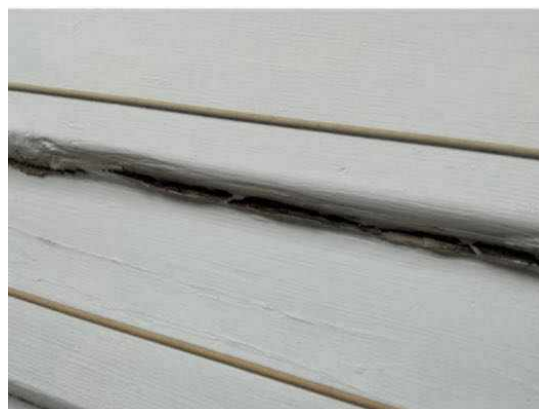
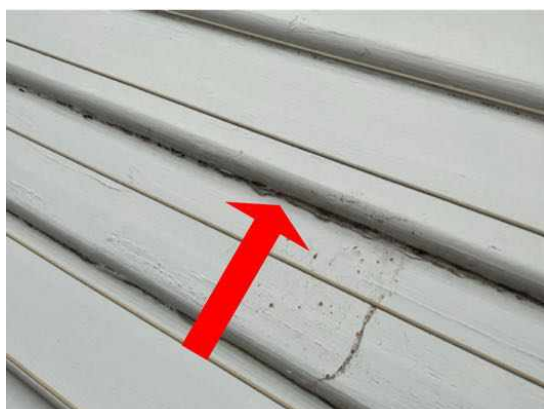
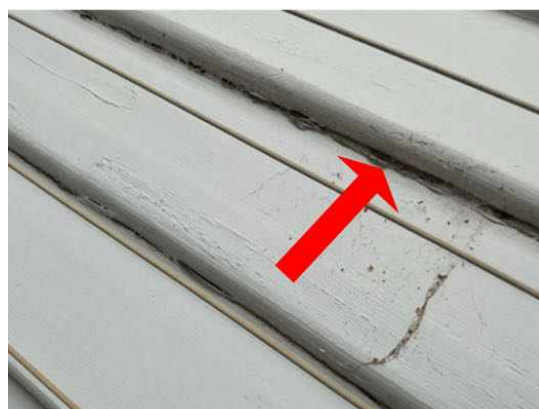
### Defects 3.31

Building: Main Building  
Location: All External Areas  
Finding: Weatherboard Deterioration – External Cladding  
Information:

The external timber weatherboards around the dwelling were generally in fair condition; however, localised areas of deterioration were observed in several sections. Some boards exhibit early signs of timber degradation consistent with weather exposure and possible minor wood rot. Surface coating breakdown was also noted in isolated areas.

Deterioration of weatherboards, if left unaddressed, may allow moisture penetration into the wall cavity, potentially affecting concealed framing and reducing the durability of the cladding system over time.

It is recommended that a qualified carpenter inspect the affected sections to assess the extent of timber deterioration. Any decayed boards should be repaired or replaced as required. All weatherboards should be properly prepared, sealed, and repainted with a suitable exterior-grade protective coating to enhance durability and prevent further moisture ingress.

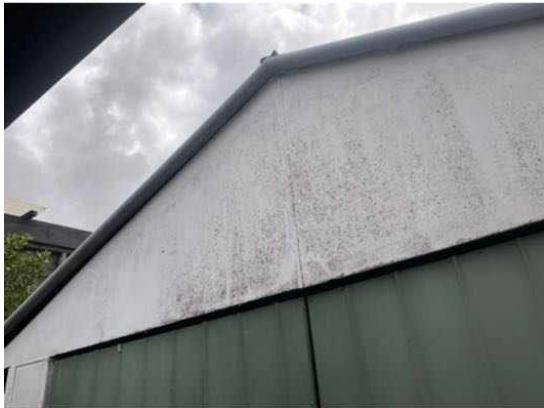
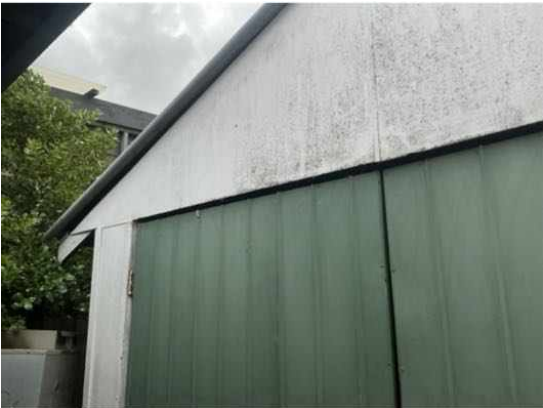
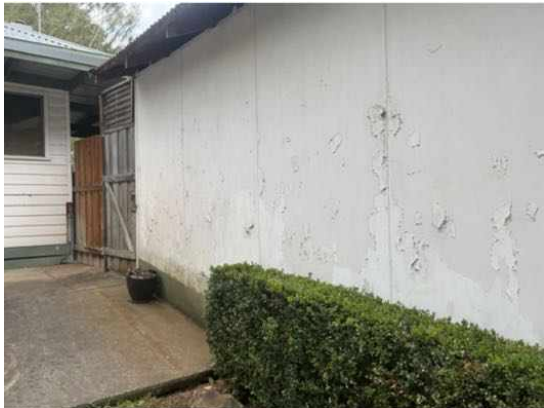
Building: Main Building  
Location: All Areas  
Finding: Asbestos - Suspected ACM Identified on Site  
Information: Reporting on Asbestos is outside the Scope of this Report. This suspected defect is highlighted as a caution only. We suspect, based on our experience in the building industry, that there is a higher risk of the identified building element containing asbestos.

As Asbestos Reporting is outside the scope of this report, we advise that you consider a separate Asbestos Inspection and Condition Audit, which can include the taking of samples for definitive confirmation of the presence of Asbestos.

In the interim, the client is advised to act with caution, especially when considering any damage to building materials general wear and tear renovations extensions demolition and general maintenance activities due to the suspected presence of Asbestos.

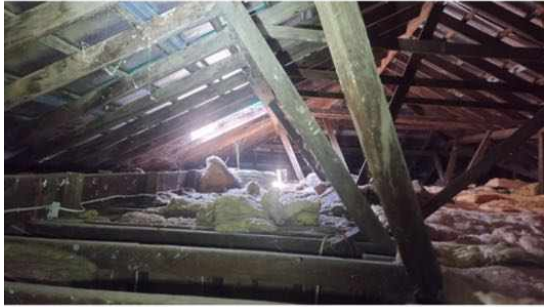
Building: Main Building  
 Location: Roof Void  
 Finding: Obstructions and Limitations - roof cavity  
 Information: photographs illustrate the obstructions and limitations that impeded the inspection of the roof cavity area of the property at the time of inspection. The access hole was particularly small, measuring approximately 35cm, which is below the minimum size required by Australian Standard AS4349.1. Such obstructions can conceal a range of defects and should be removed to allow a full inspection to be carried out. A re-inspection is recommended once the areas are made accessible.

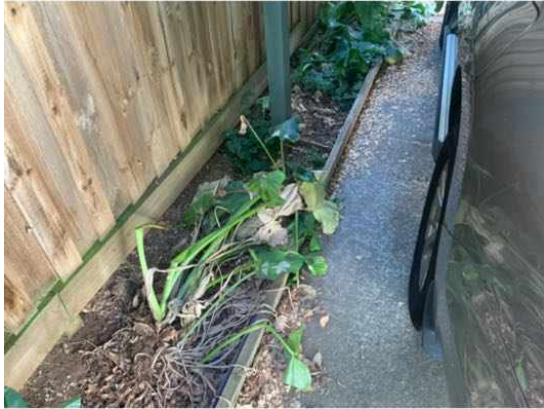
Building: Main Building  
Location: All External Areas  
Finding: Obstructions and Limitations - Exterior  
Information: These photographs are an indication of the obstructions and limitations which impeded the inspection of the external areas of the property at the time of inspection. These obstructions can hide an array of defects and should be removed to allow full inspection to be carried out. A re-inspection is recommended once the areas are made accessible.

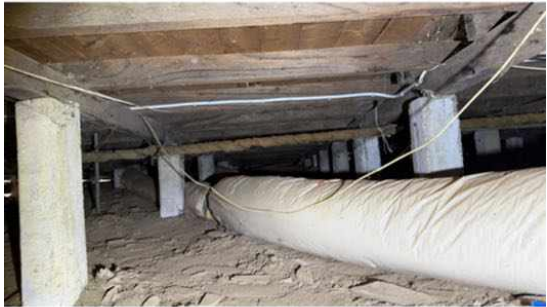
Building: Main Building  
Location: All Areas  
Finding: Obstructions and Limitations - subfloor  
Information: These photographs are an indication of the obstructions and limitations which impeded the inspection of the subfloor area of the property at the time of inspection. These obstructions can hide an array of defects and should be removed to allow full inspection to be carried out. A re-inspection is recommended once the areas are made accessible.
