# Building and Timber Pest Inspection Report VR

Inspection Date: Sat, 14 Mar 2026

Property Address: 1 McMahon St, Fairy Meadow NSW 2519,  
Australia

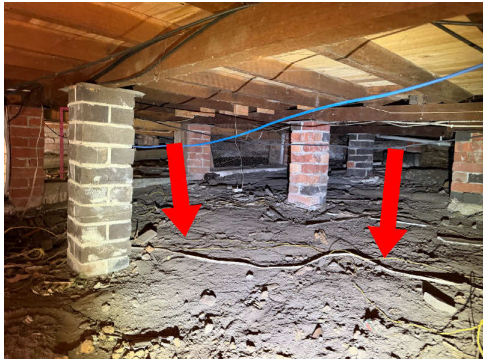
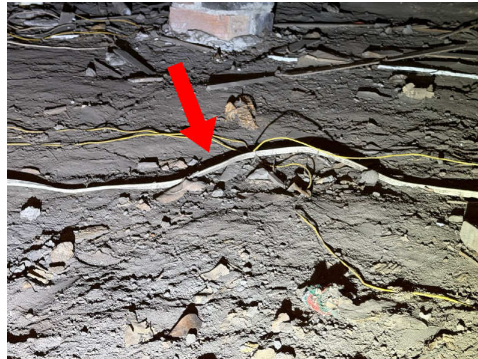
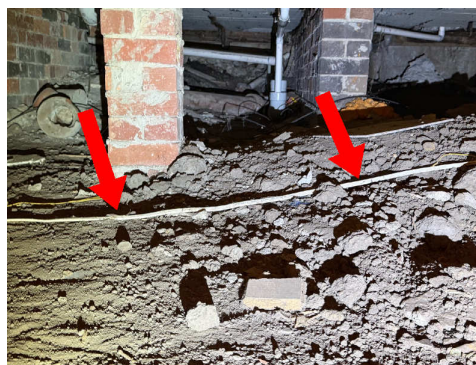
Information: Electrical wiring was observed running along the ground surface within the subfloor area at the time of inspection. This installation is considered substandard as cabling in subfloor areas should generally be adequately supported, protected, and secured clear of the ground to prevent damage from moisture, pests, or physical disturbance.

A licensed electrician should further assess the installation and rectify as required. Cabling should be properly supported and protected in accordance with applicable electrical standards to reduce the risk of damage and ensure safe operation.

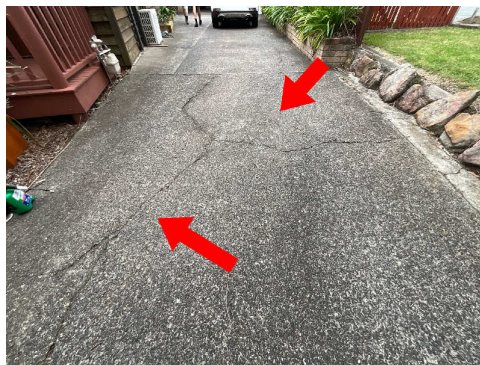
Finding: Crack in concrete slab - Category 0

Information: A crack coded as Category 0 was identified in the slab. A Category 0 crack is described as a hairline crack, representing insignificant movement of slab from level.

No rectification is required at this time. However, all cracking should be monitored over a 12 month period to identify any further damage in the area.

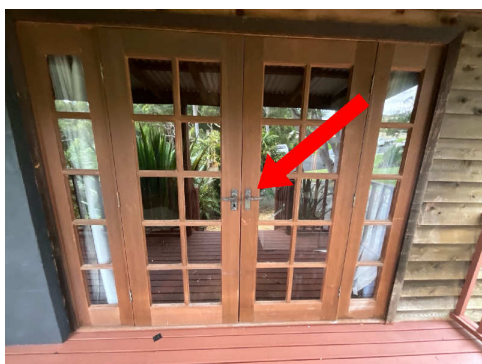
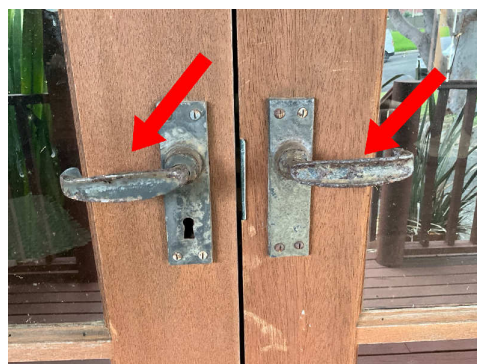
**Finding 3.02**

Building: Main Building  
Location: Entry  
Finding: Building element - Rusted or corroded

**Information:** This building element shows evidence of rusting and corrosion, which is likely to have developed as a result of excessive exposure to moisture and or inadequate coatings.

As surface rust provides no protection to the underlying iron, the deteriorating condition is likely to worsen if not addressed in the short-term future.

Rusting and corrosion should be managed by ideally removing or limiting the affected surface from exposure to moisture. A registered builder may be appointed to replace any building elements that have been severely affected by rust or water damage.

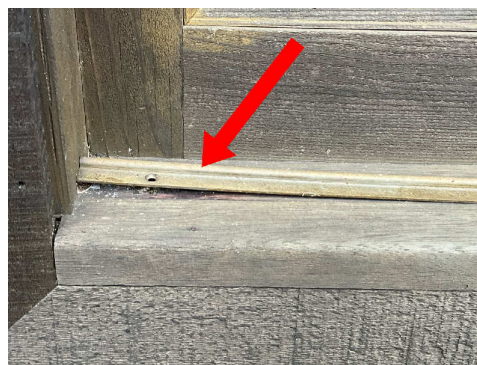
### Finding 3.03

**Information:** The window rail to the cedar window was observed to have become disconnected from the windowsill. This has resulted in a separation between the rail and sill, which may allow moisture ingress and may affect the stability and operation of the window assembly if left unrectified.

Repairs are recommended to securely refix the window rail to the windowsill. Works should include sealing of any gaps and ensuring the window assembly is properly secured and weather-resistant. Any damaged timber should also be assessed and repaired as required.

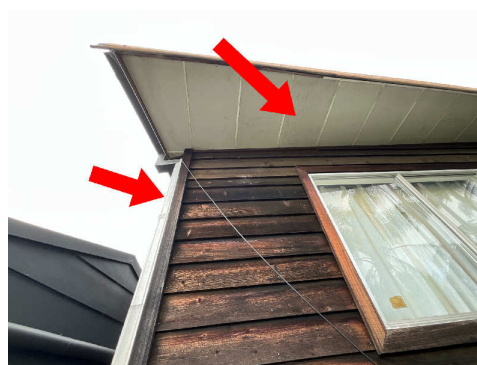
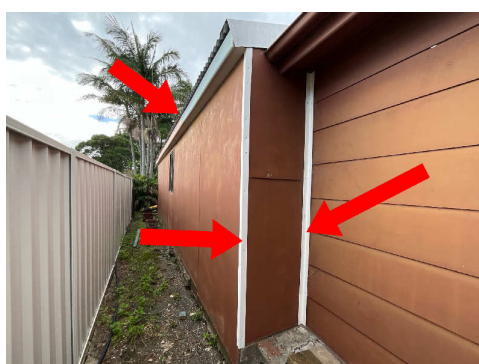
### Finding 3.04

Whilst incomplete or missing paint finish is generally an appearance defect, it can also lead to the development of secondary building defects over time. Incomplete areas of paint finish expose the area to moisture, potentially accelerating the deterioration of underlying building materials.

Incomplete paint finishes should be sanded back, filled, leveled and painted, as applicable. Where inadequate or missing paint protection has led to the deterioration of the associated building element, repair and/or replacement of this building element may be required.

A painting contractor should be appointed as soon as possible to perform necessary works to aid the appearance of the affected area and to ensure the area is protected against further deterioration. Alternatively, the homeowner following manufacturer instructions may perform these works.

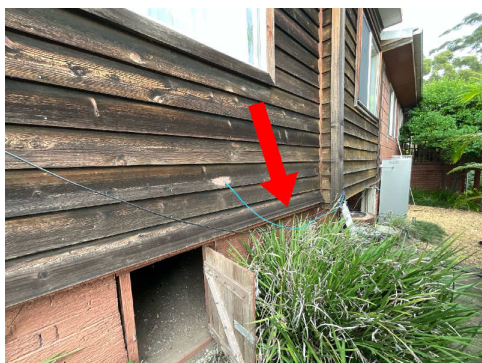
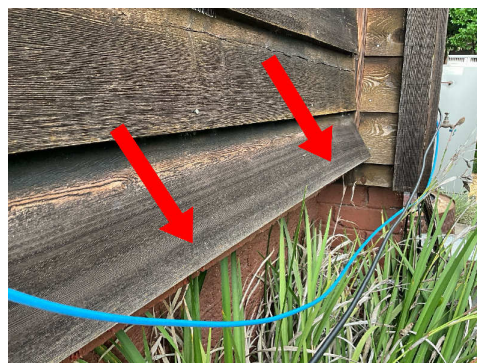
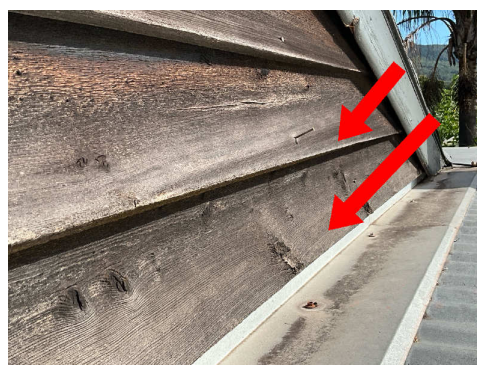
### Finding 3.05

Finding: Decay and Cupping to Bottom Cedar Cladding Board

Information: The bottom cedar cladding board was observed to be deteriorated and showing signs of decay. The board has also cupped, indicating prolonged exposure to moisture and weathering. This condition may compromise the durability of the cladding and may allow moisture ingress into the wall structure if left unrectified.

The affected cladding board should be further assessed and repaired or replaced as required. Any underlying moisture sources should be addressed, and the cladding should be properly sealed and finished to protect against further deterioration. Repairs should be carried out by a suitably qualified contractor.

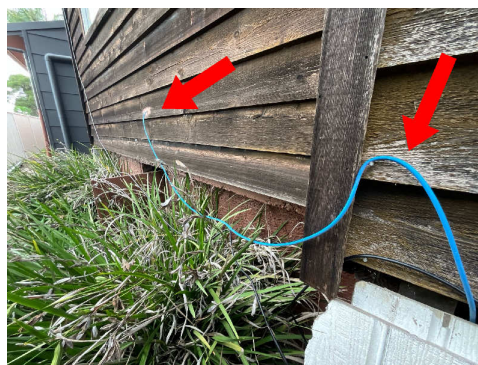
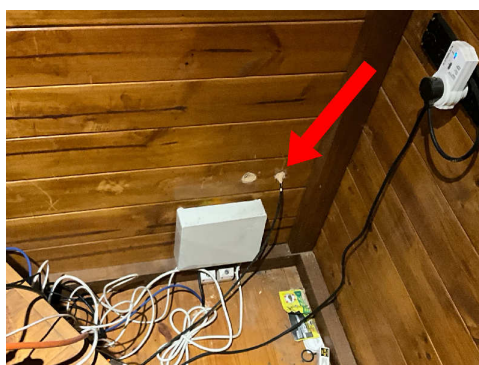
### Finding 3.06

Information: Substandard and incomplete installation of external data and Foxtel (coaxial) cabling was observed to the exterior of the building. The cabling appears to be poorly routed and not properly secured or terminated, resulting in an untidy installation that may leave the cables vulnerable to damage and weather exposure.

A licensed communications technician should inspect the installation and complete the routing and termination of the data and Foxtel cabling. Cabling should be properly secured, protected, and installed in accordance with industry standards to ensure durability and correct operation.

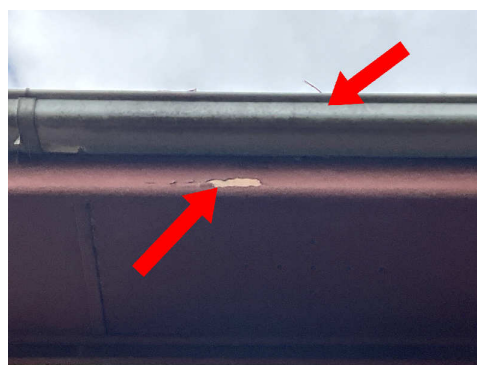
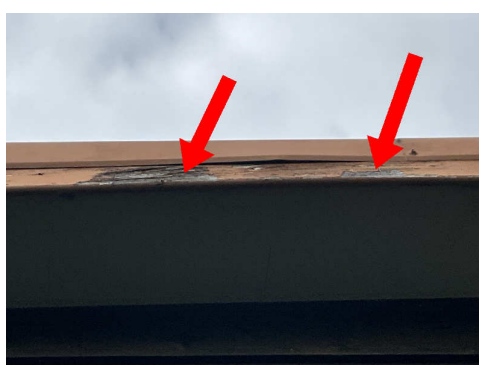
**Finding 3.07**

Building: Main Building  
Location: All External Areas  
Finding: External Painting Deteriorated

Whilst incomplete or missing paint finish is generally an appearance defect, it can also lead to the development of secondary building defects over time. Incomplete areas of paint finish expose the area to moisture, potentially accelerating the deterioration of underlying building materials.

Degraded paint finishes should be sanded back, filled, leveled and painted, as applicable. Where inadequate or missing paint protection has led to the deterioration of the associated building element, repair and/or replacement of this building element may be required.

A painting contractor should be appointed as soon as possible to perform necessary works to aid the appearance of the affected area and to ensure the area is protected against further deterioration. Alternatively, the homeowner following manufacturer instructions may perform these works.

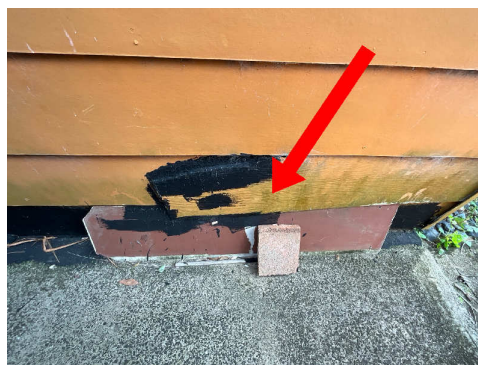
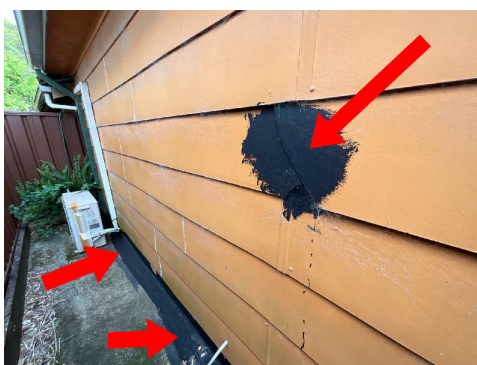
### Finding 3.09

Building:	Granny-Flat
Location:	Exterior walls - right side
Finding:	Incomplete / Substandard construction
Information:	<p>There are a number of Building elements that were identified as being incomplete or substandard works in this areas consisting of poor installation of cladding boards, sub standard repair to seal the cladding to the concrete, suspected previous water entry to granny flat.</p> <p>Sub standard and incomplete work are determined by identifying a failure to achieve the minimum requirement set out in the mandated Australian Standard as outlined in the Building Code of Australia and referenced by the Manufacturers Guideline.</p>

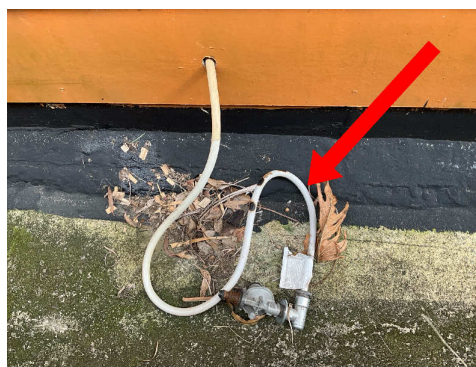
**Finding 3.10**

Building: Main Building  
Location: Garage  
Finding: Gas Regulators - Non-compliant

Unfinished and substandard building works are likely to degrade more quickly and may create potential for secondary defects to associated building elements, as well as a potential safety hazard in the case of gas service management.

The findings are that there appears to be no compliance plate and the bottle is not securely fastened. Where installation is substandard and/or incomplete, the client should contact the responsible trade (gas plumber) to undertake rectification.

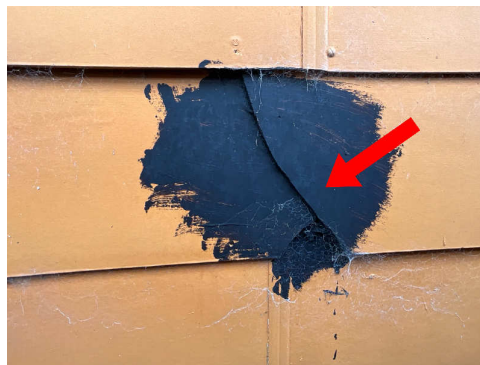
### Finding 3.11

**Finding:** Extensive Cracking to External Garage Cladding Boards – Patch Repairs Evident

Further assessment and rectification by a suitably qualified contractor is recommended. Damaged cladding boards may require proper repair or replacement, followed by appropriate preparation and repainting to restore the durability and finish of the external wall surface.

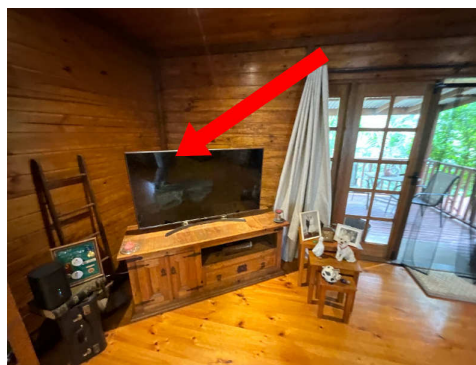
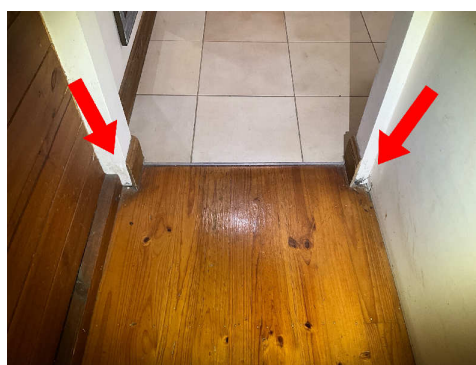
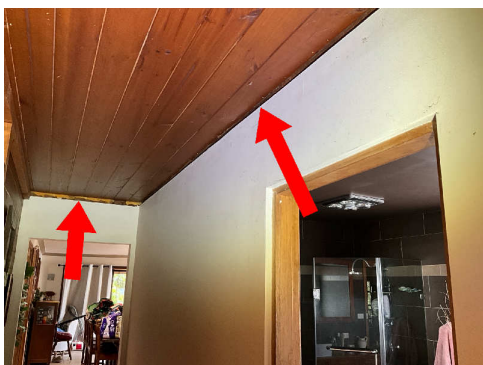
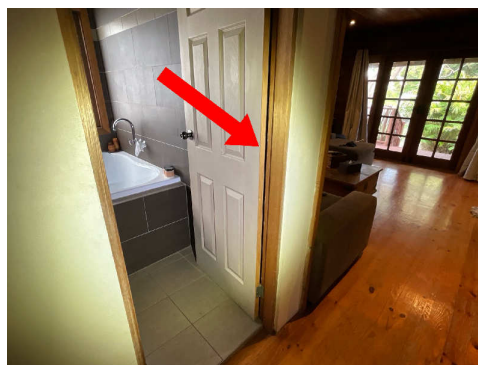
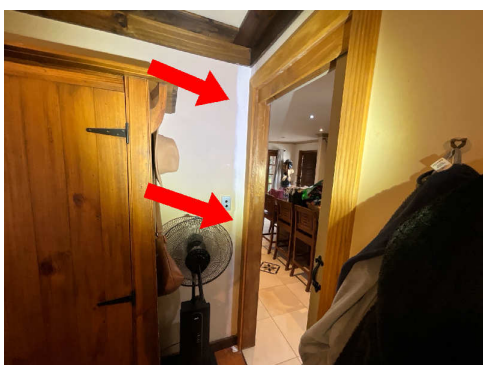
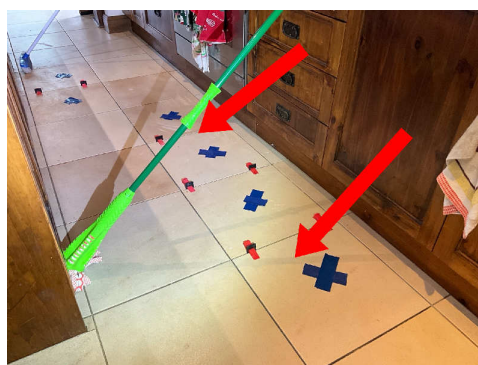
**Finding 3.12**

Building: Main Building  
Location: All Areas  
Finding: Incomplete / Substandard construction

Sub standard and incomplete work are determined by identifying a failure to achieve the minimum requirement set out in the mandated Australian Standard as outlined in the Building Code of Australia and referenced by the Manufacturers Guideline.

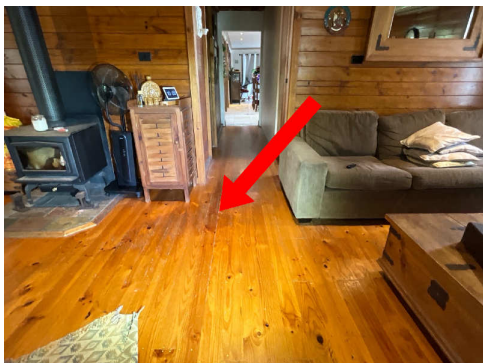
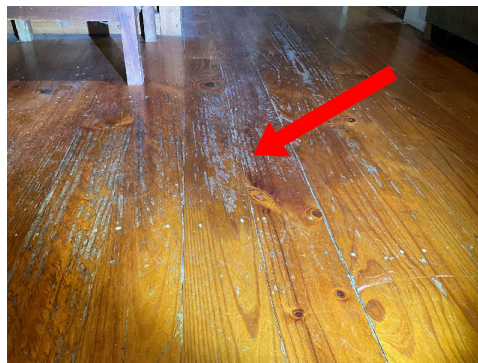
### Finding 3.13

Finding: Worn Timber Flooring

It is recommended that the flooring be professionally sanded and refinished with an appropriate protective coating to restore its appearance and provide ongoing protection to the timber surface.

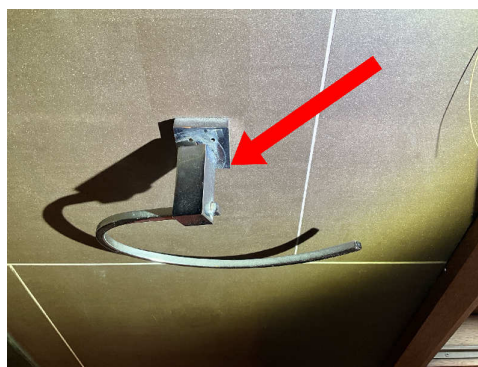
### Finding 3.14

Finding: Towel Rail - Loose

If left unmanaged, the fitting may further deteriorate, causing potential for the development of other minor secondary defects.

A relevant tradesperson should be appointed to perform these rectification works at discretion of the client.

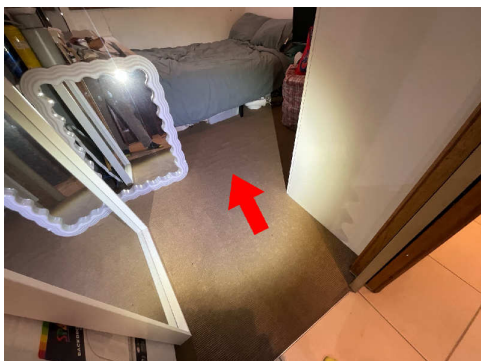
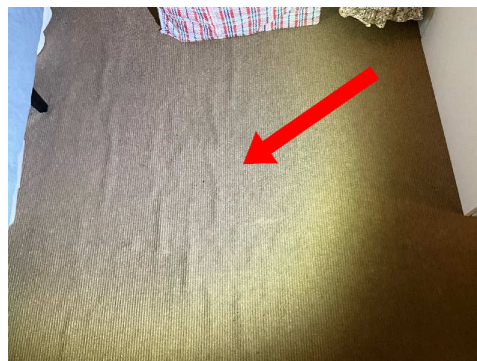
### Finding 3.16

Finding: Carpet - Deteriorated

Information: Sections of the carpet floor covering in this area appeared to be deteriorated due to wear and tear.

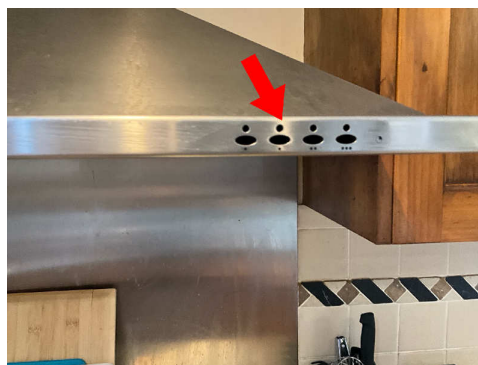
### Finding 3.18

Without a functional fan, a build-up of grease and evaporative moisture is likely to accelerate deterioration of the range hood and associated flue. This potential build up may also create a minor fire hazard, particularly if left uncleaned.

A licensed electrician should be appointed to replace the fan on the range hood to restore it to a fully operational state.

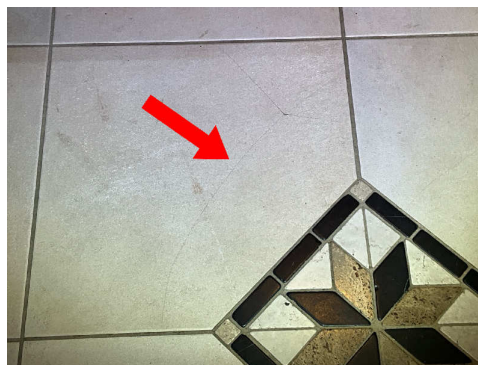
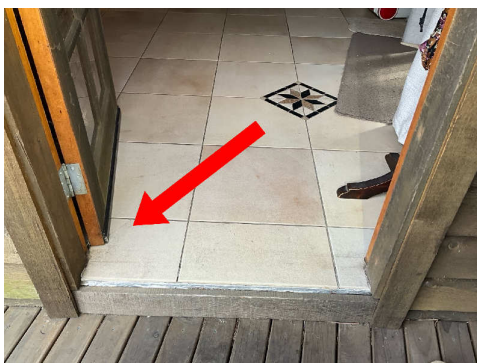
Finding: Cracked floor tiles - Bearer & Joist

Information: Cracking in the floor tiles was evident in this area at the time of inspection. It is suspected that this cracking has occurred as a result of minor settlement or shrinkage of the brick piers.

Cracked tiles throughout the household detract from the overall appearance of the affected areas however it is unlikely to create or lead to any secondary defects, as water proof membrane failure.

While not considered a matter of urgency, replacement of cracked floor tiles is recommended at the clients discretion. A tiling contractor may be appointed to perform these works. Where cracks become more numerous, contact a licensed building inspector for further investigation.

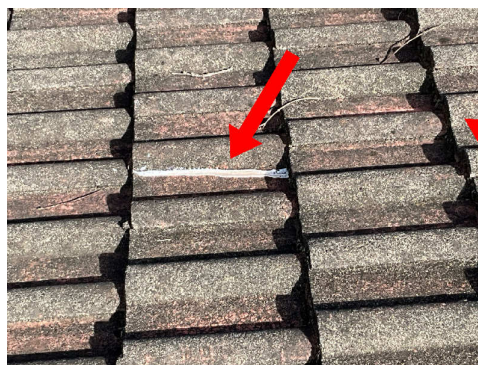
### Finding 3.20

Finding: Roof tiles - Broken

Information: Upon inspection of the exterior roof covering, broken roofing tiles were identified. Broken and friable roof tiles are generally the result of ageing and weathering of what is essentially a porous material.

If left to further deteriorate, broken and brittle roof tiles are likely to lead to water penetration via the roof into the ceiling space, causing secondary damage to ceiling linings, insulation and roof structures. Broken roof tiles are also likely to detract from the effectiveness of the roof drainage system, creating potential for secondary damage to the exterior roof covering and roof plumbing.

Replacement of broken tiles is required and should be performed by a roofing contractor as soon as possible.

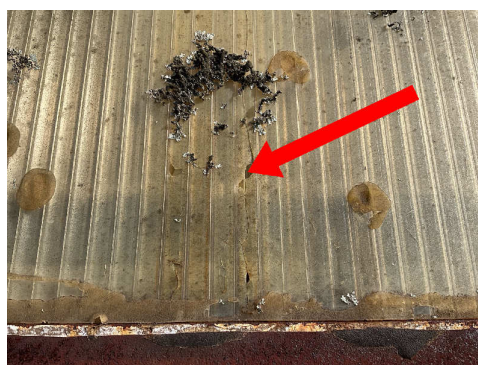
### Finding 3.21

Building: Main Building  
 Location: Yard - Back  
 Finding: Skylight - Damaged cover

Information: The skylight covering appears to have sustained minor damage and is now cracked. A temporary repair has been carried out using silicone. While there was evidence that water ingress had occurred previously, no moisture was detected at the time of inspection, and the silicone repair currently appears to be holding.

However, repair or replacement of the skylight covering is recommended to prevent further deterioration or potential water damage to the surrounding areas. These works should be carried out as soon as possible by a qualified carpenter or general handyperson.

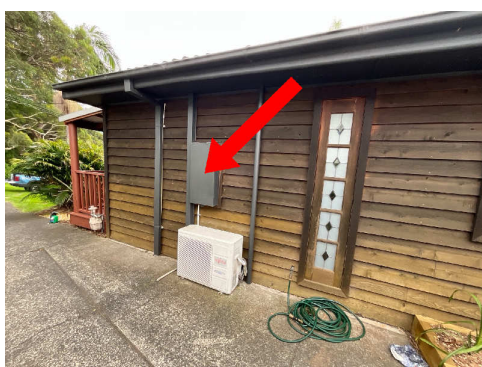
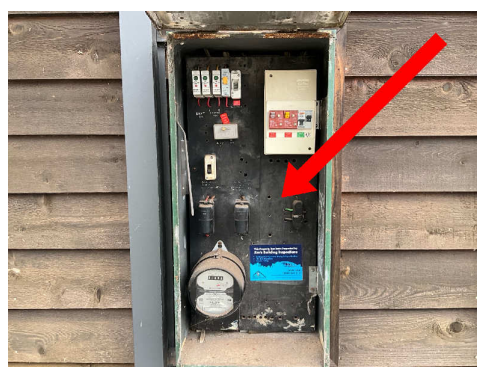
Information: The application of a post-construction chemical termite barrier is highly recommended for all properties, particularly if live termite activity has been found on the site previously. Such barriers are highly effective in preventing termite attack on any timber building elements throughout the property.

A durable notice should be placed in the switchboard unit to indicate current termite barriers. At the time of inspection, it appeared as though no termite management system has been installed, with no evidence to suggest preventative works taking place.

The client may consider gaining further advice from a pest controller as to the costs and procedures involved with this application. It is recommended that obtaining such advice be a short-term priority.

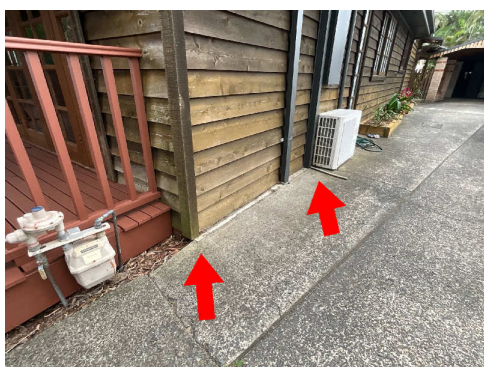
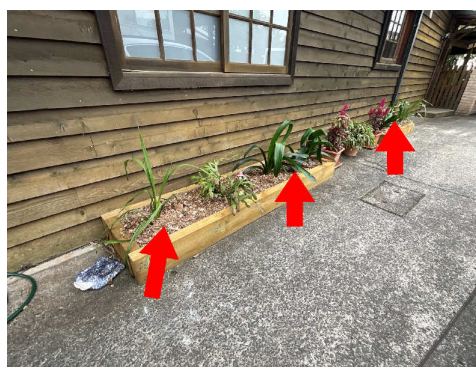
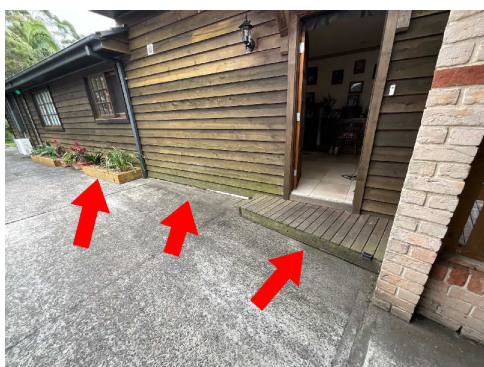
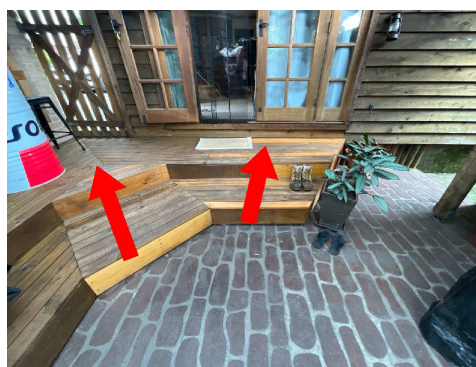
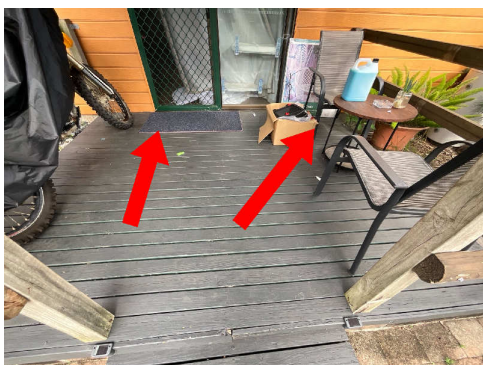
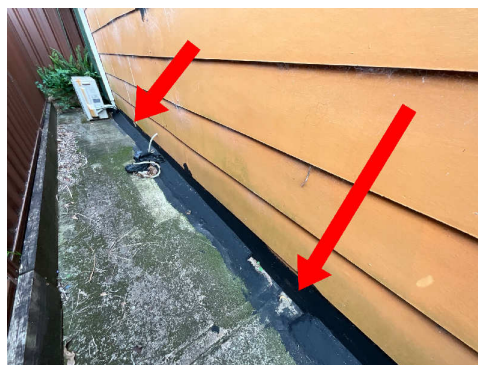
### Finding 6.02

Generally this takes the form of finished ground levels external paving or concrete being retrospectively installed above the damp course level the adjacent internal floor level or weep and ventilation holes.

Where bridging has occurred full inspection is prevented and termites may enter a property in a concealed or undetectable manner.

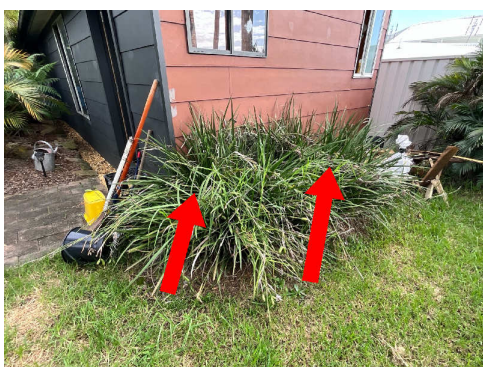
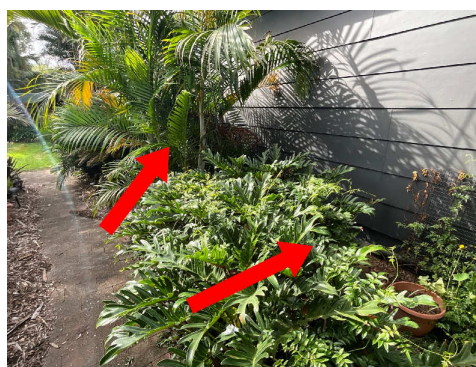
**Finding 6.03**

Building: Main Building  
Location: All Areas  
Finding: Bridging - Vegetation

**Information:** Where vegetation obstructs inspection of building elements, also known as bridging as it provides a bridging point for the access of termites, full inspection can not be achieved. Consequently moisture or dampness may be present and the areas becomes conducive to termite activity. Plants against or very close to buildings provide cover, shade and can provide an environment that is attractive to termite infestation.

The removal and replanting of species that do not provide "cover" or cutting back of existing vegetation will assist greatly in preventing Bridging from occurring.

The removal of any such materials that may be conducive to termite activity should be carried out as soon as possible and arrange re inspection to minimize the risk of termite attack.

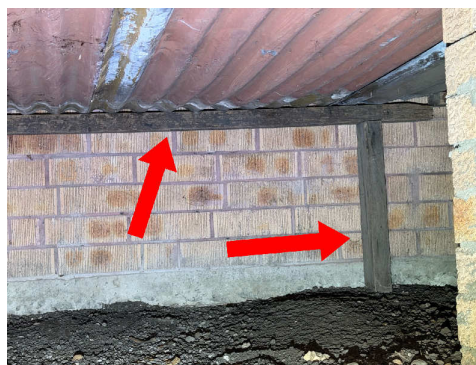
### Finding 6.06

Finding: Formwork timbers - left in situ

Information: Formwork timber appears to have been left on site and in situ after concrete construction. Formwork timber is used to support and shape the concrete while pouring during the construction process. Leaving formwork timbers in the subfloor space or around the exterior of the property increases the risk of termite activity being present. As they are likely to come into contact with weather conditions or excessive moisture wood rot is likely to develop on timbers that are not treated. It is highly recommended that any formwork timbers be immediately removed from areas in which they may attract any termite/timber pest attack. Minimisation of risk/prevention of termite attack is far more adequate than dealing with the presence of termite activity.

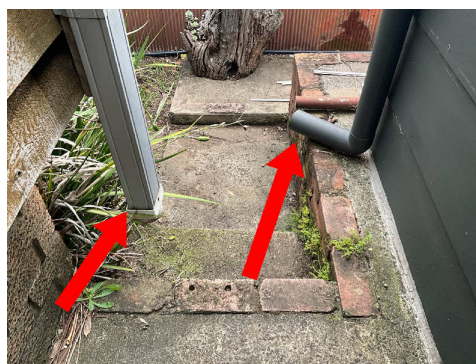
### Finding 6.07

Where roof plumbing doesn't drain adequately, the area at the base perimeter can become excessively damp, potentially creating an environment that is susceptible to rust and corrosion of surrounding building elements, as well as attracting termites and other pests.

It is highly recommended that a plumber be appointed to further inspect the area and to install adequate drainage equipment where necessary.

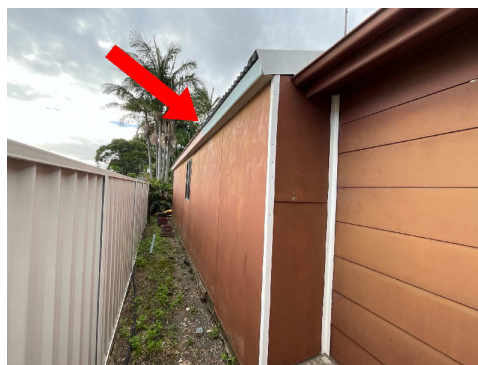
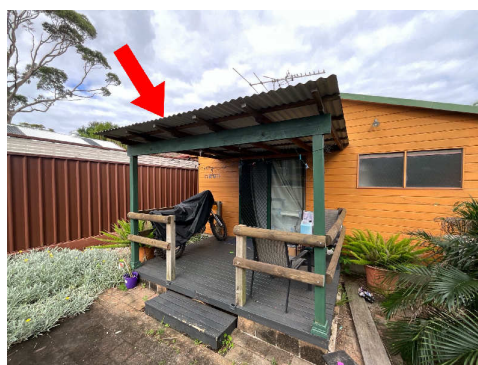
### Finding 6.08

Finding: Gutters - Missing

Information: Missing roof plumbing such as guttering and downpipes contribute to excessive moisture around the perimeter of the building, this is conducive of termites and fungal decay.

Consult a Licensed Plumber for further specific advice on remedial works that may be required.

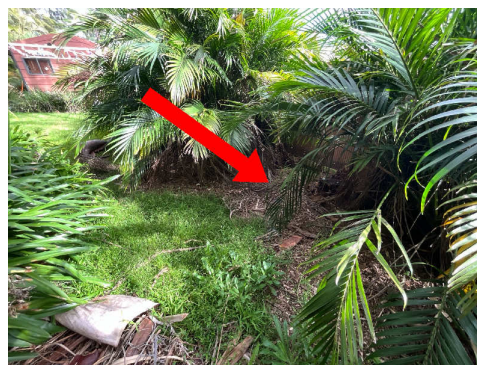
### Finding 6.09

Finding: Garden Beds - Conditions Conducive to Termites

Information: Garden beds were found to be evident in the garden area. These garden beds can include untreated timber, and with a combination of moisture from watering hosing can make conditions conducive to termite activity and termite ingress.

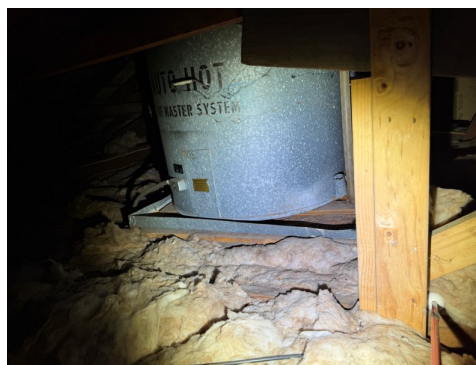
### Finding 6.10

Information: It was noted at the time of inspection that a disconnected gravity-fed hot water system (HWS) remains in this area.

Despite this plumbing structure being unused, it is likely to be storing residual water, and is therefore susceptible to rust and corrosion. If allowed to continue, rust and corrosion is likely to lead to damage to adjoining building elements, and may also make the area susceptible to termite or timber pest activity.

While it is a costly exercise to remove the disused gravity-fed HWS, it is advisable in the short-term future to prevent any further damage to the area. Further consultation with a licensed plumber is required to gain further advice on removal of the structure.

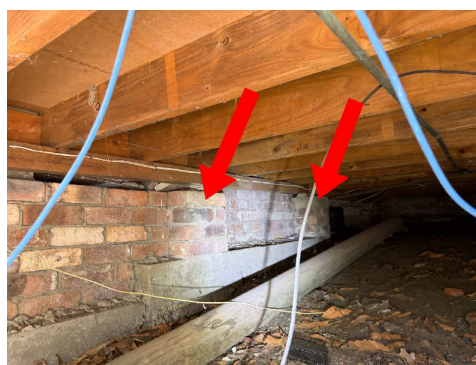
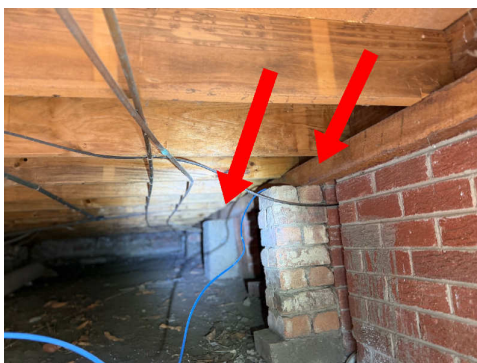
### Finding 6.11

Installed during the construction process, ant caps are designed to easily identify termite or pest ingress from stumps to the adjoining bearers.

Where ant caps have not been installed, frequent monitoring of these areas should be carried out in order to identify any signs of termite or timber pest workings.

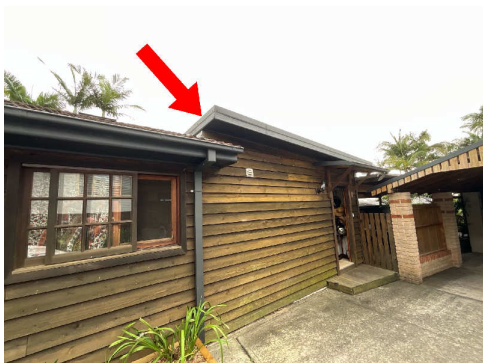
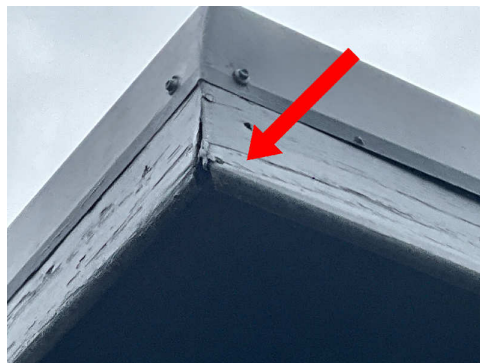
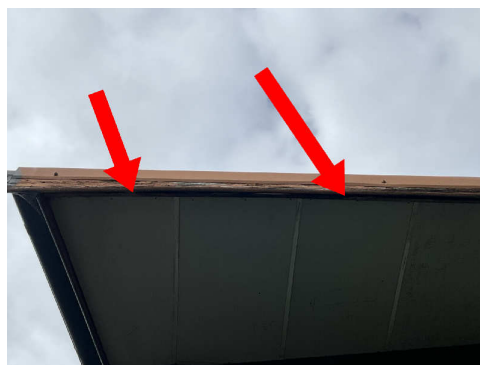
### Finding 7.01

Finding: Fascias - Wood rot

Information: Wood rot was found to be affecting fascias and barges in this area, evidenced by the presence of mould on the surface in some areas. Wood rot, also known as Fungal Decay, occurs when timbers and other cellulose building materials are exposed to damp conditions on an ongoing basis.

It is likely that this wood rot has developed as a result of faults in the roof plumbing, creating excessive moisture in this areas. Frequent exposure to rain and other weather conditions also make fascias and barges susceptible to accelerated deterioration.

Early intervention and regular maintenance will prolong the useful life of these building elements. Prior to any works being performed, the cause of the moisture that has created the visible wood rot should be identified and addressed in a suitable manner.

It is advised that a roof plumber be appointed to inspect all roof plumbing and subsequently identify the cause of the wood rot. Replacement of affected fascias and barges may then be a necessary step in protecting surrounding building elements from such deterioration.

A qualified plumber may be appointed to assess the cause of excessive moisture and to provide advice on any remedial works as required. A qualified carpenter or registered builder may also be required to replace affected building materials.

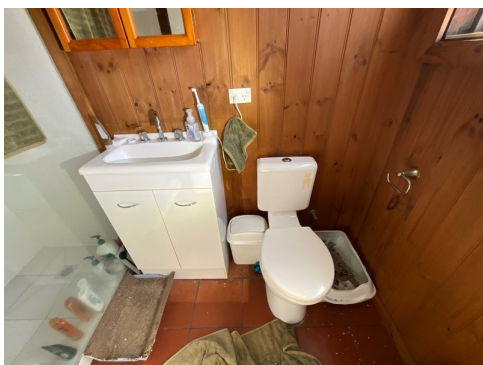
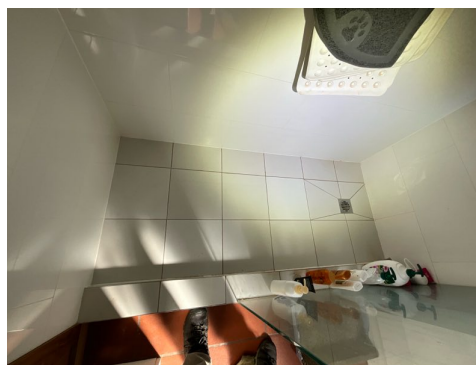
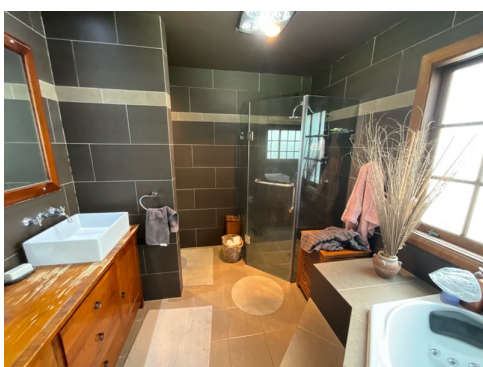
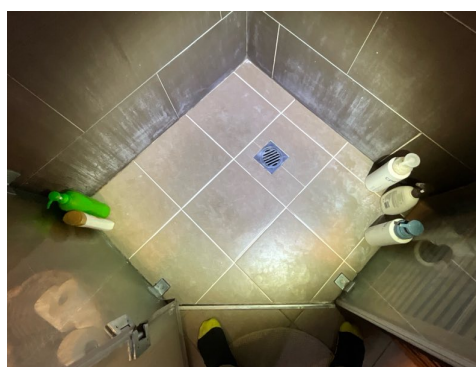
Finding: Waterproof membrane maintenance

Information: Regular maintenance of the waterproof membrane is essential to ensure its long-term effectiveness. Inspections should be conducted periodically to check for any signs of wear, damage, or deterioration, particularly around seams, joints, and high-traffic areas. Prompt repair of grout or silicone is essential and will help prevent water ingress and maintain the integrity of the structure.

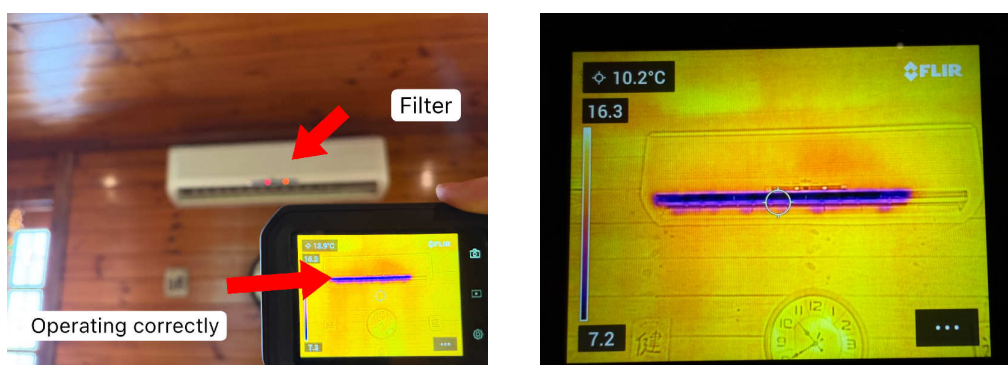
Finding: Air Conditioning Return Air Filter

Information: Maintaining return air filters is crucial for indoor air quality air conditioning system efficiency. Here's a basic maintenance routine:

1. Regular Inspection: Check the filter monthly to assess its condition.
2. Cleaning or Replacement: Clean or replace the filter as needed. Disposable filters should typically be replaced every 1-3 months, while reusable filters can be cleaned according to manufacturer instructions.
3. Cleaning Procedure: For reusable filters, vacuum or wash them with mild detergent and water. Ensure they are completely dry before reinstalling.
4. Proper Installation: Install the filter properly, following the manufacturer's instructions and ensuring it fits snugly.
5. Schedule Maintenance: Set reminders to check and replace filters regularly to maintain optimal performance and air quality.
6. Professional Inspection: Periodically, have a professional inspect your HVAC system, including the filters, to ensure everything is functioning correctly.

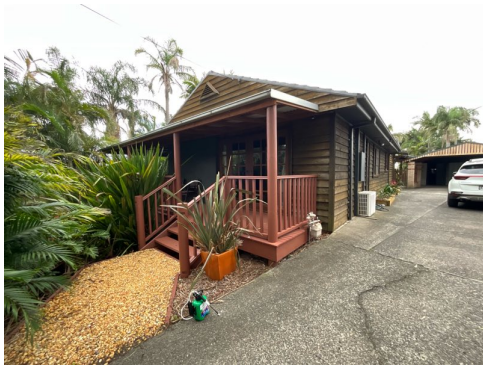
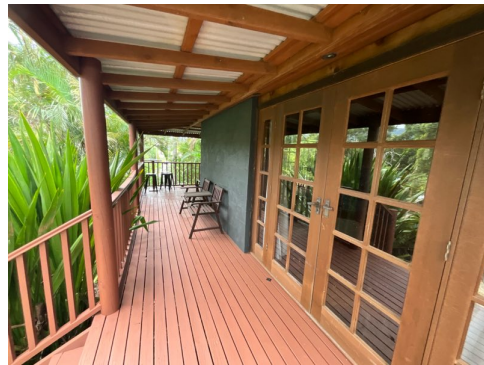
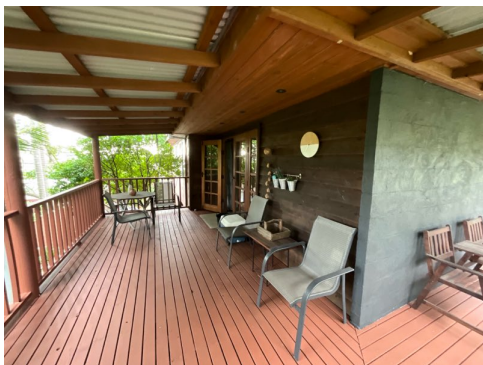
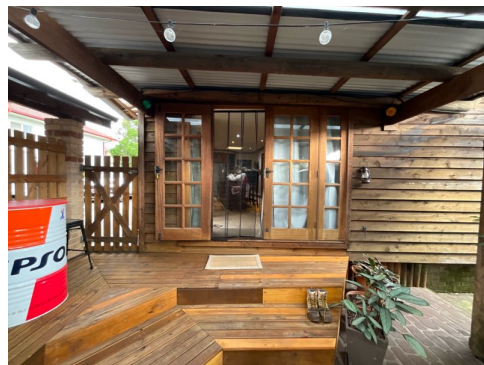
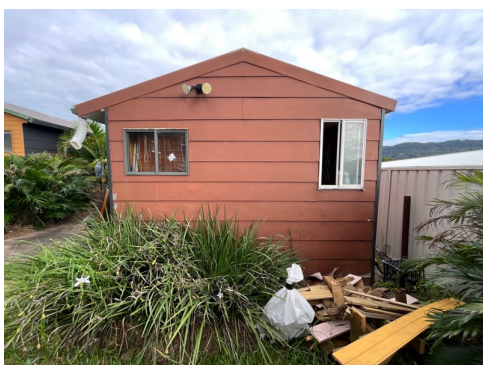
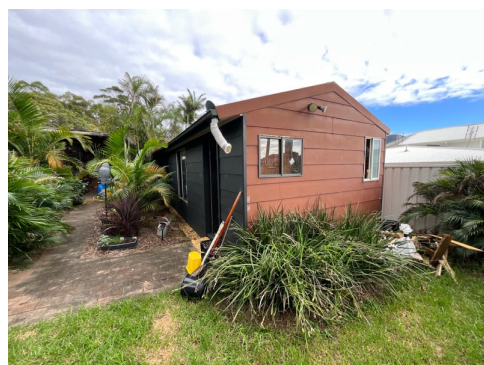
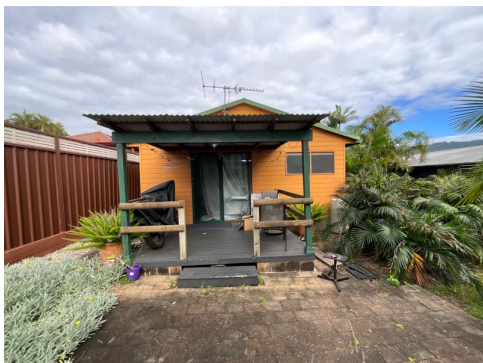
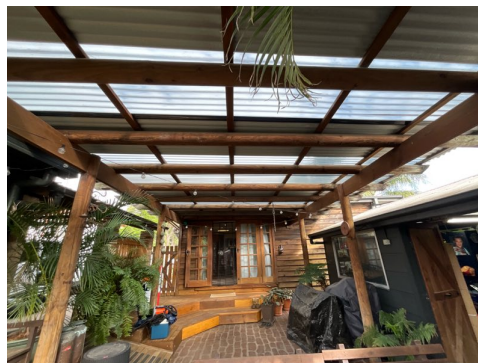
Finding: Additional Photos - Obstructions and Limitations

Information: These photographs are an indication of the obstructions and limitations which impeded full inspection of the property at the time of inspection, also for your reference.

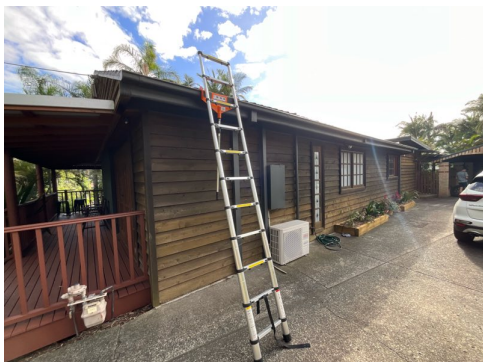
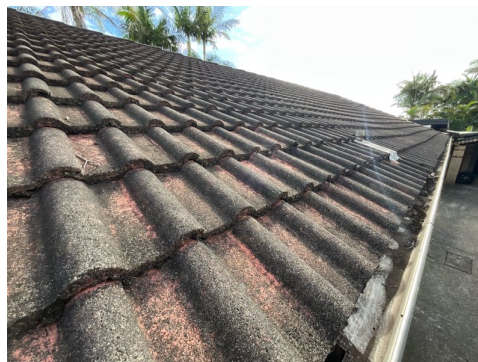
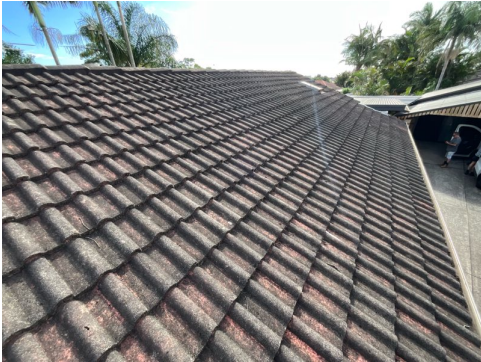
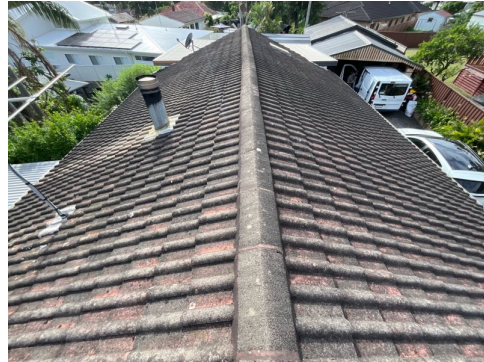
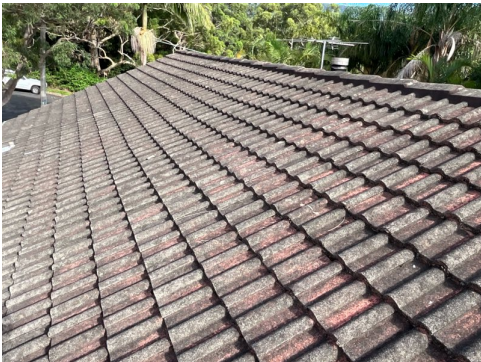
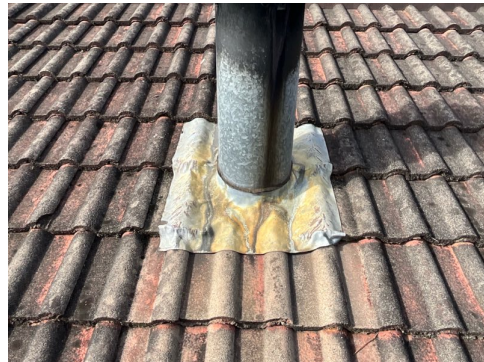
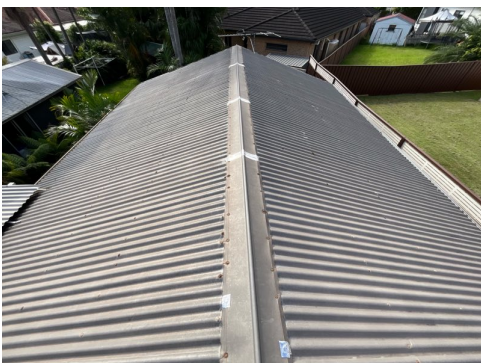
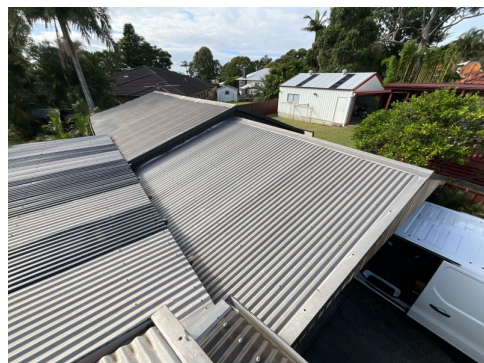
Finding: Additional Photos - Obstructions and Limitations

Information: These photographs are an indication of the obstructions and limitations which impeded full inspection of the property at the time of inspection, also for your reference.
