# Building and Timber Pest Inspection Report VR

Inspection Date: Sat, 14 Mar 2026

Property Address: 1 McMahon St, Fairy Meadow NSW 2519,  
Australia

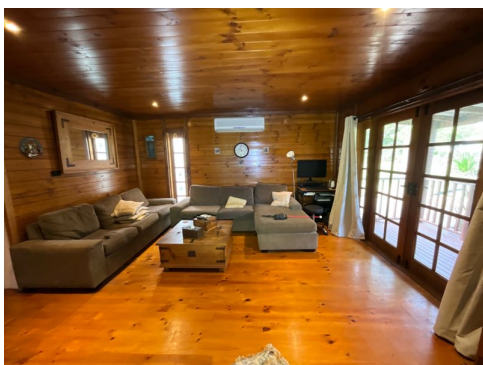
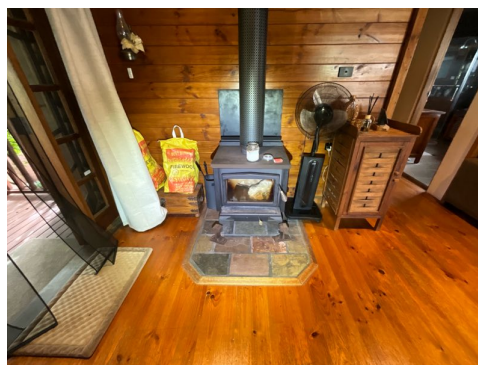
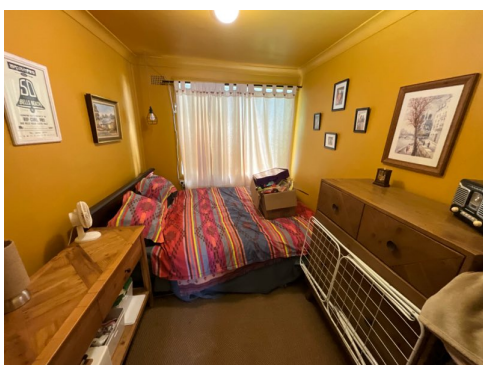
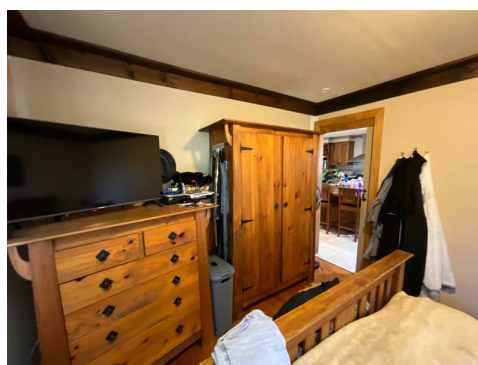
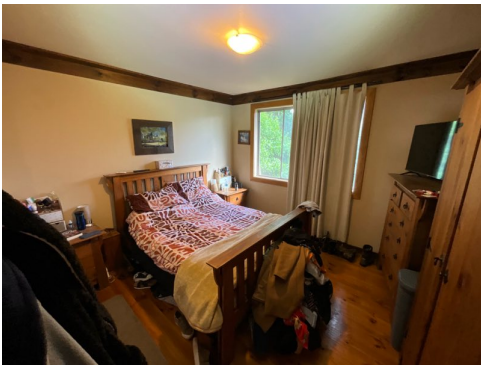
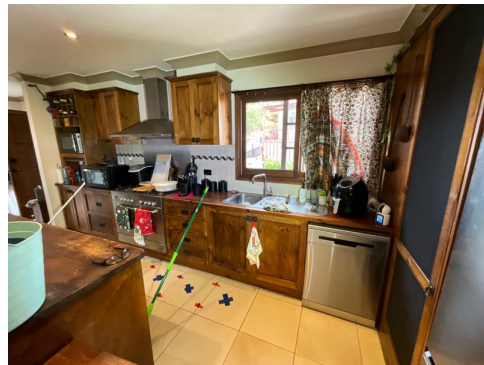
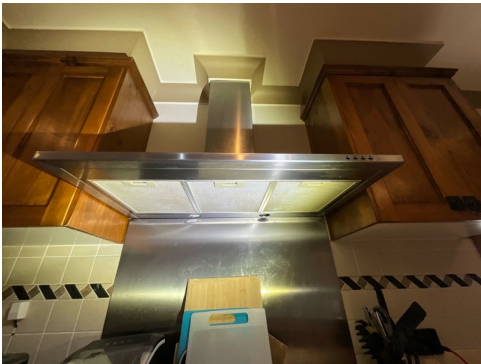
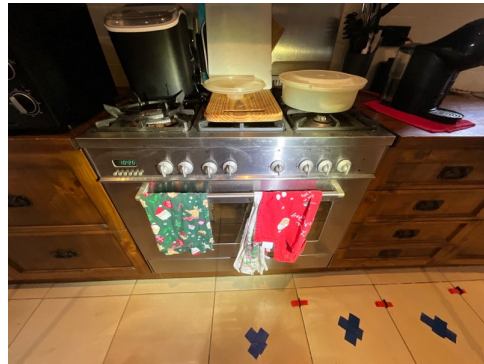
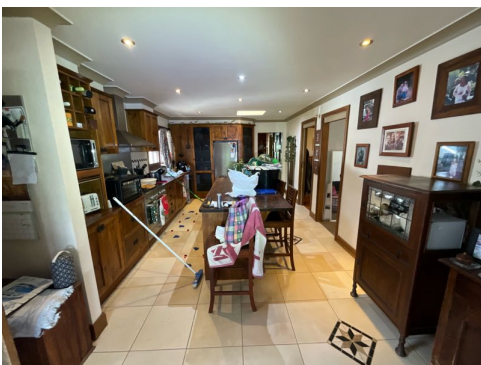
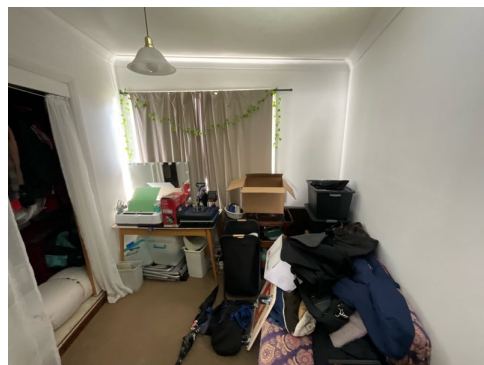
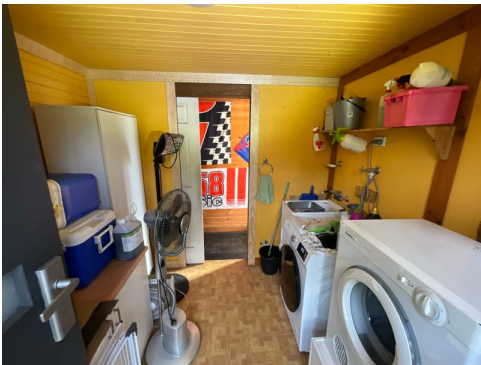
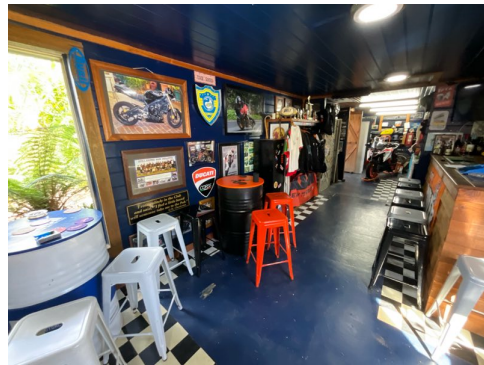
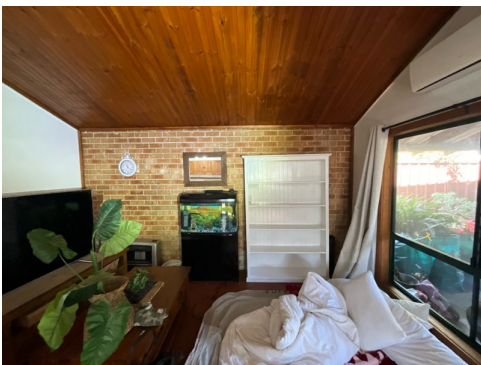
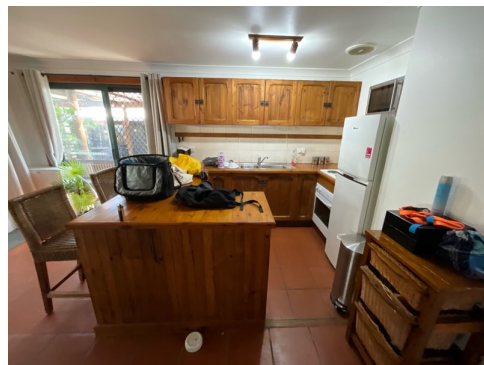
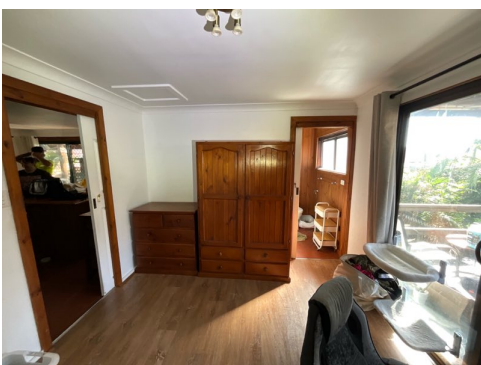
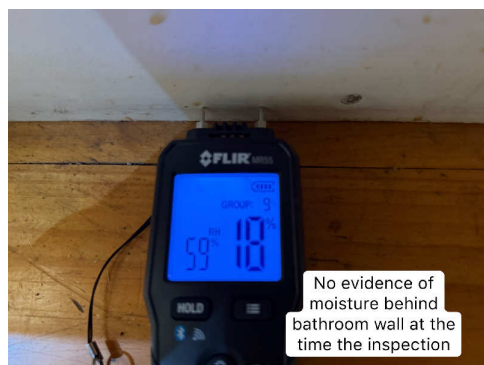
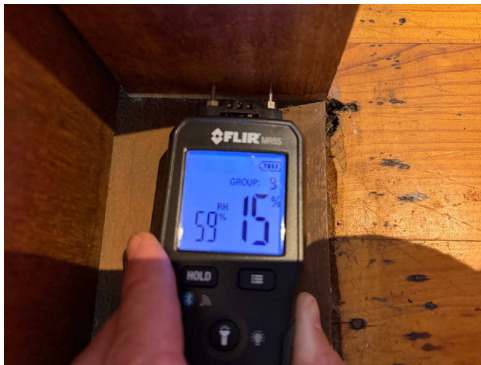
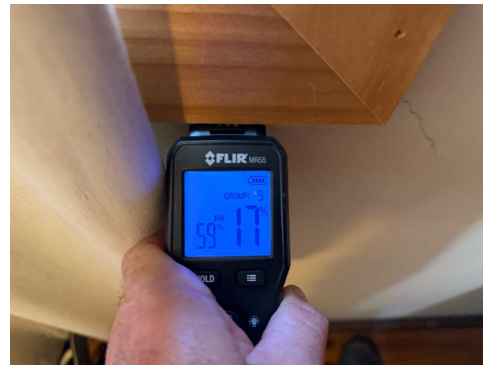
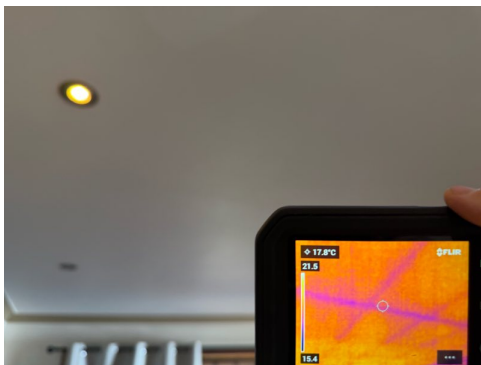
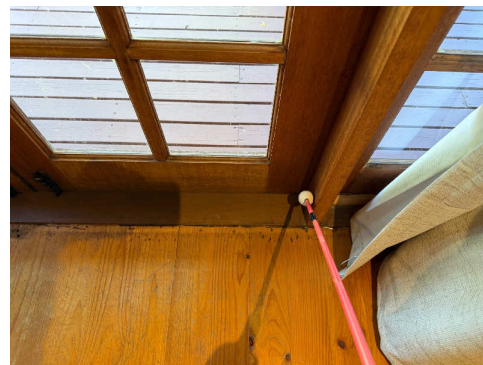
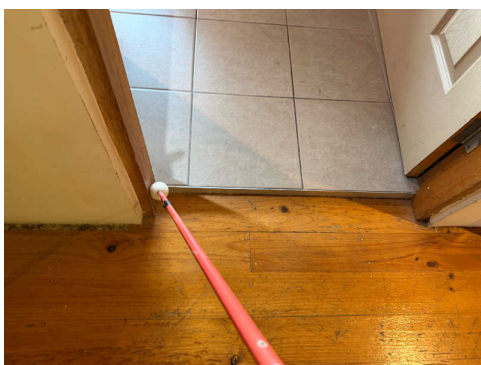
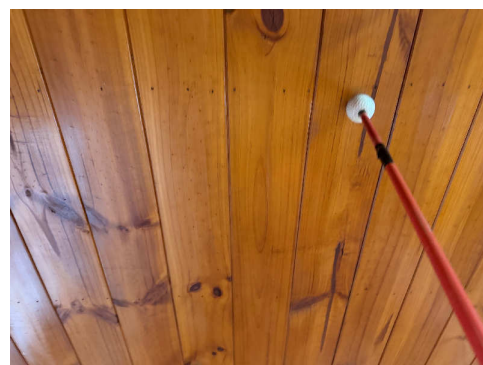
Finding: Additional Photos - Obstructions and Limitations

Information: These photographs are an indication of the obstructions and limitations which impeded full inspection of the property at the time of inspection, also for your reference.

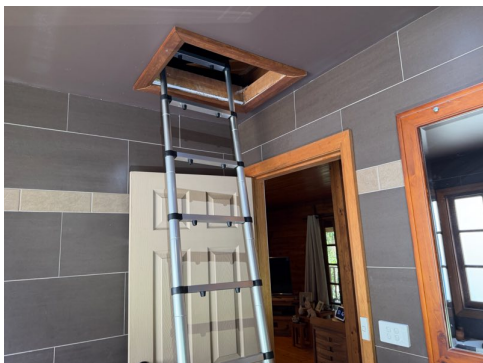
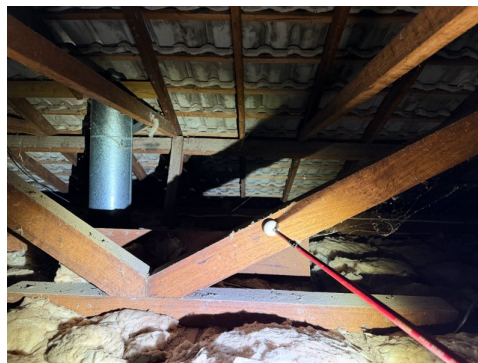
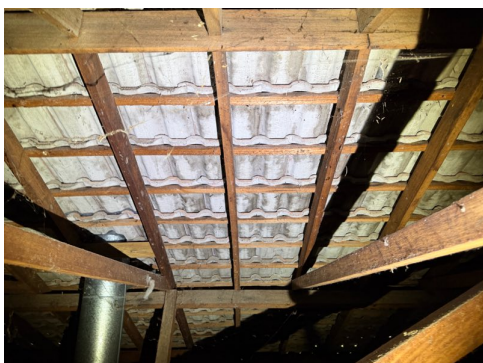
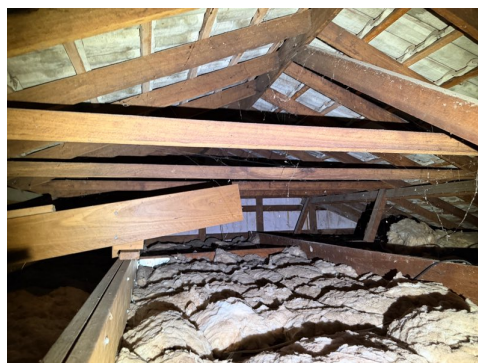
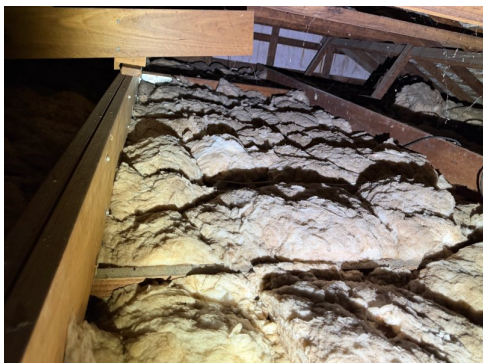
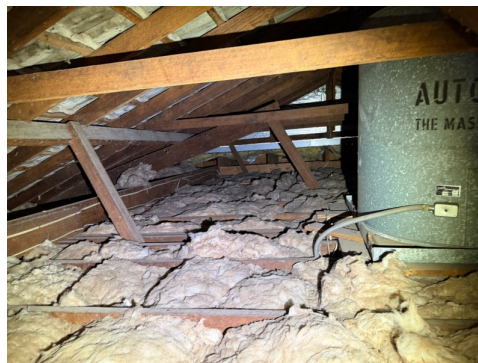
Finding: Additional Photos - Obstructions and Limitations

Information: These photographs are an indication of the obstructions and limitations which impeded full inspection of the property at the time of inspection, also for your reference.

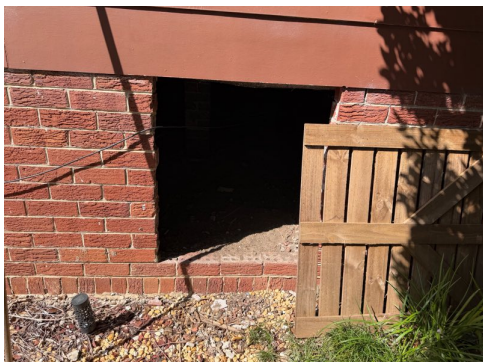
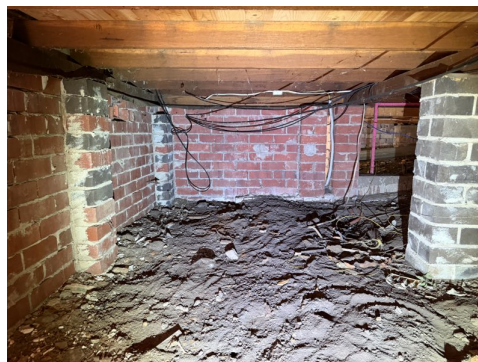
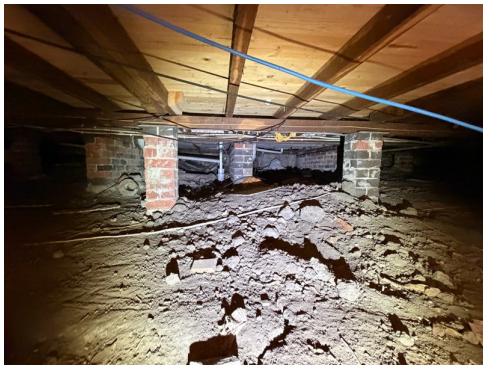
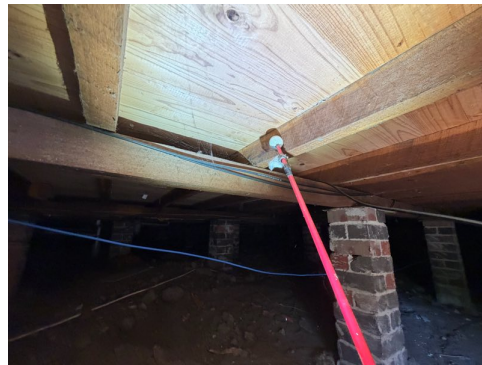
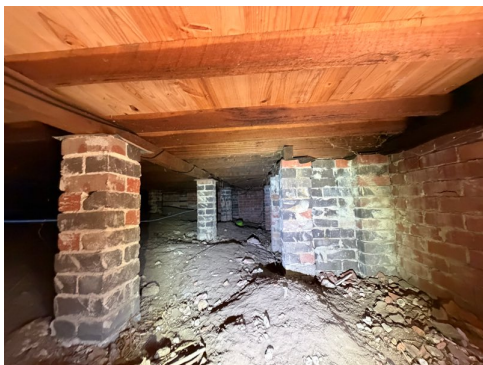
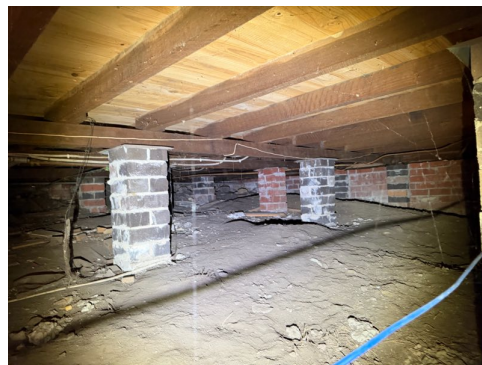
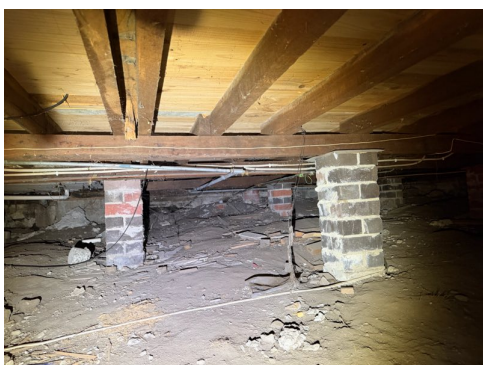
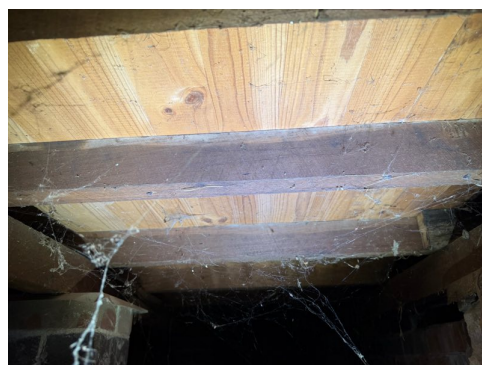
Finding: Additional Photos - Obstructions and Limitations

Information: These photographs are an indication of the obstructions and limitations which impeded full inspection of the property at the time of inspection, also for your reference.

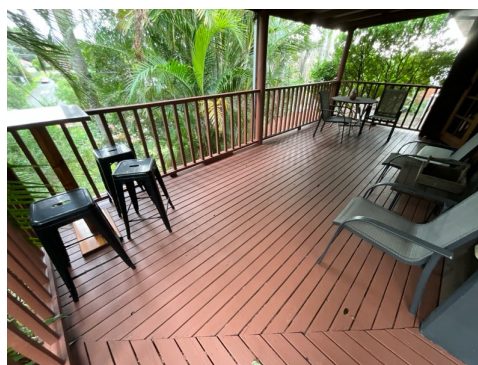
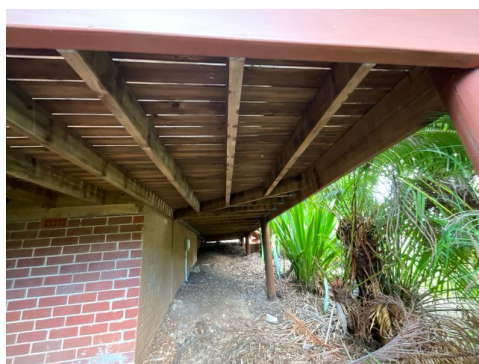
External timber structures are also constantly exposed to weather elements and can deteriorate in an accelerated manner, ongoing assessments are required.

It is highly recommended that a Structural Engineer further assess the external timber balcony or deck to inform the client of its load capacity. Regular maintenance inspections by competent practitioners is needed.
