Building Inspection Report

Inspection Date: Sat, 10 Jan 2026

Property Address: 9B Ashbourne Road, Woodend, VIC 3442

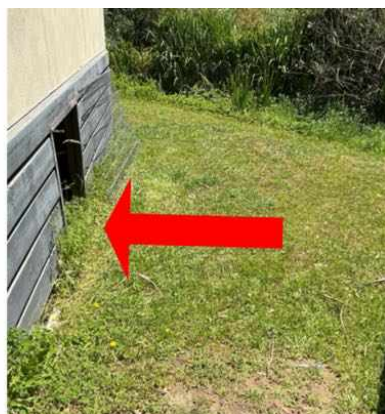
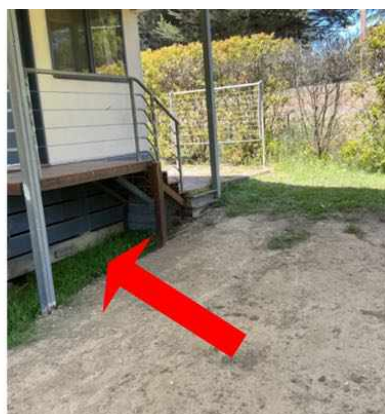
Defects 3.01

Building: Main Building
 Location: All External Areas
 Finding: Site drainage - Inadequate
 Information: The site drainage in all yards was found to be inadequate at the time of inspection, creating potential for subsequent water damage to associated building elements.

ground levels should be sloped to drain water away from walls. Downpipes should not discharge stormwater onto lower walls or plinths. Stormwater should be carried away by large, regularly cleaned drains. Ground levels may need to be lowered to expose a buried DPC.

Where site drainage is inadequate, installation of an Agricultural (Aggie) Drain may be required. A qualified plumber should be appointed to further inspect the property and perform any remedial works as necessary. Water damage and secondary defects are likely to occur if left unmanaged.

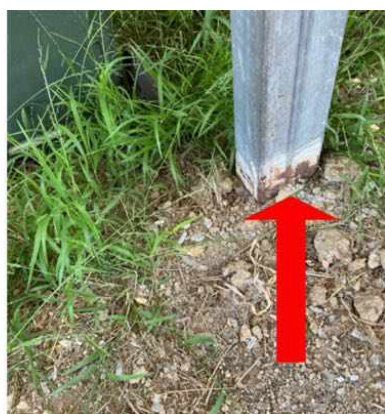
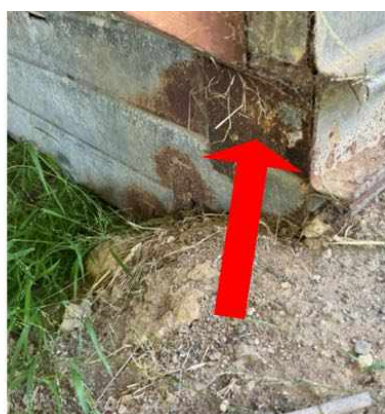
Defects 3.02

Building:	Main Building
Location:	Covered area
Finding:	Corrosion to Steel Posts and Beams – Rear Covered Area
Information:	Rust corrosion was observed to sections of the steel posts and steel beams supporting the rear covered area. The corrosion appears to be associated with the steel posts being in direct contact with the ground and exposed to ongoing weather conditions, including moisture and rainfall, which increases the risk of accelerated deterioration.

If left unaddressed, continued corrosion may compromise the protective coating and reduce the long-term durability of the steel elements. Progressive corrosion can also

lead to section loss over time, potentially affecting the structural performance and service life of the affected components.

It is recommended that a registered builder be engaged to assess the extent of corrosion and determine appropriate remedial works. Remedial measures may include removal of surface rust, application of suitable corrosion protection systems, and detailing works to isolate the steel posts from direct ground contact to prevent further deterioration.

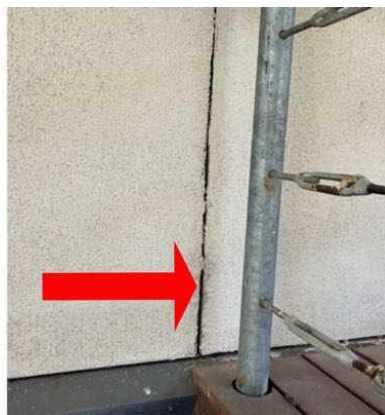
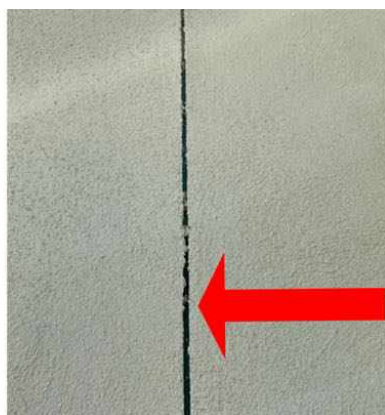
Defects 3.03

Building:	Main Building
Location:	All External Areas
Finding:	Inadequate Sealing to Expansion Joints – External Wall Cladding
Information:	The expansion joints between the external wall cladding panels on all elevations were observed to be exposed and inadequately sealed. The panel joints lack appropriate flexible sealant or compliant caulking to accommodate movement and provide effective weatherproofing.

Unsealed or poorly sealed expansion joints increase the risk of water ingress behind the cladding system, which may lead to moisture penetration, deterioration of wall framing, and potential mould growth. These openings may also provide entry points for pests and insects into the wall cavity.

It is recommended that a qualified renderer or caulking specialist be engaged to install suitable flexible sealant to all affected expansion joints in accordance with the cladding manufacturer's installation requirements. All works should ensure the joints remain flexible to accommodate thermal and structural movement while maintaining effective weatherproofing.

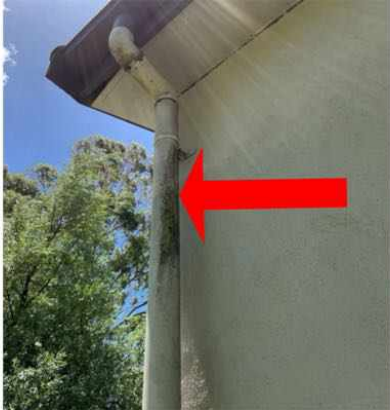
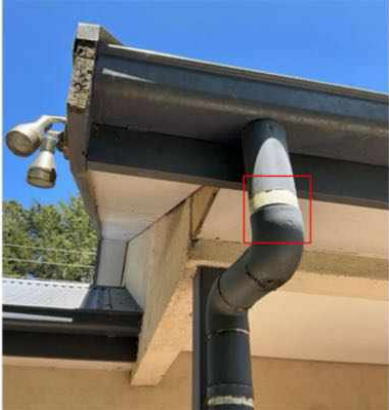
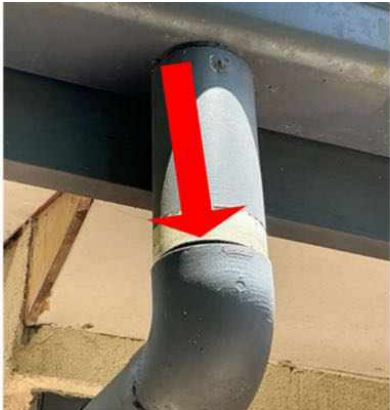
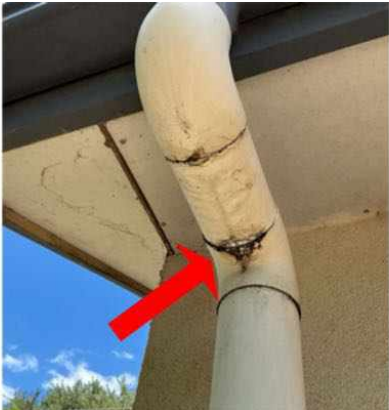
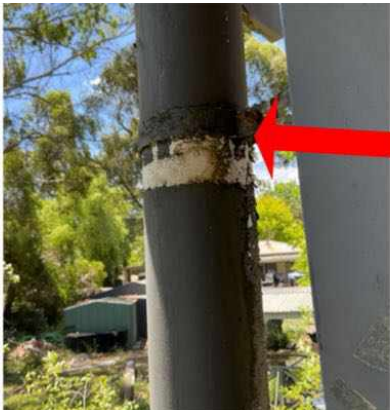
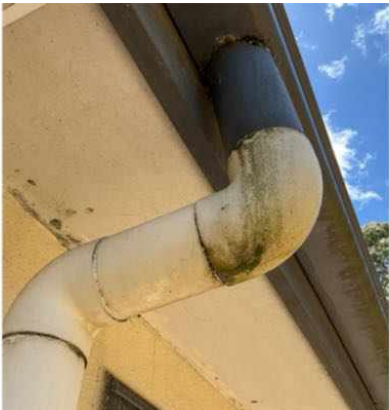
Defects 3.04

Building:	Main Building
Location:	All External Areas
Finding:	Non-Watertight Downpipe Connections
Information:	Multiple downpipes around the dwelling were observed to exhibit signs of previous water leakage, including staining and residue at joints. Several downpipe connections were noted to have small gaps, misalignments, or sections that are not fully sealed, indicating that the downpipe system is not consistently watertight. While no significant damage was evident at the time of inspection, these conditions suggest substandard jointing and/or previous movement of the downpipe components.

If left unaddressed, leaking or poorly sealed downpipes can result in uncontrolled discharge of stormwater adjacent to the building. This may contribute to moisture penetration, deterioration of external building elements, erosion at the base of walls, and increased risk of moisture-related defects over time, particularly during heavy rainfall events.

It is recommended that a licensed plumber be engaged to inspect all downpipes around the dwelling, reseal and refit defective joints, realign misaligned sections, and ensure all connections are properly secured and watertight. Any downpipes or components that cannot be adequately sealed should be repaired or replaced as required to ensure effective and compliant stormwater drainage.

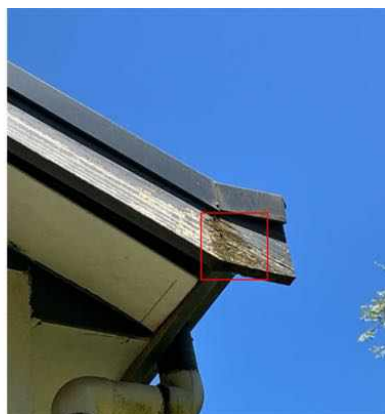
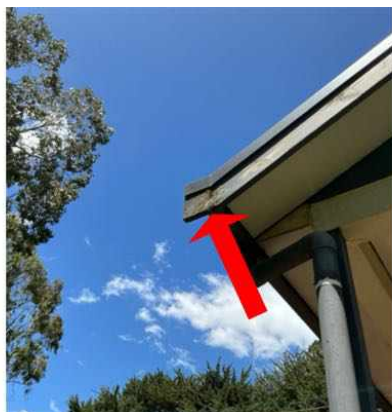
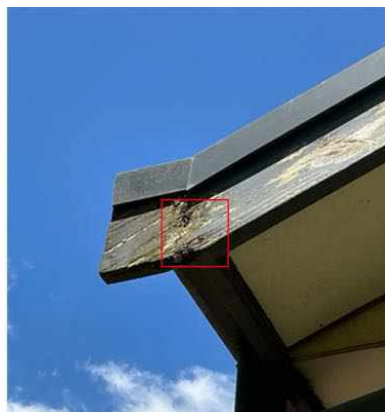
Defects 3.05

Building:	Main Building
Location:	All External Areas
Finding:	Fascias - Wood rot
Information:	Wood rot and timber deterioration was found to be affecting fascias and barges around the house, evidenced by the presence of mould on the surface in some areas. Wood rot, also known as Fungal Decay, occurs when timbers and other cellulose building materials are exposed to damp conditions on an ongoing basis.

It is likely that this wood rot has developed as a result of faults in the roof plumbing, creating excessive moisture in this areas. Frequent exposure to rain and other weather conditions also make fascias and barges susceptible to accelerated deterioration.

Early intervention and regular maintenance will prolong the useful life of these building elements. Prior to any works being performed, the cause of the moisture that has created the visible wood rot should be identified and addressed in a suitable manner.

It is advised that a roof plumber be appointed to inspect all roof plumbing and subsequently identify the cause of the wood rot. Replacement of affected fascias and barges may then be a necessary step in protecting surrounding building elements from such deterioration.

A qualified plumber may be appointed to assess the cause of excessive moisture and to provide advice on any remedial works as required. A qualified carpenter or registered builder may also be required to replace affected building materials.

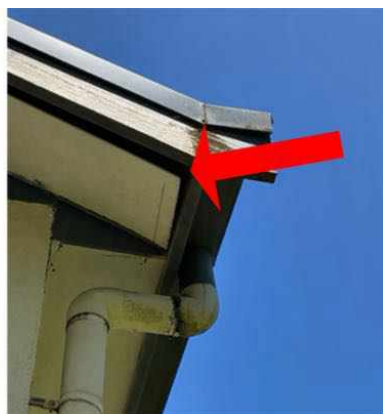
Defects 3.06

Building:	Main Building
Location:	Western/Northern elevation
Finding:	Detached and Sagging Eave Lining Sheet – Western Elevation
Information:

One eave lining sheet to the western elevation was observed to be slightly detached and sagging from its original position. The sheet appears to have loosened at its fixings, resulting in a visible deflection and an untidy finish to the eaves in this area.

If not rectified, a detached or sagging eave sheet may allow pest entry, moisture ingress, and further deterioration of the lining and associated fixings. Ongoing movement may also cause the sheet to drop further, increasing the extent of repair required and detracting from the overall presentation of the building.

It is recommended that a qualified carpenter or licensed builder be engaged to refix or replace the affected eave sheet, reinstate secure fixings, and ensure the eave lining is properly aligned and adequately supported to prevent future detachment.

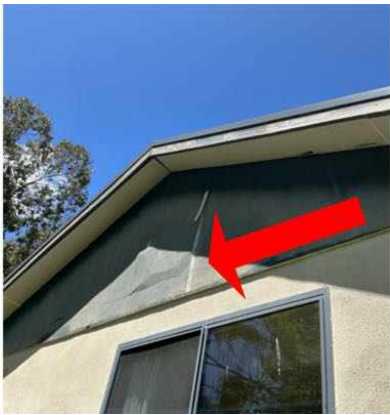
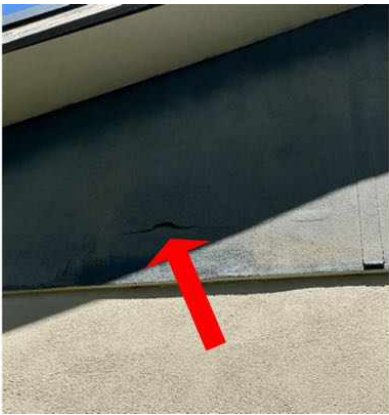
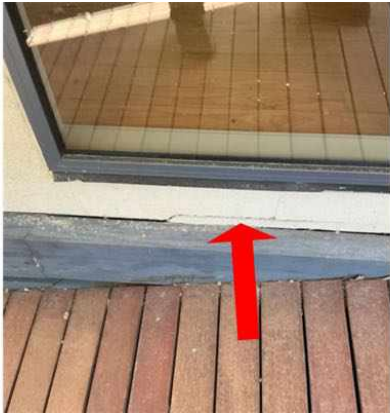
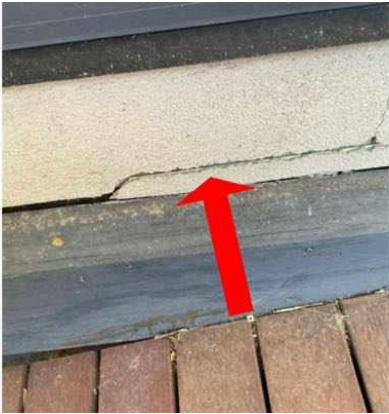
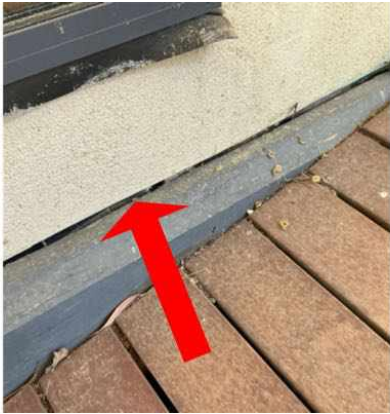
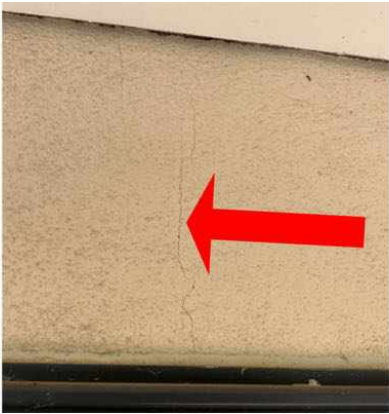
Defects 3.07

Building:	Main Building
Location:	All External Areas
Finding:	Deteriorated and Cracked Rendered External Wall Cladding
Information:

Multiple sections of the rendered external wall cladding around the dwelling were observed to be deteriorated, with cracking evident in various locations. The condition varies across the elevations, including minor hairline cracking, more pronounced cracking, and areas where cladding sheets have begun to separate, creating small gaps between panels. These defects indicate loss of continuity in the cladding system and compromise its intended performance as a weather-resistant external envelope.

Cracked or separated rendered cladding is not reliably watertight and may allow moisture ingress into the wall system. If moisture penetrates behind the cladding, it can lead to concealed damage to wall framing, insulation, and internal linings, as well as increased risk of mould growth and long-term material deterioration. Over time, unaddressed cracking may worsen due to thermal movement and weather exposure, increasing the extent and cost of repairs.

It is recommended that a qualified cladding specialist be engaged to assess all affected elevations and carry out appropriate repairs. All gaps between cladding sheets should be properly sealed using a suitable waterproof and flexible sealant, and all cracks should be professionally repaired and patched to reinstate the cladding's watertightness and improve overall appearance. Any sections of cladding that cannot be adequately repaired should be replaced as necessary to ensure ongoing durability and weather protection.

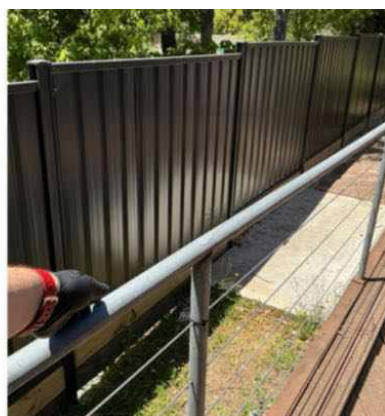
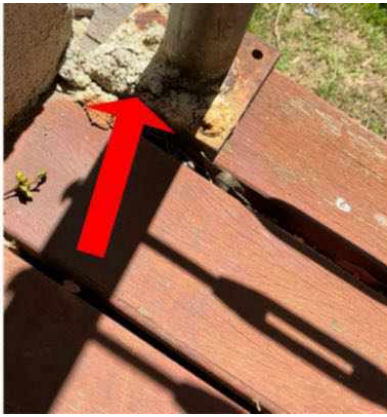
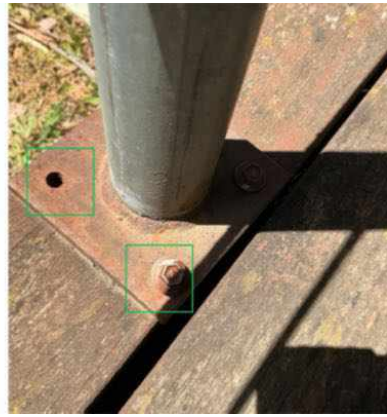
Defects 3.08

Building:	Main Building
Location:	Deck
Finding:	Unstable Deck Balustrade and Associated Subfloor Deterioration
Information:

The balustrade to the external decking area was observed to be unstable and flimsy at the time of inspection. Further inspection identified that several fixing screws to the balustrade were corroded, with some screws missing or no longer adequately secured. This has reduced the overall stability and effectiveness of the balustrade as a safety barrier.

The instability of the balustrade also appears to be contributed to by deterioration and timber decay to the subfloor structural elements beneath the decking. The compromised condition of the supporting subfloor timbers is likely reducing the capacity of the structure to adequately support the balustrade fixings, further affecting its stability.

It is recommended that a suitably qualified carpenter or registered builder be engaged to carry out a detailed assessment of the decking, balustrade, and supporting subfloor structure. Remedial works may include replacement of corroded or missing fixings, repair or replacement of deteriorated subfloor timbers, and strengthening or rebuilding sections of the balustrade as required to restore adequate stability and safety.

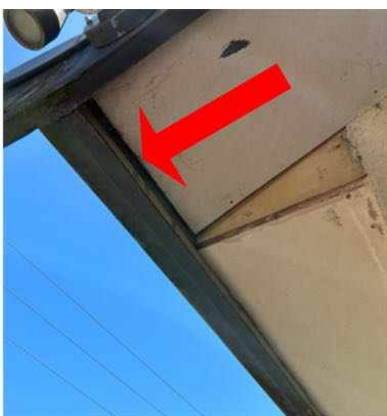
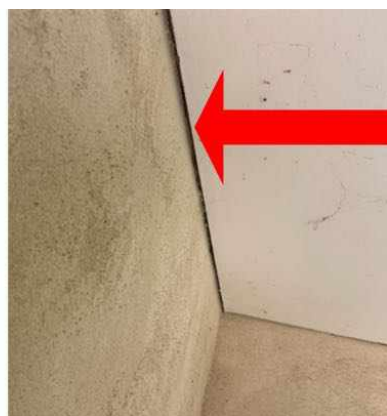
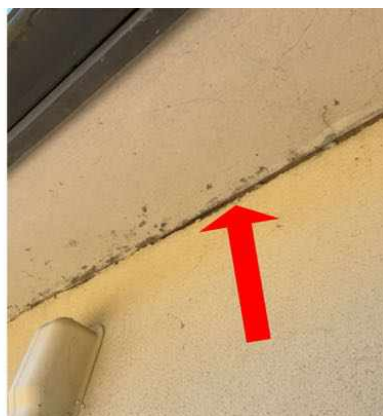
Defects 3.09

Building: Main Building
 Location: All External Areas
 Finding: Missing and Inadequate Sealant to External Junctions
 Information:

The property was observed to have inadequate and missing sealant in multiple areas around the exterior at the time of inspection. Affected areas include, but are not limited to, eaves junctions, edges, joints, and corners, where visible gaps were noted. These areas appear to have either insufficient sealant application or no sealant present at all.

Gaps and unsealed junctions reduce the weather-tightness of the building envelope and may allow wind-driven rain, moisture, dust, and pests to enter the building and roof space. Over time, this may contribute to moisture ingress, deterioration of building materials, and an increased risk of vermin or pest infestation within the roof void and wall cavities.

It is recommended that a suitably qualified caulking or sealing specialist be engaged to thoroughly inspect all external edges, joints, corners, and penetrations and to apply appropriate external-grade sealant where required. All sealing works should be completed to ensure the building envelope and roof space are made as watertight and well-sealed as reasonably practicable, reducing the risk of moisture ingress and pest entry.

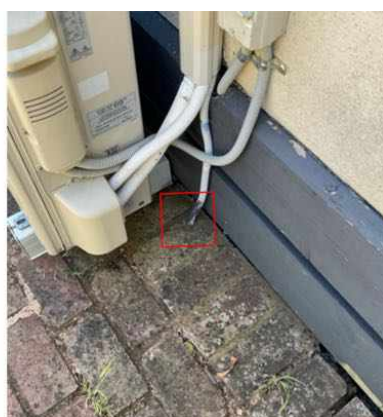
Defects 3.10

Building:	Main Building
Location:	Exterior walls - front
Finding:	AC Overflows - Not plumbed to suitable drainage
Information:	Upon inspection, it was found that the AC overflow is not plumbed or connected to suitable drainage. This could lead to the surrounding area becoming excessively damp, which in turn may cause secondary defects such as rot, rust, corrosion of associated building elements, and the formation of fungal decay. In addition, prolonged damp conditions could create potential slip hazards. Poor site drainage may exacerbate the issue, potentially attracting termite activity to the area.

We recommend that a licensed plumber be appointed to properly plumb the AC overflow and connect it to suitable drainage. This will help ensure that the area remains dry and free from secondary defects.

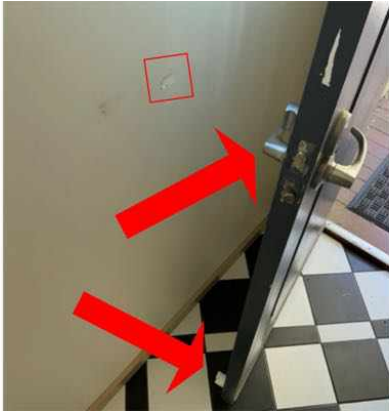
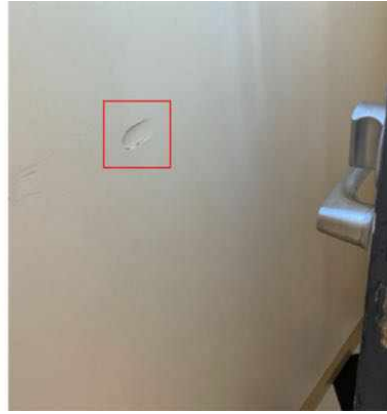
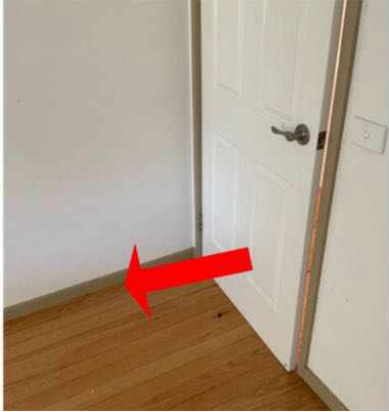
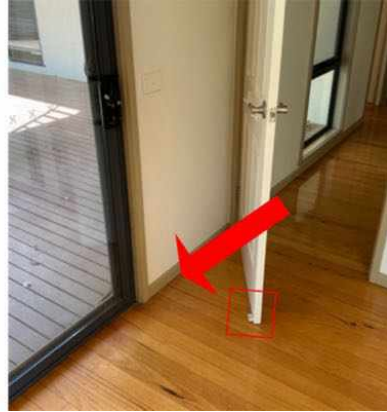
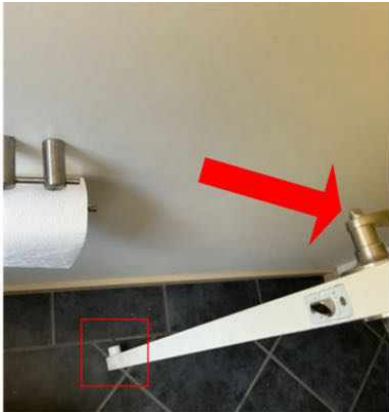
Defects 3.13

Building:	Main Building
Location:	All Internal Areas
Finding:	Missing Door Stoppers to Multiple Internal Doors
Information:	Several internal doors throughout the property were found to be missing door stoppers. Door stoppers are essential to prevent door handles or doors themselves from striking and damaging adjacent walls or finishes during normal use.

The absence of door stoppers increases the risk of impact damage to wall linings, paintwork, and door hardware, potentially leading to ongoing maintenance issues.

It is recommended that a suitably skilled handyman or carpenter install appropriate door stoppers to all affected doors to protect surrounding surfaces and ensure safe, controlled door operation.

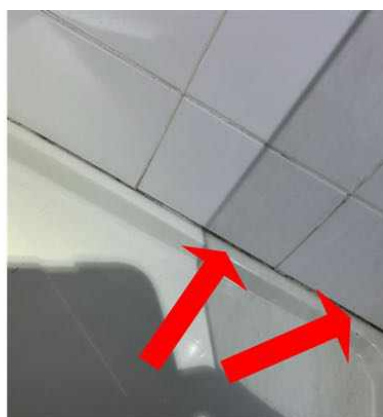
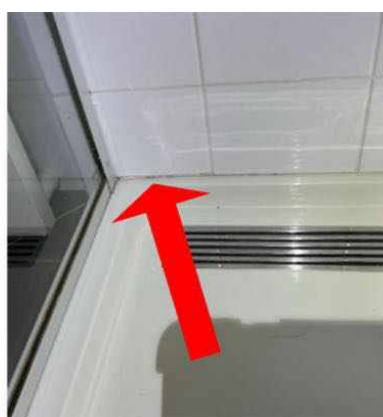
Defects 3.15

Building: Main Building
Location: Bathroom

Finding: Sealant and grouting - Deteriorated
 Information: It was noted on inspection that sealant or grout is degraded to the tiled shower alcove and or other areas of the bathroom.

Different materials and floor areas move at different rates, generally causing cracking to grout or sealant at this point. A flexible sealant is required to allow for expected expansion and contraction, while keeping the joint water tight and protective of all associated building materials.

Flexible and mould resistant materials should be applied to affected areas to prevent any subsequent water damage that is likely to occur. Regular maintenance and replacement of damage or missing or damaged sealant and grout is highly recommended to the wet areas, as this is a regular wear and tear defect. Sealant and grouting in areas that come into regular contact with water should be maintained for the long term care of your property.

A sealant specialist or tiling contractor should be appointed to complete these works as soon as possible

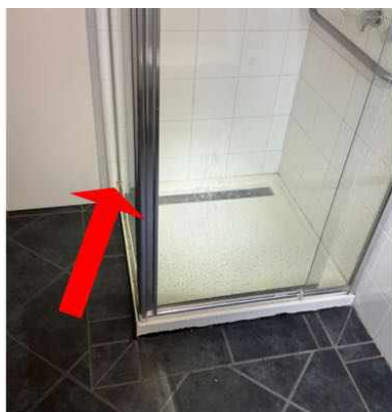
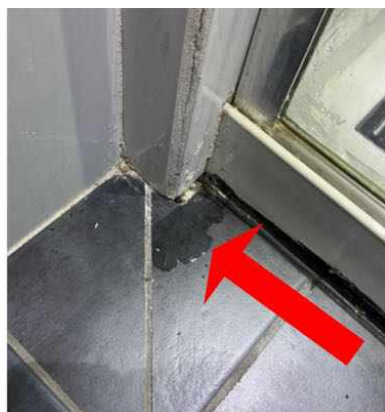
Defects 3.16

Building: Main Building
 Location: Bathroom
 Finding: Shower screen - Leaking

Information: Leaking was evident to the shower screen at the time of inspection. It is suspected that the leaking has occurred as a result of deteriorated or missing caulking to the shower or general ageing of the building elements.

Leaking from the shower where left unattended, is likely to lead to water damage to adjoining flooring and walls. Such damage can lead to water damage and necessitate extensive remedial works being required. Active water leaks may also create an environment that is susceptible to the formation and development of mould.

Appointment of a caulking contractor is required to repair or replace the caulking to the shower area. Such works should be performed as soon as possible to ensure that no further damage occurs.

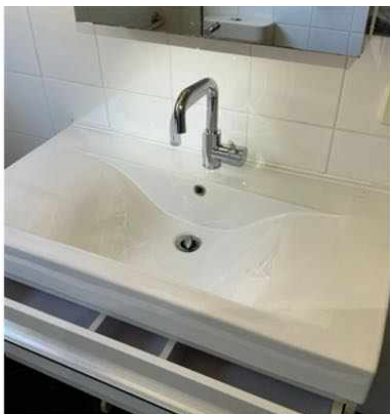
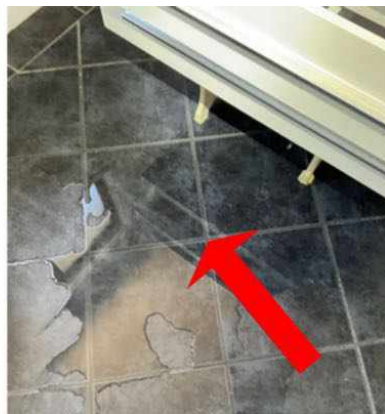
Defects 3.17

Building: Main Building
 Location: Bathroom
 Finding: Bathroom sink plumbing pipes - Leaking
 Information: The plumbing pipes in the bathroom sink were found to be leaking at the time of inspection.

This is a common defect that is consistent with general ageing of the building element. However, it may be indicative of substandard plumbing workmanship if the tap is relatively new.

While this defect only seems minor, if left unmanaged, it is likely to result in the development of rust, water damage and/or extensive water usage.

It is advised that a handyman or licensed plumber be appointed to perform remedial works on the affected tap. Such works should be performed prior to the development of secondary defects to ensure adequate functionality of all associated building elements

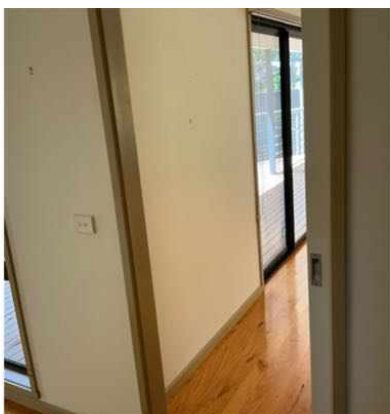
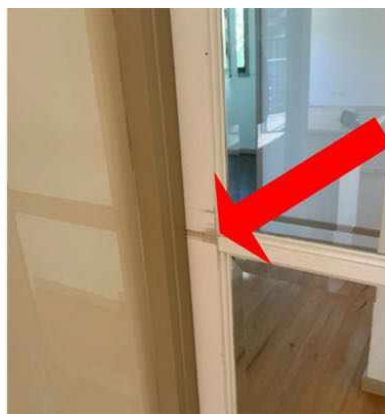
Defects 3.18

Building: Main Building
 Location: Kitchen/Hallway
 Finding: Misaligned Sliding Door – Kitchen to Hallway
 Information:

The sliding door between the kitchen and the hallway was observed to be misaligned at the time of inspection. The door is stiff to operate and does not slide smoothly within its cavity. Evidence of friction between the door leaf and the internal wall cavity was noted, resulting in visible scratching to the door surface.

A misaligned sliding door can lead to ongoing wear and damage to the door leaf, track, rollers, and surrounding wall cavity lining. Continued friction may worsen the scratching, reduce the service life of the door components, and eventually result in jamming or failure of the sliding mechanism.

It is recommended that a suitably qualified handyman or carpenter be engaged to realign the sliding door, adjust or service the rollers and track as required, and ensure the door operates smoothly without contact with the wall cavity. Any damaged finishes should be repaired as necessary after realignment.

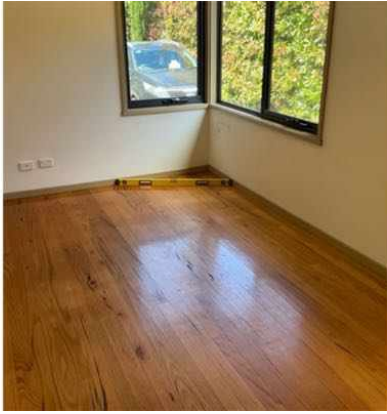
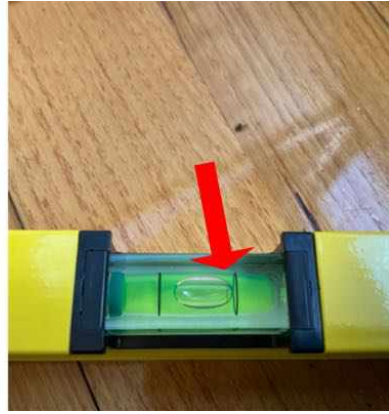
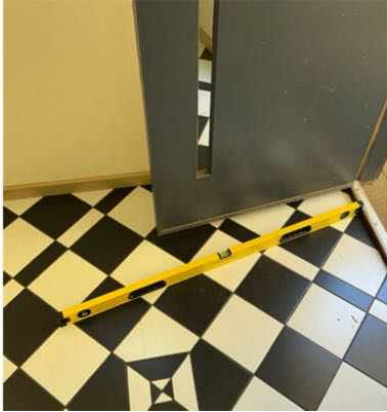
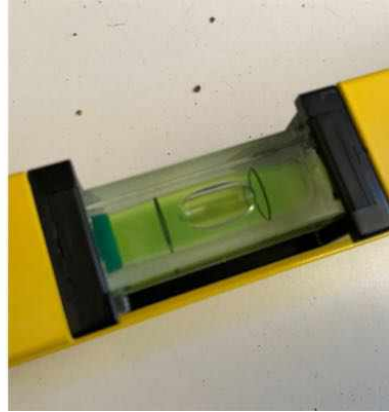
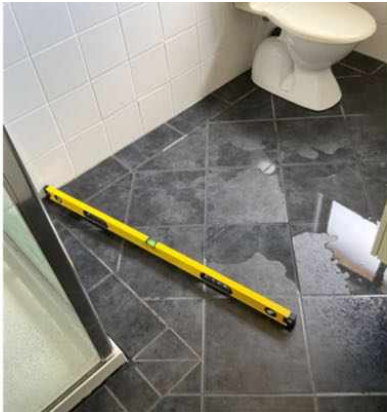
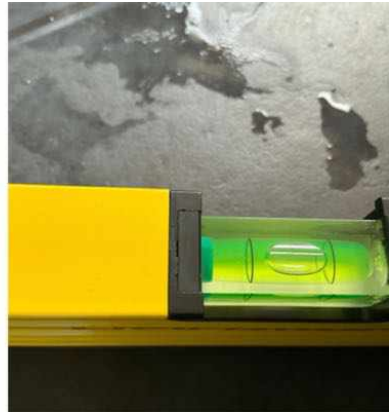
Defects 3.19

Building: Main Building
 Location: All Internal Areas
 Finding: Flooring - Uneven
 Information:

The internal flooring was observed to be uneven and out of level at the time of inspection, with measured variations of approximately 4–5 mm in multiple areas. This degree of unevenness may be consistent with minor defects such as normal or expected movement of the building foundations over time; however, it may also indicate movement or settlement of the associated subfloor structure and stumps.

Uneven flooring can affect the performance, appearance, and usability of floor finishes and may be an early indicator of subfloor movement. While minor and relatively uniform level variations are often associated with age-related settlement, any progression beyond the observed tolerances may indicate subsidence or deterioration of subfloor stumps, which could lead to more significant structural issues if left unaddressed.

It is advised that the flooring be closely monitored over several months to identify any ongoing or progressive movement. If the floor levels remain relatively unchanged during this period, the condition is likely attributable to expected foundation movement. However, if further unevenness is noted, a more detailed and potentially invasive inspection of the subfloor structure and stumps should be undertaken. In such circumstances, rectification works may be required and should be carried out by a registered builder experienced in re-stumping and subfloor rectification.

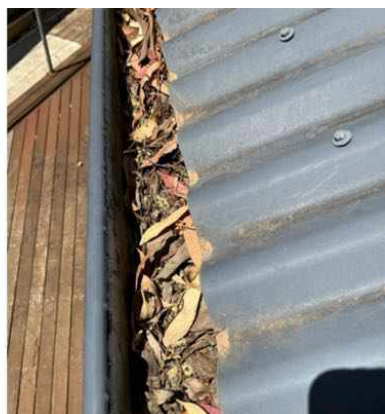
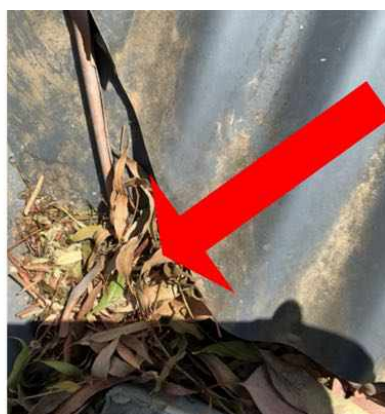
Blocked gutters are likely to lead to high levels of moisture in the affected areas. Such moisture will not only cause rust and decay of the associated building materials, but can also provide conditions that are conducive to termite and timber pest activity. Blockages in gutters should therefore be removed immediately to ensure dry conditions are maintained.

Consult a Licensed Plumber for further specific advice on remedial works that may be required. In the interim, it is highly advised that blocked gutters be removed by the homeowner or a general handyperson as a matter of urgency.

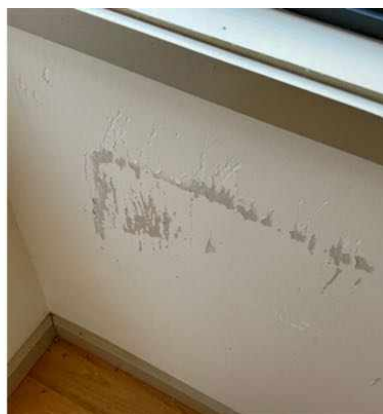
Defects 3.21

Building:	Main Building
Location:	Living Room
Finding:	Deteriorated Internal Paint Finish – Living Area Wall Below Window
Information:

The internal wall surface below the window in the living area shows deterioration to the paint finish, including peeling, flaking, and localised delamination. This condition was visible at the time of inspection and affects the appearance and finish of the internal wall lining.

Deteriorated paint finishes in this location reduce the overall presentation of the room and may continue to worsen over time if not addressed, potentially leading to further

flaking and damage to the underlying surface finish.

It is recommended that a suitably qualified painter or handyman prepare the affected wall surface by removing loose and flaking paint, lightly sanding and sealing the area as required, and repainting the wall using an appropriate internal paint system to restore an acceptable finish.

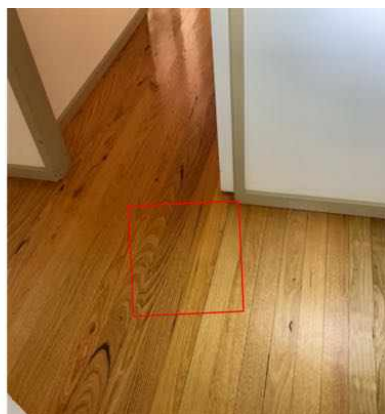
Defects 3.22

Building: Main Building
 Location: Hallway
 Finding: Squeaking Timber Flooring – Localised Areas
 Information:

The timber flooring in the areas shown was observed to produce squeaking noises when walked on. This condition is commonly associated with normal movement within the flooring system, including minor movement of the subfloor structure and/or localised inadequate fixing of the floorboards to the subfloor.

Squeaking floors are generally considered a convenience or amenity issue rather than a structural defect. At the time of inspection, no evidence was noted to suggest that this condition is indicative of a structural failure or a significant defect affecting the integrity of the floor system.

If the squeaking is of concern to the occupants, a suitably qualified carpenter or flooring contractor may be engaged to investigate and carry out localised repairs, such as re-fixing or tightening affected boards. Otherwise, the condition may be monitored as part of normal building movement and wear over time.

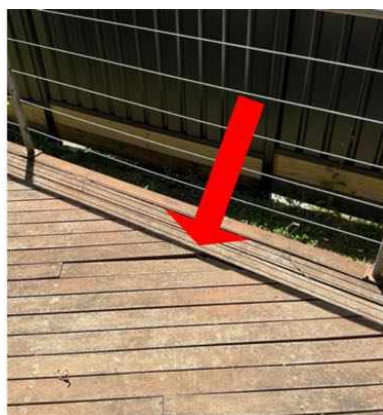
Defects 3.24

Building: Main Building
 Location: Deck
 Finding: Inadequate Support to Decking – Localised Bouncy Areas
 Information:

Several localised areas of the external decking were observed to feel bouncy and inadequately supported when walked on at the time of inspection. These sections exhibited noticeable deflection under normal foot traffic, indicating that the decking does not provide a firm or stable walking surface in those areas.

Bouncy or deflecting decking typically indicates insufficient support from the underlying substructure, which may be due to deterioration, inadequate fixings, or insufficient spacing of supporting members beneath the decking. If left unaddressed, this condition may worsen over time and increase the risk of further deterioration or potential safety concerns.

It is recommended that a suitably qualified carpenter or registered builder be engaged to assess the affected decking areas and the supporting substructure beneath. Rectification works may include strengthening or replacing supporting members and re-fixing the decking boards as required to restore adequate support and stability.

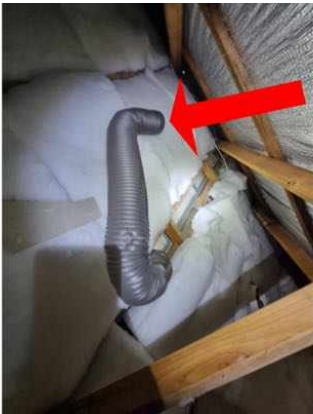
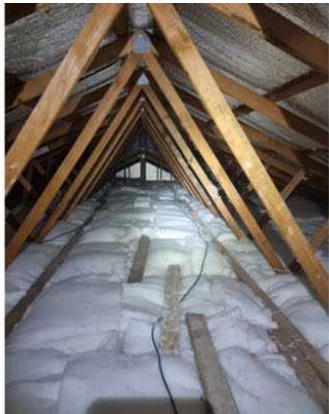
Defects 3.26

Location: Roof Void
Finding: Bathroom and kitchen Exhaust Fans Not Ducted to External Atmosphere
Information: The exhaust fans installed in the bathroom, WC and the kitchen rangehood were observed to be discharging directly into the roof cavity rather than being ducted to the external atmosphere. This configuration does not comply with best practice ventilation standards, as it allows moist air to accumulate within the roof space.

Prolonged moisture build-up in the roof cavity can lead to elevated humidity levels, which may contribute to mould growth, timber decay, and potential damage to insulation or other roof components over time.

It is recommended that a licensed ventilation specialist or electrician be engaged to install compliant ducting that vents the exhaust air to the outside of the building, in accordance with current building regulations and ventilation standards.

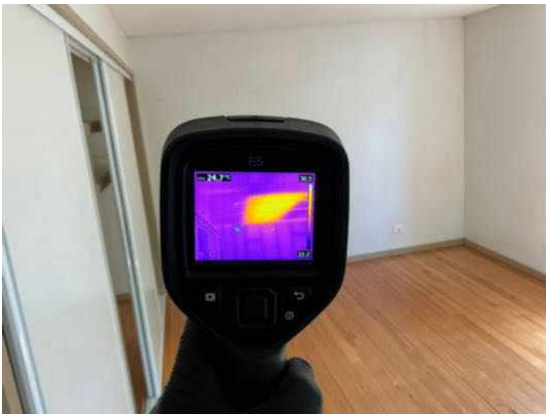
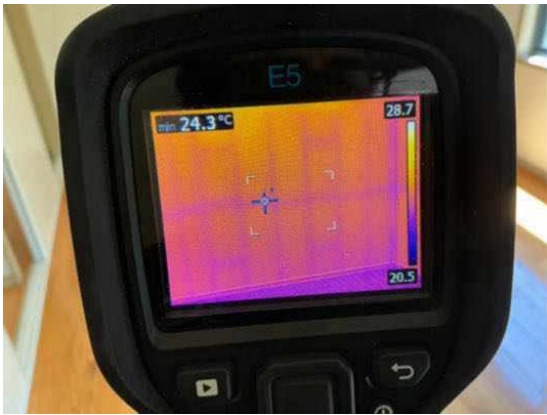
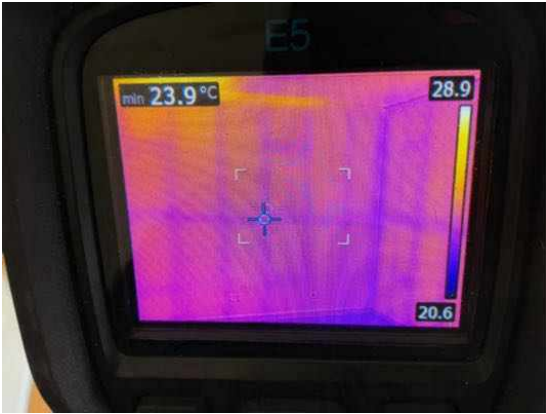
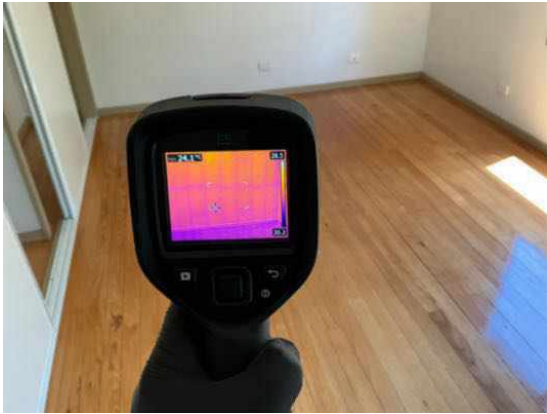
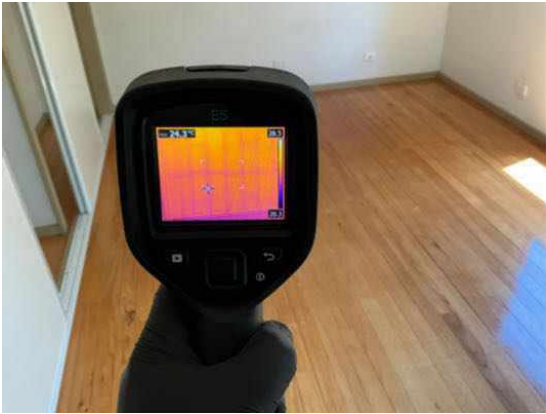
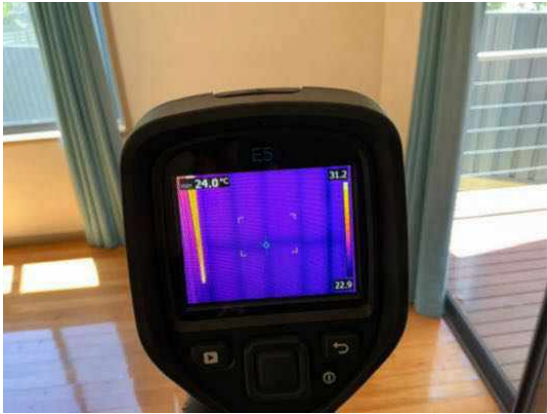
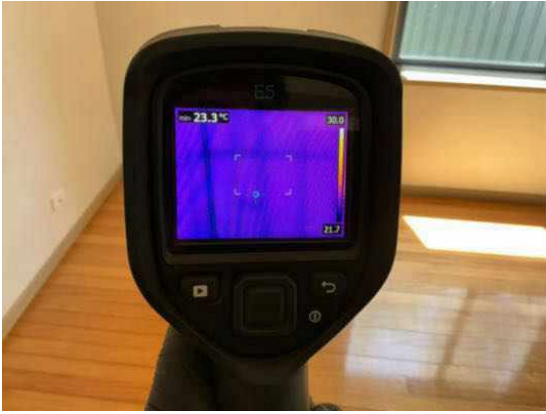
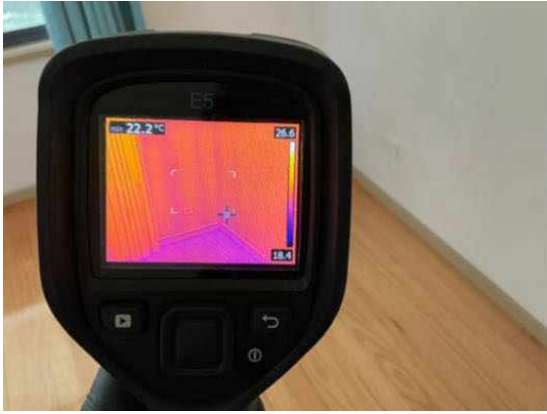
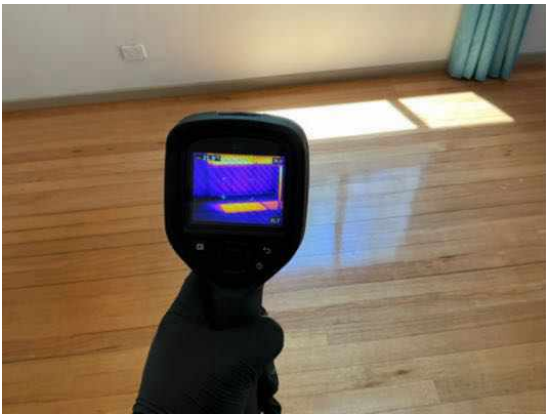
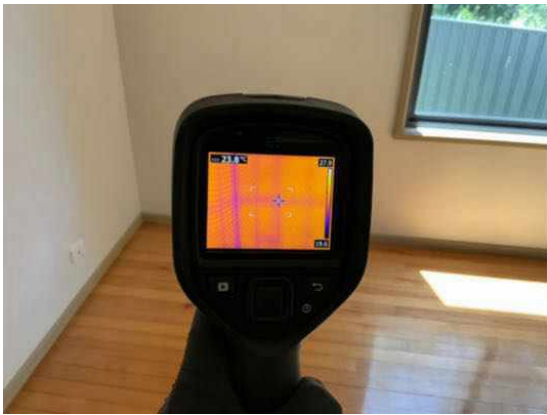
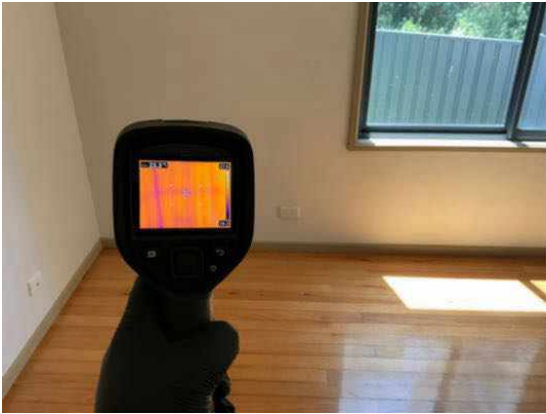
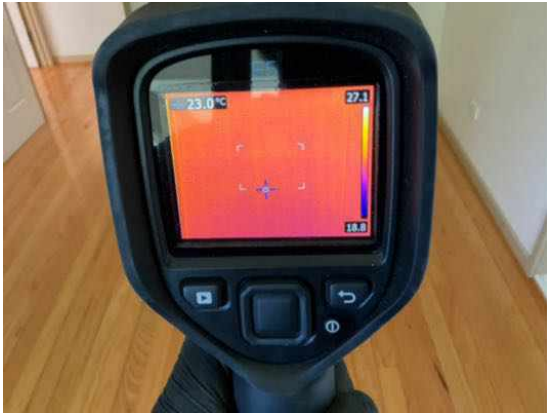
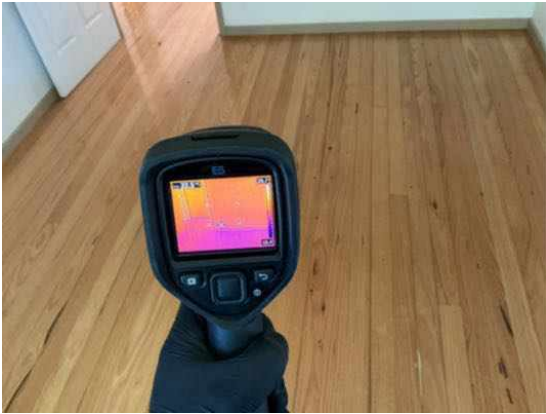
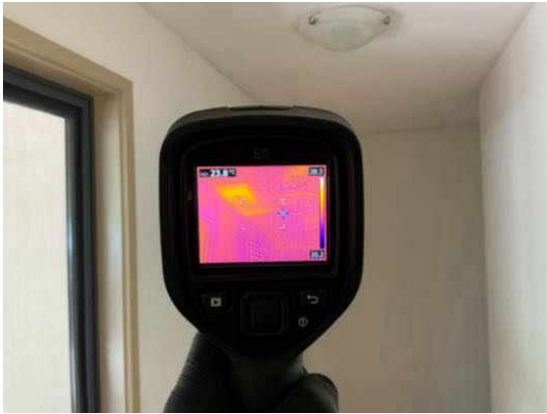
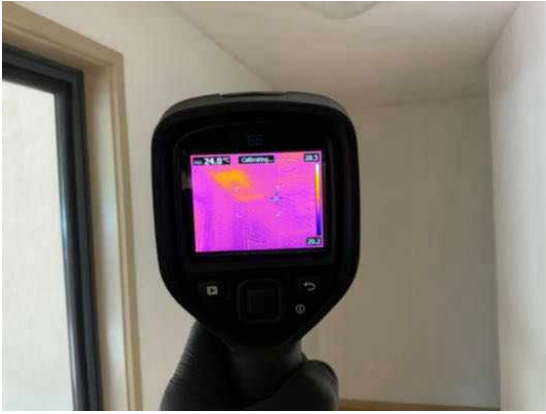
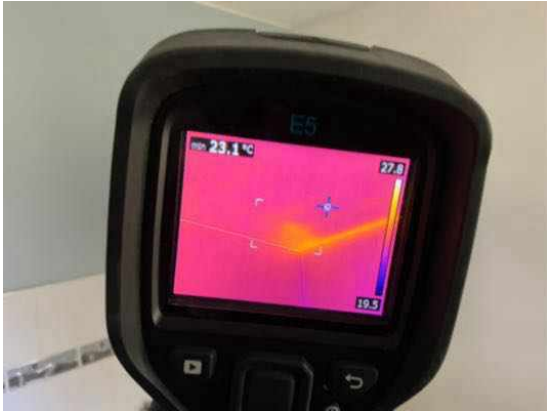
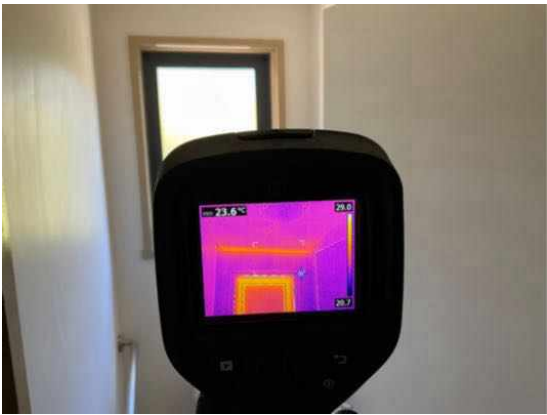
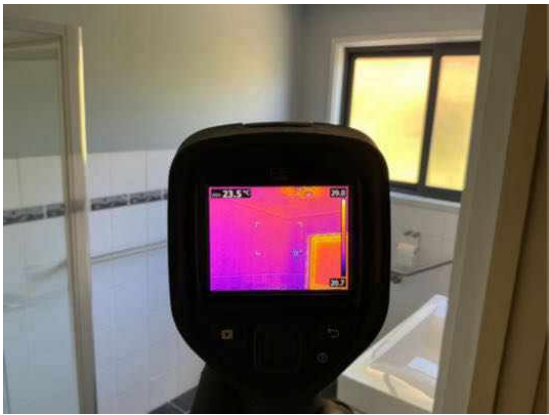
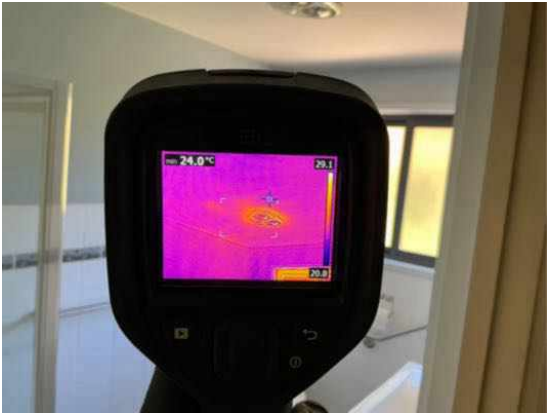
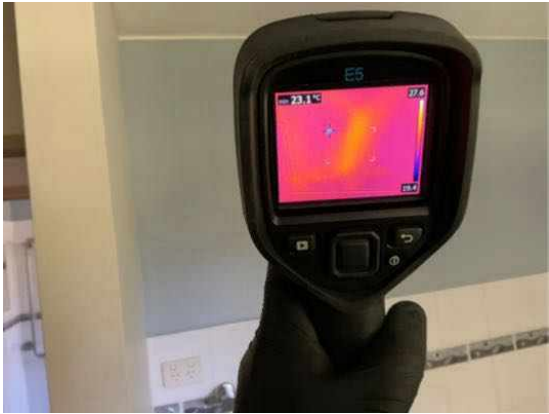
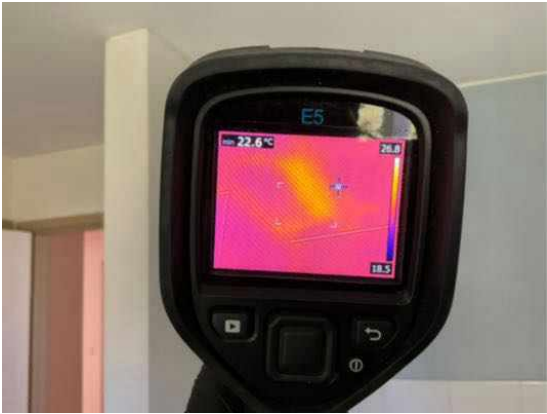
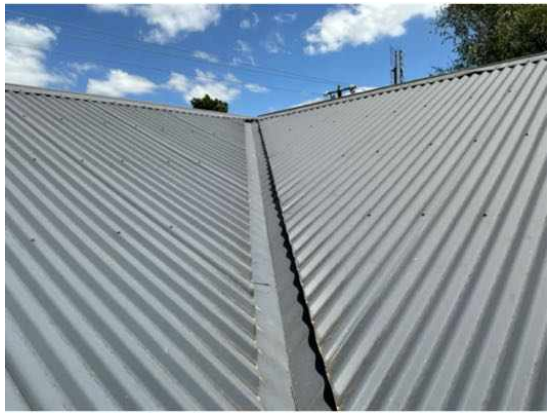
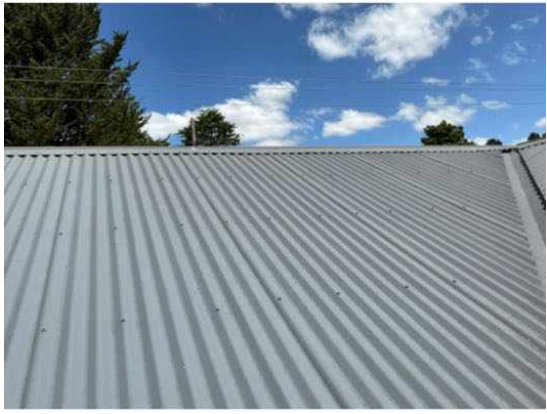
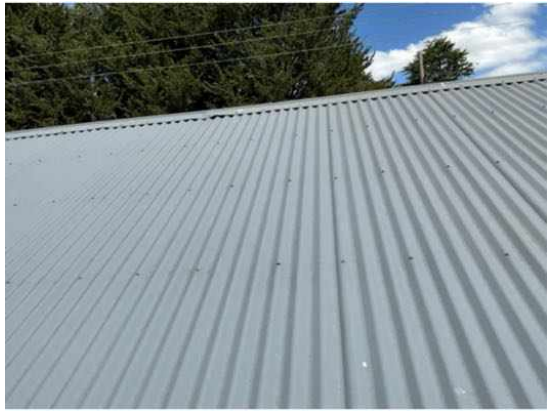
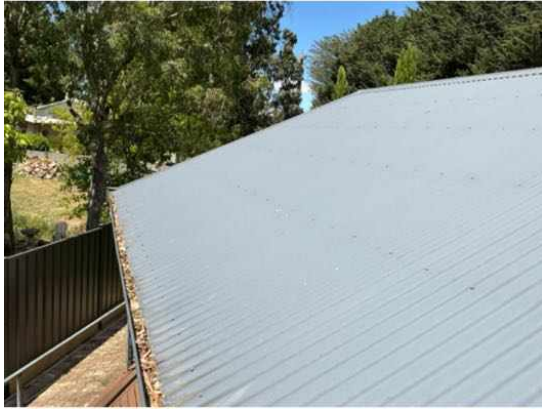
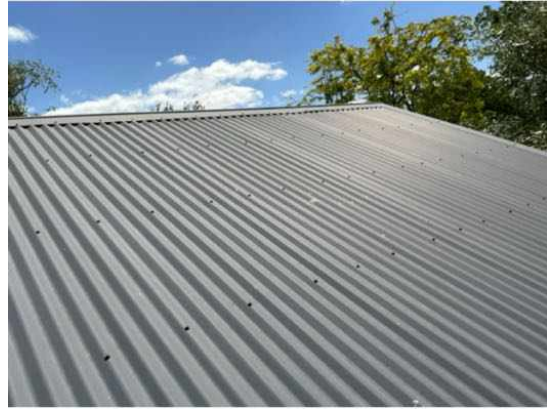
Building: Main Building
 Location: All Internal Areas
 Finding: Obstructions and Limitations - Interior
 Information: These photographs are an indication of the obstructions and limitations which impeded the inspection of the internal areas of the property at the time of inspection. These obstructions can hide an array of defects and should be removed to allow full inspection to be carried out. A re-inspection is recommended once the areas are made accessible.
