## Building Inspection Report

Inspection Date: Fri, 27 Feb 2026

Property Address: 20 Deoro Parade, Clyde North VIC 3978,  
Australia

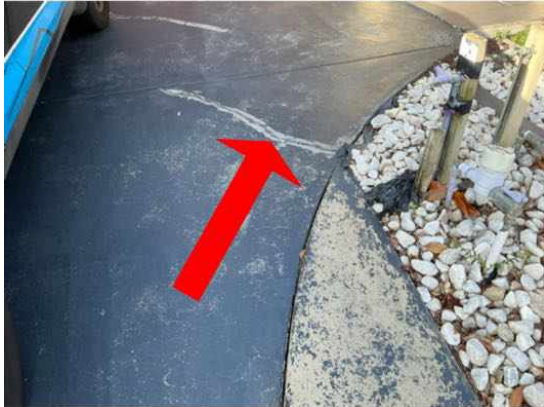
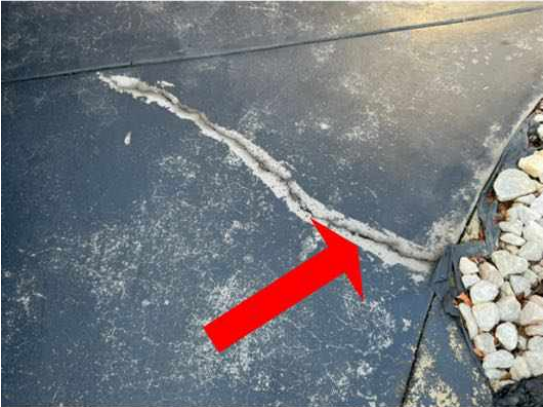
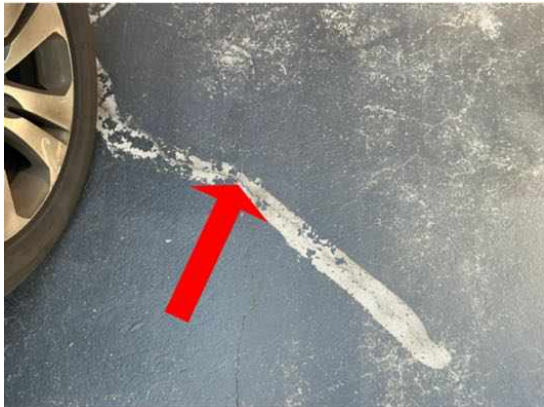
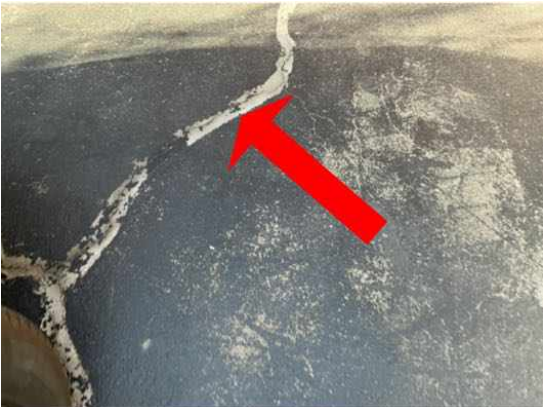
Defects 3.02

Building: Main Building  
Location: All External Areas  
Finding: Cracking - External Concrete Paving and Driveway Damage Category 2 - Distinct (less than 3mm)  
Information: Distinct cracks were identified in external concrete paving and driveway. Distinct cracks are generally found in older concrete paving, and may also present as a trip hazard as consequence of an uneven or curved surface.

General age and expected deterioration of the paved areas is a common cause of this type of cracking. However, expansion and contraction of the slab may also have occurred due to environmental factors. Such factors include variable moisture and weather conditions, the presence of trees and their roots having a settling or lifting affect on the soil, or the effect of load bearing, e.g. heavy vehicles over a sustained period of time.

Cracking to this degree may also be due to poor original installation of the concrete. Factors such as poor compaction of the sub surface and/or inadequate reinforcing of the slab may create cracking and other secondary defects.

Repairs are likely to be required to prevent further cracking and to reduce hazards associated with cracking, such as tripping. Monitoring of all cracking should be conducted frequently. Always contact a building inspector should cracks widen, lengthen, or become more numerous.

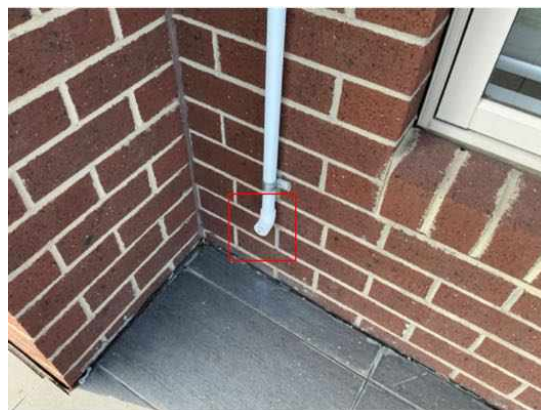
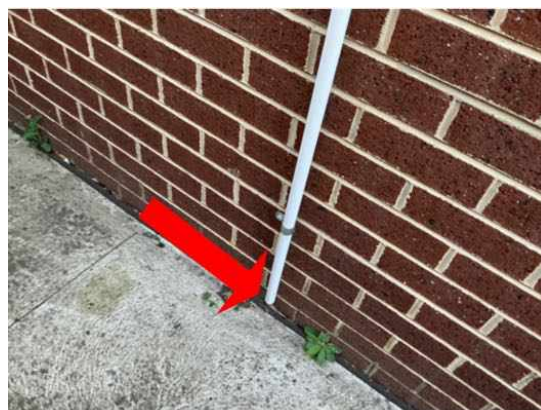
### Defects 3.03

Building:	Main Building
Location:	All External Areas
Finding:	AC Overflows - Not plumbed to suitable drainage
Information:	Upon inspection, it was found that the AC overflow is not plumbed or connected to suitable drainage. This could lead to the surrounding area becoming excessively damp, which in turn may cause secondary defects such as rot, rust, corrosion of associated building elements, and the formation of fungal decay. In addition, prolonged damp conditions could create potential slip hazards. Poor site drainage may exacerbate the issue, potentially attracting termite activity to the area.

We recommend that a licensed plumber be appointed to properly plumb the AC overflow and connect it to suitable drainage. This will help ensure that the area remains dry and free from secondary defects.

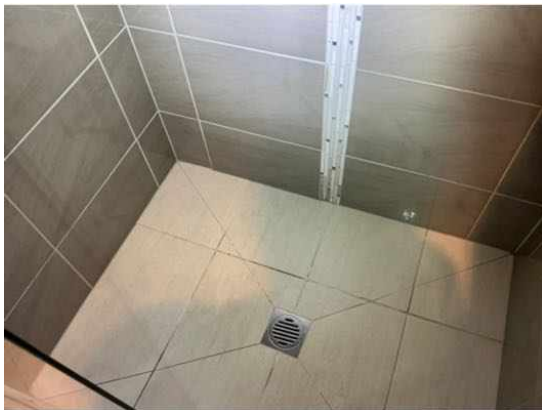
### Defects 3.07

Building:	Main Building
Location:	Ensuite - Master
Finding:	Shower - Damp
Information:	Damp is evident to the lower 300mm of wall to the shower alcove. This defect is quite common, and is suspected to have been caused by moisture permeating through the grouting in this area, which shows evidence of deterioration. Leaking pipes within the

adjoining wall is also a possible cause.

Damp (or structural damp) refers to the presence of unwanted moisture in the structure of a building, either as the result of intrusion from outside, or condensation from within the structure. In the shower area, internal water leaks or other sources of excessive moisture are generally the cause of damp.

Unmanaged damp in the shower recess is likely to facilitate the formation and development of mould and fungi growth, decaying associated building materials and compromising their structural integrity. It is important to address damp conditions, as the World Health Organisation notes that excess moisture leads - on almost all indoor materials - to growth of microbes such as moulds, fungi and bacteria, which subsequently emit spores and other matter into the indoor air. Exposure to these contaminants is associated with a wide range of respiratory and other health-related problems.

Consultation with a qualified plumber or bathroom specialist is advised immediately to identify the cause of damp and to perform remedial works as required. Where excessive mould growth is present, further inspection by a specialist environmental health inspector should also be considered.

Always ensure that sealant and grout is in good condition to prevent any moisture issues occurring in the future.

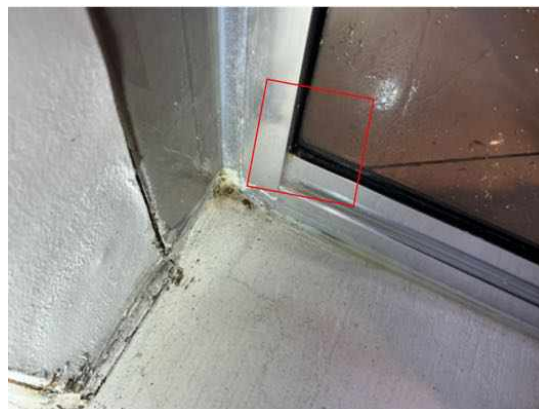
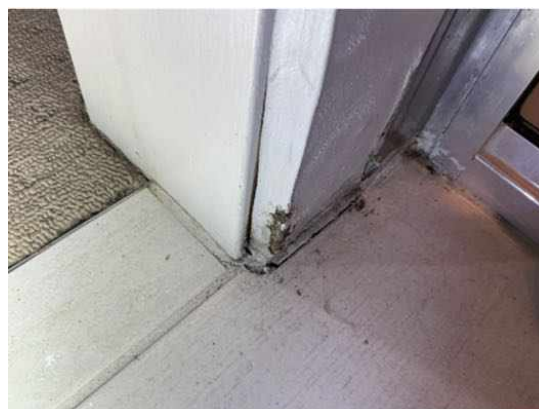
### Defects 3.09

Building:	Main Building
Location:	Ensuite - Master
Finding:	Shower screen - Leaking
Information:	Leaking was evident to the ensuite shower screen at the time of inspection. It is suspected that the leakage has occurred as a result of deteriorated and/or missing caulking to the shower screen junctions or general ageing and breakdown of sealing materials to the shower enclosure.

Leaking from the shower, if left unattended, is likely to lead to moisture ingress into adjoining flooring and wall components. Prolonged exposure to moisture can result in deterioration of building materials, swelling of timber elements, damage to finishes, and may necessitate extensive remedial works. Active moisture conditions may also create an environment conducive to mould growth.

In addition, the lower section of the adjacent door frame was observed to exhibit signs of previous moisture-related deterioration. The base of the frame appears to have sustained water damage, which is likely associated with ongoing or historical water escape from the shower screen area, or possible water ponding against the door

frame over time.

It is recommended that a qualified caulking contractor be engaged to remove and replace all deteriorated sealant to the shower screen and surrounding junctions to ensure proper waterproof sealing. These works should be undertaken without delay. Furthermore, a qualified carpenter should be consulted to assess the condition of the lower section of the door frame and undertake repairs as required, which may include cutting back damaged timber, repairing or replacing the affected section, followed by appropriate sealing and repainting to prevent recurrence.

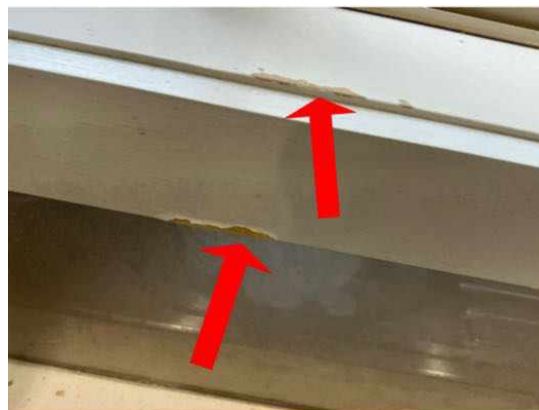
### Defects 3.10

Building: Main Building  
 Location: Kitchen  
 Finding: Kitchen Window Sill – Minor Timber Deterioration  
 Information:

At the time of inspection, minor deterioration to the timber window sill within the kitchen area was observed. The affected area appears to exhibit slight surface wear and localised finish breakdown, likely resulting from repeated water splash exposure from the adjacent kitchen sink over time.

While the deterioration is considered minor and primarily cosmetic in nature at this stage, continued moisture exposure may contribute to progressive timber degradation if not maintained.

It is recommended that the affected timber surface be lightly sanded, allowed to dry thoroughly, and refinished with an appropriate moisture-resistant primer and paint system. Ongoing care should be taken to minimise water splash onto the sill to prevent recurrence.

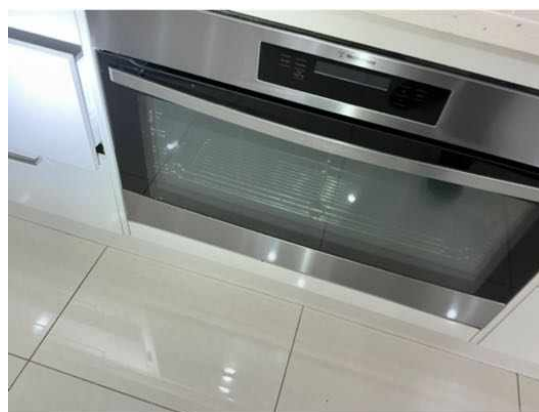
### Defects 3.11

Building: Main Building  
 Location: Kitchen  
 Finding: Oven – Inoperable at Time of Inspection  
 Information:

An inoperable oven may indicate an electrical supply issue, internal component fault, control failure, or general appliance malfunction. Without further diagnostic testing, the exact cause of the issue cannot be determined.

It is recommended that a qualified electrician or licensed appliance technician be engaged to investigate the fault, confirm the cause of non-operation, and undertake repairs or replacement as required.

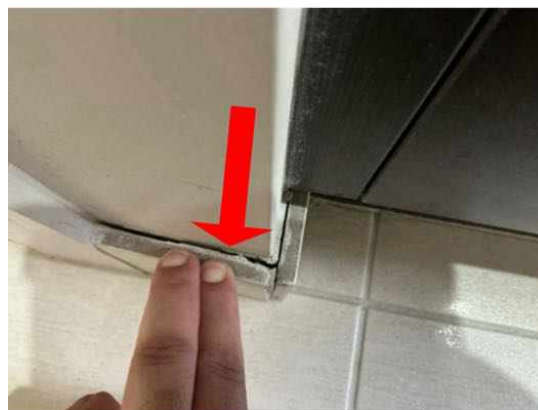
### Defects 3.13

At the time of inspection, one skirting tile to the laundry floor perimeter was observed to have detached and come away from the wall. The tile was no longer bonded in position, indicating localised adhesive failure.

Although the defect is minor in extent, detached tiles can present a sharp edge hazard and may allow moisture to penetrate behind the wall lining if left unaddressed.

It is recommended that a qualified tiler be engaged to re-fix or replace the affected skirting tile, ensuring appropriate surface preparation and bonding to prevent recurrence.

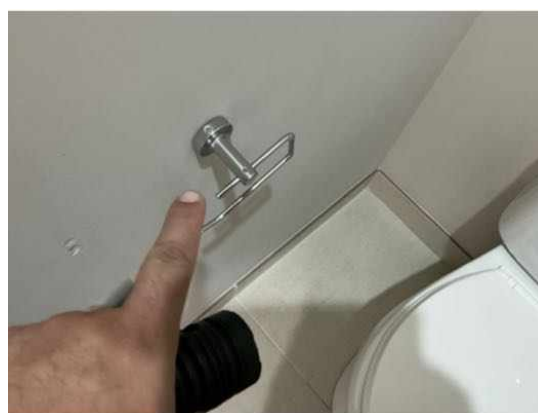
### Defects 3.14

Building:	Main Building
Location:	Toilet (WC)
Finding:	Toilet roll holder - Loose
Information:	The toilet roll holder was found to be loose at the time of inspection. While not a major operational defect, function can deteriorate if the problem is left unmanaged.

It is advised that the homeowner performs remedial works to re-attach the toilet roll holder to its original fixing. A general handyperson may be required to perform these works.

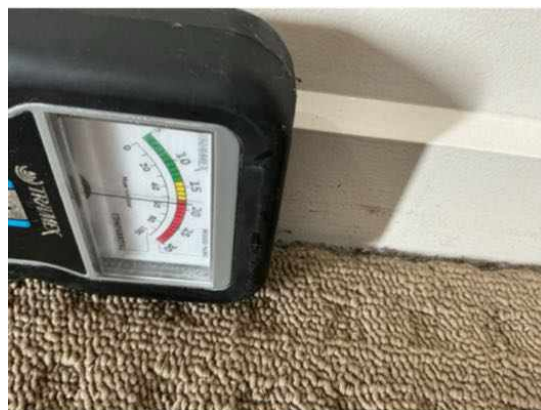
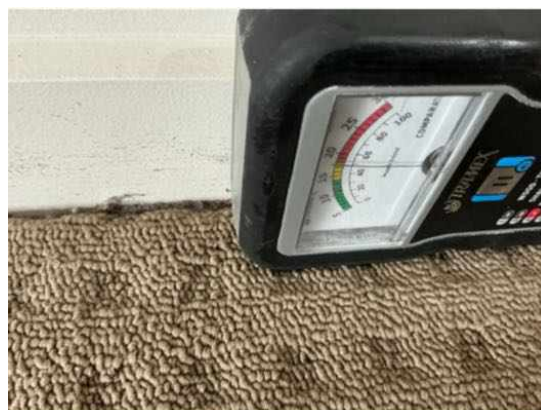
### Defects 3.18

Building:	Main Building
Location:	Bedroom - Master
Finding:	Master Ensuite – Elevated Moisture Readings to Skirting Board
Information:

Persistently elevated moisture levels within wall linings and skirting components may lead to deterioration of timber elements, swelling, material breakdown, and potential mould development if not rectified.

It is recommended that a licensed plumber be engaged to undertake further investigation, which may include invasive inspection as required, to determine the root cause of the moisture ingress. Following identification of the source, appropriate rectification works should be carried out to prevent further damage.

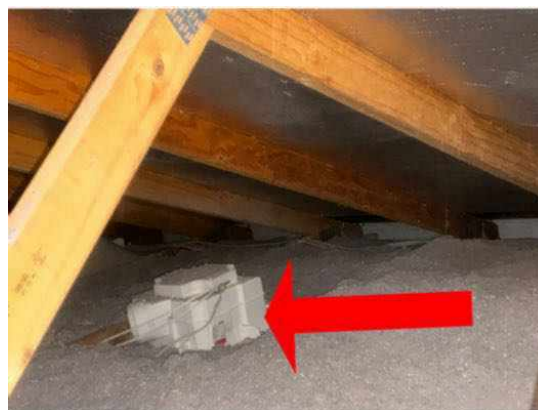
### Defects 3.19

Building:	Main Building
Location:	Roof Void
Finding:	Bathroom Exhaust Fans Not Ducted to External Atmosphere
Information:	The exhaust fans installed in the bathrooms were observed to be discharging directly into the roof cavity rather than being ducted to the external atmosphere. This configuration does not comply with best practice ventilation standards, as it allows moist air to accumulate within the roof space.

Prolonged moisture build-up in the roof cavity can lead to elevated humidity levels, which may contribute to mould growth, timber decay, and potential damage to insulation or other roof components over time.

It is recommended that a licensed ventilation specialist or electrician be engaged to install compliant ducting that vents the exhaust air to the outside of the building, in accordance with current building regulations and ventilation standards.

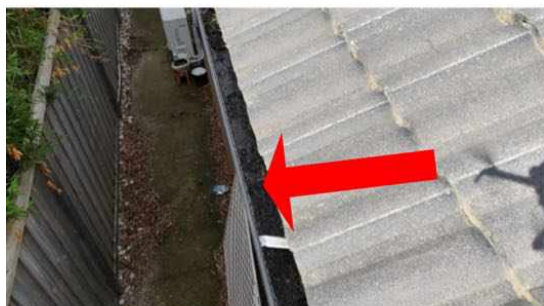
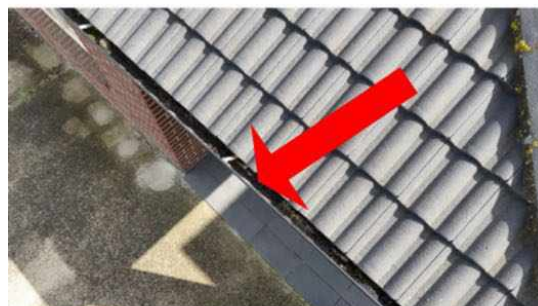
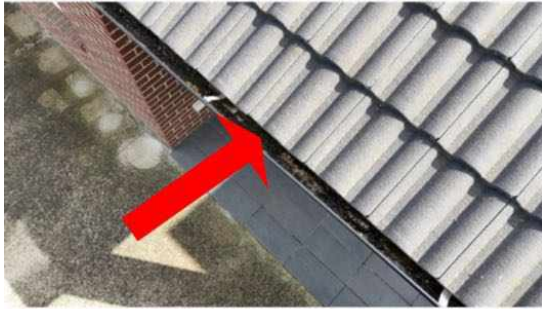
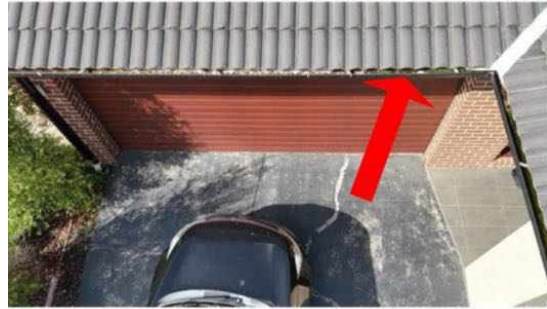
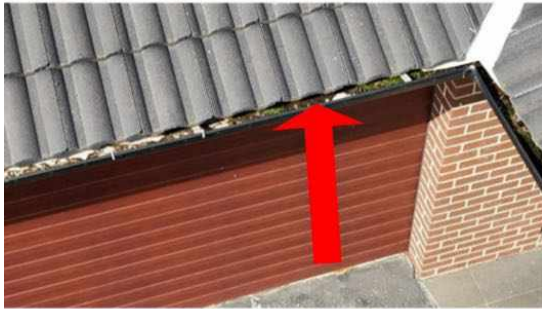
### Defects 3.20

Building:	Main Building
Location:	Roof Exterior
Finding:	Gutters - Partially Blocked
Information:	Sections of the external gutters were partially blocked with debris, soil and leaves. Roof plumbing structures, such as guttering and downpipes, should be free of all debris to prevent blockages. Blockages of the guttering and downpipes will lead to pooling and accumulated water overflows, which is likely to subsequently flood eaves and exterior walls.

Blocked gutters are likely to lead to high levels of moisture in the affected areas. Such moisture will not only cause rust and decay of the associated building materials, but can also provide conditions that are conducive to termite and timber pest activity. Blockages in gutters should therefore be removed immediately to ensure dry conditions are maintained.

Consult a Licensed Plumber for further specific advice on remedial works that may be required. In the interim, it is highly advised that blocked gutters be removed by the homeowner or a general handyperson as a matter of urgency.

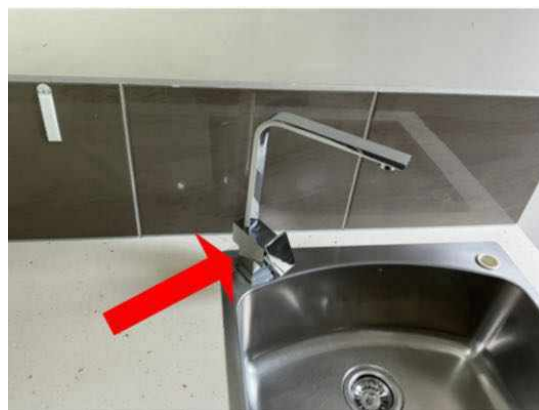
### Defects 3.21

Building: Main Building  
 Location: Laundry  
 Finding: Laundry Tap – Not Operational  
 Information:

The lack of operation may be due to a localised plumbing fault, isolation valve being closed, internal tap failure, or other supply-related issue. Without further investigation, the exact cause could not be determined at the time of inspection.

It is recommended that a licensed plumber be engaged to investigate the cause of non-operation, restore proper water supply to the fixture, and undertake repairs or replacement as required.

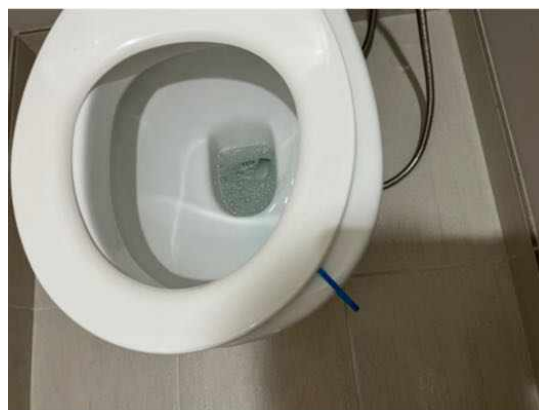
### Defects 3.22

Building:	Main Building
Location:	Toilet (WC)
Finding:	Toilet seat - loose
Information:	The toilet seat was found to be loose and shifting during use at the time of inspection. This defect likely developed due to wear and tear of the seat's fixing hardware. However, it may also be the result of improper installation or accidental impact.

If left unaddressed, the loose toilet seat could worsen, leading to potential damage to the mounting points or discomfort for users. In some cases, further instability may lead to minor injuries or increased wear on the toilet bowl.

It is recommended that the toilet seat be properly refastened or replaced by a licensed plumber to ensure safe and stable use.

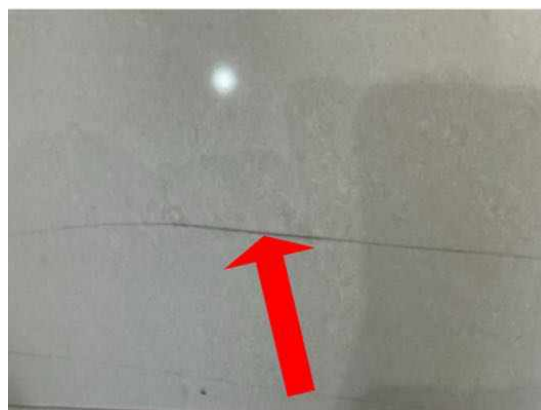
### Defects 3.23

Building:	Main Building
Location:	Hallway
Finding:	Hallway Floor Tile – Surface Scratch
Information:

The condition is considered superficial and does not affect the structural integrity or serviceability of the tiled flooring. The issue is aesthetic in nature only.

Replacement of the affected tile may be undertaken at the client's discretion should the appearance be of concern. Otherwise, no immediate repair is considered necessary, and the tile may remain in its current condition.

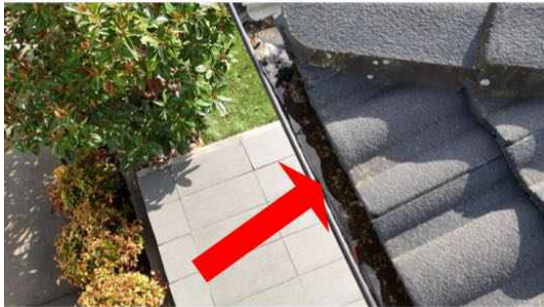
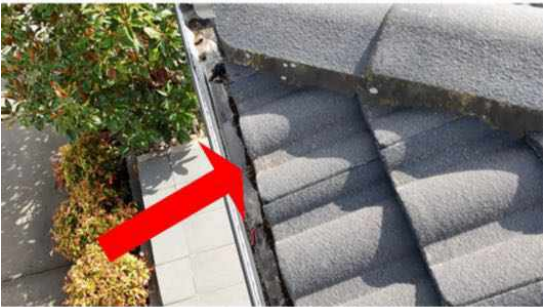
### Defects 3.24

Building:	Main Building
Location:	Gutter
Finding:	Gutters - Water pooling
Information:	Water was found to be pooling in sections of the roof guttering. This is generally a secondary defect caused by blocked or partially blocked gutters. Such blockages and subsequent water pooling are likely to lead to rust and water damage to associated structures if left unattended.

A roofing plumber should be appointed as soon as possible to rectify this issue. It is highly advised that all gutters be maintained on a frequent basis to ensure the condition of roof plumbing.

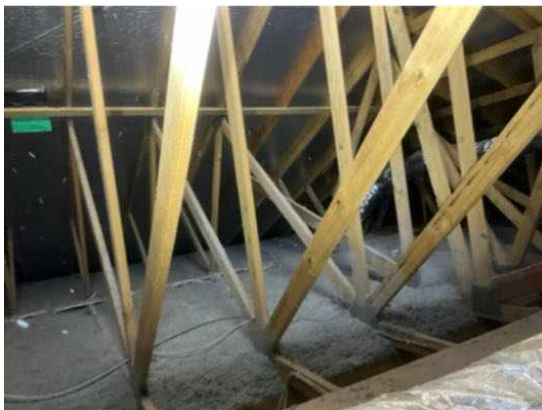
### Noted Item

Building: Main Building  
 Location: Roof Void  
 Finding: Obstructions and Limitations - roof cavity  
 Information: These photographs are an indication of the obstructions and limitations which impeded the inspection of the roof cavity area of the property at the time of inspection. These obstructions can hide an array of defects and should be removed to allow full inspection to be carried out. A re-inspection is recommended once the areas are made accessible.
