Building Inspection Report

Inspection Date: Thu, 5 Mar 2026

Property Address: 4 Keane Ct, Old Reynella SA 5161, Australia

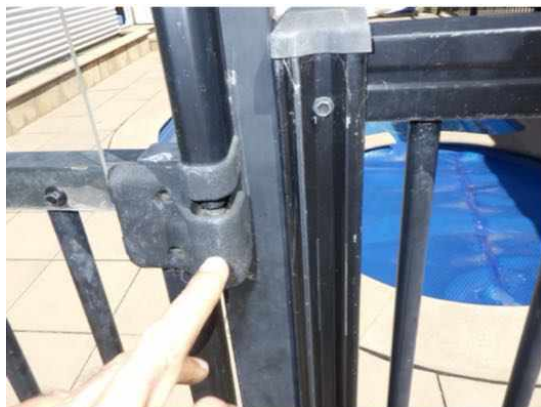
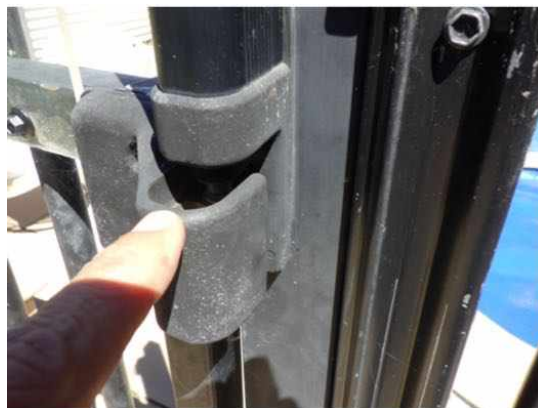
Defects 1.01

Building:	Building 1
Location:	All External Areas
Finding:	Pool fencing - Do not to comply with Australian Standards
Information:	It is suspected that areas of the pool fencing do not to comply with Australian Standards and do not appear to be safe. Assessment of the pool area is required.

Please note that this inspection does not cover pool fencing and other pool fittings and fixtures. It is highly advised that a specialist be appointed to inspect the pool and surrounding area and provide advice on rectification works that may be required.

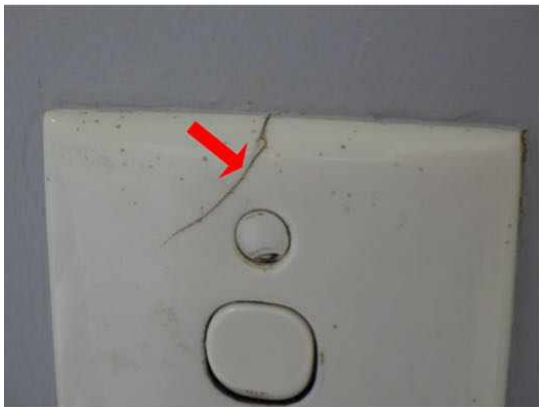
Defects 1.02

Building:	Building 1
Location:	All Internal Areas
Finding:	Electrical fitting - Broken
Information:	The electrical fitting in this ground floor and upper floor bedroom area was found to be broken at the time of inspection. Breakage occurs generally when the building materials have aged and decayed, but may also be indicative of impact damage to the building element (accidental or deliberate).

Left unmanaged, the fitting is unlikely to cause further damage to surrounding building elements. However, the broken fitting does expose electrical works, and may create a safety hazard if there is potential contact with persons in the area.

Repair and/or replacement of the broken fitting is advised. A Licensed electrician should be appointed to repair/replace the fitting immediately.

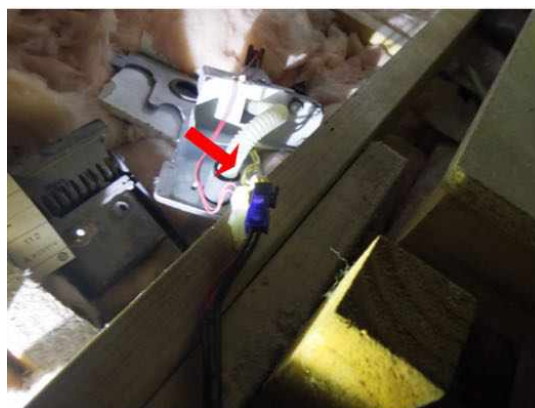
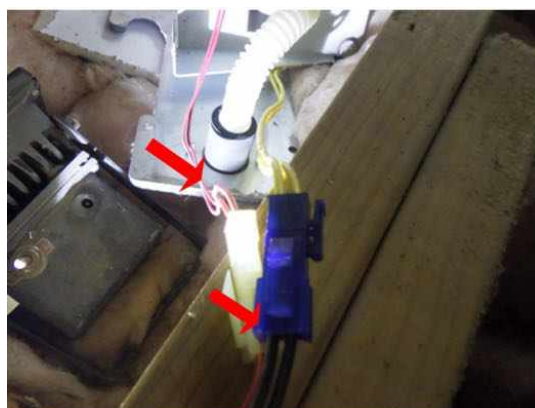
Defects 1.03

Building: Building 1
 Location: All Internal Areas
 Finding: Roof space area - Electrical wires exposed
 Information: At the time of inspection of this roof space area it was noticed that exposed electrical wiring was identified. Exposed electrical wiring represents a potential safety hazard including for fire and personal contact.

Contact a licensed electrician urgently for further inspection investigation and rectification.

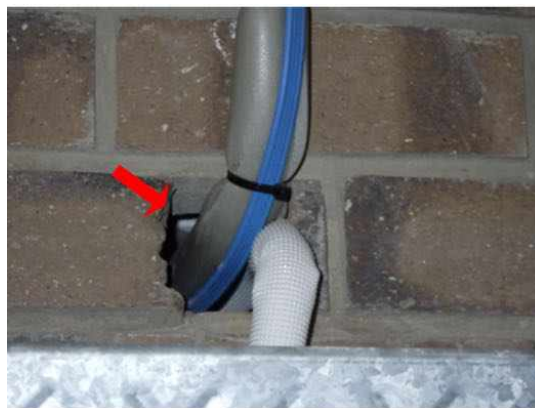
Defects 2.01

Gaps and holes around pipework makes the area susceptible to insect and vermin ingress, as well as allowing water penetration to the cavity wall. As such, associated building elements are likely to deteriorate at an accelerated rate, and major implications are expected if holes around the pipework are left unmanaged.

All excessive holes, gaps or cracks should be adequately filled by a suitable sealant or trimmings as soon as possible to prevent any further damage. Such works may be conducted by a general handyperson or licensed plumber.

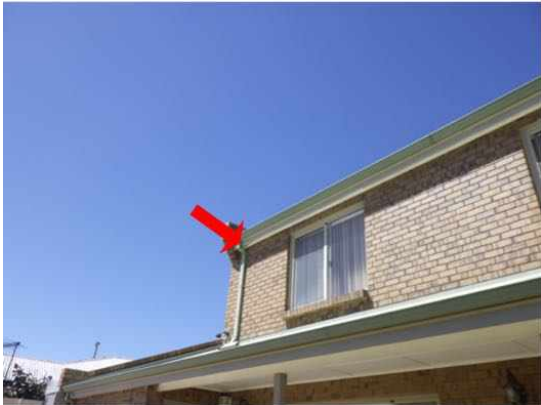
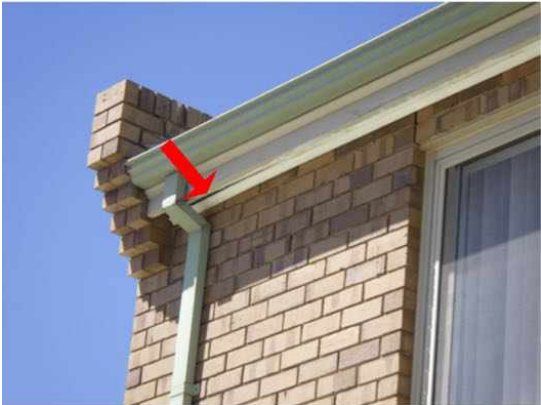
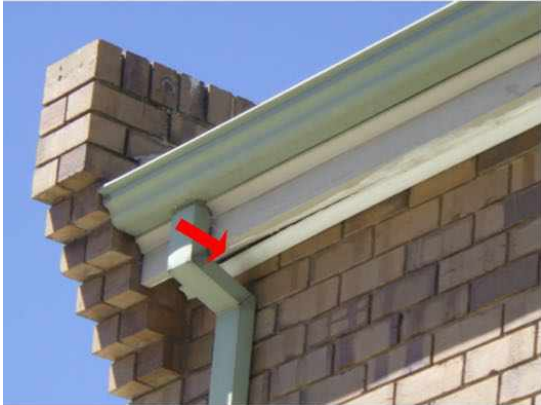
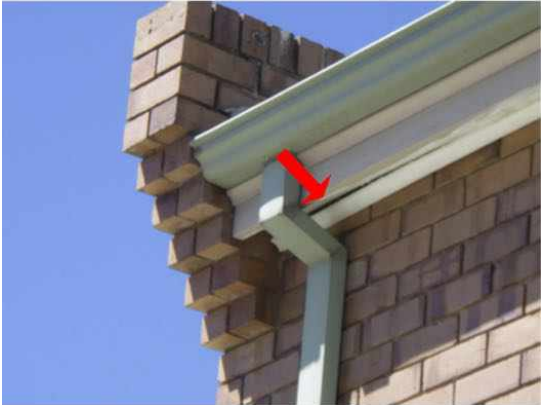
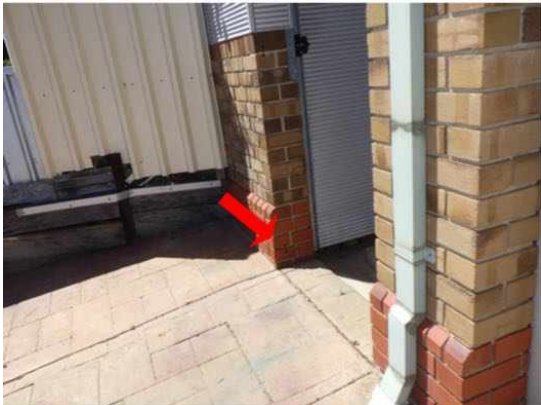
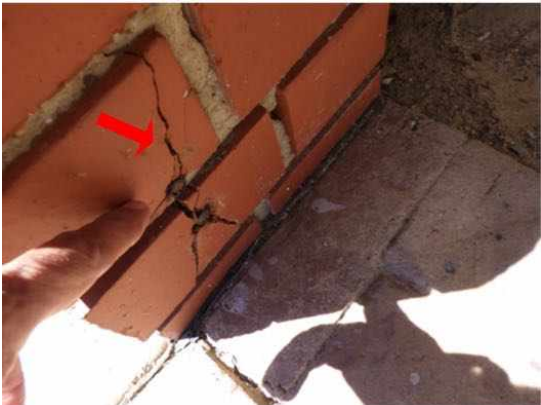
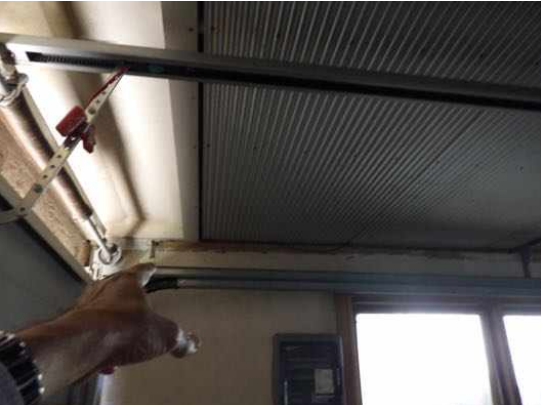
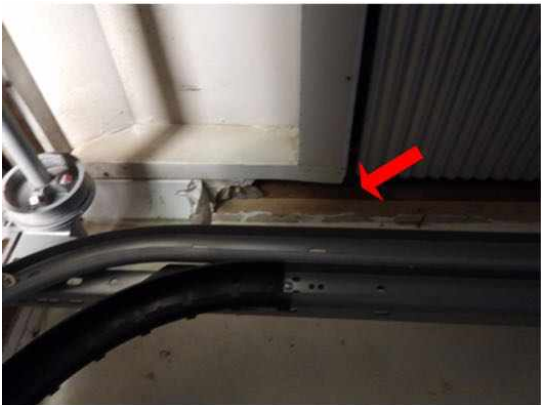
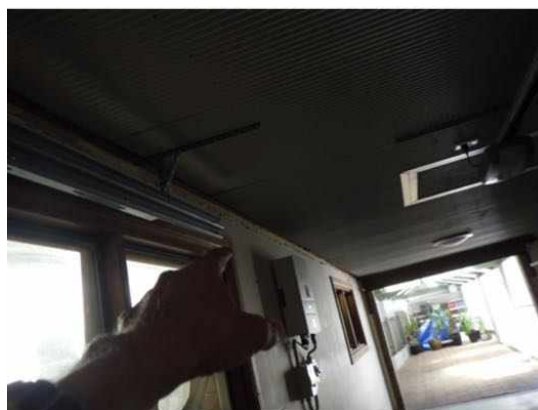
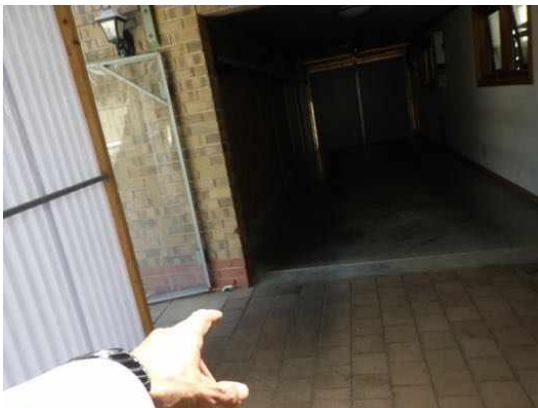
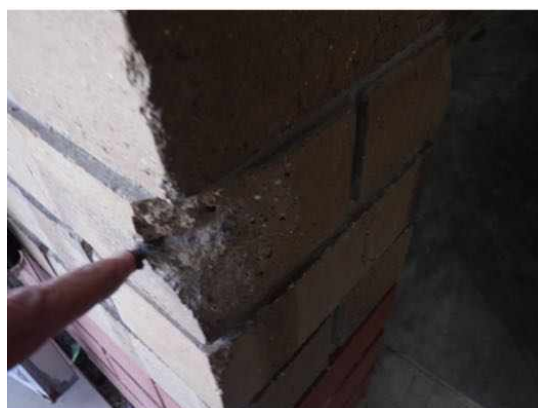
Defects 3.01

Building:	Building 1
Location:	All External Areas
Finding:	Building element - Damaged
Information:	At the time of inspection it was noticed few building elements are damaged / loose from its original fixing around the property.

Breakage occurs generally when the building materials have either aged and decayed, or as a result of damage (accidental or deliberate).

Repair and/or replacement of broken elements is advised to ensure that additional secondary defects do not arise as a consequence. Such works are necessary, as all building elements play a key role in the operation and function of the overall structure and its performance.

A relevant tradesperson should be appointed to repair or replace the affected building element prior to any subsequent damage being caused.

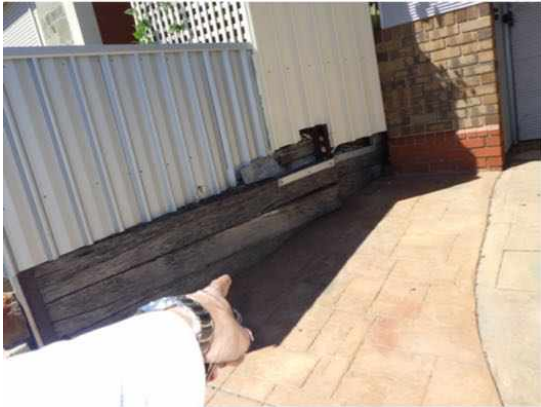
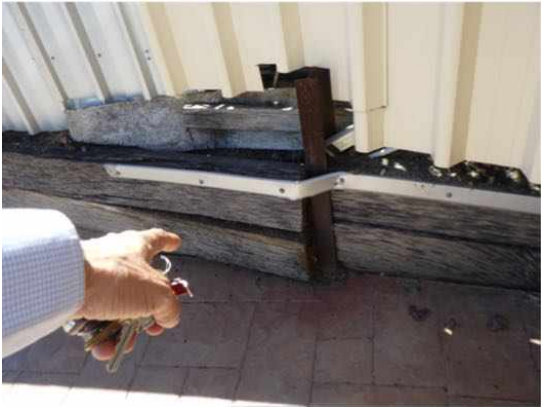
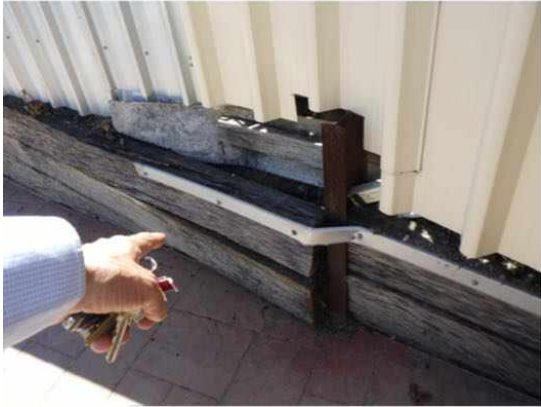
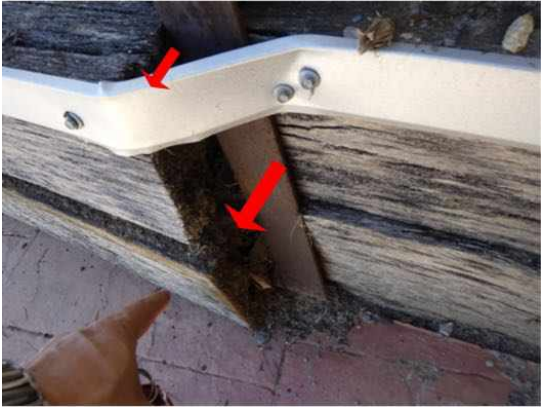
Defects 3.02

Building:	Building 1
Location:	All External Areas
Finding:	Retaining Walls – Timber Sleepers – Deterioration / Damaged
Information:	At the time of inspection, several sections of timber sleepers forming part of the retaining walls around the property were observed to be deteriorated and damaged. The deterioration appears consistent with ageing, decay, and/or possible impact damage.

Timber retaining wall elements that have decayed or broken may compromise the structural integrity and load-bearing capacity of the retaining wall system. If left unrectified, this condition may result in progressive movement, soil displacement, loss

of support, drainage issues, and potential structural failure of the retaining wall.

This condition is considered a defect and warrants further assessment.

It is recommended that a suitably qualified structural engineer be engaged to assess the retaining walls and provide advice regarding structural adequacy and required remedial measures. Following assessment, an appropriately licensed and experienced contractor should be appointed to repair or replace the affected timber sleepers in accordance with the engineer's recommendations and accepted building practices.

Rectification works should be undertaken in a timely manner to prevent further deterioration and the development of secondary defects.

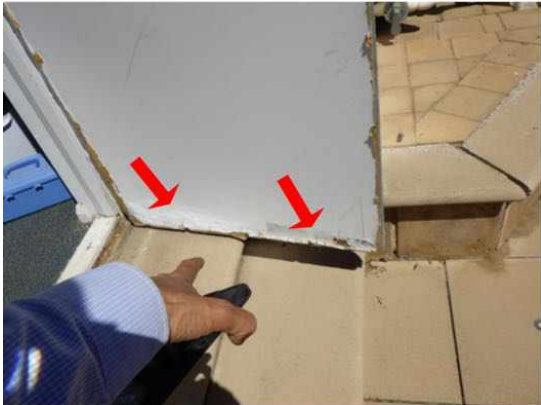
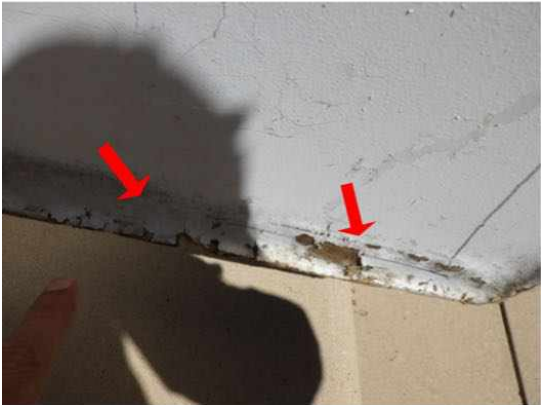
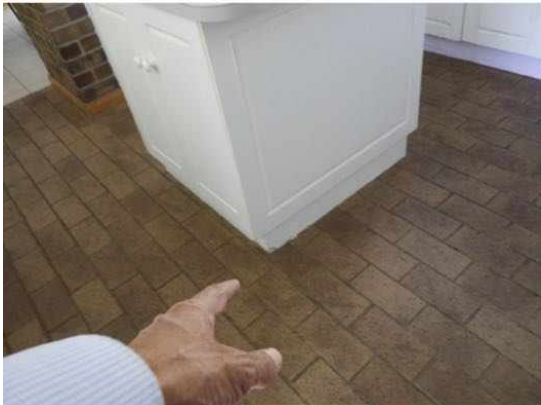
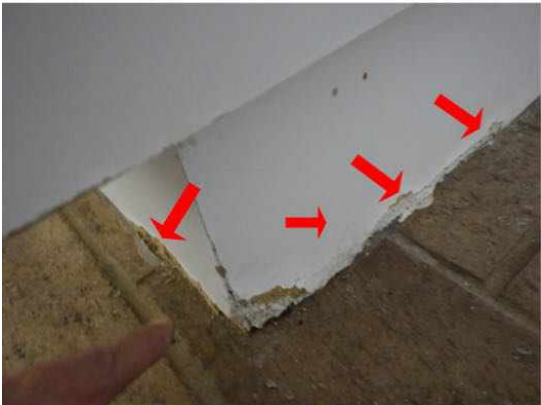
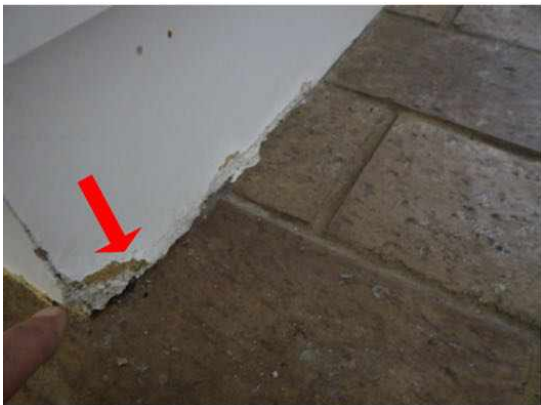
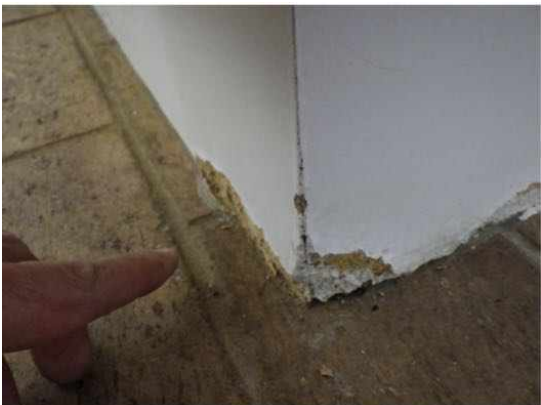
Defects 3.04

Building:	Building 1
Location:	All Areas
Finding:	Building element - Swollen
Information:	Swollen building elements generally indicate that the building materials have been affected by excessive moisture over a prolonged period of time, and have swollen as a result. The formation and development of mould/fungi or mildew is also a likely consequence of excessive moisture, which may pose major respiratory issues for occupants, particularly the elderly, the very young and those with existing illnesses and could be potential health safety hazards. In these cases an appropriately qualified

The structural integrity of swollen building elements can not be guaranteed, and further damage is likely to develop if left unmanaged. Excessive moisture is likely to lead to the development of secondary damage to any associated building elements, which may necessitate major reparation works if prolonged.

Rectification of the cause of the water leak should be addressed prior to any remedial works to the swollen building elements. A licensed plumber should be appointed immediately to identify the cause of the leak and provide advice on remedial works as necessary, Repair and/or replacement of swollen building elements should be conducted as a matter of urgency by a registered builder or qualified carpenter.

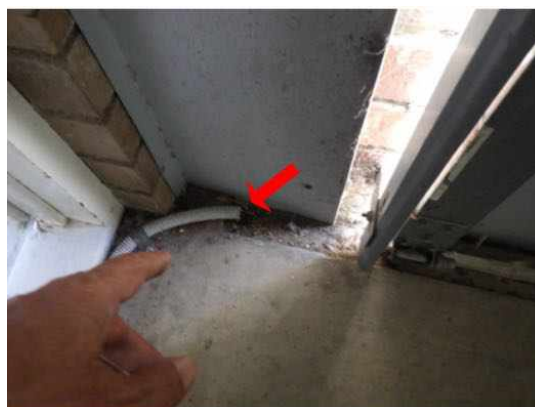
Defects 3.05

Building:	Building 1
Location:	All External Areas
Finding:	Air conditioner - Disconnected overflow
Information:	The Air Conditioner (A/C) overflow was found to be disconnected from storm water drainage and is creating excessive moisture in the surrounding area.

Such leaking creates an environment which is conducive to an array of defects, including water damage to associated building elements and the attraction of termite or timber pest infestation.

It is highly recommended that a licensed plumber be appointed to connect the A/C overflow in order to prevent such an environment from being created. These minor works should be carried out as soon as possible.

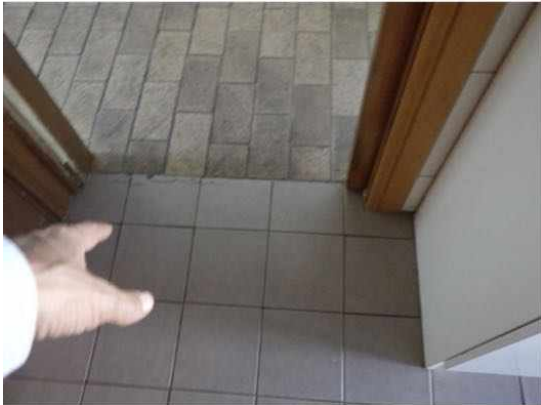
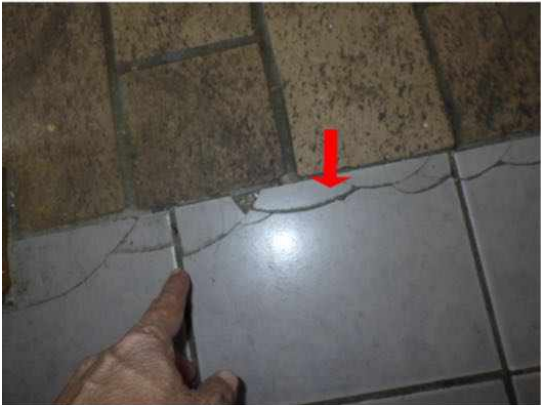
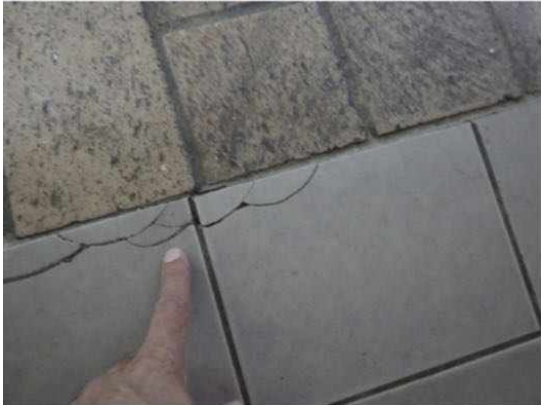
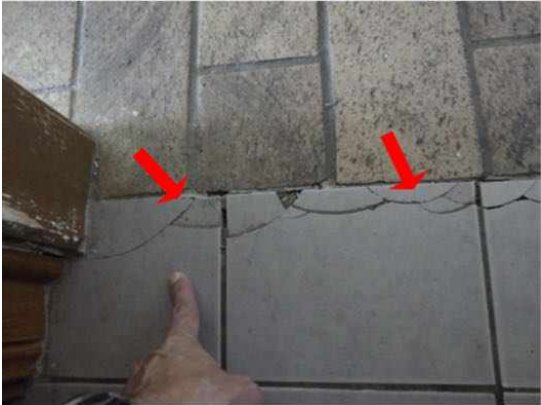
Defects 3.07

Building:	Building 1
Location:	All Internal Areas
Finding:	Cracked floor tiles
Information:	Cracking in the floor tiles was evident in this ground floor area at the time of inspection. It is suspected that this cracking has occurred as a result of minor settlement or shrinkage of the slab.

Cracked tiles throughout the household detract from the overall appearance of the affected areas however it is unlikely to create or lead to any secondary defects.

While not considered a matter of urgency, replacement of cracked floor tiles is recommended at the clients discretion. A tiling contractor may be appointed to perform these works. Where cracks become more numerous, contact a licensed building inspector for further investigation.

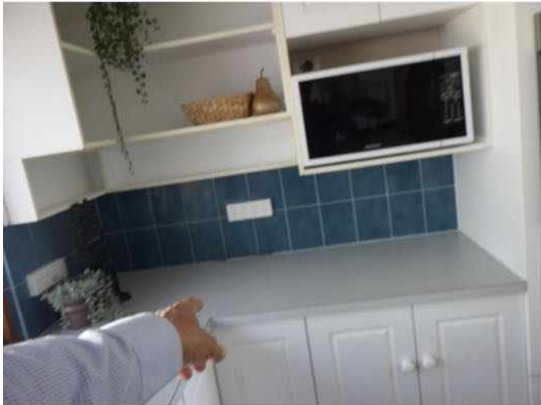
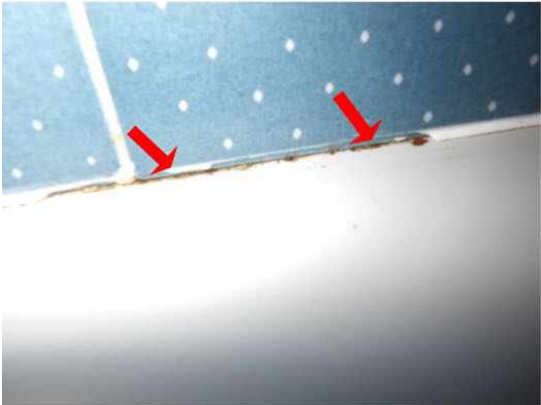
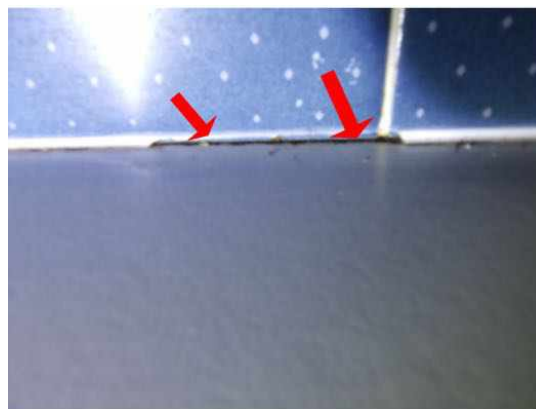
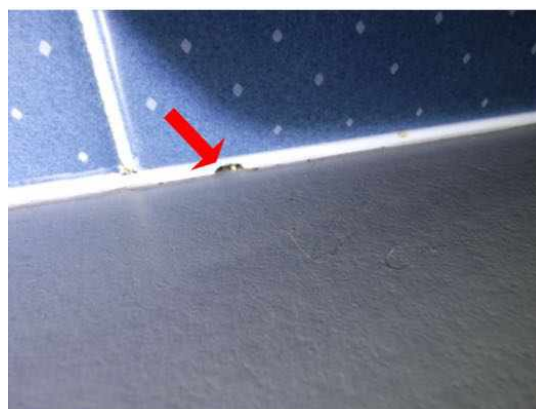
Defects 3.08

Building: Building 1
 Location: All Internal Areas
 Finding: Grout - Missing/ Deteriorated
 Information: Grout is missing/ deteriorated in this kitchen area. Grout is used to protect gaps and crevices in building materials to ensure that they are water-tight and prevent water penetration to the associated structures.

Where grout is missing, a tiling contractor should be appointed immediately to apply grout and re-apply any silicone where necessary. Failure to do so is likely to lead to water damage to the surrounding area.

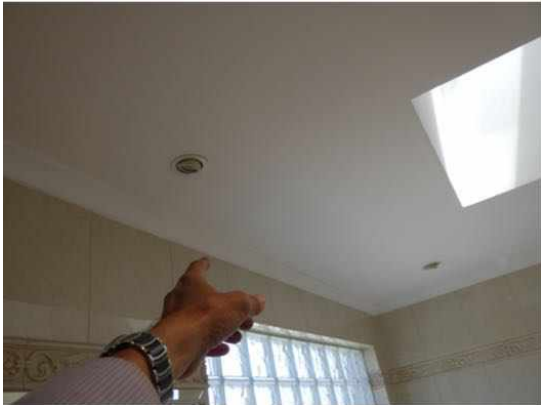
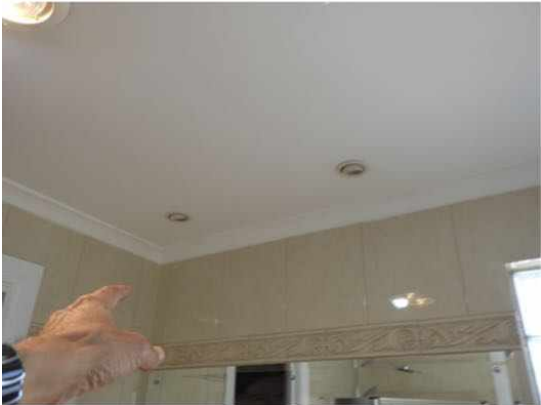
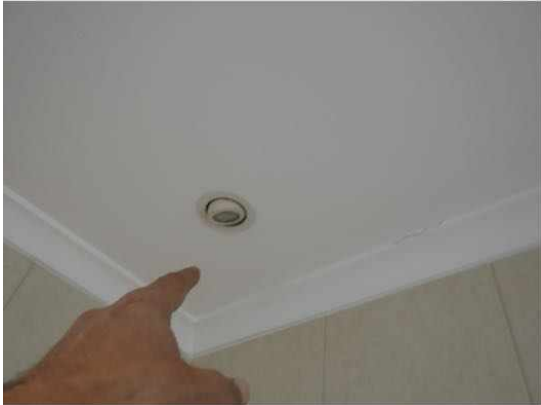
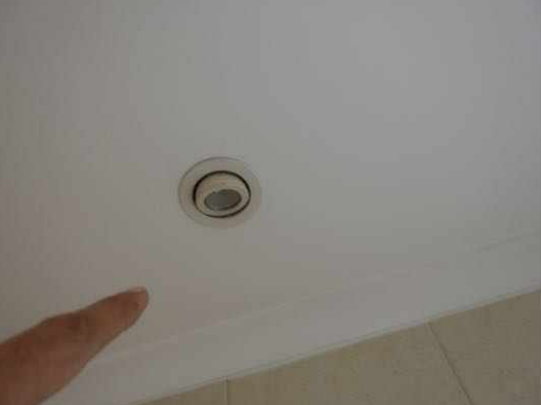
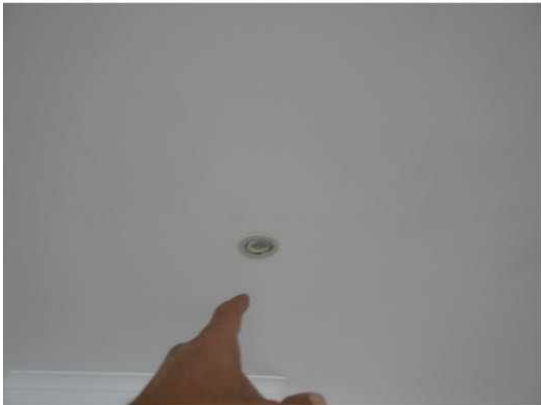
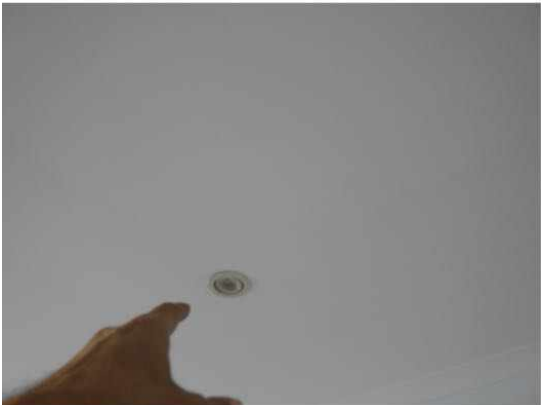
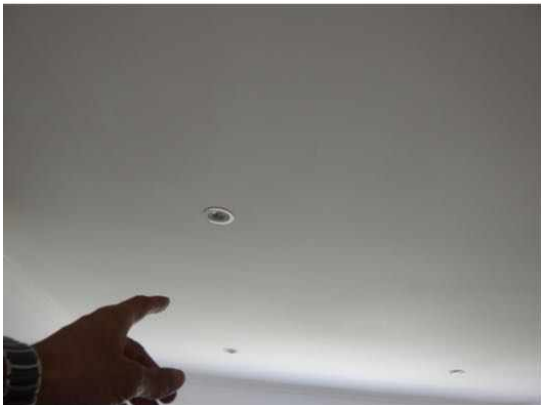
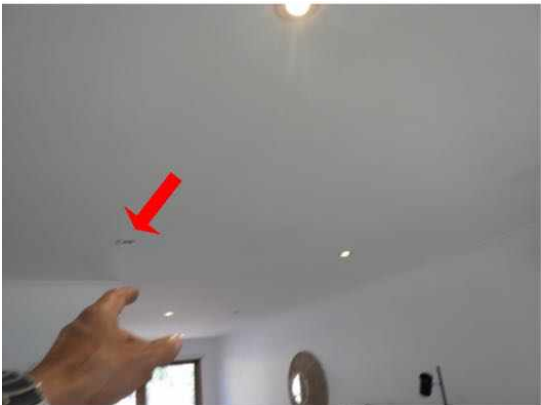
Defects 3.09

Non-operational items should be addressed to ensure that the full function of the building structure is available. Where some building elements are not operating as intended, it is possible that secondary building defects could arise due to their non-operation.

Repair and/or replacement of the faulty building element is recommended. It is highly recommended that the relevant tradesperson be engaged to perform any necessary works.

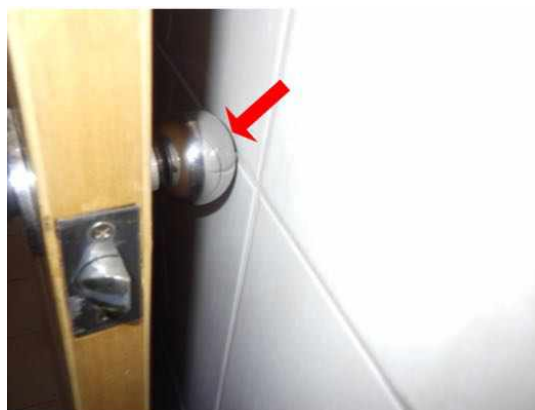
Defects 3.10

Building:	Building 1
Location:	All Internal Areas
Finding:	Door stop - Missing
Information:	The door stop is missing or is inadequate to stop the door handle from damaging the wall. Although some building elements may seem irrelevant or unnecessary, all building elements play a key role in the operation and function of the overall structure and its performance.

Re-installation or replacement of the door stop is advised as soon as possible to prevent any subsequent damage to the door or associated structures. A general handyman may be appointed to perform these works at client discretion.

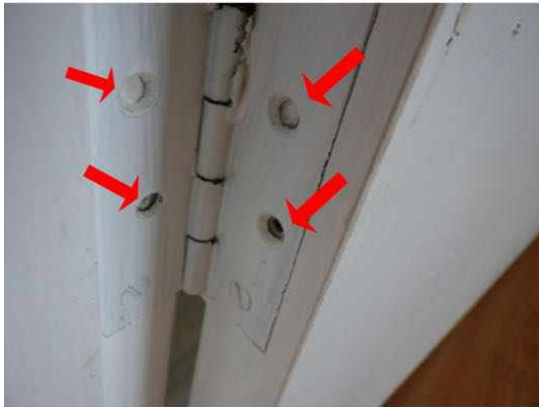
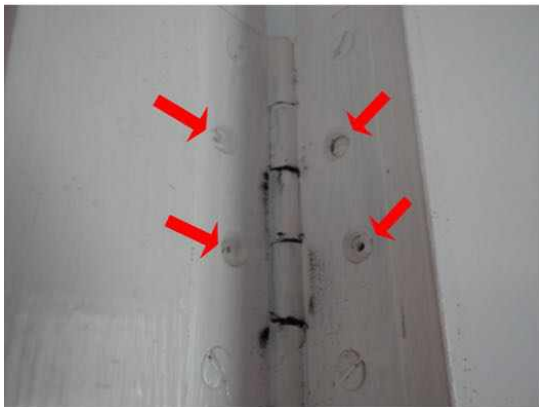
Defects 3.11

Building:	Building 1
Location:	All Internal Areas
Finding:	Door hinges - Screws - Missing
Information:	At the time of inspection it was noticed that few screws were missing from door hinges around the property.

Replacement of any missing building element should be conducted as soon as possible to ensure that no damage or functional issues occur to associated building materials.

The appropriate tradesperson should be appointed as soon as possible to replace the missing building element.

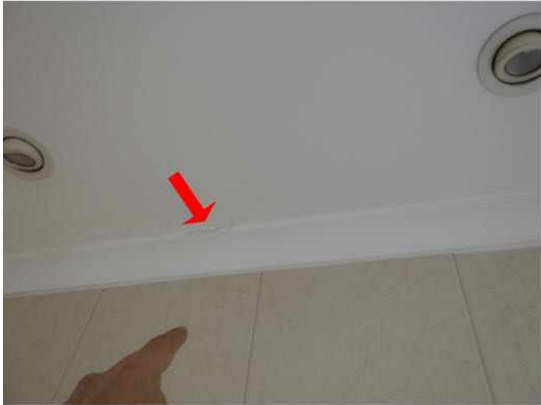
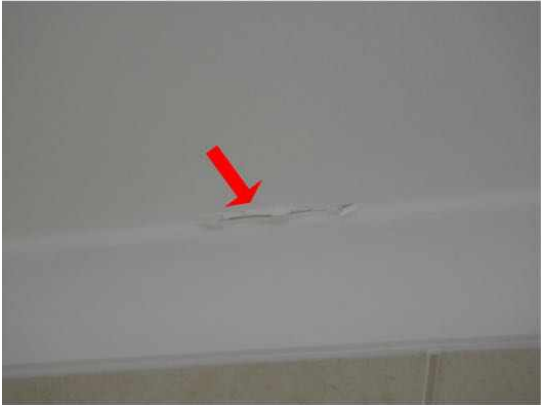
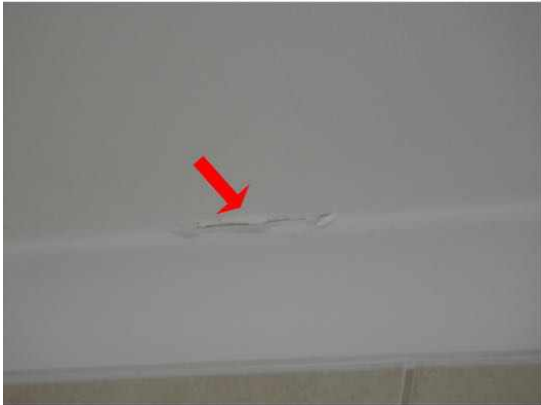
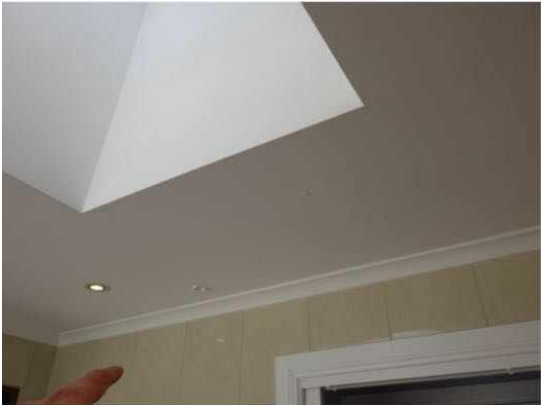
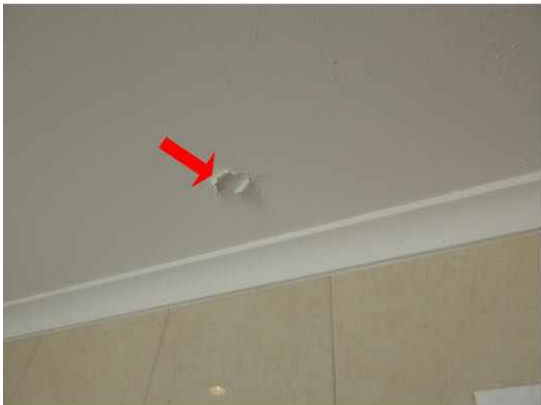
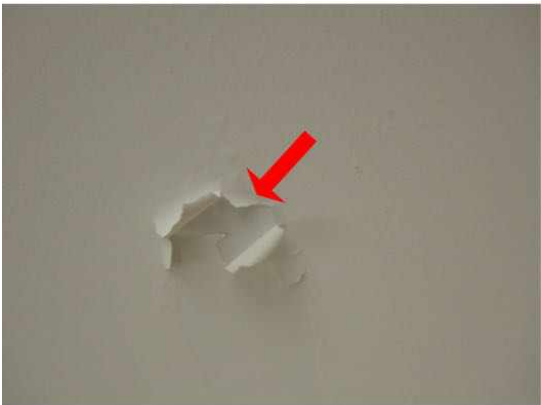
Defects 3.12

Building:	Building 1
Location:	Bathroom
Finding:	Ceilings - Scuffed
Information:	At the time of inspection it was noticed that evidence of ceilings scuffed in this bathroom area.

Scuffed surfaces, while detracting from the overall appearance of the affected building element, do not indicate any operational or structural damage. This degree of surface damage is consistent with general wear and tear and minor impact damage, normally accumulated over a number of years.

Marked surfaces may be left as is at the discretion of the client; no repairs or replacement are necessarily required, as this is an appearance defect. However, the client may wish to seek quotations for the cost to refurbish or replace the identified building element.

A general handyman or plasterer may be appointed to rectify marked surfaces if considered necessary by the client.

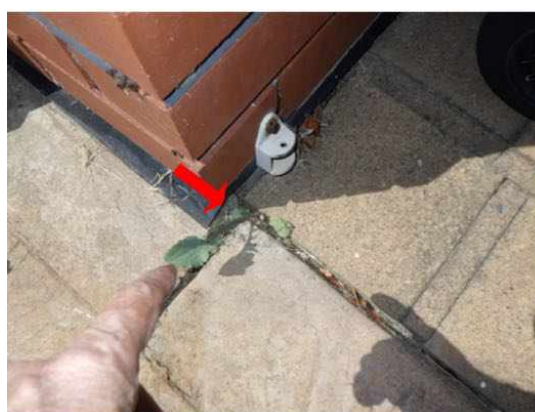
Defects 3.13

Building:	Building 1
Location:	All External Areas
Finding:	Bridging - Vegetation
Information:	Where vegetation obstructs inspection of building elements, also known as bridging as it provides a bridging point for the access of termites, full inspection can not be achieved. Consequently moisture or dampness may be present and the areas becomes conducive to termite activity. Plants against or very close to buildings provide cover, shade and can provide an environment that is attractive to termite infestation.

The removal and replanting of species that do not provide "cover" or cutting back of existing vegetation will assist greatly in preventing Bridging from occurring.

The removal of any such materials that may be conducive to termite activity should be carried out as soon as possible and arrange re inspection to minimize the risk of termite attack.

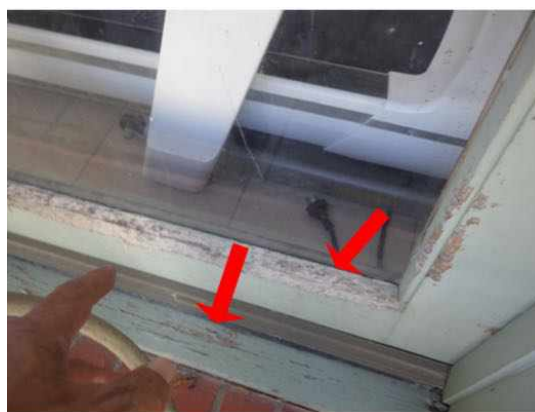
Defects 3.14

Building:	Building 1
Location:	All External Areas
Finding:	External painting deteriorated
Information:	Much of the external paintwork including but not limited to windows, fascias, guttering, veranda and other external fitments have been neglected and require attention to prepare and re-paint.

Whilst incomplete or missing paint finish is generally an appearance defect, it can also lead to the development of secondary building defects over time. Incomplete areas of paint finish expose the area to moisture, potentially accelerating the deterioration of underlying building materials.

Degraded paint finishes should be sanded back, filled, leveled and painted, as applicable. Where inadequate or missing paint protection has led to the deterioration of the associated building element, repair and/or replacement of this building element may be required.

A painting contractor should be appointed as soon as possible to perform necessary works to aid the appearance of the affected area and to ensure the area is protected against further deterioration. Alternatively, the homeowner following manufacturer instructions may perform these works.

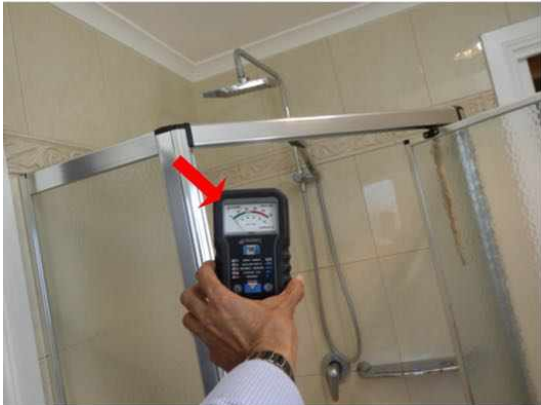
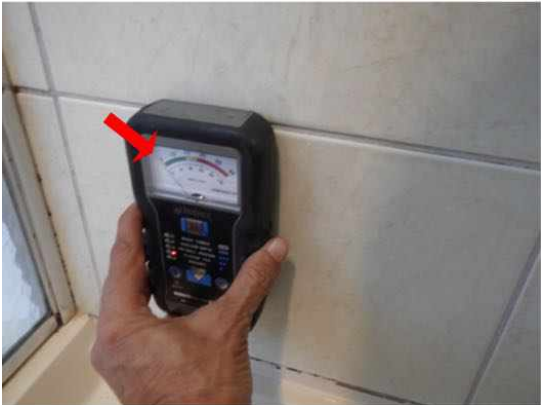
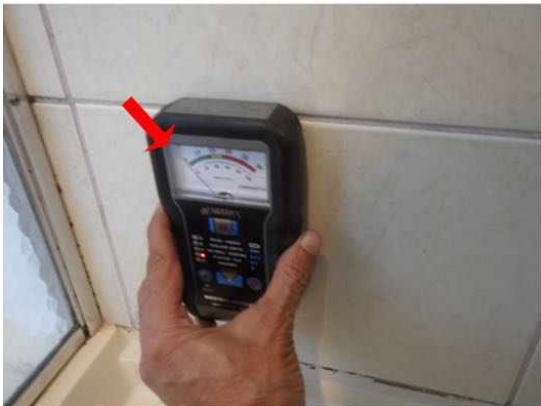
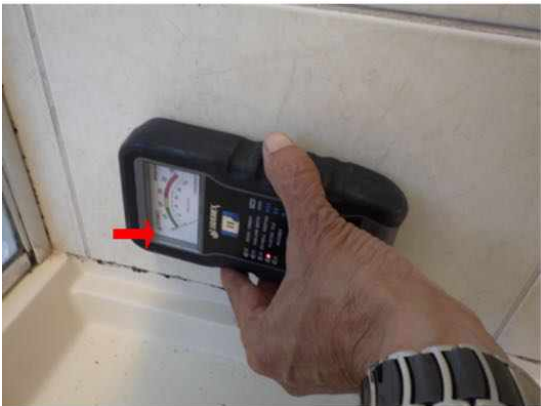
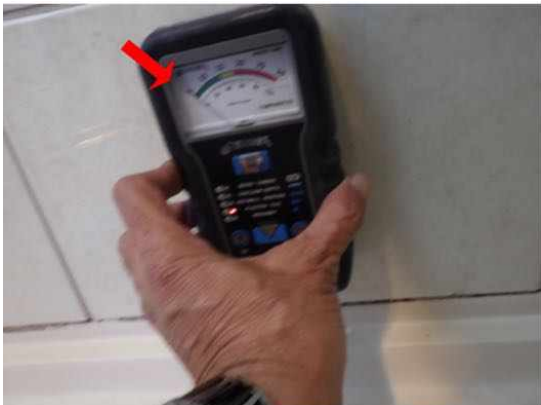
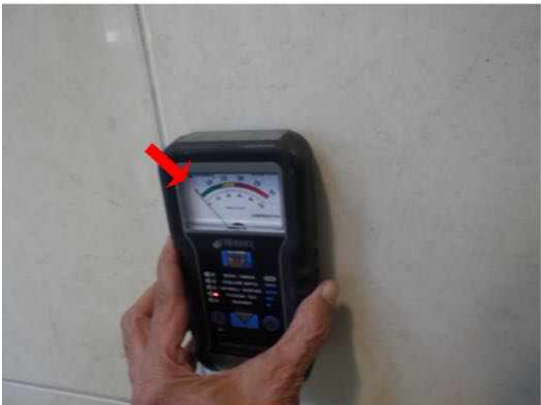
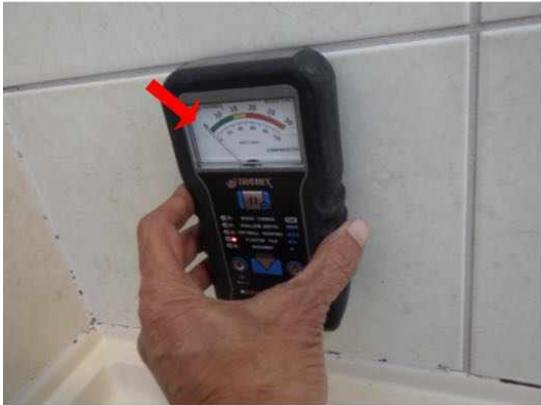
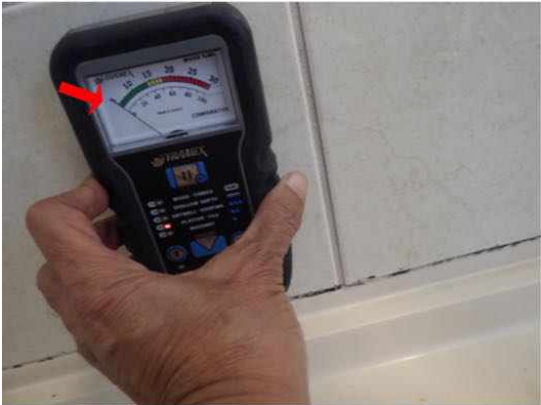
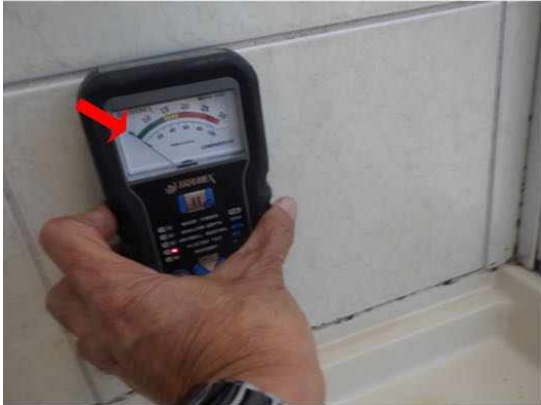
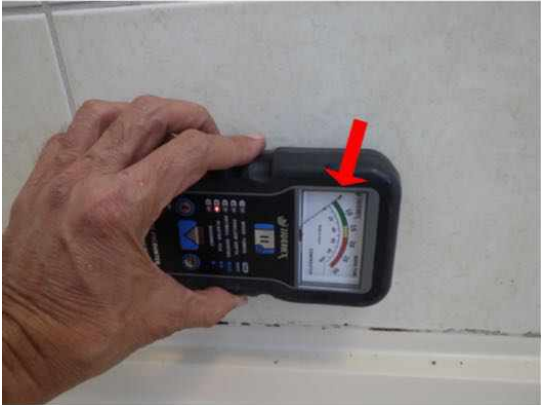
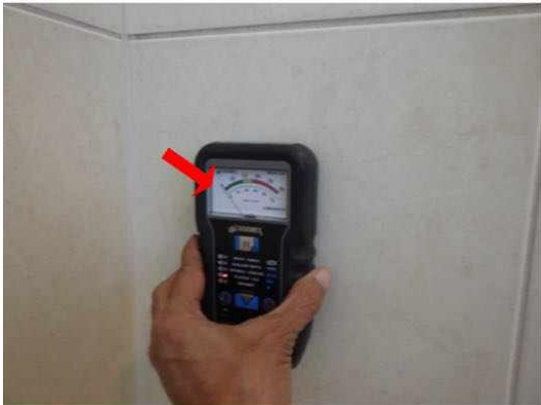
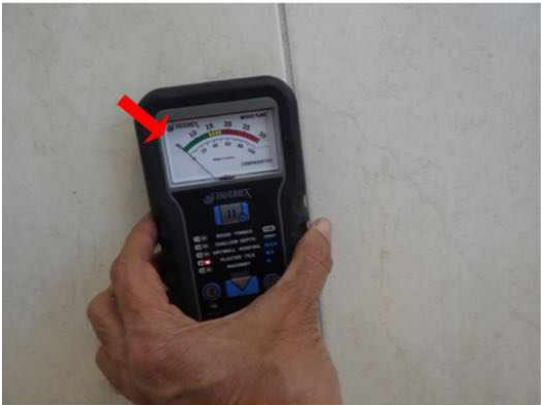
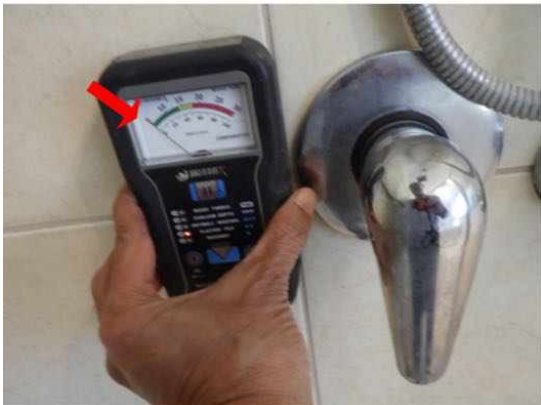
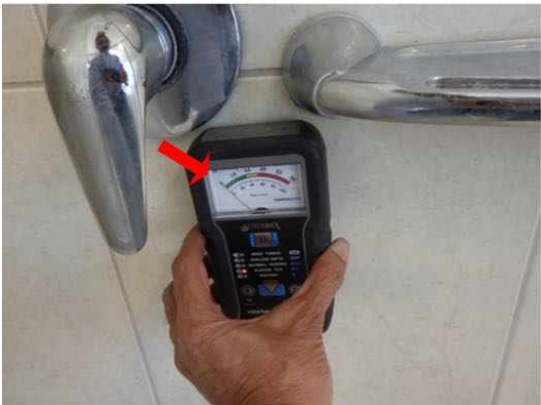
Noted Item

Damp (or structural damp) refers to the presence of unwanted moisture in the structure of a building, either as the result of intrusion from outside, or condensation

from within the structure. In the shower area, internal water leaks or other sources of excessive moisture are generally the cause of damp.

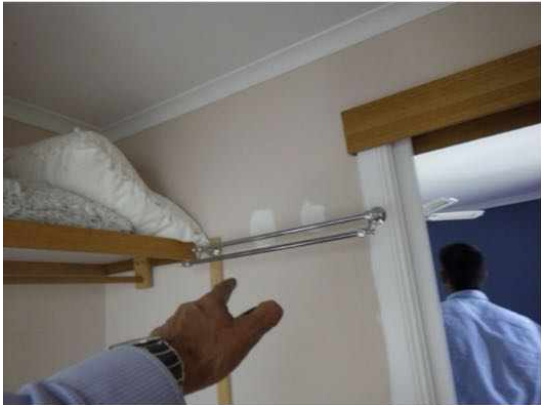
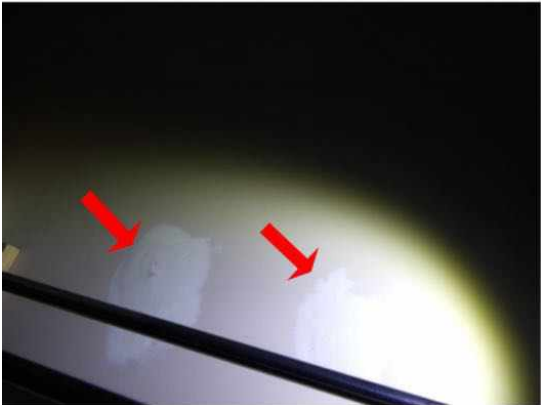
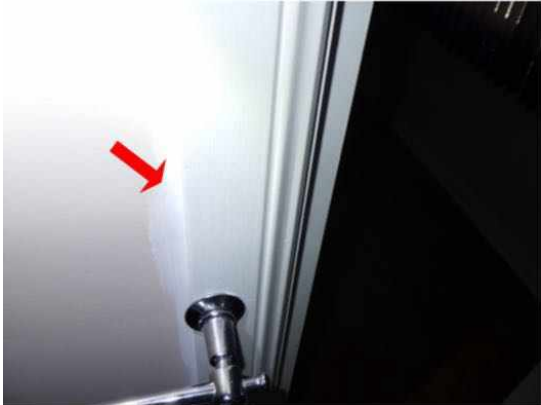
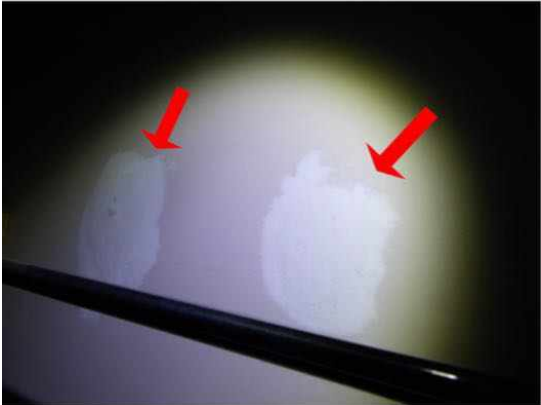
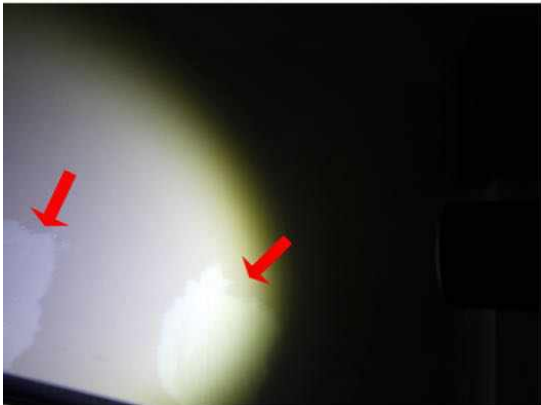
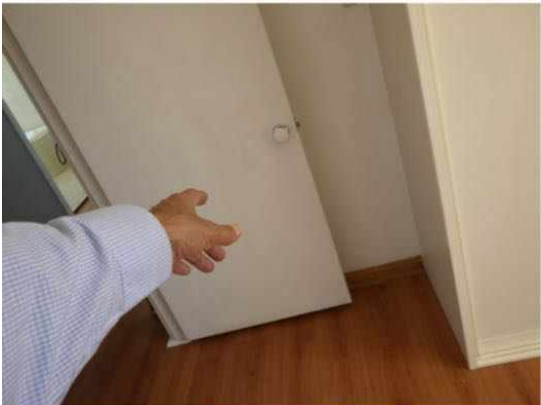
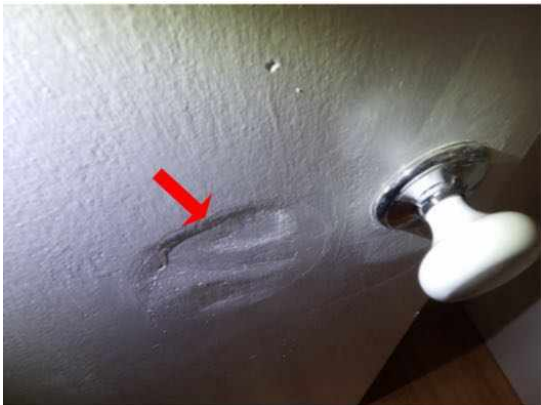
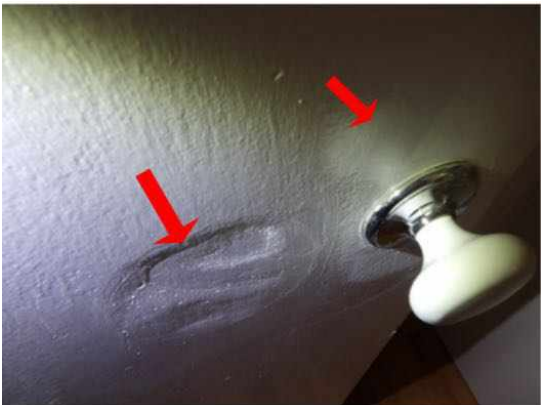
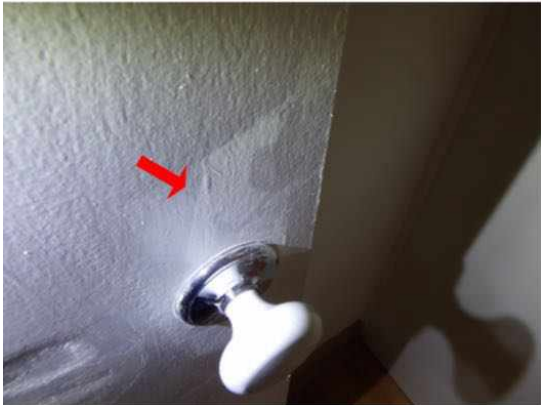
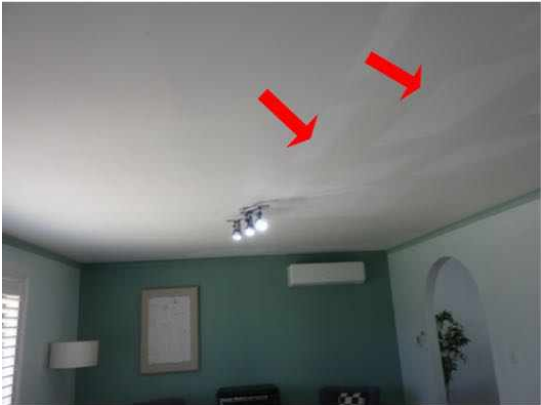
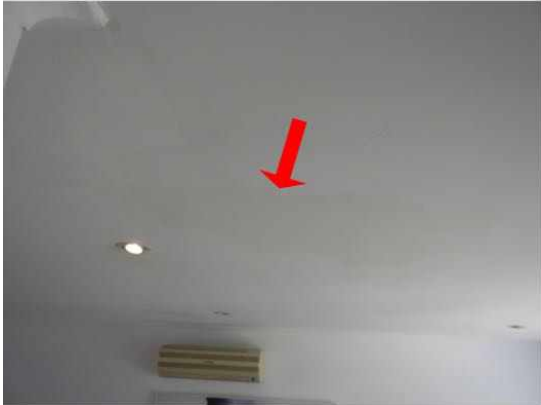
Building: Building 1
 Location: All Internal Areas
 Finding: Evidence of Previous Repairs
 Information: At the time of inspection, evidence of previous repairs to several building elements around the property was observed. The extent, quality, and compliance of these repairs could not be fully determined during the visual inspection.

While such repairs may be part of normal property maintenance, further information regarding the nature and scope of these works was not available at the time of inspection.

For further clarification, it is recommended that enquiries be made with the real estate agent, current owner, or appropriate authorities regarding the details of the repairs, including whether the works were carried out by suitably qualified trades and in accordance with relevant requirements.
