Building Inspection Report

Inspection Date: Thu, 5 Mar 2026

Property Address: 4 Keane Ct, Old Reynella SA 5161, Australia

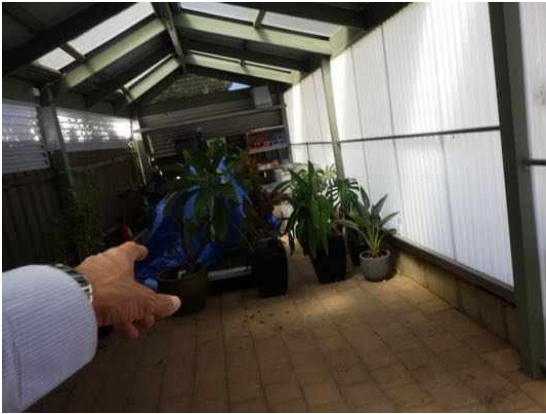
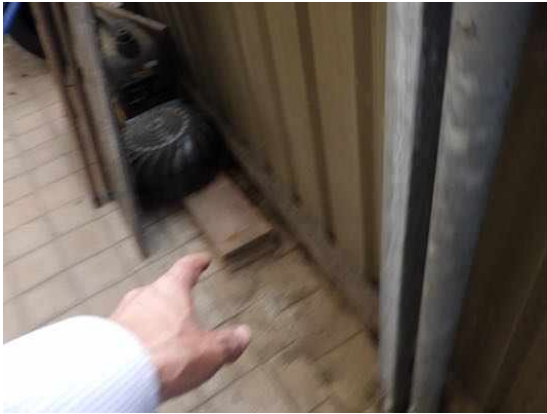
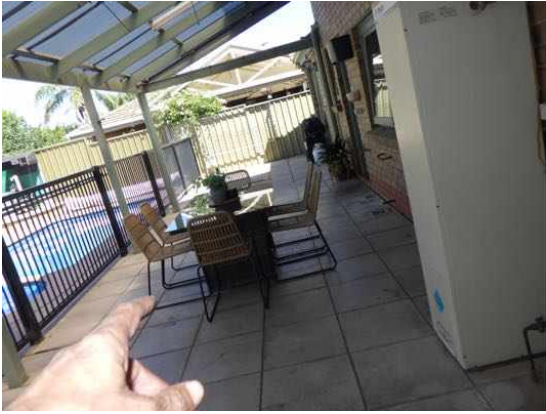
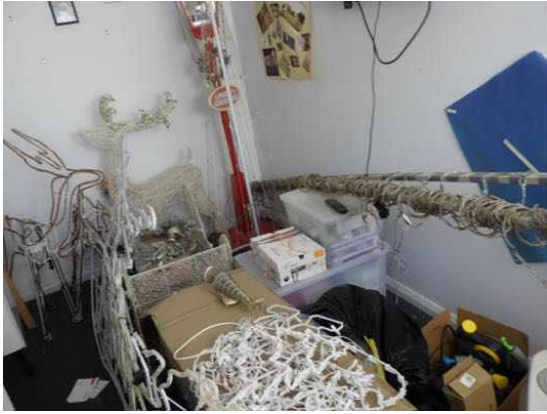
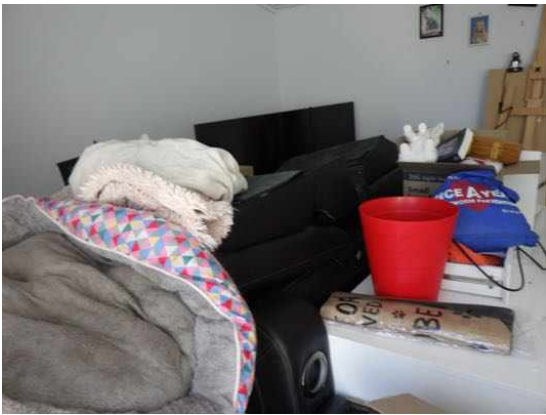
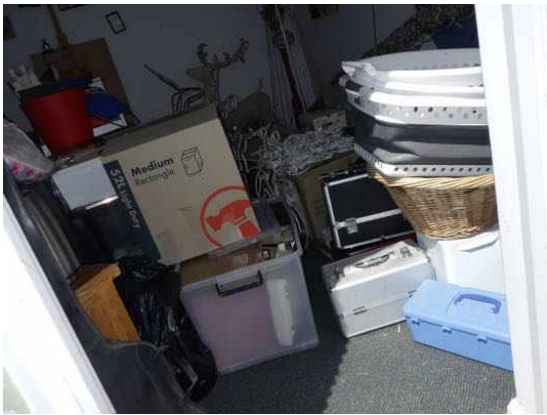
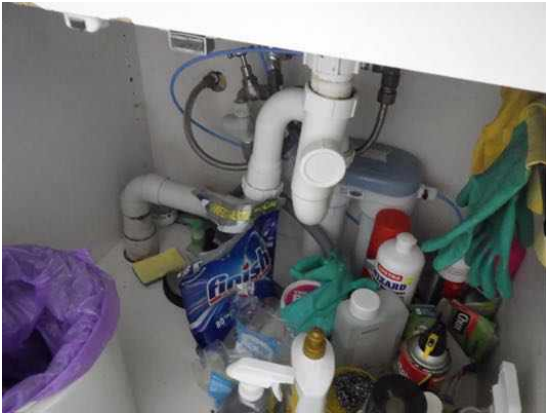
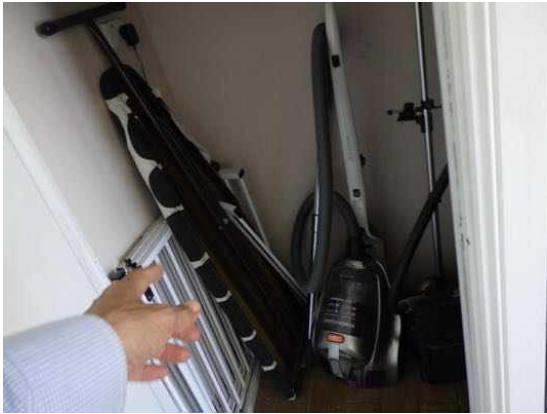
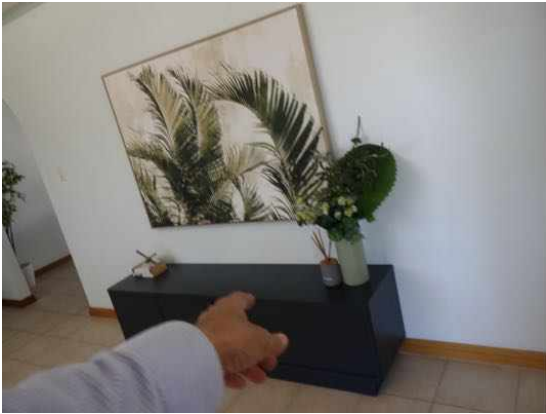
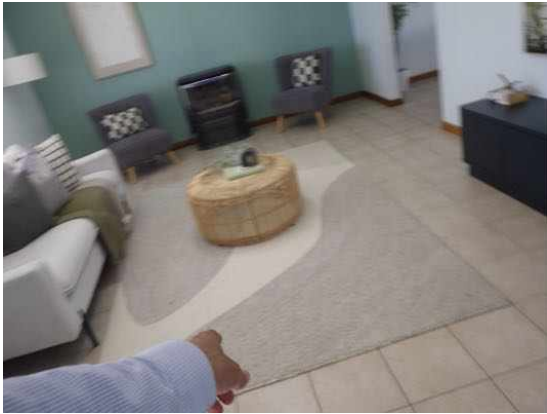
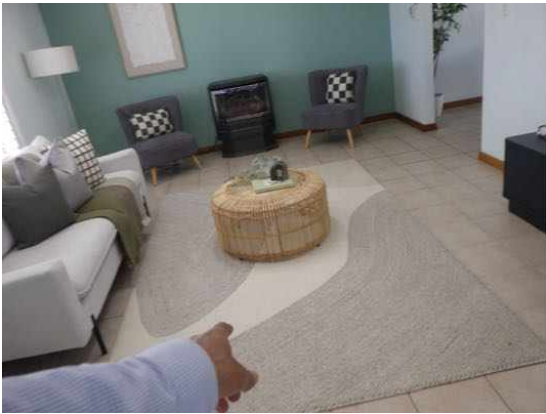
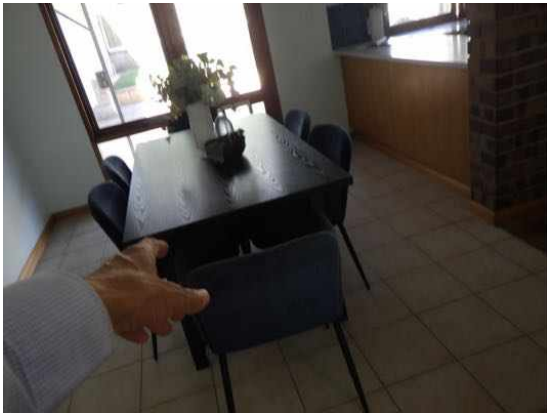
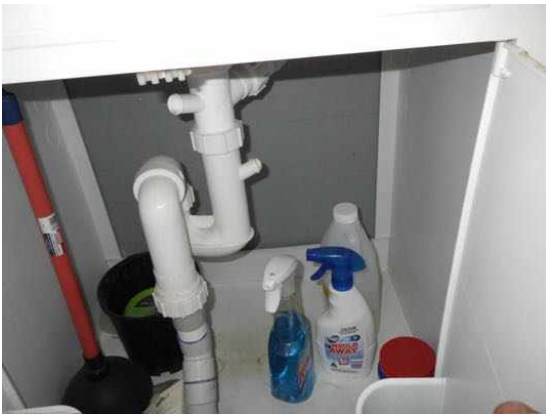
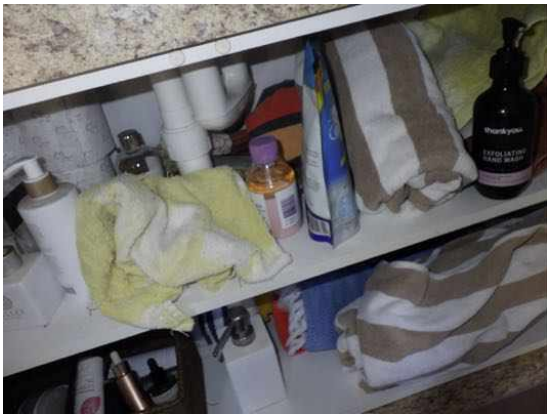
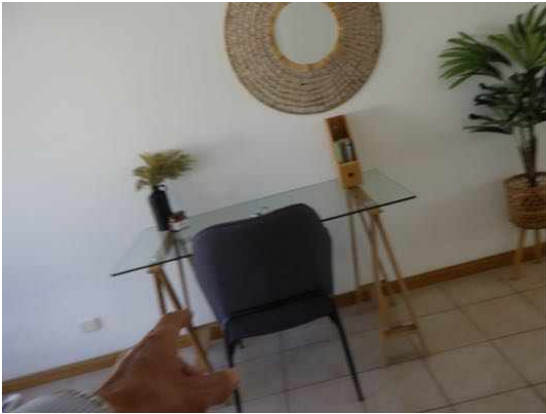
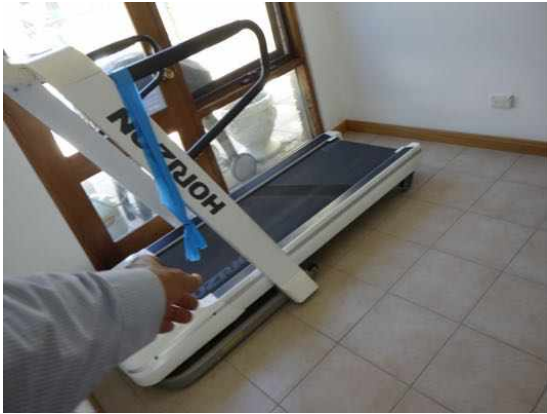
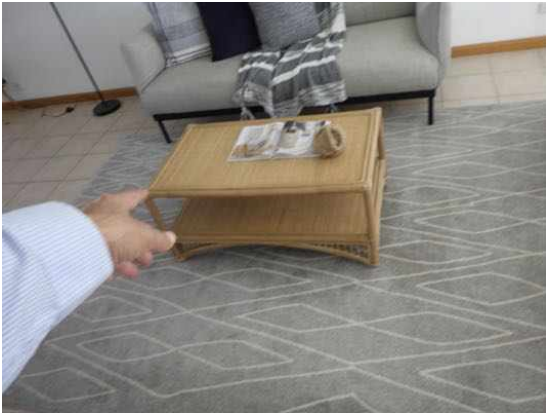
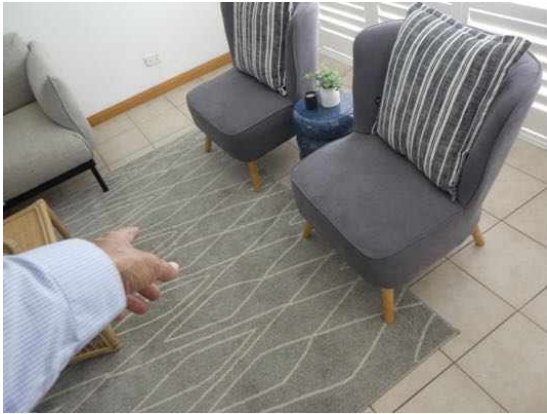
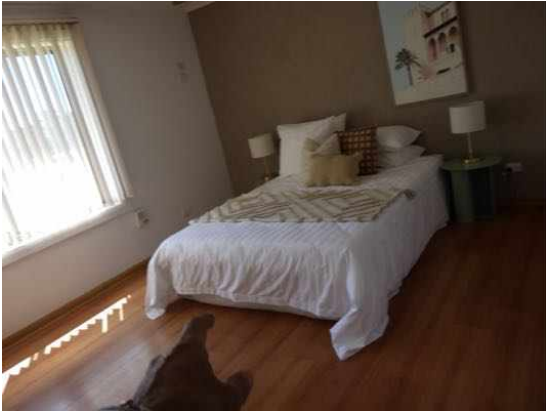
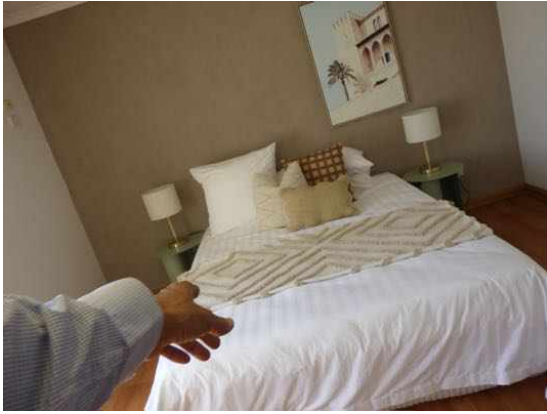
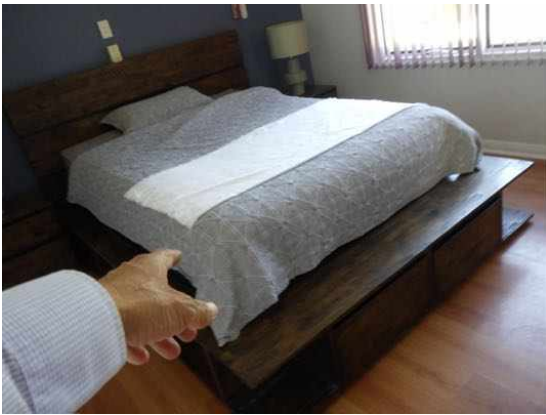
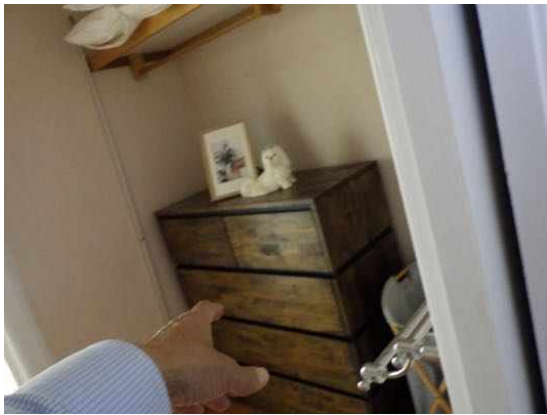
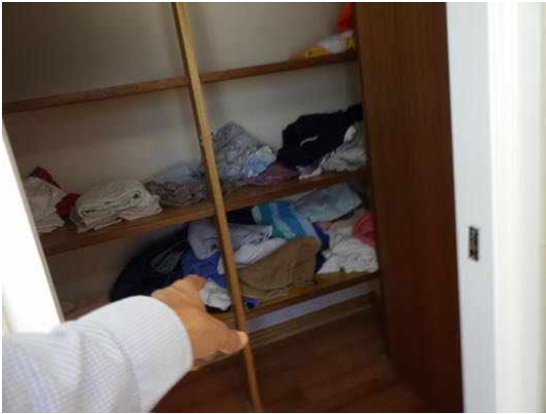
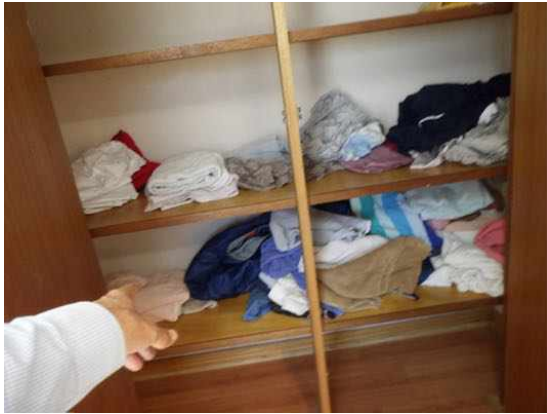
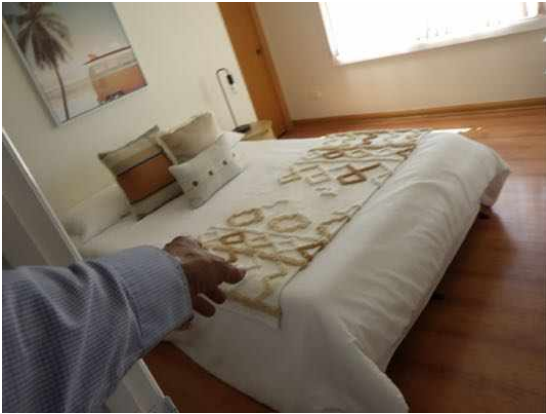
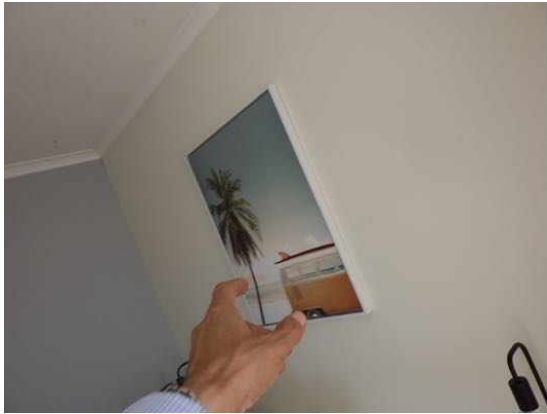
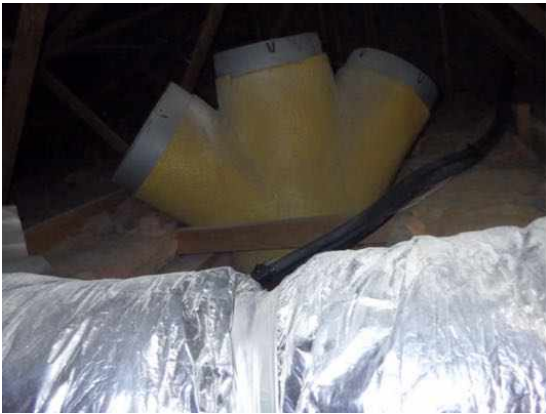
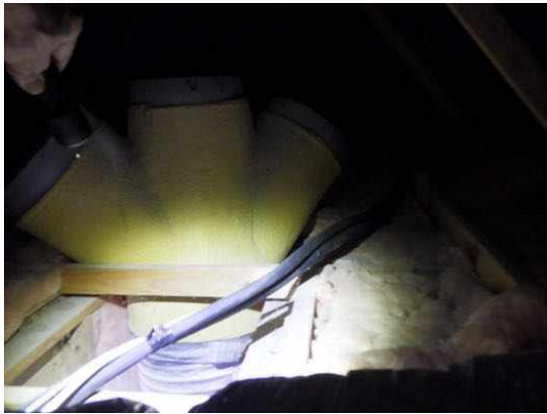
Building: Building 1
Location: All Areas
Finding: Additional Photos - Obstructions and Limitations
Information: These photographs are an indication of the obstructions and limitations which impeded full inspection of the property at the time of inspection. These obstructions can hide an array of defects and should be removed to allow full inspection to be carried out. A re-inspection is recommended once the areas are made accessible.
