Building and Timber Pest Inspection Report

Inspection Date: Mon, 09 Mar 2026

Property Address: 15 Pulley Dr, Ropes Crossing NSW 2760,
Australia

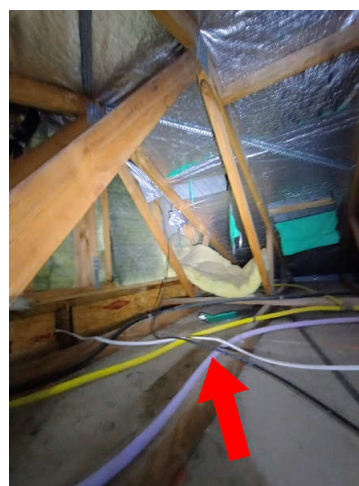
Not fixed electrical wiring at the entrance of this roof space represents a potential safety hazard to personal contact.

Contact a licensed electrician urgently for further inspection investigation and rectification.

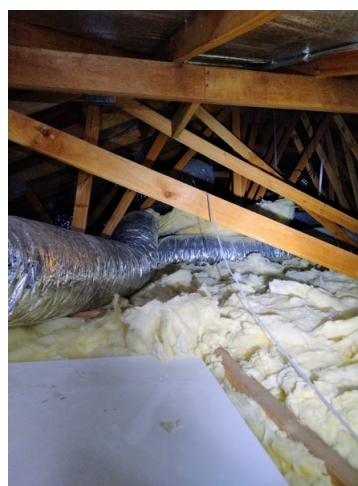
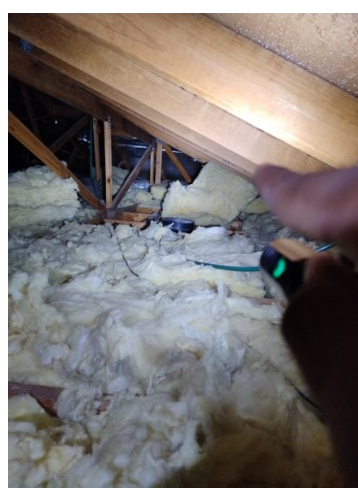
Finding 1.02

Information: Sections of insulation in the Ensuit roof void have been poorly installed or moved from their original position and are covering down light fittings at the time of inspection. While the down lights have been fitted with appropriate protective covers, the presence of this insulation creates a potential fire hazard.

Any insulation within the vicinity of down light fixtures should be moved and re-applied to more appropriate sections of the roof void, thus ensuring the area is fire-safe. An insulation contractor should be appointed as soon as possible to perform any necessary works as required.

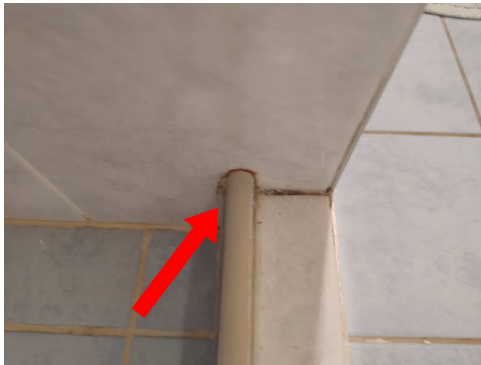
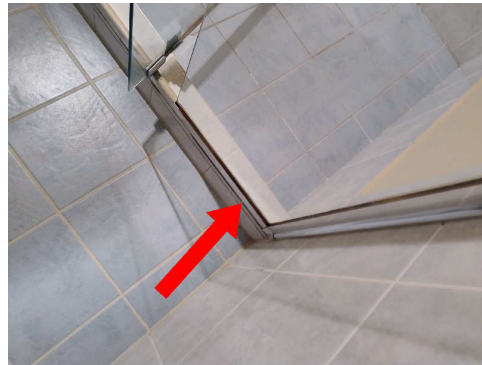
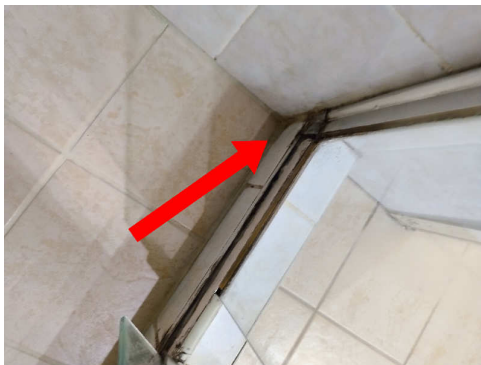
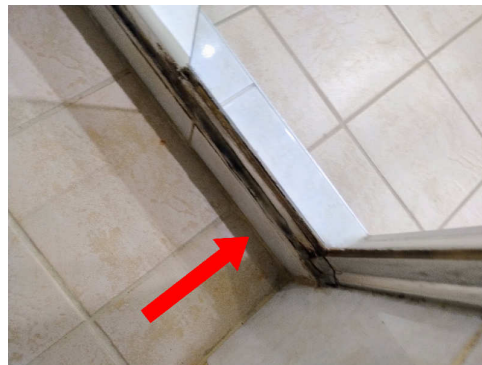
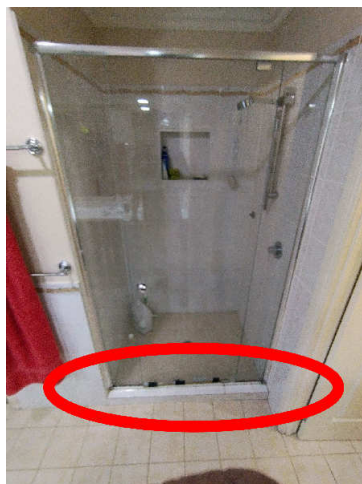
Finding 3.01

| Finding: | Sealant and Grouting - Damaged or Detoriorated |
| Information: | It was noted on inspection that sealant or grout is degraded to the tiled shower alcove and or other areas of the bathroom. |

There mould to the sealant and grout which will likely require scraping out and replacement.

This can lead to water ingress into the shower base and creates conducive condition to termite activity. If left unmanaged can cause further deterioration to building elements.

Flexible and mould resistant materials should be applied to affected areas to prevent any subsequent water damage that is likely to occur. Regular maintenance and replacement of damage or missing or damaged sealant and grout is highly recommended to the wet areas, as this is a regular wear and tear defect. Sealant and grouting in areas that come into regular contact with water should be maintained for the long term care of your property.

Qualified trade person or plumber must be appointed for rectification on priority.

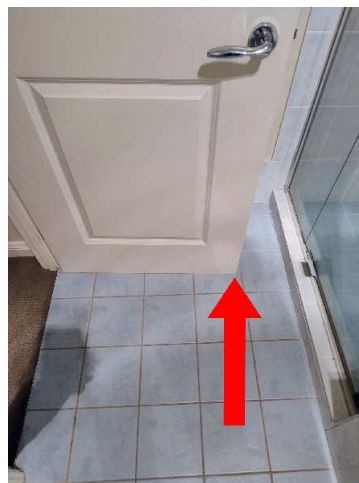
Finding 3.02

Finding: Door stop - Missing

Information: The door stop is missing and door is inadequate to stop the door handle from damaging the wall in Bathroom area. Although some building elements may seem irrelevant or unnecessary, all building elements play a key role in the operation and function of the overall structure and its performance.

Re-installation of the door stop is advised as soon as possible to prevent any subsequent damage to the door or associated structures. A general handyman may be appointed to perform these works at client discretion.

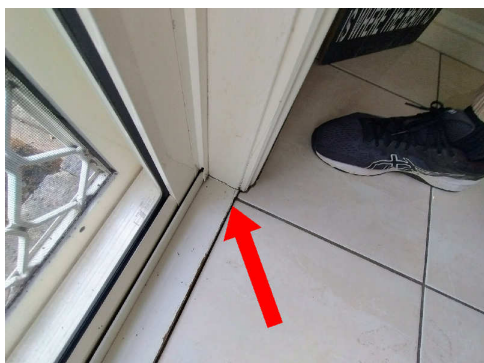
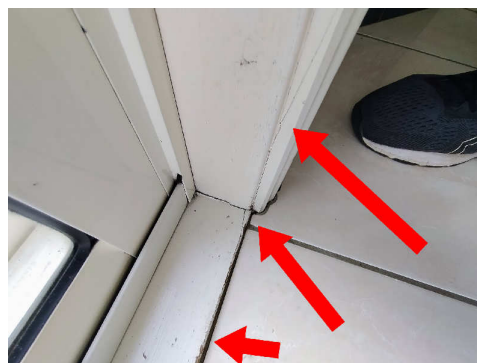
Finding 3.03

Finding: Door framing - Damaged

Information: Door framing in dining room was observed to be damaged at the time of inspection. Breakage occurs generally when the building materials have either aged and decayed, or as a result of damage (accidental or deliberate).

Repair and/or replacement of broken elements is advised to ensure that additional secondary defects do not arise as a consequence. Such works are necessary, as all building elements play a key role in the operation and function of the overall structure and its performance.

A relevant tradesperson should be appointed to repair or replace the affected building element prior to any subsequent damage being caused.

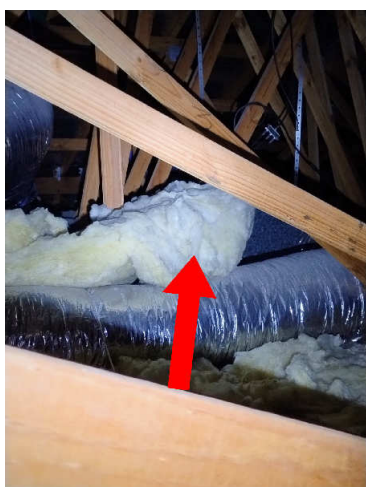
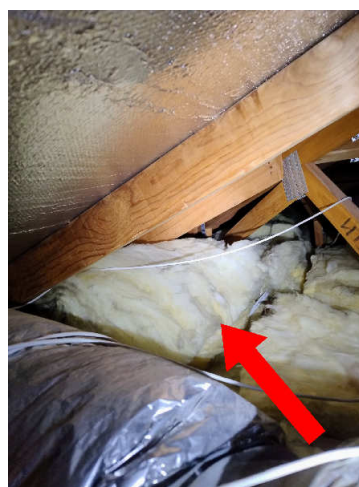
Finding 3.04

Finding: Insulation - Missing and misplaced

Information: Upon inspection of the roof void From Ensuit it was noted that insulation is not properly placed and missing at some location.

Insufficient insulation will result in a comparatively higher cost to heat and cool a property as there is a lack of Insulation (or uneven coverage of insulation) which works as a barrier to heat transfer. This helps to keep out unwanted heat in summer and preserves warmth inside your home in winter. It can also help soundproof your home from unwanted airborne noise transfer.

Where insulation is absent, the area does not meet current Australian Standards. Installation of adequate insulation is required and should be conducted as soon as possible.

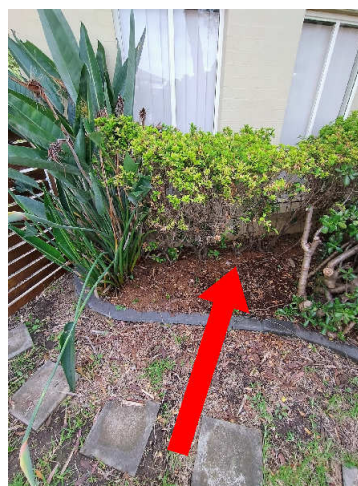
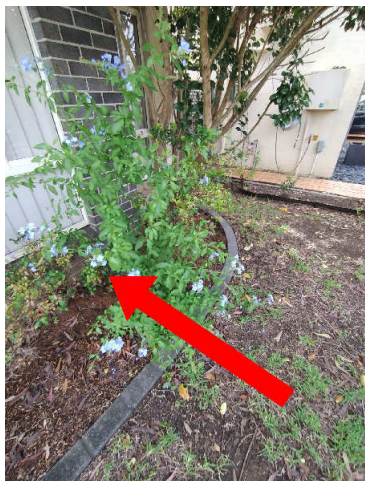
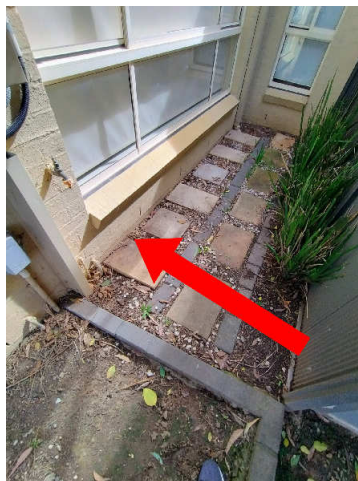
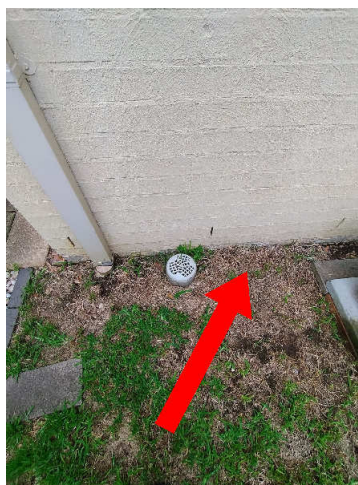
Finding 3.05

Finding: Site drainage - Inadequate

Information: The site drainage in all external area was found to be inadequate at the time of inspection, creating potential for subsequent water damage to associated building elements.

It is important that water does not lie against the base of walls; surrounding paths and ground levels should be sloped to drain water away from walls. Downpipes should not discharge stormwater onto lower walls or plinths. Stormwater should be carried away by large, regularly cleaned drains. Ground levels may need to be lowered to expose a buried DPC.

Where site drainage is inadequate, installation of an Agricultural (Aggie) Drain may be required. A qualified plumber should be appointed to further inspect the property and perform any remedial works as necessary. Water damage and secondary defects are likely to occur if left unmanaged.

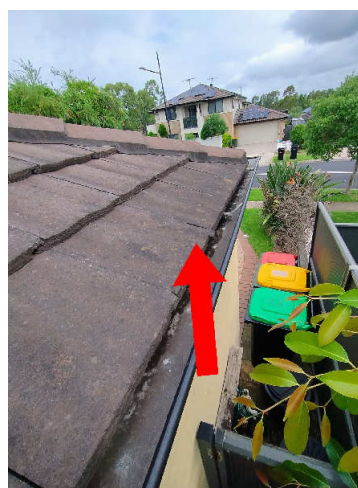
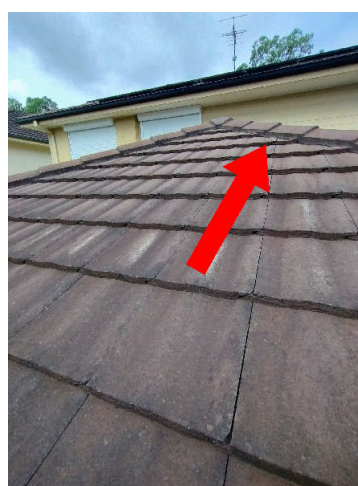
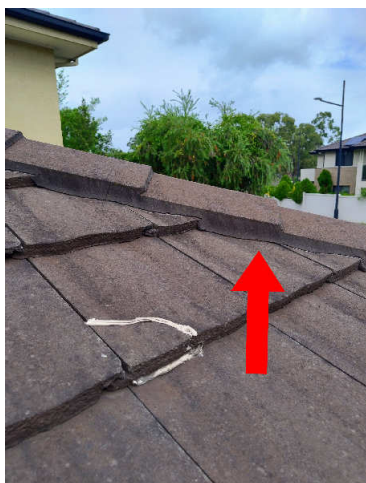
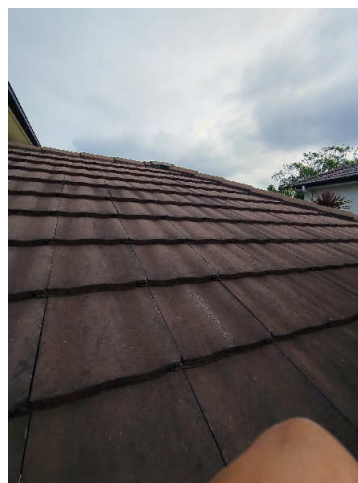
Finding 3.06

Finding: Roof tiles - Weathered and Cracking in sealant of roof structure

Upon inspection of the exterior roofing, the some of roof tiles were considered to be in a fair condition. While weathering of the tiles is consistent with the age of the property, maintenance works are required.

Isolated areas of mortar have come loose in the valleys and minor cracking is also present. Re-pointing and re-sealing the may be considered as an interim solution by the client to help preserve and extend the life span of the tiles.

Where left unmanaged, deteriorating roof tiles are likely to lead to a number of secondary defects, including minor water leaks and weather exposure to internal roofing structures.

Consultation with a roofing contractor is highly advised to gain advice on cost of remedial works that may be required in the short to medium term. Remedial works are likely to increase the longevity of the exterior roofing structure.

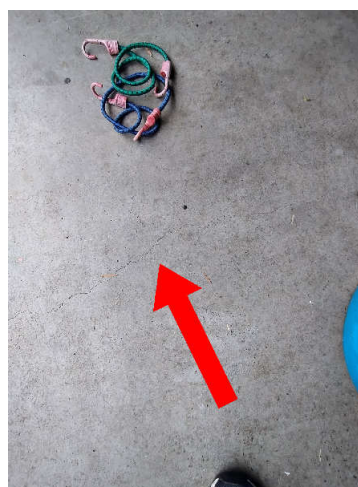
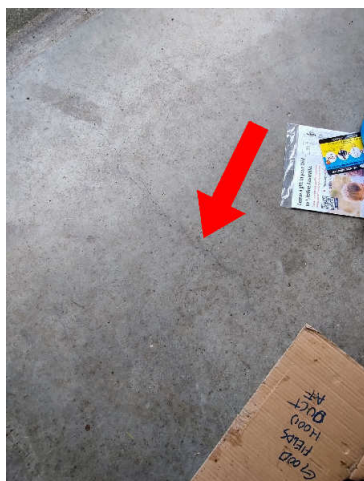
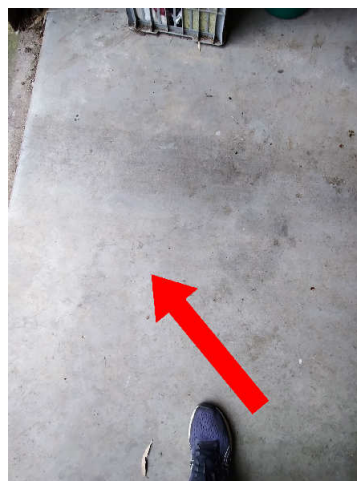
Finding 3.07

Finding: Crack in concrete slab - Category 1

To be considered Category 1, the approximate width of the crack is less than 1.0mm, or a less than 10mm change in offset when a 3m straight edge is placed over the defect.

Category 1 cracks should be monitored for a period of 12 months. At the end of the monitoring period, identified cracks that are rated greater than Category 2 are considered defects, and require rectification.

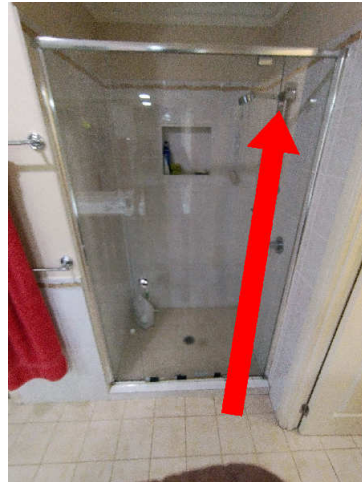
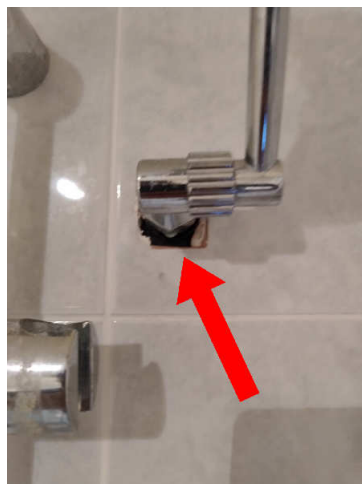
Finding 3.08

| Finding: | Building element - Damaged |

Repair and/or replacement of broken elements is advised to ensure that additional secondary defects do not arise as a consequence. Such works are necessary, as all building elements play a key role in the operation and function of the overall structure and its performance.

A relevant tradesperson should be appointed to repair or replace the affected building element prior to any subsequent damage being caused.

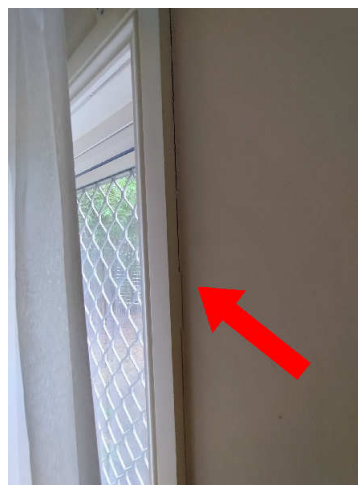
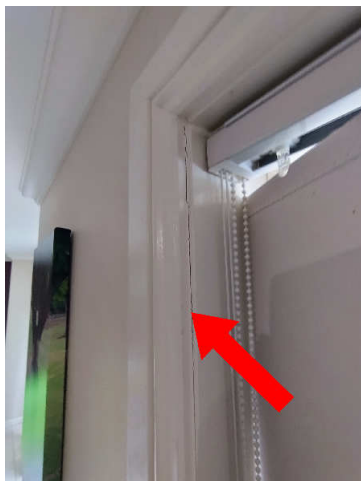
Finding 3.09

Building: Main Building
Location: Dining + Family Room

Finding: Cracking - Damage Category 2 - Noticeable (up to 5mm)

Monitoring of all cracking should be conducted frequently. Always contact a building inspector should cracks widen, lengthen, or become more numerous. Additionally, your building inspector should also be contacted if associated building elements such as doors and windows become more difficult to operate over time.

Relevant tradespeople, such as carpenters, painters and plasterers, should be appointed to perform remedial works, as deemed necessary.

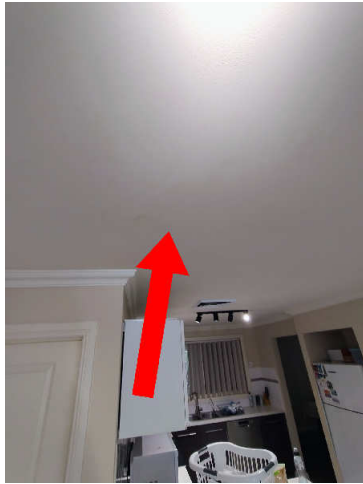
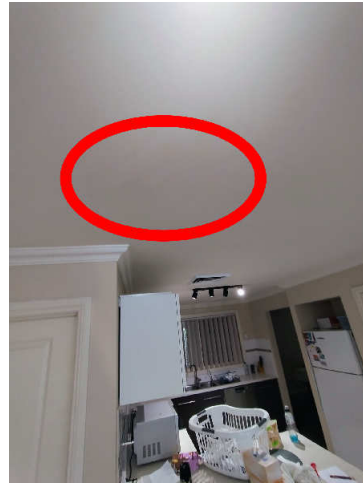
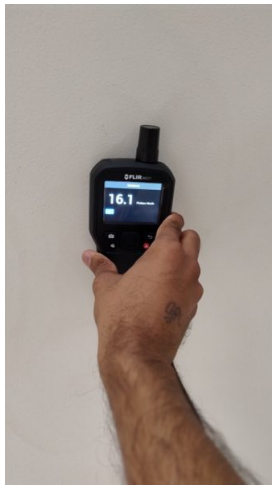
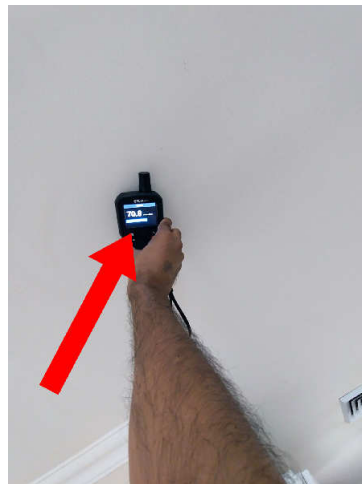
Information: Mould were observed at the time of inspection in ceiling of Family room area. Where evidence of mould growth was noted, there may be environmental, biological or health issues associated with the report. A specialist inspection by a suitably qualified environmental health inspector is warranted, where mould is extensive or where any queries regarding air quality spores or other related issues apply. Moisture reading were taken at the location of mould impression at the soffit of ceiling and high moisture reading was observed at concentrated location.

Generally, the client is advised to ensure that the general environment is free of moisture and humidity to aid in the prevention of mould formation and development. Any mould found during the inspection should be cleaned immediately by a cleaning contractor or the homeowner as applicable.

Please note that severely affected building elements may require replacement by a registered builder or qualified carpenter.

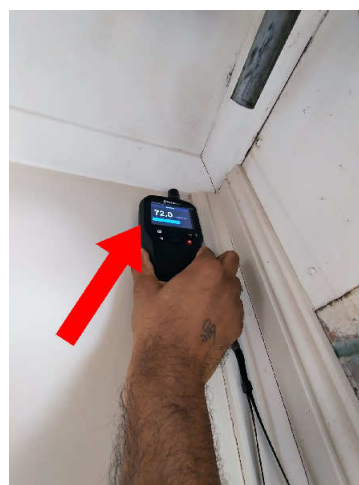
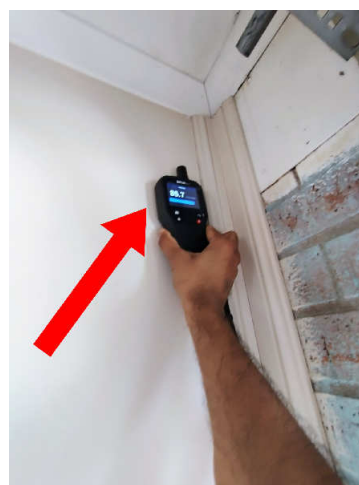
Finding 3.12

Building: Main Building
Location: Garage

Finding: Evidence of Excessive moisture and Mould - identified

Information: Evidence of excessive moisture recorded by moisture meter and mould impressions were observed in the corner area of garage near door.

Excessive moisture can attract termites and produce conditions that promote fungal growth and wood decay.

Excessive moisture is generally caused by deteriorated, inadequate or missing roof drainage, leaking plumbing pipes or fixtures, poorly plumbed HWS overflows or condenser units and poor site drainage.

If mould growth has been found there may be environmental biological or health issues involved. In these cases an appropriately qualified inspector should also be contacted.

Prior to any remedial works being performed a qualified plumber should be appointed to further inspect the property and to identify the cause of the excessive moisture. Works to remove affected building elements may then be necessary and should be performed by an appropriate tradesperson.

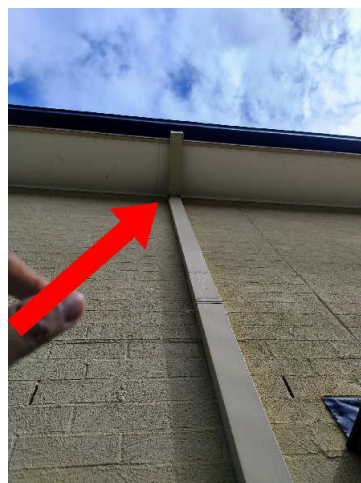
Finding 3.18

Any gaps to the exterior walls of the building that are larger than 3mm are deemed a defect and require filling, beading or replacement of brickwork to close or cover the gaps. Such gaps create potential for pest ingress, excessive moisture and structural issues, and should therefore be minimised prior to the development of secondary defects.

Such works should be carried out by the builder on site to prevent secondary defects and to comply with Australian Standards.

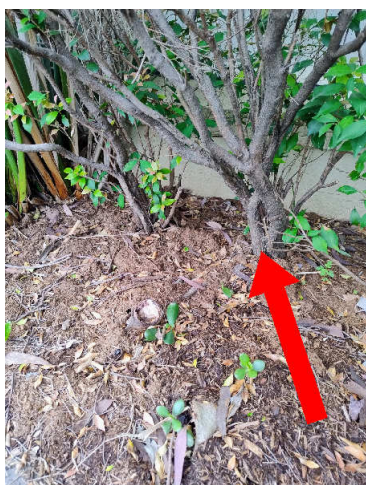
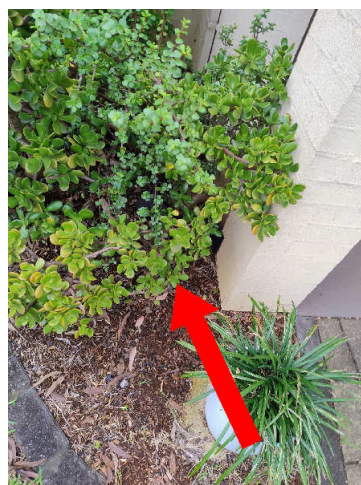
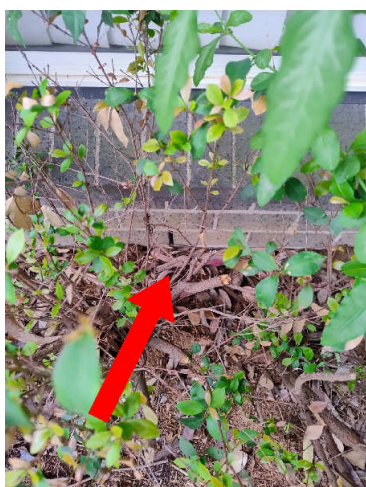
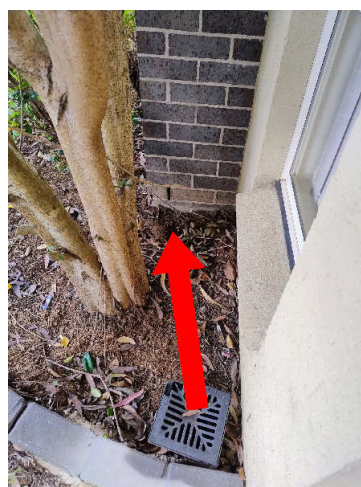
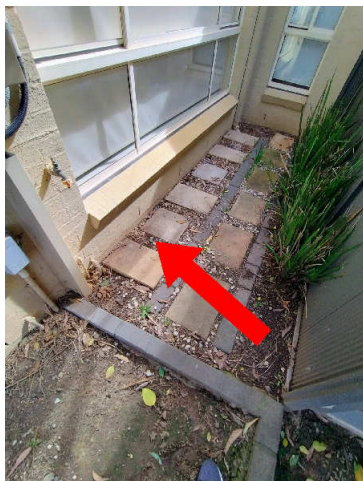
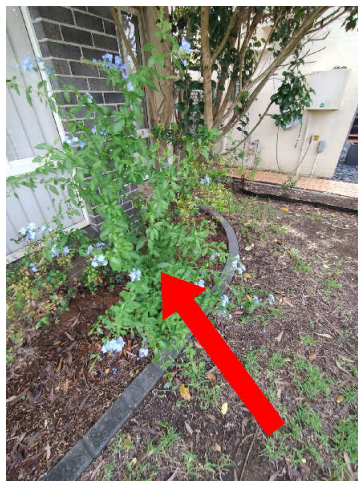
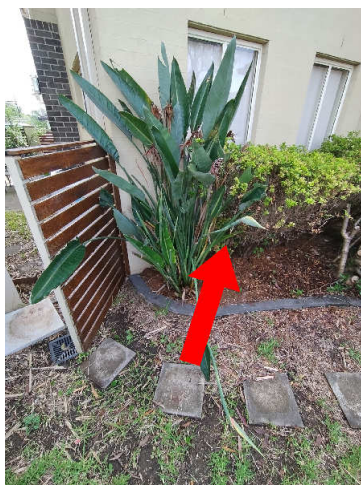
At the time of inspection breaching of termite barriers was observed.

Damp proof course (DPC) is a barrier of impervious material built into a wall or pier to prevent moisture from moving to any part of the building. Where external ground levels are built up over this barrier ingress is provided for moisture from the exterior grounds into the base brickwork or other building material and allowed to rise.

Such conditions attract termites into these damp areas which is likely to lead to infestation if left untreated.

While retrospective fitting of DPC is considered to be impractical works are required in order to prevent the extraction of moisture from the external environment into exterior brickwork or wall materials. Landscaping or re-paving of external grounds may be considered by the client. Regular annual inspections are strongly advised.

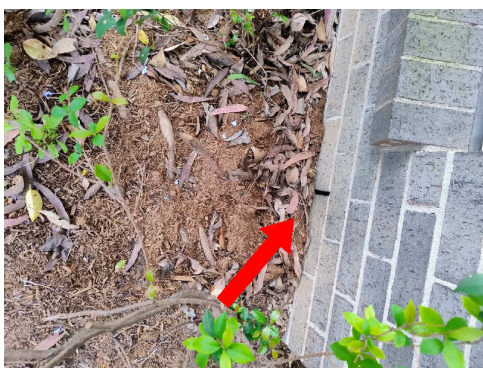
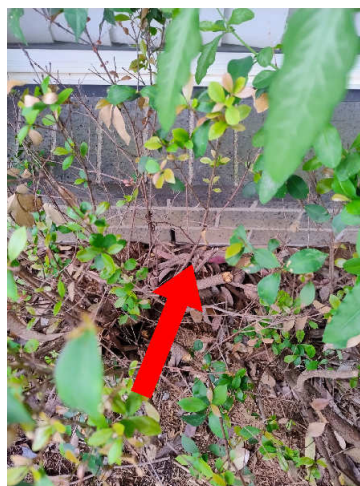
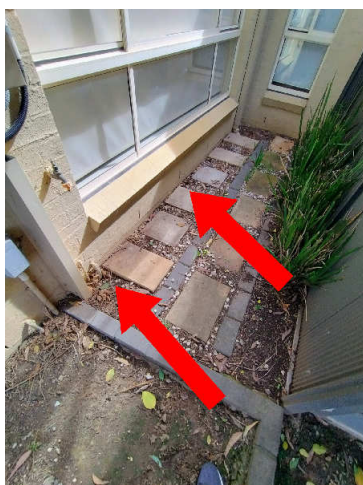
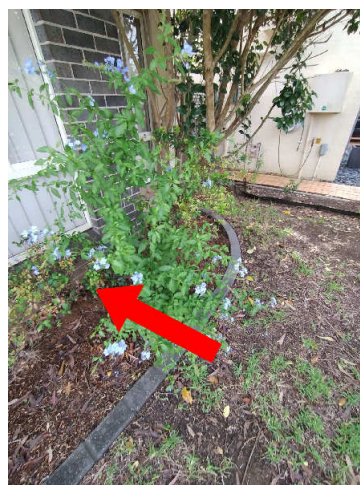
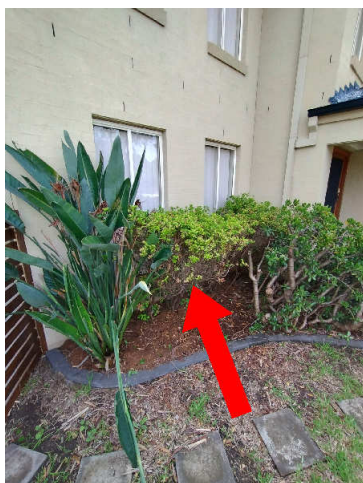
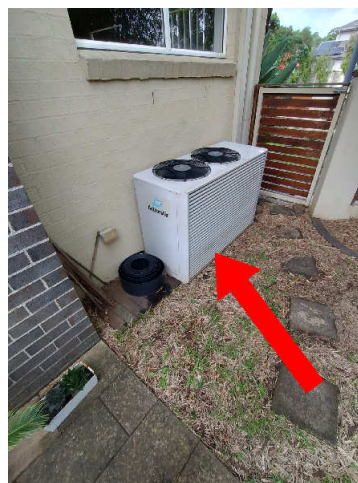
Finding 6.02

Building: Main Building
Location: All External Areas
Finding: Slab Edge - Exposure not fully available

If the slab edge is not properly exposed there is a high risk of termite attack. Sometimes, in order to determine the type of slab, a suitably qualified person such as an architect or builder may be required to consult the construction plans.

Where the slab edge cannot be properly inspected, it is highly recommended that termite or timber pest inspections be carried out every 6-12 months to aid protection of the property against infestation.

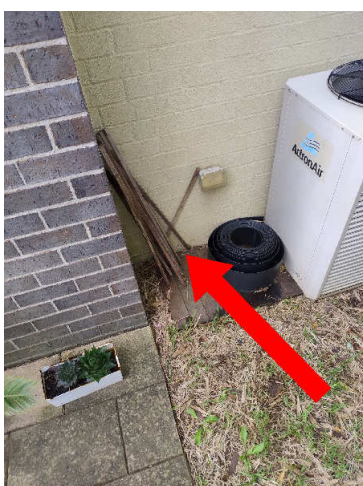
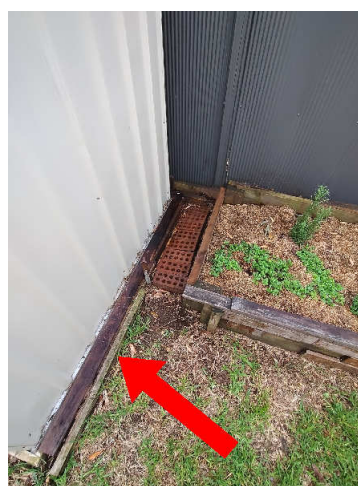
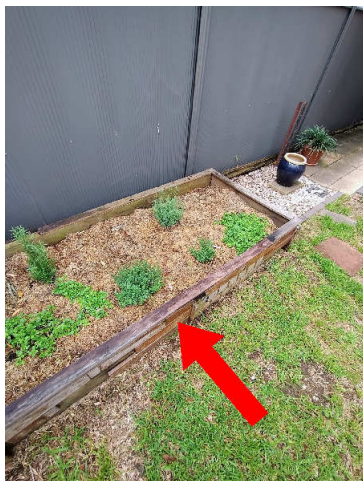
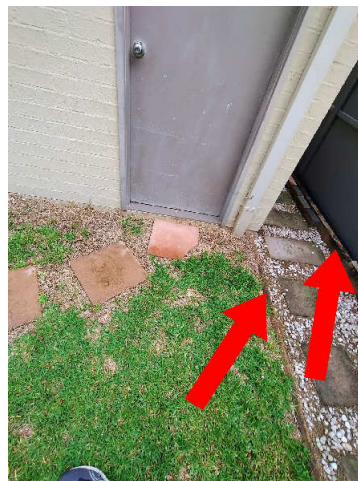
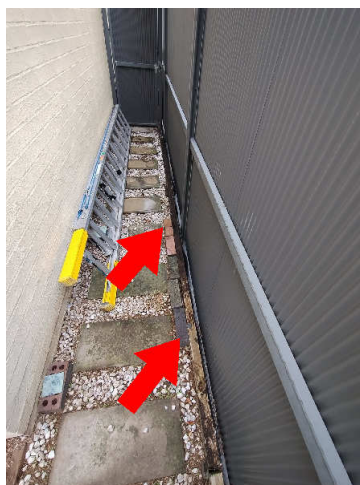
Finding 6.03

Information: The storing of timbers around the external property increases the risk of termite activity being present at the time of inspection. As they are likely to come into contact with weather conditions or excessive moisture wood rot is likely to develop on timbers that are not treated.

It is highly recommended that any stored timbers be immediately removed from areas in which they may attract any termite / timber pest attack. Minimisation of risk / prevention of termite attack is far more adequate than dealing with the presence of termite activity.

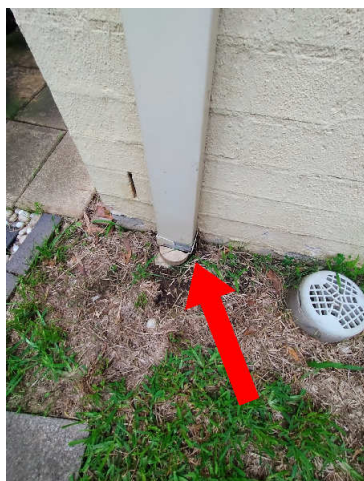
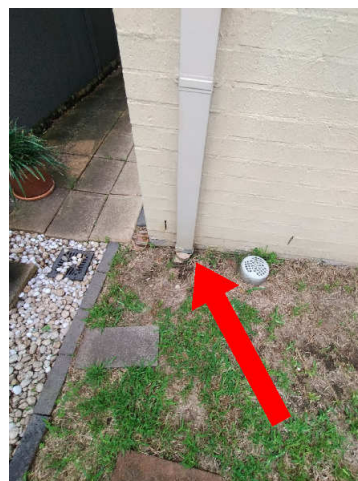
Finding 6.04

Where roof plumbing doesn't drain adequately, the area at the base perimeter can become excessively damp, potentially creating an environment that is susceptible to rust and corrosion of surrounding building elements, as well as attracting termites and other pests.

It is highly recommended that a plumber be appointed to further inspect the area and to install adequate drainage equipment where necessary.

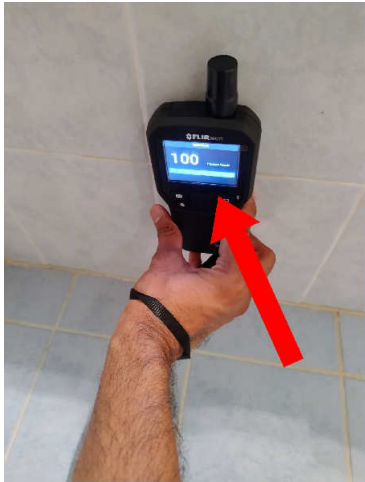
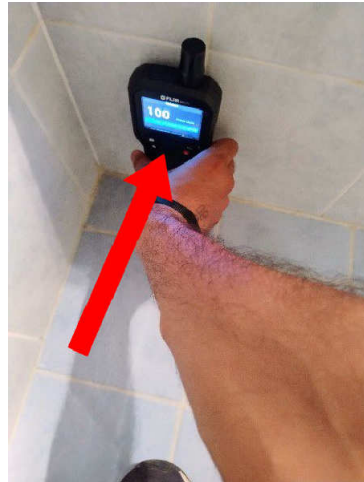
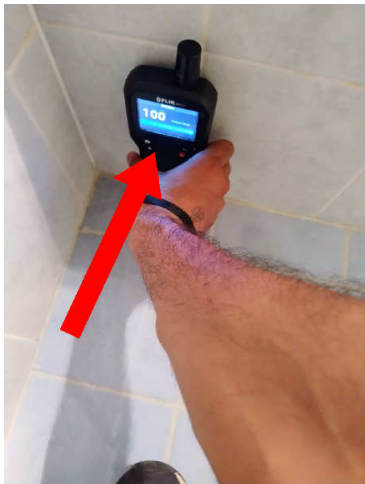
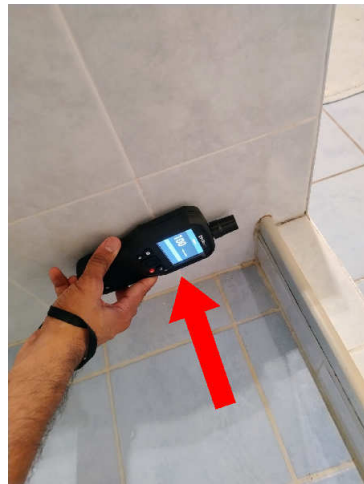
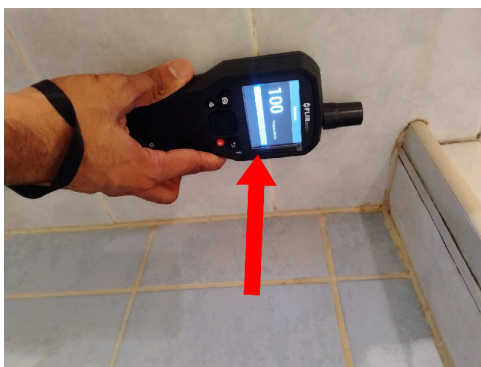
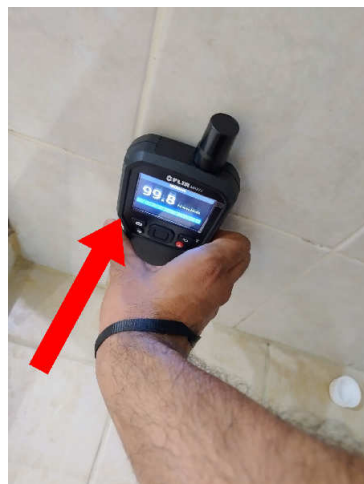
Finding 6.05

Finding: Evidence of Excessive moisture - identified

Information: Evidence of excessive moisture recorded by moisture meter in the shower wall of bathroom and Ensuit.

Excessive moisture can attract termites and produce conditions that promote fungal growth and wood decay.

Excessive moisture is generally caused by deteriorated, inadequate or missing roof drainage, leaking plumbing pipes or fixtures, poorly plumbed HWS overflows or condenser units and poor site drainage.

Prior to any remedial works being performed a qualified plumber should be appointed to further inspect the property and to identify the cause of the excessive moisture. Works to remove affected building elements may then be necessary and should be performed by an appropriate tradesperson.

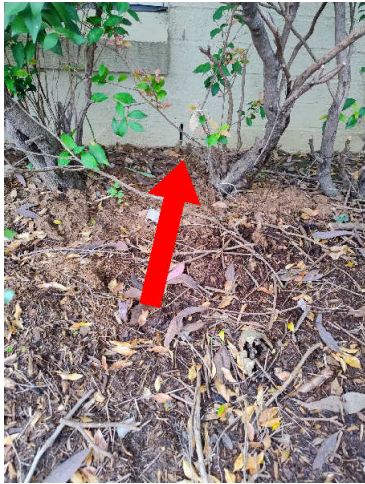
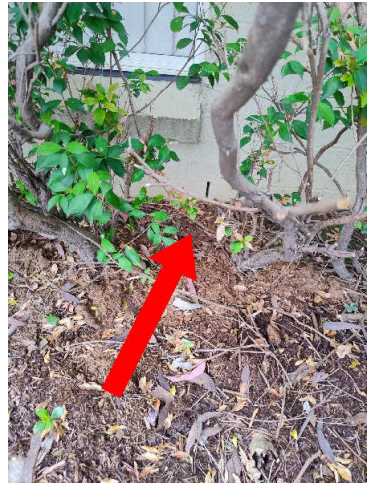
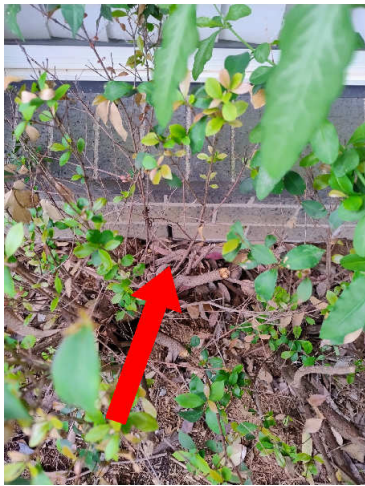
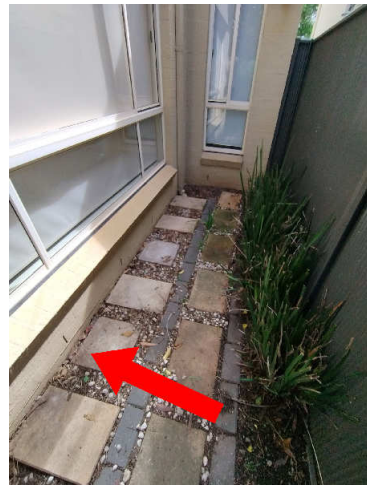
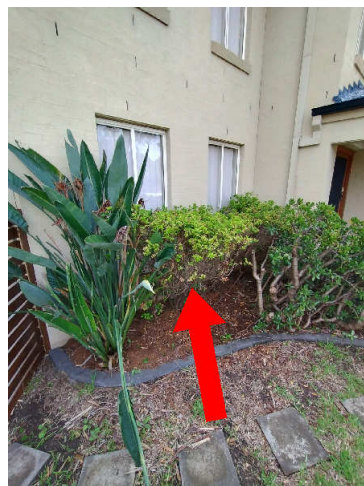
Finding 6.06

| Information: | Weep holes were observed to be covered and not provided with Screens in some location at the time of inspection. |

Weep holes in the exterior brickwork of the property are designed to allow condensation that may build up between the brickwork and subsequent timber framework to drain from within the wall hence preventing any deterioration of the timber building elements.

Where weep holes are covered by external ground levels such as paving or garden beds concealed entry is available for termites from these grounds into the brickwork or external wall materials also all weepholes around property were missing screens at the time of inspection.

Additionally build-up of moisture is likely to occur if weep holes are covered further attracting termite activity to these areas.

It is highly recommended that weep holes are left exposed in all areas throughout the external property. Therefore if any termite activity leading into weep holes becomes easily detectable during frequent pest inspections.

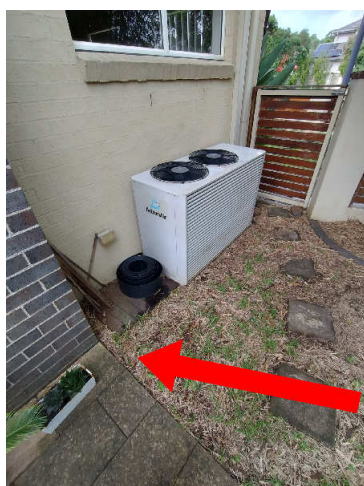
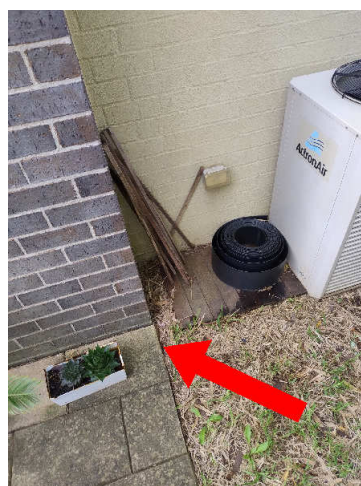
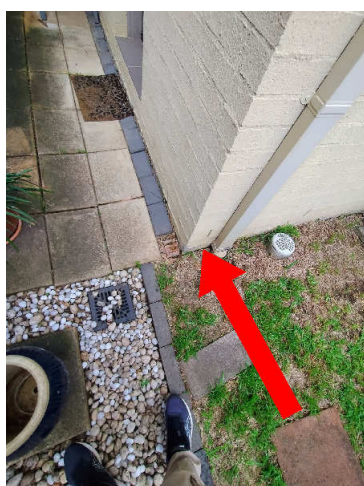
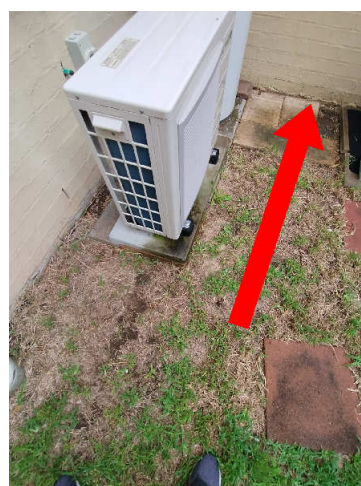
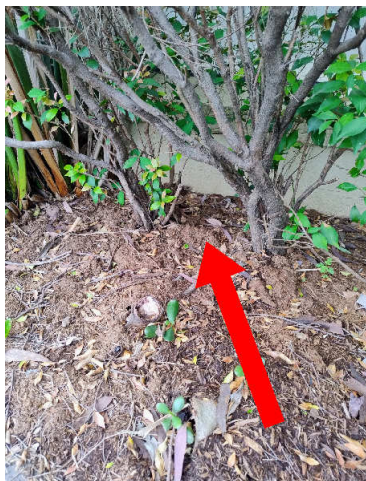
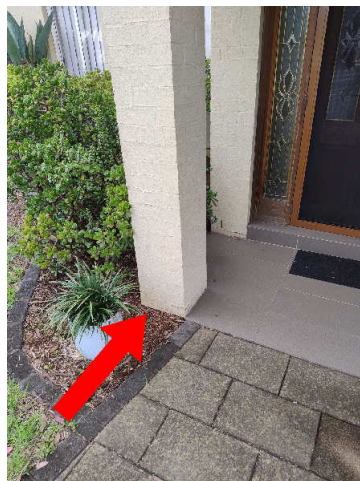
Finding 6.07

Finding: Site drainage - Inadequate

Information: The site drainage in front and left side area was found to be inadequate at the time of inspection, creating potential for subsequent water damage to associated building elements.

It is important that water does not lie against the base of walls; surrounding paths and ground levels should be sloped to drain water away from walls. Downpipes should not discharge stormwater onto lower walls or plinths. Stormwater should be carried away by large, regularly cleaned drains. Ground levels may need to be lowered to expose a buried DPC.

Where site drainage is inadequate, installation of an Agricultural (Aggie) Drain may be required. A qualified plumber should be appointed to further inspect the property and perform any remedial works as necessary. Water damage and secondary defects are likely to occur if left unmanaged.

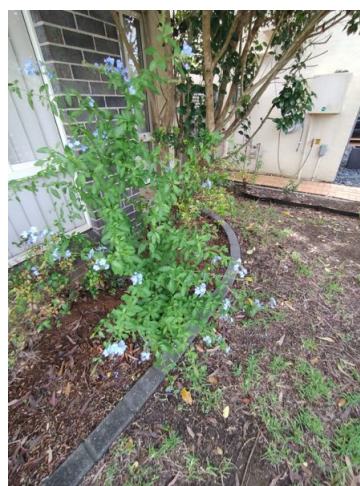
Finding 6.08

Finding: Garden Beds - Conditions Conducive to Termites

Information: Garden beds were found to be evident in the front area. These garden beds can include untreated timber, and with a combination of moisture from watering hosing can make conditions conducive to termite activity and termite ingress.

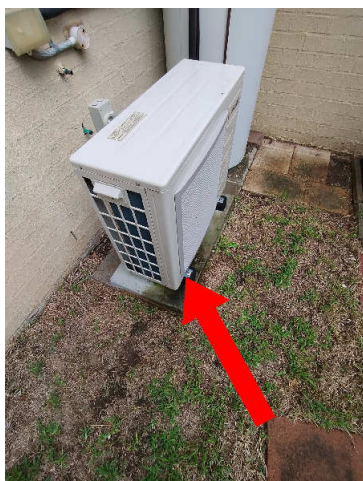
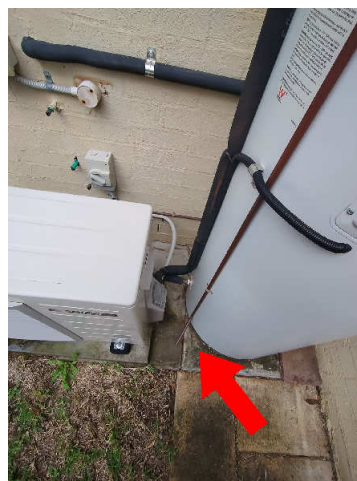
Finding 6.09

Finding: Overflow for air condition unit and hot water unit - Not plumbed for drainage

Information: The overflow for air condition and hot water unit is not plumbed or connected to suitable drainage, which has resulted in the surrounding area becoming excessively damp at the time of inspection.

These damp conditions can lead to secondary defects such as rot, rust or corrosion of associated building elements, the formation of fungal decay, or even the creation of potential slip hazards.

When coupled with poor site drainage, pooling of water may also attract termite activity to this area. It is highly recommended that a qualified plumber be appointed to install adequate drainage to the overflow. These works will ensure that the area remains dry and free of any secondary defects.

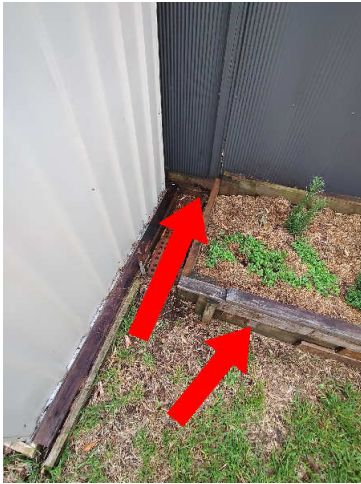
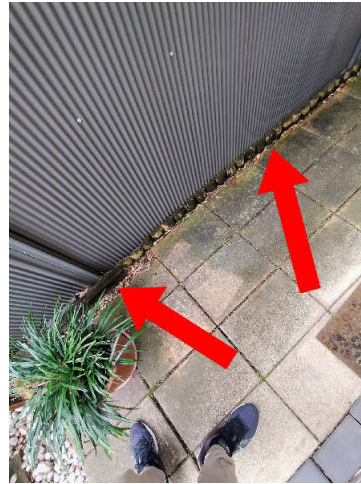
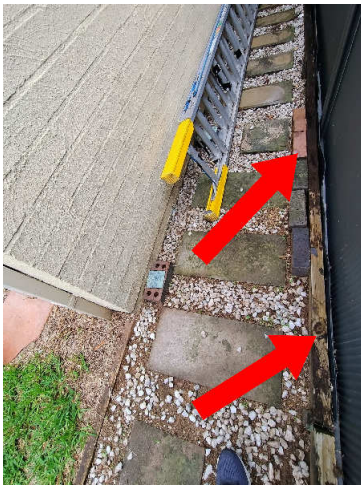
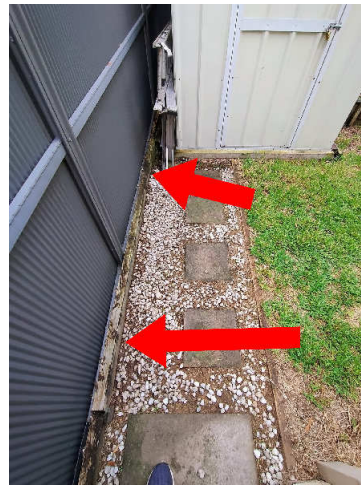
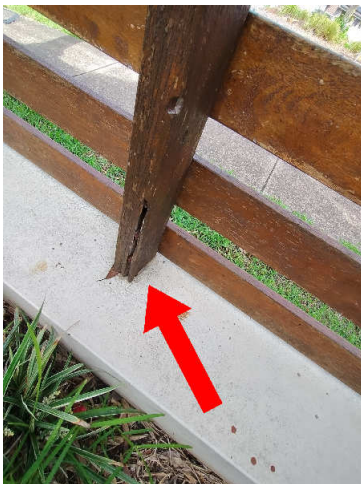
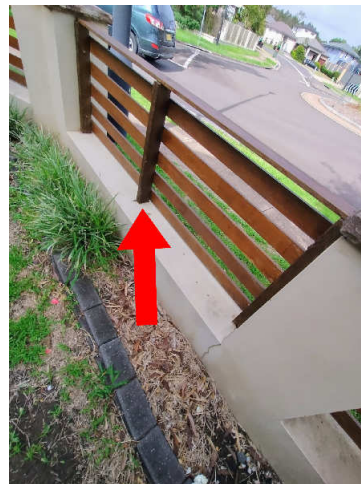
Finding 7.01

Finding: Fungal decay - present

Information: Fungal decay and timber deterioration was observed at the time of inspection in rear elevation of the property. Fungal decay also known as wood decay or wood rot generally refers to the deterioration of timber elements when in contact with excessive levels of moisture for a prolonged period of time.

The development of fungal decay is accelerated by temperatures in the range of 5degreeC to 40degreeC as well as the presence of oxygen. Generally fungal decay develops on timber elements that are in use in an external environment which are exposed to rain penetration.

In this case although the affected timber element is in a decaying state the extent of any visible damage appears to be localised to a specific area and is yet to spread to other parts of the building element or affect adjoining structures. The fungal decay is therefore likely to be of a relatively superficial nature with minimal impact on the structural integrity or tensile strength of the timber element.

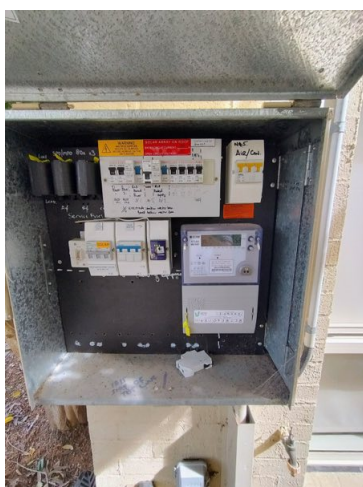
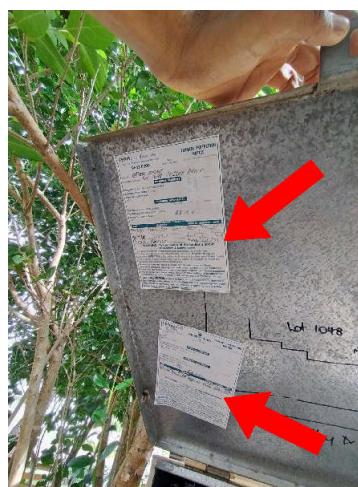
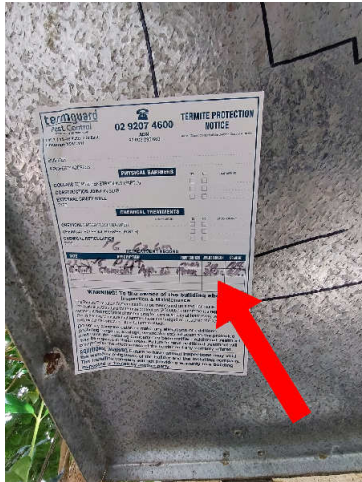
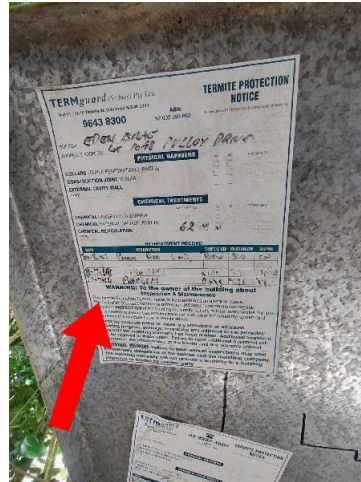
More information is required such as an installation diagram of the barrier, as well as a signed certificate of installation otherwise the integrity of the termite barrier system could be compromised and deemed inadequate or out of warranty.

It is strongly recommended that client seek advice from a qualified pest control contractor to further investigate the condition of the termite management system. Alternatively you could consult with the company who has installed the treatment to confirm this information.

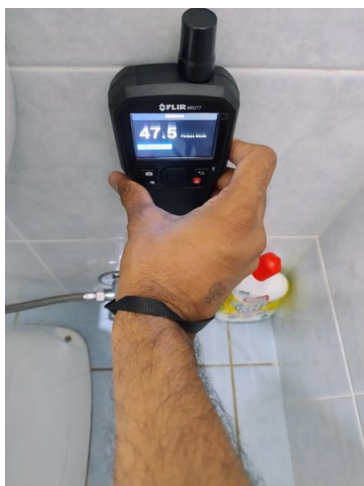
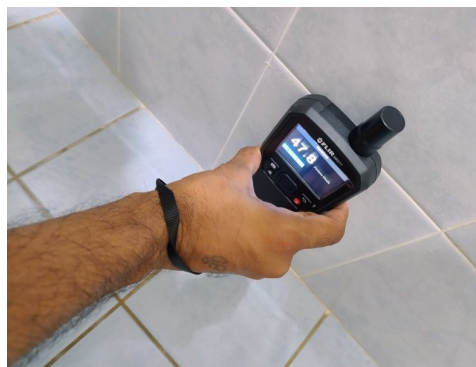
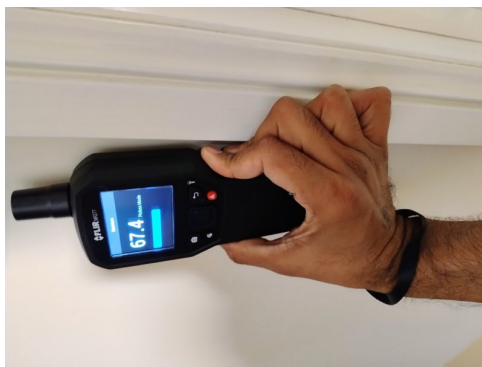
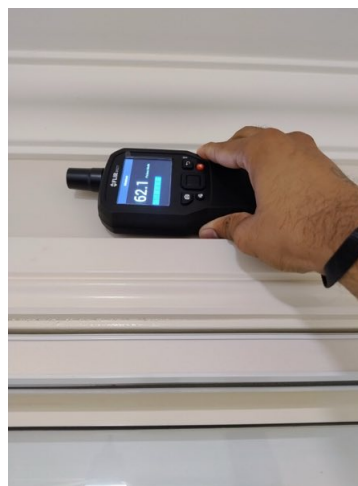
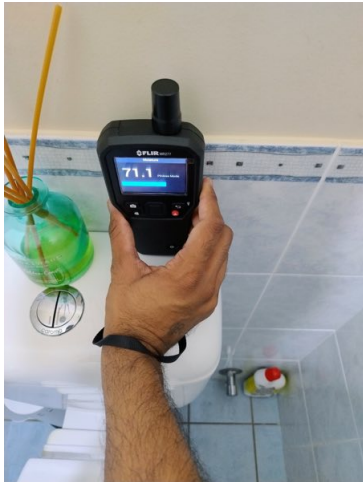
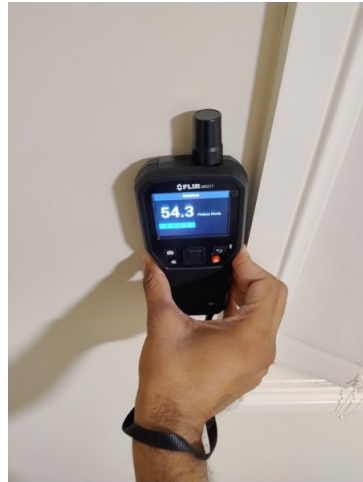
Noted Item

Building: Main Building
Location: All Areas
Finding: Moisture reading taken at different locations
Information: All area moisture reading for reference.
