Building and Timber Pest Inspection Report

Inspection Date: Mon, 09 Mar 2026

Property Address: 15 Pulley Dr, Ropes Crossing NSW 2760,
Australia

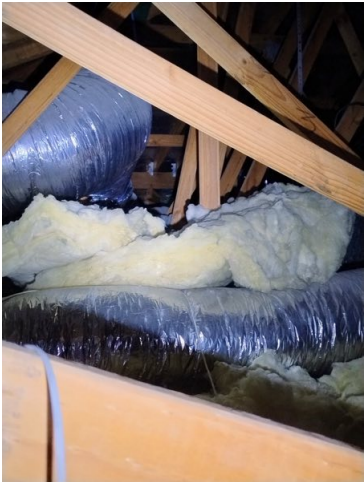
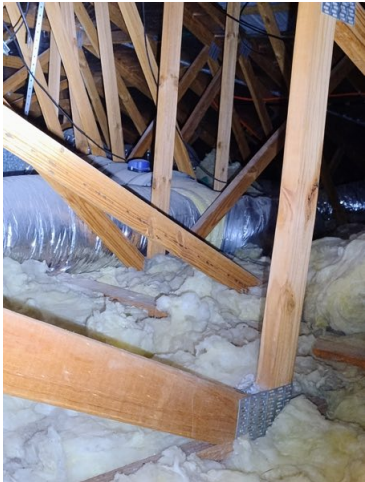
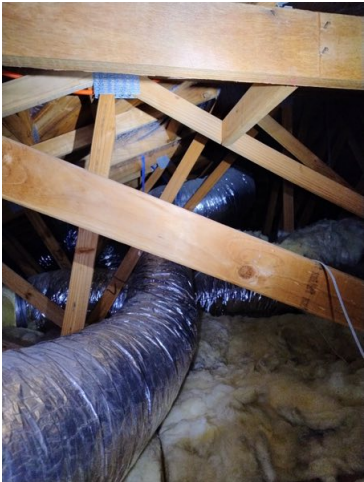
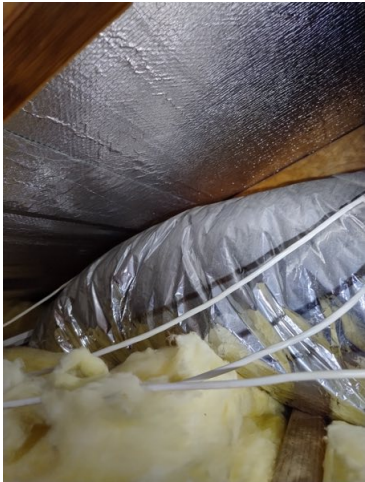
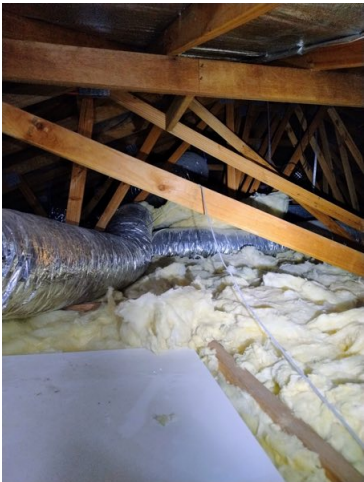
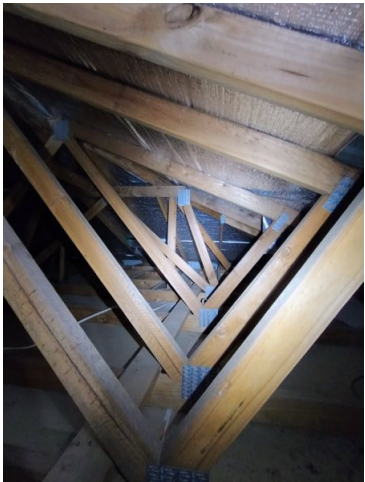
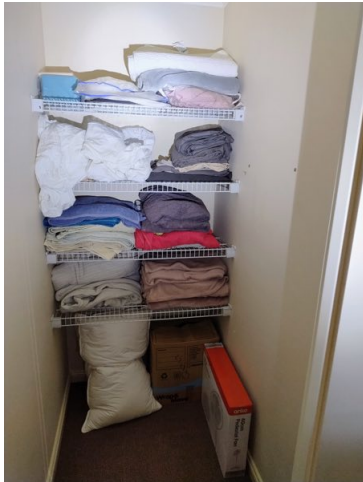
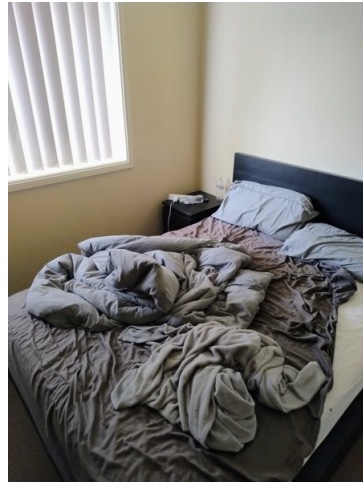
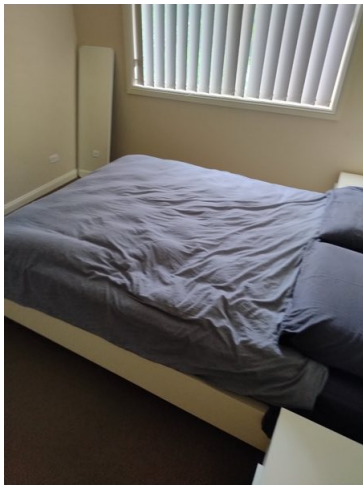
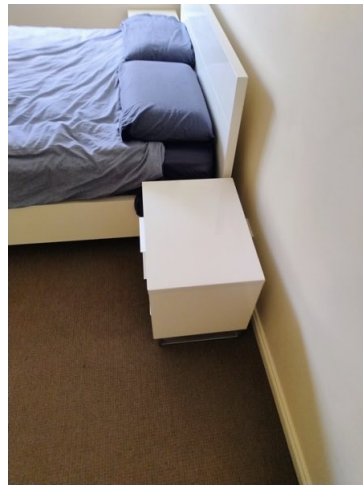
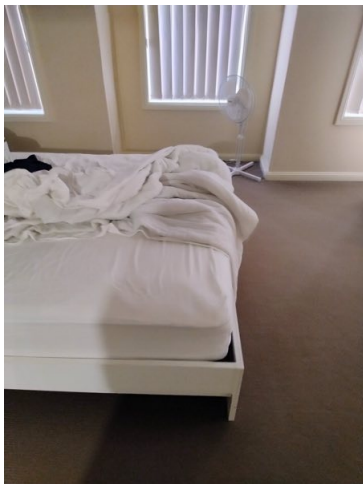
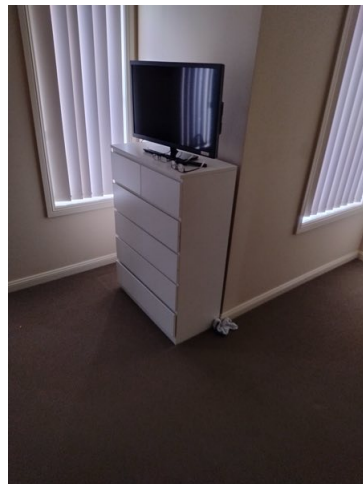
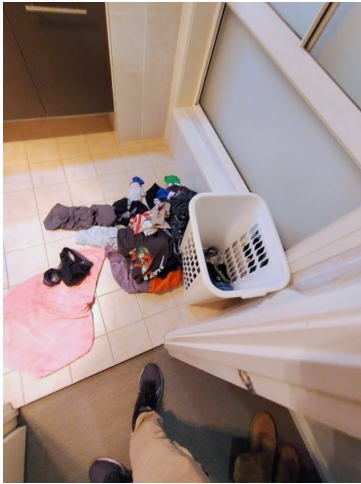
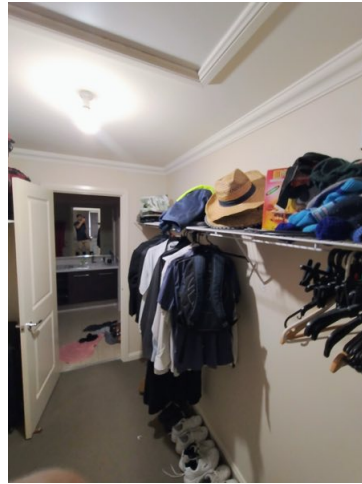
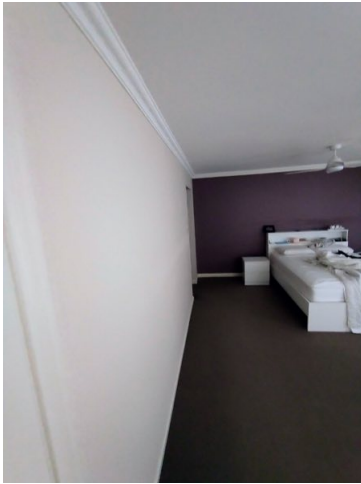
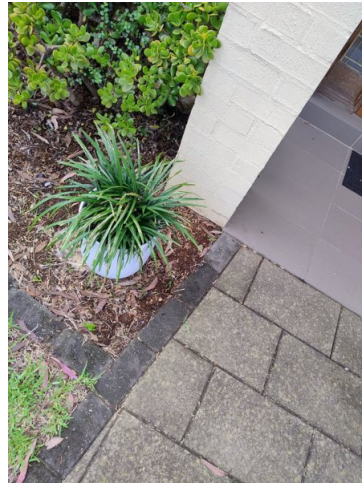
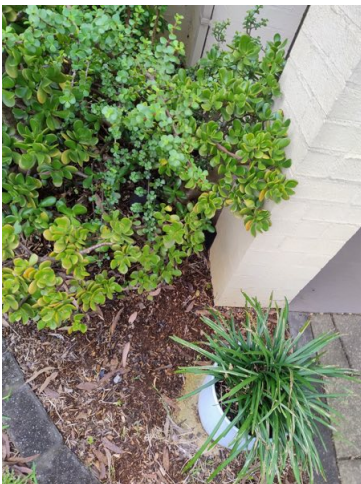
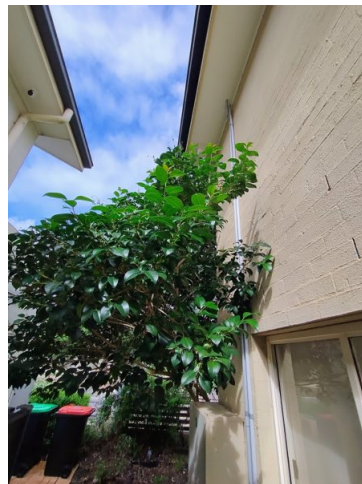
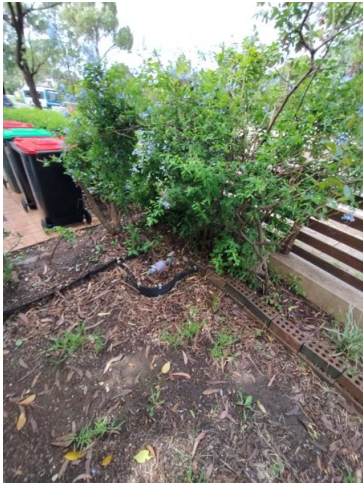
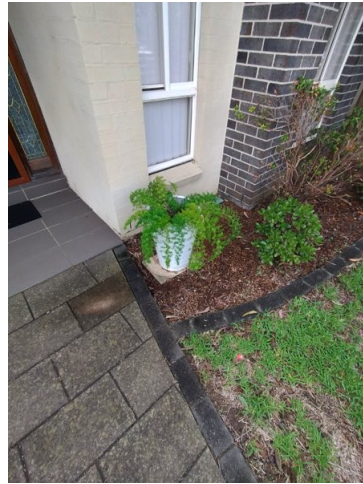
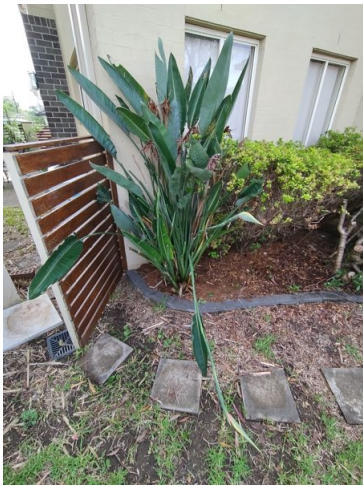
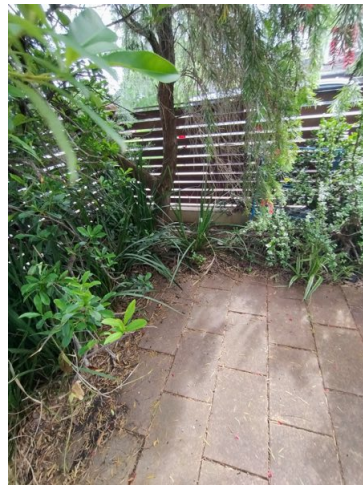
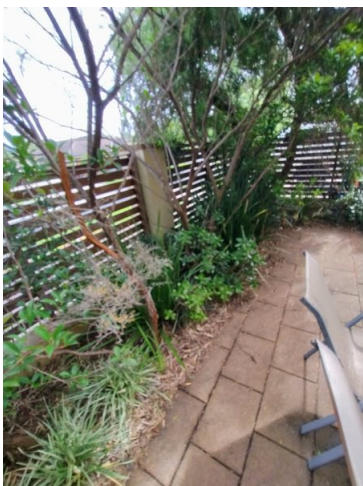
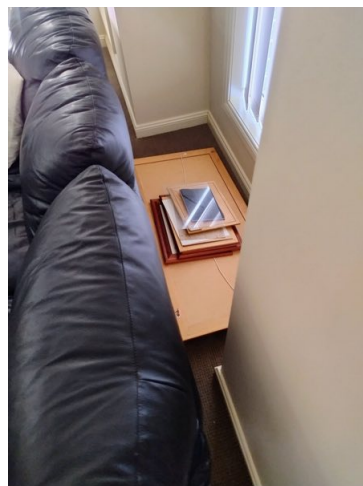
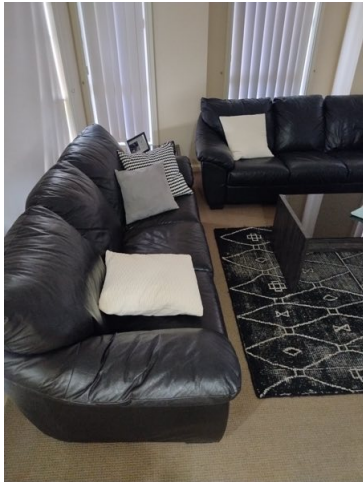
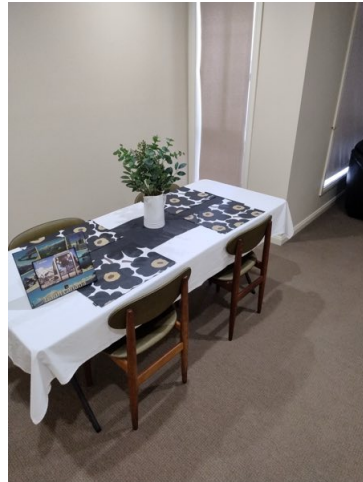
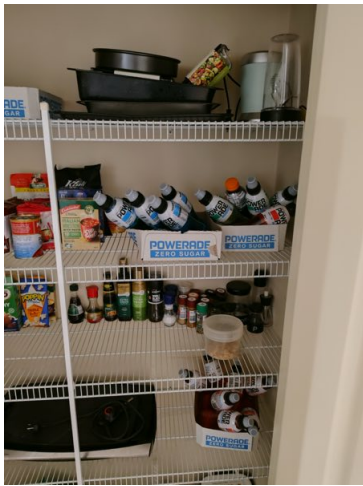
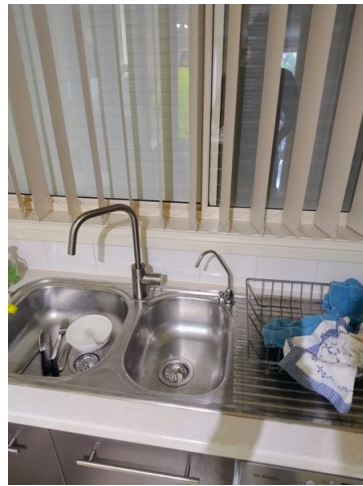
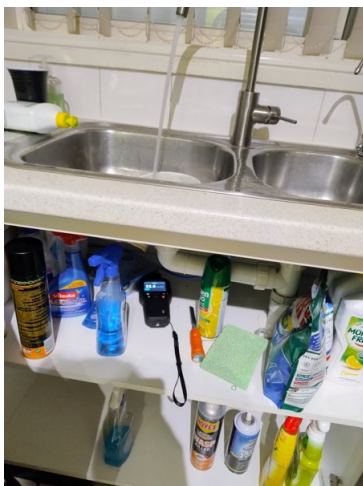
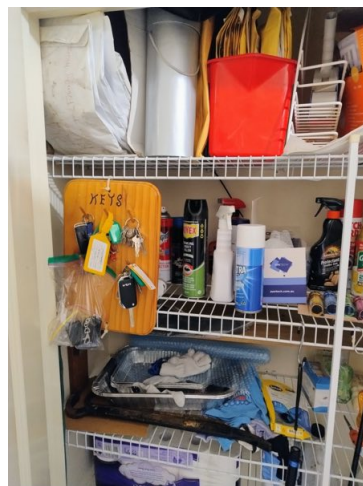
Information: These photographs are an indication of the obstructions and limitations which impeded full inspection of the property at the time of inspection. The insulation covered nearly all the ceiling joists, which are major structural elements of ceiling. The inspection was also limited to areas with an allowable crawl space of 600mm x 600mm, in particular towards the external walls where the roof line diminishes, it was not accessible. These obstructions and limitations can hide an array of defects and should be removed to allow a full inspection to be carried out.

Without full access behind these obstructions, defect, activity and damage may be concealed.

These obstructions can hide an array of defects and should be removed to allow full inspection to be carried out. A re-inspection is recommended once the areas are made accessible.

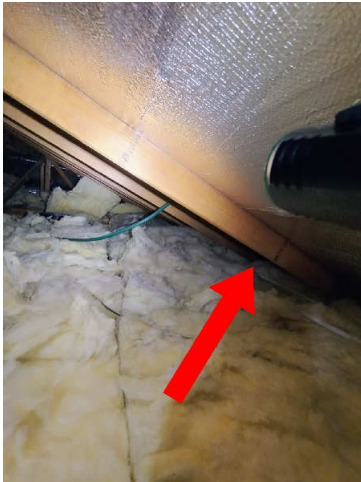
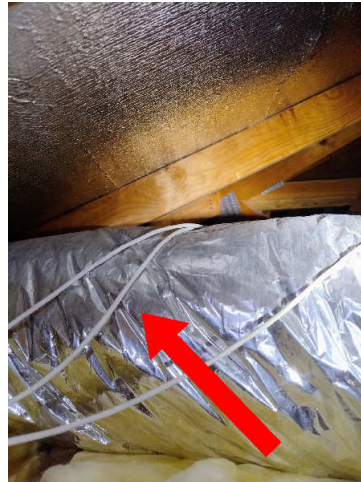
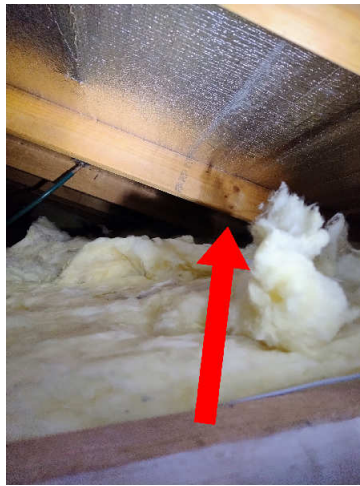
Finding: Roof void access limitations

Information: Very Limited access to the roof void was present from Ensuit due to facts including but not limited to access hatch size or placement and obstructions at the entry of roof space, The low pitch of the roof near the rood void entrance was not allowing to enter into the roof space.for this reason access to the roof void was minimal.

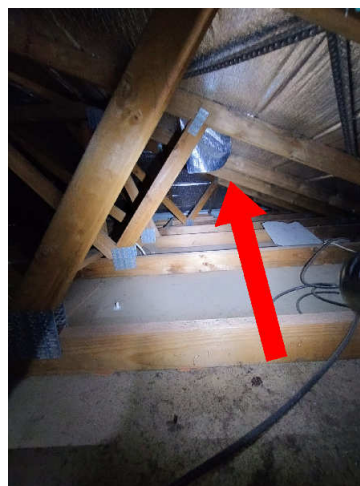
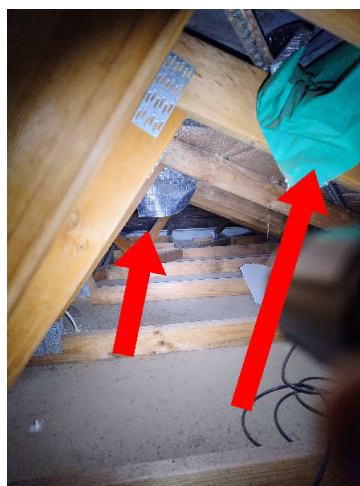
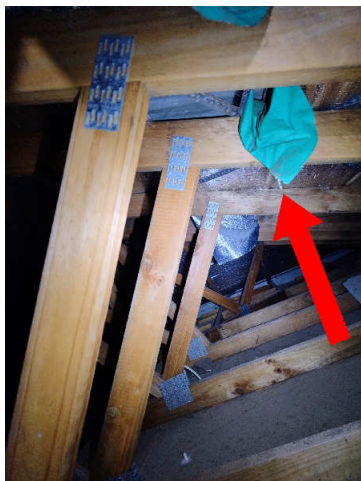
Building: Main Building
Location: Garage Roof Space
Finding: Sarking - Damaged

Sarking, a laminated aluminium foil applied to the interior of the roof covering, assists in insulating the property and acting as a vapour-barrier to the roof void and, subsequently, to the household, it observed to be damaged at multiple location in roof void of garage.

Where sarking is damaged, both insulation and moisture protection of the property are inhibited. This creates a loss of energy and thus negatively impacts the energy efficiency of the property, allowing potential for moisture ingress from condensation or leaking roof tiles.

It is important to repair any holes or damaged sections of sarking to ensure that the building material is fully functional. A registered builder or qualified carpenter should be consulted to provide further advice on this defect and to perform rectification works at client discretion.

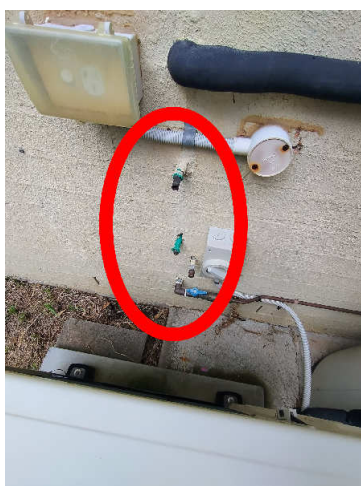
Finding: Plumbing work - appears defective

Information: Plumbing work behind the air condition unit found defective at the time of inspection. Whilst we are not licensed plumbers it appears that work which is not compliant with the relevant plumbing regulations and or the contract documents has occurred. The area of suspected non-compliance or poor workmanship should be referred to the builder and or the Building Surveyor or Certifier. The builder is required to provide a Certificate of Compliance when required by the relevant regulations.
