Building and Timber Pest Inspection Report

Inspection Date: Tue, 7 Apr 2026

Property Address: 3/19 Lalor Rd, Quakers Hill NSW 2763,
Australia

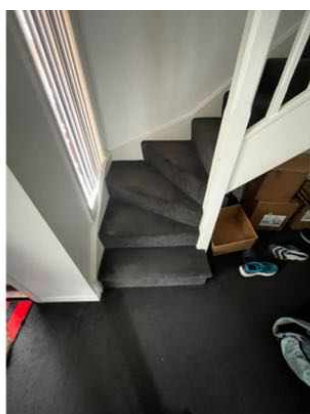
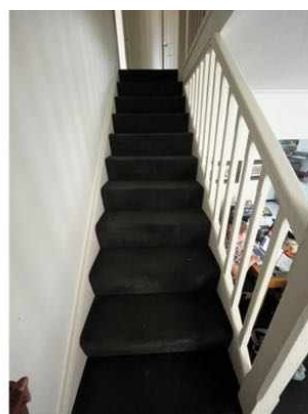
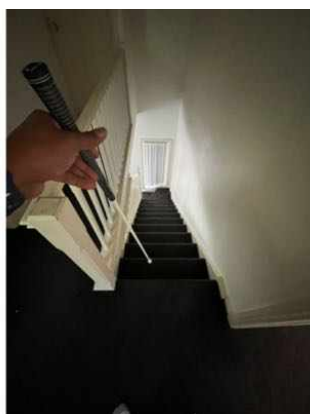
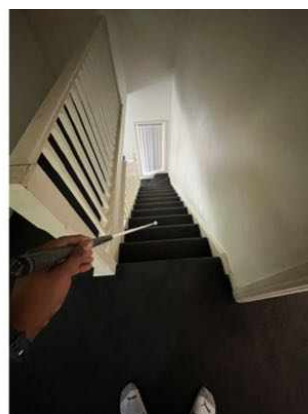
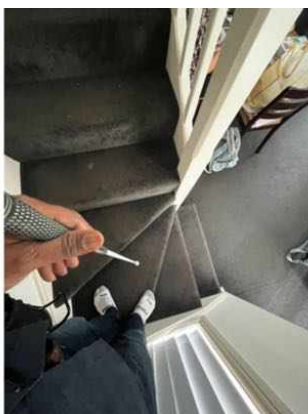
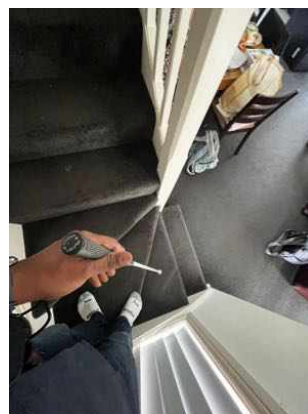
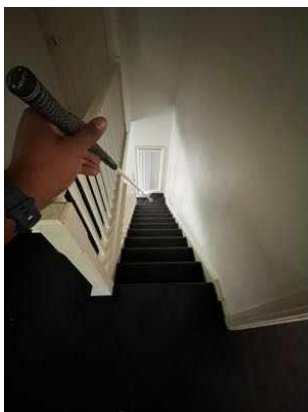
Finding: Staircase - Landing - Damage

The stairs steps and landing were found to be bouncy and the stairs board loose when found on inspection therefore causing a safety hazard.

The client is advised to seek quotations for required repairs from a Registered Builder / Carpenter specialising in Staircase structure.

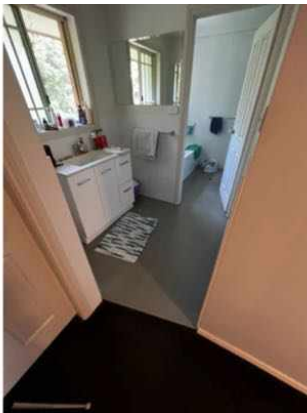
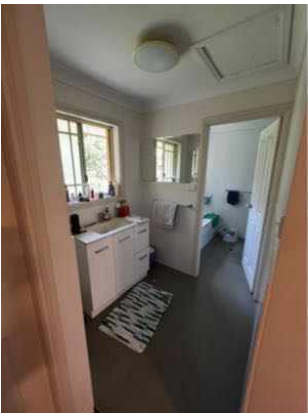
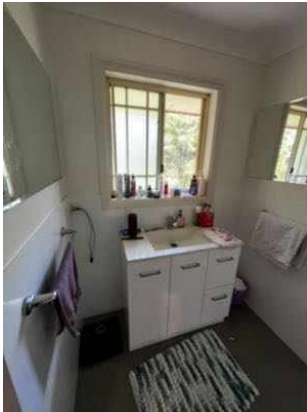
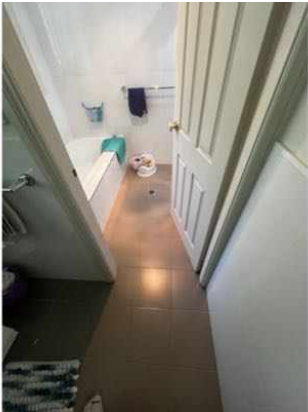
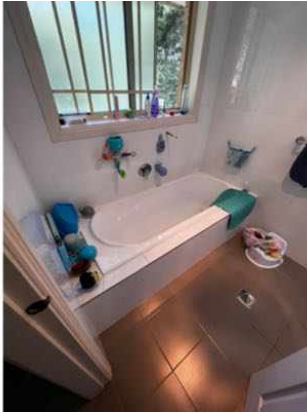
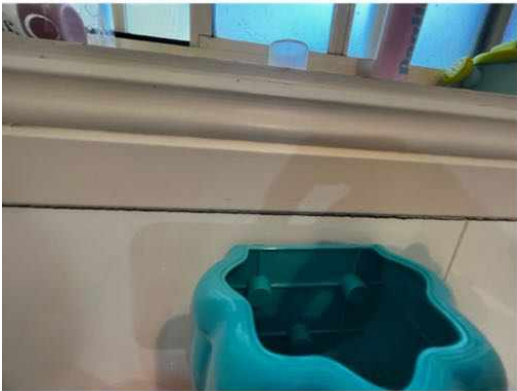
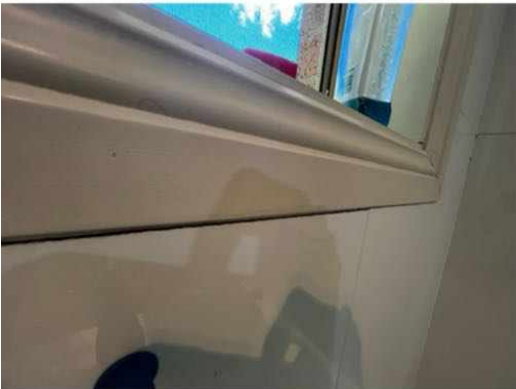
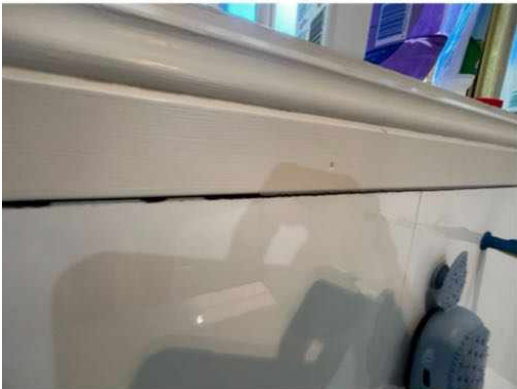
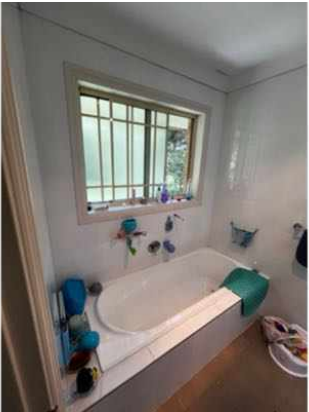
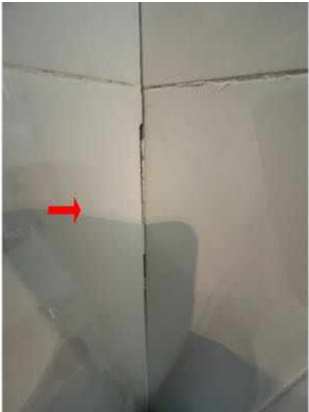
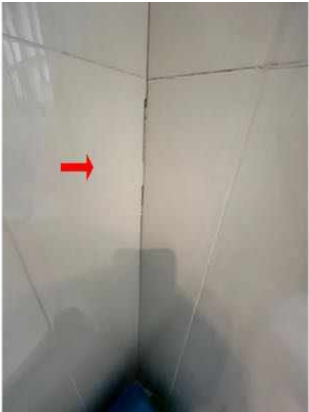
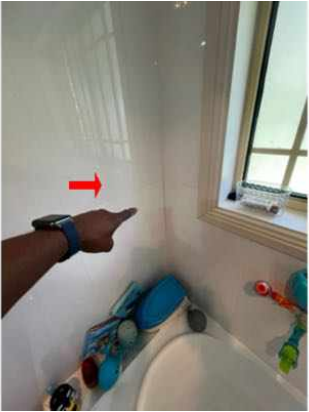
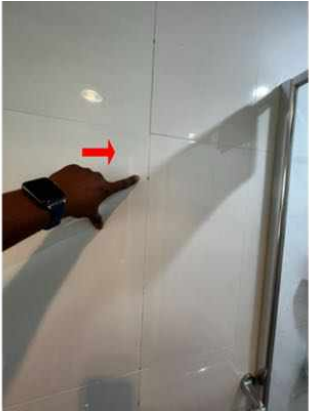
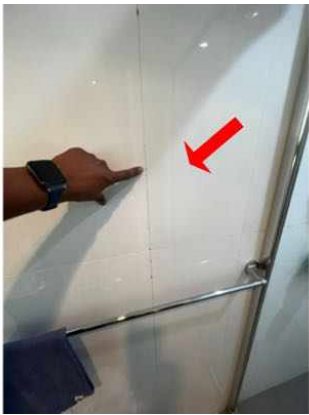
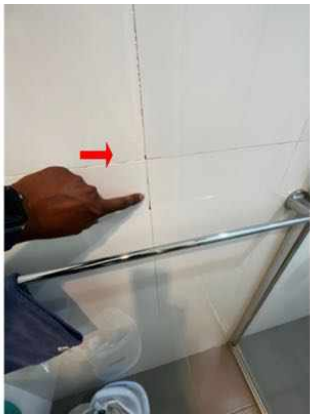
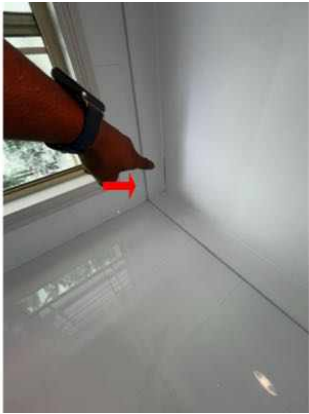
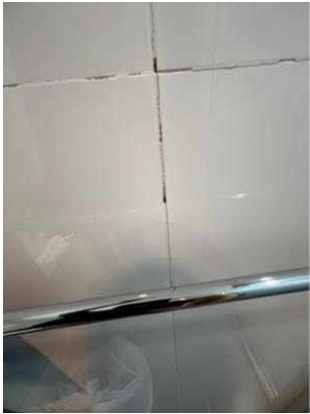
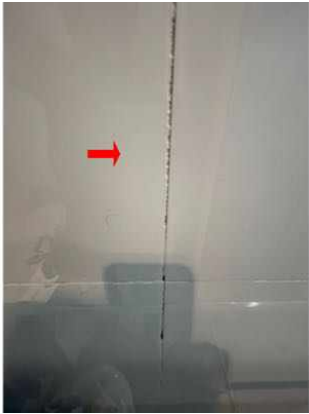
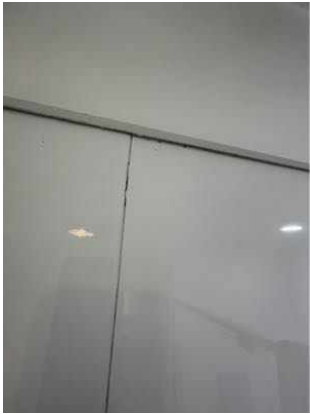
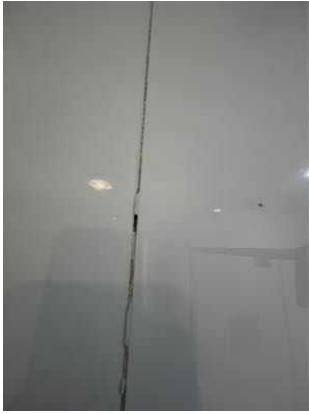
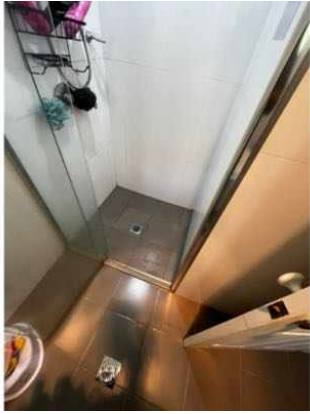
Finding 2.01

Building:	Main Building
Location:	Bathroom >
Finding:	Sealant and grouting - Missing or damaged
Information:	It was noted on inspection that sealant or grout is degraded to the tiled shower alcove and or other areas of the bathroom.

Different materials and floor areas move at different rates, generally causing cracking to grout or sealant at this point. A flexible sealant is required to allow for expected expansion and contraction, while keeping the joint water tight and protective of all associated building materials.

There appears to be excessive mould to the sealant and grout which will likely require scraping out and replacement.

Flexible and mould resistant materials should be applied to affected areas to prevent any subsequent water damage that is likely to occur. Regular maintenance and replacement of damage or missing or damaged sealant and grout is highly recommended to the wet areas, as this is a regular wear and tear defect. Sealant and grouting in areas that come into regular contact with water should be maintained for

the long term care of your property.

A sealant specialist or tiling contractor should be appointed to complete these works as soon as possible

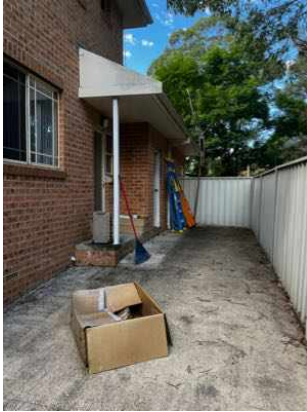
Finding 3.04

Building:	Main Building
Location:	Yard Side
Finding:	Trees - Overhanging and filling gutters
Information:	Overhanging trees often result in excessive amounts of leaf debris accumulating in gutters.

It is highly advised that all overhanging tree branches be removed as soon as possible to prevent any further damage. Repair and/or replacement of sections of damaged guttering may also be required where the extent of the damage necessitates.

Such works should be performed by the homeowner; however, appointment of a landscape contractor or an arborist may be required. Consultation with a licensed roof plumber is required where guttering has been damaged.

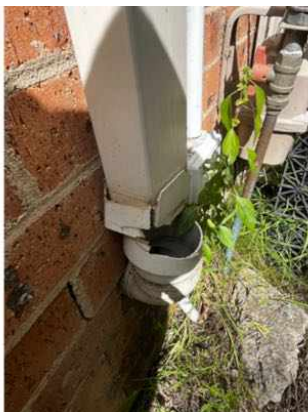
Finding 3.05

Building:	Main Building
Location:	Downpipe
Finding:	Down Pipes not Connected
Information:	The Roof plumbing is not adequately connected to stormwater drainage on the site.

Where roof plumbing doesn't drain adequately, the area at the base perimeter can become excessively damp, potentially creating an environment that is susceptible to rust and corrosion of surroundings building elements, as well as attracting termites and other pests.

It is highly recommended that a plumber be appointed to further inspect the area and to install adequate drainage equipment where necessary.

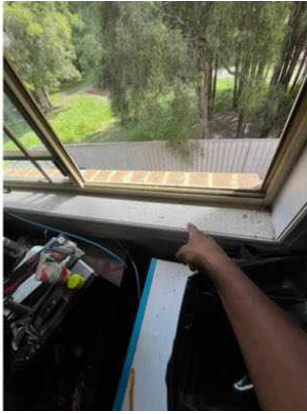
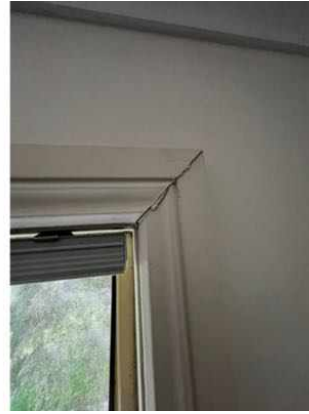
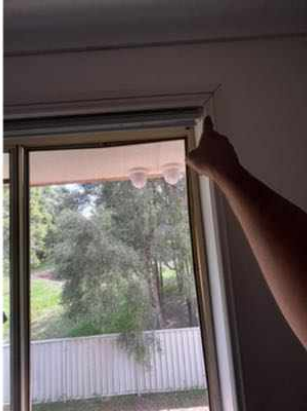
Building:	Main Building
Location:	Bedroom Window
Finding:	Windows - Wood rot
Information:	Wood rot was found to be affecting external windows. Wood rot, also known as Fungal Decay, occurs when timbers and other cellulose building materials are exposed to damp conditions on an ongoing basis.

It is likely that this wood rot has developed as a result of frequent exposure to rain and other weather conditions. It is suspected that failure to maintain the window frames over a prolonged period has resulted in them deteriorating at an accelerated rate, increasing their susceptibility to the development of wood rot. Leaks in roof plumbing or associated pipework may have also contributed to the formation of the wood rot in this area.

Early intervention and regular maintenance will prolong the useful life of these building elements. Prior to any works being performed, any associated pipework or roof plumbing should be inspected by a licensed plumber for faults or leaks.

Repair and/or replacement of affected window frames may be a necessary step in protecting surrounding building elements from such deterioration. Remedial works should be performed by a qualified carpenter or registered builder as soon as possible to prevent any further damage.

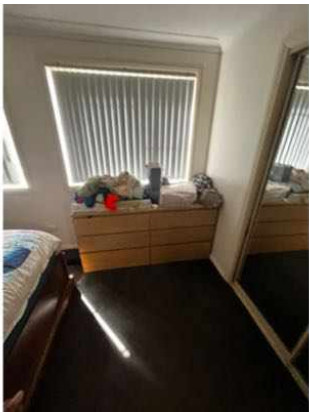
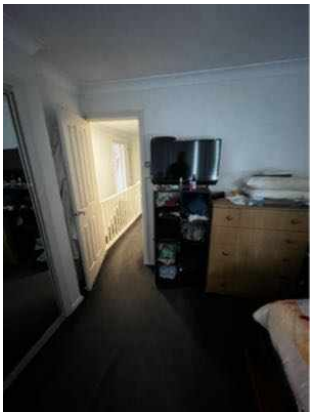
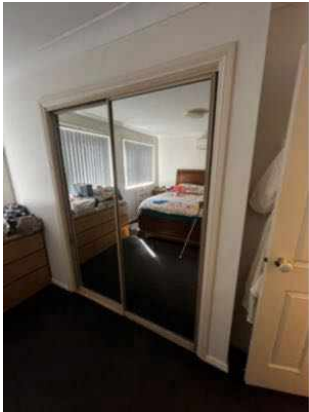
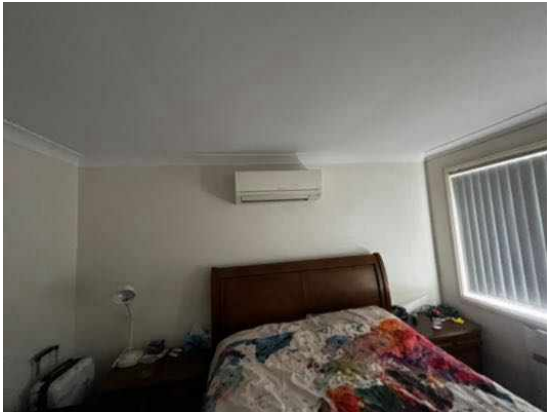
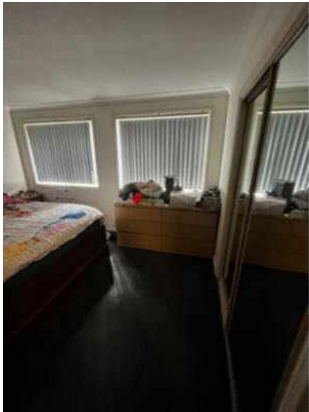
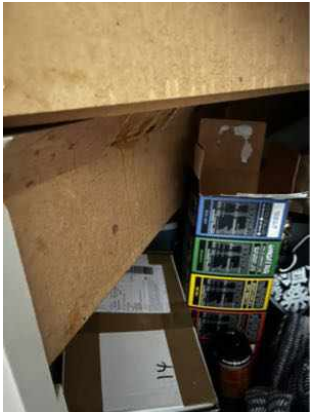
Finding 6.01

Building:	Main Building
Location:	All Areas
Finding:	Additional Photos - Obstructions and Limitations
Information:	These photographs are an indication of the obstructions and limitations which impeded full inspection of the property at the time of inspection. These obstructions can hide an array of defects and should be removed to allow full inspection to be carried out. A re-inspection is recommended once the areas are made accessible.

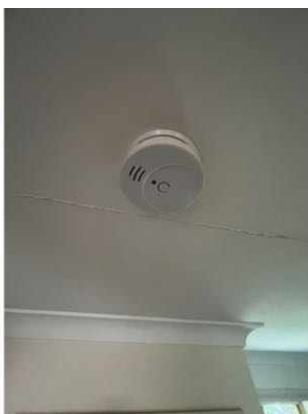
Building: Main Building
 Location: All Internal Areas
 Finding: Smoke Detector and Alarms
 Information: Reporting on Smoke Detectors or Alarms, including hard wired smoke detection systems and their legislative requirements, is outside the Scope of this Report.

Additionally, it is advised that all smoke detectors be tested by the homeowner on a monthly basis.

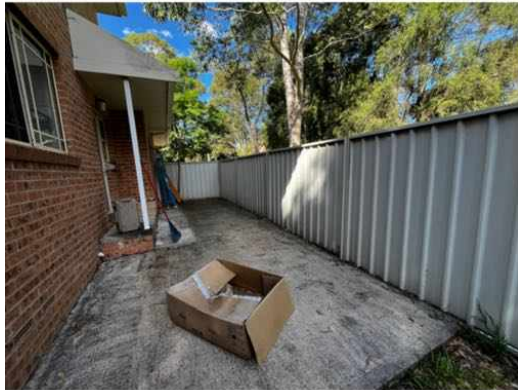
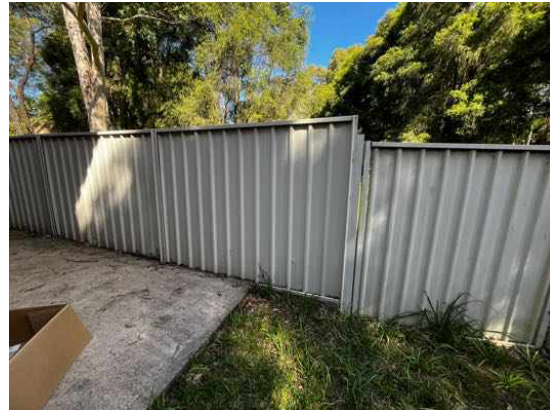
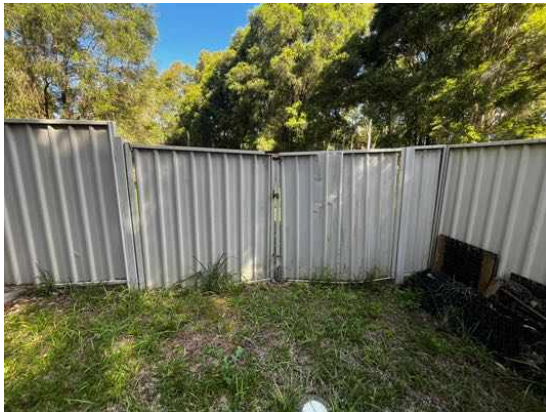
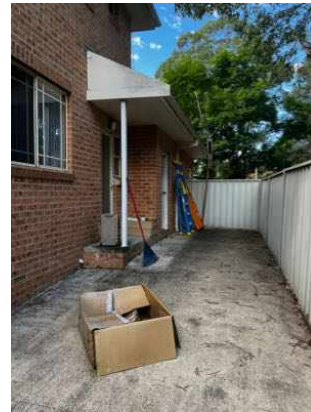
Building: Main Building
 Location: Yard - Side
 Finding: Site drainage - For your Information
 Information: Site Drainage appears to be acceptable at the time of inspection, however, the site/ Yard should be monitored during heavy rain to determine whether the existing drains cope. If it appears that they cannot cope, then additional drains may be required.

Any comments made in the section are relevant only in light of the conditions present at the time of inspection. It is recommended that a smoke test be obtained to determine any illegal connections, blocked or broken drains.

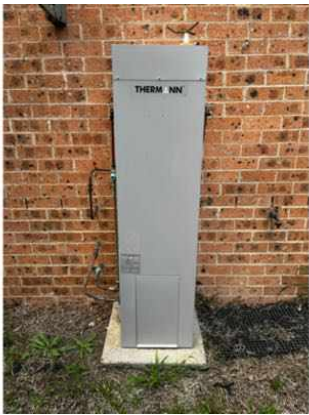
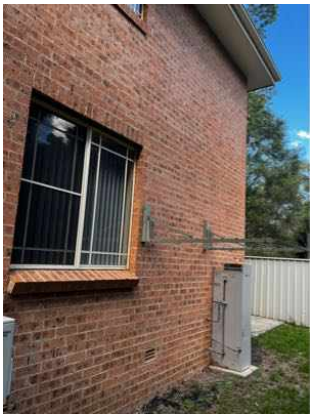
Building: Main Building
Location: Yard - Side
Finding: Hot Water Unit
Information: The HWS appeared to be in good condition at the time of inspection.

Water pressure appears to be normal, however, this is not an opinion of a licensed plumber. No water hammer was noted when taps are turned off fast.
