Building and Timber Pest Inspection Report

Inspection Date: Fri, 9 Jan 2026

Property Address: 305-309 Grey St, Glen Innes NSW 2370,
Australia

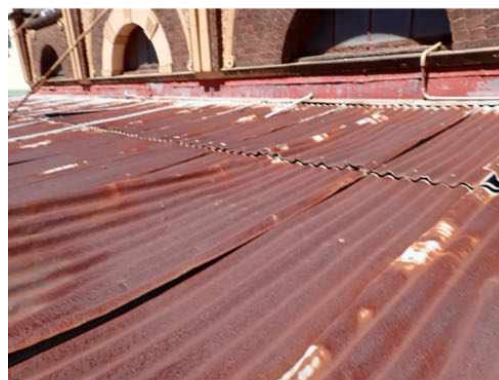
Finding 2.02

Building:	Main Building
Location:	Street awning
Finding:	Steel supports surface rust.
Information:	The steel supports to the street awning were generally in fair condition; however, surface rust was identified. This is a common defect for exposed steel and is typically caused by weather exposure over time. If left untreated, the rust may worsen and lead to further deterioration. Cleaning, treating, and repainting of the affected areas are recommended to help prevent ongoing corrosion. Due to the age of the structure, an inspection by a structural engineer is also recommended to gain a better understanding of the structural integrity of the supports and provide a scope out works if required.
