Building and Timber Pest Inspection Report

Inspection Date: Wed, 1 Apr 2026

Property Address: 100 Katanna Rd, Wedderburn NSW 2560,
Australia

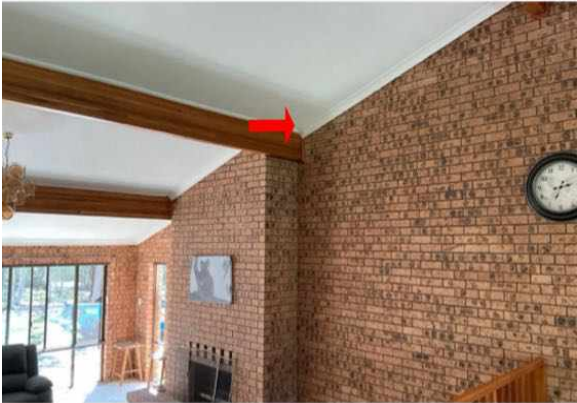
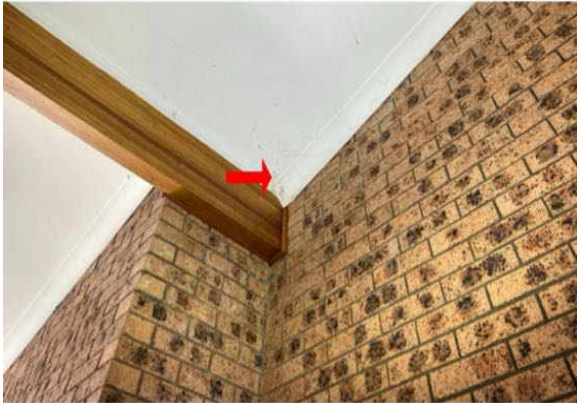
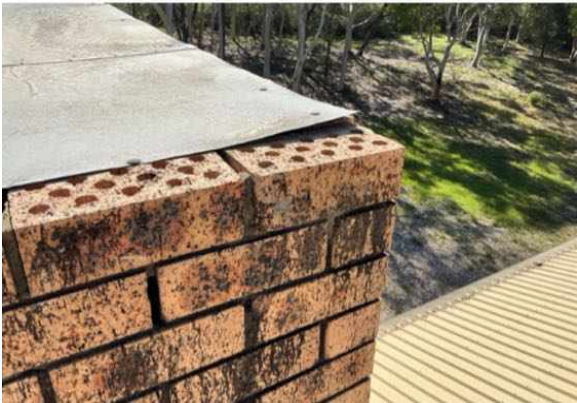
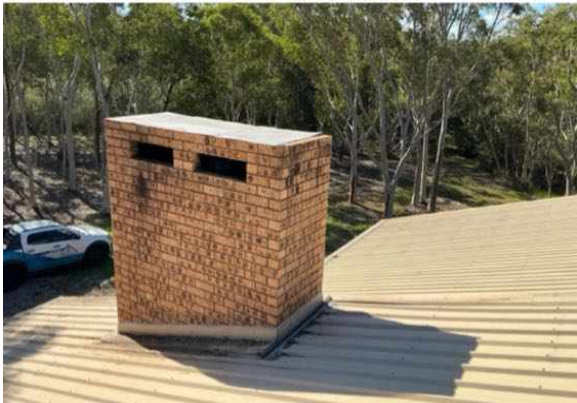
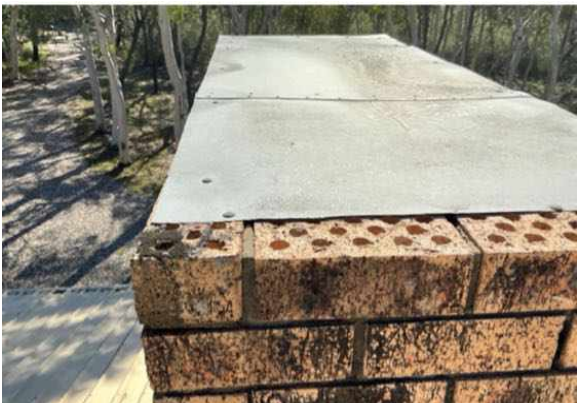
Building: Main Building
 Location: All Areas
 Finding: Ceiling Water Damage (Chimney Area)
 Information:

Water damage was observed to the ceiling. Upon roof inspection, it was identified that

the chimney has inadequate parapet flashing, which is likely allowing water ingress into the structure. This issue was also noted during a previous inspection.

This condition may lead to ongoing moisture-related damage if not addressed. It is recommended that a qualified roofing specialist install appropriate flashing to the chimney and rectify any defects. The affected ceiling area should be repaired, and the area monitored during rainfall to confirm the issue has been resolved.

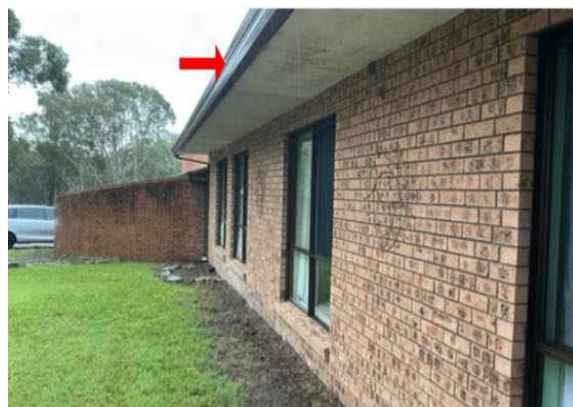
Finding 3.02

Building: Main Building
Location: Exterior walls

Finding: Gutters Insufficient Downpipes / Eaves Water Damage
 Information: During the inspection, the guttering system was found to have an insufficient number of downpipes, and water damage was observed to the eaves.

Insufficient downpipes can lead to gutter overflow during rainfall, which may result in water ingress into the eaves and surrounding building elements. Prolonged moisture exposure in these areas can contribute to material deterioration and create conditions conducive to termite activity.

It is recommended that a qualified roof plumber be engaged to assess the guttering system and install additional downpipes as required. Any damaged eaves linings should be repaired or replaced following rectification of the drainage issues.

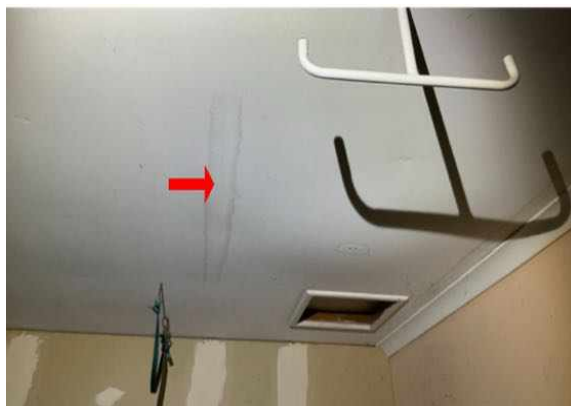
Finding 3.03

Building: Main Building
 Location: Garage
 Finding: Garage Ceiling Water Damage
 Information:

Old water damage was observed to the garage ceiling. The area appears to have been previously affected; however, the cosmetic repairs remain incomplete.

While the source of the issue may have been addressed, it is recommended that the ceiling be repaired and finished by a qualified tradesperson. The area should also be monitored during rainfall to ensure no ongoing water ingress is present.

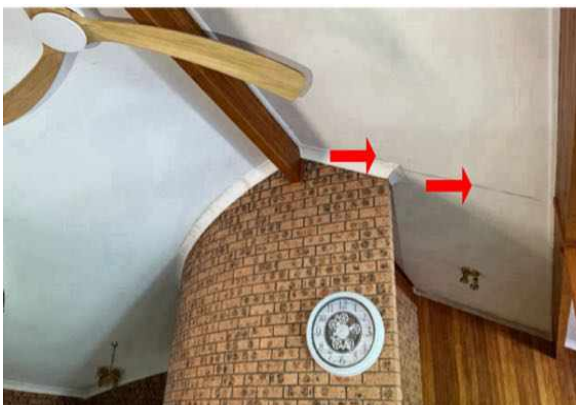
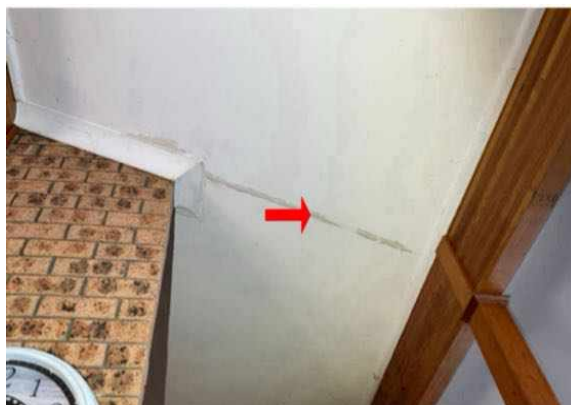
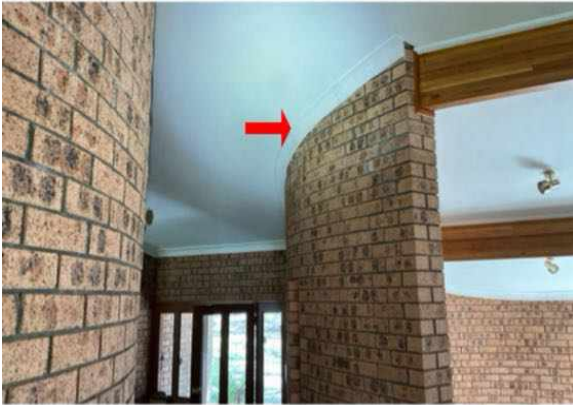
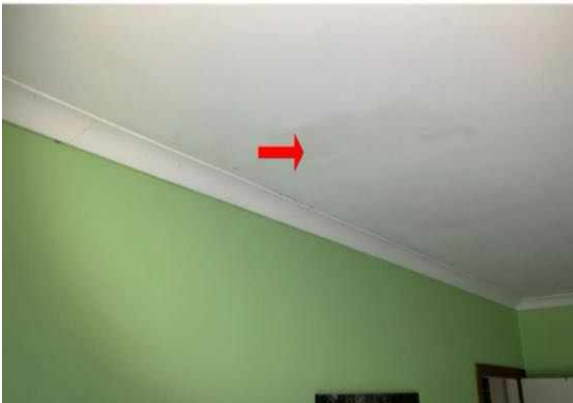
Finding 3.04

Building:	Main Building
Location:	All Areas
Finding:	Cosmetic Paint Defects
Information:	Incomplete paint coverage, minor surface blemishes, over-painting, inconsistent finishes, and colour variations were observed during the inspection. These conditions are generally considered cosmetic in nature and are commonly found in residential properties. Such irregularities may become more noticeable under certain lighting conditions while appearing less evident in lower light environments.

Rectification of these items is considered routine maintenance. To achieve a consistent appearance and improved finish, it is recommended that a qualified painter be engaged to prepare and repaint the affected areas, thereby enhancing both the visual presentation and long-term durability of the painted surfaces.

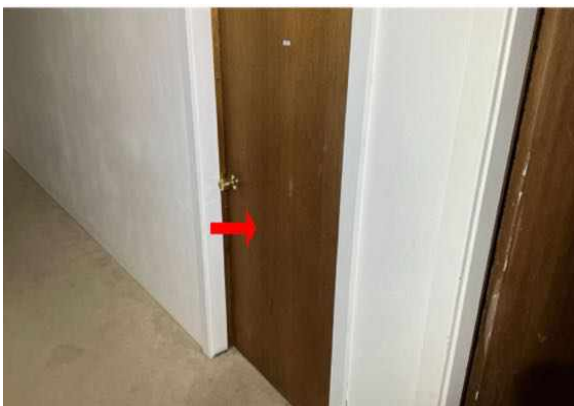
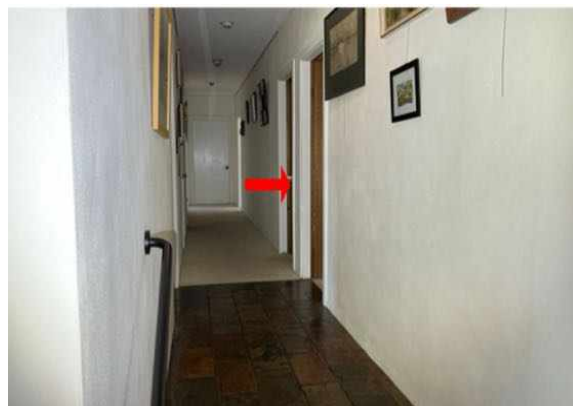
Finding 3.05

Finding: Door (Binding or Jamming)

Information: The door (as shown in the photos) is experiencing binding or jamming during standard operation. This issue may occur when a door binds to the flooring or door frame due to various factors, such as improper installation or worn-out hinges. To address this, it is recommended to enlist the services of a qualified carpenter who can perform minor rectification works as needed, based on the client's discretion. This proactive approach will help restore the door's functionality and ensure smooth operation.

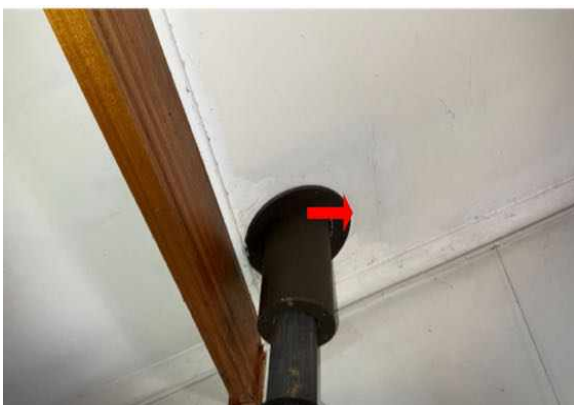
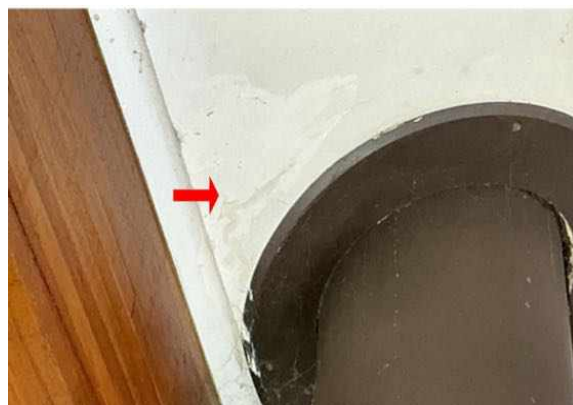
Finding 3.06

Building: Main Building
 Location: Dining Room
 Finding: Dining Room Ceiling Water Damage (Chimney Area)
 Information:

Water damage was observed to the ceiling around the chimney in the dining room. Upon roof inspection, evidence of previous repairs was noted; however, the internal cosmetic repairs remain incomplete.

While the source of the issue appears to have been addressed, the affected ceiling lining requires finishing to restore the appearance and ensure no concealed damage remains. It is recommended that a qualified tradesperson complete the necessary cosmetic repairs and monitor the area during rainfall to confirm no further water ingress occurs.

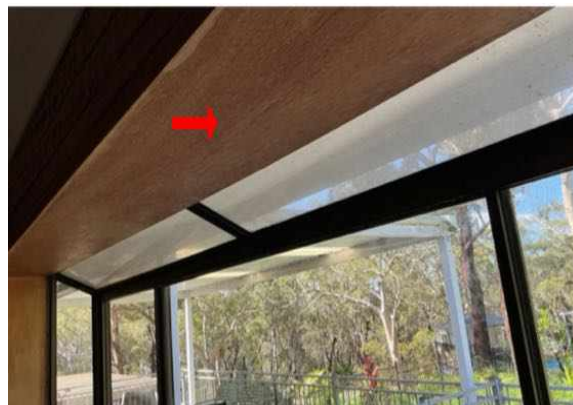
Finding 3.07

Building: Main Building
 Location: Kitchen
 Finding: Kitchen Window Reveal
 Information:

The window reveal was observed to be twisted, which may be due to prolonged sun exposure, material movement, or inadequate fixing.

This condition may affect the alignment and finish of the window and, if left unaddressed, could lead to further distortion or gaps. It is recommended that a qualified tradesperson assess the reveal and carry out any necessary adjustments or repairs to restore proper alignment and finish.

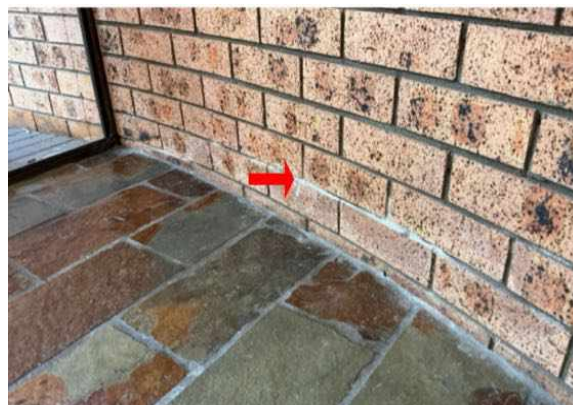
Finding 3.08

Building: Main Building
 Location: Interior and exterior
 Finding: Parapet Flashing Missing / Moisture Ingress
 Information:

The parapet flashing was found to be missing. Elevated moisture levels were detected in the adjacent masonry wall, extending from the external front outdoor area into the internal wall surfaces.

The absence of adequate flashing is likely allowing water ingress into the wall structure, which may lead to ongoing moisture-related damage, deterioration of building materials, and conditions conducive to timber pest activity.

It is recommended that a qualified roofing or waterproofing specialist install appropriate parapet flashing and assess the extent of moisture intrusion. Any affected areas should be repaired, and the area should be monitored following rectification, particularly during rainfall.

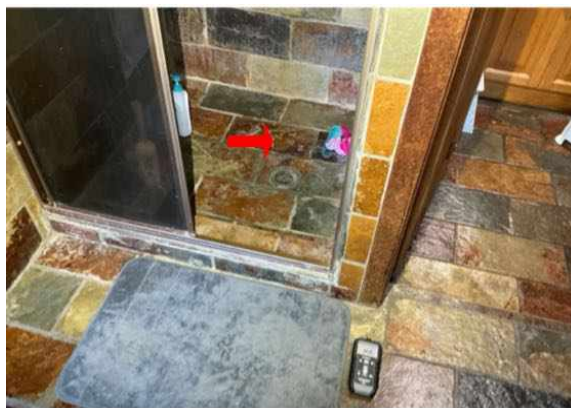
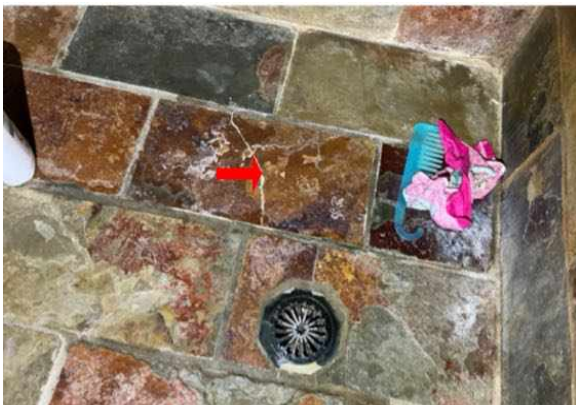
Finding 3.09

Building:	Main Building
Location:	Main Bathroom
Finding:	Shower Cracked Tiles & Elevated Moisture
Information:	During the inspection, cracked tiles were identified in the shower area. Non-invasive moisture testing confirmed elevated moisture levels beneath the tiled surface, indicating water penetration into concealed areas.

As this was a visual, non-invasive inspection, the full extent of moisture ingress and any associated damage could not be determined. A special-purpose invasive inspection is recommended to assess the severity and extent of any underlying issues.

Prolonged moisture in these areas may lead to conditions conducive to termite and timber pest activity, fungal growth, timber decay, and potential structural deterioration. It is strongly recommended that a qualified bathroom specialist be engaged to undertake the necessary remedial works. Prompt action, along with ongoing maintenance and regular inspection of wet areas, is advised to prevent further deterioration and protect the long-term integrity of the structure.

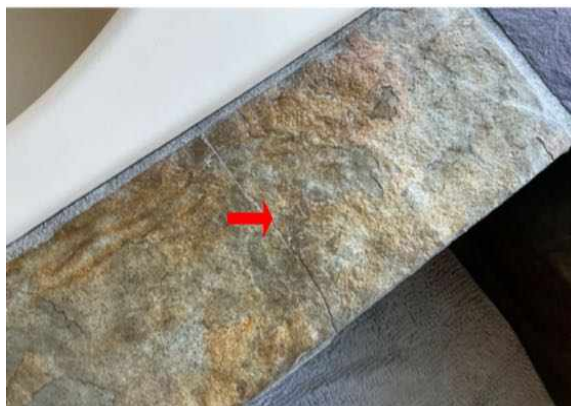
Finding 3.10

Building:	Main Building
Location:	Main Bathroom
Finding:	Cracked Tiles Bathtub
Information:	During the inspection, cracked tiles were observed on the wall of the bathtub. Non-invasive moisture testing in the affected area did not detect elevated moisture levels at the time of inspection.

Although no active moisture ingress was identified, the damaged tiles may compromise the waterproofing integrity over time if left unaddressed. It is recommended that the affected tiles be repaired or replaced to maintain the integrity of the wet area and prevent potential future moisture-related issues.

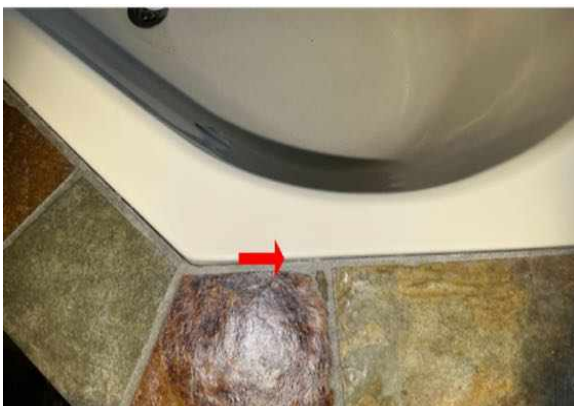
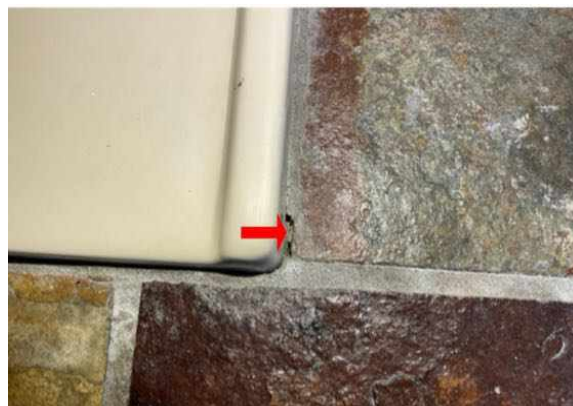
Finding 3.11

Building: Main Building
Location: Main Bathroom
Finding: Main Bathroom Bathtub Sealant
Information:

The sealant around the bathtub in the main bathroom was found to be deteriorated and requires repair or replacement. Defective or degraded sealant can allow water to penetrate into surrounding areas, potentially leading to moisture damage, mould growth, and conditions conducive to timber pest activity.

It is recommended that a qualified tradesperson remove and replace the affected sealant to ensure a watertight finish. Ongoing maintenance and regular inspection of wet area sealants are advised to prevent further deterioration.

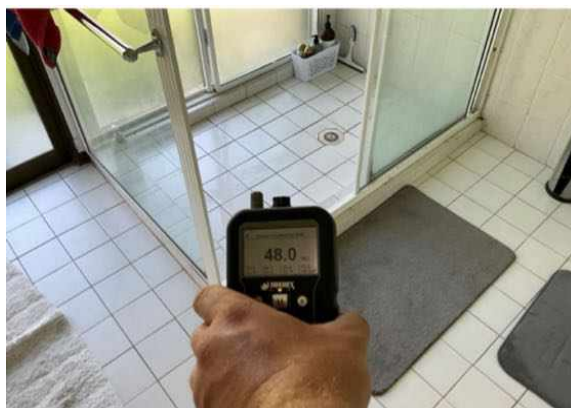
Building: Main Building
 Location: All Areas
 Finding: Elevated Moisture to Shower Area
 Information:

During the inspection, elevated moisture levels were recorded beneath the tiled surface in the ensuite shower, and extending beyond the shower zone using non-invasive moisture testing. This indicates water penetration behind the tiles and into concealed spaces.

Prolonged moisture in these areas may lead to conditions conducive to termite and

timber pest activity, fungal growth, and timber decay, potentially compromising the structural integrity of surrounding building elements.

It is recommended that a qualified bathroom renovation specialist or builder be engaged to assess the extent of the issue and carry out necessary remedial works. In addition, regular maintenance, inspection of wet areas, and ongoing moisture monitoring are essential for early detection and prevention of further deterioration.

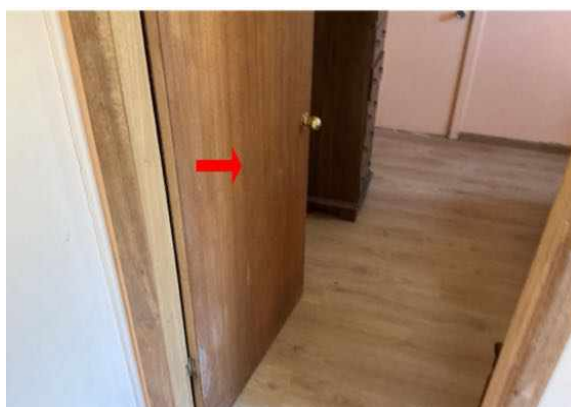
Finding 3.14

Building: Main Building
 Location: Granny Flat Bedroom
 Finding: Bedroom Door Jamming (Granny Flat)
 Information:

The bedroom door in the granny flat was found to be jamming during operation. This may be due to movement, misalignment, or deterioration of the door hardware or reveal over time. It is recommended that the door and frame be adjusted or repaired to ensure smooth operation and proper function.

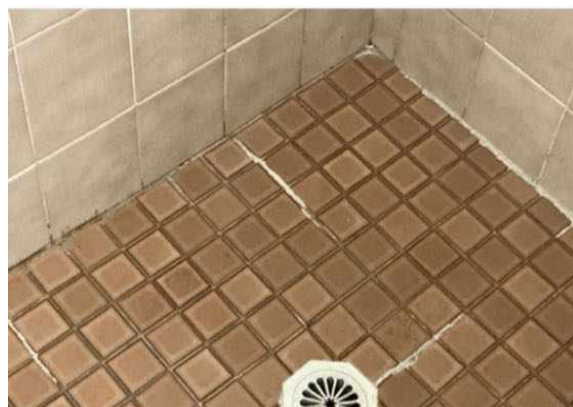
Finding 3.15

Building: Granny-Flat
 Location: Bathroom

Finding: Moisture Ingress and Efflorescence
Information: Efflorescence was observed on the grout lines of the floor tiles, indicating the presence of moisture migration through the tiled surface. Non-invasive moisture testing confirmed elevated moisture levels beneath the tiles in the shower area, extending beyond the immediate shower zone, which suggests active water penetration into concealed areas.

Due to the limitations of a visual, non-invasive inspection, the full extent of the issue could not be determined without further invasive investigation. Prolonged moisture in these areas may lead to deterioration of building materials and create conditions conducive to termite activity, timber decay, and fungal growth.

It is recommended that a qualified bathroom specialist or builder be engaged to assess the extent of the moisture issue and carry out necessary remedial works. Ongoing maintenance, regular inspection of wet areas, and moisture monitoring are advised to prevent further deterioration.

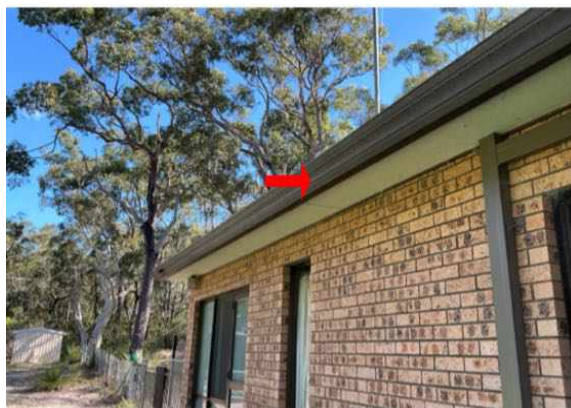
Building:	Main Building
Location:	Exterior walls
Finding:	Gutters Insufficient Downpipes
Information:	During the inspection, it was noted that the guttering system appears to have an insufficient number of downpipes, which may reduce the overall drainage performance of the roof. During heavy rainfall, this can lead to water pooling or overflowing from the gutters.

Over time, overflow can contribute to moisture around the eaves, ceilings, and building perimeter. Persistent moisture in these areas may increase maintenance requirements and can also create conditions that are attractive to termites and timber pests.

This is a common condition in homes of similar age and is generally manageable. To improve stormwater performance and reduce long-term maintenance risks, it is recommended that a qualified roof plumber assess the system and install additional downpipes if required. Improving drainage will help protect the building and support its long-term durability.

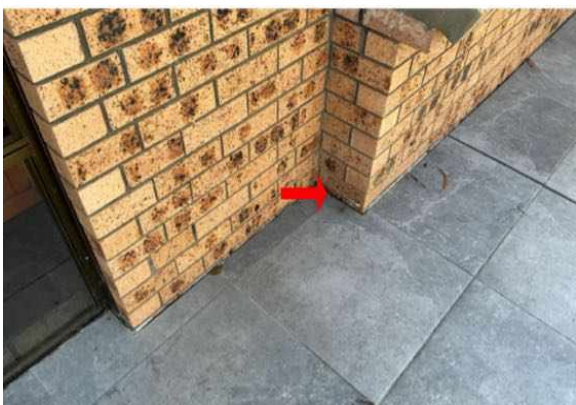
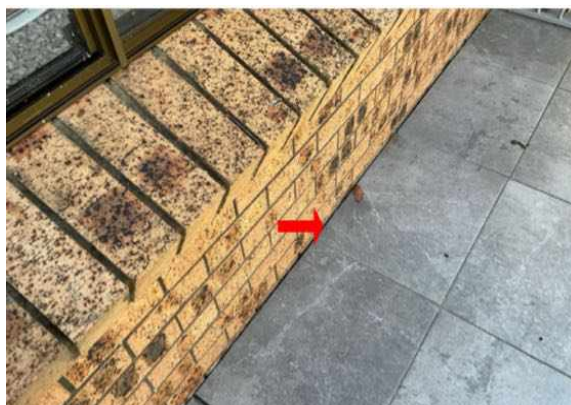
Finding 3.20

Building:	Main Building
Location:	Exterior walls
Finding:	Incomplete Sealant to Tile and Wall Junction (Alfresco)
Information:	Sealant to the junctions between the alfresco tiles and the exterior wall has been left unfinished. This condition may allow water ingress into adjacent building elements, potentially leading to moisture-related damage over time. It is recommended that the junction be properly sealed with a suitable flexible sealant to prevent water penetration and ensure durability.

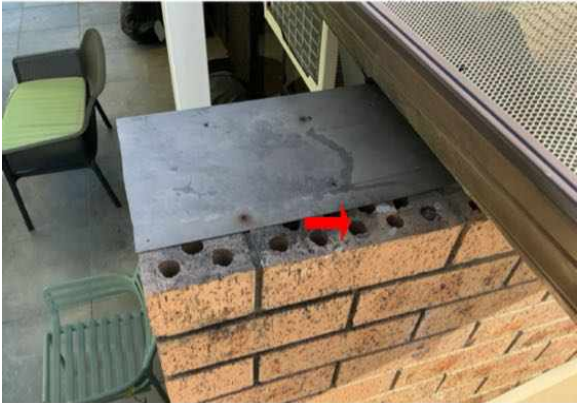
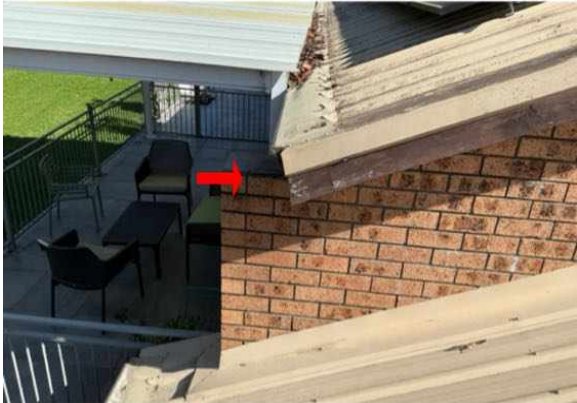
Finding 3.21

Building:	Main Building
Location:	
Finding:	Inadequate Parapet Wall Flashing Installation
Information:	During the inspection, it was observed that the parapet wall flashings have not been properly installed, with sections of the brickwork left exposed. This condition may allow water ingress during rainfall, potentially leading to moisture penetration and deterioration of internal and structural elements. It is recommended that a licensed roof plumber rectify the flashing installation to ensure full coverage, proper sealing, and adequate protection against water entry.

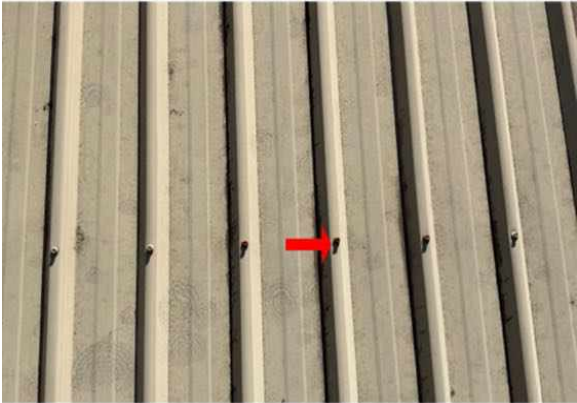
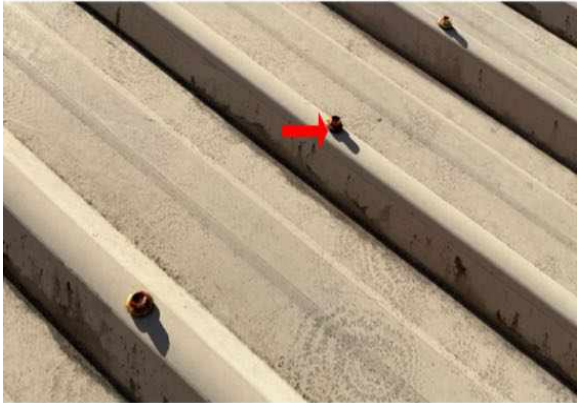
Finding 3.22

Building: Main Building
Location:
Finding: Rusted Roof Sheet Screws
Information:

Rust was observed to the roof sheet screws, which had been noted in the previous inspection. This condition remains present and may continue to deteriorate, potentially compromising the integrity of the roof fixings and increasing the risk of water ingress. It is recommended that a licensed roof plumber replace the affected screws and treat any associated corrosion to maintain the roof’s performance.

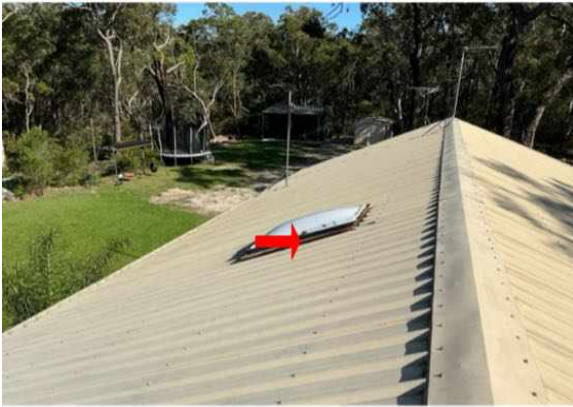
Finding 3.23

Building: Main Building
Location:
Finding: Skylight Rust Deterioration
Information:

Rust was observed to the skylight, which had been noted in the previous inspection. The corrosion has since progressed and is now extending to the surrounding roof sheets. If left unaddressed, continued deterioration may lead to water ingress and further damage to the roof structure. It is recommended that a licensed roof plumber

assess and carry out necessary repairs, including treating the rust and repairing or replacing affected components as required.

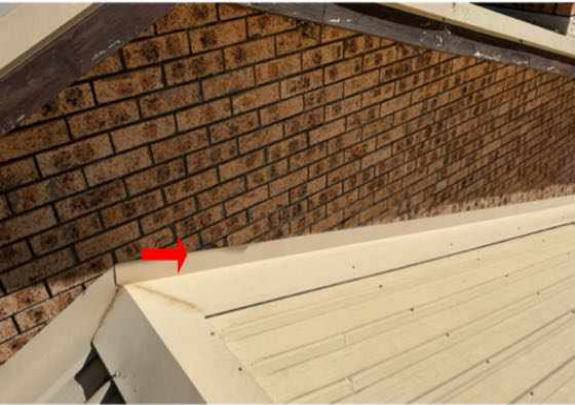
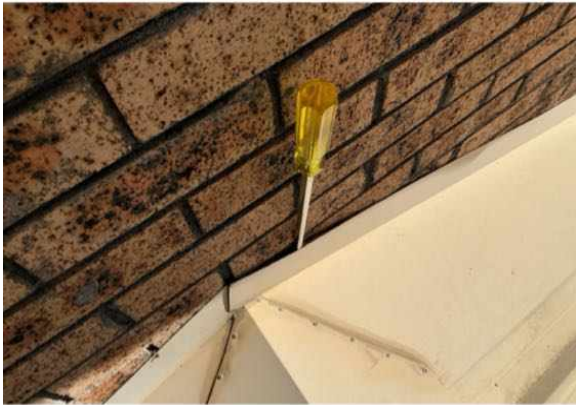
Finding 3.24

Finding: Inadequate Roof Flashing Installation

The roof flashing was found not to be properly returned or securely fixed into the brickwork. This condition may allow water ingress during rainfall, potentially leading to moisture penetration and damage to internal building elements. It is recommended that a licensed roof plumber rectify the flashing to ensure it is correctly installed, sealed, and adequately secured to prevent water entry.

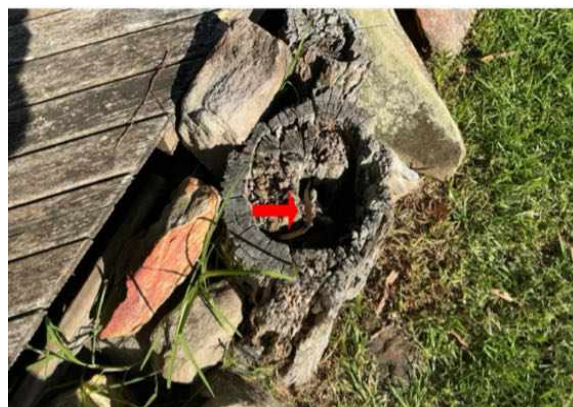
Location:	Meter Box Front and Rear Elevation
Finding:	Previous Termite Damage to Tree Stumps
Information:	During the inspection, evidence of previous termite damage was observed in tree stumps located at the front and rear of the property. This condition has been previously reported and remains present. No active termite activity was identified at the time of inspection, however, retained stumps and damaged timber may continue to attract termite activity if not addressed.

It is recommended that the affected stumps be removed or treated by a licensed pest control professional to reduce the risk of future infestation.

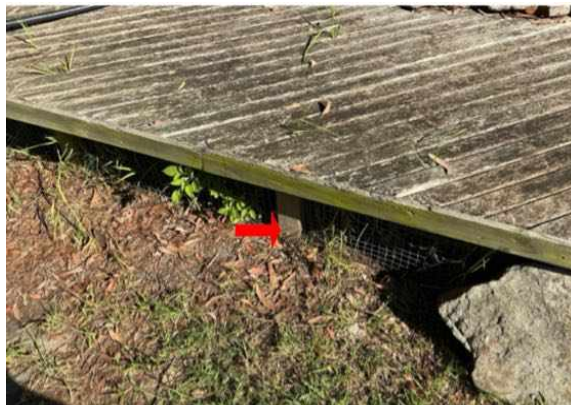
Finding 6.01

Building:	Main Building
Location:	All Areas
Finding:	In Contact With The Ground
Information:	During the inspection, wood and timber materials were observed in direct contact with the ground. This condition is highly conducive to timber pest activity, particularly termites, as it provides an ideal environment for infestation and timber decay due to elevated moisture levels, concealment, and direct access to cellulose material. Untreated or inadequately protected timber in ground contact significantly increases the risk of concealed termite entry and potential structural damage.

To reduce the risk of infestation, all ground-contacting timber should be promptly removed. It is recommended to engage a qualified pest control to assess the subfloor and implement appropriate termite management system, in accordance with AS 3660.2. Regular timber pest inspections, ideally every 90 days, are advised until all conducive conditions have been fully addressed.

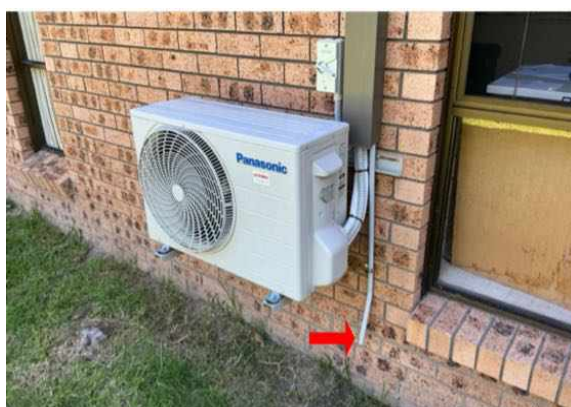
Finding 6.02

Finding: Overflows Not Connected

Information: During the inspection, it was observed that the overflows are not connected to the stormwater drainage system. This condition may result in moisture accumulation around the property and creating conditions conducive to termite activity. To mitigate these risks, it is recommended to engage a qualified plumber to connect the overflows to the stormwater drainage system. This will prevent excessive moisture accumulation, reduce the risk of termite infestations, and protect the surrounding structures from potential water-related deterioration.

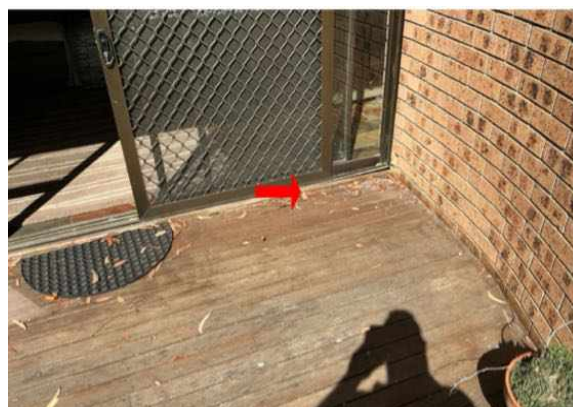
Finding 6.03

Information: Bridging of a termite physical barrier occurs when termites bypass a preventative measure designed to block or expose their access to a structure. This can happen when soil, vegetation, or debris accumulates against exterior walls above the barrier level. Appliances such as hot water units and air conditioning systems, or wooden structures like decks and porches that touch the ground and connect to the main building, can also contribute to bridging. Even structural modifications may unintentionally create pathways that allow termites to bypass barriers or inspection zones. These breaches provide termites with a direct and often undetectable route into the property, increasing the risk of substantial and unnoticed infestations that can cause extensive structural damage.

To safeguard your property from termite infestations, it is essential to maintain a minimum clearance of 75mm from the exposed slab edge. This clearance forces termites into the open, where they can be more easily detected during regular inspections. If this clearance is not achievable, it is crucial to conduct consistent timber pest inspections every 30 days or implement a post-construction termite management system compliant with Australian Standard AS 3660. Taking these precautionary measures helps ensure the property remains protected from termite threats and allows for early detection and intervention.

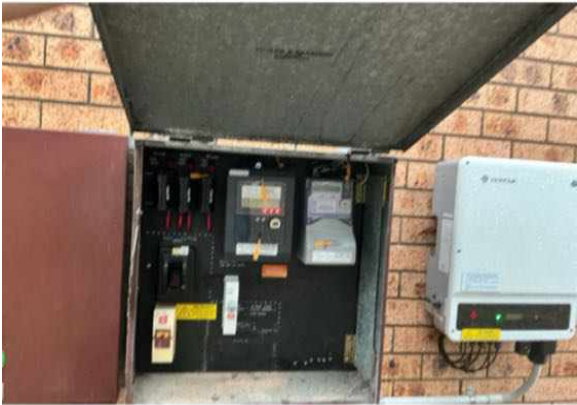
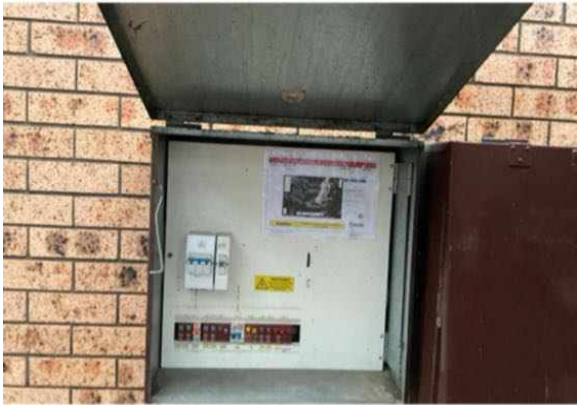
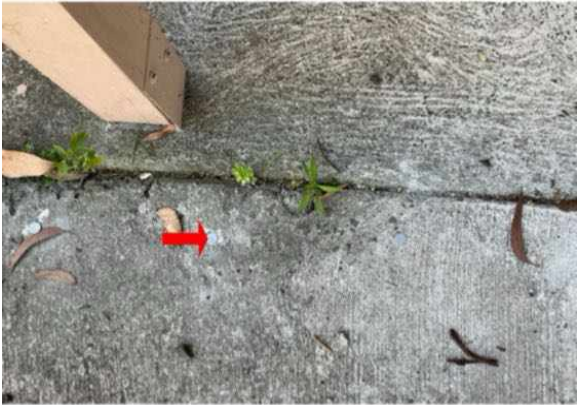
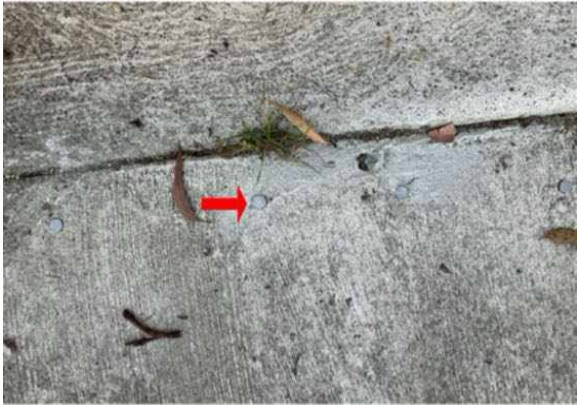
Building:	Main Building
Location:	Meter Box
Finding:	Termite Management System No Records Available
Information:	During the inspection, it was noted that a post-construction termite management system appears to have been installed previously, however, no records or durable notice were found in the meter box at the time of inspection.

Without available documentation, the type, extent, and current effectiveness of the system cannot be confirmed. It is recommended that the owner provide any relevant installation or maintenance records. If unavailable, a licensed pest control specialist should be engaged to assess the system, confirm its effectiveness, and advise on any required upgrades or ongoing maintenance in accordance with AS 3660.2.
