Building and Timber Pest Inspection Report

Inspection Date: Fri, 23 Jan 2026

Property Address: 3A Coach Cres, Currans Hill NSW 2567,
Australia

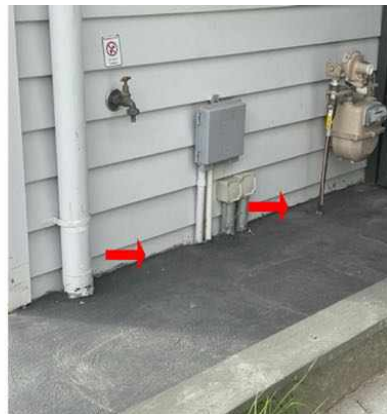
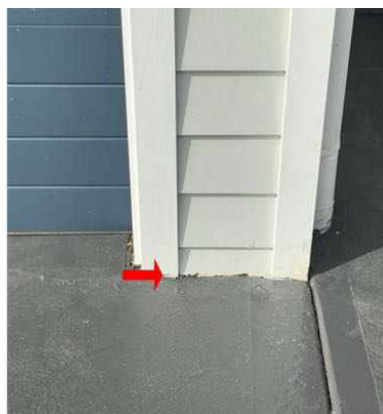
Finding 3.01

Building:	Main Building
Location:	All Internal Areas
Finding:	External Slab-to-Cladding– Moisture Bridging Risk
Information:	The external concrete path/apron appears to be finished hard against the wall cladding with minimal or no visible clearance at the base. This configuration may allow moisture bridging and capillary transfer to the lower wall elements, particularly during heavy rainfall or ponding events, and can contribute to deterioration of sealants, coatings, and lower cladding edges over time. While no active water ingress was observed at the time of inspection, the detailing limits drainage and drying at the wall base. Ongoing monitoring and maintenance of joints and clearances is recommended to reduce long-term moisture-related risks.

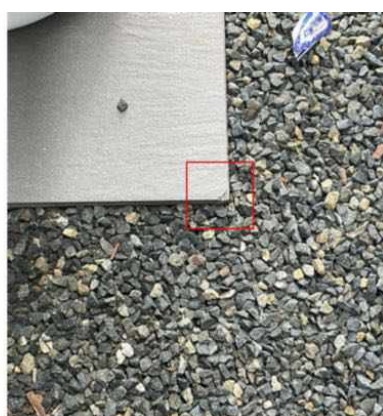
Finding 3.02

Building:	Main Building
Location:	All External Areas - Front
Finding:	Tiles - Cracked or damaged
Information:	Cracking was evident to the tiling in this area at the time of inspection. While the cracking appears to be minor, this area is frequently exposed to water, allowing potential for water penetration into adjoining sections of walls or flooring.

If left unmanaged, water penetration to these areas may lead to subsequent water damage, which is likely necessitate repair work to affected building elements.

A tiling contractor should be appointed to ensure that no further water damage occurs. The re-application of silicone and grouting throughout remaining tile work is also advised, to further protect the area against water penetration.

Where water penetration has led to water damage, appointment of a relevant tradesperson may be required to repair damaged building elements.

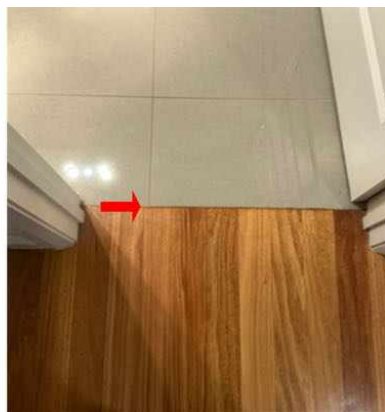
Finding 3.03

Building:	Main Building
Location:	Bathroom, Laundry
Finding:	Bathroom & external floor threshold

Information: The bathroom floor is at the same level as the adjoining timber flooring. This configuration is typical in modern builds and is permitted where compliant waterproofing and floor falls are provided. No evidence of moisture damage was observed at the time of inspection, however, waterproofing performance cannot be confirmed without invasive inspection.

Care should be taken to avoid excessive water migration beyond the bathroom during use.

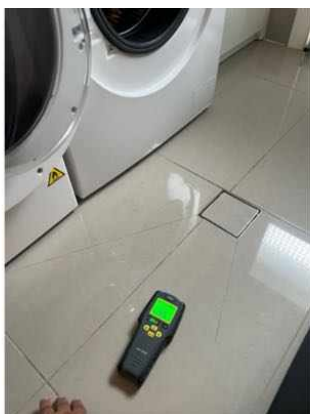
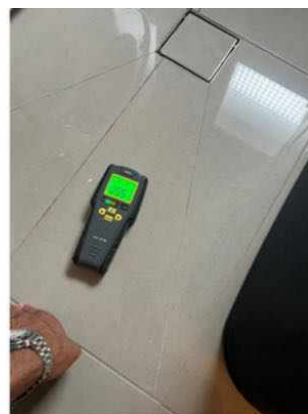
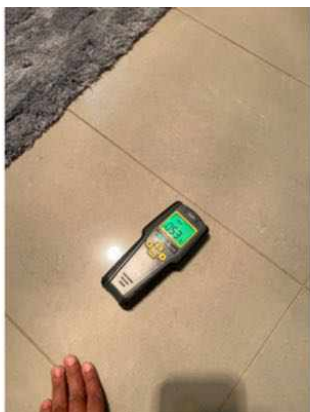
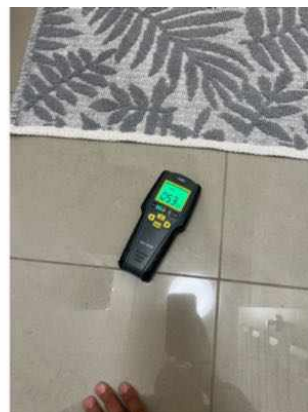
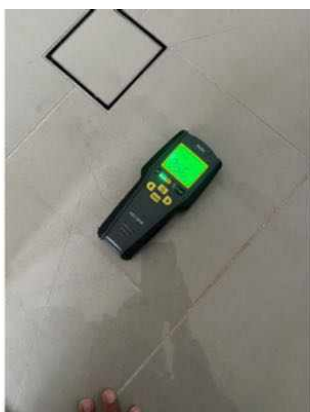
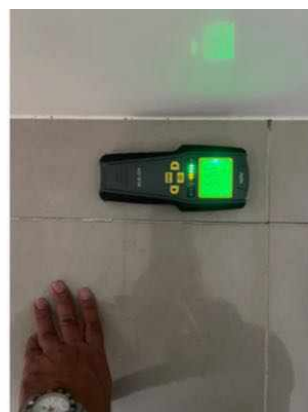
Finding 3.04

Building: Main Building
 Location: Bathrooms, Laundry
 Finding: Elevated Moisture Bathroom (No visible deterioration noted)
 Information: Elevated moisture levels were detected to tiled surfaces in bathroom/shower areas. Persistent moisture ingress can lead to concealed damage, including timber rot and mould growth.

Elevated moisture readings in tiled wet areas can occur from normal shower use, age/deterioration of waterproofing membranes, plumbing leaks or moisture absorption through grout lines. While no damage was visible, elevated readings may indicate moisture retention behind tiles, which can be a conducive condition for future deterioration if not monitored.

No immediate action required. Monitor the area over time for signs of drumming, efflorescence, tile movement, or grout deterioration. If concerns arise, a licensed waterproofing specialist can perform further investigation (e.g., pressure testing, membrane assessment).

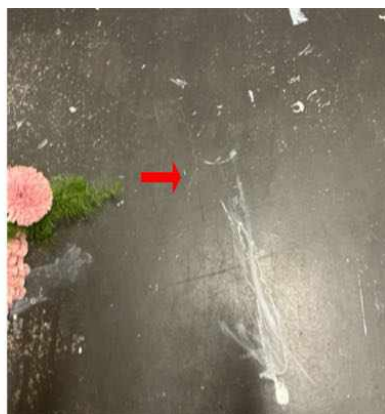
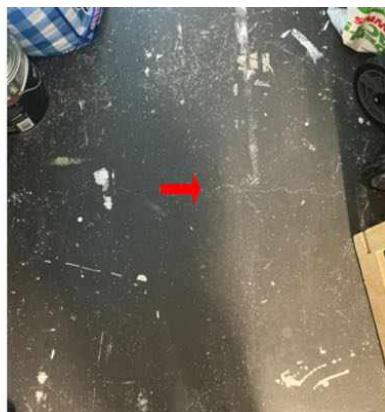
Finding 3.05

Building:	Main Building
Location:	All External Areas
Finding:	Cracking - External Concrete Paving Damage Category 1 - Fine (less than 2mm)
Information:	Fine cracks were identified in external concrete paving. Although fine cracks are quite noticeable, they are often only considered to be an appearance defect, and usually do not indicate any structural damage. To be considered a Category 1 or fine crack, the crack is found to be less than 2mm in width.

Generally the cause of a hairline crack in existing concrete paving such as driveways and pathways is indicative of the expansion and contraction of the concrete. Such causes are generally due to environmental factors, such as moisture levels, weather

conditions, root systems of nearby trees or the soil types on which they are laid.

Fine cracks may also be due to poor original installation of the concrete. Factors such as poor compaction of the sub surface and/or inadequate reinforcing of the slab may create cracking and other secondary defects.

Monitoring of all cracking should be conducted frequently. Always contact a building inspector should cracks widen, lengthen, or become more numerous.

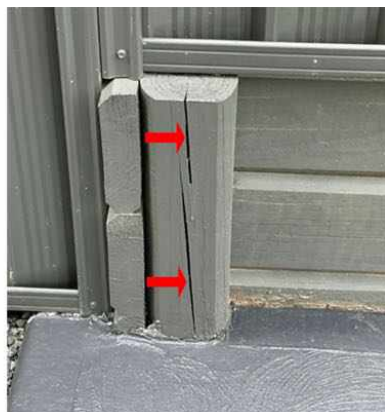
Finding 3.06

Building:	Main Building
Location:	All External Areas
Finding:	Retaining wall - Defective - Timber splitting
Information:	The retaining wall in this area was found to be defective at the time of inspection (Timber splitting). The split appears consistent with shrinkage and natural timber movement, rather than impact damage or structural failure. At the time of inspection, the post remains upright, in position, and continues to provide support to the adjoining retaining wall and fence, with no visible signs of displacement, rotation, or loss of function.

Generally, defective retaining walls are caused by poor original design or material use. However, deteriorated retaining walls may also be a result of substandard construction, poor site drainage or unmanaged stormwater flows.

If left unmanaged, the retaining wall may become a safety hazard if it continues to destabilise. Where retaining walls further rot and decay, an environment is created that is conducive to termite and pest infestation.

Significant repair and replacement should be expected. Where retaining walls are considered structural walls, a structural engineer / surveyor should be consulted regarding required remedial works. Otherwise, a landscaper or retaining wall installer may be appointed to repair or replace the wall, at the discretion of the client.

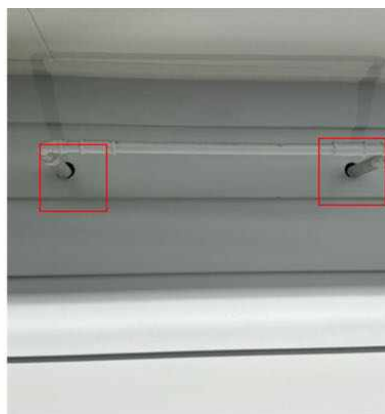
Finding 3.07

Building:	Main Building
Location:	All External Areas - Left side
Finding:	Incomplete or substandard works - Holes not sealed
Information:	The works to this area appear to be incomplete or have been completed to a substandard level.

Works that have not been completed to a satisfactory level create potential for the development of building defects and may impede on the safety and integrity of the overall structure.

It is highly recommended that the relevant trades be appointed to complete these works and ensure the safety of the area and the longevity of all associated building elements.

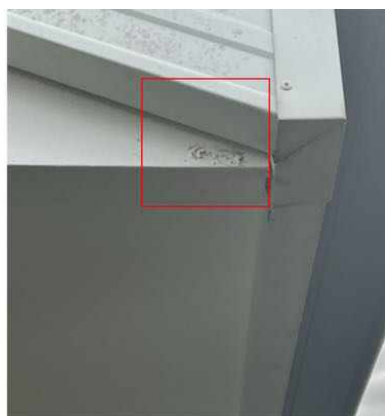
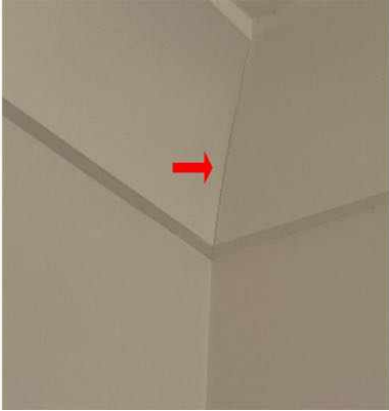
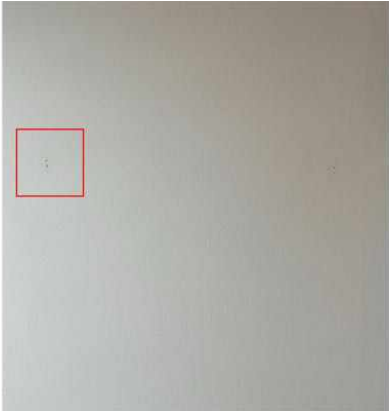
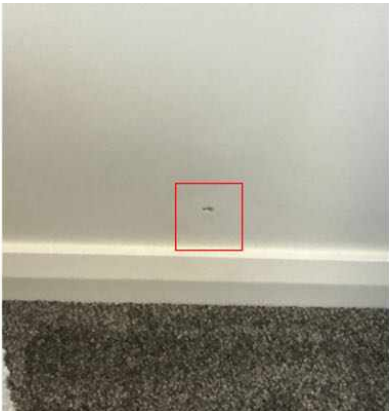
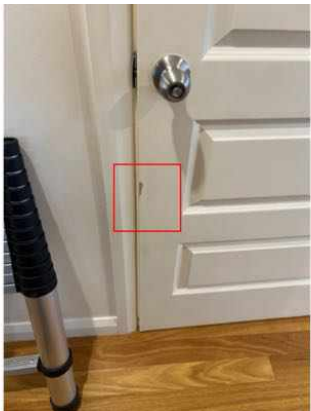
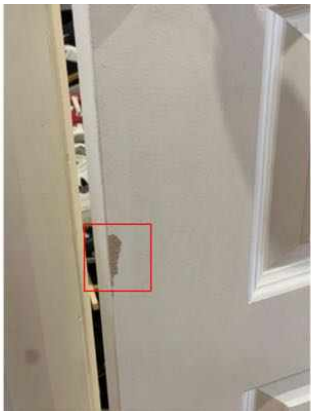
Finding 3.08

Building:	Main Building
Location:	All Internal Areas
Finding:	Paint Finish & Hairline Cracking - To some areas
Information:	The paint finish in this area was identified as being incomplete or substandard at the time of inspection including some hairline minor cracking/separation. Monitoring is recommended where cracking and separation is evident.

Whilst incomplete or missing paint finish is generally an appearance defect, it can also lead to the development of secondary building defects over time. Incomplete areas of paint finish expose the area to moisture, potentially accelerating the deterioration of underlying building materials.

Incomplete paint finishes should be sanded back, filled, leveled and painted, as applicable. Where inadequate or missing paint protection has led to the deterioration of the associated building element, repair and/or replacement of this building element may be required.

A painting contractor should be appointed as soon as possible to perform necessary works to aid the appearance of the affected area and to ensure the area is protected against further deterioration. Alternatively, the homeowner following manufacturer instructions may perform these works.

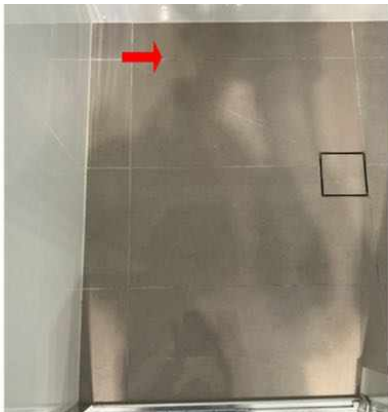
Finding 3.09

Building: Main Building
Location: All Internal Areas
Finding: Sealant and grouting - Missing or degraded
Information: It was noted on inspection that sealant or grout is degraded.

Different materials and floor areas move at different rates, generally causing cracking to grout or sealant at this point. A flexible sealant is required to allow for expected expansion and contraction, while keeping the joint water tight and protective of all associated building materials.

Excessive mould to the sealant and grout may require scraping out and replacement.

Flexible and mould resistant materials should be applied to affected areas to prevent any subsequent water damage that is likely to occur. Regular maintenance and replacement of damage or missing or damaged sealant and grout is highly recommended to the wet areas, as this is a regular wear and tear defect. Sealant and grouting in areas that come into regular contact with water should be maintained for the long term care of your property.

A sealant specialist or tiling contractor should be appointed to complete these works as soon as possible

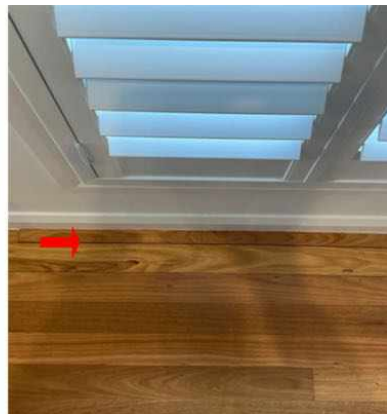
Building:	Main Building
Location:	Kitchen
Finding:	Installation - substandard or incomplete - Floorboard gaps (localised)
Information:	The installation of this building element appears to have been completed to a substandard level of workmanship or is incomplete. Generally substandard repairs or installation are related to poor workmanship, the use of inappropriate materials, or a failure to complete installation to a suitable standard.

Where installation is substandard and/or incomplete, the client should contact the responsible trade to undertake rectification. Unfinished and substandard building works are likely to degrade more quickly and may create potential for secondary defects to associated building elements.

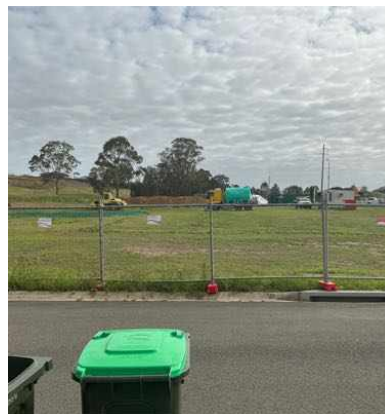
Finding 6.02

Building:	Main Building
Location:	All External Areas
Finding:	Trees within 50m
Information:	Trees within 50m of the property can be conducive to termite activity. It is recommended an invasive inspection of all trees within 50m to the property be carried out by a qualified pest control expert.

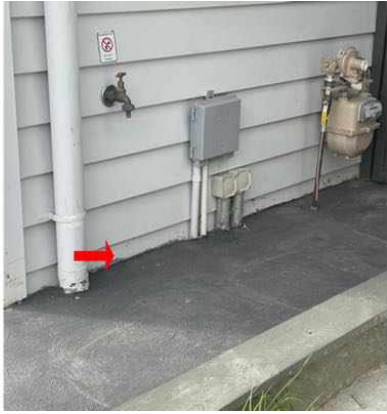
Finding 6.03

Building:	Main Building
Location:	All External Areas
Finding:	Slab Edge - Exposure
Information:	An inspection zone of at least 75mm in relation to the exposed slab edge, between the bottom brick and the perimeter pavement, is required. This inspection zone should be maintained in order to force termites into the open where they can be detected more readily during regular inspections. The slab edge should not be concealed by anything that may prevent inspection of the area, including render, landscaping, soil, turf, paving, concrete cladding or other structures.

If the slab edge is not properly exposed there is a high risk of termite attack. Sometimes, in order to determine the type of slab, a suitably qualified person such as an architect or builder may be required to consult the construction plans.

Where the slab edge cannot be properly inspected, it is highly recommended that termite or timber pest inspections be carried out every 6-12 months to aid protection of the property against infestation.

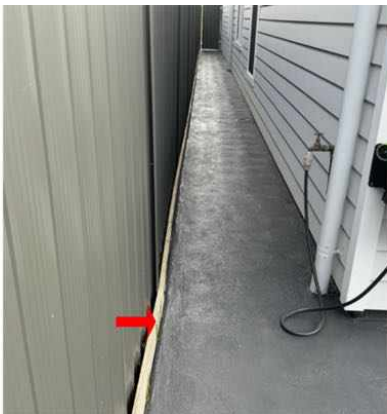
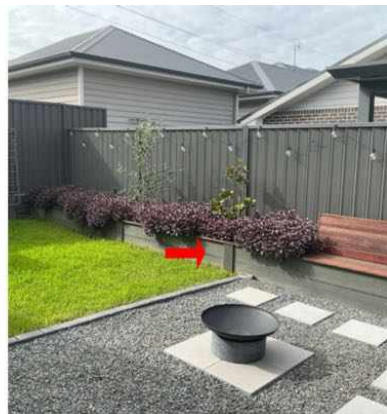
Finding 6.04

Building: Main Building
 Location: All External Areas
 Finding: In ground contact - Timber
 Information: Any timbers in direct ground contact provide opportunity for concealed termite entry and are likely to be subject to premature rot and decay as the soil retains moisture or damp conditions against the timbers.

Remove untreated timber that is in direct contact with external grounds. Consider replacement with more durable materials i.e. treated timber or non timber elements. Frequent pest inspections are advised to readily identify any termite activity in these areas.

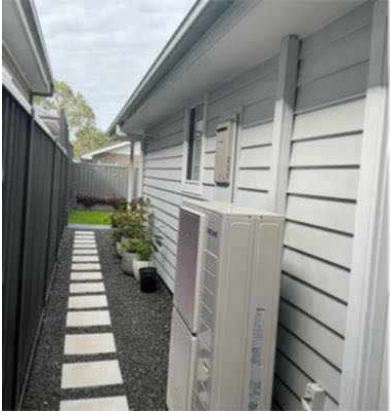
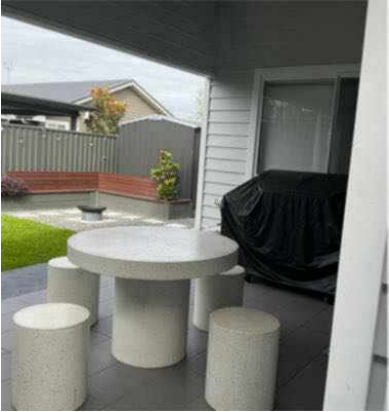
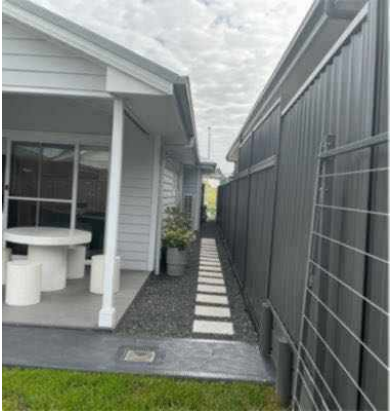
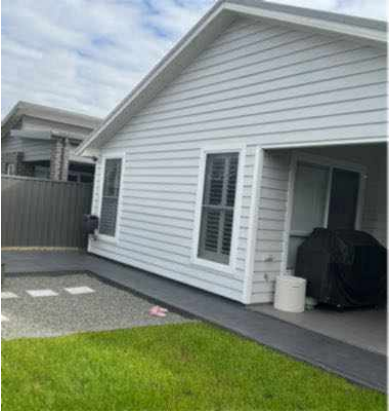
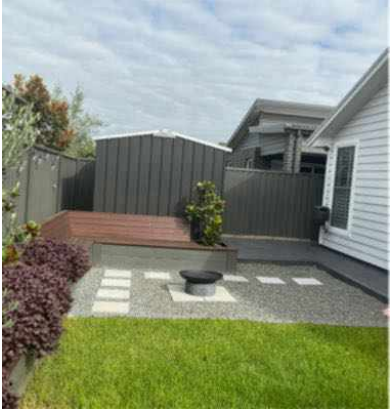
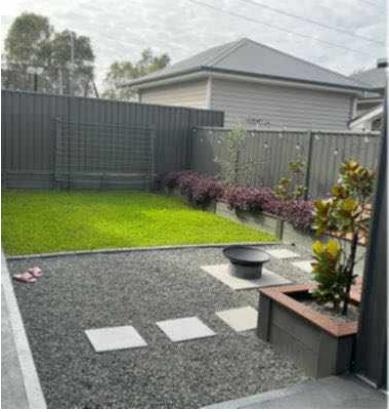
Noted Item

Building: Main Building
Location: All External Areas
Finding: Additional Photos - Obstructions and Limitations
Information: These photographs are an indication of the obstructions and limitations which impeded full inspection of the property at the time of inspection. These obstructions can hide an array of defects and should be removed to allow full inspection to be carried out. A re-inspection is recommended once the areas are made accessible.

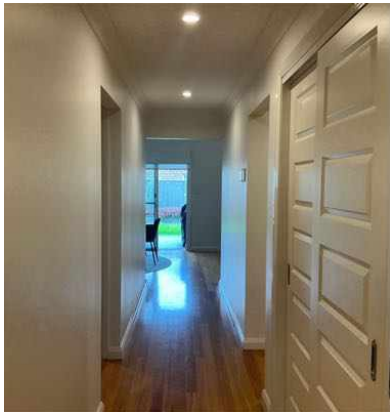
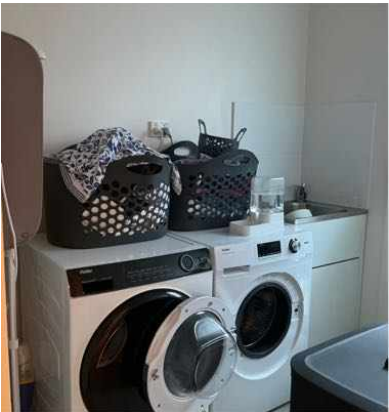
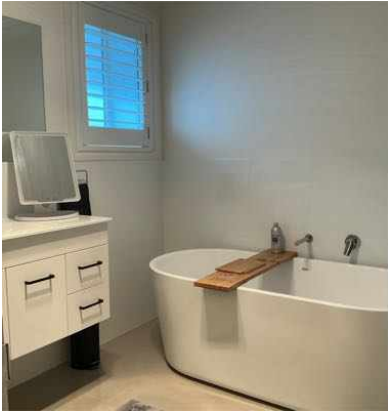
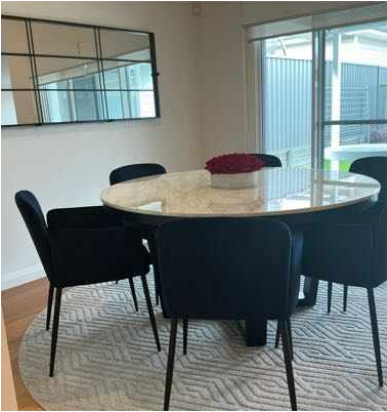
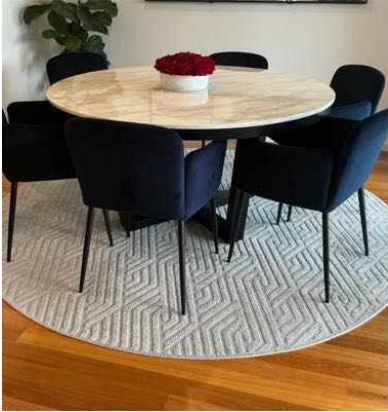
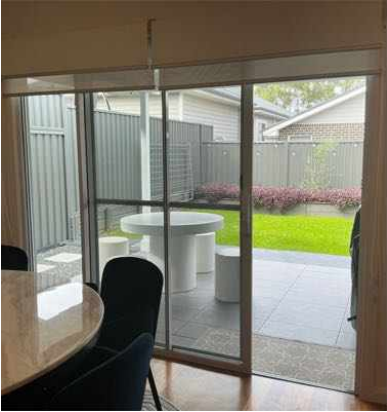
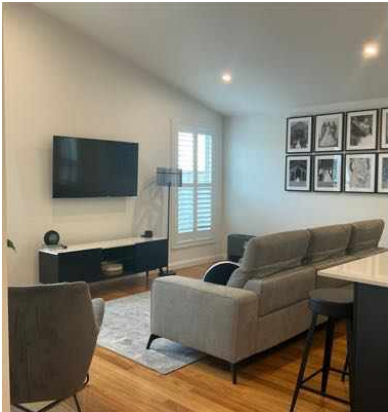
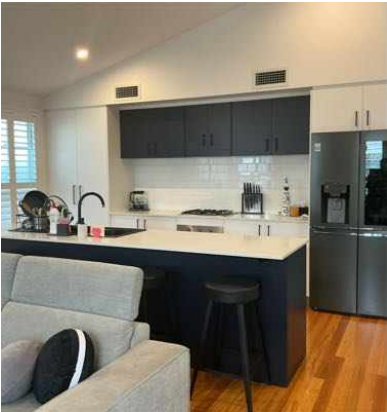
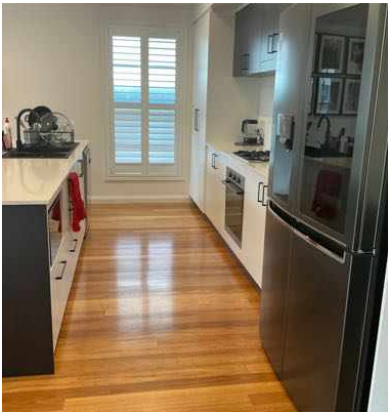
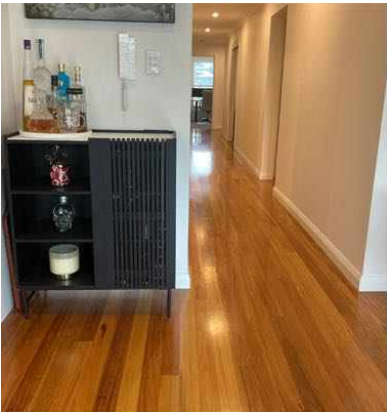
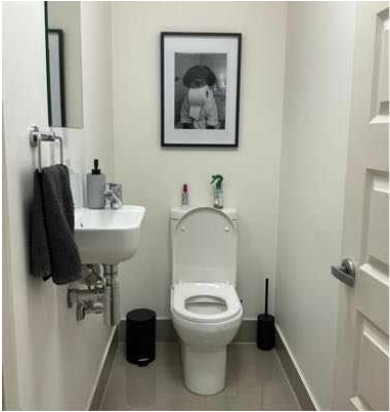
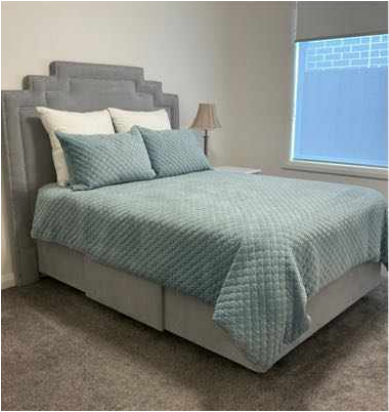
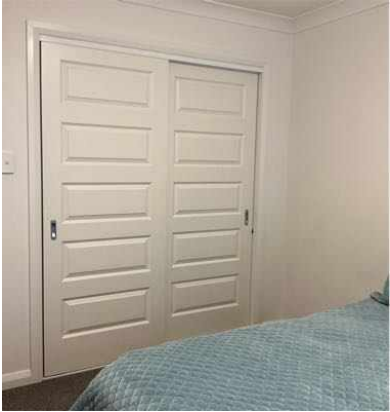
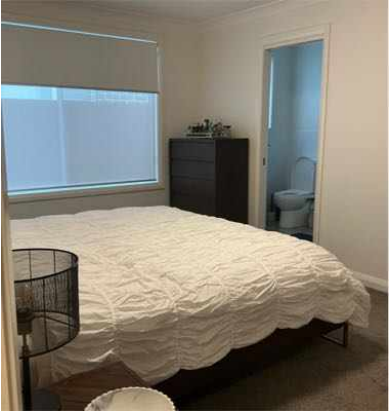
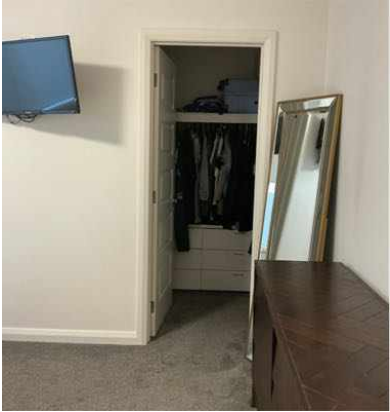
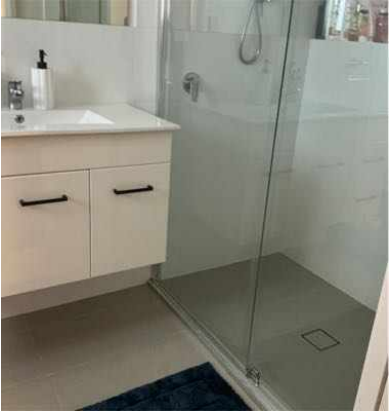
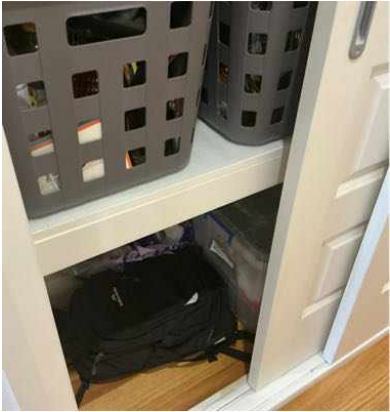
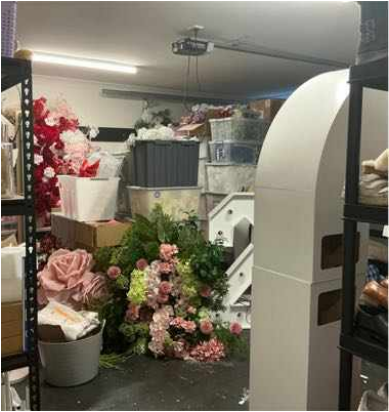
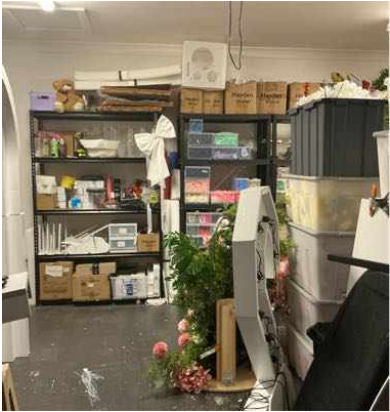
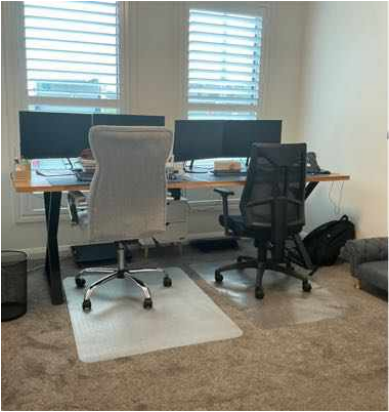
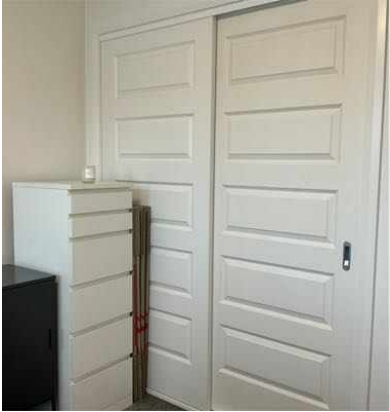
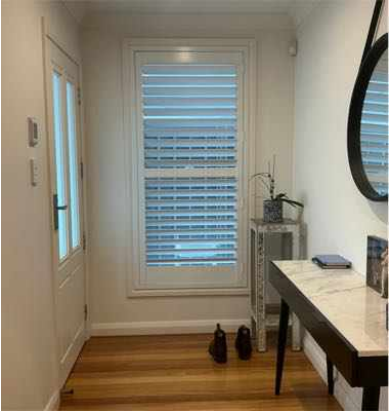
Building:	Main Building
Location:	All Internal Areas
Finding:	Additional Photos - Obstructions and Limitations
Information:	These photographs are an indication of the obstructions and limitations which impeded full inspection of the property at the time of inspection. These obstructions can hide an array of defects and should be removed to allow full inspection to be carried out. A re-inspection is recommended once the areas are made accessible.

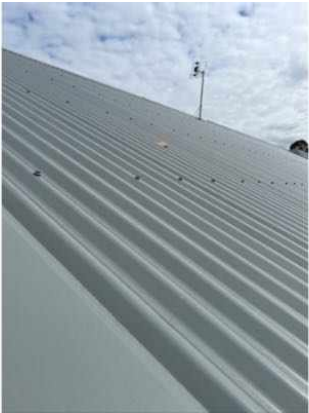
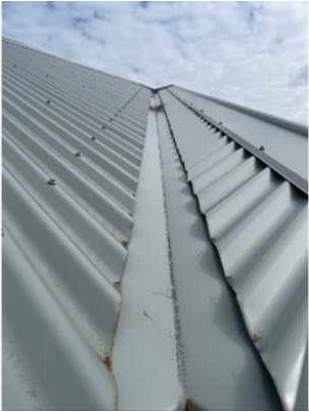
Building: Main Building
Location: Roof Exterior
Finding: Additional Photos - Obstructions and Limitations
Information: These photographs are an indication of the obstructions and limitations which impeded full inspection of the property at the time of inspection. These obstructions can hide an array of defects and should be removed to allow full inspection to be carried out. A re-inspection is recommended once the areas are made accessible.

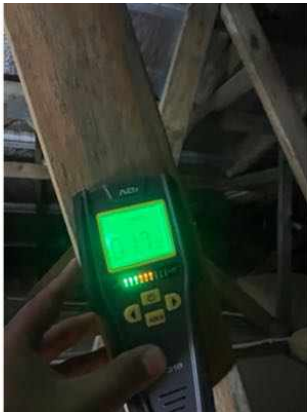
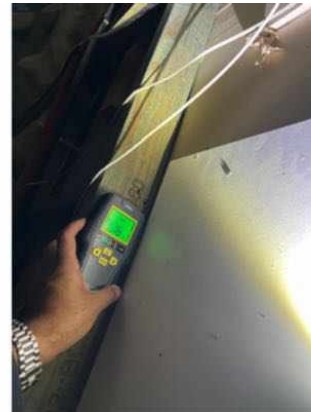
Building:	Main Building
Location:	Roof Void
Finding:	Elevated Moisture Detected – No Visual Deterioration Observed
Information:	Moisture readings taken indicated slightly elevated levels above typical thresholds. However, at the time of inspection, no visible signs of water damage, staining, timber decay, or mould growth were identified. While this may be due to recent exposure or concealed moisture, further monitoring is recommended. If concerns persist, a licensed builder or water ingress specialist should be engaged to assess concealed areas and verify the source, especially given the expectations of durability and weatherproofing.

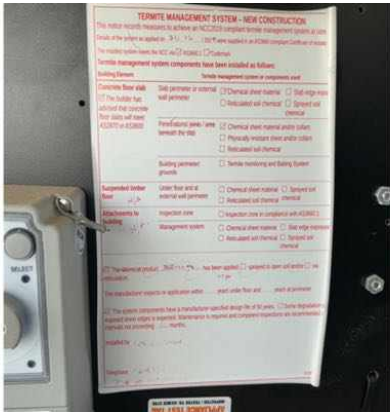
Where a Termite Management System has been identified you should refer to the type of barrier date of installation warranty conditions and any documentation provided by a builder or past owner. Consult the company who installed the barrier to confirm whether the system is still under warranty.

Most chemical termite management systems expire and require replenishment and all physical systems are primarily designed to prevent concealed entry.
