Building and Timber Pest Inspection Report

Inspection Date: Thu, 26 Mar 2026

Property Address: 6 Bournemouth St, Bundeena NSW 2230,
Australia

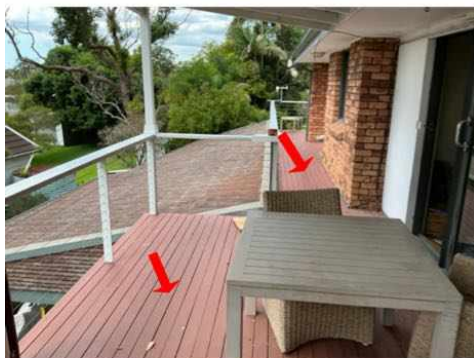
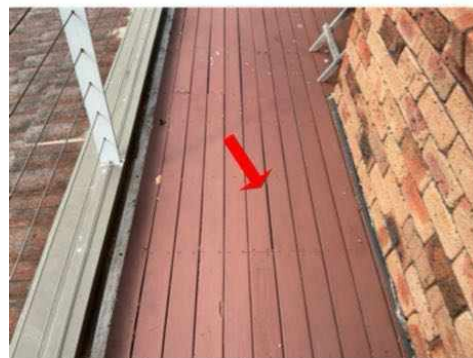
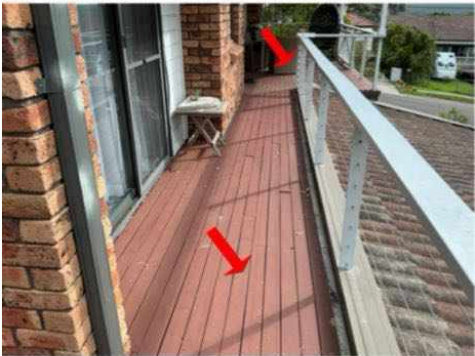
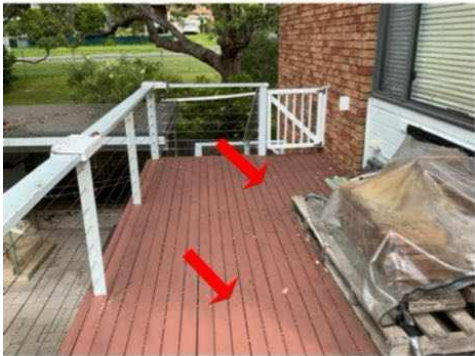
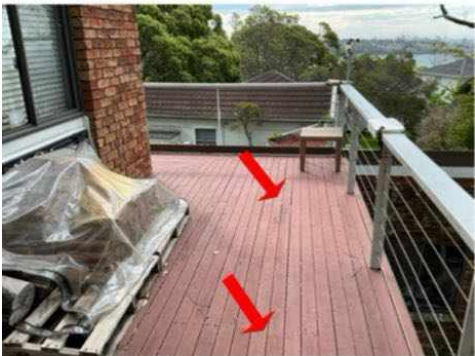
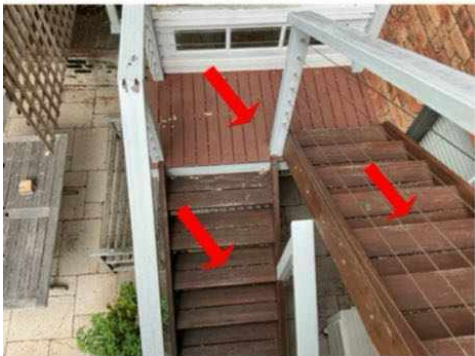
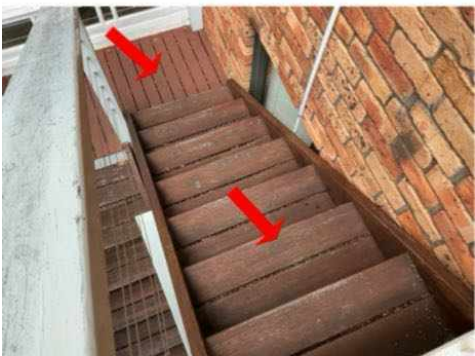
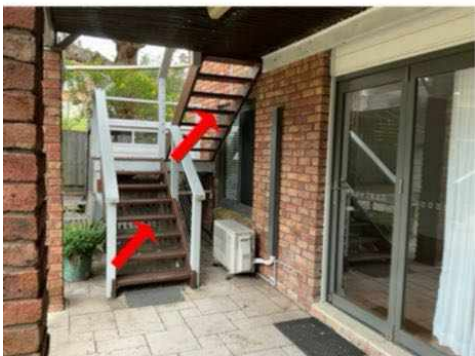
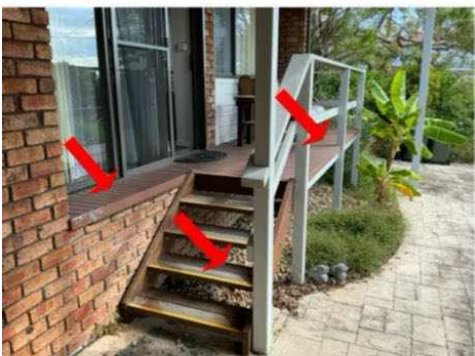
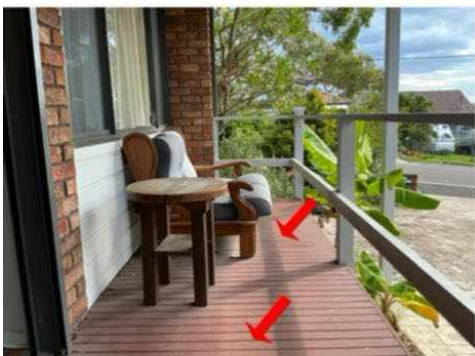
Finding 1.02

Building: Main Building
 Location: All external wooden - balcony's , porches, staircases
 Finding: Timber Balcony / Decking Safety Hazard
 Information: Sections of the upstairs timber balcony/decking were observed to be lifting, with screws protruding above the surface.

Additionally, the structural integrity of the deck is uncertain, particularly given its elevated location, increasing the risk of serious injury in the event of failure.

Immediate attention by a Structural Engineer or Registered Builder is strongly recommended to assess the decking, secure or replace loose boards, and eliminate protruding fasteners. All remedial works should be conducted under professional supervision to ensure both structural and user safety.

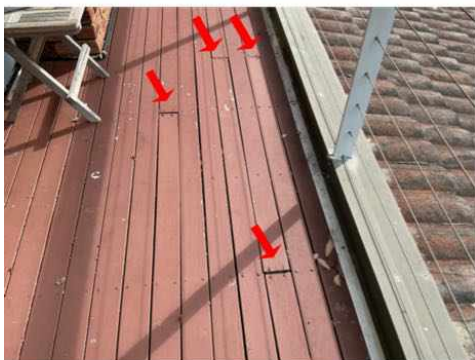
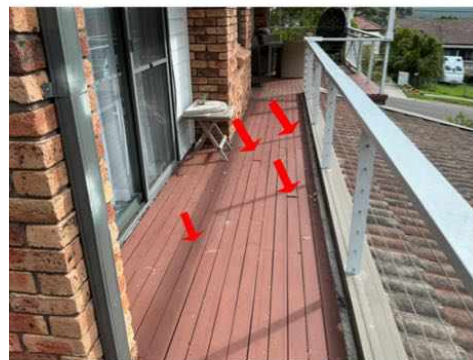
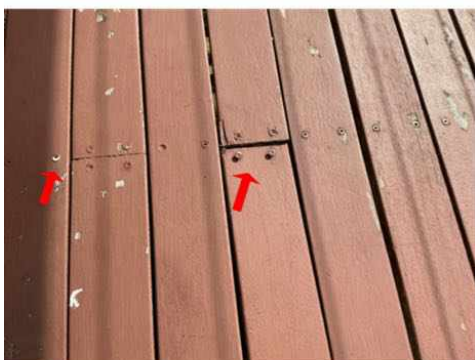
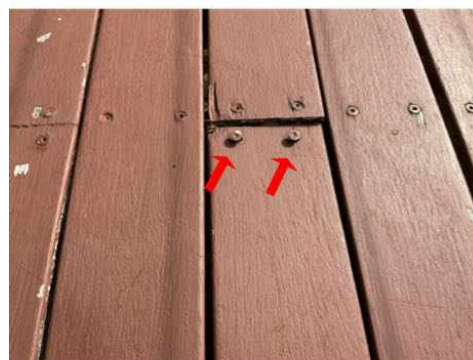
Finding 1.03

Building: Main Building
 Location: Under external wooden balconies

Excessive moisture accumulation,

Fungal decay or wood rot, and

Prolonged exposure to moisture and fungal decay can compromise the structural integrity of the balcony, increasing the risk of failure.

It is strongly recommended that the roofing material be replaced or modified to allow debris to pass through, or that the suspended areas be properly sealed to prevent debris accumulation. All remedial works should be undertaken under the supervision of a qualified builder to ensure both structural and user safety.

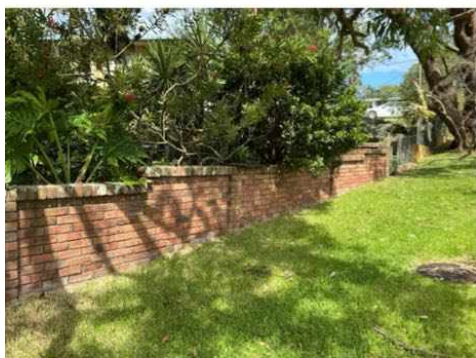
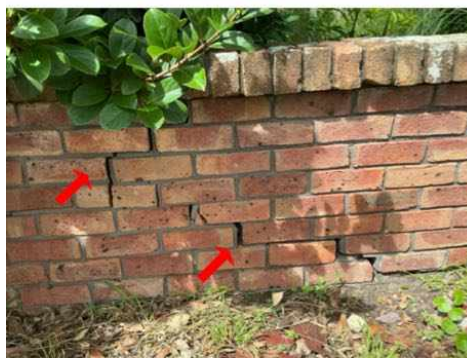
Building:	Main Building
Location:	Northern - front and side brick fences
Finding:	Brickwork - Step cracking

Information: Step cracking was observed to the front brick fence. The cracking is currently minor in nature and does not appear to impact the immediate stability of the structure.

Such cracking is typically associated with minor movement within the foundation or footing system. While not requiring immediate rectification, it should not be disregarded.

It is recommended that the affected areas be regularly monitored for any progression, including widening, lengthening, or additional cracking. Should the cracking worsen, a qualified bricklayer or builder should be engaged to assess and carry out appropriate rectification works.

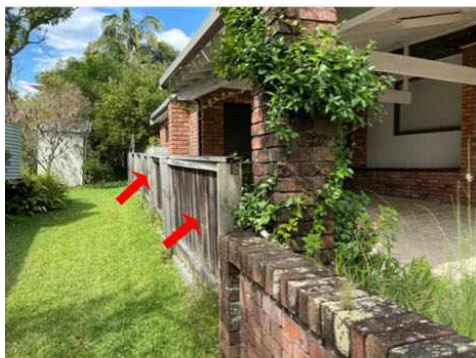
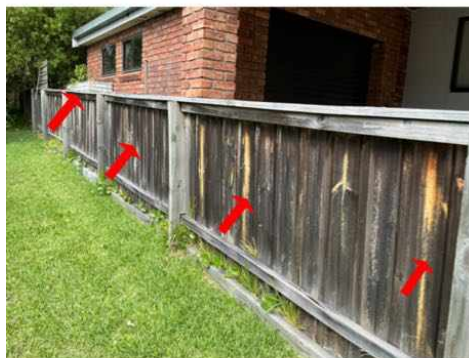
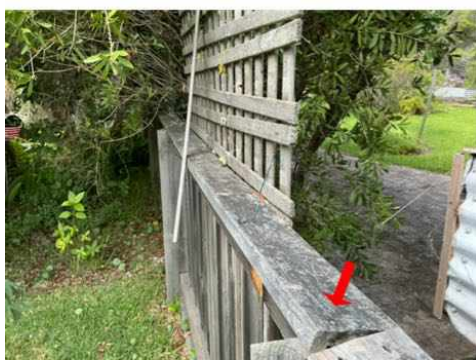
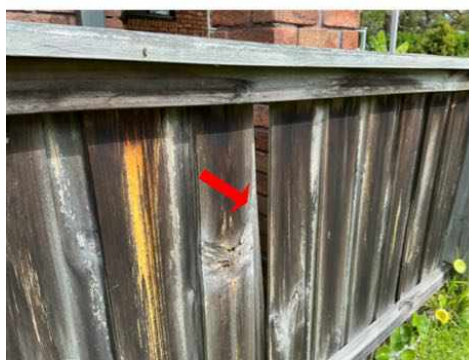
Finding 3.05

Finding: Fencing - Deteriorated

Information: It was noted at the time of inspection that sections of the fencing throughout the property have deteriorated. Typically fencing deteriorates due to age and or wear, rot and or rust which is generally expected for a structure of this age, due to prolonged exposure to weather conditions. Sometimes inadequate installation or maintenance can be to blame.

If left unattended, it is likely that further damage will occur. It is suspected that repair of several elements of the fencing may be required however replacement may be a consideration of the client also.

A licensed fencing contractor should be appointed to provide further advice and perform rectification works as necessary.

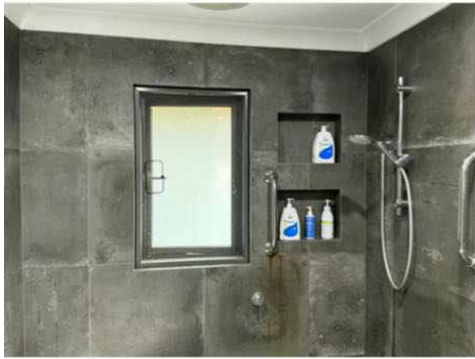
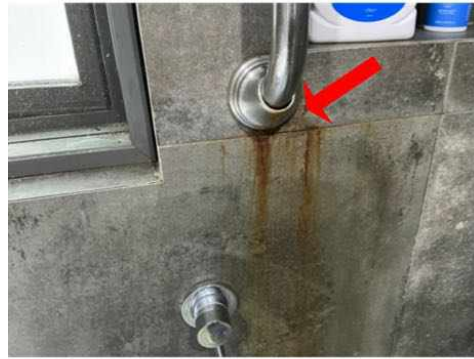
Finding 3.06

Building:	Main Building
Location:	Lower main bathroom
Finding:	Building element - Rusted or corroded
Information:	This building element shows evidence of rusting and corrosion, which is likely to have developed as a result of excessive exposure to moisture and or inadequate coatings.

As surface rust provides no protection to the underlying iron, the deteriorating condition is likely to worsen if not addressed in the short-term future.

Where possible, the use of galvanized (treated) metals or aluminium coated metals aid in rust prevention, as does regular general maintenance. Rust formation can be controlled with coatings, such as paint, that isolate the iron from the environment.

Rusting and corrosion should be managed by ideally removing or limiting the affected surface from exposure to moisture. A registered builder may be appointed to replace any building elements that have been severely affected by rust or water damage.

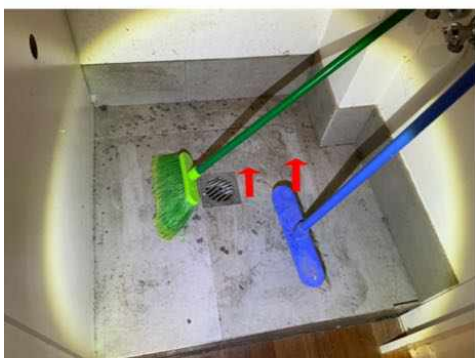
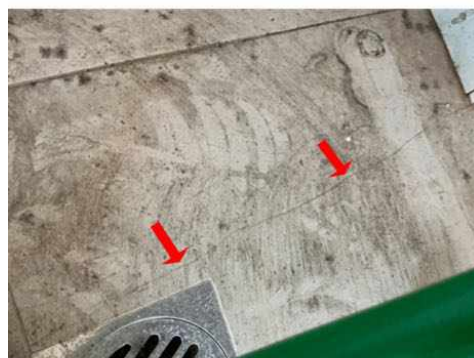
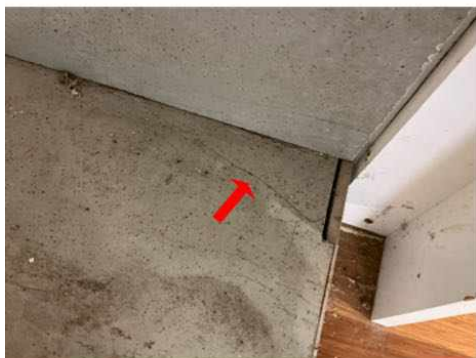
Finding 3.07

Building:	Main Building
Location:	Laundry recess- bottom floor
Finding:	Tiles cracked or damaged- (wet areas)
Information:	Cracking was evident to the tiling in this area at the time of inspection. While the cracking appears to be minor, this area is frequently exposed to water, allowing potential for water penetration into adjoining sections of walls or flooring.

If left unmanaged, water penetration to these areas may lead to subsequent water damage, which is likely necessitate repair work to affected building elements.

A tiling contractor should be appointed to ensure that no further water damage occurs. The re-application of silicone and grouting throughout remaining tile work is also advised, to further protect the area against water penetration.

Where water penetration has led to water damage, appointment of a relevant tradesperson may be required to repair damaged building elements.

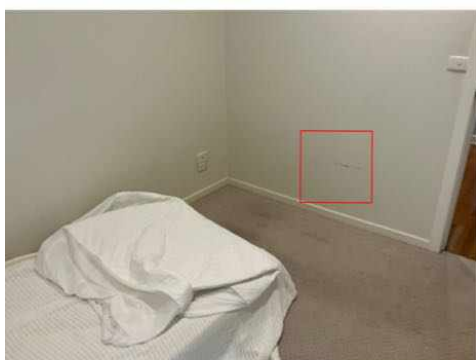
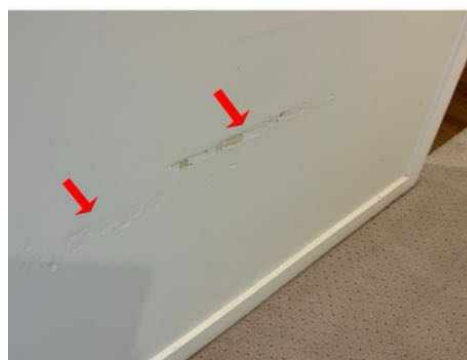
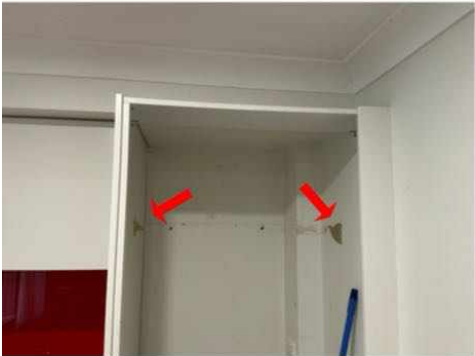
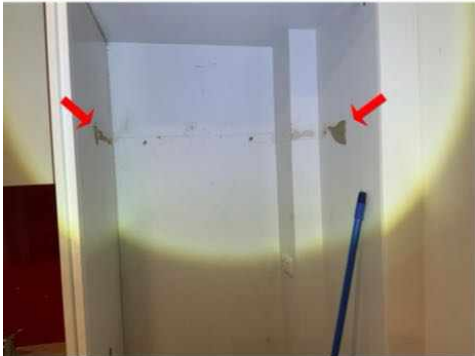
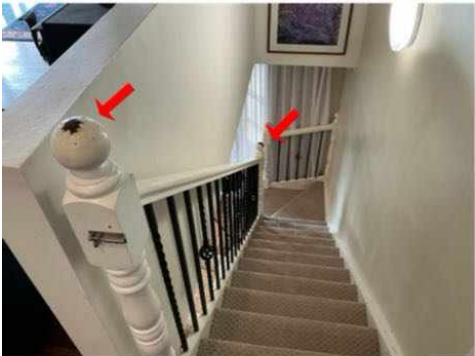
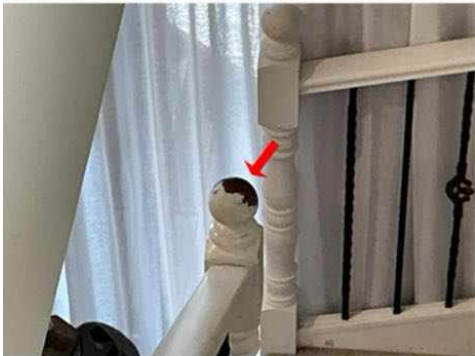
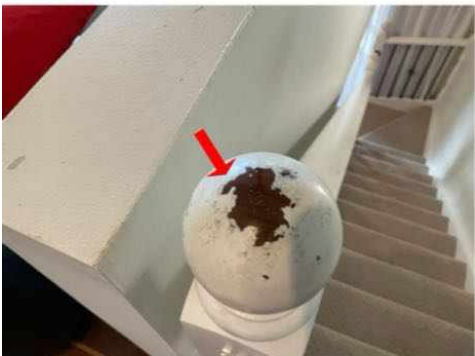
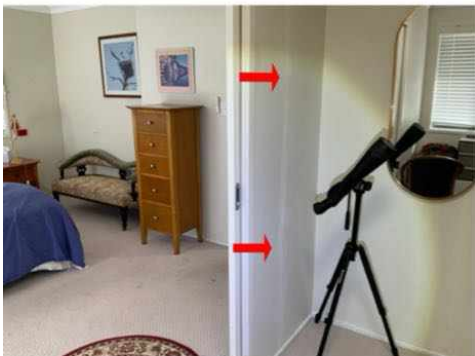
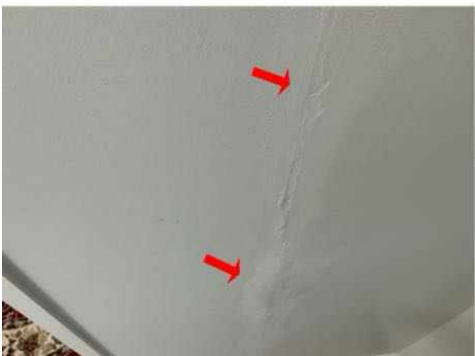
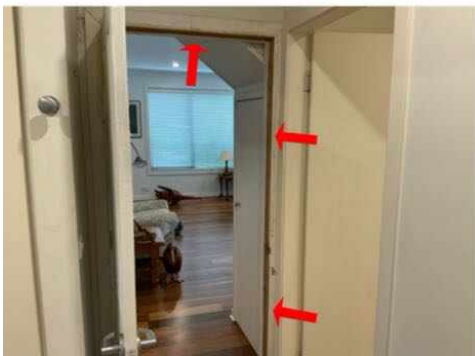
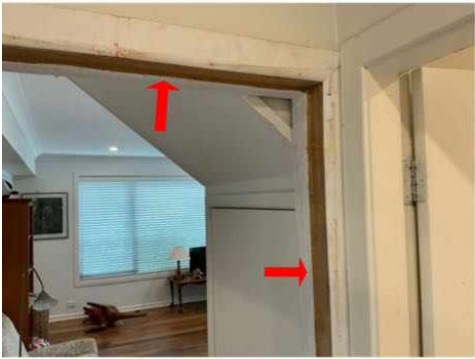
Finding 3.08

Building:	Main Building
Location:	All Areas
Finding:	Paint finish - Substandard
Information:	The paint finish in this area was found to have been completed to a substandard level. Substandard painting is generally classified as an appearance defect. However, the substandard appearance may also be indicative of poor surface preparation and substandard workmanship.

If this applies, further areas of poor and incomplete finishes could develop over time. Furthermore, substandard paint finishes in areas exposed to moisture, e.g. external areas or wet areas, could lead to deterioration of underlying building materials.

Substandard paint finishes should be sanded back, filled, leveled and repainted, as applicable. Where inadequate paint protection has led to the deterioration of the associated building element, repair and/or replacement of this building element may be required.

A painting contractor should be appointed as soon as possible to perform necessary works to aid the appearance of the affected area and to ensure that the area is protected against further deterioration. Alternatively, the homeowner following manufacturer instructions may be able to provide this service.

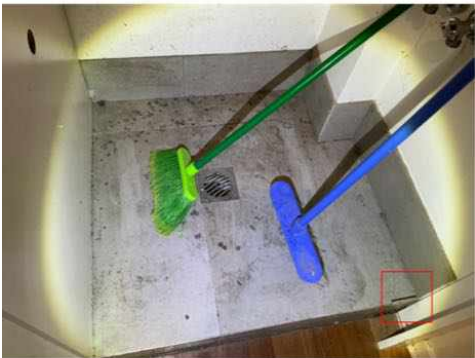
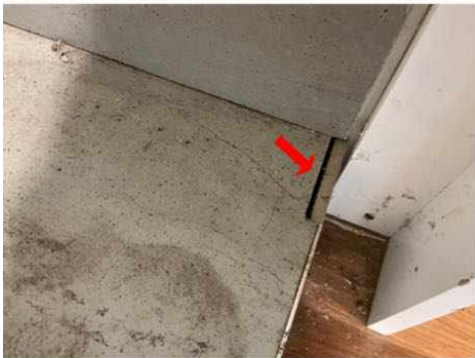
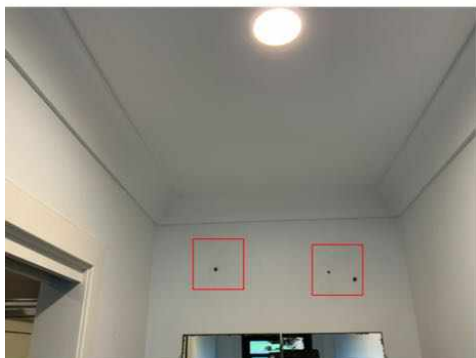
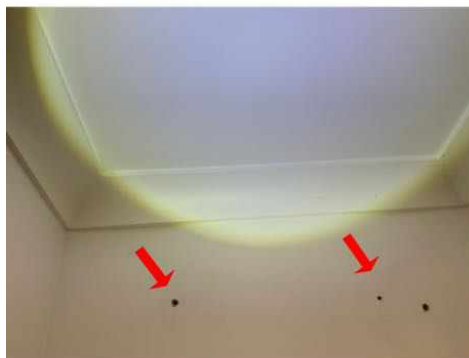
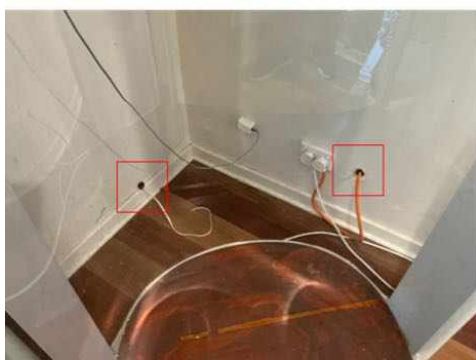
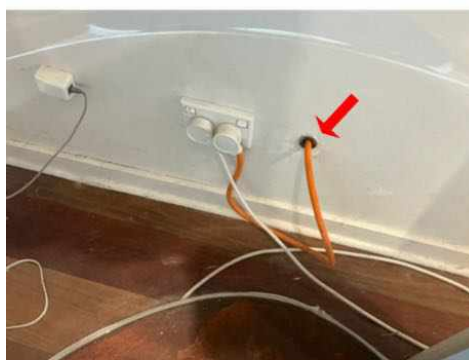
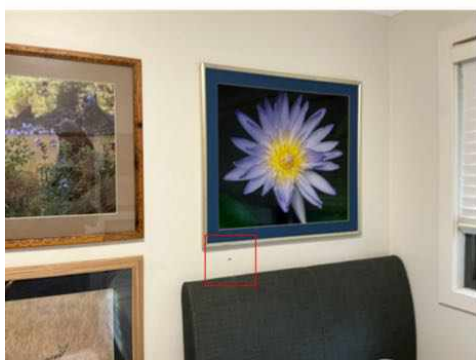
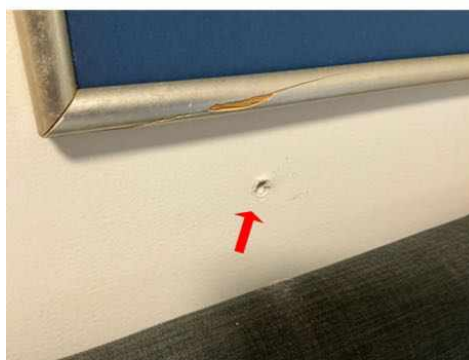
Finding 3.09

Building: Main Building
Location: Internal walls-
Finding: Surface - Holes
Information: Holes in surfaces are generally indicative of impact damage, whether accidental or deliberate, or a failing of the surface material.

Where holes are apparent in the surface of a building material, the surface is no longer sealed against water penetration or further impact damage, which may lead to additional damage to the surrounding surface.

Repair or replacement of the affected building element is recommended as soon as possible to ensure that any secondary defects are minimised. A qualified carpenter or general handyperson should be appointed to perform these works.

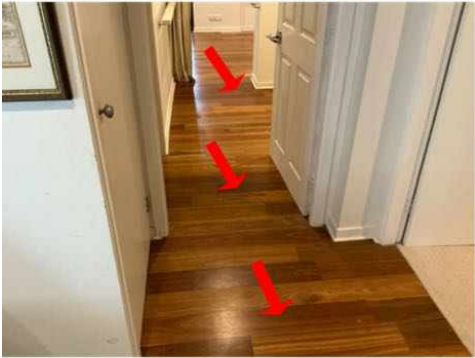
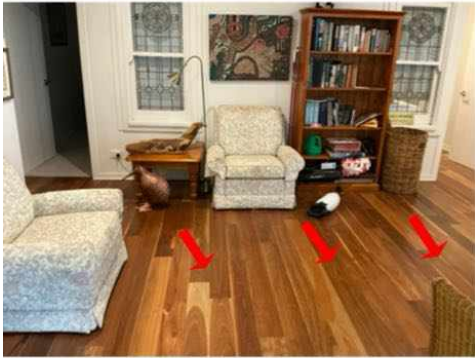
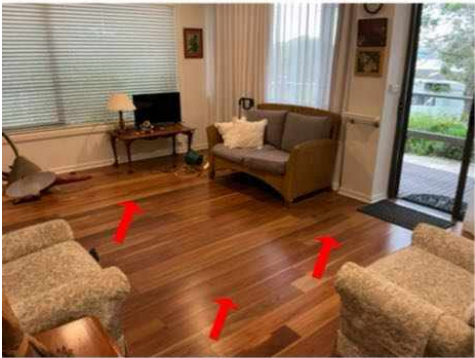
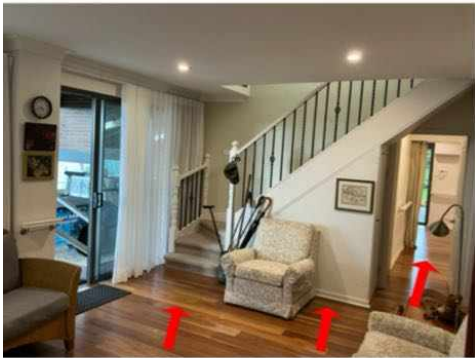
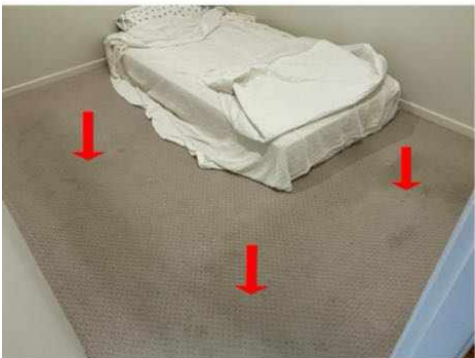
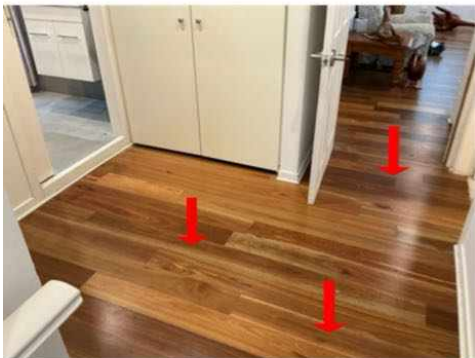
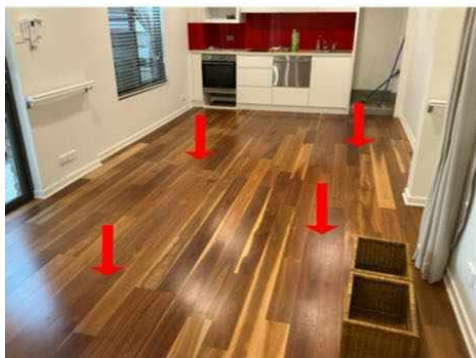
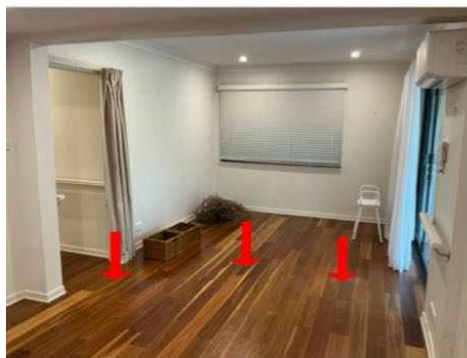
Finding 3.10

Building:	Main Building
Location:	Ground floor- all areas
Finding:	Floors - bouncy
Information:	The internal flooring in this area was observed to be bouncy underfoot at the time of inspection. A bouncy floor surface generally presents as a discernible change in level as they are walked across, in noisy or creaking flooring, or in consequent movement of surrounding furniture and fixtures sections. Vinyl floor covering appearing to separate from the underlying substrate.

Such conditions are typically indicative of movement within the subfloor structure, which may include loose or inadequately supported flooring, gaps between structural

elements, or potential subsidence of stumps or joists.

The client is advised to seek further assessment and quotations from a Registered Builder experienced in subfloor and re-stumping works. Rectification may involve packing and securing of subfloor components, through to more extensive repairs where structural movement is confirmed.

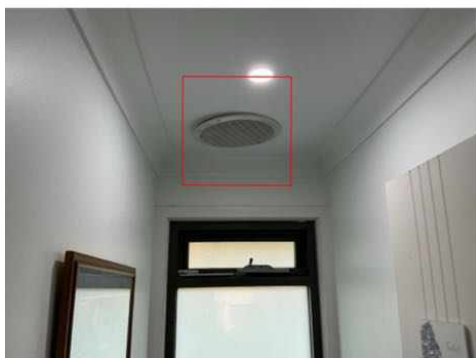
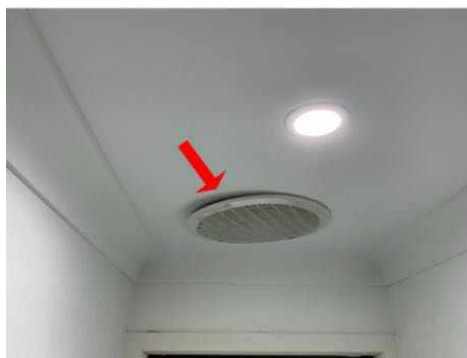
Finding 3.11

Building:	Main Building
Location:	Main toilet
Finding:	Fitting or fixture - Loose- exhaust fan
Information:	The fitting in this area is loose and requires adjustment to tighten.

If left unmanaged, the fitting may further deteriorate, causing potential for the development of other minor secondary defects.

A relevant tradesperson should be appointed to perform these rectification works at discretion of the client.

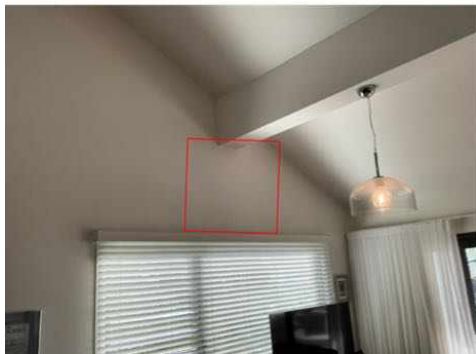
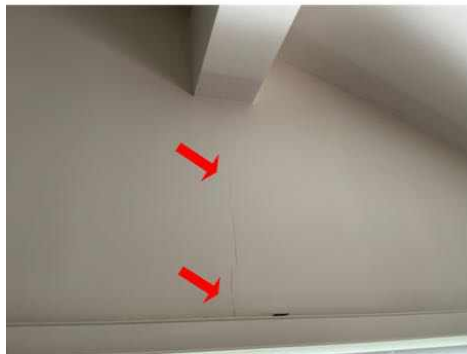
Building:	Main Building
Location:	Main living room- upstairs
Finding:	Cracks to external wall surface - Category 2
Information:	It has been observed that cracking to internal wall surface has occurred. The degree of damage falls within Category 2, described as noticeable cracks which are easily filled. Cracking of this size are generally less than 5mm in width.

Category 2 damage is required to be monitored for a period of 12 months. After the monitoring period, a crack rated at Category 2 or above is considered a defect

requiring rectification.

Always contact your building inspector should cracks widen, lengthen, or become more numerous.

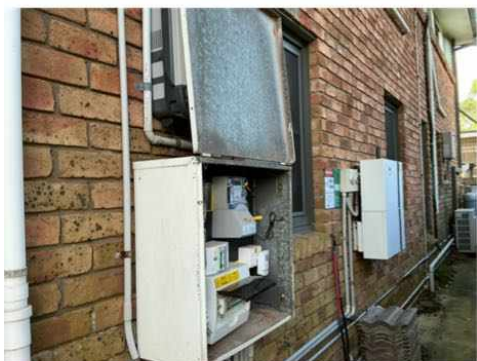
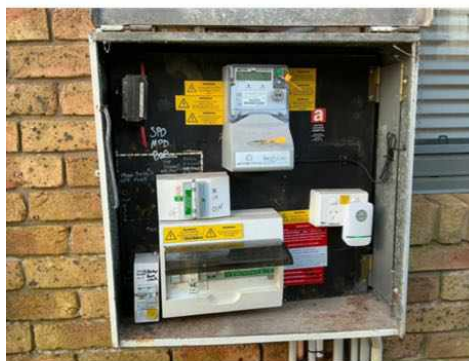
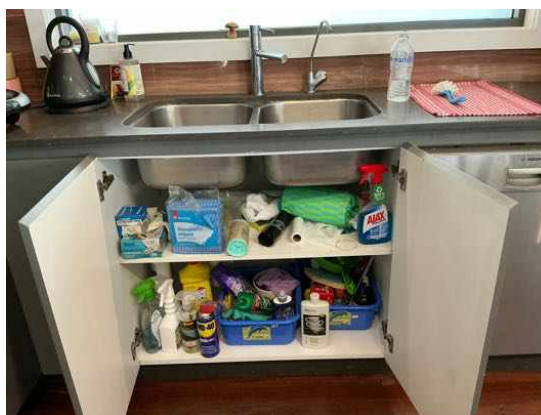
Building:	Main Building
Location:	Meter box, under kitchen sink
Finding:	Termite Management System - no evidence of a chemical installation
Information:	The application of a post-construction chemical termite barrier is highly recommended for all properties, particularly if live termite activity has been found on the site previously. Such barriers are highly effective in preventing termite attack on any timber building elements throughout the property.

A durable notice should be placed in the switchboard unit to indicate current termite barriers. At the time of inspection, it appeared as though no termite management system has been installed, with no evidence to suggest preventative works taking place.

The client may consider gaining further advice from a pest controller as to the costs and procedures involved with this application. It is recommended that obtaining such advice be a short-term priority.

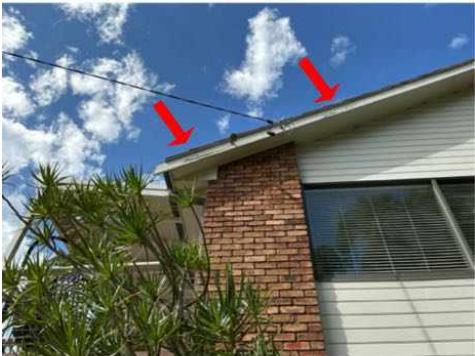
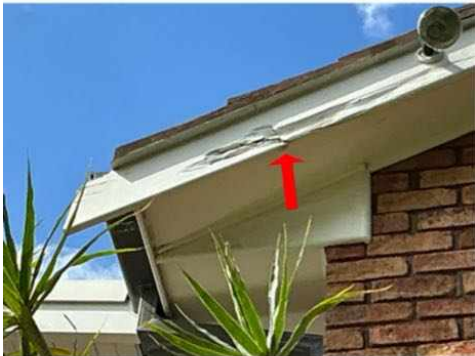
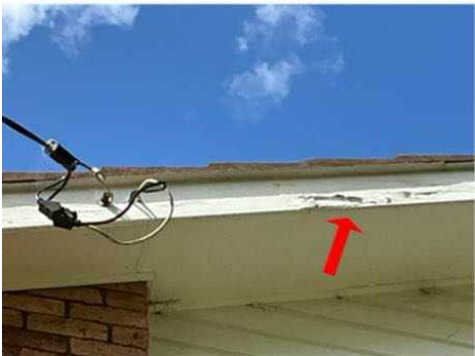
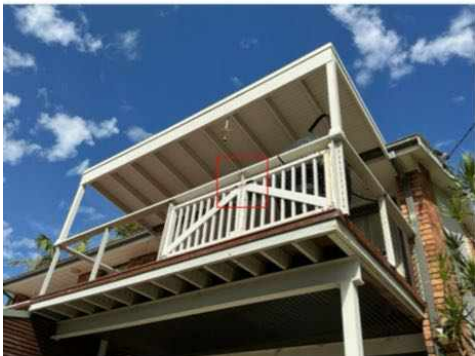
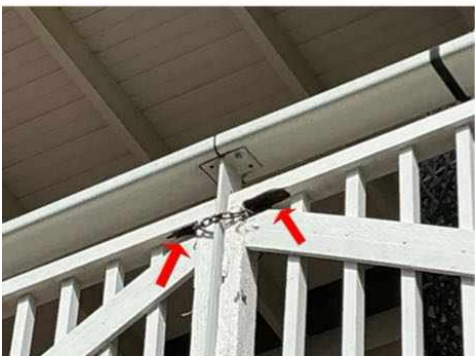
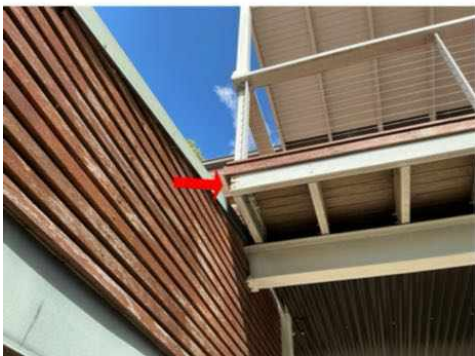
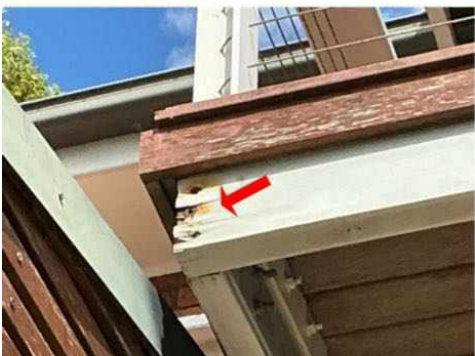
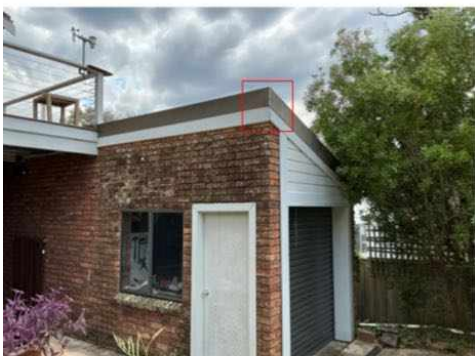
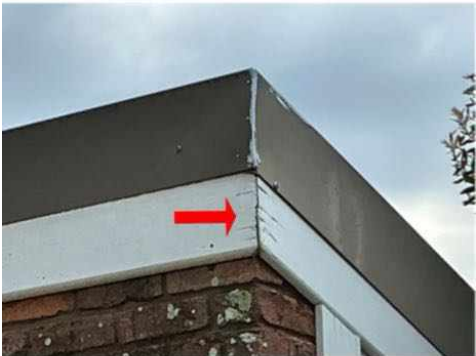
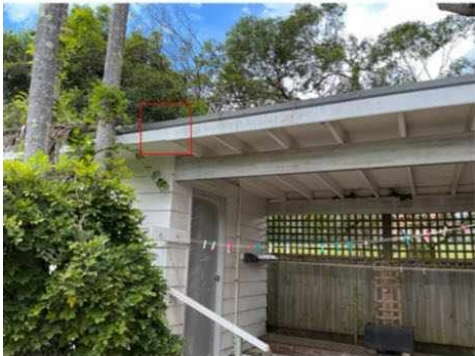
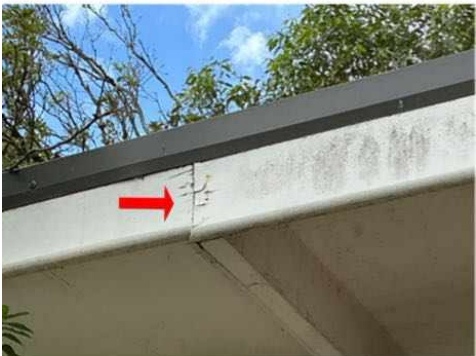
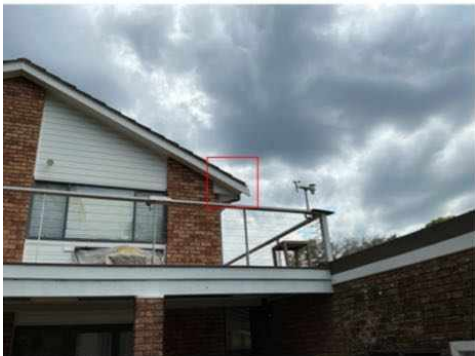
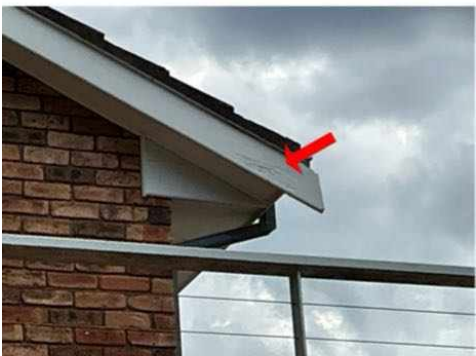
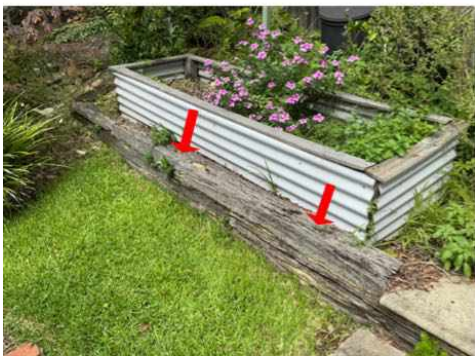
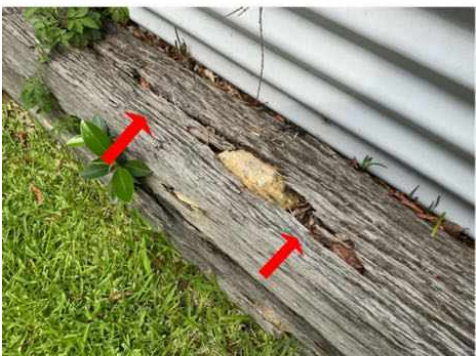
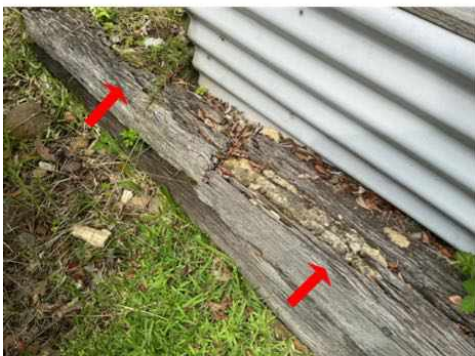
Finding 6.02

Building:	Main Building
Location:	All Areas
Finding:	Fungal decay - present (localised)
Information:	Fungal decay also known as wood decay or wood rot generally refers to the deterioration of timber elements when in contact with excessive levels of moisture for a prolonged period of time.

The development of fungal decay is accelerated by temperatures in the range of 5degreeC to 40degreeC as well as the presence of oxygen. Generally fungal decay develops on timber elements that are in use in an external environment which are exposed to rain penetration.

In this case although the affected timber element is in a decaying state the extent of any visible damage appears to be localised to a specific area and is yet to spread to other parts of the building element or affect adjoining structures. The fungal decay is therefore likely to be of a relatively superficial nature with minimal impact on the structural integrity or tensile strength of the timber element.

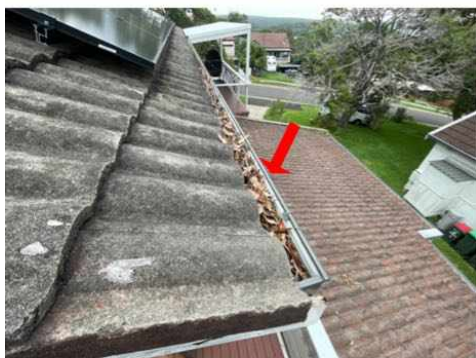
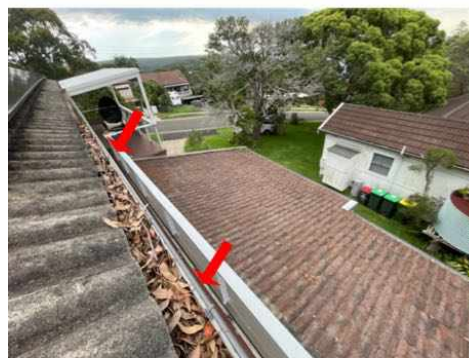
Finding 6.03

Building:	Main Building
Location:	Roof Exterior
Finding:	Gutters - Blocked
Information:	Roof plumbing structures, such as guttering and downpipes, should be free of all debris to prevent blockages. Blockages of the guttering and downpipes will lead to pooling and accumulated water overflows, which is likely to subsequently flood eaves and exterior walls.

Blocked gutters are likely to lead to high levels of moisture in the affected areas. Such moisture will not only cause rust and decay of the associated building materials, but can also provide conditions that are conducive to termite and timber pest activity. Blockages in gutters should therefore be removed immediately to ensure dry conditions are maintained.

Consult a Licensed Plumber for further specific advice on remedial works that may be required. In the interim, it is highly advised that blocked gutters be removed by the homeowner or a general handyperson as a matter of urgency.

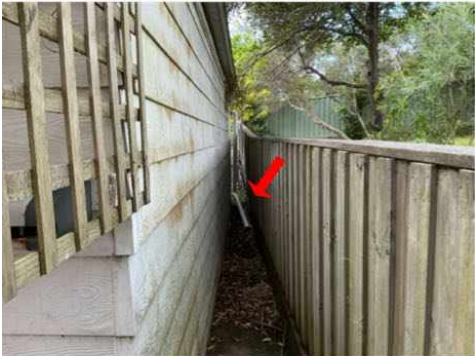
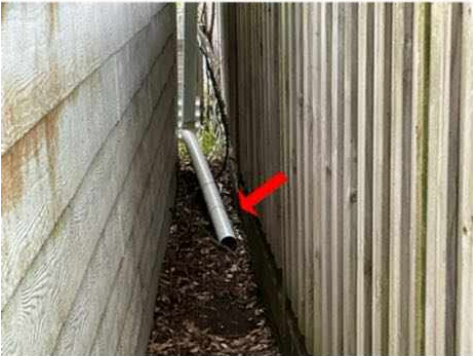
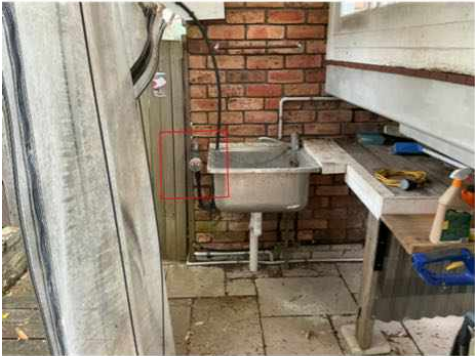
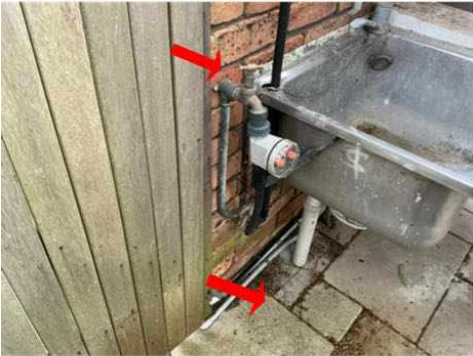
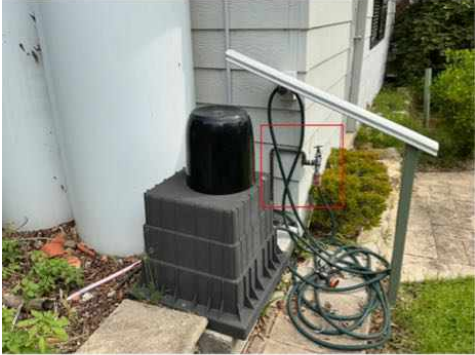
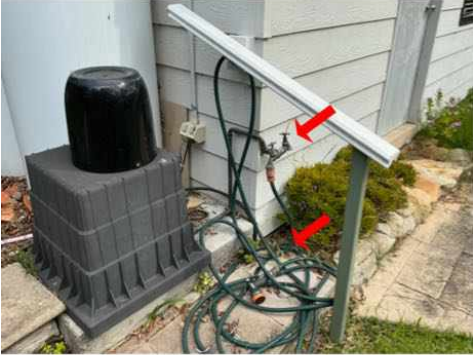
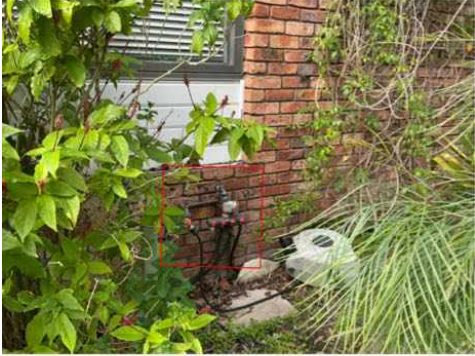
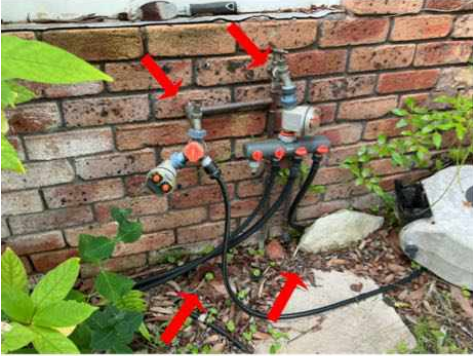
Finding 6.04

Building:	Main Building
Location:	All Areas
Finding:	Overflow - Not plumbed for drainage (Excessive Moisture)
Information:	The overflow is not plumbed or connected to suitable drainage, which has resulted in the surrounding area becoming excessively damp. These damp conditions can lead to secondary defects such as rot, rust or corrosion of associated building elements, the formation of fungal decay, or even the creation of potential slip hazards.

When coupled with poor site drainage, pooling of water may also attract termite activity to this area. It is highly recommended that a qualified plumber be appointed to install adequate drainage to the overflow. These works will ensure that the area

remains dry and free of any secondary defects.

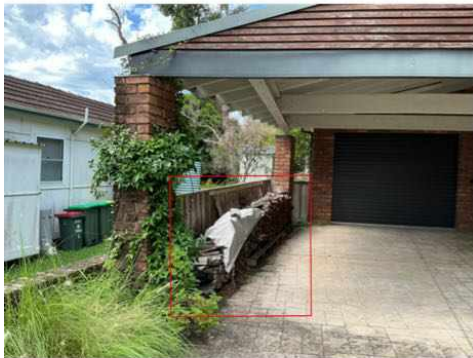
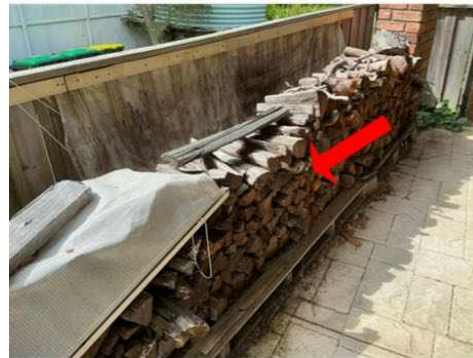
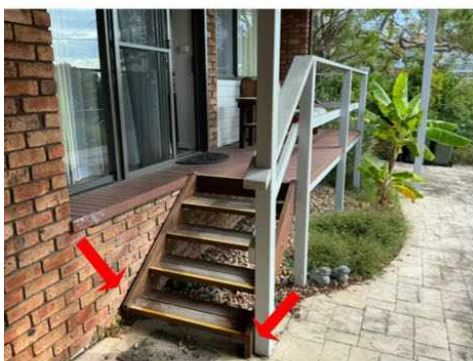
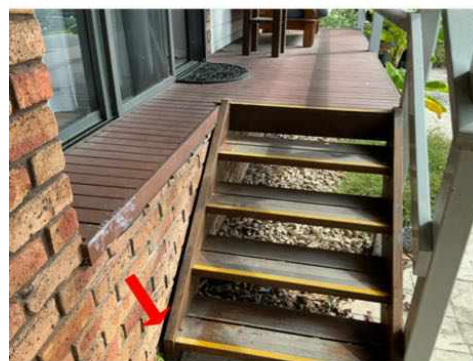
Finding 6.05

Building:	Main Building
Location:	All Areas
Finding:	Untreated or non-durable timbers in a hazardous environment (Timbers in ground contact)
Information:	To reduce the risk of timber pest attack it is essential that timber used in a hazardous environment (e.g. in direct contact with the ground or frequently exposed to damp conditions) is of sufficient durability and/or is adequately preservative treated.

Untreated timbers in direct contact with the ground are likely to develop severe wood rot and/or fungal decay if left unattended creating attraction for subterranean termites to infest the timbers from surrounding areas.

If untreated or non-durable timbers are found to be in a hazardous environment it is highly advised that replacement of these building elements be performed as soon as possible to aid the protection of the property against termite / timber pest attack.

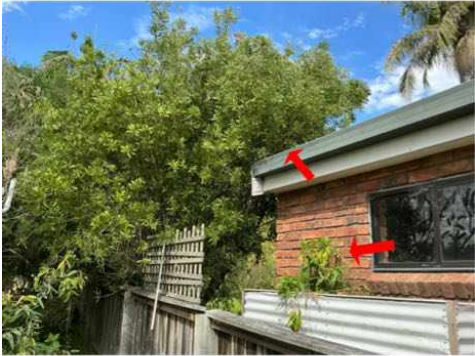
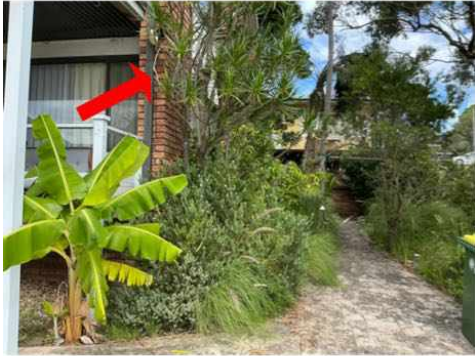
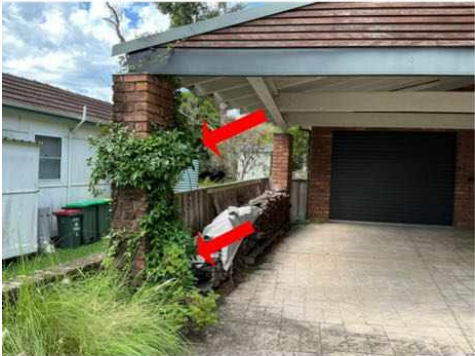
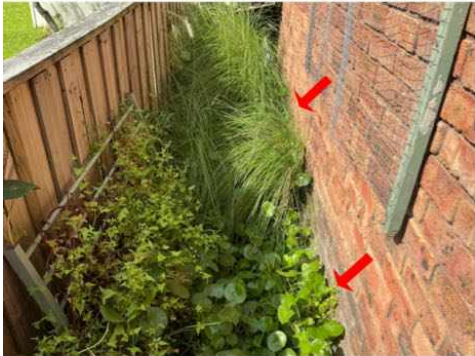
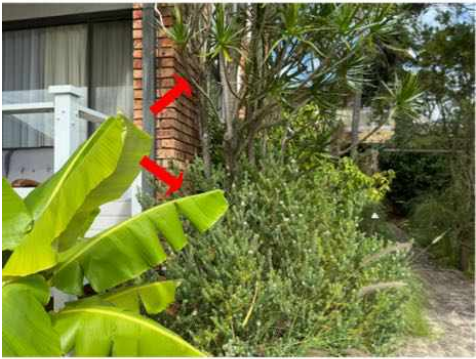
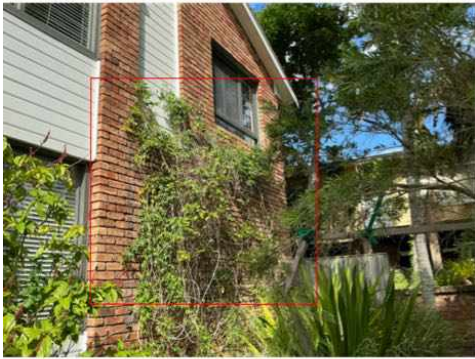
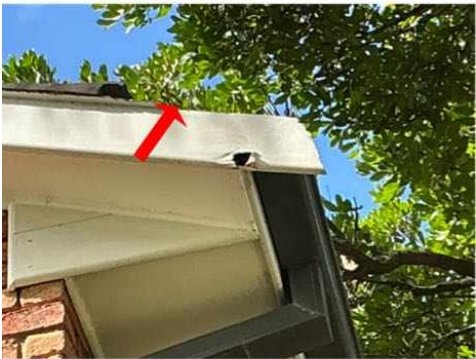
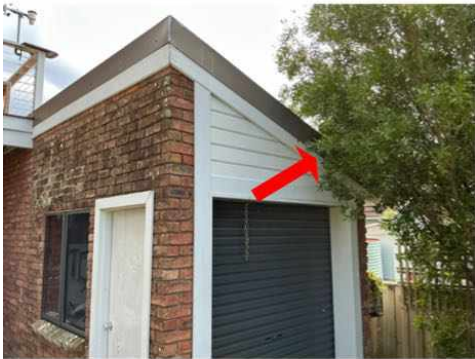
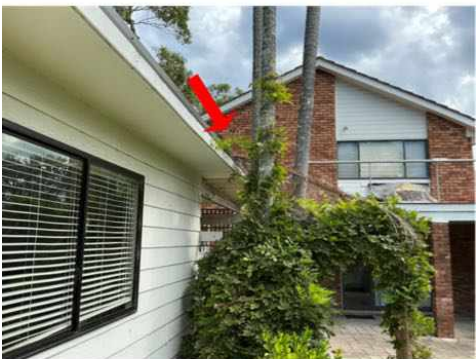
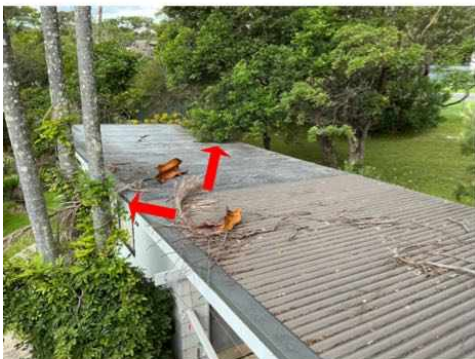
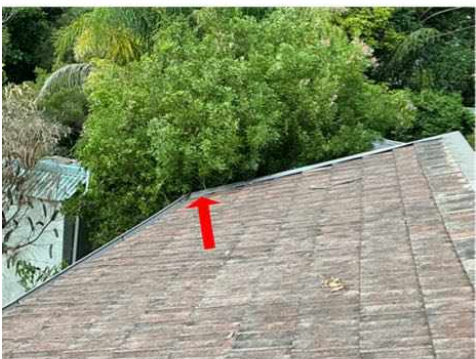
Finding 6.06

Building: Main Building
Location: All Areas
Finding: Bridging - Vegetation
Information: Where vegetation obstructs inspection of building elements, also known as bridging as it provides a bridging point for the access of termites, full inspection can not be achieved. Consequently moisture or dampness may be present and the areas becomes conducive to termite activity. Plants against or very close to buildings provide cover, shade and can provide an environment that is attractive to termite infestation.

The removal and replanting of species that do not provide "cover" or cutting back of existing vegetation will assist greatly in preventing Bridging from occurring.

The removal of any such materials that may be conducive to termite activity should be carried out as soon as possible and arrange re inspection to minimize the risk of termite attack.
