Building and Timber Pest Inspection Report

Inspection Date: Thu, 26 Mar 2026

Property Address: 6 Bournemouth St, Bundeena NSW 2230,
Australia

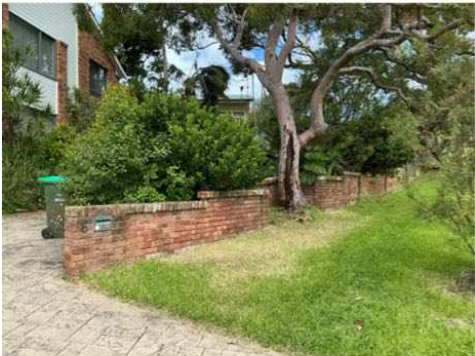
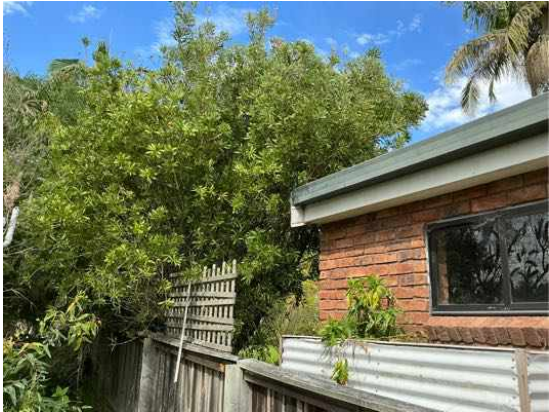
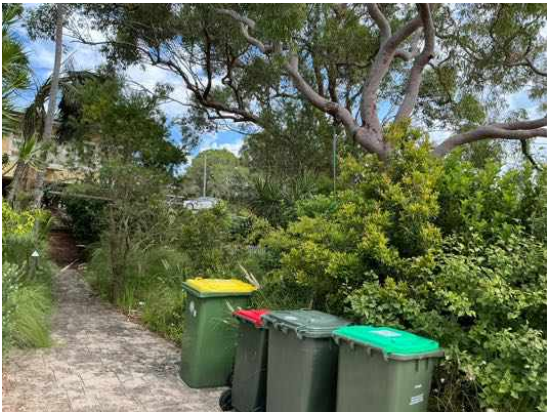
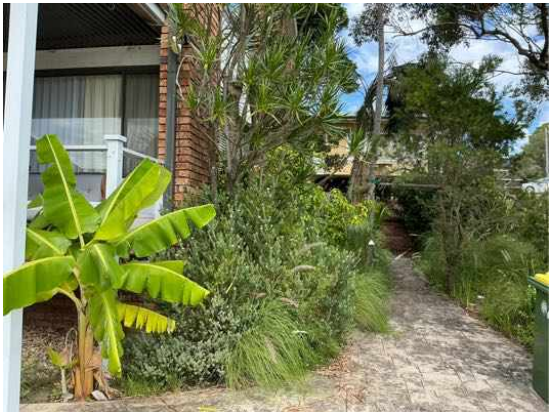
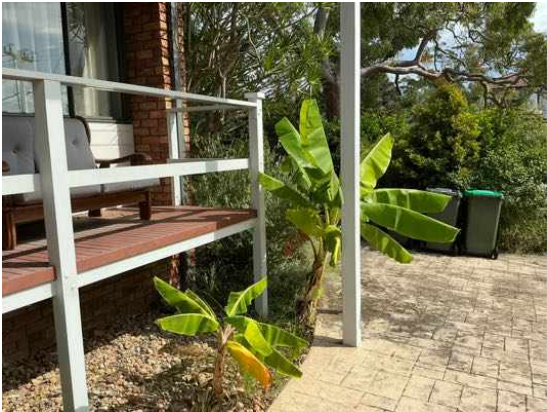
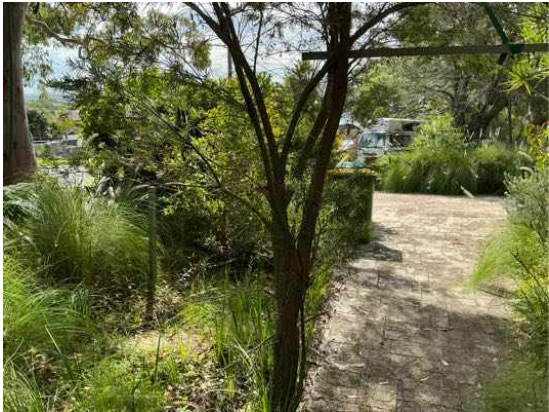
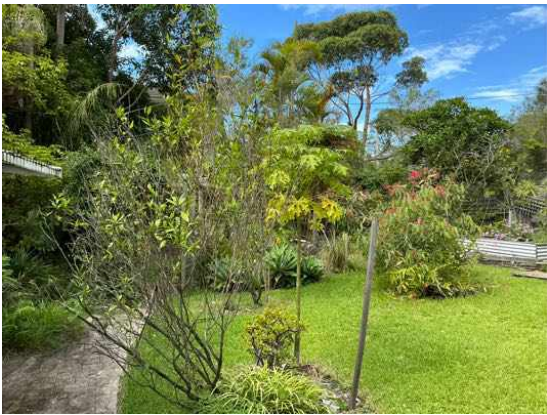
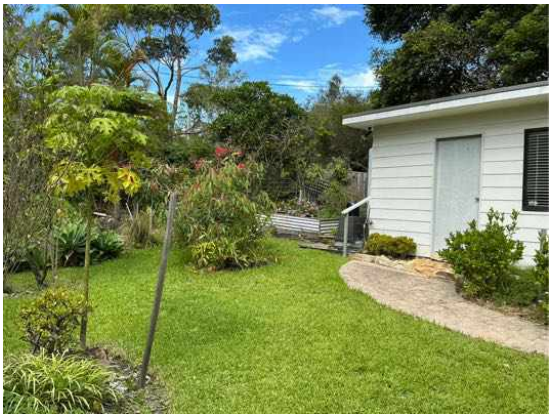
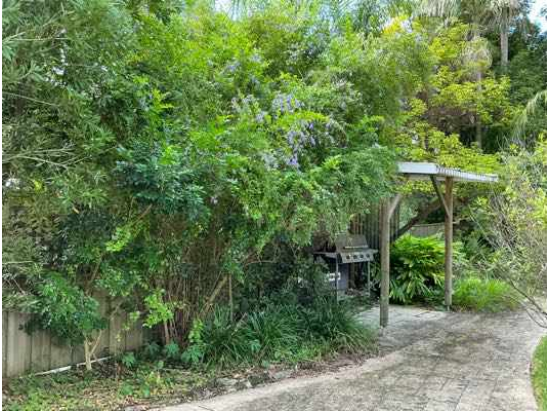
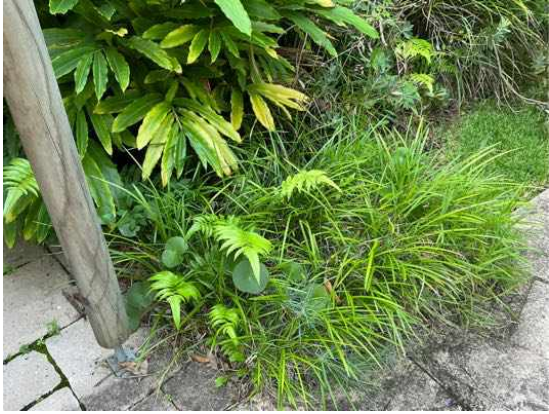
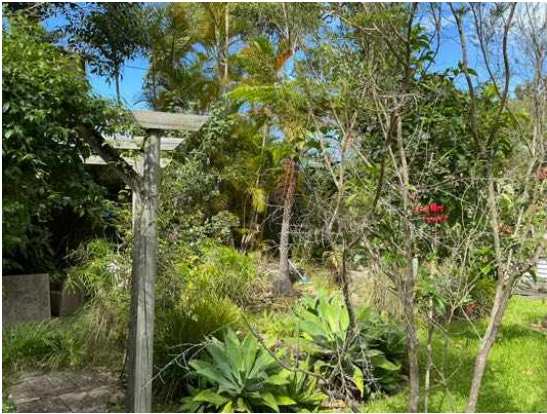
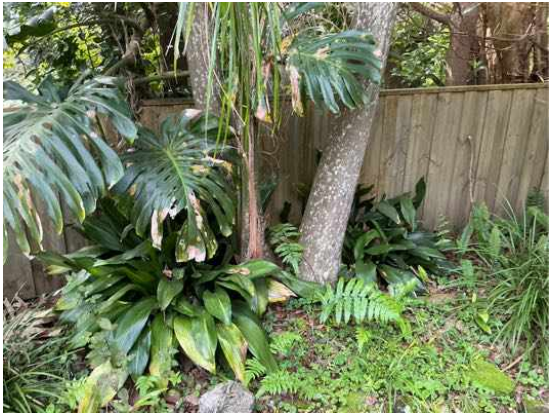
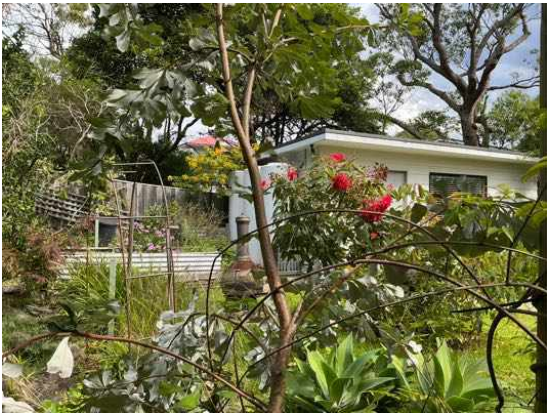
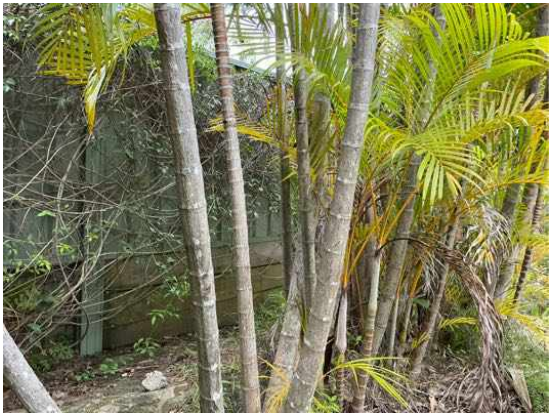
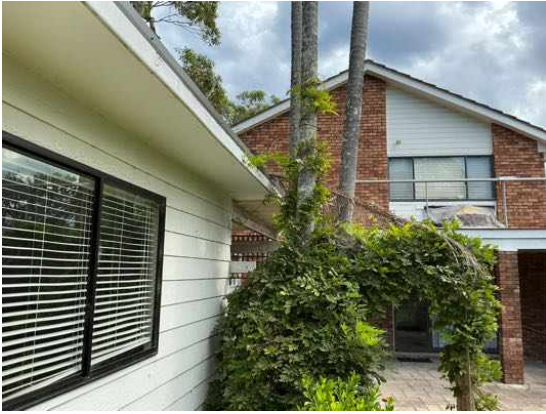
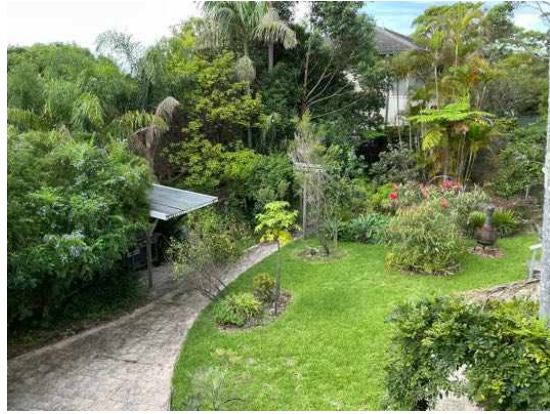
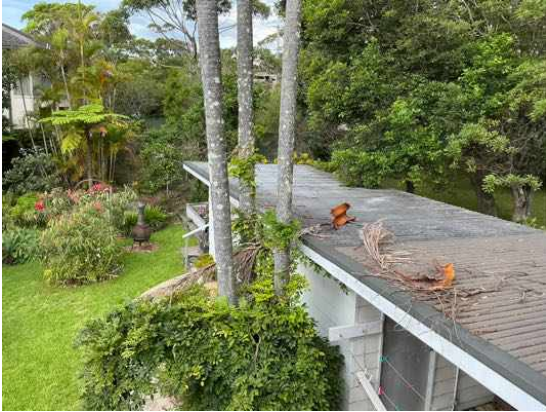
Finding 6.07

Building: Main Building
Location: All Areas
Finding: Trees to be inspected within the property.
Information: Trees can be conducive to termite activity and nesting. Trees over 100mm on the property, should be drilled and tested for termite activity.

Regular inspections every 6-12 months- or advised by the termite management system installer.

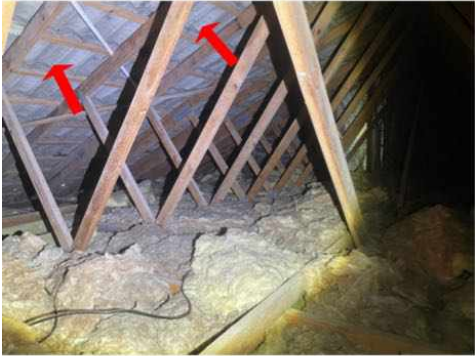
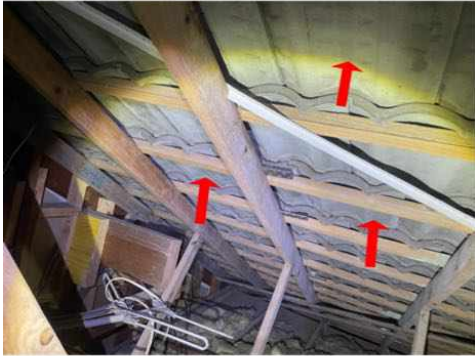
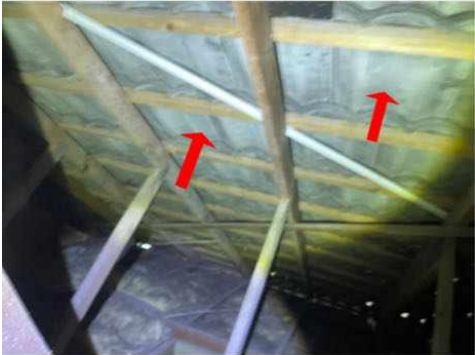
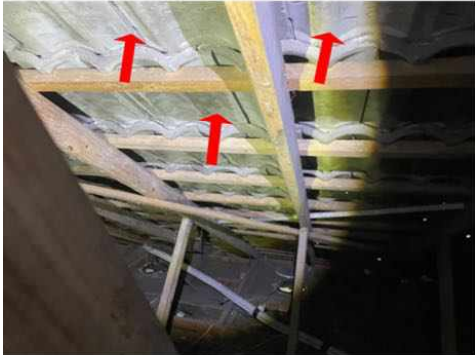
Noted Item

Building: Main Building
 Location: Roof Void
 Finding: Insulation - Missing
 Information: Upon inspection of the roof void it was noted that insulation is not present.

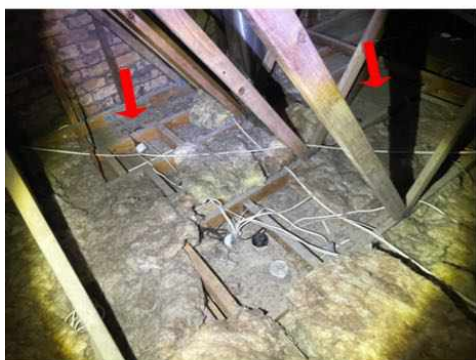
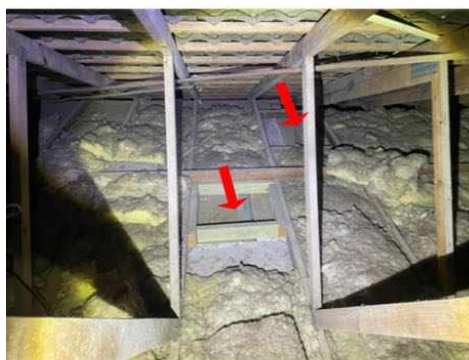
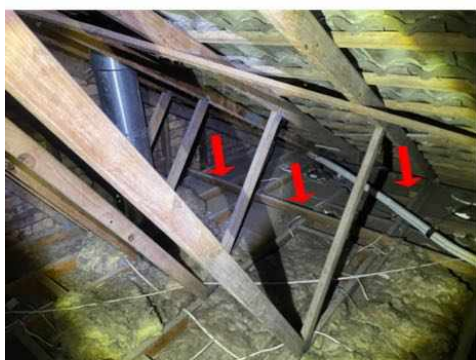
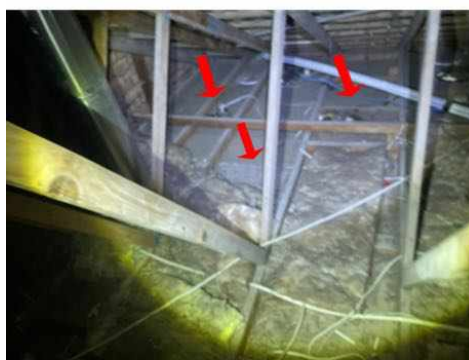
Insufficient insulation will result in a comparatively higher cost to heat and cool a property as there is a lack of Insulation (or uneven coverage of insulation) which works as a barrier to heat transfer. This helps to keep out unwanted heat in summer and preserves warmth inside your home in winter. It can also help soundproof your home from unwanted airborne noise transfer.

Where insulation is absent, the area does not meet current Australian Standards. Installation of adequate insulation is required and should be conducted as soon as possible.

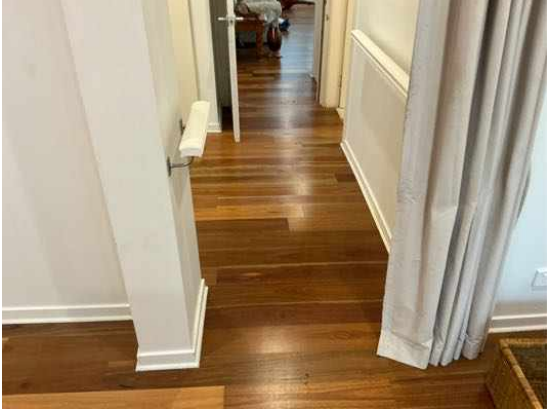
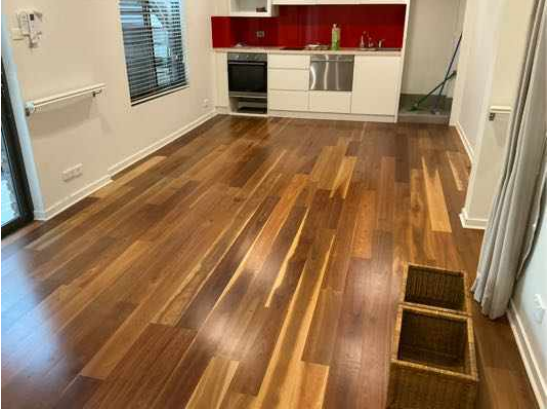
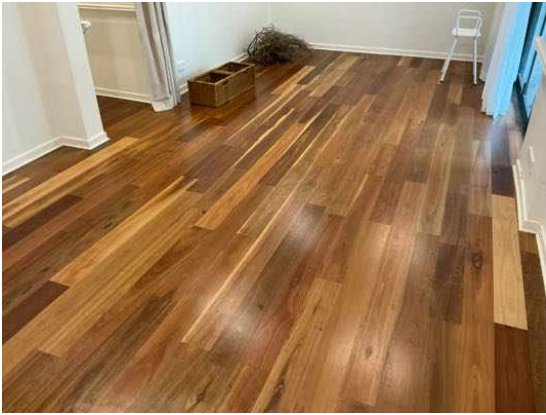
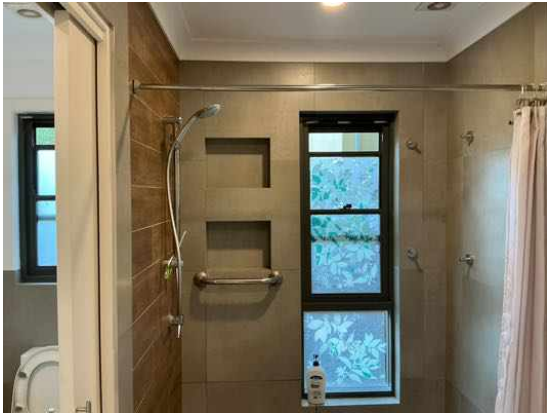
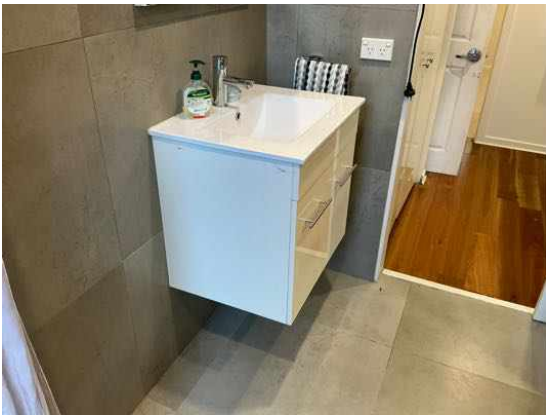
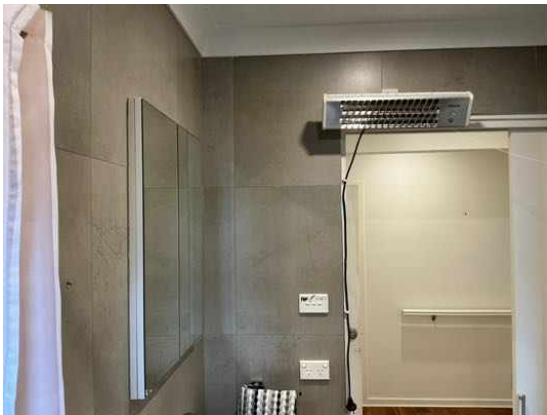
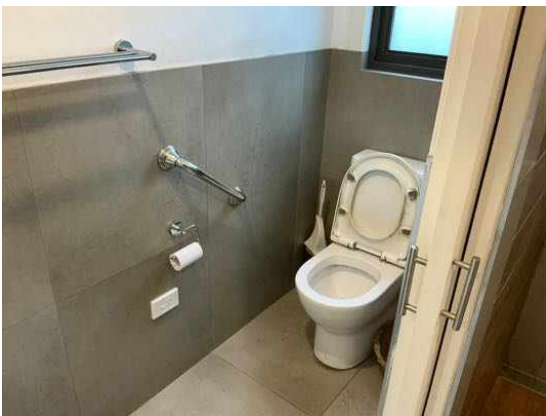
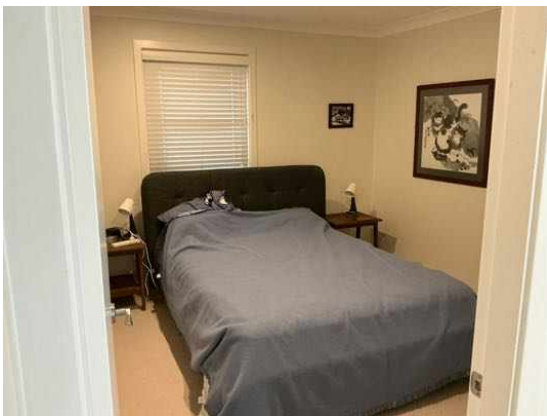
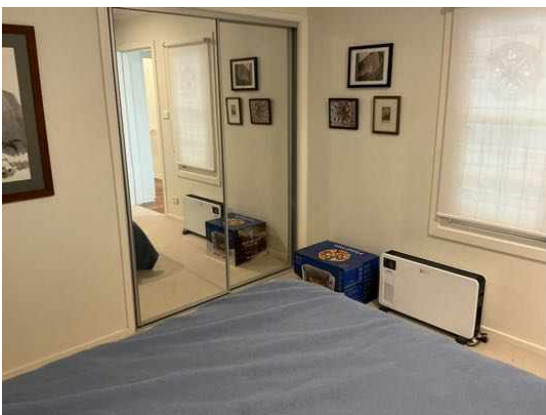
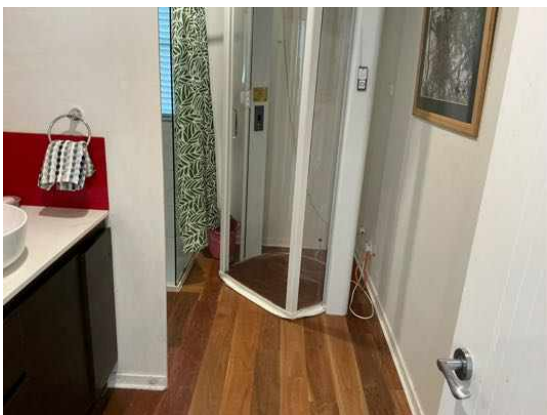
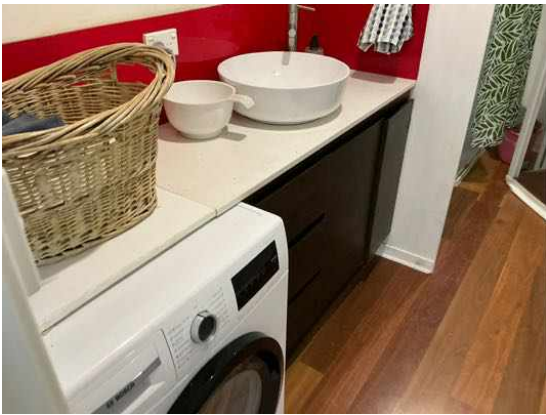
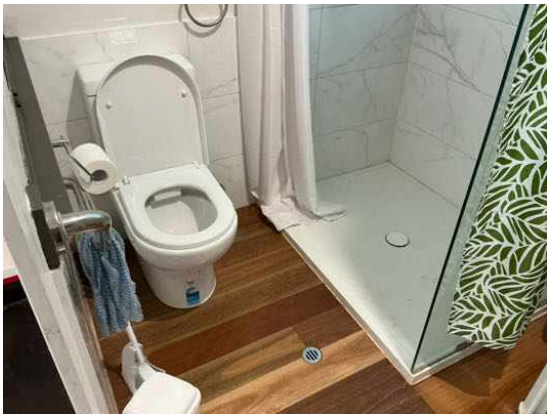
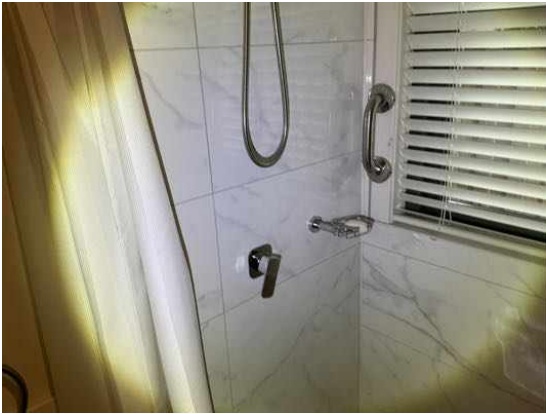
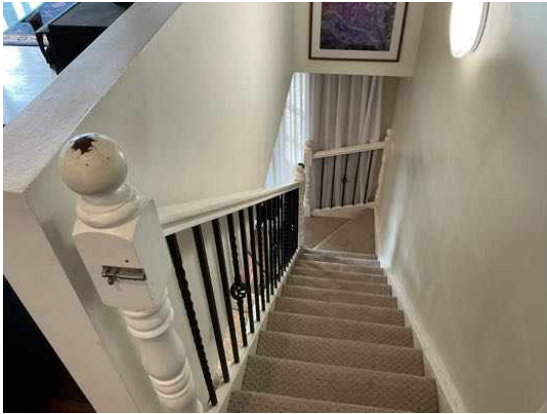
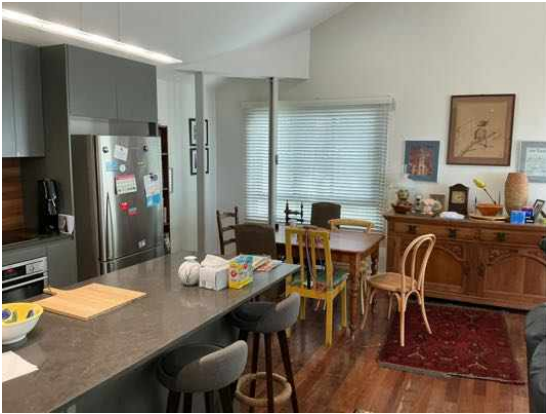
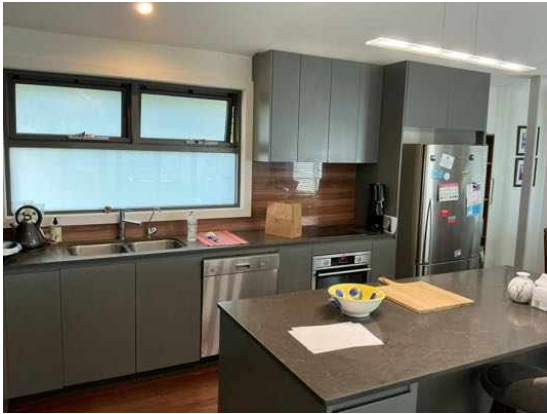
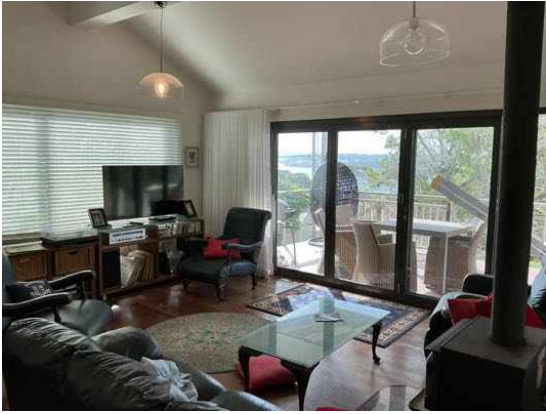
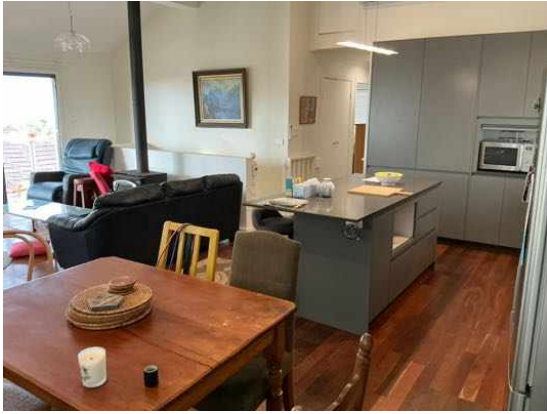
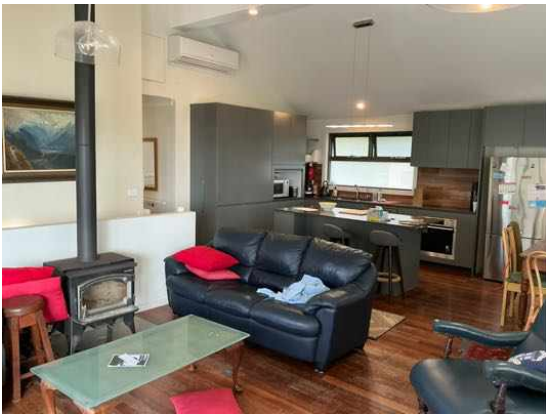
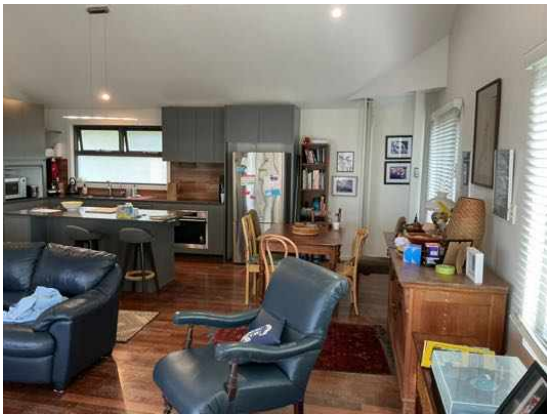
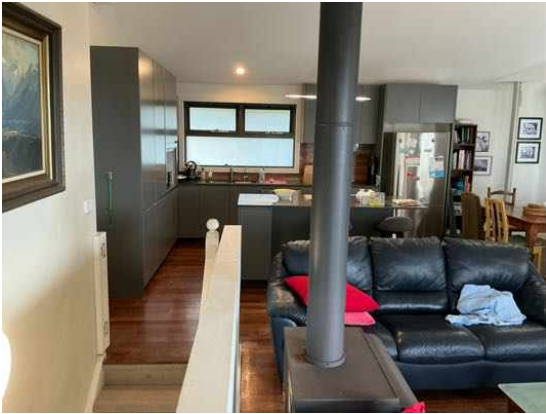
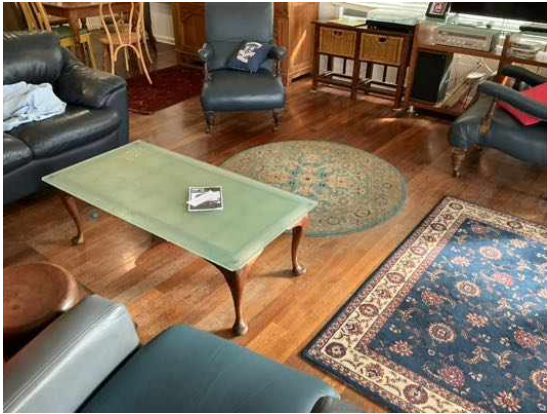
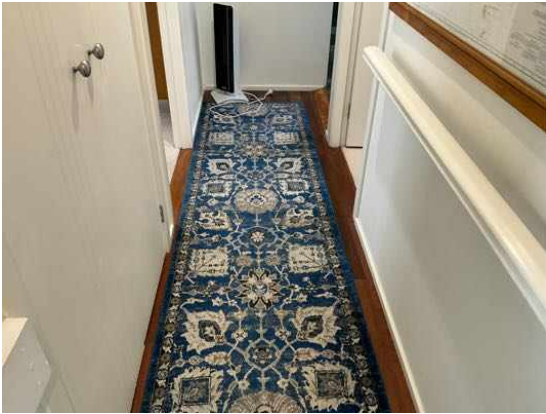
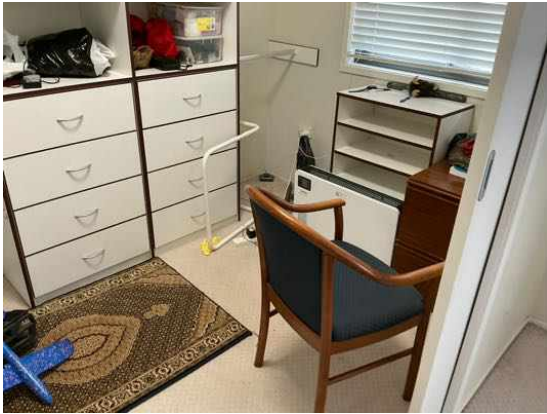
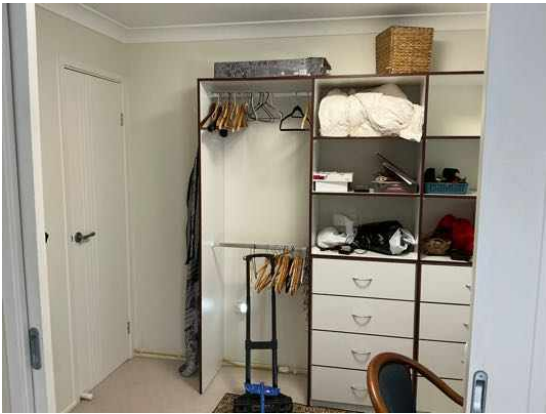
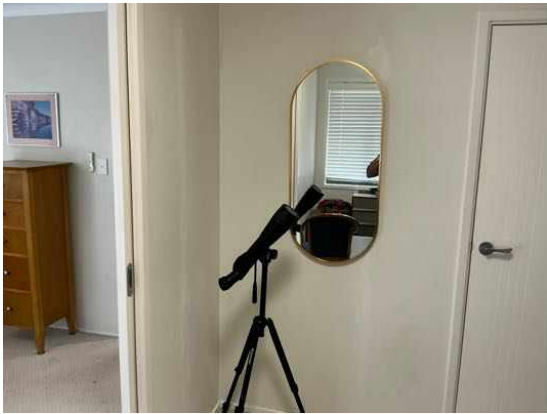
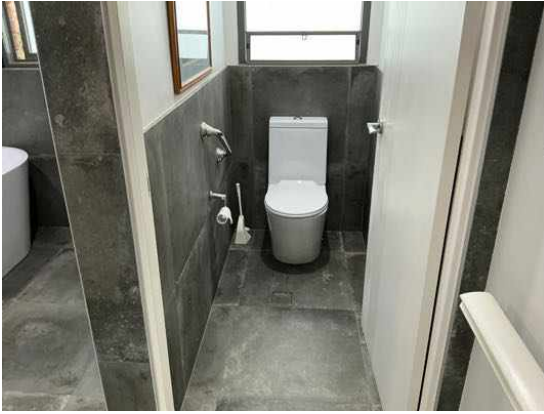
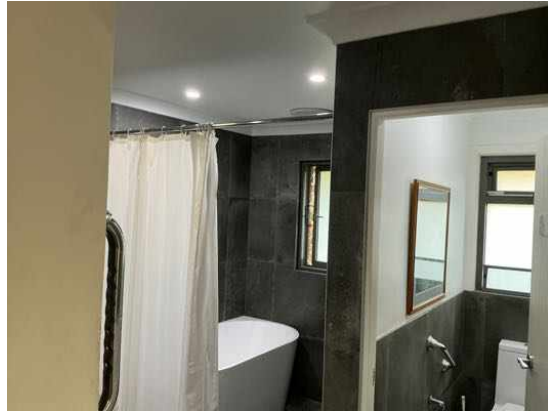
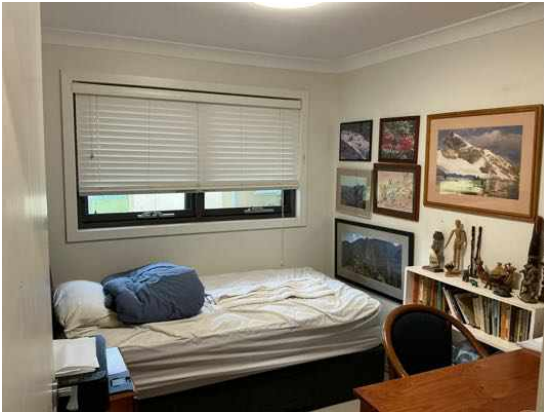
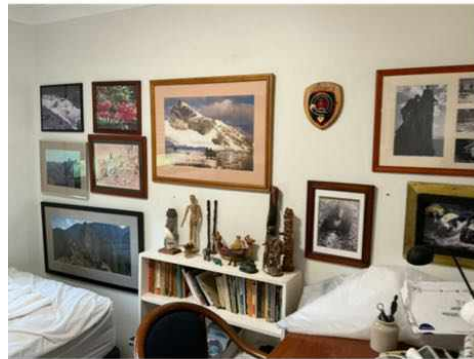
Noted Item

Building: Main Building
 Location: All Areas-internal
 Finding: Additional Photos - Obstructions and Limitations
 Information: These photographs are an indication of the obstructions and limitations which impeded full inspection of the property at the time of inspection. These obstructions can hide an array of defects and should be removed to allow full inspection to be

carried out. A re-inspection is recommended once the areas are made accessible.

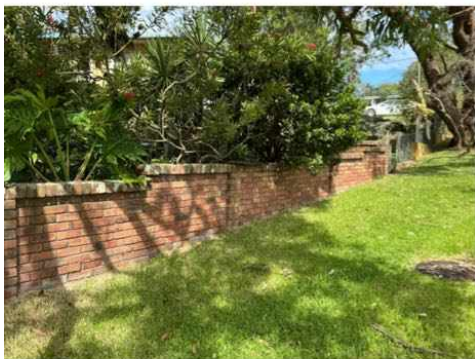
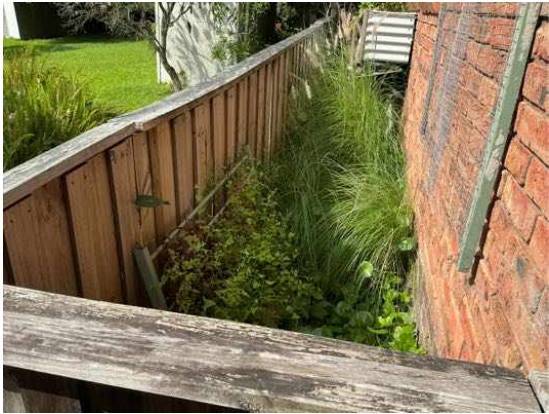
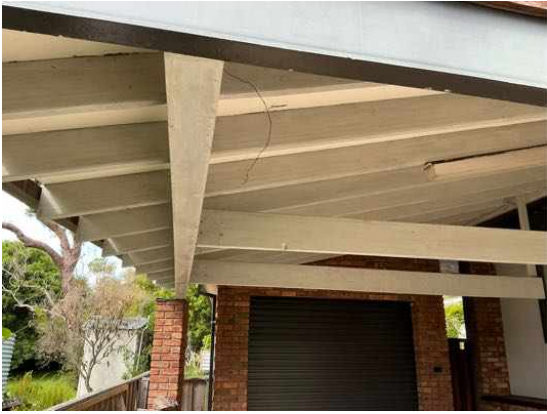
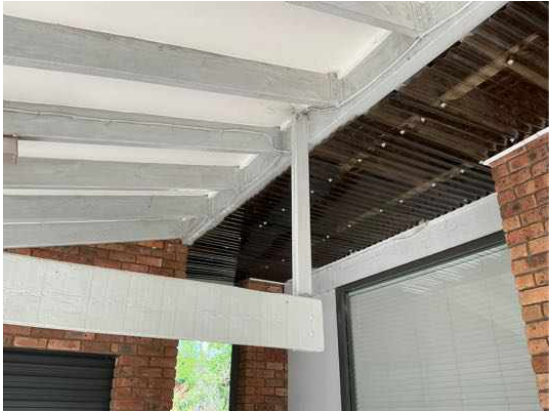
Noted Item

Building: Main Building
 Location: All Areas- external areas
 Finding: Additional Photos - Obstructions and Limitations
 Information: These photographs are an indication of the obstructions and limitations which impeded full inspection of the property at the time of inspection. These obstructions can hide an array of defects and should be removed to allow full inspection to be carried out. A re-inspection is recommended once the areas are made accessible.

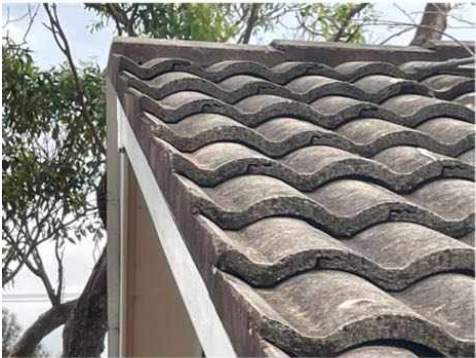
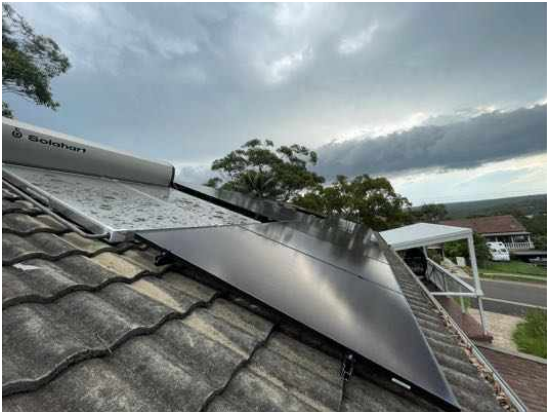
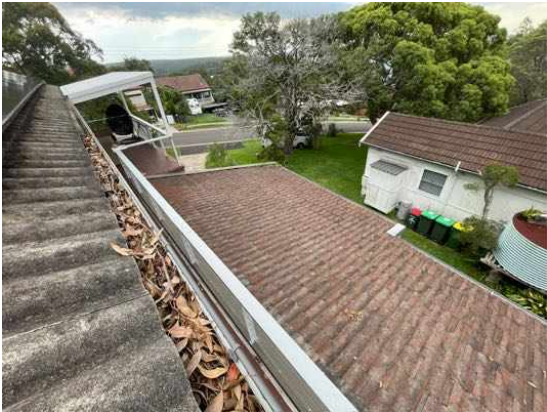
Building: Main Building
Location: Roof Exterior
Finding: Additional Photos - Obstructions and Limitations
Information: These photographs are an indication of the obstructions and limitations which impeded full inspection of the property at the time of inspection. These obstructions can hide an array of defects and should be removed to allow full inspection to be carried out. A re-inspection is recommended once the areas are made accessible.

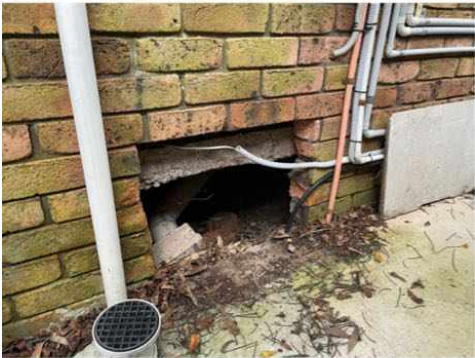
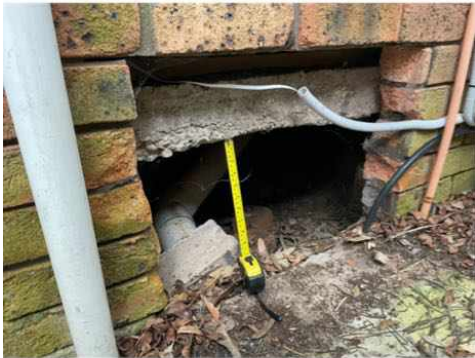
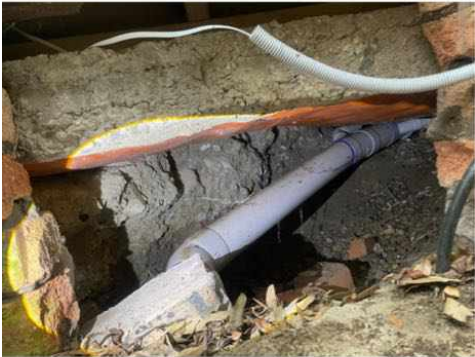
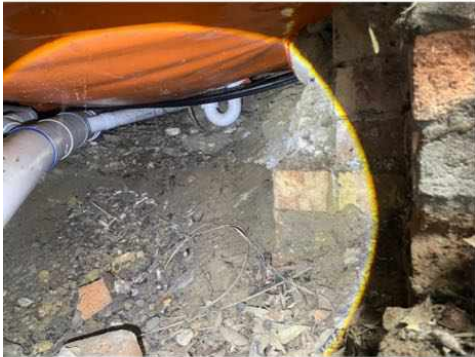
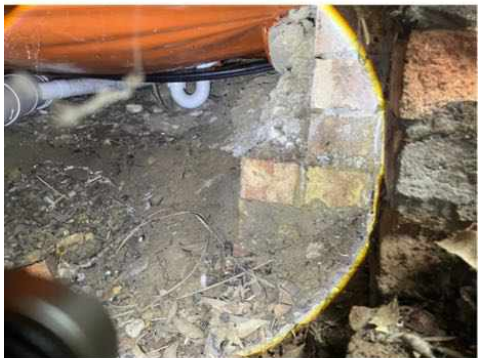
Building: Main Building
Location: Subfloor
Finding: Additional Photos - Obstructions and Limitations
Information: These photographs are an indication of the obstructions and limitations which impeded full inspection of the property at the time of inspection. These obstructions can hide an array of defects and should be removed to allow full inspection to be carried out. A re-inspection is recommended once the areas are made accessible.

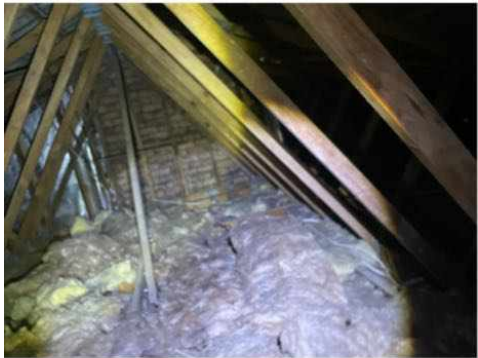
Building: Main Building
Location: Roof Void
Finding: Additional Photos - Obstructions and Limitations
Information: These photographs are an indication of the obstructions and limitations which impeded full inspection of the property at the time of inspection. These obstructions can hide an array of defects and should be removed to allow full inspection to be carried out. A re-inspection is recommended once the areas are made accessible.
