Building and Timber Pest Inspection Report

Inspection Date: Tue, 7 Apr 2026

Property Address: 111 Village Circuit, Gregory Hills NSW 2557

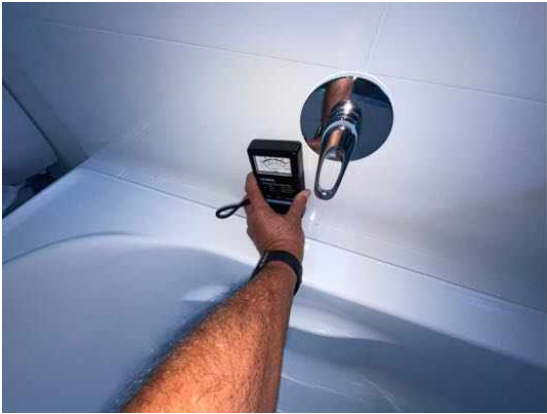
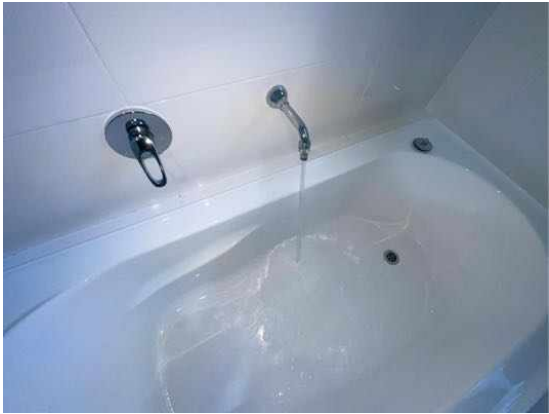
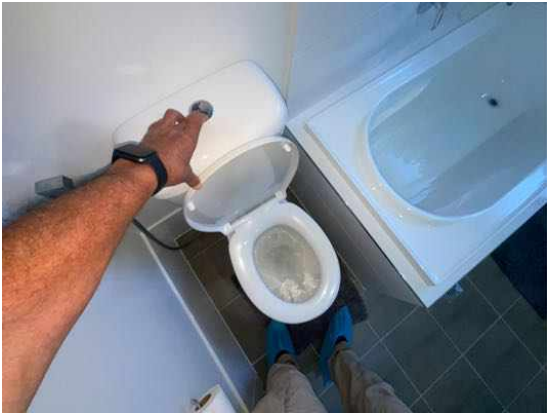
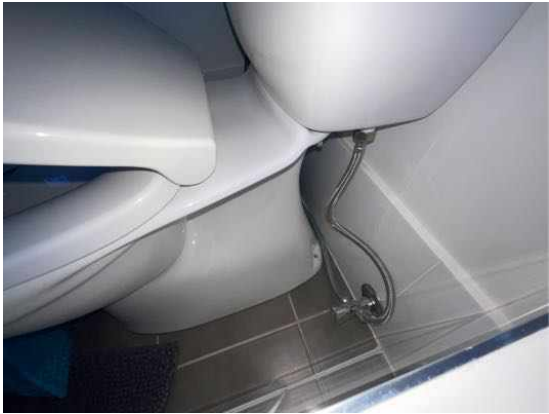
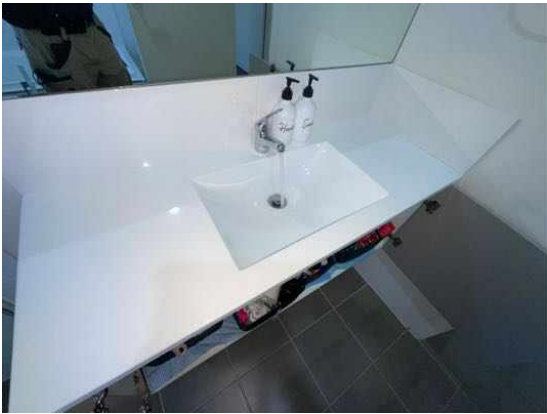
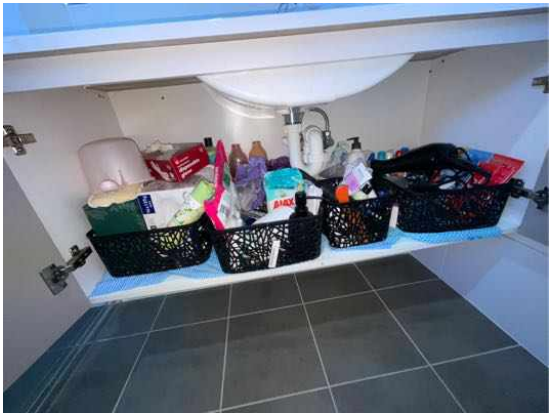
Noted Item

Building: Main Building
Location: Ensuite
Finding: Wet Areas - Bathroom(s) - Overall Condition & Recommendations.
Information: Overall Condition & Recommendations

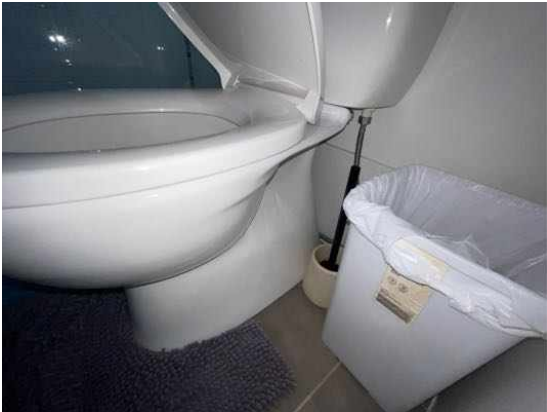
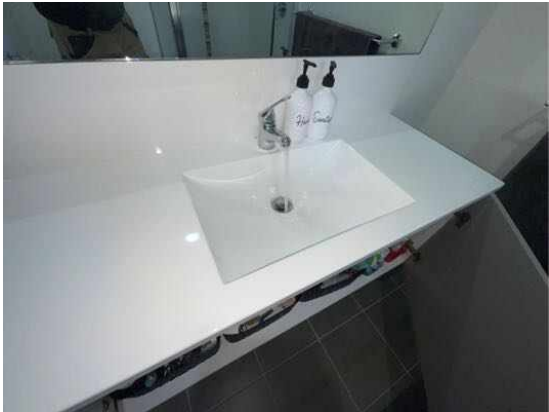
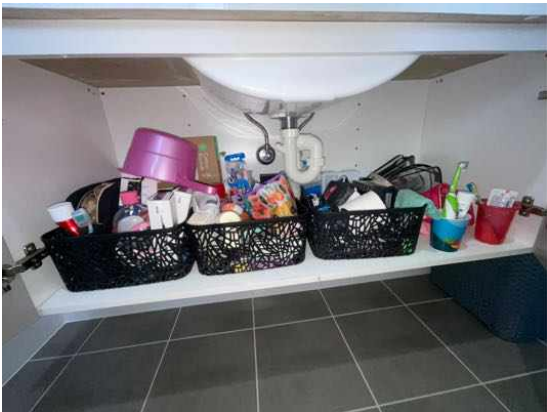
Noted Item

Building: Main Building
 Location: All Areas
 Finding: Water Pressure – Observation Only.
 Information: During the inspection, water pressure appeared to be within a normal operating range based on a basic functional check. However, this observation was made without the use of pressure testing equipment and does not constitute an assessment by a licensed plumber.
