# Building and Timber Pest Inspection Report

Inspection Date: Fri, 6 Mar 2026

Property Address: 162/8 Starling St, Buderim QLD 4556,  
Australia

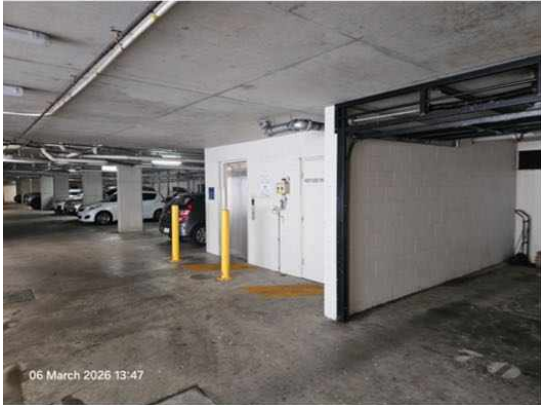
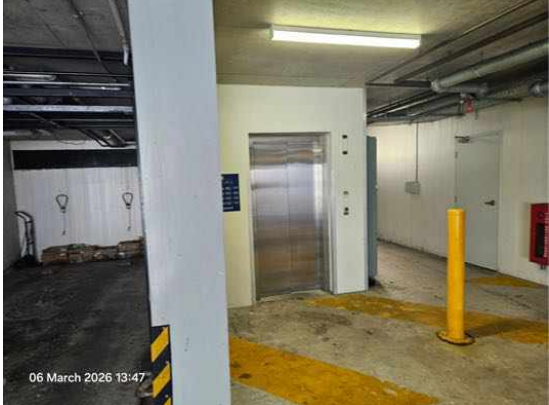
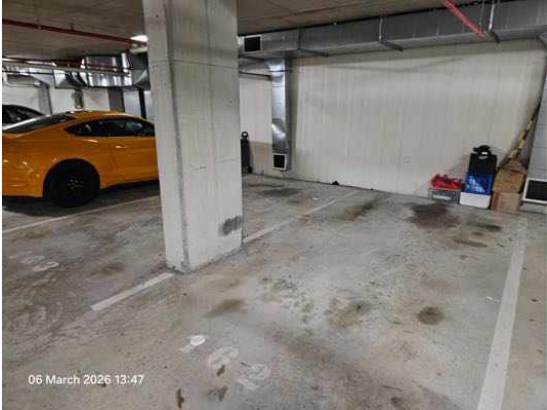
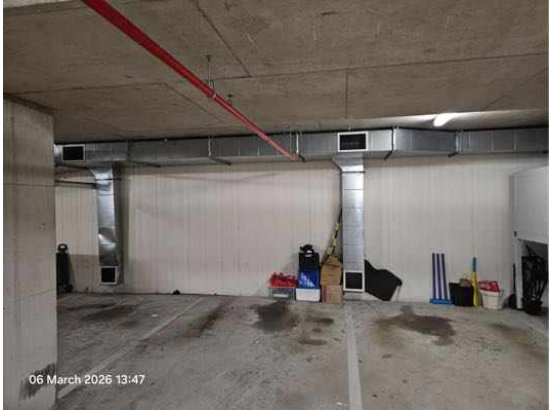
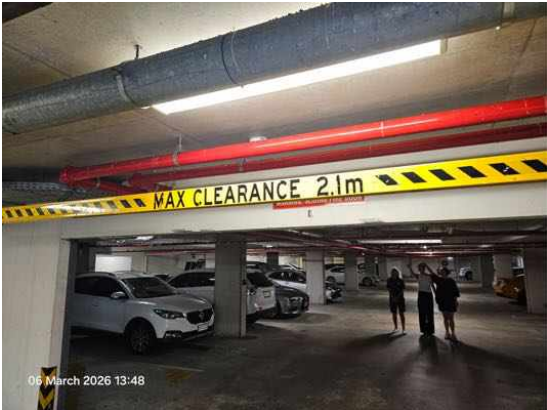
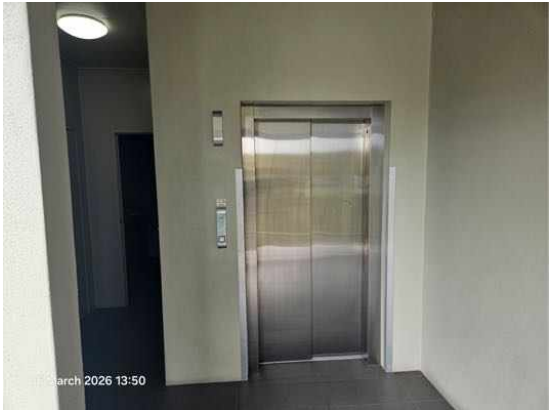
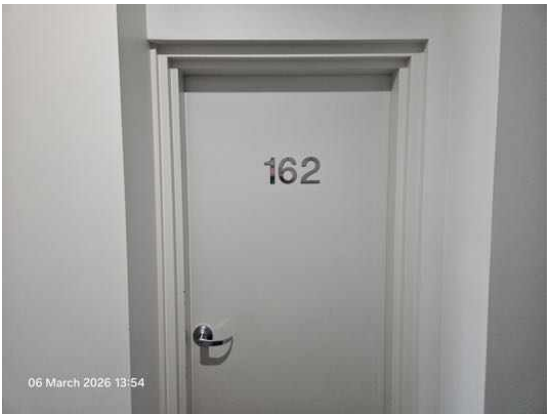
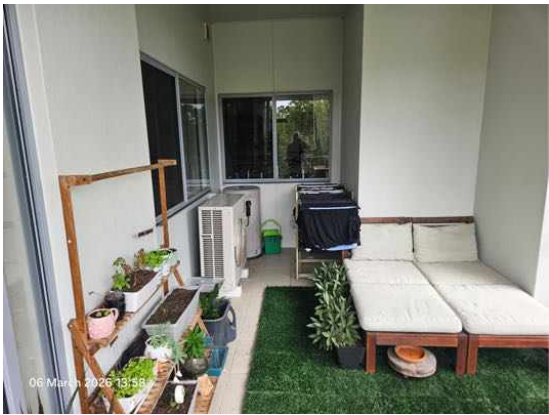
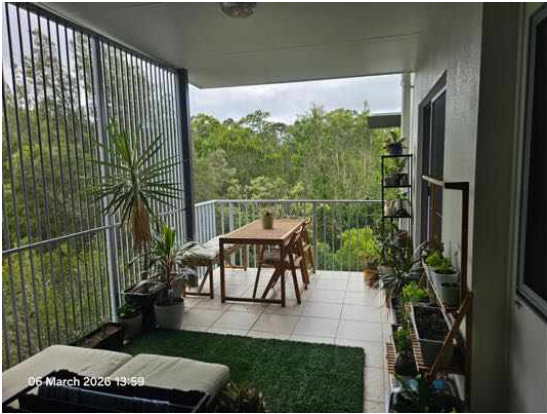
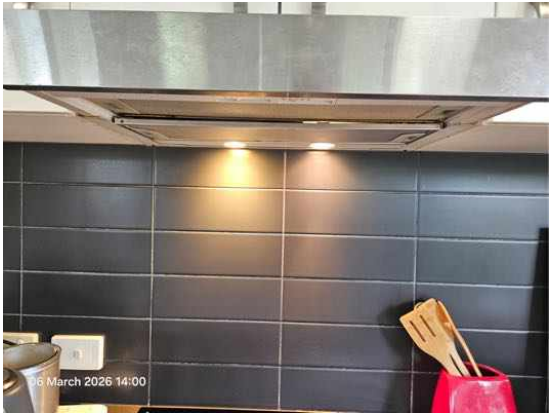
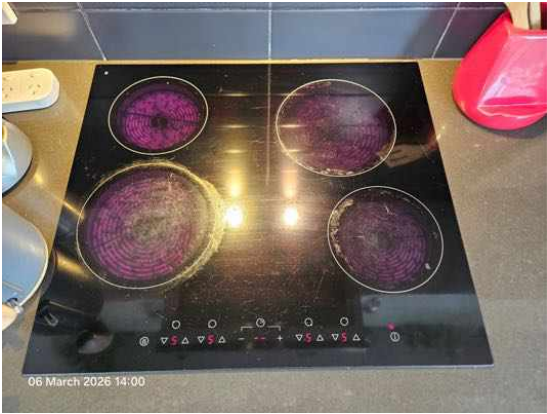
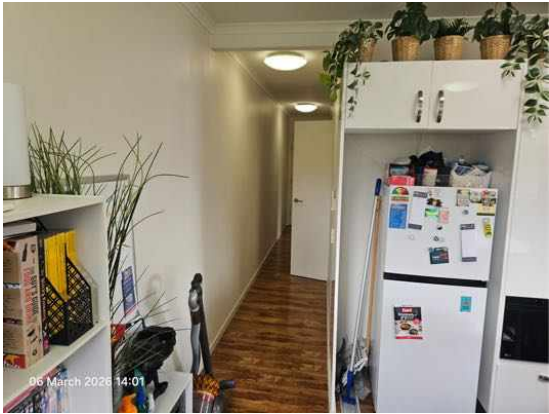
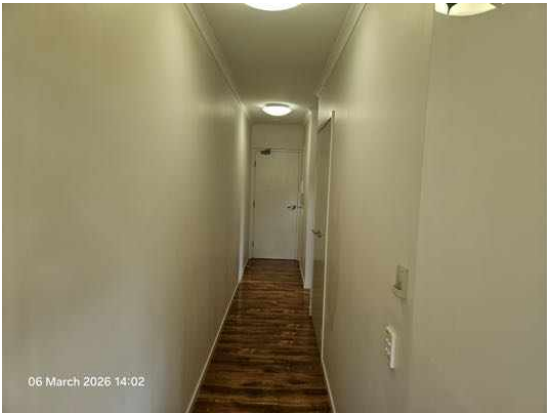
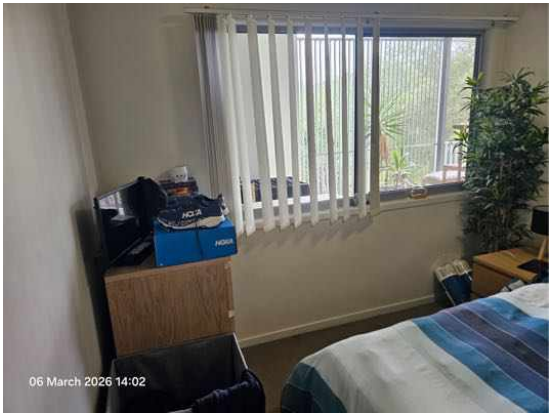
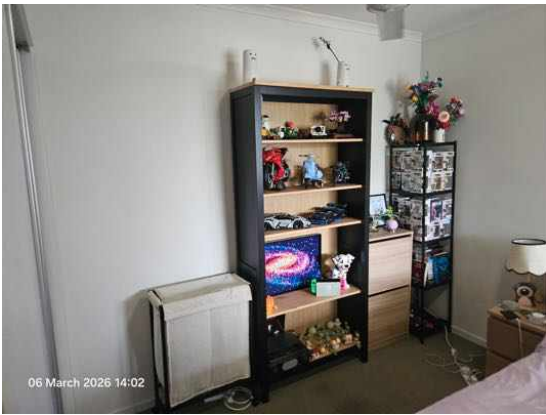
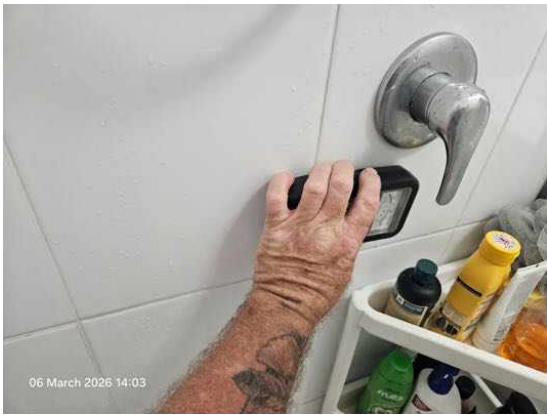
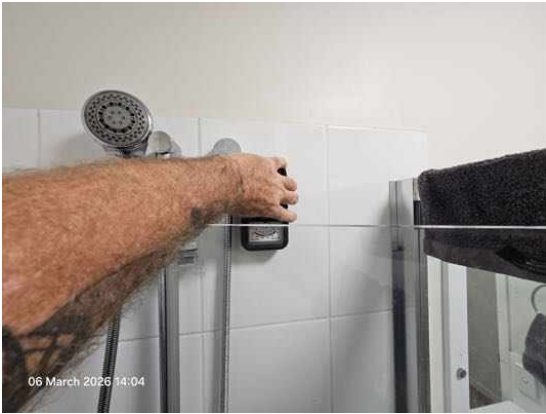
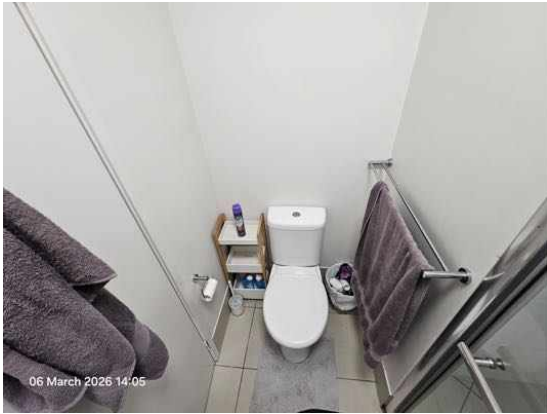
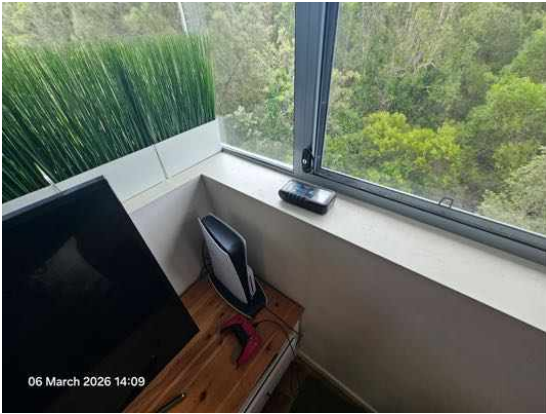
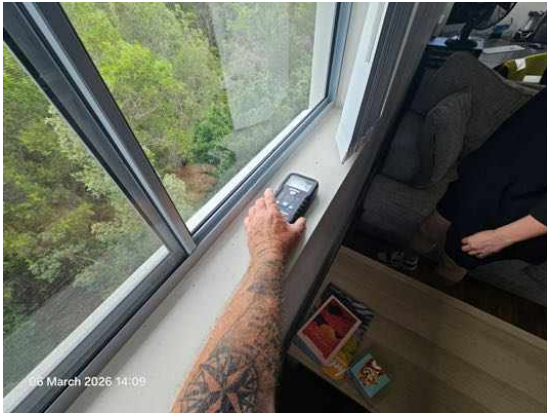
Noted Item

Building: Main Building  
Location: All Areas  
Finding: Additional Photos for client reference  
Information: Additional photos are provided for your general reference.
