Building Inspection Report VR

Inspection Date: Sun, 8 Mar 2026

Property Address: 5 Courtley Ave, Kellyville Ridge NSW 2155,
Australia

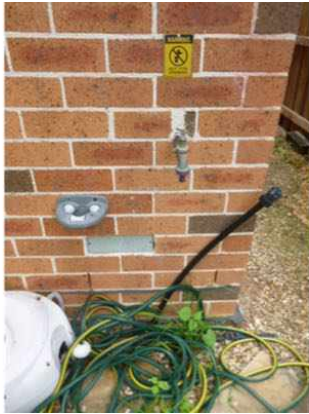
Building:	Main Building
Location:	Meter Box
Finding:	Termite Management System - Evidence of installation
Information:	<p>There are a number of factors which indicate the presence of a previously installed or applied termite barrier. The most common are a durable notice (to the inside of your meter box) observable physical barriers installed to building perimeter and in ground reticulation systems. Where a Termite Management System has been identified you should refer to the type of barrier date of installation warranty conditions and any documentation provided by a builder or past owner. Consult the company who installed the barrier to confirm whether the system is still under warranty.</p> <p>Most chemical termite management systems expire and require replenishment and all physical systems are primarily designed to prevent concealed entry. The client may consider gaining further advice from a pest controller as to the costs and procedures involved with this application. It is recommended that obtaining such advice be a short-term priority.</p>

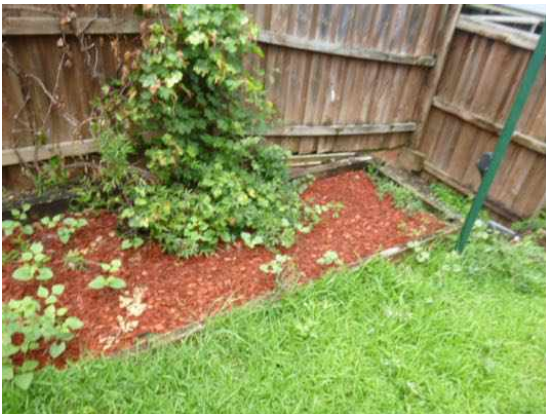
Building:	Main Building
Location:	All External Areas
Finding:	Landscaping Timber
Information:	There is no evidence of termite damage in these timber.

Any timbers in direct ground contact provide opportunity for concealed termite entry and are likely to be subject to premature rot and decay as the soil retains moisture or damp conditions against the timbers. Remove untreated timber that is in direct contact with external grounds. If there is old tree stumps present frequent pest inspections are advised to readily identify any termite activity in these areas. Monitor treated landscape timbers within the garden area, as treated pine breaks down and rots over a period of time causing conducive conditions for termite activity.

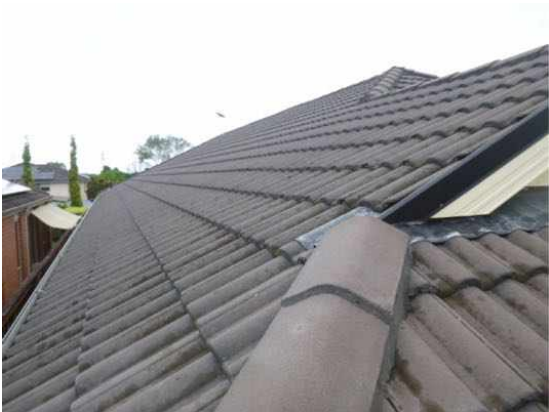
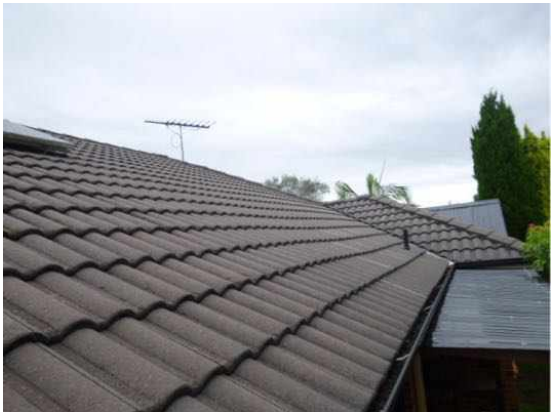
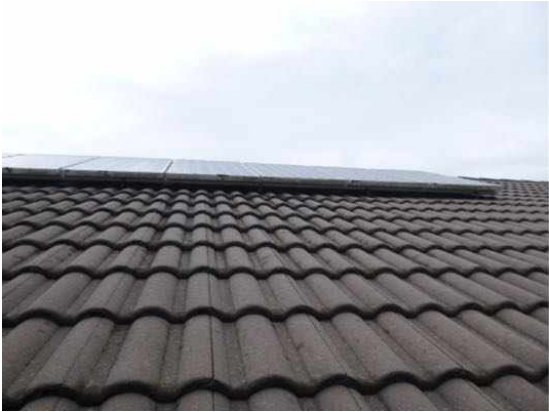
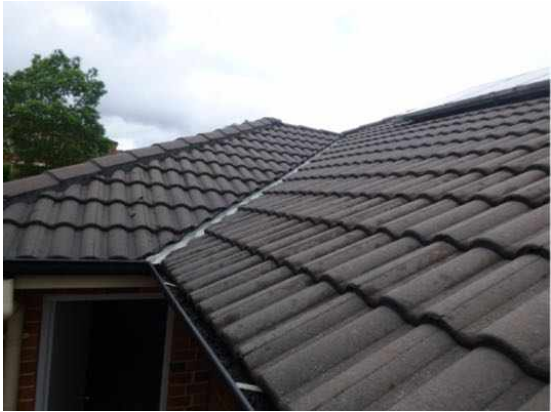
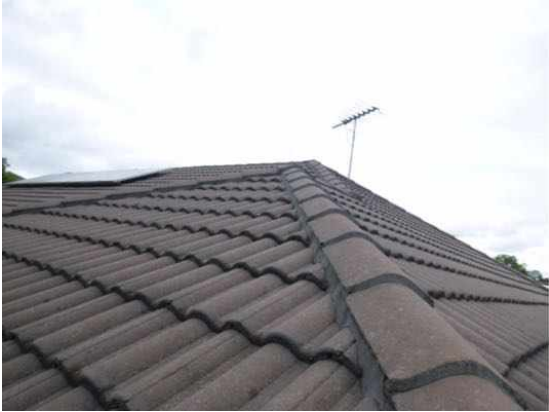
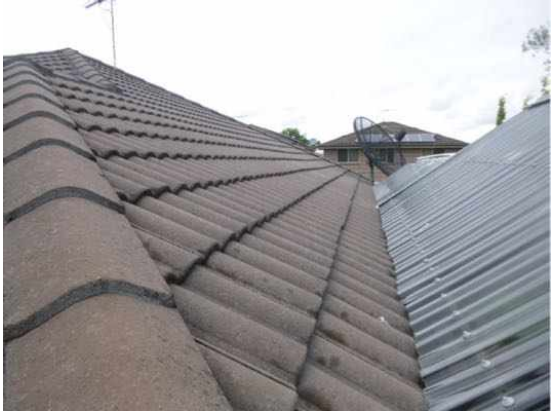
Building: Main Building
Location: Roof Exterior
Finding: Roof Tile - Good condition
Information: Upon inspection of the exterior and interior roofing, the majority of rood tiles were considered to be in a good condition. There is no leakages at the time of the inspection.

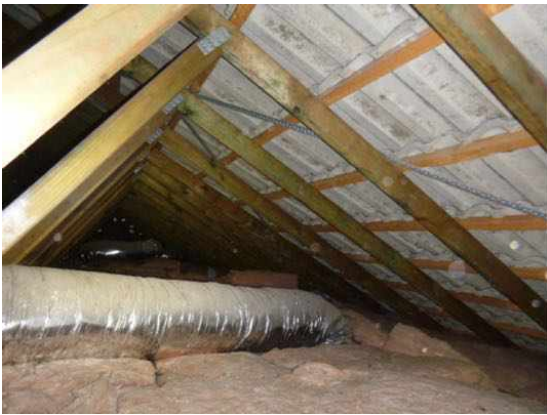
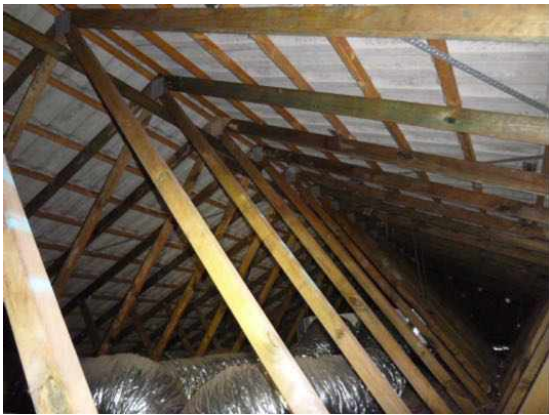
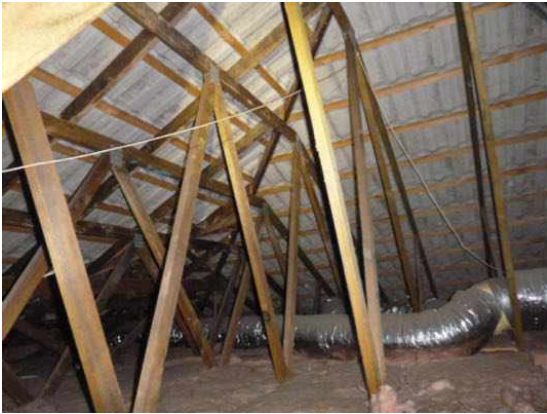
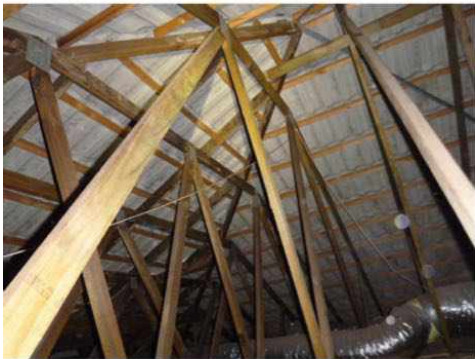
Building: Main Building
Location: Roof Void
Finding: Insulation - adequate
Information: Upon inspection of the roof void it was noted that there is adequate insulation. Insufficient insulation will result in a comparatively higher cost to heat and cool a property as there is adequate Insulation which works as a barrier to heat transfer. This helps to keep out unwanted heat in summer and preserves warmth inside your home in winter. It can also help soundproof your home from unwanted airborne noise transfer.

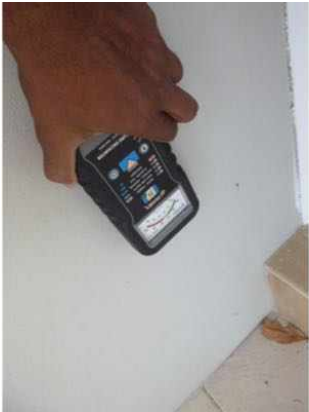
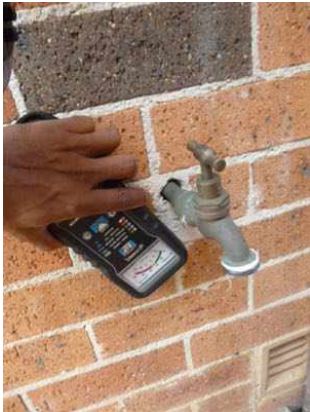
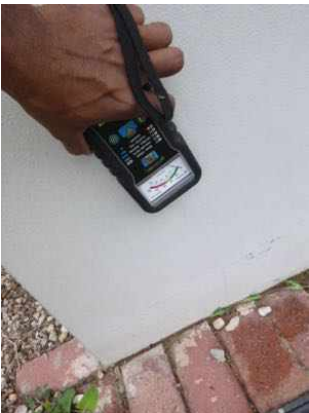
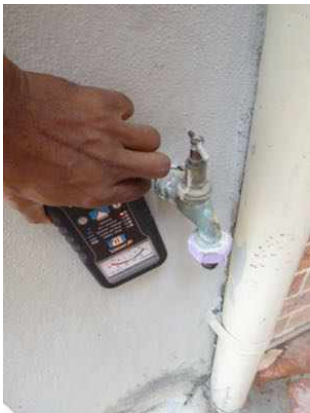
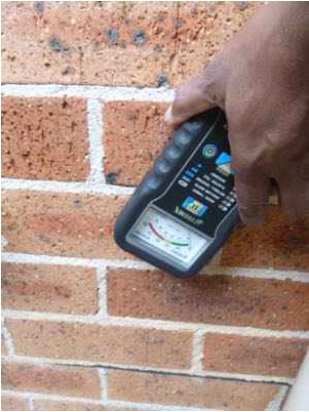
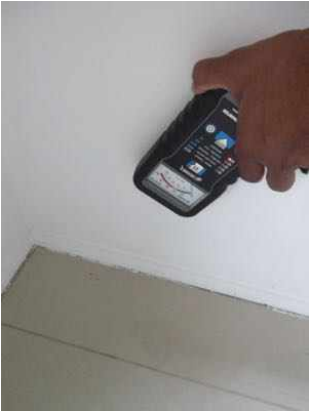
Building: Main Building
Location: All Areas
Finding: No Excessive Moisture
Information: All areas of the dwelling are checked with particular attention paid to wet areas which were closely assessed to check for excessive levels of moisture and temperature anomalies. No evidence of excessive moisture was found inside the house at the time of the inspection.

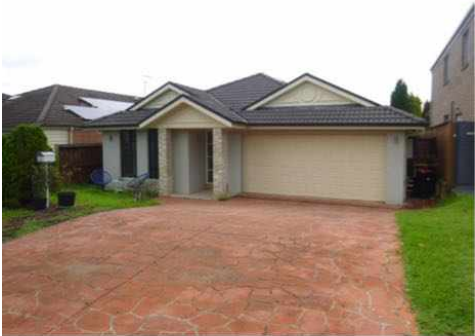
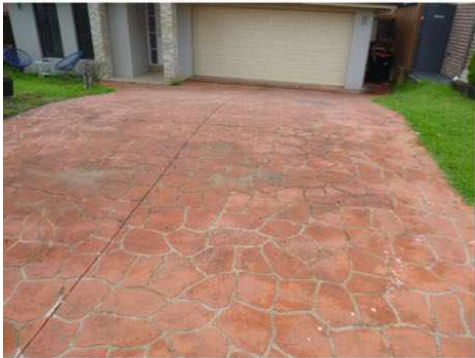
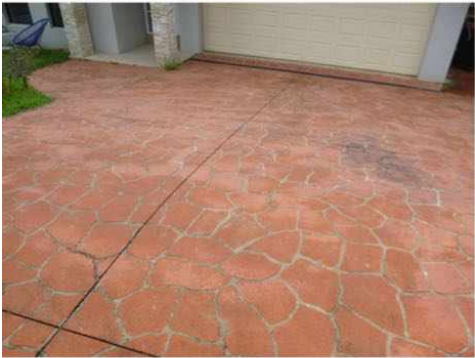
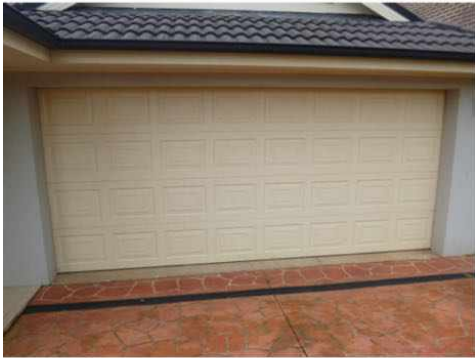
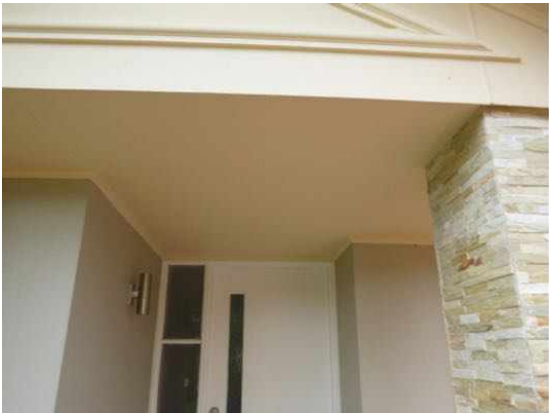
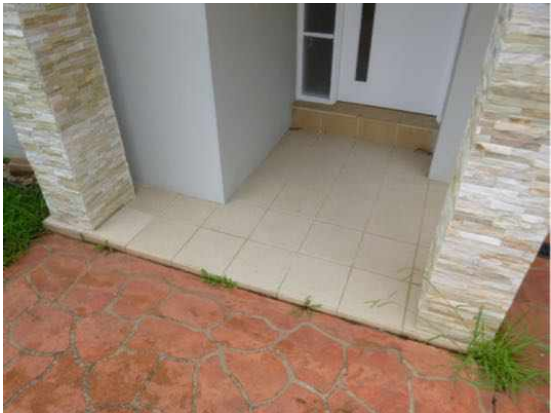
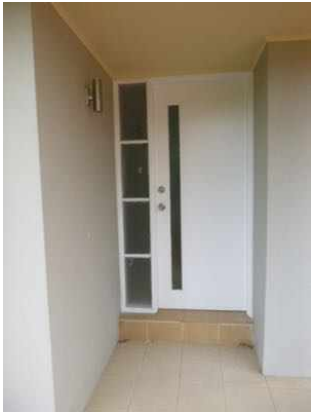
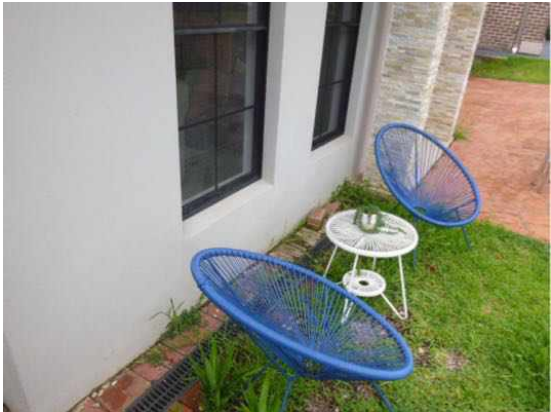
Building: Main Building
 Location: All Areas
 Finding: Additional Photos
 Information: Additional photos are provided for your general reference. Arrows have been included to highlight areas of importance. Please discuss these photos with your building consultant for clarification.
