Building Inspection Report

Inspection Date: Thu, 5 Mar 2026

Property Address: 10/ 548 Marine Parade, Biggera Waters
QLD

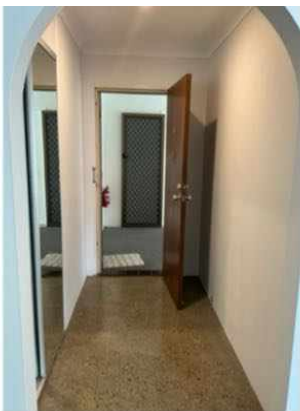
Defects 1.01

Building: Main Building
 Location: Entry > Front
 Finding: Door entry - Damaged
 Information: It was noted at the time of inspection that the entry door is damaged. This deterioration is suspected to have been caused by impact damage.

Replacement or repairs of the door is advised to ensure the protection and longevity of any associated building elements. Such works may be performed by a general handyman or qualified carpenter.

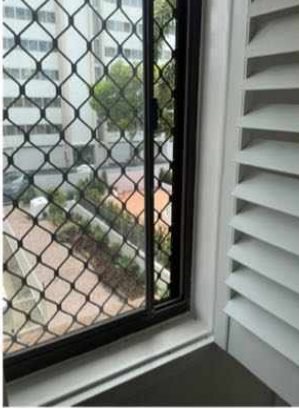
Defects 1.02

Building: Main Building
 Location: Kitchen > Front
 Finding: Window restrictors not installed.
 Information: At the time of inspection it was noted that windows to leisure room (first floor) does not have window restrictors installed.

Accordance with NCC volume1 clause d2.24 or NCC volume 2 clause 3.9.2.6 any window that has a fall of 2 meters or more should be restricted so that a sphere of 125mm (12.5cm) cannot pass through the opening at force of 250n or 25kg of force.

It recommended that restrictors be fitted before handover.

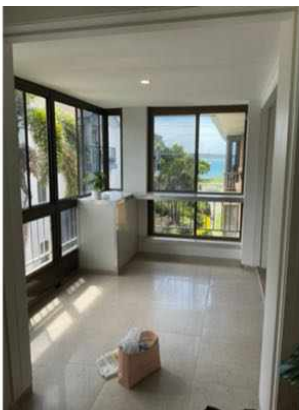
Defects 1.03

Information: At the time of inspection it was noted that windows to leisure room (first floor) does not have window restrictors installed.

Accordance with NCC volume1 clause d2.24 or NCC volume 2 clause 3.9.2.6 any window that has a fall of 2 meters or more should be restricted so that a sphere of 125mm (12.5cm) cannot pass through the opening at force of 250n or 25kg of force.

It recommended that restrictors be fitted before handover.

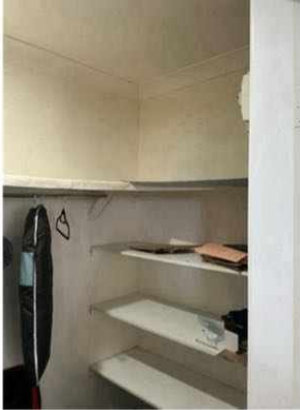
Defects 3.05

It is suspected that this defect has occurred due to minor issues with the associated hinges. Such damage is identified as general wear and tear, which is expected for building elements of this age.

A qualified carpenter or general handyperson may be appointed to perform rectification works as necessary, at client discretion. If left unattended, further functional impairment is likely to occur.

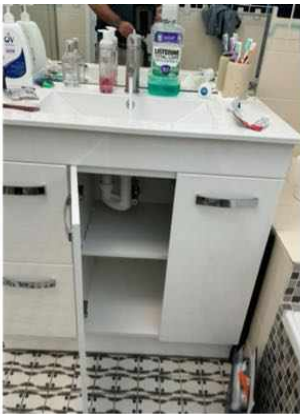
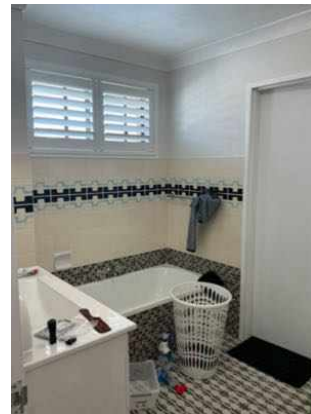
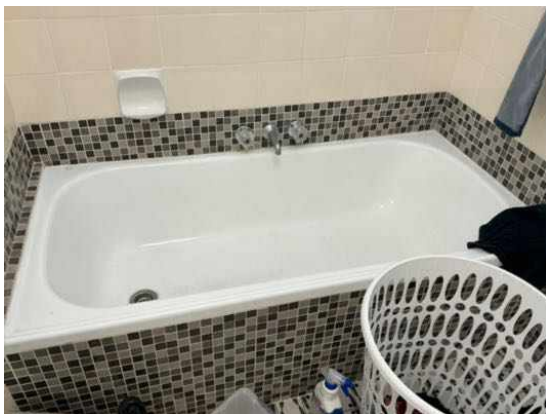
Building: Main Building
Location: Bathroom > Existing
Finding: Additional Photos
Information: Additional photos are provided for your general reference

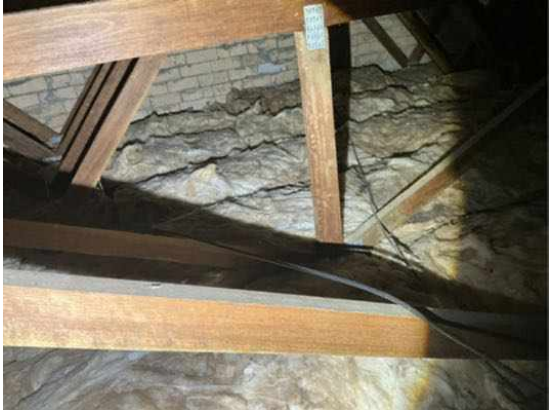
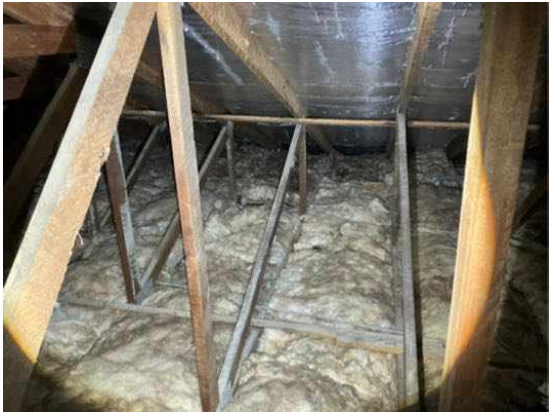
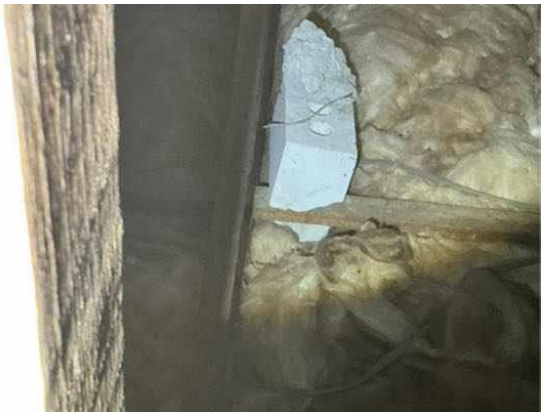
Building: Main Building
Location: Roof Void > Existing
Finding: Additional Photos
Information: Additional photos are provided for your general reference
