Building and Timber Pest Inspection Report

Inspection Date: Fri, 20 Feb 2026

Property Address: 12 Rosemary Cres, Bowral NSW 2576,
Australia

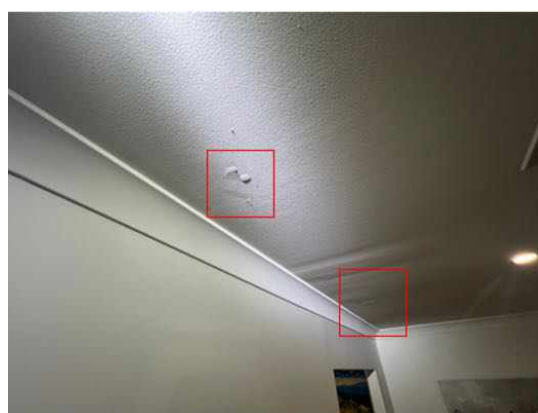
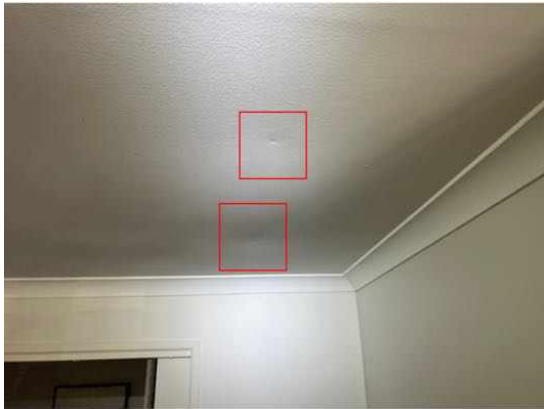
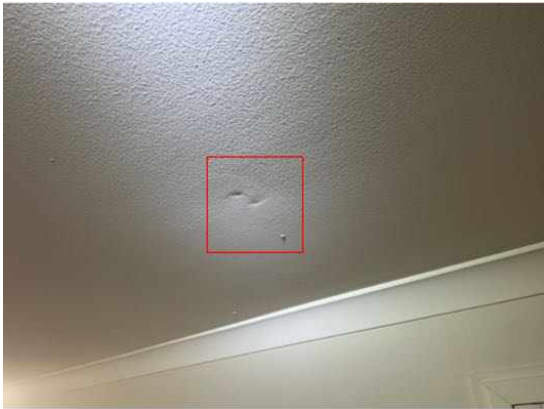
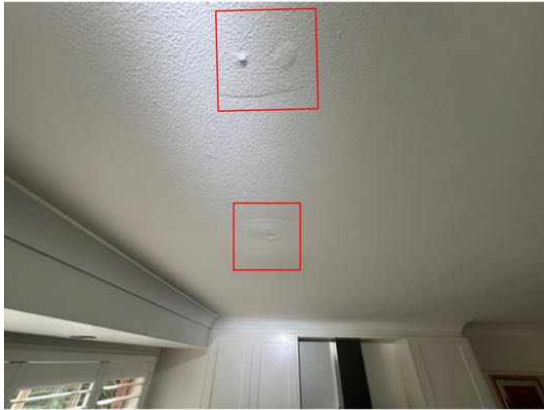
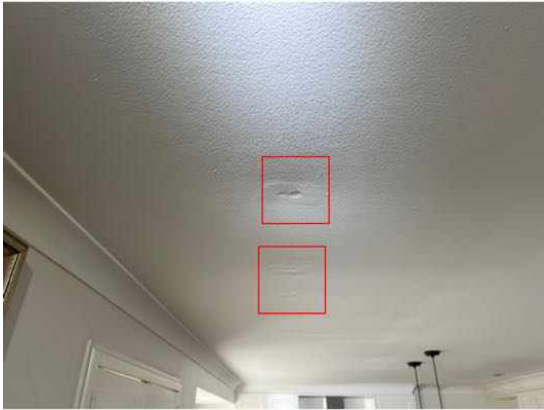
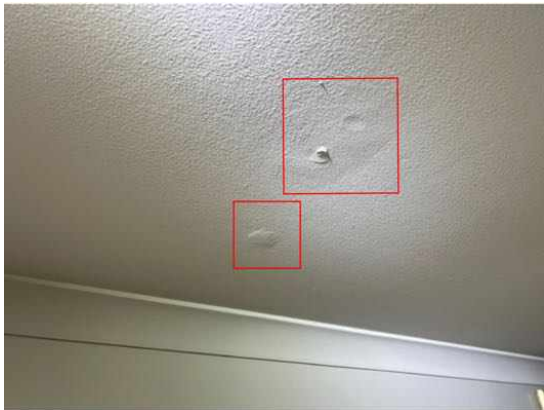
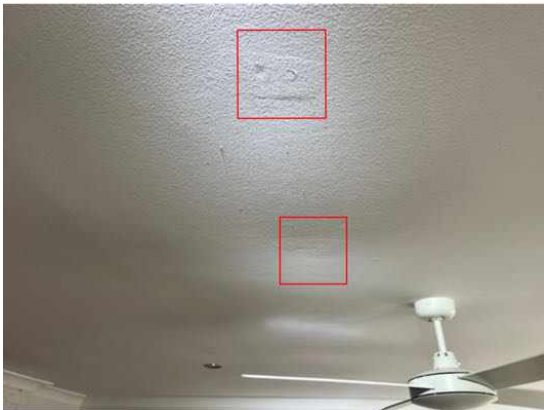
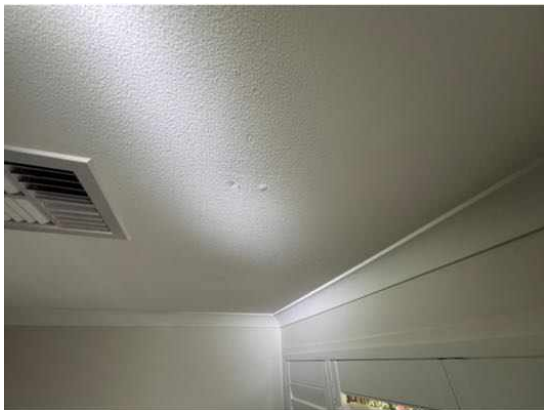
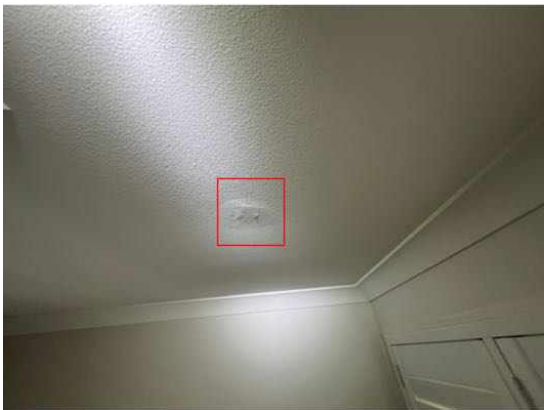
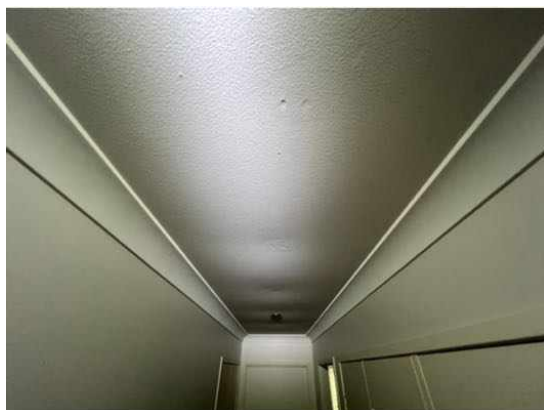
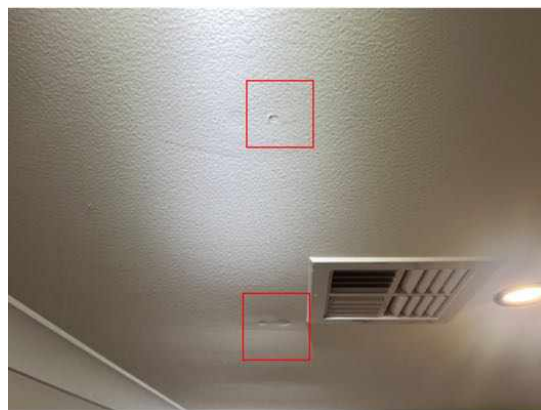
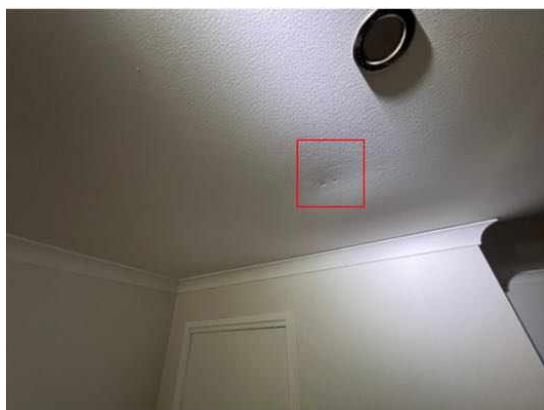
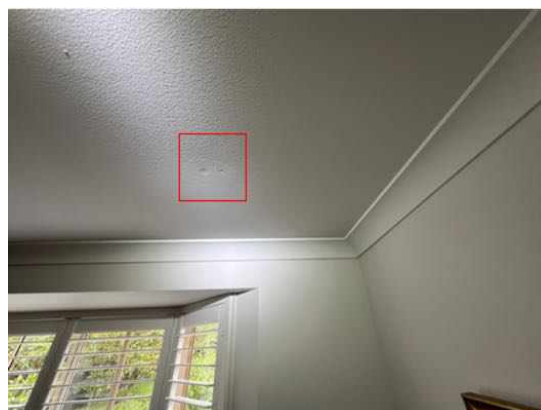
Building: Main Building
Location: All Internal Areas
Finding: Ceiling nails - Popping
Information: Numerous popped nails were identified in the internal ceiling at the time of inspection. Nails and screws hold simply by the friction between them and the surface they are applied to. Over time, the nails and screws can back out, which is often a result of general ageing and deterioration of the building structure.

If left unmanaged, the ceiling sheets may become loose and unstable, increasing the rate of deterioration of the internal ceiling and creating potential for the development of secondary defects.

Re-fastening of popped nails will help to maintain the stability of the internal ceiling and associated building elements. Such minor works will also help to improve the appearance of the affected area and secure the ceiling sheets, so as to prevent the onset of ceiling sagging. These works should be performed by a qualified carpenter or plasterer at client discretion.

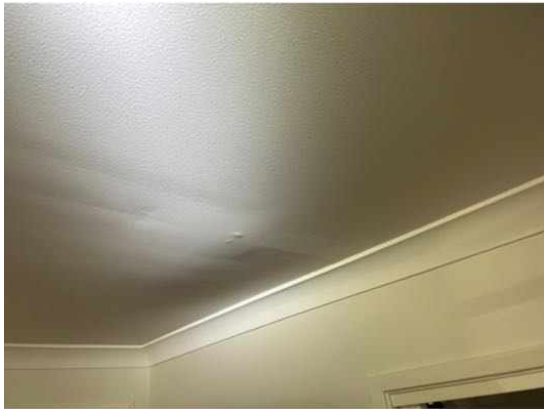
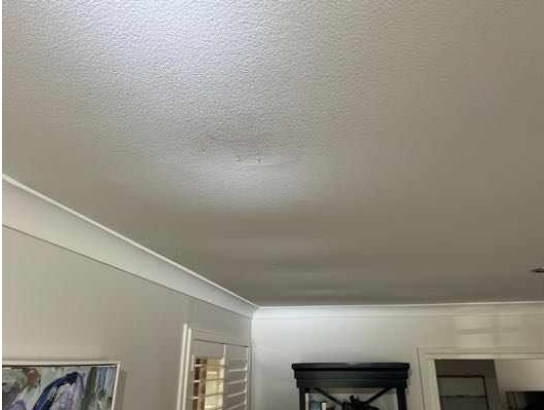
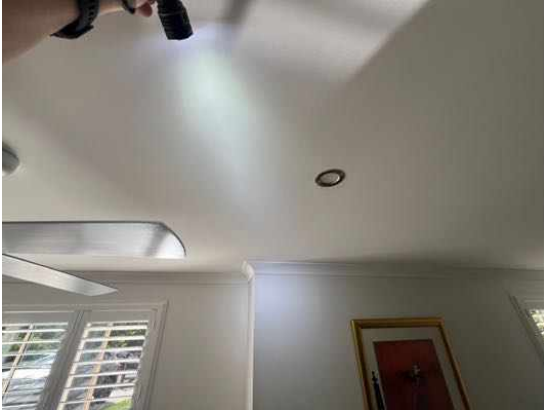
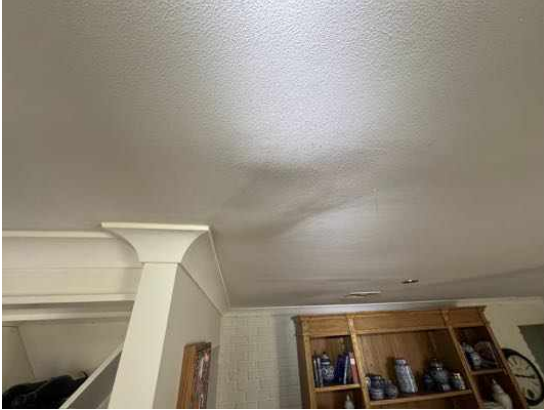
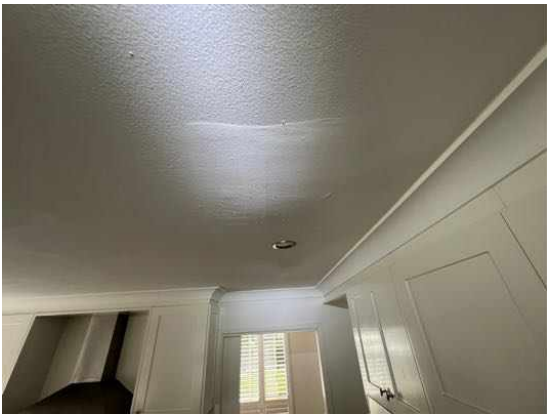
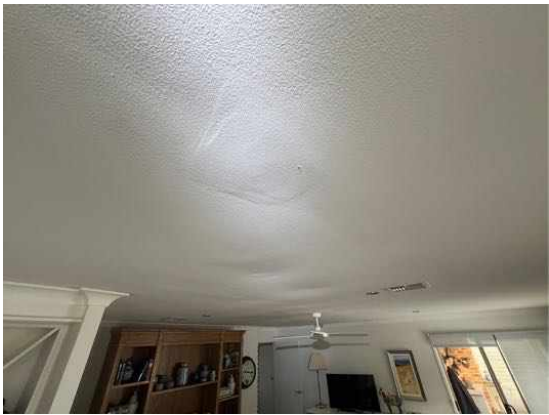
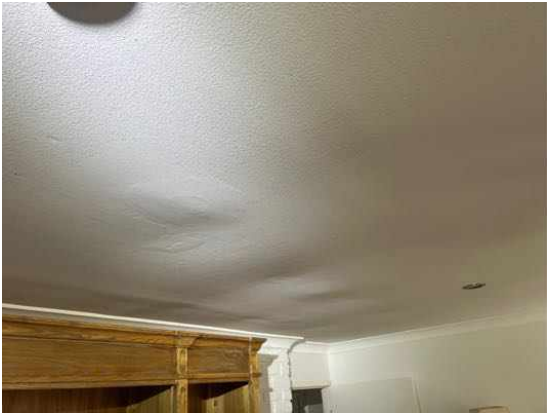
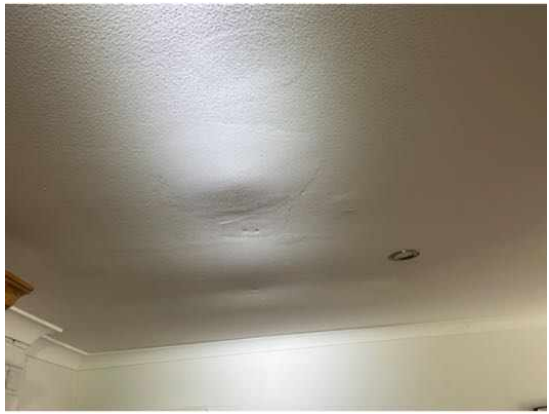
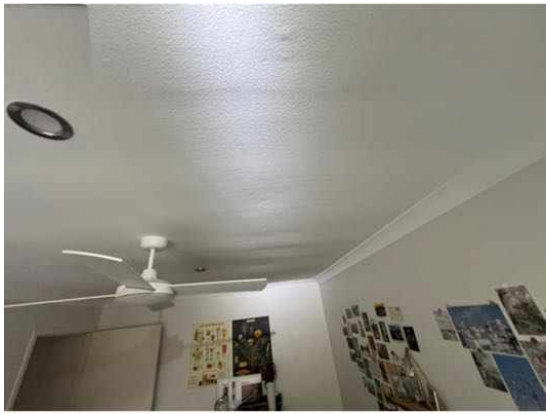
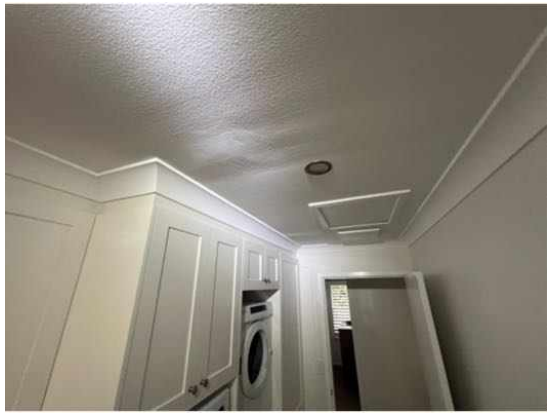
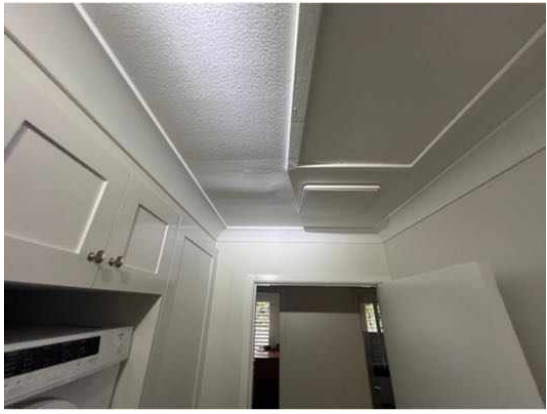
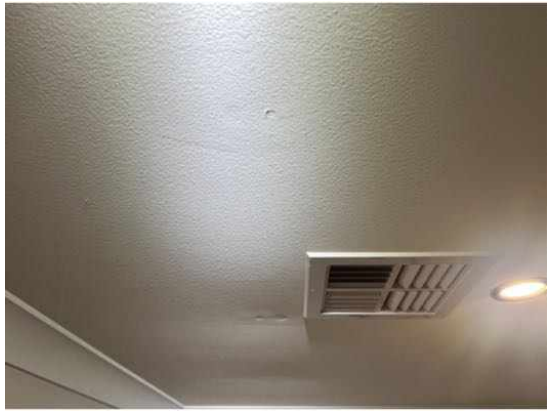
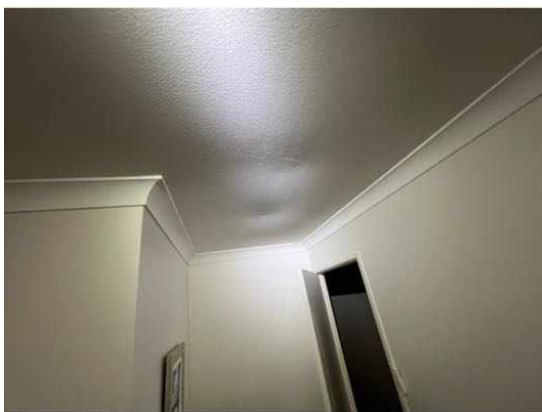
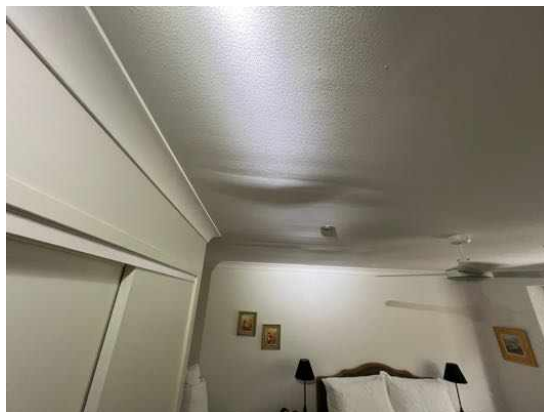
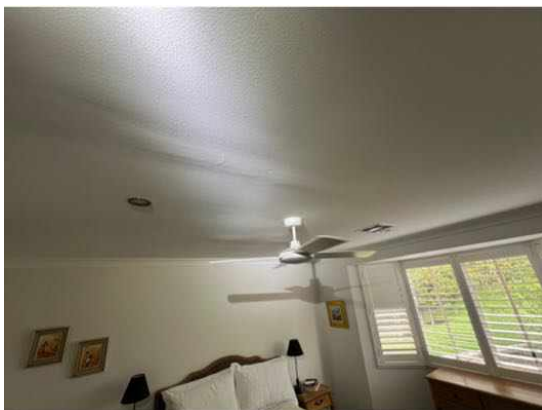
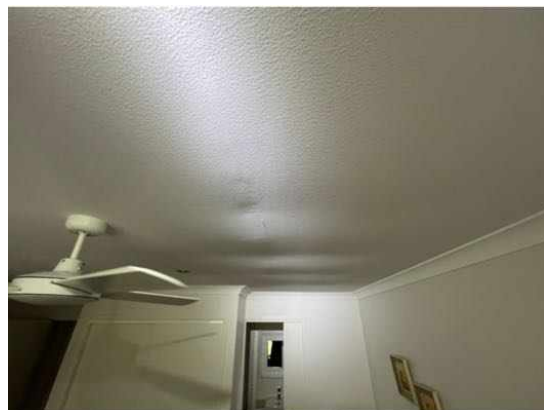
Finding 3.02

Building:	Main Building
Location:	All Internal Areas
Finding:	Ceiling - localised sagging, hairline cracks, substandard works
Information:	The internal ceiling lining in this area exhibits localised sagging between framing members, accompanied by hairline cracking and substandard flushing to joints and screw fixings. Sagging of this nature generally occurs where ceiling sheets are inadequately fixed, where fixings have loosened over time, or where the ceiling lining has not been properly supported during installation. Hairline cracking to joints and screw heads is commonly associated with minor movement within the framing or insufficient joint finishing.

If left unmanaged, continued movement or loosening of fixings may result in further joint separation, visible deflection, and deterioration of the ceiling finish.

It is recommended that a qualified plasterer assess the affected ceiling area and undertake rectification works as required to restore alignment and finish.

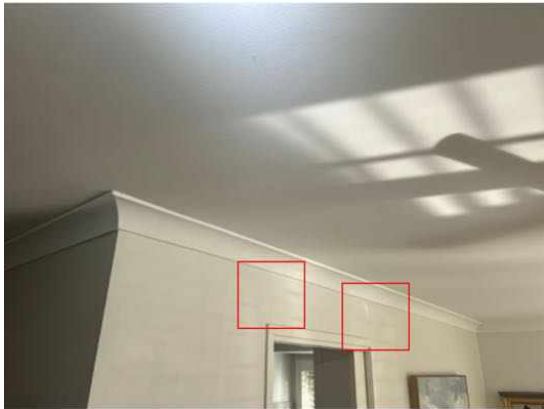
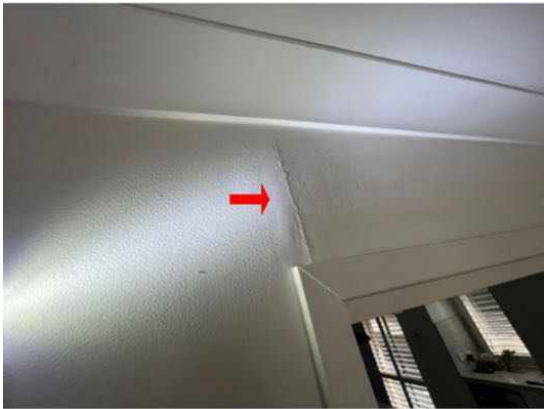
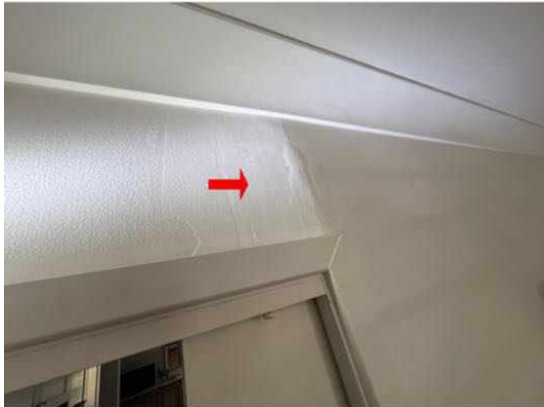
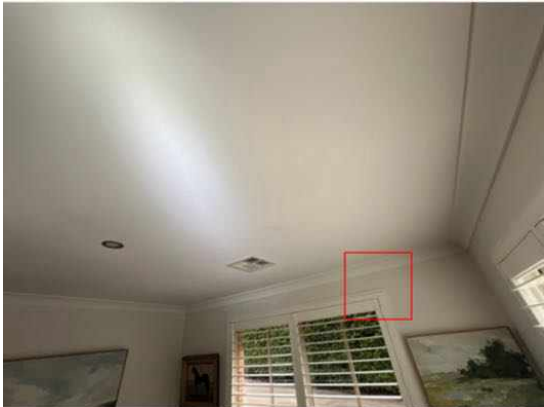
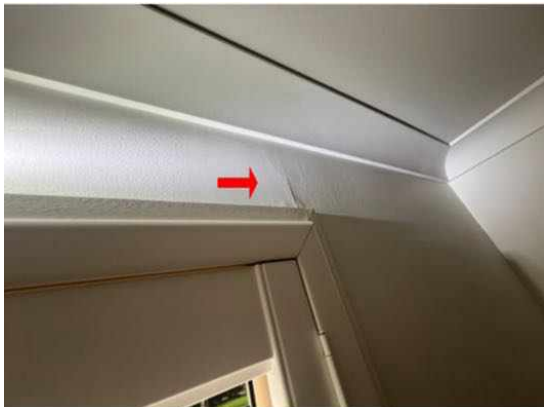
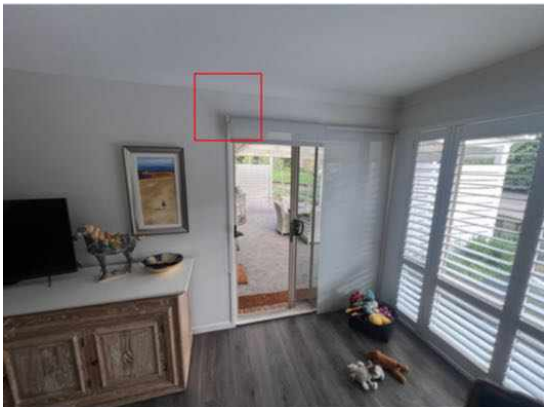
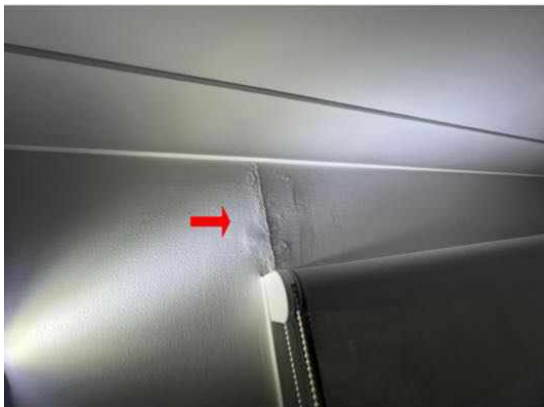
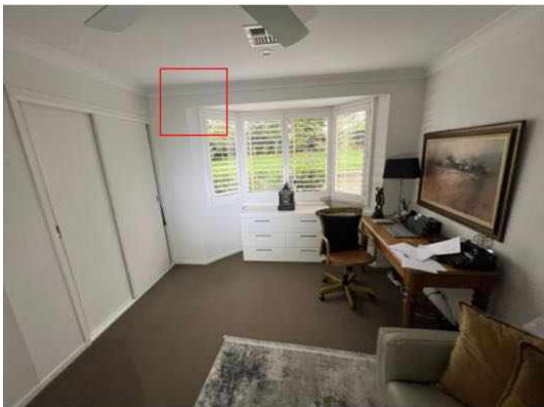
Finding 3.03

Building:	Main Building
Location:	All Internal Areas
Finding:	Plasterboard - cracking
Information:	A crack was identified in the linings at the time of inspection. This type of defect is commonly caused by minor settlement, thermal movement, or general ageing of building materials.

While currently an appearance defect, if left unmanaged, cracks may widen over time, potentially leading to further deterioration of the plasterboard lining.

Remedial works, such as patching and repainting, may be required to restore the plasterboards appearance and maintain its integrity.

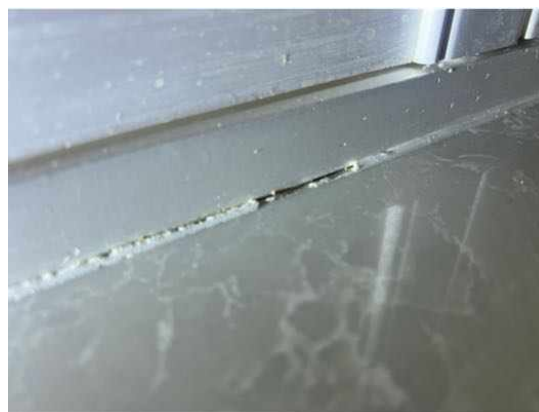
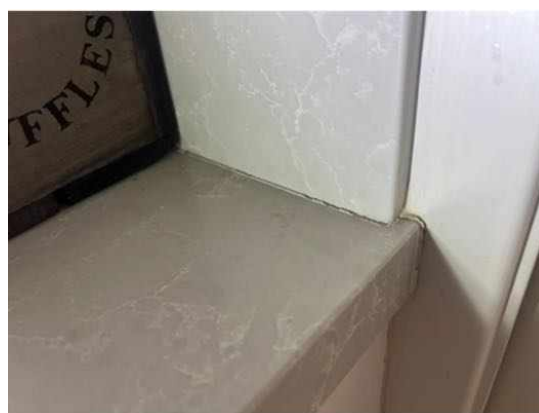
Finding 3.04

Building:	Main Building
Location:	Kitchen
Finding:	Kitchen Sealant - degraded
Information:	It was noted on inspection that sealant or grout is degraded to the kitchen sink and splashback.

Different materials move at different rates, generally causing cracking to grout or sealant at this point. A flexible sealant is required to allow for expected expansion and contraction, while keeping the joint water tight and protective of all associated building materials.

Flexible and mould resistant materials should be applied to affected areas to prevent any subsequent water damage that is likely to occur. Regular maintenance and replacement of damage or missing or damaged sealant and grout is highly recommended to the wet areas, as this is a regular wear and tear defect. Sealant and grouting in areas that come into regular contact with water should be maintained for the long term care of your property.

A sealant specialist or tiling contractor should be appointed to complete these works as soon as possible

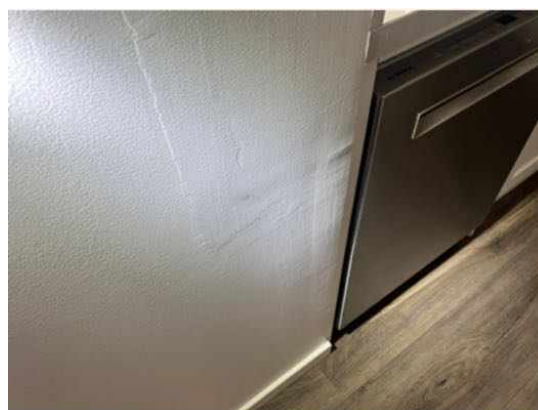
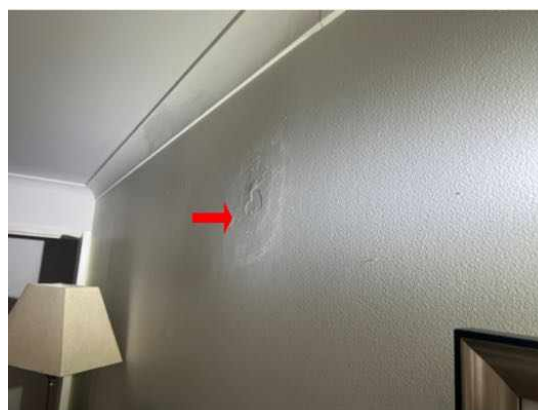
Finding 3.05

Building: Main Building
 Location: Kitchen, Family Room
 Finding: Wall - Incomplete or substandard works
 Information: The plasterboard finishing to this area appear to be incomplete or have been completed to a substandard level.

Works that have not been completed to a satisfactory level create potential for the development of building defects and may impede on the safety and integrity of the overall structure.

It is highly recommended that a licensed plasterboard contractor or painter should be appointed to finish the wall.

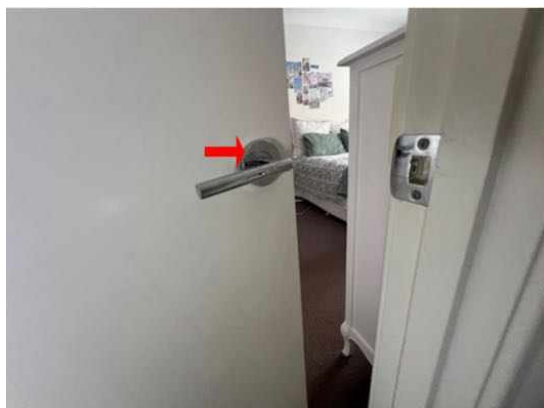
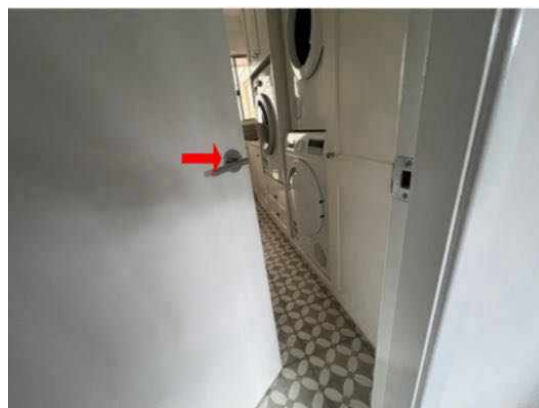
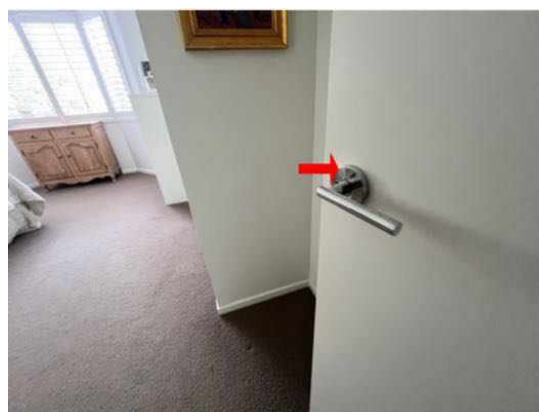
Finding 3.06

Building: Main Building
 Location: Bedroom 2, Laundry, Bedroom - Guest, Bedroom - Master
 Finding: Door Handle - Loose
 Information: The door handle in this area was identified as loose at the time of inspection. A loose door handle can impede the proper operation of the door and, if left unattended, may lead to further deterioration or damage to the associated door structure.

This defect is typically caused by wear and tear, insufficient fixing, or deterioration of

the handle's components.

It is recommended that a qualified carpenter or general handyman be appointed to secure or replace the handle to restore its functionality and ensure proper operation.

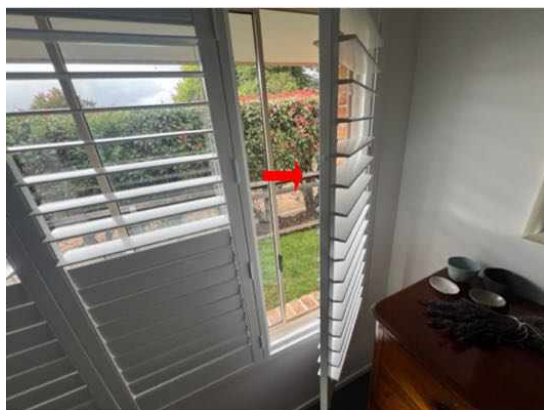
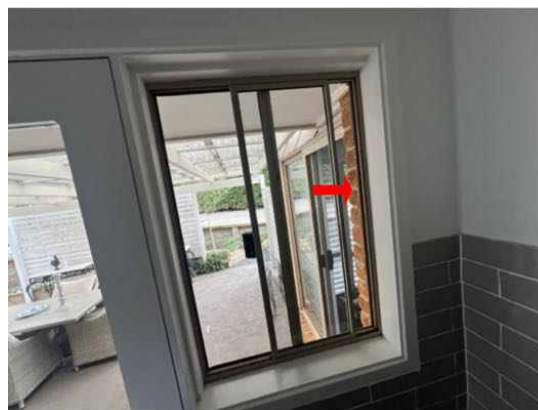
Finding 3.07

Building:	Main Building
Location:	Bedroom 3, Laundry
Finding:	Flyscreens - Missing
Information:	Flyscreens were found to be missing to the windows in this area at the time of inspection. Whether the flyscreens have not been installed or have been removed post-installation, this missing building element detracts from the operational state of the window.

Where not replaced, missing flyscreens allow pest and insect ingress into the adjoining room/s. It is advised that all missing building elements be replaced in order to ensure the full function of all building structures.

A general handyman may be appointed to replace flyscreens at the discretion of the client.

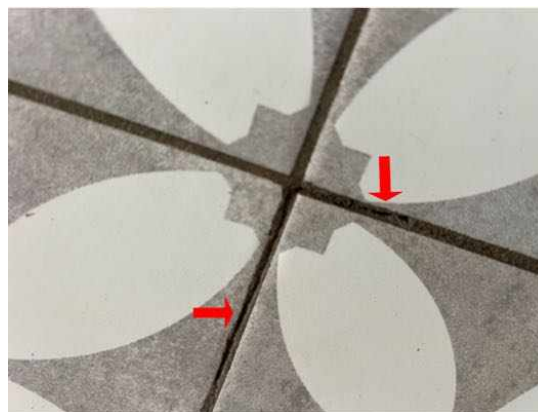
Finding 3.08

Building:	Main Building
Location:	Laundry
Finding:	Grout - Missing
Information:	Grout is missing in this area. Grout is used to protect gaps and crevices in building materials to ensure that they are water-tight and prevent water penetration to the associated structures.

Where grout is missing, a tiling contractor should be appointed immediately to apply grout and re-apply any silicone where necessary. Failure to do so is likely to lead to water damage to the surrounding area.

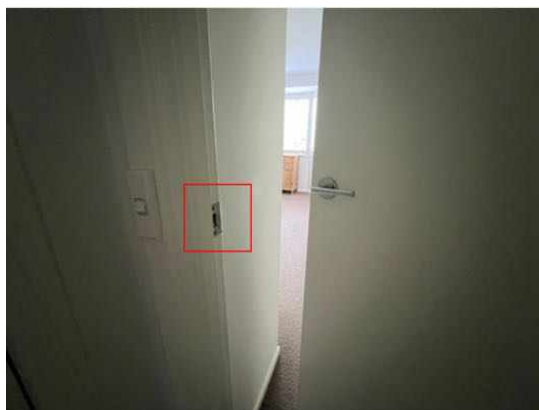
Finding 3.09

Building:	Main Building
Location:	Laundry, Bedroom - Master
Finding:	Doors - Striker plates misaligned. Doors rattle when closed.
Information:	The striker plates to a few doors throughout the home appear to have become misaligned and has consequently resulted in the door's operation being compromised.

This is a common defect and is expected in a property of this age, whether being due to substandard installation or general deterioration of the door hardware.

Readjustment of the striker plate is recommended at client discretion. Works such as these can be completed by a general handyman or qualified carpenter.

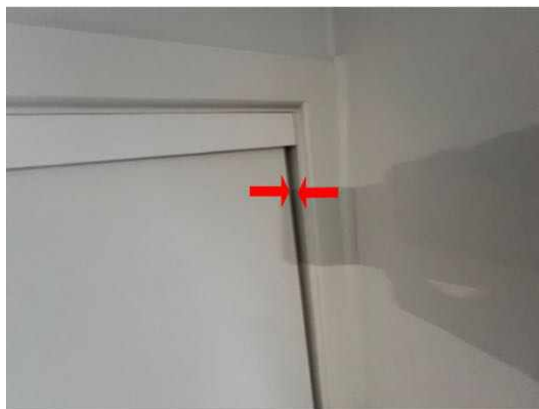
Finding 3.10

Finding: Robe Sliding door - not plumb

Information: The sliding robe doors are not plumb with the wall when closed, resulting in visible misalignment. This issue is generally caused by improper track installation, frame movement, or an out-of-square opening. Misaligned robe doors can affect operation, closing functionality, and the overall finish. The responsible carpenter or installer should assess the issue and undertake corrective work as required to ensure the doors align properly within the opening.

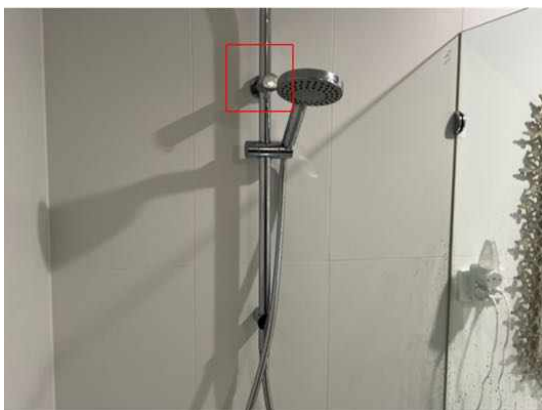
Finding 3.14

Building:	Main Building
Location:	Bathroom, Ensuite - Guest, Ensuite - Master
Finding:	Sealant - degraded/missing
Information:	It was noted on inspection that sealant or grout is degraded/missing to this area.

Different materials move at different rates, generally causing cracking to grout or sealant at this point. A flexible sealant is required to allow for expected expansion and contraction, while keeping the joint water tight and protective of all associated building materials.

Flexible and mould resistant materials should be applied to affected areas to prevent any subsequent water damage that is likely to occur. Regular maintenance and replacement of damage or missing or damaged sealant and grout is highly recommended to the wet areas, as this is a regular wear and tear defect. Sealant and grouting in areas that come into regular contact with water should be maintained for the long term care of your property.

A sealant specialist or tiling contractor should be appointed to complete these works as soon as possible

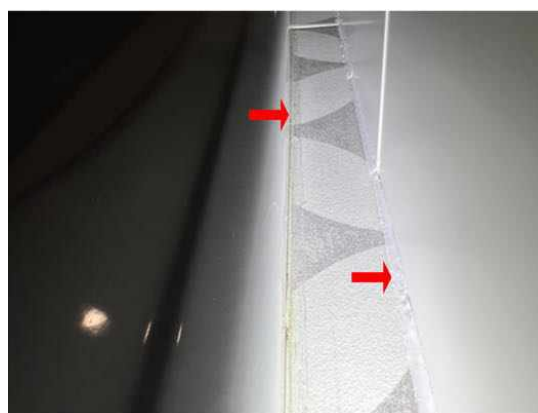
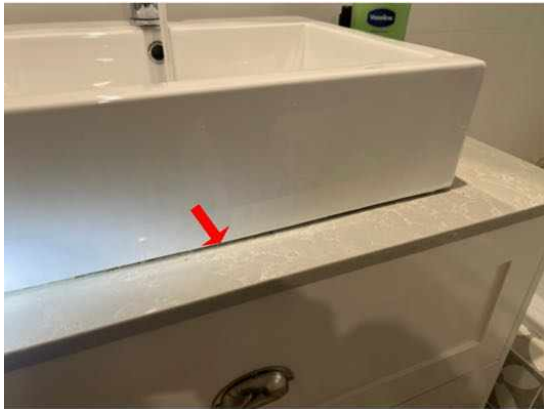
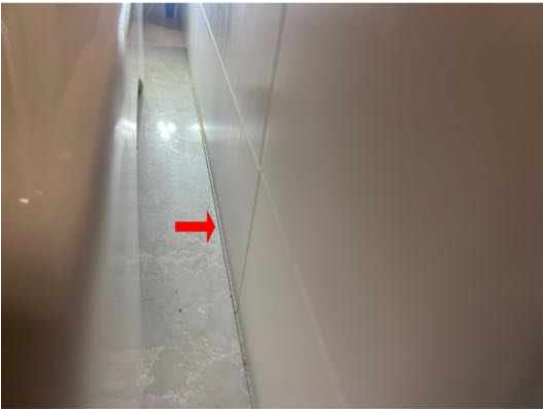
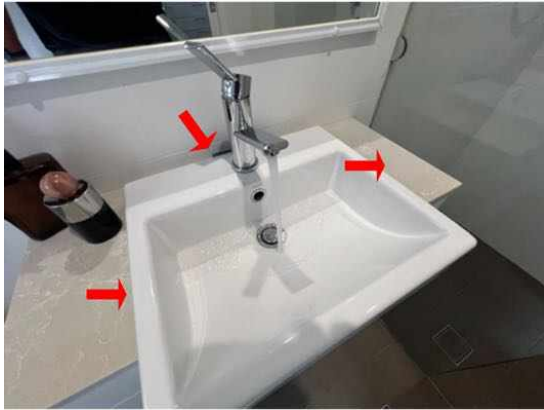
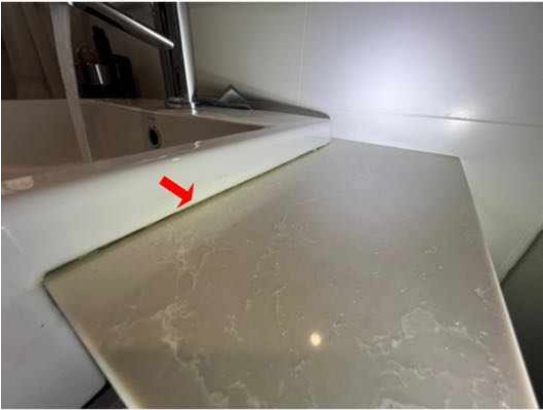
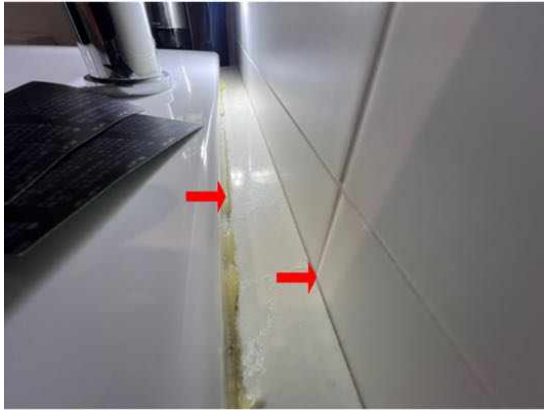
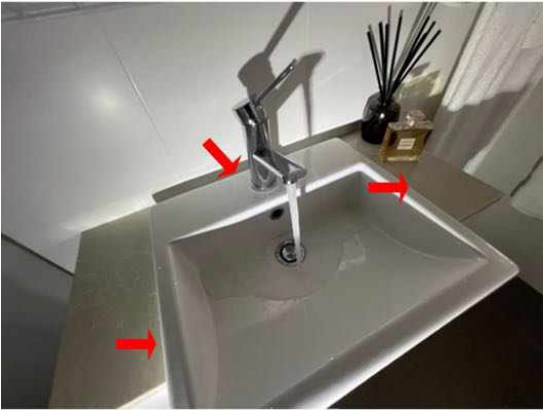
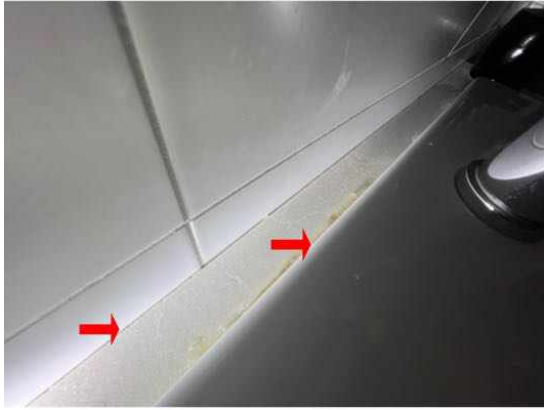
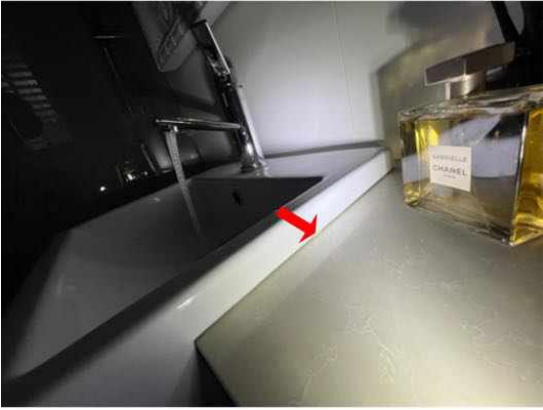
Finding 3.15

Building:	Main Building
Location:	Bathroom, Ensuite - Guest, Ensuite - Master
Finding:	Sealant and grouting - Missing or damaged
Information:	It was noted on inspection that sealant or grout is degraded to the tiled shower alcove and or other areas of the bathroom.

Different materials and floor areas move at different rates, generally causing cracking to grout or sealant at this point. A flexible sealant is required to allow for expected expansion and contraction, while keeping the joint water tight and protective of all associated building materials.

There appears to be excessive mould to the sealant and grout which will likely require scraping out and replacement.

Flexible and mould resistant materials should be applied to affected areas to prevent any subsequent water damage that is likely to occur. Regular maintenance and replacement of damage or missing or damaged sealant and grout is highly recommended to the wet areas, as this is a regular wear and tear defect. Sealant and grouting in areas that come into regular contact with water should be maintained for the long term care of your property.

A sealant specialist or tiling contractor should be appointed to complete these works as soon as possible

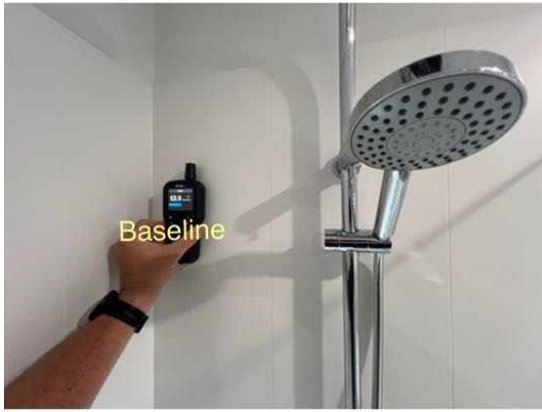
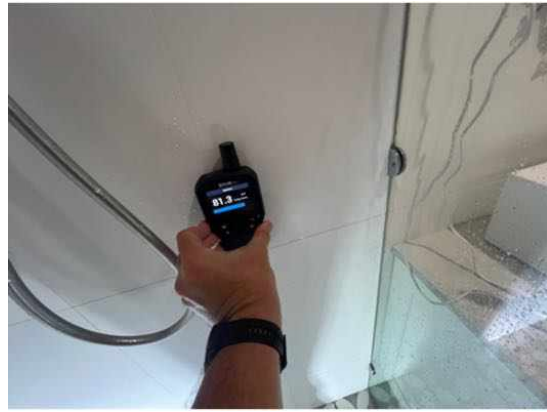
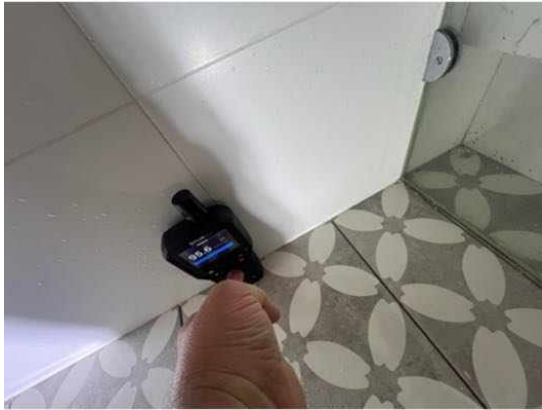
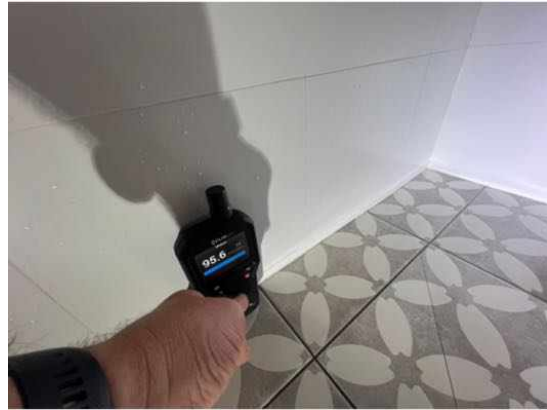
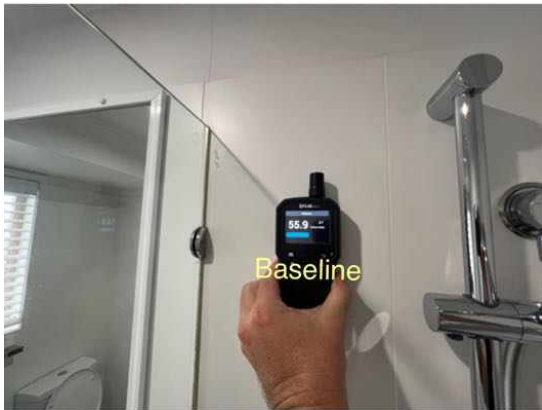
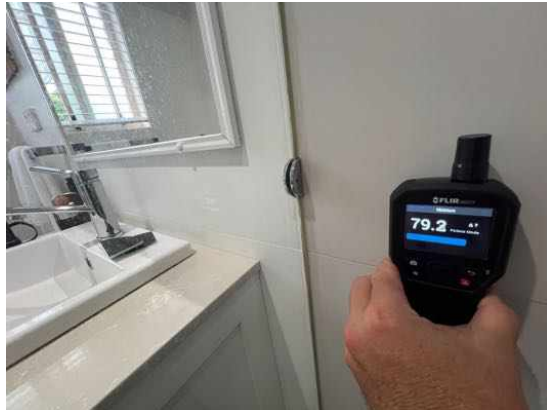
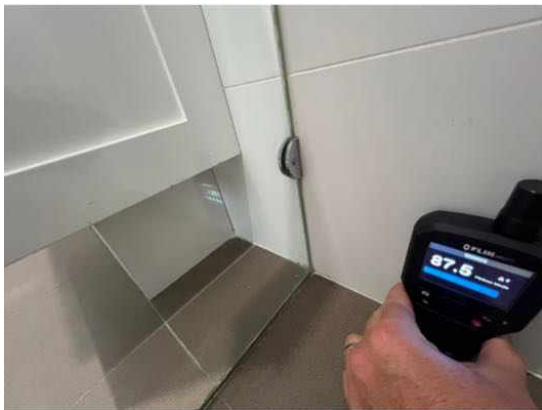
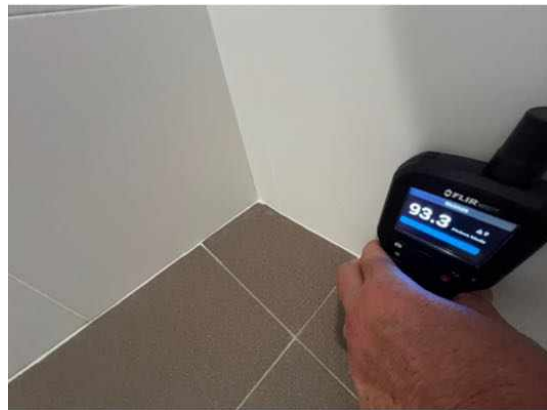
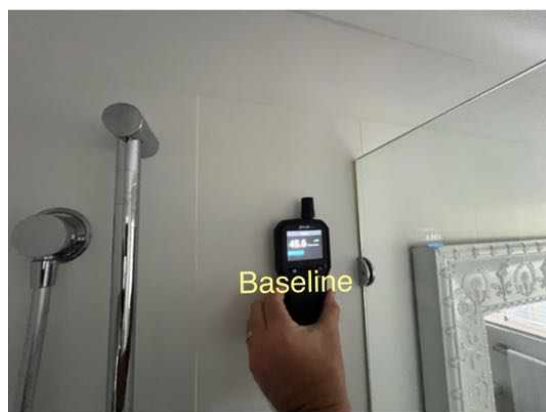
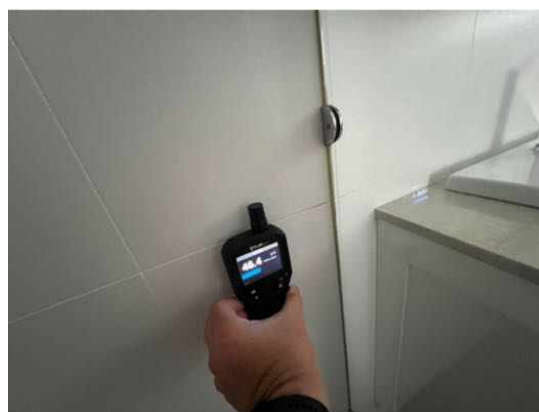
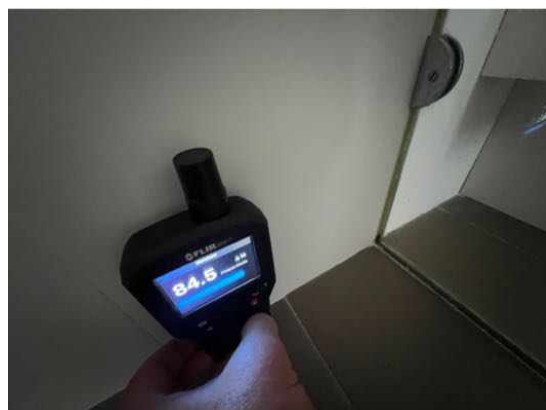
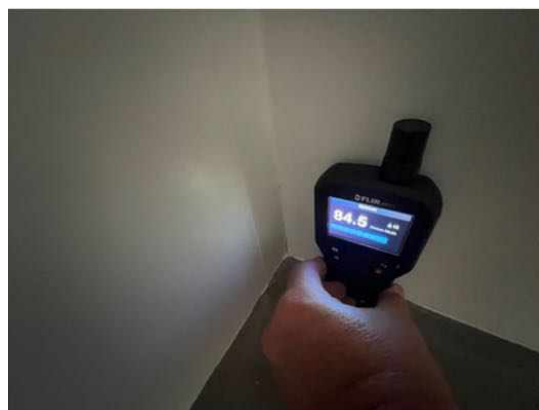
Finding 3.16

Building:	Main Building
Location:	Bathroom, Ensuite - Guest, Ensuite - Master
Finding:	Moisture in Shower
Information:	Moisture is evident behind the tiles to the shower alcove. This defect is quite common, and is suspected to have been caused by moisture permeating through the grouting in this area. Leaking pipes within the adjoining wall is also a possible cause.

Damp (or structural damp) refers to the presence of unwanted moisture in the structure of a building, either as the result of intrusion from outside, or condensation from within the structure. In the shower area, internal water leaks or other sources of excessive moisture are generally the cause of damp. Always ensure that sealant and grout is in good condition to prevent any moisture issues occurring in the future.

Consultation with a qualified plumber or bathroom specialist is advised to identify the cause of damp and to perform remedial works as required.

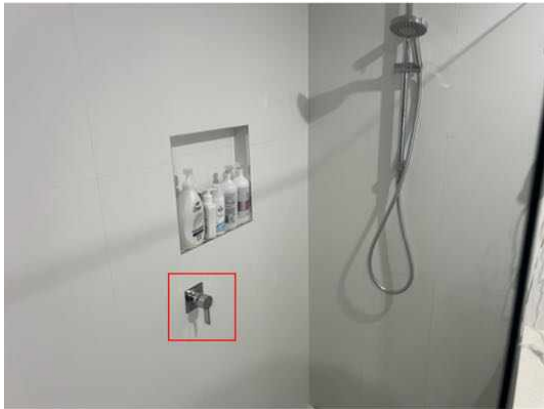
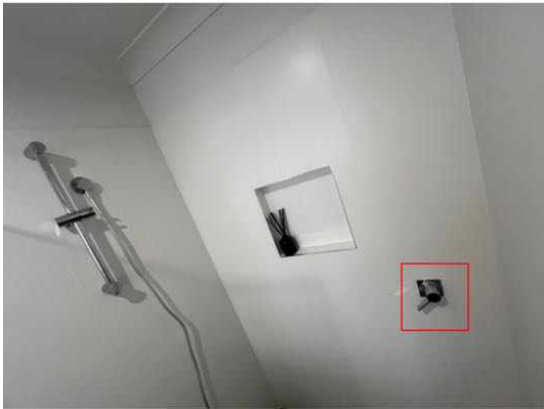
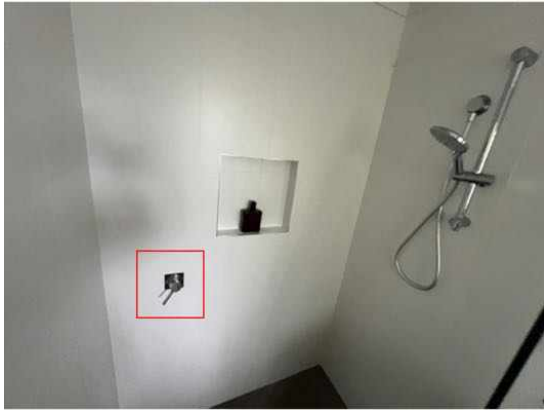
Finding 3.17

Building:	Main Building
Location:	Bathroom, Ensuite - Guest, Ensuite - Master
Finding:	Tap - Water hammer
Information:	This tap shows evidence of water hammer being present. Water hammer, a pressure surge resulting when a fluid is forced to suddenly change direction, is a common defect in plumbing fittings, particularly those that are aged and not frequently maintained. Water hammer is generally caused by factors that create high water pressure in the affected plumbing fixture, usually evidenced by a faint banging noise during operation of the affected tap.

Although water hammer is generally considered to be a minor defect, subsequent damage such as erosion of tap hardware and/or water damage to associated building elements is likely to occur if left unmanaged.

A licensed plumber should be appointed as soon as possible to replace any affected tap hardware and perform any remedial works as necessary. Please be advised that the appointment of a cabinet maker or qualified carpenter may be necessary if water damage to associated building elements has occurred.

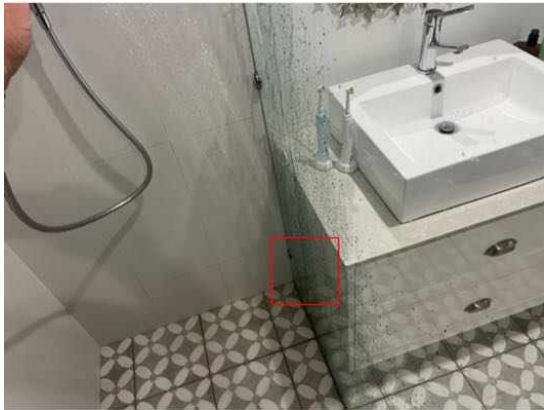
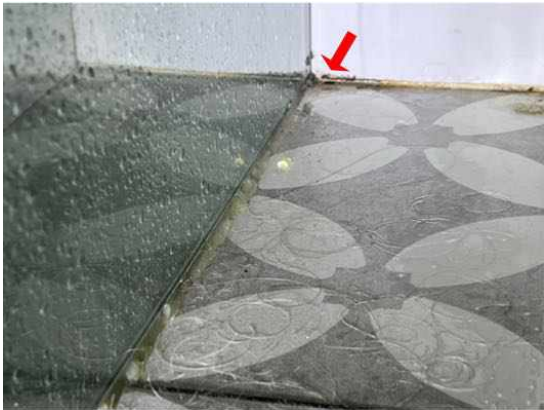
Finding 3.18

Building: Main Building
Location: Bathroom, Ensuite - Guest, Ensuite - Master
Finding: Shower screen - active leak
Information: A active leak was identified to the shower screen, likely due to deteriorated or inadequate sealant. If left unmanaged, water ingress may lead to damage to adjacent walls and flooring, as well as creating conditions conducive to mould growth.

Resealing is recommended to restore a watertight seal and prevent further deterioration.

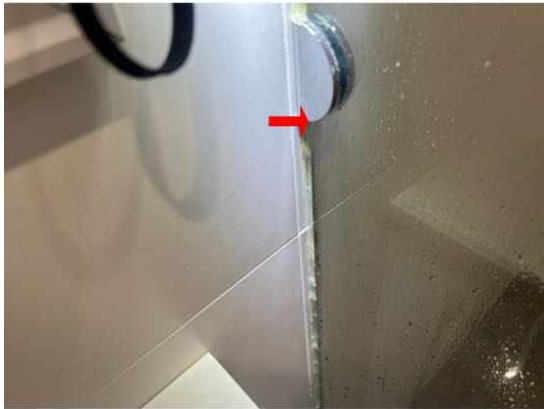
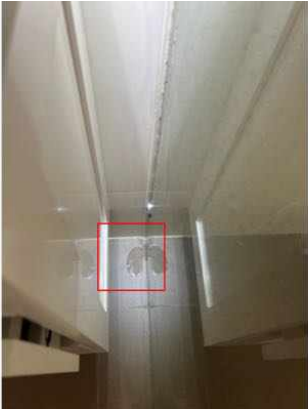
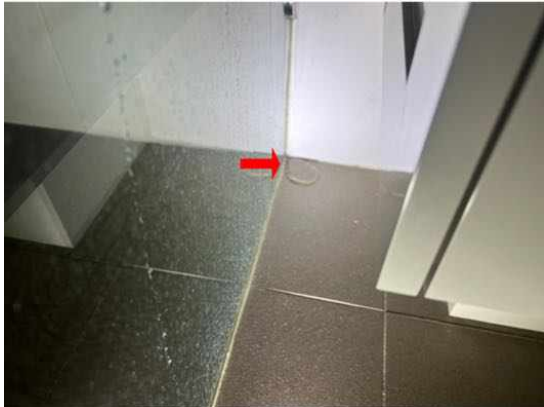
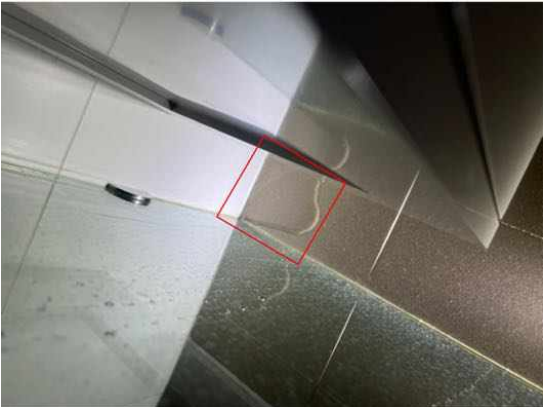
Finding 3.19

Building: Main Building
Location: Ensuite - Guest, Ensuite - Master
Finding: Fitting or fixture - Loose
Information: The fitting in this area is loose and requires adjustment to tighten.

If left unmanaged, the fitting may further deteriorate, causing potential for the development of other minor secondary defects.

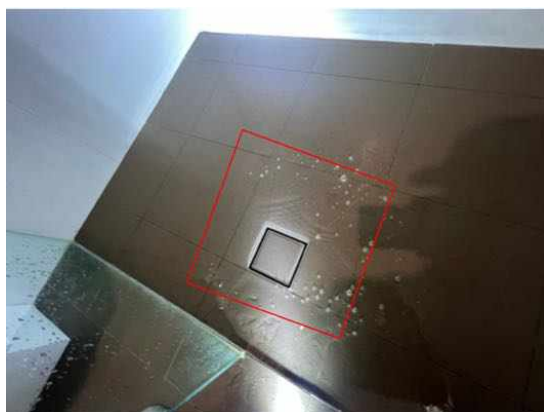
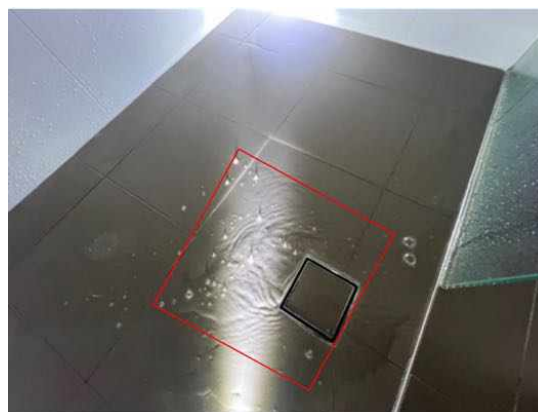
Finding 3.20

Building:	Main Building
Location:	Ensuite - Guest, Ensuite - Master
Finding:	Shower base - Water pooling
Information:	Evidence of water pooling around the floor waste in the shower recess was noticed at the time of inspection. It is suspected that this excessive moisture is attributed to insufficient fall in the shower floor tiles.

This pooling is minor overall but is still considered unsatisfactory, as standard tiling practices would not permit this situation to occur. Pooling water around floor wastes can create a slip hazard in extreme cases and create conditions that are conducive to mould growth over time. Where left unmanaged, the degradation of sealant and grouting is also likely to occur, possibly necessitating further repair works.

Remedial works may involve some sections of tiling and flooring repair and replacement. A tiling contractor or bathroom specialist should be appointed to provide further advice on reparation options and to perform works as necessary.

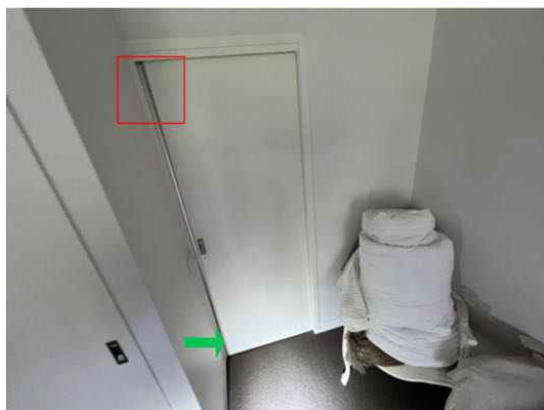
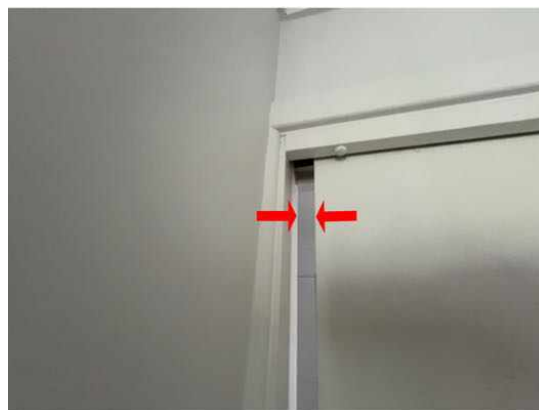
Finding 3.21

Building:	Main Building
Location:	Ensuite - Master
Finding:	Cavity Sliding Door - Out of Alignment
Information:	The cavity sliding door was noted to be misaligned or not running correctly within its floor or wall guide. This condition is typically caused by loose fixings, movement within the door frame, or lack of proper adjustment to the guide mechanism.

If left unadjusted, the door may scrape, jam, or fail to close properly over time.

A carpenter should be engaged to realign and adjust the door guide to ensure smooth and correct operation.
