Building and Timber Pest Inspection Report

Inspection Date: Fri, 20 Feb 2026

Property Address: 12 Rosemary Cres, Bowral NSW 2576,
Australia

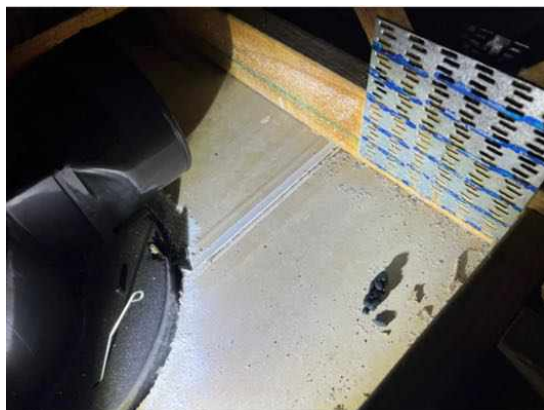
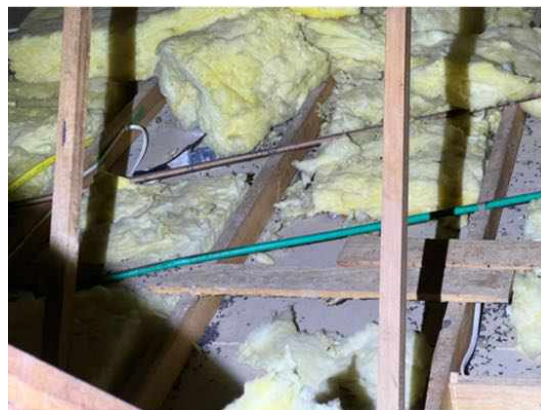
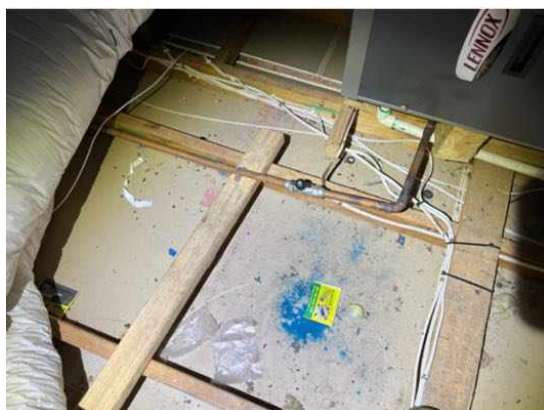
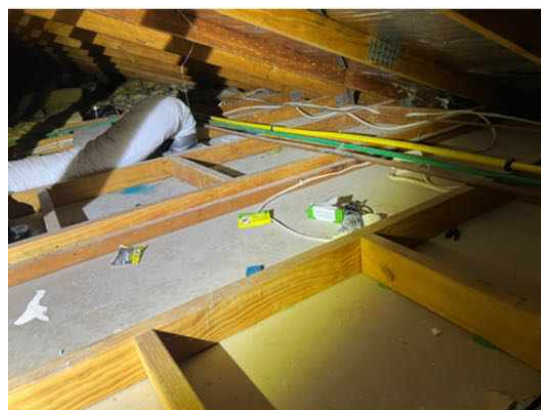
Finding 3.24

Building:	Main Building
Location:	Roof Void
Finding:	Evidence of Vermin

Information: Evidence of pests or rodents faeces in the roof space at time of inspection. Rodents can cause issues ranging from smells and stains through to physical damage to wiring and other elements in the roof void. A licensed pest controller should be appointed to free the roof void of any pests and to install deterrents or seal access points to ensure that rodents can not enter the roof space as easily.

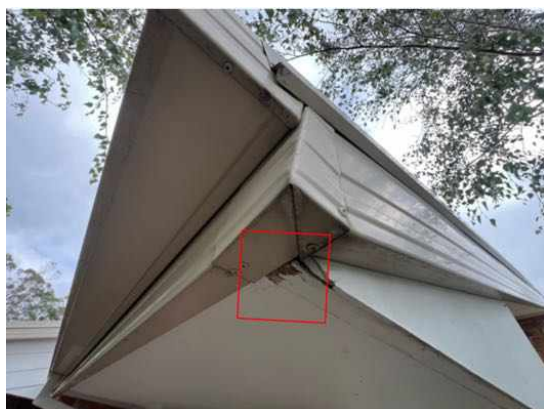
Finding 3.25

Building: Main Building
 Location: Exterior walls - front
 Finding: Eave trims - Wood rot
 Information: Wood rot was found to be affecting eave trims in this area, evidenced by the presence of mould on the surface in some areas. Wood rot, also known as Fungal Decay, occurs when timbers and other cellulose building materials are exposed to damp conditions on an ongoing basis.

It is likely that this wood rot has developed as a result of faults in the roof plumbing, creating excessive moisture in this areas. Frequent exposure to rain and other weather conditions also make fascias and barges susceptible to accelerated deterioration.

Early intervention and regular maintenance will prolong the useful life of these building elements. Prior to any works being performed, the cause of the moisture that has created the visible wood rot should be identified and addressed in a suitable manner.

It is advised that a roof plumber be appointed to inspect all roof plumbing and subsequently identify the cause of the wood rot. Replacement of affected fascias and barges may then be a necessary step in protecting surrounding building elements from such deterioration.

A qualified plumber may be appointed to assess the cause of excessive moisture and to provide advice on any remedial works as required. A qualified carpenter or registered builder may also be required to replace affected building materials.

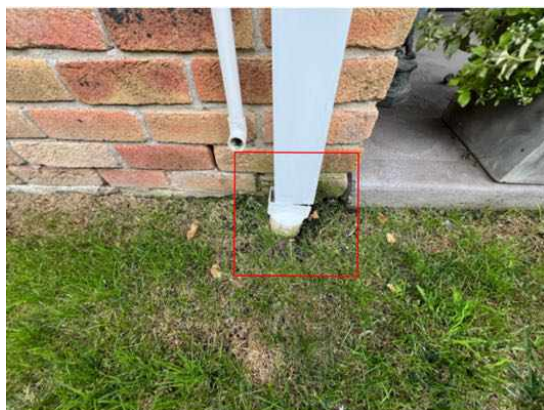
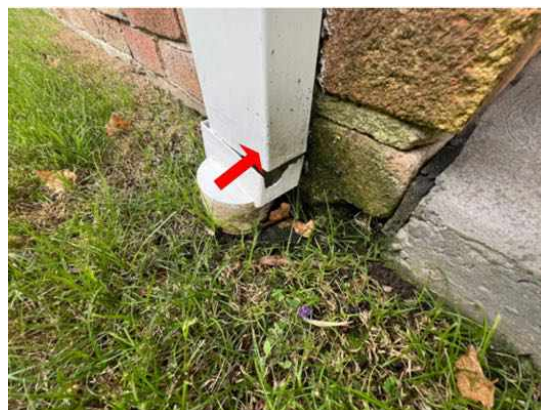
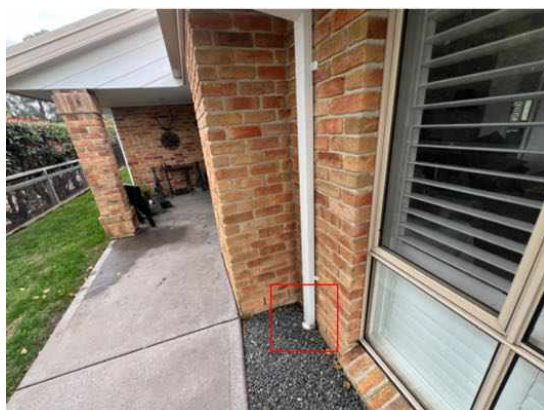
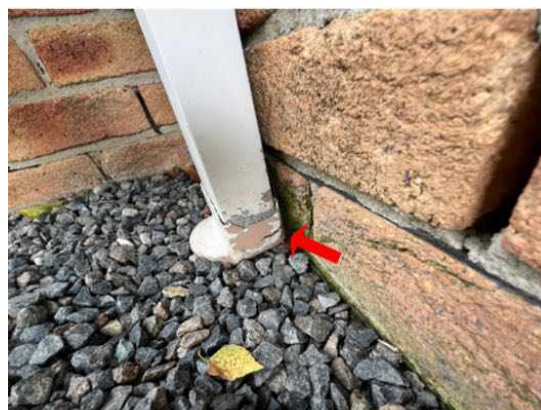
Finding 3.26

Building:	Main Building
Location:	Exterior walls - left side
Finding:	Downpipe - Damage, conditions conducive to termites
Information:	The downpipe in this area shows visible damage, which hinders its ability to effectively direct water away from the building. This creates conditions conducive to termite activity by increasing the likelihood of water pooling around the foundation. Prolonged moisture retention can lead to structural degradation, soil erosion, or water ingress into lower building areas, all of which may attract and sustain termite infestations.

The observed damage may be attributed to impact, corrosion, or general wear. It is recommended that a licensed roof plumber be engaged to inspect the downpipe and carry out necessary repairs or replacement as a priority to mitigate moisture-related risks and potential termite activity.

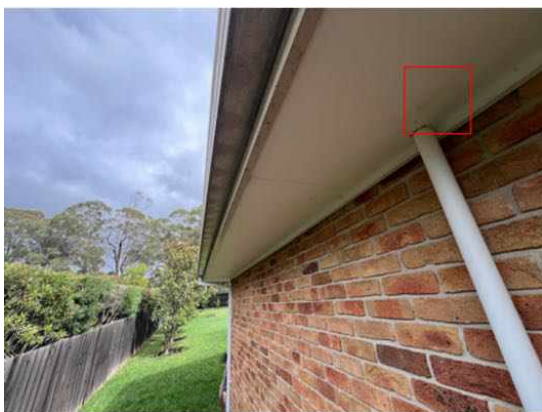
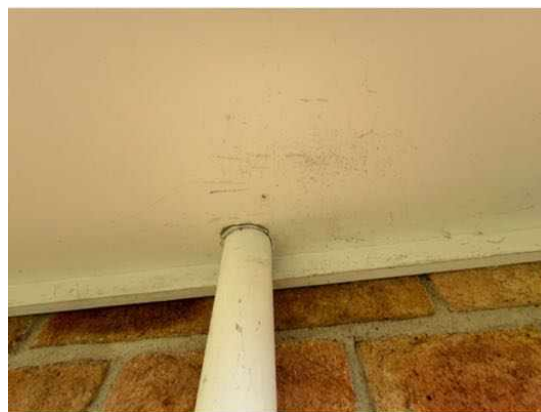
Finding 3.27

Building:	Main Building
Location:	Exterior walls - left side
Finding:	Eave - mould spotting
Information:	Mould spotting was identified on sections of the eave lining at the time of inspection. The presence of mould is typically indicative of excessive moisture in the area, which may result from inadequate ventilation, roof leaks, or condensation buildup.

If left unmanaged, mould growth can contribute to the deterioration of building materials and may indicate underlying moisture issues requiring further investigation.

It is recommended that a registered builder assess the affected area to determine the source of moisture and undertake any necessary remedial works. Cleaning and treatment of the mould-affected areas may also be required by a suitably qualified professional.

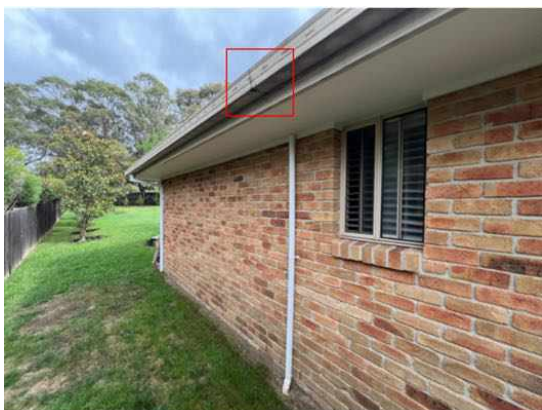
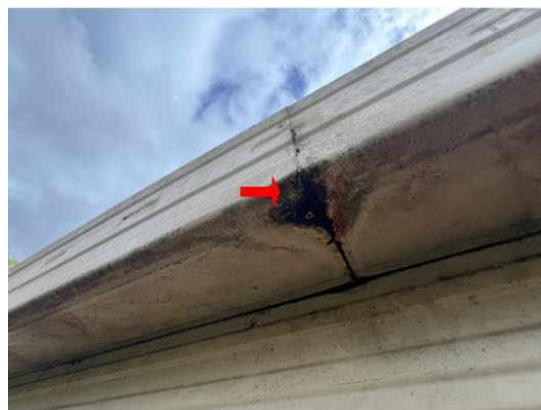
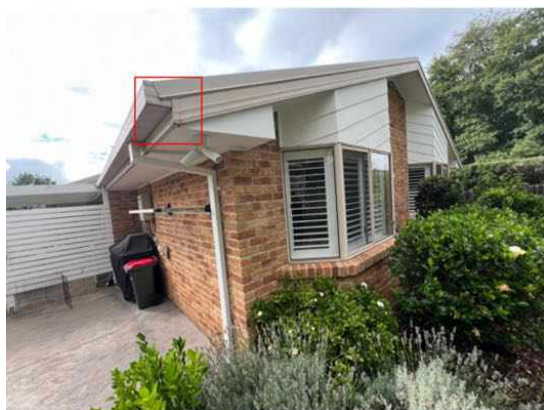
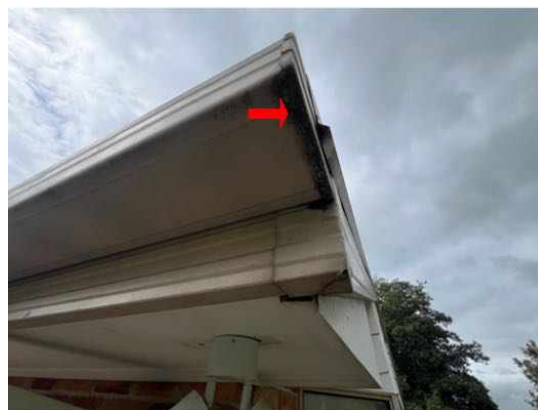
Finding 3.28

Building:	Main Building
Location:	Exterior walls - left side, rear
Finding:	Gutter - Water staining
Information:	Water staining was evident in this area at the time of inspection to guttering. Water staining indicates that surfaces have been exposed to excessive moisture over time. The minerals and other elements in the water lead to staining, which may graduate to corrosion and deterioration if left unmanaged.

While mostly an appearance defect, water staining can be indicative of more serious defects, which may be currently concealed by other building elements.

Where water staining is active, a licensed roof plumber must be consulted to identify the cause of the staining and to provide advice on any reparation works that may be required. Replacement of any broken or damaged structures is advised.

Conversely, where water staining is old and inactive, affected building materials may be repaired or replaced at client discretion. A qualified carpenter or registered builder may be appointed to perform these works.

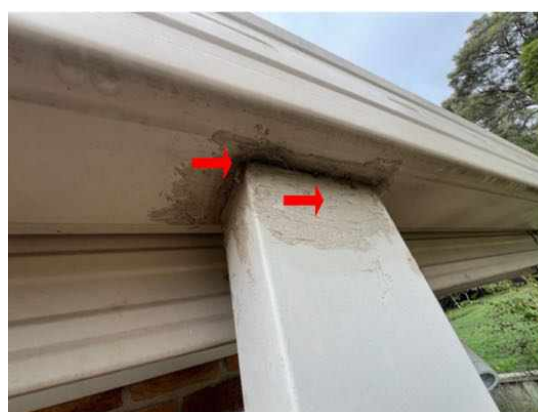
Finding 3.29

Building:	Main Building
Location:	Exterior walls - right side
Finding:	Excessive Silicone - substandard
Information:	Excessive silicone was observed to the building element, This application appears to have been used as a waterproofing measure. While silicone can provide temporary sealing, excessive application is often indicative of substandard workmanship and may not be a long-term solution to prevent water ingress.

If the underlying issue is inadequate drainage or waterproofing, reliance on excessive silicone may fail over time.

It is recommended that a registered builder, roof plumber assess the installation to determine if additional remedial works are required to ensure adequate water management and long-term durability.

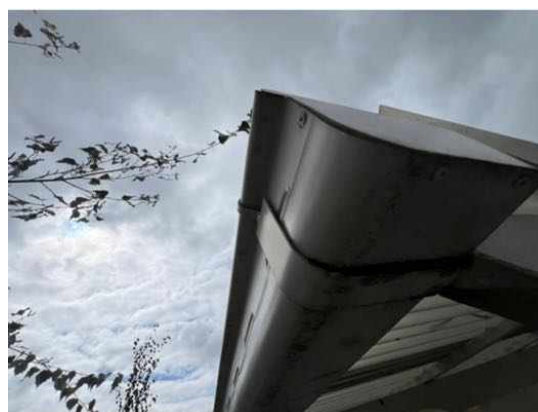
Finding 3.30

Building:	Main Building
Location:	Pergola
Finding:	Water leak - External
Information:	Water leaks were found to be present to exterior plumbing work. Leaks are generally

caused by deterioration of the plumbing elements over time, due to exposure to weather conditions, but may have also been caused by minor impact damage.

Such leaking creates damp conditions in the affected area, causing potential for water pooling and subsequent water damage if left unattended. These conditions may also attract termite attack, particularly if the area is subject to minimal levels of sun throughout daylight hours.

It is highly advised that a licensed plumber be appointed to rectify any water leaks that may be present. Areas of repair and replacement of plumbing fittings and fixtures may be required and, as such, a quotation should be sought.

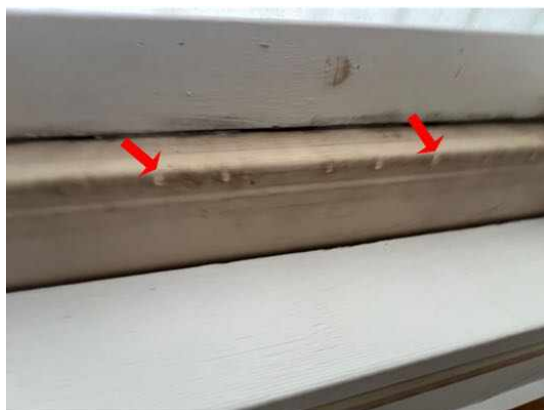
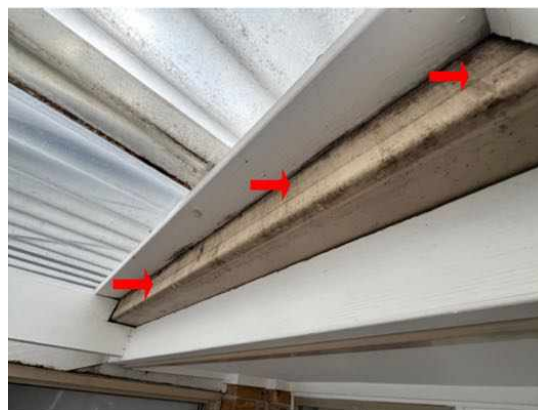
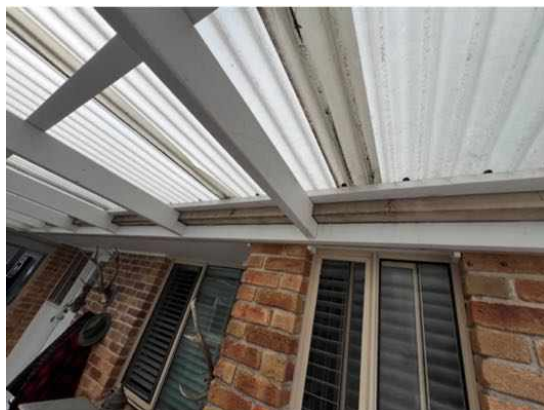
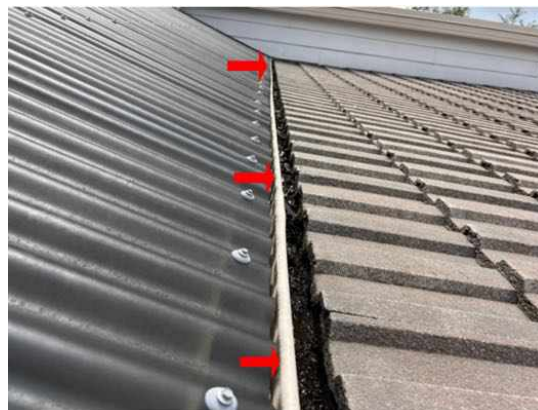
Finding 3.31

Building:	Main Building
Location:	Pergola
Finding:	Roof plumbing - Flashing inadequate
Information:	Some sections of the roof are missing or have inadequate roof flashings. Flashings are metal and other materials which are applied to seals and intersections between roof coverings and building elements. They are designed to aid in weatherproofing of roof joins.

Flashings that are not installed adequately or are missing are likely to result in water penetration to the interior of the property, as well as creating excessively damp conditions against the exterior surfaces and around the base perimeter of the building.

Premature ageing and secondary building defects are imminent where roof plumbing is missing or inadequately installed. Additionally, water pooling also creates an environment that is susceptible to termite and pest infestation.

A roofing plumber should be appointed as soon as possible to install relevant roof plumbing materials, ensuring that no further damage is sustained.

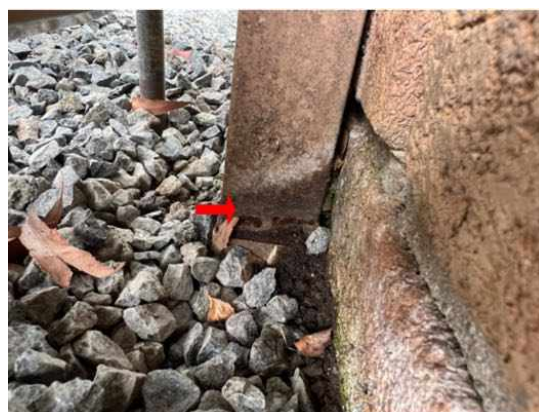
Finding: Plumbing components - Rusted or corroded
Information: The plumbing components shows evidence of rusting and corrosion, which is likely to have developed as a result of excessive exposure to moisture and or inadequate coatings.

As surface rust provides no protection to the underlying iron, the deteriorating condition is likely to worsen if not addressed in the short-term future.

Where possible, the use of galvanized (treated) metals or aluminium coated metals aid in rust prevention, as does regular general maintenance. Rust formation can be controlled with coatings, such as paint, that isolate the iron from the environment.

Rusting and corrosion should be managed by ideally removing or limiting the affected surface from exposure to moisture. A licensed plumber may be appointed to replace any plumbing elements that have been severely affected by rust or water damage.

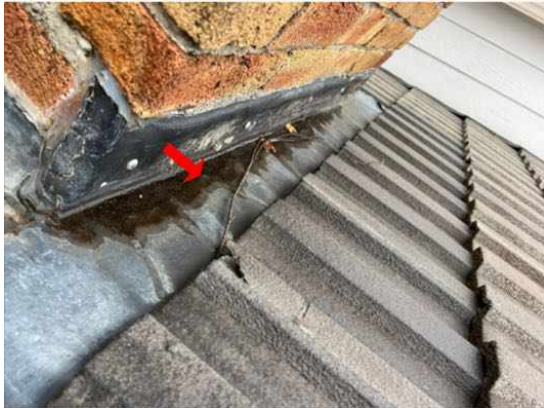
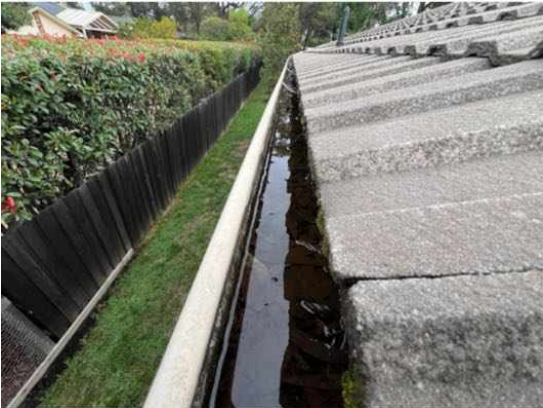
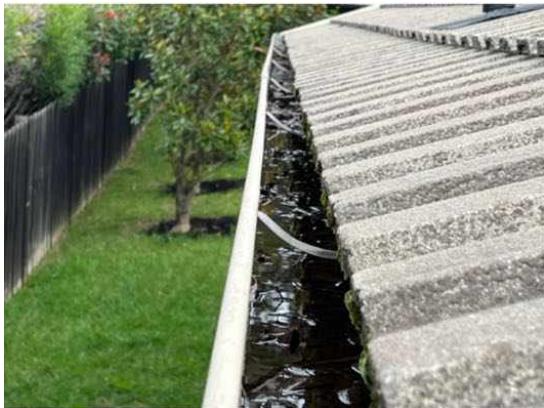
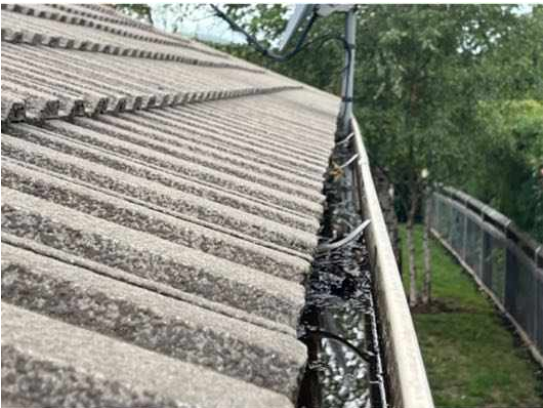
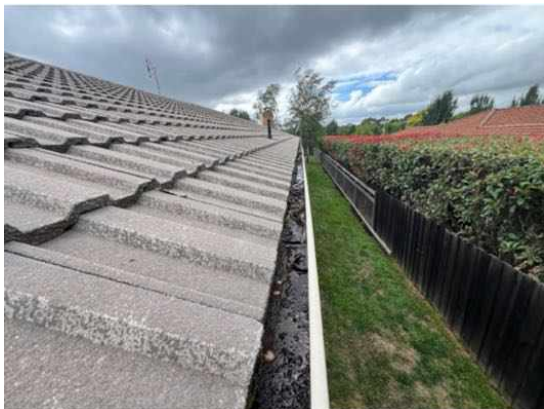
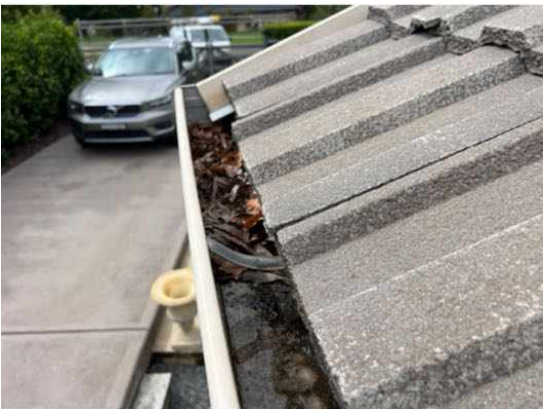
Finding 3.35

Building:
Location: Roof Exterior -Main Building, Garage
Finding: Gutters - Water pooling
Information: Water was found to be pooling in sections of the roof guttering. This is generally a secondary defect caused by blocked or partially blocked gutters. Such blockages and subsequent water pooling are likely to lead to rust and water damage to associated structures if left unattended.

Any areas of guttering that shows evidence of water pooling should be checked for partial or full blockages and any secondary damage that may have occurred as a result. Depending on the extent of the damage, building elements may require repair and/or replacement to ensure adequate roof drainage and function of exterior plumbing system.

A roofing plumber should be appointed as soon as possible to rectify this issue. It is highly advised that all gutters be maintained on a frequent basis to ensure the condition of roof plumbing.

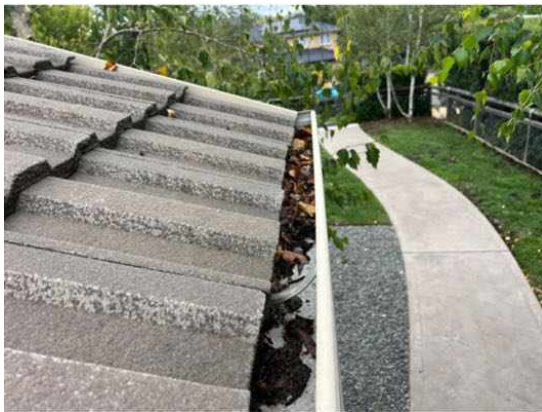
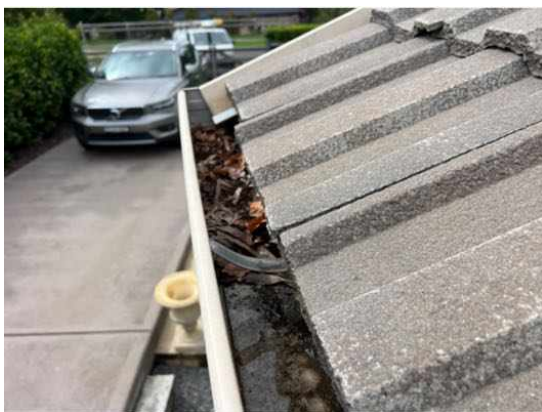
Blocked gutters are likely to lead to high levels of moisture in the affected areas. Such moisture will not only cause rust and decay of the associated building materials, but can also provide conditions that are conducive to termite and timber pest activity. Blockages in gutters should therefore be removed immediately to ensure dry conditions are maintained.

Consult a Licensed Plumber for further specific advice on remedial works that may be required. In the interim, it is highly advised that blocked gutters be removed by the homeowner or a general handyperson as a matter of urgency.

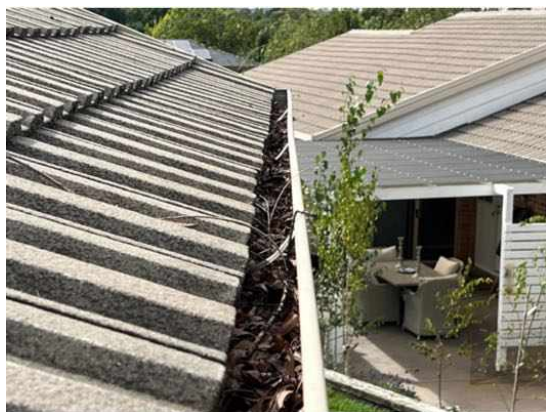
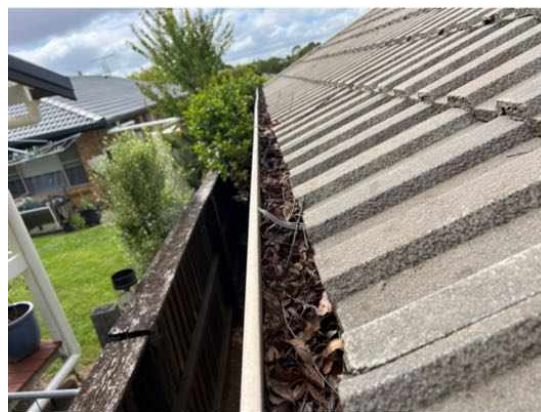
Finding 3.37

Gutters are a critical part of the building's management of storm water and rain. It is therefore important that they be kept clear to prevent secondary damage to associated building elements, including exterior and interior walls, ceiling linings and any adjoining building elements. Where gutters are blocked, pooling of rainwater is likely to occur, fast-tracking rust and corrosion of the roof plumbing elements.

It is highly advised that all overhanging tree branches be removed as soon as possible to prevent any further damage. Repair and/or replacement of sections of damaged guttering may also be required where the extent of the damage necessitates.

Such works should be performed by the homeowner; however, appointment of a landscape contractor or an arborist may be required. Consultation with a licensed roof plumber is required where guttering has been damaged.

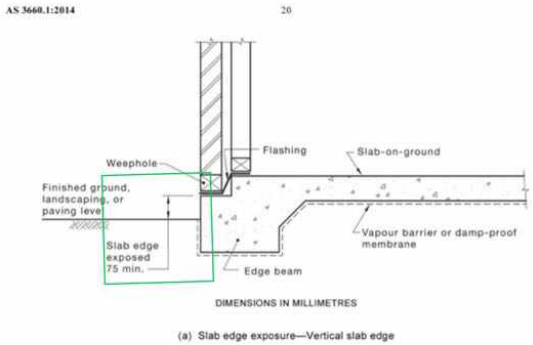
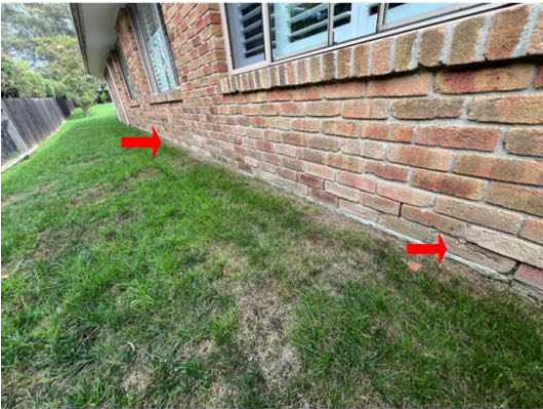
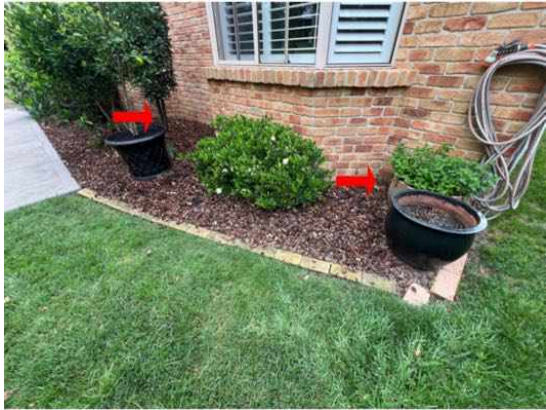
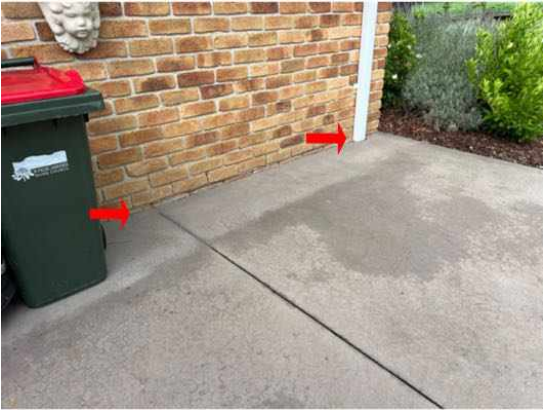
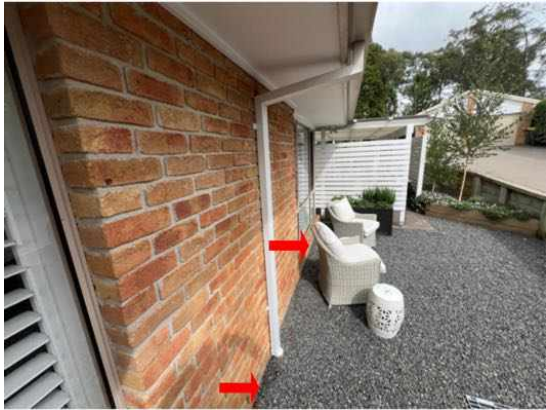
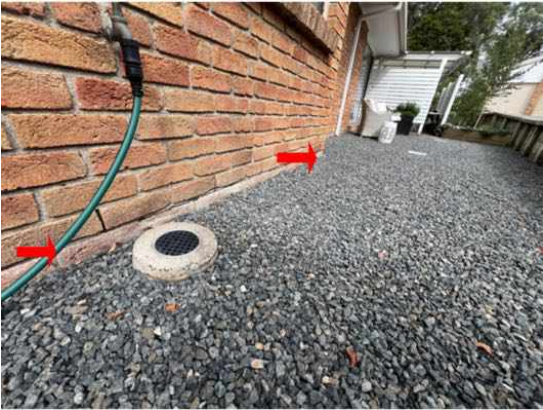
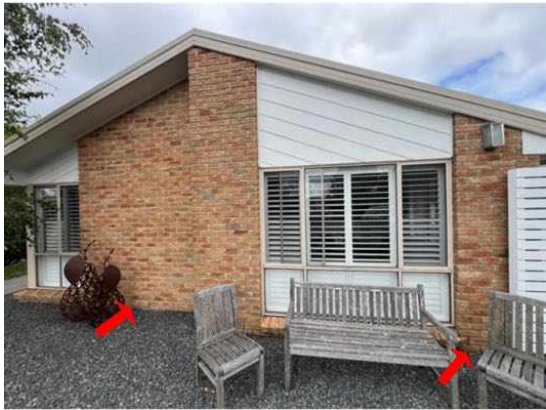
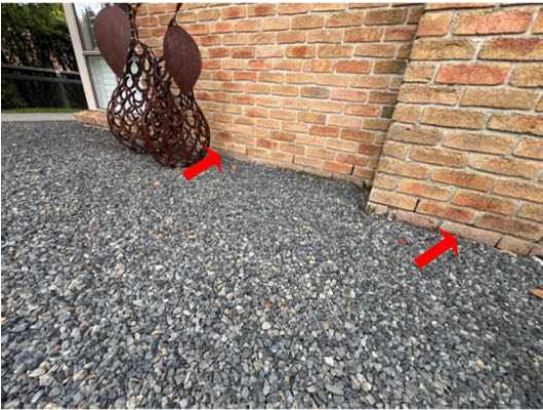
Finding 6.02

Building:	Main Building
Location:	All External Areas
Finding:	Slab Edge - Exposure
Information:	<p>An inspection zone of at least 75mm in relation to the exposed slab edge, between the bottom brick and the perimeter pavement, is required. This inspection zone should be maintained in order to force termites into the open where they can be detected more readily during regular inspections. The slab edge should not be concealed by anything that may prevent inspection of the area, including render, landscaping, soil, turf, paving, concrete cladding or other structures.</p> <p>If the slab edge is not properly exposed there is a high risk of termite attack. Sometimes, in order to determine the type of slab, a suitably qualified person such as an architect or builder may be required to consult the construction plans.</p> <p>Where the slab edge cannot be properly inspected, it is highly recommended that termite or timber pest inspections be carried out every 6-12 months to aid protection of the property against infestation.</p>

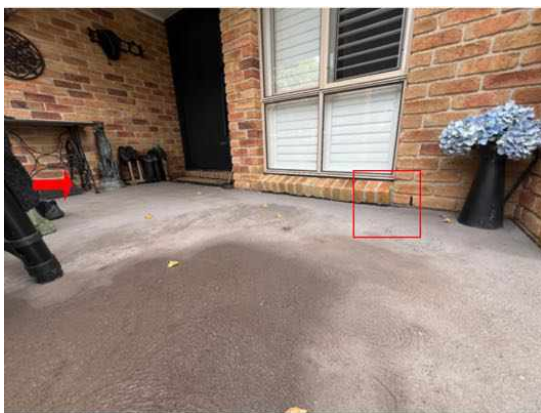
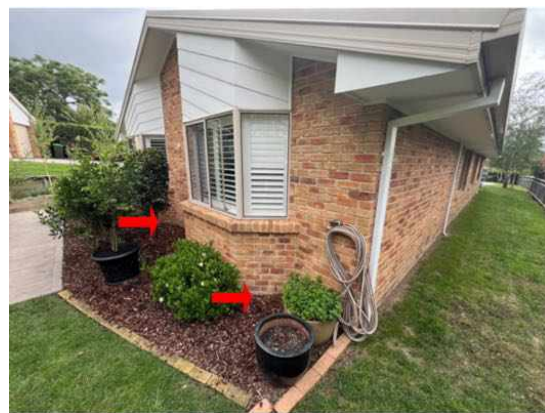
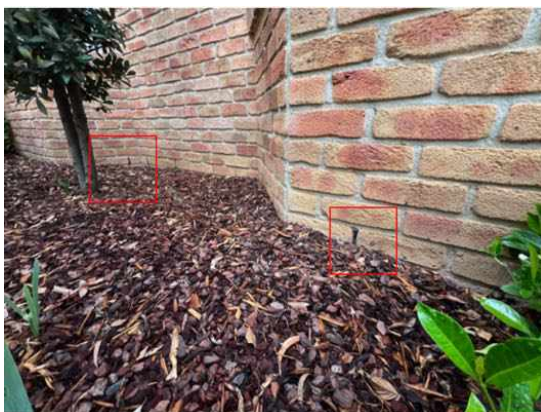
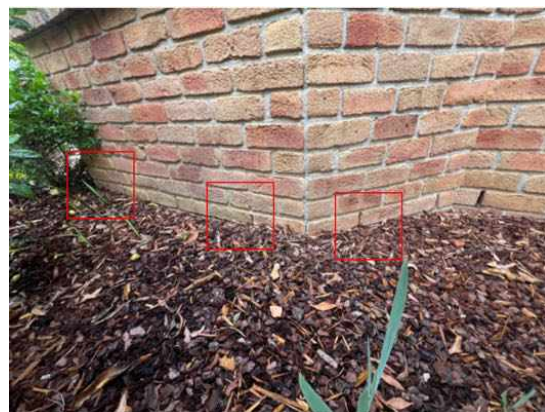
Generally this takes the form of finished ground levels external paving or concrete being retrospectively installed above the damp course level the adjacent internal floor level or weep and ventilation holes.

Where bridging has occurred full inspection is prevented and termites may enter a property in a concealed or undetectable manner.

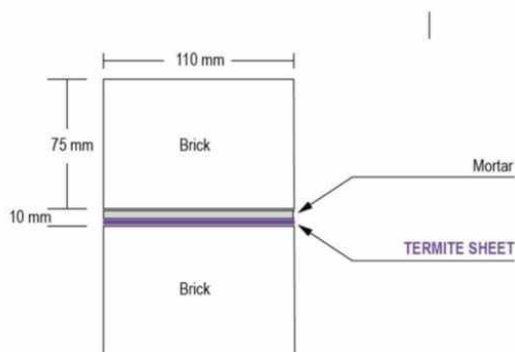
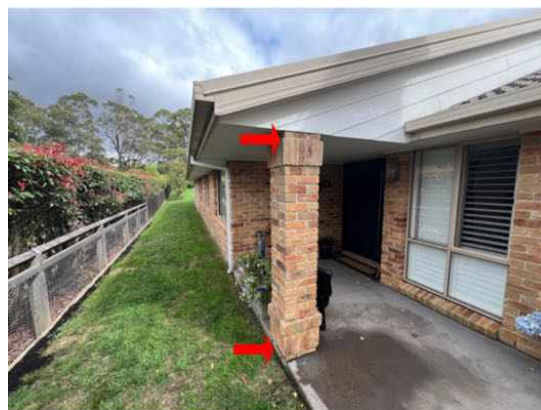
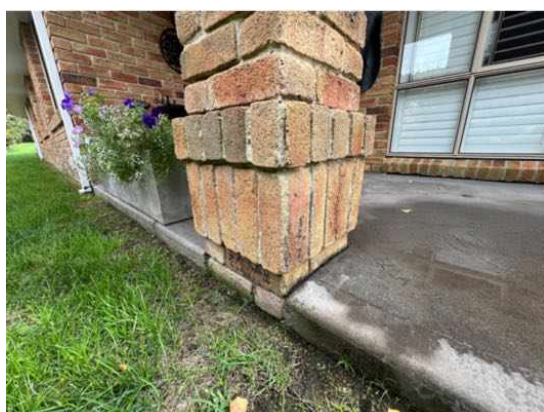
Finding 6.04

Building:	Main Building
Location:	Porch, Alfresco
Finding:	Bridging of termite barrier - brick piers.
Information:	Brick pier that are attached from ground to structure without a visible inspection zone (barrier 75mm AFL) causes a bridging point. Bridging of termite barriers occurs when termites bridge (usually by building a mud tunnel) a termite barrier or inspection zone or where termites have a passage allowing them to bridge the barrier.

Generally this takes the form of finished ground levels external paving or concrete being retrospectively installed above the damp course level the adjacent internal floor level or weep and ventilation holes.

Where bridging has occurred full inspection is prevented and termites may enter a property in a concealed or undetectable manner.

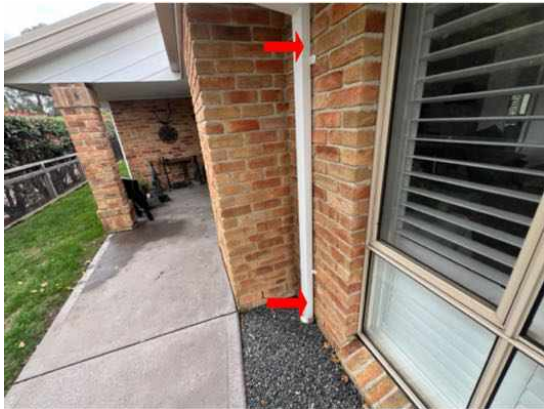
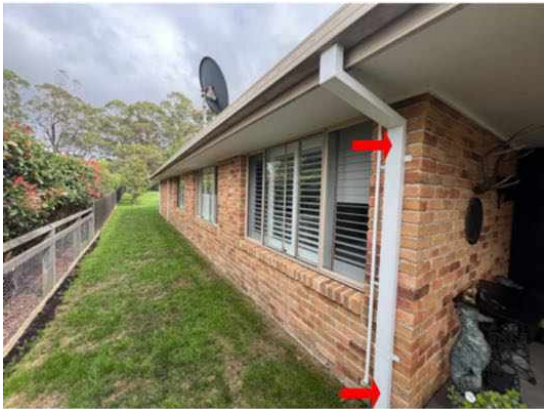
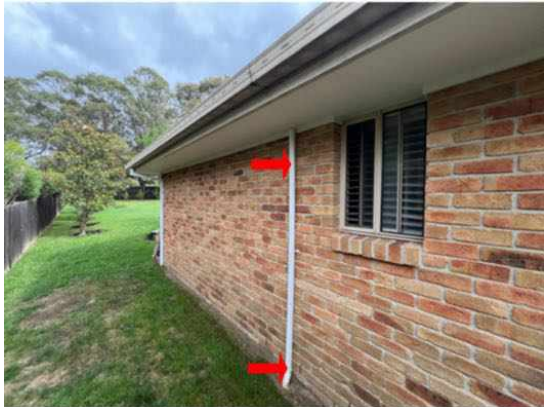
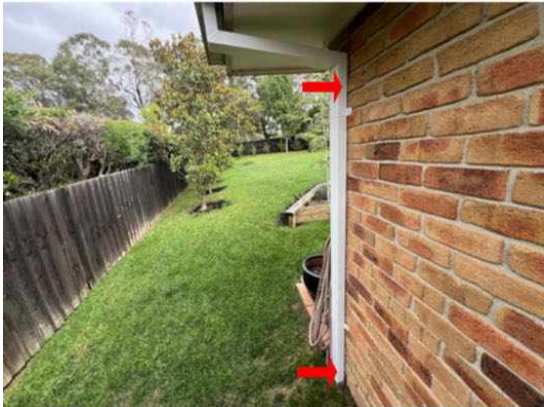
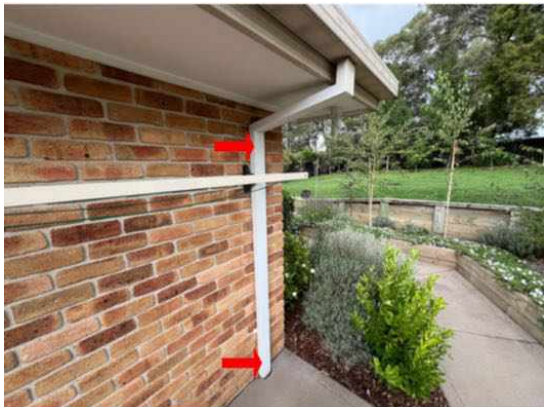
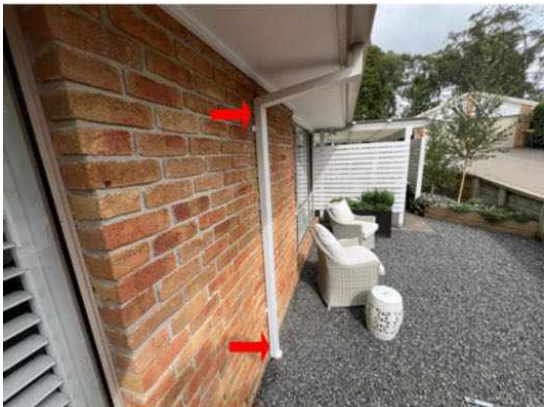
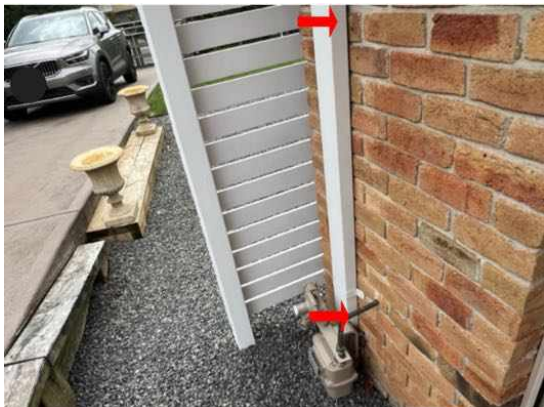
Finding 6.05

Building: Main Building
 Location: All External Areas
 Finding: Bridging - Attachments to Buildings.
 Information: Bridging occurs when items against a building provide a concealed entry point for termites into the building or by passing around a termite management system.

Where any part of an attachment to a building is not isolated and is not provided with a clear gap of not less than 25mm from the building, bridging occurs. Attachments to buildings such as hot water services, downpipes, verandahs, decks, steps, fences, service conduits and the like provide the opportunity for concealed entry.

Building attachments of this nature need to be frequently inspected for termite activity by a qualified inspector

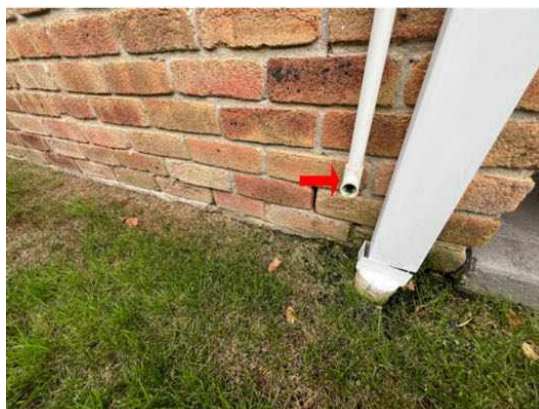
Building:	Main Building
Location:	Exterior walls - left side
Finding:	Air conditioner - Disconnected overflow
Information:	<p>The Air Conditioner (A/C) overflow was found to be disconnected from storm water drainage and is creating excessive moisture in the surrounding area.</p> <p>Such leaking creates an environment which is conducive to an array of defects, including water damage to associated building elements and the attraction of termite or timber pest infestation.</p>

It is highly recommended that a licensed plumber be appointed to connect the A/C overflow in order to prevent such an environment from being created. These minor works should be carried out as soon as possible.

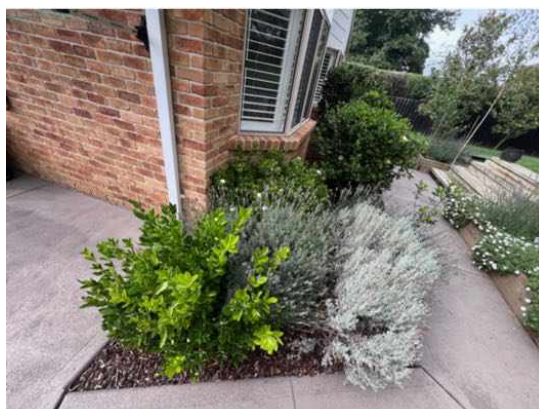
Finding 6.09

Building:	Main Building
Location:	All External Areas
Finding:	Garden Beds - Conditions Conducive to Termites
Information:	Garden beds were observed around the perimeter of the building, obstructing visual inspection of lower wall areas and providing potential concealed termite entry points.

Raised soil levels and retained moisture from watering can allow termites to access wall cavities or weep holes undetected, while timber edging materials may further encourage activity.

It is recommended that garden beds be reduced or cleared from the building perimeter, or that regular timber pest inspections be carried out in accordance with AS 4349.3 or AS 3660.2 to monitor risk.

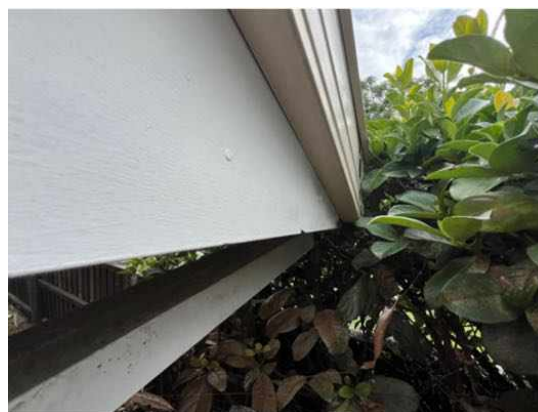
Finding 6.10

Information: Vegetation and trees were observed in direct contact or in close proximity to the building at the time of inspection. This condition creates a conducive environment for termite activity by providing concealed access points, retaining moisture against the structure, and reducing ventilation. Additionally, vegetation can contribute to organic debris buildup, further increasing the risk of pest infestation.

It is recommended that all vegetation be trimmed back to allow adequate clearance from the building. Ongoing maintenance is advised to reduce the risk of termite activity and improve ventilation around the structure. Regular termite inspections should also be conducted to monitor for any signs of infestation.

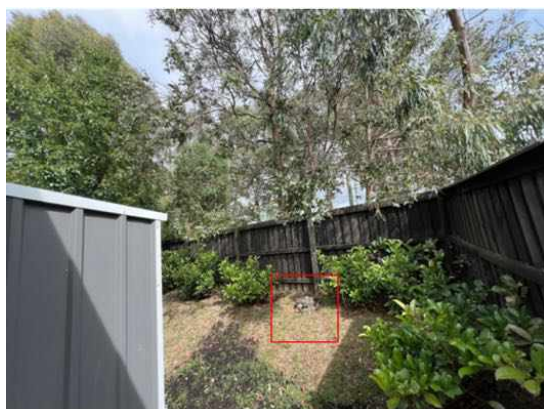
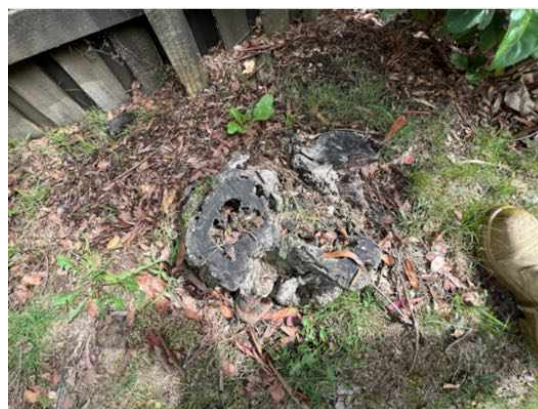
Building:	Yard
Location:	The Site
Finding:	Stumps, Dead or Decayed Trees - conductive conditions
Information:	Stumps and/or dead or decaying trees were observed within the property boundary during the inspection. These elements are recognised as significant conducive conditions, as they retain moisture and provide a cellulose-rich environment ideal for sustaining termite activity.

Even in the absence of visible termite workings at the time of inspection, decayed timber material can support undetected subterranean termite harbourage, particularly when located in close proximity to the dwelling. The risk of concealed termite ingress into structural timbers is increased when such materials are not removed or managed appropriately.

The client is advised to consult a licensed pest management professional to assess the site and determine whether treatment or removal of the stumps or trees is required. Ongoing timber pest inspections should be maintained at regular intervals to monitor for any future activity.

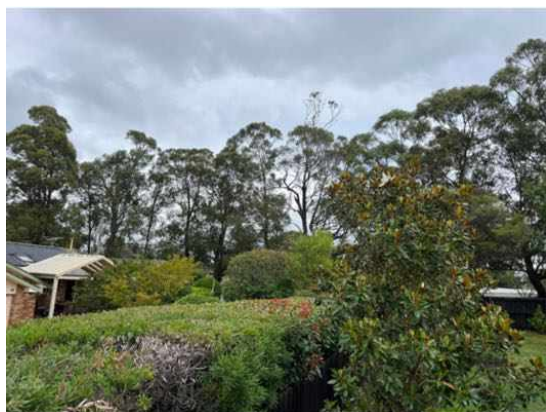
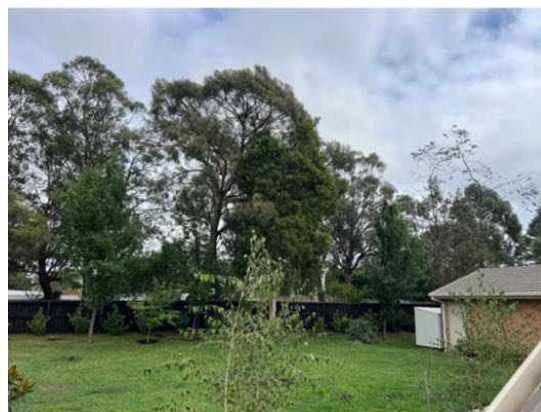
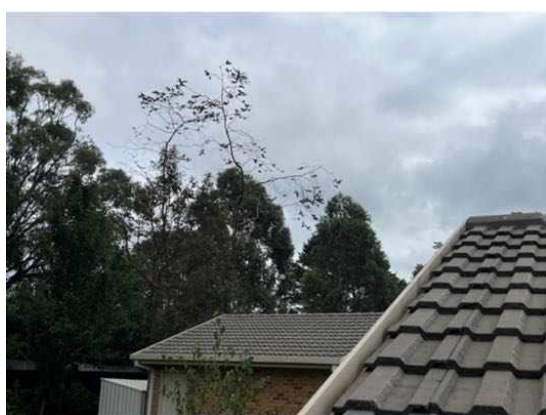
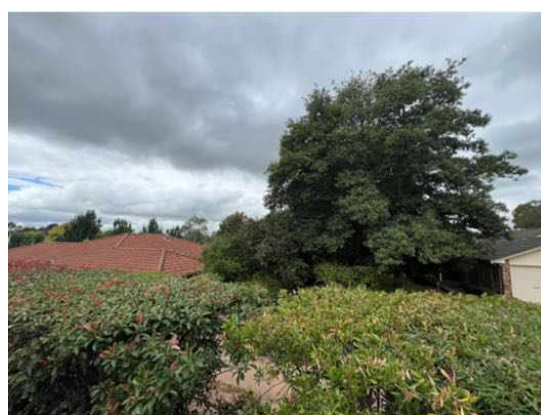
Finding 6.13

Building:	Yard
Location:	The Site
Finding:	Timber Pest Risk – Trees Within 50m of Dwelling
Information:	Mature trees were identified within 50 metres of the dwelling. The presence of trees in close proximity to the structure increases the risk of termite activity, as trees provide a natural food source and nesting environment for termites. Tree roots can also contribute to excessive moisture retention in the soil, creating conducive conditions for timber pest activity.

Regular monitoring for signs of termite activity is advised. A licensed pest inspector

should be engaged to assess the area and provide further recommendations on risk mitigation and management.

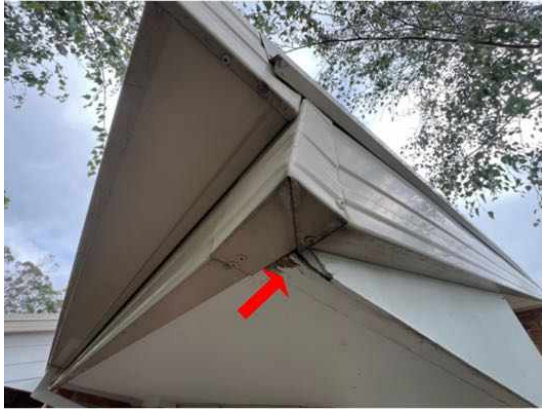
Finding 7.01

Building:	Main Building
Location:	Exterior walls - front
Finding:	Fungal decay - present (localised)
Information:	Fungal decay also known as wood decay or wood rot generally refers to the deterioration of timber elements when in contact with excessive levels of moisture for a prolonged period of time.

The development of fungal decay is accelerated by temperatures in the range of 5degreeC to 40degreeC as well as the presence of oxygen. Generally fungal decay develops on timber elements that are in use in an external environment which are exposed to rain penetration.

In this case although the affected timber element is in a decaying state the extent of any visible damage appears to be localised to a specific area and is yet to spread to other parts of the building element or affect adjoining structures. The fungal decay is

therefore likely to be of a relatively superficial nature with minimal impact on the structural integrity or tensile strength of the timber element.

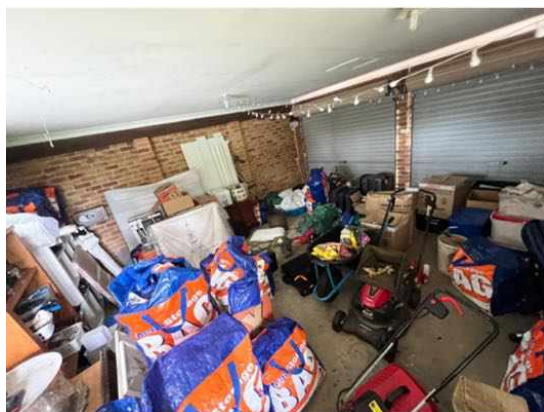
Building:	Shed
Location:	Shed
Finding:	No Access
Information:	Access to this area was restricted at the time of inspection, preventing a full assessment. The condition of any concealed elements could not be determined, and defects may exist that were not visible during the inspection.

Further inspection is recommended once access is made available.
