Building and Timber Pest Inspection Report

Inspection Date: Fri, 20 Feb 2026

Property Address: 12 Rosemary Cres, Bowral NSW 2576,
Australia

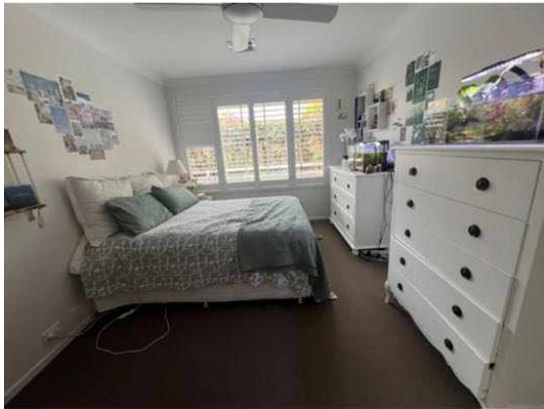
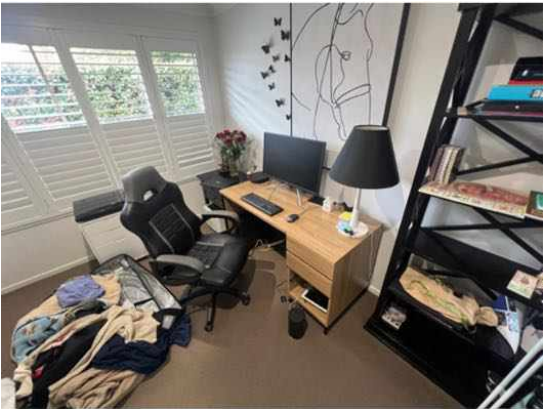
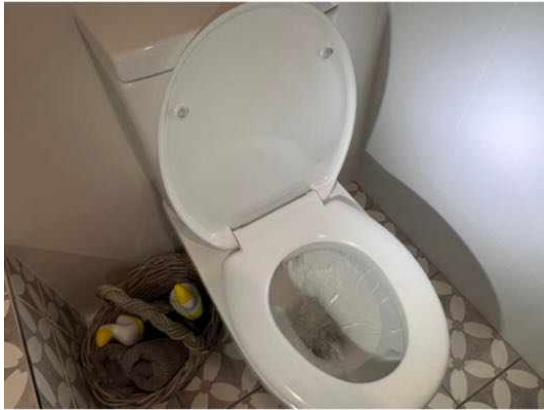
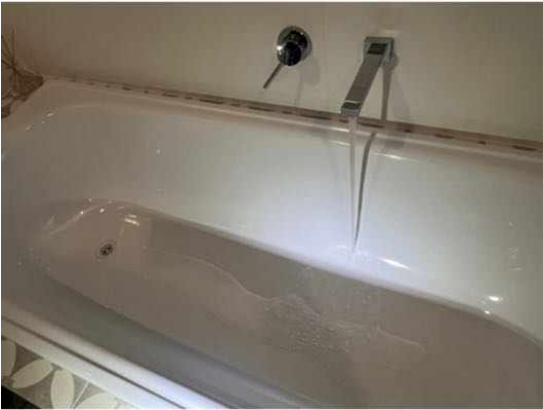
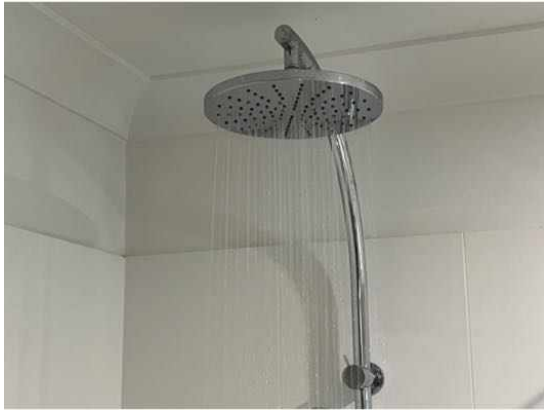
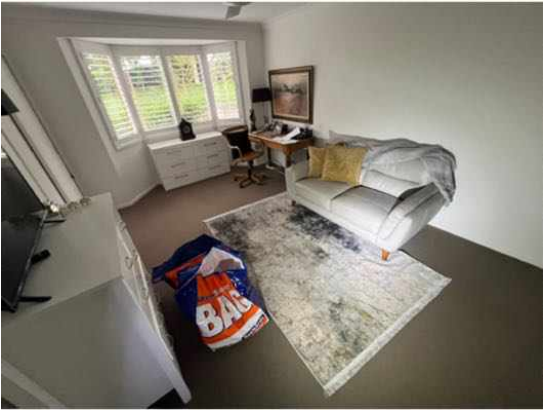
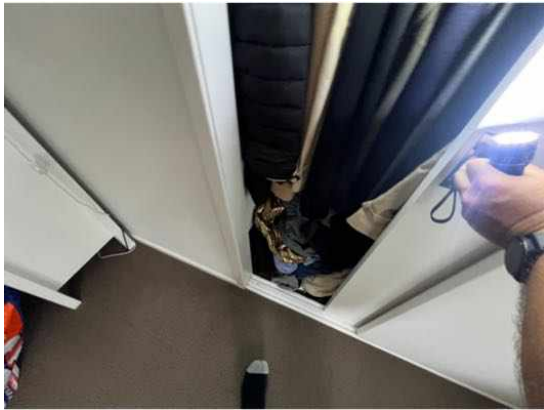
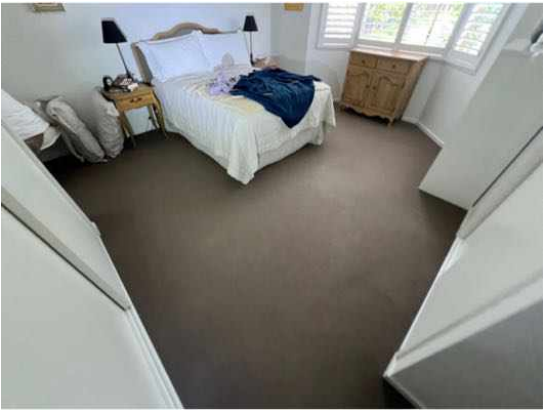
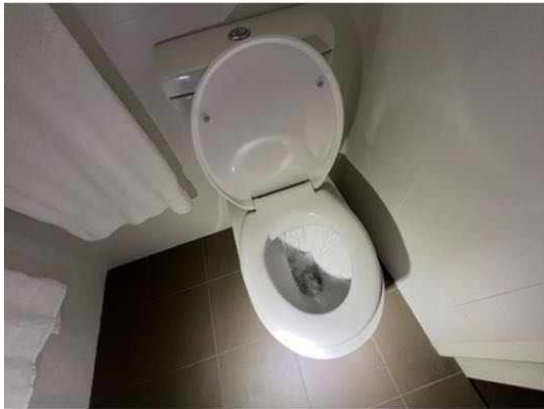
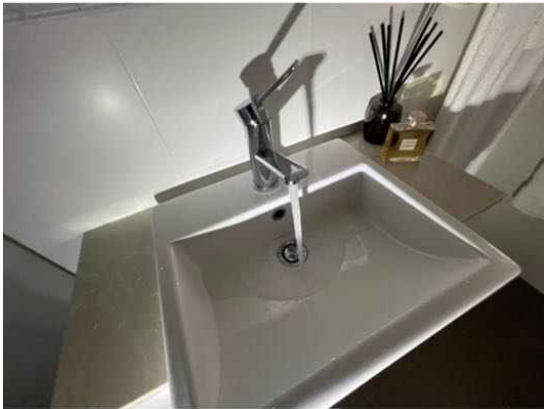
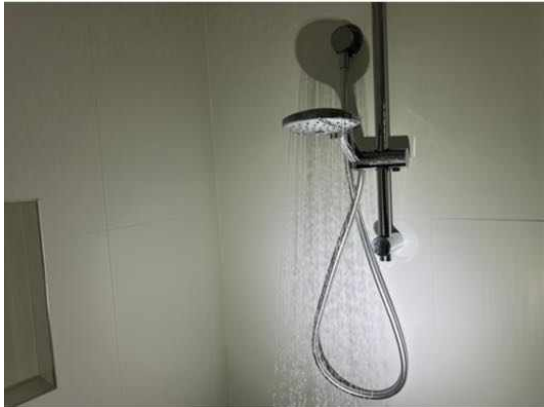
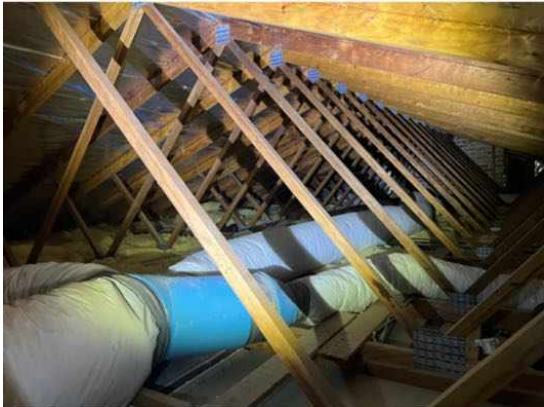
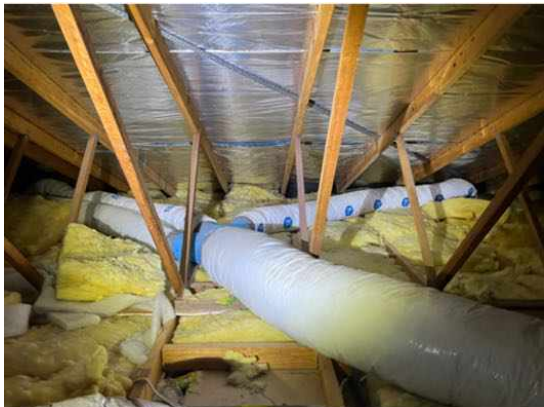
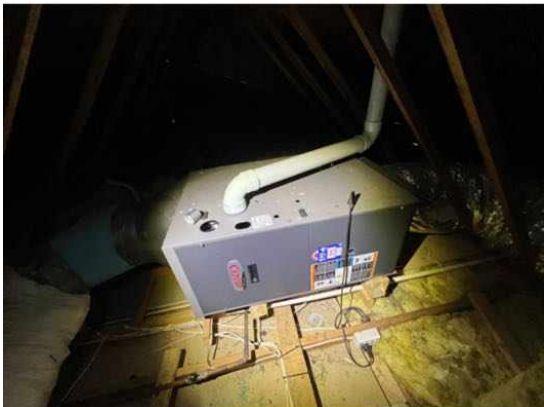
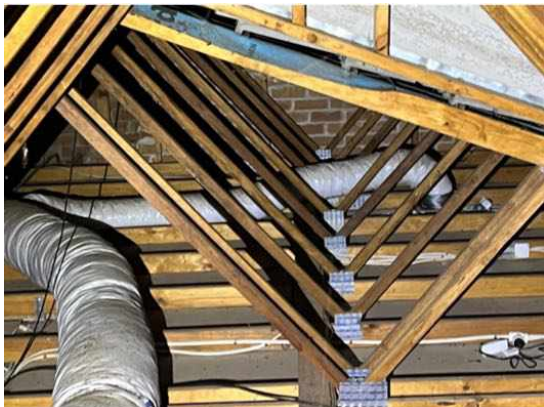
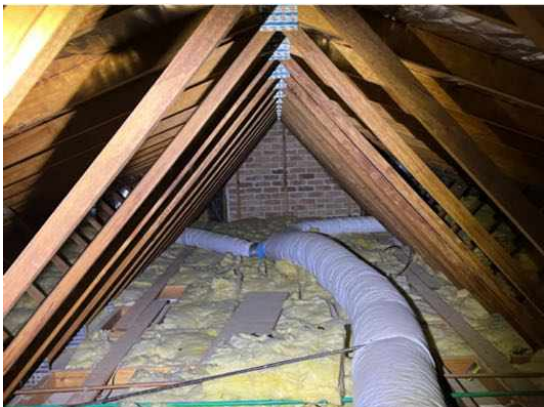
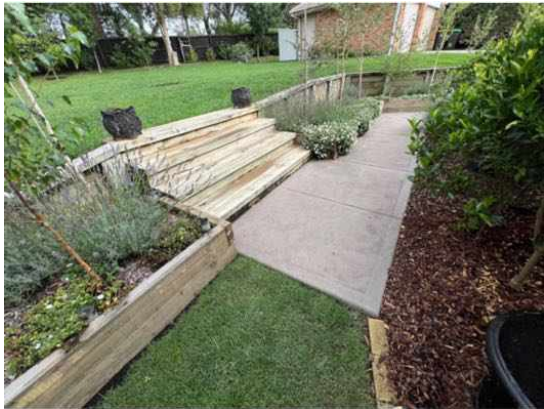
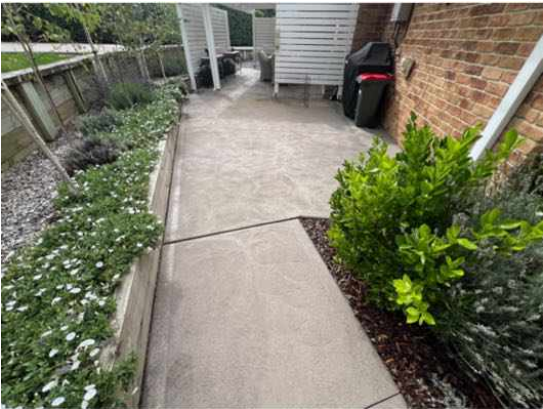
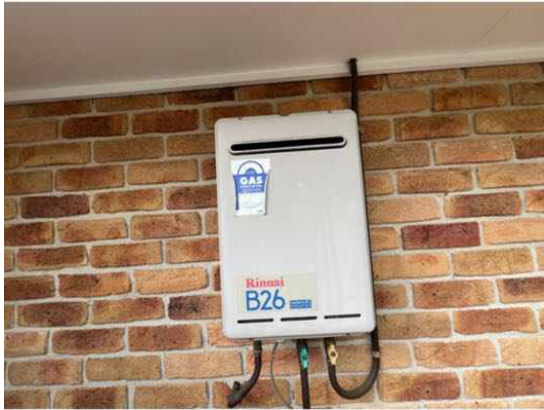
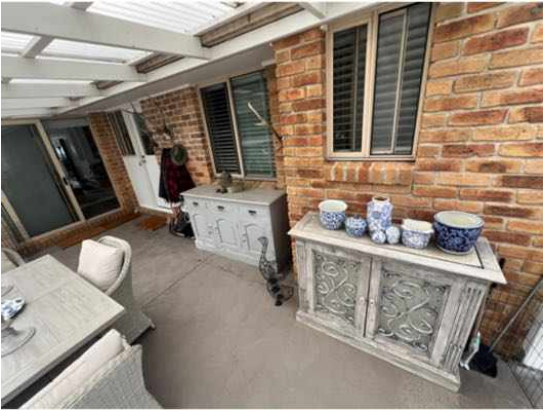
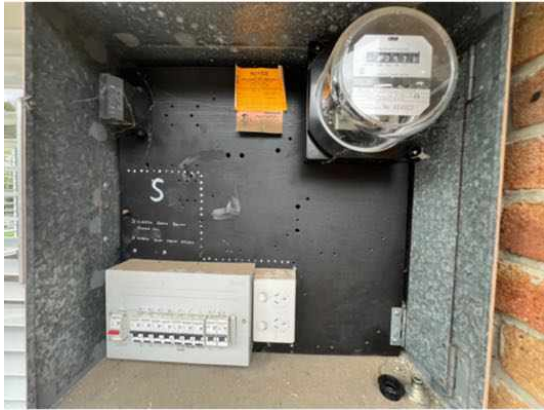
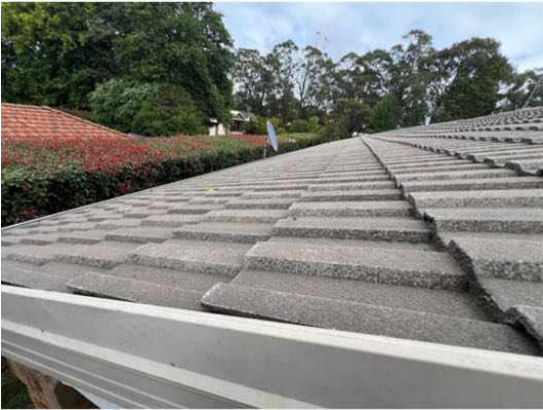
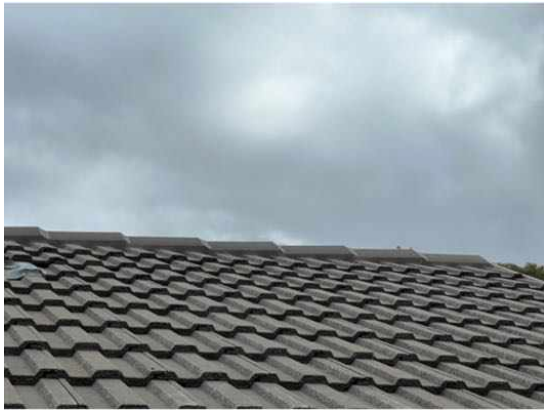
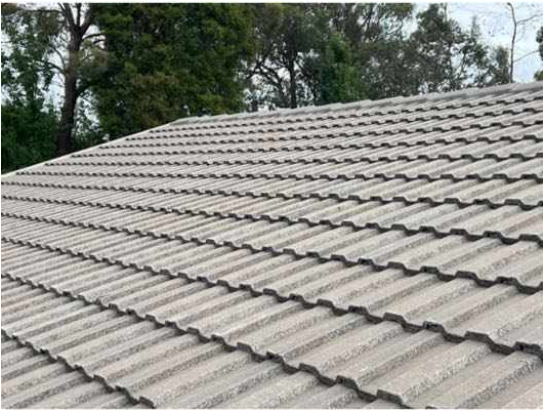
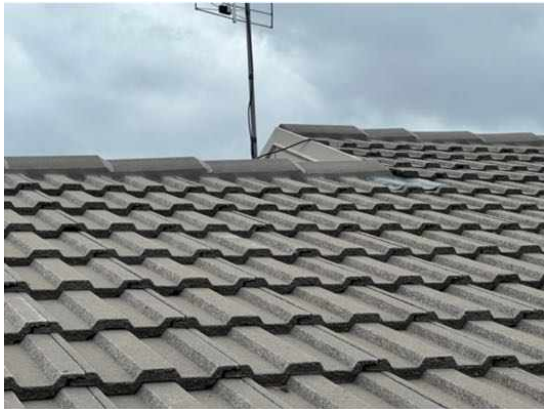
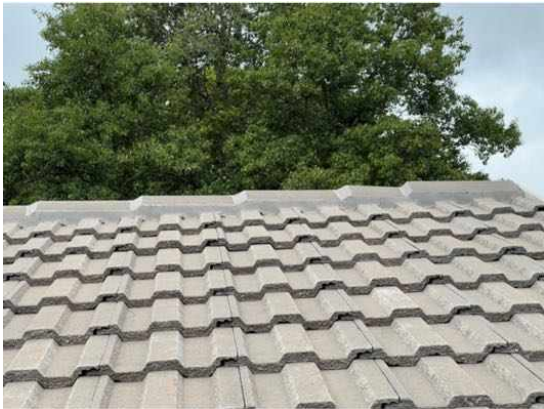
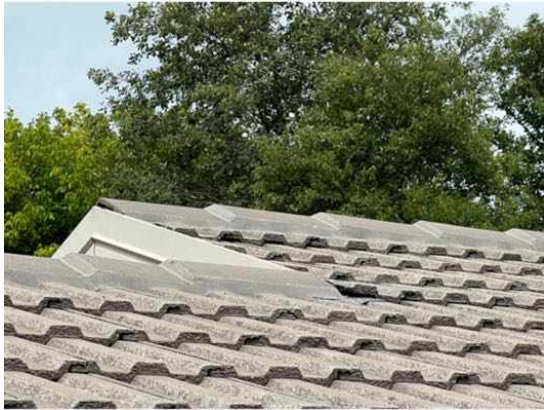
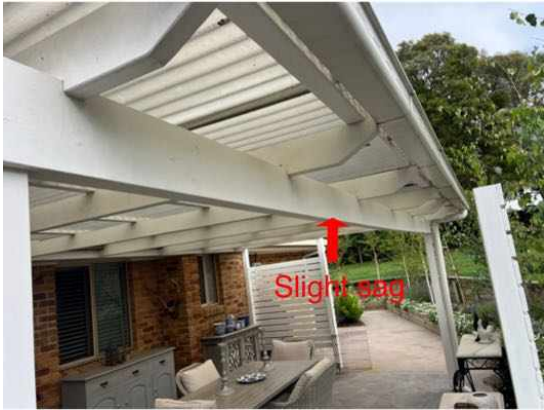
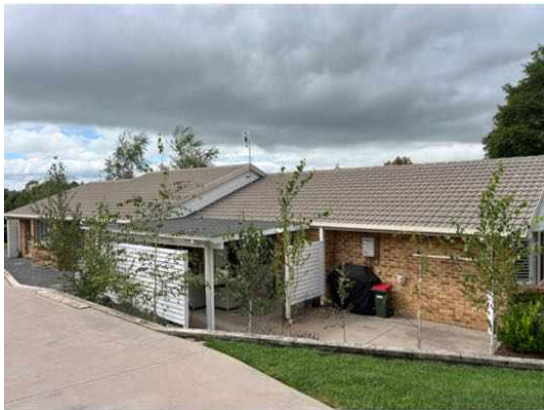
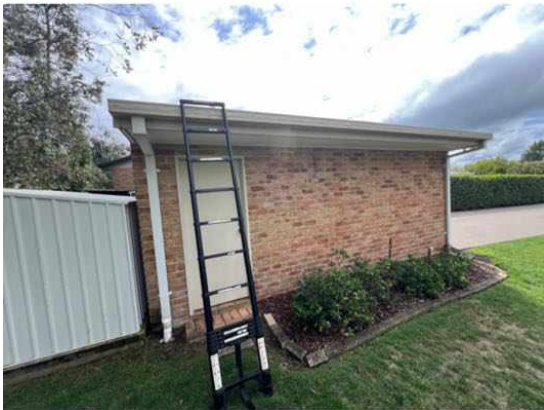
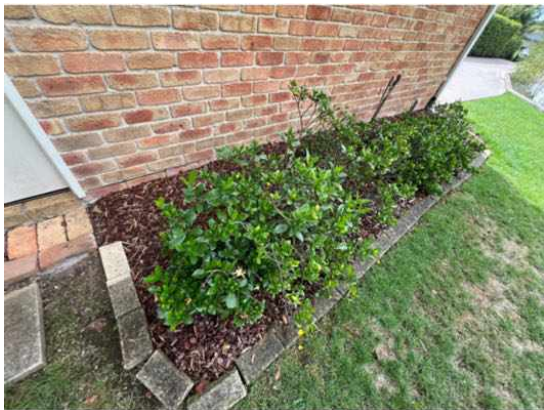
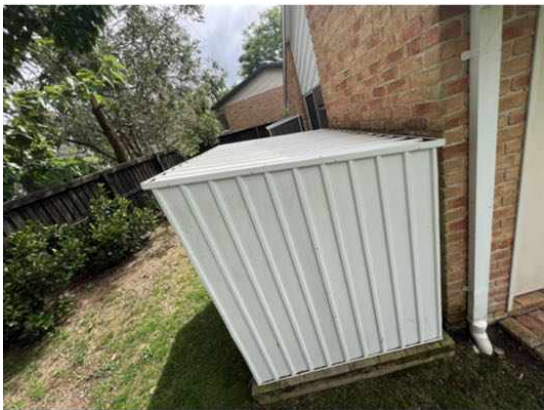
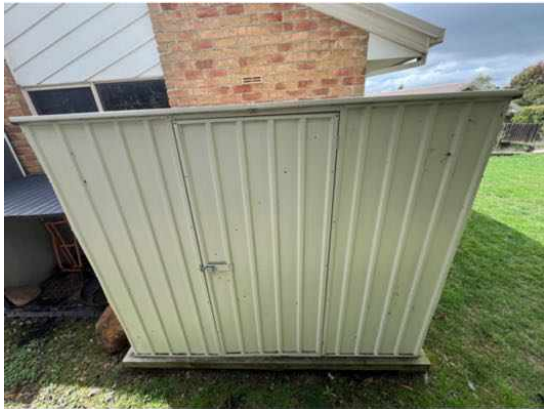
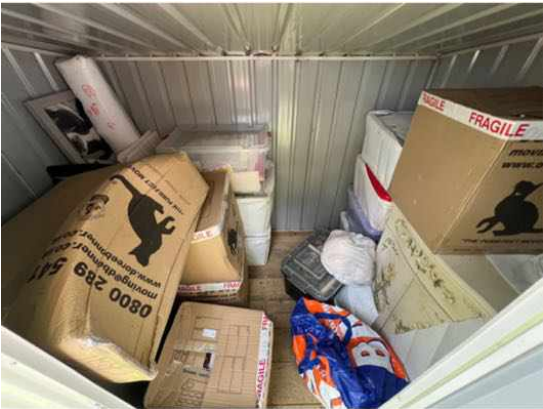
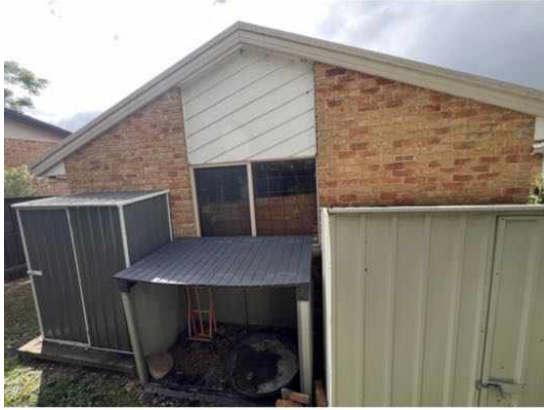
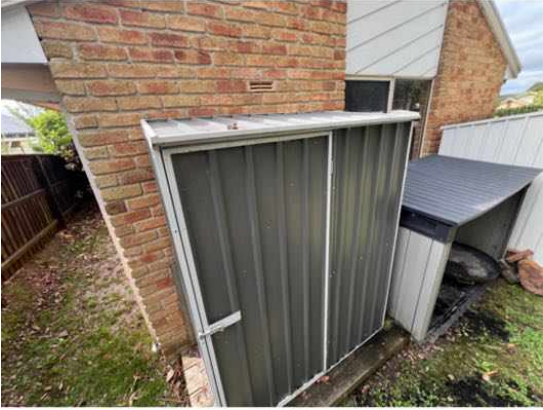
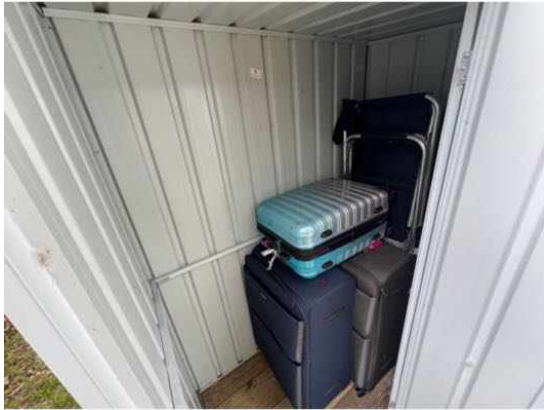
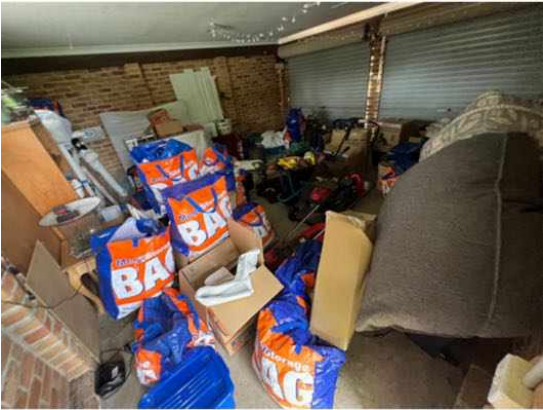
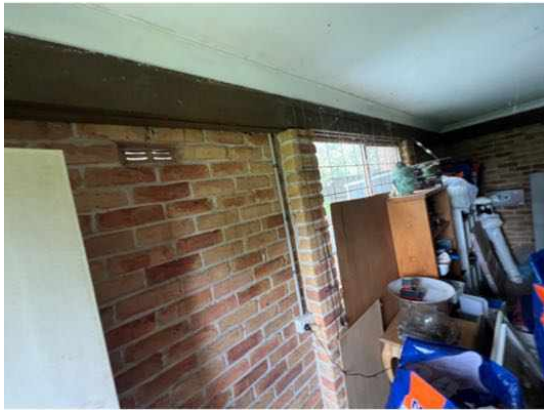
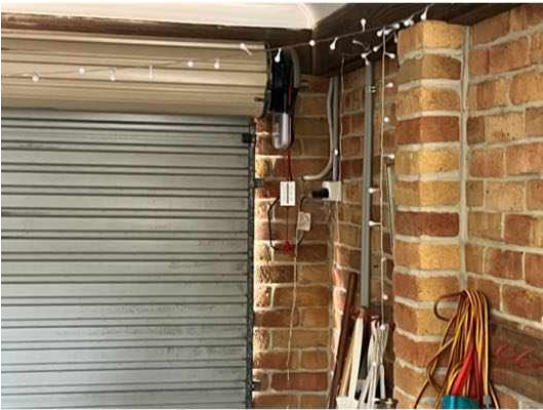
Building: Main Building
Location:
Finding: FYI - Additional Photos
Information: Additional photos are provided for your general reference and may include obstructions, testing of water & windows, moisture readings or minor maintenance items.

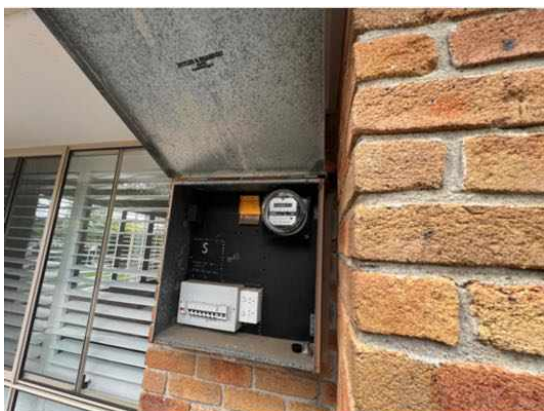
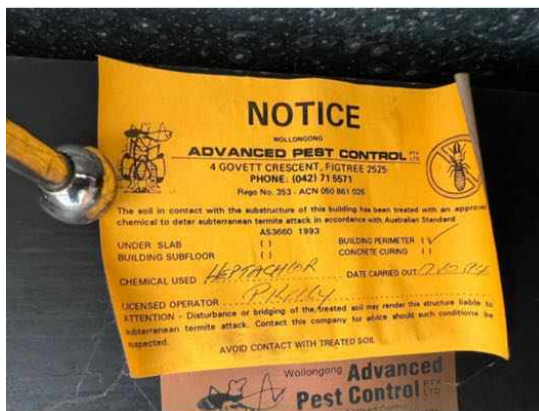
The following items were noted as - Evidence of a previous termite management program

Where a Termite Management System has been identified you should refer to the type of barrier date of installation warranty conditions and any documentation provided by a builder or past owner. Consult the company who installed the barrier to confirm whether the system is still under warranty.

Most chemical termite management systems expire and require replenishment and all physical systems are primarily designed to prevent concealed entry.
