Building and Timber Pest Inspection Report

Inspection Date: Tue, 19 Aug 2025

Property Address: 16 Maytone Ave, Killara NSW 2071,
Australia

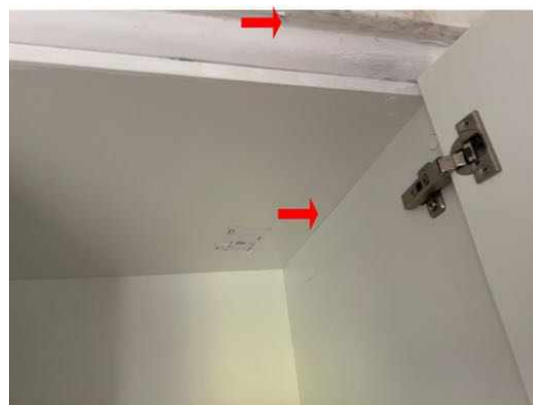
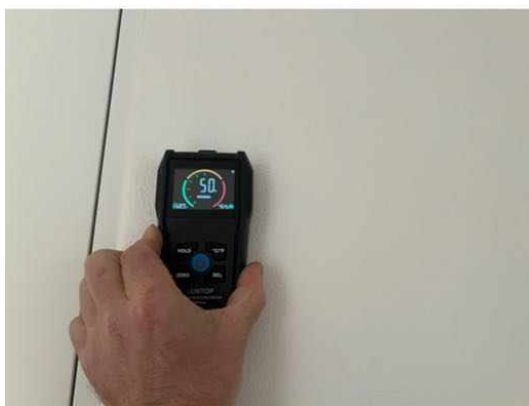
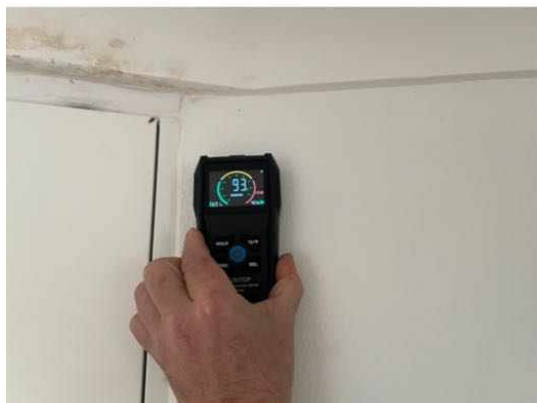
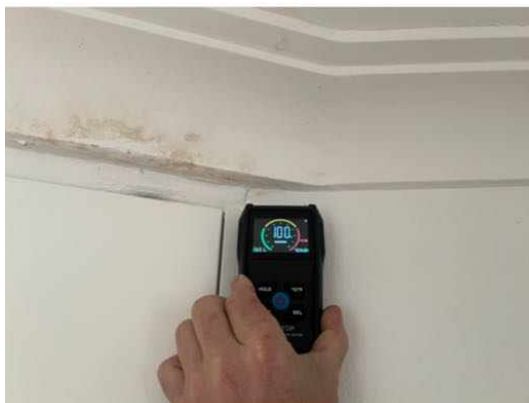
| Finding: | Water leak - Active |
| Information: | Generally, water leaks occur when a particular area of the property is not weather or water tight. As the surrounding area was found to be damp at the time of inspection, the leak is considered ongoing and hence requires urgent action. |

Regardless of the location, even minor leaks that are left unmanaged can lead to serious damage of associated building elements and result in the need for replacement of building materials. Mould and other hazards such as electrical hazards may also arise if the leak is left to develop.

It is highly advised that the cause of the leak be identified and resolved immediately by a licensed plumber to prevent any further damage. Depending on the extent of the damage previously sustained, repair and/or replacement of any affected building materials may be required.

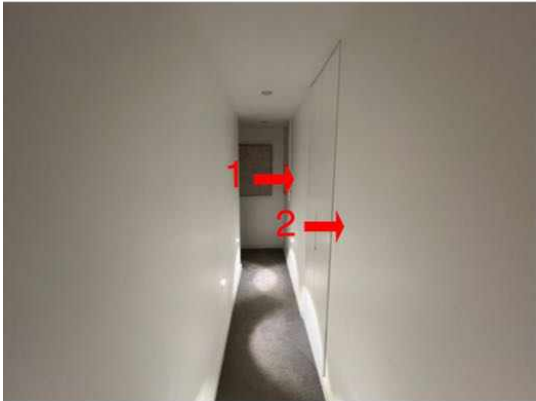
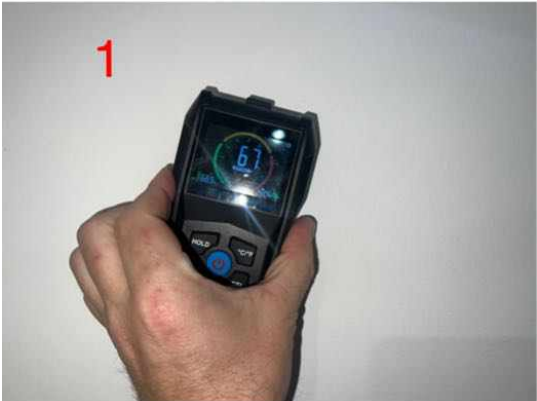
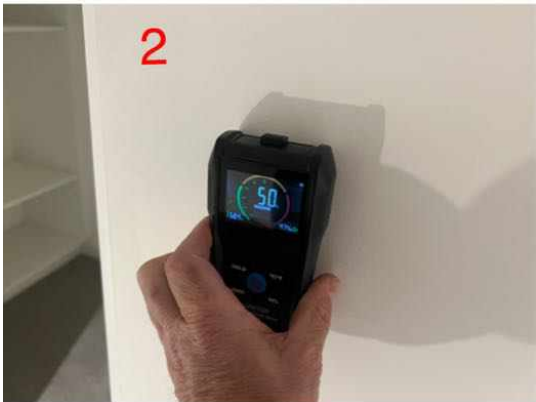
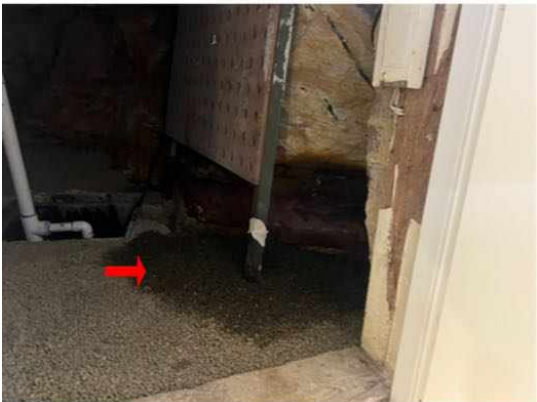
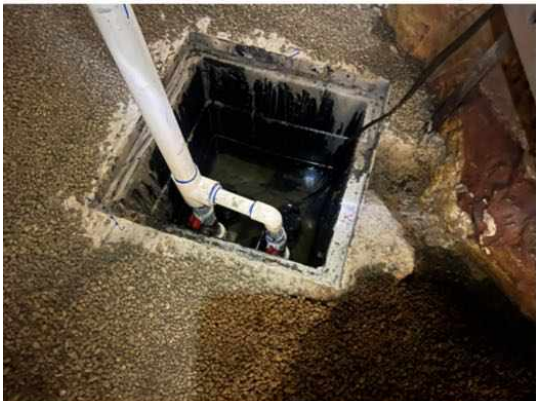
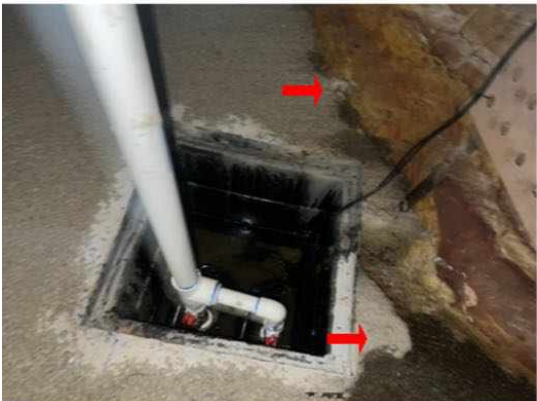
Finding 2.02

| Finding: | Excessive moisture - identified |
| Information: | Excessive moisture can attract termites and produce conditions that promote fungal growth and wood decay. |

Excessive moisture is generally caused by deteriorated, inadequate or missing roof drainage, leaking plumbing pipes or fixtures, poorly plumbed HWS overflows or condenser units and poor site drainage.

In this case the position of the dwelling and the site conditions (being built into sandstone) means the subfloor and the perimeter of the building are subject to higher than usual levels of moisture.

It is crucial that these levels are monitored to ensure no damage to the dwellings is sustained. Humidity levels in the lower ground floor areas are relatively high.

There were also signs of water in the subfloor area as well as rust appearing on painted structural steel members supporting the floor structure above.

I recommend a mechanical ventilation contractor be engaged to discuss and plan a suitable ventilation system to service and protect the lower ground floor area

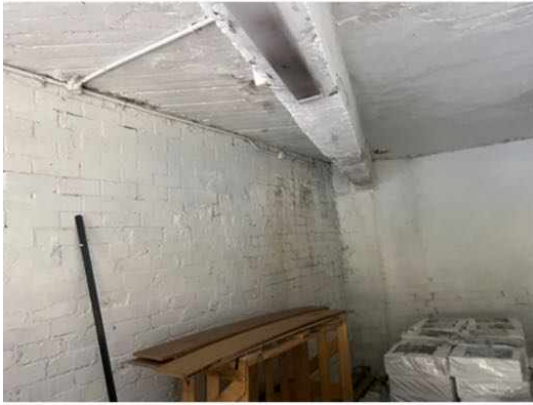
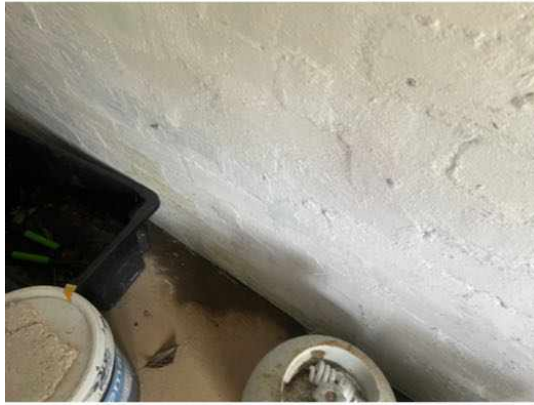
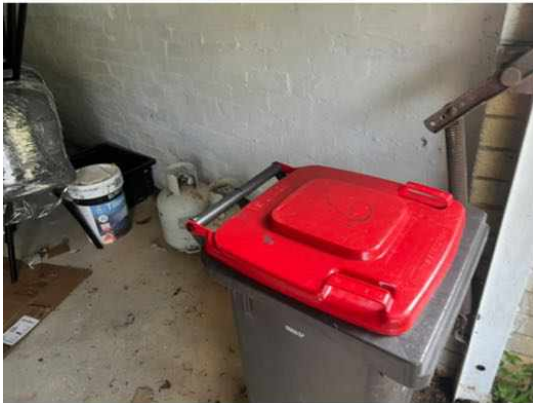
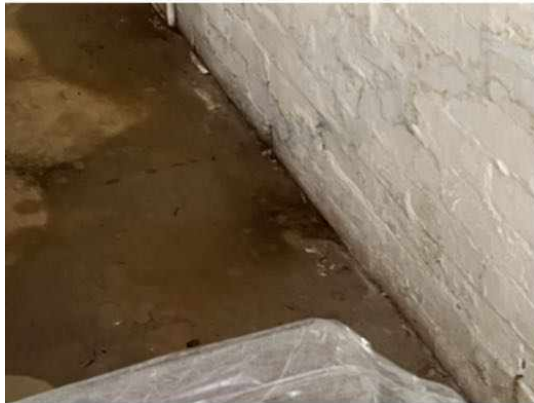
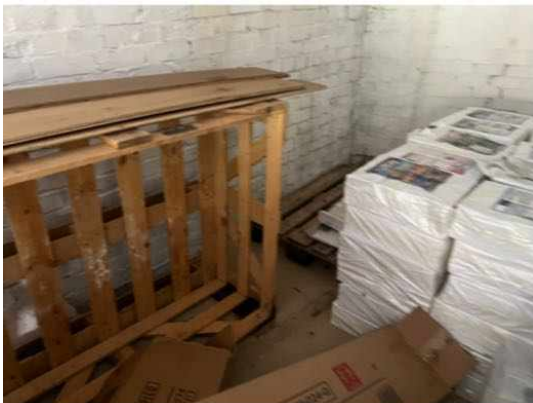
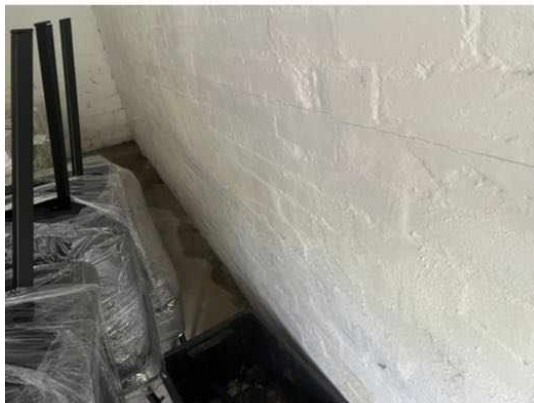
Finding 2.05

| Finding: | Water leak - Active |
| Information: | Generally, water leaks occur when a particular area of the property is not weather or water tight. As the surrounding area was found to be damp at the time of inspection, the leak is considered ongoing and hence requires urgent action. |

Regardless of the location, even minor leaks that are left unmanaged can lead to serious damage of associated building elements and result in the need for replacement of building materials. Mould and other hazards such as electrical hazards may also arise if the leak is left to develop.

It is highly advised that the cause of the leak be identified and resolved immediately by a licensed plumber to prevent any further damage. Depending on the extent of the damage previously sustained, repair and/or replacement of any affected building materials may be required.

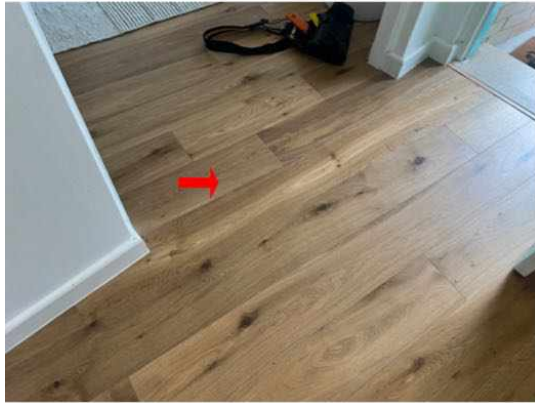
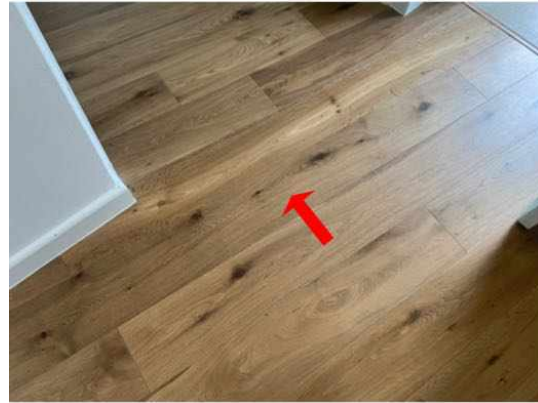
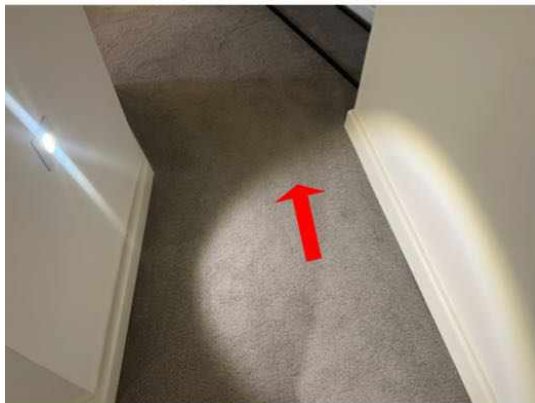
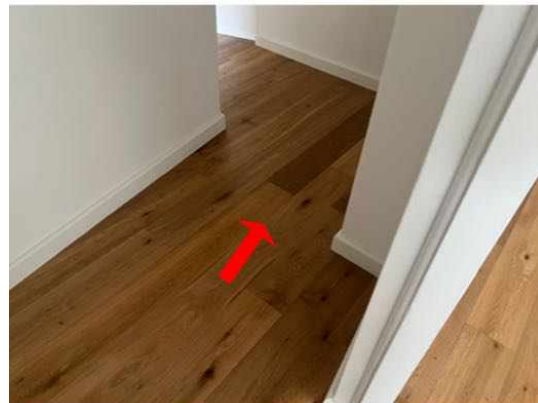
Finding 3.01

| Information: | The internal flooring in this area is out of level and uneven. Uneven flooring is likely to indicate minor defects such as expected movement of the foundations of the property, but may also indicate subsidence of the associated subfloor structure. |

It is advised that the flooring be closely monitored to identify any further movement. Where flooring remains relatively unchanged for an extended period of time (i.e. several months), it is likely that this defect has been caused by expected movement of the foundations of the property.

However, where flooring is uneven further, potentially invasive inspection of the subfloor structures and stumps in this area is required. In this case, works to repair are likely to be required, and would be carried out by a registered builder specialising in foundation rectification.

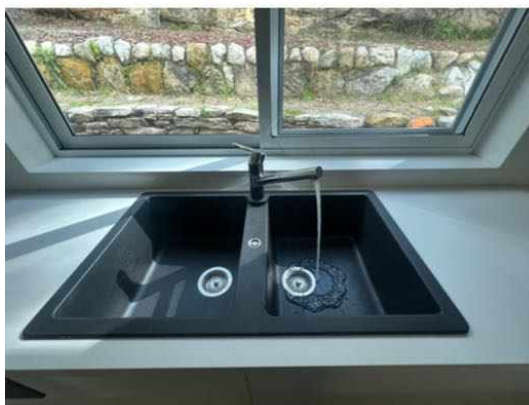
Finding 3.02

Building: Main Building
 Location: Kitchen > Centre
 Finding: Tap - Water hammer
 Information: This tap shows evidence of water hammer being present. Water hammer, a pressure surge resulting when a fluid is forced to suddenly change direction, is a common defect in plumbing fittings, particularly those that are aged and not frequently maintained. Water hammer is generally caused by factors that create high water pressure in the affected plumbing fixture, usually evidenced by a faint banging noise during operation of the affected tap.

Although water hammer is generally considered to be a minor defect, subsequent damage such as erosion of tap hardware and/or water damage to associated building elements is likely to occur if left unmanaged.

A licensed plumber should be appointed as soon as possible to replace any affected tap hardware and perform any remedial works as necessary. Please be advised that the appointment of a cabinet maker or qualified carpenter may be necessary if water damage to associated building elements has occurred.

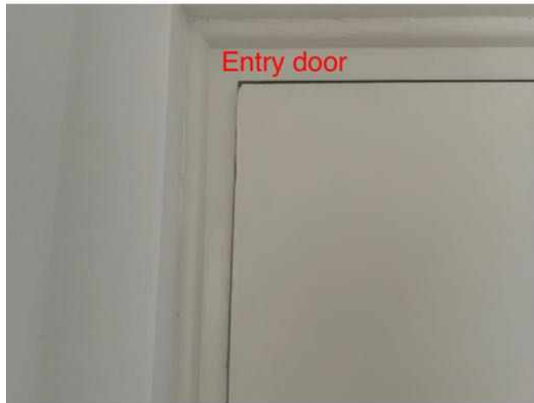
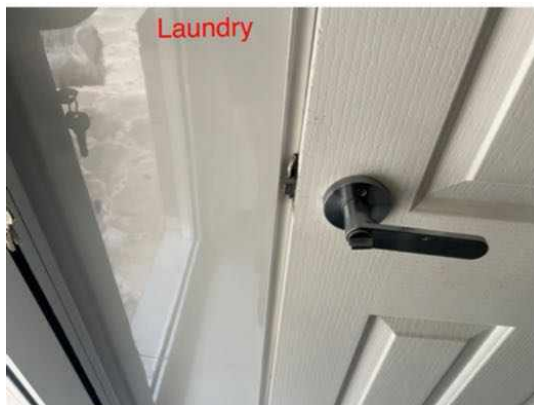
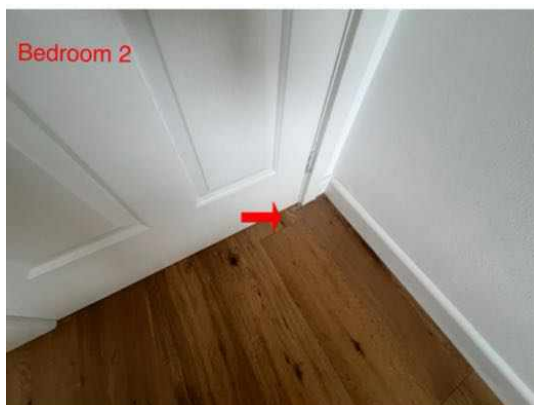
Finding 3.03

Building: Main Building
 Location: All Areas > All Areas
 Finding: Doors - Binding/Jamming
 Information: Binding and/or jamming of several doors throughout the property were evident during standard operation. This defect inhibits the functionality of affected doors as well as creating potential for secondary defects to associated building elements, such as damage to the floor covering.

A door that binds to flooring or to the associated door frame may have several causes, ranging from minor defects, such as poor installation of the door or deteriorated hinges, through to major structural issues, such as damage to subfloor structures.

Where door binding/jamming appears to indicate major structural issues, a registered builder specialising in re-stumping should be appointed to provide an estimate on the cost of rectification.

For minor causes, a qualified carpenter or general handyman should be appointed to perform minor rectification works at client discretion.

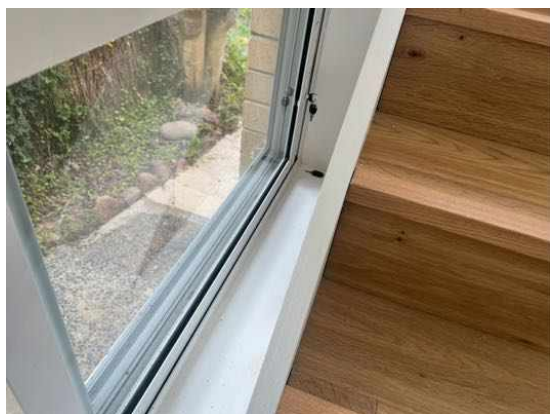
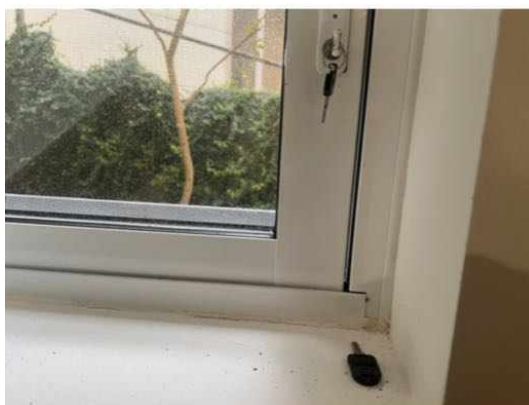
Finding 3.04

Building: Main Building
 Location: Family Room > Lower-Ground Level
 Finding: Window - stiff to close.

Information: The window in this area slides to just before the closed position but does not close properly. This can be remedied at the discretion of the homeowner.

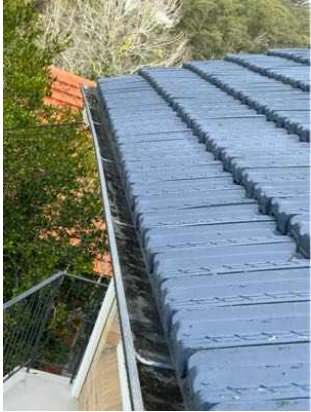
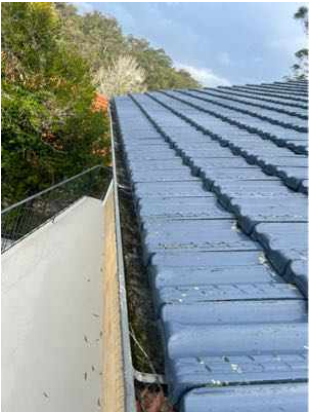
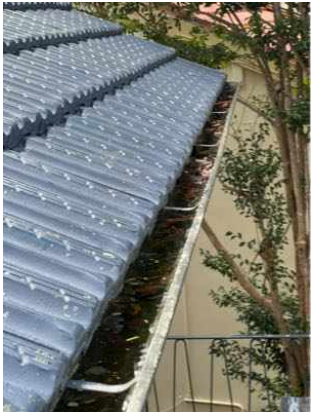
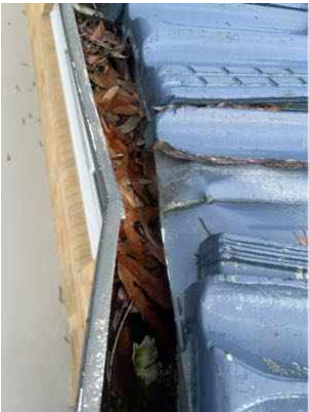
Gutters are a critical part of the building's management of storm water and rain. It is therefore important that they be kept clear to prevent secondary damage to associated building elements, including exterior and interior walls, ceiling linings and any adjoining building elements. Where gutters are blocked, pooling of rainwater is likely to occur, fast-tracking rust and corrosion of the roof plumbing elements.

It is highly advised that all overhanging tree branches be removed as soon as possible to prevent any further damage. Repair and/or replacement of sections of damaged guttering may also be required where the extent of the damage necessitates.

Such works should be performed by the homeowner; however, appointment of a landscape contractor or an arborist may be required. Consultation with a licensed roof plumber is required where guttering has been damaged.

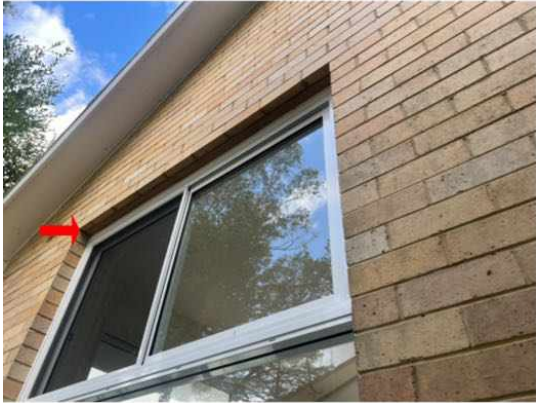
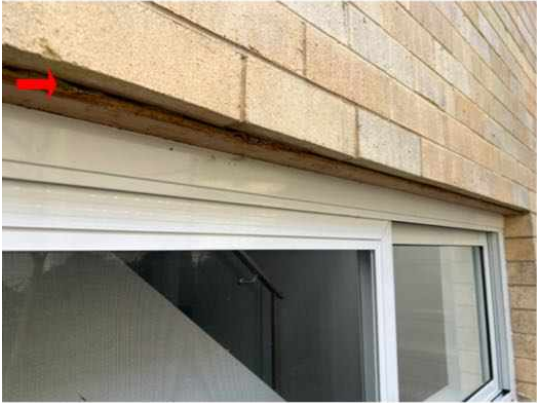
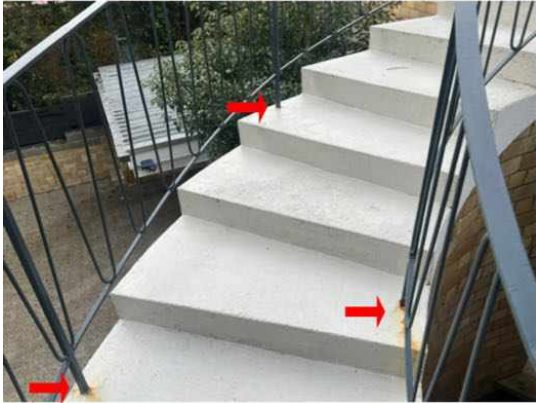
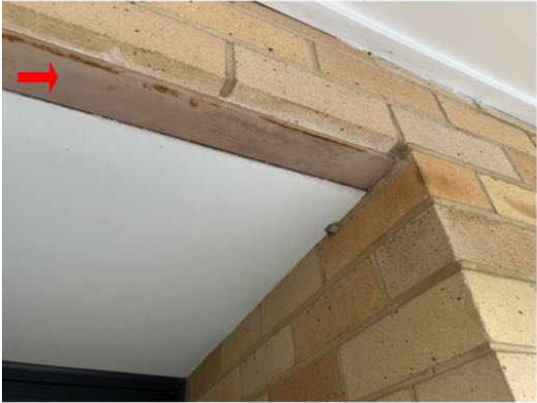
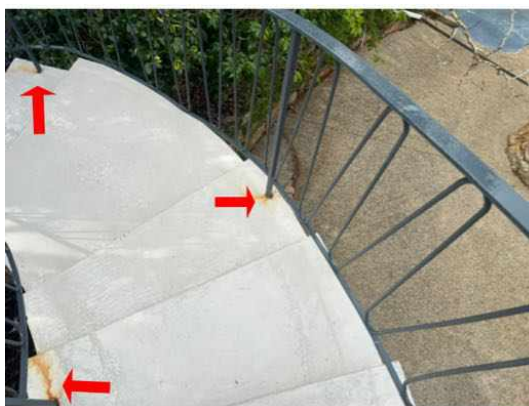
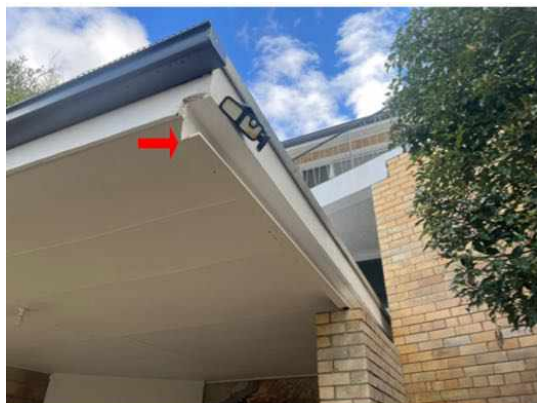
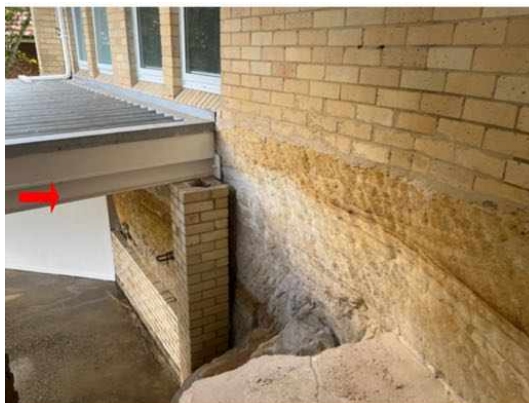
Finding 3.06

Building: Main Building
Location: All Areas > All Areas
Finding: Deteriorated components
Information: It was identified that some elements around the exterior of the home have suffered from environmental effects.

Rust has formed in various areas where metal has been exposed to the elements for prolonged periods of time and the paint has not been unkept.

Secondary defects are likely if the issue is not addressed.

A licensed painter is recommended to take back affected areas and treat prior to painting. If areas of serious damage are found a licensed builder should be engaged to remedy.

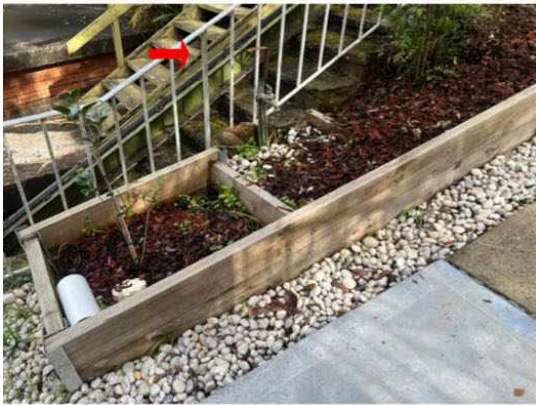
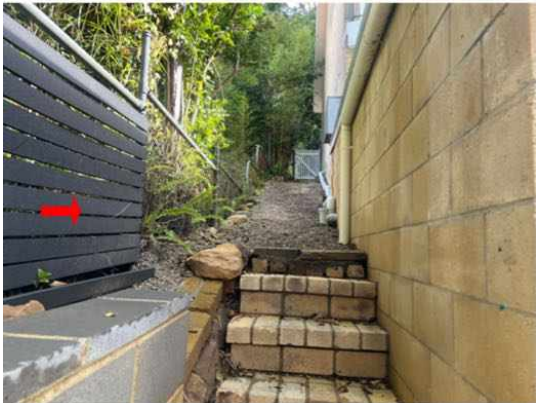
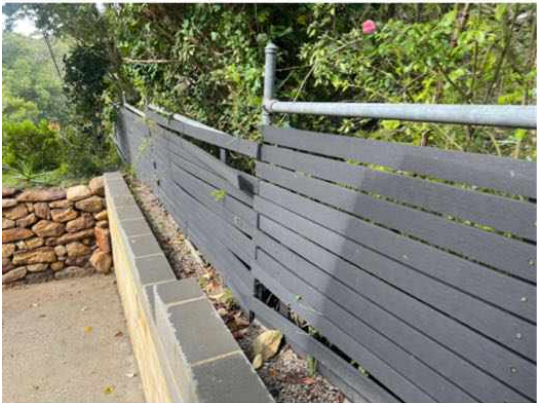
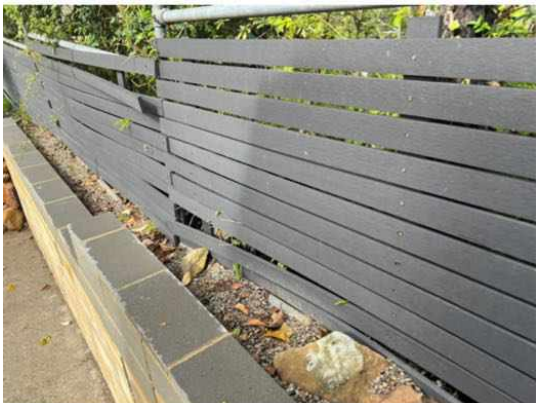
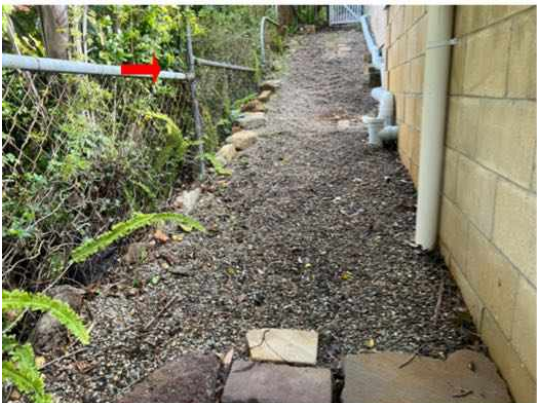
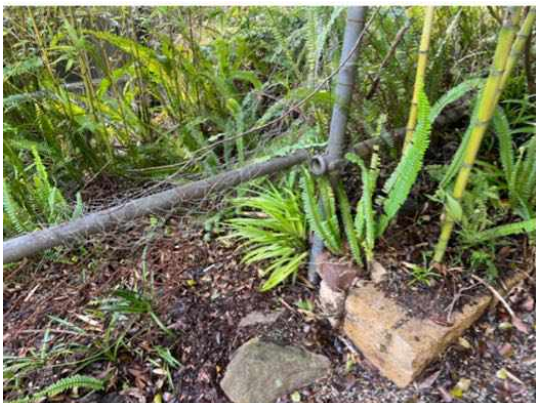
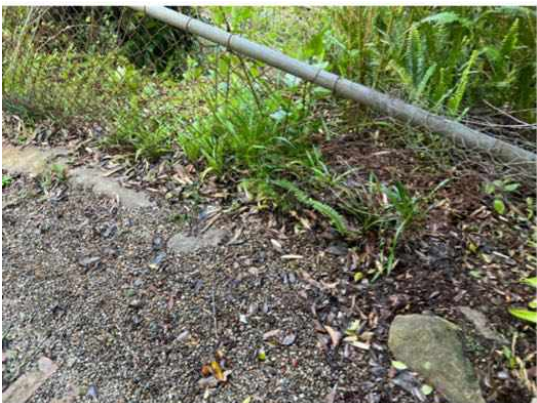
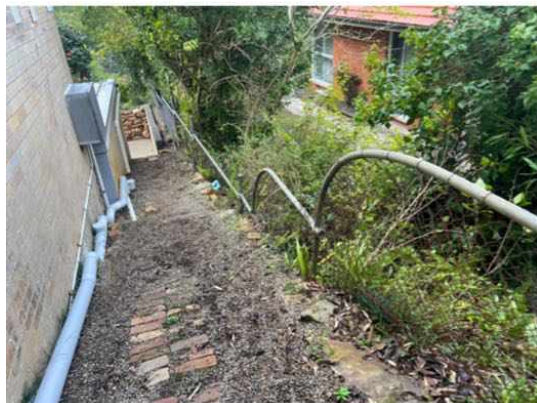
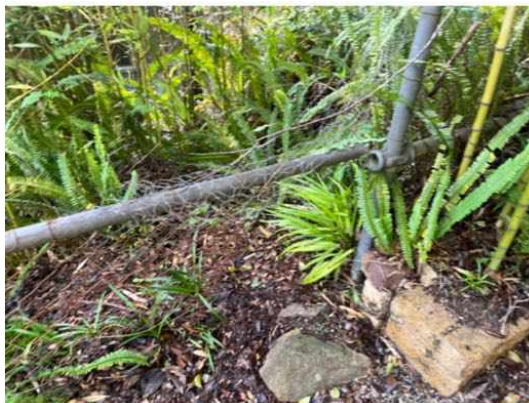
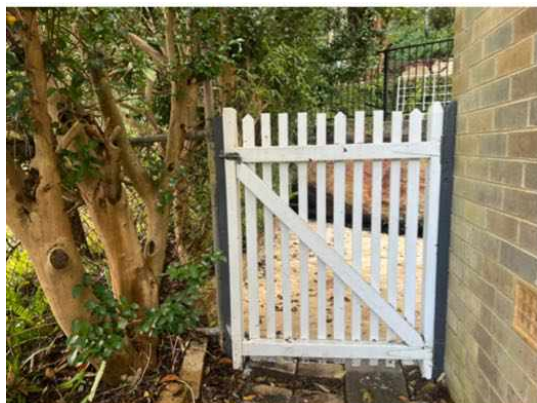
Finding 3.07

| Finding: | Fencing - Deteriorated |
| Information: | It was noted at the time of inspection that sections of the fencing throughout the property have deteriorated. Typically fencing deteriorates due to age and or wear, rot and or rust which is generally expected for a structure of this age, due to prolonged exposure to weather conditions. Sometimes inadequate installation or maintenance can be to blame. |

If left unattended, it is likely that further damage will occur. It is suspected that repair of several elements of the fencing may be required however replacement may be a consideration of the client also.

A licensed fencing contractor should be appointed to provide further advice and perform rectification works as necessary.

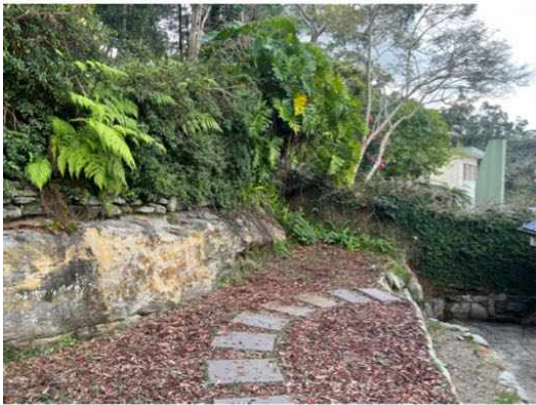
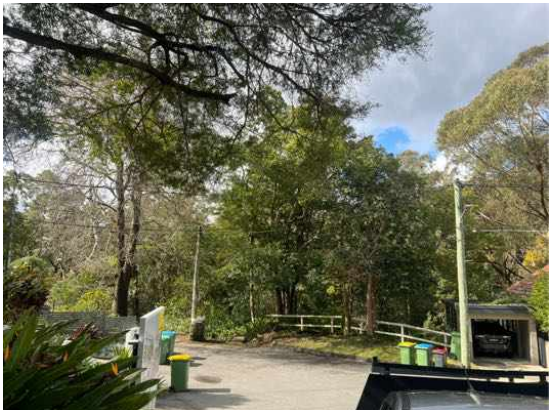
Finding 6.01

Building: Main Building
Location: All Areas > All Areas
Finding: Dwelling Location - Highly susceptible to timber pest
Information: The dwelling is located in a very green, leafy area. It is also built into sandstone which is a moist/damp environment. The combination of these two factors makes the site highly susceptible to timber pest. This has been included for your information.

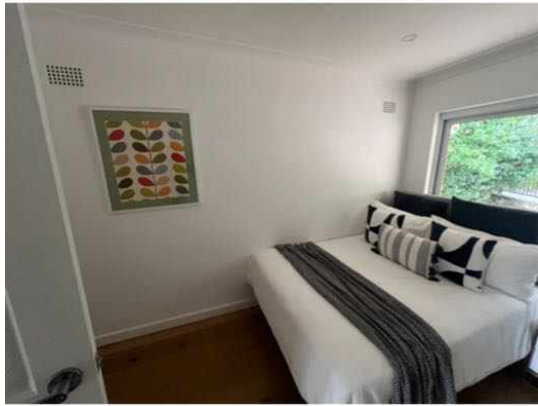
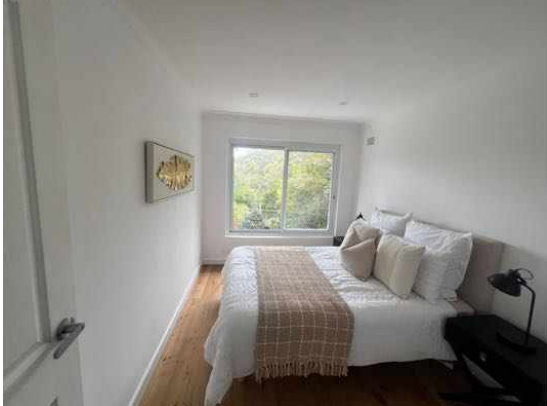
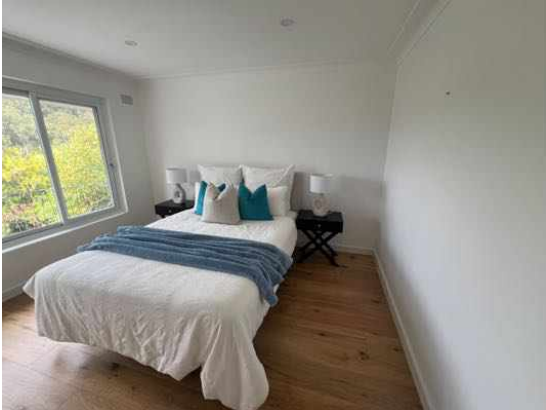
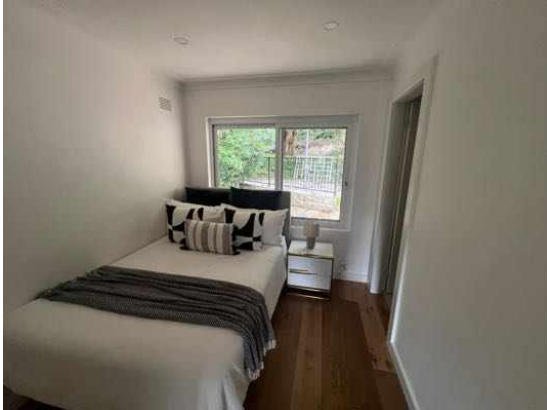
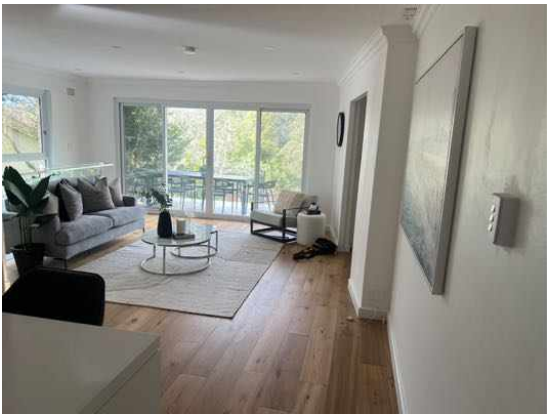
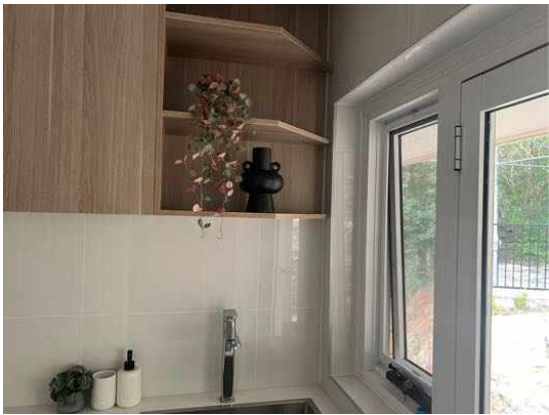
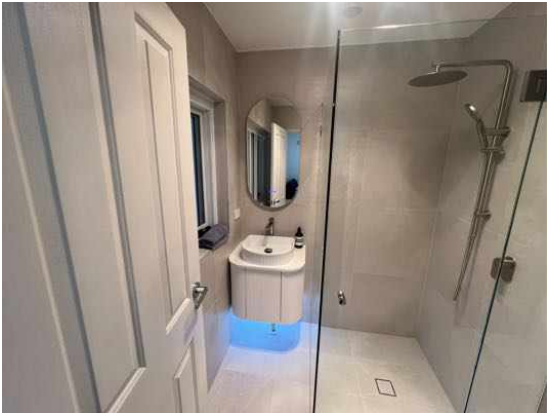
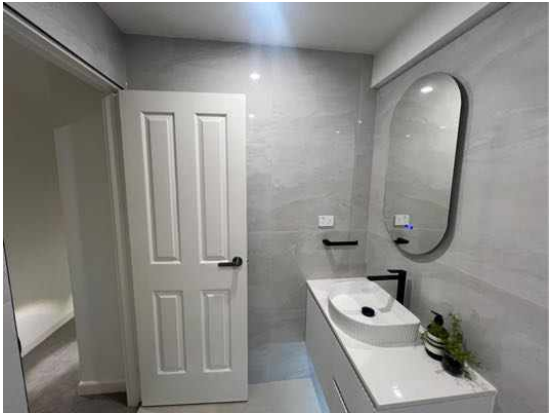
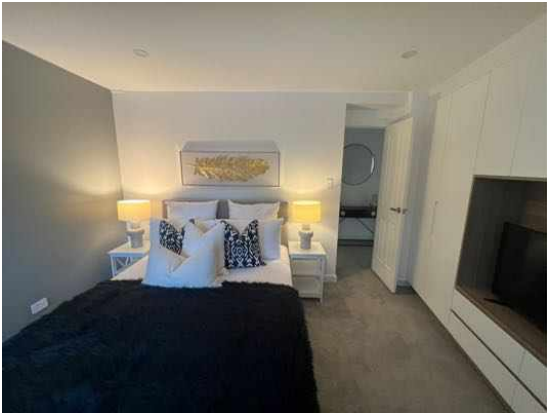
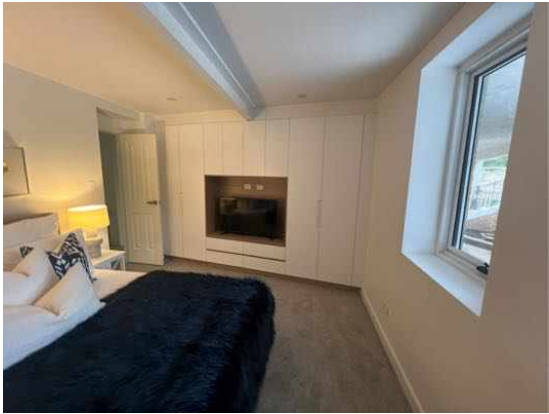
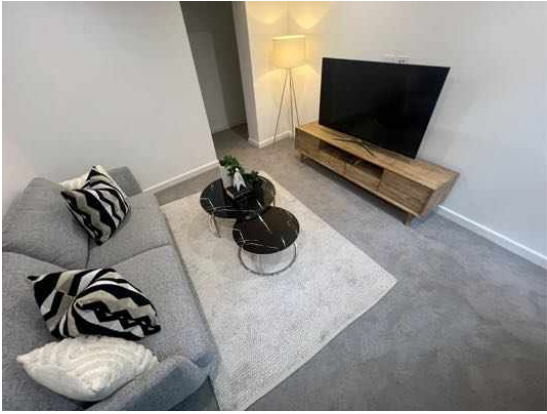
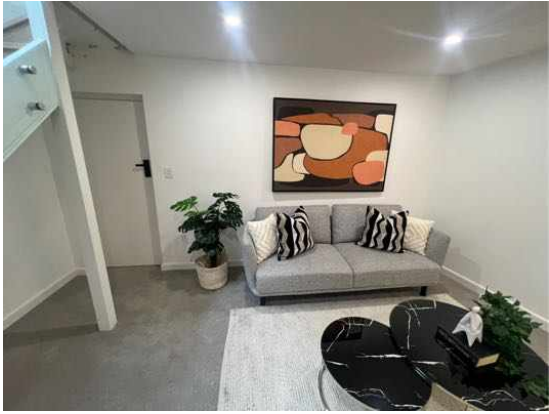
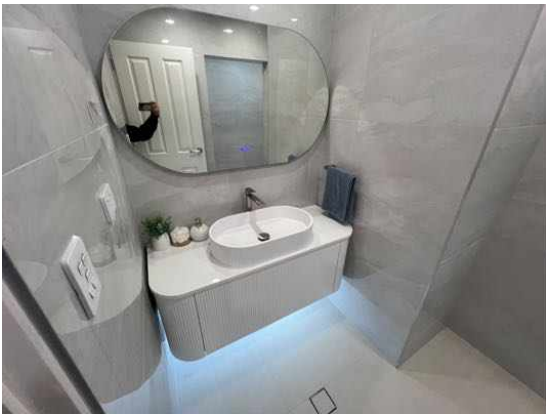
Building: Main Building
Location: All Areas > All Areas
Finding: Additional Photos - Obstructions and Limitations
Information: These photographs are an indication of the obstructions and limitations which impeded full inspection of the property at the time of inspection. These obstructions can hide an array of defects and should be removed to allow full inspection to be carried out. A re-inspection is recommended once the areas are made accessible.

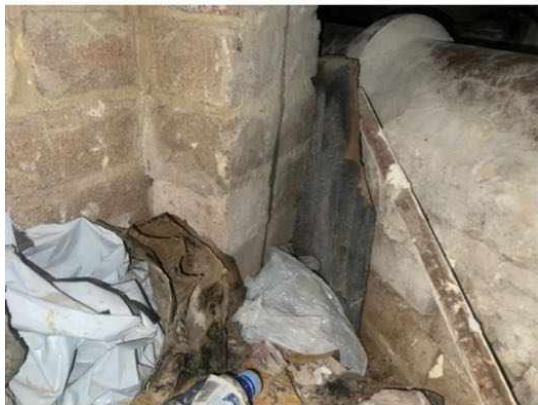
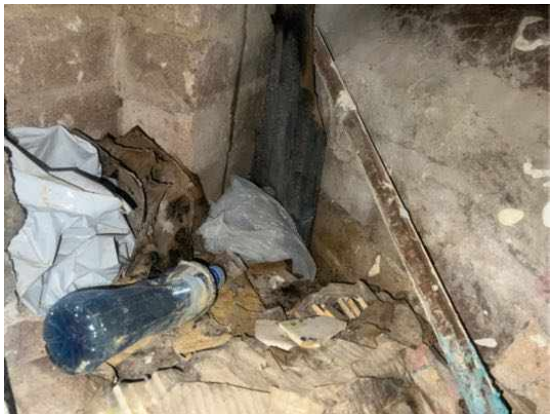
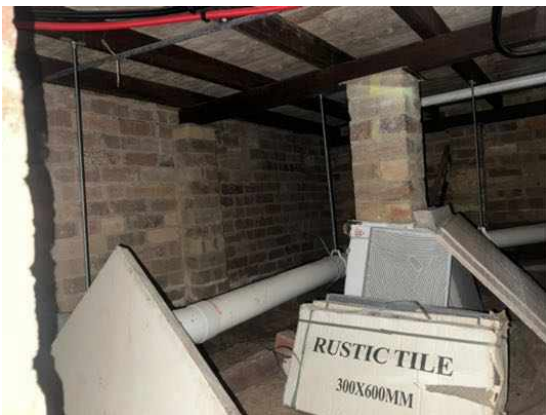
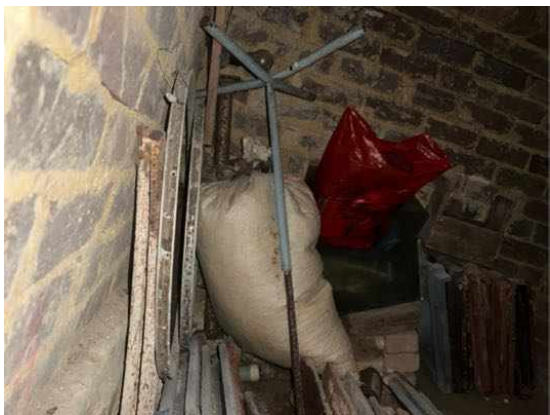
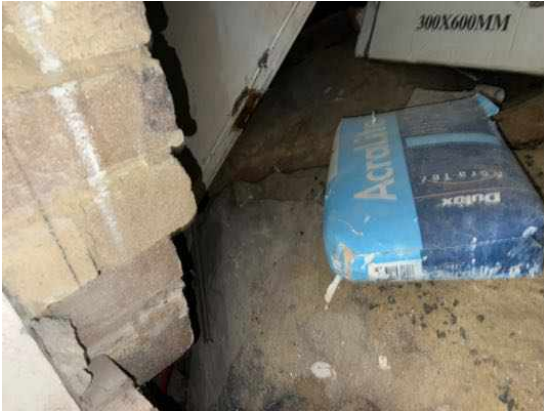
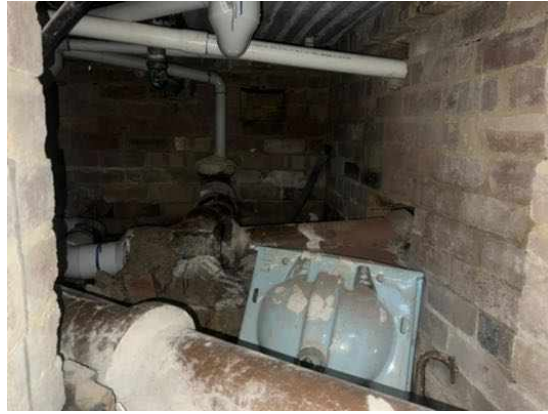
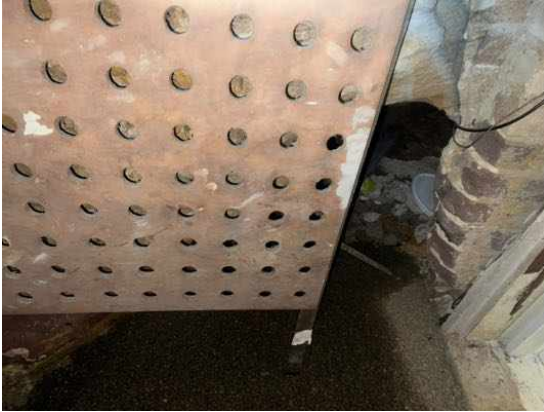
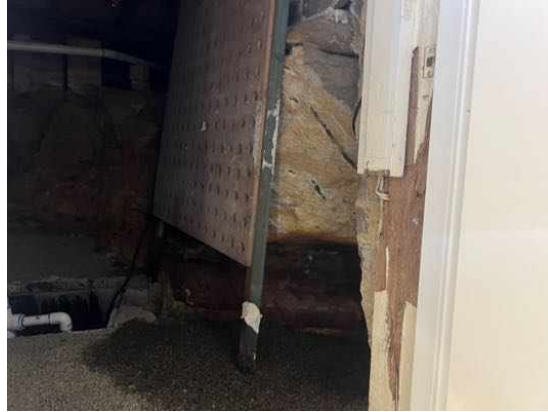
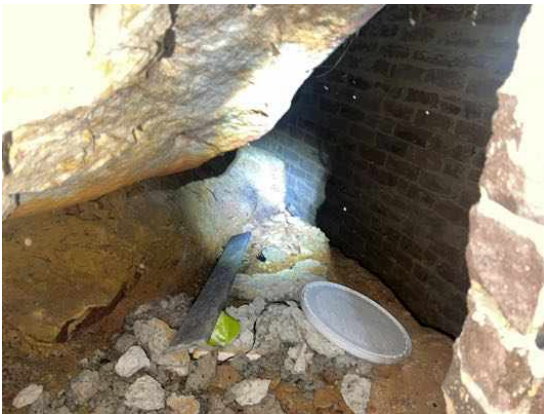
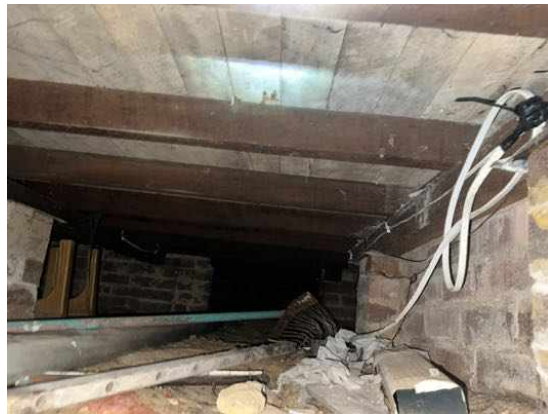
Building: Main Building
Location: Subfloor > All Areas
Finding: Additional Photos - Obstructions and Limitations
Information: These photographs are an indication of the obstructions and limitations which impeded full inspection of the property at the time of inspection. These obstructions can hide an array of defects and should be removed to allow full inspection to be carried out. A re-inspection is recommended once the areas are made accessible.

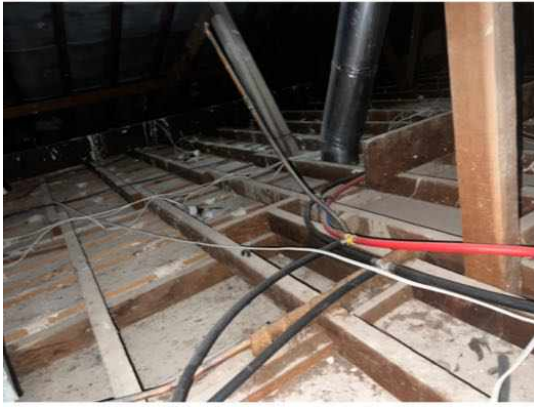
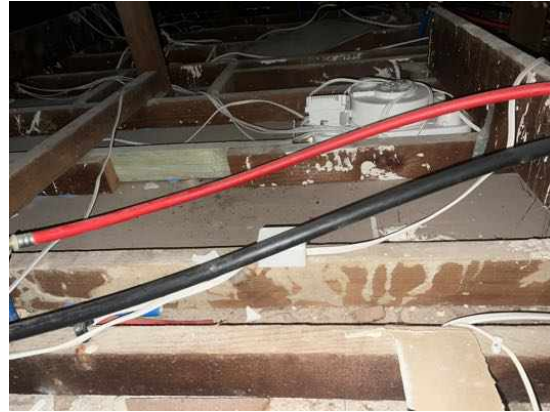
| Finding: | Additional Photos - Obstructions and Limitations |
| Information: | These photographs are an indication of the obstructions and limitations which impeded full inspection of the property at the time of inspection. These obstructions can hide an array of defects and should be removed to allow full inspection to be carried out. A re-inspection is recommended once the areas are made accessible. |

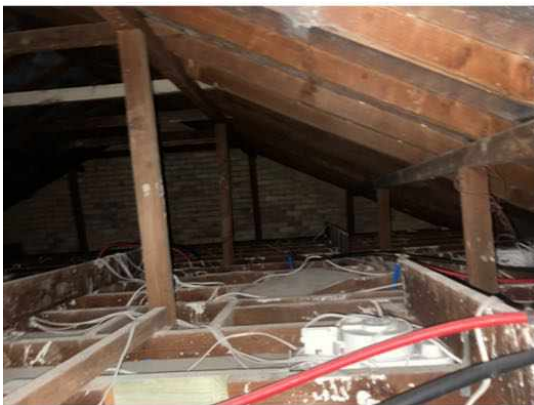
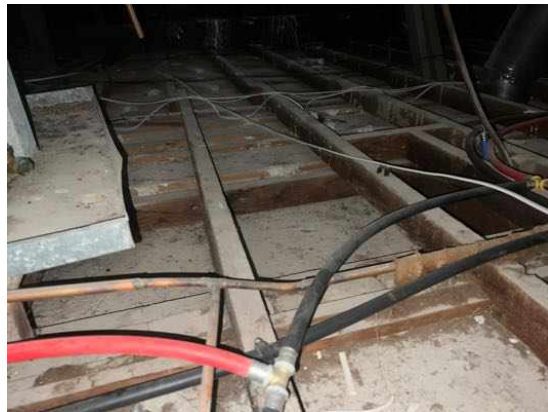
Building: Main Building
 Location: Roof Void > All Areas
 Finding: Insulation - Missing
 Information: Upon inspection of the roof void it was noted that insulation is not present.

Insufficient insulation will result in a comparatively higher cost to heat and cool a property as there is a lack of Insulation (or uneven coverage of insulation) which works as a barrier to heat transfer. This helps to keep out unwanted heat in summer and preserves warmth inside your home in winter. It can also help soundproof your home from unwanted airborne noise transfer.

Where insulation is absent, the area does not meet current Australian Standards. Installation of adequate insulation is required and should be conducted as soon as possible.

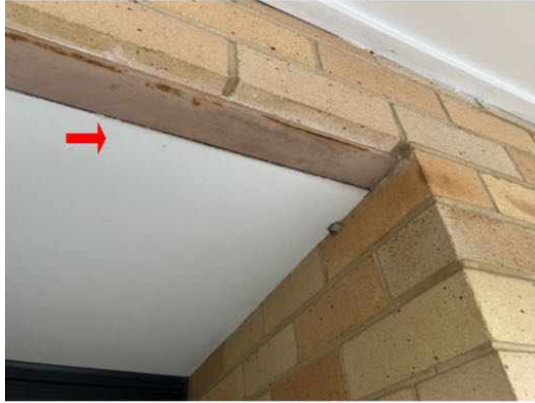
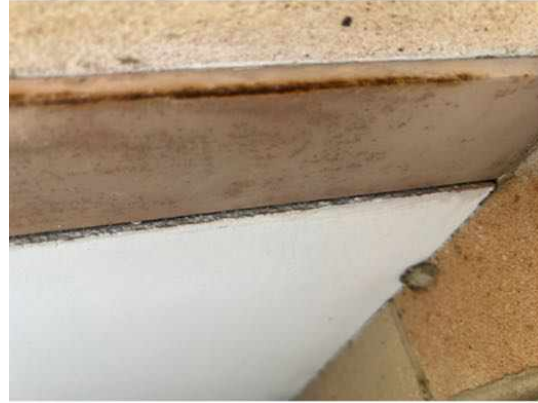
Building: Main Building
 Location: Entry > Centre
 Finding: Asbestos - Suspected ACM Identified on Site
 Information: Reporting on Asbestos is outside the Scope of this Report. This suspected defect is highlighted as a caution only. We suspect, based on our experience in the building industry, that there is a higher risk of the identified building element containing asbestos.

As Asbestos Reporting is outside the scope of this report, we advise that you consider a separate Asbestos Inspection and Condition Audit, which can include the taking of samples for definitive confirmation of the presence of Asbestos.

In the interim, the client is advised to act with caution, especially when considering any damage to building materials general wear and tear renovations extensions demolition and general maintenance activities due to the suspected presence of Asbestos.
