# Building and Timber Pest Inspection Report

Inspection Date: Wed, 28 Jan 2026

Property Address: 14/27 James St, Enmore NSW 2042,  
Australia

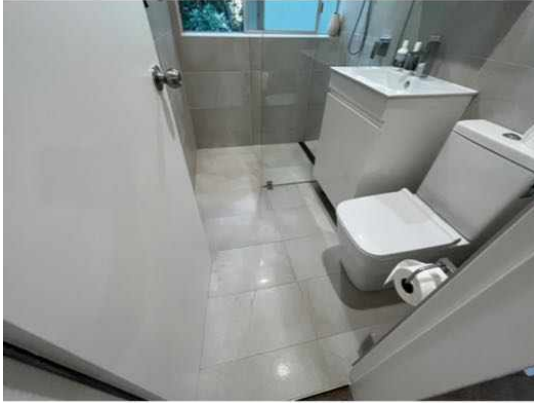
- Membrane used and Manufacturers Specifications.
- The Installer and Installation Certification.

With older properties where this information is unavailable, all wet areas should be monitored. If any leaks, water staining, peeling or bubbling of the paint become evident to any adjacent walls or ceilings below a licensed builder or waterproofing specialist is recommended to investigate further.

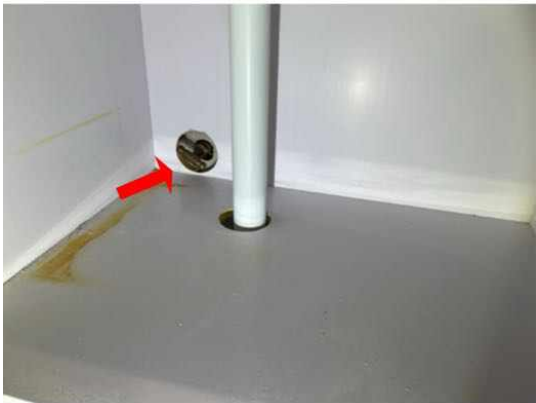
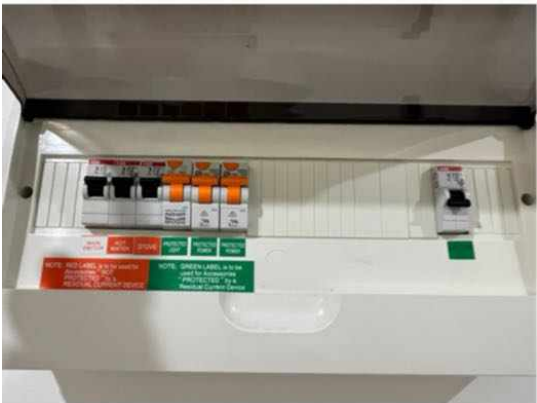
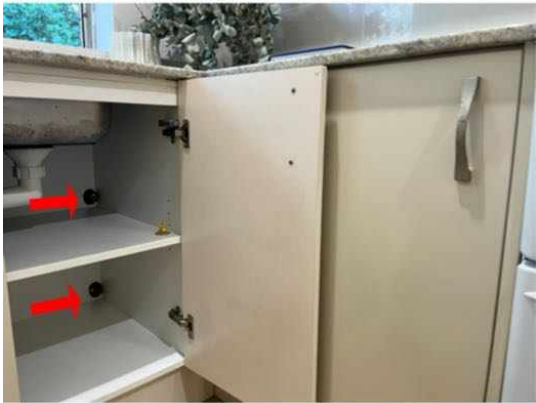
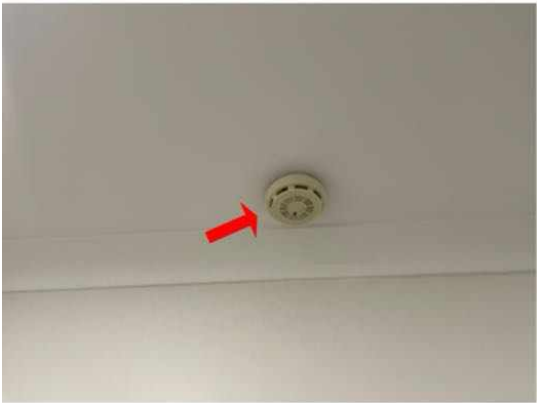
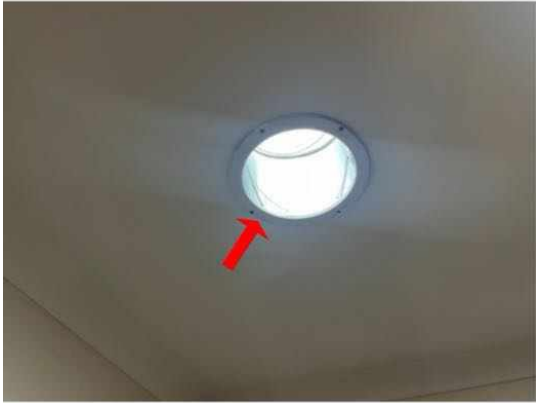
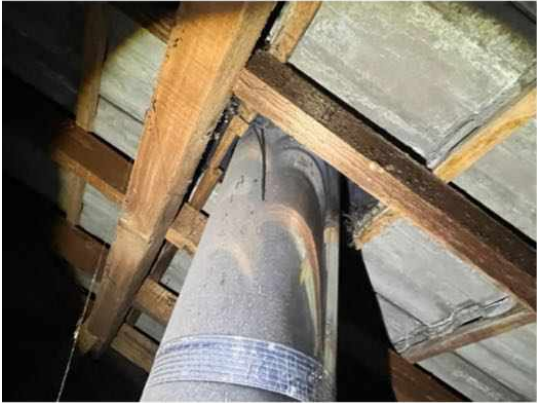
Building: Main Building  
Location: All Internal Areas  
Finding: Additional Photos  
Information: Additional photos are provided for your general reference. Please discuss these

photos with your building consultant for clarification.

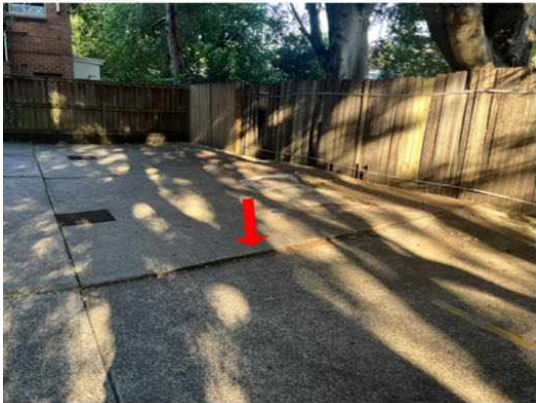
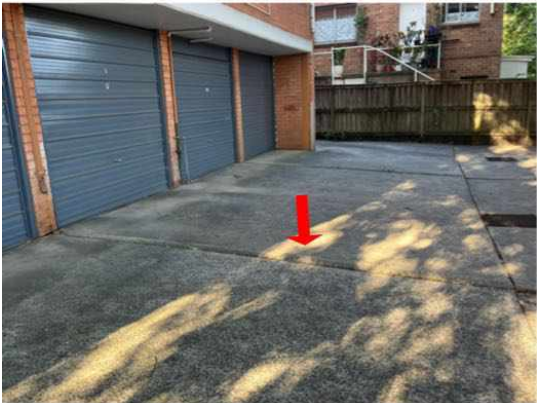
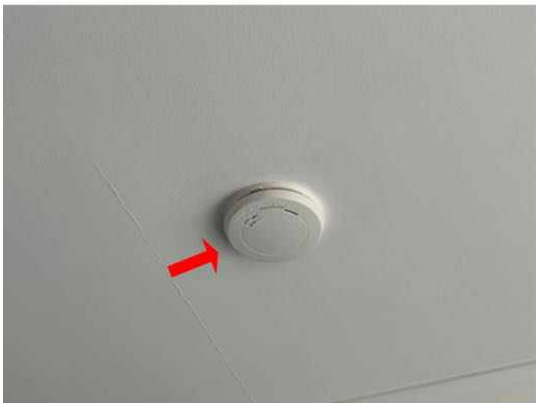
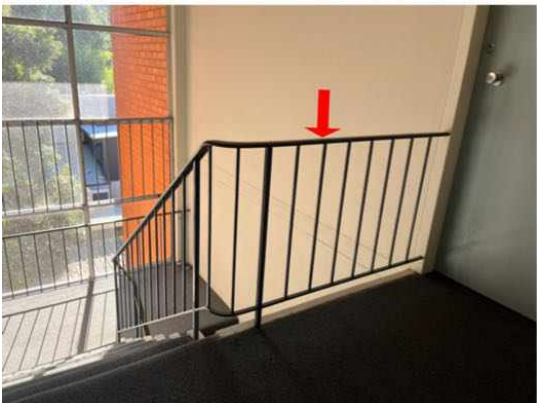
Building: Main Building  
 Location: All Common Areas  
 Finding: Additional Photos  
 Information: Additional photos are provided for your general reference. Please discuss these photos with your building consultant for clarification.

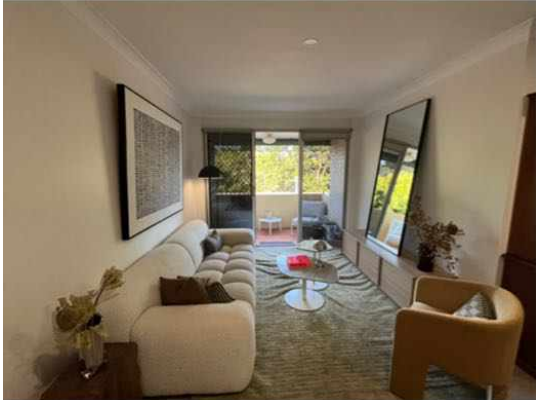
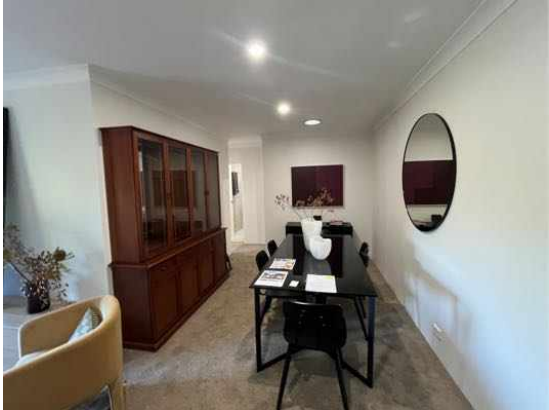
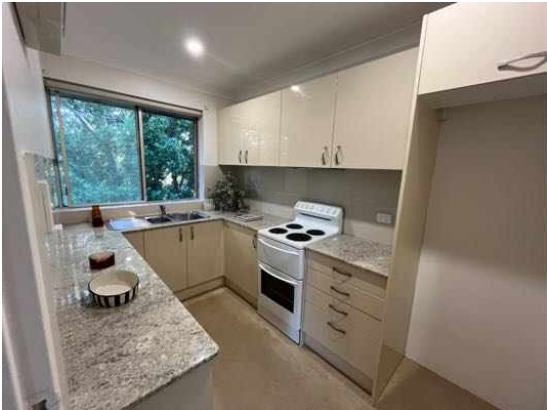
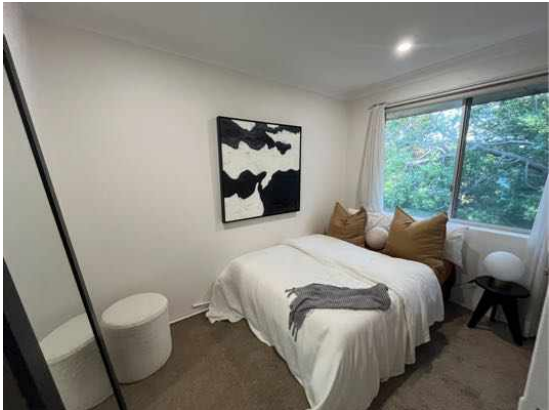
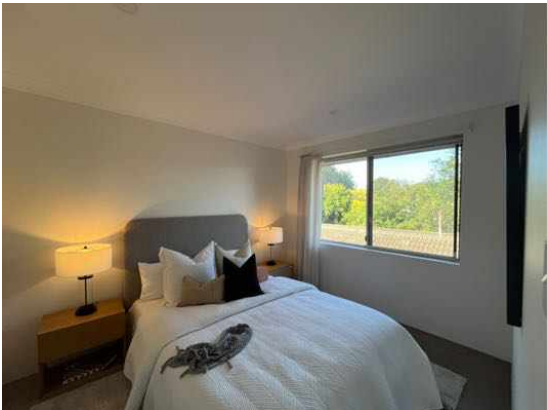
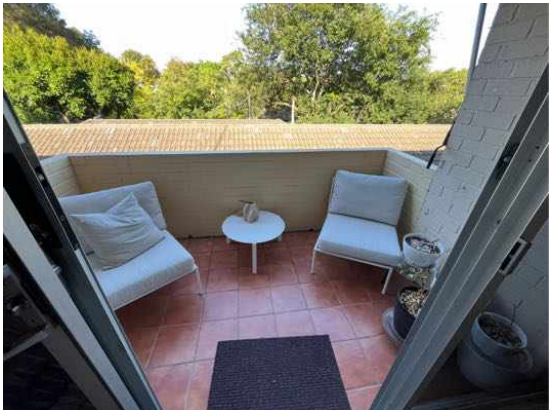
Building: Main Building  
 Location: All Internal Areas

Finding: Additional Photos - Obstructions and Limitations  
Information: These photographs are an indication of the obstructions and limitations which impeded full inspection of the property at the time of inspection. These obstructions can hide an array of defects and should be removed to allow full inspection to be carried out. A re-inspection is recommended once the areas are made accessible.
