Building Inspection Report

Inspection Date: Wed, 18 Mar 2026

Property Address: 21 Horton St, Elizabeth Park SA 5113,
Australia

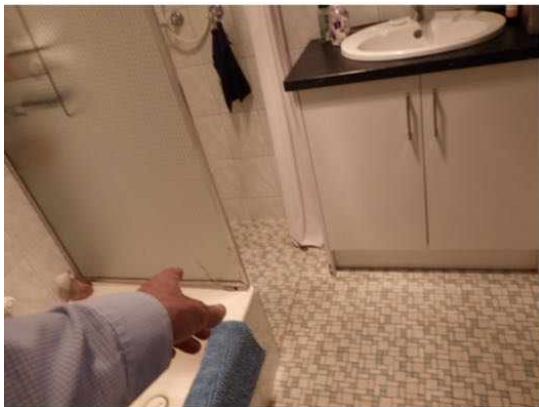
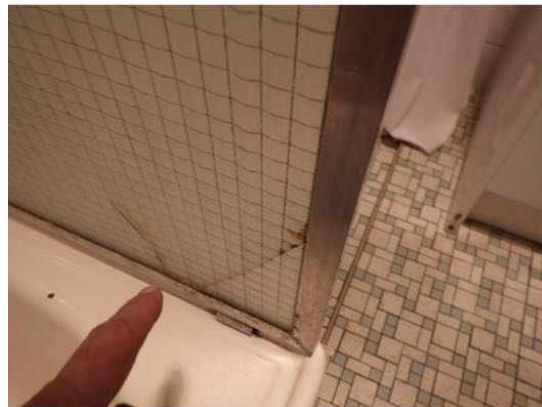
Defects 1.01

Building:	Building 1
Location:	Bathroom
Finding:	Shower screen - Cracked
Information:	Cracking was evident to the shower screen at the time of inspection, which is suspected to be due to accidental impact damage.

While the cracking appears to be minor, any further impact may lead to additional cracking and or shattering of the shower screen, creating a potential safety hazard in the area. Further damage would almost certainly necessitate replacement of the entire shower screen.

A qualified glazier is required to repair the shower screen as soon as possible. Please be advised that any persons coming into contact with the cracked shower screen should do so with due caution to avoid any personal injury that may ensue.

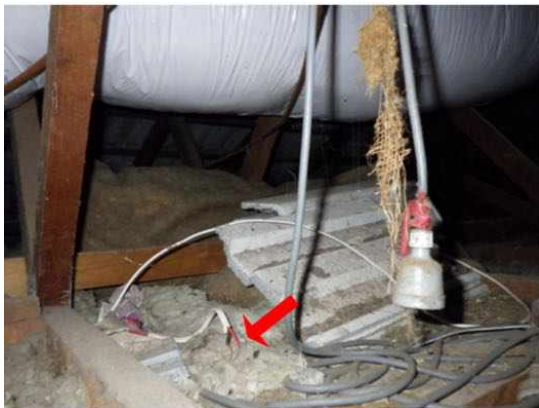
Defects 1.02

Building:	Building 1
Location:	All Internal Areas
Finding:	Roof space Area - Electrical wires exposed
Information:	At the time of inspection of this roof space area it was noticed that exposed electrical wiring was identified. Exposed electrical wiring represents a potential safety hazard including for fire and personal contact.

Contact a licensed electrician urgently for further inspection investigation and rectification.

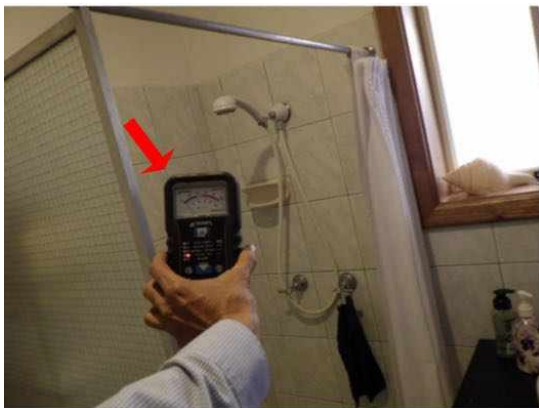
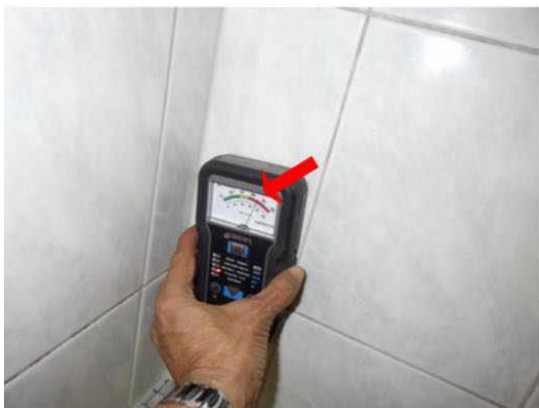
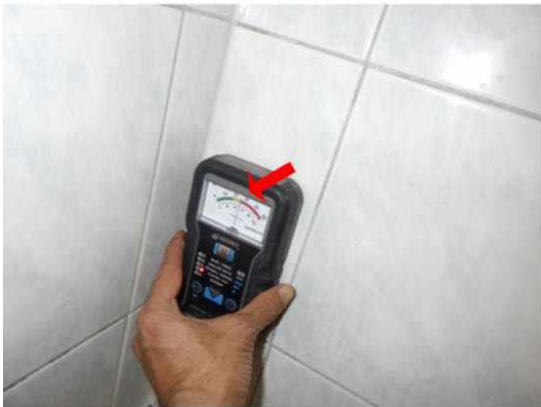
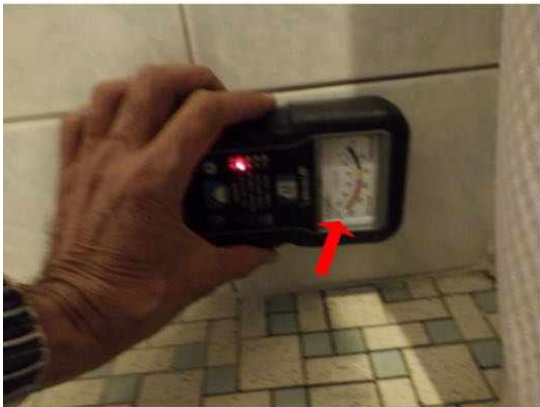
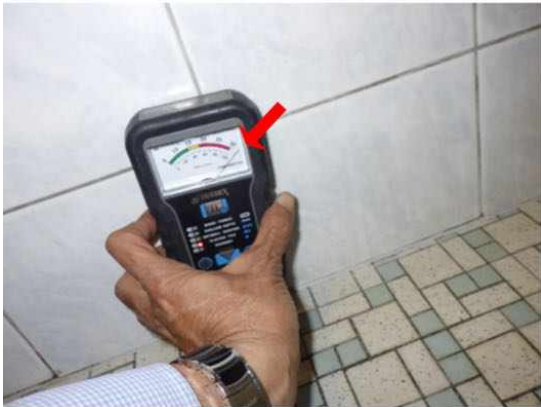
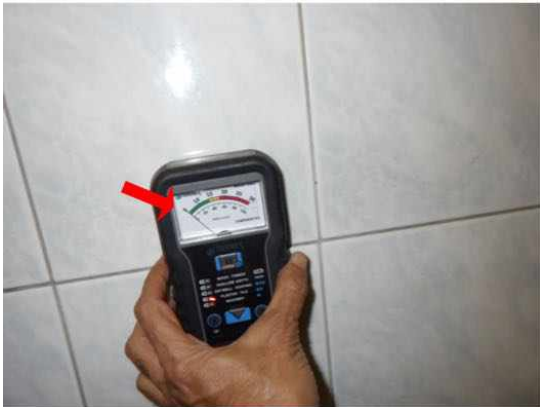
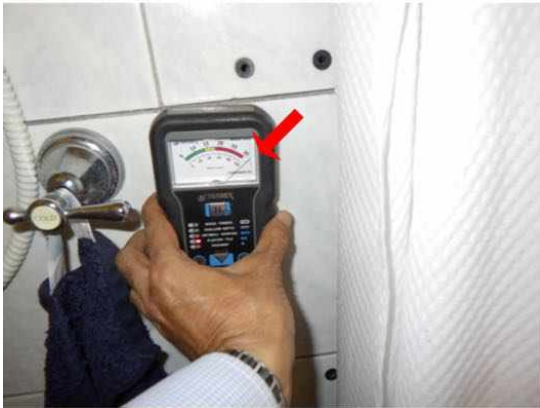
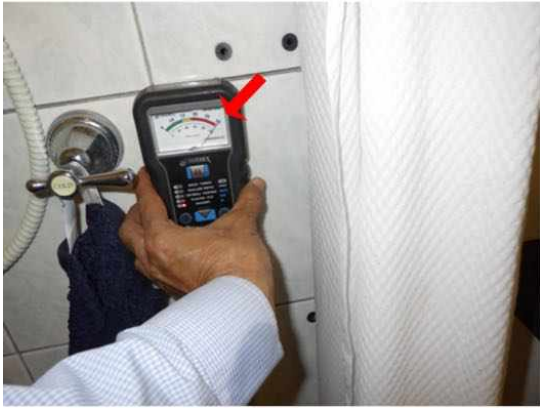
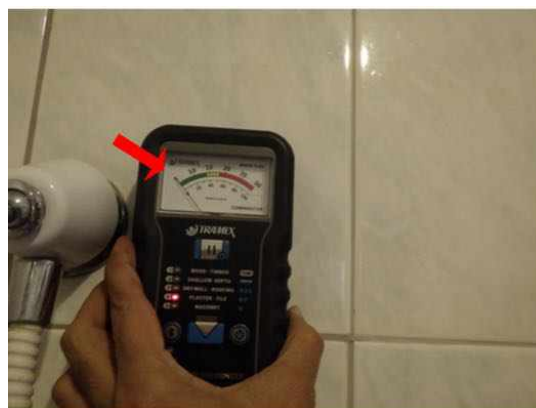
Defects 2.01

Building:	Building 1
Location:	Bathroom
Finding:	Shower Alcove - Damp
Information:	Damp is evident to the lower 400mm approximately of wall to the shower alcove. This defect is quite common, and is suspected to have been caused by moisture permeating through the grouting in this area, which shows evidence of deterioration.

Leaking pipes within the adjoining wall is also a possible cause.

Unmanaged damp in the shower recess is likely to facilitate the formation and development of mould and fungi growth, decaying associated building materials and compromising their structural integrity. Exposure to these contaminants is associated with a wide range of respiratory and other health-related problems.

Consultation with a qualified plumber or bathroom specialist is advised immediately to identify the cause of damp and to perform remedial works as required. Where excessive mould growth is present, further inspection by a specialist environmental health inspector should also be considered.

Always ensure that sealant and grout is in good condition to prevent any moisture issues occurring in the future.

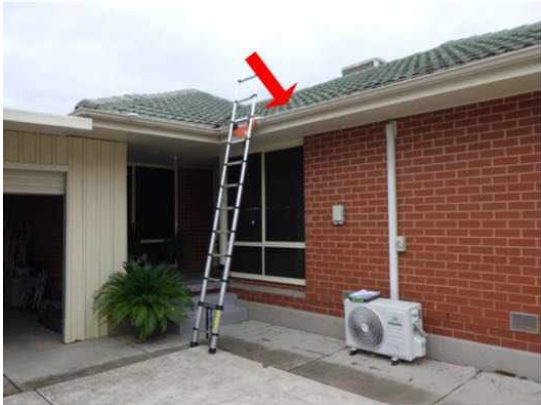
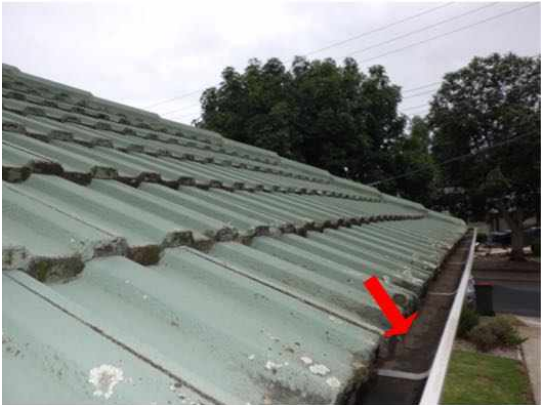
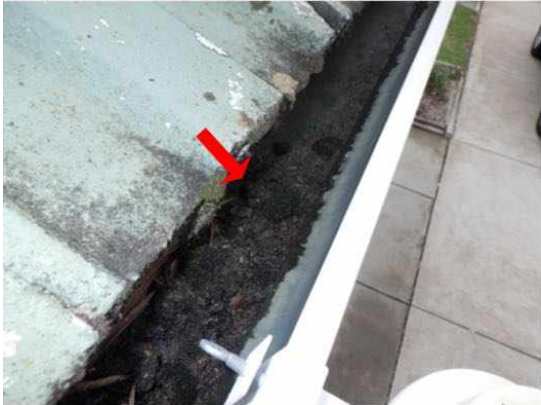
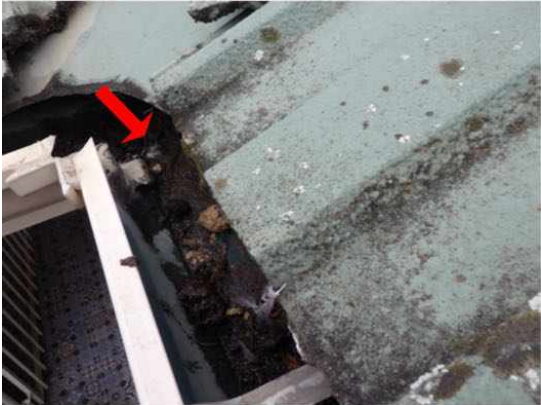
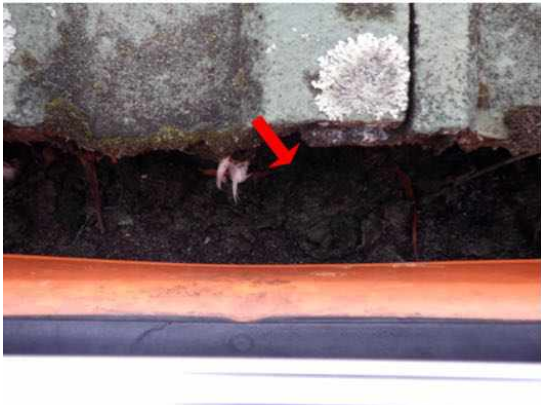
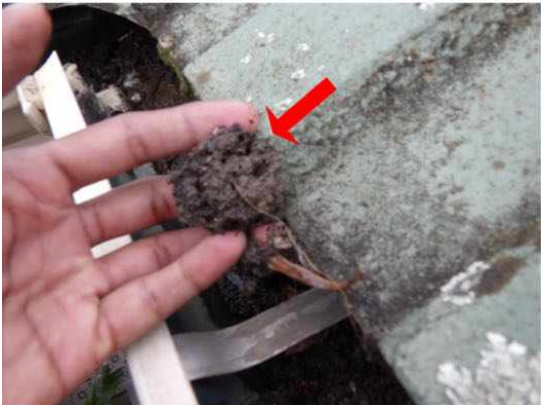
Defects 3.01

Blocked gutters are likely to lead to high levels of moisture in the affected areas. Such moisture will not only cause rust and decay of the associated building materials, but can also provide conditions that are conducive to termite and timber pest activity. Blockages in gutters should therefore be removed immediately to ensure dry conditions are maintained.

Consult a Licensed Plumber for further specific advice on remedial works that may be required. In the interim, it is highly advised that blocked gutters be removed by the homeowner or a general handyperson as a matter of urgency.

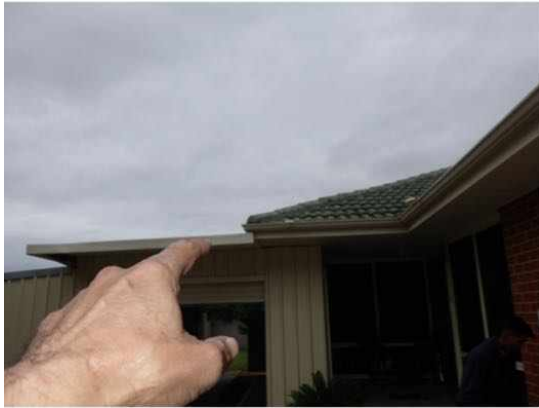
Defects 3.02

Building: Building 1
 Location: All External Areas >
 Finding: Mortar - Deterioration
 Information: At the time of inspection it was noticed that evidence of mortar deterioration to few tiles around the property.

Mortar, or 'bedding', is the material which fills joins and intersections between tiles and other building elements on the exterior roof covering, such as gable ends, hip capping and valleys. Upon inspection of the exterior roof, it was noted that sections of the mortar show varying levels of deterioration.

Mortar generally deteriorates as a result of frequent exposure to weather conditions over a prolonged period of time. Mortar that is deteriorating may allow water ingress into the roof void, putting associated building elements and roofing structures at risk of water damage. Deteriorated mortar also detracts from the functionality of roof tiles and other roofing elements, potentially decreasing weather tightness and roof drainage.

Mortar deterioration can be attended to by a handyperson where areas of deterioration are localised and easily accessible. Otherwise, consultation with a roofing contractor is advised where greater works are required.

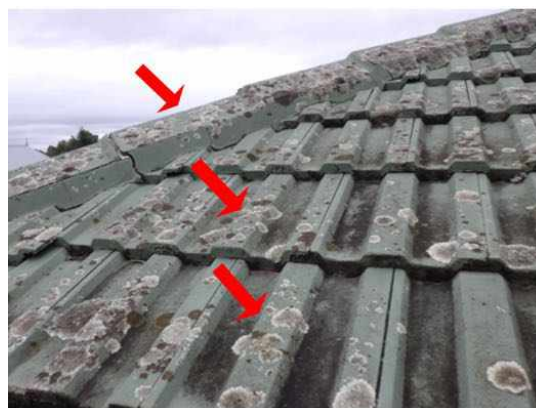
Defects 3.03

Building:	Building 1
Location:	All External Areas
Finding:	Roof tiles - Weathered
Information:	Upon inspection of the exterior roofing, the majority of roof tiles were considered to be in a fair condition. While weathering of the tiles is consistent with the age of the property, maintenance works are required.

Isolated areas of mortar have come loose in the valleys and minor cracking is also present. Re-pointing and re-sealing the may be considered as an interim solution by the client to help preserve and extend the life span of the tiles.

Where left unmanaged, deteriorating roof tiles are likely to lead to a number of secondary defects, including minor water leaks and weather exposure to internal roofing structures.

Consultation with a roofing contractor is highly advised to gain advice on cost of remedial works that may be required in the short to medium term. Remedial works are likely to increase the longevity of the exterior roofing structure.

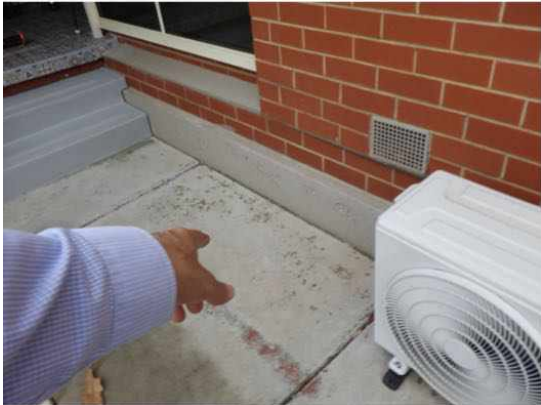
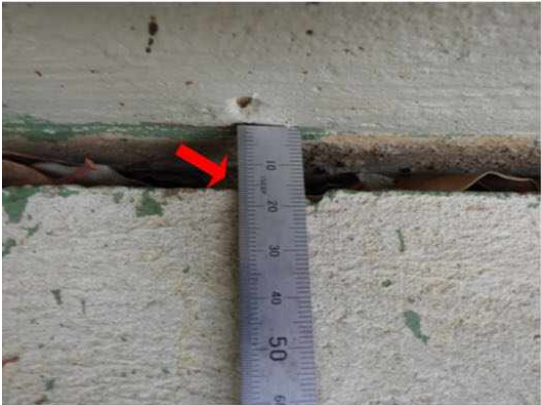
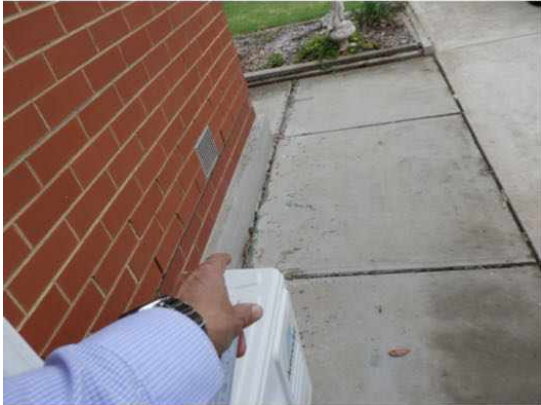
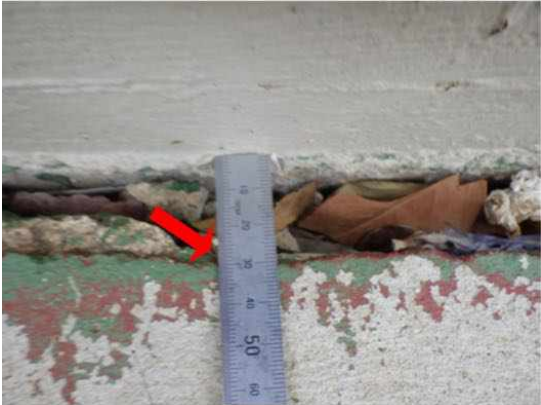
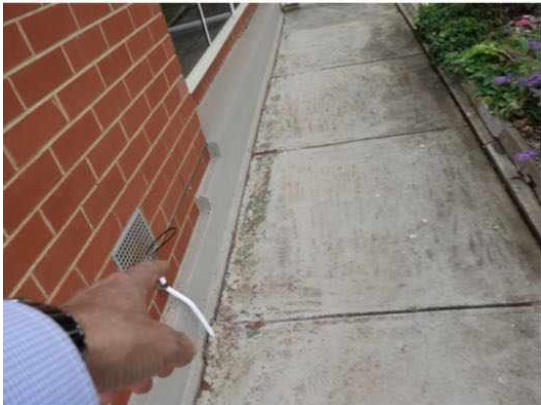
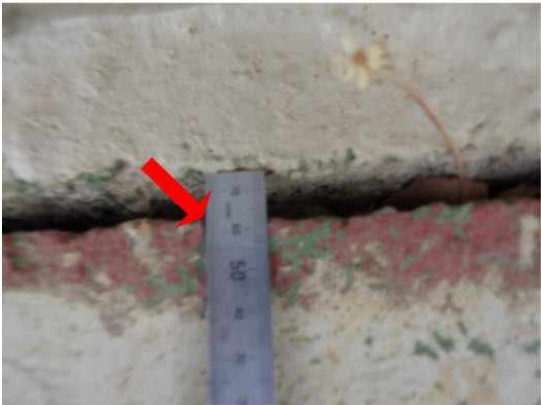
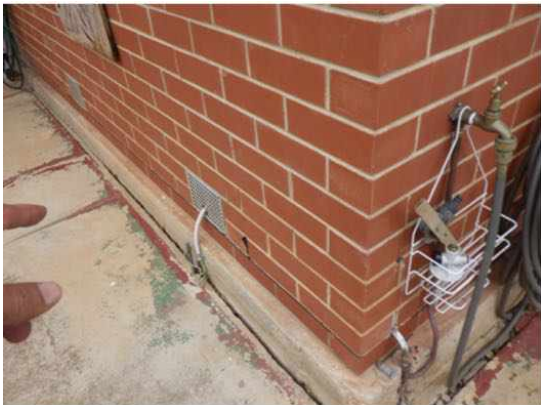
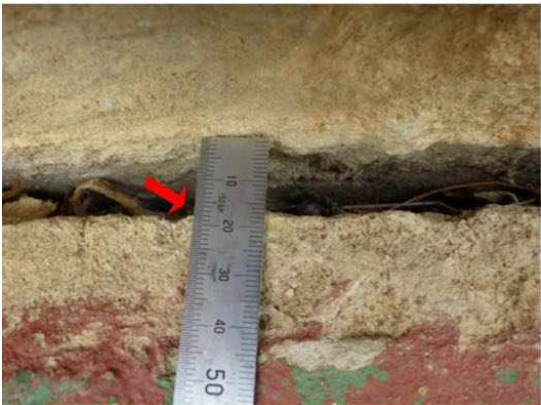
Defects 3.04

Building:	Building 1
Location:	All External Areas
Finding:	Gaps in perimeter pavement
Information:	Gaps in the external concrete paving were identified at the time of inspection. Gaps in the slab are significant and are likely to lead to the development of secondary defects if left unmanaged, such as the creation of a trip hazard and water entry points.

With reactive clay soils, it is extremely important to ensure that all stormwater flows including roof and ground flows, contained and continually maintained. High moisture also creates an environment that is conducive to termite attack.

A licensed Plumber should be appointed immediately to ensure that the stormwater pipework is intact and adequate, and all gaps to concrete, driveways and paths should be sealed by a licensed builder or a general handy person to keep moisture from entering.

A licensed concretor may be required to replace pavements that are beyond repair.

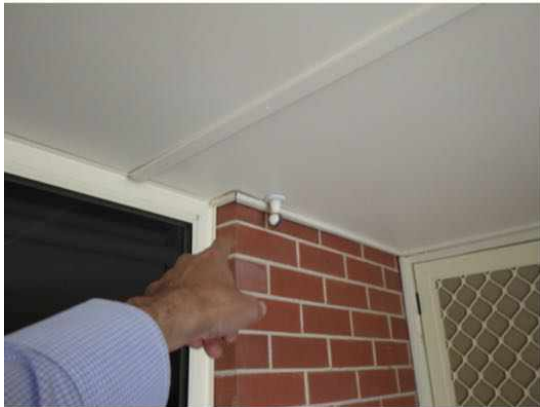
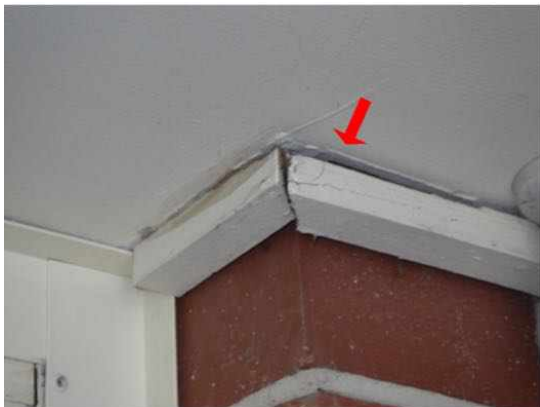
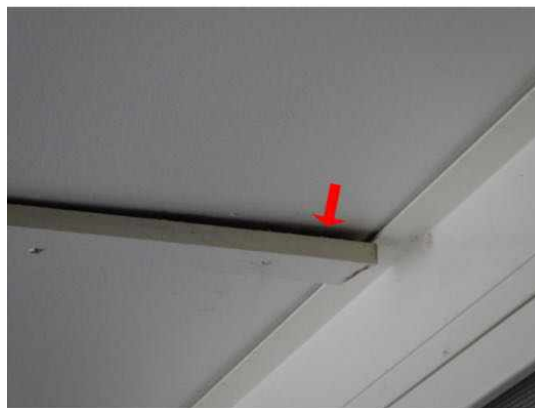
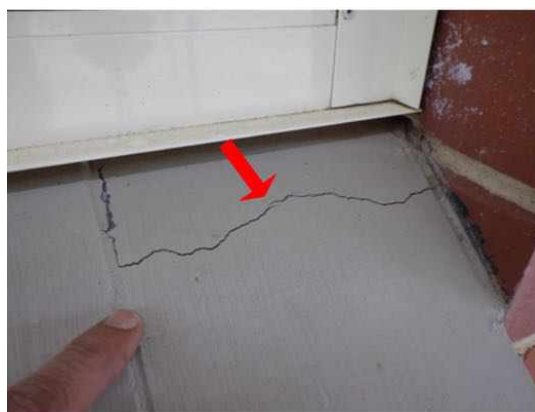
Defects 3.05

Building: Building 1
Location: All External Areas
Finding: Building element - Damaged/ Loose from its original fixing
Information: At the time of inspection it was noticed at few sections of building elements were damaged / loose from its original fixing around property.

Breakage occurs generally when the building materials have either aged and decayed, or as a result of damage (accidental or deliberate).

Repair and/or replacement of broken elements is advised to ensure that additional secondary defects do not arise as a consequence. Such works are necessary, as all building elements play a key role in the operation and function of the overall structure and its performance.

A relevant tradesperson should be appointed to repair or replace the affected building element prior to any subsequent damage being caused.

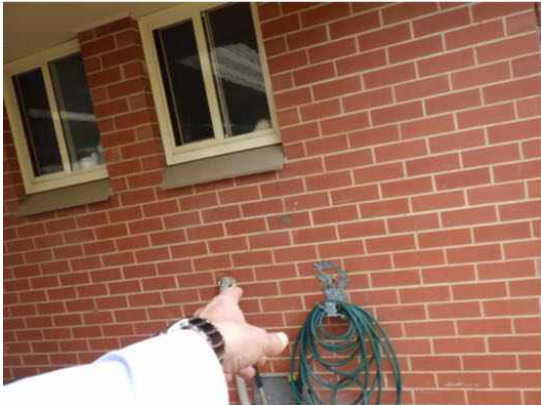
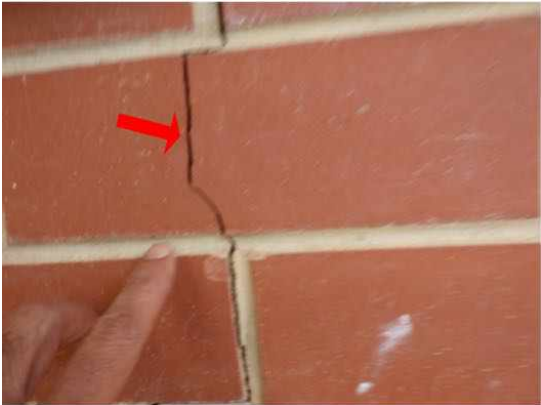
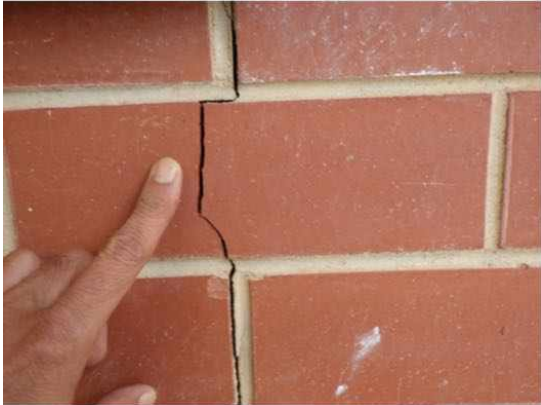
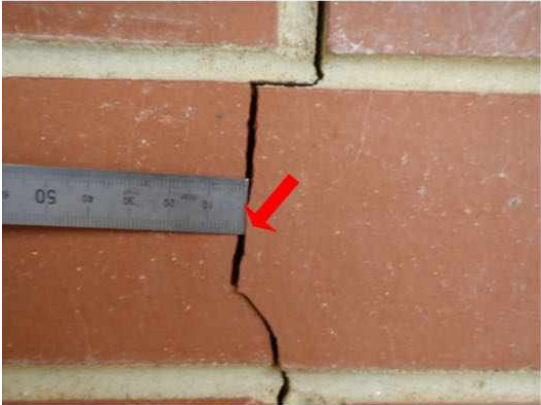
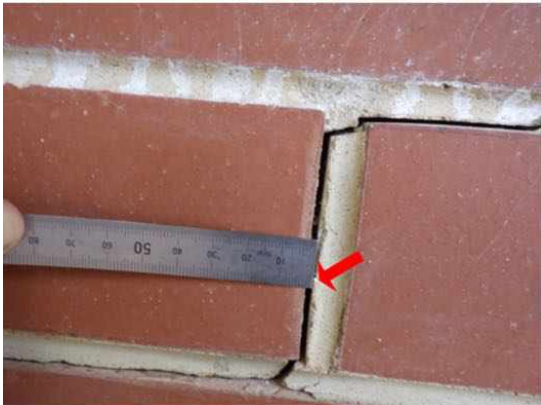
Defects 3.06

Building:	Building 1
Location:	All External Areas
Finding:	Brickwork - Step cracking
Information:	Step cracking was identified to the brickwork in this area at the time of inspection. Step cracking, which is similar to other forms of cracking, has a variety of possible causes. However, the most common is the subsidence of adjacent footings.

Step cracking is a relatively common defect, and is most likely to occur adjacent to windows, doors and other openings. Mortar failure in the gaps between affected bricks indicates the stresses and tensions affecting the wall.

Where step cracking is extensive or severe, the client is advised to consult a structural engineer. Minor step cracking can be used as a warning sign to address factors causing stress to the wall, which can include the effect of surrounding trees, water leaks, soil erosion, or even the presence of reactive soils in the surrounding area.

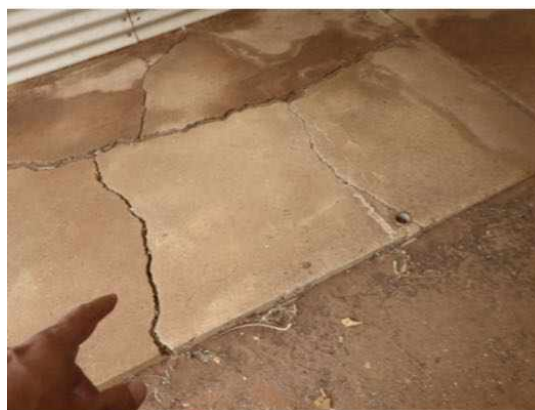
Defects 3.08

Building:	Building 1
Location:	All External Areas
Finding:	Paving - Uneven
Information:	Sections of the external paved area are uneven, creating a potential trip hazard. It appears as though the area has been subject to rough installation, or that paving sections have lifted due to movements in the foundation of the property.

Where paving creates a trip hazard, personal injury may ensue if due caution is not taken by all persons within this area.

Re-paving of the area is required as soon as possible to remedy this situation. Further consultation with a specialist concreter is advised.

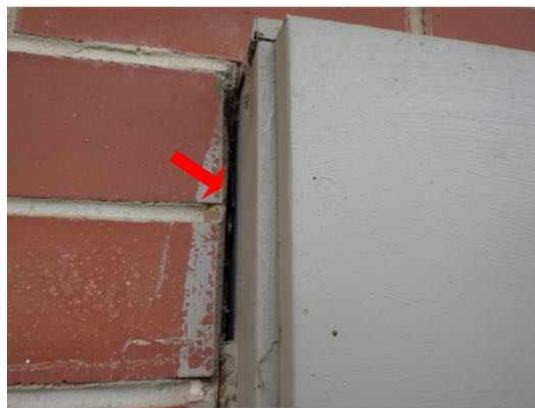
Defects 3.09

Building:	Building 1
Location:	All External Areas
Finding:	Brickwork - Deteriorated mortar
Information:	At the time of inspection it was noticed that evidence of mortar deterioration / missing from this external meter box area.

Mortar, or 'bedding', is the material which fills joins and intersections between bricks in masonry walls and structures. Sections of mortar in this brickwork were identified as having deteriorated, which is generally expected for a property of this age and condition.

Mortar may deteriorate as a result of age of building materials, minor movement of bricks, or frequent exposure to weathering. Mortar should be replaced to ensure that bricks remain in their intended location and to prevent gaps, which would allow water or moisture ingress and secondary damage as a result.

Mortar deterioration can be addressed by a bricklayer where areas of deterioration are localised and easily accessible. Alternatively, appointment of a registered builder is advised, to repoint large areas of decaying mortar. Where secondary structural defects have become evident, consultation with a structural engineer may be required.

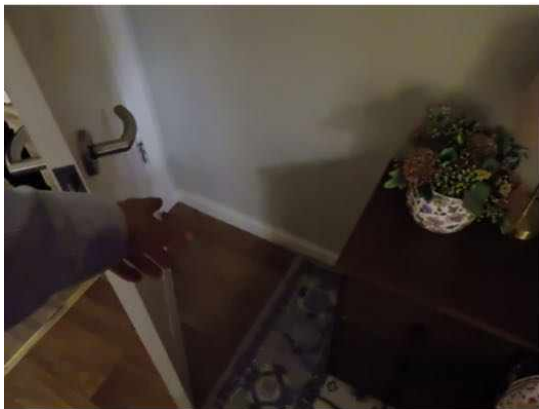
Defects 3.11

Building:	Building 1
Location:	All Internal Areas
Finding:	Door stop - Missing
Information:	The door stop is missing or is inadequate to stop the door handle from damaging the wall. Although some building elements may seem irrelevant or unnecessary, all building elements play a key role in the operation and function of the overall structure and its performance.

Re-installation or replacement of the door stop is advised as soon as possible to prevent any subsequent damage to the door or associated structures. A general handyman may be appointed to perform these works at client discretion.

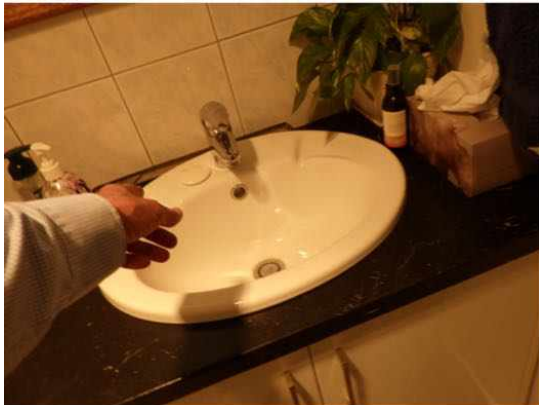
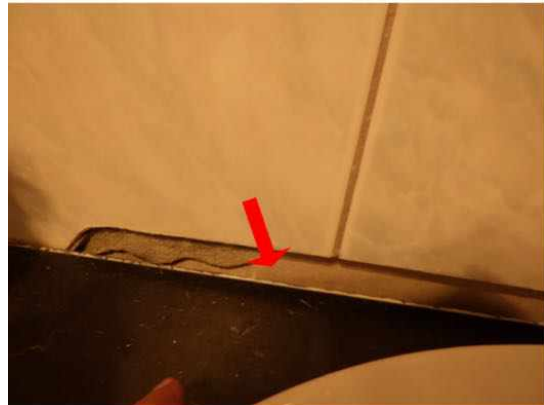
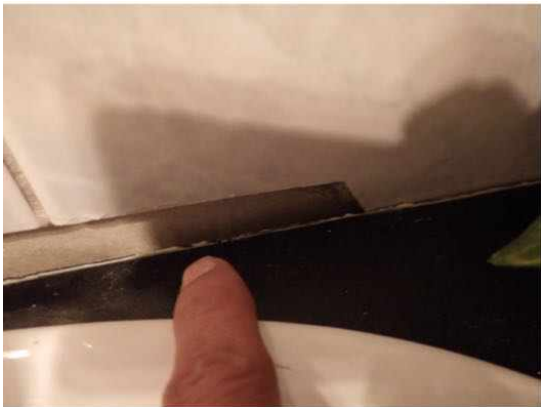
Defects 3.12

Building:	Building 1
Location:	Bathroom
Finding:	Bathroom - Wash basin area - Tiles - Missing
Information:	Tiles were found to be missing in this tiled bathroom washbasin area. It appears as though broken tiles have been removed and not replaced, or have come loose from their original fixing through general deterioration.

Where tiles are missing, water penetration is likely to occur to exposed walls and flooring, creating potential for subsequent water damage.

Any tiles that are missing should be replaced immediately by a tiling contractor or general handyman. If left unmanaged over a prolonged period of time, water damage is likely to necessitate repair works to surrounding building elements.

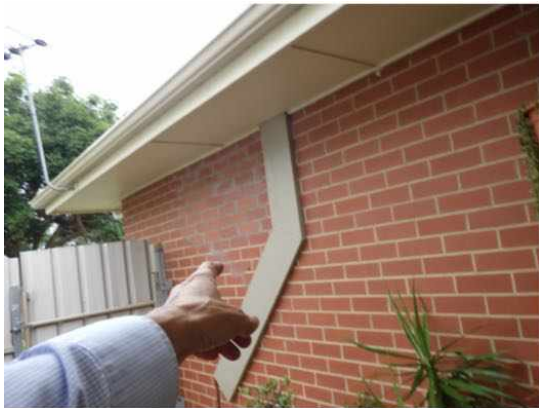
Building: Building 1
Location: All External Areas
Finding: External walls - Evidence of repairs
Information: At the time of inspection it was noticed that evidence of repairs to the few sections of external walls.

For further details please discuss with your realestate agent or appropriate trades.

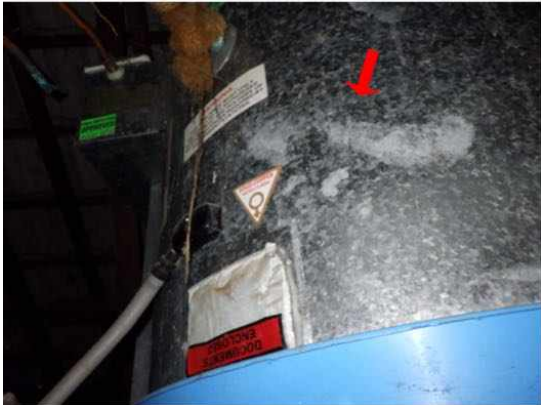
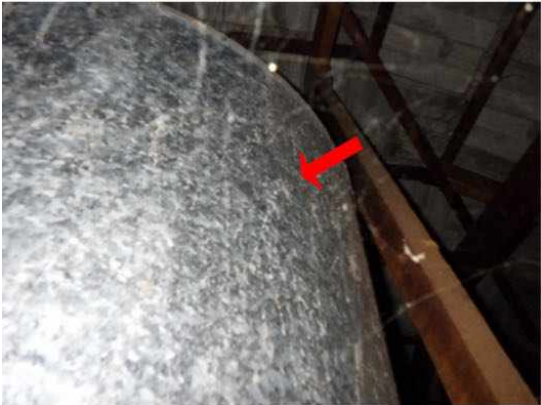
Building: Building 1
Location: All Internal Areas
Finding: Roof space area - Old hot water tank installed
Information: At the time of inspection of this roof space area , it was noticed that old hot water tank is installed.

For further details please discuss with your realestate agent or appropriate authorities.

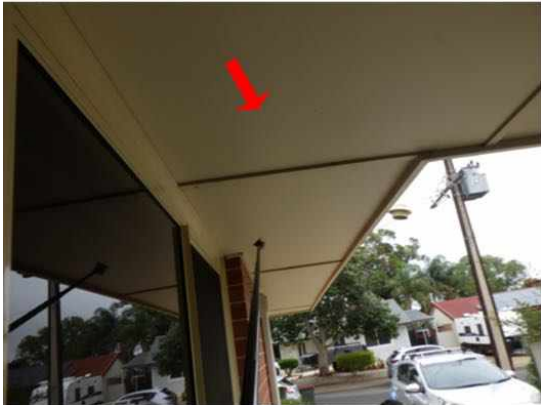
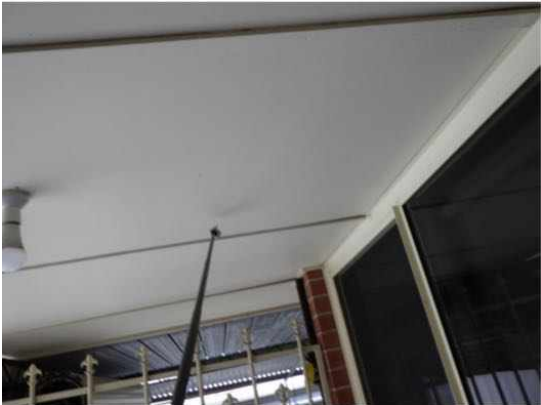
Building: Building 1
 Location: All External Areas
 Finding: Asbestos - Suspected ACM Identified on Site
 Information: Reporting on Asbestos is outside the Scope of this Report. This suspected defect is highlighted as a caution only. We suspect, based on our experience in the building industry, that there is a higher risk of the identified building element containing asbestos.

As Asbestos Reporting is outside the scope of this report, we advise that you consider a separate Asbestos Inspection and Condition Audit, which can include the taking of samples for definitive confirmation of the presence of Asbestos.

In the interim, the client is advised to act with caution, especially when considering any damage to building materials general wear and tear renovations extensions demolition and general maintenance activities due to the suspected presence of Asbestos.

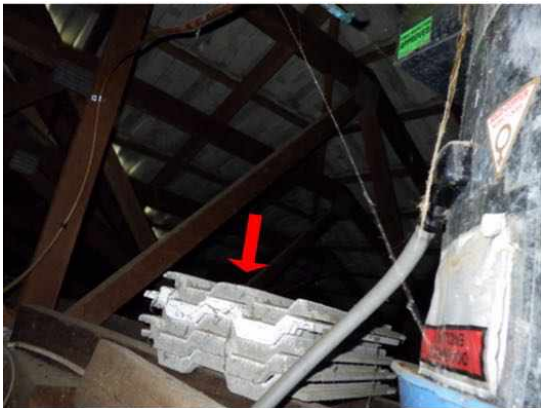
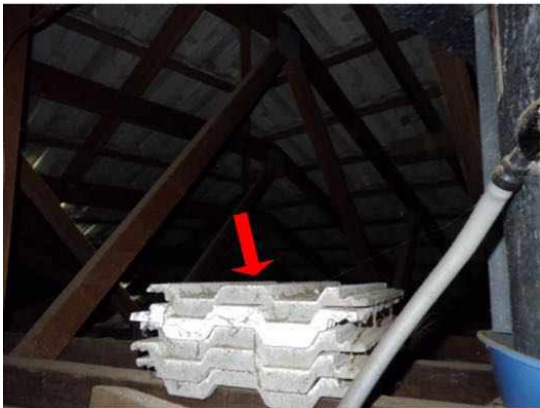
Building: Building 1
 Location: All Internal Areas
 Finding: Roof Space – Materials Stored

Information: At the time of inspection, materials were observed to be stored within the roof space area. Storing materials in the roof space may restrict ventilation, place unintended loads on ceiling linings or framing, and limit safe access for inspection or maintenance.

It is advised that all stored materials be removed from the roof space to reduce the risk of damage to building elements and to allow safe access and proper ventilation.

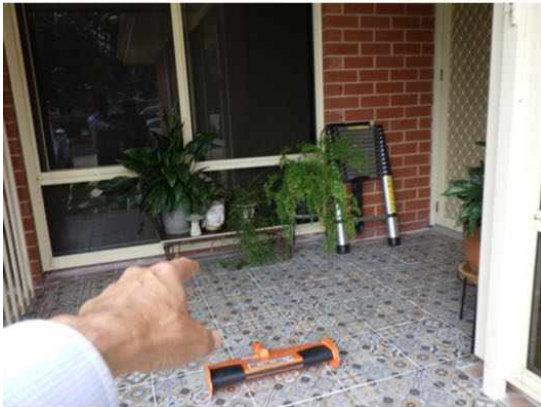
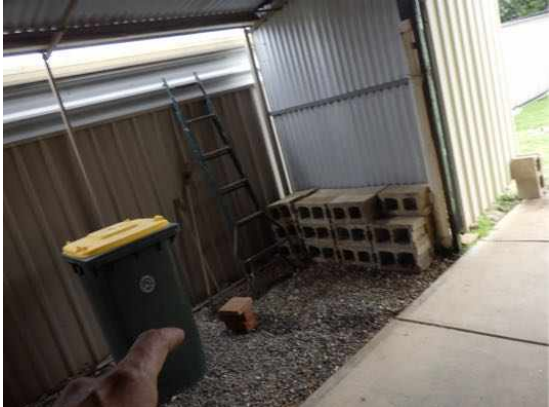
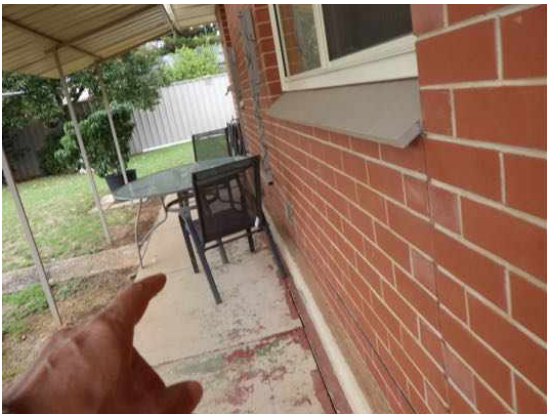
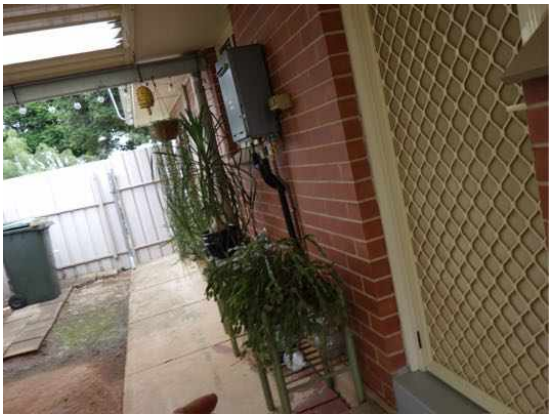
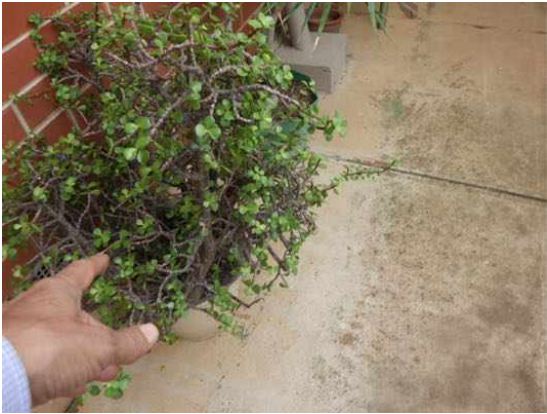
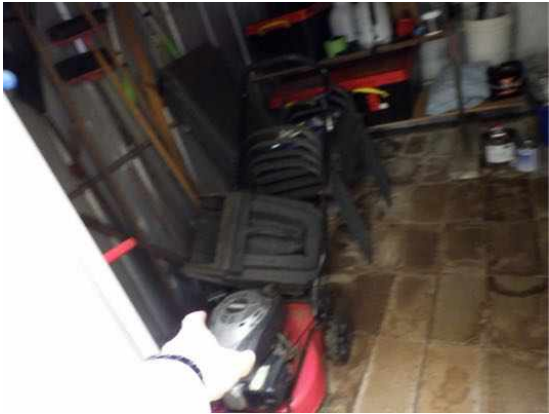
Building: Building 1
Location: All Areas
Finding: Additional Photos - Obstructions and Limitations
Information: These photographs are an indication of the obstructions and limitations which impeded full inspection of the property at the time of inspection. These obstructions can hide an array of defects and should be removed to allow full inspection to be carried out. A re-inspection is recommended once the areas are made accessible.

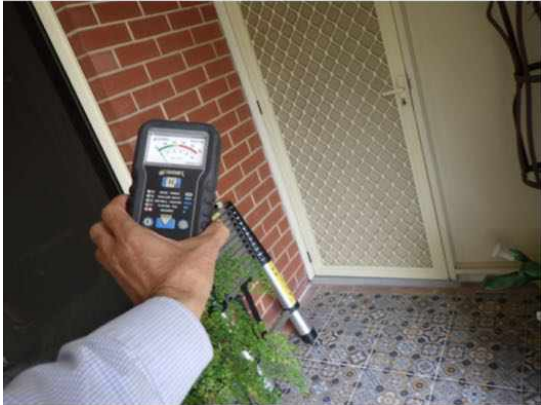
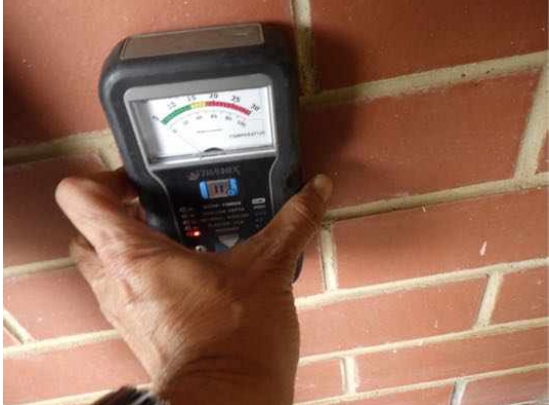
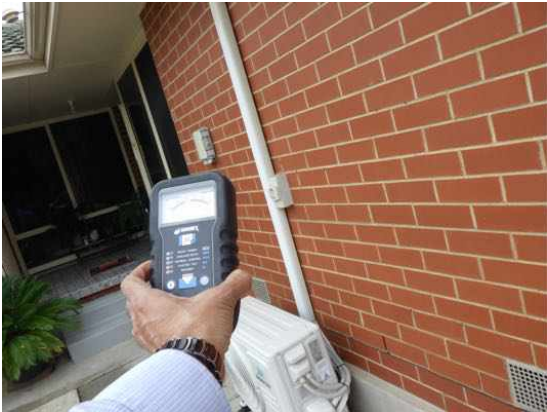
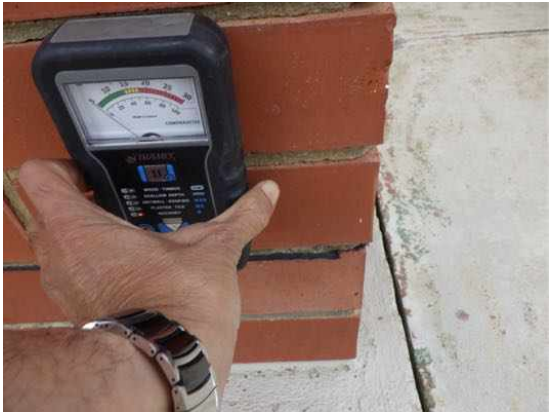
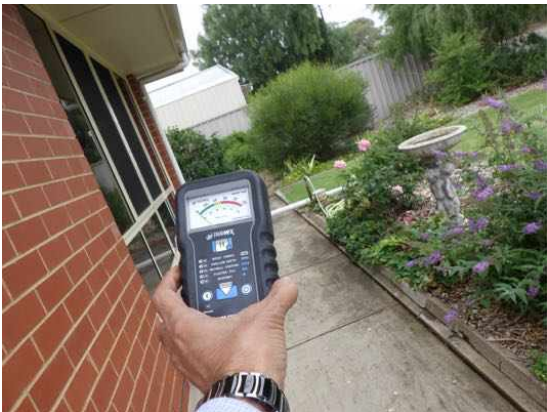
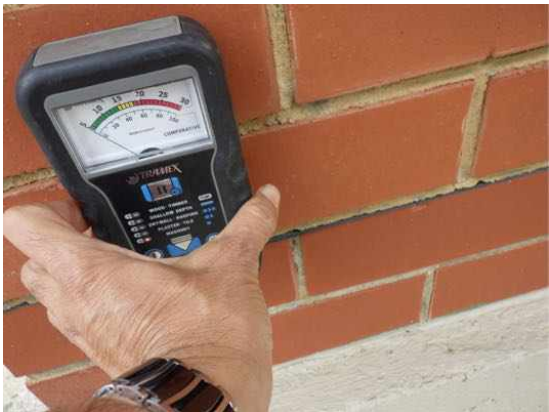
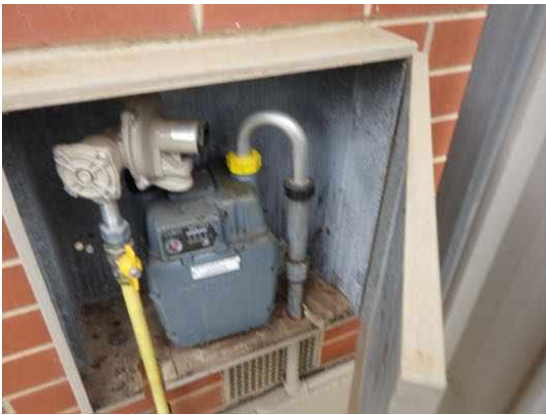
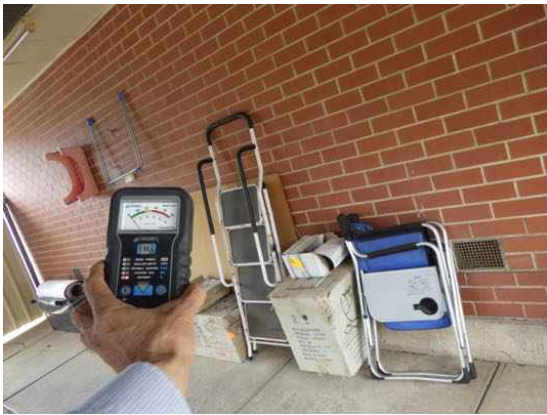
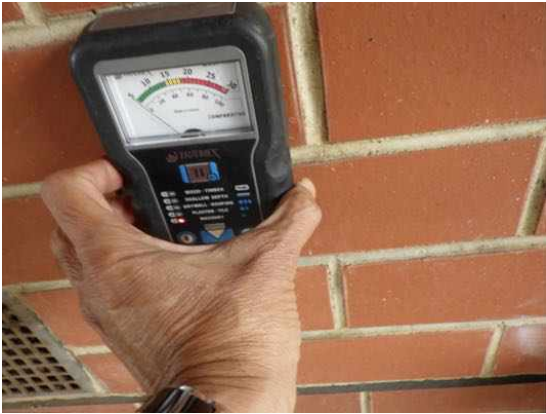
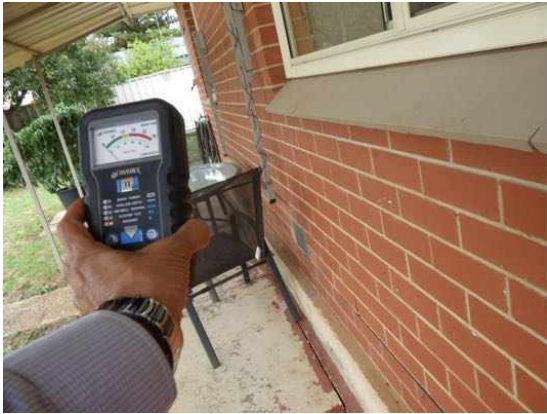
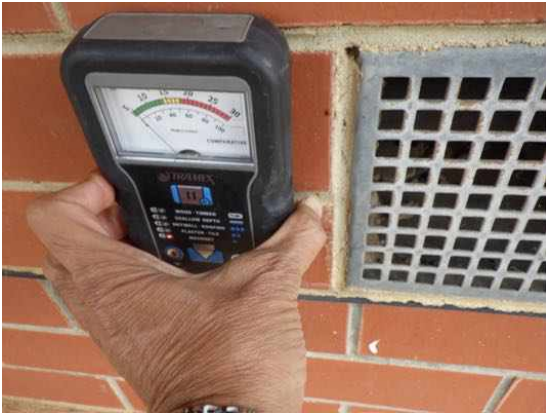
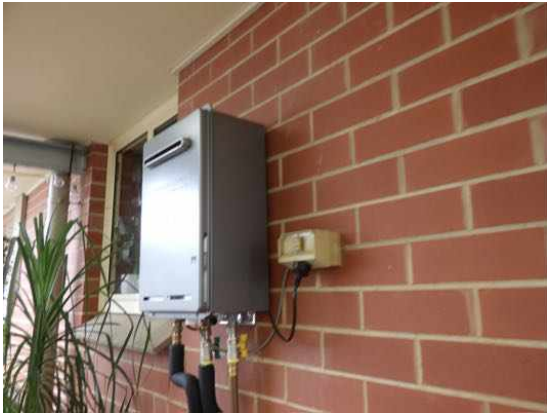
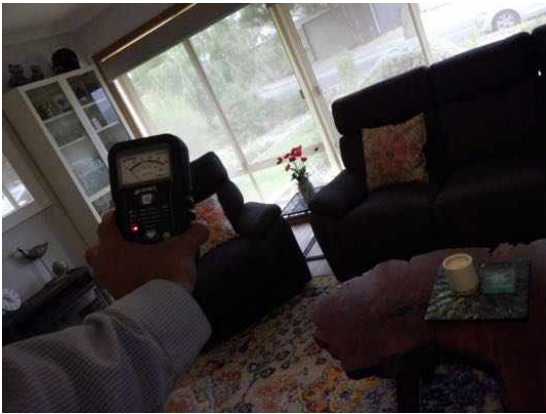
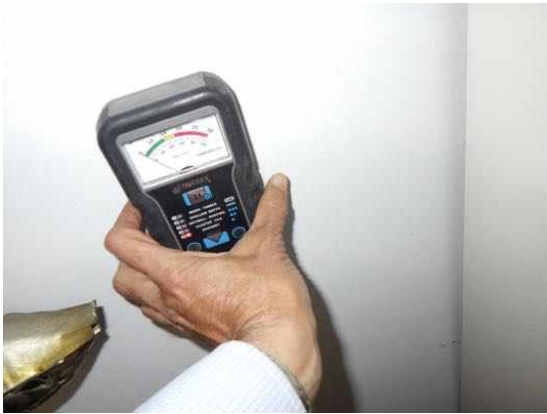
Building: Building 1
Location: All Areas
Finding: Additional Photos
Information: Additional photos are provided for your general reference
