Building Inspection Report

Inspection Date: Wed, 18 Mar 2026

Property Address: 21 Horton St, Elizabeth Park SA 5113,
Australia

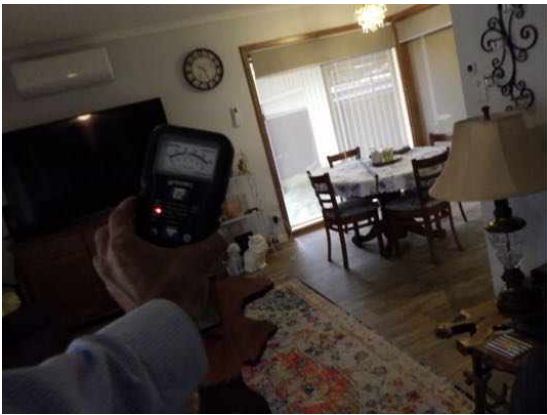
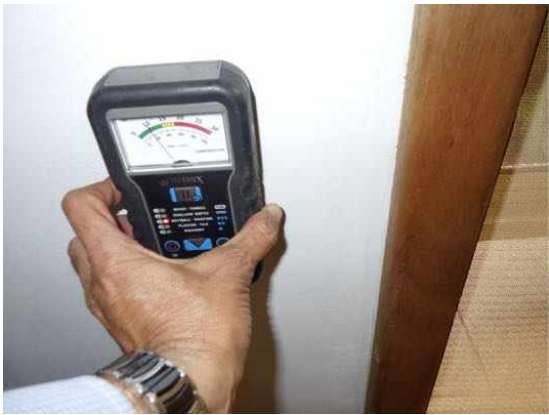
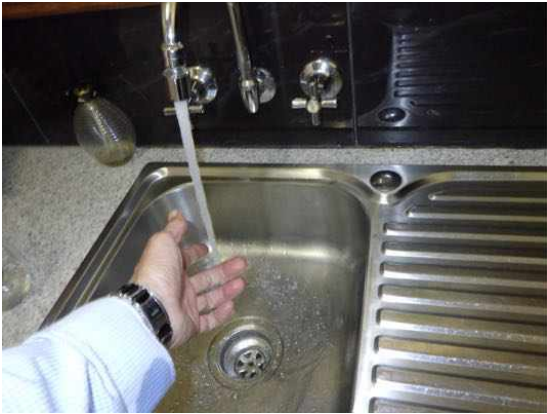
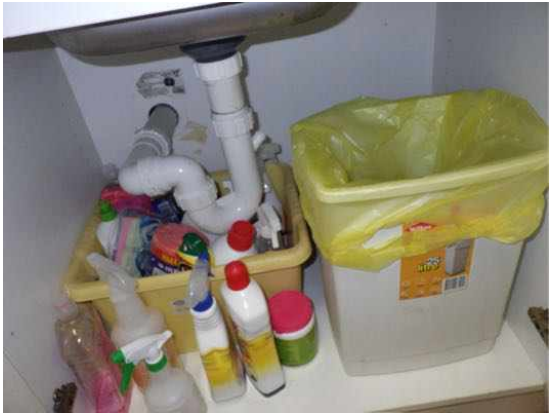
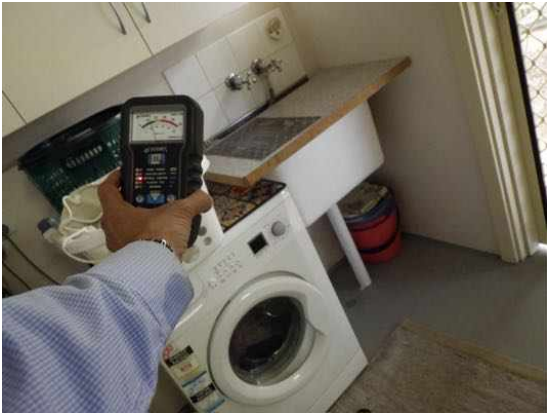
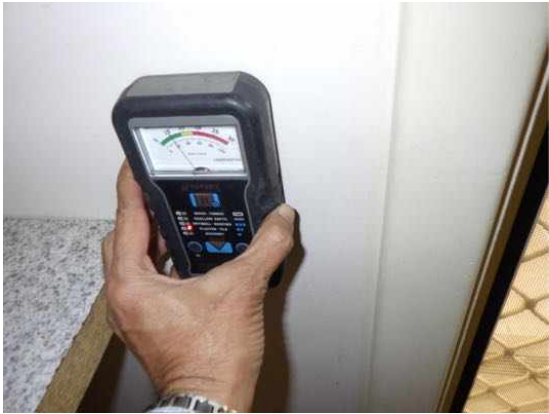
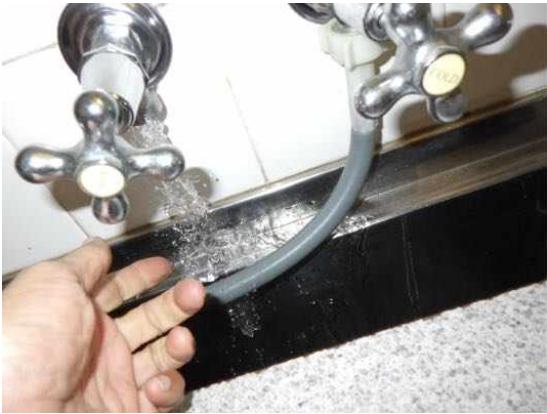
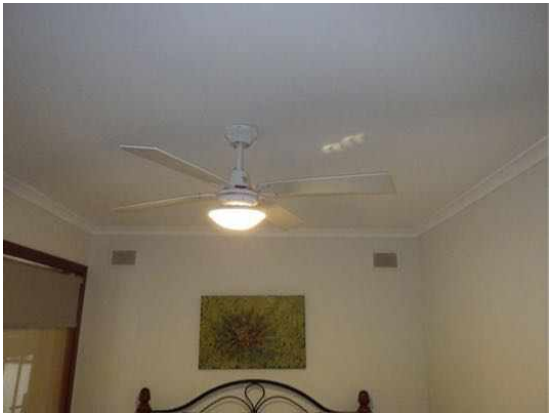
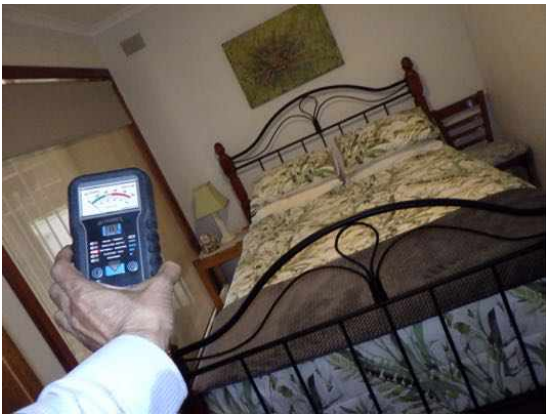
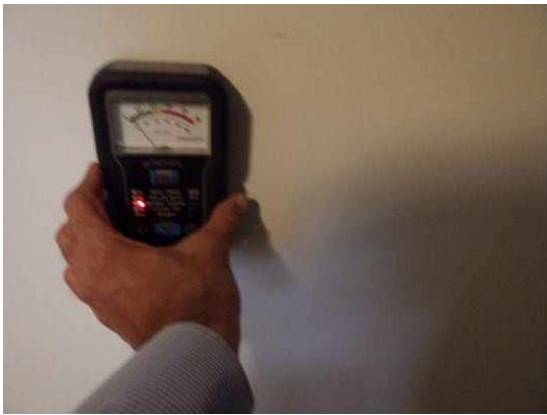
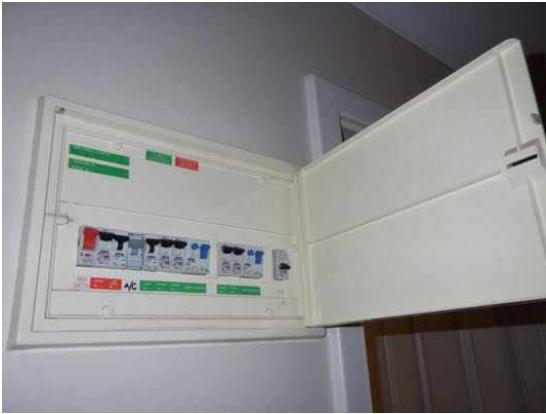
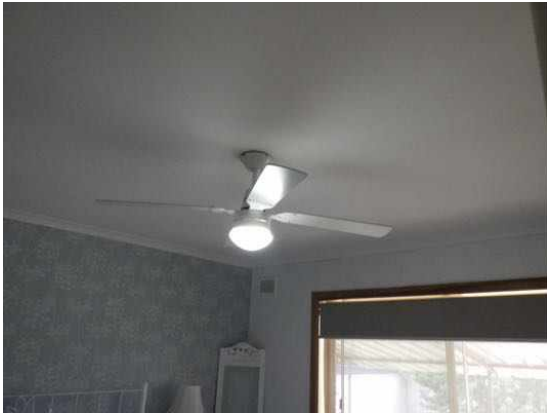
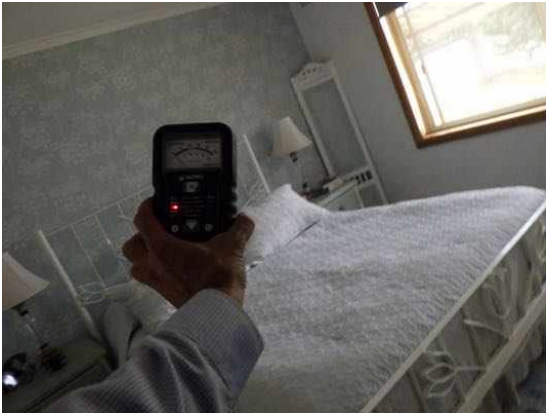
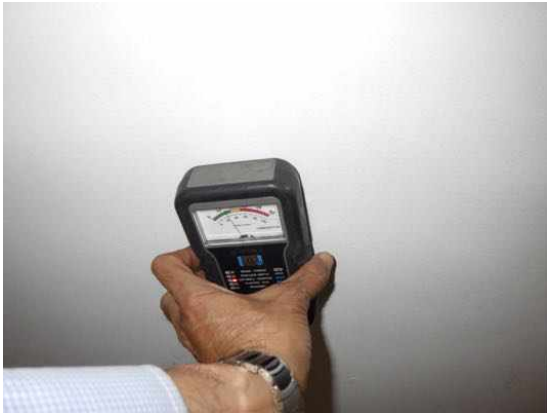
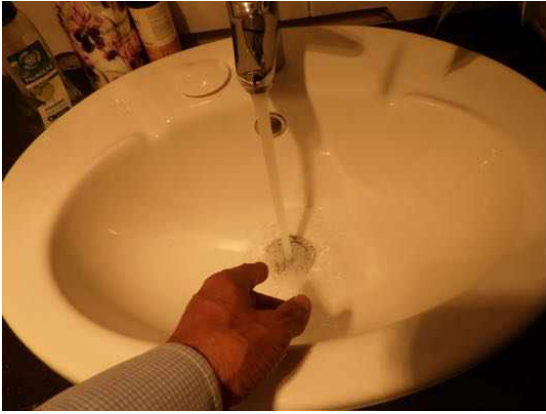
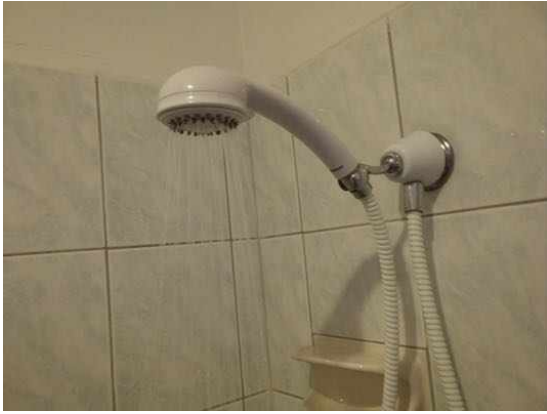
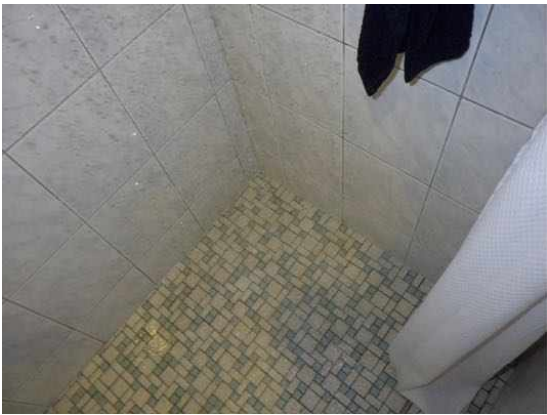
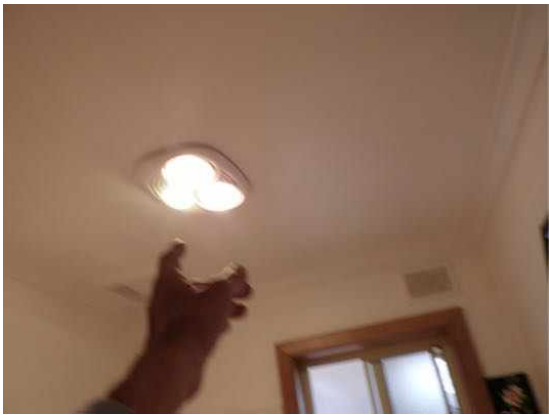
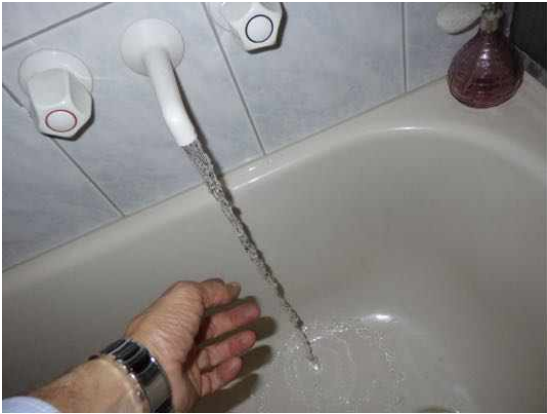
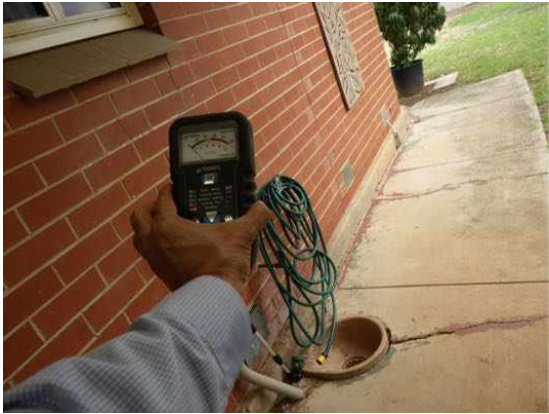
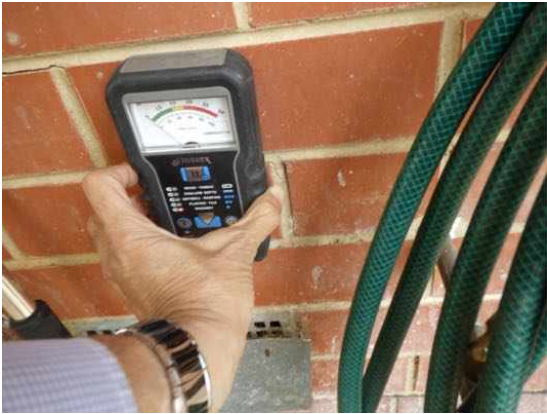
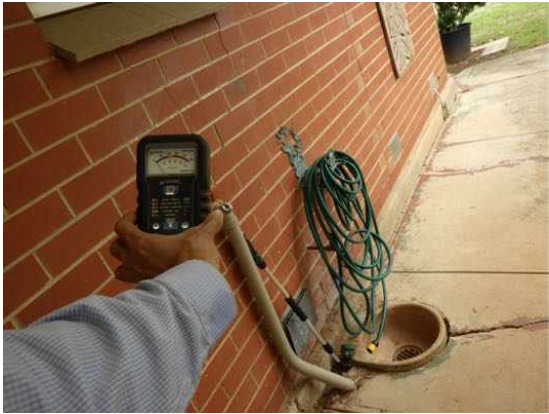
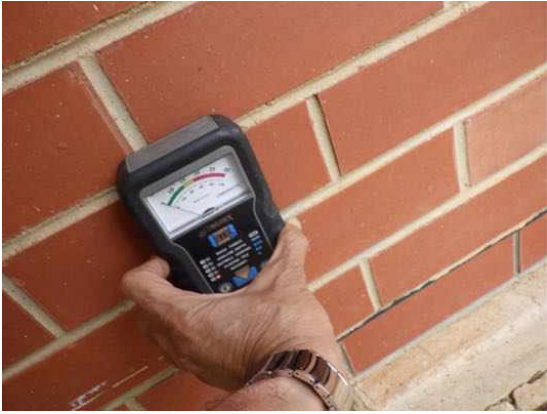
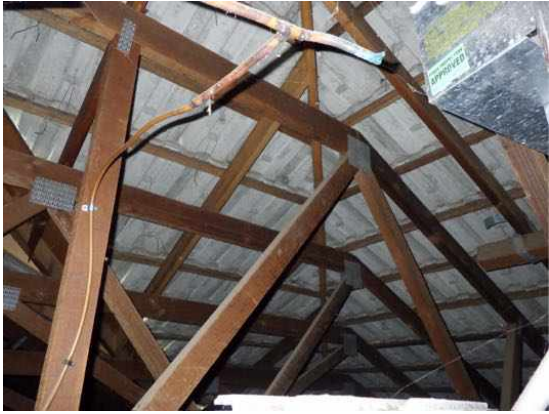
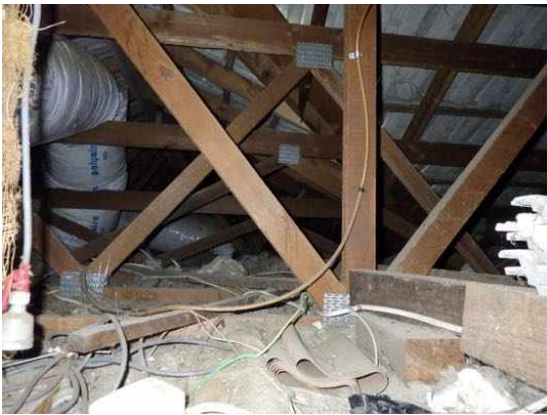
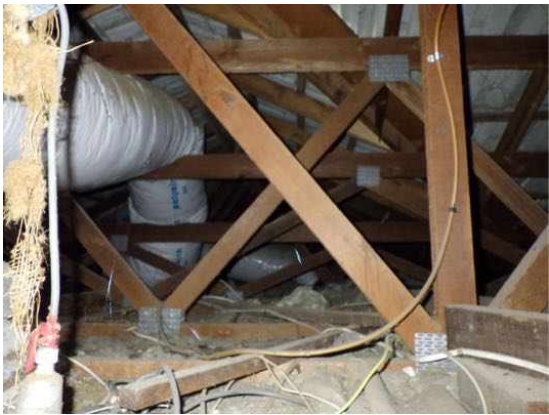
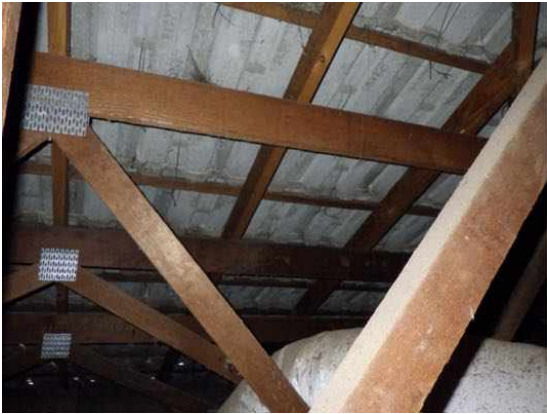
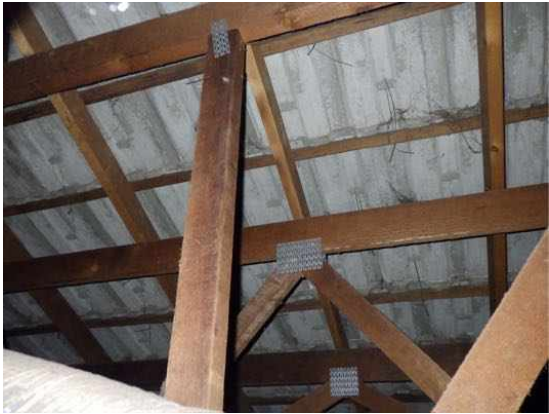
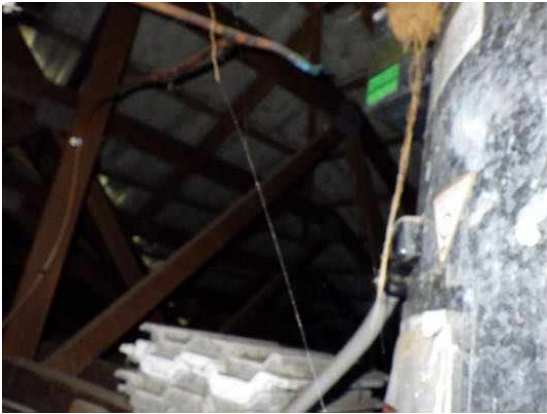
Building: Building 1
Location: All Areas
Finding: Additional Photos - Obstructions and Limitations
Information: These photographs are an indication of the obstructions and limitations which impeded full inspection of the property at the time of inspection. These obstructions can hide an array of defects and should be removed to allow full inspection to be carried out. A re-inspection is recommended once the areas are made accessible.
