# Building and Timber Pest Inspection Report

Inspection Date: Wed, 11 Mar 2026

Property Address: 2/71 Prospect St, Rosehill NSW 2142,  
Australia

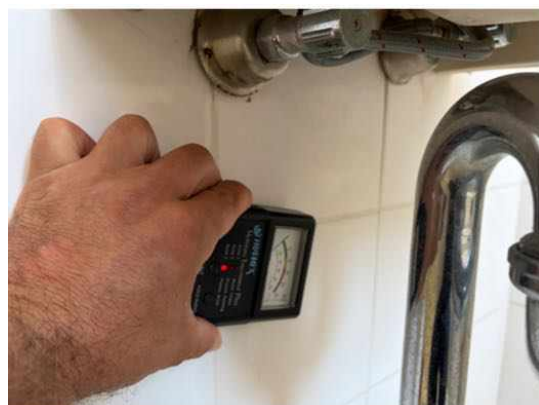
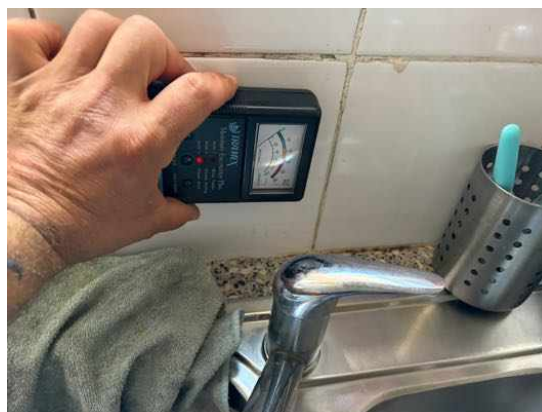
Building: Main Building  
 Location: All Areas  
 Finding: Moisture metre  
 Information: During the inspection the property was checked for moisture using a moisture metre.

This is for information only.

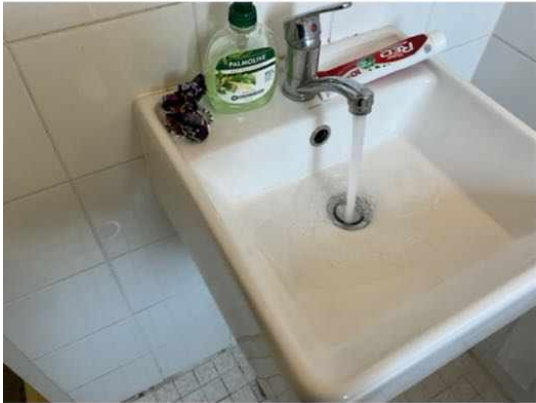
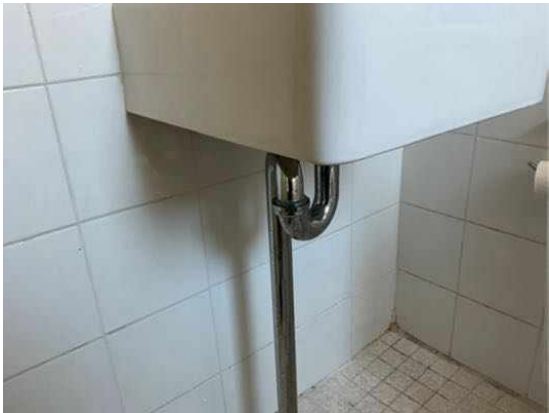
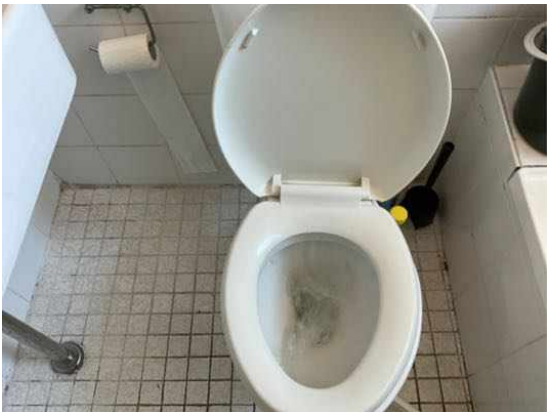
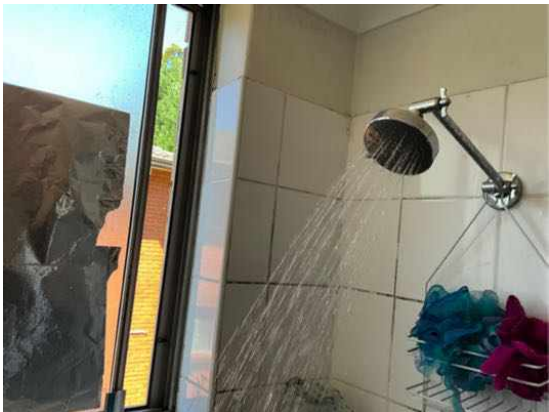
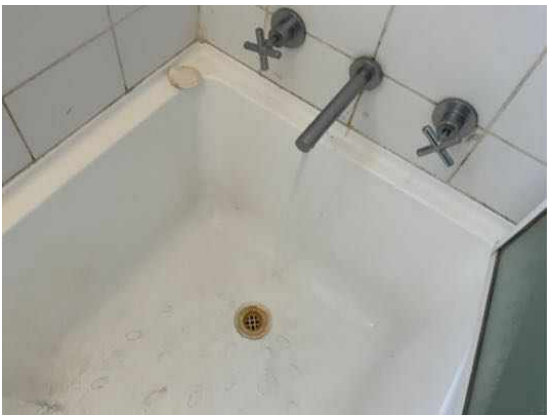
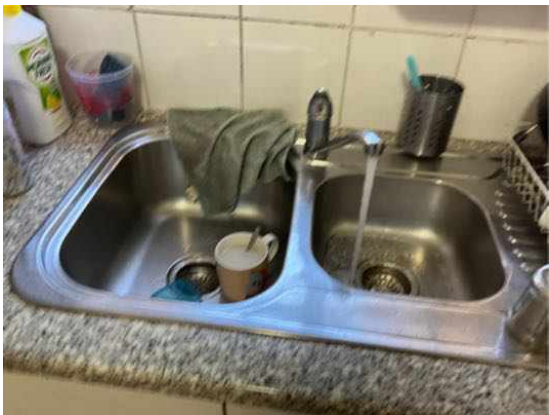
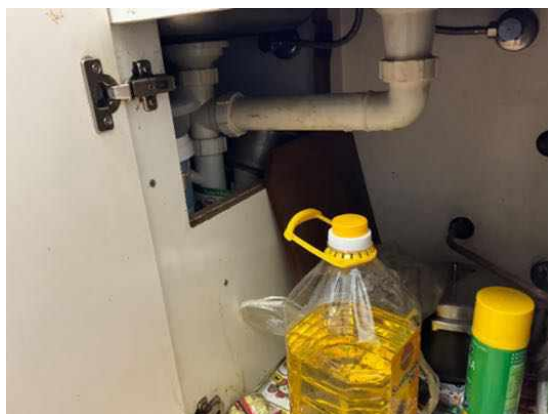
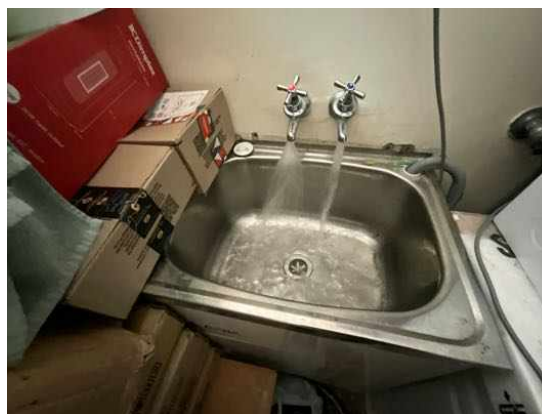
Finding: Additional Photos

Information: Additional photos are provided for your general reference.

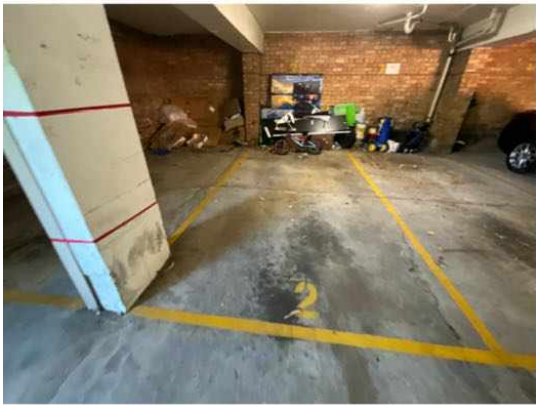
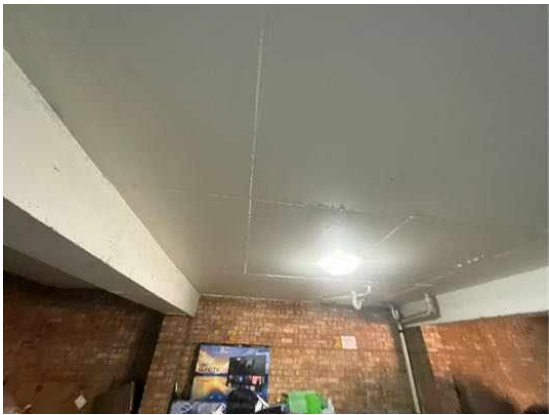
Building: Main Building  
 Location: Garage  
 Finding: Additional Photos- Garage  
 Information: Additional photos are provided for your general reference. Arrows may have been included to highlight areas of importance. Please discuss these photos with your building consultant for clarification.

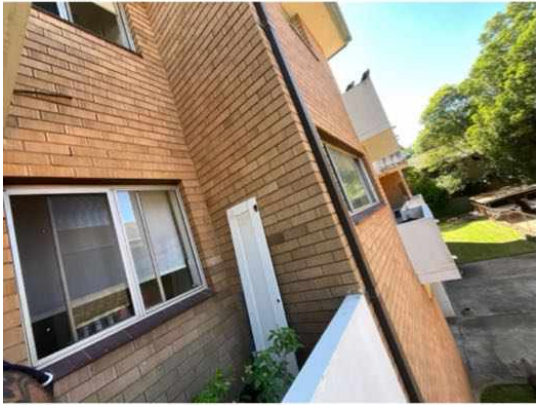
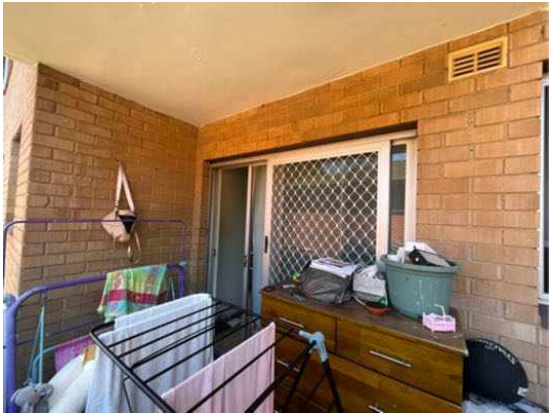
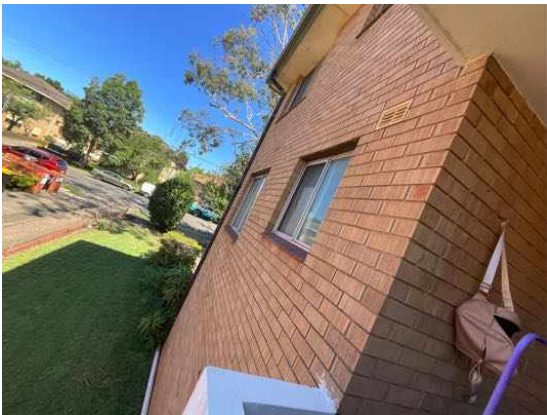
Building: Main Building  
Location: Exterior  
Finding: Additional Photos  
Information:

Additional photos are provided for your general reference.

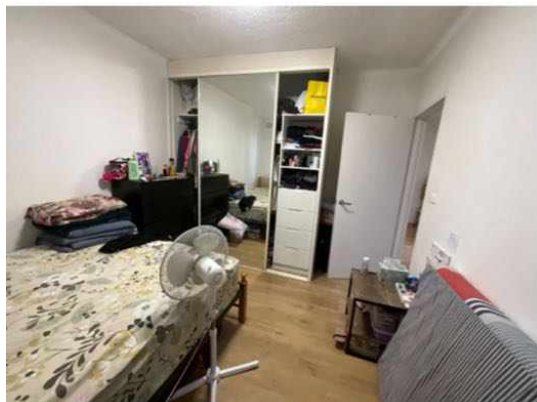
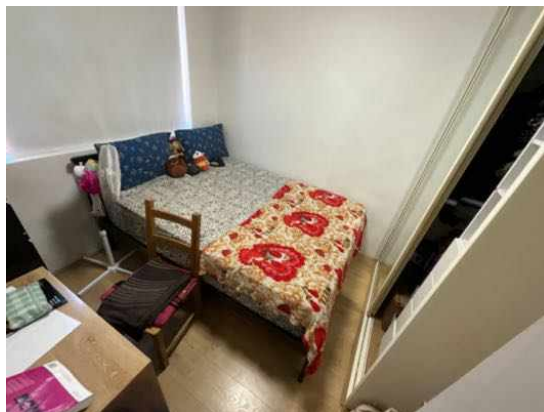
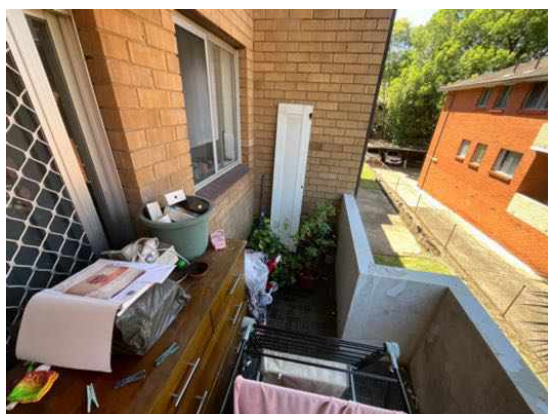
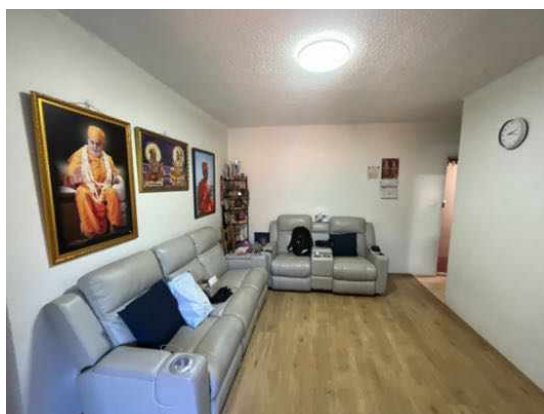
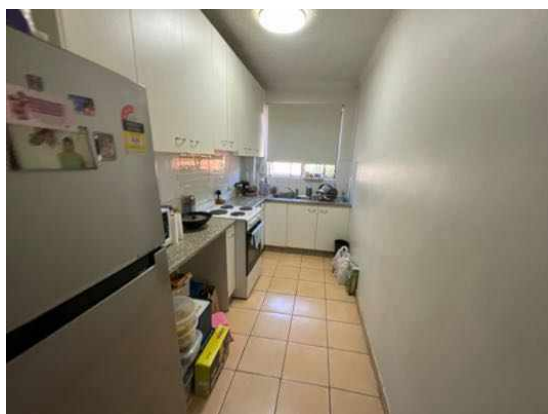
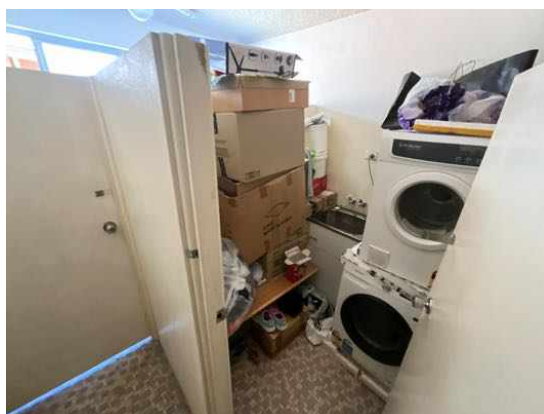
Building: Main Building  
Location: All Areas

These photographs are an indication of the obstructions and limitations which impeded full inspection of the property at the time of inspection. These obstructions can hide an array of defects and should be removed to allow full inspection to be carried out. A re-inspection is recommended once the areas are made accessible.
