## Building Inspection Report

Inspection Date: Thu, 5 Mar 2026

Property Address: 10/ 548 Marine Parade, Biggera Waters  
QLD

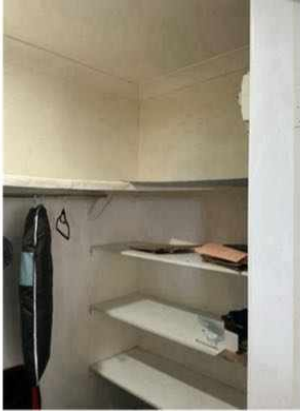
### Defects 3.06

Building: Main Building  
 Location: Walk-In Robe - Master > Rear Right  
 Finding: Cracks to internal render - Category 1  
 Information: It has been observed that cracking to internal rendered surfaces has occurred. The degree of damage falls within Category 1, described as fine cracks that do not need repair and which are less than 1.0mm in width limit.

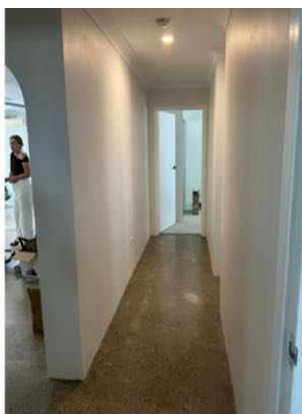
#### Noted Item

Building:	Main Building
Location:	Hallway > Existing
Finding:	Additional Photos
Information:	Additional photos are provided for your general reference

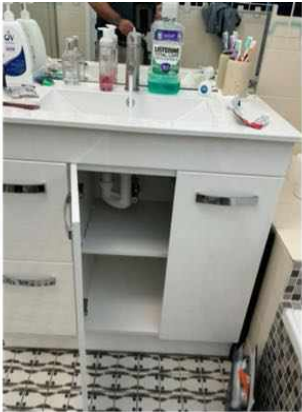
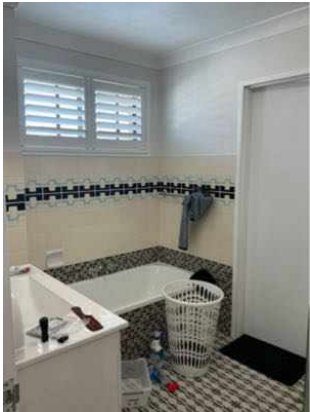
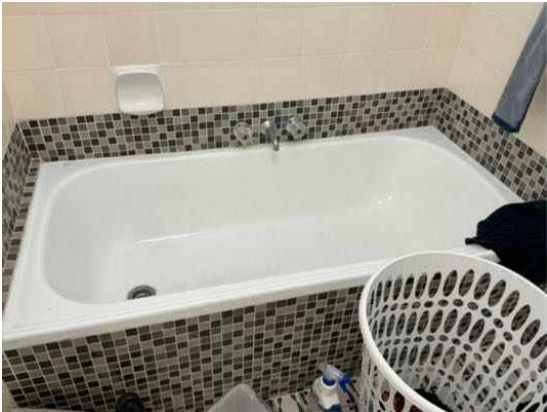
**Noted Item**

Building: Main Building  
Location: Bathroom > Existing  
Finding: Additional Photos  
Information: Additional photos are provided for your general reference

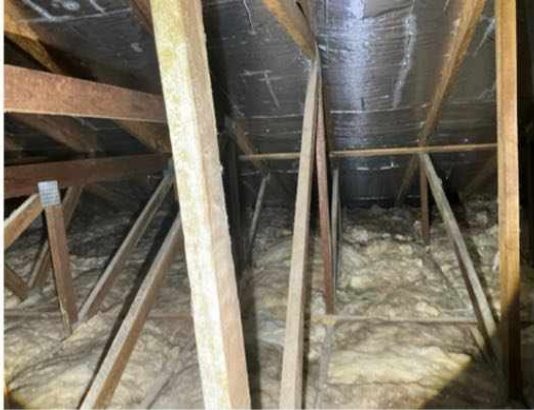
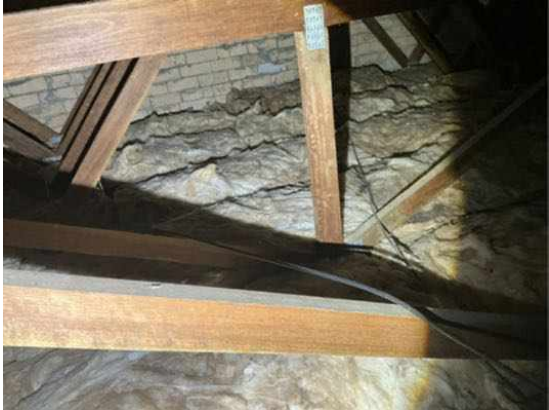
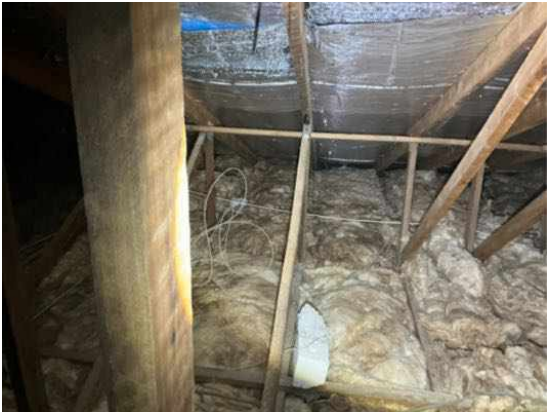
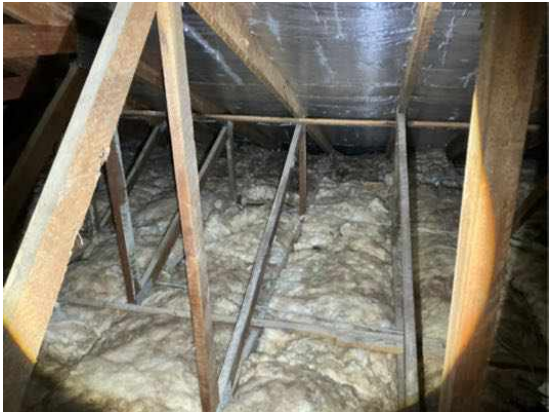
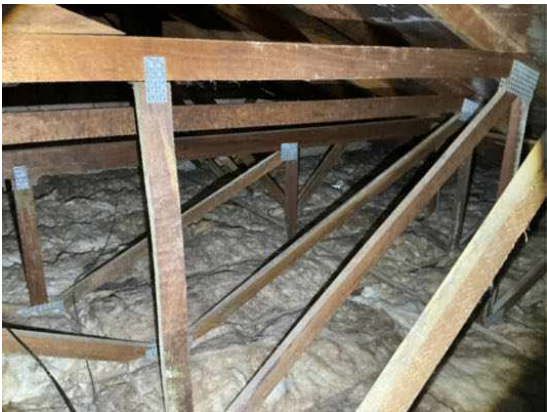
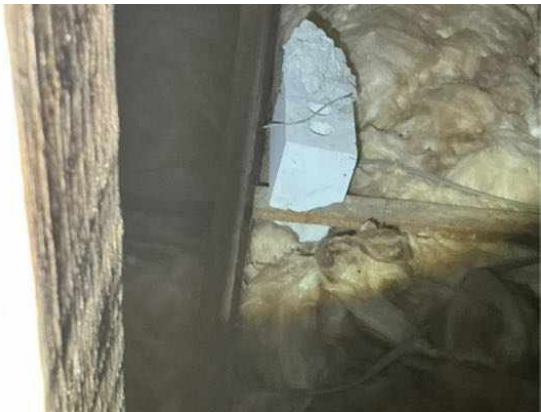
**Noted Item**

Building: Main Building  
Location: Roof Void > Existing  
Finding: Additional Photos  
Information: Additional photos are provided for your general reference
