Building and Timber Pest Inspection Report

Inspection Date: Tue, 17 Mar 2026

Property Address: 201/55 Hill Rd, Wentworth Point NSW
2127, Australia

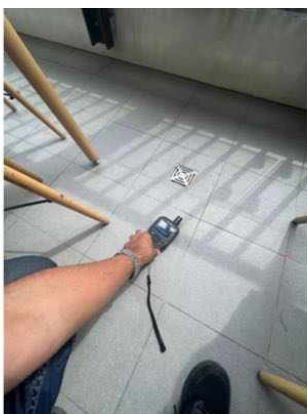
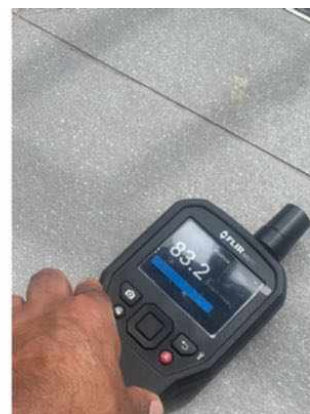
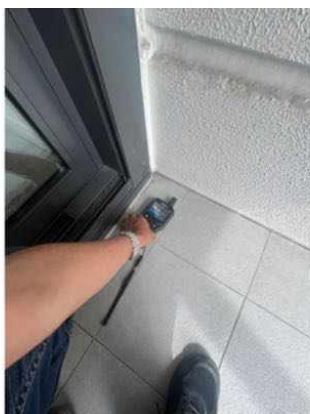
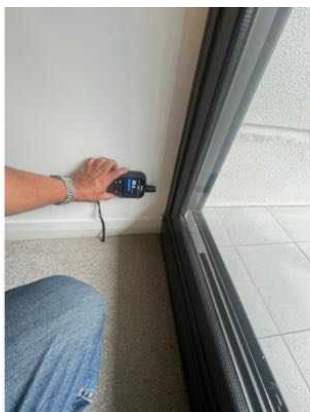
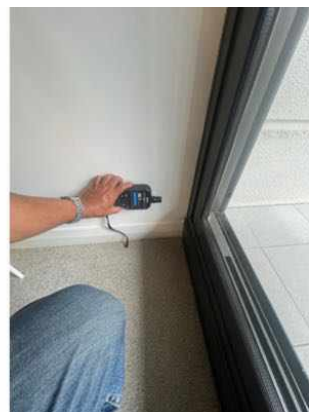
Building: Main Building
Location: Balcony
Finding: Balcony Elevated Moisture - Strata (No internal visible damage noted at the time of inspection)
Information: Elevated moisture was recorded at the base of the balcony wall, internal adjacent wall and tiles. While no internal damage was visible at the time of inspection, balconies in multi-unit dwellings are high-risk areas for waterproofing failure, which can lead to leaks into adjoining units and significant rectification costs. Further investigation by a licensed waterproofing contractor is recommended.

Depending on the strata plan, this area may form part of the common property, in which case remedial responsibility may rest with the owners corporation (strata). Purchasers should seek clarification from the strata manager and legal adviser prior to purchase.

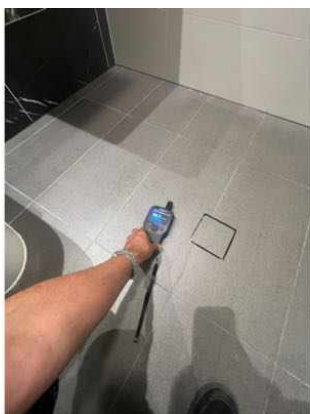
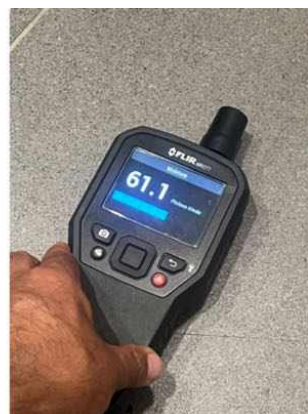
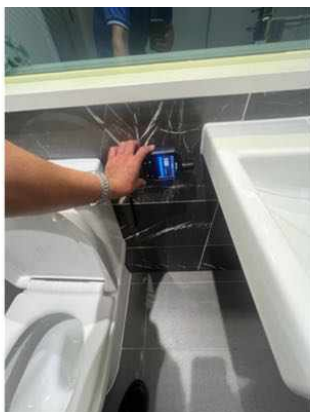
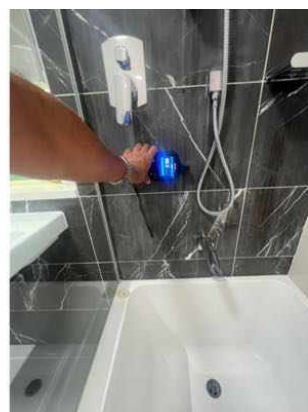
Finding 3.02

Building:	Main Building
Location:	Bathroom
Finding:	Elevated Moisture Bathroom (No visible deterioration)
Information:	Elevated moisture levels were detected to tiled surfaces in bathroom floor, wall around sink area and shower areas. Persistent moisture ingress can lead to concealed damage, including timber rot and mould growth.

Elevated moisture readings in tiled wet areas can occur from normal shower use, age/deterioration of waterproofing membranes, plumbing leaks or moisture absorption through grout lines. While no damage was visible, elevated readings may indicate moisture retention behind tiles, which can be a conducive condition for future deterioration if not monitored.

No immediate action required. Monitor the area over time for signs of drumming, efflorescence, tile movement, or grout deterioration. A further inspection by a licensed waterproofing specialist and/or plumber is recommended to determine cause of elevated moisture.

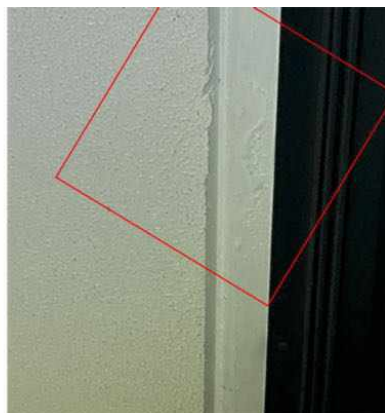
Finding 3.03

Building:	Main Building
Location:	Balcony soffit
Finding:	Painted surface - Bubbling
Information:	Sections of paint in this area was found to have bubbled and deteriorated. Paint bubbling is generally an indication of excessive moisture in the area, that is currently hidden by the painted surface.

The presence of excessive moisture can have major implications on associated building elements if left unattended. While only seemingly minor at this stage, the damage cannot be determined due to the paint obstructing any further inspection of the damage.

It is highly advised that the affected paint be cleaned to allow a further, more invasive inspection by a licensed plumber. Failure to act on this defect may necessitate major works in the future.

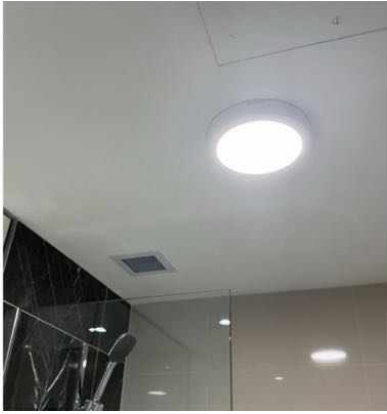
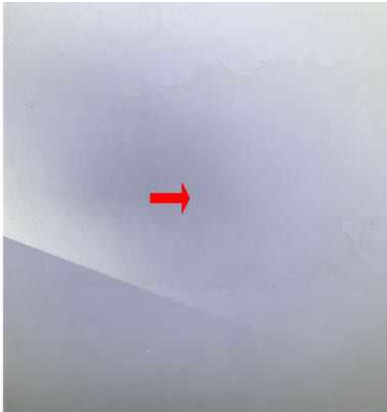
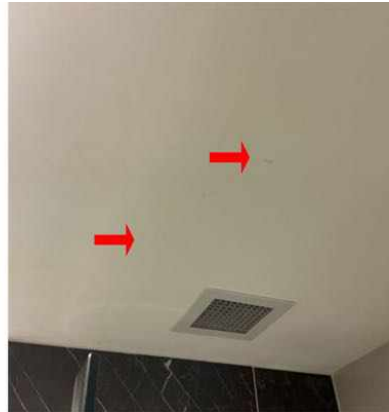
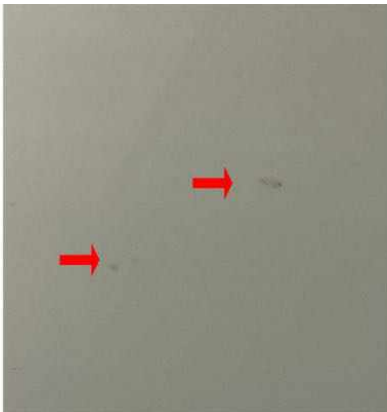
Finding: Water staining

Information: Water staining was evident in this area at the time of inspection. Water staining indicates that surfaces have been exposed to excessive moisture over time. The minerals and other elements in the water lead to staining, which may graduate to corrosion and deterioration if left unmanaged.

While mostly an appearance defect, water staining can be indicative of more serious defects, which may be currently concealed by other building elements.

Where water staining is active, a licensed plumber must be consulted to identify the cause of the staining and to provide advice on any reparation works that may be required. Replacement of any broken or damaged structures is advised.

Conversely, where water staining is old and inactive, affected building materials may be repaired or replaced at client discretion. A qualified carpenter or registered builder may be appointed to perform these works.

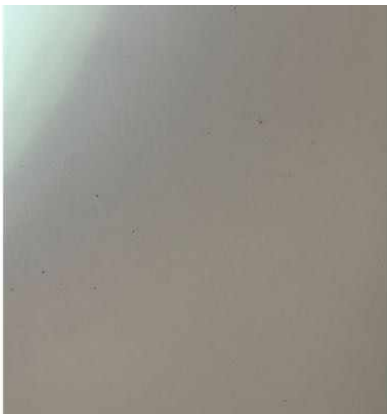
Finding 3.06

Building:	Main Building
Location:	Lounge Room
Finding:	Fainted Dark Spots - Ceiling
Information:	Very minor spotting was identified at the time of inspection, the pattern is consistent with airborne dust accumulation and/or minor environmental staining or possible insect droppings. No visible evidence of moisture ingress or structural defect was observed at the time of inspection.

Cleaning and repainting may be undertaken for cosmetic improvement. Regular cleaning and maintenance of air-conditioning filters and ventilation is recommended.

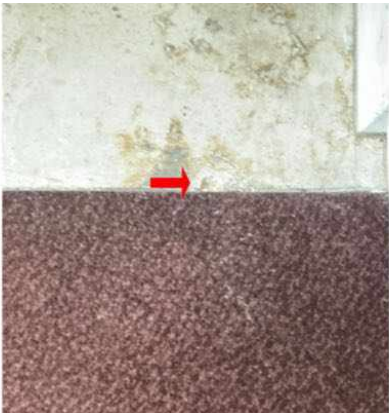
Building: Main Building
Location: All Internal Areas - Front
Finding: Tiles - Cracked or damaged
Information:

Cracking was evident to the tiling in this area at the time of inspection. While the cracking appears to be minor, this area is frequently exposed to water, allowing potential for water penetration into adjoining sections of walls or flooring.

If left unmanaged, water penetration to these areas may lead to subsequent water damage, which is likely necessitate repair work to affected building elements.

A tiling contractor should be appointed to ensure that no further water damage occurs. The re-application of silicone and grouting throughout remaining tile work is also advised, to further protect the area against water penetration.

Where water penetration has led to water damage, appointment of a relevant tradesperson may be required to repair damaged building elements.

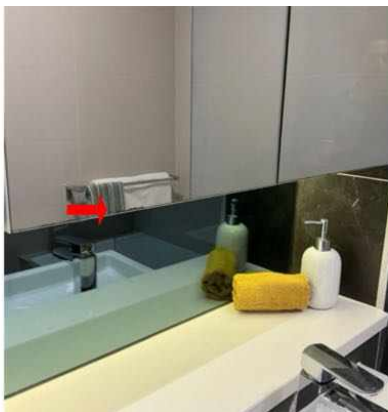
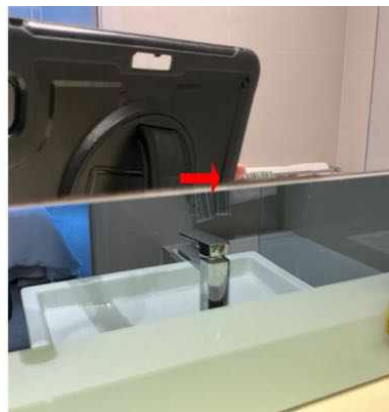
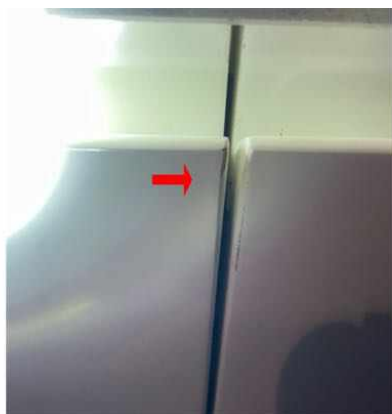
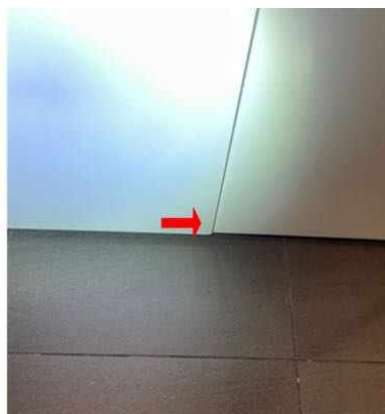
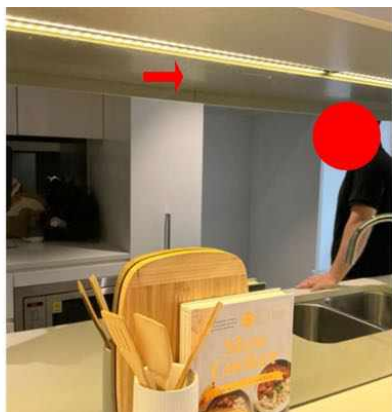
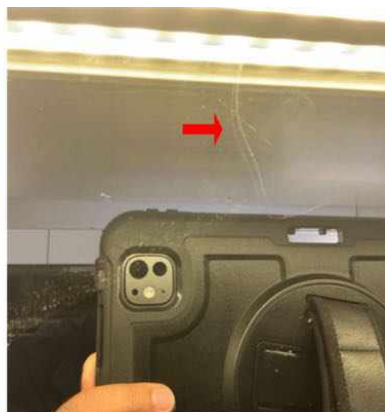
Finding 3.09

Building:	Main Building
Location:	All Internal Areas
Finding:	Building element - Damaged - Mirror desilvering bathroom , Basin hairline cracking , carpet stained to some areas , kitchen cupboards minor chips , splash back minor hairline scratch
Information:	Breakage occurs generally when the building materials have either aged and decayed, or as a result of damage (accidental or deliberate).

Repair and/or replacement of broken elements is advised to ensure that additional secondary defects do not arise as a consequence. Such works are necessary, as all building elements play a key role in the operation and function of the overall structure and its performance.

A relevant tradesperson should be appointed to repair or replace the affected building element prior to any subsequent damage being caused.

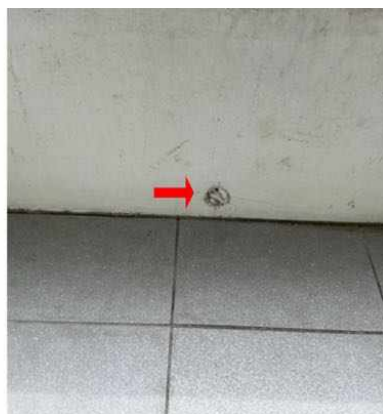
Building:	Main Building
Location:	Balcony
Finding:	Building element - Damaged - Hole not sealed
Information:	Breakage occurs generally when the building materials have either aged and decayed, or as a result of damage (accidental or deliberate).

Repair and/or replacement of broken elements is advised to ensure that additional secondary defects do not arise as a consequence. Such works are necessary, as all building elements play a key role in the operation and function of the overall structure and its performance.

A relevant tradesperson should be appointed to repair or replace the affected building element prior to any subsequent damage being caused.

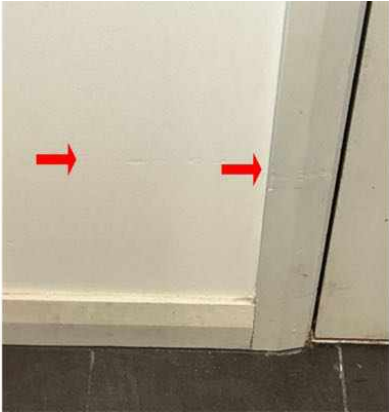
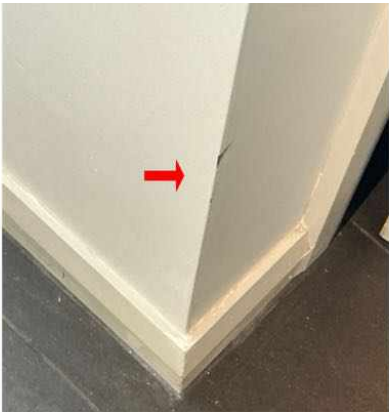
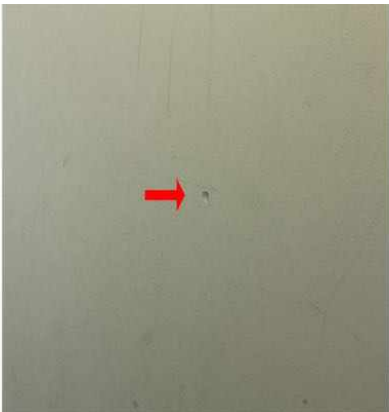
Finding 3.13

Building:	Main Building
Location:	All Internal Areas
Finding:	Paint finish and hairline cracking to some areas
Information:	The paint finish in this area was identical at the time of inspection including some hairline minor cracking.

Whilst incomplete or missing paint finish is generally an appearance defect, it can also lead to the development of secondary building defects over time. Incomplete areas of paint finish expose the area to moisture, potentially accelerating the deterioration of underlying building materials.

Incomplete paint finishes should be sanded back, filled, leveled and painted, as applicable. Where inadequate or missing paint protection has led to the deterioration of the associated building element, repair and/or replacement of this building element may be required.

A painting contractor should be appointed as soon as possible to perform necessary works to aid the appearance of the affected area and to ensure the area is protected against further deterioration. Alternatively, the homeowner following manufacturer instructions may perform these works.

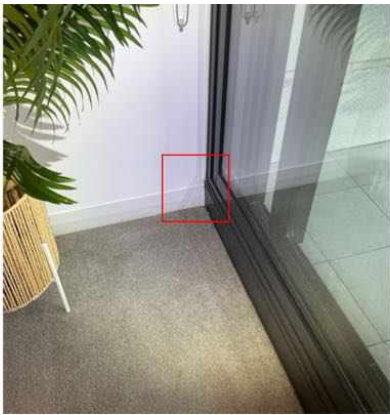
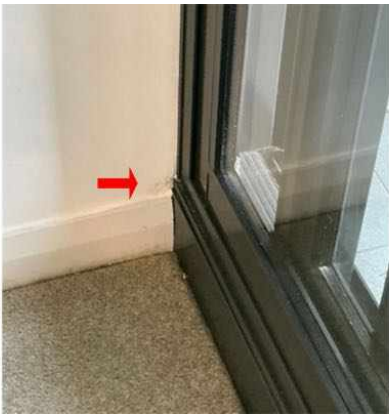
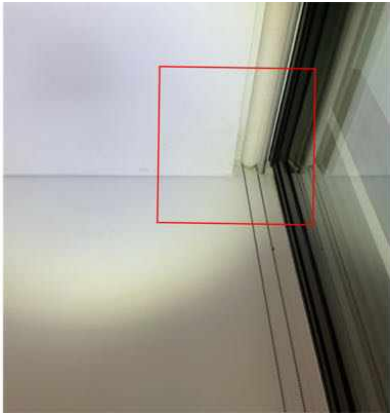
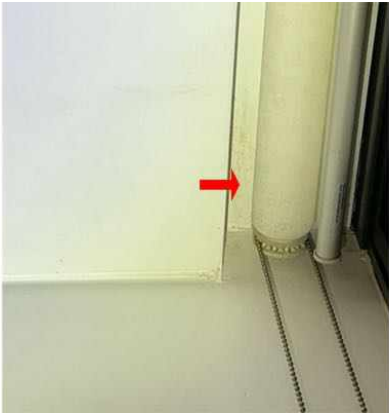
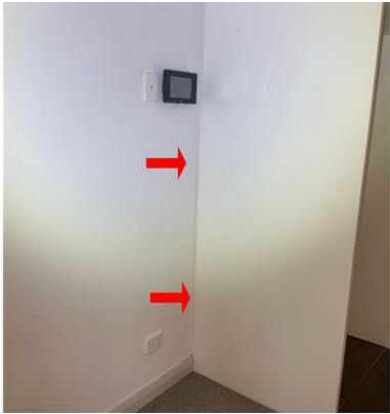
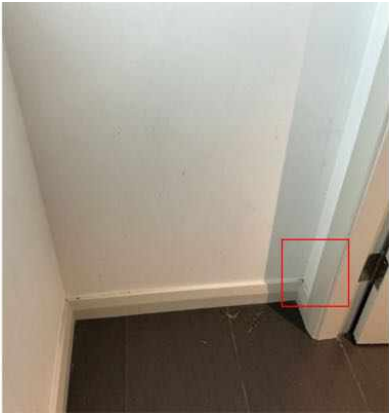
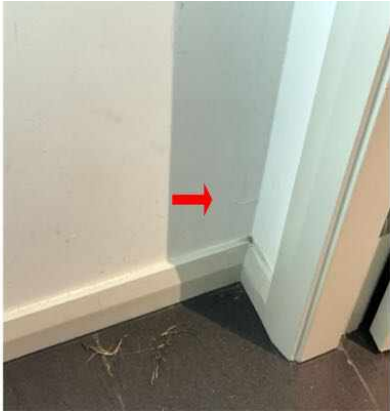
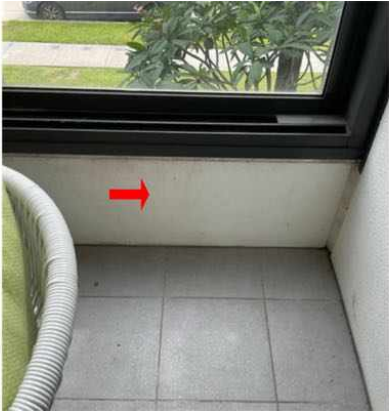
Finding 3.14

Building:	Main Building
Location:	All Internal Areas
Finding:	Sealant and grouting - Missing or degraded
Information:	It was noted on inspection that sealant or grout is degraded. There is also evidence of poor workmanship and excessive use of sealant. Silicone should never be used as a first line of defence against waterproofing. Further inspection by a licensed waterproofing contractor is highly recommended.

Different materials and floor areas move at different rates, generally causing cracking to grout or sealant at this point. A flexible sealant is required to allow for expected expansion and contraction, while keeping the joint water tight and protective of all associated building materials.

There appears to be excessive mould to the sealant and grout which will likely require scraping out and replacement.

Flexible and mould resistant materials should be applied to affected areas to prevent any subsequent water damage that is likely to occur. Regular maintenance and replacement of damage or missing or damaged sealant and grout is highly recommended to the wet areas, as this is a regular wear and tear defect. Sealant and grouting in areas that come into regular contact with water should be maintained for the long term care of your property.

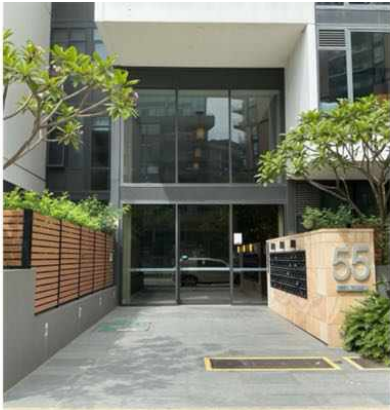
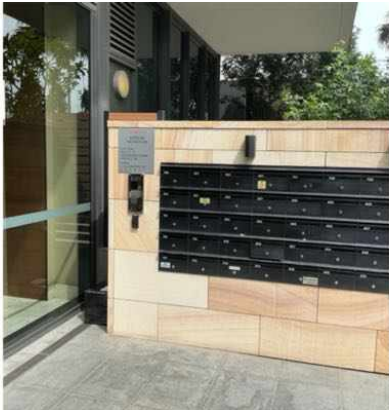
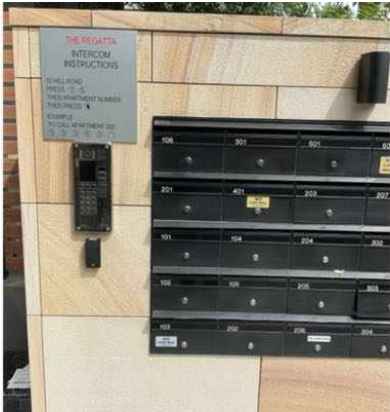
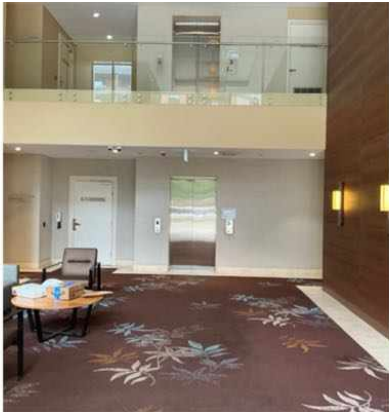
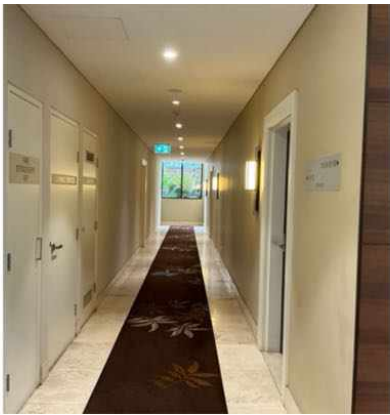
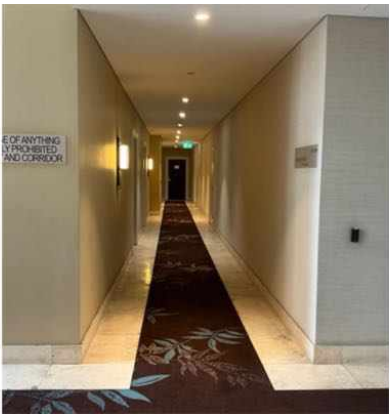
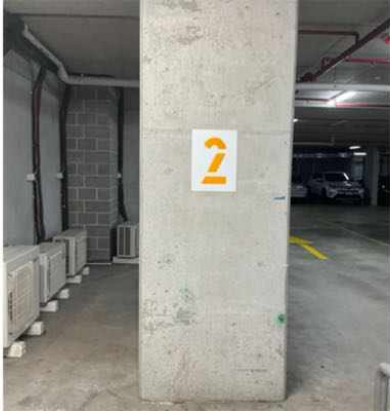
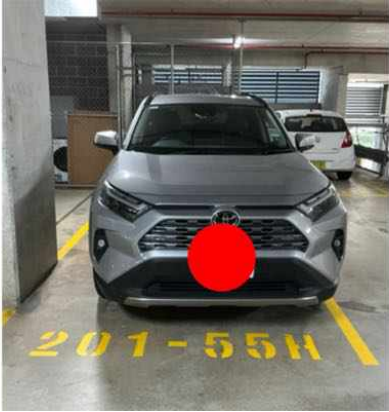
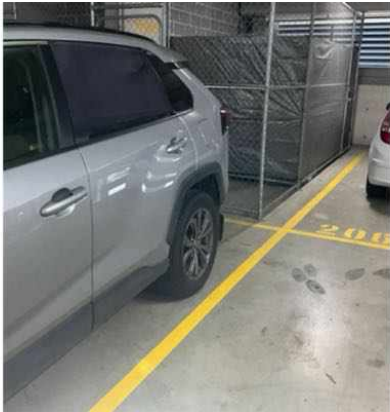
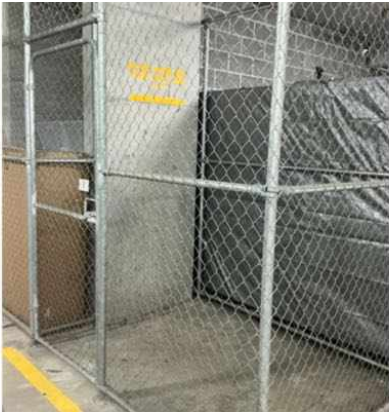
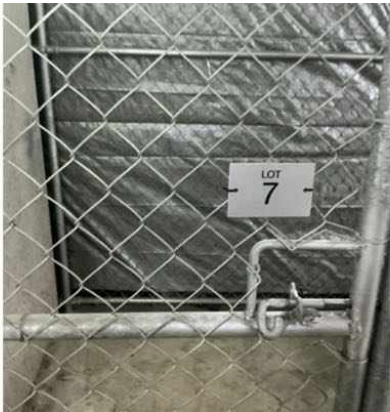
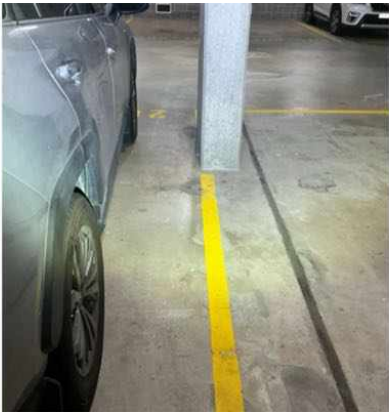
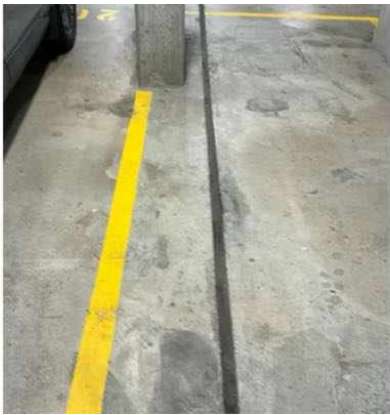
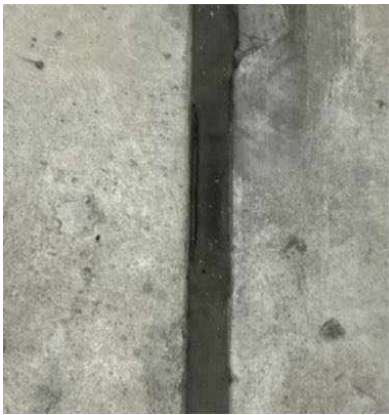
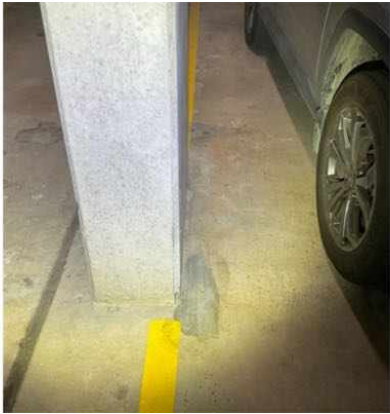
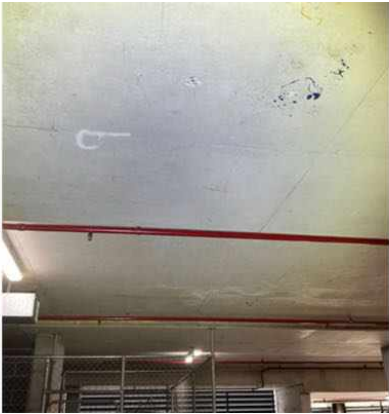
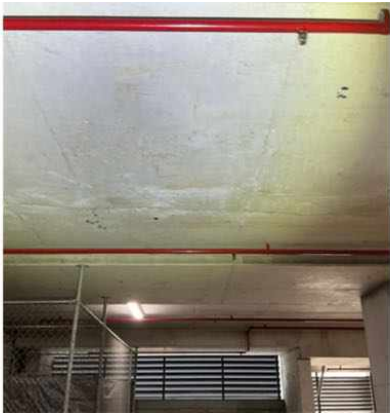
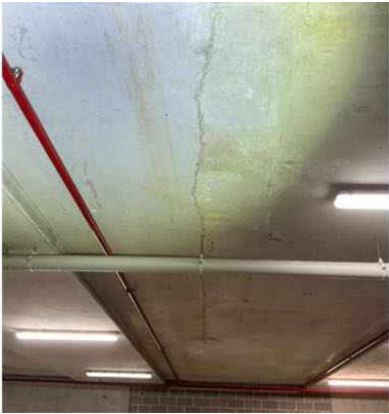
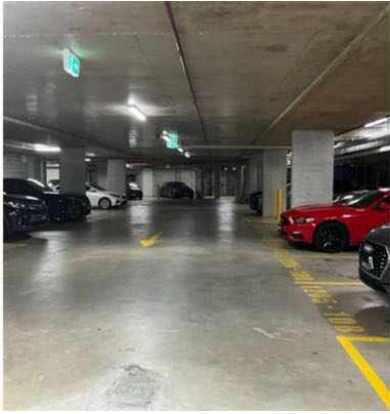
Noted Item

Building: Main Building
Location: All External Areas
Finding: Additional Photos - Obstructions and Limitations
Information: These photographs are an indication of the obstructions and limitations which impeded full inspection of the property at the time of inspection. These obstructions can hide an array of defects and should be removed to allow full inspection to be carried out. A re-inspection is recommended once the areas are made accessible.

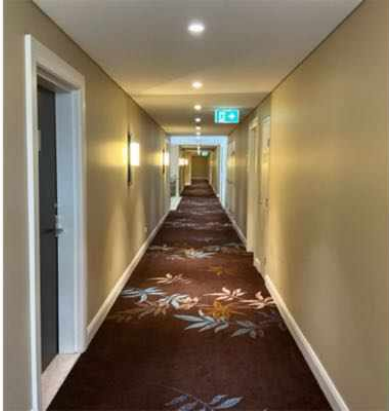
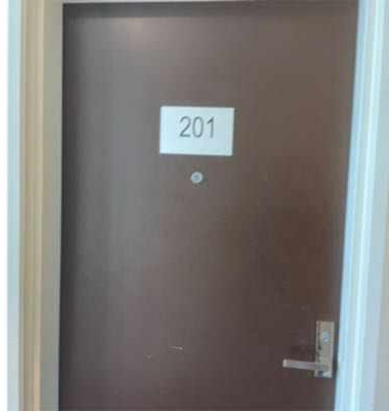
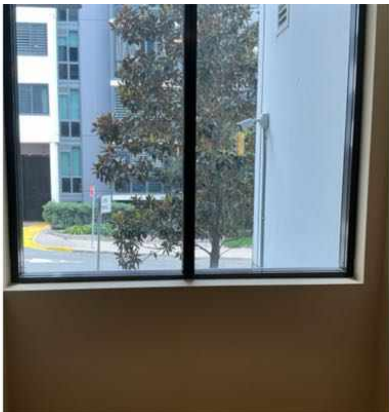
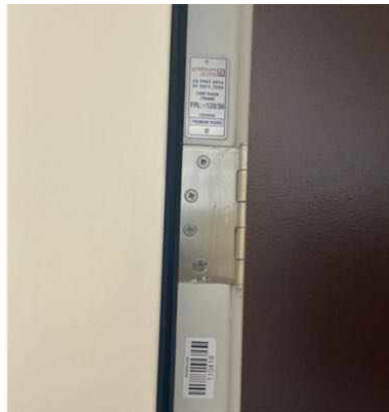
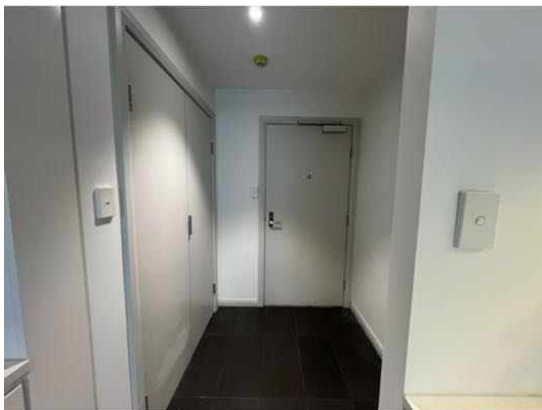
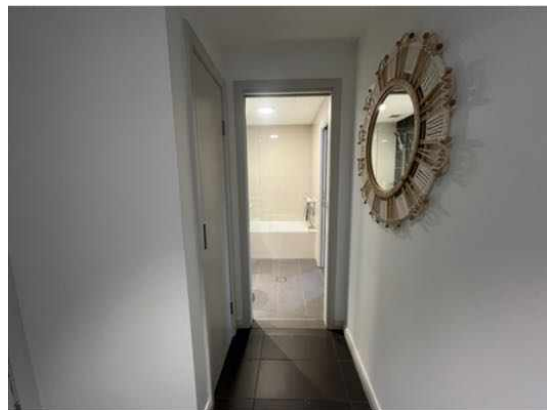
Noted Item

Finding: Additional Photos - Obstructions and Limitations

Information: These photographs are an indication of the obstructions and limitations which impeded full inspection of the property at the time of inspection. These obstructions can hide an array of defects and should be removed to allow full inspection to be carried out. A re-inspection is recommended once the areas are made accessible.

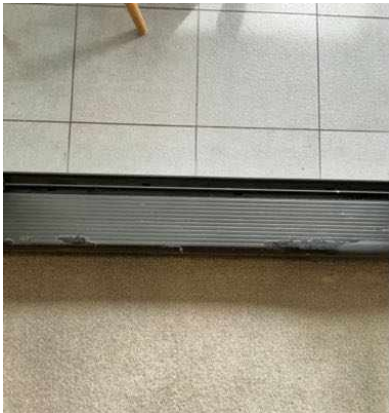
Building: Main Building
Location: All Internal Areas
Finding: Balcony Floor Level Differential
Information: The balcony finished surface appears to be close to, or at the same level as, the internal floor. Standard construction practice requires a step-down of approximately 50 mm unless a fully engineered threshold drainage system is provided. No such drainage features were visible during inspection. This configuration increases the risk of water ingress, and confirmation of the balcony waterproofing detail through strata/building management is recommended.
