Building and Timber Pest Inspection Report

Inspection Date: Wed, 4 Mar 2026

Property Address: 35 Merrick Cct, Kiama NSW 2533, Australia

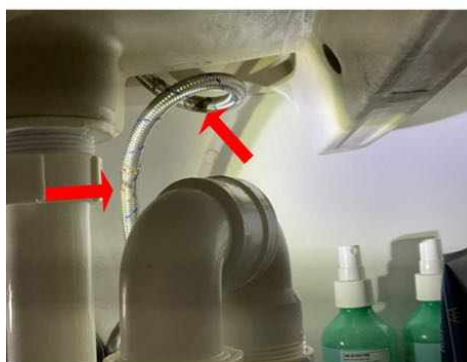
Building: Building 1
Location: All Bathrooms
Finding: Areas rusted plumbing lines
Information: These vanity areas shows evidence of rusting and corrosion, which is likely to have developed as a result of excessive exposure to moisture and or inadequate coatings.

A registered plumber or skilled handy person should be appointed immediately to replace these plumbing lines that have been severely affected by rust or water damage.

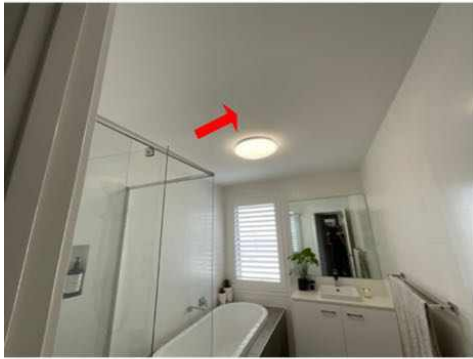
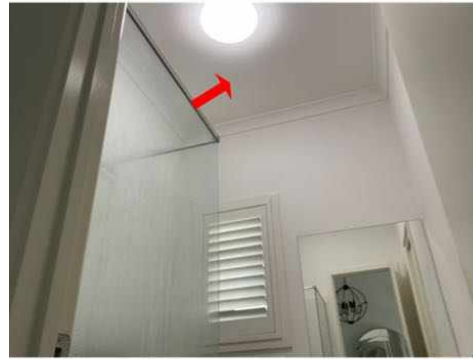
Finding 3.02

Building:	Building 1
Location:	Bathroom
Finding:	Exhaust fans - Missing
Information:	The exhaust fans has not been installed in 2 bathroom areas. Missing exhaust fans may lead to the development of more significant defects such as moisture damage to surrounding building materials from inadequate ventilation. Inadequate ventilation in internal areas creates an environment that is conducive to the formation and development of mould and other respiratory hazards. It is highly advised that a licensed electrician be appointed to retrospectively install exhaust fans. Failure to perform works to aid the ventilation of the area may lead to the development of these secondary defects.

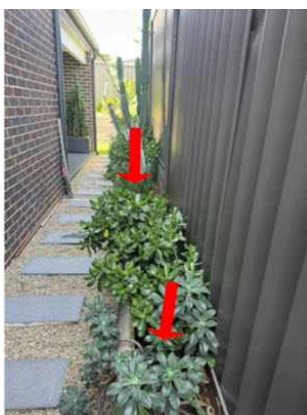
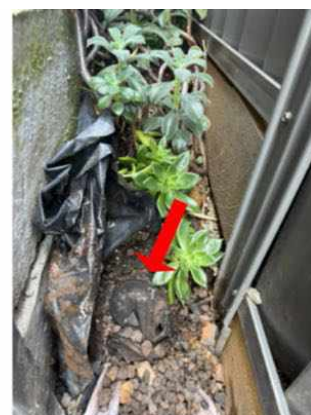
Finding 3.03

Building:	Building 1
Location:	Walls - right middle area
Finding:	Site drainage - Inadequate
Information:	The site drainage in this right area was found to be unfinished at the time of inspection, creating potential for subsequent water damage to associated building elements.

A qualified plumber should be appointed to finish off this Ag drain. The right rear roof gutter has a loose end cap requiring repair. Secondary defects are likely to occur if left unmanaged.

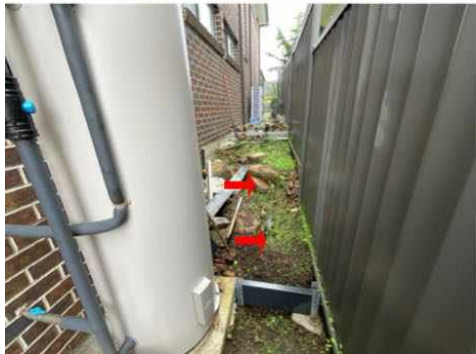
Finding 3.04

Building:	Building 1
Location:	Exterior walls - right side
Finding:	Unfinished construction
Information:	The construction of this right path and drainage appears to be incomplete. The safety of the structure can therefore not be ensured and the creation of secondary defects to surrounding building elements may be likely.

A Registered Builder should be appointed immediately to complete this construction process.

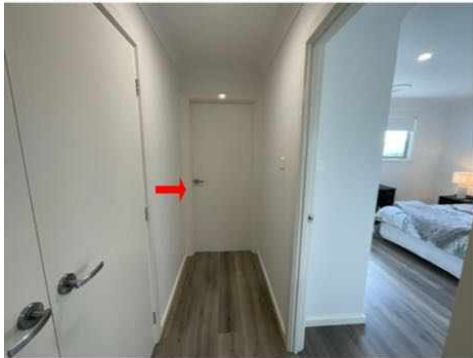
Building:	Building 1
Location:	Bedroom - Master
Finding:	Door - Binding/jamming
Information:	Binding and/or jamming of this door is evident during standard operation. This defect inhibits the functionality of the affected door as well as creating potential for secondary defects to associated building elements, such as damage to the floor covering.

A door that binds to flooring or to the associated door frame may have several causes, ranging from minor defects, such as poor installation of the door or deteriorated hinges, through to major structural issues, such as damage to subfloor structures.

For this minor cause, a qualified carpenter or general handyperson should be appointed to perform minor rectification works at client discretion.

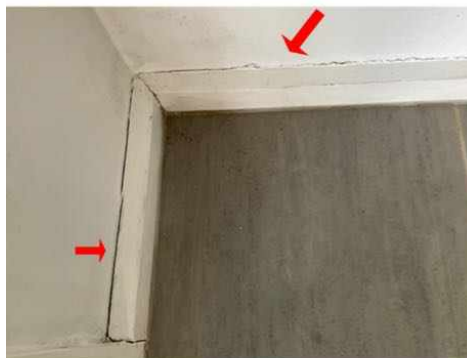
Finding 3.08

Building:	Building 1
Location:	Master bedroom and lounge room
Finding:	Cracking - Damage Category 1 - Fine (up to 1mm)
Information:	Although fine cracks are quite noticeable, they are often only considered to be an appearance defect, and usually do not indicate any structural damage. Generally, the cause of a fine crack is indicative of a separation between building materials and finishes (e.g. paint, plaster, etc.) along joins.

Cracking of this nature can generally be repaired with minor sanding, filling and/or repainting. Such works should be performed by a qualified painter or a general handyman.

Monitoring of all cracking should be conducted frequently. Always contact a building inspector should cracks widen, lengthen, or become more numerous.

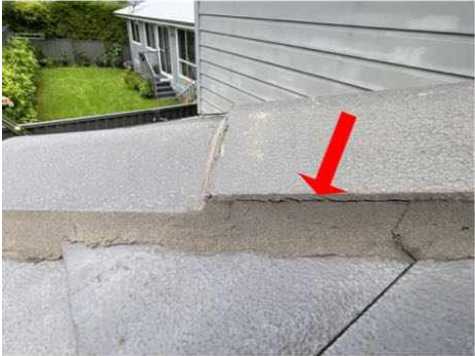
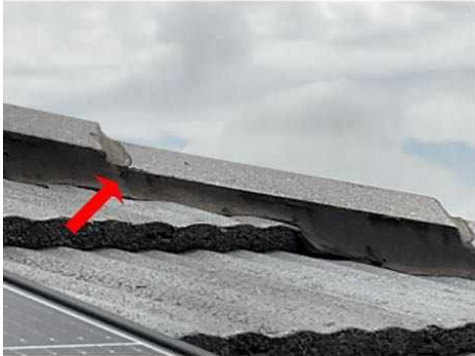
Building:	Building 1
Location:	Roof Exterior
Finding:	Roof tiles - Weathered
Information:	Upon inspection of the exterior roofing, the majority of roof tiles were considered to be in a good condition. While weathering of the tiles is consistent with the age of the property, maintenance works are required. Isolated areas of mortar show minor cracking. Re-pointing and re-sealing the may be considered as an interim solution by the client to help preserve and extend the life span of the tiles. A roofing contractor

can repair these minor areas in the near future.

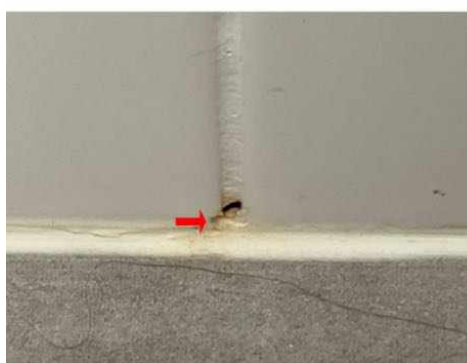
Finding 3.11

Building: Building 1
Location: Bathroom
Finding: Sealant and grouting - Missing or damaged
Information: It was noted on inspection that sealant or grout is degraded to these pictured areas.

Different materials and floor areas move at different rates, generally causing cracking to grout or sealant at this point. A flexible sealant is required to allow for expected

Flexible and mould resistant materials should be applied to affected areas to prevent any subsequent water damage that is likely to occur. Regular maintenance and replacement of damage or missing or damaged sealant and grout is highly recommended to the wet areas, as this is a regular wear and tear defect. Sealant and grouting in areas that come into regular contact with water should be maintained for the long term care of your property.

A sealant specialist or tiling contractor should be appointed to complete these works as soon as possible

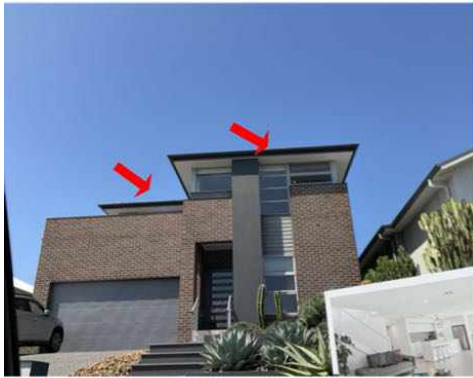
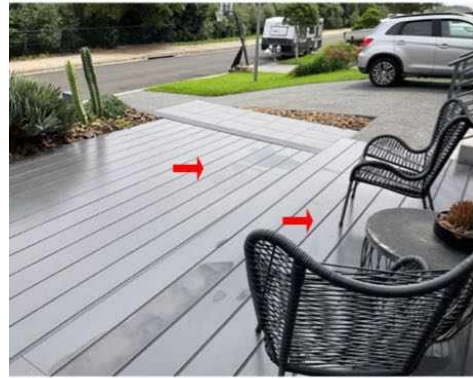
Building: Building 1
 Location: All External Areas
 Finding: Additional Photos - Obstructions and Limitations of EXTERNAL AREAS
 Information: These photographs are an indication of the obstructions and limitations which impeded full inspection of external areas at the time of inspection. These obstructions can hide an array of defects and should be removed to allow full inspection to be carried out. A re-inspection is recommended once the areas are made accessible.

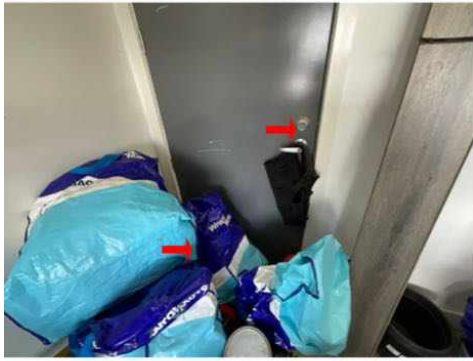
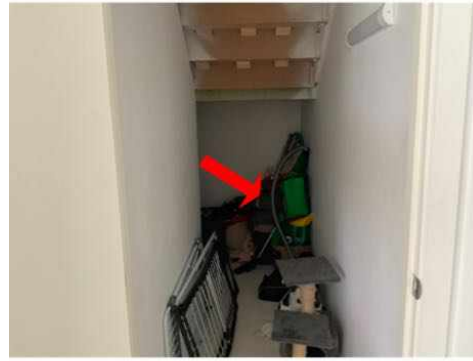
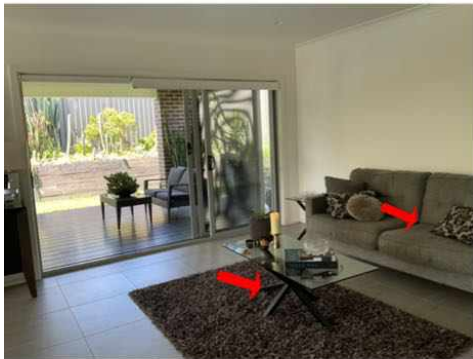
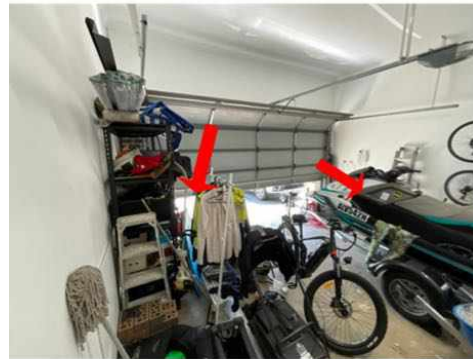
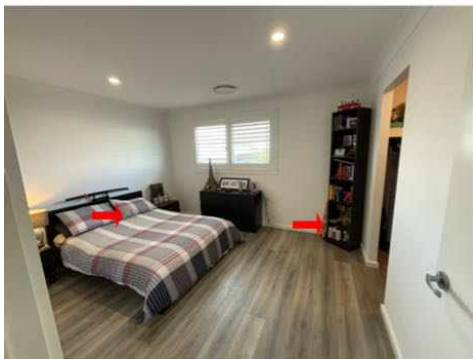
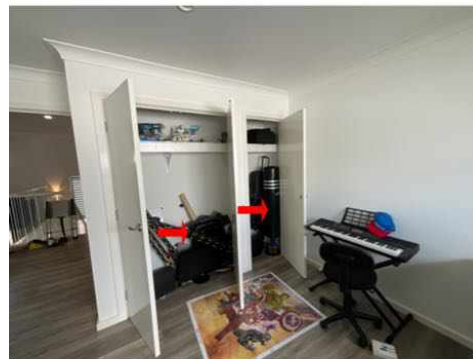
Building: Building 1
 Location: All Internal Areas
 Finding: Additional Photos - Obstructions and Limitations of INTERNAL AREAS
 Information: These photographs are an indication of the obstructions and limitations which impeded full inspection of Internal areas at the time of inspection. These obstructions can hide an array of defects and should be removed to allow full inspection to be carried out. A re-inspection is recommended once the areas are made accessible.

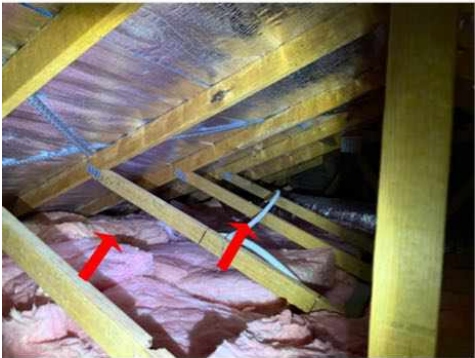
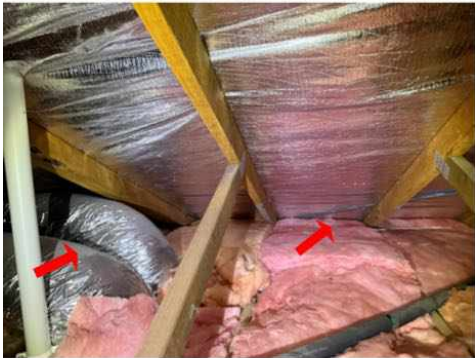
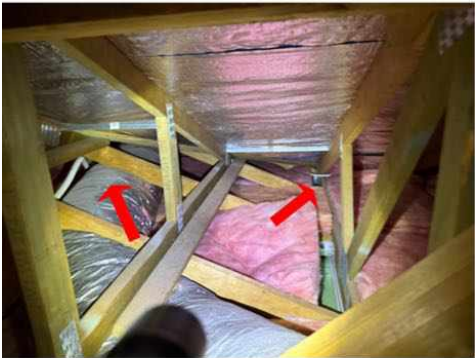
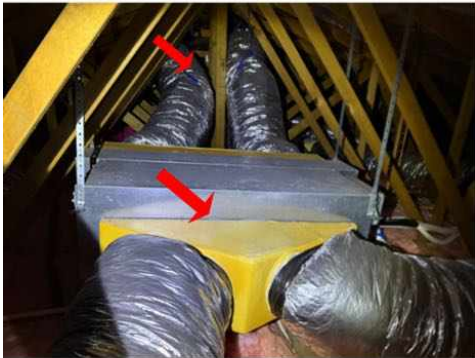
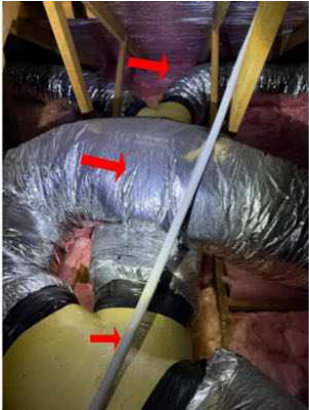
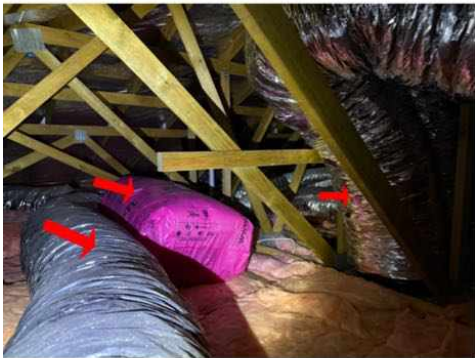
Building: Building 1
 Location: All Roof cavity areas
 Finding: Additional Photos - Obstructions and Limitations of the ROOF CAVITY
 Information: These photographs are an indication of the obstructions and limitations which impeded full inspection of roof cavity areas at the time of inspection. These obstructions can hide an array of defects and should be removed to allow full inspection to be carried out if applicable. A re-inspection is recommended once the areas are made accessible.

The inspection was also limited to areas with an allowable crawl space of 600mm x 600mm, in particular towards the external walls where the roof line diminishes, these

areas were not accessible.

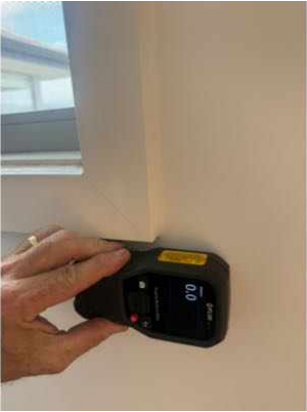
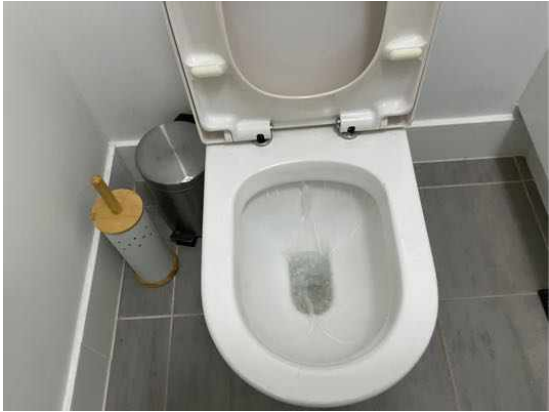
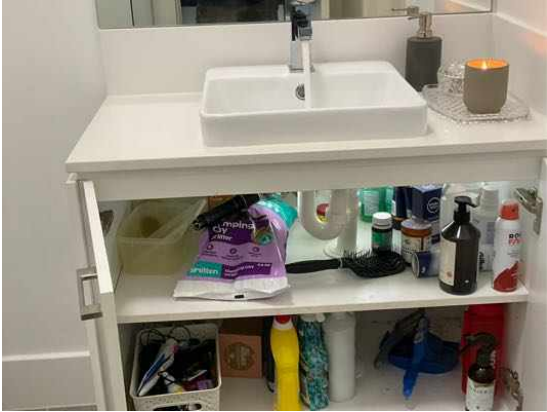
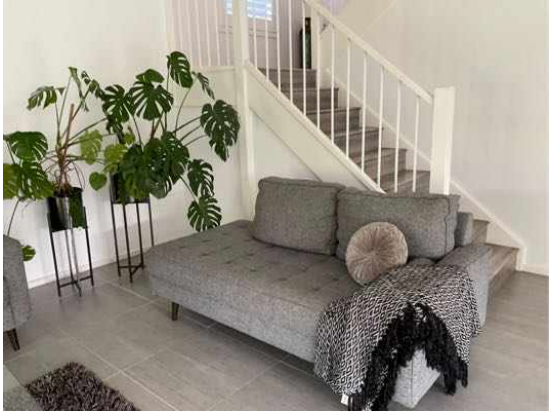
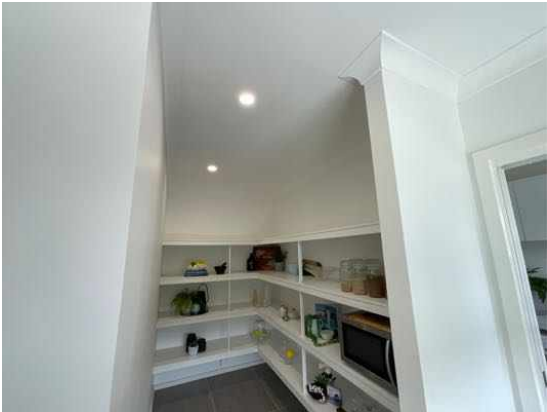
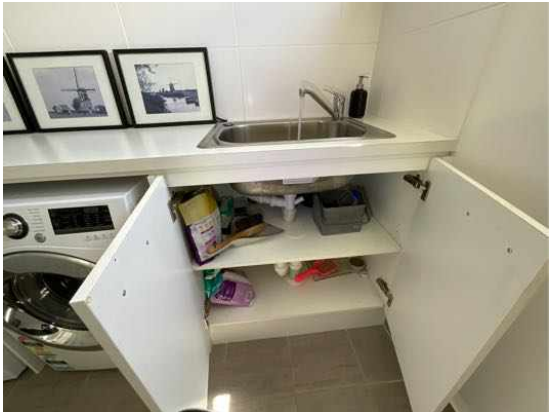
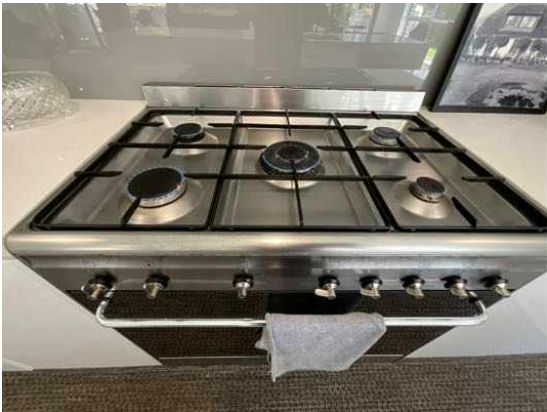
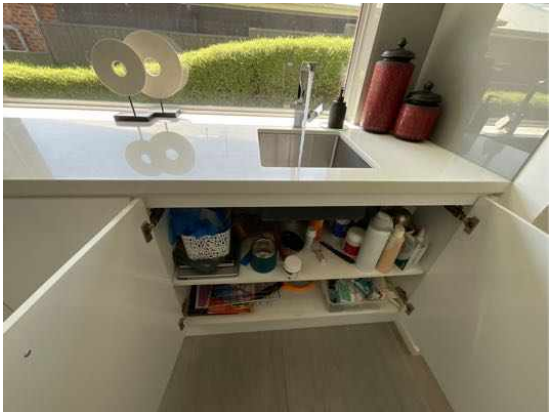
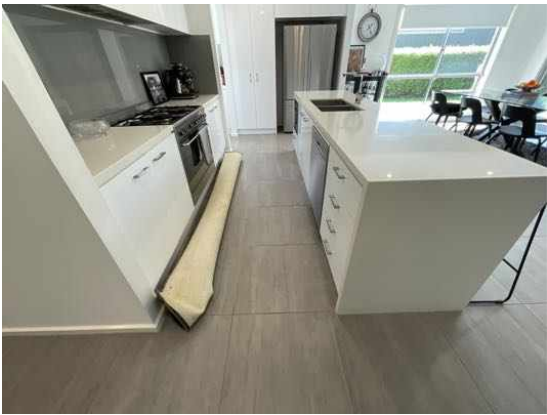
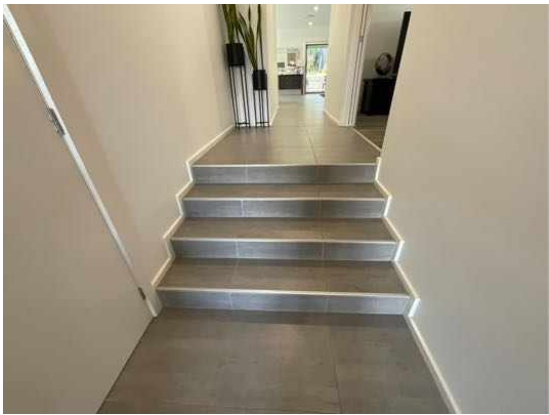
Building: Building 1
Location: All Internal Areas
Finding: Additional Photos
Information: Additional photos are provided for your general reference

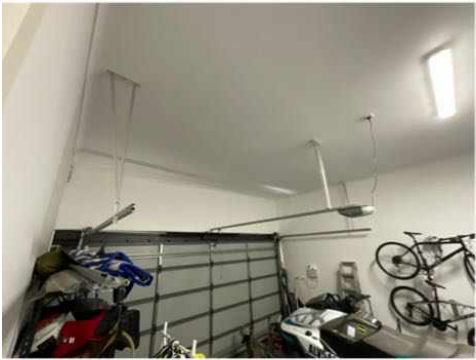
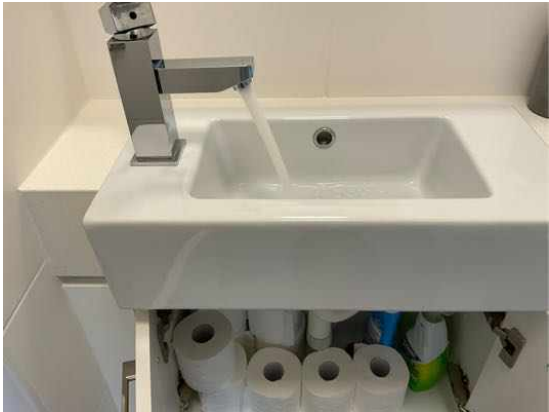
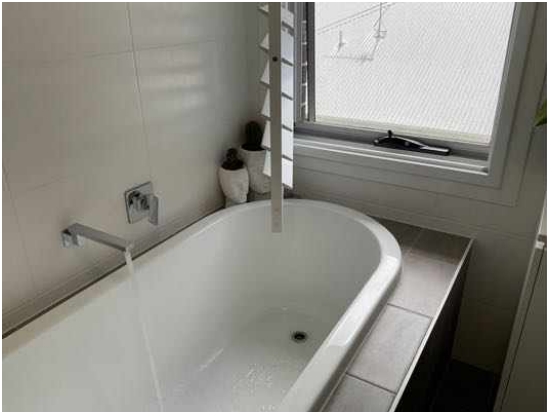
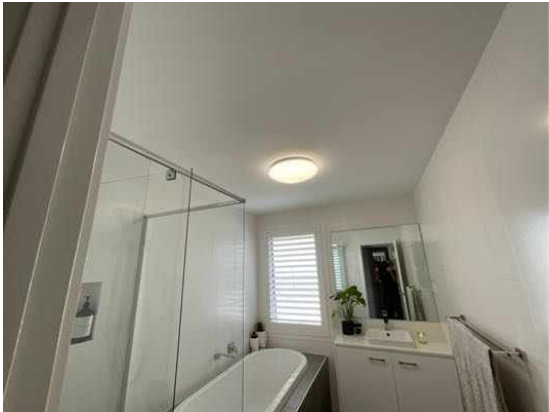
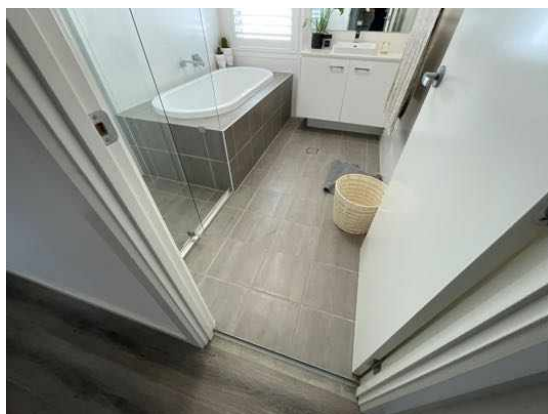
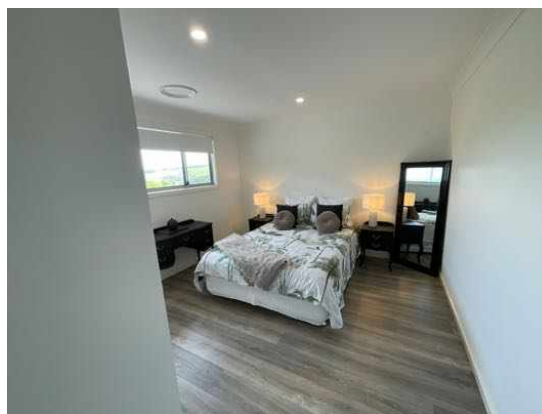
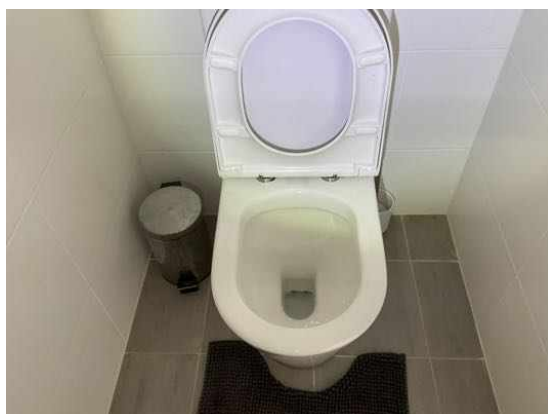
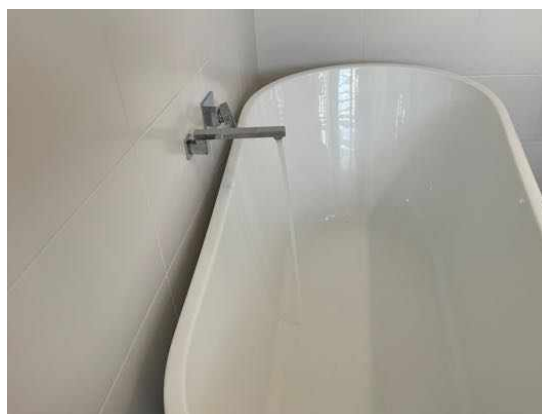
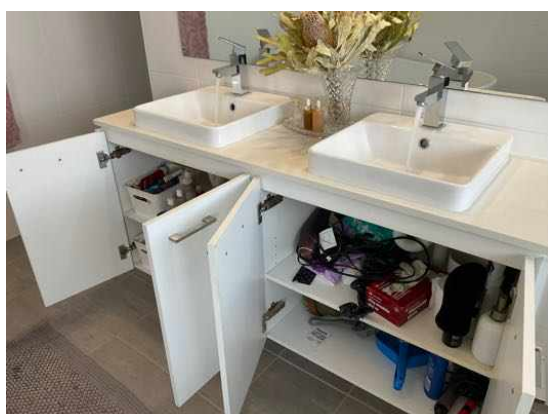
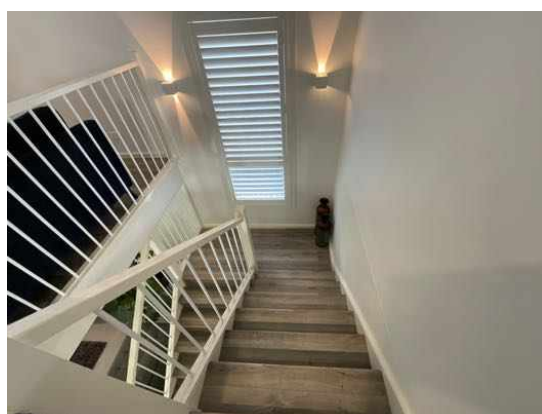
Building: Building 1
Location: All Internal Areas
Finding: Additional Photos
Information: Additional photos are provided for your general reference

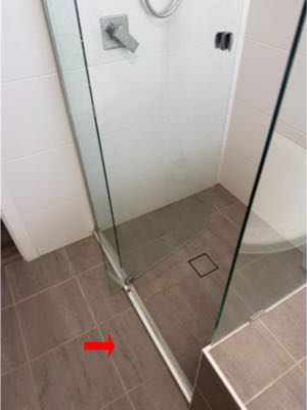
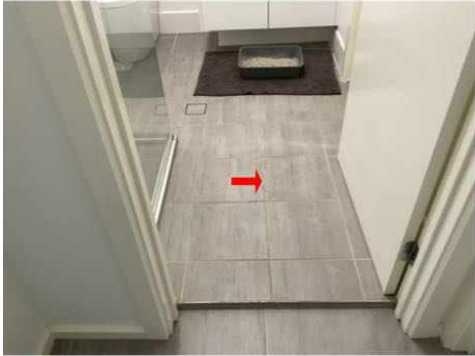
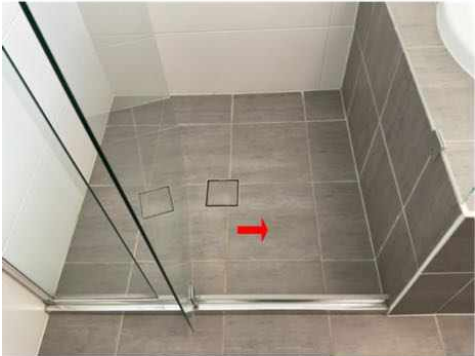
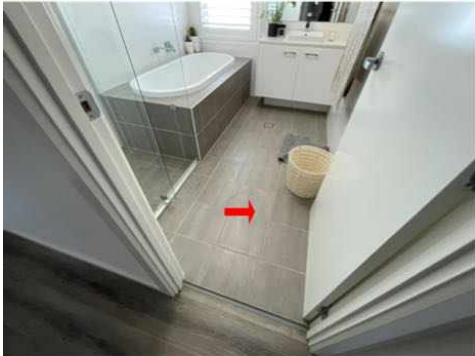
Building: Building 1
 Location: Bathrooms and laundry
 Finding: Waterproofing membranes - Information Only
 Information: Internal Water Proofing Membranes, are crucial in preventing water ingress into the property is important to know that the Membrane System used is to Australian Standards and has been installed correctly.

With older property's where this information is unavailable all wet areas should be monitored. If any leaks, water staining, peeling or bubbling of the paint become evident to any adjacent walls or ceilings below a licensed builder or waterproofing specialist is recommended to investigate further.
