Building and Timber Pest Inspection Report

Inspection Date: Tue, 17 Feb 2026

Property Address: 11/33 Clovelly Rd, Hornsby NSW 2077,
Australia

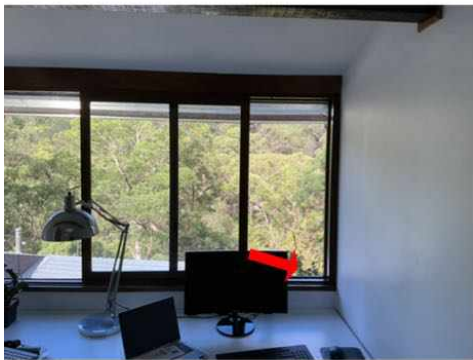
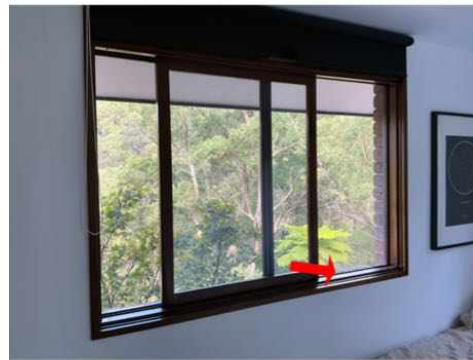
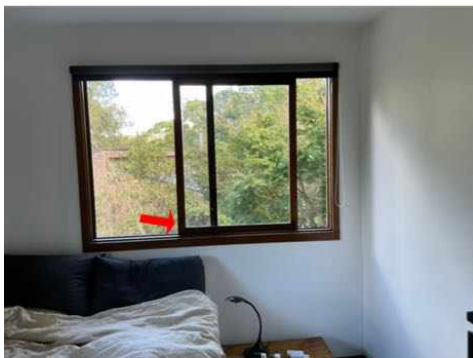
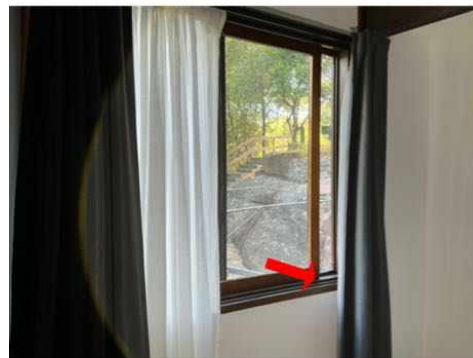
Building: Main Building
 Location: All Areas
 Finding: Window Restrictors - Recommended
 Information: Upstairs windows did not have window restrictors installed. Although not a requirement at the time of construction, it is advisable to install window opening restrictors on all second storey windows with sill heights below 1.7 meter and potential fall of 2 meters or more.

If you live in a strata scheme, window safety devices must be installed on all applicable windows by 13 March 2018. Residents with safety devices installed can still fully open their windows but it's recommended that devices be engaged whenever children are present, to prevent falls.

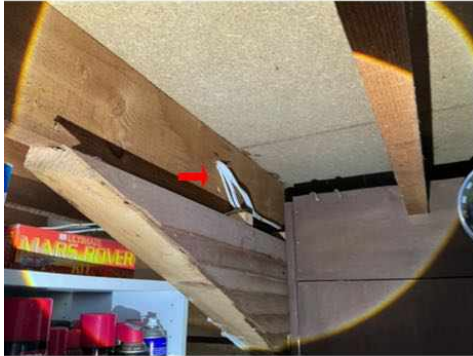
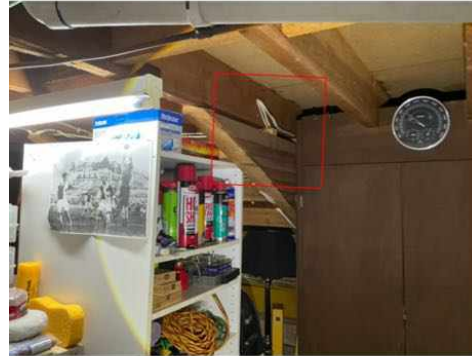
Finding 1.02

Building: Main Building
 Location: Garage, Workshop, StoreRoom

Finding: Electrical Wires - Exposed

Information: During the inspection, exposed electrical wires were noted. This condition poses a significant safety hazard, as it increases the risk of electrical shock, short circuits, and potential fire. It is imperative that a qualified electrician addresses this issue immediately by properly insulating the exposed wires and ensuring all electrical connections comply with safety standards. Prompt action will mitigate the risks associated with exposed wiring and maintain the safety and integrity of the property's electrical system.

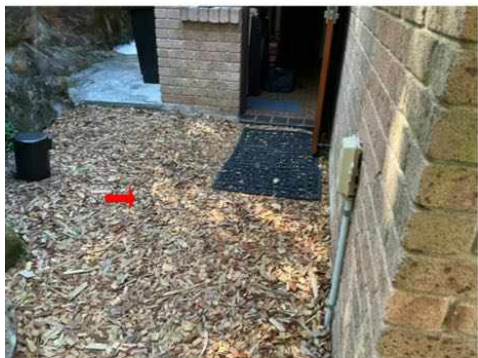
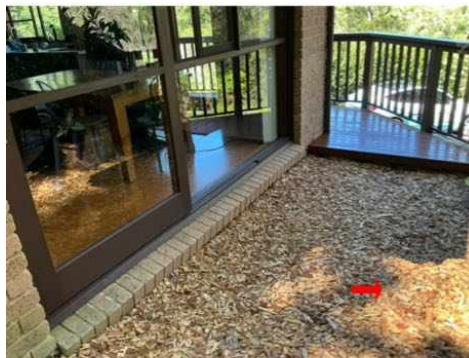
Finding: Inadequate Site Drainage - Exterior Areas

Information: At the time of inspection, inadequate site drainage was observed around the perimeter of the building, which can lead to water pooling and insufficient runoff management.

This condition may result in moisture being absorbed by the foundation or lower walls, potentially leading to rising damp, cracks in brickwork, erosion of the soil around the building, or structural issues over time. Water pooling can also create ideal conditions for mould growth, contribute to the deterioration of exterior materials, and act as conducive conditions for termite activity, as termites are attracted to areas with elevated and persistent moisture levels.

It is recommended that proper site drainage be installed, such as redirecting water flow away from the building or incorporating drainage systems, to prevent further damage and ensure the long-term stability of the structure.

To address the inadequate site drainage, a qualified landscaper or drainage specialist should be engaged to design and install appropriate drainage solutions, such as grading the ground away from the building or installing French drains, surface drains, or downspout extensions. If more complex issues are present, such as damage to the foundation or moisture entering the walls, a structural engineer may need to assess the situation, and a builder may be required for repairs.

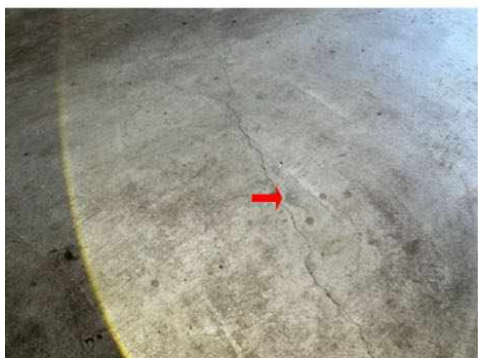
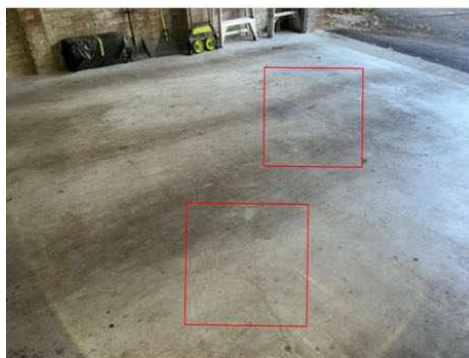
Finding 3.02

Finding: Crack in concrete slab - Category 2

Information: A crack coded as Category 2 was identified in the slab. A Category 2 crack is described as a distinct crack, with the slab being noticeably curved or changed in level.

To be considered Category 2, the approximate width of the crack is less than 2.0mm, or a change in offset of less than 15mm when a 3m straight edge is placed over the defect.

Category 2 cracks to slabs should be monitored for a period of 12 months. At the end of the monitoring period, cracks rated greater than Category 2 are considered defects that require rectification.

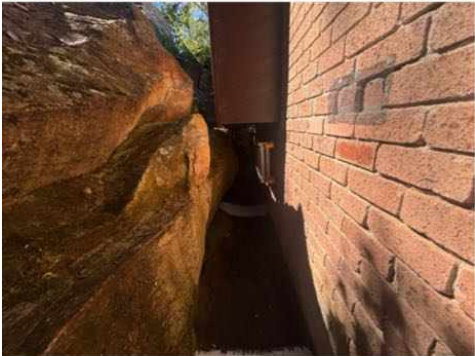
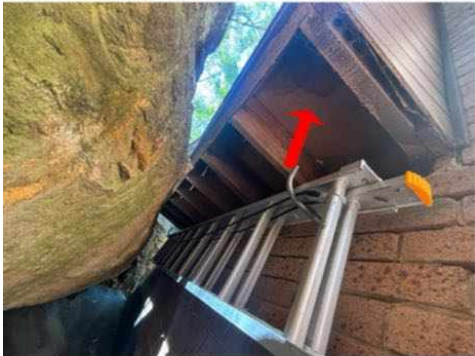
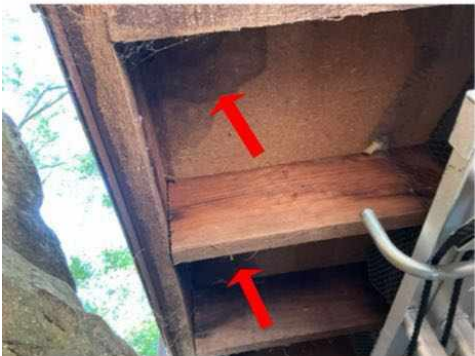
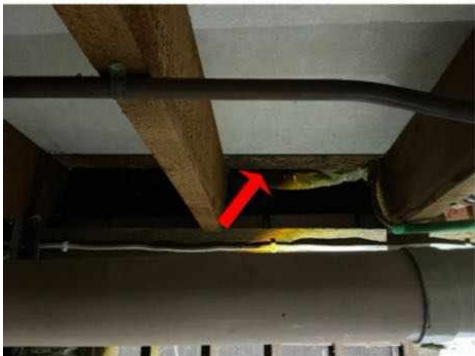
Finding 3.03

Building: Main Building
Location: Store Room, Workshop
Finding: Stains (Dry)
Information:

At the time of inspection, staining was noted to sections of the accessible structural timbers and adjoining surfaces within the subfloor and external undercroft areas. The affected areas appeared dry at the time of inspection, and thermal imaging did not indicate the presence of active moisture. The staining is consistent with previous moisture exposure, which may have been the result of past plumbing leaks, water ingress, or condensation; however, no active leakage was identified during the inspection. While the areas currently appear stable, historic moisture can contribute to timber deterioration or mould growth if conditions recur. The client is advised to monitor these areas over time and to ensure that all plumbing, drainage and ventilation systems remain in good working order. Should any signs of renewed dampness, mould growth, odour, or timber deterioration become evident, a licensed plumber or suitably qualified contractor should be engaged

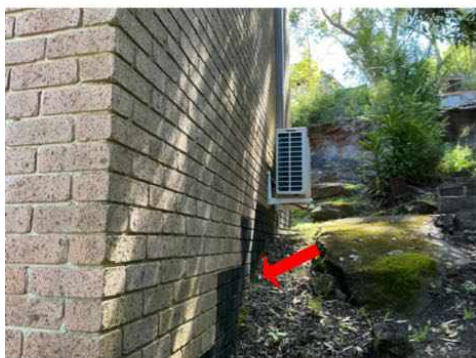
Finding 6.02

Building:	Main Building
Location:	All Areas
Finding:	Bridging or Breaching of Termite Barriers - Adjacent Internal Flooring
Information:	Bridging is the spanning of a termite barrier or inspection zone so that subterranean termites are provided with passage over or around that barrier.

It is important for internal flooring to be raised above adjacent external ground levels. Where external ground levels are above or same level as internal flooring, water pooling and subsequent internal flooding is likely to occur which may attract termite activity to the internal area.

It is highly advised that a landscaper or relevant tradesperson be appointed to lower external grounds that are raised above or same as adjacent internal flooring. Alternatively if external grounds and internal flooring is level installation of a raised door sill may be appropriate in preventing any water pooling in the area. If the client wishes not to make any changes, then a qualified pest controller is recommended for termite treatment around the perimeter of the house and subfloor (if any) as soon as possible.

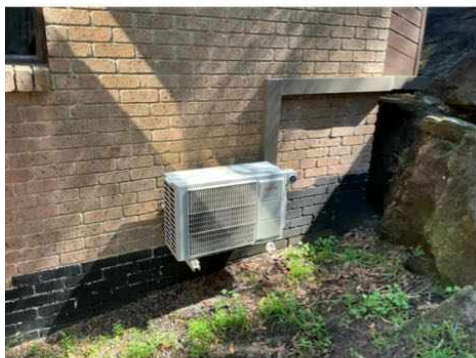
Finding 6.04

Building:	Main Building
Location:	Exterior walls - right side
Finding:	Overflow Disconnected - HWS/AC/Gas - Conducive Conditions to Termites
Information:	The overflow to this service was found to be disconnected from stormwater drainage and is creating excessive moisture in the surrounding area.

Such leaking creates an environment that is conducive to an array of defects, including water damage to associated building elements and the attraction of termite or timber pest infestation. These damp conditions can lead to secondary defects such as rot, rust, or corrosion of associated building elements, the formation of fungal decay, or even the creation of potential slip hazards. When coupled with poor site drainage, pooling of water may also attract termite activity to this area.

It is highly recommended that a licensed plumber be appointed to connect the overflow in order to prevent such an environment from being created. These minor works should be carried out as soon as possible.

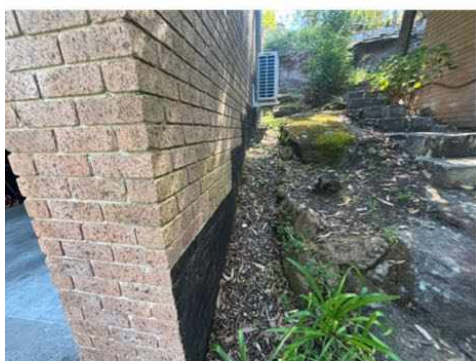
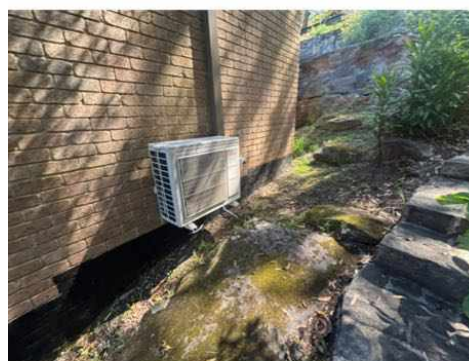
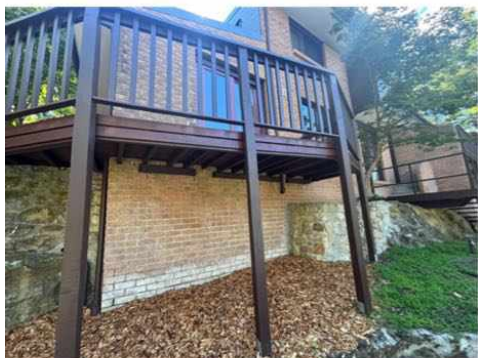
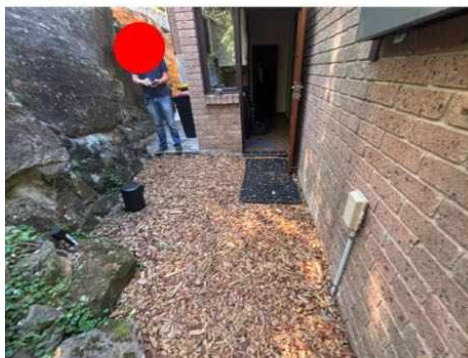
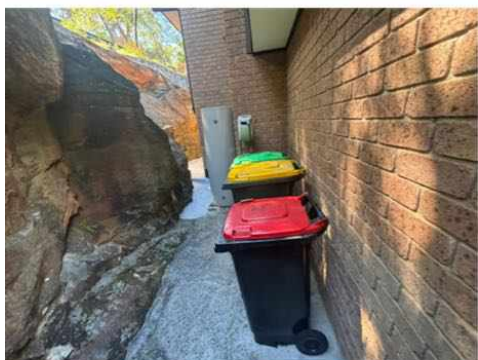
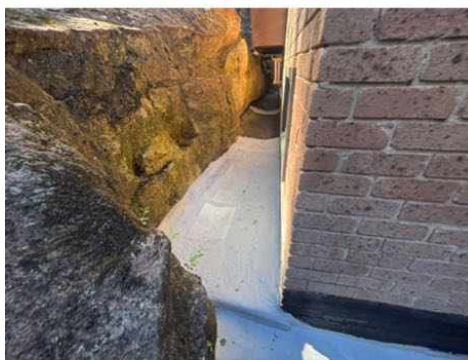
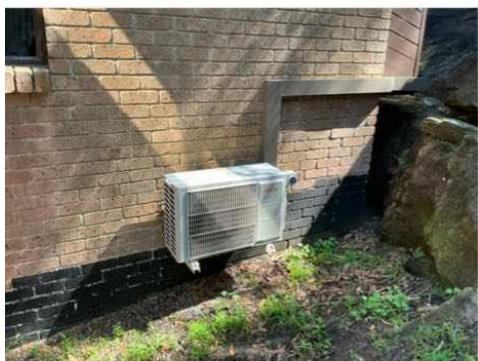
Building: Main Building
Location: All External Areas
Finding: Obstructions and Limitations - External Areas
Information: The attached photographs provide a visual representation of the obstructions and limitations that impeded a full inspection of the external areas of the property at the time of assessment. These obstructions, which may include vegetation, stored items, debris, or other physical barriers, can obscure potential defects and prevent a thorough evaluation of the property's condition. Obstructions of this nature can conceal a wide range of issues, such as structural damage, water ingress, pest infestations, or deteriorating building materials, which may not be visible during the initial inspection.

It is essential that these obstructions be cleared to allow for a comprehensive inspection of the external areas. Removing these barriers will enable a more accurate assessment of the property's condition and allow any hidden defects to be identified and addressed promptly. Failure to do so could result in undetected issues worsening over time, potentially leading to more costly repairs in the future.

Therefore, it is strongly recommended that the obstructions be removed and a re-inspection be scheduled once the affected areas are made fully accessible. This will ensure a complete evaluation of the property's exterior and provide the client with a clear understanding of any potential issues that may have been concealed during the initial inspection.

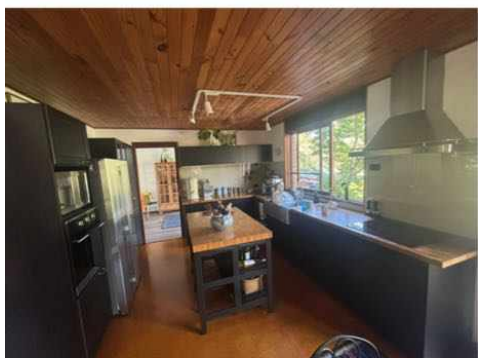
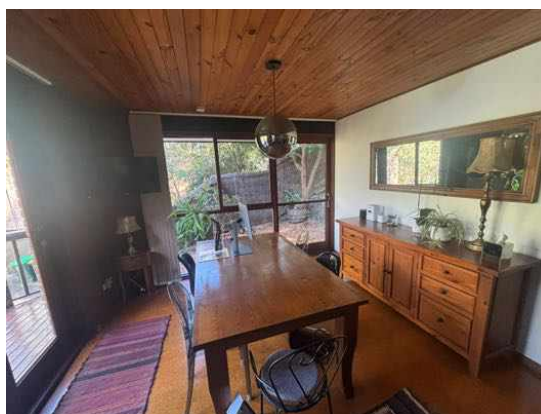
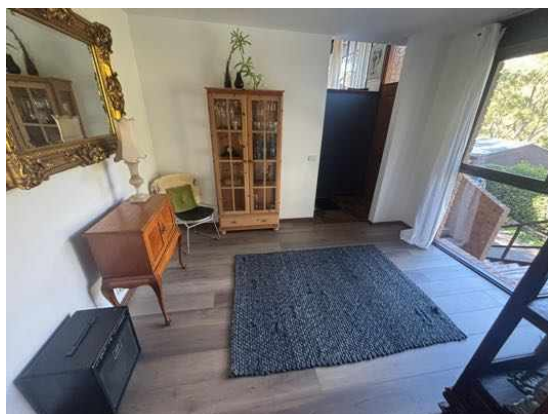
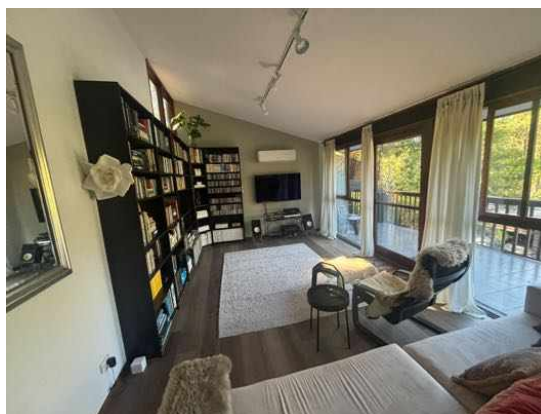
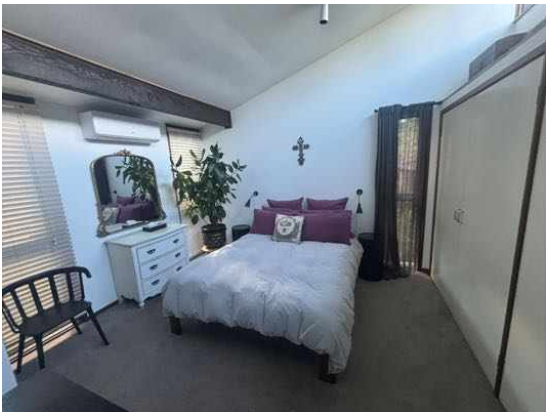
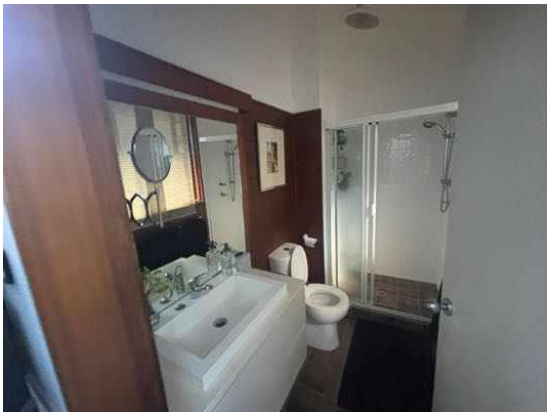
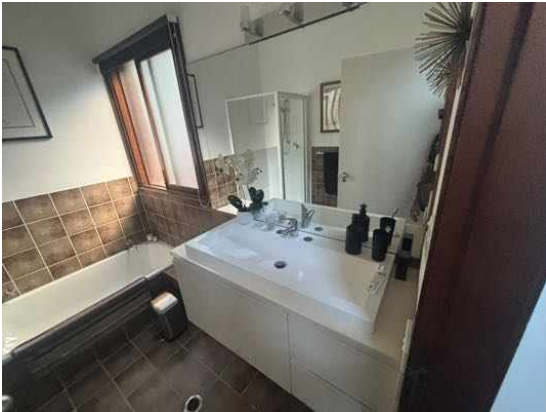
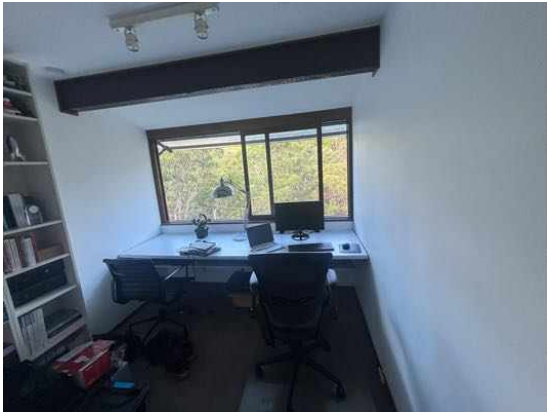
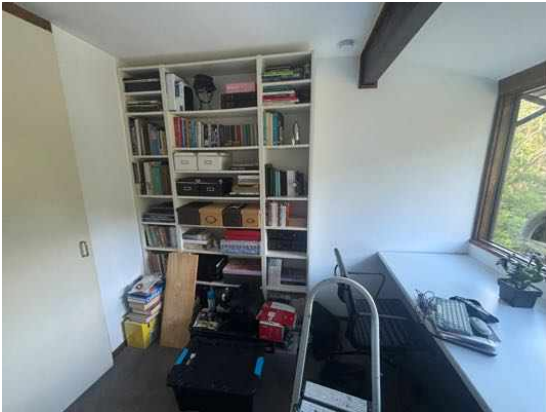
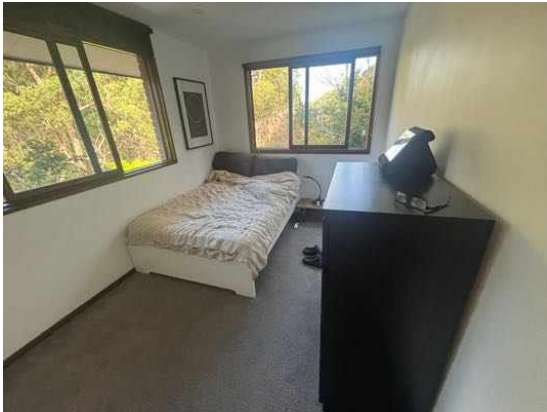
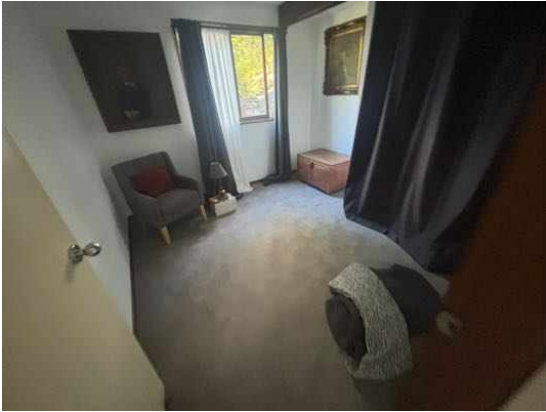
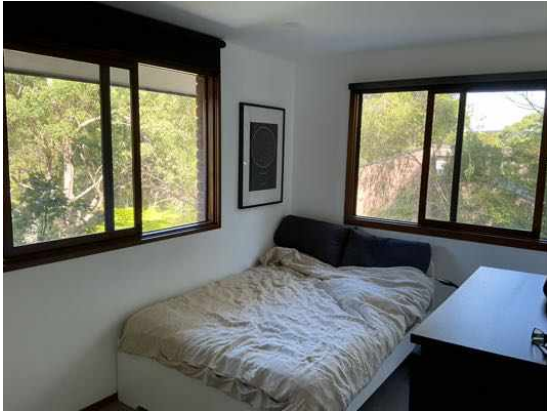
Building:	Main Building
Location:	All Internal Areas
Finding:	Obstructions and Limitations - Internal Areas
Information:	The accompanying photographs provide clear evidence of the obstructions and limitations that restricted a comprehensive inspection of the internal areas of the property at the time of assessment. These obstructions, which may include furniture, personal belongings, stored items, or structural elements such as wall coverings and built-ins, significantly hindered the ability to thoroughly evaluate these areas. It is important to note that such obstructions can potentially conceal a wide array of defects, ranging from hidden structural damage, water leaks, pest infestations, or

electrical issues, to deteriorating materials that may not be visible during the initial inspection.

The presence of these impediments means that critical areas of the property were not accessible, and therefore, any underlying defects that may affect the integrity and safety of the property could remain undetected. These hidden defects, if left unaddressed, could worsen over time and may result in costly repairs or pose potential safety hazards to the occupants.

It is highly recommended that all obstructions be cleared to facilitate a complete and thorough inspection of the internal areas. Once the obstructions have been removed and full access is available, a re-inspection should be carried out to ensure that any previously concealed issues can be properly identified and rectified. This follow-up inspection will provide a more accurate assessment of the property's internal condition and help the client make informed decisions about any necessary repairs or maintenance.

In summary, the limitations encountered during the inspection highlight the importance of ensuring full access to all areas of the property to accurately assess its overall condition. A re-inspection is strongly advised once these areas are made accessible.

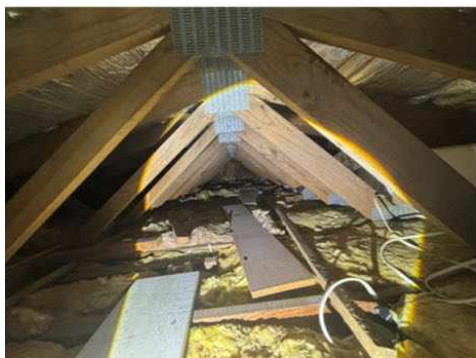
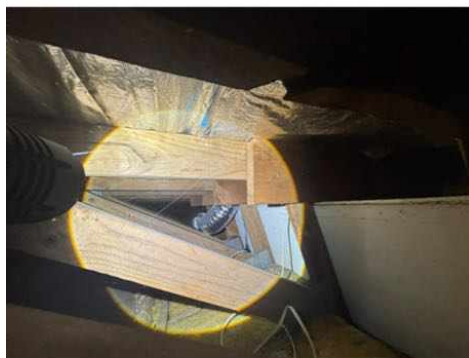
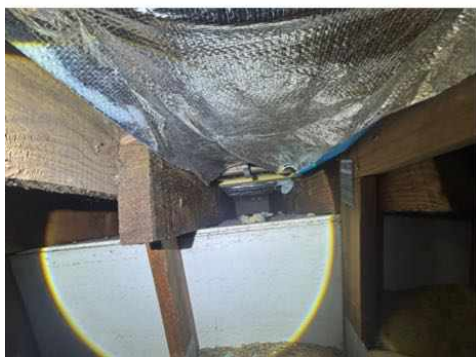
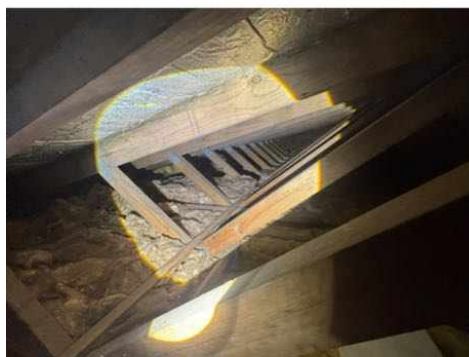
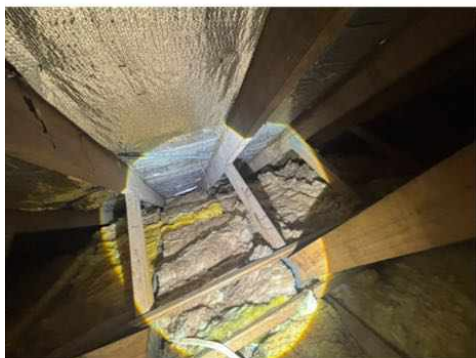
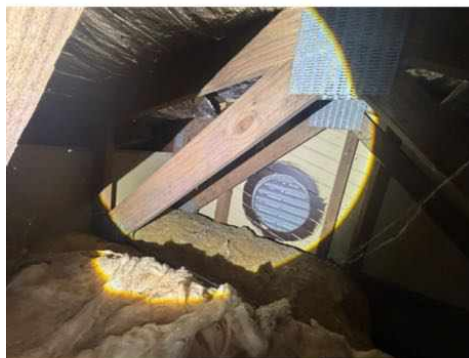
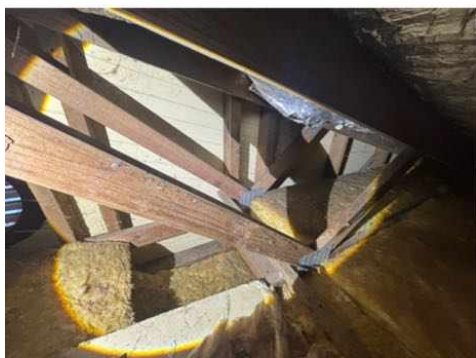
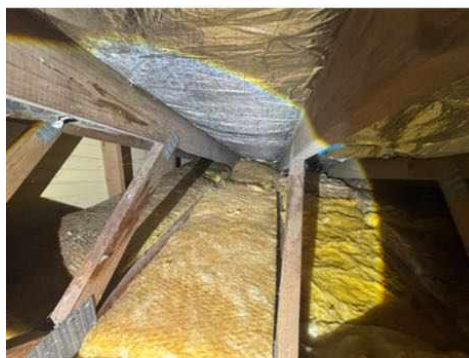
Building: Main Building
Location: Roof Void
Finding: Obstructions, Limitations, and General Roof Space Condition
Information: The photographs provided document both the general condition and the obstructions and limitations that were present in the roof cavity of the main building at the time of inspection. These obstructions—such as insulation materials, stored items, structural elements, or electrical wiring—restricted safe and adequate access to key areas within the roof space. As a result, a comprehensive inspection of all components could not be completed.

Obstructions of this nature may conceal a variety of potential defects, including damaged framing, compromised insulation, evidence of moisture ingress, pest activity, or electrical hazards. While no major issues were observed in the visible areas, the presence of these limitations means that some defects may remain undetected.

It is recommended that these barriers be removed or repositioned to facilitate full and safe access to the roof space. Once clear, a follow-up inspection should be conducted to allow for a thorough assessment of all concealed areas. This will help ensure that the condition of the roof cavity is accurately evaluated and any hidden issues are appropriately identified and addressed.

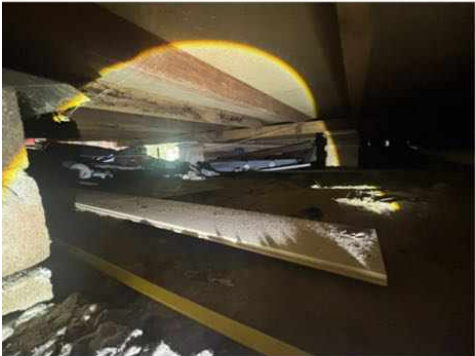
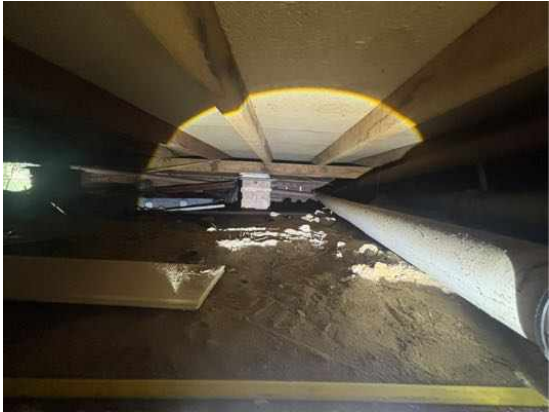
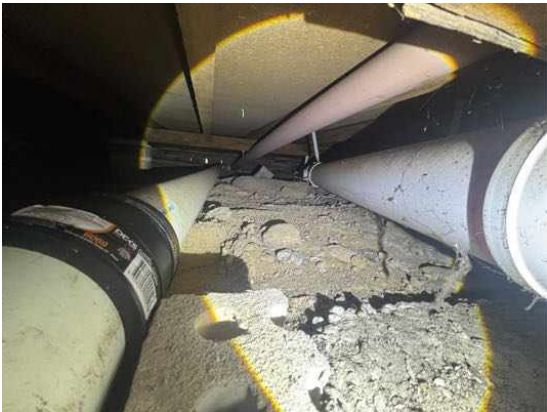
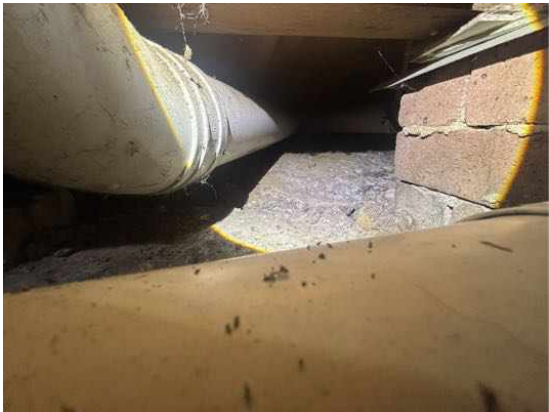
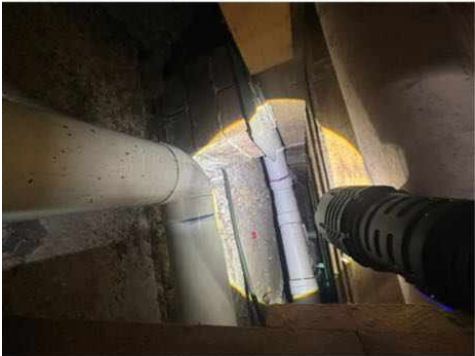
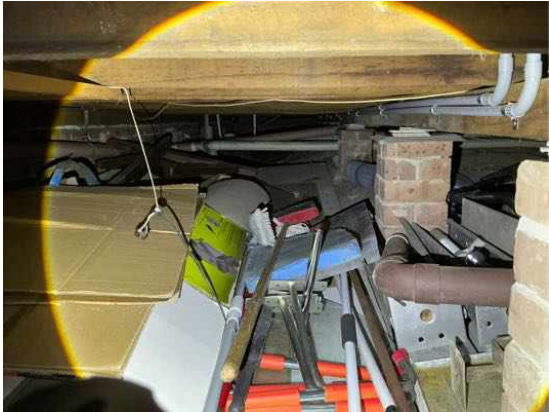
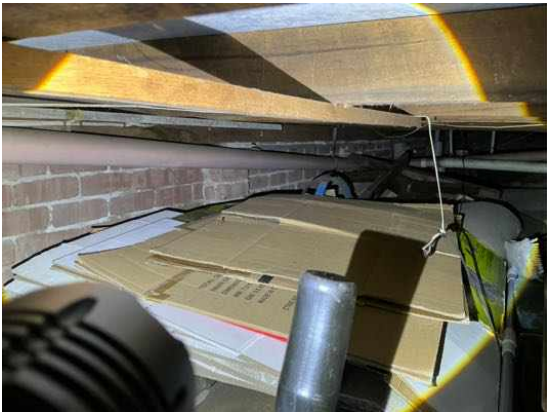
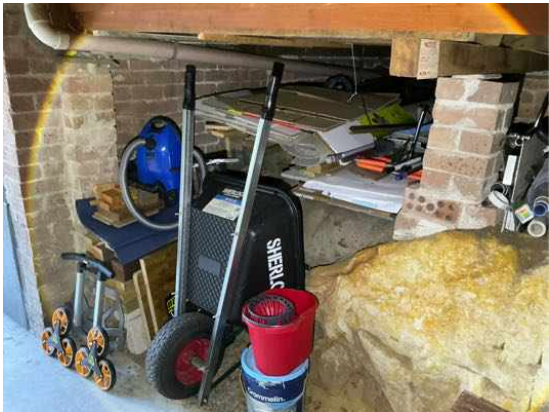
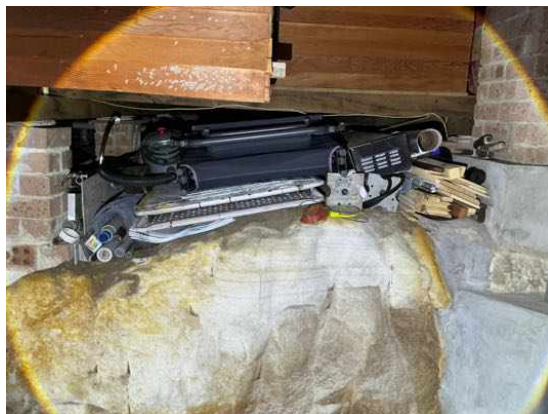
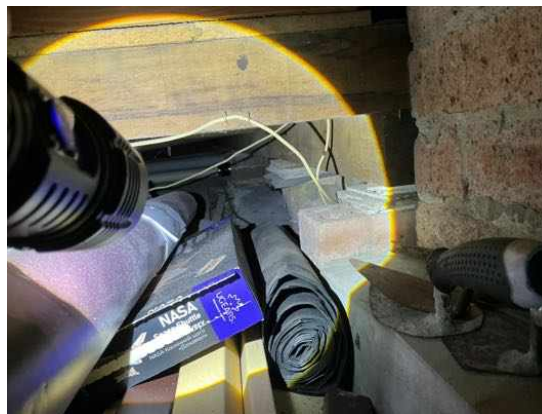
Building:	Main Building
Location:	Subfloor
Finding:	Obstructions, Limitations, and General Subfloor Condition
Information:	The attached photographs illustrate the obstructions and access limitations that restricted a full inspection of the subfloor area of the main property at the time of assessment. Items such as stored materials, construction debris, low-hanging services, and insulation impeded movement and visibility within key sections of the subfloor. In addition, the limited crawl height further restricted safe access to inspect critical structural components.

Restricted access and confined spaces can significantly hinder the ability to evaluate important elements such as floor joists, bearers, stumps, drainage, subfloor ventilation, and signs of moisture or pest activity. These obstructions may also conceal defects such as timber decay, water ingress, termite damage, inadequate support, or ventilation issues that are not immediately visible during a limited inspection.

While no major concerns were identified in the accessible areas, a full and unobstructed inspection is necessary to properly assess the overall condition of the subfloor. It is recommended that obstructions be removed and access improved where possible. Once adequate clearance is provided, a re-inspection should be arranged to ensure that any concealed defects can be identified and addressed accordingly. This will assist in providing a more comprehensive understanding of the

subfloor's condition and reduce the risk of unforeseen issues.

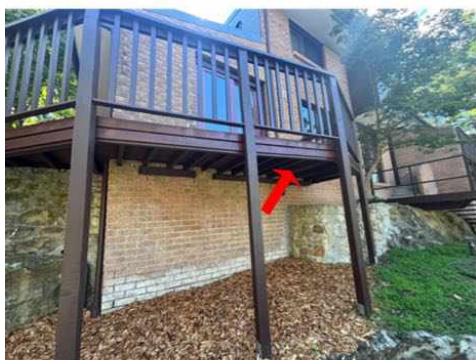
You should also arrange annual inspections of the structure by an engineer or other suitably qualified person to ensure any maintenance, that may become necessary, is identified. Care must be taken not to overload the structure.

Nothing contained in this report should be taken as an indicator that an assessment has been made, on any elevated structure, as suitable for any specific number of people or purpose. This can only be done by a qualified engineer. For the purpose of this report, the Structure includes elevated decks, verandah, pergolas, balconies, handrails, stairs and children's play areas.

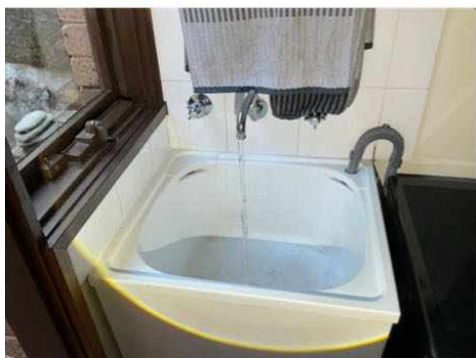
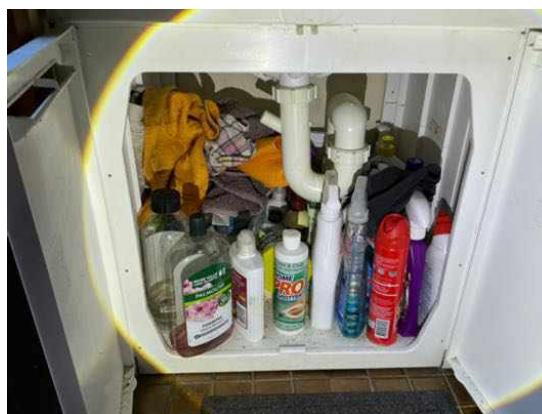
Building: Main Building
 Location: All Areas
 Finding: FYI - Taps, Drainage & Toilets Tested and Cabinetry Obstructions
 Information: During the inspection, all accessible taps, drainage systems, and toilets were tested for water flow and drainage efficiency, and checked for any visible signs of leakage. At the time of the inspection, no issues were noted in these areas. Unless highlighted in a separate defect statement, no immediate remedial work appears necessary. Supporting images may be found in the additional photos section for reference.

It is important to note that while a visual inspection of cupboards and cabinetry beneath sinks and vanities was undertaken, stored personal items and fixtures presented obstructions that limited full visibility of the internal areas. As per standard inspection practices, inspectors are not permitted to move or disturb personal belongings during the inspection process. Therefore, only visible and accessible sections were inspected, and concealed water damage or plumbing defects may not have been detected.

Given this, a re-inspection is recommended after all obstructions have been cleared to allow for a comprehensive assessment of these areas. Regular maintenance and monitoring of plumbing and drainage systems is also advised to ensure ongoing functionality and early detection of potential issues.

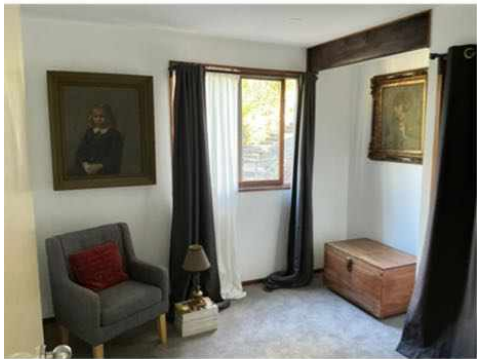
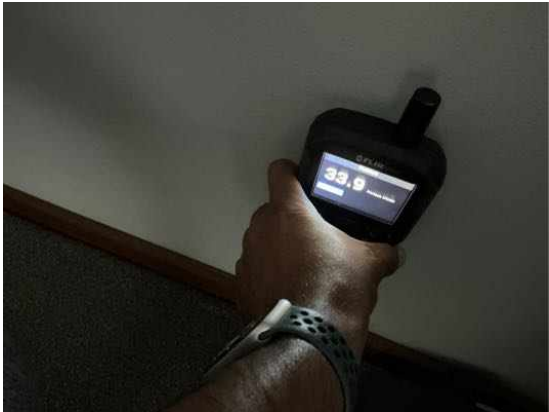
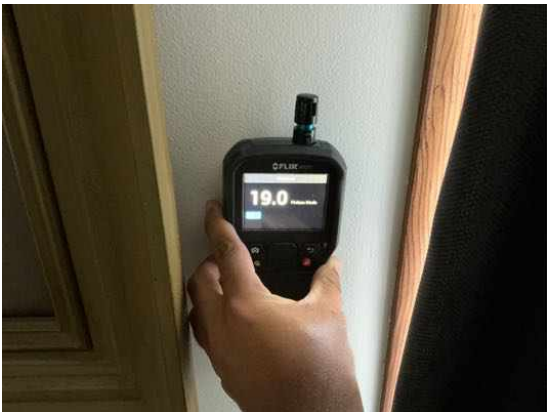
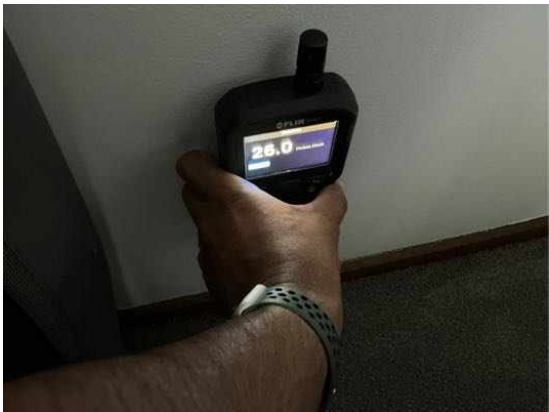
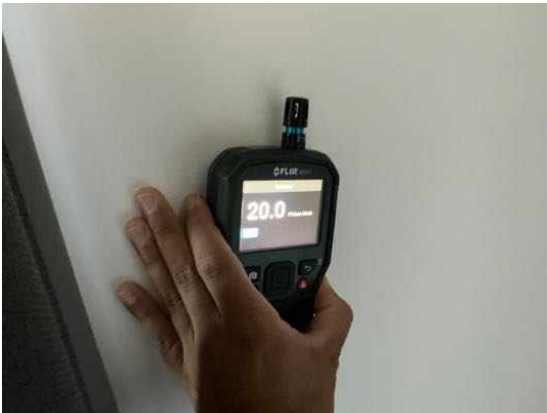
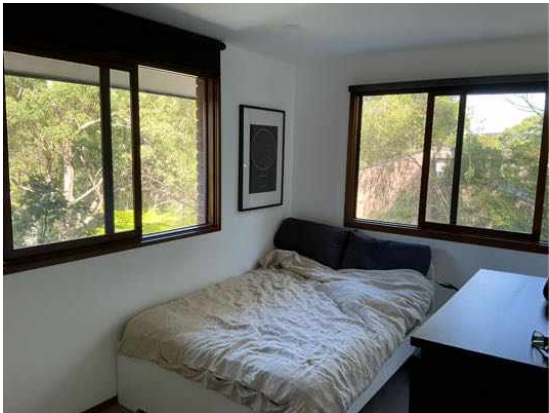
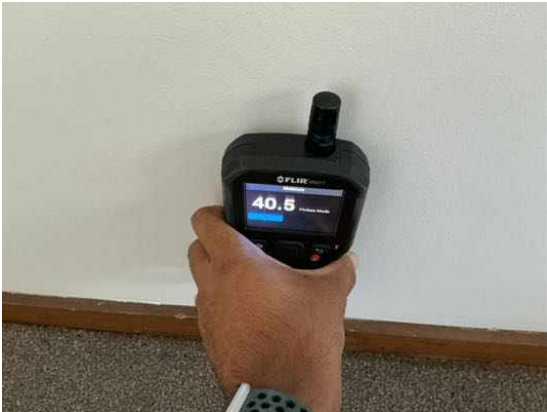
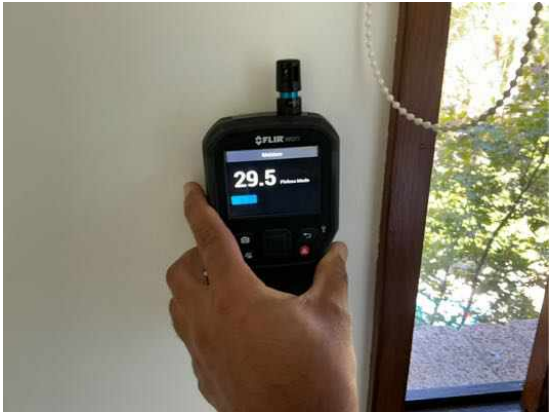
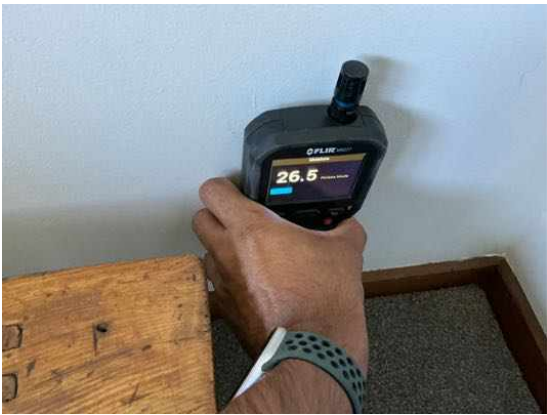
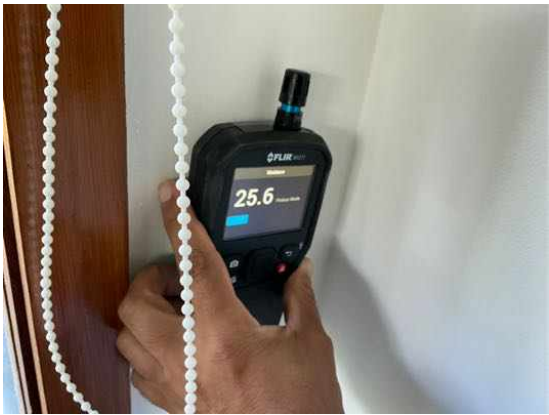
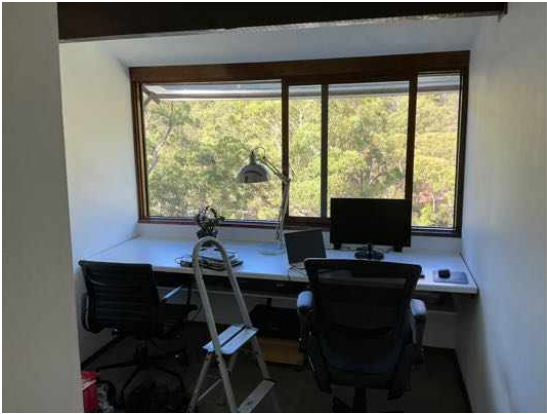
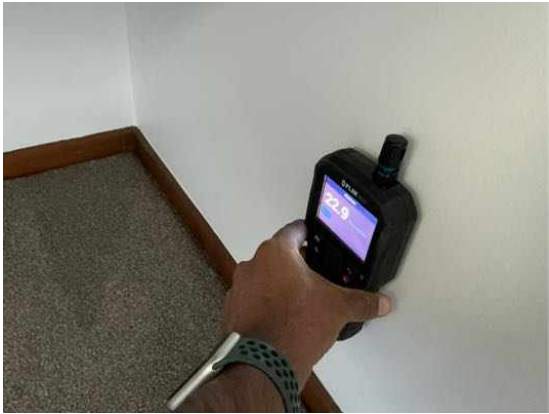
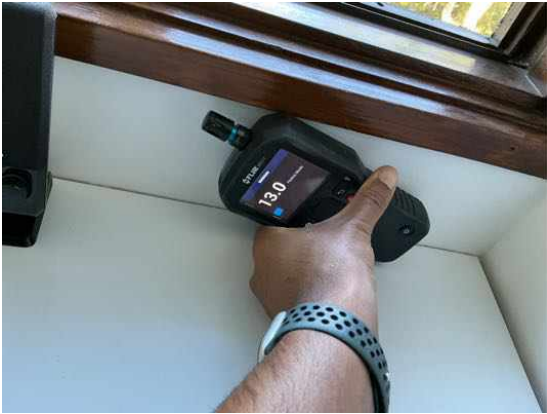
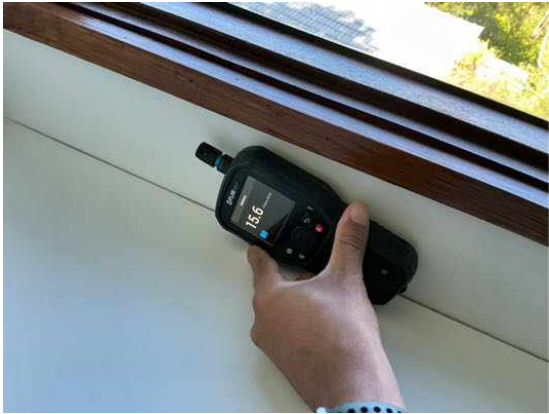
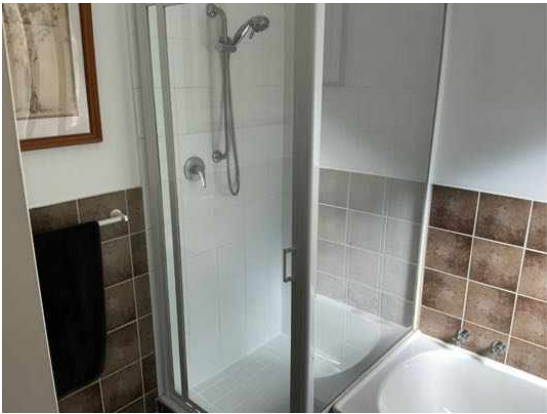
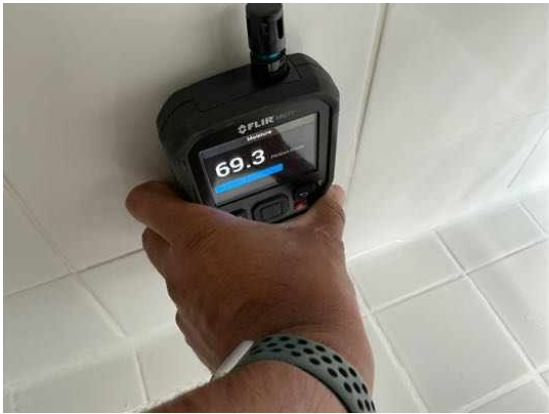
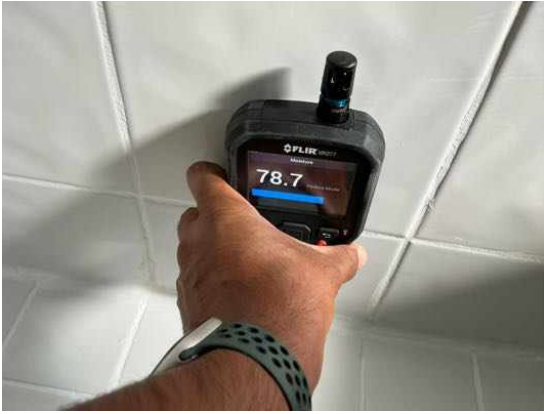
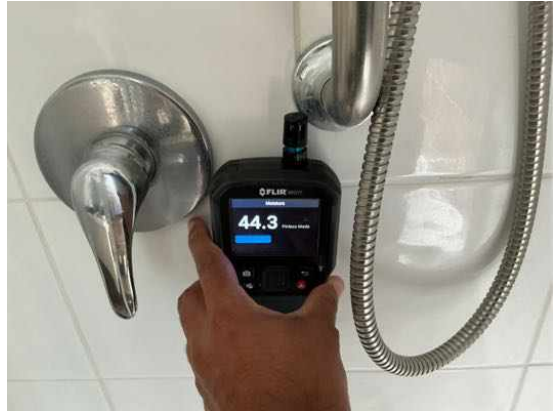
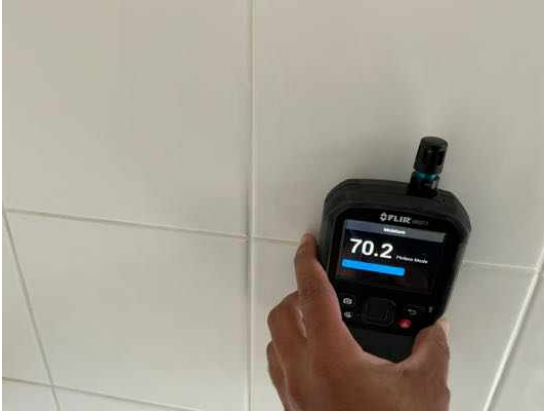
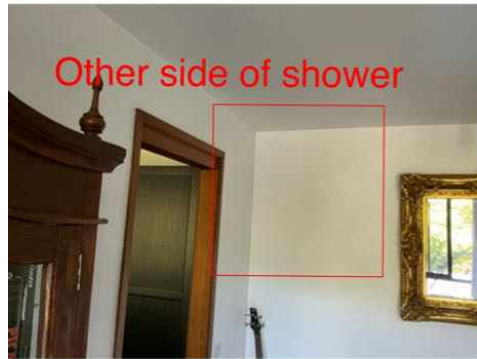
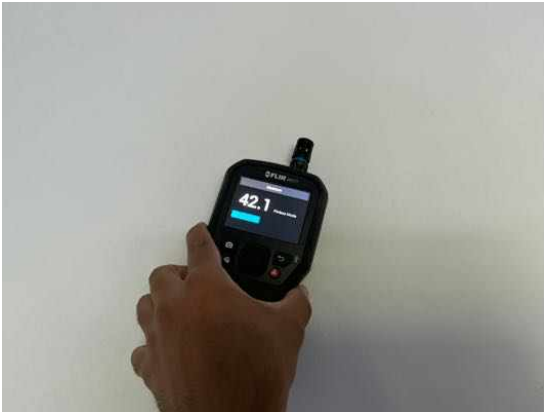
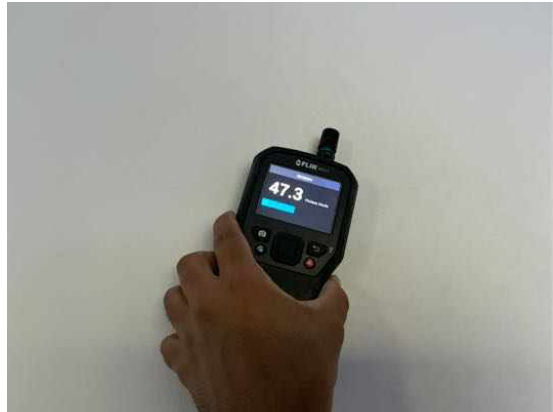
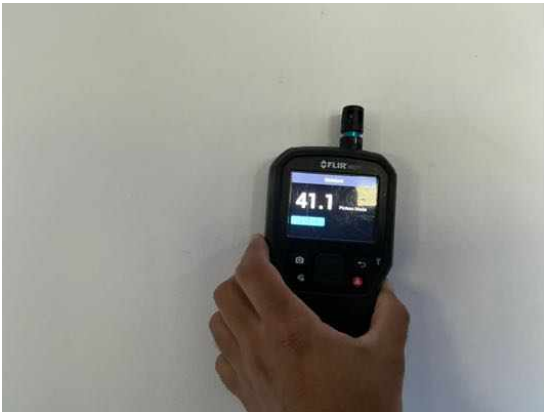
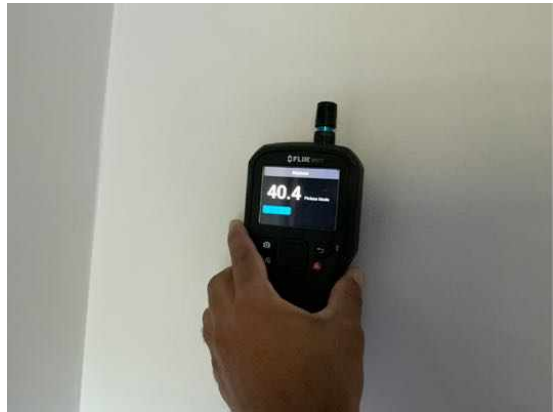
Building:	Main Building
Location:	All Areas
Finding:	Additional Photos - Moisture Meter Readings
Information:	Additional moisture meter reading photos have been provided for the property to offer further clarity on areas tested during the inspection. These photos are intended to give a visual reference for the specific locations where moisture levels were measured. These readings were taken at the time of the inspection to assess any potential moisture-related issues within the property. Any defects related to moisture that were identified during the inspection have been separately mentioned in the defect statements within the report.

It is important for the client to understand that moisture levels can fluctuate over time due to various factors, including changes in weather, humidity, and environmental conditions. While the readings reflect the property's moisture levels during the inspection, they may not represent future conditions, and increased moisture could lead to issues such as dampness, mould growth, or deterioration of building materials if left unmonitored.

For further clarification or additional information regarding the moisture readings, the client is encouraged to contact the building inspector directly. Regular monitoring of moisture-prone areas is recommended to ensure any emerging concerns are addressed promptly, particularly during wetter seasons or in high-humidity conditions.

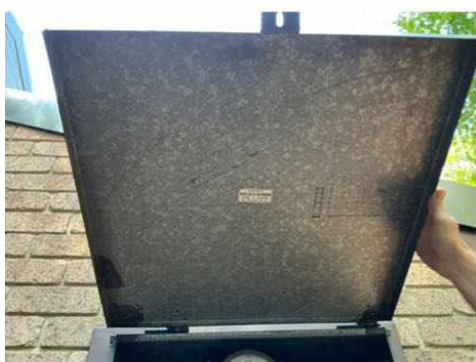
Building: Main Building
 Location: Meter Box
 Finding: Termite Management Recommendation – No Evidence of Chemical Installation
 Information: At the time of inspection, there was no visible evidence of a chemical termite management system installed around the property. Chemical barriers are a key component of termite protection and are particularly important in preventing concealed termite entry into timber elements of the structure.

In accordance with standard requirements, a durable notice should be located within the electrical switchboard to detail any termite protection systems applied, including chemical treatments. No such notice was observed during the inspection.

It is recommended that the client engage a licensed pest controller to assess the suitability of installing a chemical barrier, and to provide advice on associated costs and procedures. This should be considered a short-term priority, particularly if the property has any history of termite activity or is located in a high-risk area.

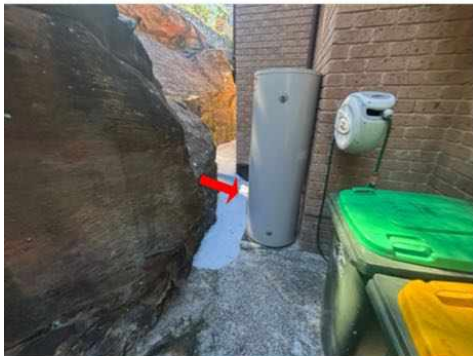
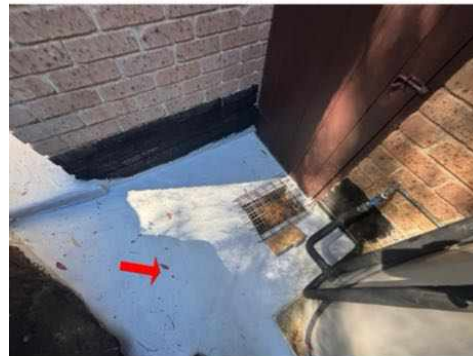
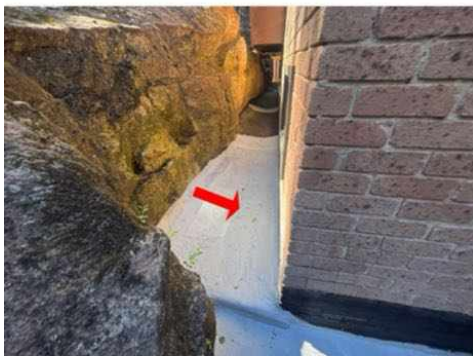
Finding: High External Ground Levels – Moisture Risk

Information: At the time of inspection, the external ground levels at the rear of the property were noted to be higher than the internal floor levels. This condition increases the risk of moisture ingress into the structure, particularly if the existing waterproofing system becomes compromised over time. Although no active water penetration was observed at the time of inspection, the elevated external levels place additional reliance on the integrity of the waterproofing membrane and damp-proofing measures. The client is advised to regularly monitor the condition of the waterproofing in this area and ensure that all membranes, seals and protective coatings remain intact and well maintained. Failure of the waterproofing system may result in moisture-related issues, including dampness, staining, deterioration of building materials and potential mould growth. Ongoing monitoring and maintenance are recommended to reduce the likelihood of future moisture intrusion.
