Building and Timber Pest Inspection Report

Inspection Date: Tue, 17 Mar 2026

Property Address: 310/26-32 Marsh St, Wollie Creek NSW
2205, Australia

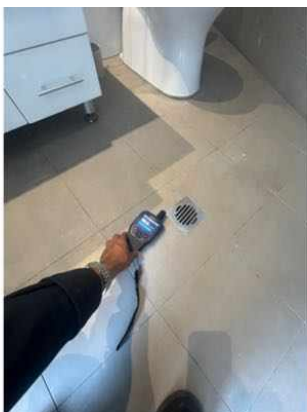
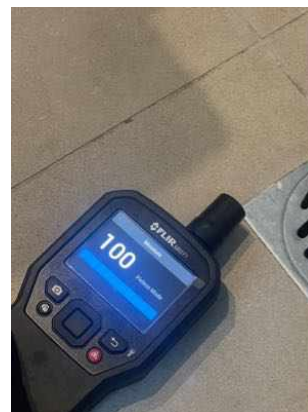
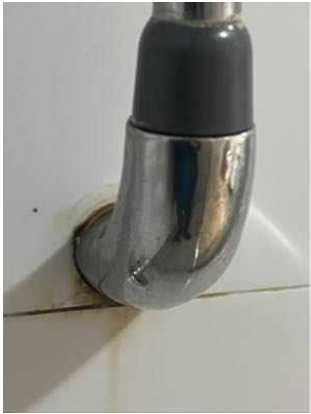
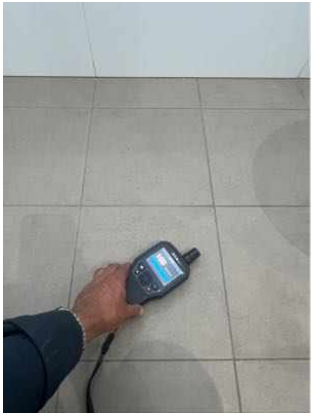
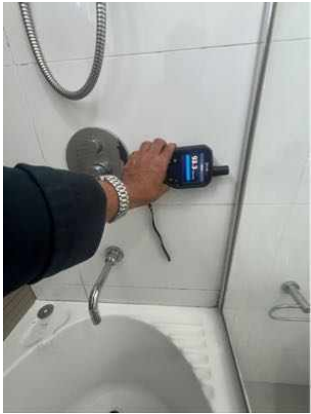
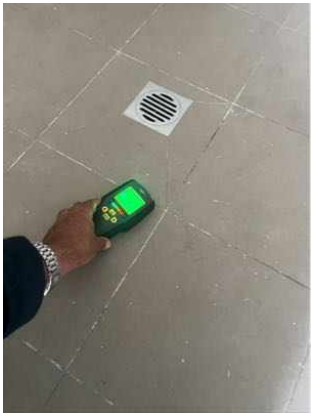
Building: Main Building
Location: Bathrooms, Laundry
Finding: Elevated Moisture Bathroom
Information: Elevated moisture levels were detected to tiled surfaces in bathroom/shower areas and laundry with minor deterioration also present at the time of inspection. Persistent moisture ingress can lead to concealed damage.

Elevated moisture readings in tiled wet areas can occur from normal shower use, age/deterioration of waterproofing membranes, plumbing leaks or moisture absorption through grout lines. While no damage was visible, elevated readings may indicate moisture retention behind tiles, which can be a conducive condition for future deterioration if not monitored.

A further inspection by a licensed waterproofing specialist is recommended to determine cause of elevated moisture (e.g., pressure testing, membrane assessment) and advise remedial actions.

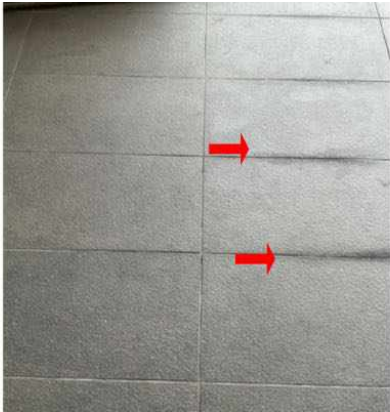
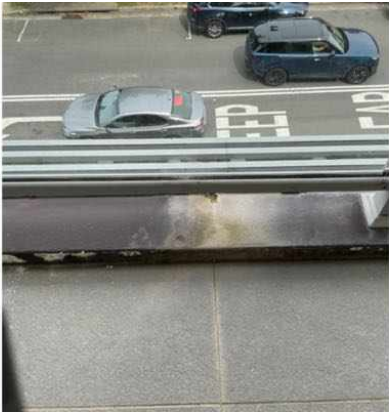
Finding 3.02

Building: Main Building
Location: Balcony
Finding: Balcony Elevated Moisture - Strata
Information:

Elevated moisture was recorded at the base of the balcony wall and tiles, with associated staining consistent with water exposure. While no internal damage was visible at the time of inspection, balconies in multi-unit dwellings are high-risk areas for waterproofing failure, which can lead to leaks into adjoining units and significant rectification costs. Further investigation by a licensed waterproofing contractor is strongly recommended.

Depending on the strata plan, this area may form part of the common property, in which case remedial responsibility may rest with the owners corporation (strata). Purchasers should seek clarification from the strata manager and legal adviser prior to purchase.

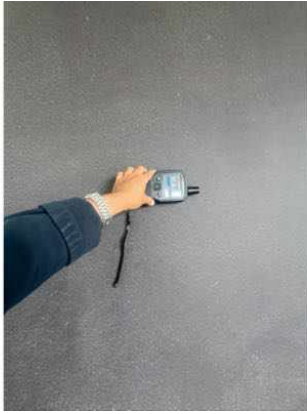
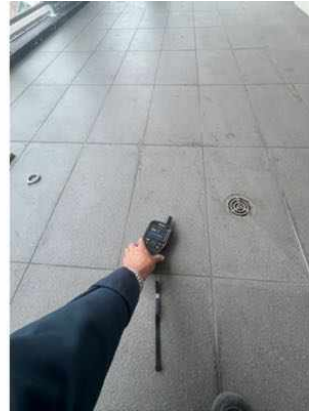
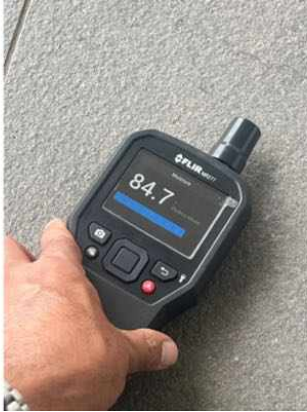
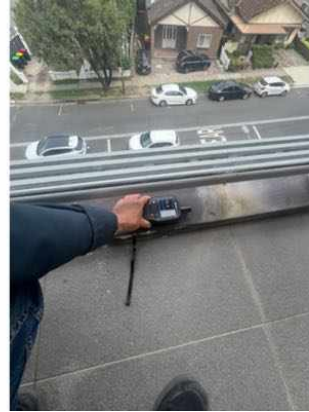
Finding 3.03

Building:	Main Building
Location:	Ensuite, main bath , laundry, balcony , front entrance , balcony
Finding:	Tiles - Cracked or damaged
Information:	Cracking was evident to the tiling in this area at the time of inspection. While the cracking appears to be minor, this area is frequently exposed to water, allowing potential for water penetration into adjoining sections of walls or flooring.

If left unmanaged, water penetration to these areas may lead to subsequent water damage, which is likely necessitate repair work to affected building elements.

A tiling contractor should be appointed to ensure that no further water damage occurs. The re-application of silicone and grouting throughout remaining tile work is also advised, to further protect the area against water penetration.

Where water penetration has led to water damage, appointment of a relevant tradesperson may be required to repair damaged building elements.

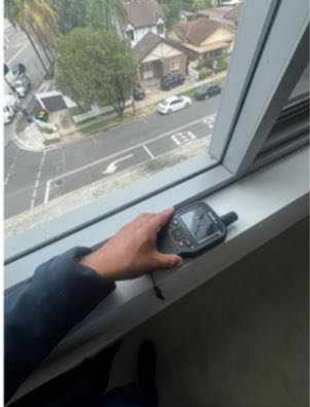
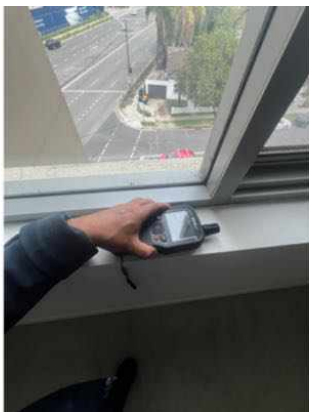
Finding 3.04

Building: Main Building
Location: All Internal Areas. Bedroom wall and window reveals
Finding: Elevated moisture - No visible deterioration
Information: Elevated moisture meter readings were recorded to the wall bases and window reveals when tested using a non-invasive (pinless) moisture meter. No visual evidence of moisture ingress, staining, mould growth, or related moisture damage was observed at the time of inspection. Ongoing monitoring is recommended, and further investigation by a strata appointed licensed plumber is recommended.

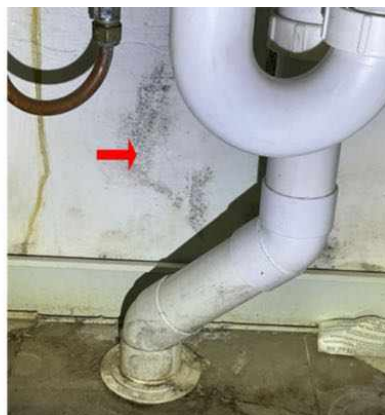
Finding 3.05

Building:	Main Building
Location:	Laundry
Finding:	Minor Mould Growth
Information:	Minor mould growth was observed to the laundry. The exact cause could not be confirmed due to the non-invasive nature of the inspection. Cleaning, improved ventilation, and ongoing monitoring are recommended. A further investigation by a licensed plumber is advised.

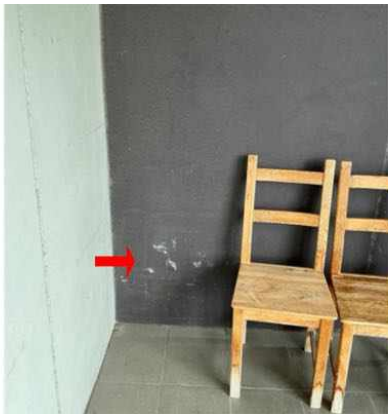
Finding 3.06

Building:	Main Building
Location:	Balcony
Finding:	Painted surface - Bubbling
Information:	Sections of paint in this area was found to have bubbled and deteriorated. Paint bubbling is generally an indication of excessive moisture in the area, that is currently hidden by the painted surface.

The presence of excessive moisture can have major implications on associated building elements if left unattended. While only seemingly minor at this stage, the damage cannot be determined due to the paint obstructing any further inspection of the damage.

It is highly advised that the affected paint be cleaned to allow a further, more invasive inspection by a licensed plumber. Failure to act on this defect may necessitate major works in the future.

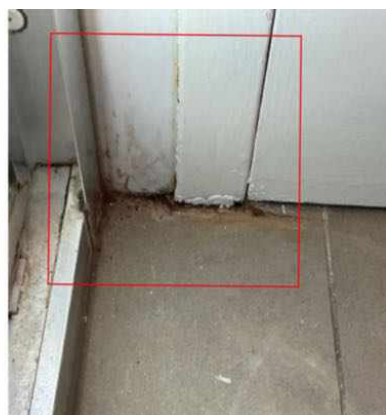
Building:	Main Building
Location:	Ensuite
Finding:	Wet-Area Door Jambs – Moisture Staining / Decay
Information:	moisture staining and deterioration were observed at the base of the wet-area door jamb and architraves. This is commonly due to water splashing or moisture tracking from the bathroom floor into adjacent joinery or inadequate waterproof transition at the bathroom threshold.

Further inspection by a licensed waterproofing contractor is recommended to verify exact cause and remedial measures.

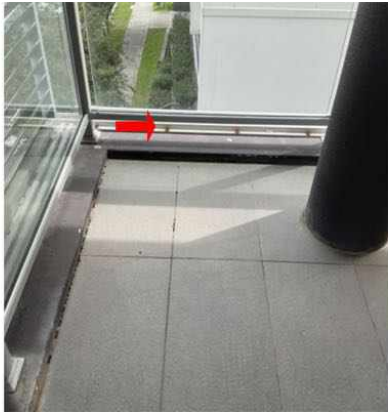
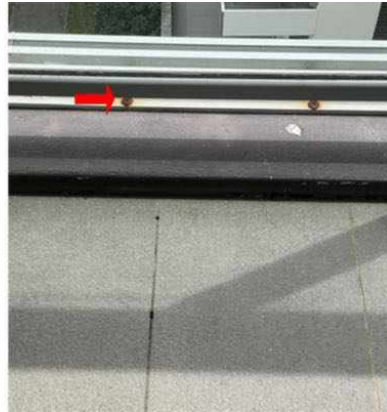
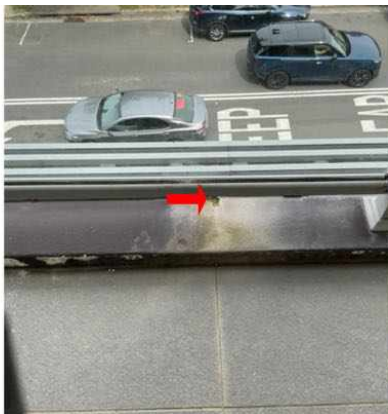
Finding 3.09

Building:	Main Building
Location:	Balcony
Finding:	Building element - Rusted or corroded and moisture staining
Information:	This building element shows evidence of rusting and corrosion, which is likely to have developed as a result of excessive exposure to moisture and or inadequate coatings.

As surface rust provides no protection to the underlying iron, the deteriorating condition is likely to worsen if not addressed in the short-term future.

Where possible, the use of galvanized (treated) metals or aluminium coated metals aid in rust prevention, as does regular general maintenance. Rust formation can be controlled with coatings, such as paint, that isolate the iron from the environment.

Rusting and corrosion should be managed by ideally removing or limiting the affected surface from exposure to moisture. A registered builder may be appointed to replace any building elements that have been severely affected by rust or water damage.

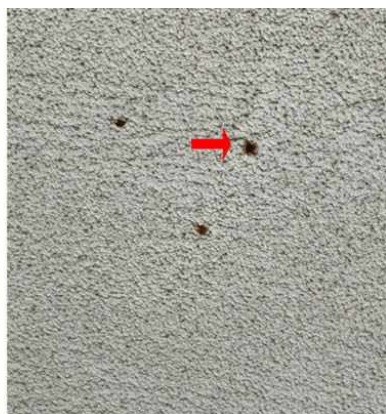
Finding 3.10

Finding: Rust Staining - Balcony soffit

Information: The marks appear consistent with historic screw penetrations and minor rust staining through paint. No symptoms of concrete spalling was observed. Recommend the Owners Corporation engage a painter or remedial contractor to seal any exposed steel and apply an appropriate external-grade coating during routine maintenance. If moisture staining worsens or cracking develops, further investigation by a remedial engineer is advisable.

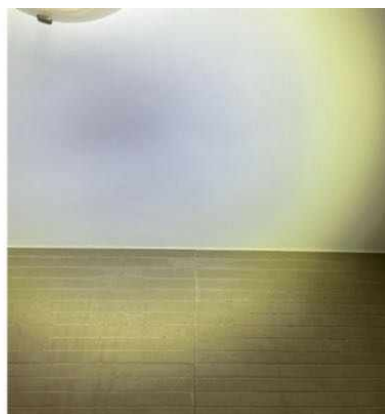
Finding 3.11

Building:	Main Building
Location:	Ensuite
Finding:	Water Staining - Humidity or Ventilation
Information:	The ceiling surface shows peeling paint and water staining on the walls faint commonly consistent with humidity-related staining, often found in bathroom or wet areas with insufficient ventilation. While there is no visible sagging or major water damage, the pattern suggests prolonged moisture exposure, possibly due to steam accumulation or minor condensation issues. According to AS 4349.1–2007 (Appendix C), this would be classified as a minor defect unless further deterioration or active leaks are found. Recommend improving mechanical or natural ventilation, cleaning the surface with mould treatment, and monitoring for recurrence.

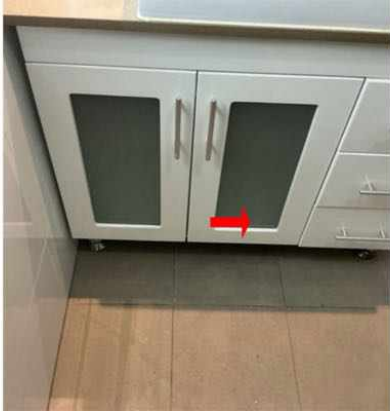
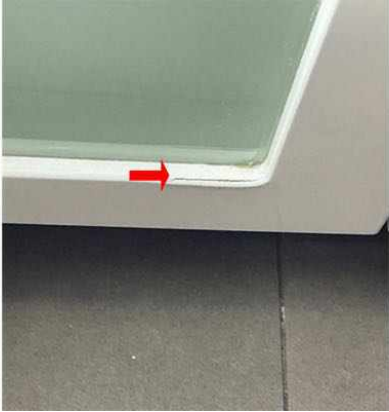
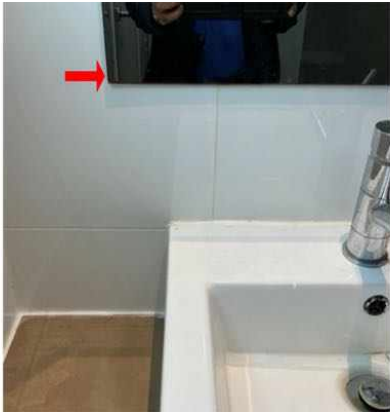
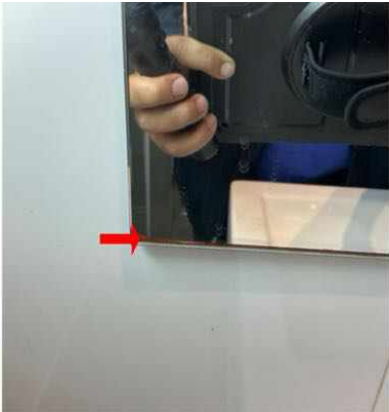
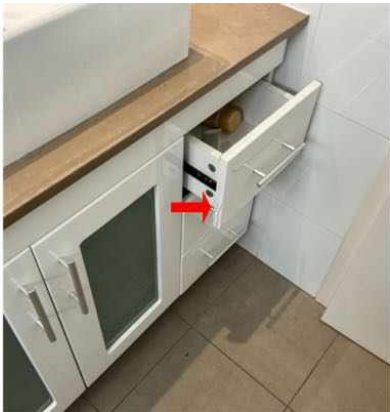
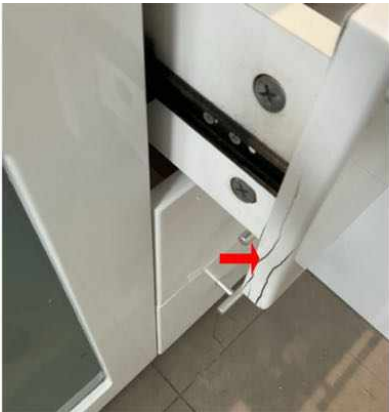
Building:	Main Building
Location:	All Internal Areas
Finding:	Building element - Damaged - Ensuite basin damaged , vanity chipped ensuite , mirror desilvering ensuite and bathroom , kitchen cabinets scratches, minor chips on kitchen top
Information:	Breakage occurs generally when the building materials have either aged and decayed, or as a result of damage (accidental or deliberate).

Repair and/or replacement of broken elements is advised to ensure that additional secondary defects do not arise as a consequence. Such works are necessary, as all building elements play a key role in the operation and function of the overall structure and its performance.

A relevant tradesperson should be appointed to repair or replace the affected building element prior to any subsequent damage being caused.

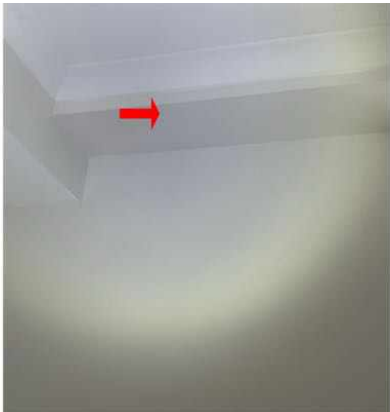
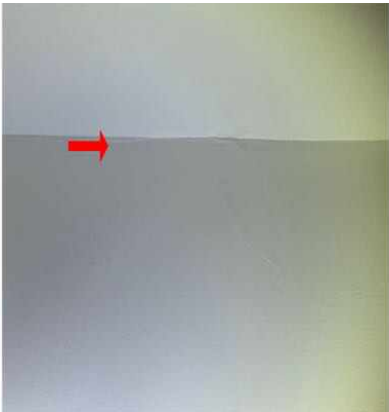
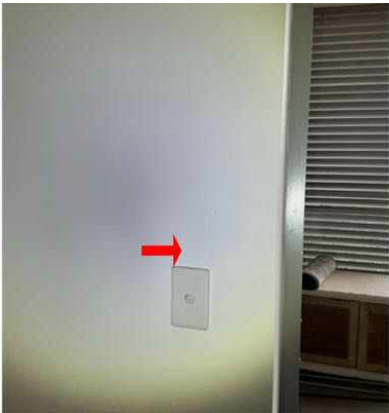
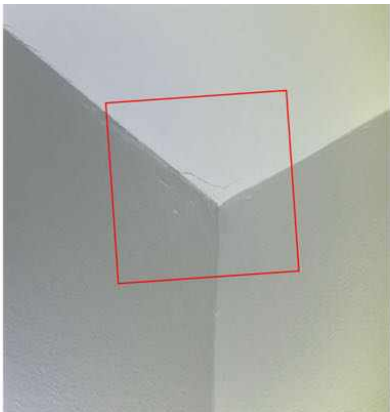
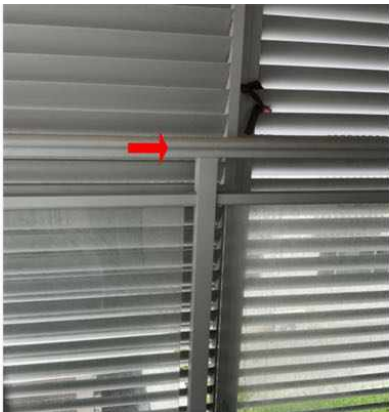
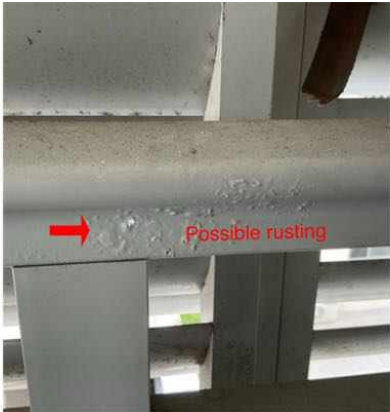
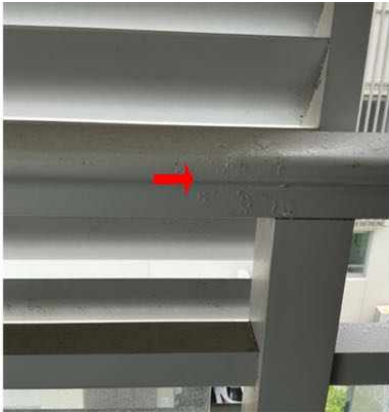
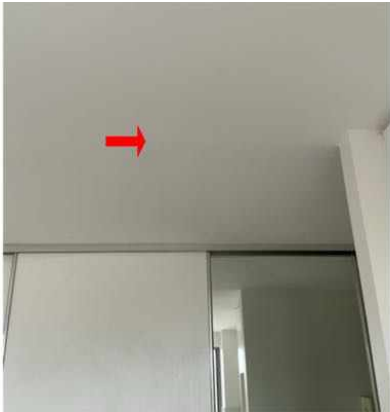
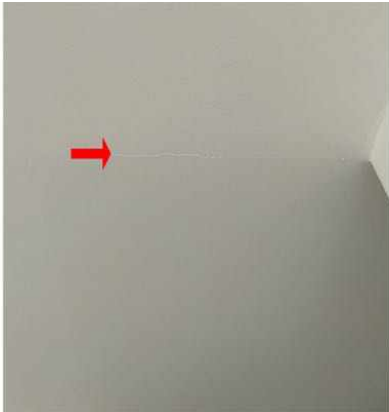
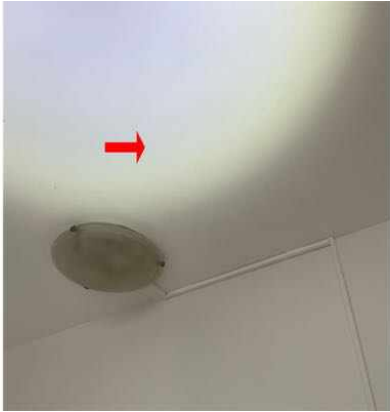
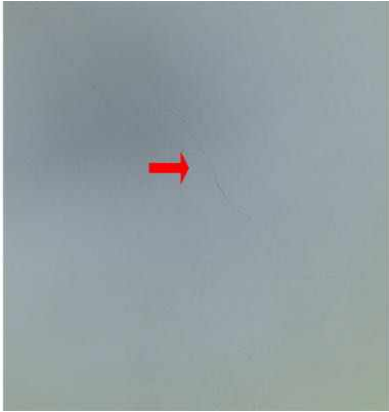
Finding 3.14

Building: Main Building
Location: All Internal Areas
Finding: Paint finish and hairline cracking
Information: The paint finish in this area was identified as being incomplete at the time of inspection including some hairline minor cracking.

Whilst incomplete or missing paint finish is generally an appearance defect, it can also lead to the development of secondary building defects over time. Incomplete areas of paint finish expose the area to moisture, potentially accelerating the deterioration of underlying building materials.

Incomplete paint finishes should be sanded back, filled, leveled and painted, as applicable. Where inadequate or missing paint protection has led to the deterioration of the associated building element, repair and/or replacement of this building element may be required.

A painting contractor should be appointed as soon as possible to perform necessary works to aid the appearance of the affected area and to ensure the area is protected against further deterioration. Alternatively, the homeowner following manufacturer instructions may perform these works.

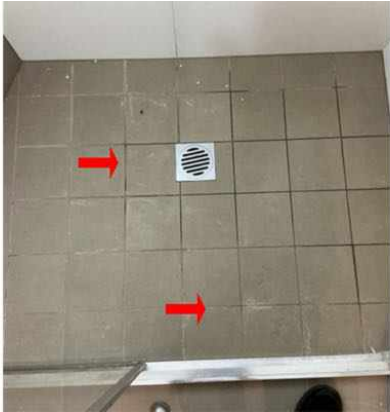
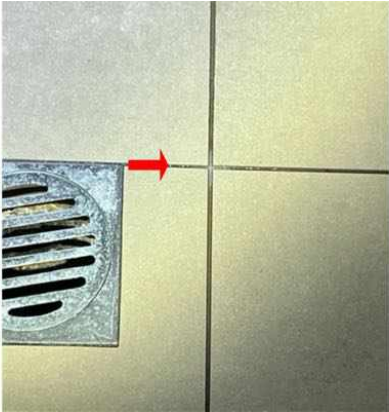
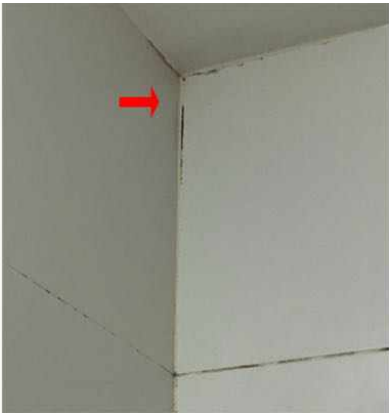
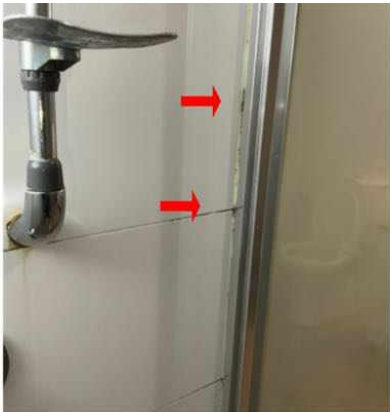
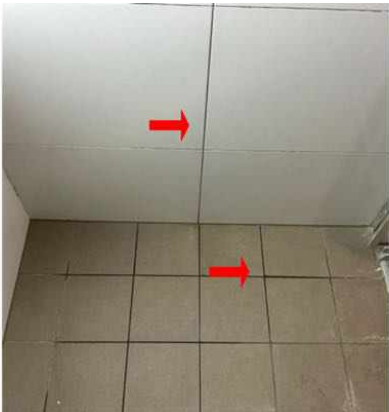
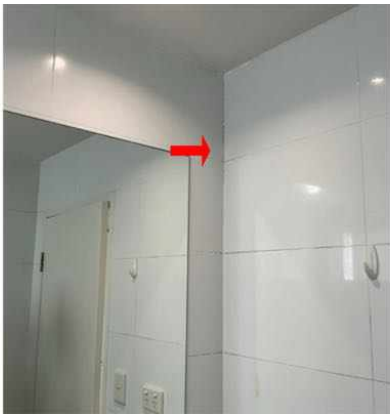
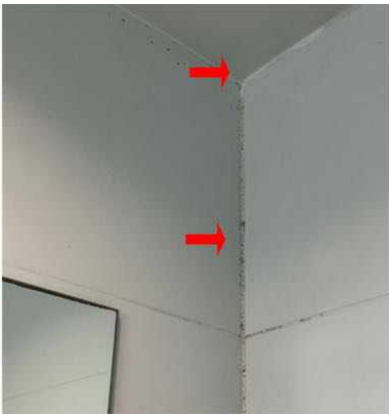
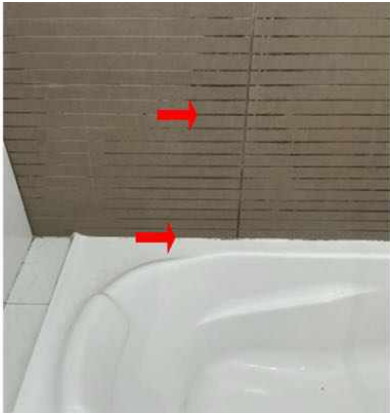
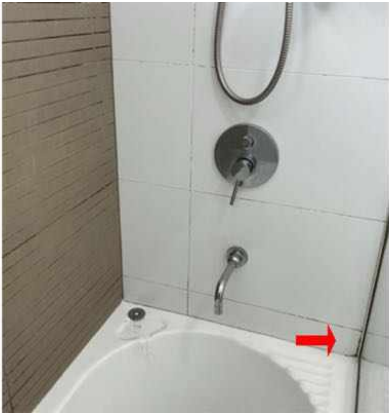
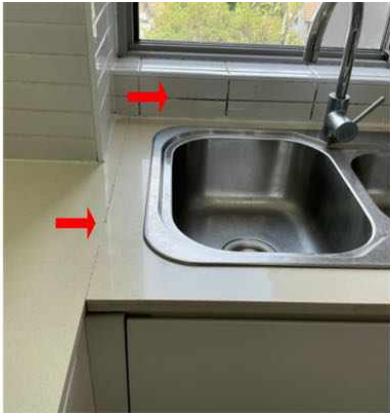
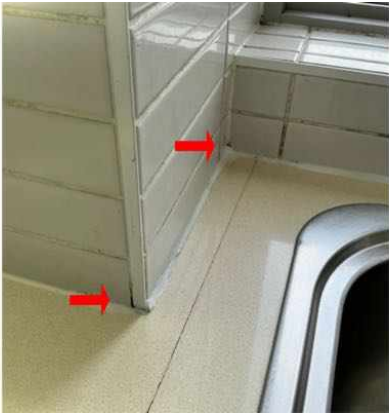
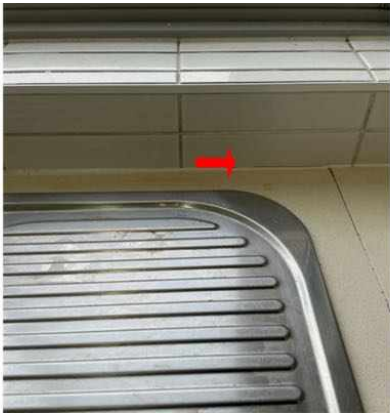
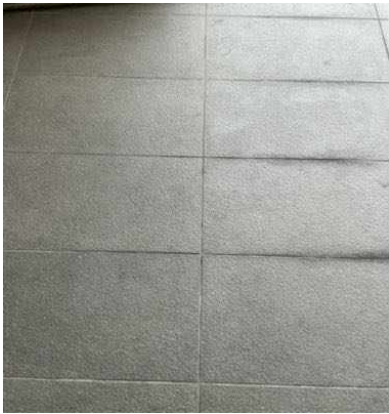
Finding 3.15

Building:	Main Building
Location:	All Internal Areas & balcony
Finding:	Sealant and grouting - Missing or degraded
Information:	It was noted on inspection that sealant or grout is degraded. There is also evidence of poor workmanship and excessive use of sealant. Silicone should never be used as a first line of defence against waterproofing. Further inspection by a licensed waterproofing contractor is highly recommended.

Different materials and floor areas move at different rates, generally causing cracking to grout or sealant at this point. A flexible sealant is required to allow for expected expansion and contraction, while keeping the joint water tight and protective of all associated building materials.

There appears to be excessive mould to the sealant and grout which will likely require scraping out and replacement.

Flexible and mould resistant materials should be applied to affected areas to prevent any subsequent water damage that is likely to occur. Regular maintenance and replacement of damage or missing or damaged sealant and grout is highly recommended to the wet areas, as this is a regular wear and tear defect. Sealant and grouting in areas that come into regular contact with water should be maintained for the long term care of your property.

A sealant specialist or tiling contractor should be appointed to complete these works as soon as possible

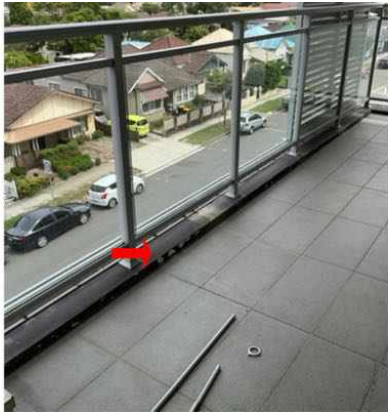
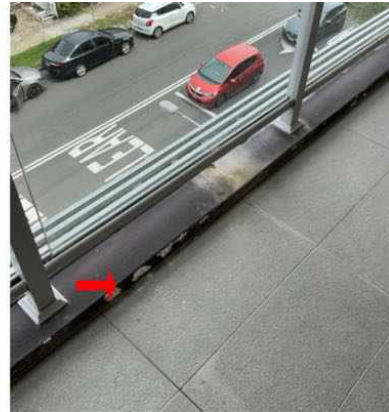
Building:	Main Building
Location:	Balcony
Finding:	Building element - Damaged - Render damaged and moisture staining
Information:	Breakage occurs generally when the building materials have either aged and decayed, or as a result of damage (accidental or deliberate).

Repair and/or replacement of broken elements is advised to ensure that additional secondary defects do not arise as a consequence. Such works are necessary, as all building elements play a key role in the operation and function of the overall structure and its performance.

A relevant tradesperson should be appointed to repair or replace the affected building element prior to any subsequent damage being caused.

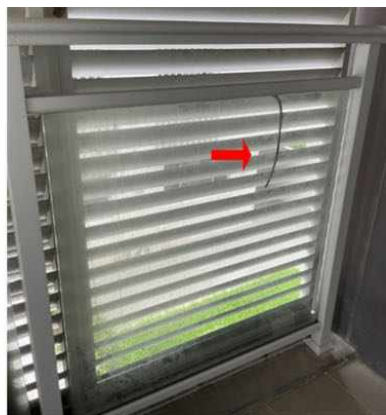
Finding 3.18

Building:	Main Building
Location:	Balcony
Finding:	Building element - Damaged - Balustrade seals coming off to some areas
Information:	Breakage occurs generally when the building materials have either aged and decayed, or as a result of damage (accidental or deliberate).

Repair and/or replacement of broken elements is advised to ensure that additional secondary defects do not arise as a consequence. Such works are necessary, as all building elements play a key role in the operation and function of the overall structure and its performance.

A relevant tradesperson should be appointed to repair or replace the affected building element prior to any subsequent damage being caused.

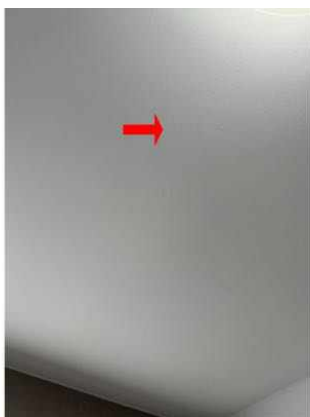
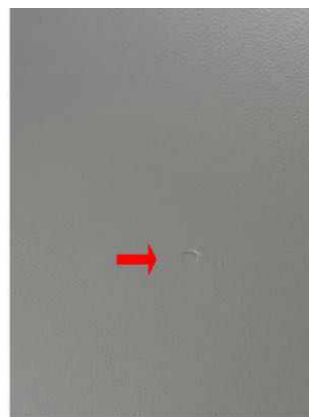
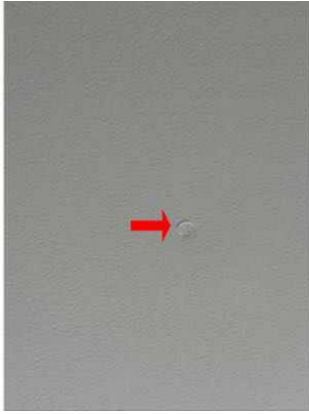
Finding 3.19

Building:	Main Building
Location:	All Internal Areas
Finding:	Ceiling nails - Popping to some areas
Information:	Numerous popped nails were identified in the internal ceiling at the time of inspection. Nails and screws hold simply by the friction between them and the surface they are applied to. Over time, the nails and screws can back out, which is often a result of general ageing and deterioration of the building structure.

If left unmanaged, the ceiling sheets may become loose and unstable, increasing the rate of deterioration of the internal ceiling and creating potential for the development of secondary defects.

Re-fastening of popped nails will help to maintain the stability of the internal ceiling and associated building elements. Such minor works will also help to improve the appearance of the affected area and secure the ceiling sheets, so as to prevent the onset of ceiling sagging. These works should be performed by a qualified carpenter or plasterer at client discretion.

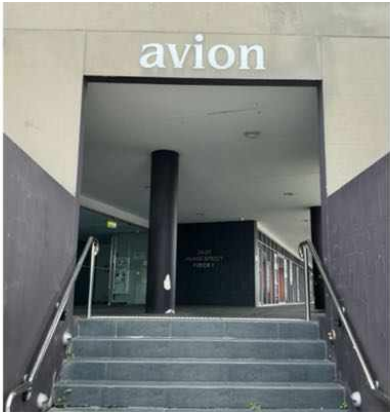
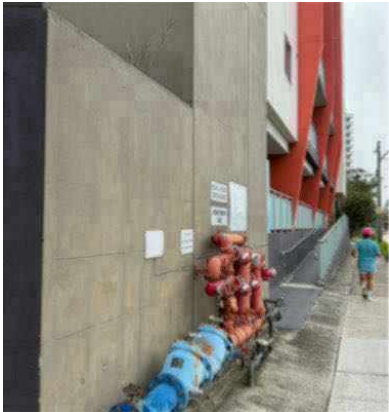
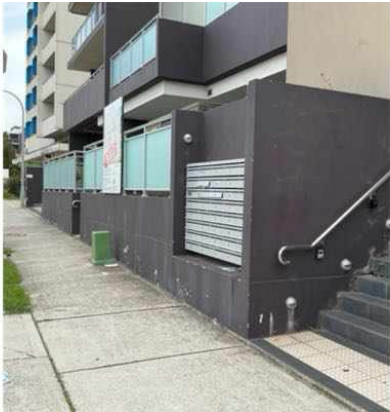
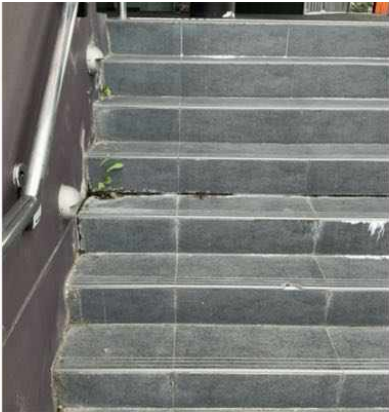
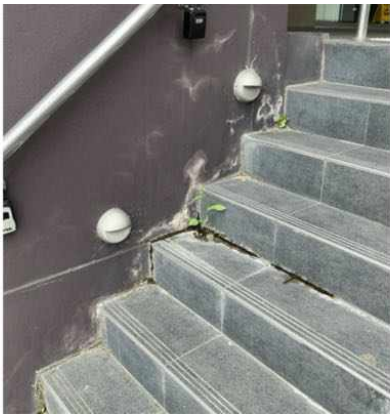
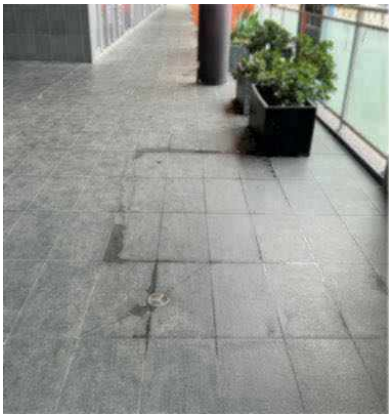
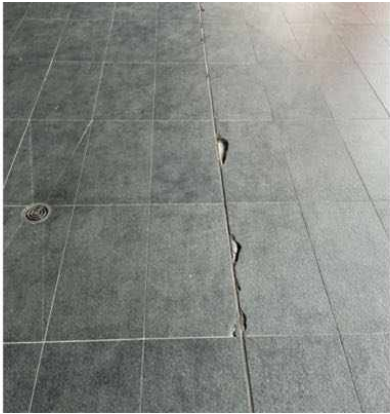
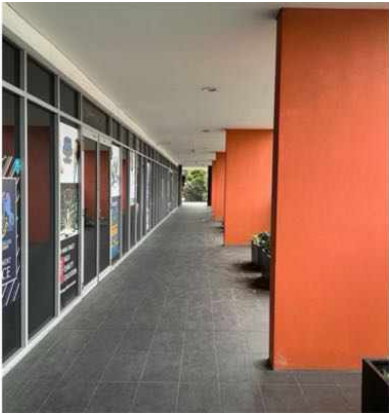
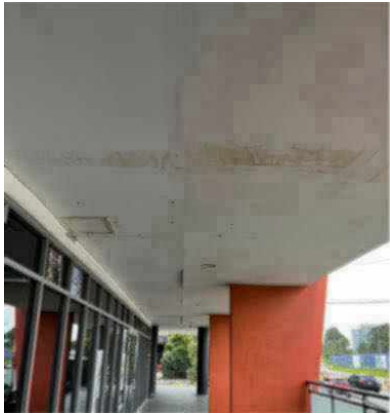
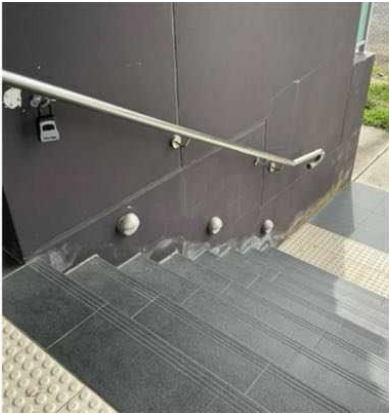
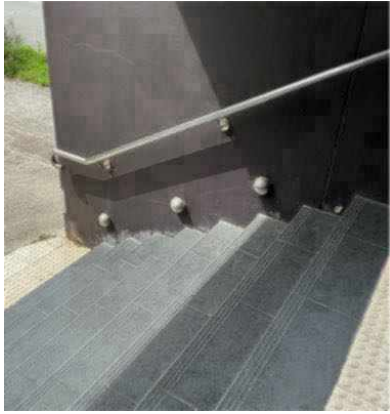
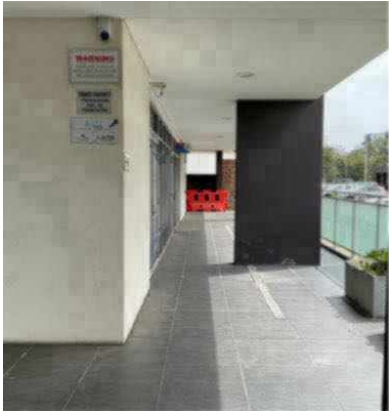
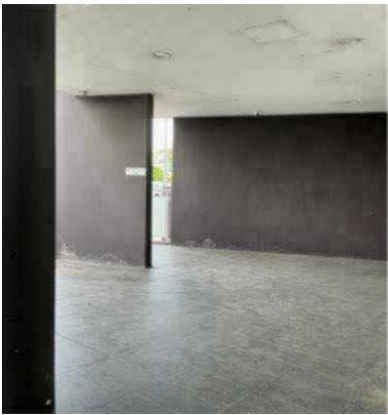
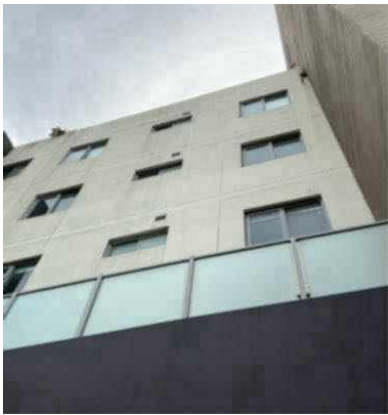
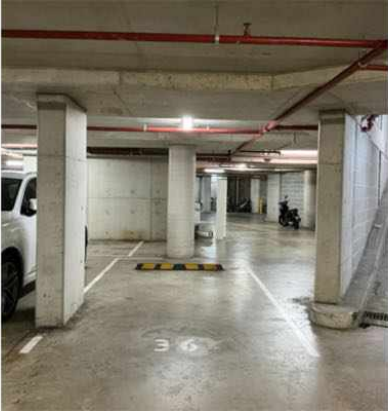
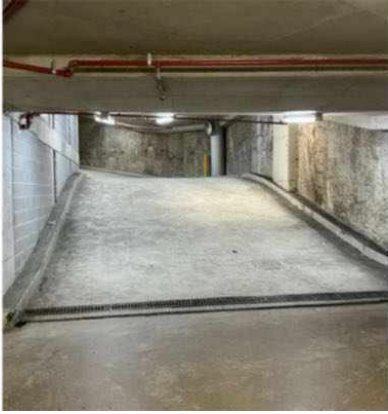
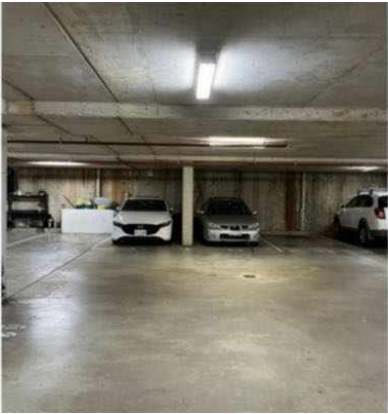
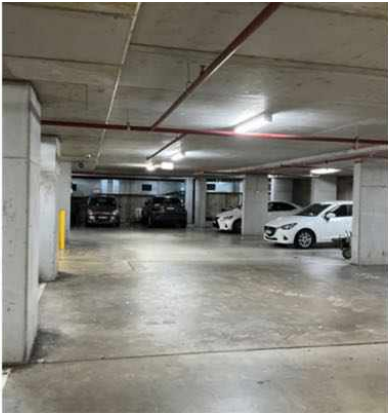
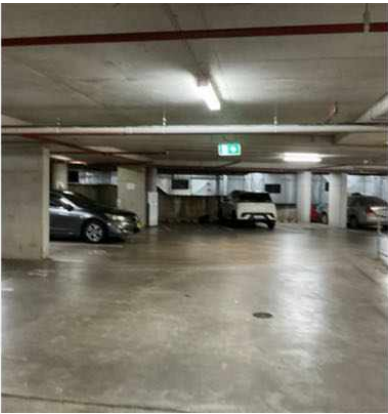
Building: Main Building
Location: All External Areas
Finding: Additional Photos - Obstructions and Limitations
Information: These photographs are an indication of the obstructions and limitations which impeded full inspection of the property at the time of inspection. These obstructions can hide an array of defects and should be removed to allow full inspection to be carried out. A re-inspection is recommended once the areas are made accessible.

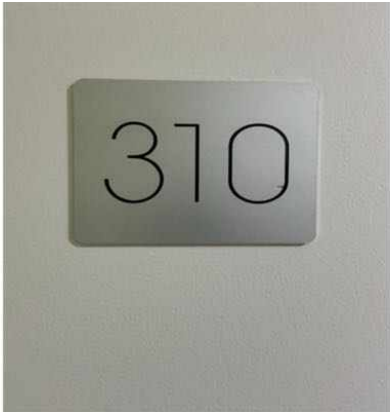
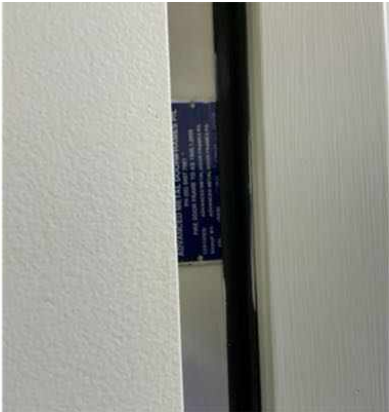
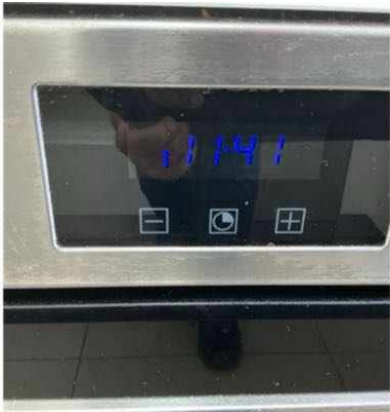
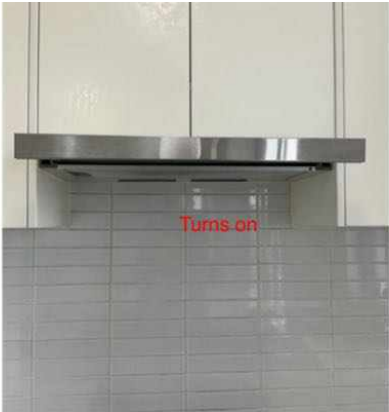
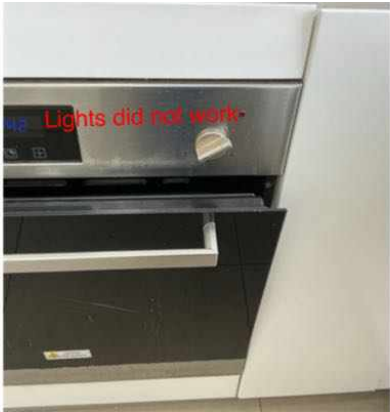
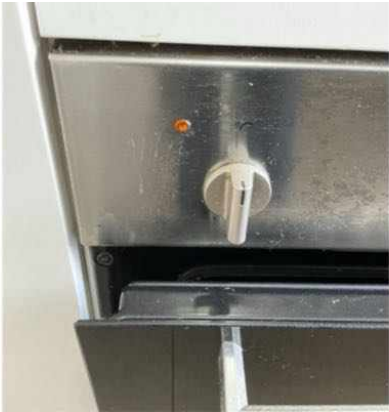
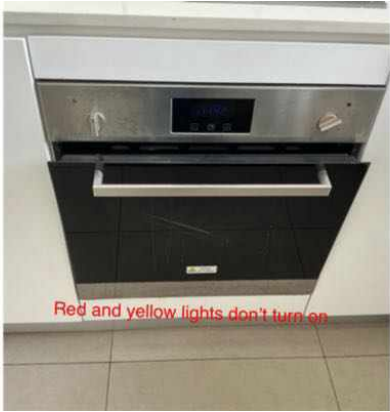
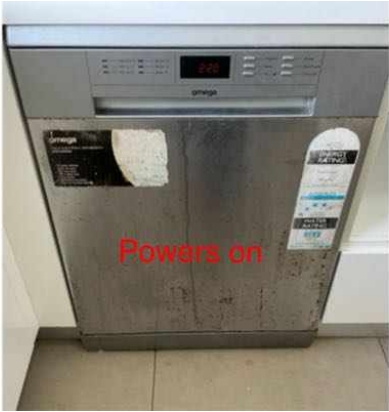
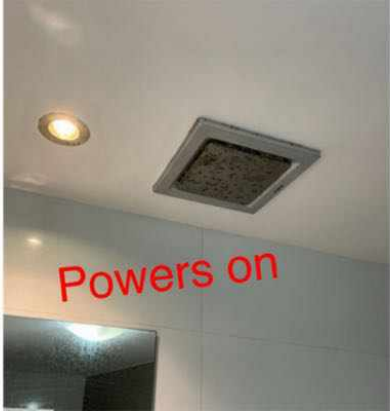
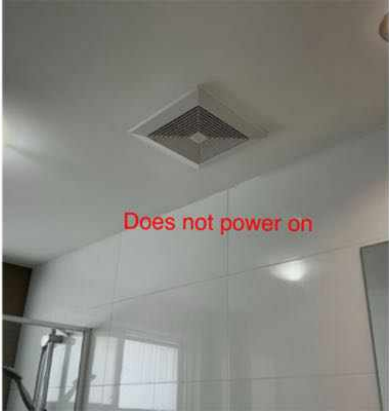
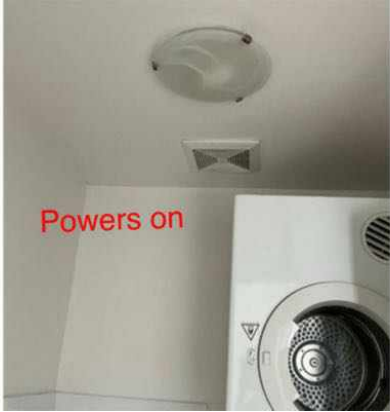
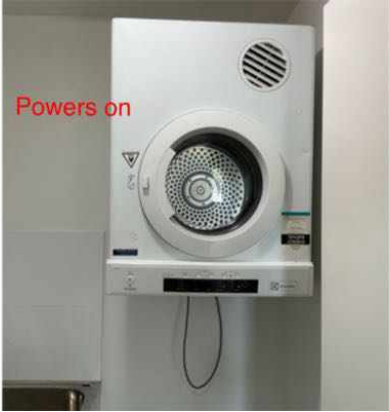
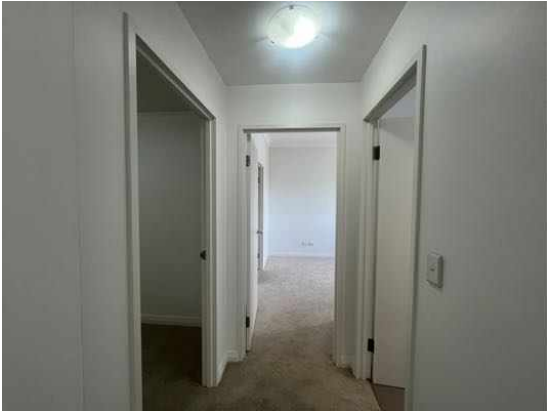
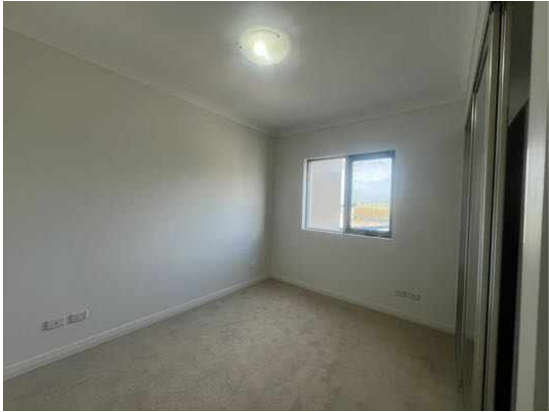
Building: Main Building
Location: All Internal Areas
Finding: Additional Photos - Obstructions and Limitations
Information: These photographs are an indication of the obstructions and limitations which impeded full inspection of the property at the time of inspection. These obstructions can hide an array of defects and should be removed to allow full inspection to be carried out. A re-inspection is recommended once the areas are made accessible.
