Building and Timber Pest Inspection Report

Inspection Date: Thu, 12 Feb 2026

Property Address: a305/147 Great Western Hwy, Mays Hill
NSW 2145, Australia

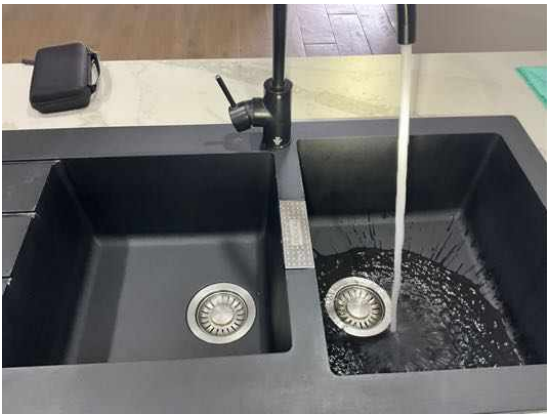
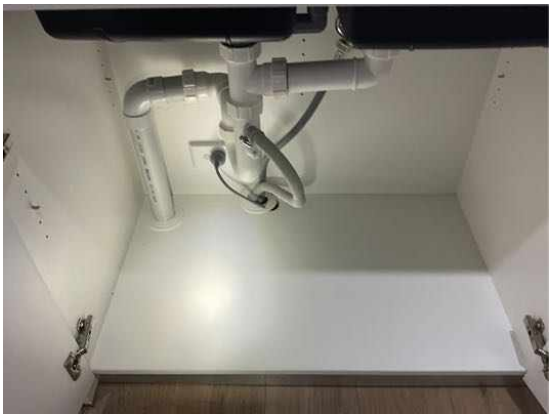
Building: Main Building
Location: All Wet Areas
Finding: Waterproofing
Information:

Consequently, there is no conclusive evidence of any current shower recess leakage other than those which may have already been mentioned earlier in this report. It is reasonable to assume the shower waterproofing is sound. Note that if the shower is not used, or has not been used for some time, moisture readings would not vary significantly and this can lead to erroneous results. It is not possible under the visual inspection criteria (under which a prepurchase inspection is carried out) to categorically determine if there are leaks. If a more accurate assessment is required, a special purpose inspection should be requested. Alternatively, the assumption should be made that the shower may leak.

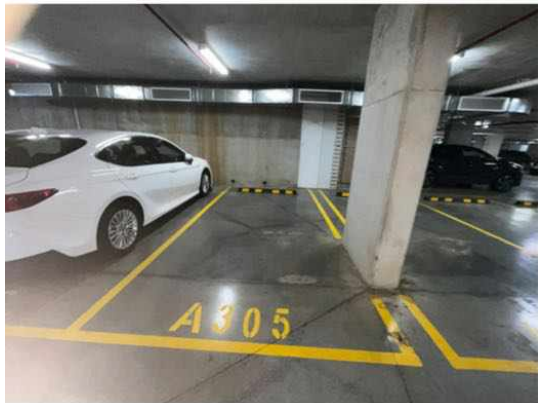
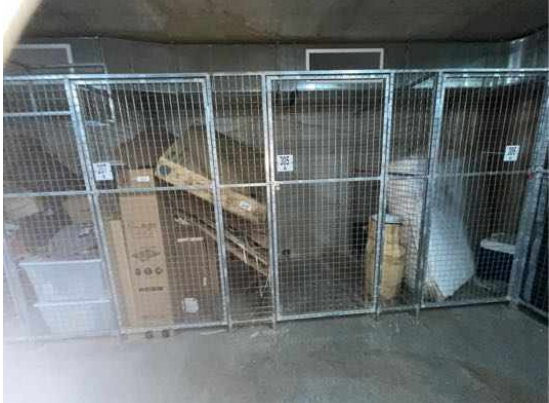
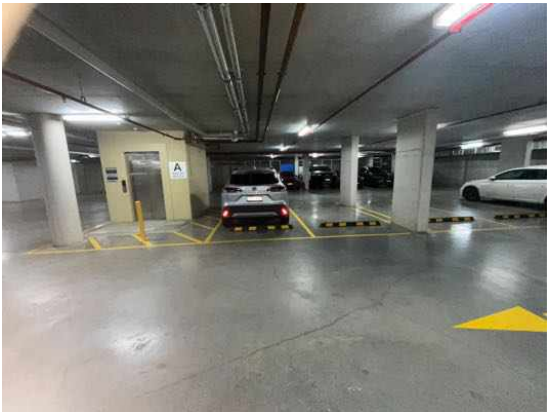
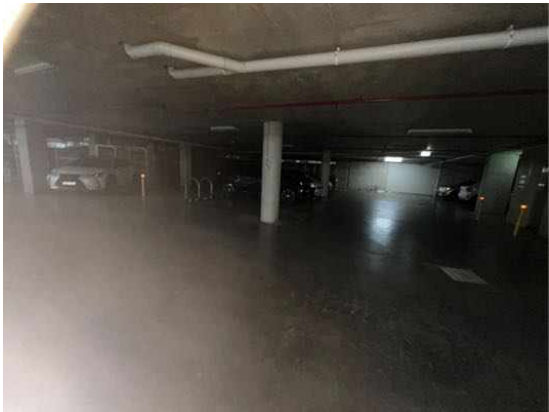
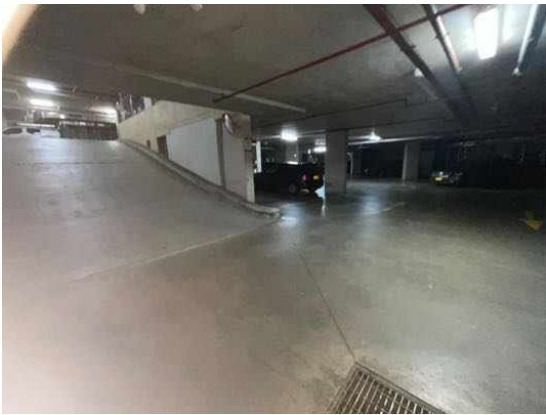
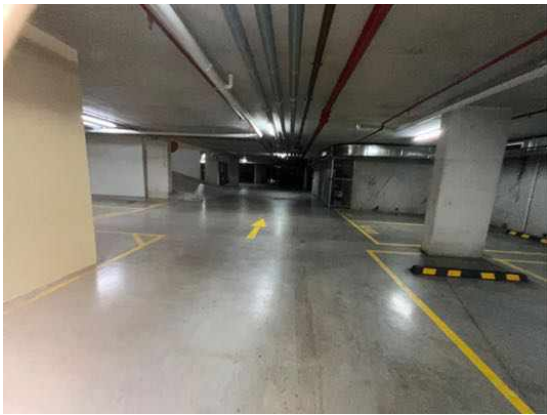
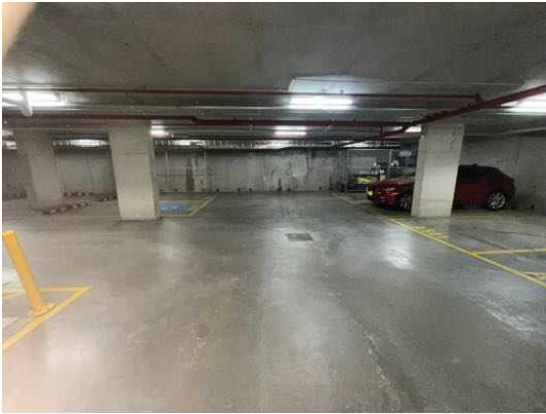
Building: Main Building
Location: Garage
Finding: Additional Photos- Garage
Information: Additional photos are provided for your general reference. Arrows may have been included to highlight areas of importance. Please discuss these photos with your building consultant for clarification.

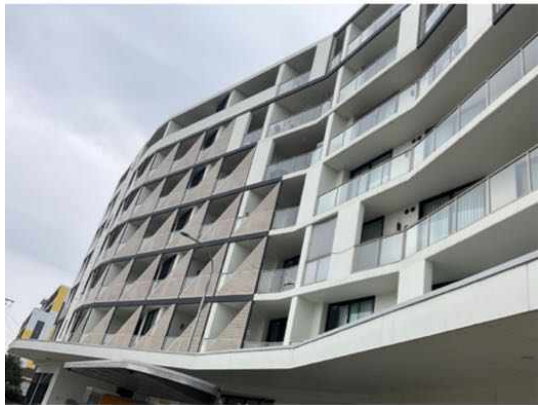
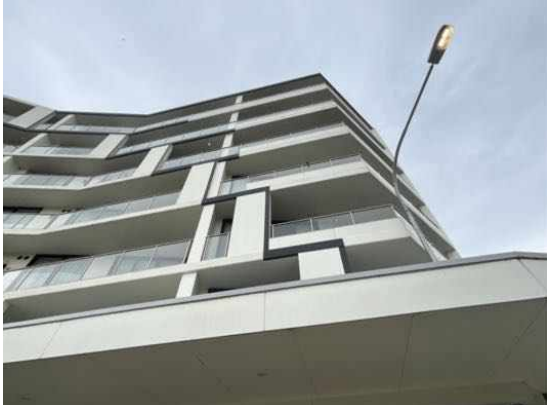
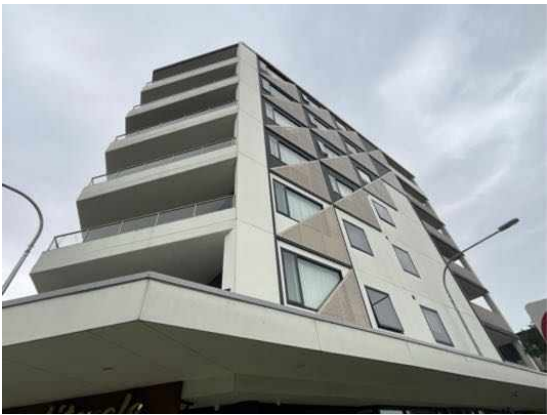
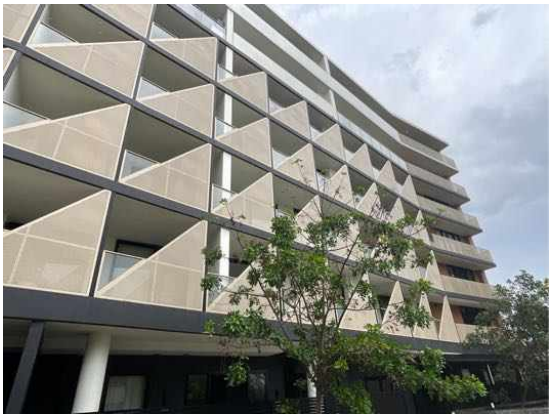
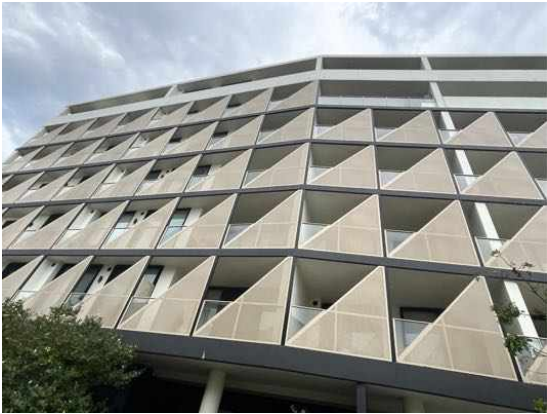
Building: Main Building
Location: Exterior
Finding: Additional Photos
Information:

Additional photos are provided for your general reference.

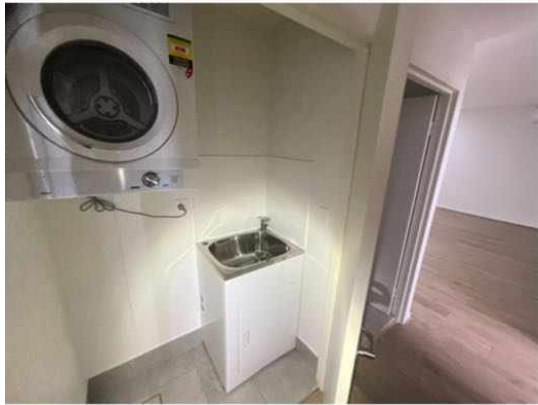
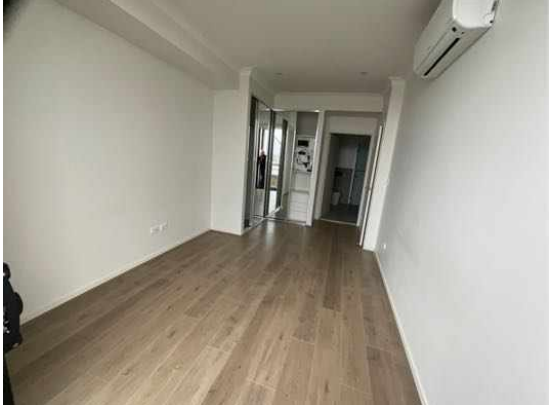
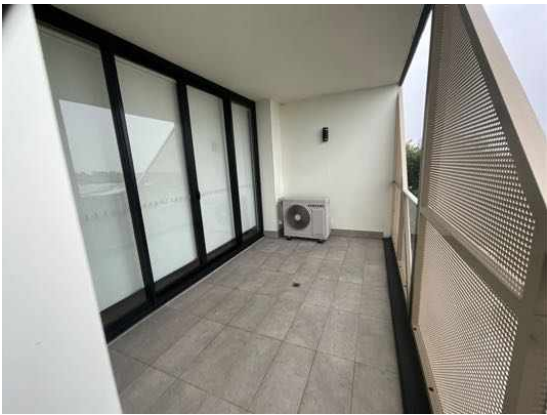
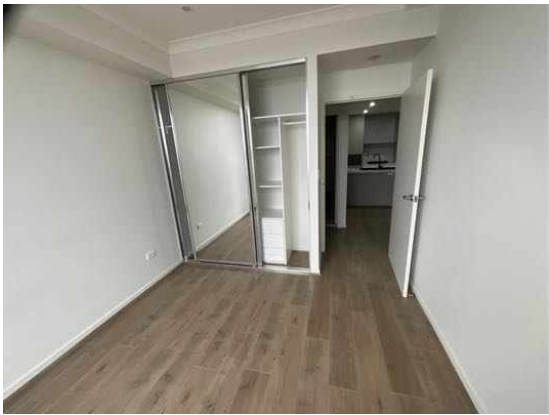
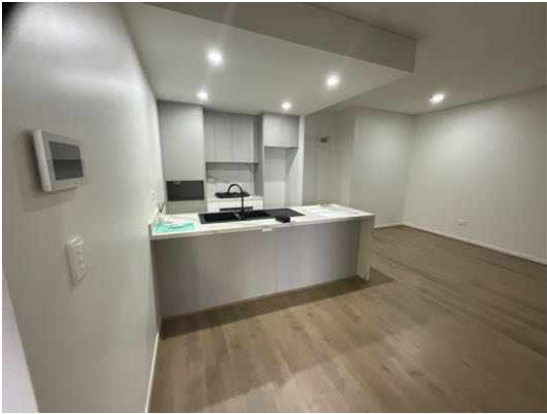
Building: Main Building
Location: All Areas
Finding: Additional Photos - Obstructions and Limitations
Information:

These photographs are an indication of the obstructions and limitations which impeded full inspection of the property at the time of inspection. These obstructions can hide an array of defects and should be removed to allow full inspection to be carried out. A re-inspection is recommended once the areas are made accessible.
