Building and Timber Pest Inspection Report

Inspection Date: Tue, 3 Mar 2026

Property Address: 270 King St, Mascot NSW 2020, Australia

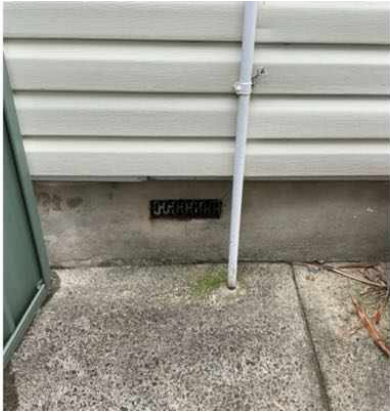
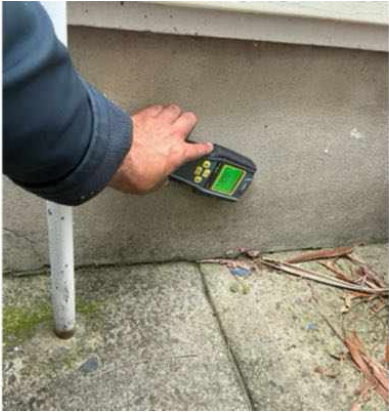
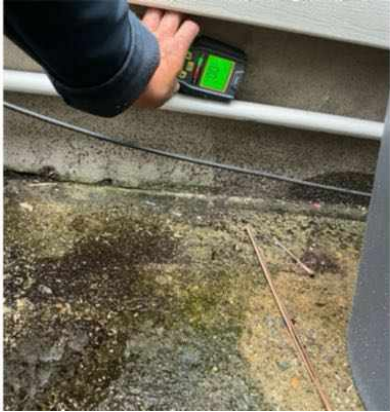
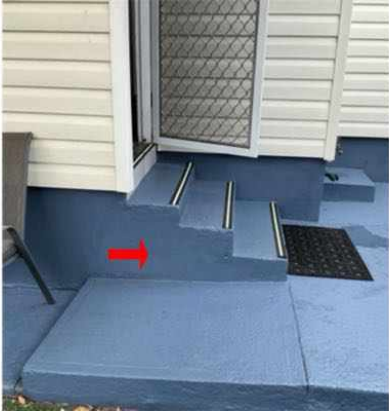
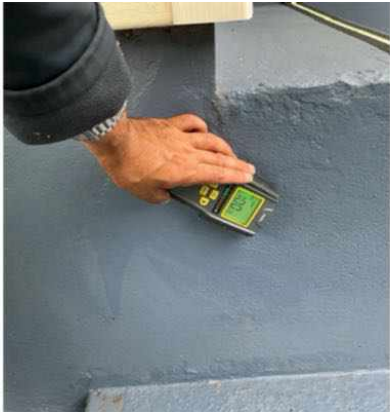
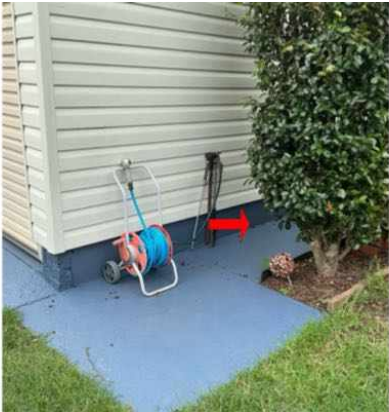
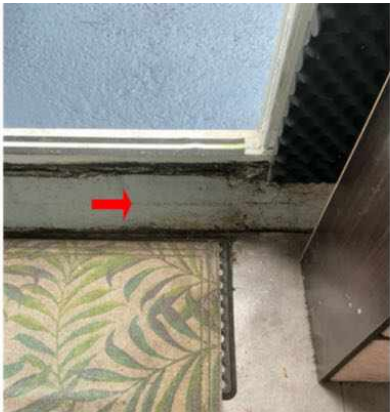
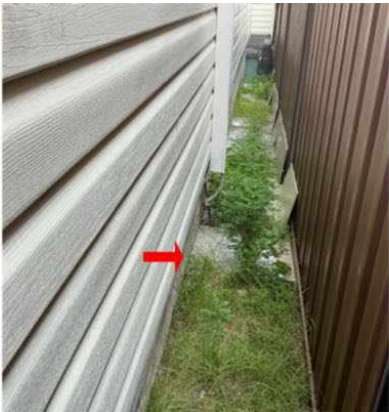
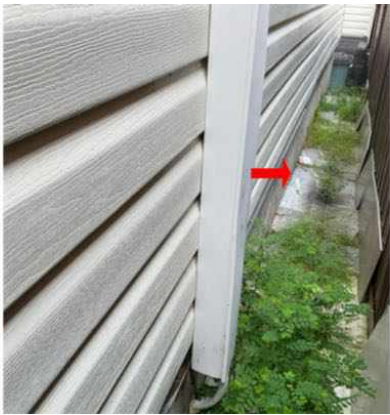
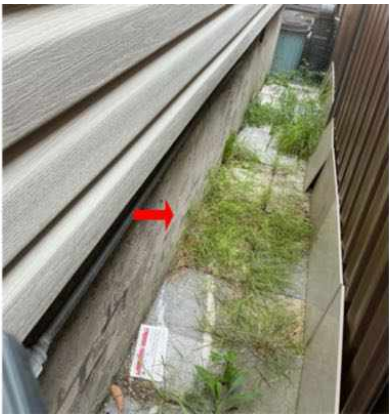
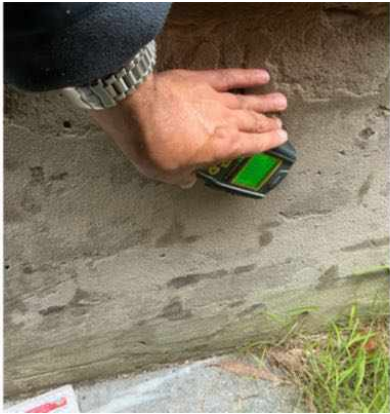
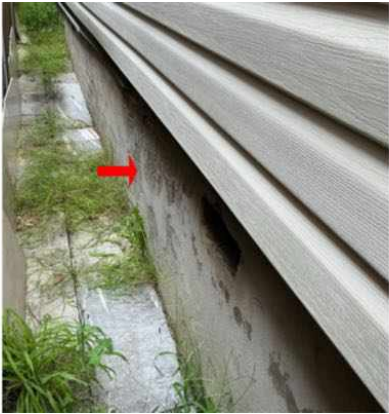
Building:	Main Building
Location:	All External Areas
Finding:	Damp - Also see Defect 3.1
Information:	Damp (or structural damp) refers to the presence of unwanted moisture in the structure of a building, either as the result of intrusion from outside, or condensation from within the structure. Generally, structural damp is caused by rain penetration, rising damp, and leaks from plumbing pipes.

Unmanaged damp facilitates the formation and development of mould, fungi growth and wood rot, decaying associated building materials and compromising their structural integrity. Damage to finishes is also likely to occur, including lifting, bubbling, peeling and staining of paint, plaster and wallpaper.

It is important to address damp conditions, as the World Health Organisation notes that excess moisture leads - on almost all indoor materials - to growth of microbes such as moulds, fungi and bacteria, which subsequently emit spores and other matter into the indoor air. Exposure to these contaminants is associated with a wide range of respiratory and other health-related problems. Additionally, the development of damp in timber building elements also provides an environment that is conducive to termite / timber pest attack.

The first step in addressing damp is to diagnose the cause. The identified cause should be addressed first prior to repairing the appearance and other defects which have resulted from the rising damp. If the original cause is not resolved, further cases of damp are likely to ensue, resulting in secondary defects.

Consultation with a qualified plumber is advised immediately to identify the cause of damp and perform remedial works as required. Where excessive mould growth is present, further inspection by a specialist environmental health inspector should also be considered.

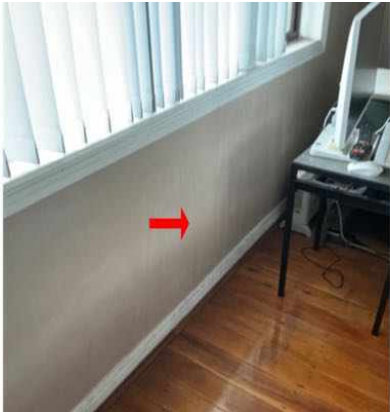
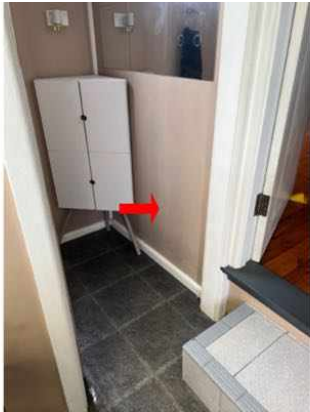
Finding 3.01

Building: Main Building
Location: Toilet (WC), front
Finding: Elevated Moisture – Further Investigation Recommended possible damp
Information: Elevated moisture readings were detected in several locations, with some areas also showing signs of dampness while others did not present visible surface issues, although no significant structural damage was evident at the time of inspection, dampness can contribute to deterioration if left unaddressed. A further investigation by a licensed plumber or waterproofing specialist is recommended to confirm the source and ensure no concealed issues are developing.

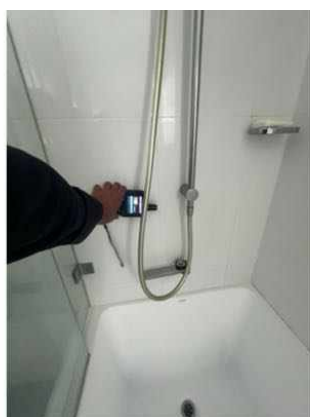
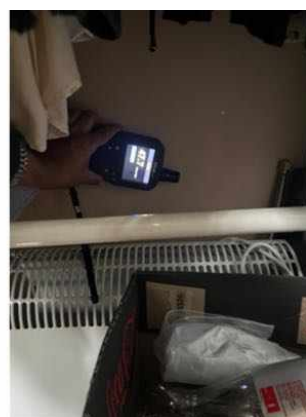
Finding 3.02

Building:	Main Building
Location:	Bathroom
Finding:	Elevated Moisture Bathroom & Back of shower (Further investigation recommended)
Information:	Elevated moisture levels were detected to tiled surfaces in bathroom/shower areas. This may be due to porous or missing grout, cracked tiles or recent use, however the possibility of waterproofing membrane failure or plumbing leaks cannot be excluded. Persistent moisture ingress can lead to concealed damage, including timber rot and mould growth.

Further investigation by a licensed plumber and/or waterproofing contractor is recommended as soon as possible. The back of shower area also showed elevated moisture but no visible deterioration was evident at the time of inspection.

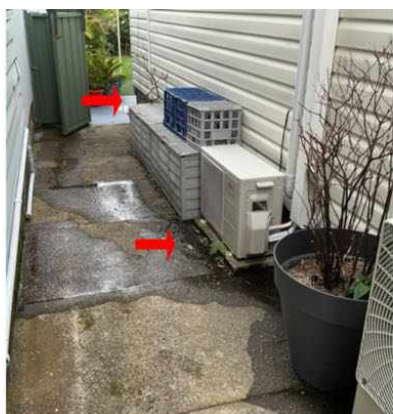
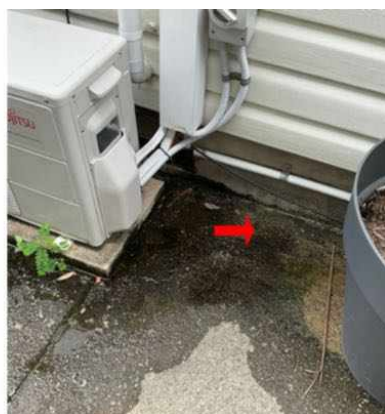
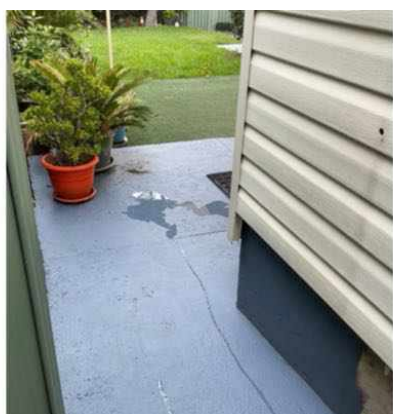
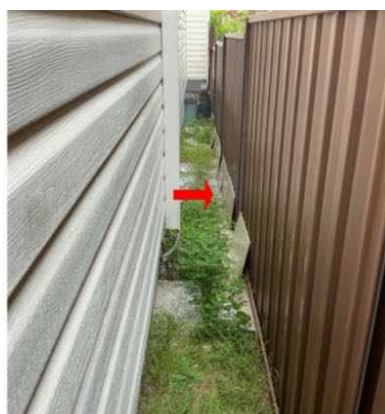
Finding 3.03

Building:	Main Building
Location:	All External Areas
Finding:	Site drainage - Inadequate
Information:	The site drainage in this area was found to be inadequate at the time of inspection, creating potential for subsequent water damage to associated building elements.

It is important that water does not lie against the base of walls; surrounding paths and ground levels should be sloped to drain water away from walls. Downpipes should not discharge stormwater onto lower walls or plinths. Stormwater should be carried away by large, regularly cleaned drains. Ground levels may need to be lowered to expose a buried DPC.

Where site drainage is inadequate, installation of an Agricultural (Aggie) Drain may be required. A qualified plumber should be appointed to further inspect the property and perform any remedial works as necessary. Water damage and secondary defects are likely to occur if left unmanaged.

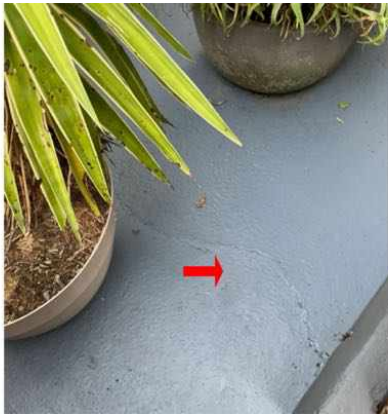
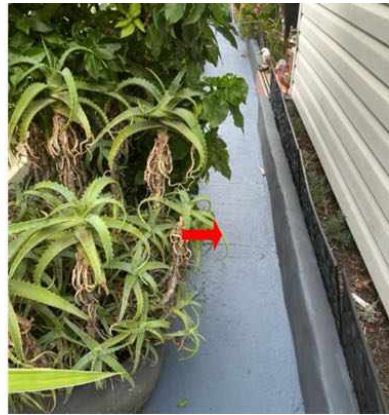
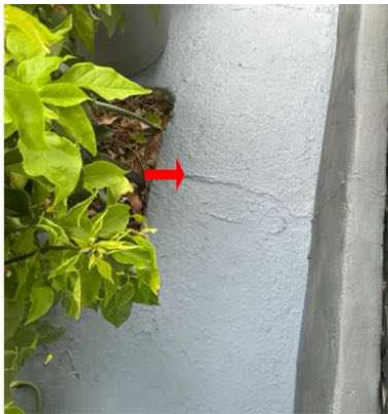
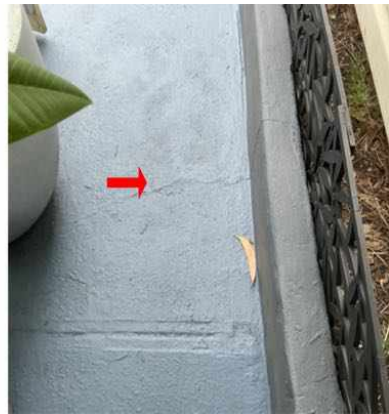
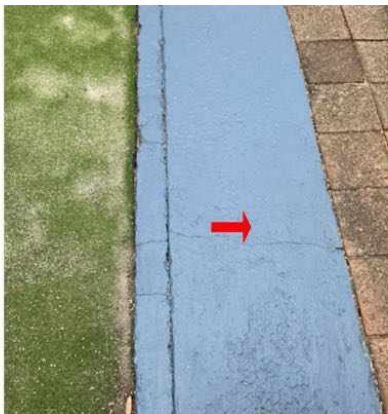
Building:	Main Building
Location:	All External Areas
Finding:	Cracking - External Concrete Paving Damage Category 2 - Distinct (less than 3mm)
Information:	Distinct cracks were identified in external concrete paving. Distinct cracks are generally found in older concrete paving, and may also present as a trip hazard as consequence of an uneven or curved surface.

General age and expected deterioration of the paved areas is a common cause of this type of cracking. However, expansion and contraction of the slab may also have occurred due to environmental factors. Such factors include variable moisture and weather conditions, the presence of trees and their roots having a settling or lifting affect on the soil, or the effect of load bearing, e.g. heavy vehicles over a sustained period of time.

Cracking to this degree may also be due to poor original installation of the concrete. Factors such as poor compaction of the sub surface and/or inadequate reinforcing of the slab may create cracking and other secondary defects.

Repairs are likely to be required to prevent further cracking and to reduce hazards

associated with cracking, such as tripping. Monitoring of all cracking should be conducted frequently. Always contact a building inspector should cracks widen, lengthen, or become more numerous.

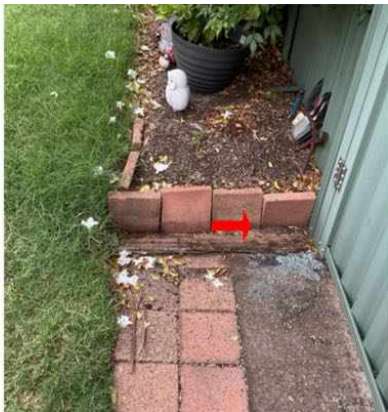
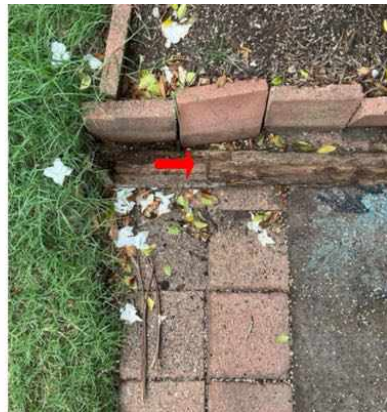
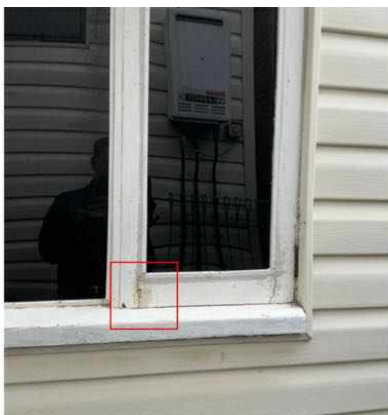
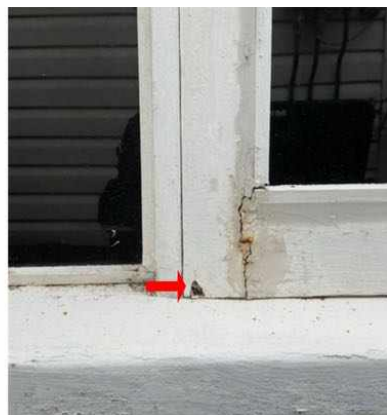
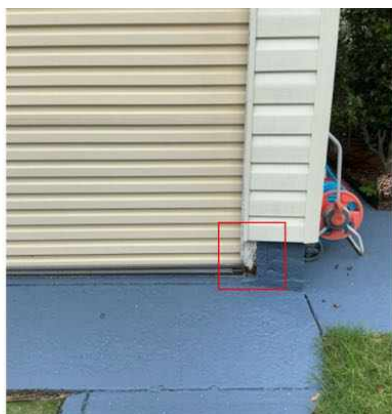
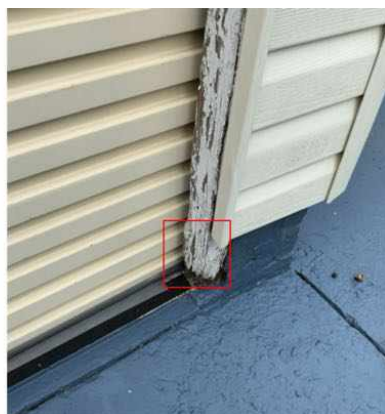
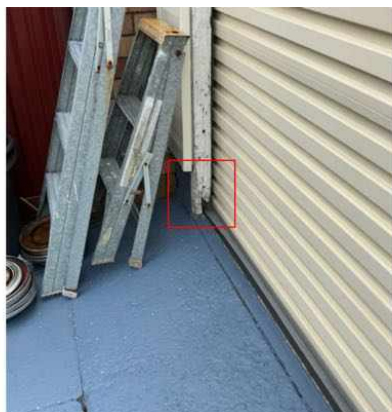
Finding 3.06

Building:	Main Building
Location:	All External Areas
Finding:	Wood rot to some areas
Information:	This building element shows evidence of wood rot. Wood rot, also known as Fungal Decay, occurs when timbers and other cellulose building materials are exposed to damp conditions on an ongoing basis. This could be the result of exposure to

weathering over a prolonged period of time, or the attraction of excessive moisture from other abutting building materials. Contributing factors also include poor air ventilation in the area.

A qualified plumber may be appointed to assess the cause of excessive moisture and to provide advice on any remedial works as required. A qualified carpenter or registered builder may also be required to replace affected building materials.

Even though Liverpool termite activity was not visible. A further invasive inspection by a licensed termite technician its also highly recommended to eliminate possibility of potential termite activity.

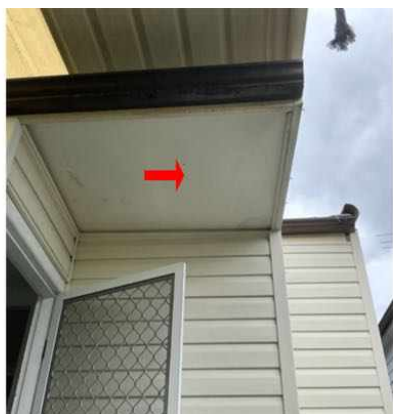
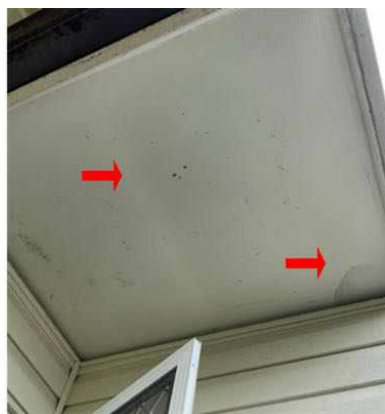
Finding 3.07

Building:	Main Building
Location:	All External Areas - Rear
Finding:	Water staining
Information:	Water staining was evident in this area at the time of inspection. Water staining indicates that surfaces have been exposed to excessive moisture over time. The minerals and other elements in the water lead to staining, which may graduate to corrosion and deterioration if left unmanaged.

Where water staining is active, a licensed plumber must be consulted to identify the cause of the staining and to provide advice on any reparation works that may be required. Replacement of any broken or damaged structures is advised.

Conversely, where water staining is old and inactive, affected building materials may be repaired or replaced at client discretion. A qualified carpenter or registered builder may be appointed to perform these works.

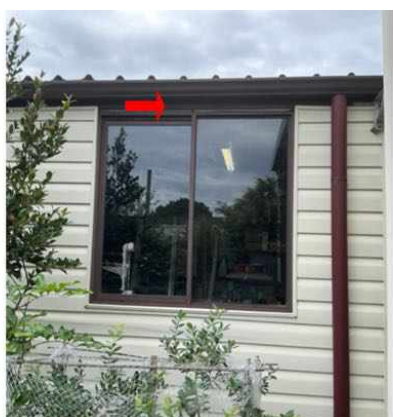
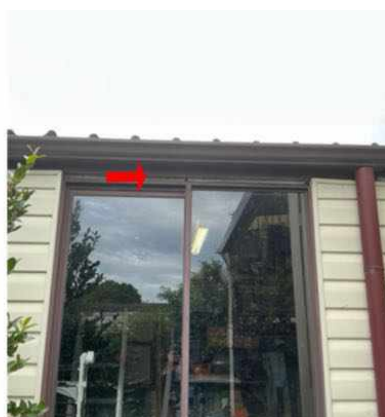
Finding 3.08

Building:	Main Building
Location:	All External Areas
Finding:	Gap Between Window Frame and Masonry to some areas
Information:	A visible gap is present between the external window frame and the adjacent masonry wall. This gap may allow water ingress, air infiltration, and potential pest entry if not adequately sealed. Over time, such exposure can contribute to frame deterioration, internal water damage, or reduced thermal performance. Sealing or filling the gap with a suitable weatherproof compound is recommended to maintain the integrity of the building envelope, in accordance with good building practice and AS 4349.1

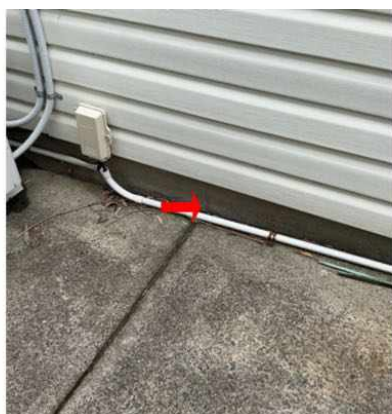
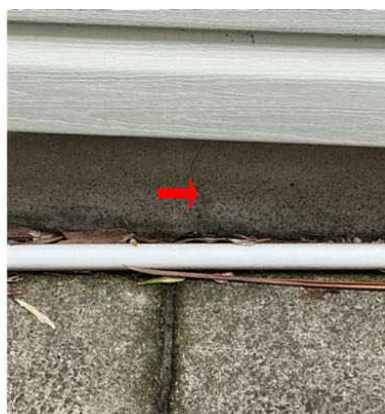
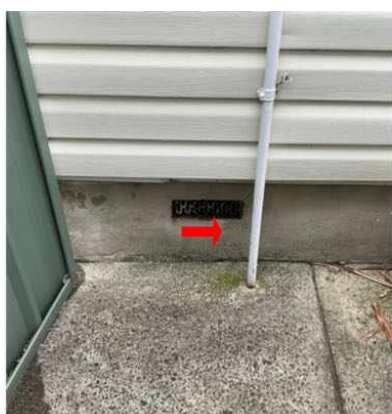
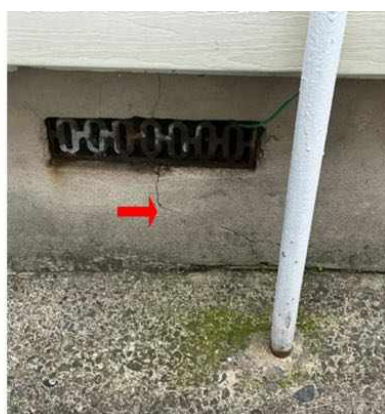
Building:	Main Building
Location:	All External Areas
Finding:	Cracks to render - Category 1 to some areas
Information:	It has been observed that cracking to rendered surfaces has occurred. The degree of damage falls within Category 1, described as fine cracks that do not need repair and which are less than 1.0mm in width limit.

Damage of this category is not considered a defect for rectification. Always contact your building inspector should cracks widen, lengthen, or become more numerous.

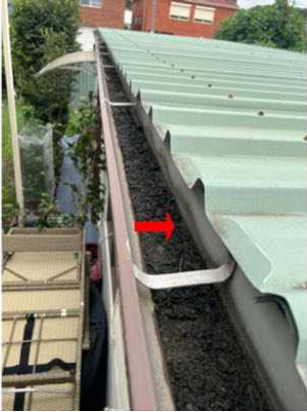
Finding 3.10

Building:	Main Building
Location:	All External Areas
Finding:	Gutters - Blocked to some areas
Information:	Roof plumbing structures, such as guttering and downpipes, should be free of all debris to prevent blockages. Blockages of the guttering and downpipes will lead to pooling and accumulated water overflows, which is likely to subsequently flood eaves and exterior walls.

Blocked gutters are likely to lead to high levels of moisture in the affected areas. Such moisture will not only cause rust and decay of the associated building materials, but can also provide conditions that are conducive to termite and timber pest activity. Blockages in gutters should therefore be removed immediately to ensure dry conditions are maintained.

Consult a Licensed Plumber for further specific advice on remedial works that may be required. In the interim, it is highly advised that blocked gutters be removed by the homeowner or a general handyperson as a matter of urgency.

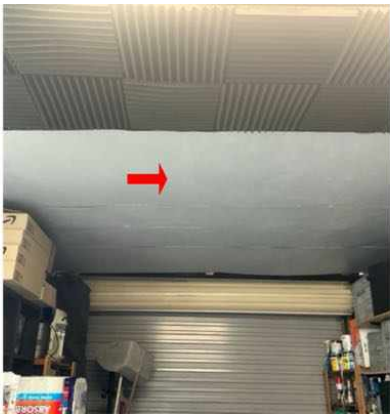
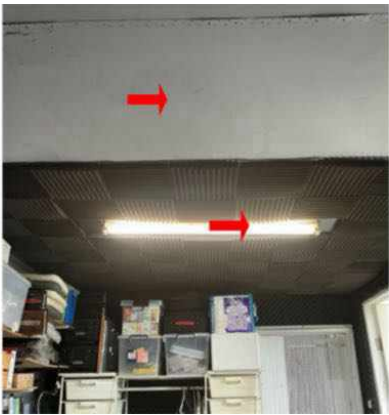
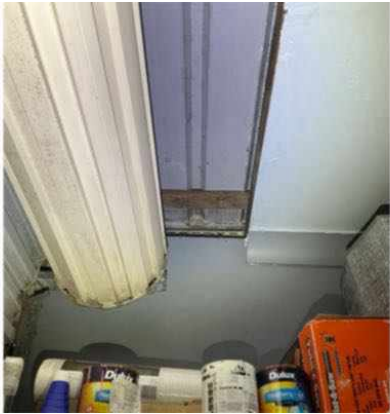
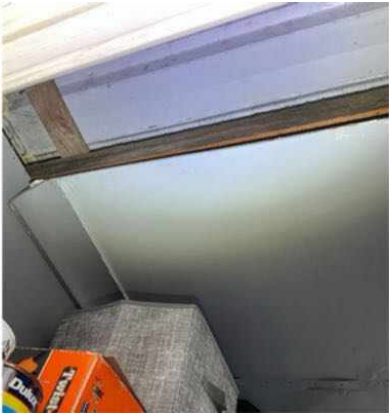
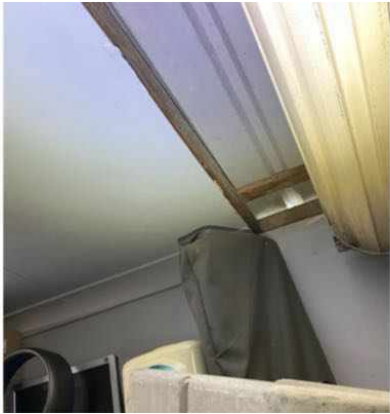
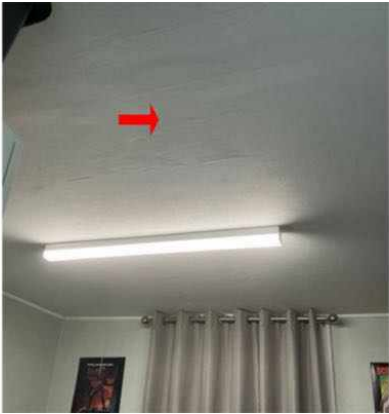
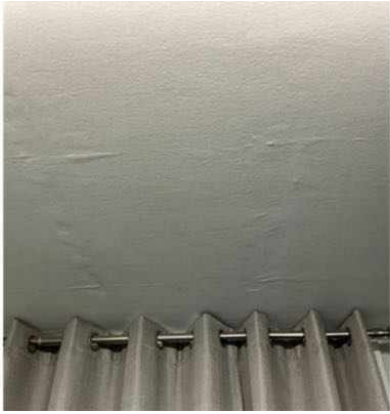
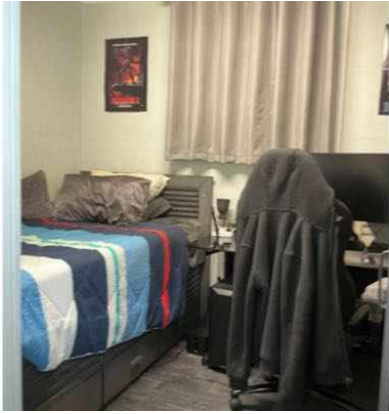
Finding 3.11

Building:	Main Building
Location:	All External Areas - Rear Garage
Finding:	Incomplete or substandard works - Poor workmanship - ceiling and wall paper
Information:	The works to this area appear to be incomplete or have been completed to a substandard level.

Works that have not been completed to a satisfactory level create potential for the development of building defects and may impede on the safety and integrity of the overall structure.

It is highly recommended that the relevant trades be appointed to complete these works and ensure the safety of the area and the longevity of all associated building elements.

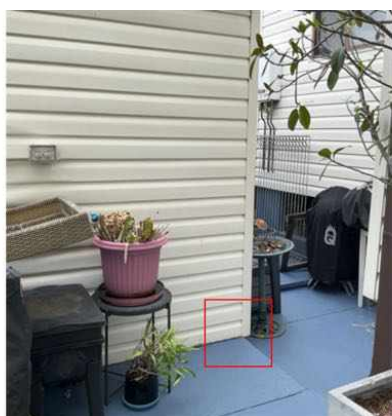
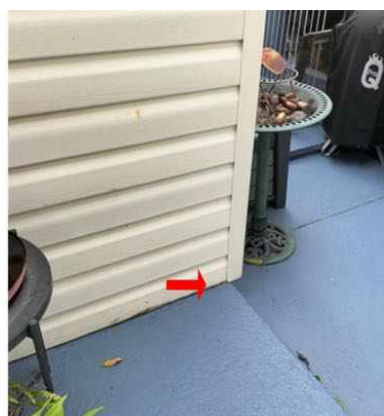
Finding 3.12

Building:	Main Building
Location:	All External Areas - Rear
Finding:	External Slab-to-Cladding– Moisture Bridging Risk
Information:	The external concrete path/apron appears to be finished hard against the wall cladding with minimal or no visible clearance at the base. This configuration may allow moisture bridging and capillary transfer to the lower wall elements, particularly during heavy rainfall or ponding events, and can contribute to deterioration of sealants, coatings, and lower cladding edges over time. While no active water ingress was observed at the time of inspection, the detailing limits drainage and drying at the wall base. Ongoing monitoring and maintenance of joints and clearances is recommended to reduce long-term moisture-related risks.

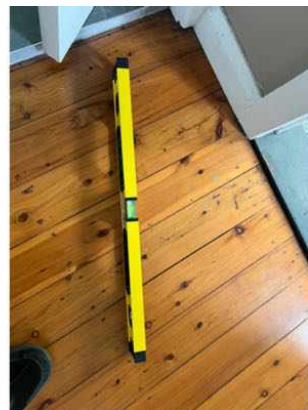
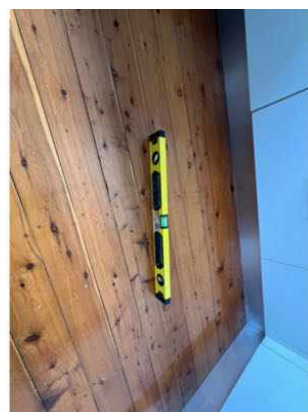
Finding 3.13

Building:	Main Building
Location:	All Internal Areas
Finding:	Flooring - Uneven to some areas
Information:	The internal flooring in this area is out of level and uneven. Uneven flooring is likely to indicate minor defects such as expected movement of the foundations of the property, but may also indicate subsidence of the associated subfloor stumps.

It is advised that the flooring be closely monitored to identify any further movement. Where flooring remains relatively unchanged for an extended period of time (i.e. several months), it is likely that this defect has been caused by expected movement of the foundations of the property.

However, where flooring is uneven further, potentially invasive inspection of the subfloor structures and stumps in this area is required. In this case, works to repair are likely to be required, and would be carried out by a registered builder specialising in re-stumping.

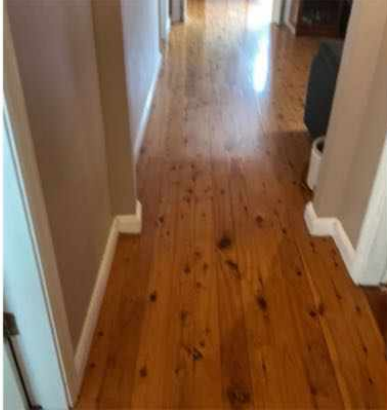
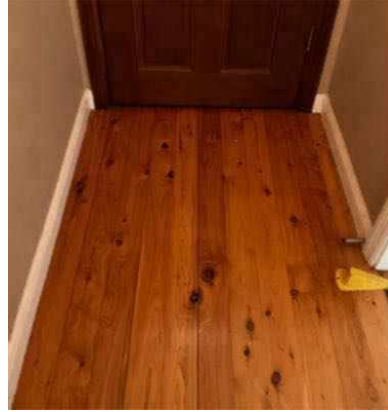
Finding 3.14

Building:	Main Building
Location:	All Internal Areas
Finding:	Floors - bouncy
Information:	The internal flooring in this area was identified as being bouncy at the time of inspection. A bouncy floor surface generally presents as a discernible change in level as they are walked across, in noisy or creaking flooring, or in consequent movement of surrounding furniture and fixtures.

Bouncy floors generally indicate that the floorboards or the subfloor structures are coming loose from the joists that they are installed on. Bouncy flooring may also be the result of gaps between flooring and stumps or joist structures, which require packing.

The client is advised to seek quotations for required repairs from a Registered Builder specialising in re-stumping. The potential resolution may range from packing gaps in subfloor structures through to replacement of subfloors stumps and refixing of flooring.

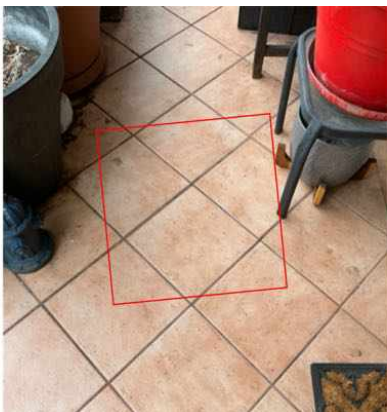
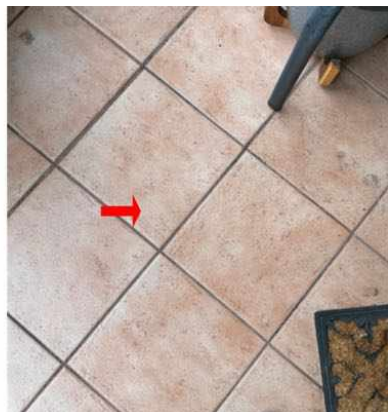
Finding 3.15

Building:	Main Building
Location:	All External Areas - Front
Finding:	Tiles - Cracked or damaged
Information:	Cracking was evident to the tiling in this area at the time of inspection. While the cracking appears to be minor, this area is frequently exposed to water, allowing potential for water penetration into adjoining sections of walls or flooring.

If left unmanaged, water penetration to these areas may lead to subsequent water damage, which is likely necessitate repair work to affected building elements.

A tiling contractor should be appointed to ensure that no further water damage occurs. The re-application of silicone and grouting throughout remaining tile work is also advised, to further protect the area against water penetration.

Where water penetration has led to water damage, appointment of a relevant tradesperson may be required to repair damaged building elements.

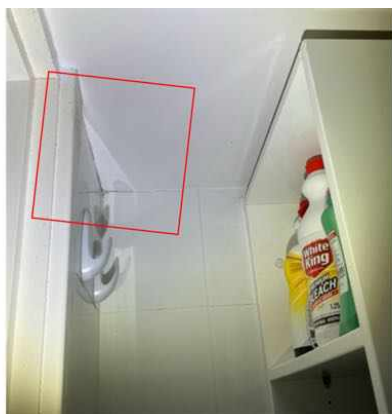
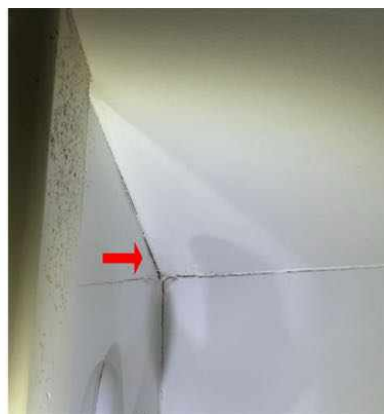
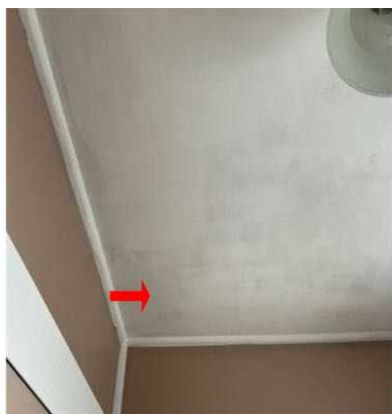
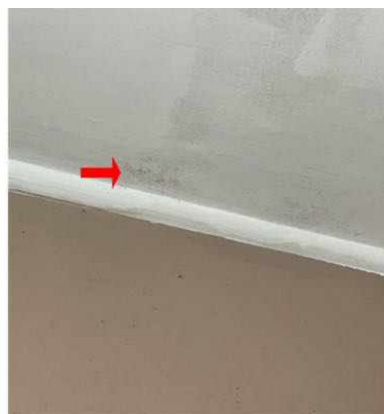
Finding 3.16

Building:	Main Building
Location:	Laundry , WC
Finding:	Water Staining - Humidity or Ventilation
Information:	The ceiling surface shows faint darkened spotting or shadowing, commonly consistent with surface mould or humidity-related staining, often found in bathroom or wet area ceilings with insufficient ventilation. While there is no visible sagging or major water damage, the pattern suggests prolonged moisture exposure, possibly due to steam accumulation or minor condensation issues. According to AS 4349.1–2007 (Appendix C), this would be classified as a minor defect unless further deterioration or active leaks are found. Recommend improving mechanical or natural ventilation, cleaning the surface with mould treatment, and monitoring for recurrence.

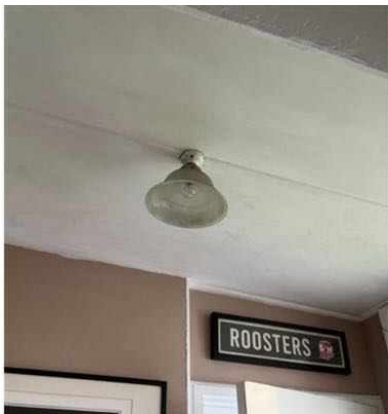
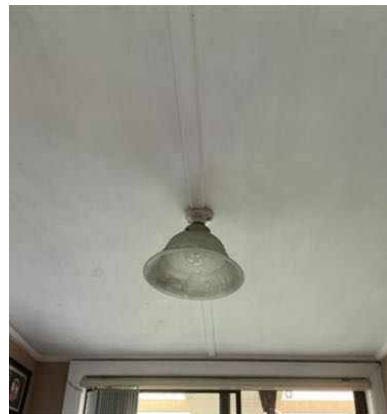
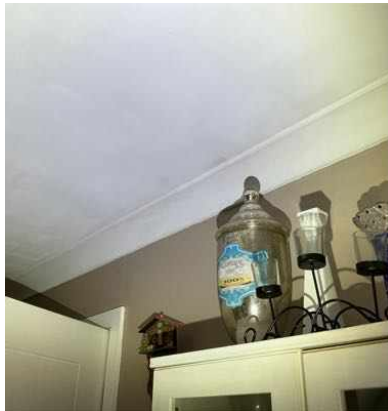
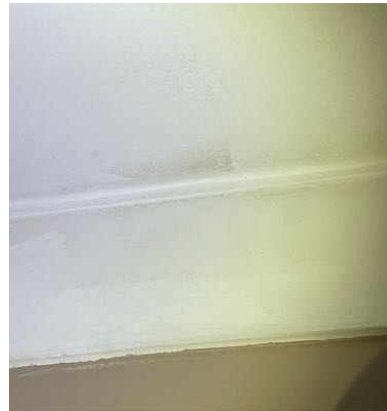
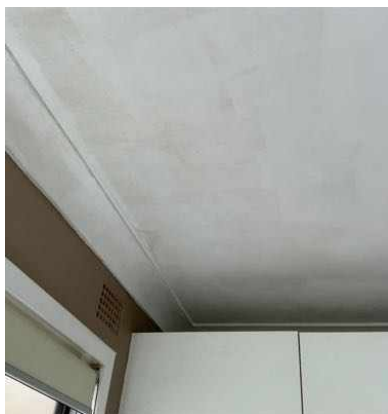
Finding 3.17

Building:	Main Building
Location:	All Internal Areas - Rear, kitchen
Finding:	Water staining
Information:	Water staining was evident in this area at the time of inspection. Water staining indicates that surfaces have been exposed to excessive moisture over time. The minerals and other elements in the water lead to staining, which may graduate to

corrosion and deterioration if left unmanaged.

While mostly an appearance defect, water staining can be indicative of more serious defects, which may be currently concealed by other building elements.

Where water staining is active, a licensed plumber must be consulted to identify the cause of the staining and to provide advice on any reparation works that may be required. Replacement of any broken or damaged structures is advised.

Conversely, where water staining is old and inactive, affected building materials may be repaired or replaced at client discretion. A qualified carpenter or registered builder may be appointed to perform these works.

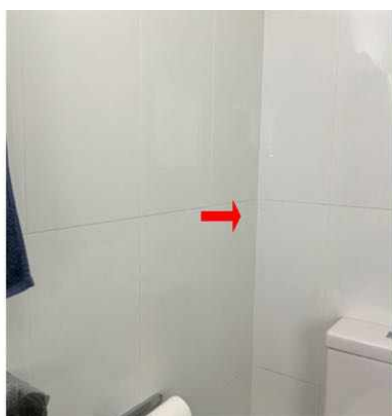
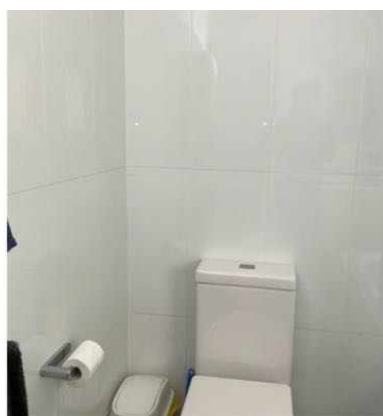
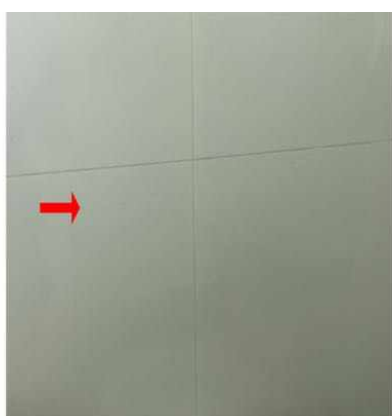
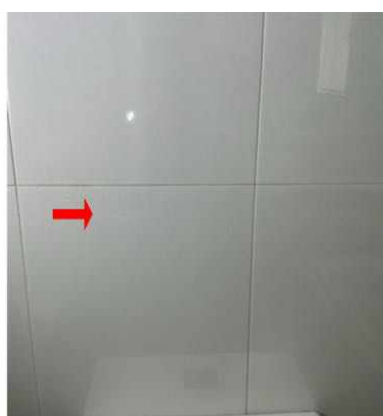
Finding 3.18

Finding: Tiles - Cracked or damaged

Information: Cracking was evident to the tiling in this area at the time of inspection. While the cracking appears to be minor, this area is frequently exposed to water, allowing potential for water penetration into adjoining sections of walls or flooring.

If left unmanaged, water penetration to these areas may lead to subsequent water damage, which is likely necessitate repair work to affected building elements.

A tiling contractor should be appointed to ensure that no further water damage occurs. The re-application of silicone and grouting throughout remaining tile work is also advised, to further protect the area against water penetration.

Where water penetration has led to water damage, appointment of a relevant tradesperson may be required to repair damaged building elements.

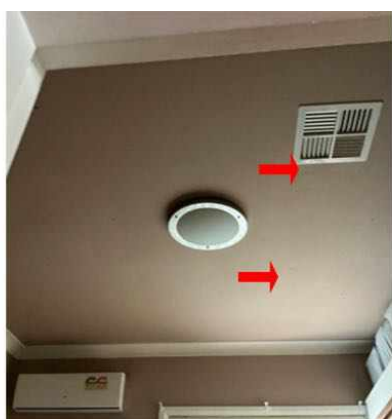
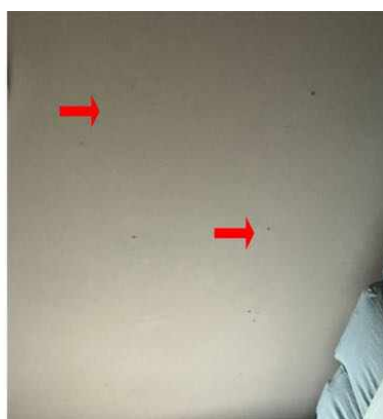
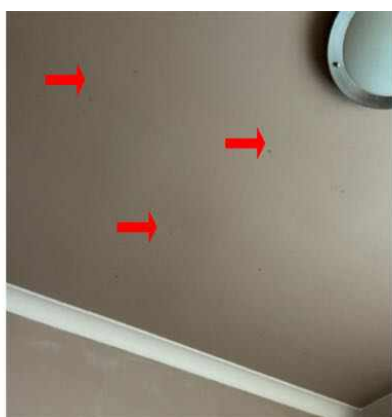
Finding 3.19

Finding: Ceiling nails - Popping To some areas
Information: Numerous popped nails were identified in the internal ceiling at the time of inspection. Nails and screws hold simply by the friction between them and the surface they are applied to. Over time, the nails and screws can back out, which is often a result of general ageing and deterioration of the building structure.

If left unmanaged, the ceiling sheets may become loose and unstable, increasing the rate of deterioration of the internal ceiling and creating potential for the development of secondary defects.

Re-fastening of popped nails will help to maintain the stability of the internal ceiling and associated building elements. Such minor works will also help to improve the appearance of the affected area and secure the ceiling sheets, so as to prevent the onset of ceiling sagging. These works should be performed by a qualified carpenter or plasterer at client discretion.

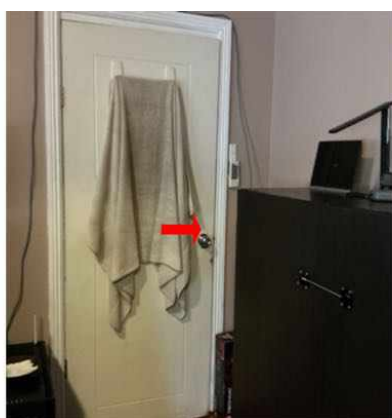
Finding 3.20

Building: Main Building
Location: All Internal Areas - Bedroom front
Finding: Doors - Binding/Jamming
Information: Binding and/or jamming of several doors throughout the property were evident during standard operation. This defect inhibits the functionality of affected doors as well as

creating potential for secondary defects to associated building elements, such as damage to the floor covering.

A door that binds to flooring or to the associated door frame may have several causes, ranging from minor defects, such as poor installation of the door or deteriorated hinges, through to major structural issues, such as damage to subfloor structures.

Where door binding/jamming appears to indicate major structural issues, a registered builder specialising in re-stumping should be appointed to provide an estimate on the cost of rectification.

For minor causes, a qualified carpenter or general handyman should be appointed to perform minor rectification works at client discretion.

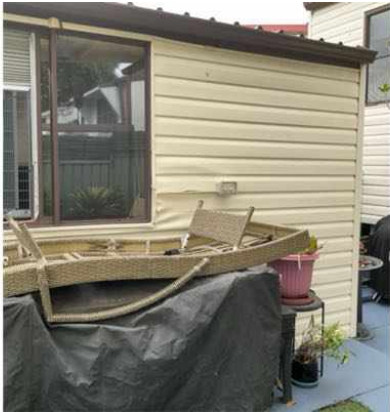
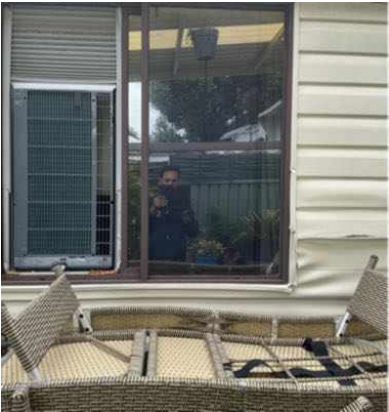
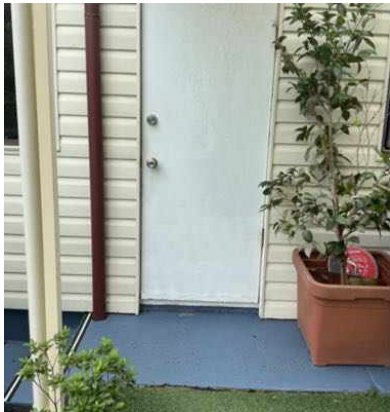
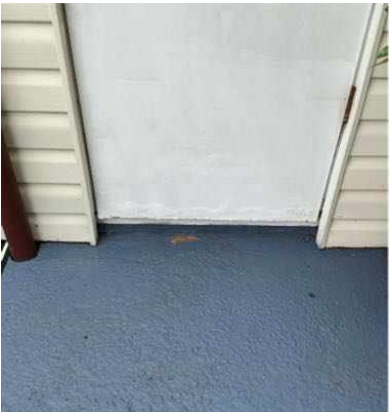
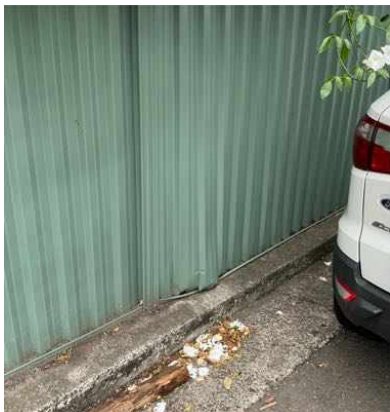
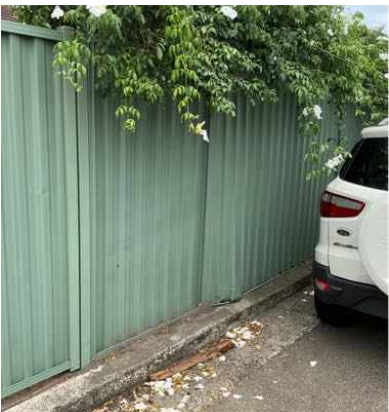
Finding 3.22

Building:	Main Building
Location:	All External Areas
Finding:	Building element - Damaged - Cladding moisture damaged rear shed , door moisture damaged shed rear , fence damaged
Information:	Breakage occurs generally when the building materials have either aged and decayed, or as a result of damage (accidental or deliberate).

Repair and/or replacement of broken elements is advised to ensure that additional secondary defects do not arise as a consequence. Such works are necessary, as all building elements play a key role in the operation and function of the overall structure and its performance.

A relevant tradesperson should be appointed to repair or replace the affected building element prior to any subsequent damage being caused.

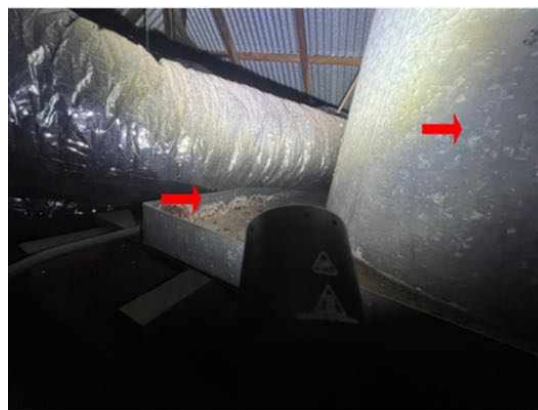
Finding 3.25

Building:	Main Building
Location:	Roof Void
Finding:	HWS - Gravity Fed (rusted)
Information:	A galvanised hot water storage tank is present in the roof void. Tanks of this type are typically part of older gravity-fed systems, many of which have since been decommissioned when properties were upgraded to mains pressure hot water. A licensed plumber should access whether the tank and advise on decommissioning or upgrading as necessary.

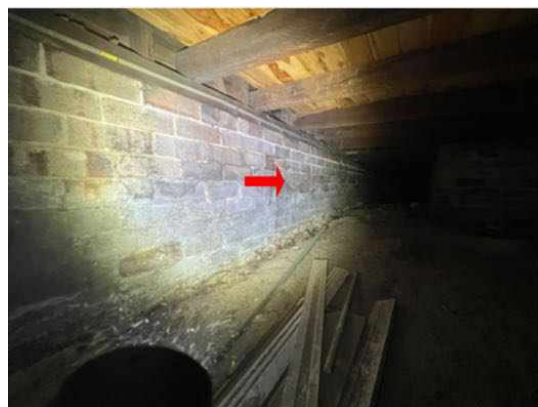
Building:	Main Building
Location:	Subfloor
Finding:	Subfloor Moisture and Efflorescence
Information:	efflorescence and visible damp staining were observed along the lower brickwork within the subfloor, indicating active or historic rising damp.

The presence of salt deposits and discolouration suggests that moisture is migrating through the masonry via capillary action, likely due to inadequate subfloor drainage or ventilation.

These conditions may contribute to further degradation of mortar joints, promote mould growth, and increase the risk of timber pest activity if left unaddressed. The area should be further assessed by a damp remediation specialist, and improvements to subfloor ventilation and moisture control are recommended. A further invasive timber pest inspection is recommended to check for any concealed activity.

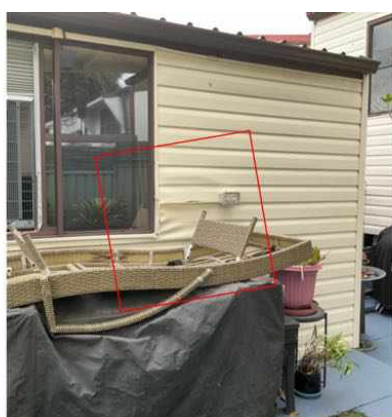
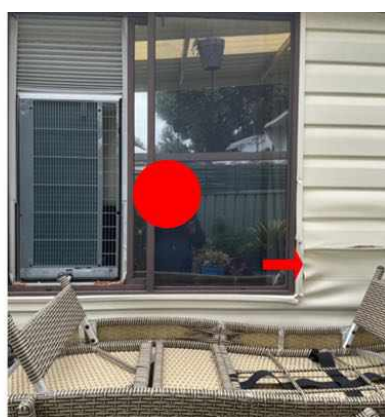
Building:	Main Building
Location:	All External Areas
Finding:	Building element - Damaged - damage weatherboards shed
Information:	Breakage occurs generally when the building materials have either aged and decayed, or as a result of damage (accidental or deliberate).

Repair and/or replacement of broken elements is advised to ensure that additional secondary defects do not arise as a consequence. Such works are necessary, as all building elements play a key role in the operation and function of the overall structure and its performance.

A relevant tradesperson should be appointed to repair or replace the affected building element prior to any subsequent damage being caused.

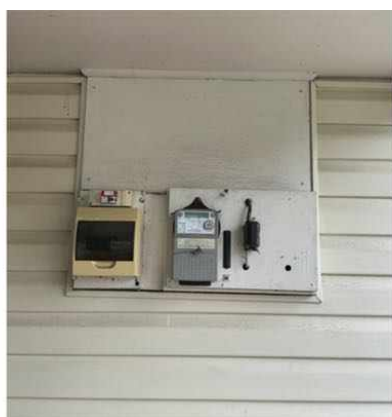
Building:	Main Building
Location:	All External Areas
Finding:	Termite Management System - no evidence of a chemical installation
Information:	The application of a post-construction chemical termite barrier is highly recommended for all properties, particularly if live termite activity has been found on the site previously. Such barriers are highly effective in preventing termite attack on any timber building elements throughout the property.

A durable notice should be placed in the switchboard unit to indicate current termite barriers. At the time of inspection, it appeared as though no termite management system has been installed, with no evidence to suggest preventative works taking place.

The client may consider gaining further advice from a pest controller as to the costs and procedures involved with this application. It is recommended that obtaining such advice be a short-term priority.

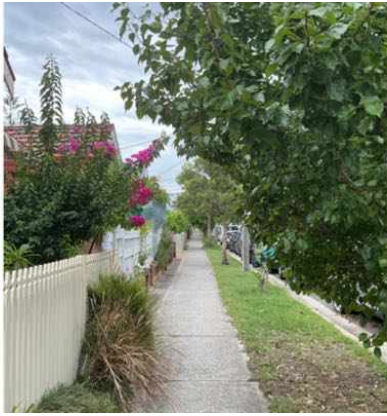
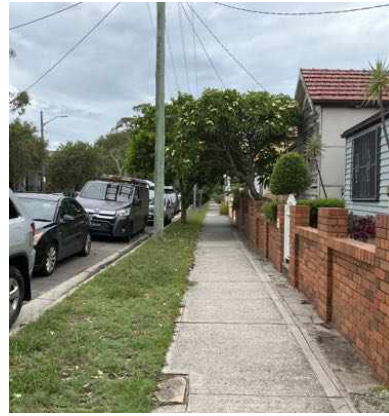
Finding 6.02

Building:	Main Building
Location:	All External Areas
Finding:	Trees within 50m
Information:	Trees within 50m of the property can be conducive to termite activity. It is recommended an invasive inspection of all trees with 50m to the property be carried out by a qualified pest control expert.

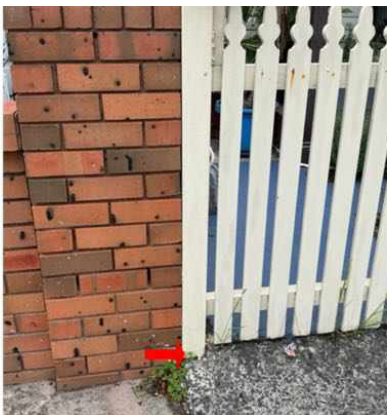
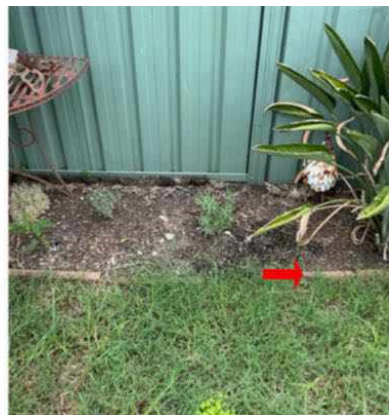
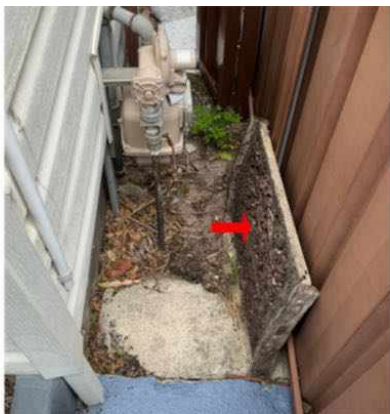
Finding 6.03

Building:	Main Building
Location:	All External Areas, subfloor
Finding:	In ground contact - Timber to some areas
Information:	Any timbers in direct ground contact provide opportunity for concealed termite entry and are likely to be subject to premature rot and decay as the soil retains moisture or damp conditions against the timbers.

Remove untreated timber that is in direct contact with external grounds. Consider replacement with more durable materials i.e. treated timber or non timber elements. Frequent pest inspections are advised to readily identify any termite activity in these areas.

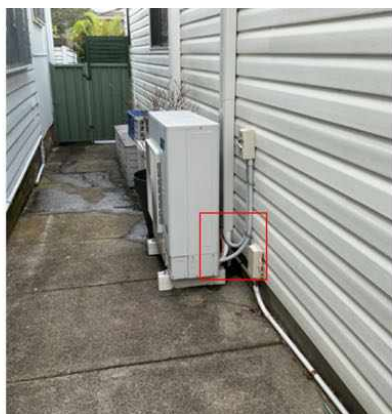
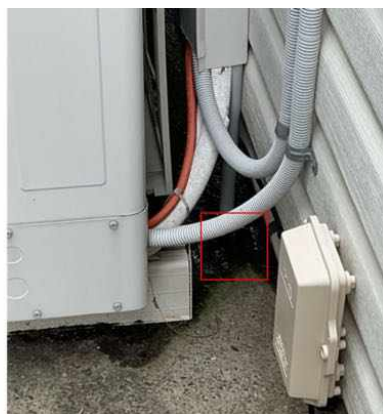
Finding 6.04

Building:	Main Building
Location:	All External Areas
Finding:	Air conditioner - Disconnected overflow
Information:	The Air Conditioner (A/C) overflow was found to be disconnected from storm water drainage and is creating excessive moisture in the surrounding area.

Such leaking creates an environment which is conducive to an array of defects, including water damage to associated building elements and the attraction of termite or timber pest infestation.

It is highly recommended that a licensed plumber be appointed to connect the A/C overflow in order to prevent such an environment from being created. These minor works should be carried out as soon as possible.

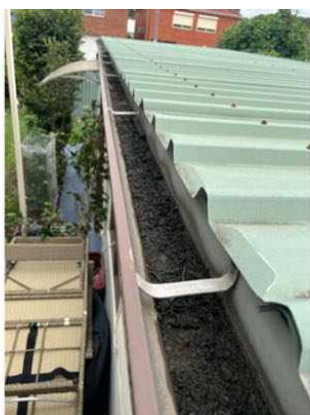
Finding 6.05

Blocked gutters are likely to lead to high levels of moisture in the affected areas. Such moisture will not only cause rust and decay of the associated building materials, but can also provide conditions that are conducive to termite and timber pest activity. Blockages in gutters should therefore be removed immediately to ensure dry conditions are maintained.

Consult a Licensed Plumber for further specific advice on remedial works that may be required. In the interim, it is highly advised that blocked gutters be removed by the homeowner or a general handyperson as a matter of urgency.

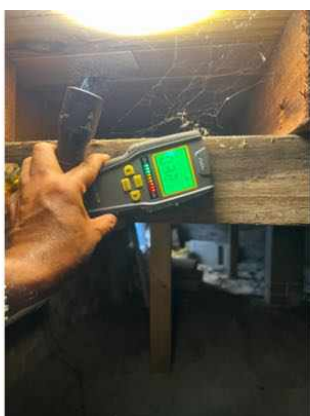
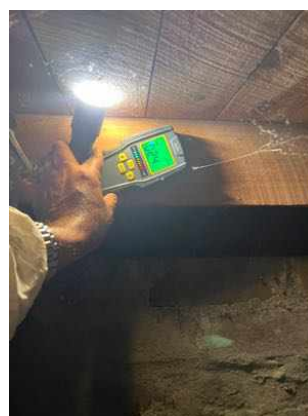
Finding 6.06

Building:	Main Building
Location:	Subfloor
Finding:	Elevated moisture - identified
Information:	Elevated moisture can attract termites and produce conditions that promote fungal growth and wood decay.

Elevated moisture is generally caused by deteriorated, inadequate or missing roof drainage, leaking plumbing pipes or fixtures, poorly plumbed HWS overflows or condenser units and poor site drainage.

If mould growth has been found there may be environmental biological or health issues involved. In these cases an appropriately qualified inspector should also be contacted.

Prior to any remedial works being performed a qualified plumber should be appointed to further inspect the property and to identify the cause of the excessive moisture. Works to remove affected building elements may then be necessary and should be performed by an appropriate tradesperson.
