Building and Timber Pest Inspection Report

Inspection Date: Tue, 3 Mar 2026

Property Address: 270 King St, Mascot NSW 2020, Australia

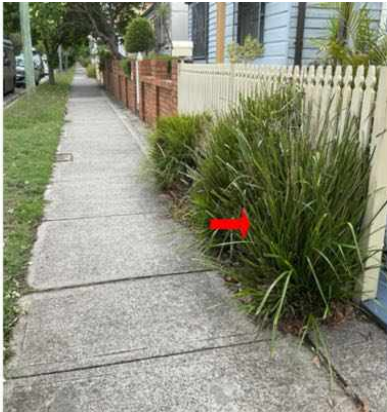
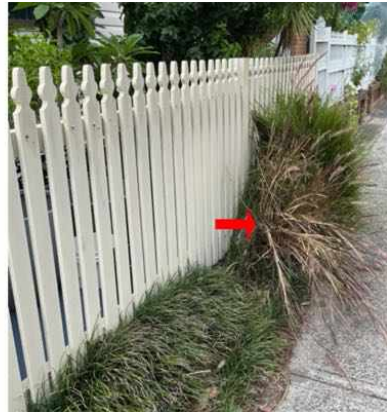
Finding 6.07

Building:	Main Building
Location:	All External Areas
Finding:	Bridging - Vegetation
Information:	Where vegetation obstructs inspection of building elements, also known as bridging as it provides a bridging point for the access of termites, full inspection can not be achieved. Consequently moisture or dampness may be present and the areas becomes conducive to termite activity. Plants against or very close to buildings provide cover, shade and can provide an environment that is attractive to termite infestation.

The removal and replanting of species that do not provide "cover" or cutting back of existing vegetation will assist greatly in preventing Bridging from occurring.

The removal of any such materials that may be conducive to termite activity should be carried out as soon as possible and arrange re inspection to minimize the risk of termite attack.

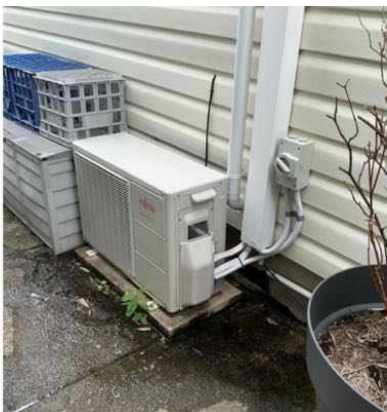
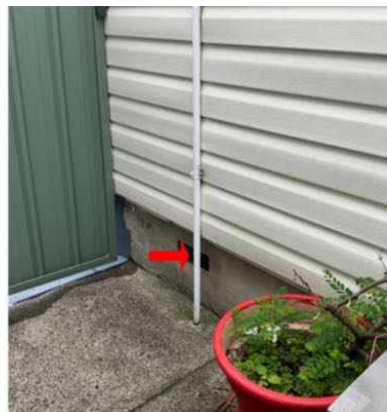
Finding 6.08

Building:	Main Building
Location:	Subfloor
Finding:	Subfloor ventilation - Inadequate
Information:	Adequate subfloor ventilation aids in preventing excessive moisture wood rot and termite activity by ensuring a dry subfloor environment.

Where ventilation is substandard it is usually caused by factors such as failure to install adequate vents during construction subsequent building works or earth and vegetation covering over vents low subfloor clearance and items or debris in the subfloor restricting airflow.

Subfloor ventilation can be improved in most cases by addressing the causes such as exposing subfloor vents installing additional new vents installing mechanical (forced airflow) ventilation and removing debris from the subfloor.

A registered builder should be appointed as soon as possible to perform these works as necessary.

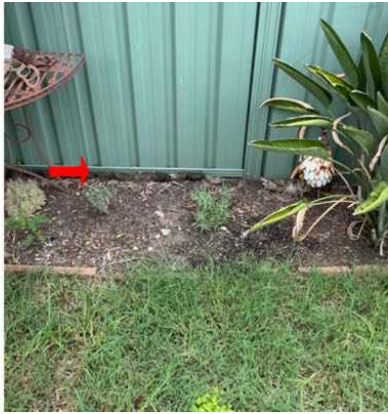
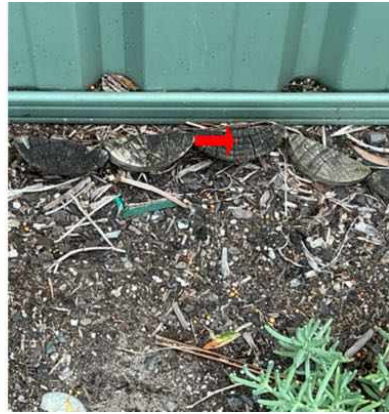
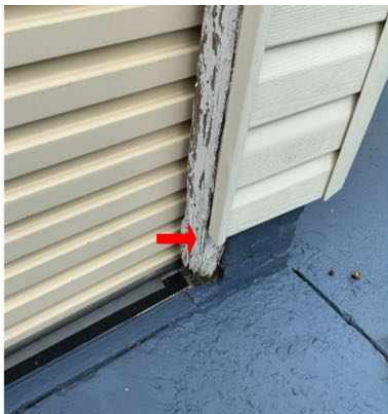
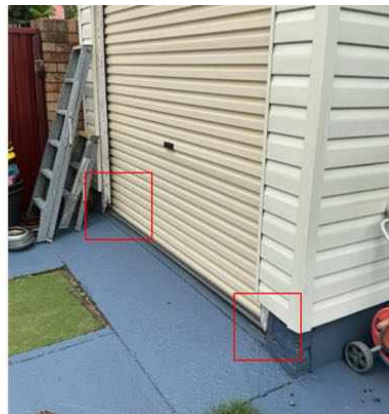
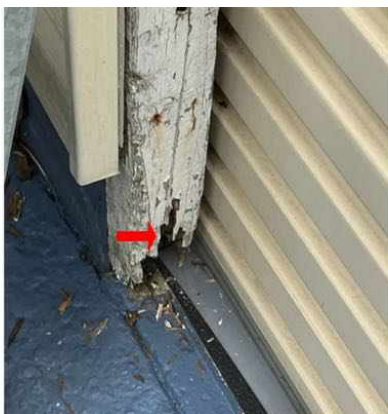
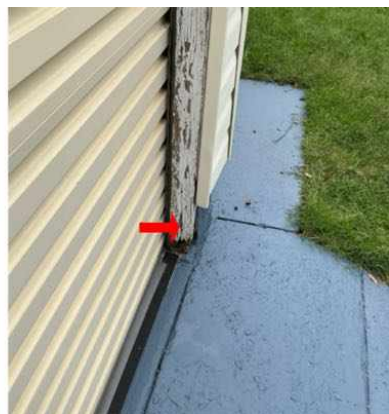
Building:	Main Building
Location:	All External Areas
Finding:	Fungal decay - present to some areas
Information:	Fungal decay also known as wood decay or wood rot generally refers to the deterioration of timber elements when in contact with excessive levels of moisture for a prolonged period of time.

The development of fungal decay is accelerated by temperatures in the range of 5degreeC to 40degreeC as well as the presence of oxygen. Generally fungal decay develops on timber elements that are in use in an external environment which are exposed to rain penetration.

In this case although the affected timber element is in a decaying state the extent of any visible damage appears to be localised to a specific area and is yet to spread to

other parts of the building element or affect adjoining structures. The fungal decay is therefore likely to be of a relatively superficial nature with minimal impact on the structural integrity or tensile strength of the timber element.

A further invasive inspection by a licensed timber pest technician is highly recommended to check for concealed activity.

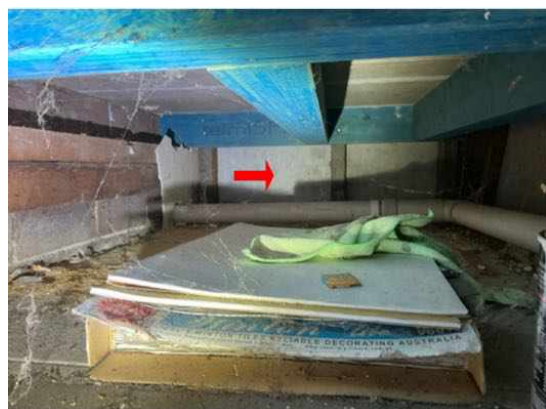
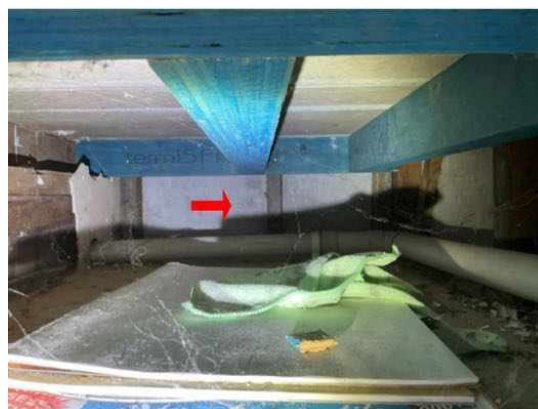
As Asbestos Reporting is outside the scope of this report, we advise that you consider a separate Asbestos Inspection and Condition Audit, which can include the taking of samples for definitive confirmation of the presence of Asbestos.

In the interim, the client is advised to act with caution, especially when considering any damage to building materials general wear and tear renovations extensions demolition and general maintenance activities due to the suspected presence of Asbestos.

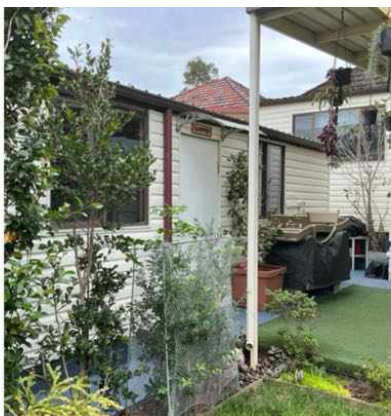
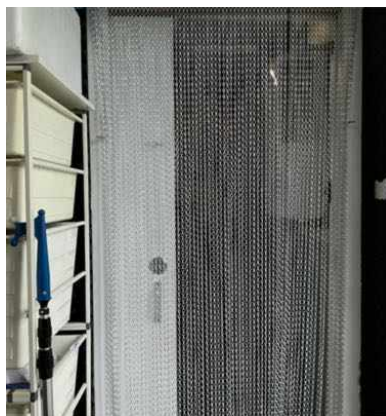
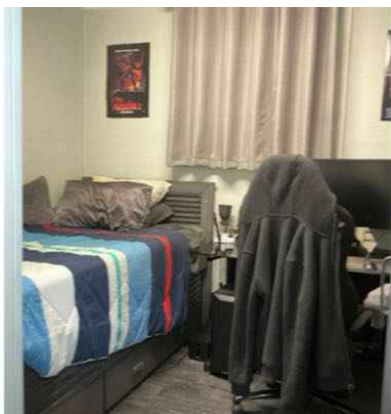
Building:	Main Building
Location:	All External Areas
Finding:	Renovations and refurbishment - Rear shed conversion
Information:	renovations, refurbishments or repairs were observed at the time of inspection. As this is a visual inspection only, the inspector is unable to determine the quality, compliance, or durability of such works where construction details are concealed. No comment can be made on whether these works were undertaken with the appropriate permits, approvals, or by licensed tradespersons. It is recommended that the purchaser seek clarification from the vendor or builder and request relevant documentation such as occupation certificates, warranties, or council approvals to confirm compliance and

workmanship quality.

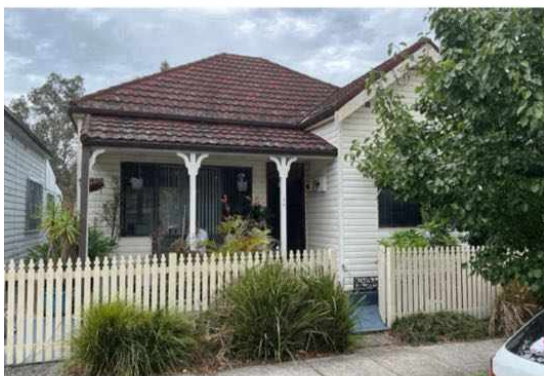
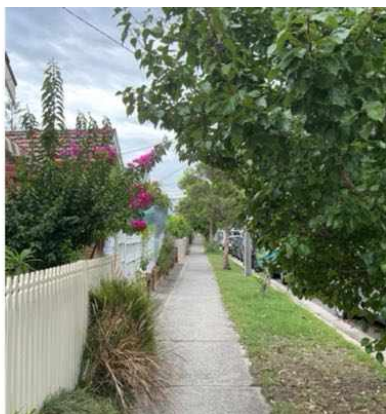
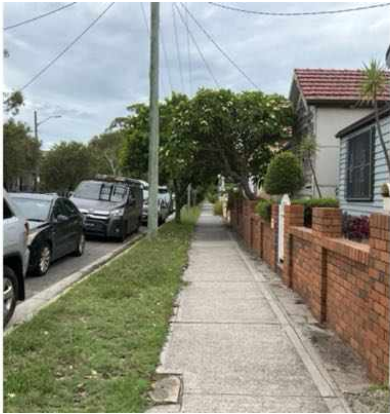
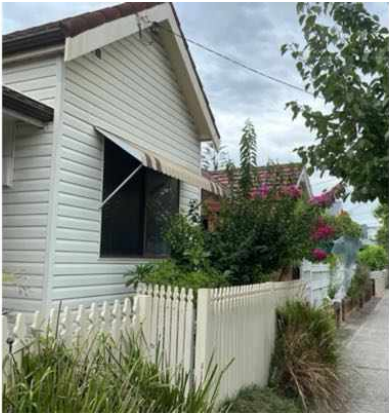
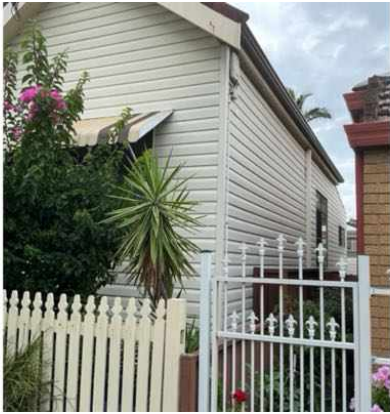
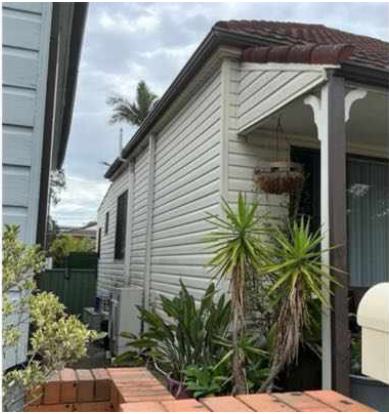
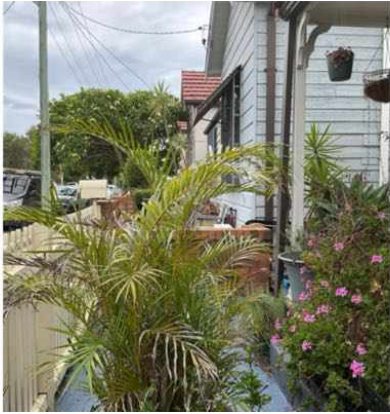
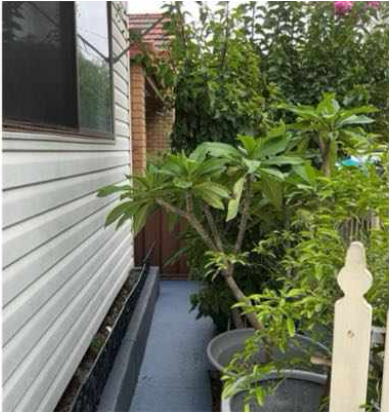
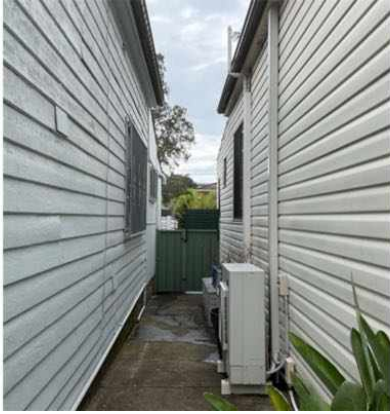
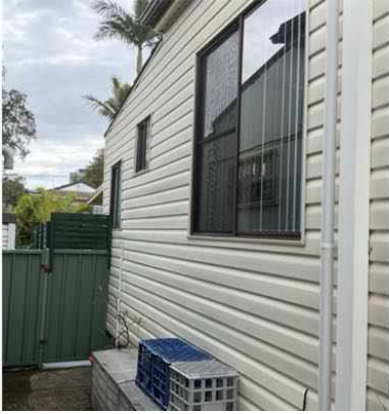
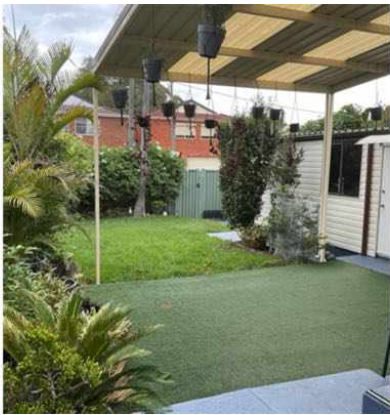
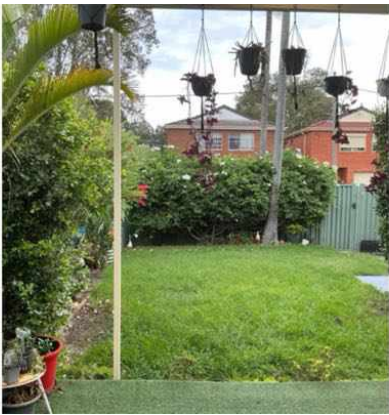
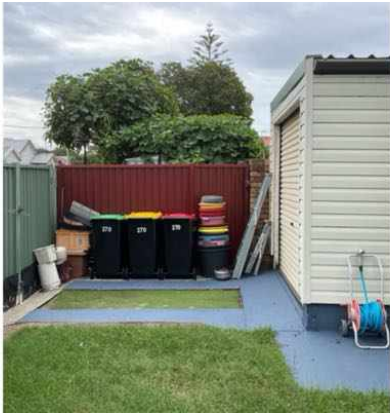
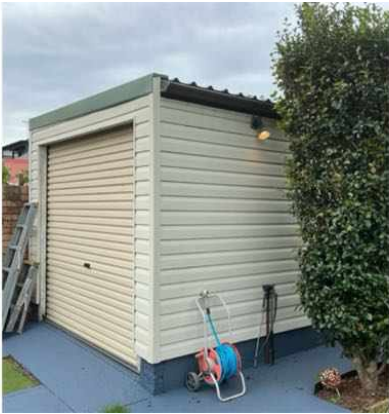
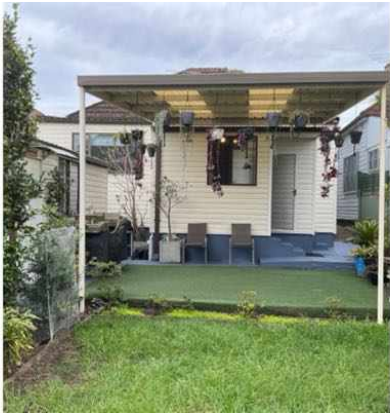
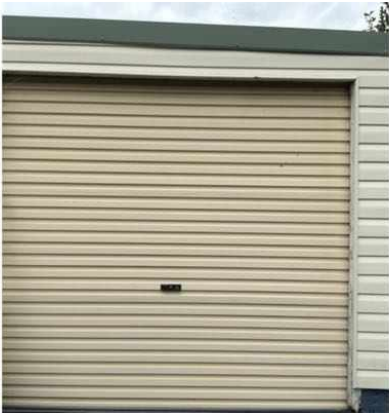
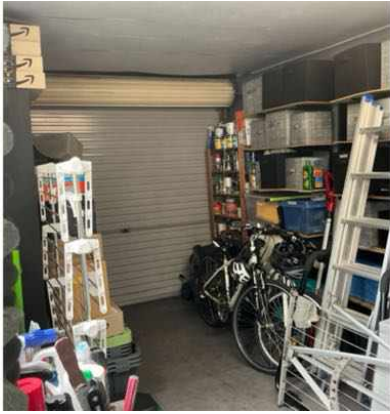
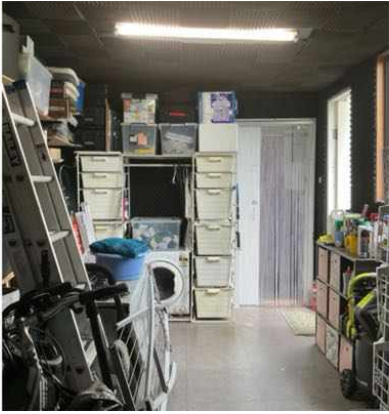
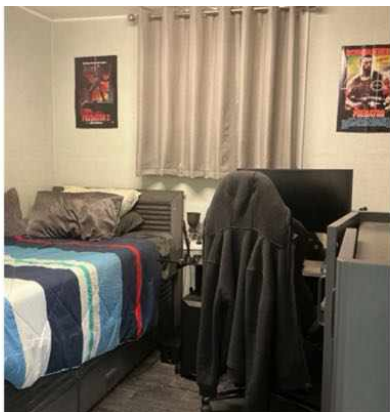
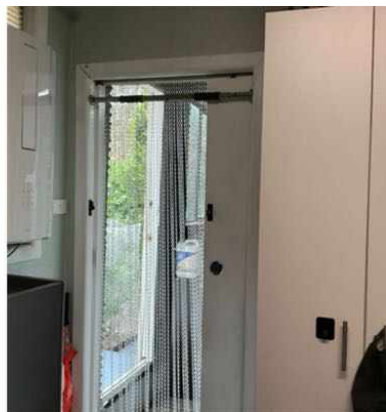
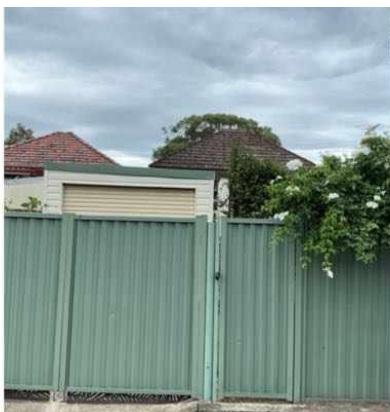
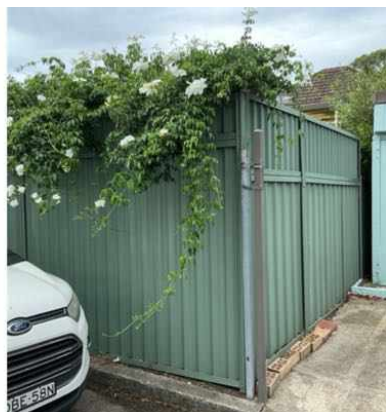
Building: Main Building
Location: All External Areas
Finding: Additional Photos - Obstructions and Limitations
Information: These photographs are an indication of the obstructions and limitations which impeded full inspection of the property at the time of inspection. These obstructions can hide an array of defects and should be removed to allow full inspection to be carried out. A re-inspection is recommended once the areas are made accessible.

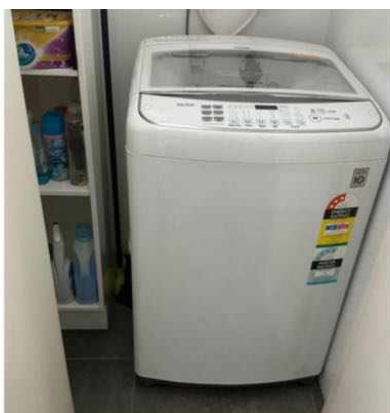
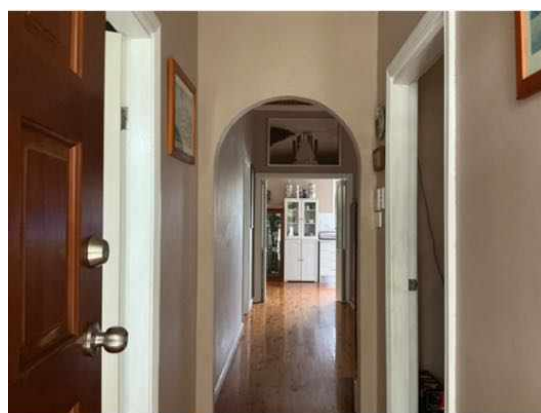
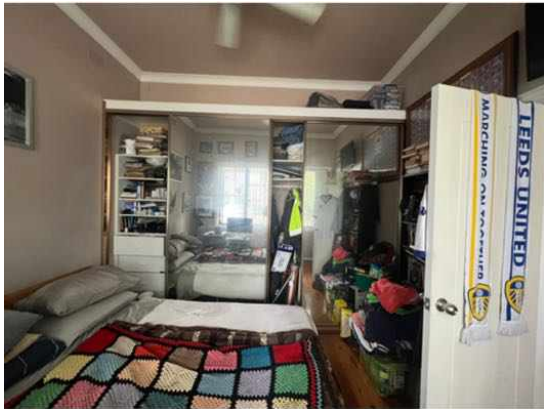
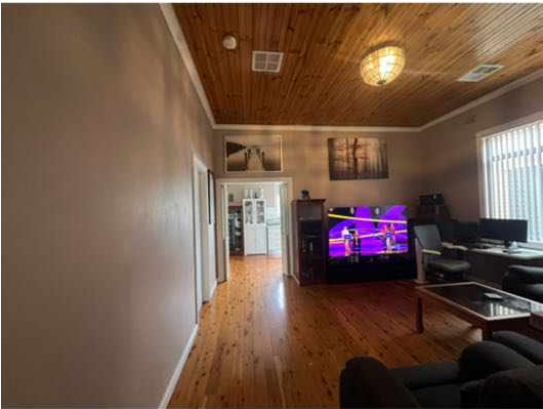
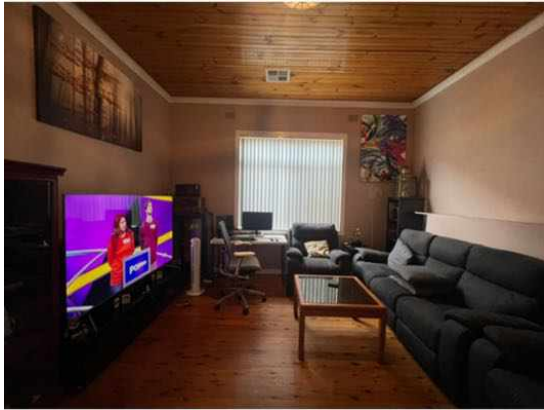
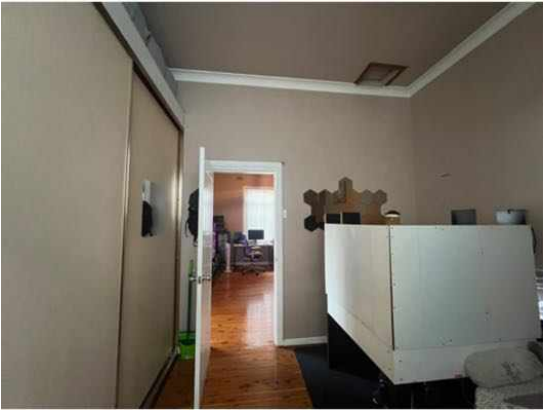
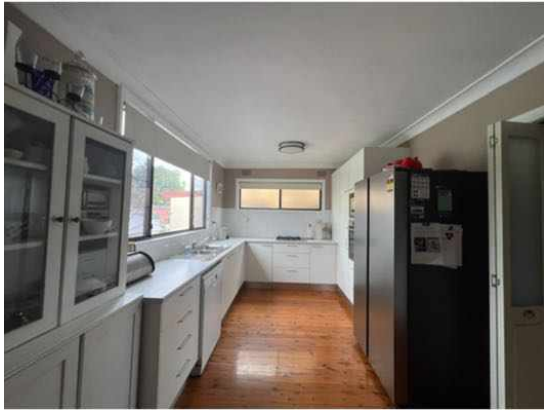
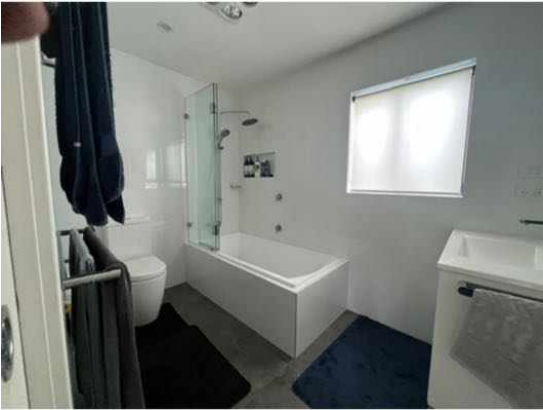
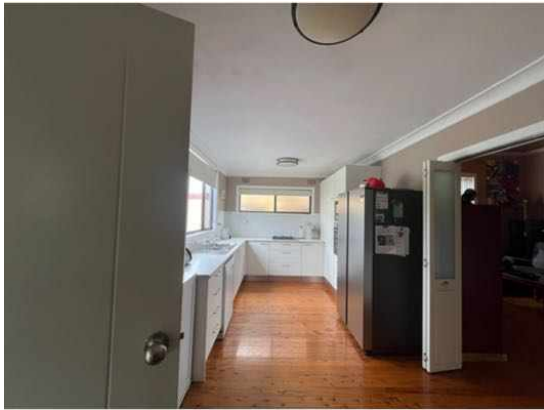
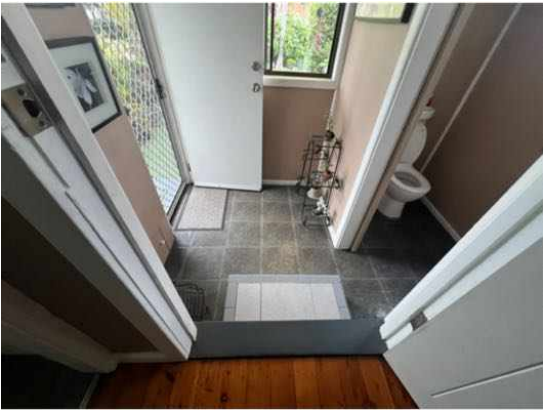
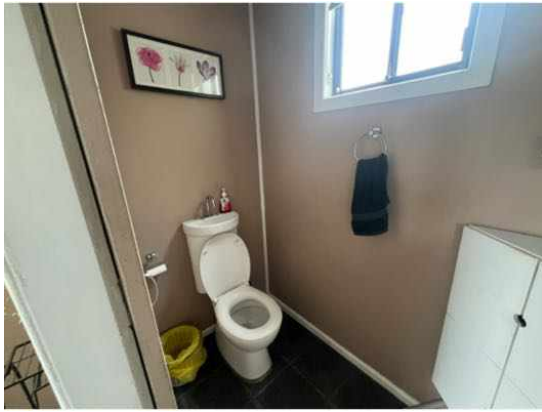
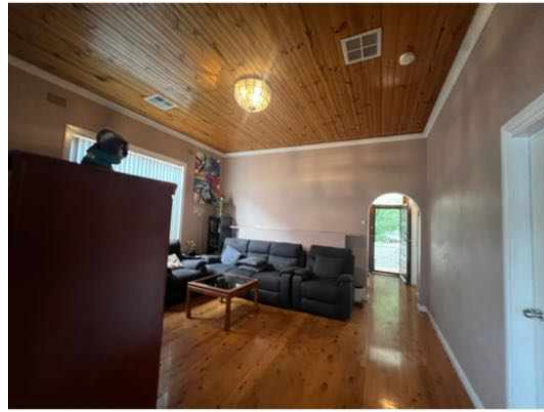
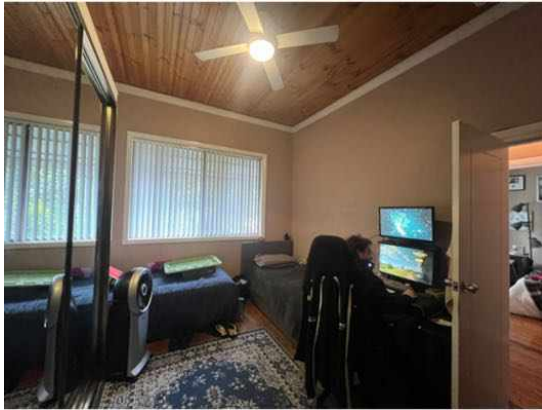
Building: Main Building
Location: All Internal Areas
Finding: Additional Photos - Obstructions and Limitations
Information: These photographs are an indication of the obstructions and limitations which impeded full inspection of the property at the time of inspection. These obstructions can hide an array of defects and should be removed to allow full inspection to be carried out. A re-inspection is recommended once the areas are made accessible.

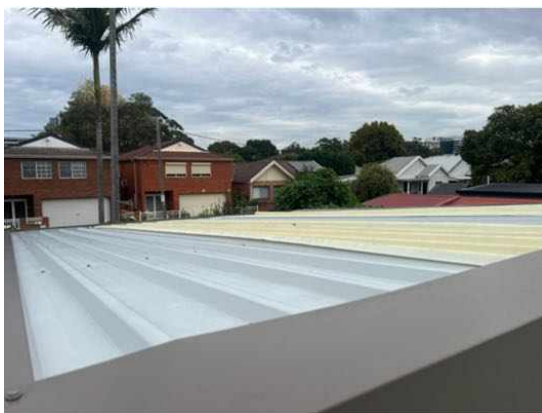
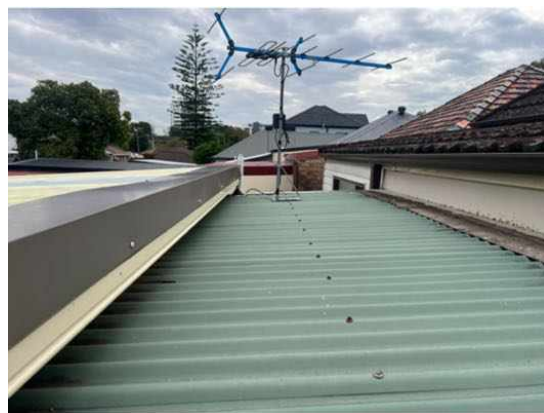
Building: Main Building
 Location: Roof Exterior
 Finding: Additional Photos - Obstructions and Limitations
 Information: These photographs are an indication of the obstructions and limitations which impeded full inspection of the property at the time of inspection. These obstructions can hide an array of defects and should be removed to allow full inspection to be carried out. A re-inspection is recommended once the areas are made accessible.

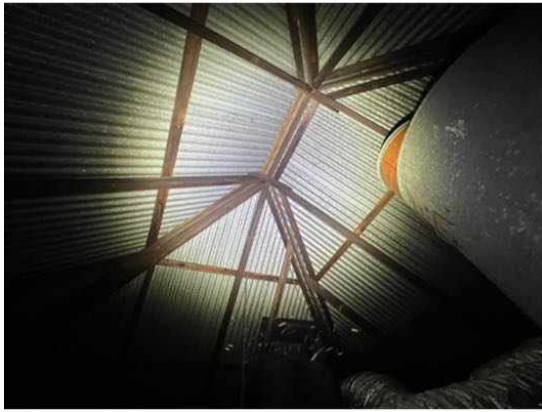
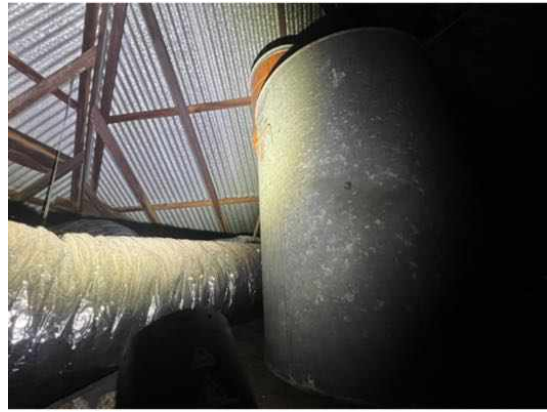
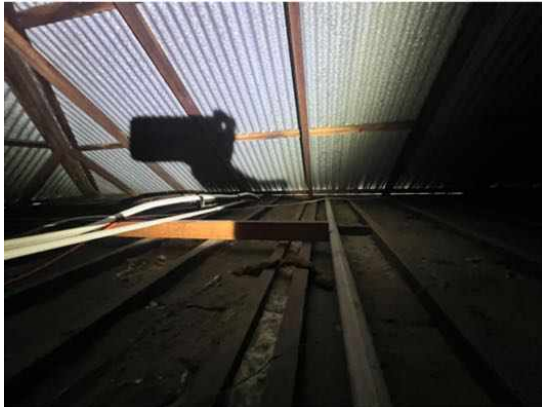
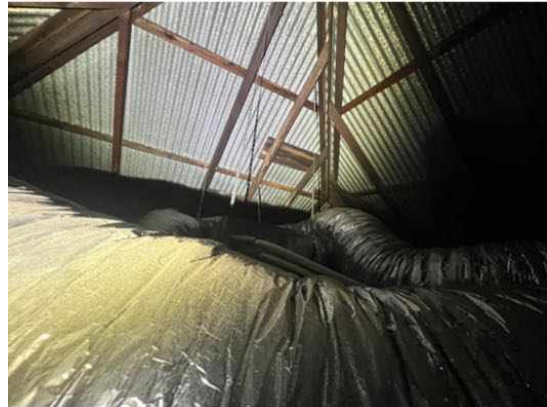
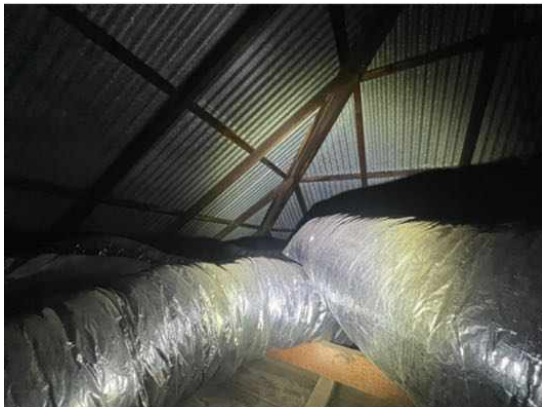
Building:	Main Building
Location:	Roof Void
Finding:	Additional Photos - Obstructions and Limitations
Information:	These photographs are an indication of the obstructions and limitations which impeded full inspection of the property at the time of inspection. These obstructions can hide an array of defects and should be removed to allow full inspection to be carried out. A re-inspection is recommended once the areas are made accessible.

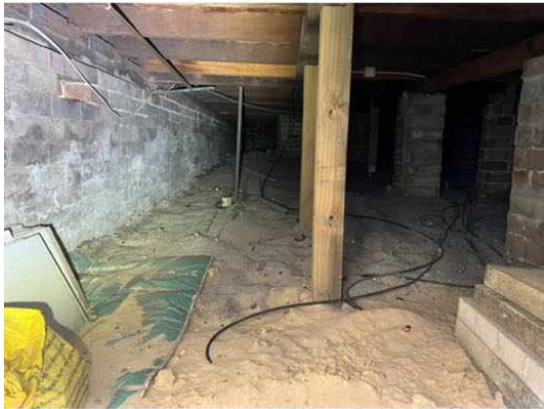
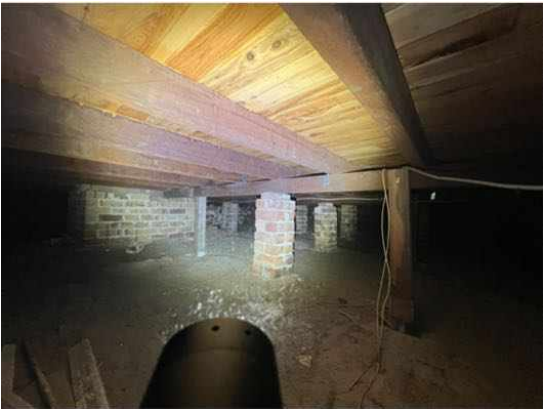
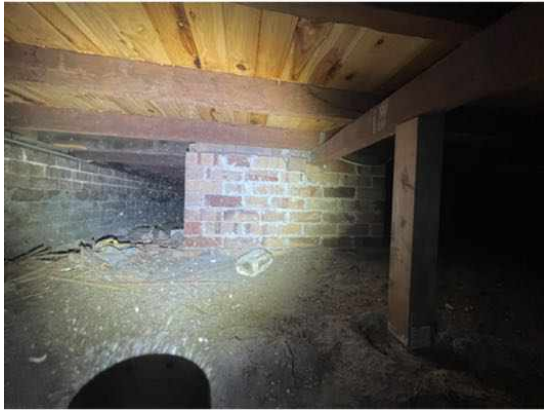
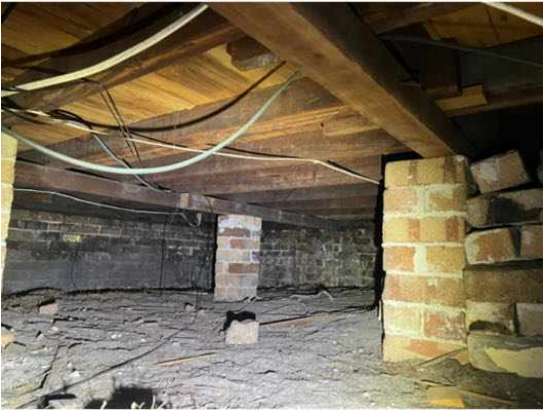
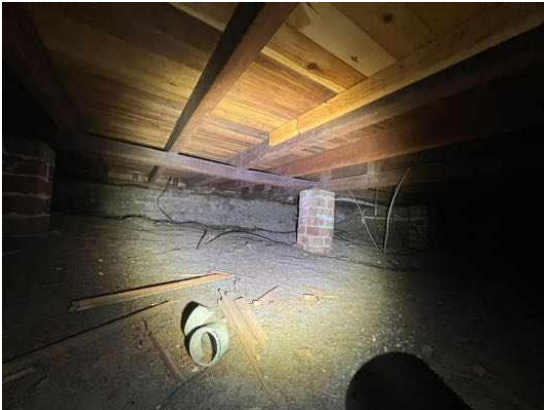
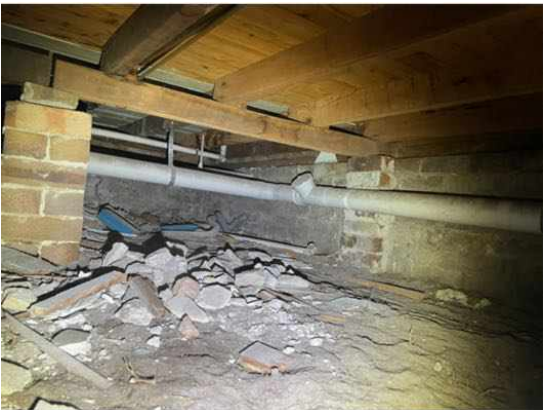
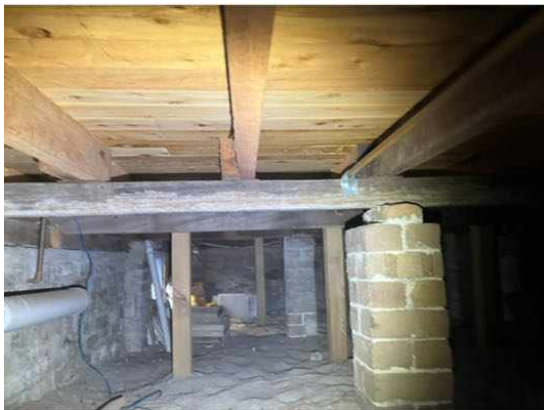
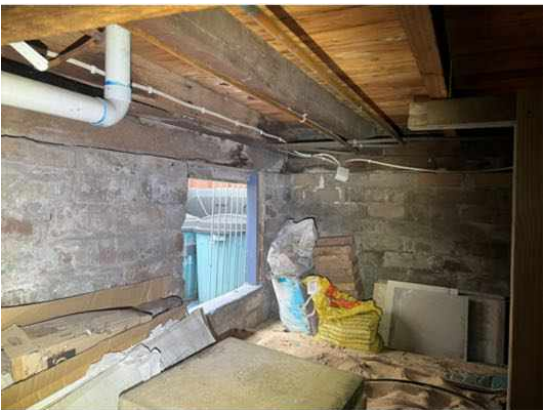
Building:	Main Building
Location:	Subfloor
Finding:	Additional Photos - Obstructions and Limitations
Information:	These photographs are an indication of the obstructions and limitations which impeded full inspection of the property at the time of inspection. These obstructions can hide an array of defects and should be removed to allow full inspection to be carried out. A re-inspection is recommended once the areas are made accessible.
