Building and Timber Pest Inspection Report

Inspection Date: Tue, 3 Feb 2026

Property Address: 3-154 neerim rd Caulfield east

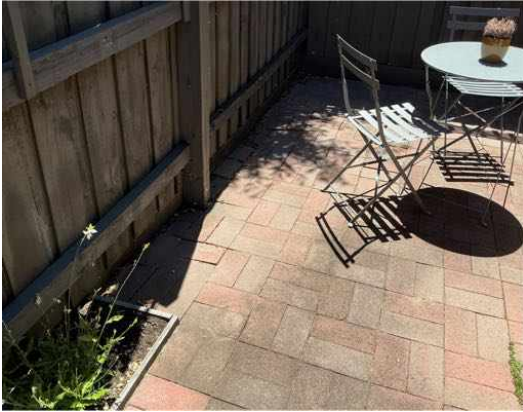
Information: Sections of the external paved area are uneven, creating a potential trip hazard. It appears as though the area has been subject to rough installation, or that paving sections have lifted due to movements in the foundation of the property.

Where paving creates a trip hazard, personal injury may ensue if due caution is not taken by all persons within this area.

Re-paving of the area is required as soon as possible to remedy this situation. Further consultation with a specialist concreter is advised.

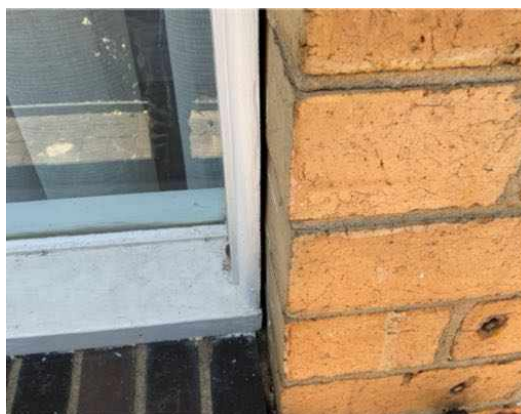
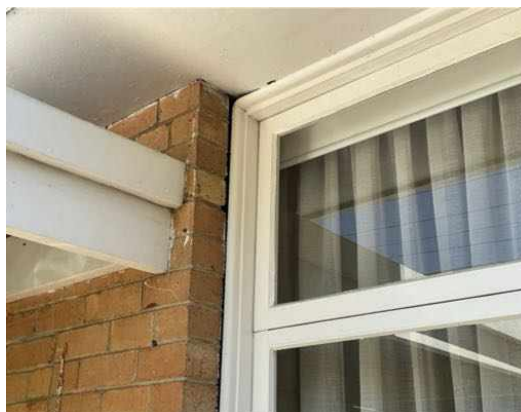
Building: Main Building
 Location: Various parts of the building
 Finding: A few gaps to the exterior walls/windows
 Information: A few gaps were noticed to some of the exterior walls/windows to the building. These gaps can let in water, drafts, and pests. Overtime moisture ingress may cause damage to internal walls, mould growth, or structural issues. Gaps also reduce the energy efficiency of the property. Recommend engaging a caulker to seal gaps with an exterior grade flexible sealant that is UV and weather resistant to reduce the risk of pest/water penetration to the building as soon as possible.

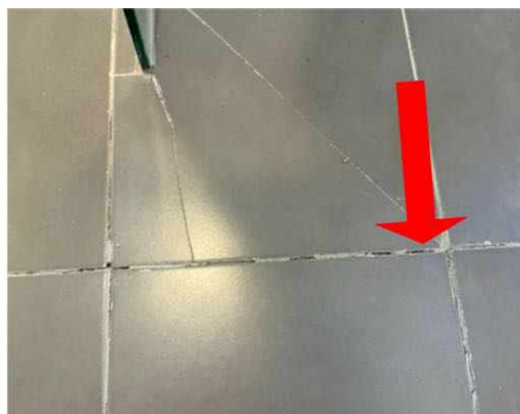
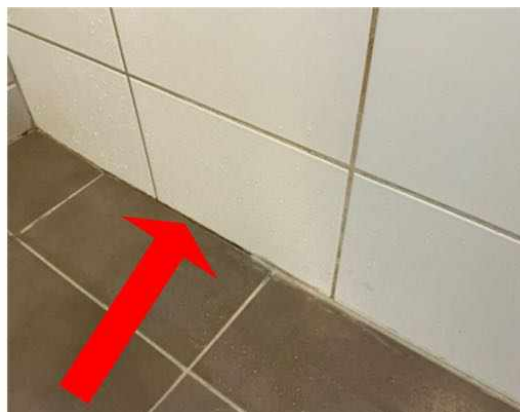
Finding 3.08

Building:	Main Building
Location:	Bathroom
Finding:	Bathroom Sealant and grouting - Missing or damaged
Information:	It was noted on inspection that sealant or grout is degraded to the tiled shower alcove and or other areas of the bathroom.

Different materials and floor areas move at different rates, generally causing cracking to grout or sealant at this point. A flexible sealant is required to allow for expected expansion and contraction, while keeping the joint water tight and protective of all associated building materials.

Flexible and mould resistant materials should be applied to affected areas to prevent any subsequent water damage that is likely to occur. Regular maintenance and replacement of damage or missing or damaged sealant and grout is highly recommended to the wet areas, as this is a regular wear and tear defect. Sealant and grouting in areas that come into regular contact with water should be maintained for the long term care of your property.

A sealant specialist or tiling contractor should be appointed to complete these works as soon as possible

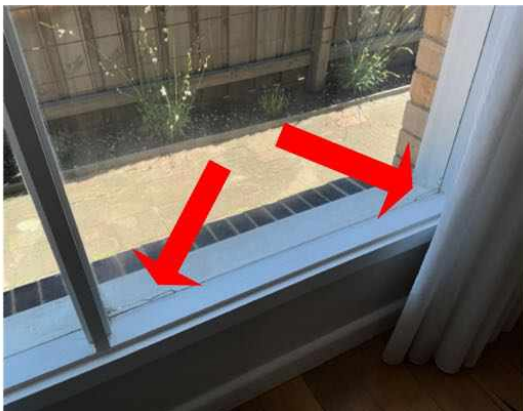
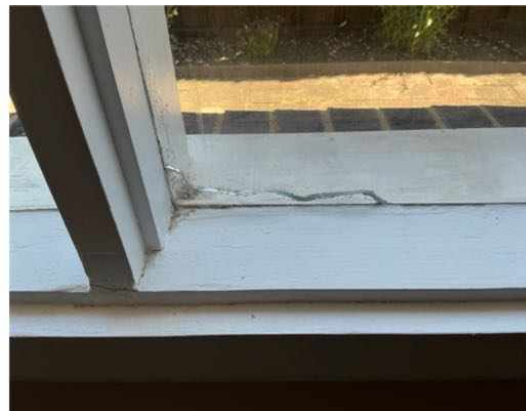
Building:	Main Building
Location:	Bedroom
Finding:	Window - glass broken
Information:	Broken glass identified in the bedroom window. Cracking in windows is generally the result of impact damage, and is likely to develop further when left unmanaged.

The likelihood of this windowpane further cracking and shattering is increased exponentially, providing a safety hazard in the area. The cracked window also impairs the weather tightness of the building, creating potential for minor water leaks.

A qualified glazier is required to repair the window as soon as possible. Depending on the extent of the cracking, replacement of the window may be required. Please be advised that any persons coming into contact with the cracked window should do so with due caution to avoid any personal injury that may ensue.

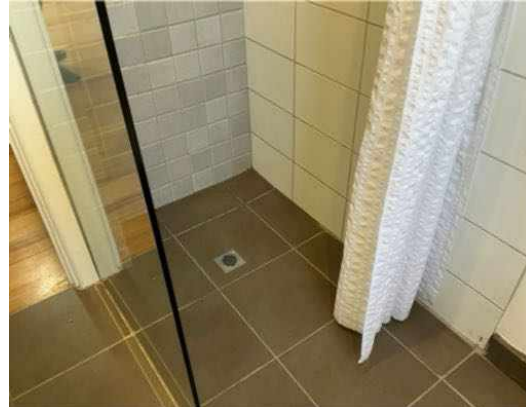
Building:	Main Building
Location:	Bathroom
Finding:	Shower - Damp
Information:	Damp is evident to parts of the bathroom shower alcove found using using a moisture meter. This defect is quite common, and is suspected to have been caused by moisture permeating through the grouting in this area, which shows evidence of deterioration creating moist conditions. Leaking pipes within the adjoining wall is also a possible cause. Excessive moisture can attract termites.

Consultation with a qualified plumber or bathroom specialist is advised immediately to identify the cause of damp and to perform remedial works as required. Where excessive mould growth is present, further inspection by a specialist environmental health inspector should also be considered.

Always ensure that sealant and grout is in good condition to prevent any moisture issues occurring in the future.

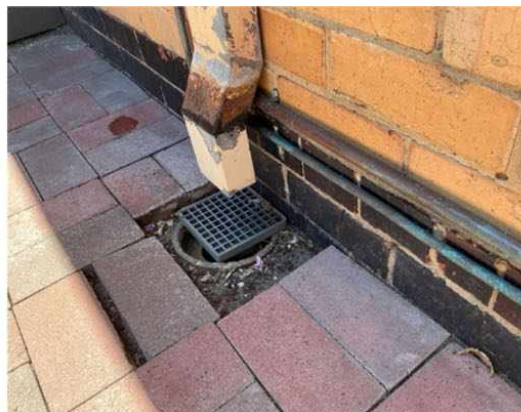
Finding 6.03

Building:	Main Building
Location:	Exterior walls - rear
Finding:	Downpipe not properly connected to stormwater
Information:	The rear downpipe is not properly connected to stormwater. This disconnection negatively impacts the functional capacity of the plumbing.

Where plumbing doesn't drain adequately, the area at the base perimeter can become excessively damp, potentially creating an environment that is susceptible to rust and corrosion of surrounding building elements, as well as attracting termites and other pests.

It is highly recommended that a plumber be appointed to further inspect the area and to install adequate drainage equipment immediately where necessary.

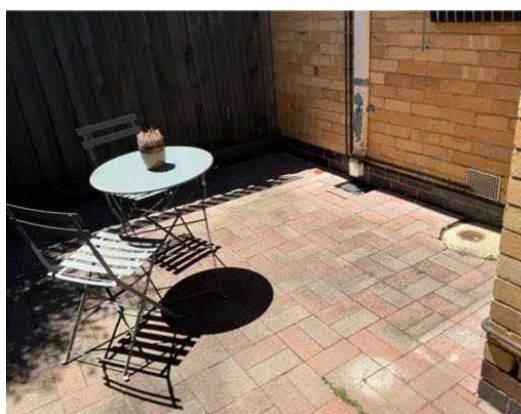
Finding 6.04

Finding: Site drainage - poor/inadequate

It is important that water does not lie against the base of walls; surrounding paths and ground levels should be sloped to drain water away from walls. Downpipes should not discharge stormwater onto lower walls or plinths. Stormwater should be carried away by large, regularly cleaned drains. Ground levels may need to be lowered to expose a buried DPC.

Where site drainage is inadequate, installation of an Agricultural (Aggie) Drain may be required. A qualified plumber should be appointed to further inspect the property and perform any remedial works as necessary. Water damage and secondary defects are likely to occur if left unmanaged.

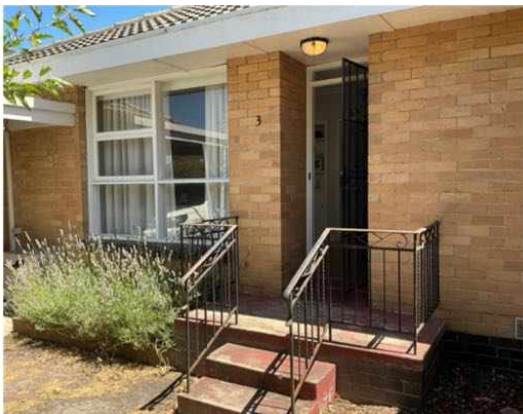
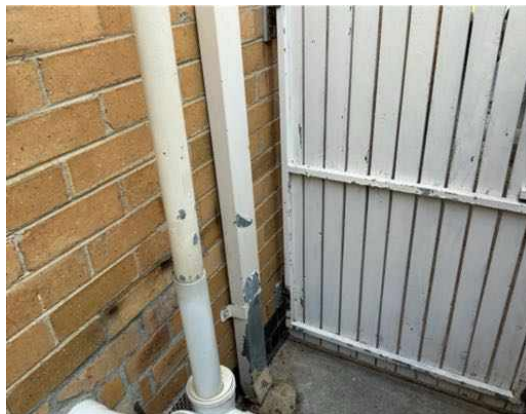
Finding 6.05

Where any part of an attachment to a building is not isolated and is not provided with a clear gap of not less than 25mm from building, bridging occurs. Attachments to buildings such as hot water services, downpipes, verandahs, decks, steps, fences, service conduits and the like provide the opportunity for concealed entry.

Building attachments of this nature need to be frequently inspected for termite activity by a qualified inspector.

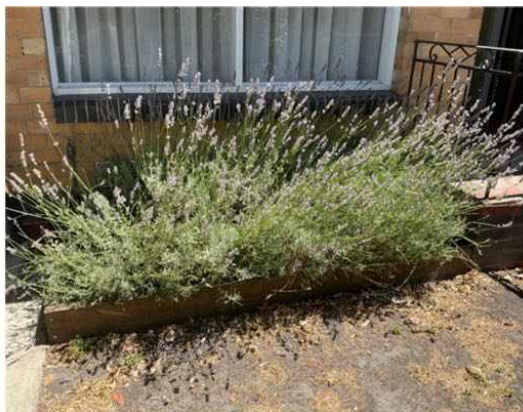
Finding 6.07

Building: Main Building
 Location: Yard - Front
 Finding: Garden Beds Conditions Conducive to Termites
 Information: Garden beds were found to be evident in close proximity to the building. Garden beds immediately adjacent to the perimeter of the building block the visual inspection of these areas, providing a concealed termite entry point.

These garden beds can include untreated timber, and with a combination of moisture from watering hosing can make conditions conducive to termite activity and termite ingress.

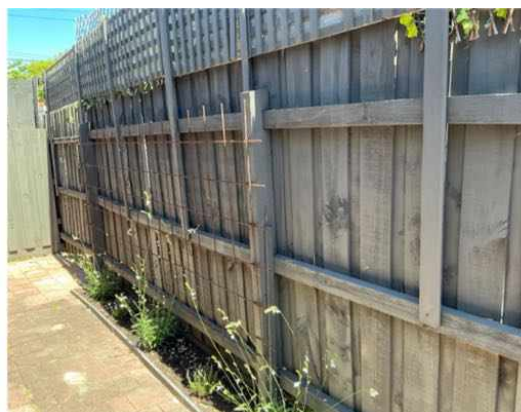
If left unattended, it is likely that further damage will occur. It is suspected that repair of several elements of the fencing may be required however replacement may be a consideration of the client also.

A licensed fencing contractor should be appointed to provide further advice and perform rectification works as necessary.

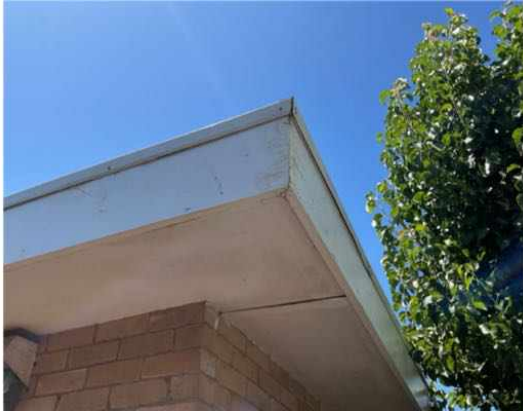
Finding 7.02

Building:	Main Building
Location:	Exterior walls - rear
Finding:	Fascias - Wood rot
Information:	Wood rot was found to be affecting the rear fascias of the building evidenced by the presence of mould on the surface in some areas. Wood rot, also known as Fungal Decay, occurs when timbers and other cellulose building materials are exposed to damp conditions on an ongoing basis.

It is advised that a roof plumber be appointed to inspect all roof plumbing and subsequently identify the cause of the wood rot. Replacement of affected fascias and barges may then be a necessary step in protecting surrounding building elements from such deterioration.

A qualified plumber may be appointed to assess the cause of excessive moisture and to provide advice on any remedial works as required. A qualified carpenter or registered builder may also be required to replace affected building materials.

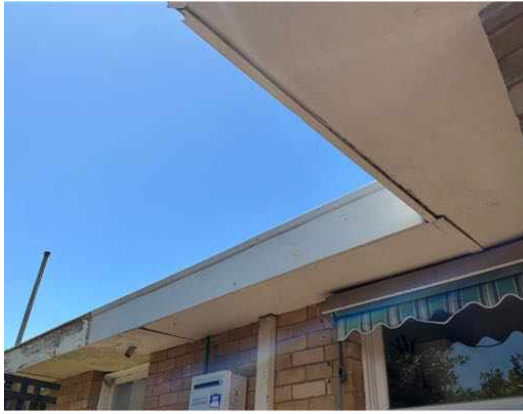
Building:	Main Building
Location:	All External Areas
Finding:	Obstructions and Limitations -exterior
Information:	These photographs are an indication of the obstructions and limitations which impeded full inspection of the exterior at the time of inspection. These obstructions can hide an array of defects and should be removed to allow full inspection to be carried out. A re-inspection is recommended once the areas are made accessible.
