Building and Timber Pest Inspection Report

Inspection Date: Thu, 12 Mar 2026

Property Address: 13 Gallipoli St, Condell Park NSW 2200, Australia

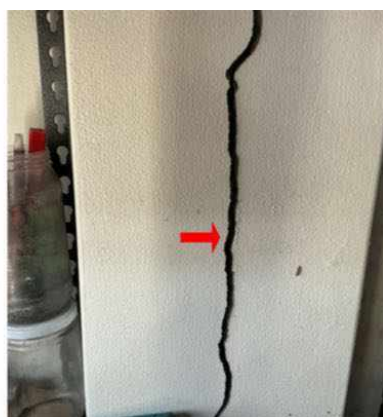
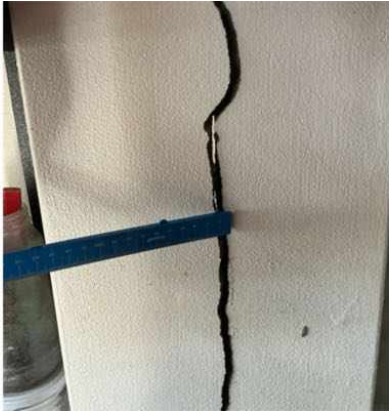
Building: Main Building
Location: All External Areas - Rear boundary wall
Finding: Brickwork - Cracking [Repair required]
Information: Major cracking was identified to the brickwork in this area. Cracks of this type are likely to have been caused by minor expected movement of building elements, but may also have a structural cause that is more significant.

A crack of this size may be repaired by extensive filling. A qualified bricklayer should be contacted immediately to estimate and perform repair and restoration works. Consultation with a structural engineer may be required where structural instability is found to be the underlying cause of the cracking.

Always contact a building inspector should cracks widen, lengthen, or become more numerous.

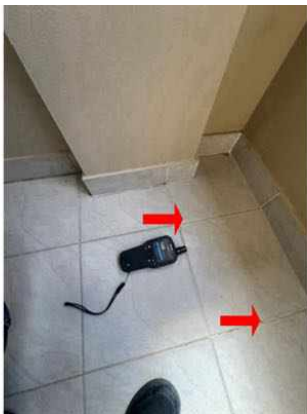
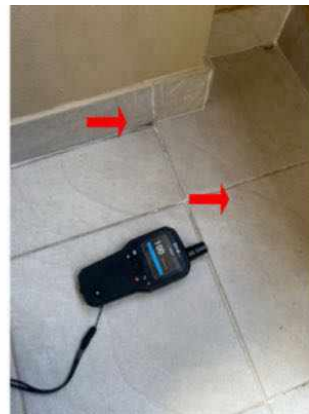
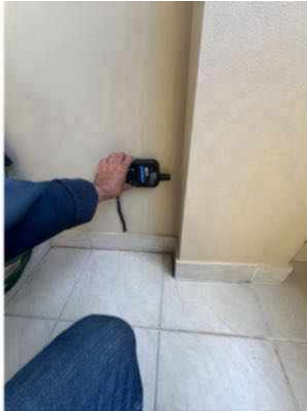
Finding 3.01

Building:	Main Building
Location:	Balcony
Finding:	Elevated Moisture – Further Investigation Recommended
Information:	Elevated moisture readings were detected in several locations and paint bubbling outside the balcony near planter area, with some areas also showing signs of dampness while others did not present visible surface issues, although no significant structural damage was evident at the time of inspection, dampness can contribute to deterioration if left unaddressed. A further investigation by a licensed plumber or waterproofing specialist is recommended to confirm the source and ensure no concealed issues are developing.

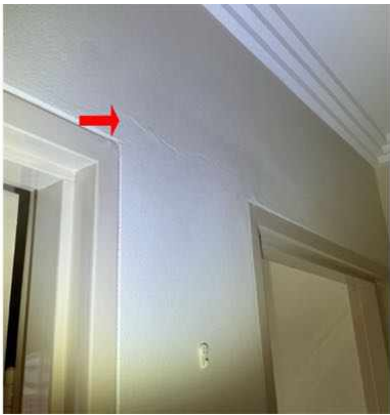
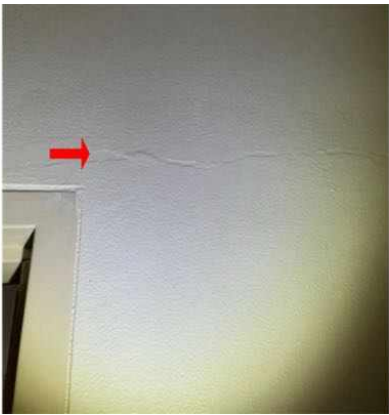
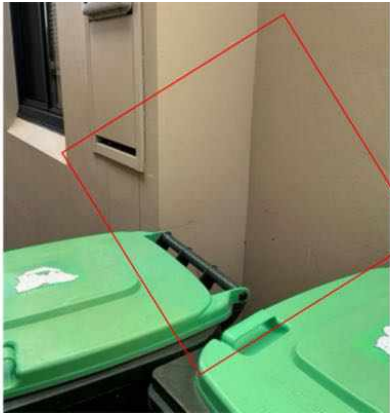
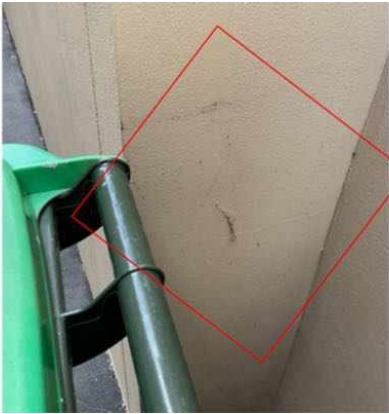
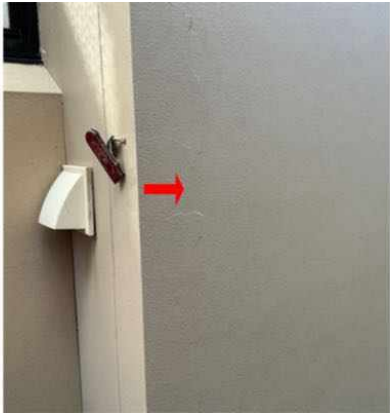
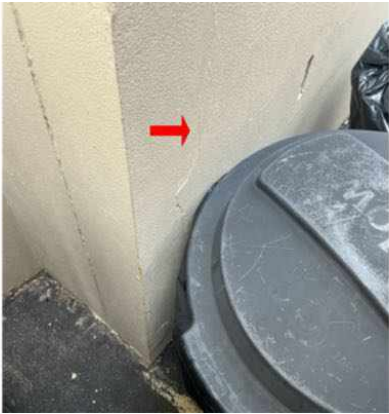
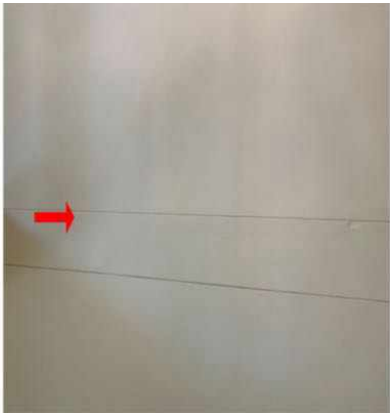
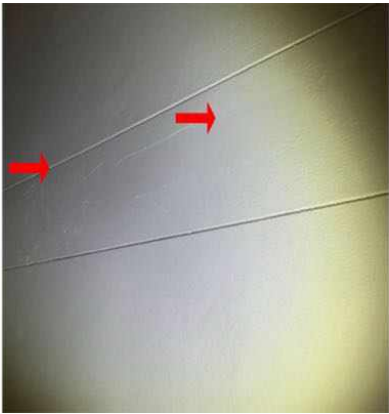
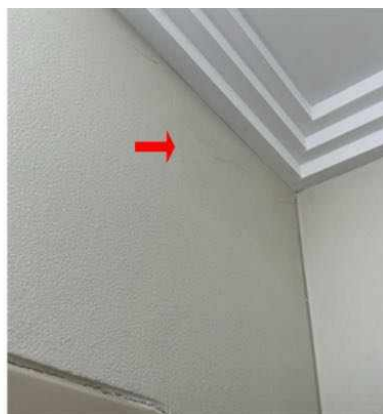
Finding 3.02

Building:	Main Building
Location:	All Areas
Finding:	Past Repairs - Refer to Defect 3.56 to 3.10 (Further investigation required)
Information:	Cracking to render , numerous tiles cracking in bathrooms , laundry areas, a door slightly binding and evidence of past repairs were noted in this area. The extent and adequacy of any previous repair work cannot be confirmed during a visual inspection. This pattern of defects may be consistent with past or ongoing building movement. Further assessment by a suitably qualified structural engineer is recommended to determine the cause and extent of movement.

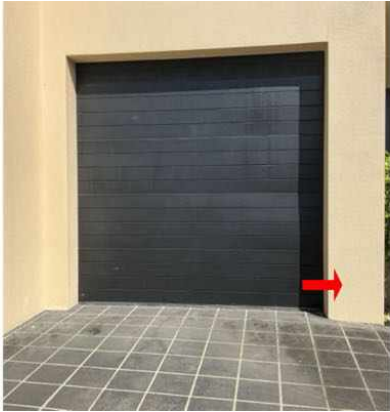
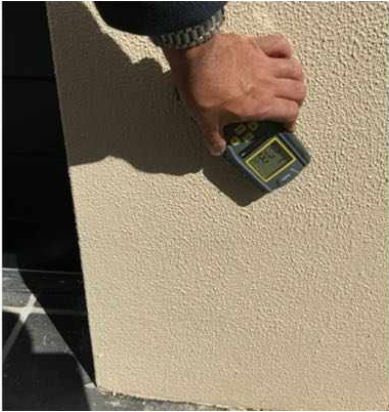
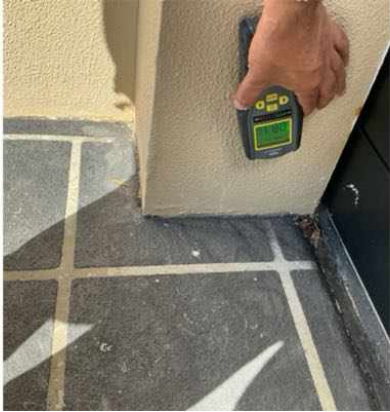
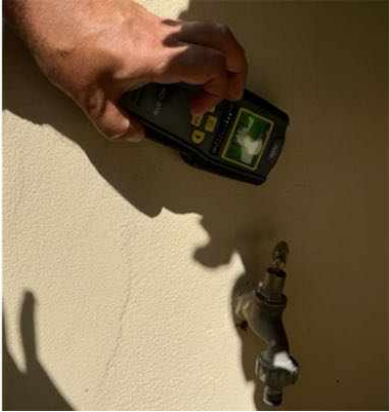
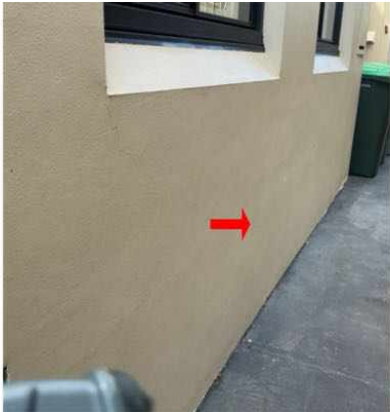
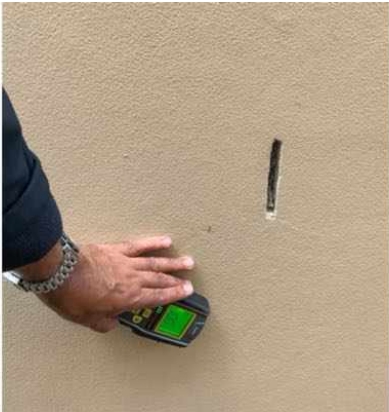
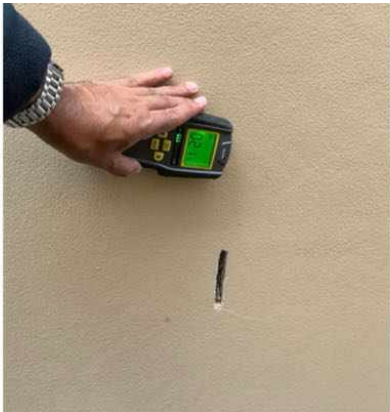
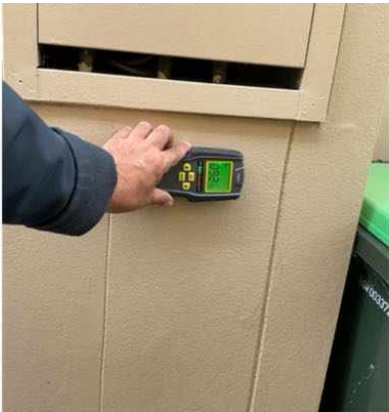
Finding 3.03

Information: Damp (or structural damp) refers to the presence of unwanted moisture in the structure of a building, either as the result of intrusion from outside, or condensation from within the structure. Generally, structural damp is caused by rain penetration, rising damp, and leaks from plumbing pipes.

The first step in addressing damp is to diagnose the cause. The identified cause should be addressed first prior to repairing the appearance and other defects which have resulted from the rising damp. If the original cause is not resolved, further cases of damp are likely to ensue, resulting in secondary defects.

Consultation with a qualified plumber is advised immediately to identify the cause of damp and perform remedial works as required. Where excessive mould growth is present, further inspection by a specialist environmental health inspector should also be considered.

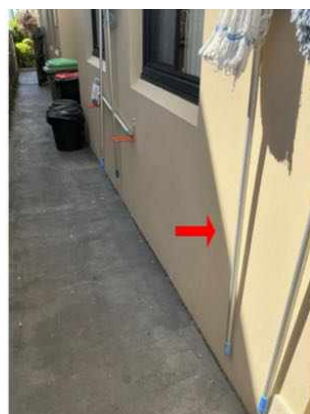
Finding 3.04

Building: Main Building
 Location: All External Areas
 Finding: Render Finish Covering Damp Membrane
 Information: During the inspection, it was noted that the applied render finish is covering the damp-proof membrane. This is affecting the membrane’s ability to prevent moisture movement above it, leading to moisture-related issues over time. It is recommended to consult a qualified builder to ensure the damp-proof membrane is properly exposed, maintaining its effectiveness in preventing moisture ingress.

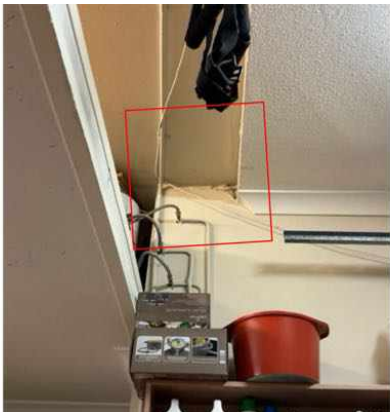
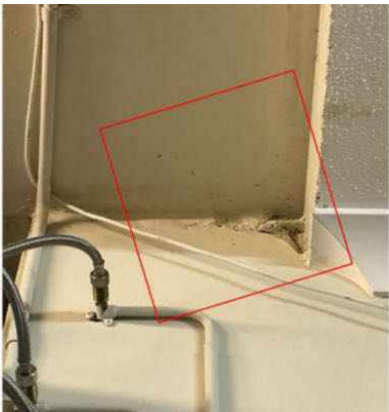
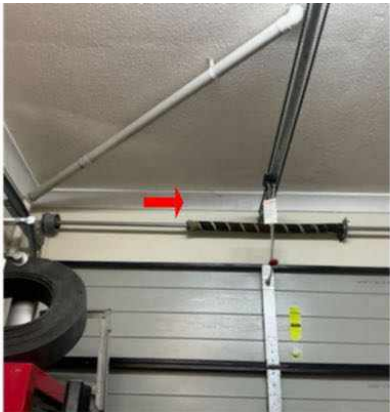
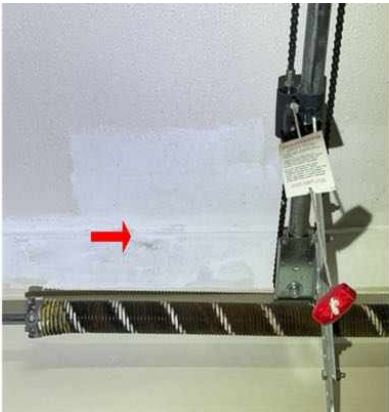
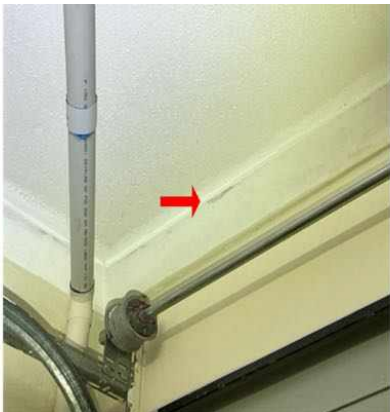
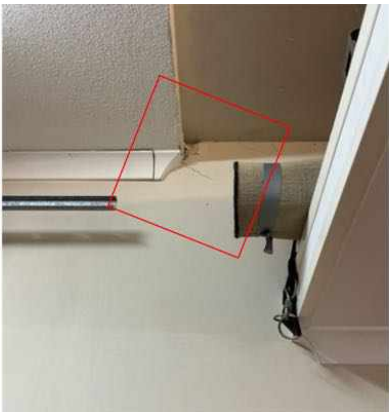
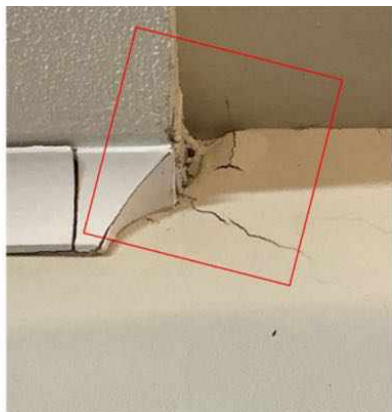
Finding 3.05

Building: Main Building
 Location: Garage
 Finding: Ceiling - Water damaged - Requires further investigation
 Information: Water damage to the ceiling lining is generally an indication of excessive moisture being present in the roof void, usually via a leak to the roof covering.

Where water damage is evident to the ceiling, the primary requirement is to identify and rectify the source of the leak. A roofing plumber should be appointed as soon as possible to identify the leak and perform rectification works as necessary, ensuring the water damage is restricted.

Once the leak is repaired, consultation with relevant tradespeople, including plasterers and painters, is advised. Rectification works may include replacement of ceiling lining or minor repainting, depending on the extent of the damage.

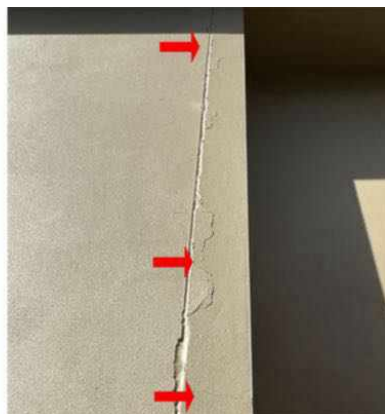
Finding 3.06

Category 2 damage is required to be monitored for a period of 12 months. After the monitoring period, a crack rated at Category 2 or above is considered a defect requiring rectification.

Always contact your building inspector should cracks widen, lengthen, or become more numerous.

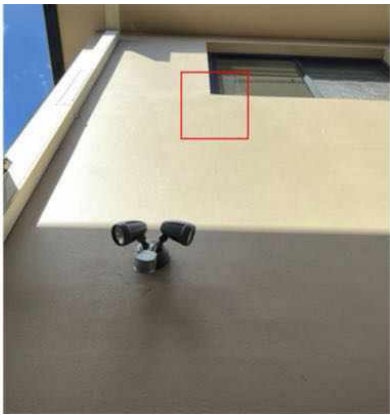
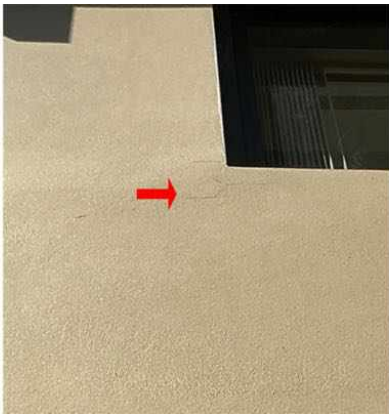
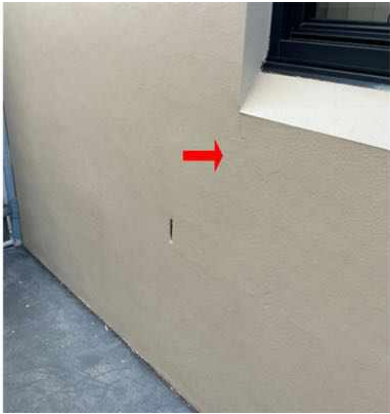
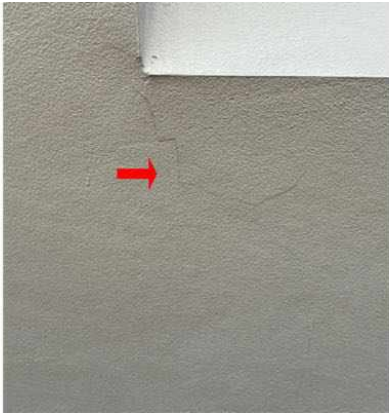
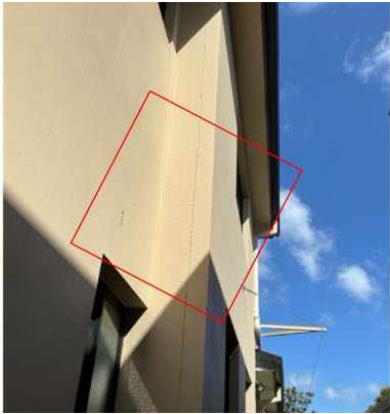
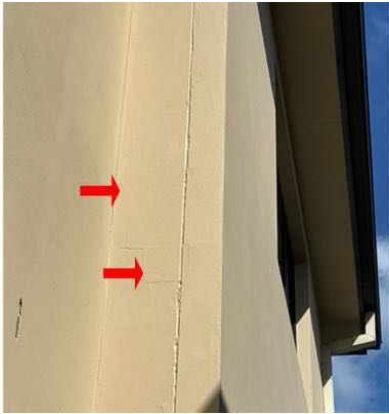
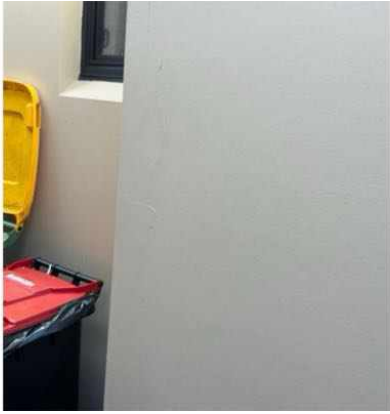
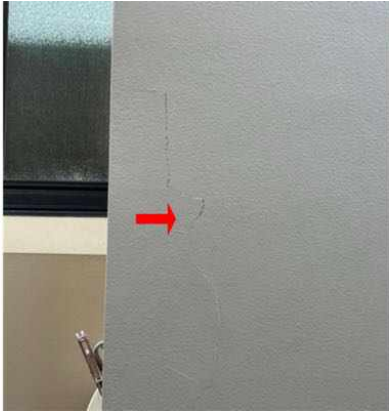
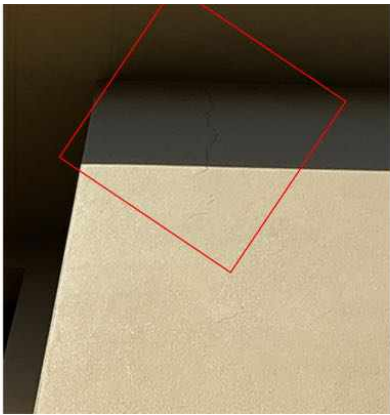
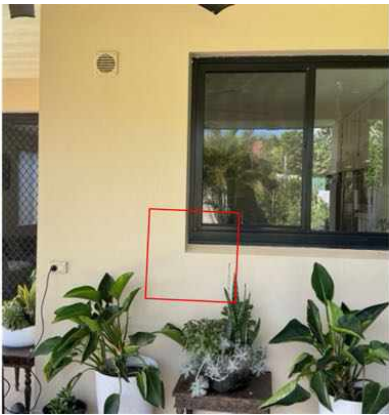
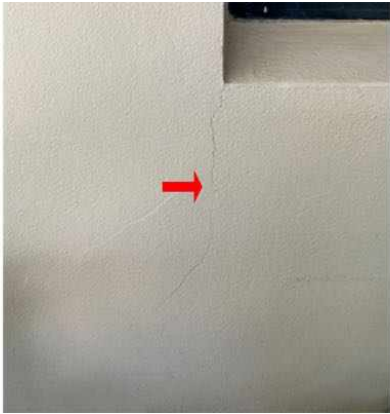
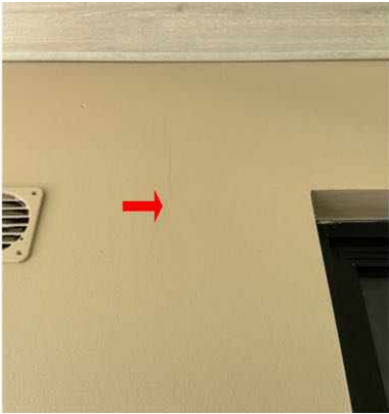
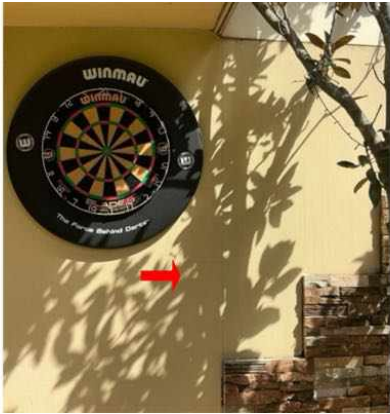
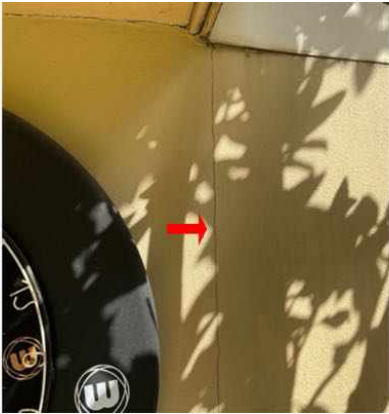
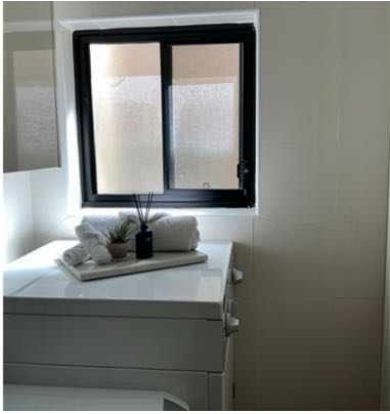
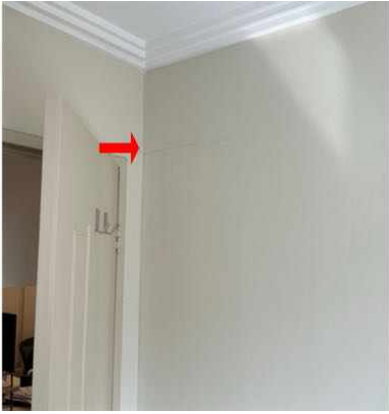
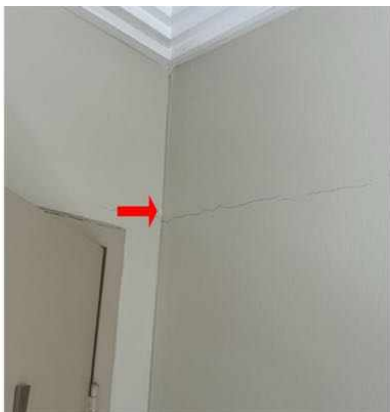
Finding: Cracks to render - Category 2

Information: It has been observed that cracking to rendered surfaces has occurred. The degree of damage falls within Category 2, described as noticeable cracks which are easily filled. Cracking of this size are generally less than 5mm in width.

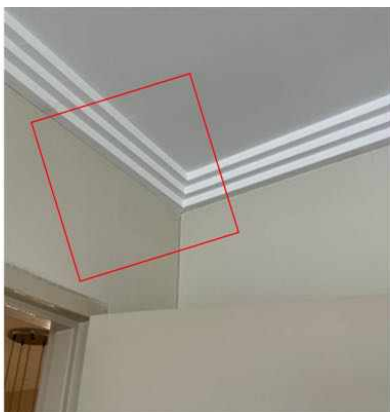
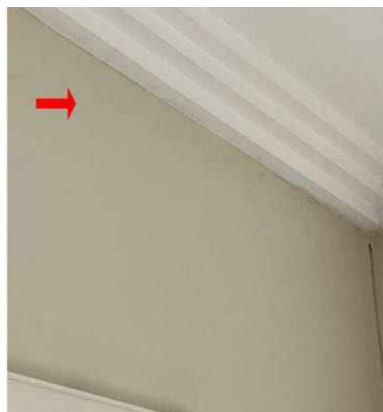
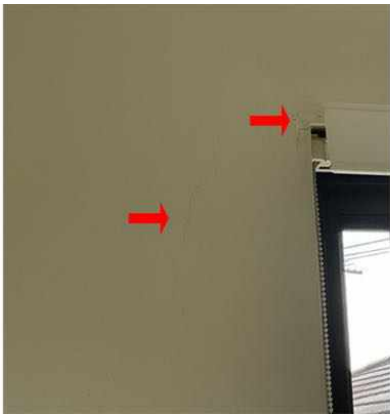
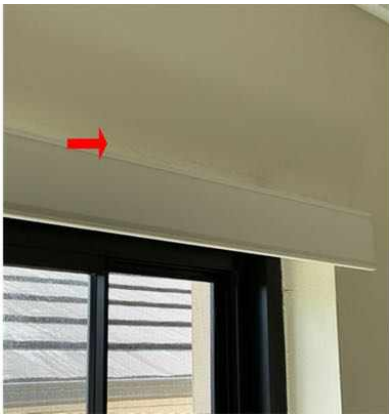
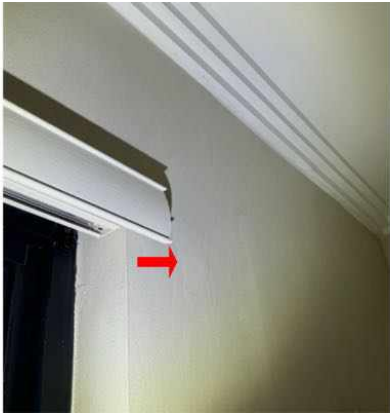
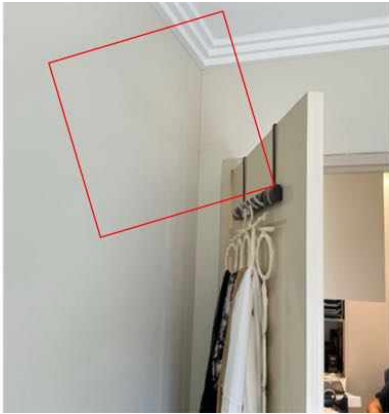
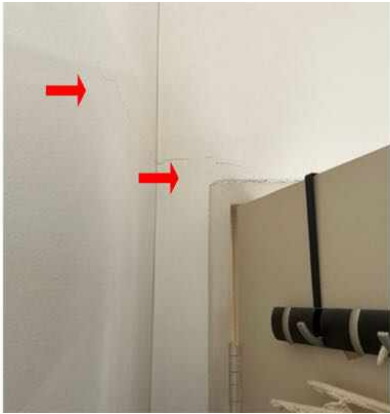
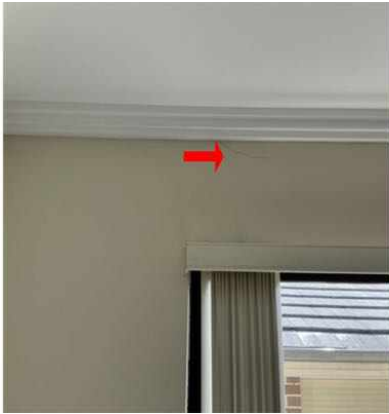
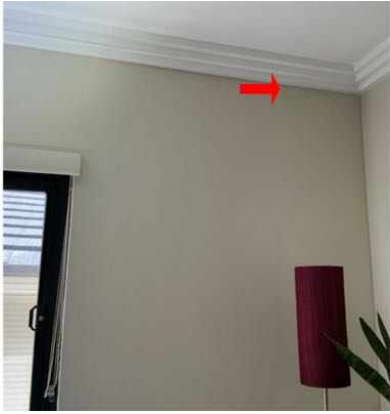
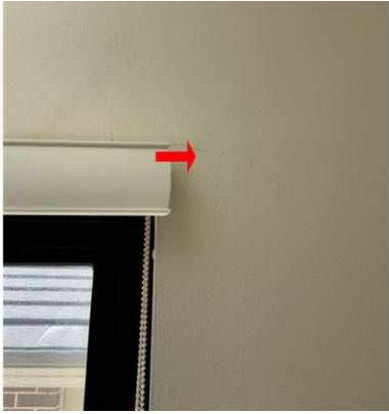
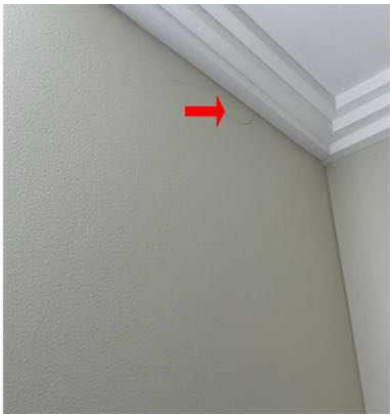
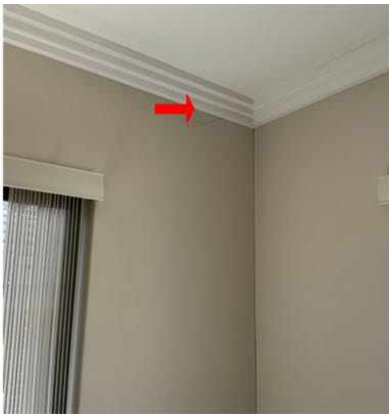
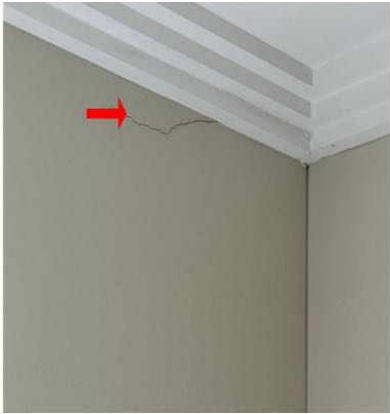
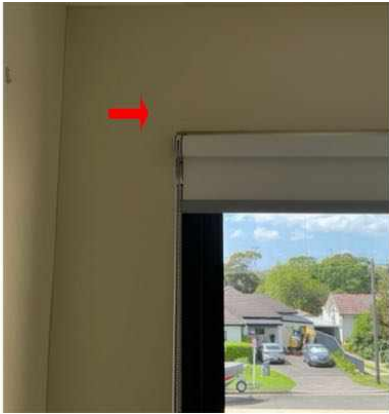
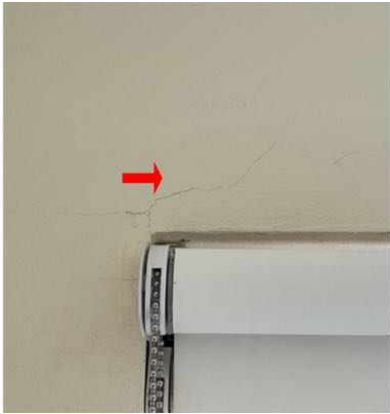
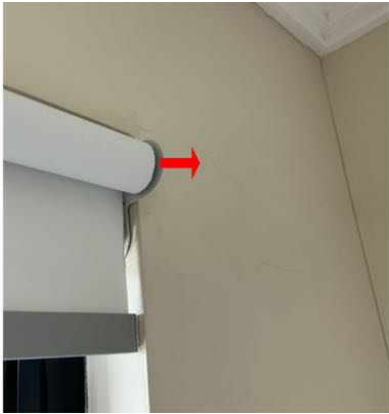
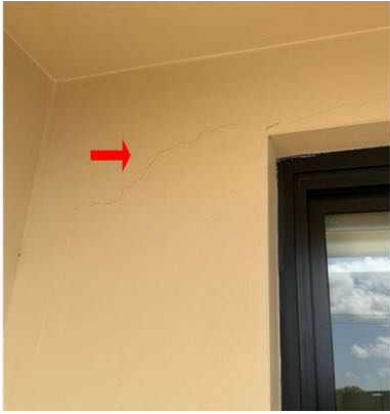
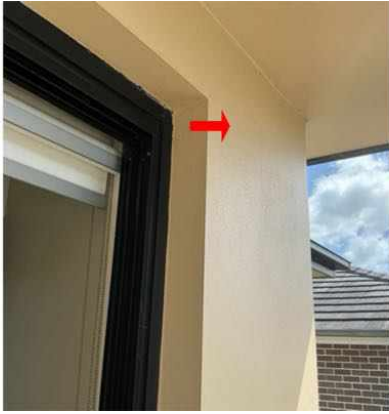
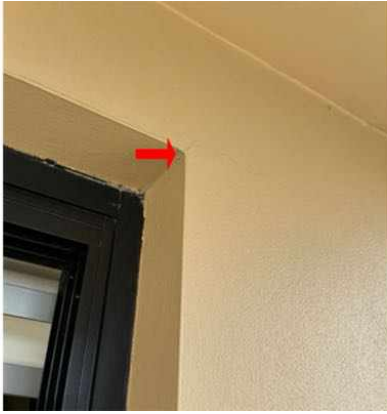
Finding 3.07

Building:	Main Building
Location:	All Internal Areas
Finding:	Cracks to internal render - Category 2
Information:	It has been observed that cracking to internal rendered surfaces has occurred. The degree of damage falls within Category 2, described as noticeable cracks which are easily filled. Cracking of this size are generally less than 5mm in width.

Category 2 damage is required to be monitored for a period of 12 months. After the monitoring period, a crack rated at Category 2 or above is considered a defect requiring rectification.

Always contact your building inspector should cracks widen, lengthen, or become more numerous.

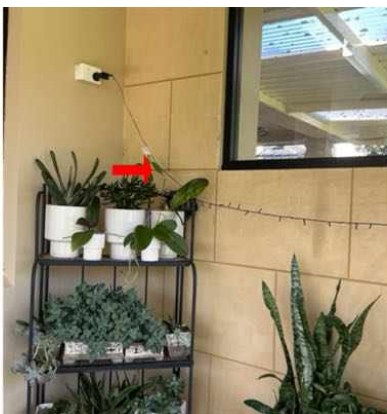
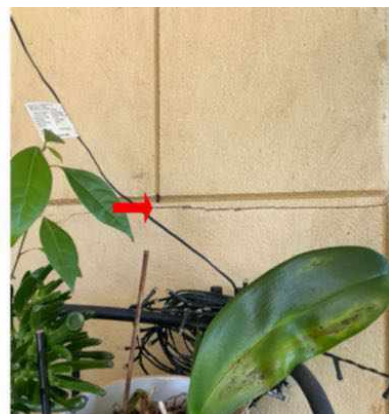
Finding 3.08

Building:	Main Building
Location:	All External Areas
Finding:	Brickwork - Cracking noticeable
Information:	There were several cracks and or crack repairs evident to external brickwork.

Noticeable cracks are a common occurrence in external brickwork and are a likely result of age expected building movement, general expansion, and/or contraction of building materials in different weather conditions. Noticeable cracks in brickwork may develop if left unattended, with potential for necessitating major remedial works or replacement of the brickwork.

It is highly advised that a qualified bricklayer be appointed to provide necessary works to cracked brickwork to prevent any further damage. Such works should be conducted as soon as possible.

Always monitor these cracks and contact a building inspector should cracks widen, lengthen, or become more numerous.

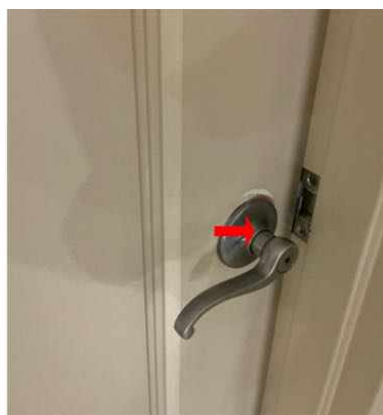
Finding 3.09

Building:	Main Building
Location:	All Internal Areas - Bedroom master

Finding: Doors - Binding/Jamming
Information: Binding and/or jamming of several doors throughout the property were evident during standard operation. This defect inhibits the functionality of affected doors as well as creating potential for secondary defects to associated building elements, such as damage to the floor covering.

A door that binds to flooring or to the associated door frame may have several causes, ranging from minor defects, such as poor installation of the door or deteriorated hinges, through to major structural issues, such as damage to subfloor structures.

Where door binding/jamming appears to indicate major structural issues, a registered builder specialising in re-stumping should be appointed to provide an estimate on the cost of rectification.

For minor causes, a qualified carpenter or general handyperson should be appointed to perform minor rectification works at client discretion.

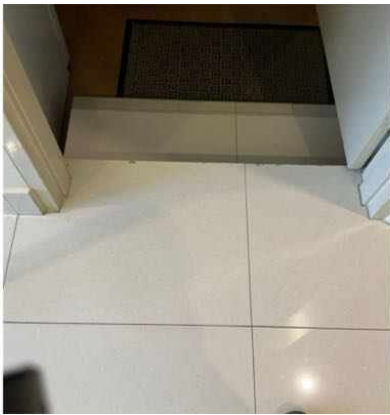
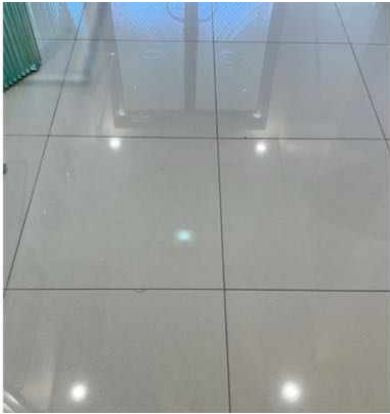
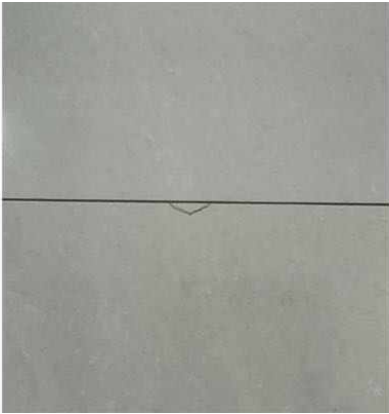
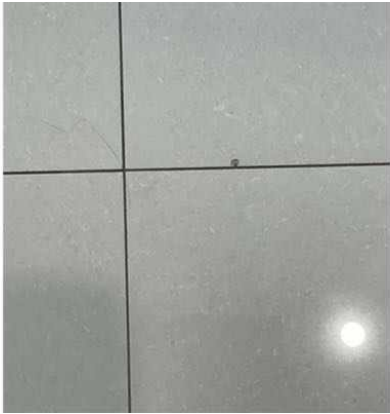
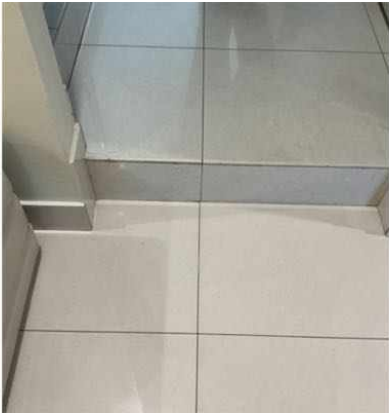
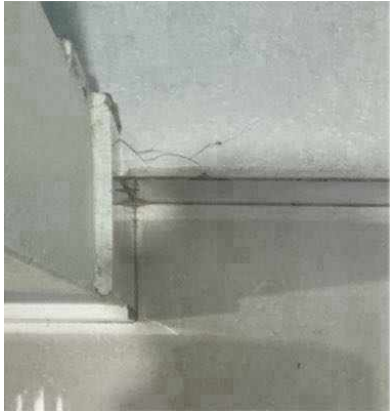
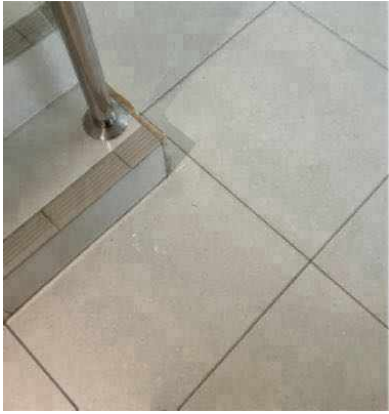
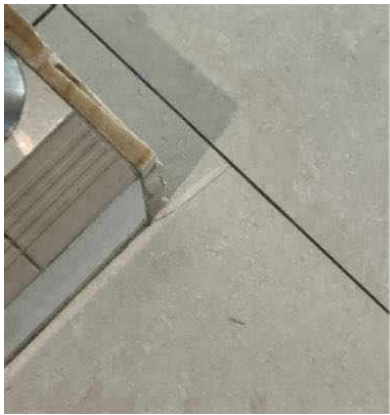
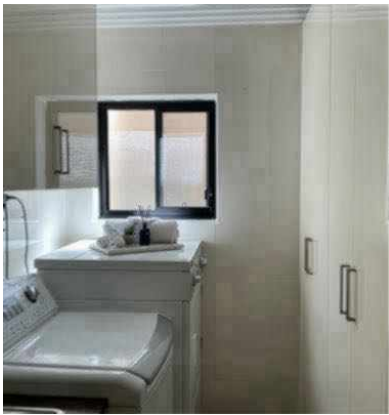
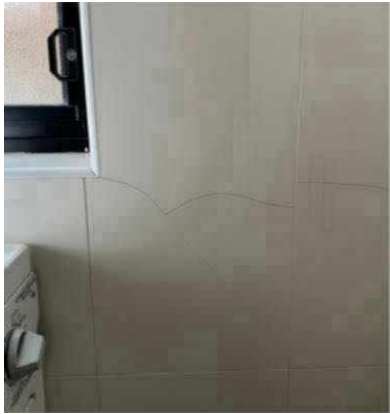
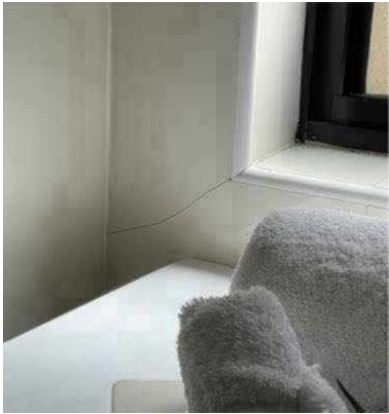
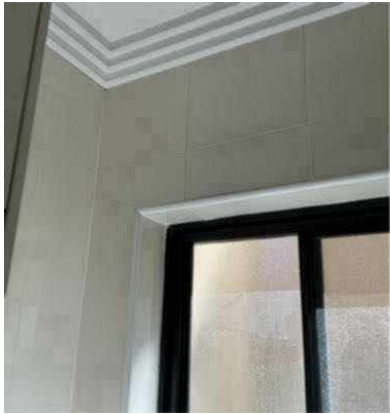
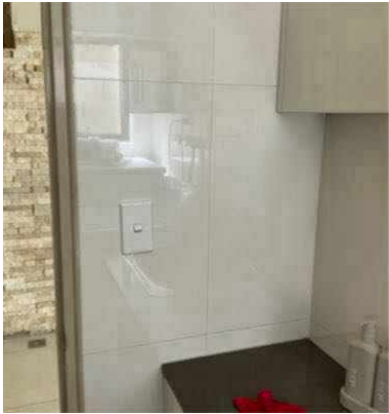
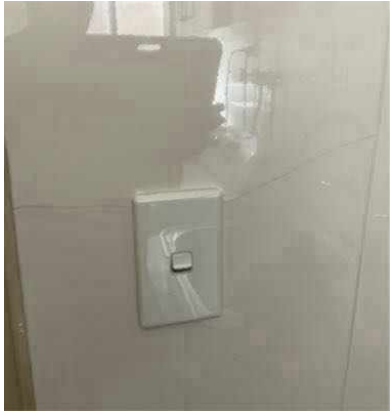
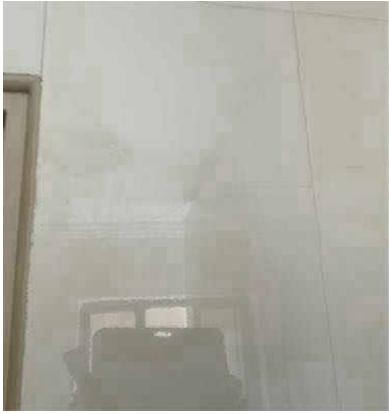
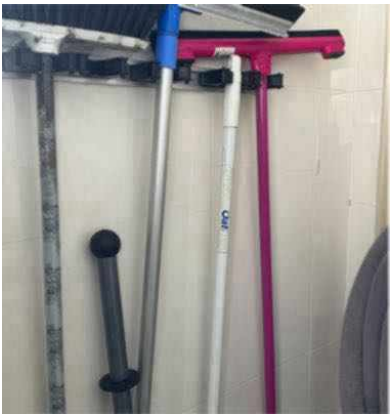
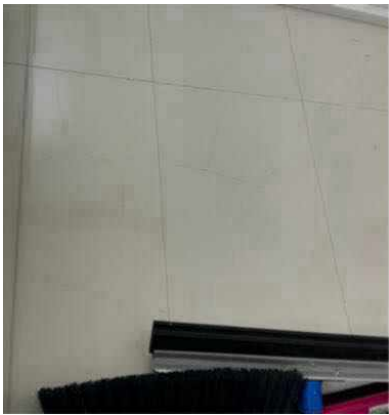
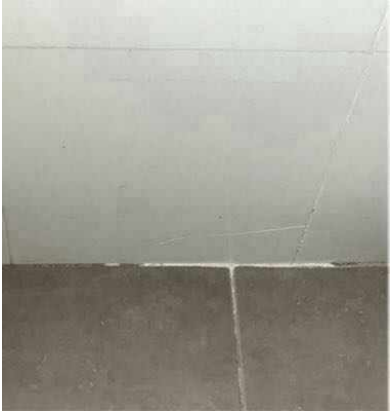
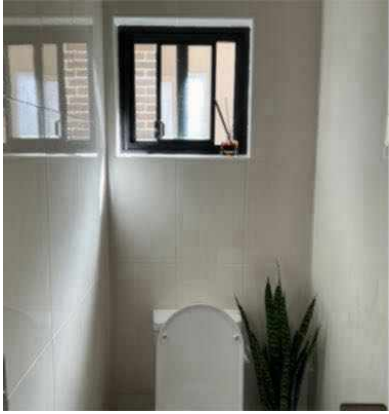
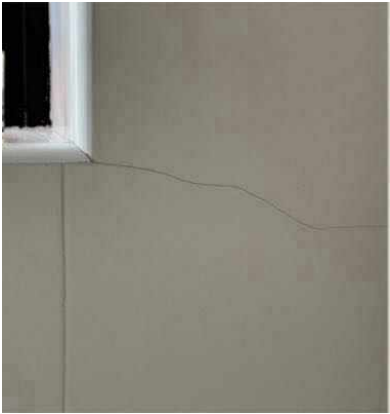
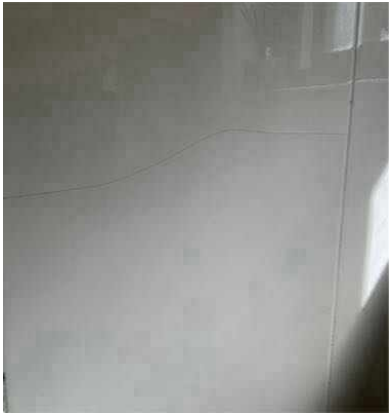
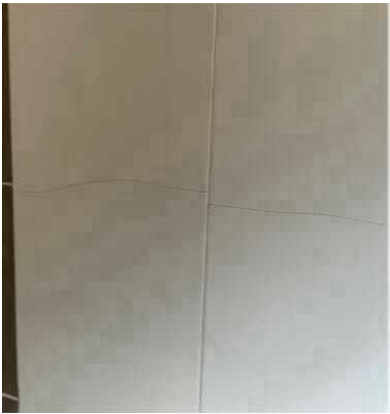
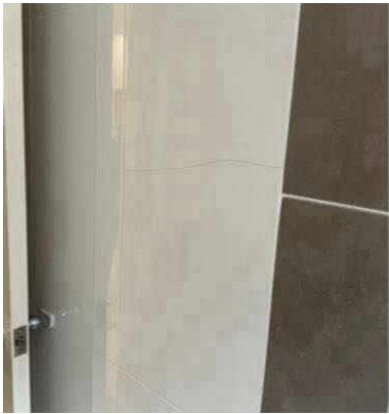
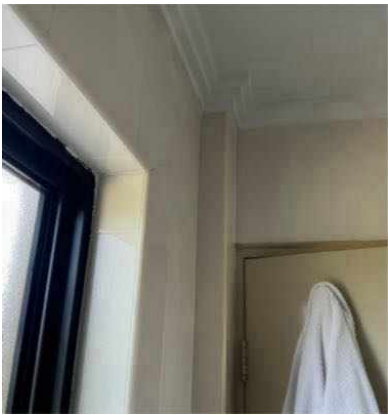
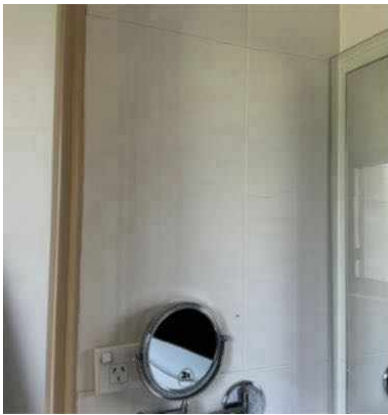
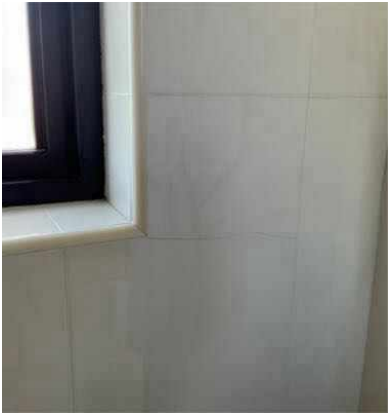
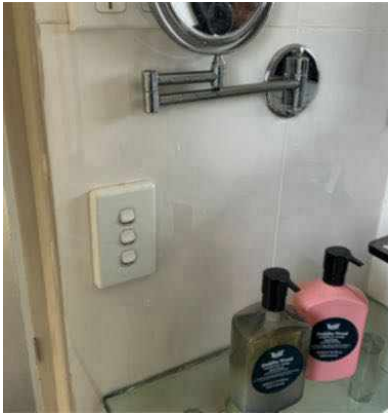
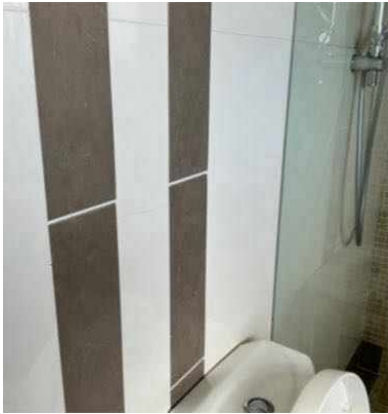
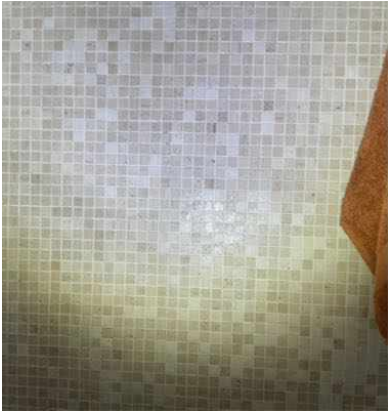
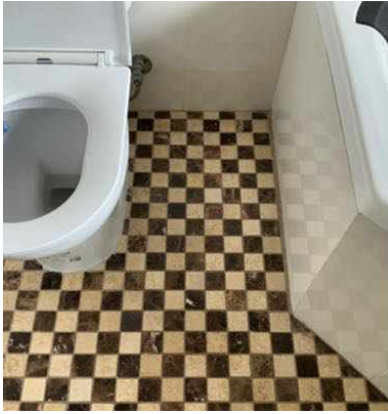
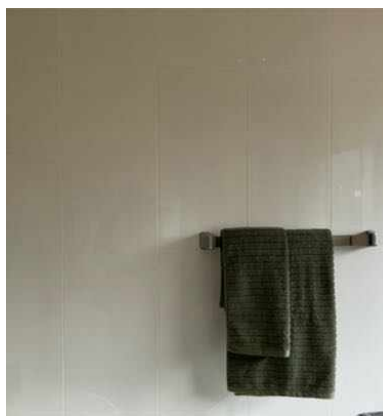
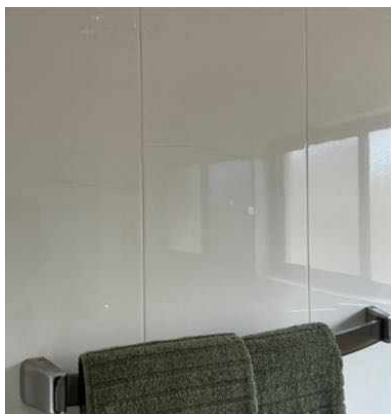
Finding 3.10

Building: Main Building
Location: All Internal Areas - laundry , ensuite , WC
Finding: Tiles Cracked - multiple tiles
Information: Hairline cracking was observed to wall tiles in the bathroom, extending vertically and branching. These defects are considered minor at present, but are likely caused by substrate movement, water-induced expansion, or installation stresses. Failure to address this may compromise waterproofing integrity. Prompt rectification by a qualified tiler is recommended to prevent further damage and potential water ingress behind the tiled surface.

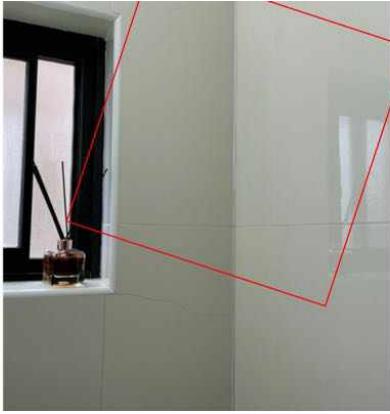
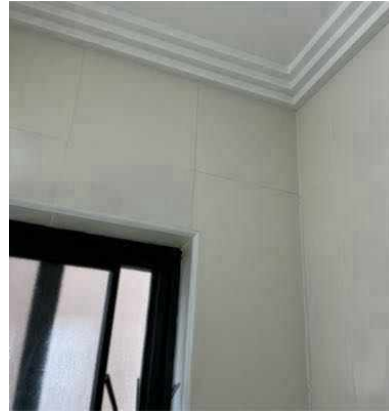
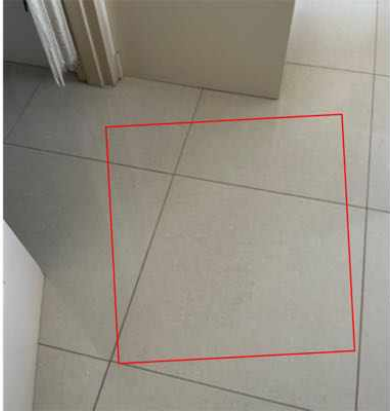
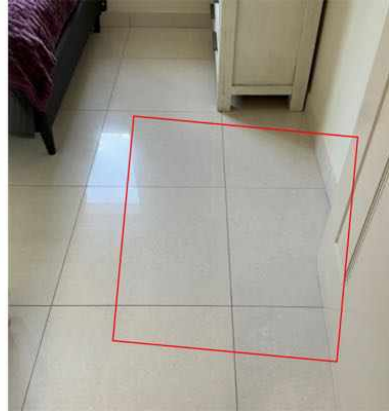
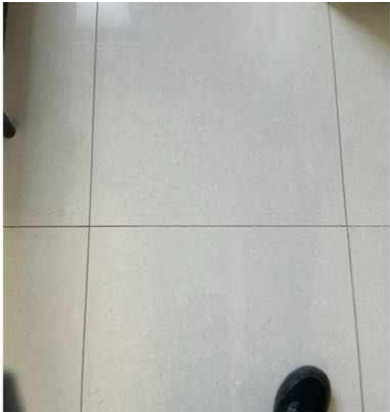
Finding 3.11

Building:	Main Building
Location:	All Internal Areas - laundry , WC, master bedroom, bedrooms
Finding:	Tiles - Drummy to some areas
Information:	Drummy tiled areas were identified at the time of inspection. The term 'drummy' refers to tiles that have become detached from their fixing, despite otherwise being in relatively good condition. Such defects are generally caused by physical or moisture damage to the area. Drummy tiled areas may also be a direct result of poor workmanship during the construction process.

Tiled areas may swell and shrink with changes in air humidity if the area has sustained moisture damage. Any exposure to moisture is capable of causing tiled areas to become drummy and/or cracked over a prolonged period of time. Drummy tiled areas generally require removal and replacement of affected tiles, with adequate sealant and grouting.

Specialist trades are available for these types of services. A registered builder may be required to undertake works if damage is extensive or if secondary building defects have resulted. Otherwise, it is advised that a tiling contractor be appointed to perform works as necessary. Immediate action is recommended to ensure that no further damage is sustained in the affected area.

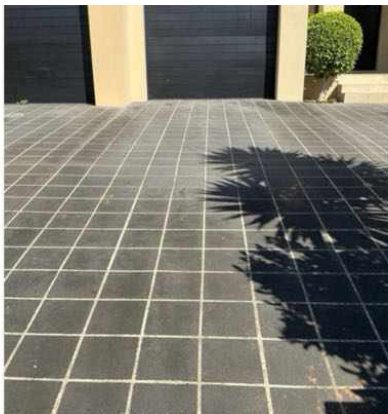
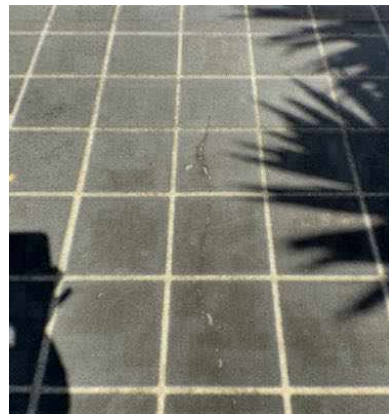
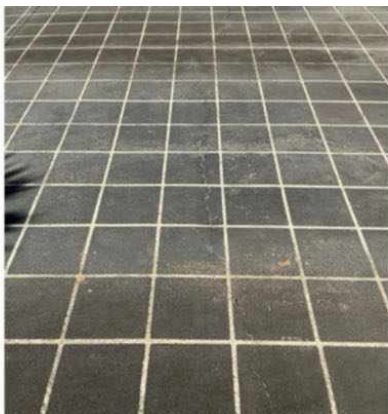
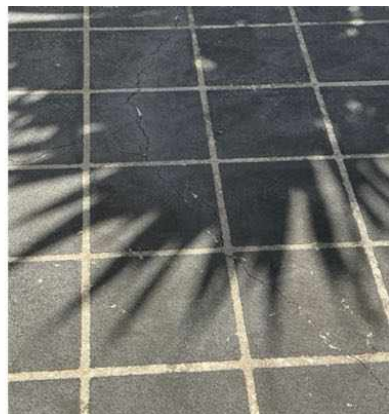
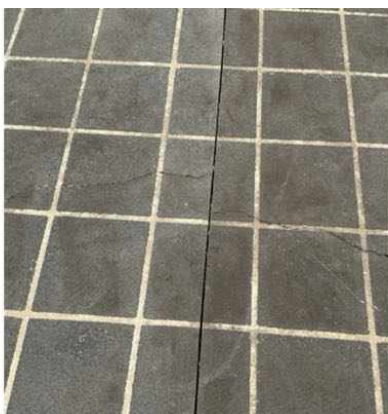
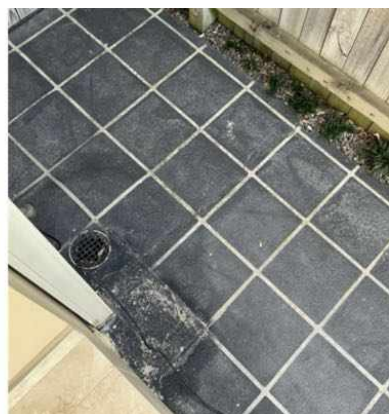
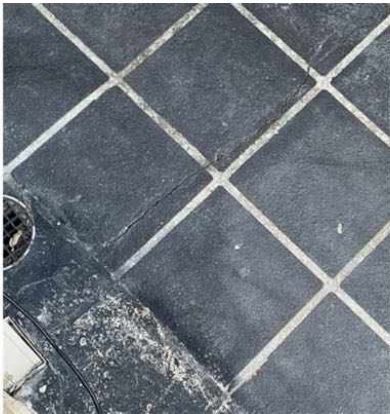
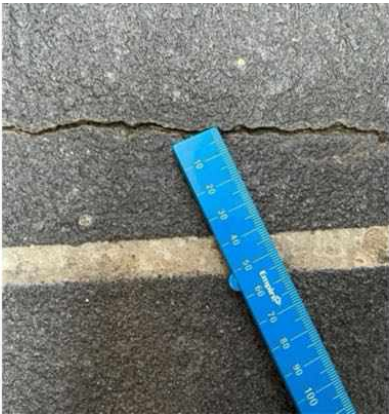
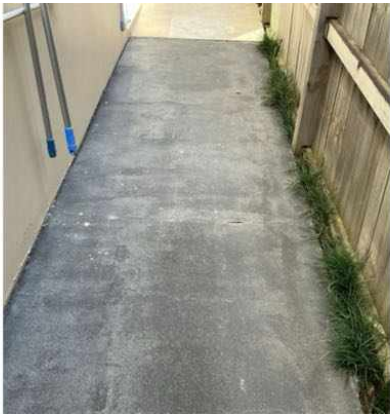
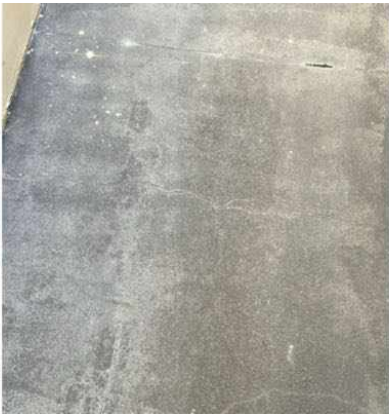
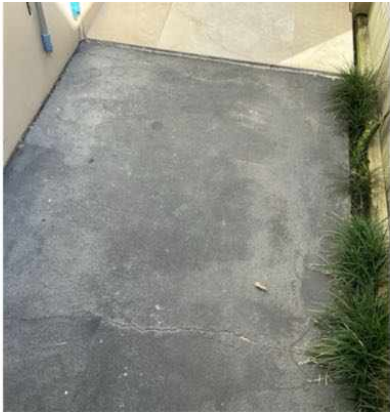
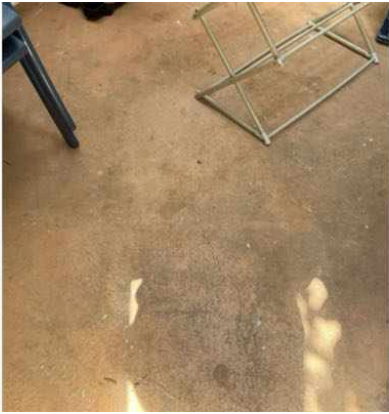
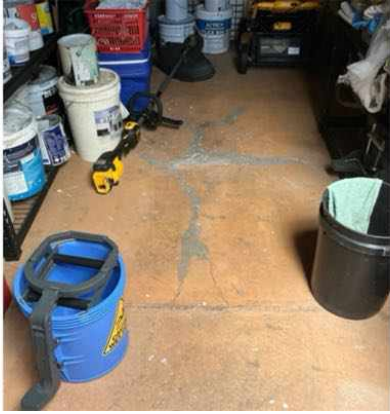
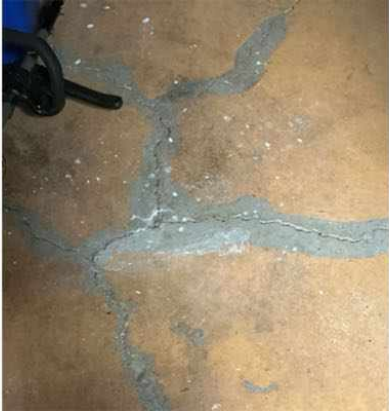
Building:	Main Building
Location:	All External Areas
Finding:	Cracking - External Concrete Paving Damage Category 4 - Gaps in Slab (4mm - 10mm +)
Information:	Gaps in the slab were identified in external concrete paving. Gaps in the slab are significant and are likely to lead to the development of safety hazards and secondary defects if left unmanaged, such as the creation of a trip hazard.

General age and expected deterioration of the paved areas is a common cause of this type of cracking. However, expansion and contraction of the slab may also have occurred due to environmental factors. Such factors include variable moisture and

weather conditions, the presence of trees and their roots having a settling or lifting affect on the soil, or the effect of load bearing, e.g. heavy vehicles over a sustained period of time.

Cracking to this degree may also be due to poor original installation of the concrete. Factors such as poor compaction of the sub surface and/or inadequate reinforcing of the slab may create cracking and other secondary defects. Gaps in the concrete paving may also have a more significant structural cause, such as subsidence of soils.

Where gaps in the concrete paving are adjacent to structural elements of the building, the advice of a Structural Engineer is advisable before undertaking repairs. Significant repair and likely replacement of the concrete paving is probable.
