Building and Timber Pest Inspection Report

Inspection Date: Thu, 12 Mar 2026

Property Address: 13 Gallipoli St, Condell Park NSW 2200, Australia

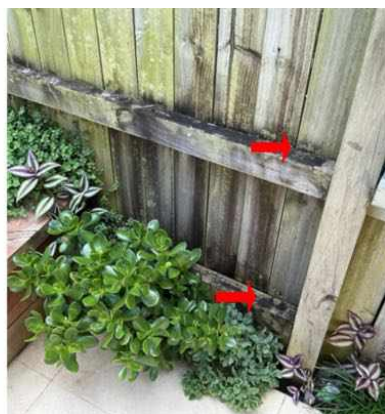
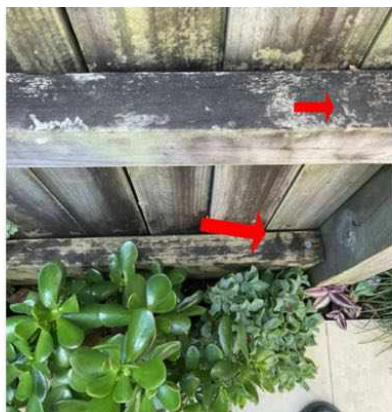
Finding 3.13

Building:	Main Building
Location:	All External Areas
Finding:	Wood rot to some areas
Information:	This building element shows evidence of wood rot. Wood rot, also known as Fungal Decay, occurs when timbers and other cellulose building materials are exposed to damp conditions on an ongoing basis. This could be the result of exposure to weathering over a prolonged period of time, or the attraction of excessive moisture from other abutting building materials. Contributing factors also include poor air ventilation in the area.

Wood rot is often associated with general damp problems and is evidenced by a 'musty' smell or mould and mildew occurring on surfaces. If left unmanaged, damp conditions can lead to further health problems and the decay of timbers will continue.

Early intervention and regular maintenance, particularly of exterior timbers, will prolong the useful life of these building elements. Prior to any works being performed, the cause of the moisture that has created the visible wood rot should be identified and addressed in a suitable manner. Replacement of affected timbers may then be a necessary step in protecting surrounding building elements from such deterioration.

A qualified plumber may be appointed to assess the cause of excessive moisture and to provide advice on any remedial works as required. A qualified carpenter or registered builder may also be required to replace affected building materials.

Even though Liverpool termite activity was not visible. A further invasive inspection by a licensed termite technician its also highly recommended to eliminate possibility of potential termite activity.

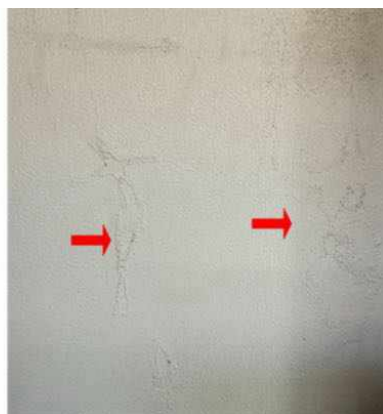
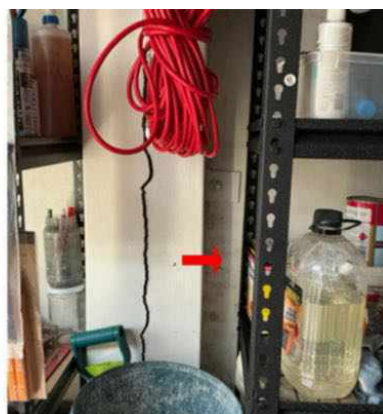
Finding 3.14

Building:	Main Building
Location:	All External Areas - Rear covered area
Finding:	Painted surface - Bubbling
Information:	Sections of paint in this area was found to have bubbled and deteriorated. Paint bubbling is generally an indication of excessive moisture in the area, that is currently hidden by the painted surface.

The presence of excessive moisture can have major implications on associated building elements if left unattended. While only seemingly minor at this stage, the damage cannot be determined due to the paint obstructing any further inspection of the damage.

It is highly advised that the affected paint be cleaned to allow a further, more invasive inspection by a licensed plumber. Failure to act on this defect may necessitate major works in the future.

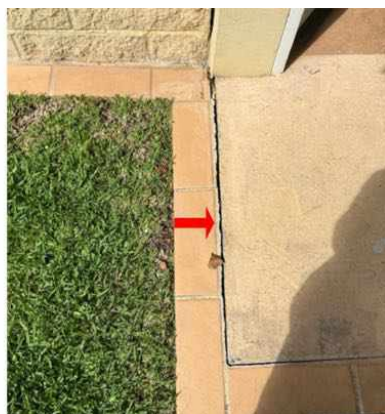
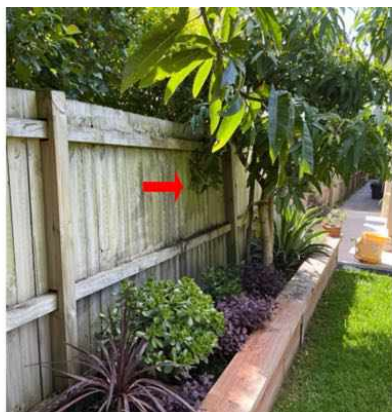
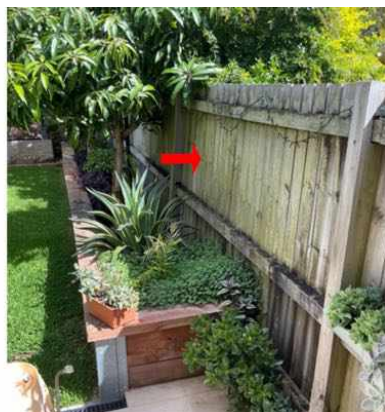
Finding 3.15

Building:	Main Building
Location:	All External Areas - rear , side
Finding:	Building element - Damaged - Paving separation , Fence leaning
Information:	Breakage occurs generally when the building materials have either aged and decayed, or as a result of damage (accidental or deliberate).

Repair and/or replacement of broken elements is advised to ensure that additional secondary defects do not arise as a consequence. Such works are necessary, as all building elements play a key role in the operation and function of the overall structure and its performance.

A relevant tradesperson should be appointed to repair or replace the affected building element prior to any subsequent damage being caused.

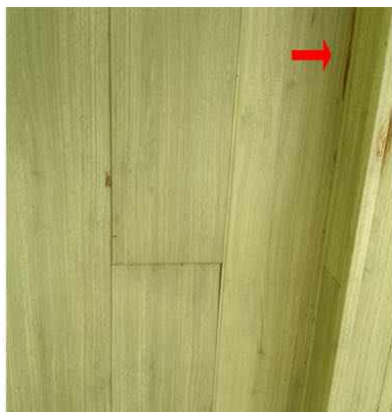
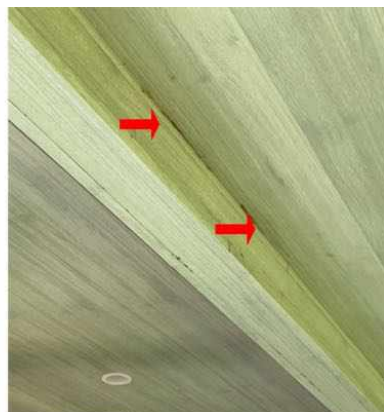
Finding 3.16

Building:	Main Building
Location:	All External Areas
Finding:	Incomplete or substandard works - Poor workmanship
Information:	The works to this area appear to be incomplete or have been completed to a substandard level.

Works that have not been completed to a satisfactory level create potential for the development of building defects and may impede on the safety and integrity of the overall structure.

It is highly recommended that the relevant trades be appointed to complete these works and ensure the safety of the area and the longevity of all associated building elements.

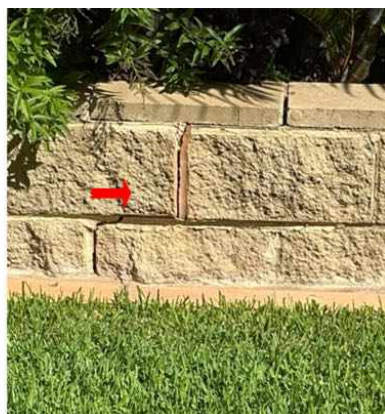
Finding 3.17

Building:	Main Building
Location:	All External Areas
Finding:	Retaining wall - Defective - Small planter wall cracking
Information:	The retaining wall in this area was found to be defective at the time of inspection. Generally, defective retaining walls are caused by poor original design or material use. However, deteriorated retaining walls may also be a result of substandard construction, poor site drainage or unmanaged stormwater flows.

If left unmanaged, the retaining wall may become a safety hazard if it continues to destabilise. Where retaining walls further rot and decay, an environment is created that is conducive to termite and pest infestation.

Significant repair and replacement should be expected. Where retaining walls are considered structural walls, a structural engineer / surveyor should be consulted regarding required remedial works. Otherwise, a landscaper or retaining wall installer may be appointed to repair or replace the wall, at the discretion of the client.

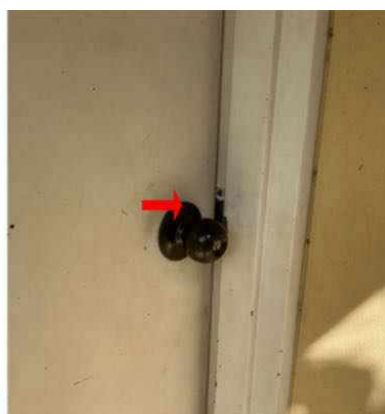
Finding 3.18

Building:	Main Building
Location:	All External Areas - Rear Shed
Finding:	Door - Binding/jamming
Information:	Binding and/or jamming of this door is evident during standard operation. This defect inhibits the functionality of the affected door as well as creating potential for secondary defects to associated building elements, such as damage to the floor covering.

A door that binds to flooring or to the associated door frame may have several causes, ranging from minor defects, such as poor installation of the door or deteriorated hinges, through to major structural issues, such as damage to subfloor structures.

Where door binding/jamming appears to indicate major structural issues, a registered builder specialising in re-stumping should be appointed to provide an estimate on the cost of rectification.

For minor causes, a qualified carpenter or general handyperson should be appointed to perform minor rectification works at client discretion.

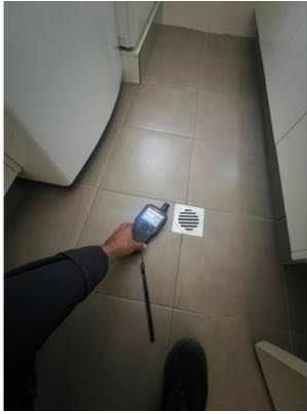
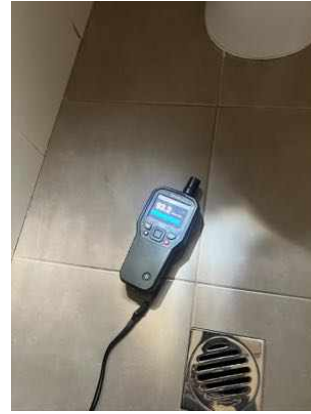
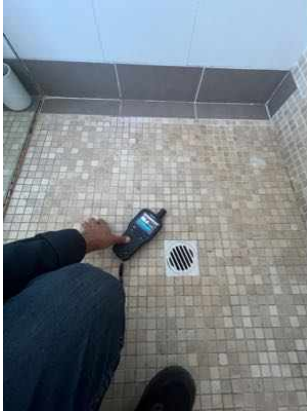
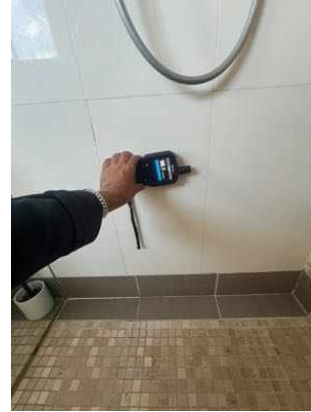
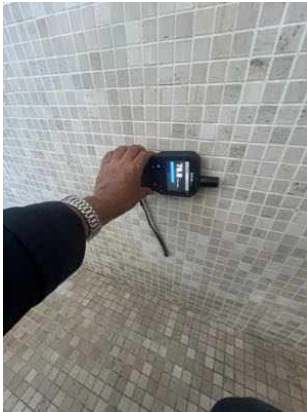
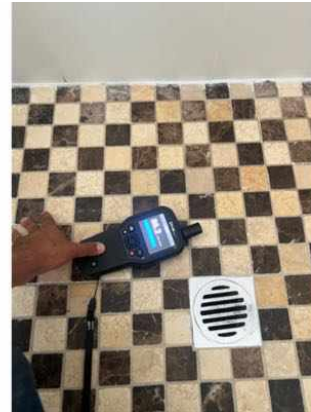
Finding 3.20

Building:	Main Building
Location:	Bathrooms & laundry
Finding:	Elevated Moisture Bathroom (No visible deterioration noted)
Information:	Elevated moisture levels were detected to tiled surfaces in bathroom/shower areas. Persistent moisture ingress can lead to concealed damage, including timber rot and mould growth.

Elevated moisture readings in tiled wet areas can occur from normal shower use, age/deterioration of waterproofing membranes, plumbing leaks or moisture absorption through grout lines. While no damage was visible, elevated readings may indicate moisture retention behind tiles, which can be a conducive condition for future deterioration if not monitored.

No immediate action required. Monitor the area over time for signs of drumming, efflorescence, tile movement, or grout deterioration. If concerns arise, a licensed waterproofing specialist can perform further investigation (e.g., pressure testing, membrane assessment).

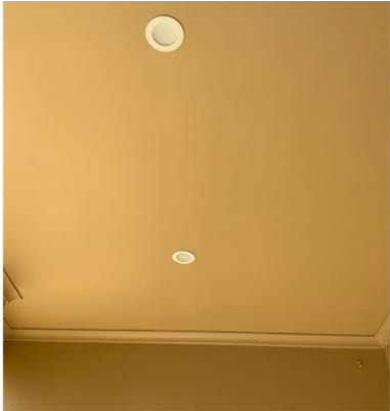
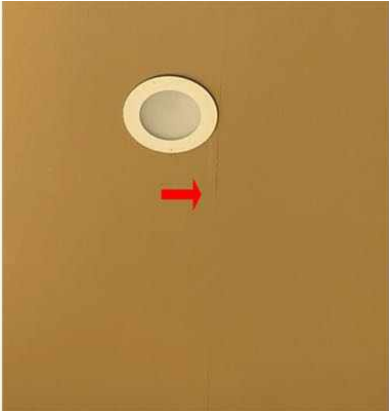
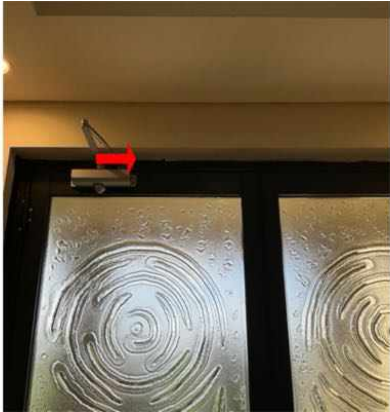
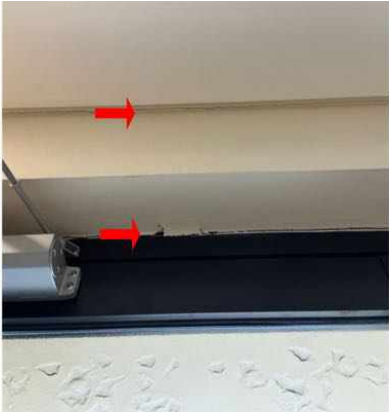
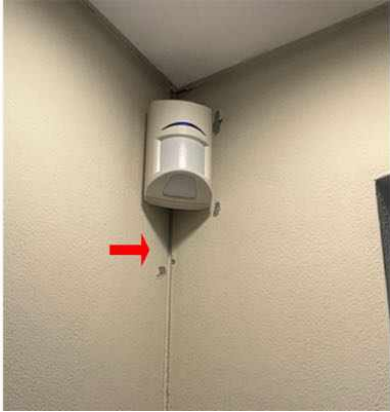
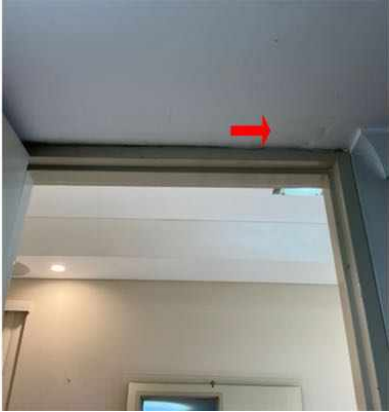
Finding 3.21

Building:	Main Building
Location:	All Internal Areas
Finding:	Paint Finish & Hairline Cracking - To some areas
Information:	The paint finish in this area was identified as being incomplete or substandard at the time of inspection including some hairline minor cracking/separation. Monitoring is recommended where cracking and separation is evident.

Whilst incomplete or missing paint finish is generally an appearance defect, it can also lead to the development of secondary building defects over time. Incomplete areas of paint finish expose the area to moisture, potentially accelerating the deterioration of underlying building materials.

Incomplete paint finishes should be sanded back, filled, leveled and painted, as applicable. Where inadequate or missing paint protection has led to the deterioration of the associated building element, repair and/or replacement of this building element may be required.

A painting contractor should be appointed as soon as possible to perform necessary works to aid the appearance of the affected area and to ensure the area is protected against further deterioration. Alternatively, the homeowner following manufacturer instructions may perform these works.

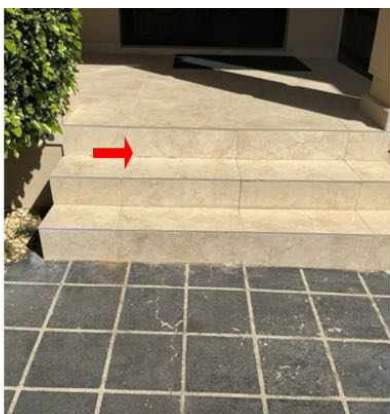
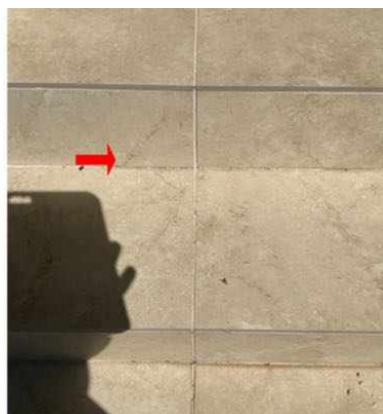
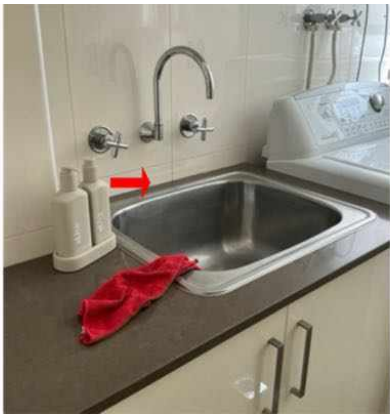
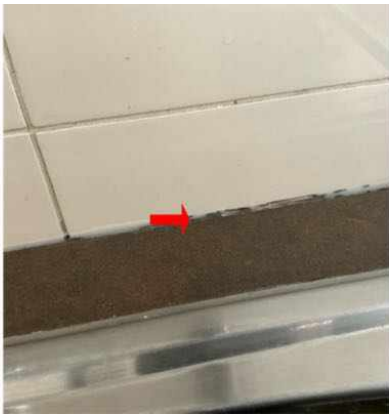
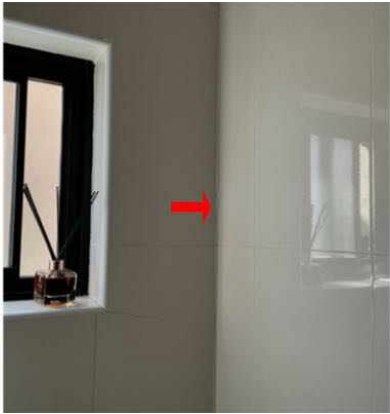
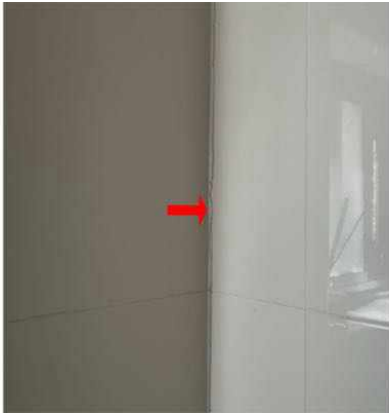
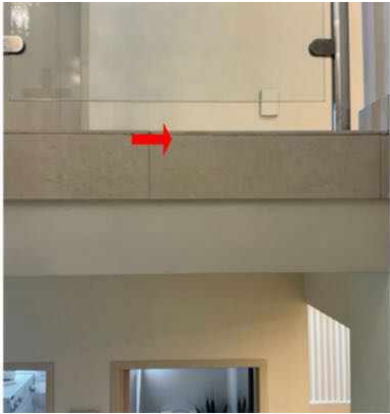
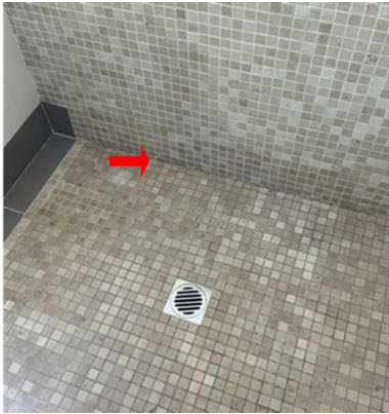
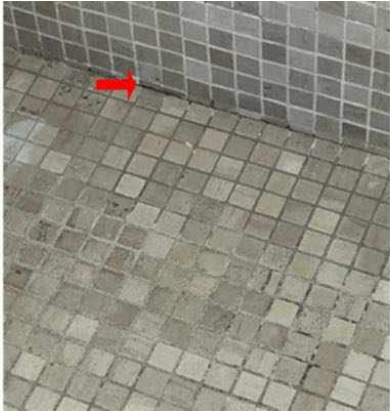
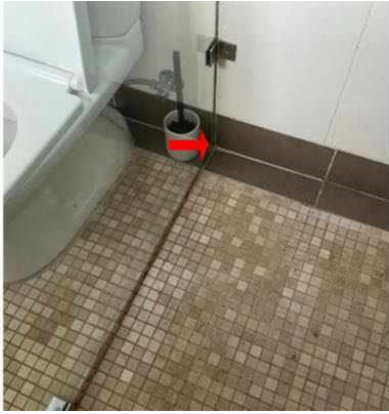
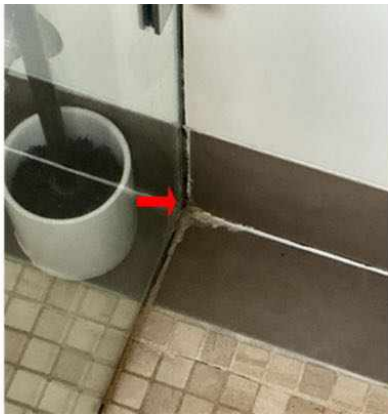
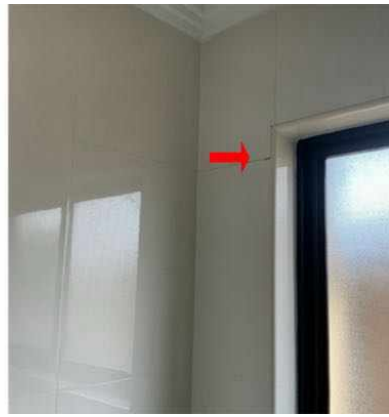
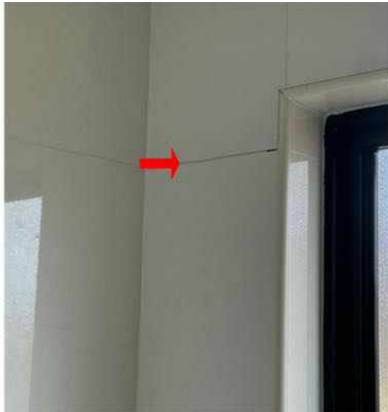
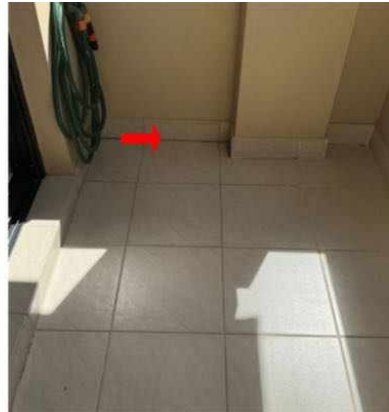
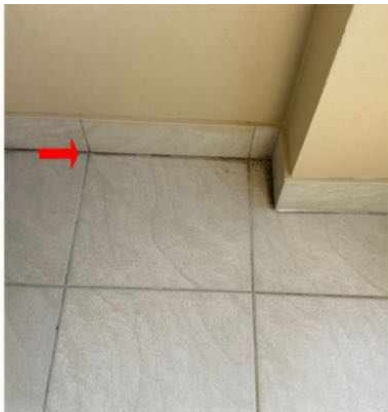
Finding 3.22

Building:	Main Building
Location:	All Internal Areas
Finding:	Sealant and grouting - Missing or degraded to some areas
Information:	It was noted on inspection that sealant or grout is degraded.

Different materials and floor areas move at different rates, generally causing cracking to grout or sealant at this point. A flexible sealant is required to allow for expected expansion and contraction, while keeping the joint water tight and protective of all associated building materials.

Excessive mould to the sealant and grout may require scraping out and replacement.

Flexible and mould resistant materials should be applied to affected areas to prevent any subsequent water damage that is likely to occur. Regular maintenance and replacement of damage or missing or damaged sealant and grout is highly recommended to the wet areas, as this is a regular wear and tear defect. Sealant and grouting in areas that come into regular contact with water should be maintained for the long term care of your property.

A sealant specialist or tiling contractor should be appointed to complete these works as soon as possible

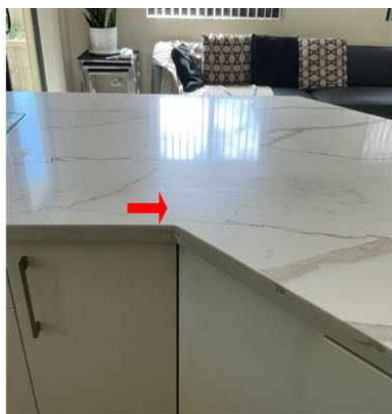
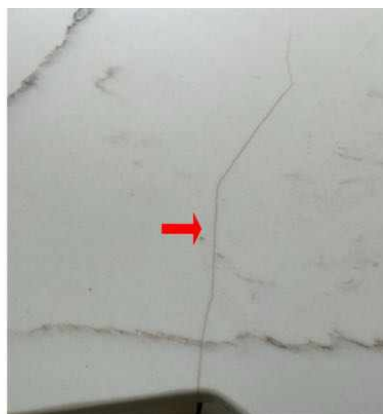
Finding 3.23

Building:	Main Building
Location:	All Internal Areas
Finding:	Building element - Damaged - Benchtop cracked
Information:	Breakage occurs generally when the building materials have either aged and decayed, or as a result of damage (accidental or deliberate).

Repair and/or replacement of broken elements is advised to ensure that additional secondary defects do not arise as a consequence. Such works are necessary, as all building elements play a key role in the operation and function of the overall structure and its performance.

A relevant tradesperson should be appointed to repair or replace the affected building element prior to any subsequent damage being caused.

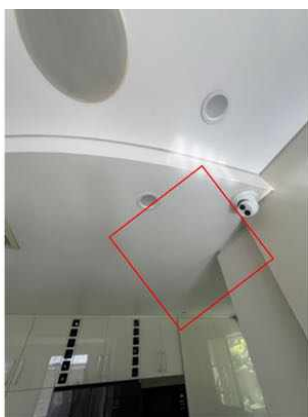
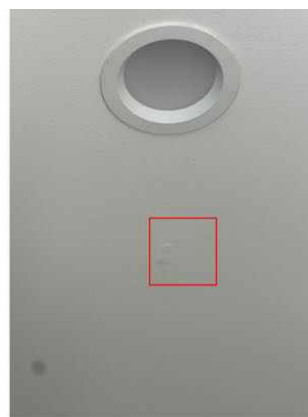
Finding 3.24

Building:	Main Building
Location:	All Internal Areas
Finding:	Ceiling nails - Popping To some areas
Information:	Numerous popped nails were identified in the internal ceiling at the time of inspection. Nails and screws hold simply by the friction between them and the surface they are applied to. Over time, the nails and screws can back out, which is often a result of general ageing and deterioration of the building structure.

If left unmanaged, the ceiling sheets may become loose and unstable, increasing the rate of deterioration of the internal ceiling and creating potential for the development of secondary defects.

Re-fastening of popped nails will help to maintain the stability of the internal ceiling and associated building elements. Such minor works will also help to improve the appearance of the affected area and secure the ceiling sheets, so as to prevent the onset of ceiling sagging. These works should be performed by a qualified carpenter or plasterer at client discretion.

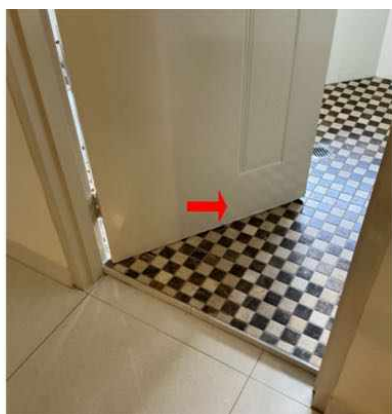
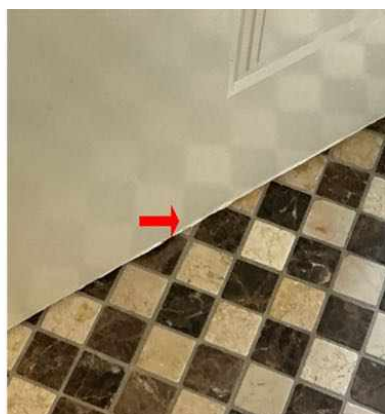
Finding 3.25

Building:	Main Building
Location:	All Internal Areas
Finding:	Delamination of timbers
Information:	Localised delamination and surface deterioration were observed to sections of laminated joinery panels. This condition commonly occurs where moisture exposure or wear causes separation of laminate finishes from the underlying substrate. The defect is generally cosmetic in nature but may worsen over time if moisture exposure continues. Repair or replacement of affected joinery components may be considered as part of routine maintenance.

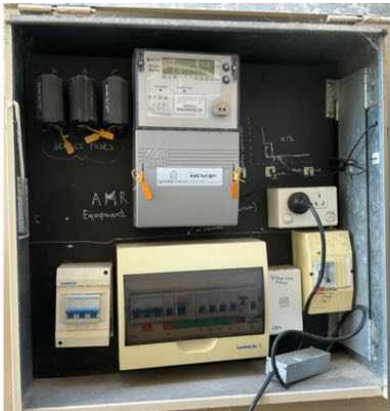
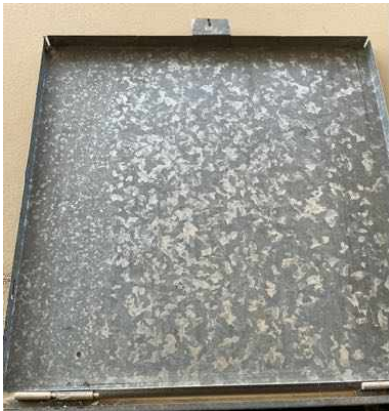
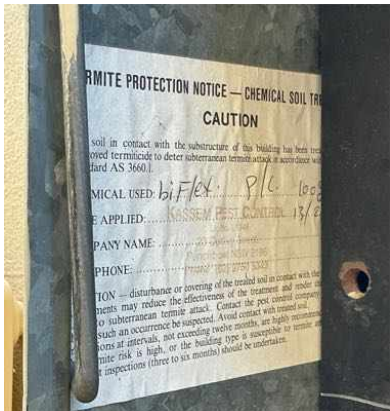
Building: Main Building
 Location: All External Areas
 Finding: Termite Management System - no evidence of a chemical installation
 Information: The application of a post-construction chemical termite barrier is highly recommended for all properties, particularly if live termite activity has been found on the site previously. Such barriers are highly effective in preventing termite attack on any timber building elements throughout the property.

A durable notice should be placed in the switchboard unit to indicate current termite barriers. At the time of inspection, it appeared as though no termite management system has been installed, with no evidence to suggest preventative works taking place.

The client may consider gaining further advice from a pest controller as to the costs and procedures involved with this application. It is recommended that obtaining such advice be a short-term priority.

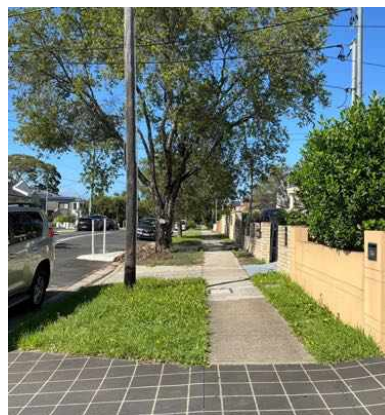
Finding 6.02

Finding:	Trees within 50m
Information:	Trees within 50m of the property can be conducive to termite activity. It is recommended an invasive inspection of all trees within 50m to the property be carried out by a qualified pest control expert.

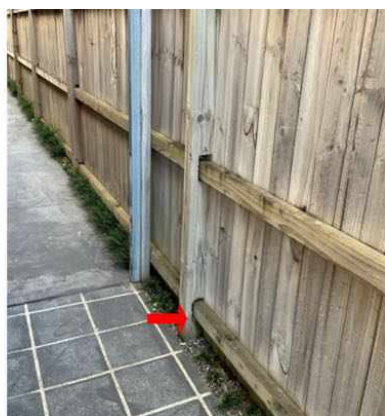
Building:	Main Building
Location:	All External Areas
Finding:	In ground contact - Timber
Information:	Any timbers in direct ground contact provide opportunity for concealed termite entry and are likely to be subject to premature rot and decay as the soil retains moisture or damp conditions against the timbers.

Remove untreated timber that is in direct contact with external grounds. Consider replacement with more durable materials i.e. treated timber or non timber elements. Frequent pest inspections are advised to readily identify any termite activity in these areas.

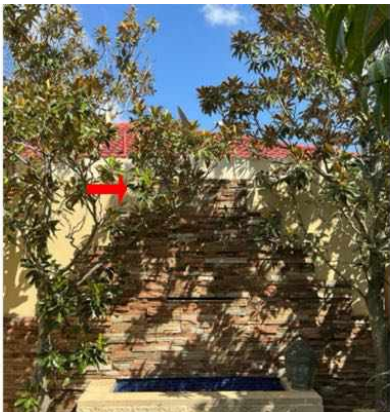
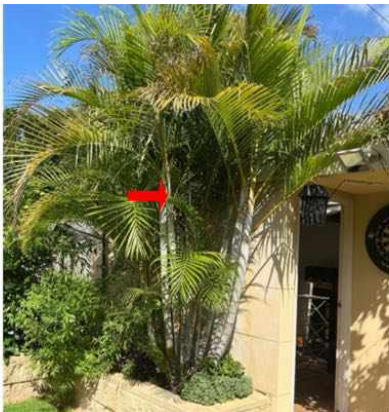
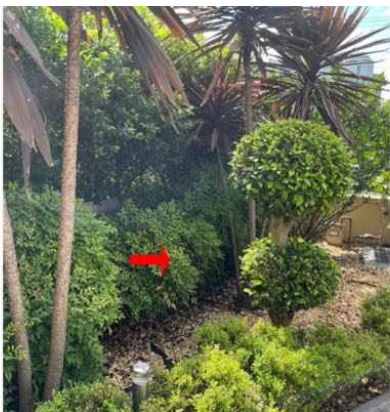
Finding 6.05

Building:	Main Building
Location:	All External Areas
Finding:	Bridging - Vegetation
Information:	Where vegetation obstructs inspection of building elements, also known as bridging as it provides a bridging point for the access of termites, full inspection can not be achieved. Consequently moisture or dampness may be present and the areas becomes conducive to termite activity. Plants against or very close to buildings

The removal and replanting of species that do not provide "cover" or cutting back of existing vegetation will assist greatly in preventing Bridging from occurring.

The removal of any such materials that may be conducive to termite activity should be carried out as soon as possible and arrange re inspection to minimize the risk of termite attack.

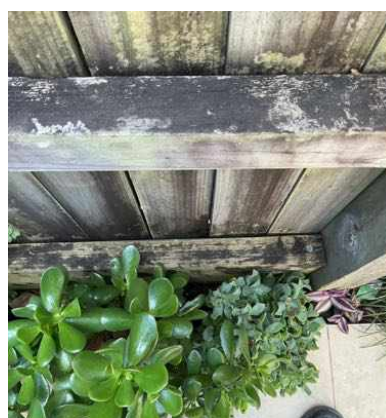
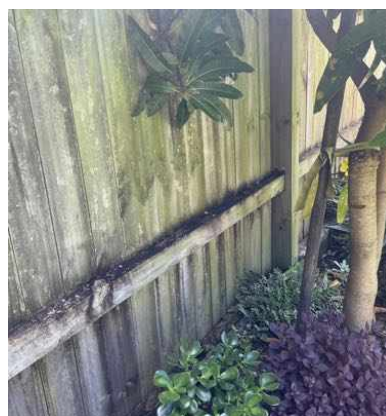
Finding 7.01

Building:	Main Building
Location:	All External Areas
Finding:	Fungal decay - present
Information:	Fungal decay also known as wood decay or wood rot generally refers to the deterioration of timber elements when in contact with excessive levels of moisture for a prolonged period of time.

The development of fungal decay is accelerated by temperatures in the range of 5degreeC to 40degreeC as well as the presence of oxygen. Generally fungal decay develops on timber elements that are in use in an external environment which are exposed to rain penetration.

In this case although the affected timber element is in a decaying state the extent of any visible damage appears to be localised to a specific area and is yet to spread to other parts of the building element or affect adjoining structures. The fungal decay is therefore likely to be of a relatively superficial nature with minimal impact on the structural integrity or tensile strength of the timber element.

A further invasive inspection by a licensed timber pest technician is highly recommended to check for concealed activity.

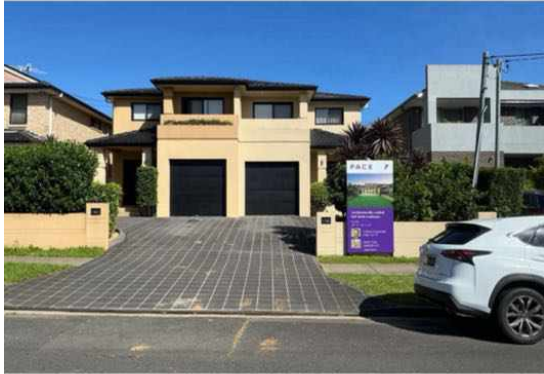
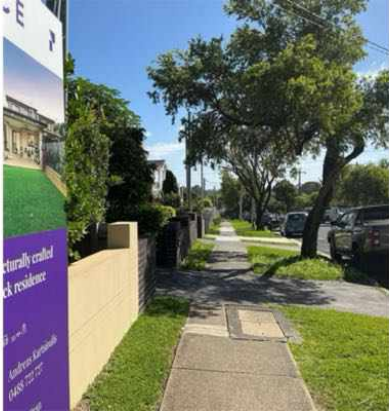
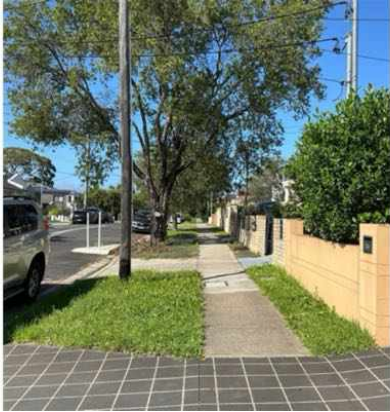
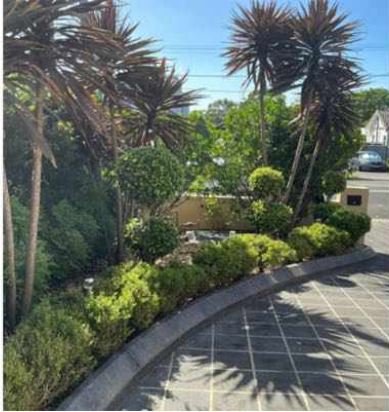
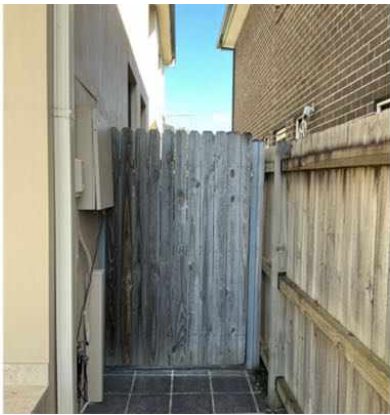
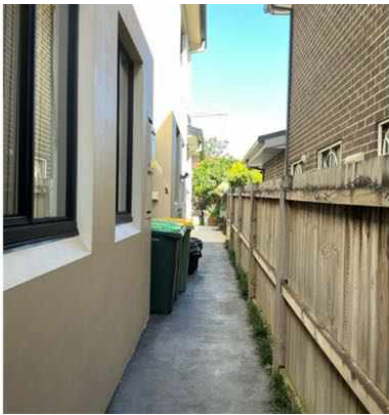
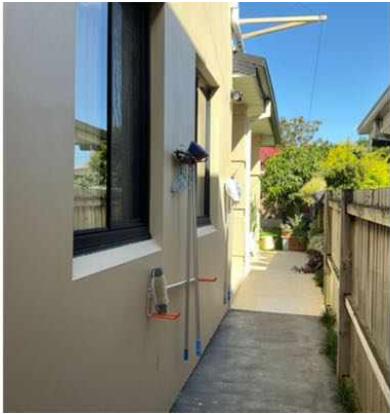
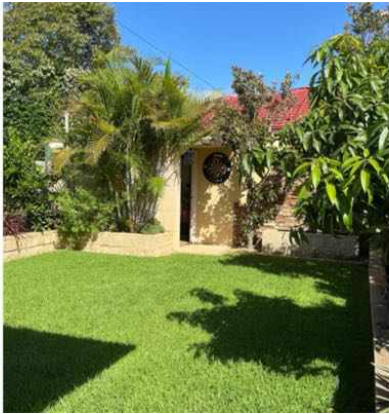
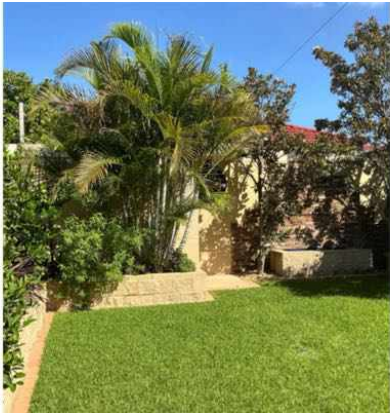
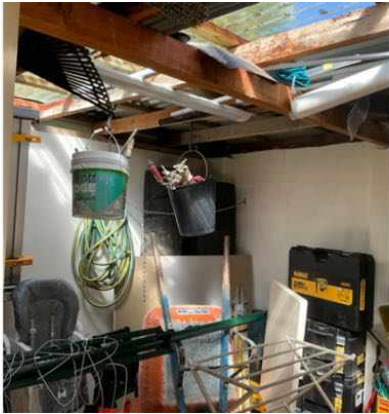
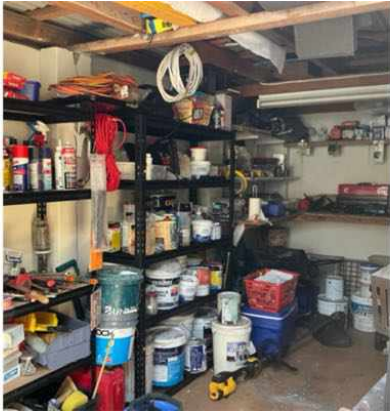
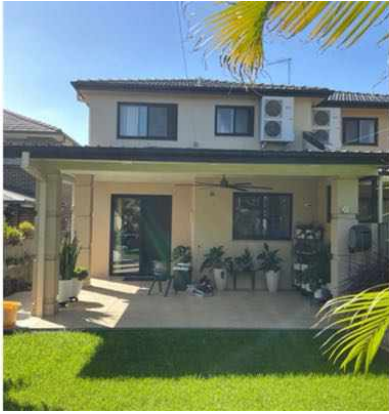
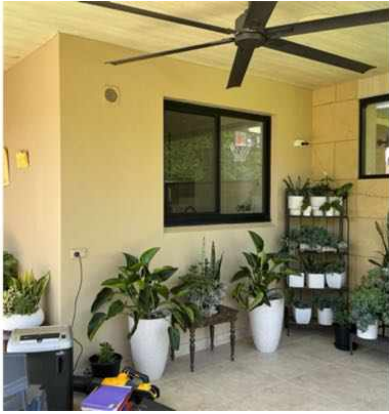
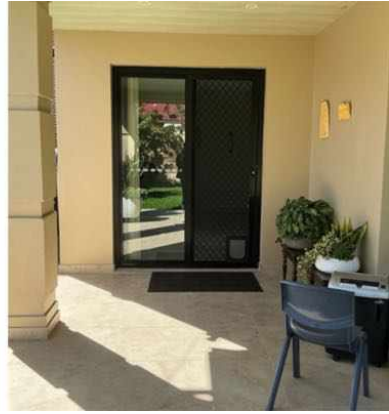
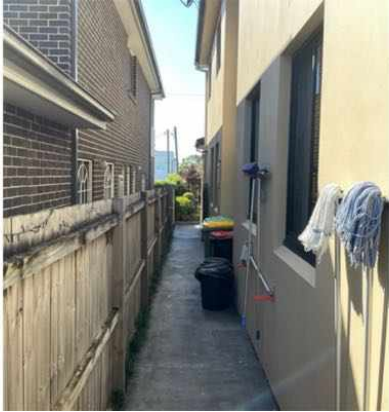
Building: Main Building
Location: All External Areas
Finding: Additional Photos - Obstructions and Limitations
Information: These photographs are an indication of the obstructions and limitations which impeded full inspection of the property at the time of inspection. These obstructions can hide an array of defects and should be removed to allow full inspection to be carried out. A re-inspection is recommended once the areas are made accessible.

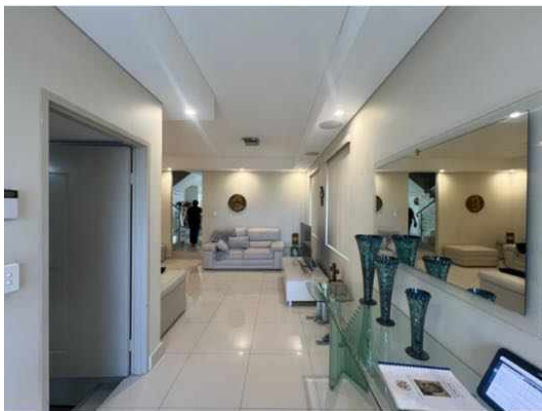
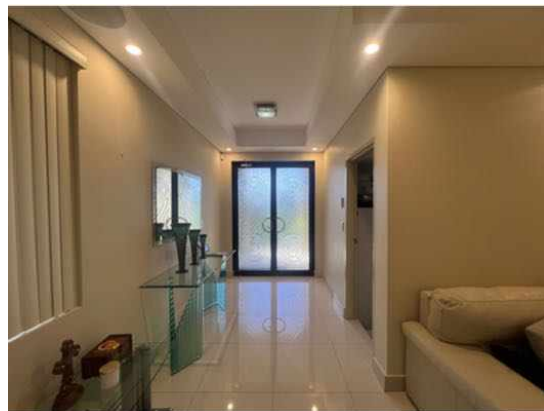
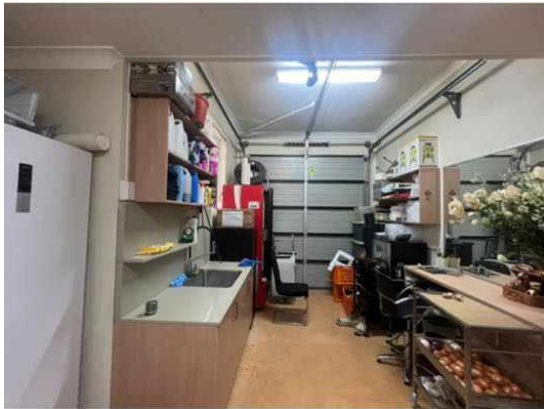
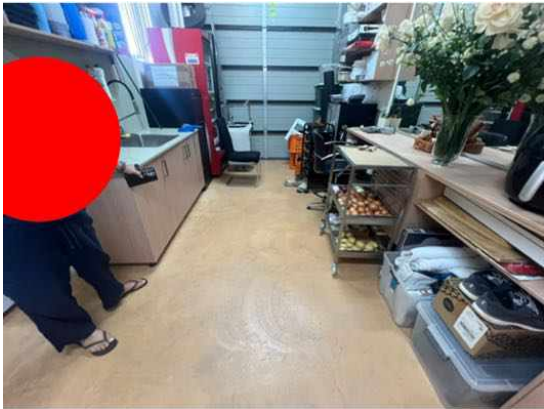
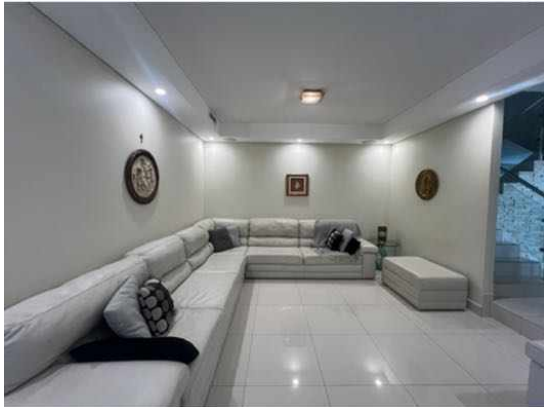
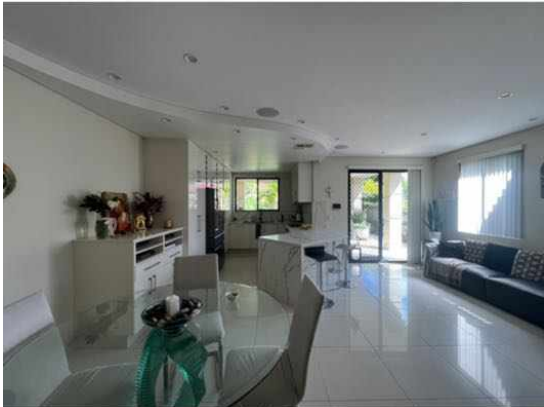
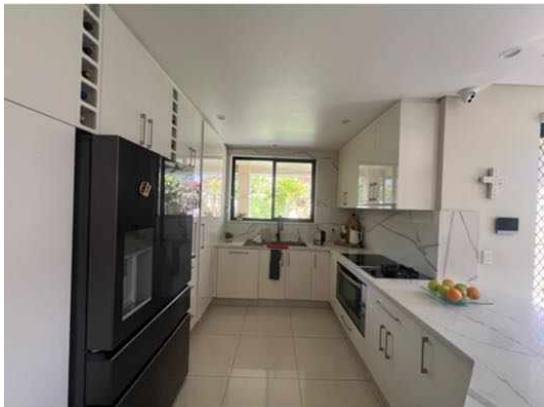
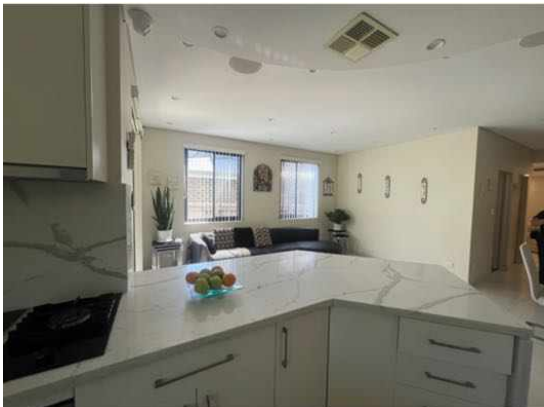
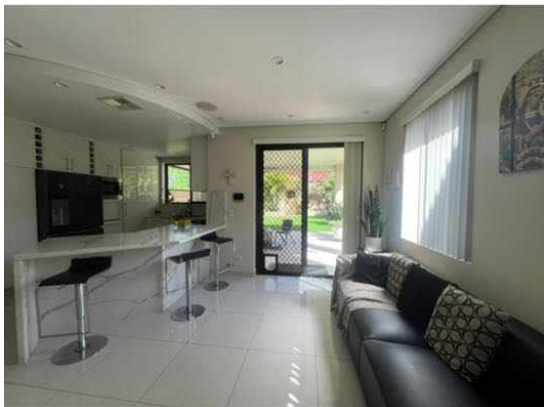
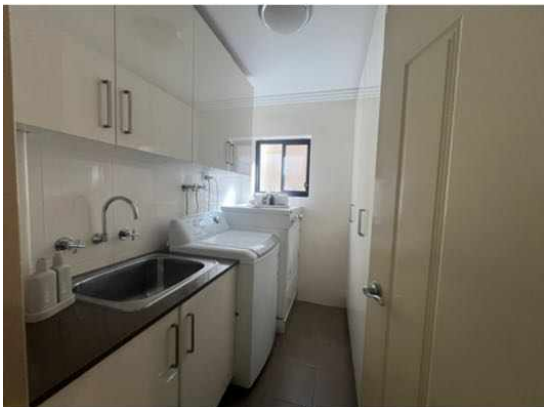
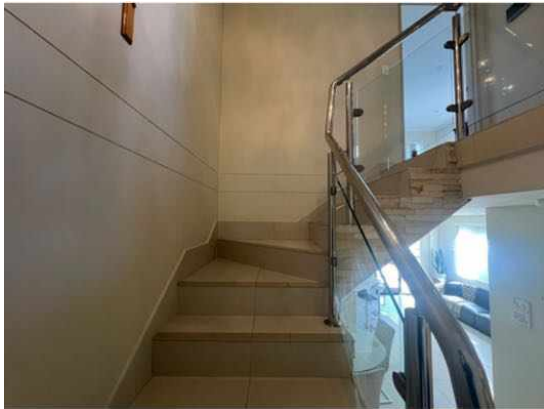
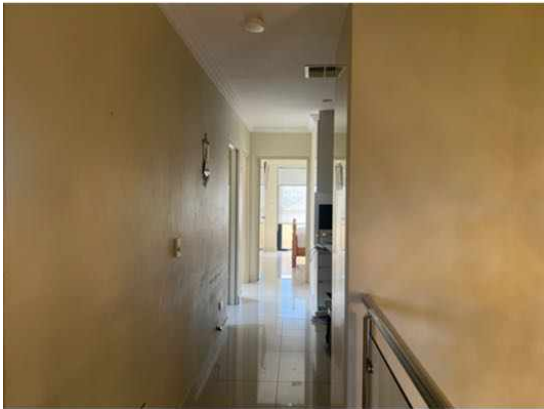
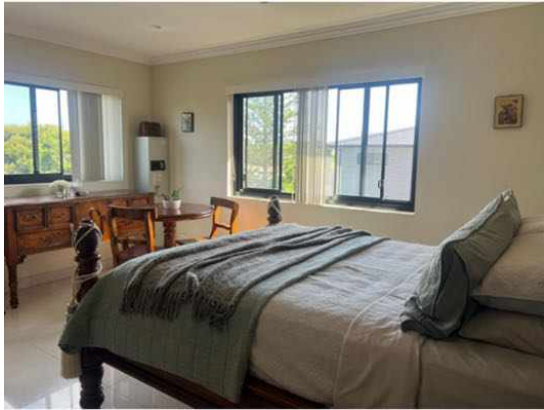
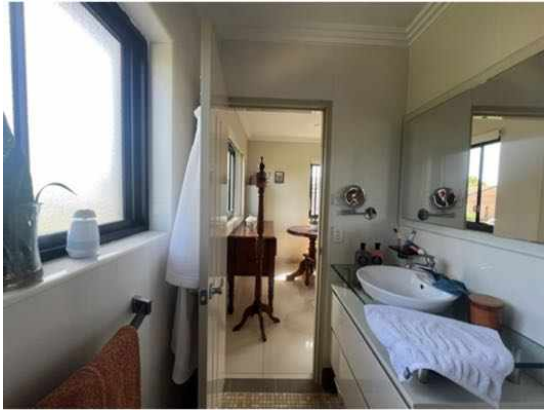
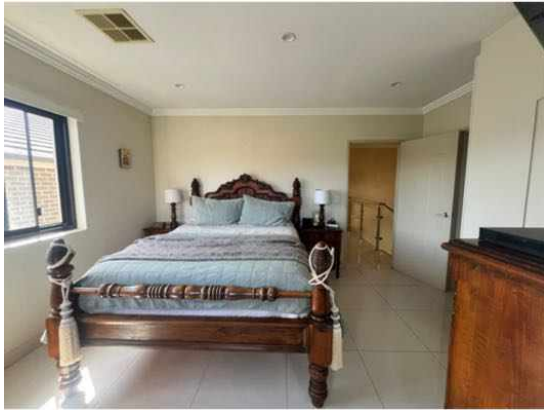
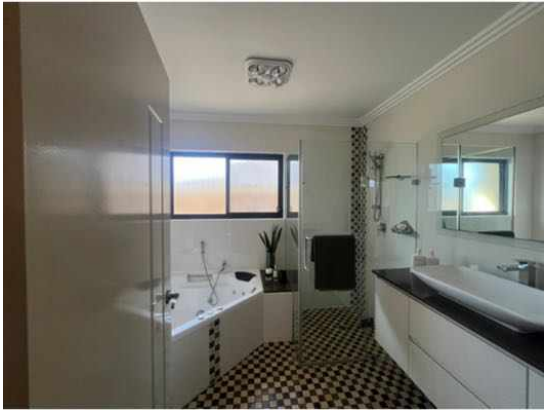
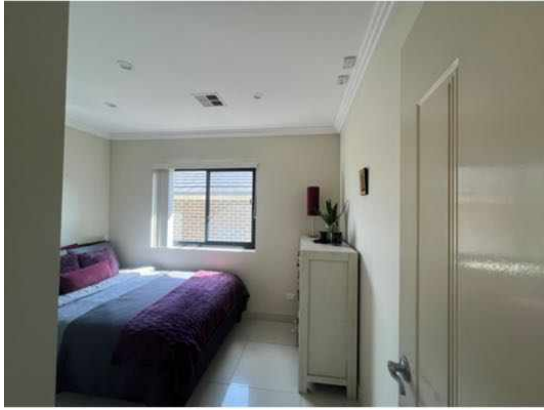
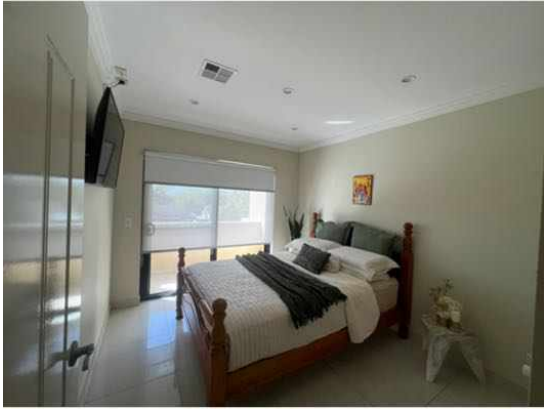
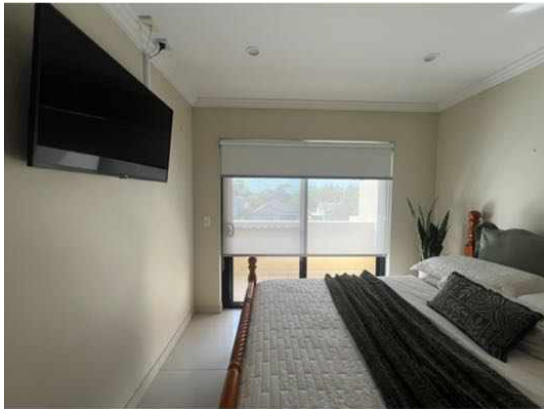
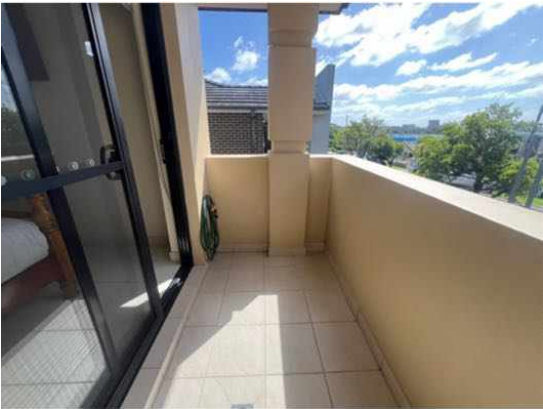
Building: Main Building
 Location: All Internal Areas
 Finding: Additional Photos - Obstructions and Limitations
 Information: These photographs are an indication of the obstructions and limitations which impeded full inspection of the property at the time of inspection. These obstructions can hide an array of defects and should be removed to allow full inspection to be carried out. A re-inspection is recommended once the areas are made accessible.

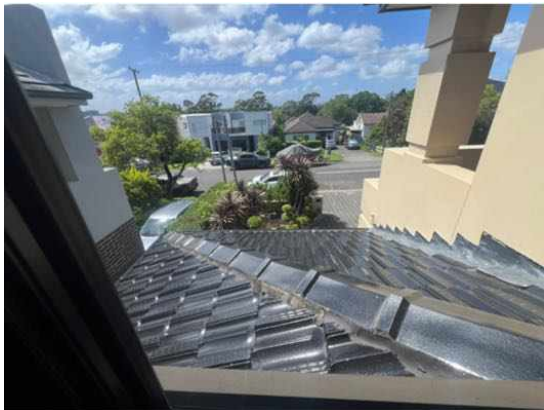
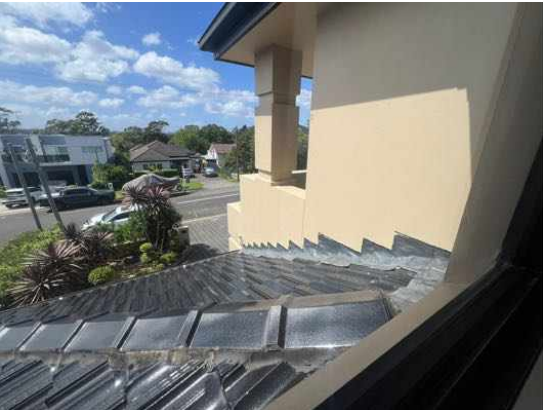
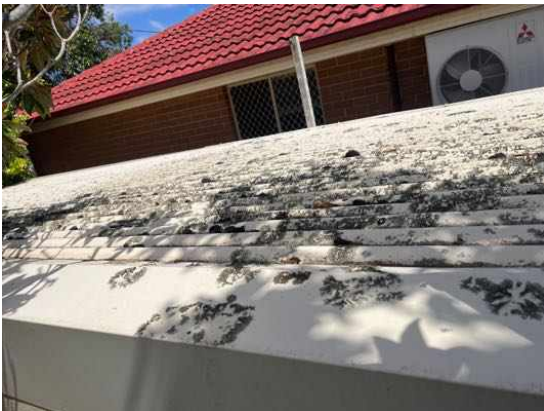
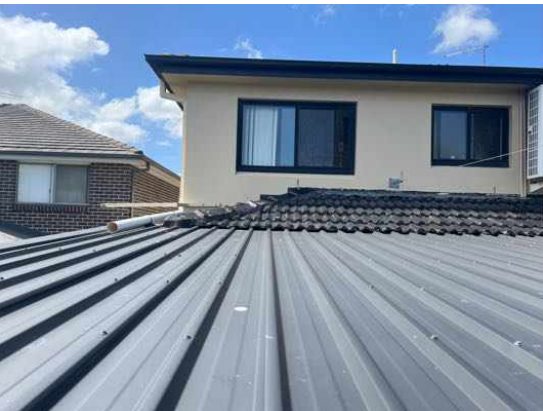
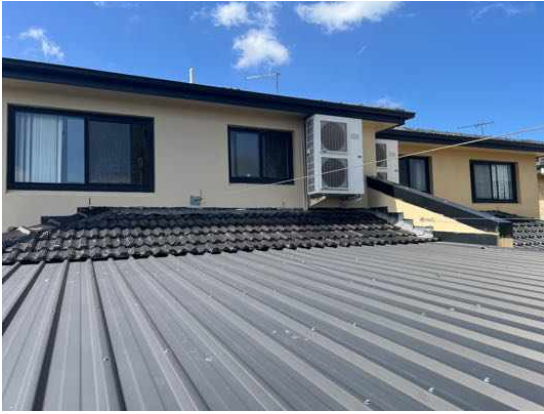
Building: Main Building
Location: Roof Exterior
Finding: Additional Photos - Obstructions and Limitations
Information: These photographs are an indication of the obstructions and limitations which impeded full inspection of the property at the time of inspection. These obstructions can hide an array of defects and should be removed to allow full inspection to be carried out. A re-inspection is recommended once the areas are made accessible.

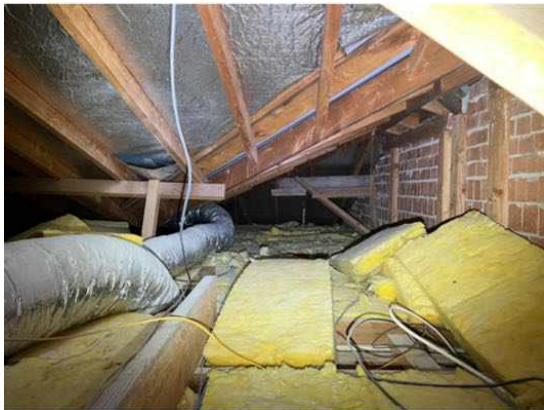
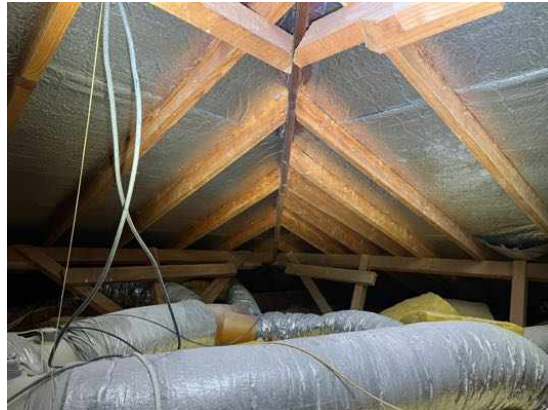
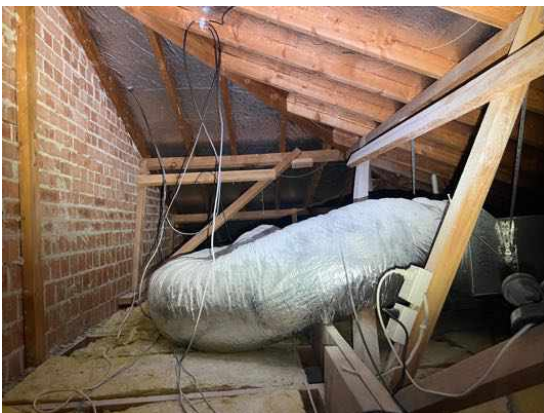
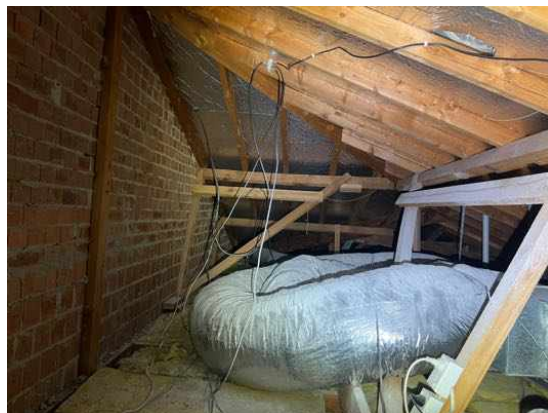
Building: Main Building
 Location: Roof Void
 Finding: Additional Photos - Obstructions and Limitations
 Information: These photographs are an indication of the obstructions and limitations which impeded full inspection of the property at the time of inspection. These obstructions can hide an array of defects and should be removed to allow full inspection to be carried out. A re-inspection is recommended once the areas are made accessible.

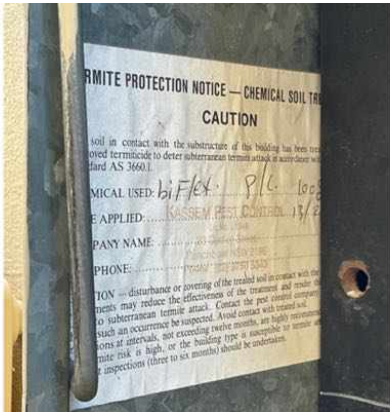
Where a Termite Management System has been identified you should refer to the type of barrier date of installation warranty conditions and any documentation provided by a builder or past owner. Consult the company who installed the barrier to confirm whether the system is still under warranty.

Most chemical termite management systems expire and require replenishment and all physical systems are primarily designed to prevent concealed entry.
