## Building and Timber Pest Inspection Report

Inspection Date: Fri, 30 Jan 2026

Property Address: Unit 1/33 Windermere Ave, NORTHMEAD,  
NSW, 2152, Australia

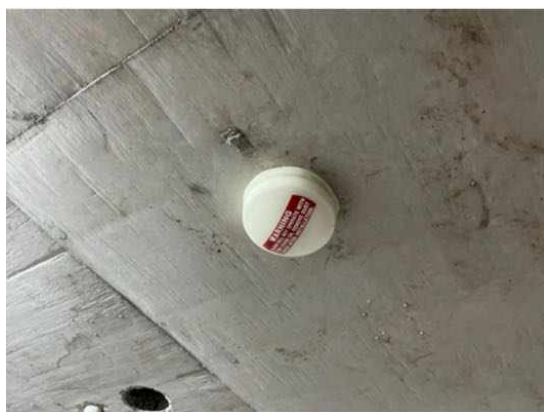
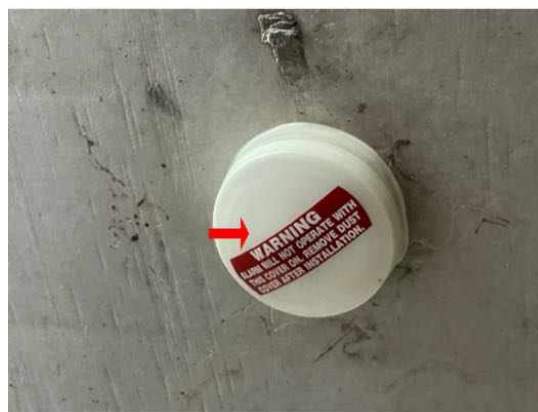
#### Finding 1.01

Building:	Main Building
Location:	Garage > Lower-Ground Level
Finding:	Smoke Detectors and Alarms
Information:	A smoke alarm installed within the garage was noted to have a cover fitted that stated it should be removed, as the alarm would not operate correctly with the cover in place. The presence of this cover may impair the function of the smoke alarm and reduce its effectiveness in detecting smoke. Assessment of smoke alarm compliance and correct installation is outside the scope of this inspection; however, given the potential safety implications, it is recommended that a licensed electrician be engaged to inspect all smoke alarms, remove any incorrect covers, and confirm that the system is installed, operating and compliant with the relevant requirements.

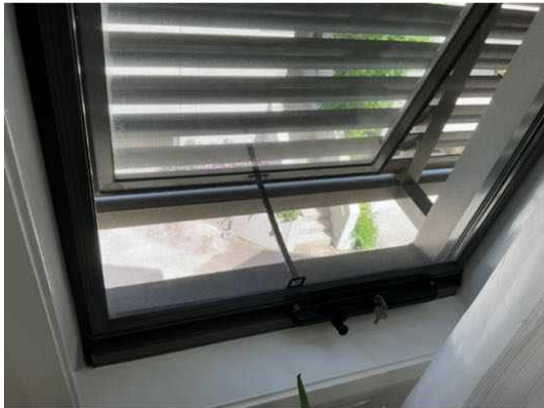
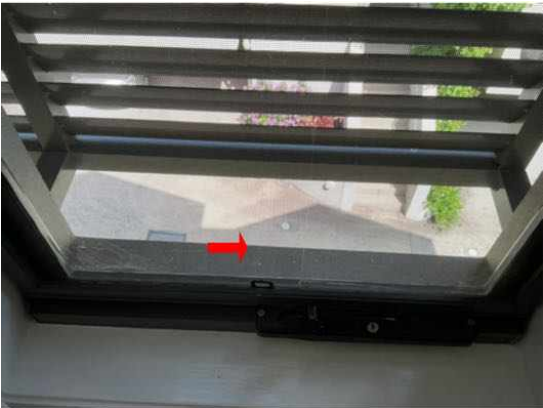
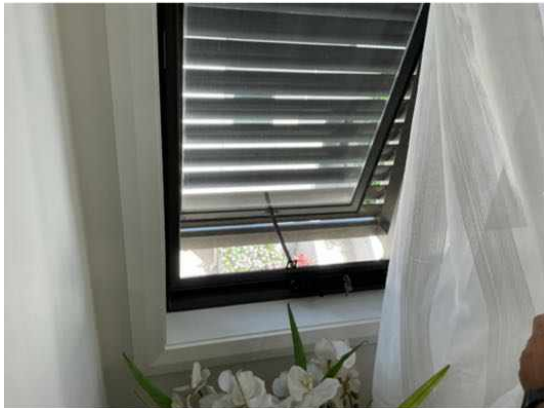
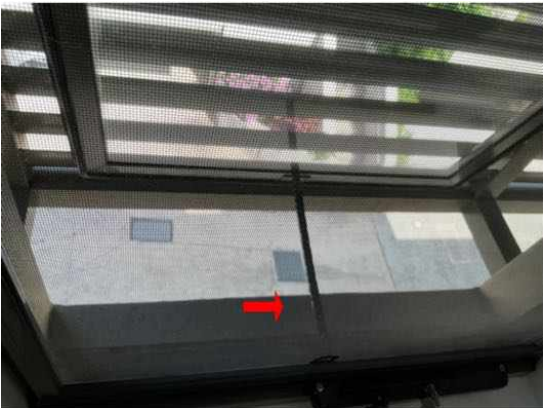
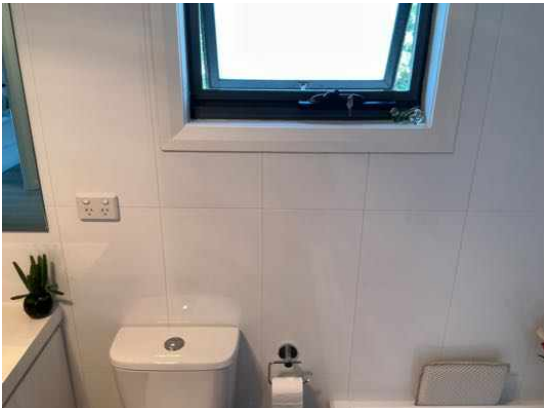
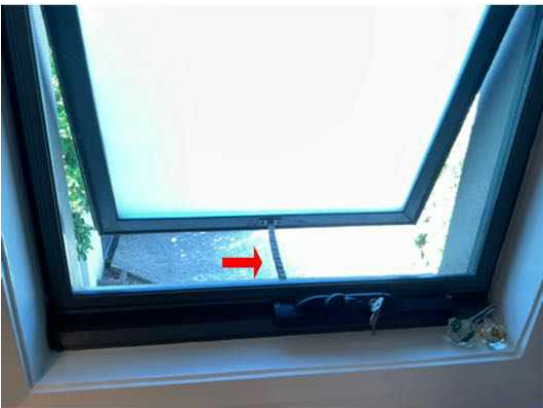
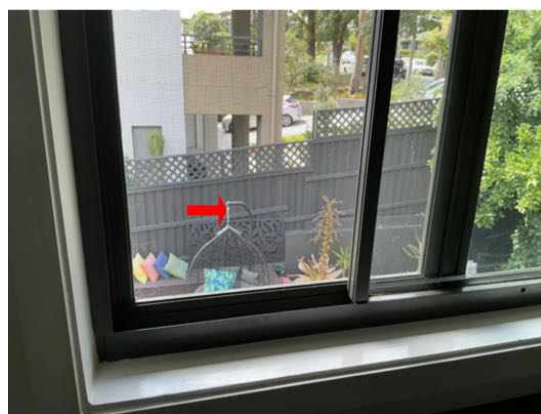
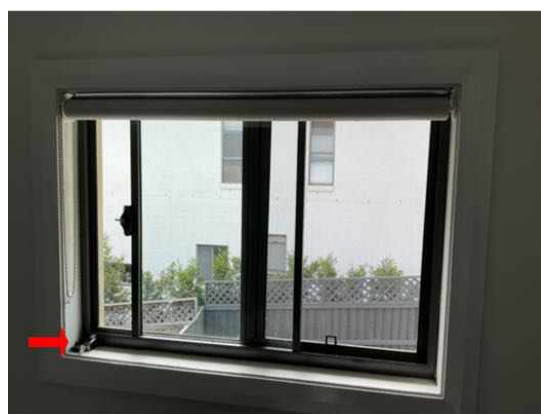
#### Finding 1.02

Building:	Main Building
Location:	All Areas > Upstairs
Finding:	Safety hazard - Window restrictors.
Information:	At the time of inspection, window restrictors were not present on one or more openable windows in the second-level.

The absence of window restrictors in this location presents a potential fall hazard, especially for children or vulnerable occupants.

It is recommended that a licensed window installer or builder be engaged to assess

the windows and install compliant restrictors where required.

This issue should be rectified as a priority to ensure occupant safety

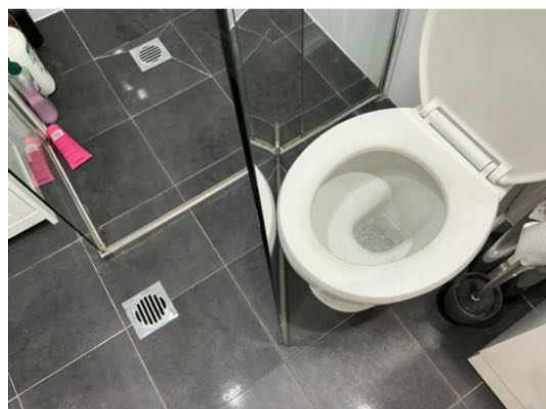
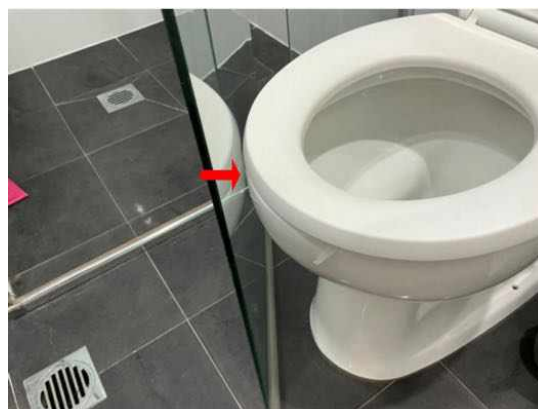
### Finding 1.03

Building:	Main Building
Location:	Ensuite > Upstairs
Finding:	Shower Screen - Safety Hazard.
Information:	The shower screen to the ensuite bathroom was noted to impact the front of the toilet during normal operation at the time of inspection. This condition indicates inadequate clearance and/or incorrect installation of the shower screen and presents a safety hazard, as contact during operation may result in damage to the screen, toilet fixture, or injury to occupants. Continued use in this condition may also lead to glass breakage or loosening of fixings over time.

It is recommended that a suitably qualified glazier or contractor be engaged to adjust,

reposition or modify the shower screen to provide adequate clearance and ensure safe operation. This matter should be addressed as a priority due to the safety risk.

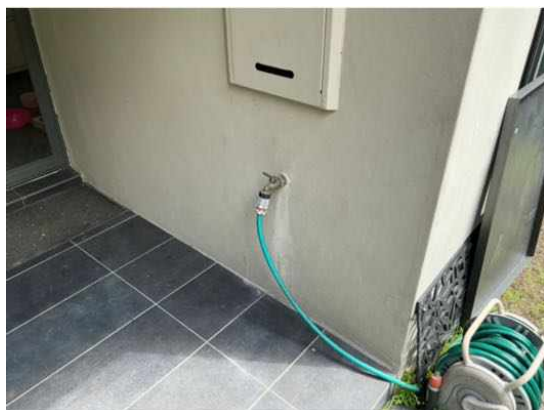
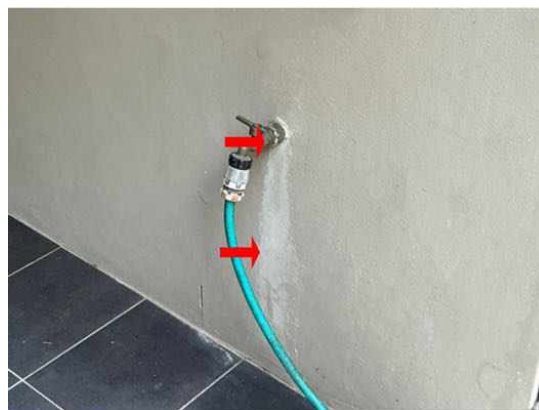
Building: Main Building  
 Location: Alfresco > Rear  
 Finding: Water leak - External  
 Information: Water leaks were found to be present to exterior plumbing work. Leaks are generally caused by deterioration of the plumbing elements over time, due to exposure to weather conditions, but may have also been caused by minor impact damage.

Such leaking creates damp conditions in the affected area, causing potential for water pooling and subsequent water damage if left unattended. These conditions may also attract termite attack, particularly if the area is subject to minimal levels of sun throughout daylight hours.

It is highly advised that a licensed plumber be appointed to rectify any water leaks that may be present. Areas of repair and replacement of plumbing fittings and fixtures may be required and, as such, a quotation should be sought.

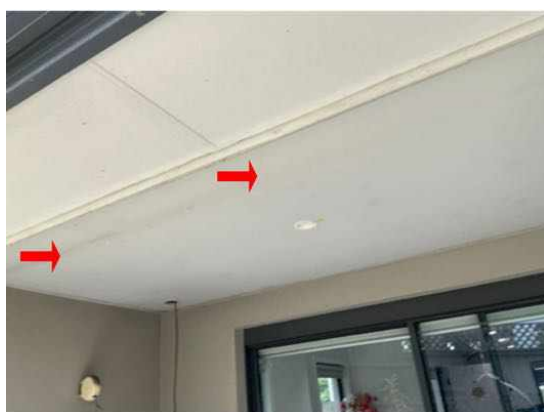
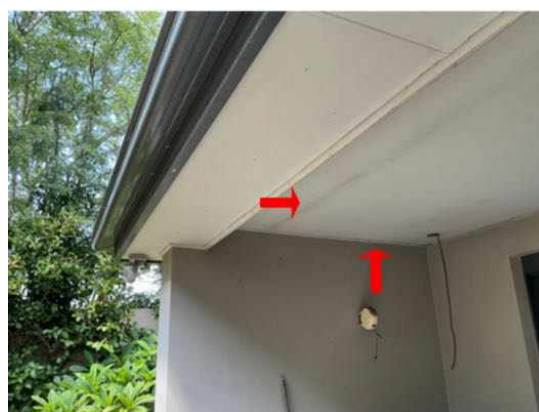
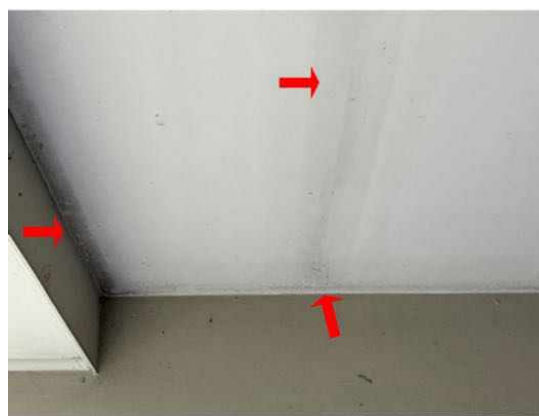
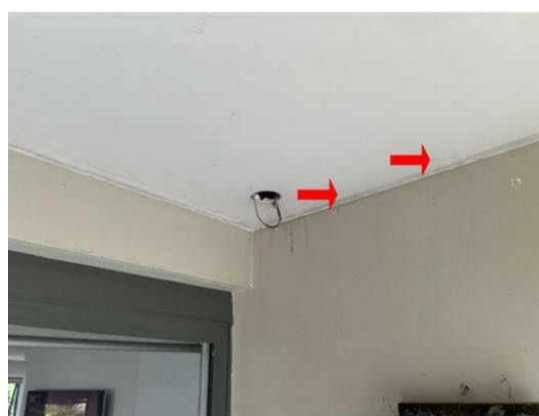
### Finding 3.02

Building:	Main Building
Location:	Alfresco > All Areas
Finding:	Mould on alfresco ceiling
Information:	Mould growth was noted along the plaster setting lines to the alfresco ceiling at the time of inspection. This type of mould formation commonly occurs where moisture affects the plaster setting compounds, which are more porous than the surrounding plasterboard surface and therefore more susceptible to moisture absorption. Alfresco areas are particularly prone to this condition due to exposure to humidity, condensation and wind-driven moisture. The pattern of mould growth along the setting lines suggests that the surface may not have been adequately prepared or sealed prior to painting.

Where setting compounds are not properly sealed or primed, moisture can permeate into the plaster, creating conditions conducive to mould growth. The application of a suitable sealing or oil-based primer prior to painting is generally required to isolate the setting compound, reduce moisture absorption and minimise the risk of mould reoccurrence.

It is recommended that the affected areas be cleaned, treated for mould, appropriately sealed with a suitable primer and repainted to reduce the likelihood of ongoing mould formation.

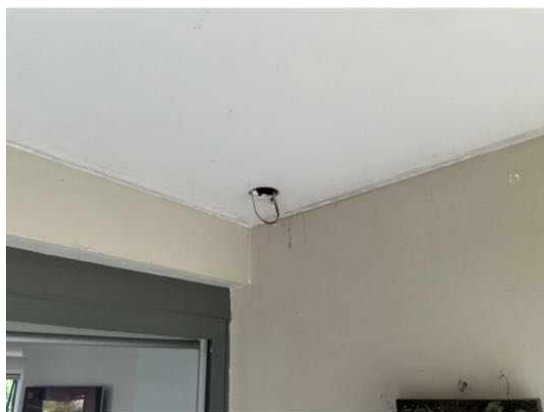
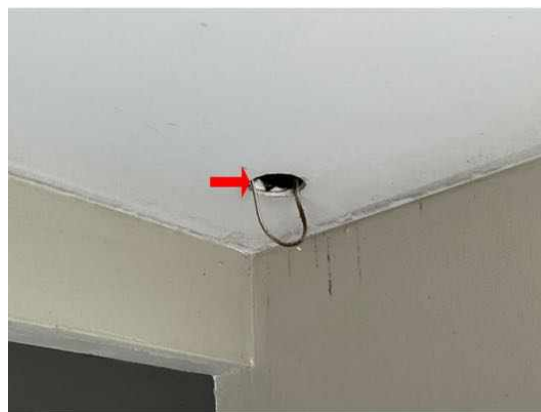
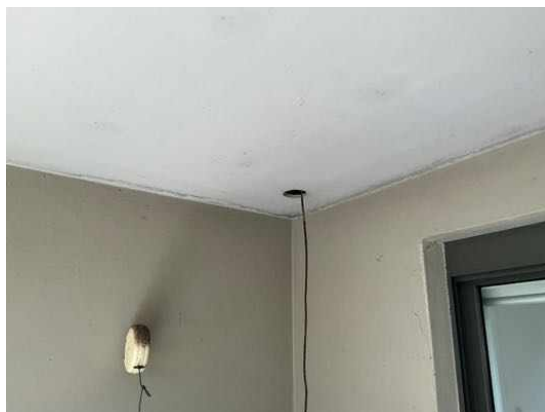
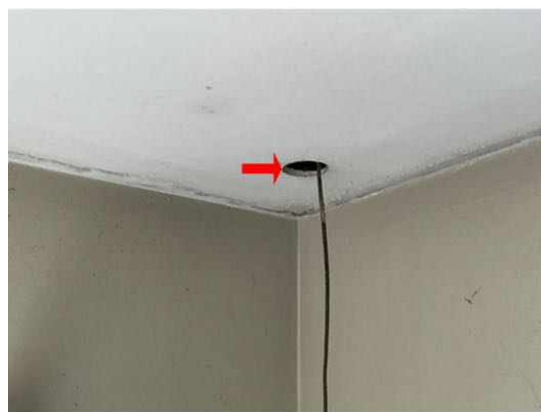
### Finding 3.03

Building:	Main Building
Location:	Alfresco > All Areas
Finding:	Surface - Holes alfresco ceiling
Information:	Two circular penetrations were noted to the alfresco ceiling immediately outside the sliding doors at the time of inspection. Low-voltage cabling was observed hanging through these openings, and the penetrations had not been sealed or finished. These unsealed openings detract from the presentation of the alfresco area and may allow insects, dust and debris to enter the roof void. The condition represents incomplete finishing work and does not reflect acceptable workmanship standards. It is recommended that a suitably qualified contractor be engaged to terminate the cabling correctly and patch, seal and make good the ceiling linings to restore a complete and neat finish.

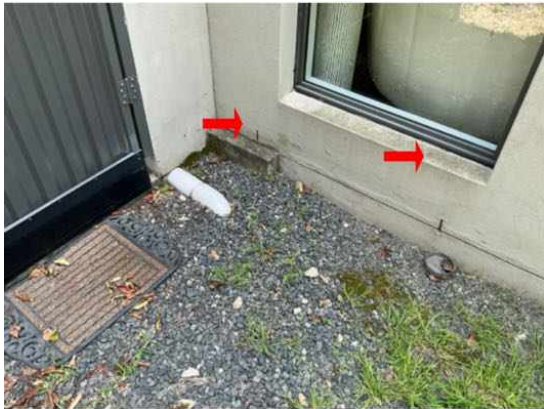
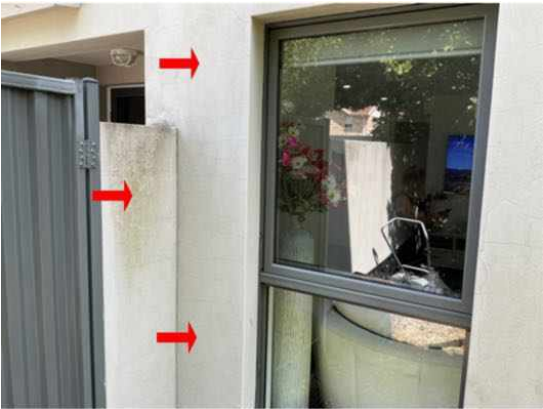
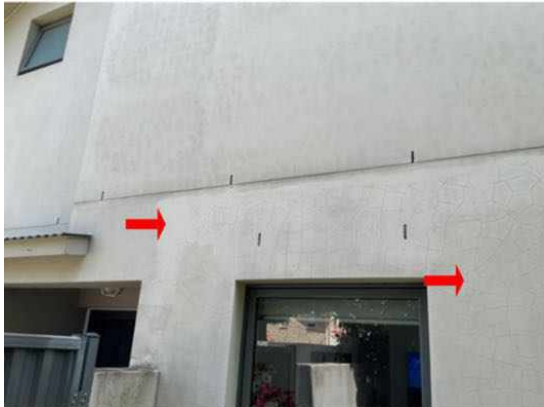
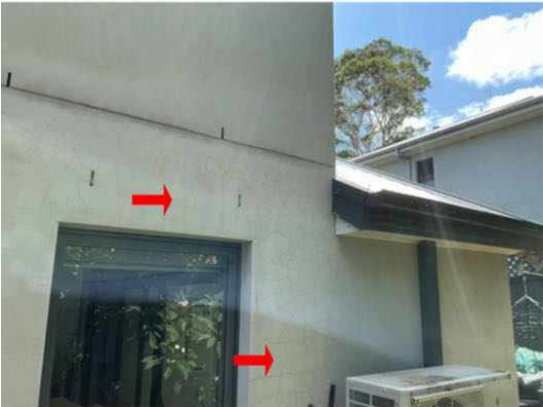
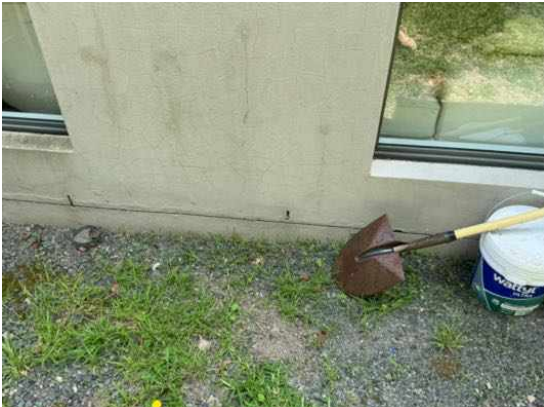
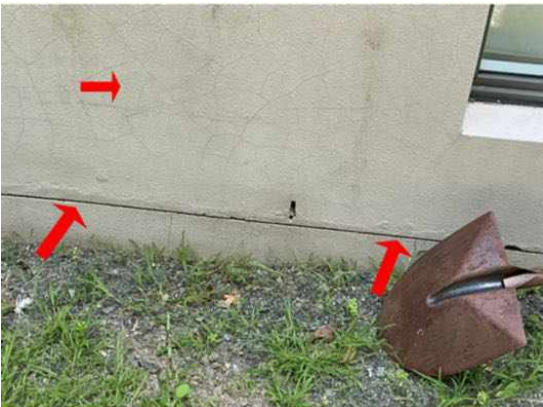
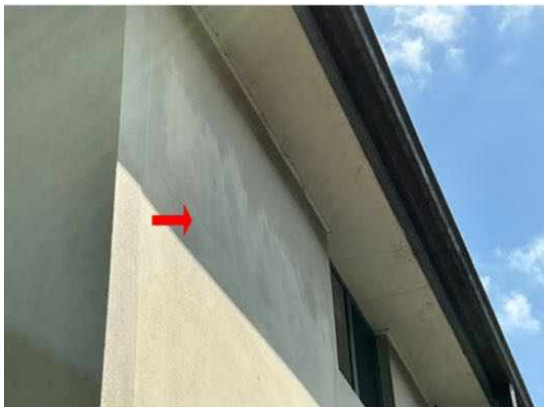
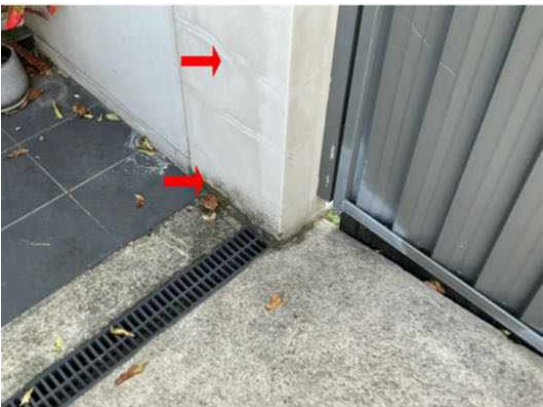
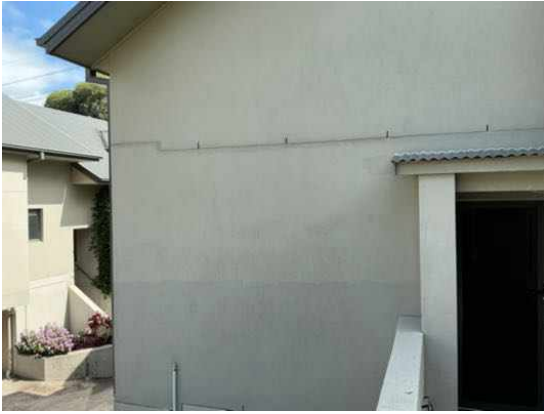
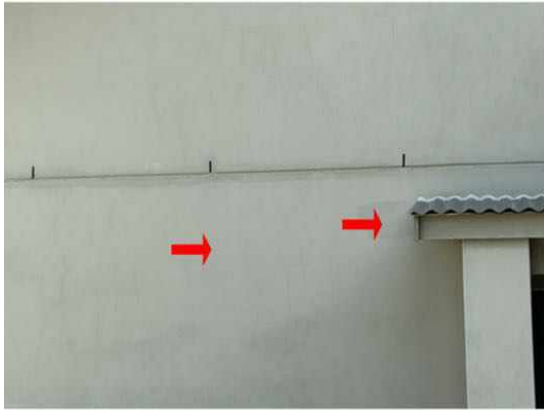
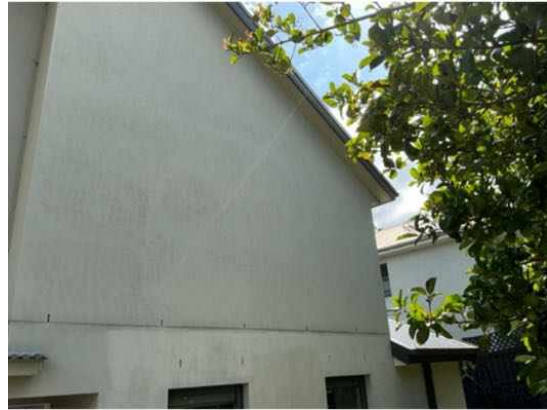
### Finding 3.04

Building:	Main Building
Location:	Exterior walls > All Areas
Finding:	Surface - Marked
Information:	The external walls were noted to contain numerous surface marks, and hairline cracking was visible through the finish coatings at the time of inspection. These conditions are generally consistent with normal ageing, minor building movement and exposure to the elements for a dwelling of this age. The cracking observed was minor in nature and does not indicate a structural concern; however, it detracts from the overall presentation of the building. These items are noted as appearance-related conditions only and may be addressed as part of routine maintenance or future repainting at the client's discretion.

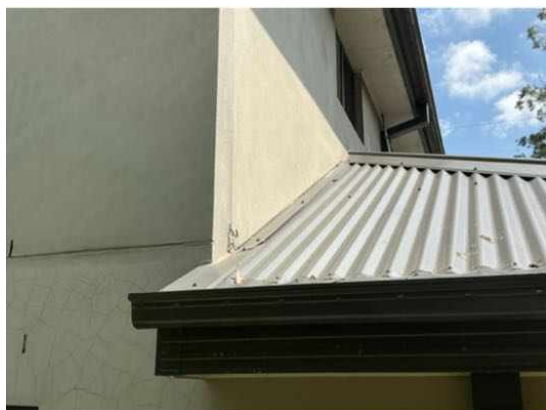
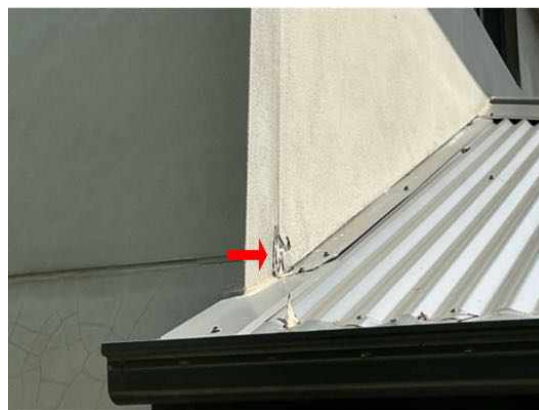
### Finding 3.05

Building:	Main Building
Location:	Exterior wall > Rear
Finding:	Surface - Chipped
Information:	A small section of render was noted to be missing from the rear external wall above the flashing to the lower roof at the time of inspection, with the plastic setting beads visible through the affected area. The damage is likely the result of minor cracking associated with movement or possible physical impact. While the defect is localised, the exposed substrate detracts from the presentation of the façade and may allow moisture ingress and further deterioration of the render system if left unaddressed. It is recommended that a suitably qualified renderer be engaged to reinstate the missing render and restore a uniform and weather-resistant finish to this area.

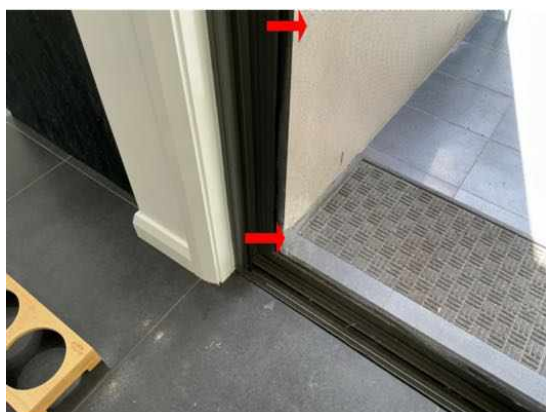
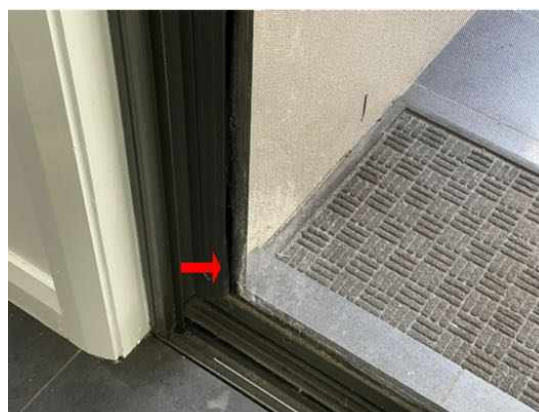
### Finding 3.06

Building:	Main Building
Location:	Alfresco > Rear
Finding:	Flyscreens - Damaged
Information:	The flyscreen fitted to the sliding door between the living area and the alfresco was noted to contain damage around the handle area and at the bottom left corner at the time of inspection. The damage appears consistent with physical impact and has compromised the integrity and appearance of the flyscreen.

While the defect does not affect the operation of the sliding door itself, the damaged flyscreen reduces functionality and detracts from the presentation of the opening. It is recommended that a suitably qualified contractor be engaged to repair or replace the damaged flyscreen to restore proper function and appearance.

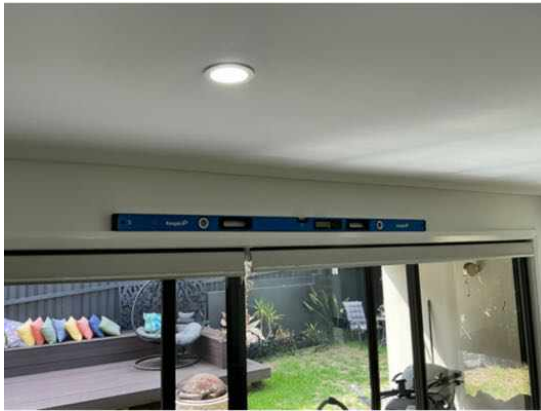
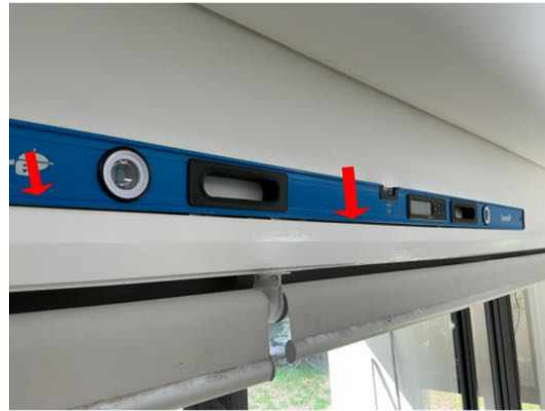
Building:	Main Building
Location:	Living Room > Rear
Finding:	Window head sagging
Information:	The head reveal and architrave above the rear sliding door were noted to sag at the centre at the time of inspection. This condition is likely the result of inadequate fixing or support during installation, causing the trim to deflect over time. The sagging detracts

from the presentation of the opening and may worsen if left unaddressed. It is recommended that a licensed carpenter be engaged to straighten, adequately support and securely refix the head reveal and architrave to restore proper alignment and finish.

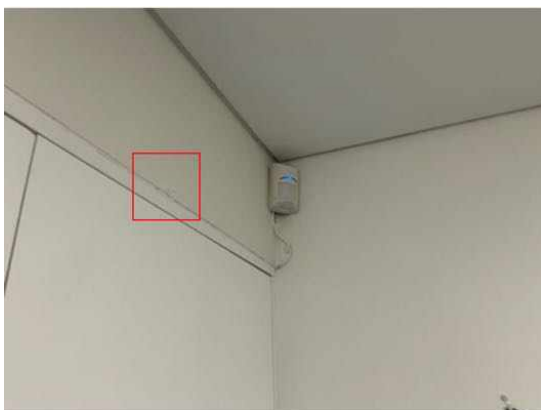
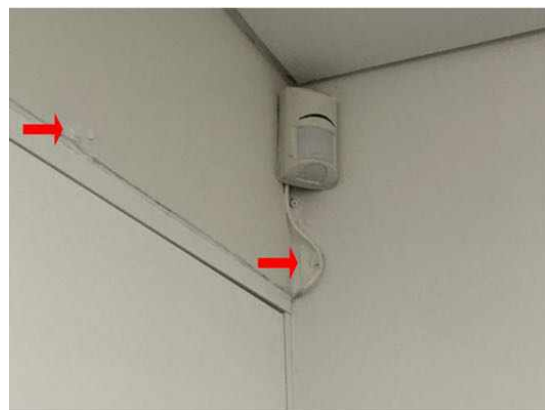
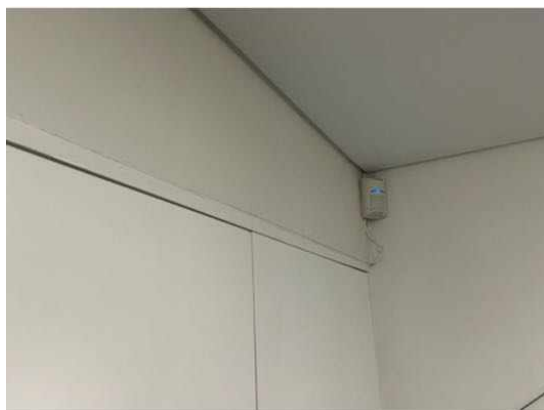
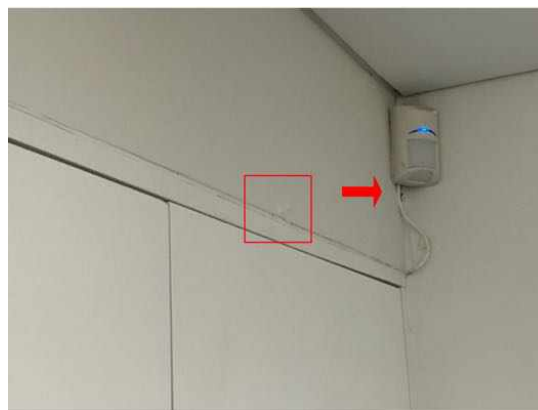
### Finding 3.08

Building:	Main Building
Location:	Entry > Front Left
Finding:	Incomplete patching above joinery in dining room.
Information:	Substandard patching and painting were noted to the wall area above the joinery located to the left of the front entry door at the time of inspection. The finish was uneven and inconsistent, indicating inadequate preparation and painting following patch repairs. This condition detracts from the presentation of the area and does not reflect acceptable workmanship standards. It is recommended that the affected area be properly prepared, patched and repainted to achieve a uniform and compliant finish.

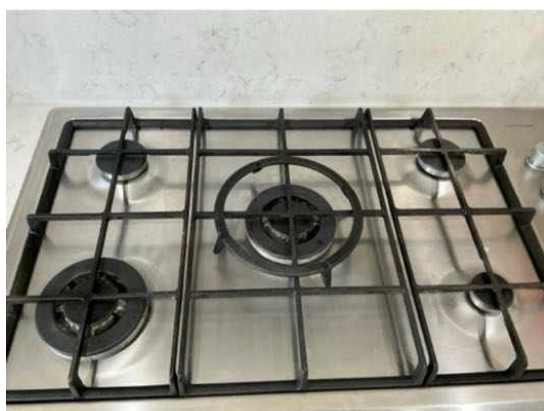
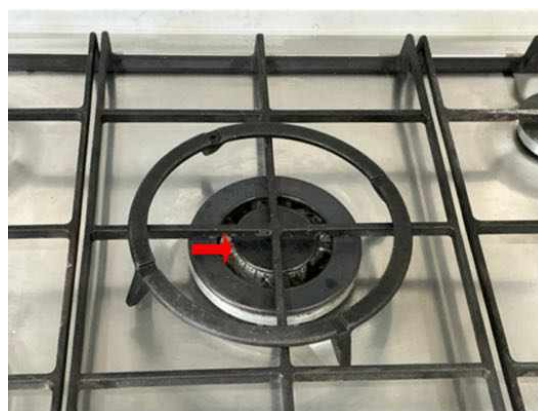
### Finding 3.09

Building:	Main Building
Location:	Kitchen > Centre
Finding:	Building element - Not operating cooktop
Information:	The centre burner of the gas cooktop was not igniting at the time of inspection, while all other burners were operating correctly. This condition indicates a fault with the ignition system or gas delivery to the affected burner and limits the full functionality of the appliance. It is recommended that a licensed plumber or suitably qualified gas fitter be engaged to further assess the cooktop, identify the cause of the fault and carry out any necessary repairs to restore proper operation.

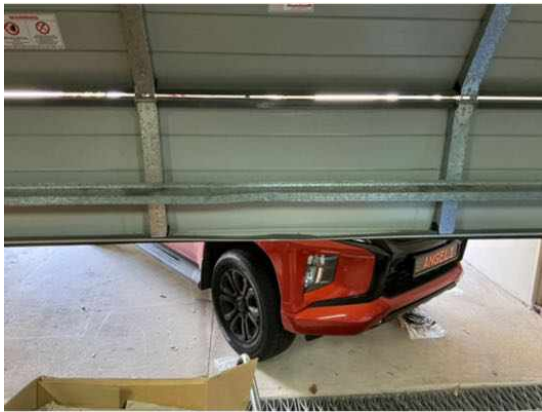
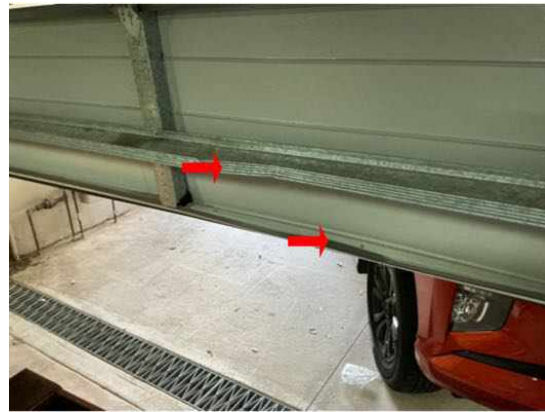
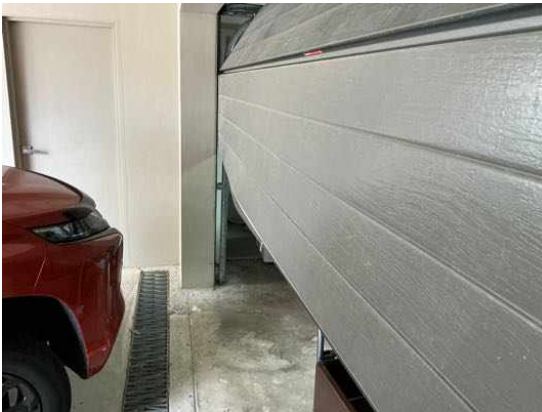
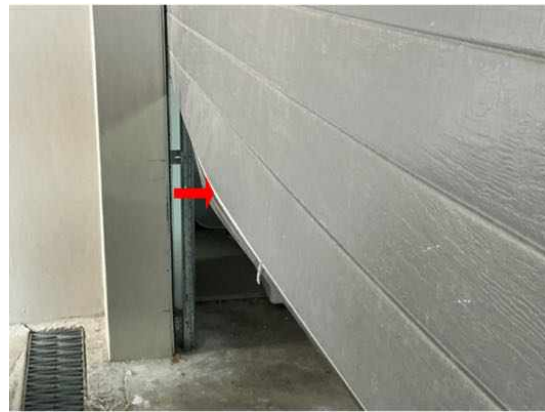
### Finding 3.10

Building:	Main Building
Location:	Garage > Lower-Ground Level
Finding:	Garage door - Damage
Information:	Impact damage was noted to the centre of the garage door at the time of inspection. The damage appears consistent with physical impact and detracts from the presentation of the garage door.

While the impact damage did not appear to affect the operation of the door at the time of inspection, continued use may lead to further deterioration if not addressed. It is

recommended that a suitably qualified contractor be engaged to assess the extent of the damage and carry out repairs or replacement as required to restore the door's appearance and functionality.

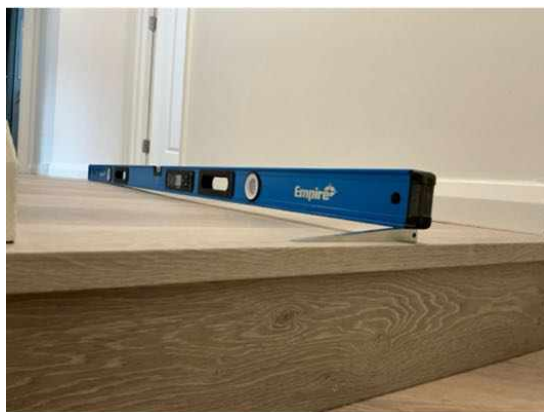
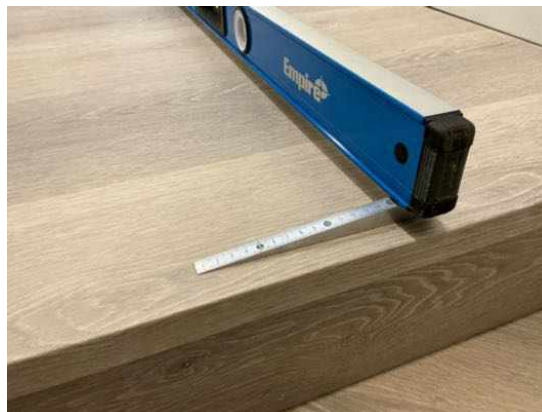
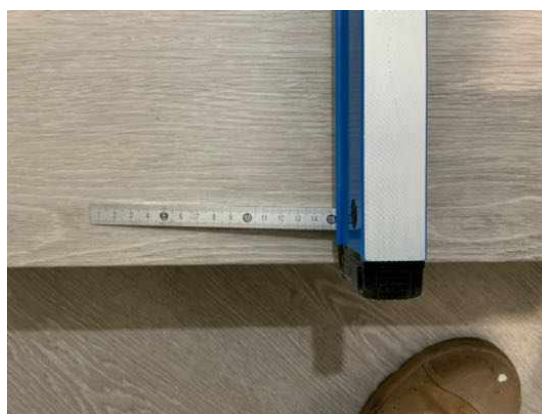
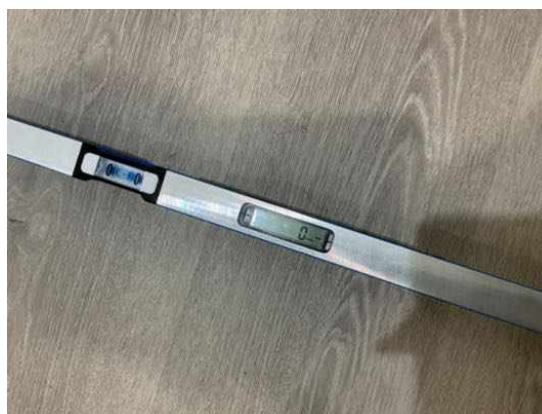
Building:	Main Building
Location:	Stairs - Internal > Centre
Finding:	Flooring - Uneven
Information:	The flooring at the top of the internal staircase was noted to deviate underfoot at the time of inspection. When measured with a 1.8-metre straightedge, the floor was observed to deviate by approximately 15 mm over this length. Information provided by the current owner, who was present at the time of inspection, indicated that new floor coverings had recently been installed and previously laid carpet had been removed. The installation of floating floorboards in this area has accentuated both the visible and physical nature of the deviation.

The condition is most likely the result of incorrect set-out or alignment of the subfloor framing members during the original installation, rather than recent movement. No evidence was observed to suggest subsidence or significant structural movement, with surrounding building elements not displaying associated signs of footing or foundation movement.

While not considered a structural failure, the deviation exceeds typical expectations for floor levelness. It is recommended that a suitably qualified builder or carpenter be engaged to further assess the subfloor framing and determine appropriate rectification options.

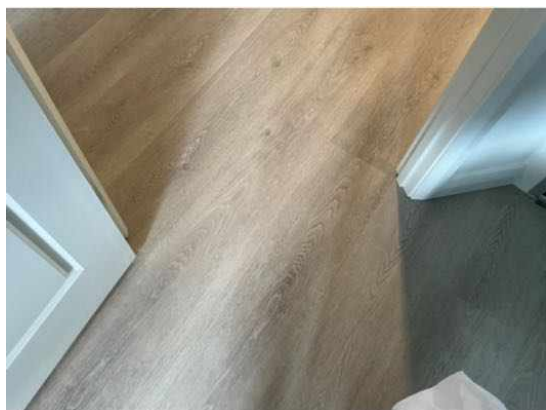
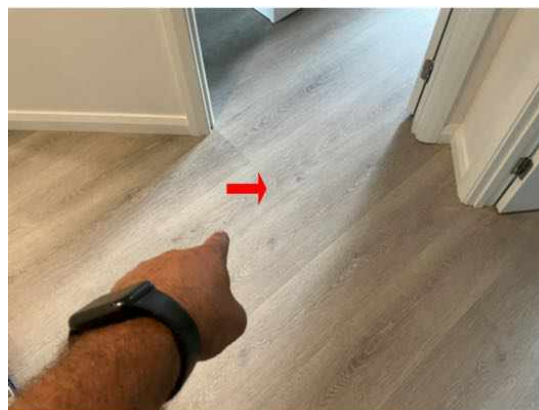
### Finding 3.13

Building:	Main Building
Location:	Hallway > Upstairs
Finding:	Floor squeaking.
Information:	A minor floor squeak was noted at the entry to the ensuite from the bedroom at the rear right side on the upper level. The squeak was isolated to a small area in the centre of the doorway opening and is likely the result of inadequate fixing of the substrate or floor sheeting to the supporting framing beneath.

While the condition is localised and not considered a structural concern, it affects the amenity and quality of the finished floor. It is recommended that a suitably qualified

carpenter be engaged to further investigate the area and provide additional fixing as required to eliminate the squeak.

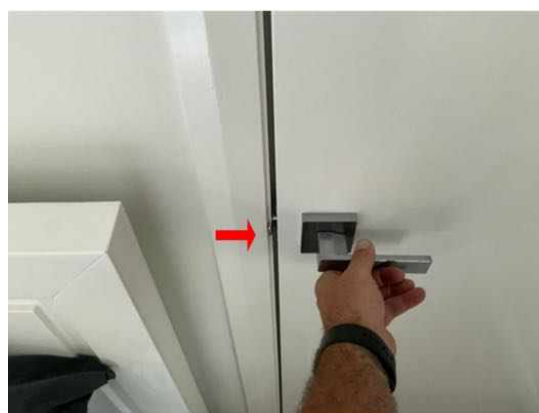
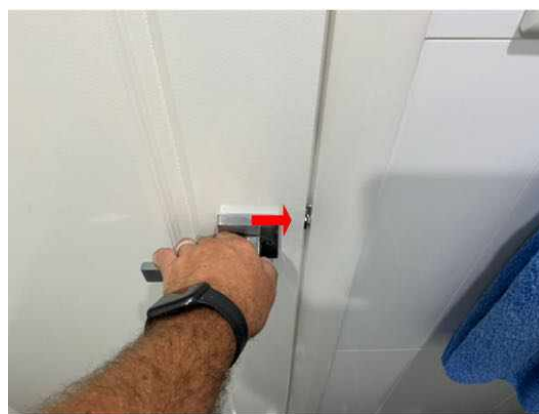
### Finding 3.14

Building:	Main Building
Location:	Bedroom and bathroom. > Upstairs
Finding:	Door handle - Not latching
Information:	It was noted that the rear left bedroom and bathrooms door handles were not latching during operation at the time of inspection. Whilst detracting from the functionality of this building element, this minor defect may also be a security risk, and may therefore have serious implications if left unattended.

It is suspected that this defect has occurred due to minor issues with the associated hinges. Such damage is identified as general wear and tear, which is expected for building elements of this age.

A qualified carpenter or general handyperson may be appointed to perform rectification works as necessary, at client discretion. If left unattended, further functional impairment is likely to occur.

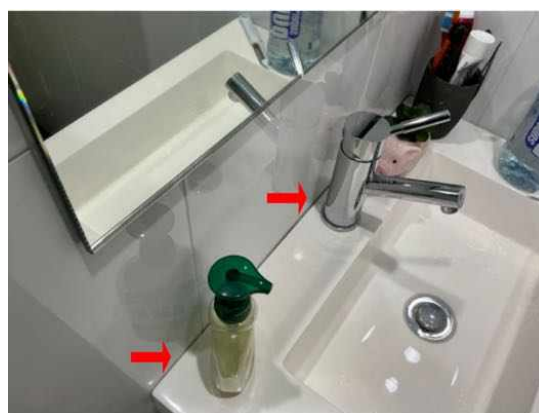
### Finding 3.15

Building:	Main Building
Location:	Ensuite > Upstairs
Finding:	Sealant and grouting - Missing or damaged
Information:	It was noted on inspection that sealant was missing from the back of the vanity in the ensuite bathroom.

Different materials and floor areas move at different rates, generally causing cracking to grout or sealant at this point. A flexible sealant is required to allow for expected expansion and contraction, while keeping the joint water tight and protective of all associated building materials.

Flexible and mould resistant materials should be applied to affected areas to prevent any subsequent water damage that is likely to occur. Regular maintenance and replacement of damage or missing or damaged sealant and grout is highly recommended to the wet areas, as this is a regular wear and tear defect. Sealant and grouting in areas that come into regular contact with water should be maintained for the long term care of your property.

A sealant specialist should be appointed to complete these works as soon as possible

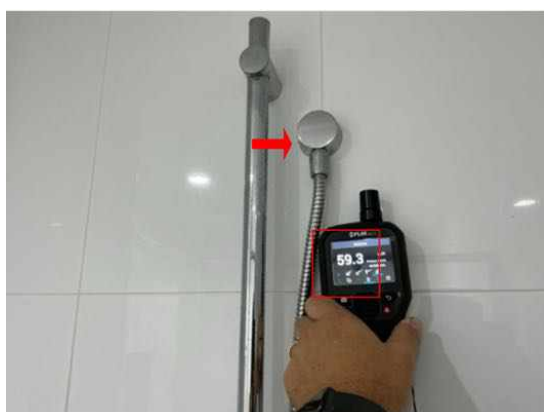
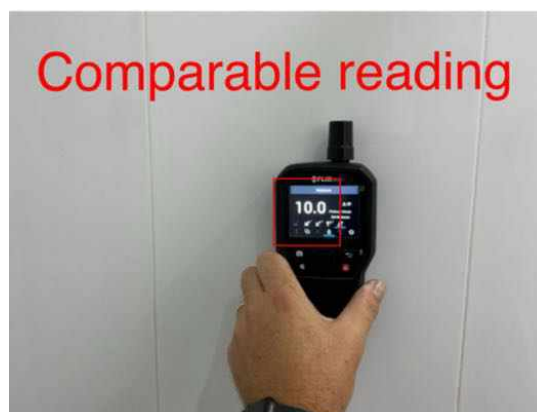
### Finding 3.16

Building:	Main Building
Location:	Ensuite > Upstairs
Finding:	Shower Damp - Elevated Moisture
Information:	Elevated moisture readings were obtained around the water point at the time of inspection. Moisture readings obtained in other areas of the shower enclosure were within normal relative ranges, indicating that the moisture issue is localised to the water point rather than a broader waterproofing failure.

The condition is likely the result of a slow leak where the shower head fixture connects to the water point, or inadequate sealing applied where the water point penetrates through the tiled wall surface. While no active leak was observed during the inspection, ongoing moisture ingress at this location may lead to deterioration of concealed building elements if not addressed.

It is recommended that a licensed plumber be engaged to inspect the shower outlet, rectify any leaks identified and reinstate compliant sealing around the penetration.

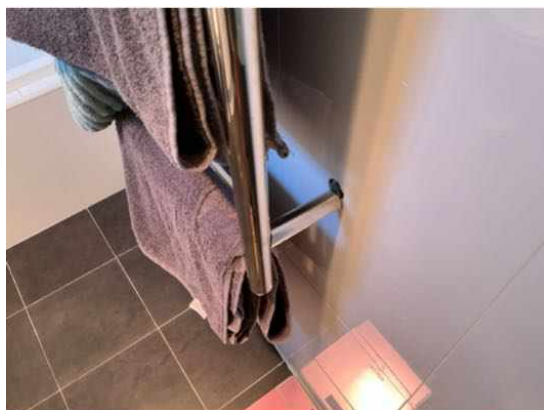
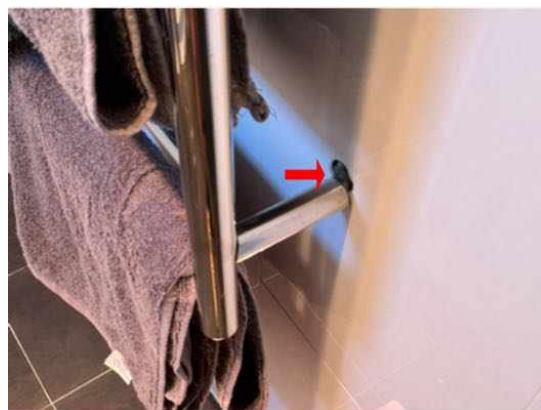
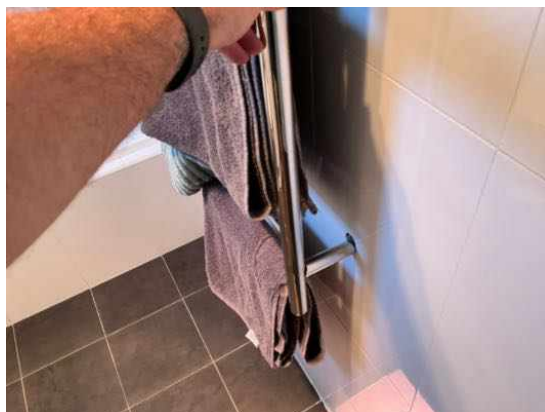
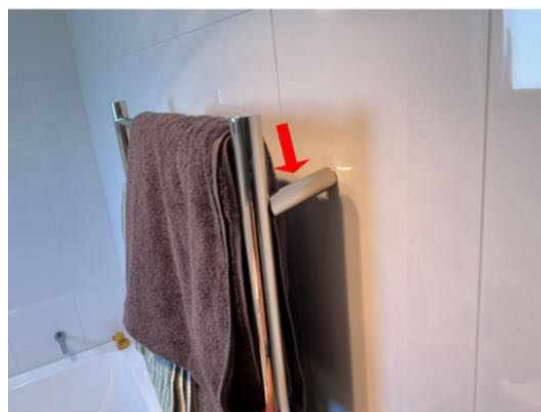
### Finding 3.17

Building:	Main Building
Location:	Bathroom > Upstairs
Finding:	Fitting or fixture - Loose
Information:	The heated towel rail within the main bathroom was noted to be loose and to wobble under light hand pressure at the time of inspection. This condition indicates inadequate fixing to the wall substrate and may result in further loosening, damage to wall linings, or failure of the fixture if not rectified. It is recommended that a suitably qualified electrician or contractor be engaged to securely refix the heated towel rail in accordance with the manufacturer's installation requirements to ensure safe and stable operation.

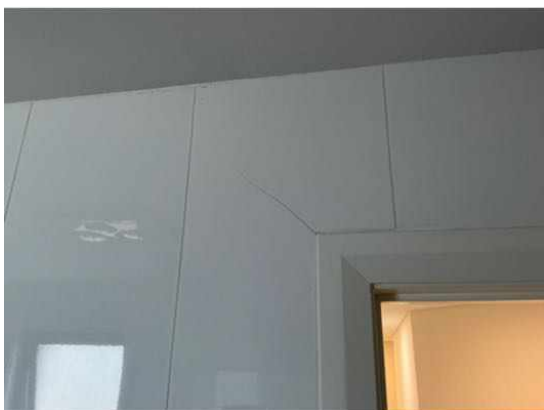
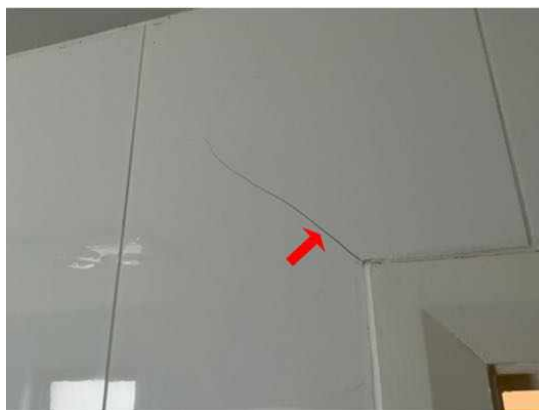
### Finding 3.18

Building:	Main Building
Location:	Bathroom > Upstairs
Finding:	Tiles - Cracked or damaged.
Information:	Cracking was observed to a wall tile located above the bathroom entry door at the time of inspection. The cracking is likely the result of minor movement applying pressure to a vulnerable tile that has been cut around the door architraves. Where adequate clearance is not provided between the tile edge and the architrave, normal building movement can transfer stress directly into the cut tile, which is more susceptible to cracking than an uncut tile. This condition indicates insufficient allowance for movement at the tile-to-architrave junction. It is recommended that a suitably qualified tiler be engaged to remove and replace the cracked tile, and to ensure appropriate clearances and flexible sealing are provided around the architrave to accommodate movement and prevent recurrence.

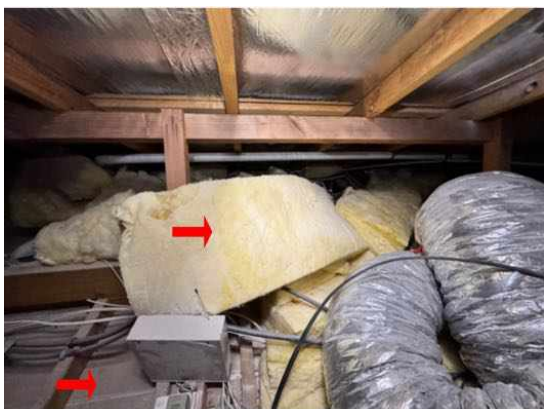
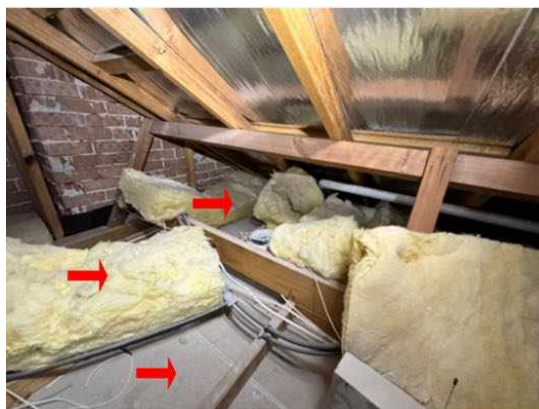
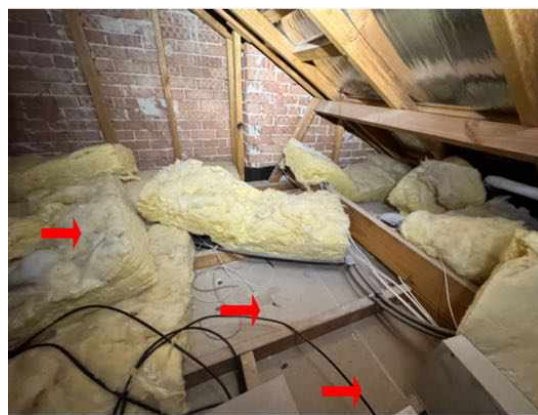
**Finding 3.19**

Building: Main Building  
 Location: Roof Void > All Areas  
 Finding: Insulation - Inadequate  
 Information: Upon inspection of the roof void it was noted that insulation had been removed from the intended spacing between the bottom cords of the roof trusses and stock piled within the roof void.

Installation of adequate insulation is required and should be conducted as soon as possible.

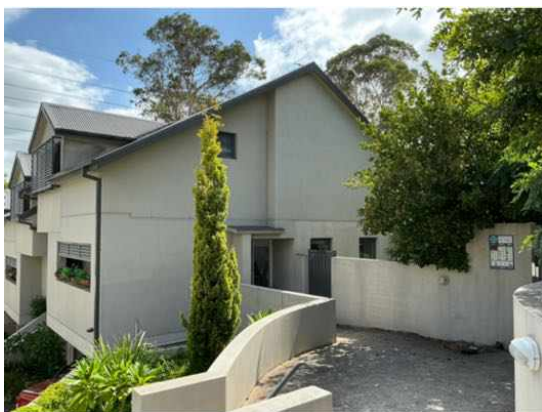
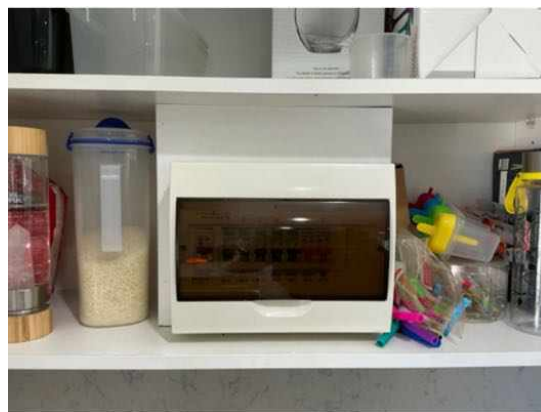
Building:	Main Building
Location:	All Areas > All Areas
Finding:	No Evidence of Termite Management System.
Information:	The application of a post-construction chemical termite barrier is highly recommended for all properties, as such systems are highly effective in reducing the risk of termite attack to timber building elements throughout the dwelling. At the time of inspection, no durable notice was observed within the dwelling indicating the installation of any termite management system, treatment or barrier.

In the absence of a visible durable notice and supporting documentation, it could not be confirmed that any termite management system has been installed to the property. It is recommended that a licensed pest control contractor be engaged to provide further advice regarding suitable termite management options and to install an appropriate system as required, with a compliant durable notice to be placed within the switchboard upon completion. This matter should be addressed as a short-term priority.

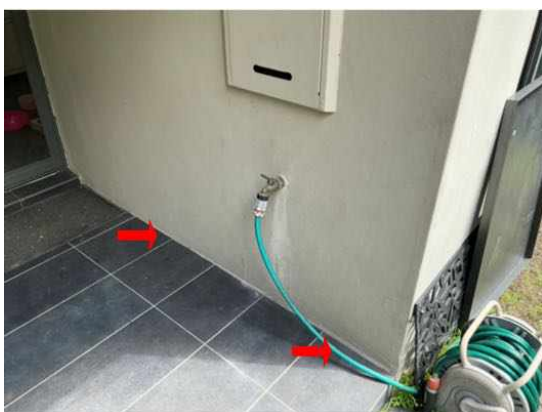
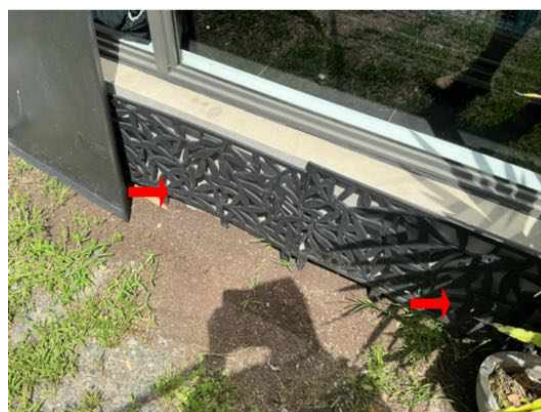
## Finding 6.02

Building:	Main Building
Location:	All Areas > All Areas
Finding:	Slab Edge - Exposure.
Information:	An inspection zone of at least 75mm in relation to the exposed slab edge, between the bottom brick and the perimeter pavement, is required. This inspection zone should be maintained in order to force termites into the open where they can be detected more readily during regular inspections. The slab edge should not be concealed by anything that may prevent inspection of the area, including render, landscaping, soil, turf, paving, concrete cladding or other structures.

If the slab edge is not properly exposed there is a high risk of termite attack. Sometimes, in order to determine the type of slab, a suitably qualified person such as an architect or builder may be required to consult the construction plans.

Where the slab edge cannot be properly inspected, it is highly recommended that termite or timber pest inspections be carried out every 6-12 months to aid protection of the property against infestation.
