## Building and Timber Pest Inspection Report

Inspection Date: Fri, 30 Jan 2026

Property Address: Unit 1/33 Windermere Ave, NORTHMEAD,  
NSW, 2152, Australia

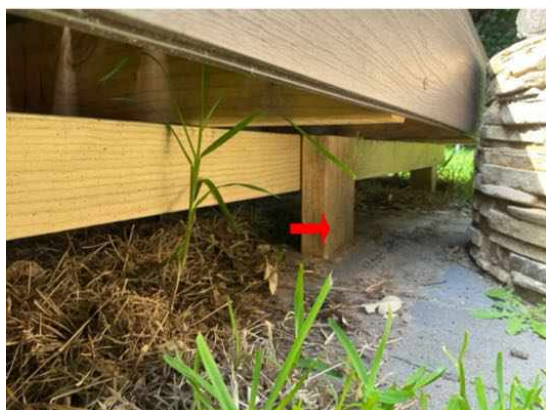
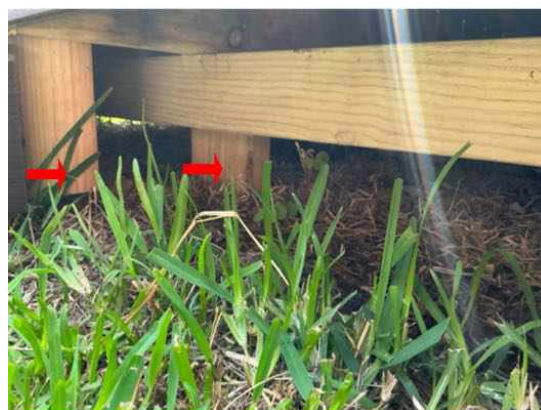
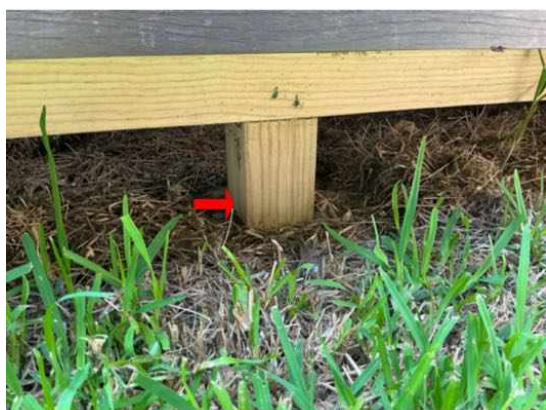
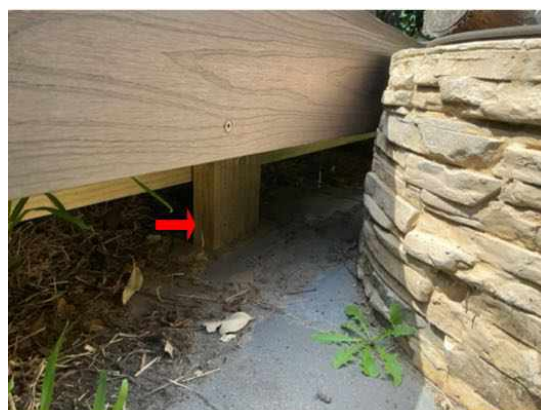
### Finding 6.03

Building:	Main Building
Location:	Yard - Back > Centre
Finding:	Timber on ground / conducive conditions to termite damage.
Information:	At the time of inspection, the timber deck framing located in the rear yard were found to have a number of components in direct contact with the ground. This condition is considered conducive to timber pest activity, particularly termite attack and fungal decay, as it provides a moisture-retaining environment and concealed access to timber elements.

Timber components that are embedded in or resting directly in or on the ground are highly susceptible to degradation due to constant exposure to moisture and organic

material. Ground contact also obstructs visual inspection of the lower sections of the stringers, increasing the risk of undetected pest ingress or decay.

A licensed contractor should be engaged to modify the deck construction to ensure that all timber components are adequately elevated above ground level. Suitable measures include the use of galvanised steel stirrups or concrete footings to provide a physical separation between the timber and soil. All timber should be appropriately treated for external use and maintained in accordance with durability requirements.

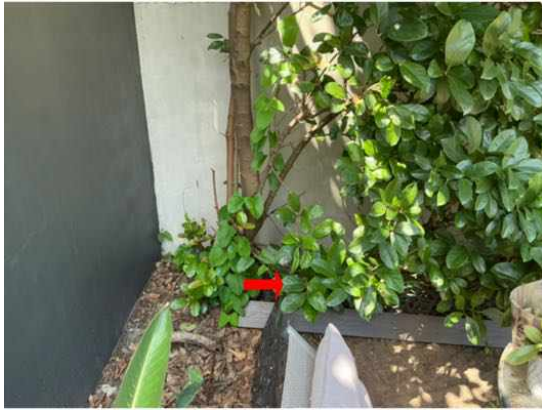
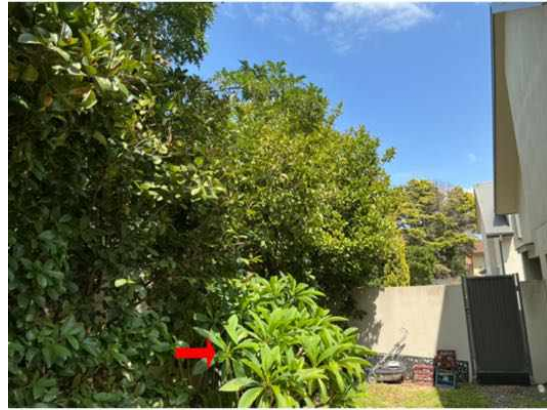
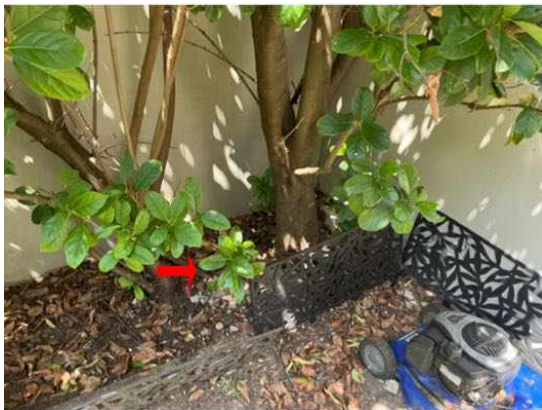
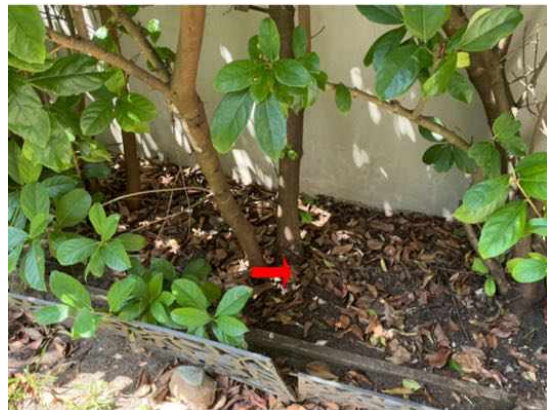
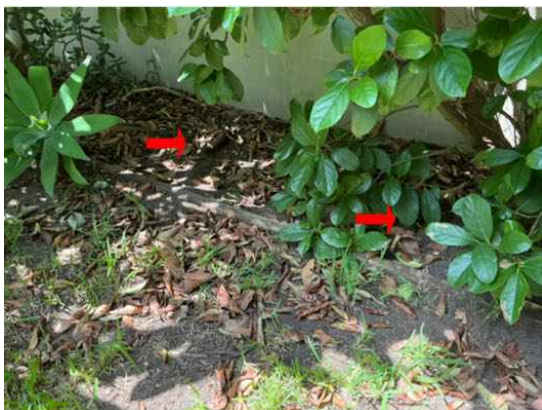
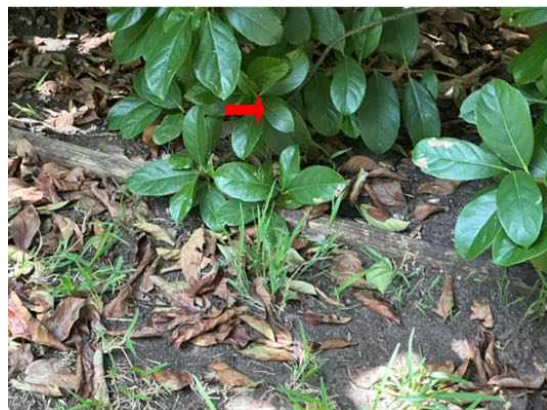
### Finding 6.04

Building:	Main Building
Location:	Yard - Back > Rear,Rear Right,Front Right
Finding:	Garden Beds - Conditions Conducive to Termites.
Information:	Garden beds were located at the rear and right hand side of the property in close proximity to the external walls.

These garden beds can include untreated timber, and with a combination of moisture from watering hosing can make conditions conducive to termite activity and termite ingress.

Garden beds against buildings or fences as a condition conducive to timber pest activity. The increased moisture retention and concealment of inspection zones may

facilitate undetected termite entry or contribute to fungal decay in nearby timber elements.

It is recommended that a licensed landscaper or builder be consulted to review the layout of garden beds and modify them as needed to reduce moisture accumulation and improve visibility of building perimeters.

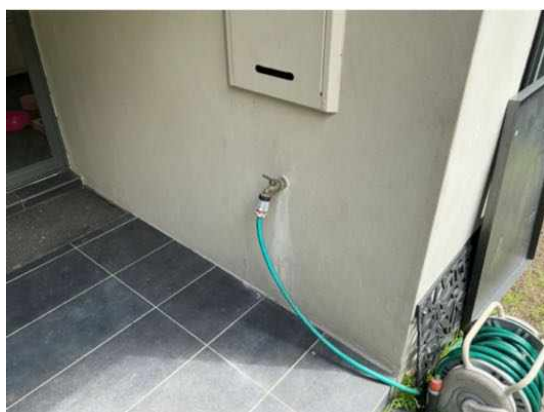
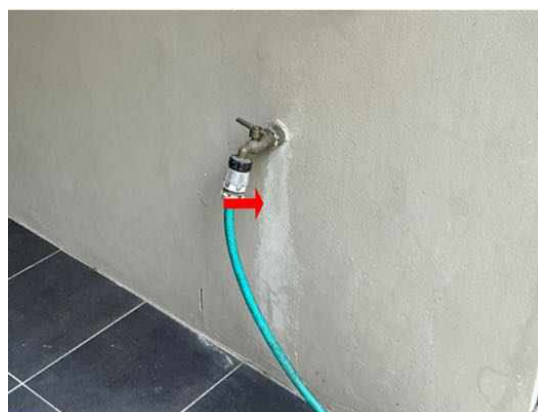
### Finding 6.05

Building: Main Building  
Location: Alfresco > Rear  
Finding: Water leak - External

Information: Water leaks were found to be present to exterior plumbing work. Leaks are generally caused by deterioration of the plumbing elements over time, due to exposure to weather conditions, but may have also been caused by minor impact damage.

Such leaking creates damp conditions in the affected area, causing potential for water pooling and subsequent water damage if left unattended. These conditions may also attract termite attack, particularly if the area is subject to minimal levels of sun throughout daylight hours.

It is highly advised that a licensed plumber be appointed to rectify any water leaks that may be present. Areas of repair and replacement of plumbing fittings and fixtures may be required and, as such, a quotation should be sought.

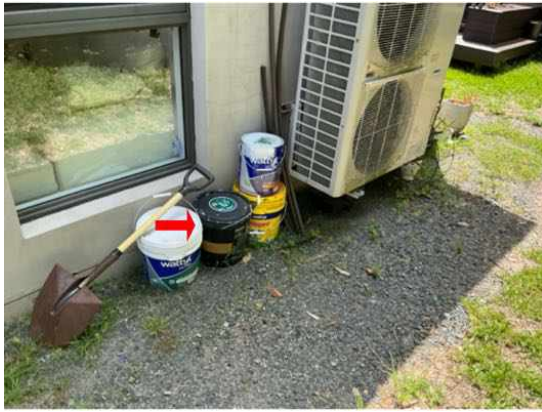
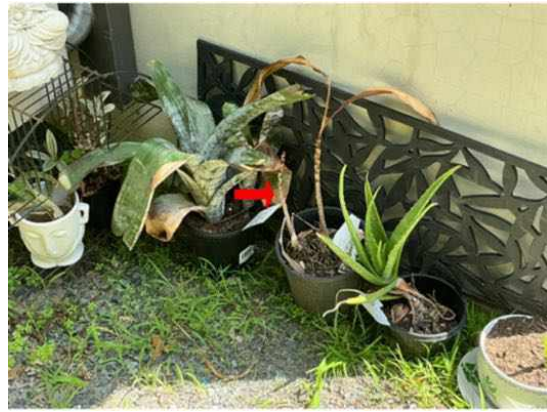
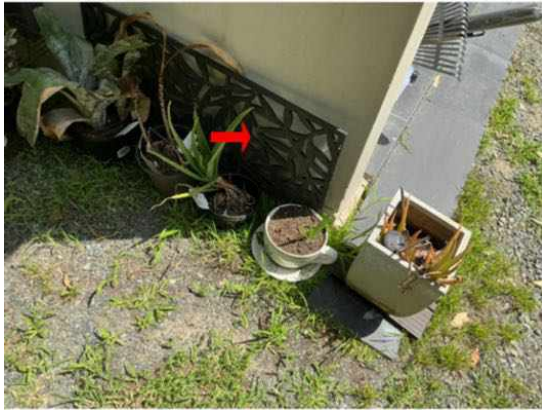
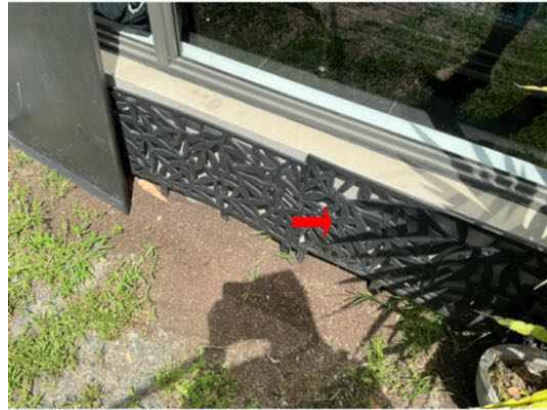
### Finding 6.06

Information: At the time of inspection, various stored items were observed placed directly against the external walls on the rear and right side external walls of the dwelling, obstructing visibility of the slab edge, weep holes, and lower brickwork. The placement of these materials bridges the termite inspection zone, creating a potential concealed entry point for subterranean termites.

Stored items such as timber, containers, and other materials in contact with the wall may allow termites to bypass physical or chemical termite barriers and enter the structure undetected. These obstructions also prevent effective visual inspection of critical areas where early signs of termite activity would typically be detected.

It is recommended that all items be removed from the base of the external wall, and that a clear and continuous inspection zone be reinstated in accordance with termite management best practices. Ongoing maintenance of this inspection zone is essential for preserving the effectiveness of any existing termite protection system.

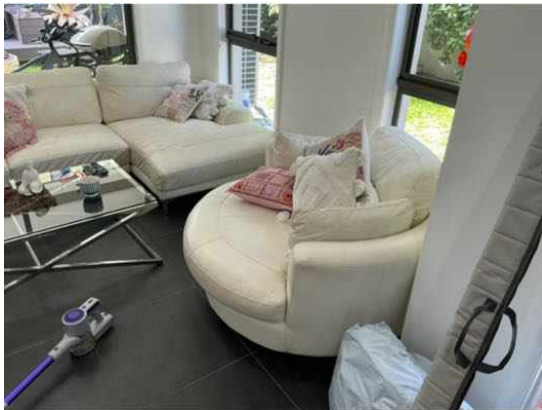
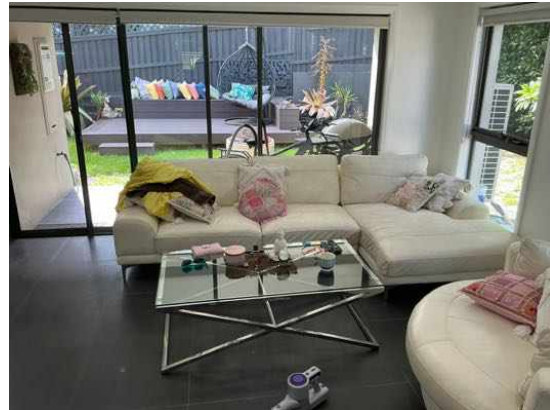
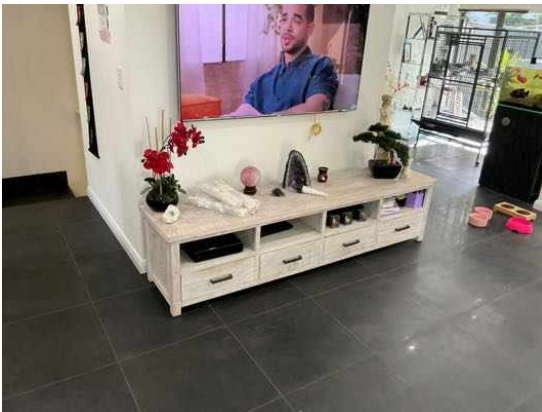
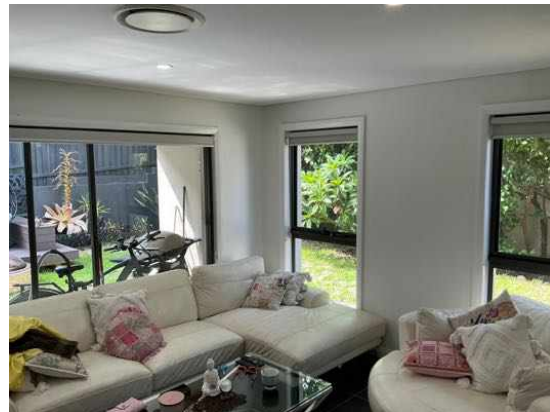
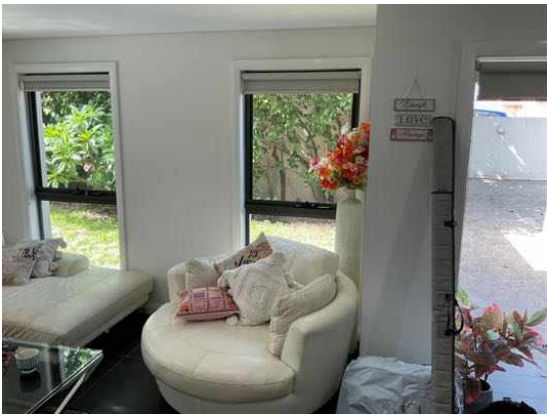
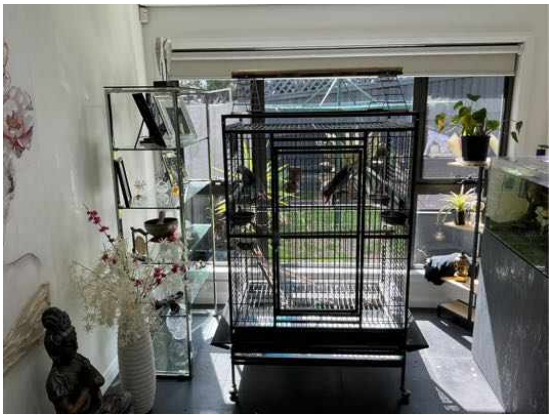
### Noted Item

Building: Main Building  
Location: All Areas > All Areas  
Finding: Additional Photos - Obstructions and Limitations  
Information: These photographs are an indication of the obstructions and limitations which impeded full inspection of the property at the time of inspection. These obstructions can hide an array of defects and should be removed to allow full inspection to be carried out. A re-inspection is recommended once the areas are made accessible.

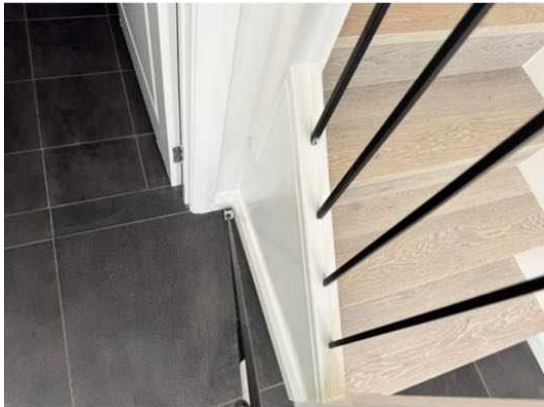
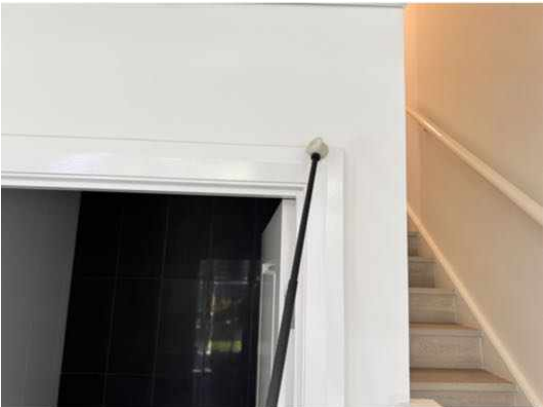
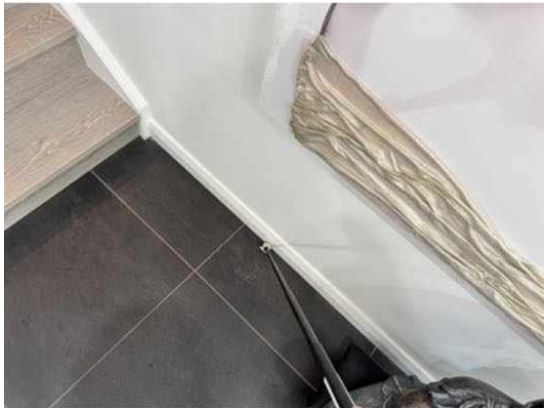
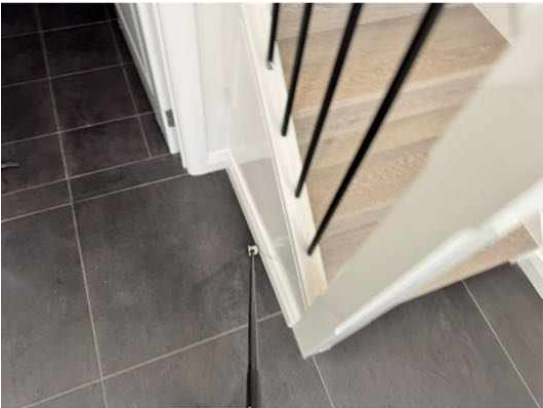
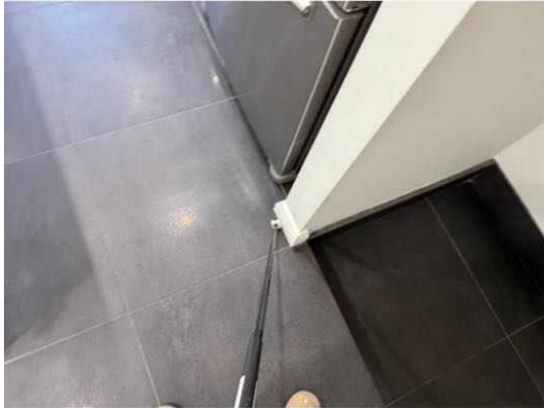
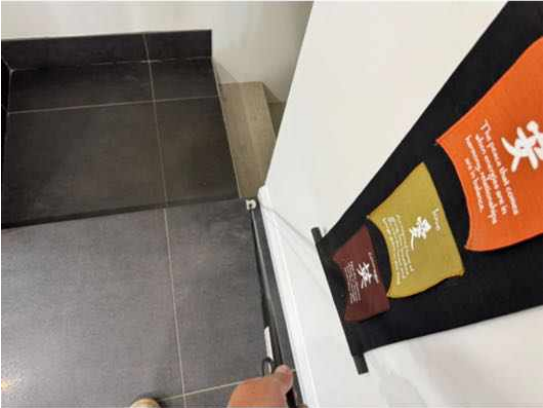
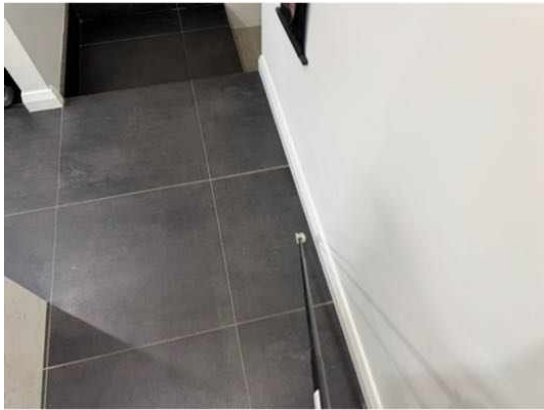
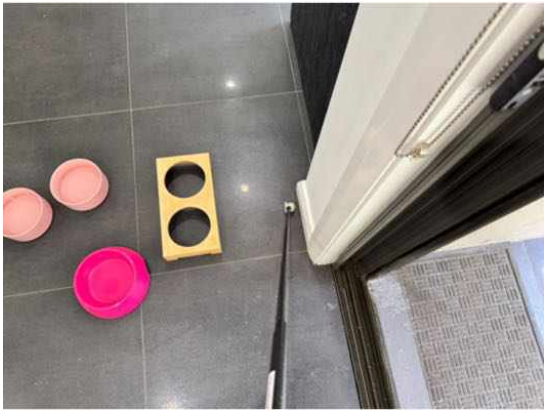
Building: Main Building  
Location: All Areas > All Areas  
Finding: For information only - tap testing.  
Information:

As part of this timber pest inspection, accessible internal timber elements such as architraves, skirting boards, door jambs, and window reveals were tap-tested using a standard timber sounding tool. This method is used to identify areas that may be affected by termite activity or internal deterioration not visible on the surface.

Photographs have been included for reference to illustrate areas where tap testing was carried out. Please note that this is a non-invasive inspection, and where elements are obstructed, painted, or covered, accurate assessment may be limited.

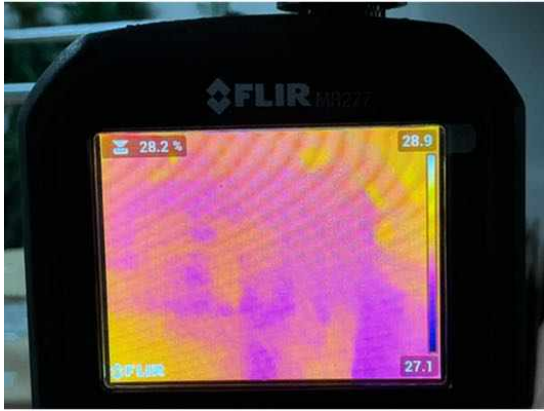
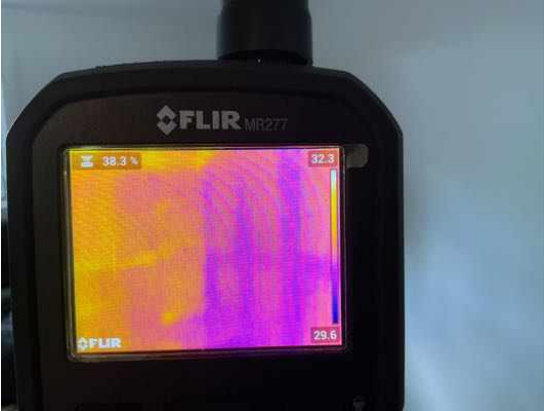
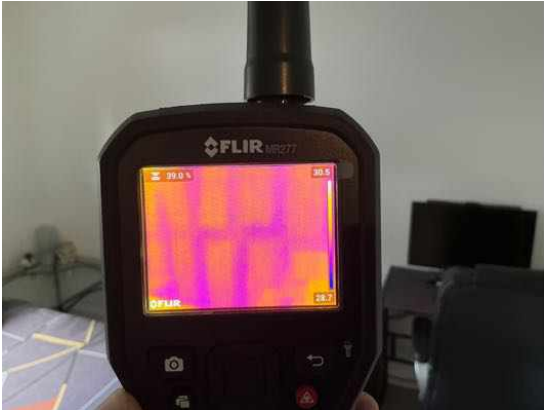
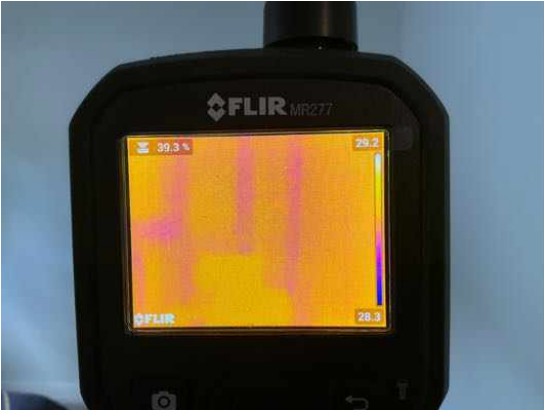
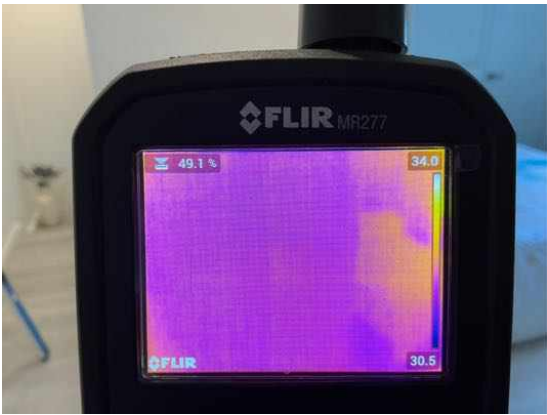
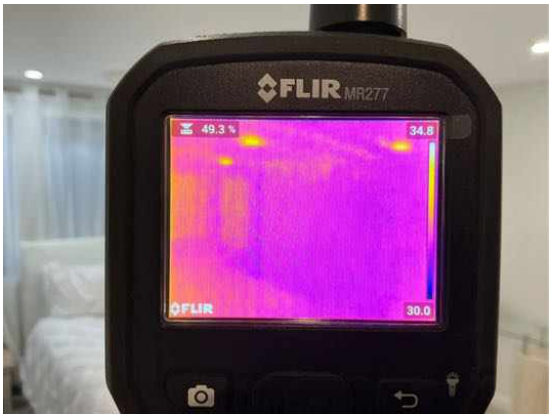
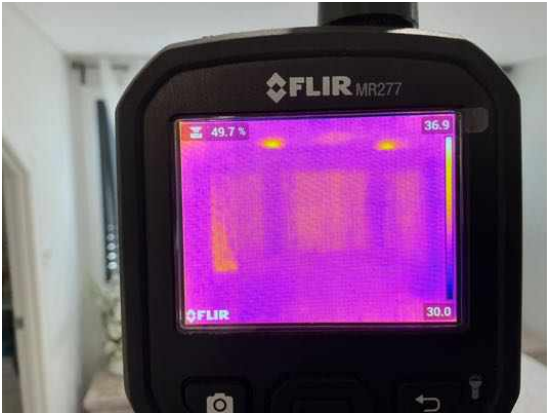
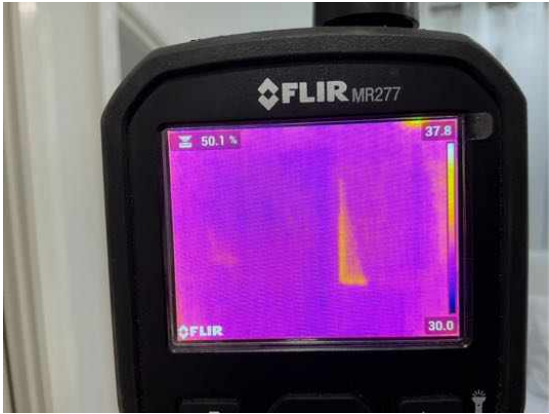
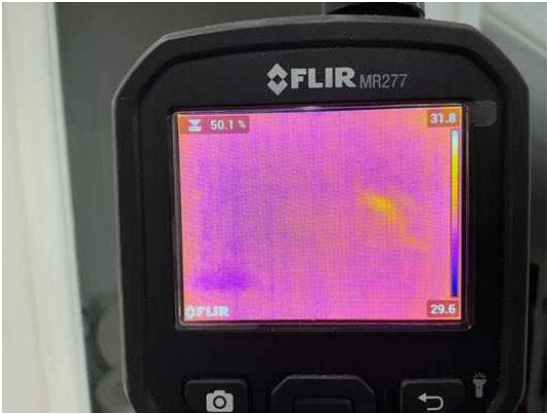
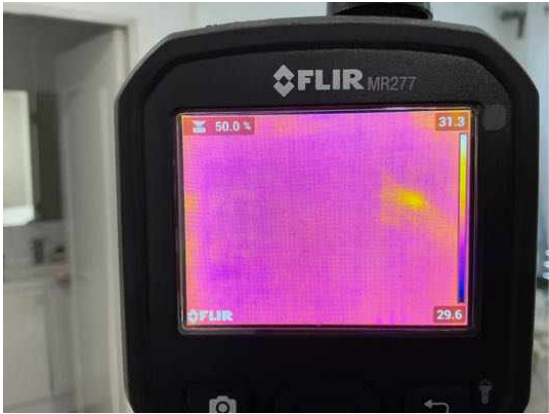
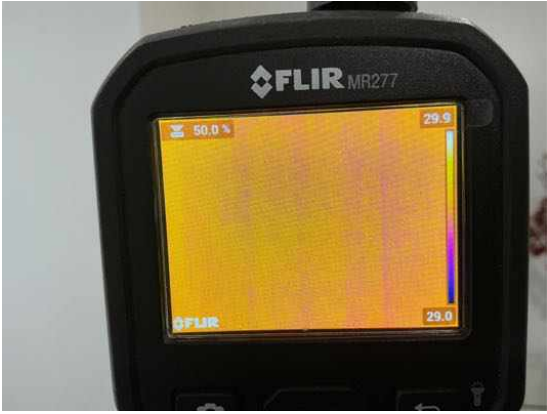
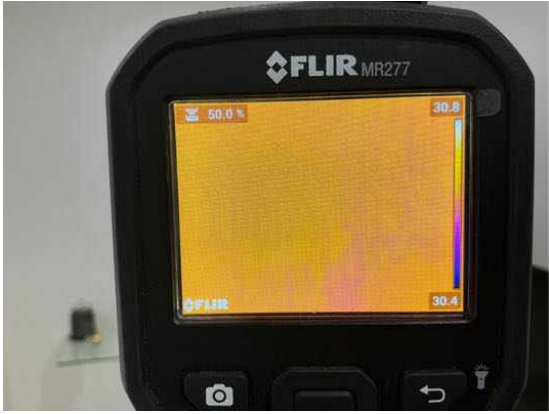
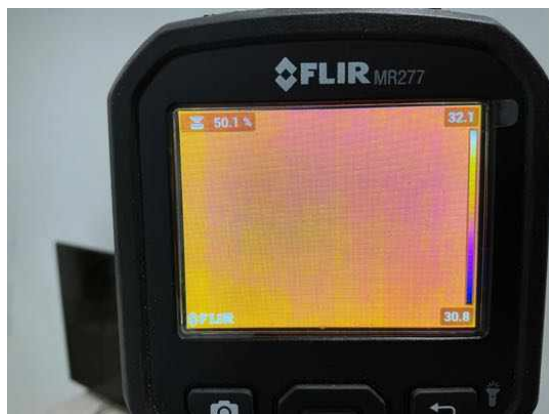
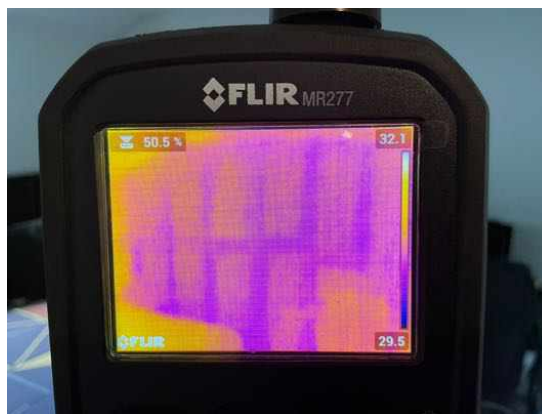
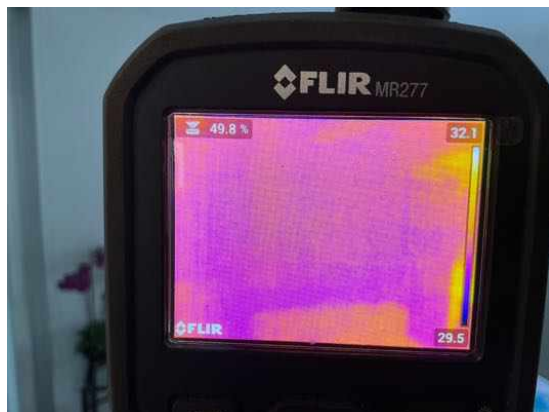
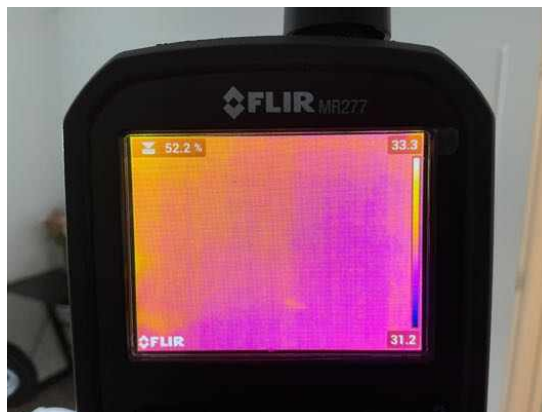
Building: Main Building  
 Location: All Areas > All Areas  
 Finding: For your information-Thermal camera.  
 Information: AS 3660.2:2017 is the recommendation for the carrying out of 'Additional Tests' using specialist non-destructive tools:

A thermal imaging inspection was carried out throughout the interior of the house using a Flir MR277 thermal camera. No thermal anomalies were noted that would be consistent with any current termite activity.

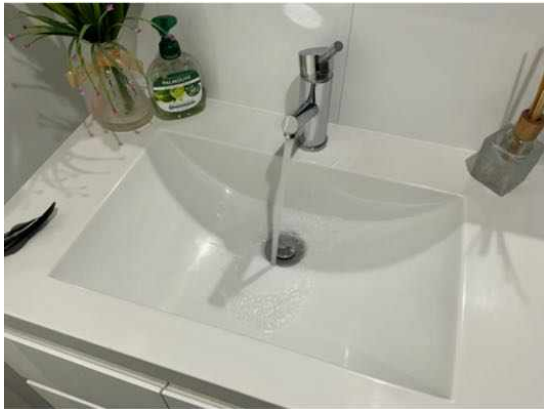
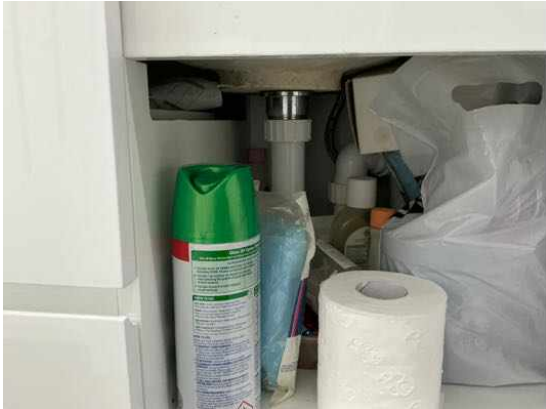
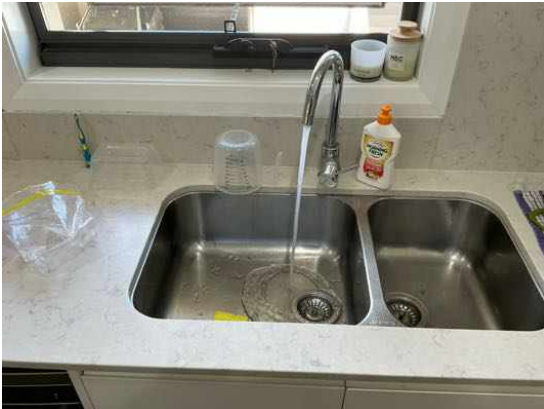
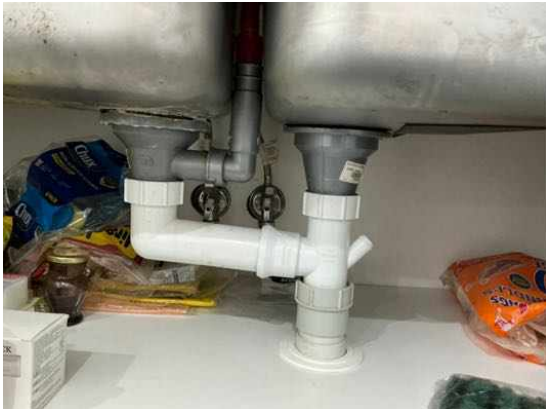
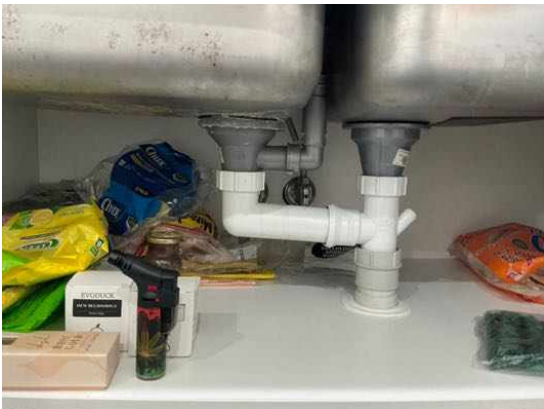
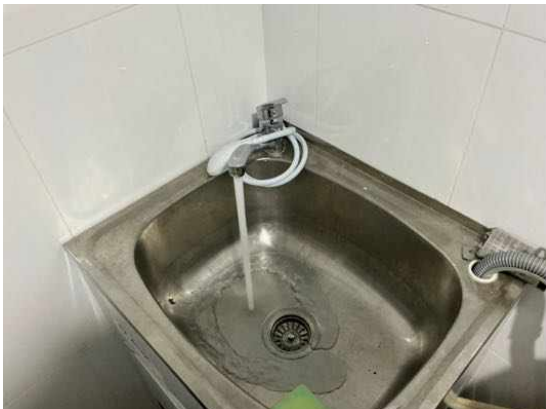
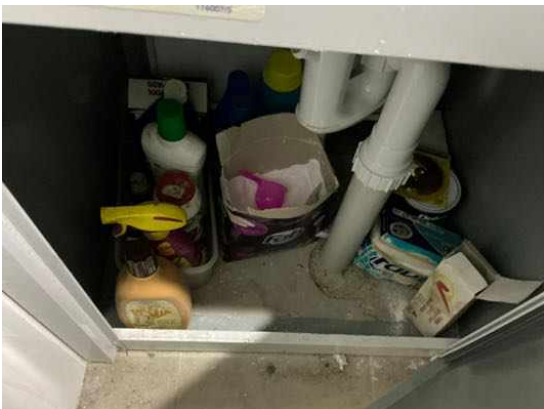
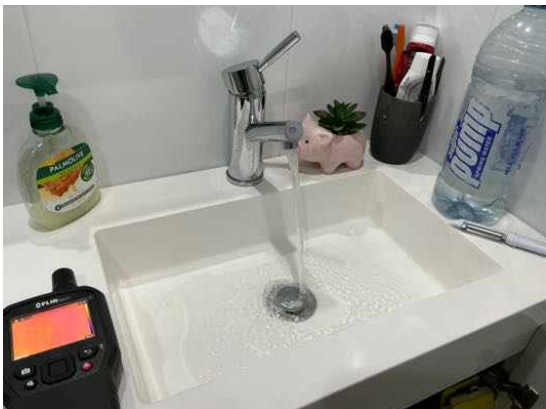
Building: Main Building  
 Location: All Areas > All Areas  
 Finding: For your information.  
 Information: Cabinetry plumbing - No leaks evident

All cupboards where sinks and basins with drainage plumbing were inspected and no evidence of leaks were present at the time of inspection. No leaks to the drainage pipes in the subfloor was evident at the time of inspection.

For your information only no remedial works are required at the time of inspection.

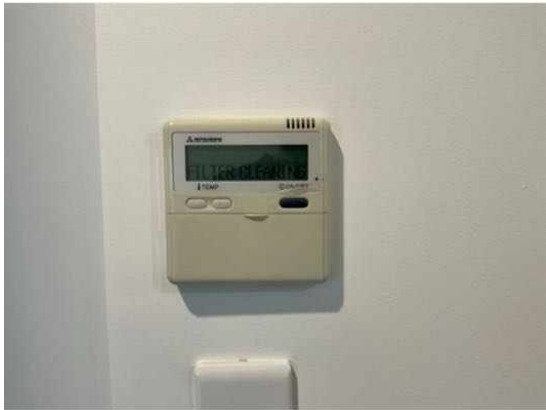
Building: Main Building  
 Location: Hallway > Upstairs  
 Finding: Air conditioning - For your information.  
 Information: The ducted air-conditioning indoor control module was observed to display the message “filters cleaning” during normal operation at the time of inspection. The system appeared to be operating and providing conditioned air as intended at the time. This item is noted for the information of the client only, as no functional fault was identified during the inspection; however, it is recommended that the owner monitor the system and seek further advice from a suitably qualified air-conditioning technician if the message persists or system performance is affected.
