Building Inspection Report

Inspection Date: Thu, 12 Mar 2026

Property Address: 402/6 Gillespie St, Liverpool NSW 2170,
Australia

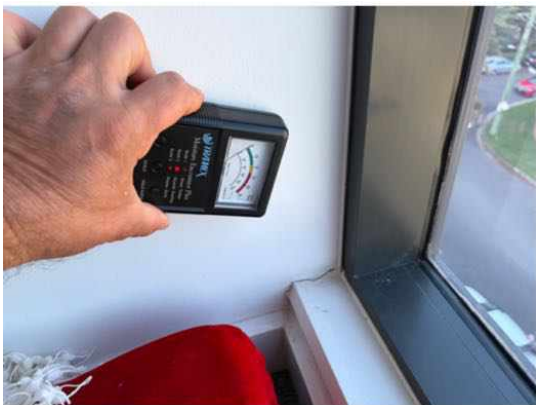
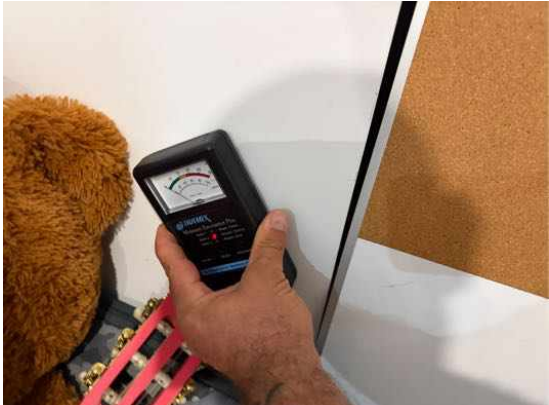
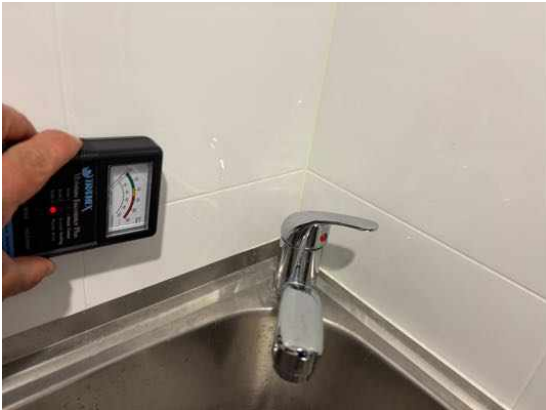
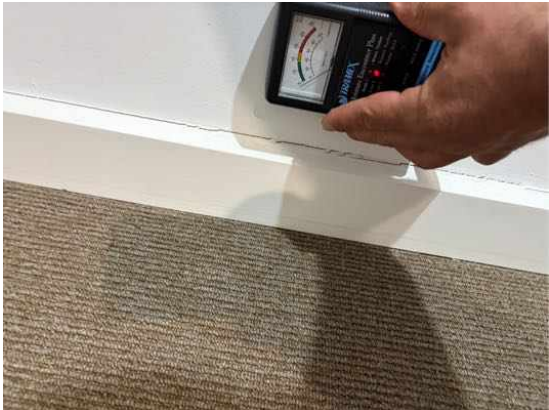
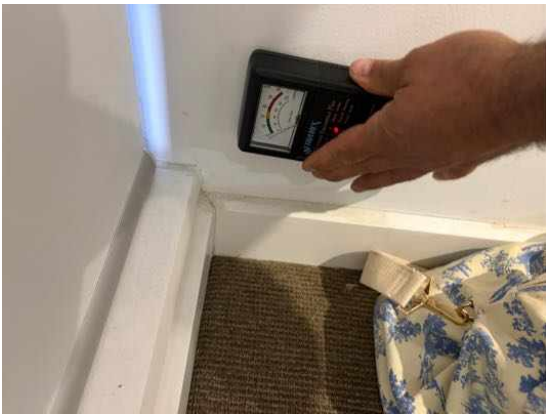
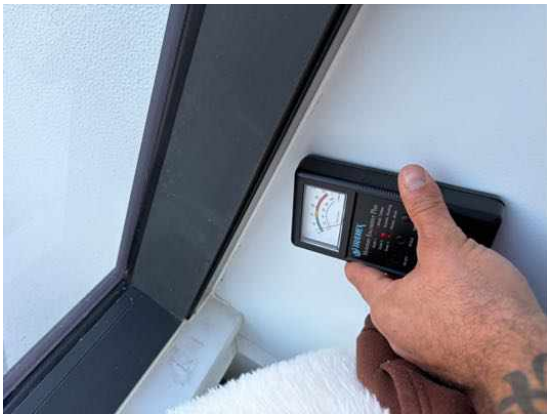
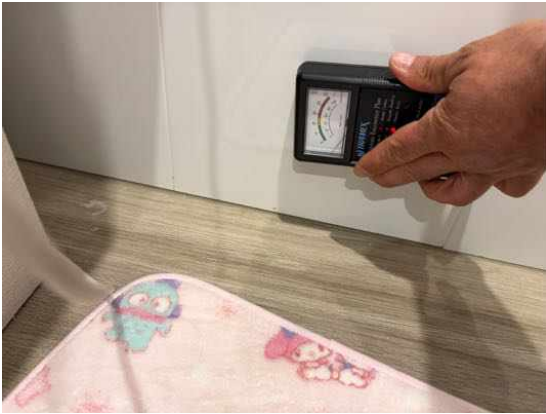
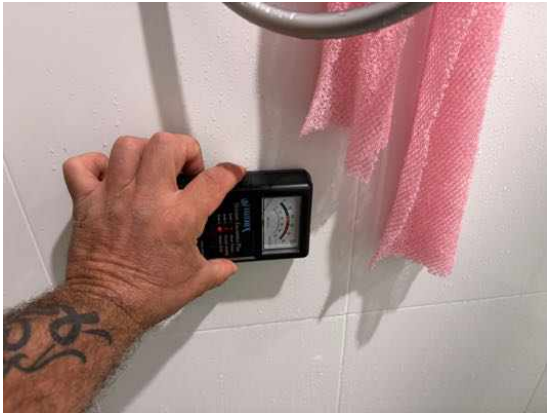
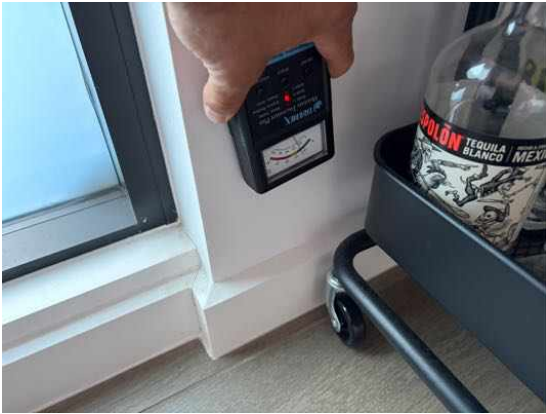
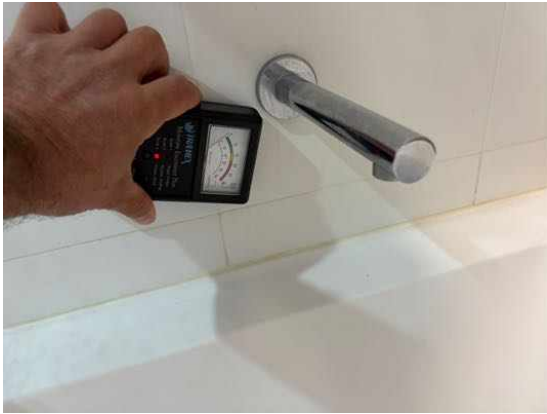
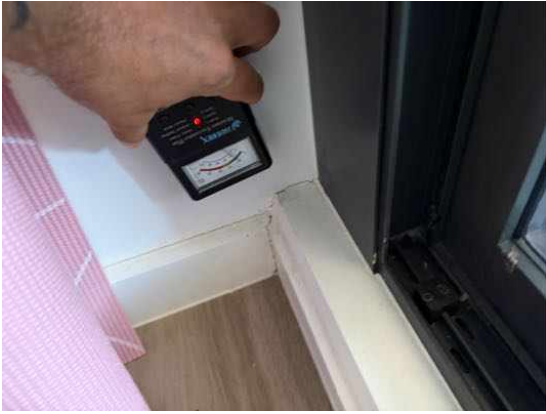
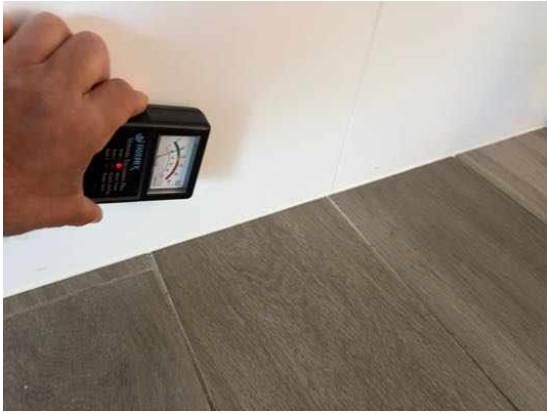
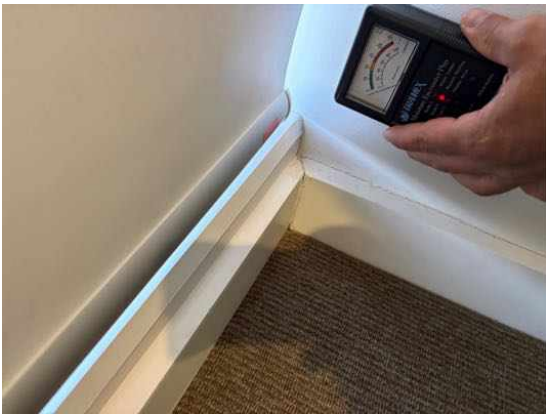
Noted Item

Building: Main Building
Location: All Areas
Finding: Moisture metre
Information: During the inspection the property was checked for moisture using a moisture metre.

This is for information only.

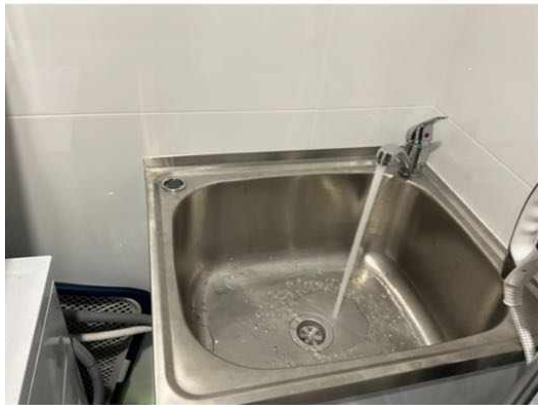
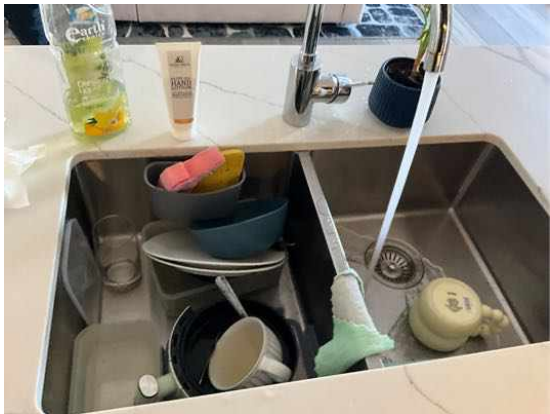
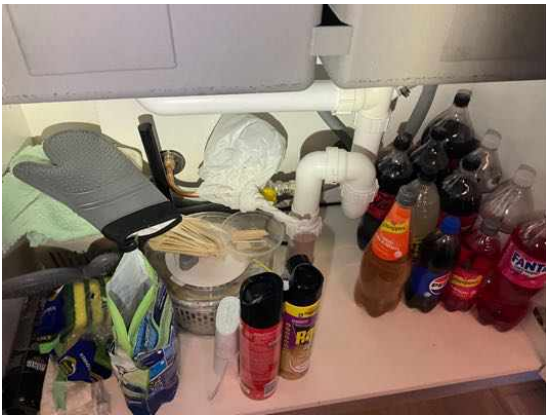
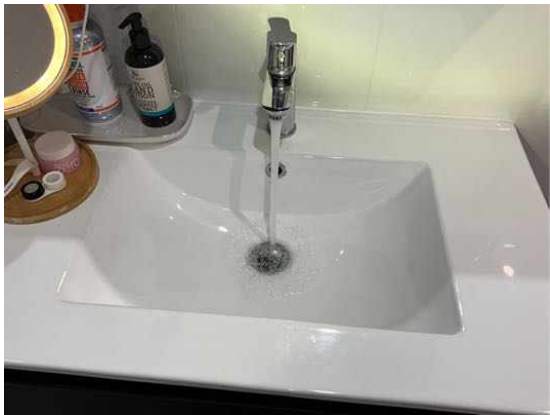
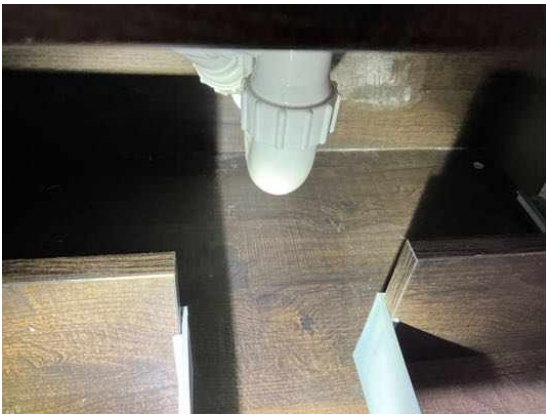
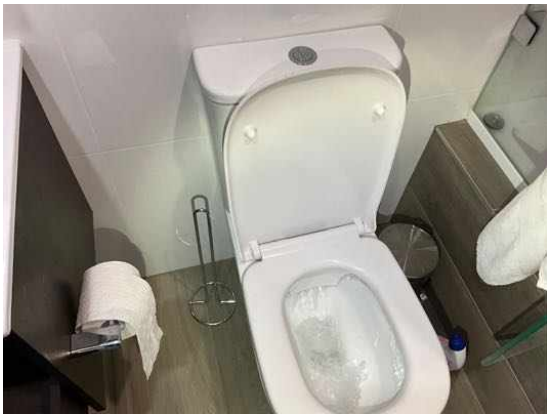
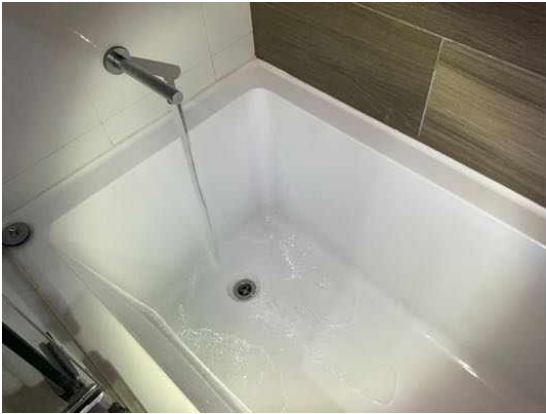
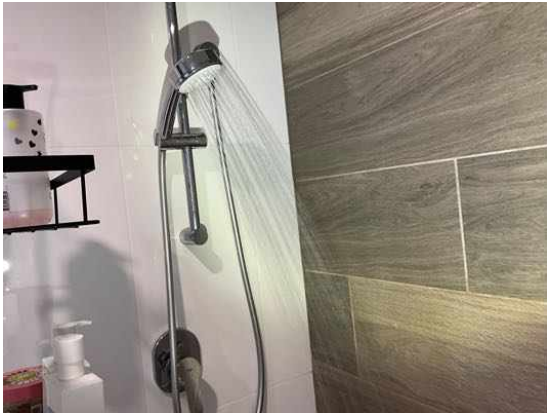
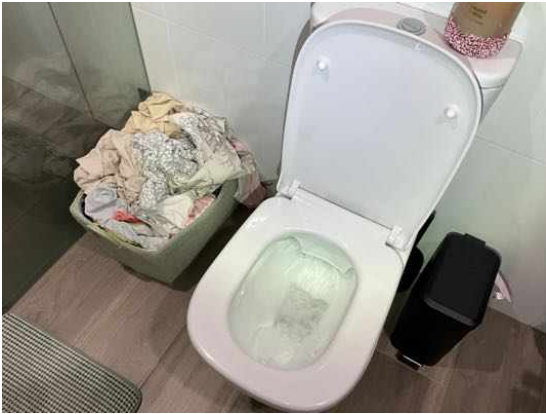
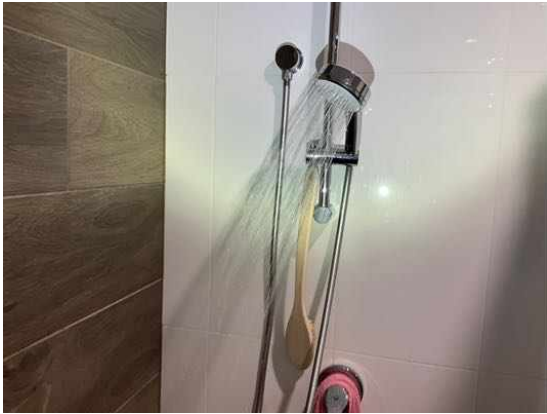
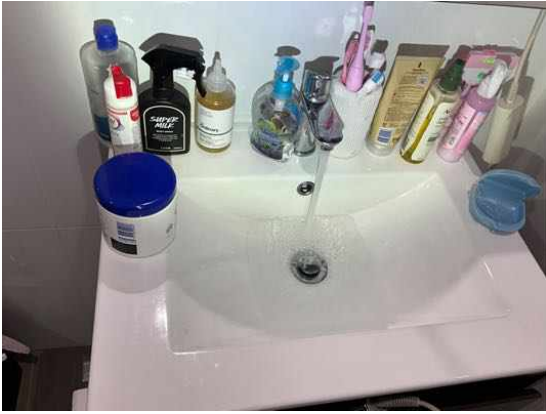
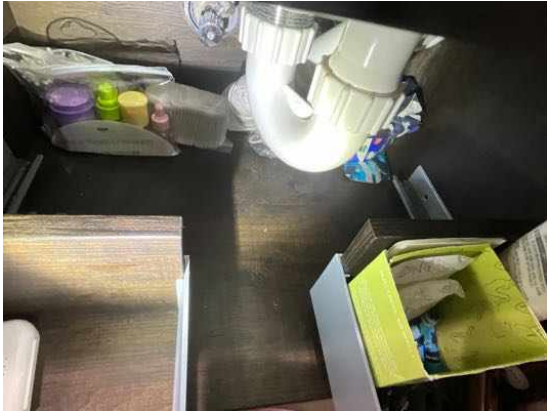
Noted Item

Building: Main Building
Location: All Wet Areas
Finding: Additional Photos
Information:

Additional photos are provided for your general reference.

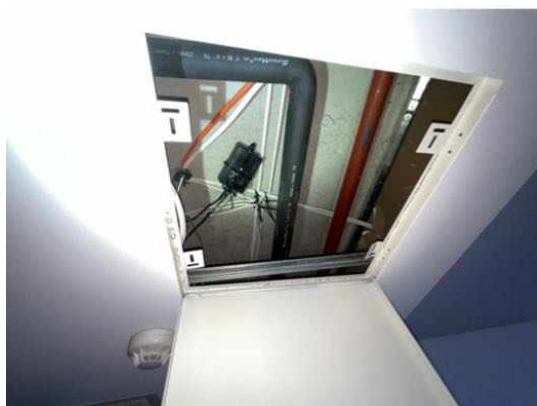
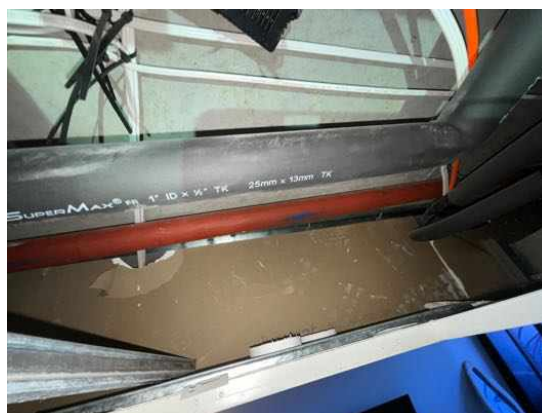
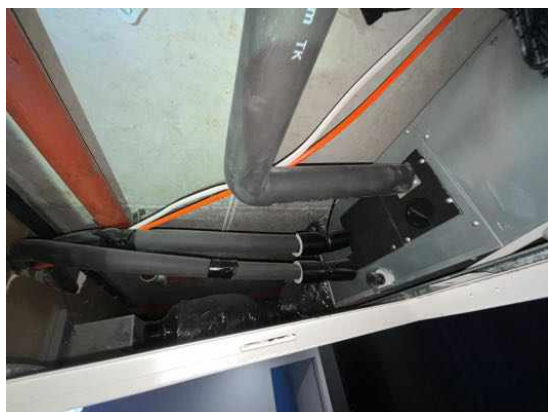
Noted Item

Building:	Main Building
Location:	Ceiling cavity
Finding:	Additional Photos- ceiling cavity
Information:	Additional photos are provided for your general reference. Arrows may have been included to highlight areas of importance. Please discuss these photos with your building consultant for clarification.

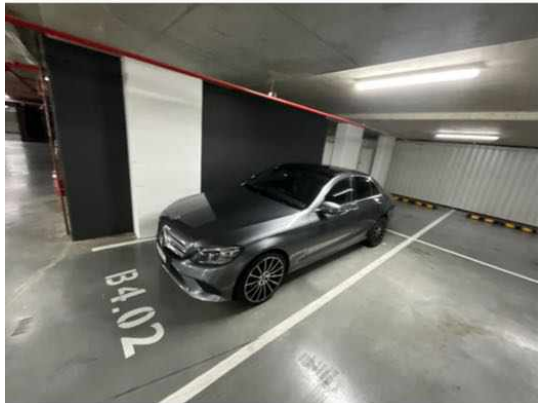
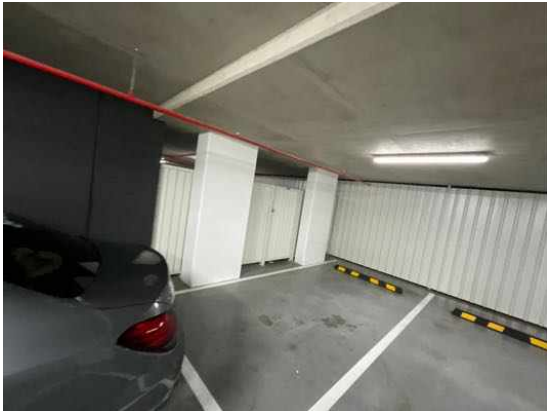
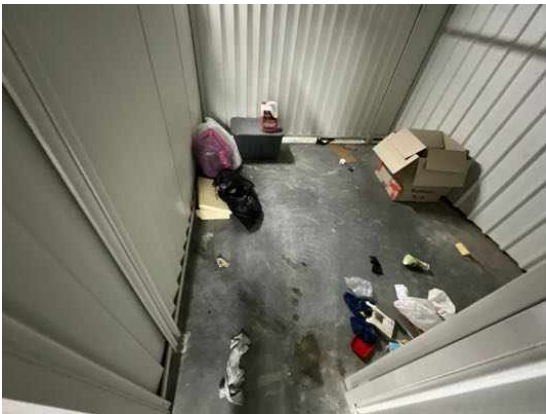
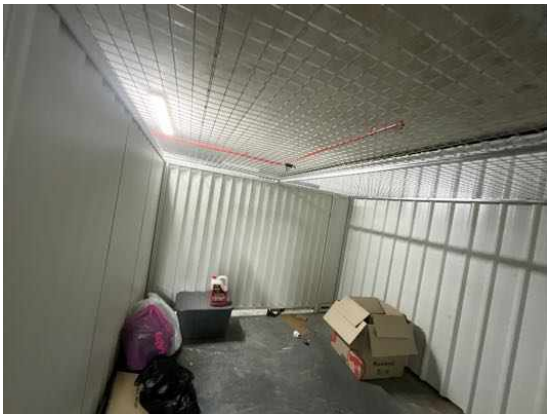
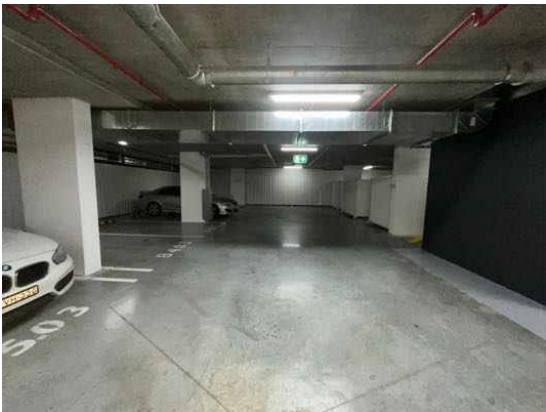
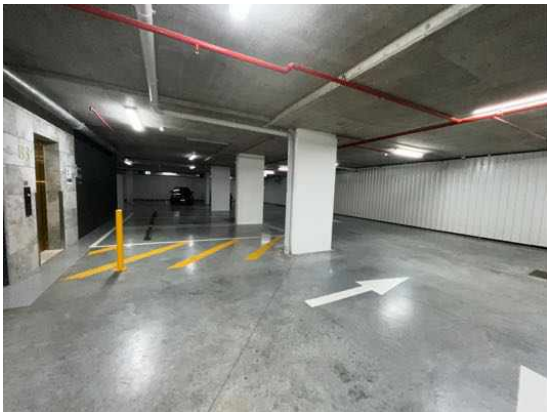
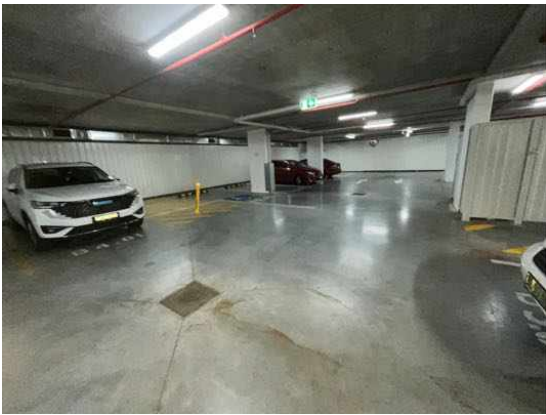
Noted Item

Building: Main Building
Location: Garage
Finding: Additional Photos- Garage
Information: Additional photos are provided for your general reference. Arrows may have been included to highlight areas of importance. Please discuss these photos with your building consultant for clarification.

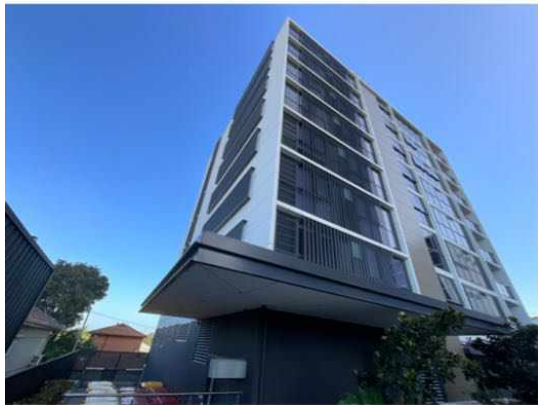
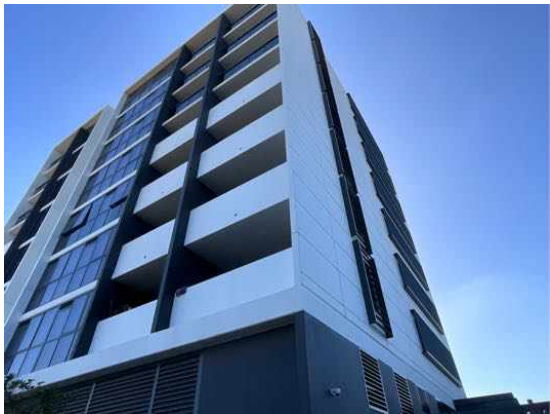
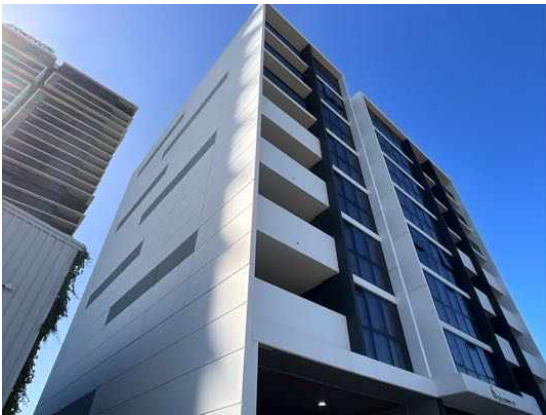
Noted Item

Building: Main Building

Finding: Additional Photos

Information: Additional photos are provided for your general reference.
