Building and Timber Pest Inspection Report

Inspection Date: Fri, 27 Mar 2026

Property Address: 71/17 Piccadilly St, Bellmere QLD 4510,
Australia

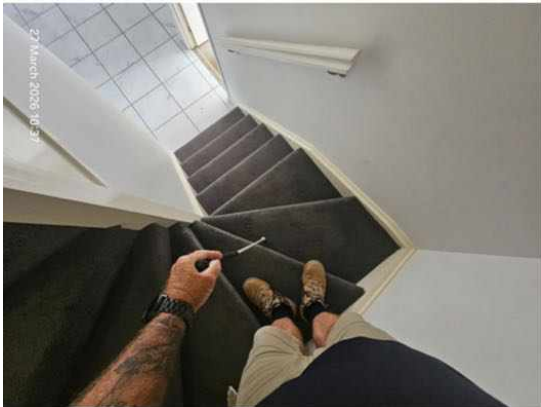
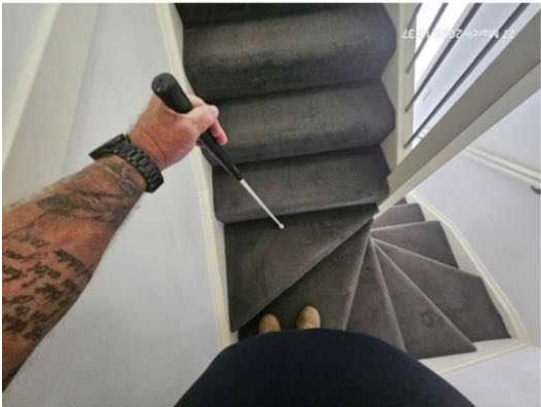
Building:	Main Building
Location:	Stairs - Internal
Finding:	Stairs - noisy or squeaking
Information:	On the day of inspection the stairs were noisy / squeaking when walked on. This is generally an aesthetic or nuisance defect and in most cases not a structural issue.

This could be due to the movement of the wedges securing the treads in place. In most cases this is a relatively simple repair.

A licensed carpenter or suitable qualified handy person could be engaged at the

clients discretion.

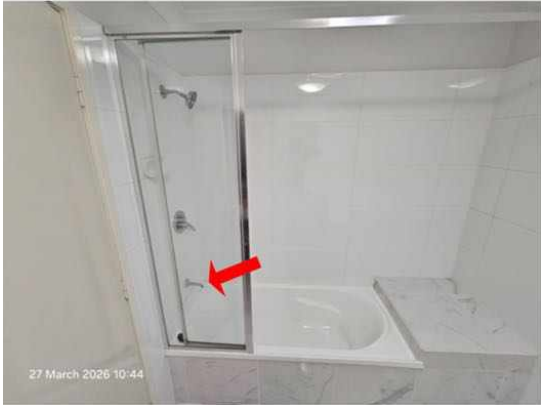
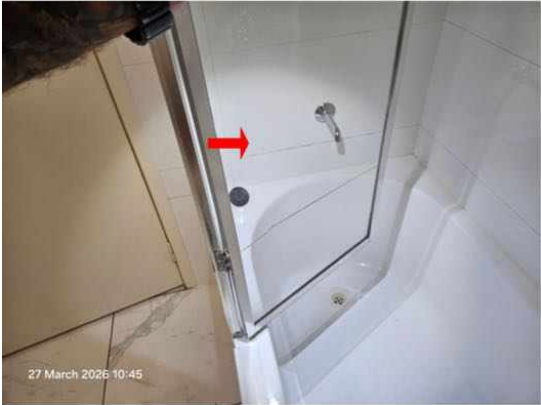
Finding 3.07

Building: Main Building
 Location: Bathroom
 Finding: Grout - degraded
 Information: It was noted on inspection that the grout is degraded to the tiles of the shower recess. There was a noticeable crack above the bath taps in the grout joint.

Although not defective at this time, deterioration is noted and renewal work will be required in the short term.

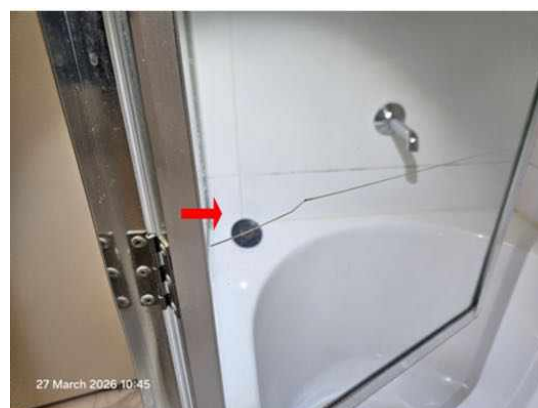
Finding 3.08

Building:	Main Building
Location:	Bathroom
Finding:	Shower screen - Cracked
Information:	Cracking was evident to the shower screen at the time of inspection, which is suspected to be due to accidental impact damage.

While the cracking appears to be minor, any further impact may lead to additional cracking and or shattering of the shower screen, creating a potential safety hazard in the area. Further damage would almost certainly necessitate replacement of the entire shower screen.

A qualified glazier is required to repair the shower screen as soon as possible. Please be advised that any persons coming into contact with the cracked shower screen should do so with due caution to avoid any personal injury that may ensue.

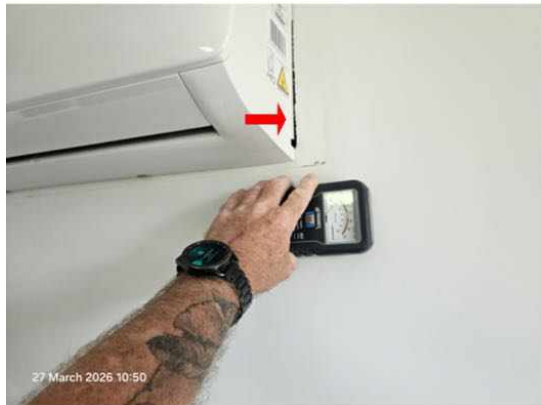
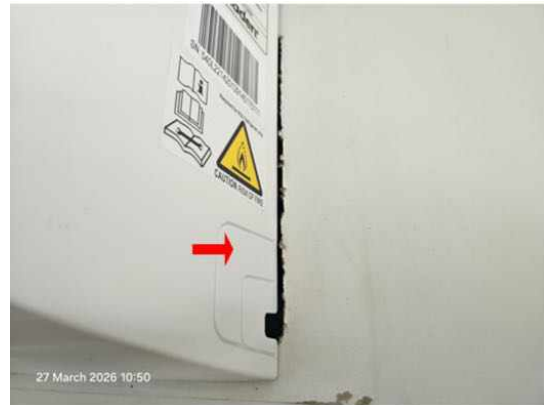
Finding 3.09

Building:	Main Building
Location:	Bedroom - Master
Finding:	Air conditioner installation
Information:	Whilst inspecting the master bedroom it was noted that the air conditioner unit has

been install poorly. There is a noticeable gap beside the head unit.

An air conditioner technician could be engaged to rectify the installation.

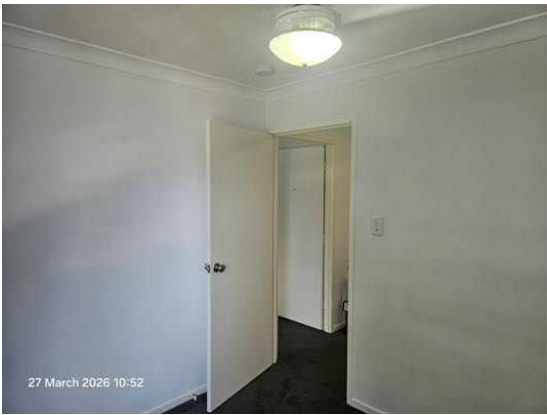
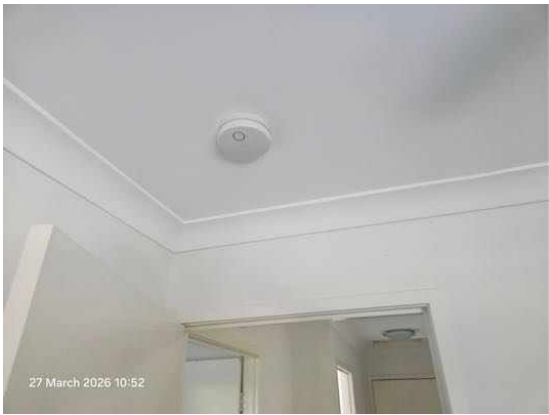
Building: Main Building
Location: All Areas
Finding: Additional Photos - Obstructions and Limitations
Information: These photographs are an indication of the obstructions and limitations which impeded full inspection of the property at the time of inspection. These obstructions can hide an array of defects and should be removed to allow full inspection to be carried out. A re-inspection is recommended once the areas are made accessible.

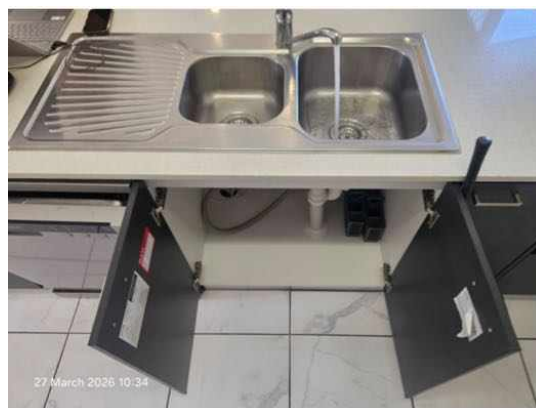
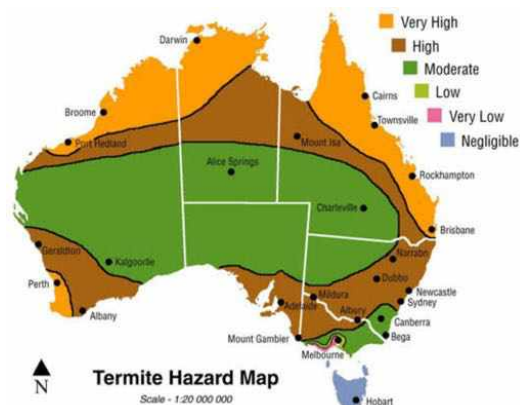
Building: Main Building
 Location: Meter box, kitchen cupboard
 Finding: Durable pest inspection notice
 Information: On the day of inspection it was noted that the durable pest inspection / treatment notice was in place and the most current inspection was notated and in date. These notices / stickers are to verify the timber pest inspection dates, the inspector, and, at times, the currency and type of timber pest system / barrier in place or being used in and around the property.

The client is advised to maintain annual inspections with the company listed or a company of their choosing.

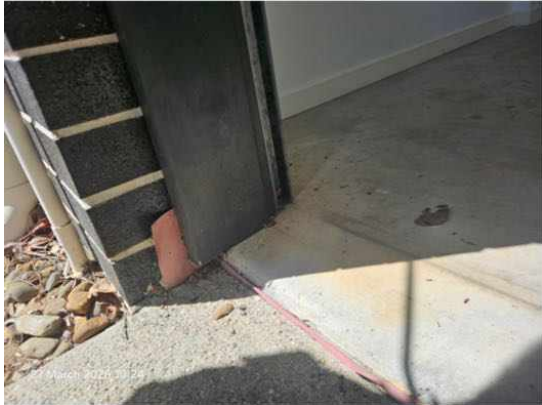
The building employs a "Protectant" physical barrier system to the perimeter and slab penetrations. In order for a barrier system to be effective, the property must have regular inspections at intervals of not greater than 12 months. Depending on the risk profile attributed to the property, these inspections may be recommended at lesser time periods.

Where a Termite Management System has been identified you should refer to the type of barrier, date of installation, warranty conditions and any documentation provided by a builder or past owner. Consult the company who installed the barrier to confirm whether the system is still under warranty.
