Building and Timber Pest Inspection Report

Inspection Date: Wed, 18 Mar 2026

Property Address: 3 Warrane Rd, Roseville Chase NSW 2069,
Australia

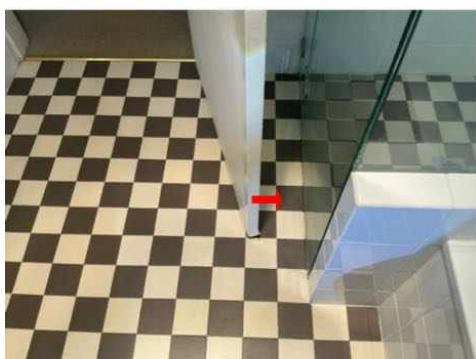
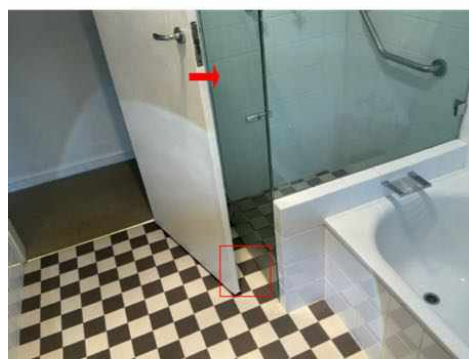
Building:	Main Building
Location:	Bathroom
Finding:	Door Stopper Missing - Near Shower Screen
Information:	At the time of inspection, a safety hazard was identified in the bathroom involving the door handle, which is striking the shower screen when the door is opened. The lack of a door stop or buffer in place allows the handle to make direct contact with the glass shower screen, posing a risk of breakage. A shattered screen could result in sharp glass fragments, potentially causing injury to occupants. This issue highlights the absence of a proper door stop mechanism, which is essential to prevent such contact and ensure safe operation of the door.

It is strongly recommended that the client engage a qualified handyman to install a suitable door stop or buffer to prevent the handle from hitting the shower screen. Immediate action is advised to mitigate the risk of glass breakage and ensure the safety of all users.

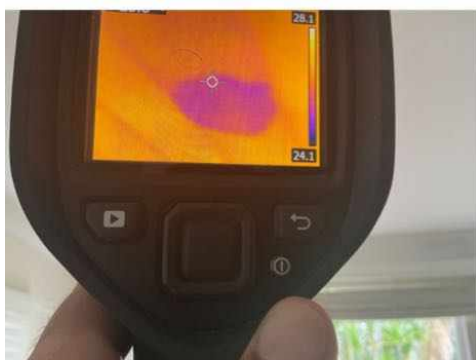
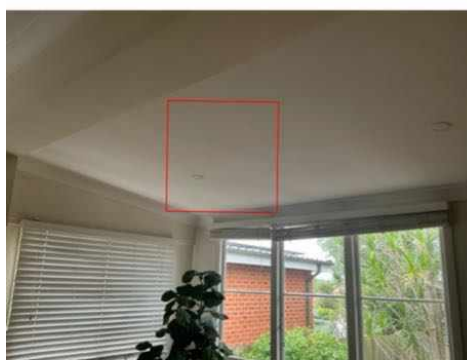
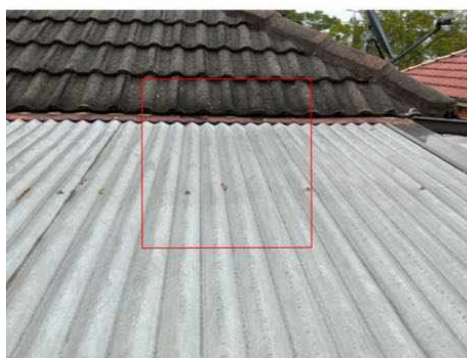
Building:	Main Building
Location:	Living Room
Finding:	Active Roof Leak Affecting Ceiling

Information: At the time of inspection, signs consistent with water ingress were observed to the internal ceiling area, supported by thermal imaging indicating elevated moisture levels. This condition suggests an active leak originating from above.

Based on visual assessment of the roof externally, the junction between the tiled roof section and the adjoining metal roof sheeting appears to rely on flashing at the transition point. It is likely that the flashing in this area is either inadequate, deteriorated, or improperly installed, allowing rainwater to penetrate through the junction and enter the ceiling space.

If left unaddressed, ongoing water ingress can lead to progressive damage to ceiling linings, insulation, and structural components, as well as increase the risk of mould growth and further internal deterioration.

This issue will turn into a major defect if urgent attention is not taken. The client is strongly advised to engage the services of a licensed roofing specialist as a matter of urgency to inspect the flashing detail, identify the exact point of failure, and carry out appropriate repairs to prevent further water ingress and damage.

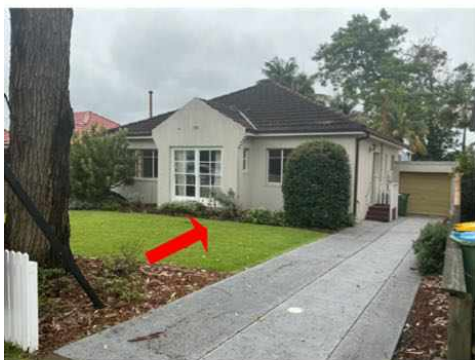
Finding 3.02

Building: Main Building
Location: Yard - Front

Finding: Inadequate Site Drainage - Exterior Areas
 Information: At the time of inspection, inadequate site drainage was observed around the perimeter of the building, which can lead to water pooling and insufficient runoff management.

This condition may result in moisture being absorbed by the foundation or lower walls, potentially leading to rising damp, cracks in brickwork, erosion of the soil around the building, or structural issues over time. Water pooling can also create ideal conditions for mould growth, contribute to the deterioration of exterior materials, and act as conducive conditions for termite activity, as termites are attracted to areas with elevated and persistent moisture levels.

It is recommended that proper site drainage be installed, such as redirecting water flow away from the building or incorporating drainage systems, to prevent further damage and ensure the long-term stability of the structure.

To address the inadequate site drainage, a qualified landscaper or drainage specialist should be engaged to design and install appropriate drainage solutions, such as grading the ground away from the building or installing French drains, surface drains, or downspout extensions. If more complex issues are present, such as damage to the foundation or moisture entering the walls, a structural engineer may need to assess the situation, and a builder may be required for repairs.

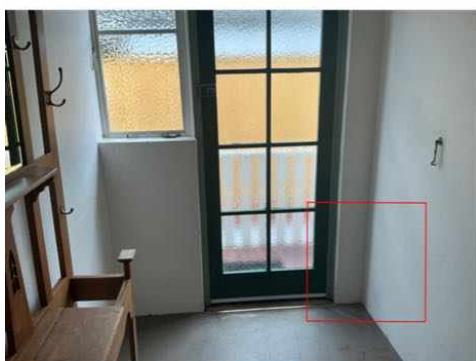
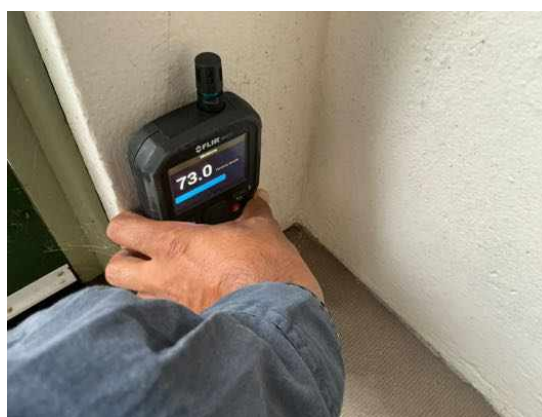
Finding 3.03

Building: Main Building
 Location: Entry
 Finding: Damp - Rising
 Information: At the time of inspection, rising damp was identified within the property. This condition results from the upward movement of moisture through porous building materials, such as bricks, sandstone, or mortar, via capillary action. A damp-proof course (DPC), an impermeable barrier installed at the base of walls above ground level during construction, is typically used to prevent rising damp. However, the absence, deterioration, or bridging of the DPC can compromise its effectiveness, specially in older buildings, leading to moisture ingress. Inadequate site drainage, which allows

water to accumulate around the foundation, is a common contributing factor to this issue.

If left unaddressed, rising damp can pose significant health risks due to mould growth and cause extensive damage to building elements, including wall finishes such as paint and plasterwork. The current condition should be monitored over a 12-month period to assess its progression.

It is strongly recommended that the client engage a qualified damp-proofing specialist for remedial actions. Additionally, consulting a qualified plumber or drainage specialist to assess and improve site drainage is advised to mitigate further risks. Monitoring the condition for 12 months is essential to evaluate its status and prevent potential recurrence or further damage.

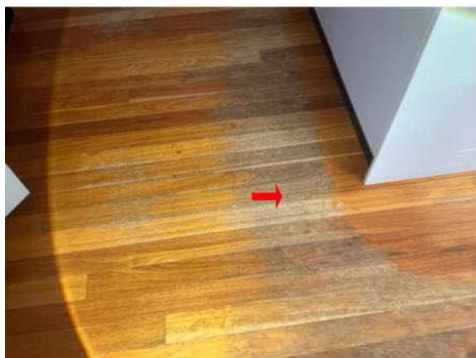
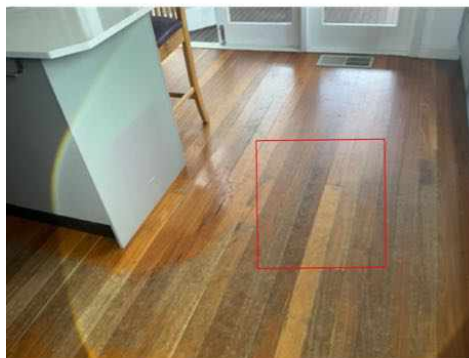
Finding 3.04

Building:	Main Building
Location:	All Areas
Finding:	Internal Flooring - Wear & Tear
Information:	At the time of inspection, general wear and tear was noted on the timber flooring, including surface scratches, scuff marks, and areas where the finish has worn away. These signs of deterioration are consistent with age and regular foot traffic and may detract from the overall appearance of the flooring.

It is recommended that a qualified flooring specialist be engaged to assess the condition of the floor and provide advice on appropriate maintenance or refinishing options, such as sanding and re-coating, to restore surface protection and improve presentation.

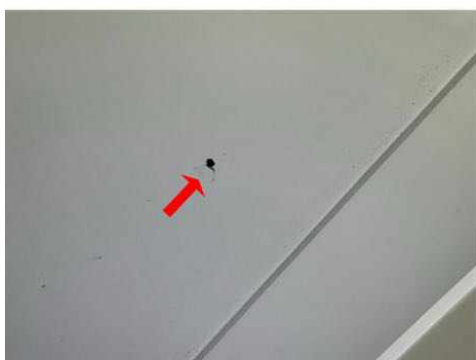
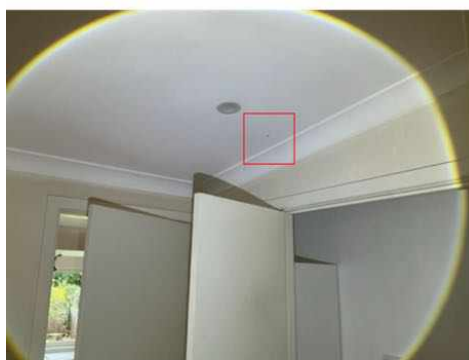
Finding 3.05

Building:	Main Building
Location:	Dining/Laundry
Finding:	Plasterboard - Holes
Information:	A hole has been observed in the ceiling plasterboard at the time of inspection.

This damage can lead to several issues, including compromised structural integrity of the ceiling, potential water damage if located near plumbing or roof leaks, and an entry point for pests. Additionally, the hole detracts from the aesthetic appeal of the room and may impact insulation efficiency, leading to increased energy costs. It is essential to repair the plasterboard promptly to prevent further deterioration and maintain the overall safety and appearance of the property.

The client is advised to hire services of a handyman or plasterer to fix the issue.

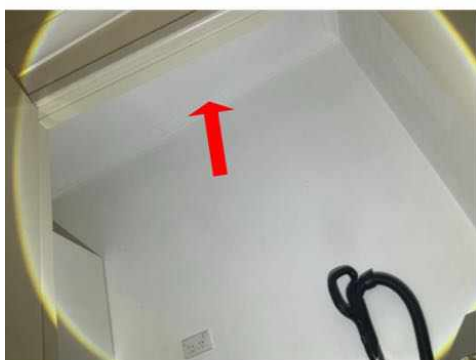
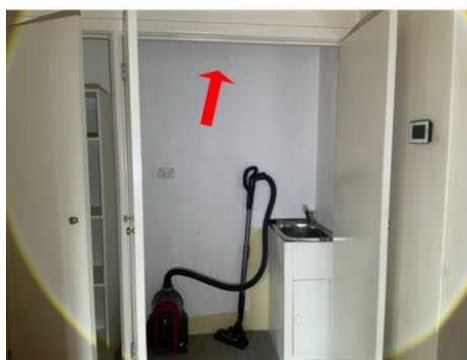
Finding 3.06

Building:	Main Building
Location:	Laundry
Finding:	Laundry - No Exhaust Fan Installed
Information:	At the time of inspection, it was noted that the laundry area is not equipped with an exhaust fan.

The absence of mechanical ventilation in a confined space such as a laundry can lead to the accumulation of excess moisture and humidity, particularly during the use of washing machines and dryers. Over time, this can result in condensation build-up on walls and ceilings, increasing the risk of mould and mildew growth, which may cause health issues such as respiratory irritation and allergies. Additionally, persistent damp conditions can contribute to the deterioration of paint, plaster, and other building materials, potentially leading to more extensive and costly repairs.

A licensed electrician should be appointed to carry out this work to ensure the fan is installed safely and in accordance with Australian electrical standards at clients own discretion.

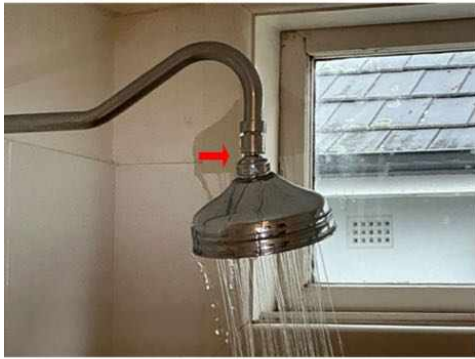
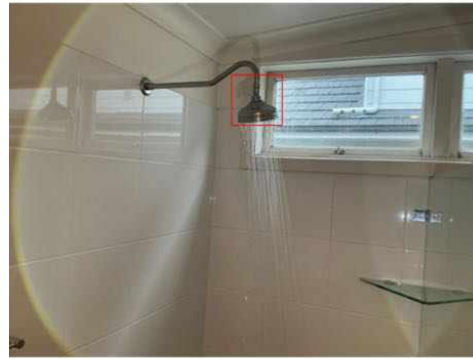
Finding 3.07

Building:	Main Building
Location:	Ensuite - Master
Finding:	Shower Head - Leaking
Information:	Showerhead was found to be leaking at the time of inspection. This is a common defect.

A leaking shower head could be due to issues like a worn-out washer, a loose connection, a damaged O-ring, or mineral deposits blocking the flow. Inspecting and replacing any damaged components or tightening connections might help resolve the leakage.

A qualified plumber should be engaged to rectify the situation as soon as possible.

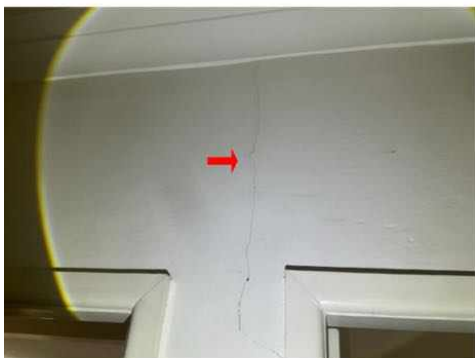
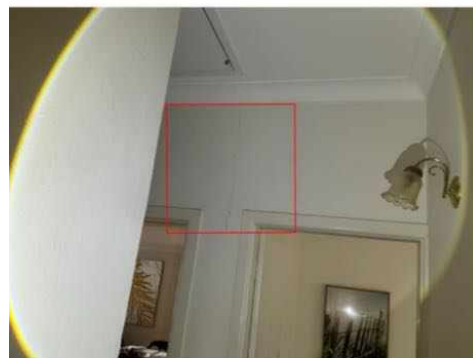
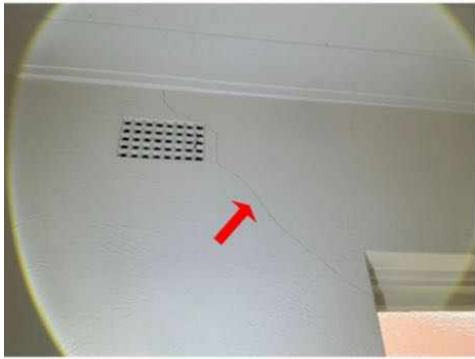
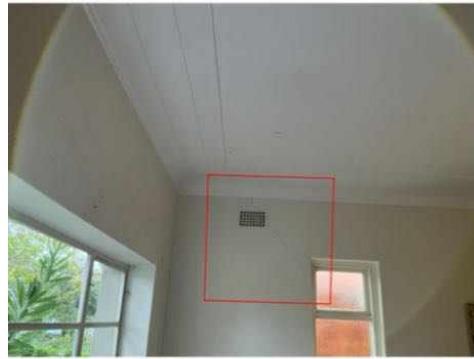
Finding 3.08

Building:	Main Building
Location:	Hallway, Lounge Room
Finding:	Cracking - Damage Category 2 - Noticeable (up to 5mm)
Information:	Noticeable cracks are a common occurrence as a result of many primary defects. Such causes may include age, general wear and tear, expected building movement, general expansion/contraction of building materials in different weather conditions, and/or minor failings in the installation or application of building materials.

Noticeable cracks may result in minor sticking or jamming of associated doors and windows, which require easement. However, noticeable cracks are easily filled and repaired. A plasterer can be consulted to install an expansion joint at this point to allow for this movement during different weather conditions.

Monitoring of all cracking should be conducted frequently. Always contact a building inspector should cracks widen, lengthen, or become more numerous. Additionally, your building inspector should also be contacted if associated building elements such as doors and windows become more difficult to operate over time.

Relevant tradespeople, such as carpenters, painters and plasterers, should be appointed to perform remedial works, as deemed necessary.

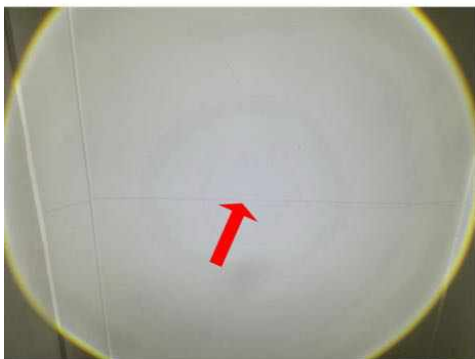
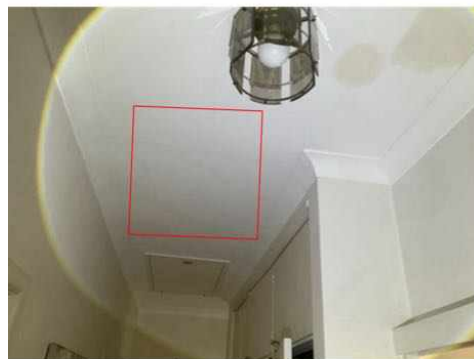
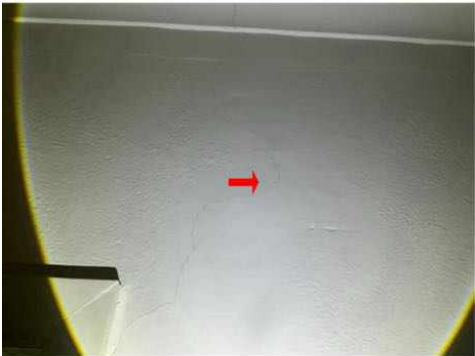
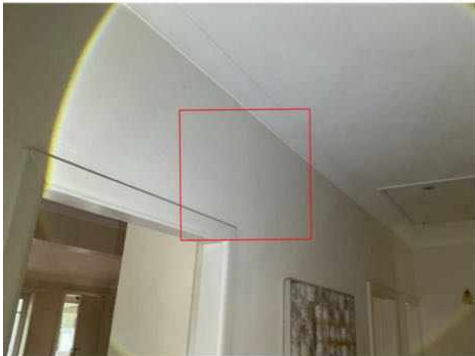
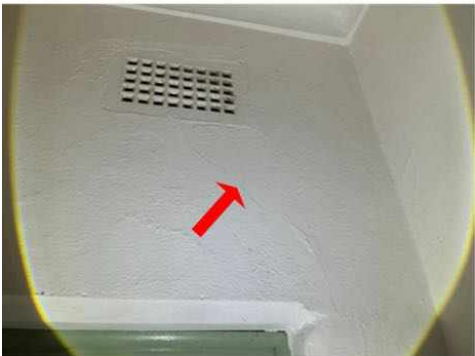
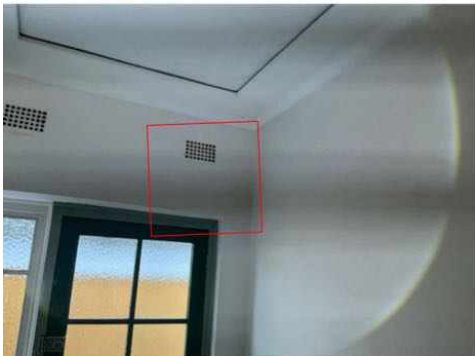
Finding 3.09

Finding: Cracking - Damage Category 1 - Fine (up to 1mm)

Information: Although fine cracks are quite noticeable, they are often only considered to be an appearance defect, and usually do not indicate any structural damage. Generally, the cause of a fine crack is indicative of a separation between building materials and finishes (e.g. paint, plaster, etc.) along joints.

Cracking of this nature can generally be repaired with minor sanding, filling and/or repainting. Such works should be performed by a qualified painter or a general handyman.

Monitoring of all cracking should be conducted frequently. Always contact a building inspector should cracks widen, lengthen, or become more numerous.

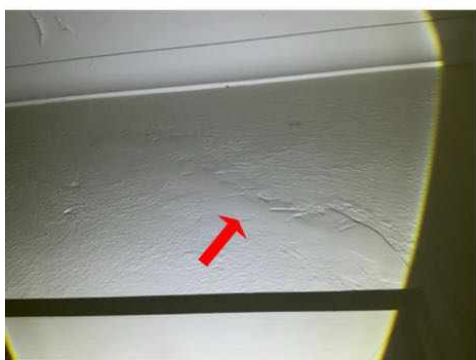
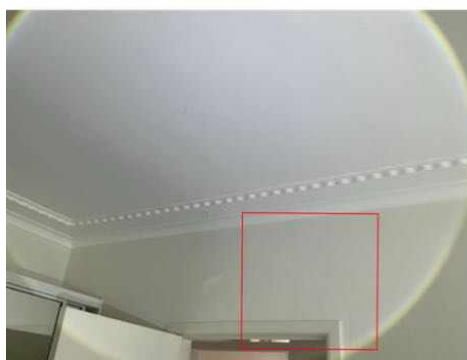
Finding 3.10

Building:	Main Building
Location:	Bedroom 3
Finding:	Cracks Repaired - House
Information:	For your information, it has been observed that the cracks inside the house have been repaired. While this indicates that previous issues with the structure have been addressed, it is important to understand the extent and quality of these repairs. It is advisable to obtain details about the repairs, including the methods used, the materials applied, and any professional evaluations or warranties associated with the work. This information can provide assurance regarding the stability and durability of the repairs, as well as guide any future maintenance or monitoring efforts to ensure the ongoing integrity of the property.

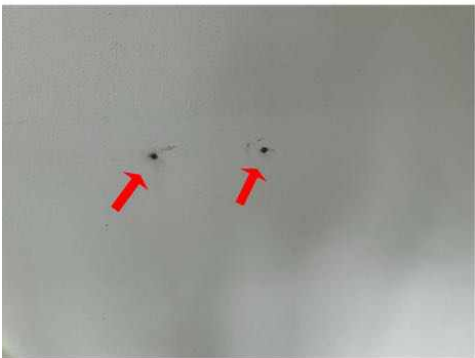
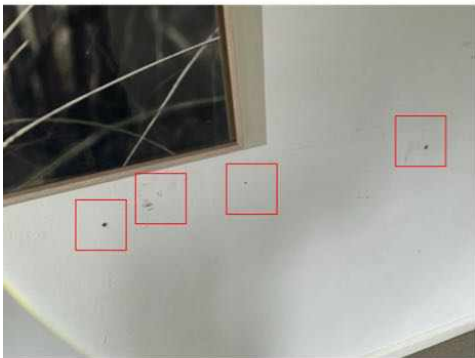
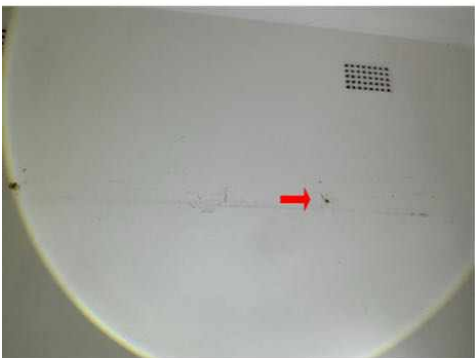
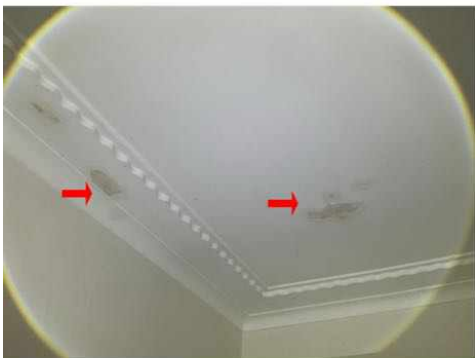
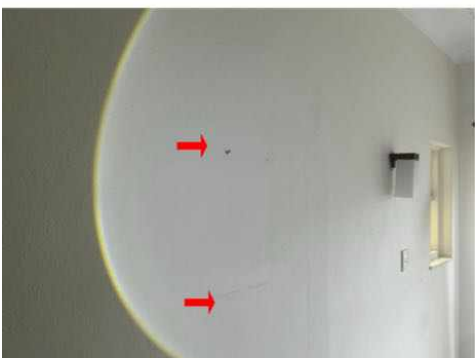
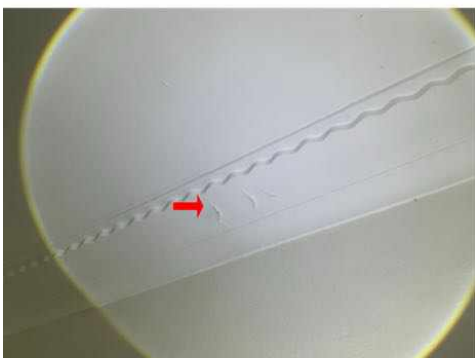
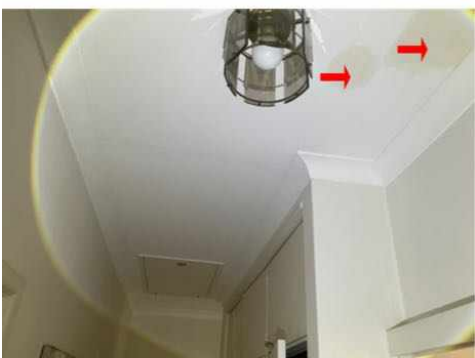
Building:	Main Building
Location:	All Areas
Finding:	Maintenance and/or Wear and tear on building elements
Information:	It was observed at the time of inspection that some building elements and areas around the property require general maintenance and/or exhibit signs of wear and tear. These typically include minor imperfections such as paint scuff marks, scratches on surfaces, small chips, nails or hooks left in walls from previous picture hanging, and other superficial blemishes.

These are generally considered minor items that are common in established homes. While they may be noticeable on visual inspection, they do not affect the structural integrity or functionality of the property. In most cases, these issues can be easily addressed by a qualified handyman as part of routine maintenance.

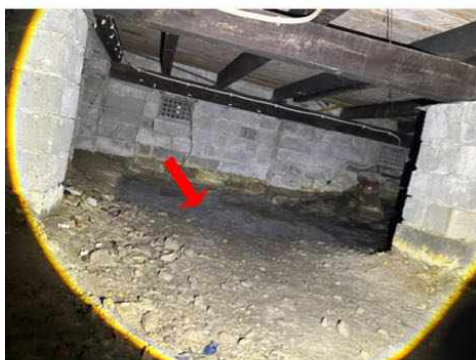
Finding 3.12

Building:	Main Building
Location:	Subfloor
Finding:	Water Pooling - Subfloor
Information:	At the time of inspection, water pooling was noted in the subfloor area. This condition can lead to excessive moisture retention, which may damage timber structures, contribute to mould growth, and impact the overall structural integrity of the property if not addressed. The presence of standing water also creates conducive conditions for termite activity, increasing the risk of infestation.

It is recommended that a drainage specialist be engaged as soon as possible to design and implement appropriate site drainage solutions. In addition, the installation of mechanical ventilation should be considered to improve airflow and reduce ongoing dampness within the subfloor.

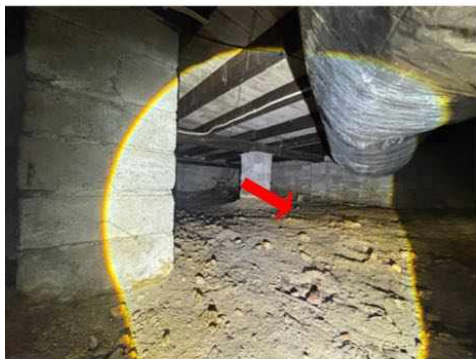
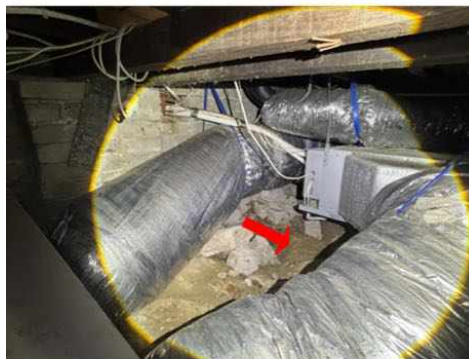
Finding 3.13

Building:	Main Building
Location:	Subfloor
Finding:	Subfloor Site Drainage - Inadequate
Information:	At the time of inspection, inadequate site drainage was observed under the subfloor, allowing water to accumulate and fail to drain effectively, creating a hazardous condition. This is a common defect in houses constructed on brick stumps, where poor site grading and limited subfloor ventilation can contribute to ongoing moisture retention. The resulting water pooling may lead to structural deterioration from prolonged dampness, mould and mildew growth, and create conditions conducive to termite activity. These issues can also impact indoor air quality and pose safety risks to occupants.

The client is advised to engage a licensed plumber or builder experienced in drainage and foundation work to assess and implement suitable solutions, such as improving site grading, installing appropriate drainage systems, and enhancing moisture barriers. In addition, the installation of mechanical subfloor ventilation is recommended to improve air circulation, assist with moisture control, and reduce the risk of ongoing damp-related issues.

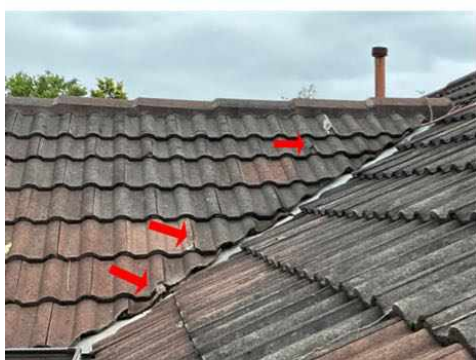
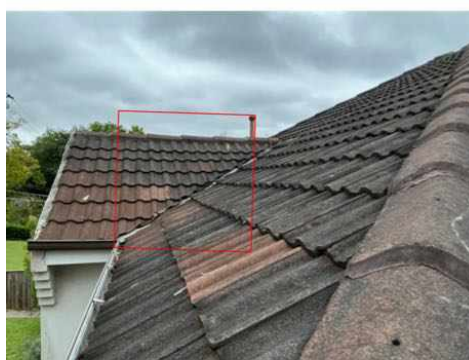
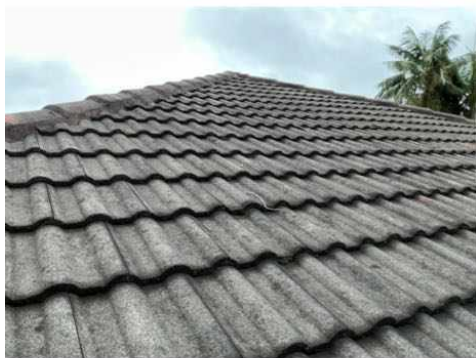
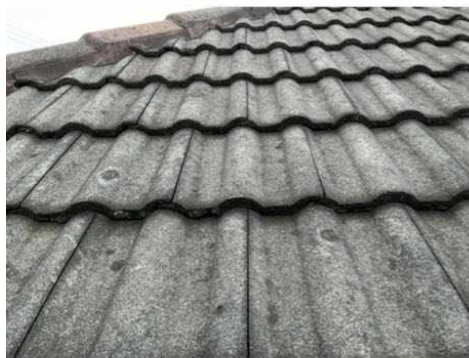
Finding 3.14

Building:	Main Building
Location:	All Areas
Finding:	Roof Tiles - Weathered, Mortar, Cracked & Slippage Identified
Information:	Upon inspection of the exterior roofing, the majority of roof tiles were considered to be in a fair condition. While weathering of the tiles is consistent with the age of the property, maintenance works are required. Some tiles noted to be damaged as well.

Isolated areas of tiles have come loose in the valleys and minor cracking of mortar is also present. Re-pointing and re-sealing the tiles may be considered as an interim solution by the client to help preserve and extend the life span of the tiles. Where left unmanaged, deteriorating roof tiles are likely to lead to a number of secondary defects, including minor water leaks and weather exposure to internal roofing structures.

The client is advised to engage services of a professional roofer for further consultation.

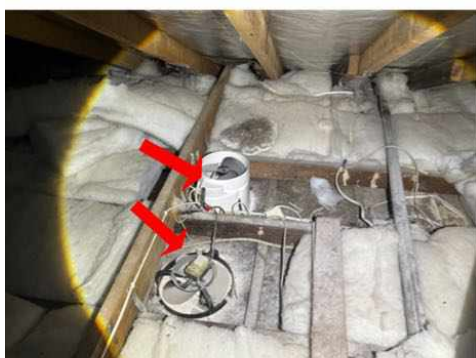
Finding 3.15

Building:	Main Building
Location:	Roof Void
Finding:	Vent - Extracted into Roof Space
Information:	During the inspection, it was noted that the exhaust vent has been improperly terminated into the roof space instead of being ducted to the exterior of the property.

This configuration is a defect as it allows moist air to accumulate within the roof cavity, increasing the risk of condensation, mould growth, and deterioration of insulation or timber framing. Proper ventilation is essential to maintain a healthy indoor environment and protect the structural integrity of the building. It is recommended that the vent be appropriately re-routed to discharge externally in compliance with relevant building standards.

A licensed mechanical ventilation contractor/electrician should be appointed as soon as possible to provide further consultation on the scope of these works and to provide quotations for any necessary works.

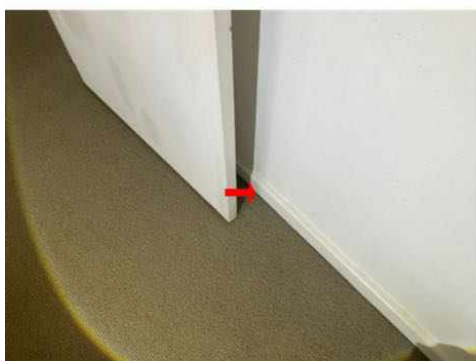
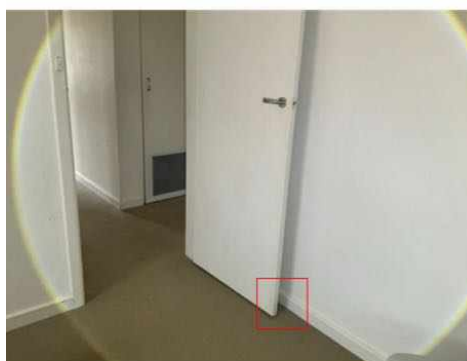
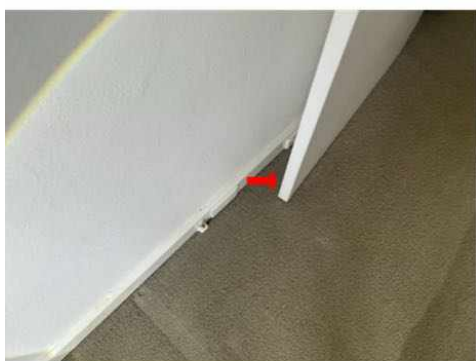
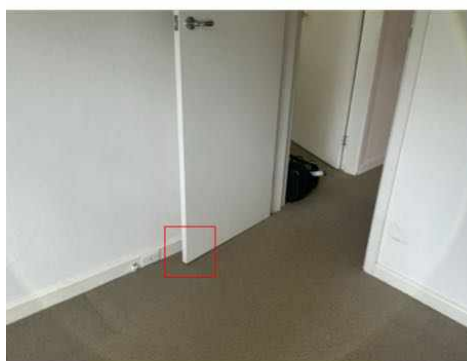
Finding 3.16

Building:	Main Building
Location:	All Areas

Finding: Door Stopper(s) - Missing
 Information: At the time of inspection, it was noted that a door stopper was missing in this area.

The absence of a door stopper can lead to potential damage to the door, wall, or surrounding finishes, as the door may swing open too far and impact the wall or adjacent objects. Over time, this can cause dents, scuffs, or even structural damage to the wall or door. It is recommended that a door stopper be installed to prevent further damage and ensure the protection of both the door and the surrounding area.

The client is advised to engage services of a handyman to install the door stopper.

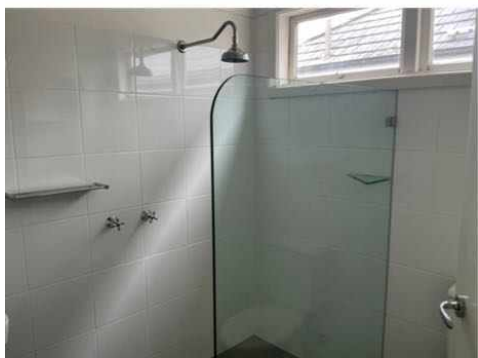
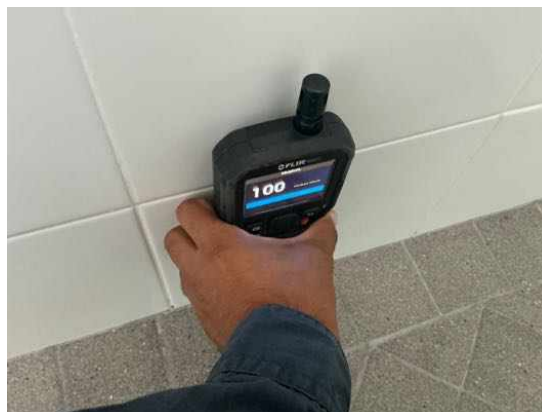
Finding 3.17

Building: Main Building
 Location: Ensuite - Master
 Finding: Excessive Moisture - Shower Damp
 Information: At the time of inspection, excessive moisture was noted within the shower area, which is a common issue in wet areas due to the continual exposure to water. This condition is typically caused by moisture seeping through grout lines and settling behind tiles, resulting in localised high-moisture zones. Provided there is no evidence of water staining or elevated moisture readings on the opposite side of the wall, this is considered a minor defect.

However, persistently damp conditions may act as conducive conditions for termite activity, as termites are strongly attracted to moisture-rich environments. It is recommended that the client ensures regular use of the exhaust fan and maintains adequate ventilation after shower use to promote drying and reduce long-term moisture build-up, thereby also reducing the risk of attracting termites.

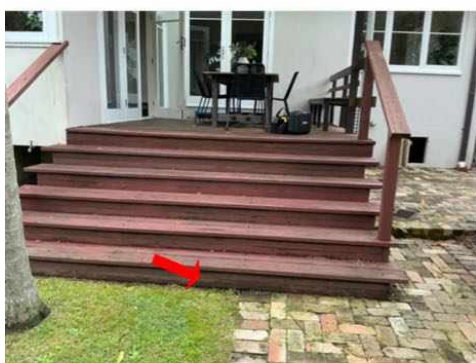
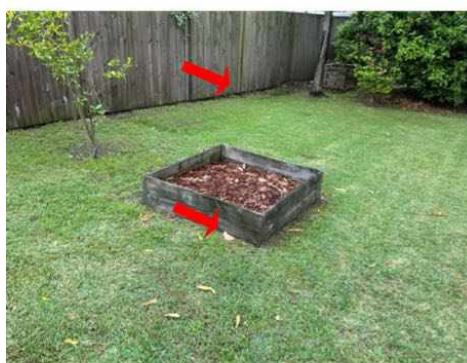
Finding 6.02

Building:	Yard
Location:	All Areas
Finding:	Building Materials in Direct Ground Contact - Conducive to Termites
Information:	Timber elements that are in direct contact with the ground and exposed to moisture or damp conditions are highly conducive to termite activity. This susceptibility arises because timber, when in contact with soil and dampness, creates an environment that is particularly attractive to termites, encouraging infestation and potential structural compromise. Whether the timber is used as a part of the building's construction or incorporated into fencing, its presence near or on the ground can become a pathway for termites to access and damage the property.

When exposed to excessive moisture, timber begins to deteriorate, developing conditions such as wood decay and rot. These compromised areas of timber are even more appealing to termites, as they are easier to infest and consume. This is especially true for untreated or non-durable timber, which lacks the protective treatments that can deter or withstand termite attacks. Termites can use these weakened, moisture-laden elements as a bridge into other parts of the structure, creating an entry point for potential infestations that can spread and cause extensive damage if left unchecked.

For any timber in direct contact with the external ground, special attention is required. The combination of moisture, untreated wood, and direct ground contact not only accelerates the decay process but also provides subterranean termites with a straightforward means of ingress into the structure. This entry can lead to termites moving undetected into other vulnerable areas, resulting in potentially significant structural issues and costly repairs.

To mitigate the risk of termite activity, it is imperative that any such materials or timber elements be appropriately treated or removed as soon as possible. Timbers that are necessary for use should be made durable through appropriate treatments and maintained to ensure they do not create conditions conducive to termites. Additionally, the client is advised to schedule regular termite treatments to maintain an effective barrier against infestations and ensure ongoing protection.

The client is strongly advised to assess the property for any timber elements that may be in direct contact with the ground and ensure prompt action is taken to remove or treat them effectively. Regular inspections, proactive maintenance, and consistent termite treatment are essential steps in minimising the risk of termite attack and protecting the structural integrity of the property. Taking these preventive measures is crucial for maintaining a termite-free environment and avoiding potentially costly damage and future repairs.

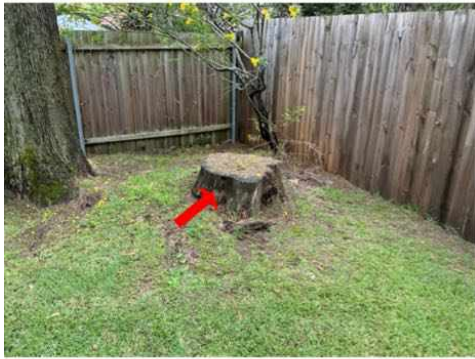
Finding 6.03

Building:	Yard
Location:	Yard - Back
Finding:	Tree Stumps - Remove
Information:	Old tree stumps were found around the property.

Any tree stumps in ground contact provide opportunity for concealed termite infestation and are likely to be subject to decay as the soil retains moisture or damp conditions against the tree stump.

All tree stumps should be removed where possible or alternatively be test drilled and treated. Frequent pest inspections are advised to readily identify any termite activity in these areas.

Timber pest management plan should be implemented and 6-12 monthly Timber Pest inspections carried out in accordance with AS4349.3 or AS 3660.2.

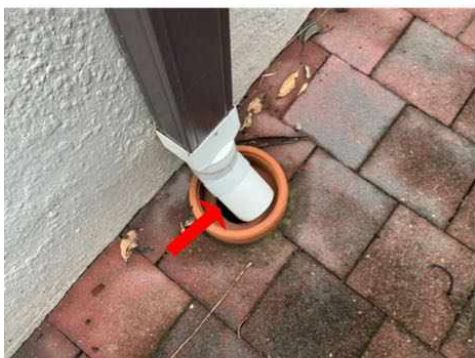
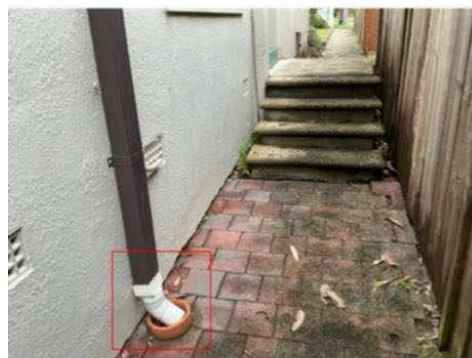
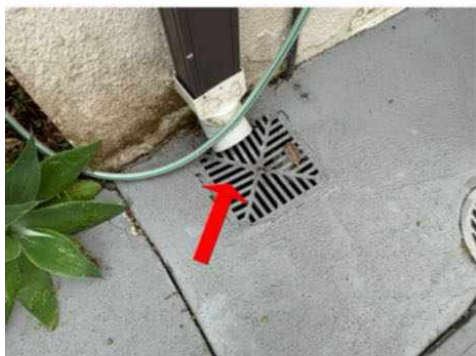
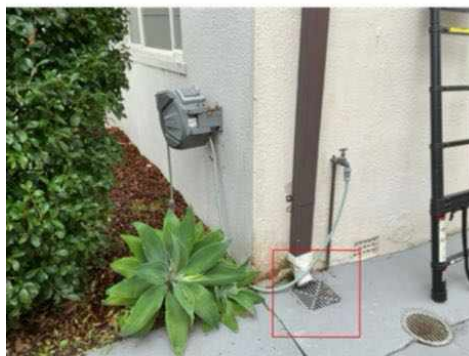
Finding 6.04

Information: The inspection revealed that the roof plumbing system is not adequately connected to the site's stormwater drainage, reducing its functional efficiency. This disconnection can lead to water pooling around the base of the property, increasing the risk of rust and corrosion to building elements, structural damage, and attracting termites due to the persistent dampness.

Improper drainage can also contribute to mould and mildew growth, affecting indoor air quality and health, and may lead to ground movement, causing cracks in walls and other structural issues.

It is strongly recommended that a licensed roof plumber be engaged to assess the system and ensure appropriate connections to stormwater outlets are installed to effectively redirect water away from the structure.

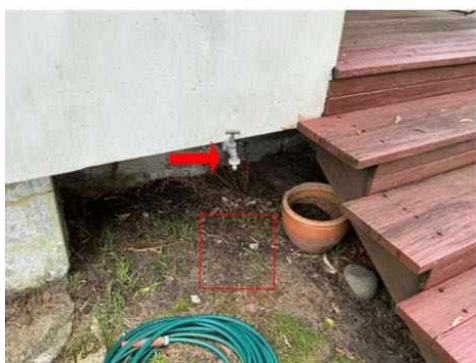
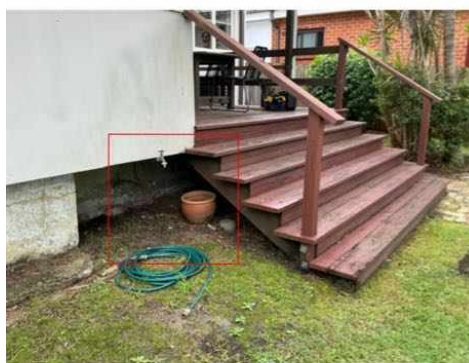
Finding 6.05

Building:	Main Building
Location:	Exterior walls - rear
Finding:	No Stormwater Drain - Under Exterior Tap
Information:	The inspection identified that the exterior tap is not connected to a stormwater drainage system, allowing water to pool around the base. This can lead to moisture-related issues such as deterioration of nearby building materials, mould growth, and increased risk of termite activity—each of which may compromise the property’s structural integrity and create health or safety concerns.

To prevent these risks, it is strongly recommended that a licensed plumber be engaged to assess the area and install appropriate drainage, such as a stormwater connection or splash block, to redirect water away from the property. Ongoing maintenance and monitoring of external water sources are also advised to ensure long-term protection.

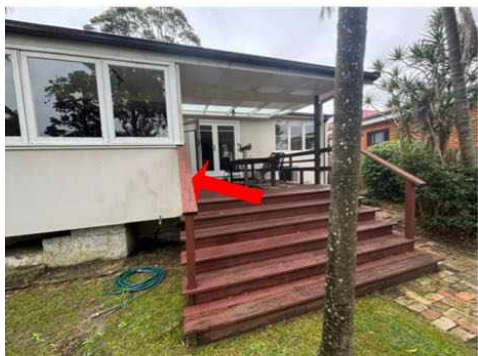
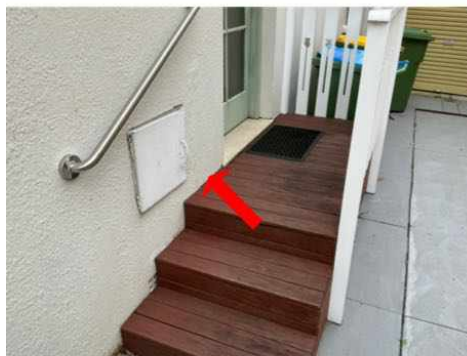
Finding 6.06

Building:	Main Building
Location:	Entry, Deck
Finding:	Timber Directly Attached to Building
Information:	At the time of inspection, timber materials were noted to be directly attached to the

external wall of the dwelling. This practice is considered a conducive condition for termite activity, as it provides both a potential food source and concealed entry point for termites into the structure.

It is recommended that the timber be removed, isolated, or appropriately treated to reduce the risk of termite infestation. A licensed pest management specialist should be consulted for further assessment and advice in line with AS 3660.2 (Termite Management).

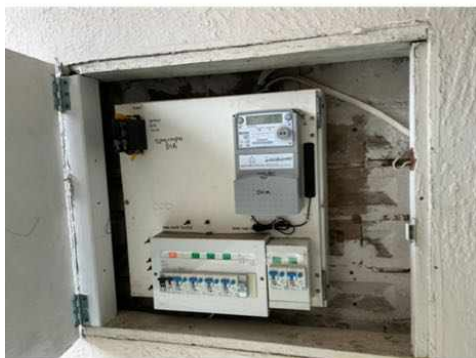
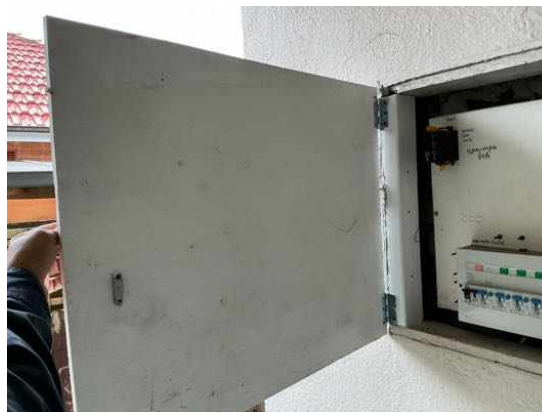
Finding 6.07

Information: The application of a post-construction chemical termite barrier is strongly recommended for all properties, especially if there has been any history of live termite activity on-site. These barriers are highly effective in protecting timber building elements throughout the property by preventing termite attacks. It is also advisable to install a durable notice within the switchboard unit, indicating the presence of any termite barriers for future reference.

During the inspection, there was no indication that a termite management system had been installed, nor was there any evidence to suggest that preventative measures had previously been undertaken. The client is encouraged to seek further advice from a licensed pest controller regarding the costs and procedures involved in the application of a termite barrier. Prioritizing this step in the short term is strongly advised to ensure long-term protection.

Additionally, the client may want to consult with the vendor to determine whether regular Timber Pest inspections, as per AS4349.3 or AS 3660.2, have been conducted in the past. This will provide further insights into any past termite management practices and help inform the appropriate course of action.

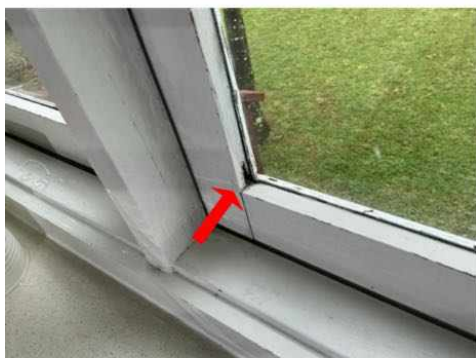
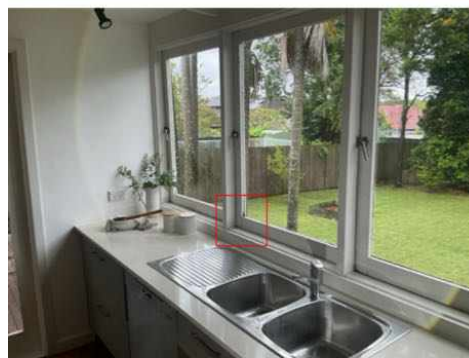
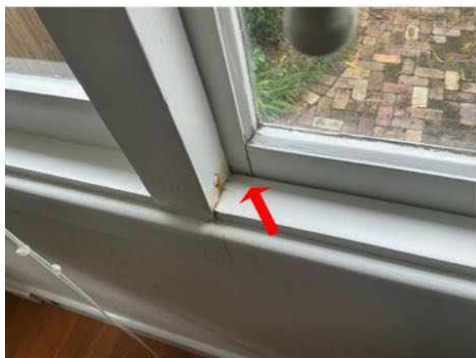
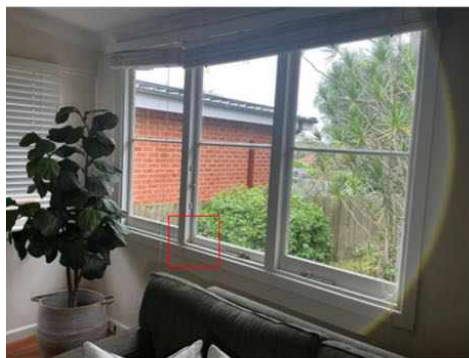
Finding 7.01

Building:	Main Building
Location:	Windows
Finding:	Fungal Decay - Present (Localised)
Information:	Fungal decay, also referred to as wood decay or wood rot, typically occurs when timber elements are exposed to excessive moisture for extended periods. This deterioration process is accelerated by temperatures ranging between 5°C and 40°C, as well as the presence of oxygen. Fungal decay is commonly found in timber components used in external environments, particularly when they are exposed to rain or moisture penetration.

In this instance, although the timber element shows signs of decay, the visible damage appears to be localized to a specific area and has not yet spread to adjoining structures or other parts of the building element. As a result, the fungal decay is likely to be relatively superficial, with minimal impact on the structural integrity or tensile strength of the timber. However, it is advisable to monitor the affected area to prevent further deterioration and address the underlying moisture issue to mitigate future risk.

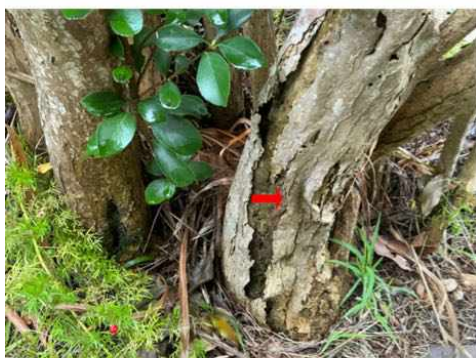
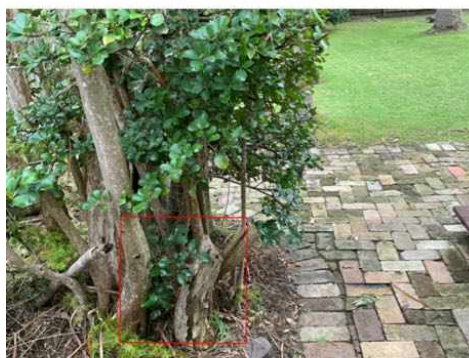
Finding: Wood Borer Damage - Trees

Information: At the time of inspection, signs consistent with wood borer activity were observed in trees located within the garden area. Evidence included small entry holes and localised timber deterioration within the affected trees, which is typical of wood borer infestation in external vegetation.

Wood borers commonly attack stressed or decaying timber in trees and are generally confined to external garden elements. Based on the location and extent observed, this condition is not considered a matter of concern in relation to the main building structure at the time of inspection.

No immediate action is required. However, if the client has concerns or wishes to address the issue proactively, it is recommended to engage the services of a licensed pest control specialist or arborist to assess the trees and carry out appropriate treatment or maintenance if necessary.

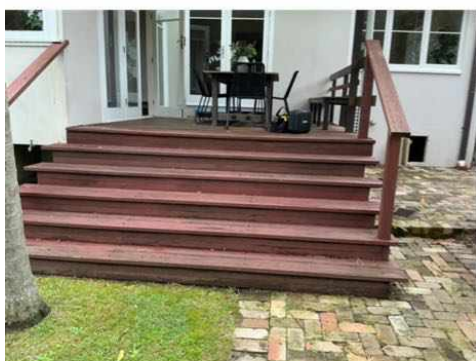
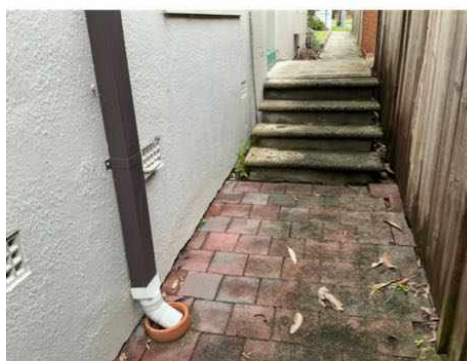
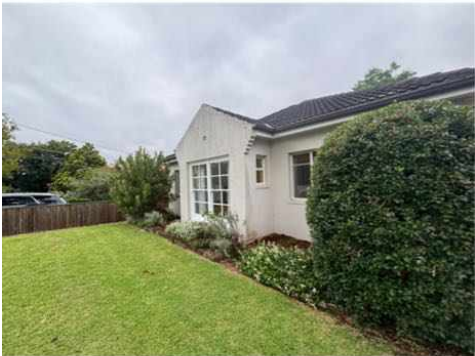
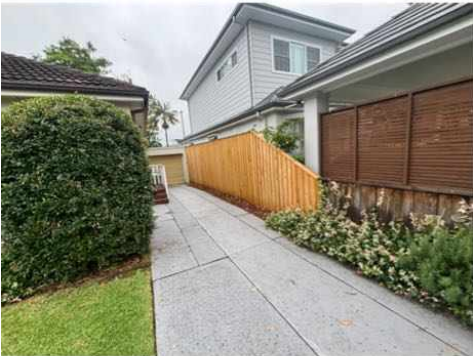
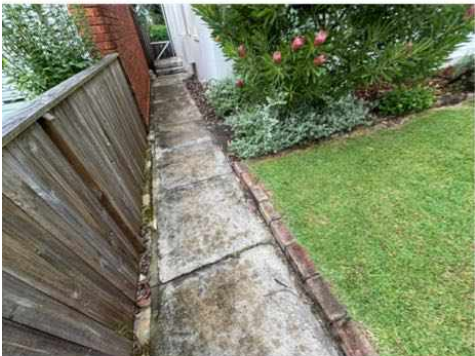
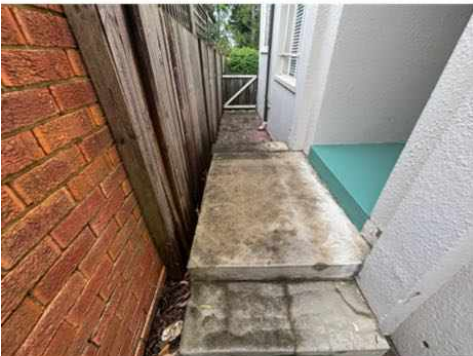
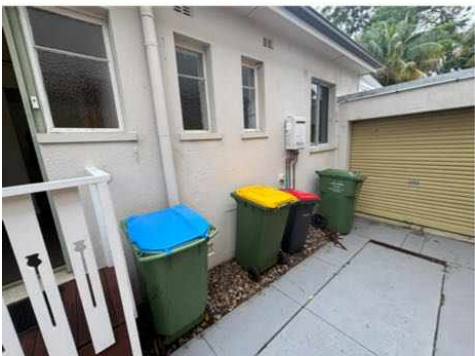
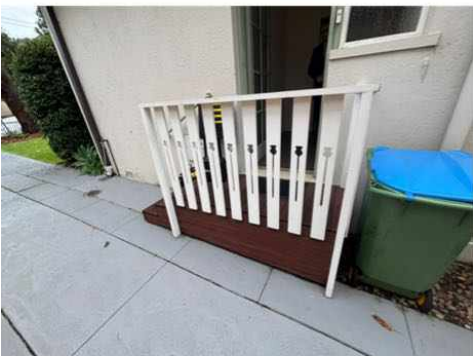
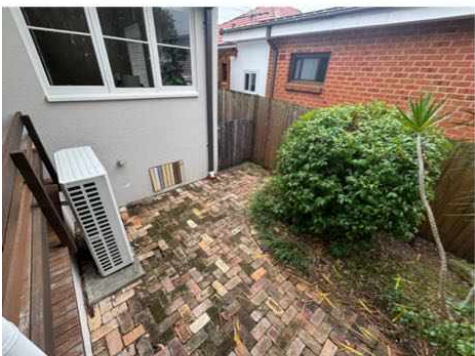
Building: Main Building
Location: All External Areas
Finding: Obstructions and Limitations - External Areas
Information: The attached photographs provide a visual representation of the obstructions and limitations that impeded a full inspection of the external areas of the property at the time of assessment. These obstructions, which may include vegetation, stored items, debris, or other physical barriers, can obscure potential defects and prevent a thorough evaluation of the property's condition. Obstructions of this nature can conceal a wide range of issues, such as structural damage, water ingress, pest infestations, or deteriorating building materials, which may not be visible during the initial inspection.

It is essential that these obstructions be cleared to allow for a comprehensive inspection of the external areas. Removing these barriers will enable a more accurate assessment of the property's condition and allow any hidden defects to be identified and addressed promptly. Failure to do so could result in undetected issues worsening over time, potentially leading to more costly repairs in the future.

Therefore, it is strongly recommended that the obstructions be removed and a re-inspection be scheduled once the affected areas are made fully accessible. This will ensure a complete evaluation of the property's exterior and provide the client with a clear understanding of any potential issues that may have been concealed during the initial inspection.
