Building and Timber Pest Inspection Report

Inspection Date: Wed, 18 Mar 2026

Property Address: 3 Warrane Rd, Roseville Chase NSW 2069,
Australia

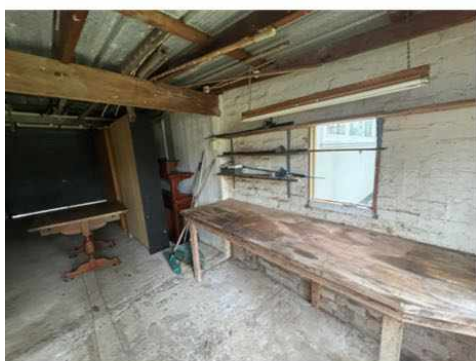
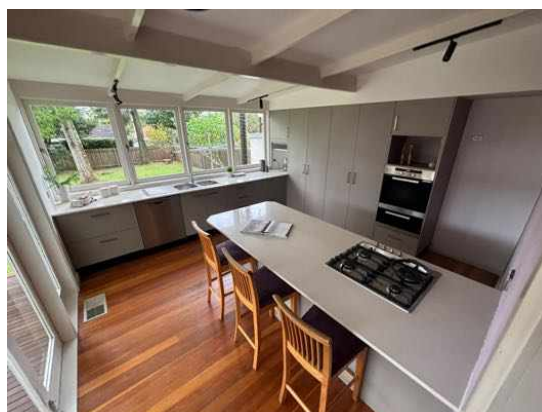
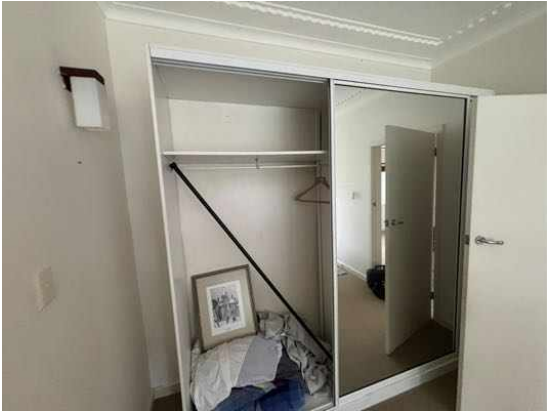
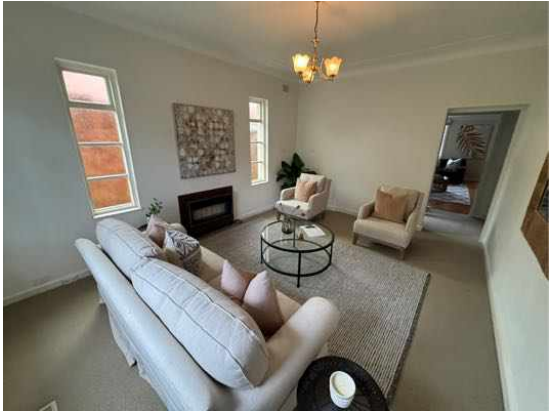
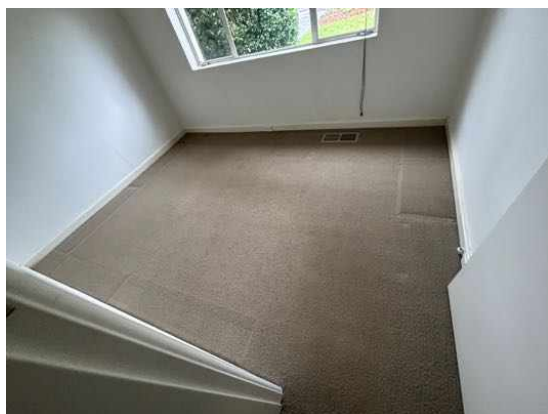
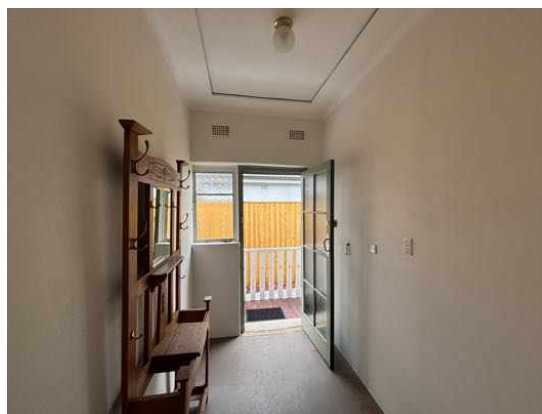
Building:	Main Building
Location:	All Internal Areas
Finding:	Obstructions and Limitations - Internal Areas
Information:	<p>The accompanying photographs provide clear evidence of the obstructions and limitations that restricted a comprehensive inspection of the internal areas of the property at the time of assessment. These obstructions, which may include furniture, personal belongings, stored items, or structural elements such as wall coverings and built-ins, significantly hindered the ability to thoroughly evaluate these areas. It is important to note that such obstructions can potentially conceal a wide array of defects, ranging from hidden structural damage, water leaks, pest infestations, or electrical issues, to deteriorating materials that may not be visible during the initial inspection.</p>

The presence of these impediments means that critical areas of the property were not accessible, and therefore, any underlying defects that may affect the integrity and safety of the property could remain undetected. These hidden defects, if left unaddressed, could worsen over time and may result in costly repairs or pose potential safety hazards to the occupants.

It is highly recommended that all obstructions be cleared to facilitate a complete and thorough inspection of the internal areas. Once the obstructions have been removed and full access is available, a re-inspection should be carried out to ensure that any previously concealed issues can be properly identified and rectified. This follow-up inspection will provide a more accurate assessment of the property's internal condition and help the client make informed decisions about any necessary repairs or maintenance.

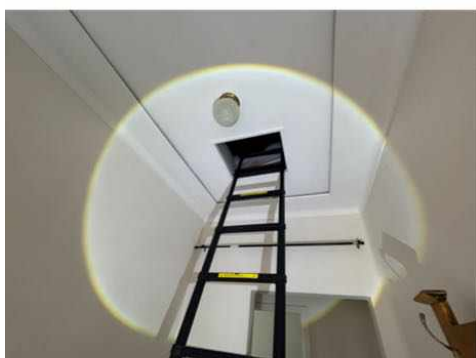
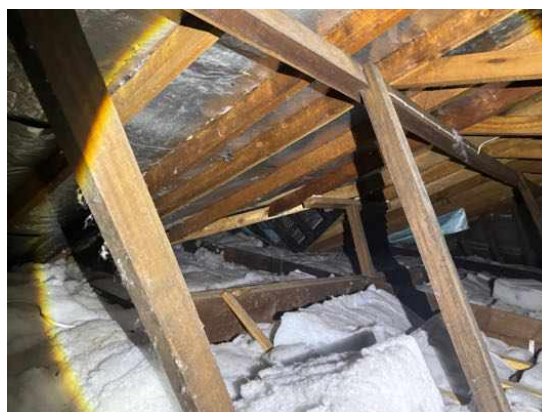
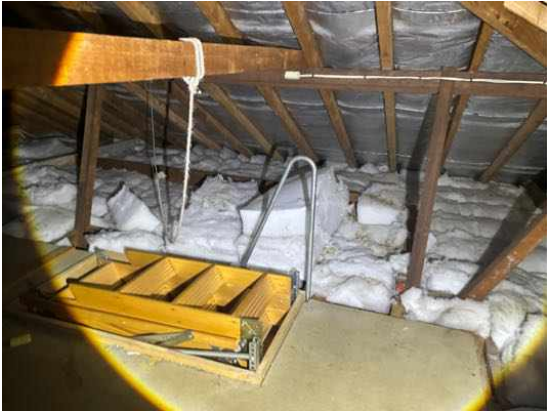
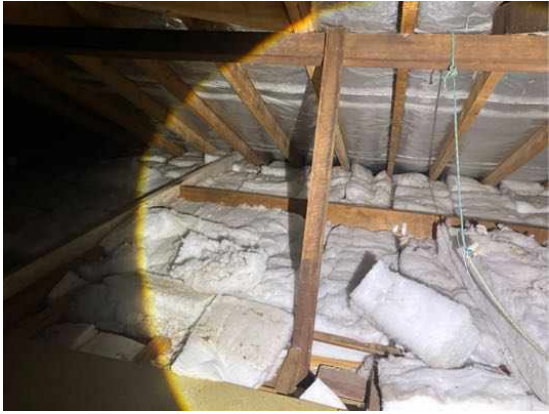
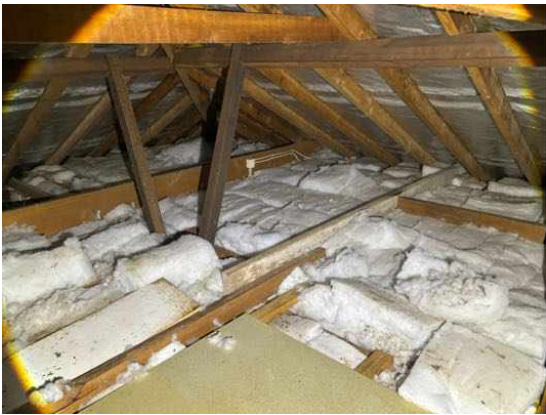
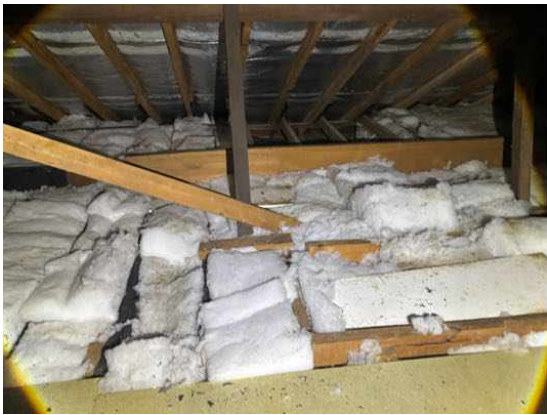
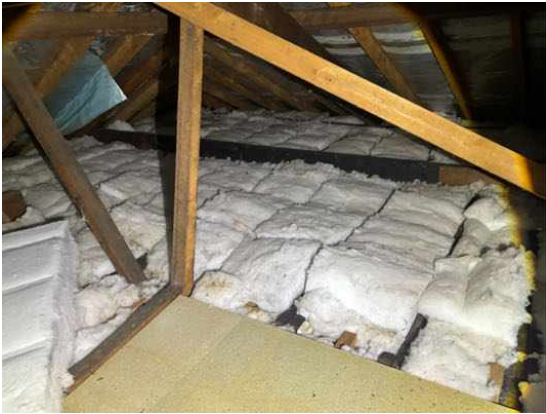
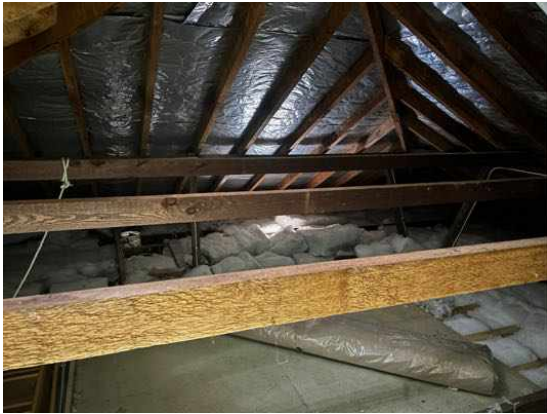
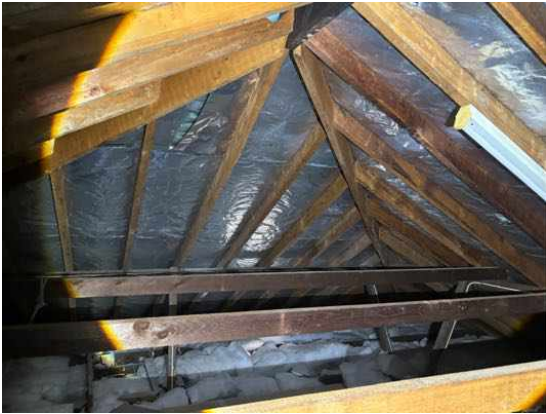
Building: Main Building
 Location: Roof Void
 Finding: Obstructions, Limitations, and General Roof Space Condition
 Information: The photographs provided document both the general condition and the obstructions and limitations that were present in the roof cavity of the main building at the time of inspection. These obstructions—such as insulation materials, stored items, structural elements, or electrical wiring—restricted safe and adequate access to key areas within the roof space. As a result, a comprehensive inspection of all components could not be completed.

Obstructions of this nature may conceal a variety of potential defects, including damaged framing, compromised insulation, evidence of moisture ingress, pest activity, or electrical hazards. While no major issues were observed in the visible areas, the presence of these limitations means that some defects may remain undetected.

It is recommended that these barriers be removed or repositioned to facilitate full and safe access to the roof space. Once clear, a follow-up inspection should be conducted to allow for a thorough assessment of all concealed areas. This will help ensure that the condition of the roof cavity is accurately evaluated and any hidden issues are appropriately identified and addressed.

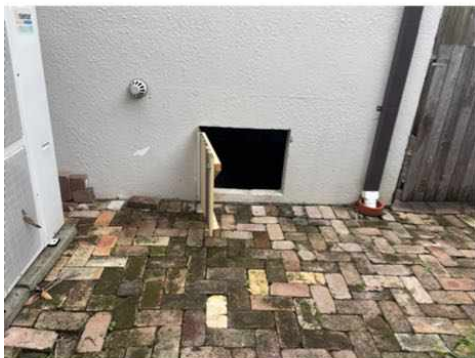
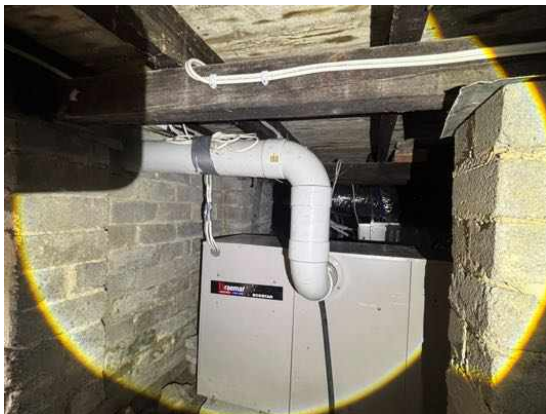
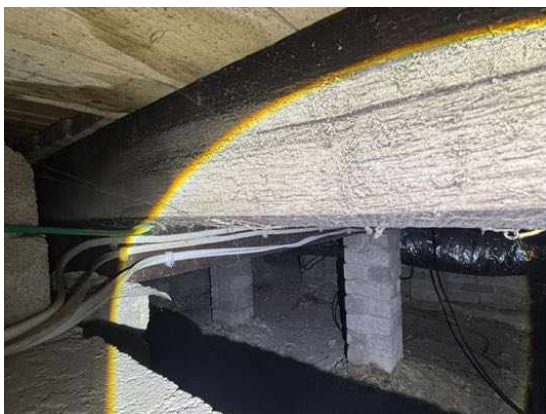
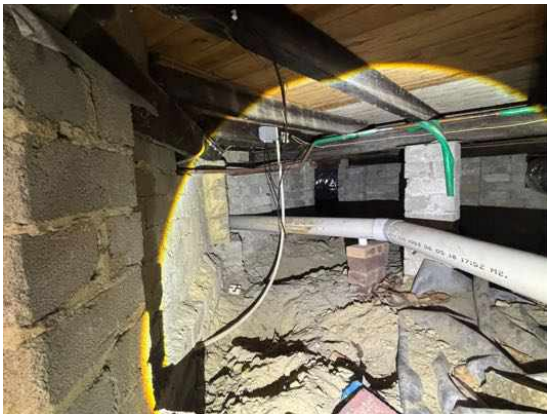
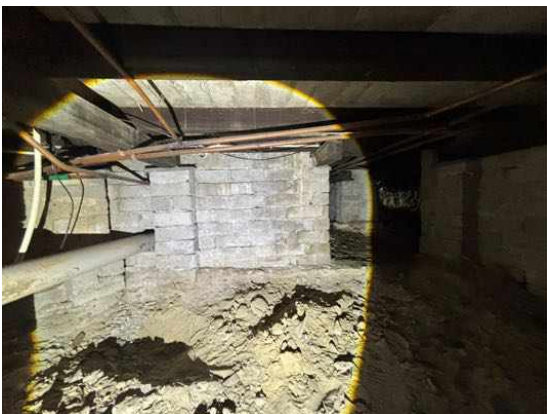
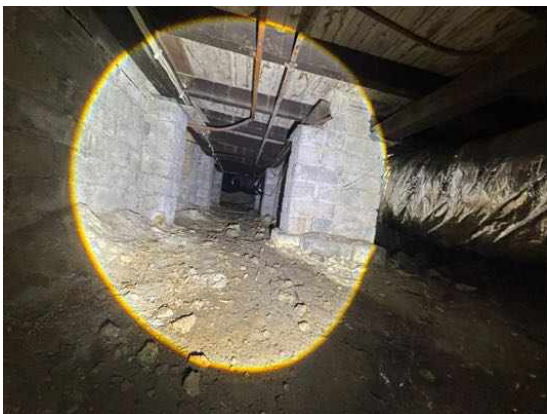
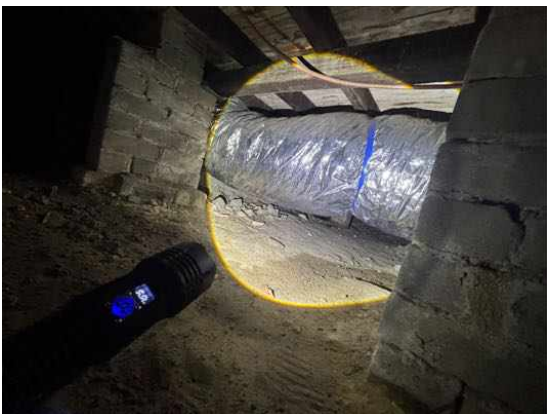
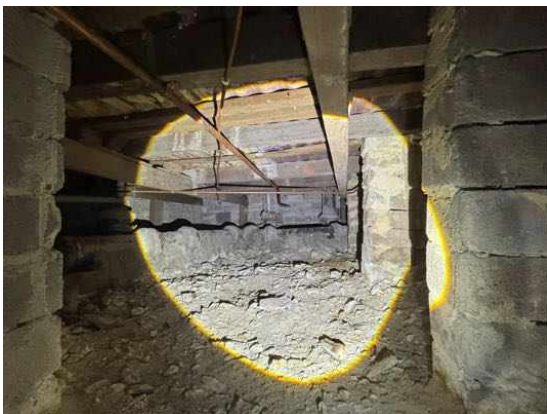
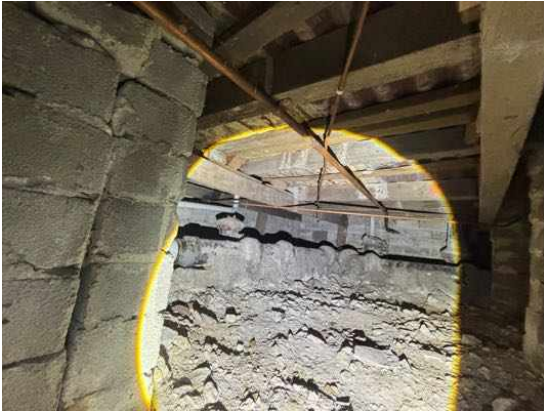
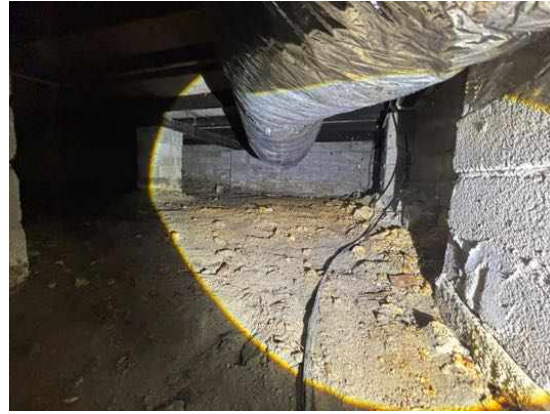
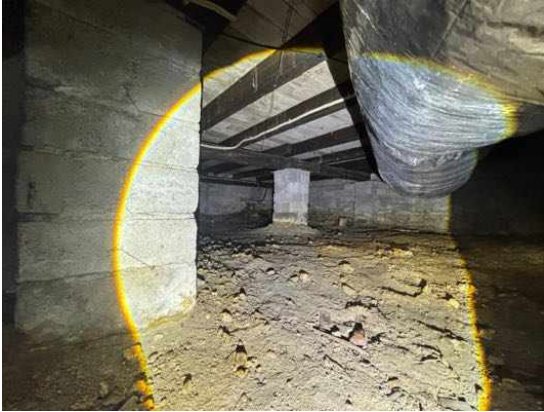
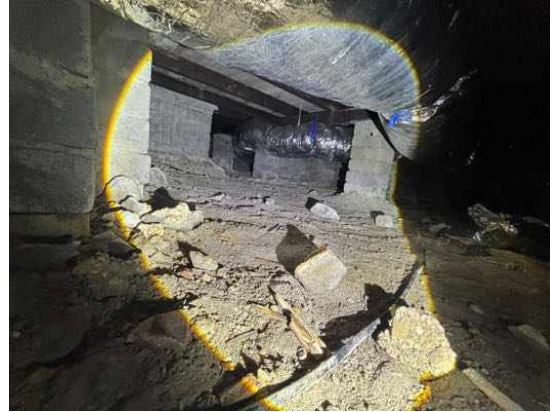
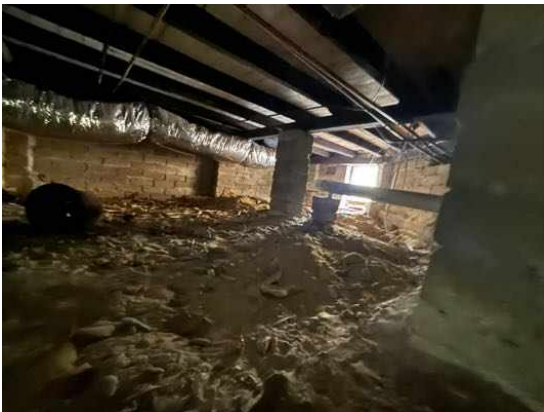
Building: Main Building
Location: Subfloor
Finding: Obstructions, Limitations, and General Subfloor Condition
Information: The attached photographs illustrate the obstructions and access limitations that restricted a full inspection of the subfloor area of the main property at the time of assessment. Items such as stored materials, construction debris, low-hanging services, and insulation impeded movement and visibility within key sections of the subfloor. In addition, the limited crawl height further restricted safe access to inspect critical structural components.

important elements such as floor joists, bearers, stumps, drainage, subfloor ventilation, and signs of moisture or pest activity. These obstructions may also conceal defects such as timber decay, water ingress, termite damage, inadequate support, or ventilation issues that are not immediately visible during a limited inspection.

While no major concerns were identified in the accessible areas, a full and unobstructed inspection is necessary to properly assess the overall condition of the subfloor. It is recommended that obstructions be removed and access improved where possible. Once adequate clearance is provided, a re-inspection should be arranged to ensure that any concealed defects can be identified and addressed accordingly. This will assist in providing a more comprehensive understanding of the subfloor's condition and reduce the risk of unforeseen issues.

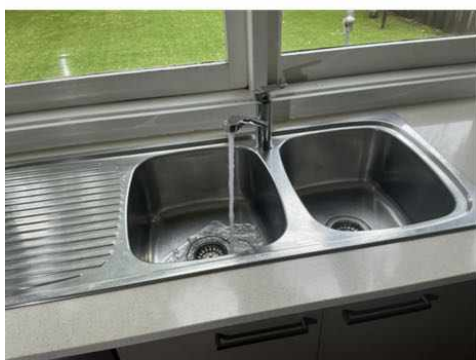
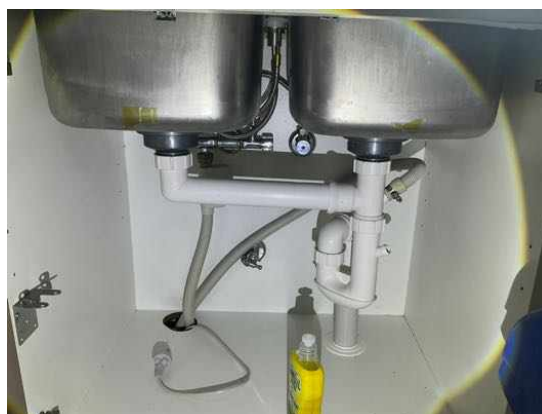
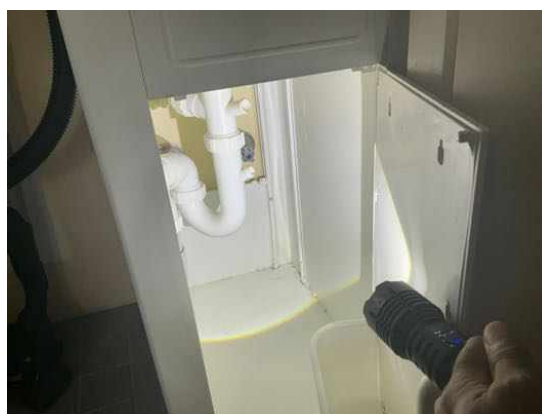
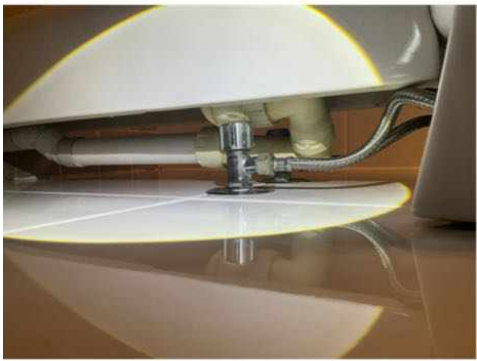
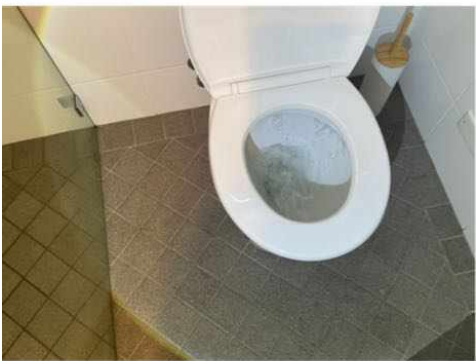
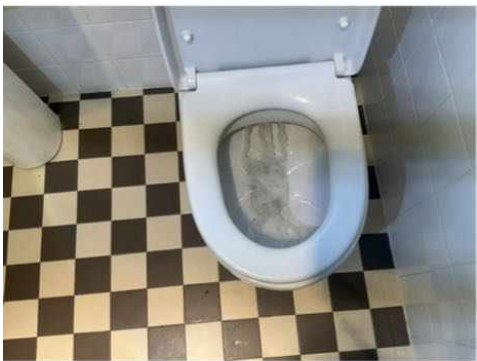
Building: Main Building
Location: All Areas
Finding: FYI - Taps, Drainage & Toilets Tested and Cabinetry Obstructions
Information: During the inspection, all accessible taps, drainage systems, and toilets were tested for water flow and drainage efficiency, and checked for any visible signs of leakage. At the time of the inspection, no issues were noted in these areas. Unless highlighted in a separate defect statement, no immediate remedial work appears necessary. Supporting images may be found in the additional photos section for reference.

It is important to note that while a visual inspection of cupboards and cabinetry beneath sinks and vanities was undertaken, stored personal items and fixtures presented obstructions that limited full visibility of the internal areas. As per standard inspection practices, inspectors are not permitted to move or disturb personal belongings during the inspection process. Therefore, only visible and accessible sections were inspected, and concealed water damage or plumbing defects may not have been detected.

Given this, a re-inspection is recommended after all obstructions have been cleared to allow for a comprehensive assessment of these areas. Regular maintenance and monitoring of plumbing and drainage systems is also advised to ensure ongoing functionality and early detection of potential issues.

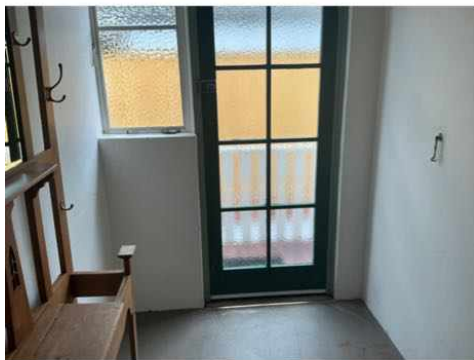
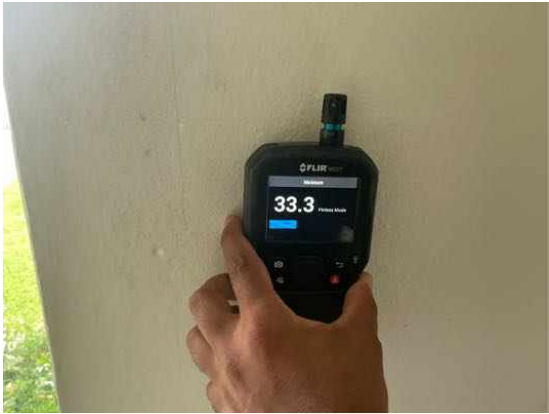
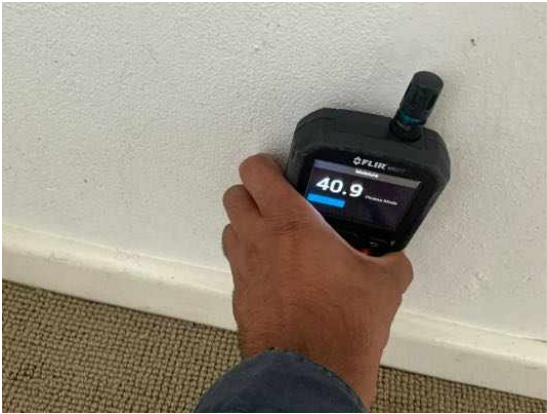
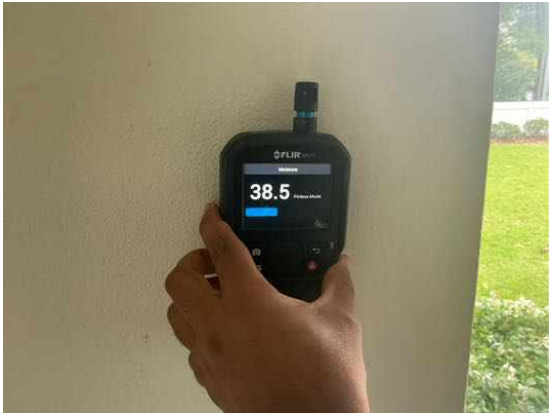
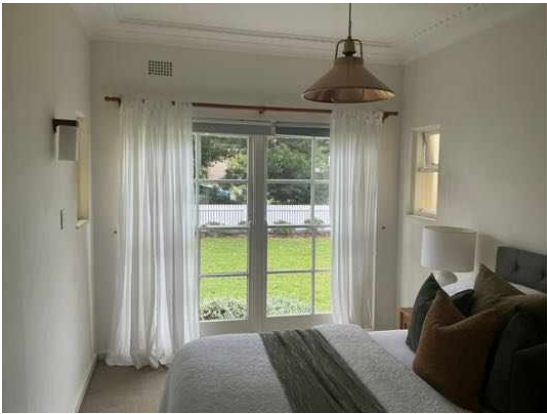
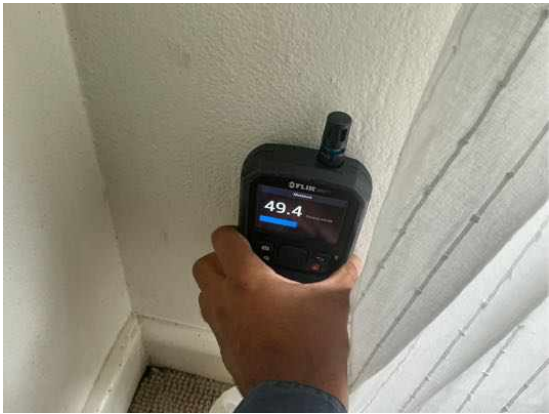
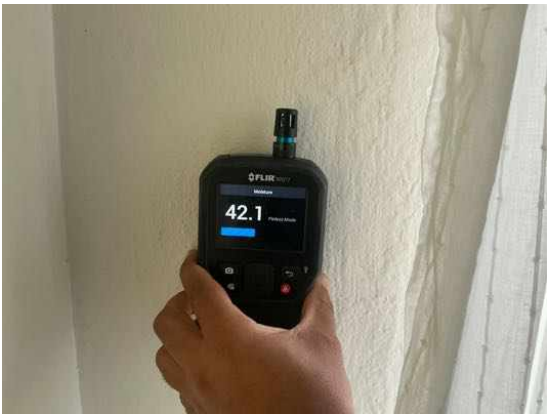
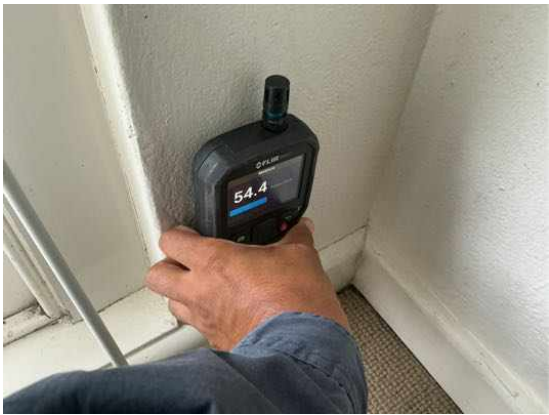
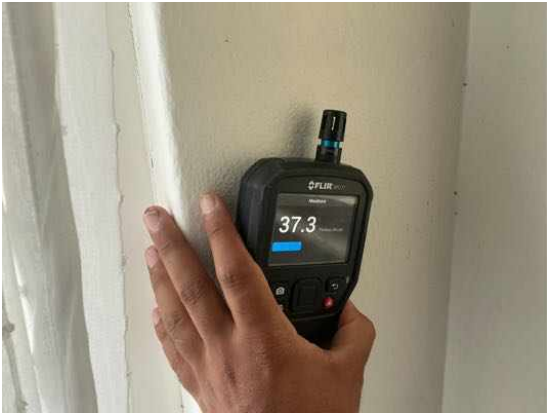
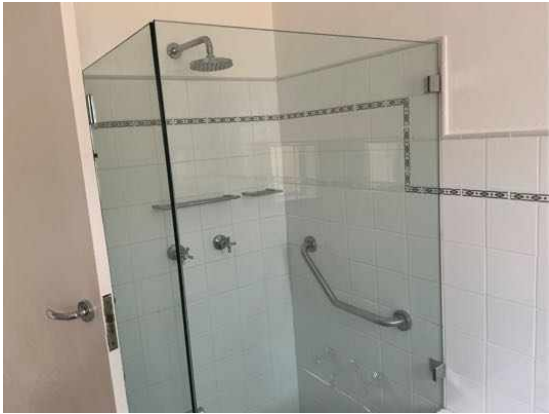
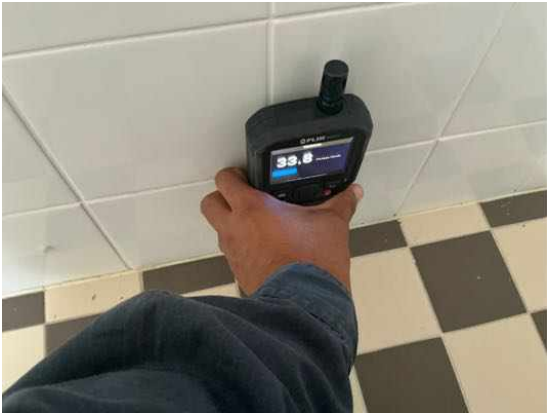
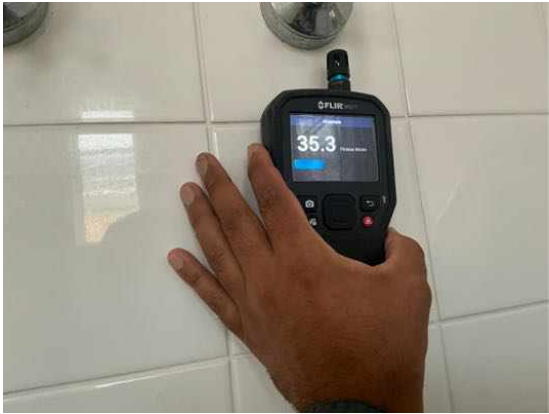
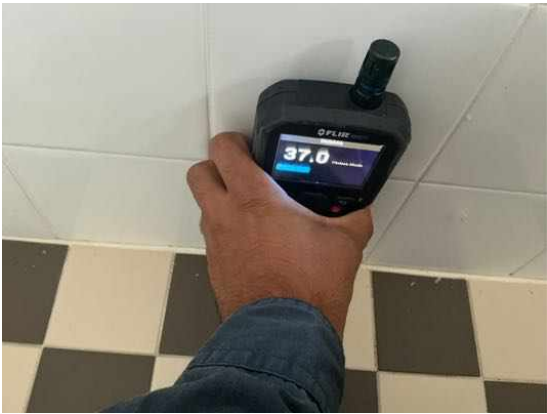
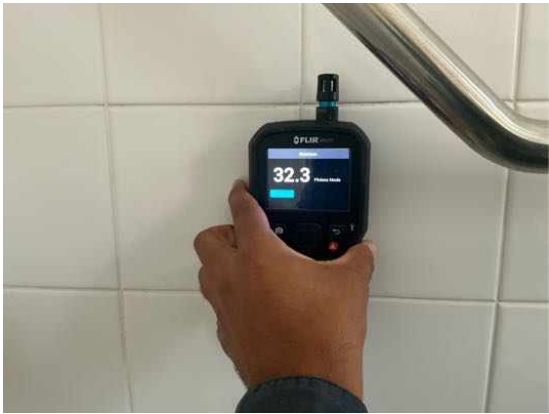
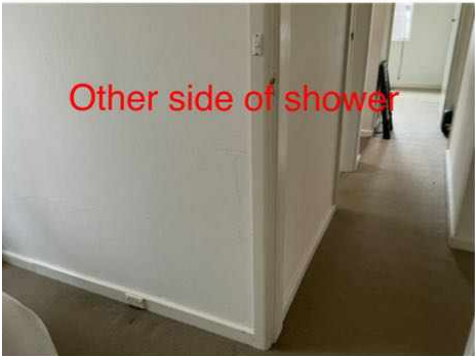
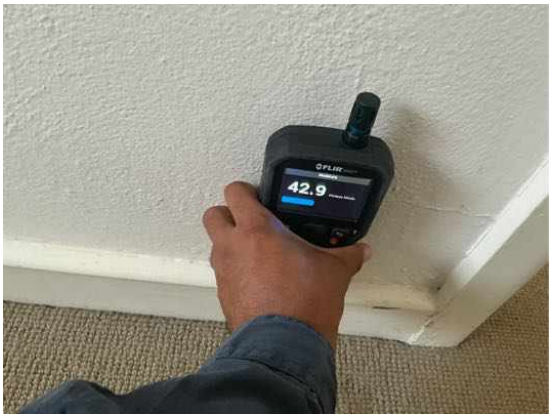
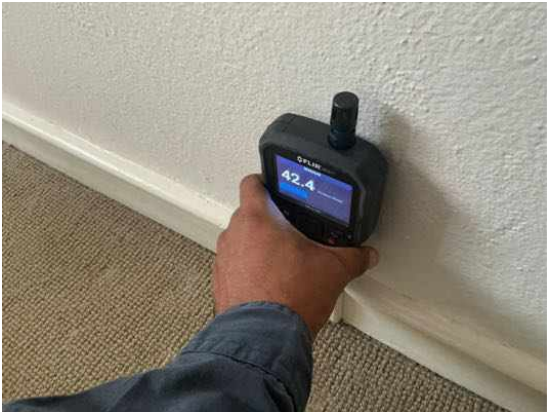
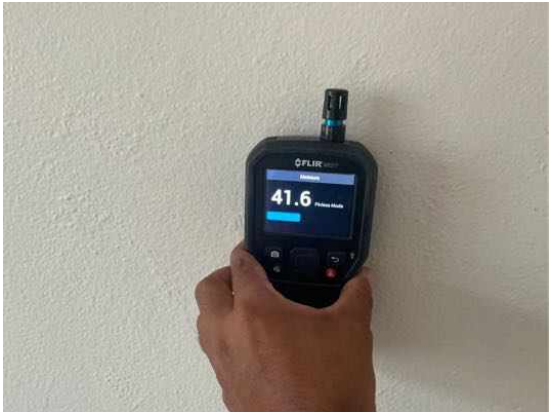
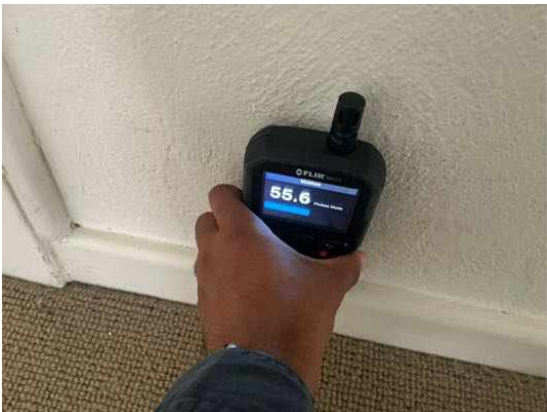
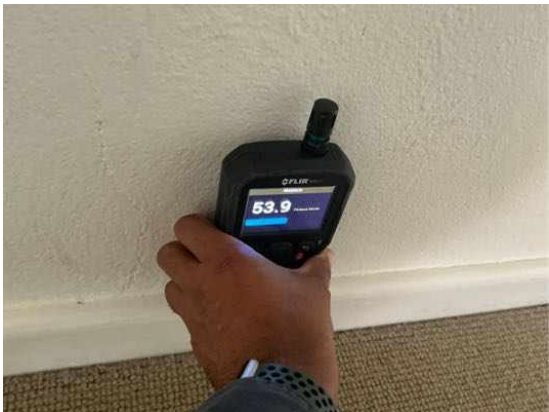
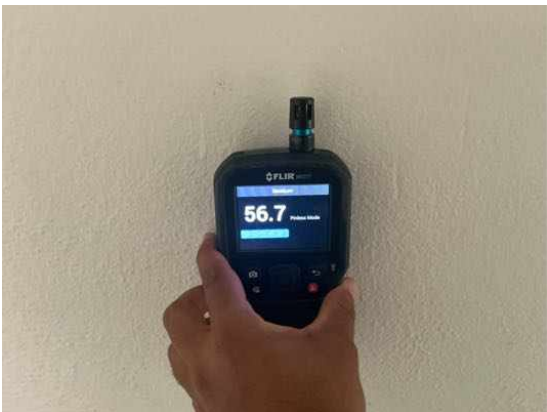
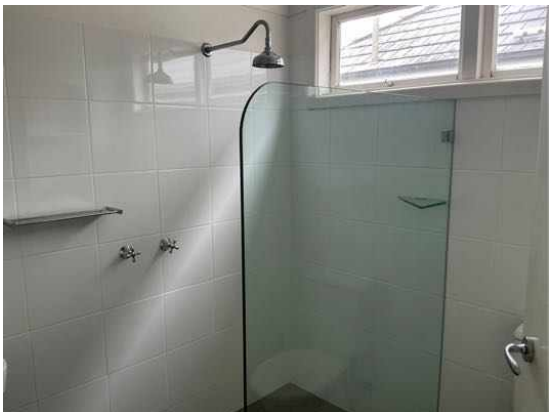
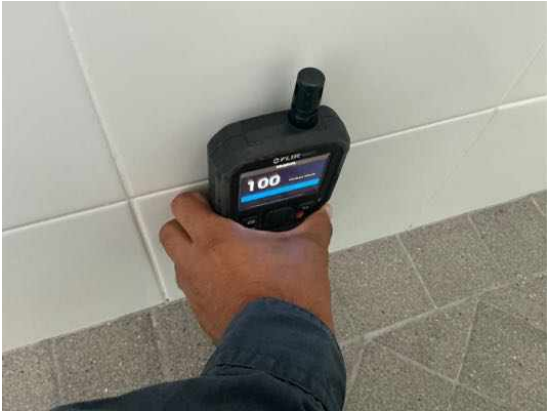
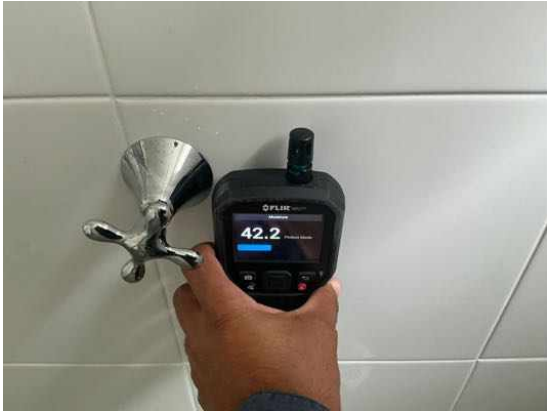
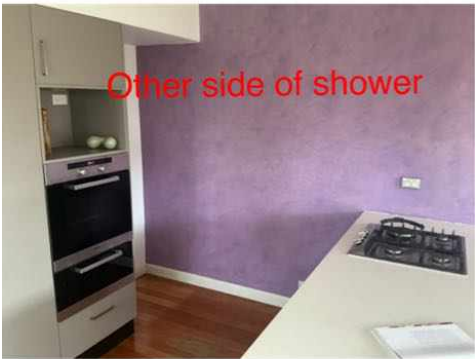
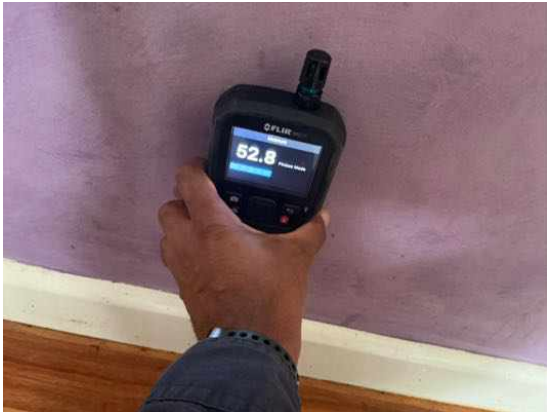
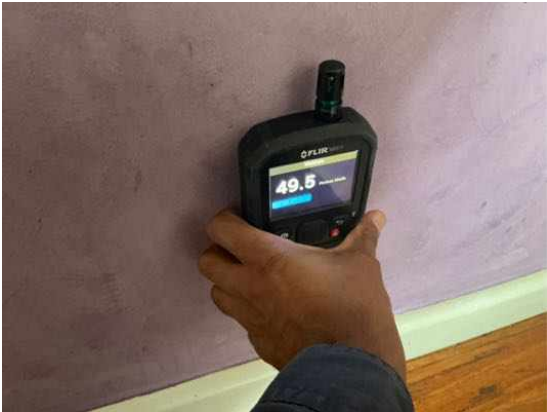
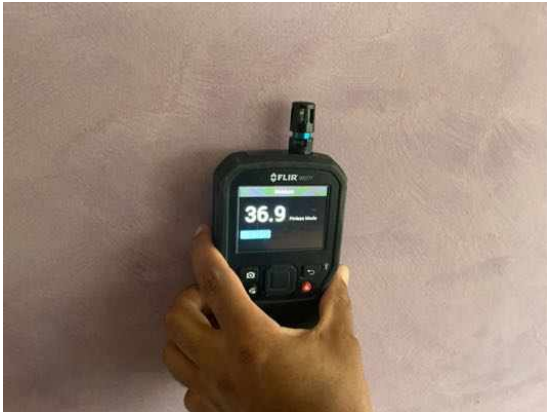
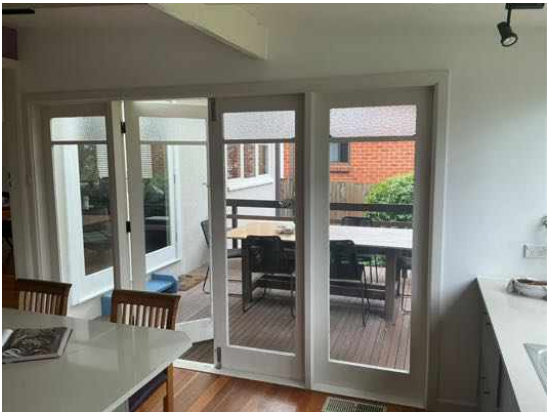
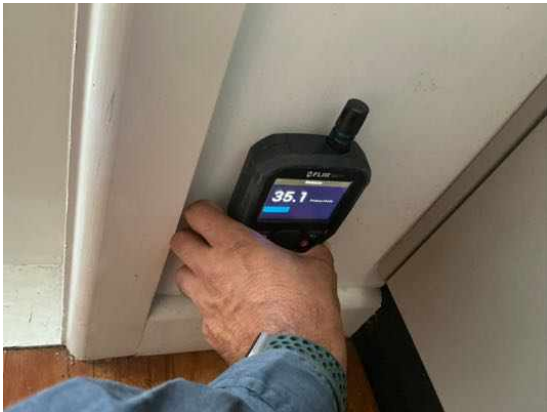
Building: Main Building
Location: All Areas
Finding: Additional Photos - Moisture Meter Readings
Information: Additional moisture meter reading photos have been provided for the property to offer further clarity on areas tested during the inspection. These photos are intended to give a visual reference for the specific locations where moisture levels were measured. These readings were taken at the time of the inspection to assess any potential moisture-related issues within the property. Any defects related to moisture that were identified during the inspection have been separately mentioned in the defect statements within the report.

It is important for the client to understand that moisture levels can fluctuate over time due to various factors, including changes in weather, humidity, and environmental conditions. While the readings reflect the property's moisture levels during the inspection, they may not represent future conditions, and increased moisture could lead to issues such as dampness, mould growth, or deterioration of building materials if left unmonitored.

For further clarification or additional information regarding the moisture readings, the client is encouraged to contact the building inspector directly. Regular monitoring of moisture-prone areas is recommended to ensure any emerging concerns are addressed promptly, particularly during wetter seasons or in high-humidity conditions.
