Building and Timber Pest Inspection Report

Inspection Date: Wed, 18 Mar 2026

Property Address: 3 Warrane Rd, Roseville Chase NSW 2069,
Australia

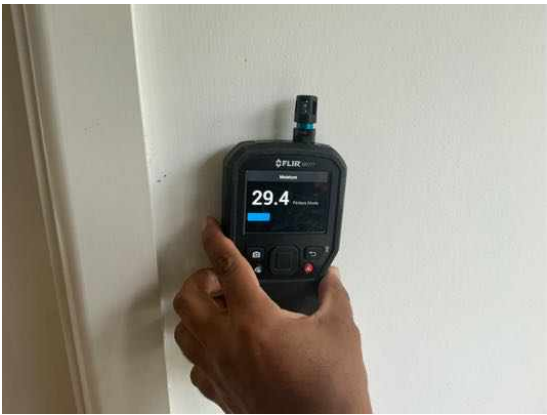
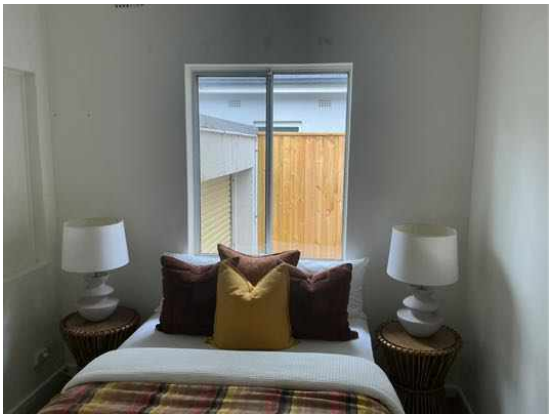
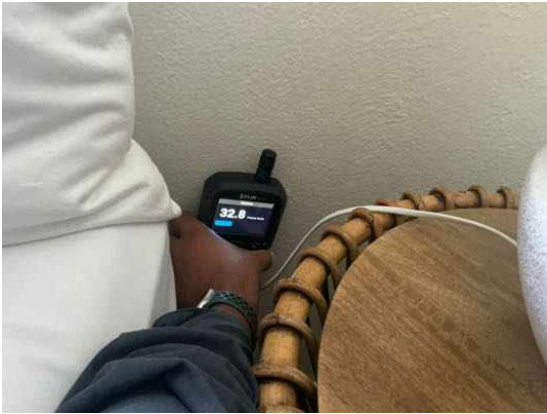
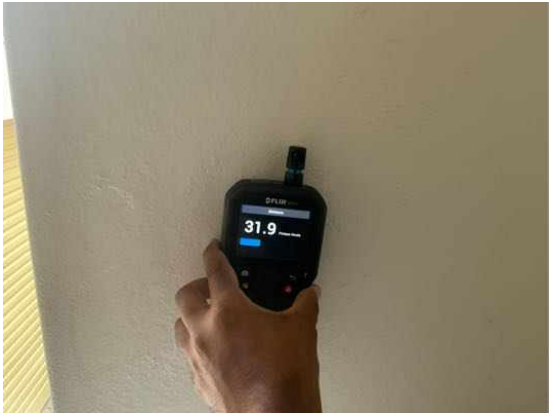
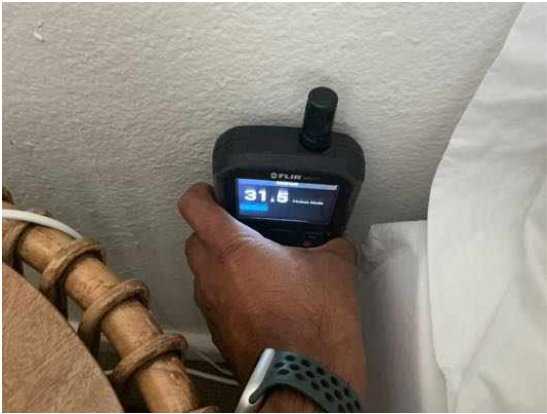
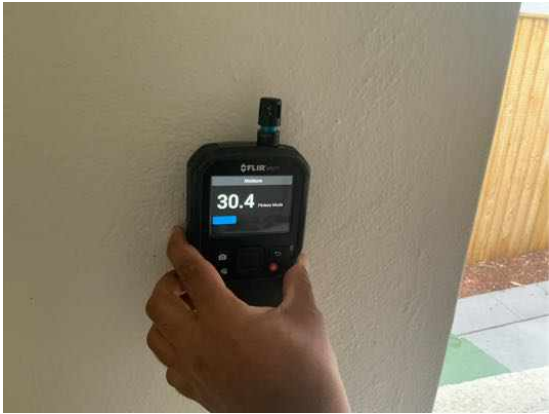
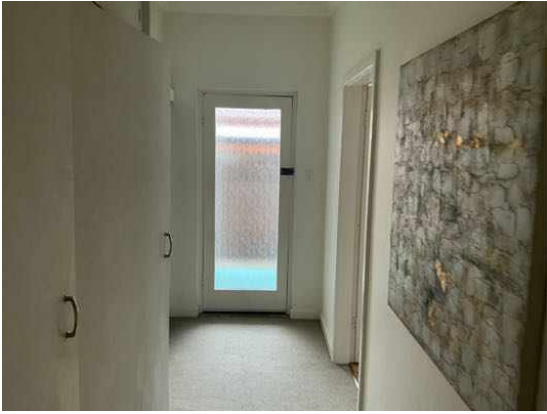
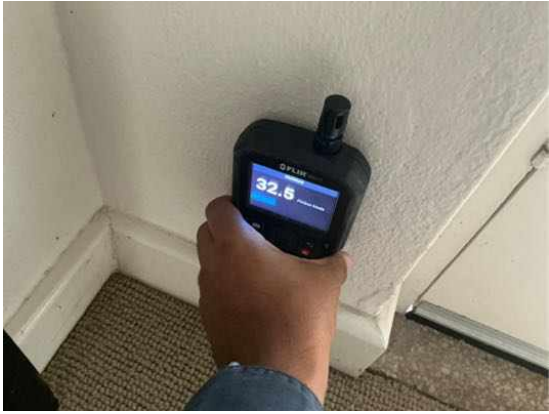
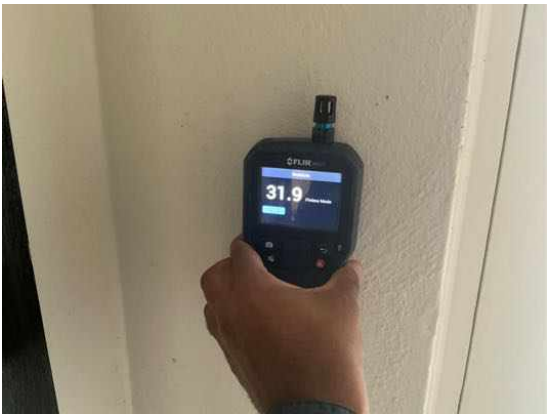
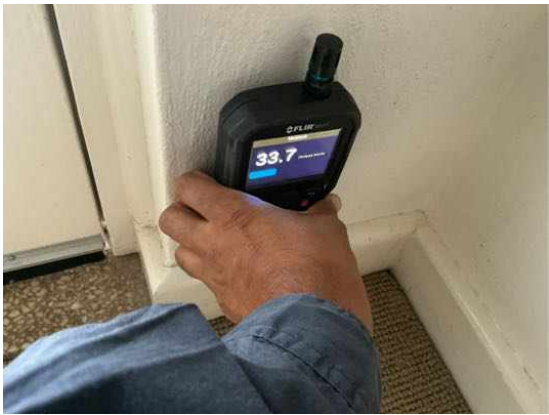
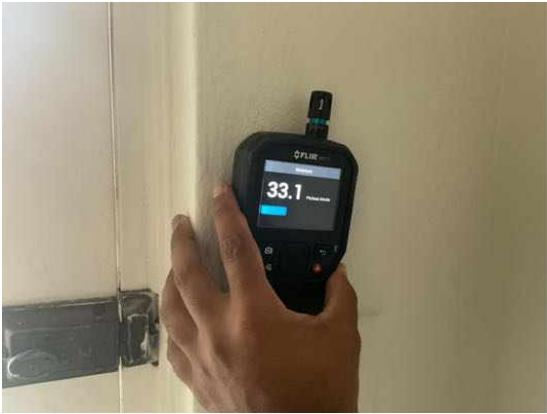
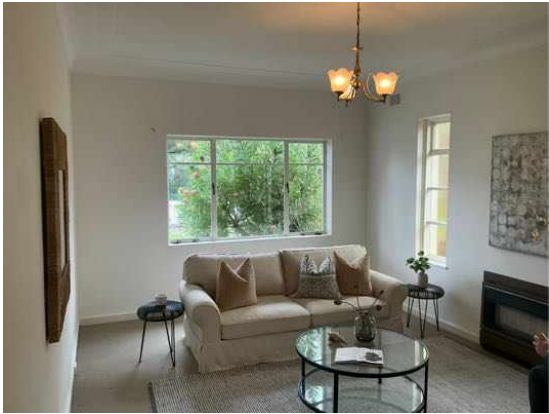
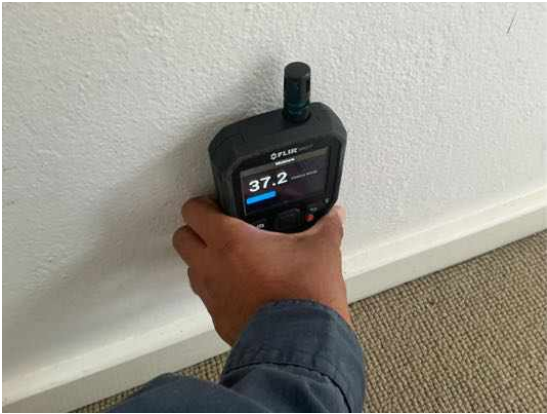
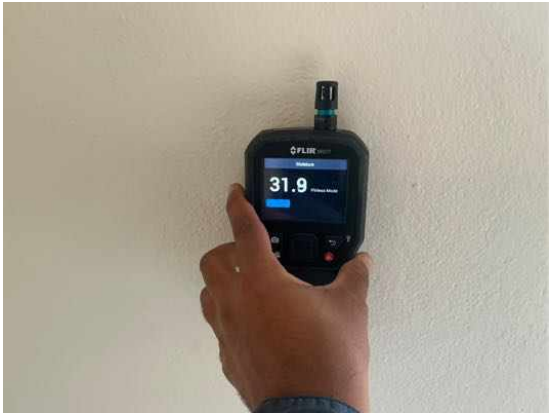
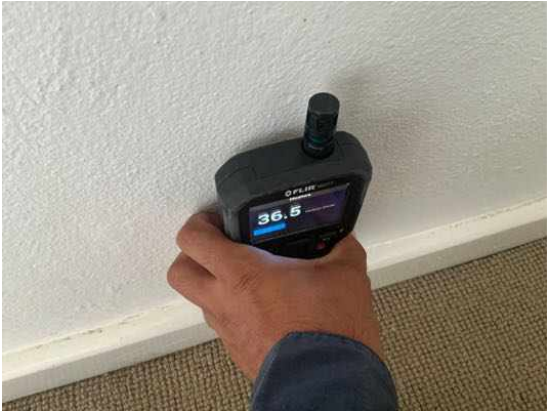
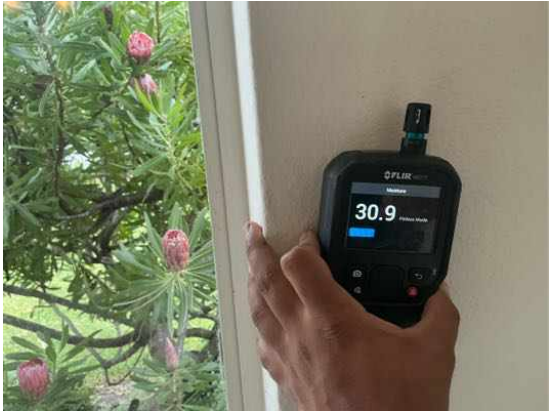
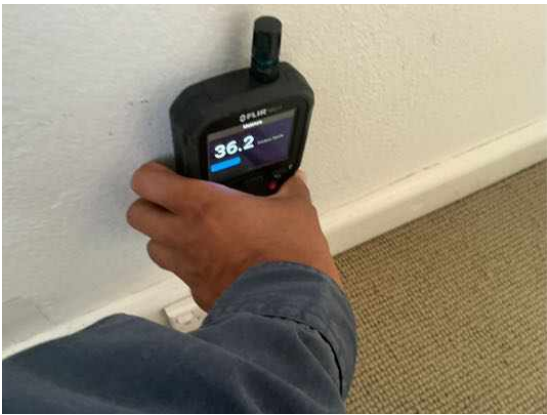
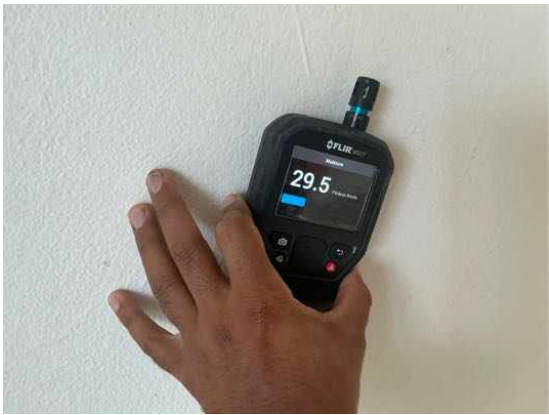
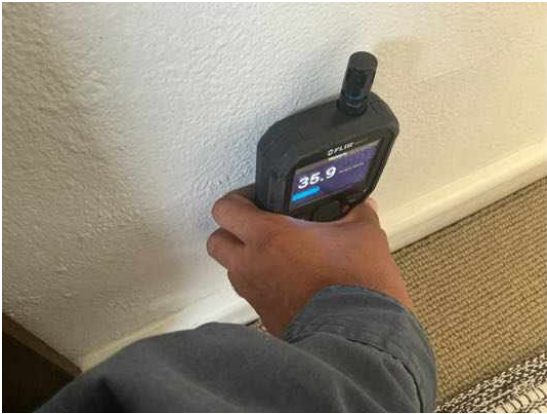
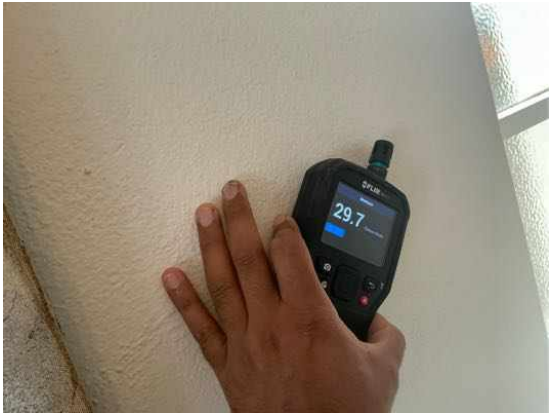
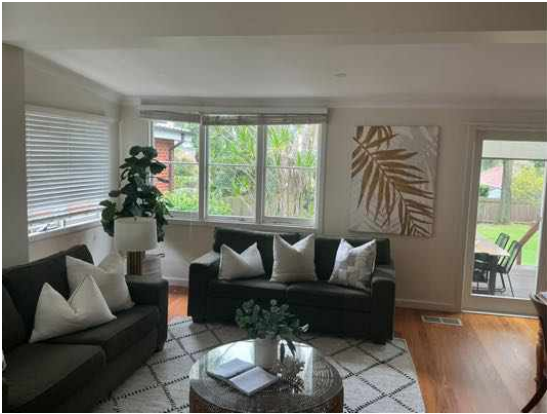
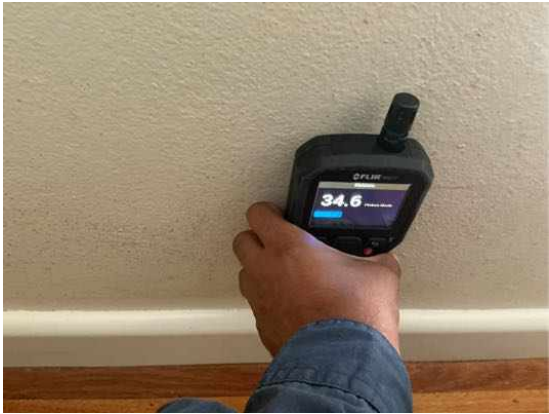
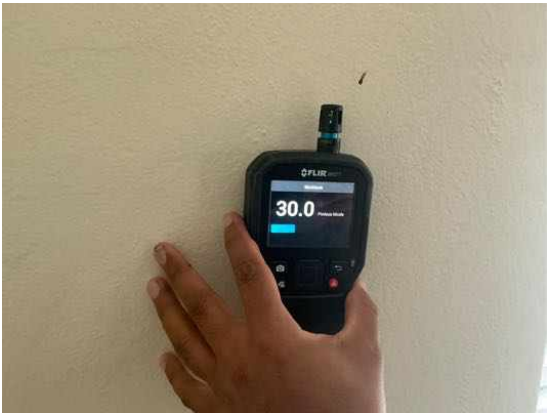
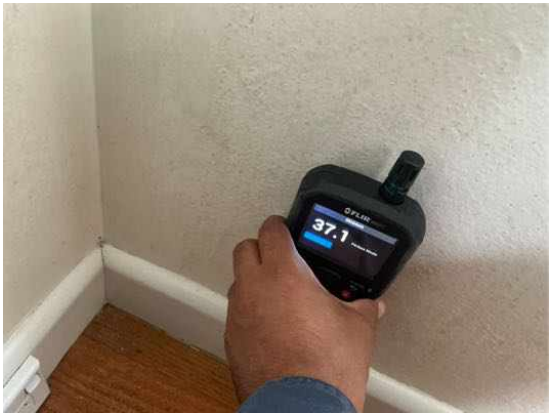
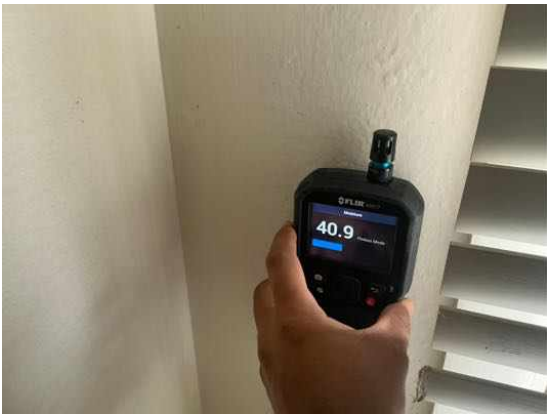
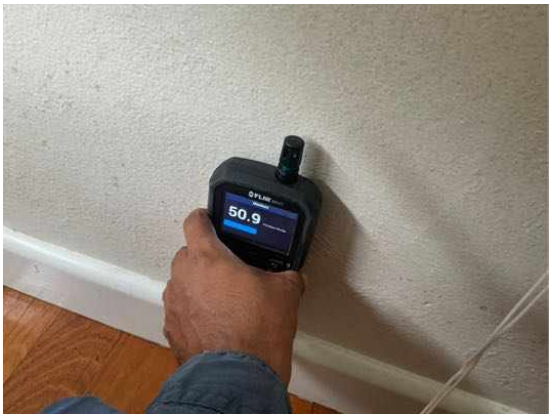
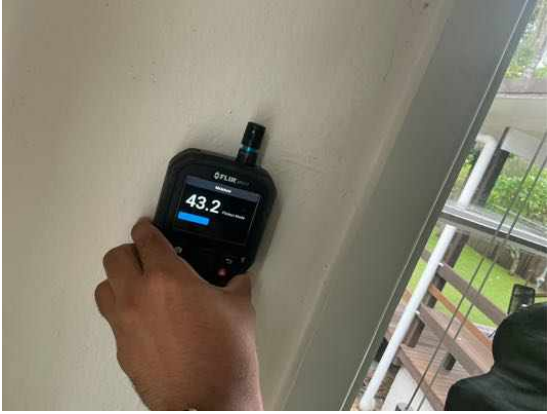
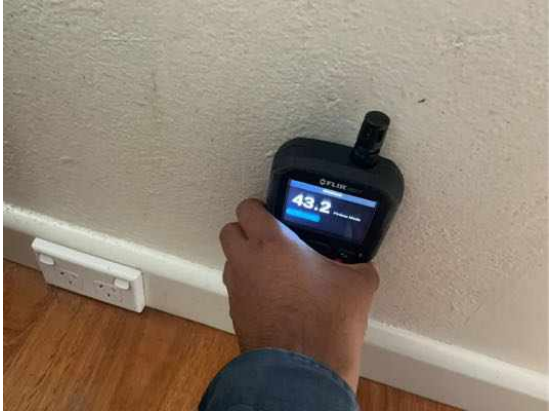
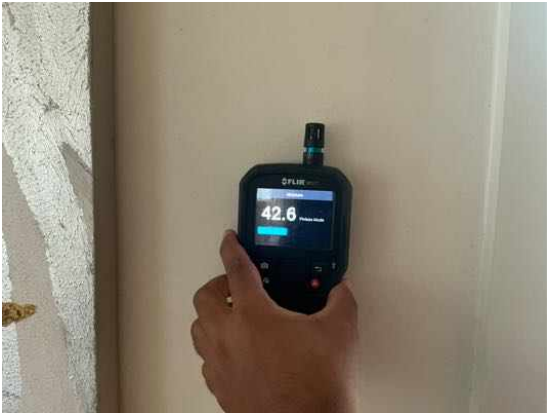
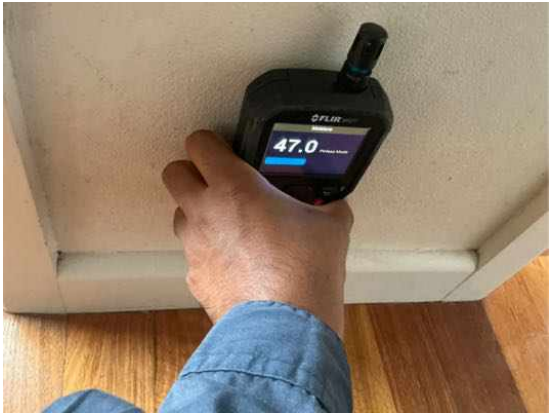
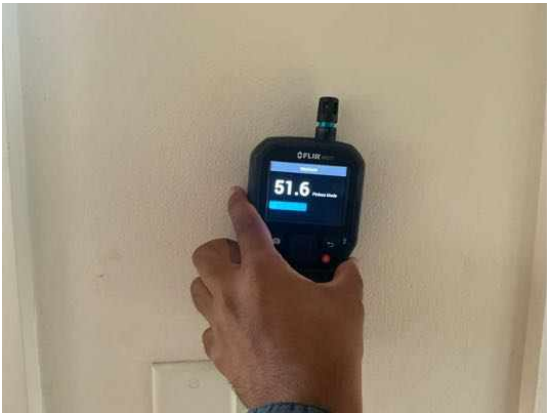
Building: Main Building
Location: All Areas
Finding: Additional Photos - Moisture Meter Readings
Information: Additional moisture meter reading photos have been provided for the property to offer further clarity on areas tested during the inspection. These photos are intended to give a visual reference for the specific locations where moisture levels were measured. These readings were taken at the time of the inspection to assess any potential moisture-related issues within the property. Any defects related to moisture that were identified during the inspection have been separately mentioned in the defect statements within the report.

For further clarification or additional information regarding the moisture readings, the client is encouraged to contact the building inspector directly. Regular monitoring of moisture-prone areas is recommended to ensure any emerging concerns are addressed promptly, particularly during wetter seasons or in high-humidity conditions.

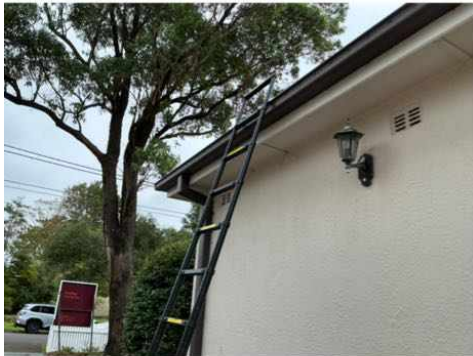
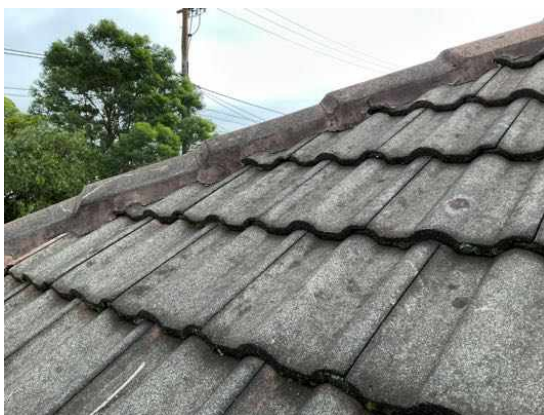
Building: Main Building
Location: Roof Exterior
Finding: Additional Roof Photos
Information:

As part of the information provided, please note that the attached roof photos represent the condition of the roof at the time of inspection. These photos are for visual reference only and do not constitute a detailed roofing assessment. Any defects or issues identified with the roof are mentioned separately in the defect statements. It is strongly recommended that the client engage a qualified roofer to conduct a thorough inspection of the roof, ensuring that any potential issues, such as leaks, structural integrity, or wear and tear, are properly identified and addressed.

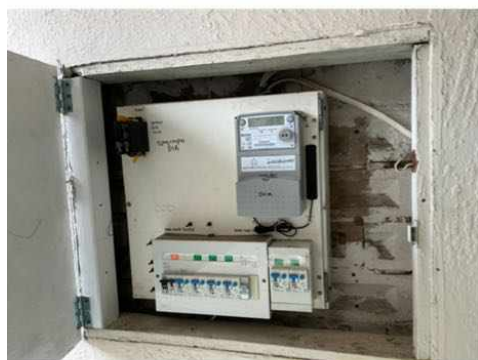
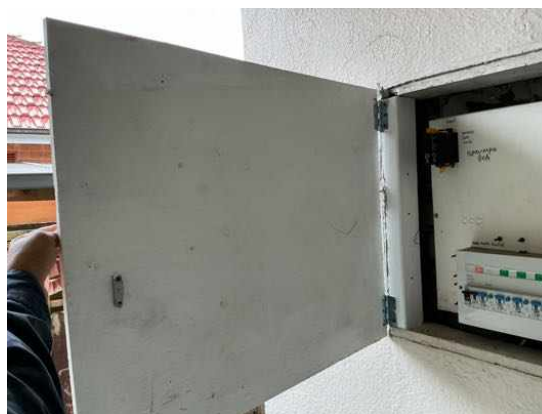
Building:	Main Building
Location:	Meter Box
Finding:	Termite Management Recommendation – No Evidence of Chemical Installation
Information:	At the time of inspection, there was no visible evidence of a chemical termite management system installed around the property. Chemical barriers are a key component of termite protection and are particularly important in preventing concealed termite entry into timber elements of the structure.

In accordance with standard requirements, a durable notice should be located within the electrical switchboard to detail any termite protection systems applied, including chemical treatments. No such notice was observed during the inspection.

It is recommended that the client engage a licensed pest controller to assess the suitability of installing a chemical barrier, and to provide advice on associated costs and procedures. This should be considered a short-term priority, particularly if the property has any history of termite activity or is located in a high-risk area.

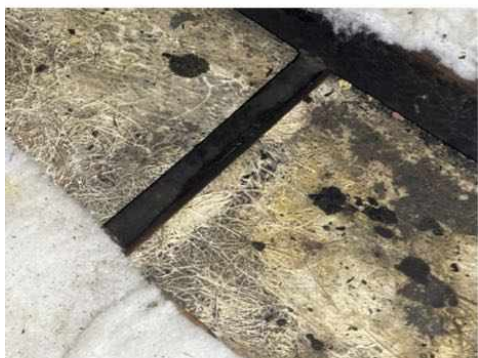
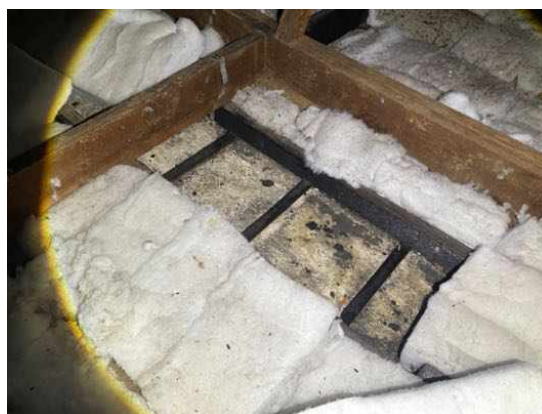
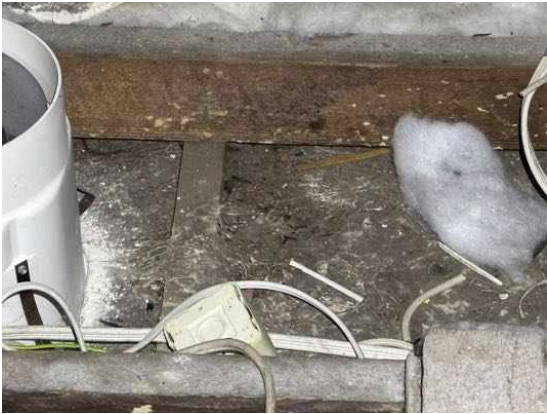
Building:	Main Building
Location:	All Areas
Finding:	Asbestos - Suspected ACM Identified on Site
Information:	Reporting on Asbestos is outside the Scope of this Report. This suspected defect is highlighted as a caution only. We suspect, based on our experience in the building industry, that there is a higher risk of the identified building element containing asbestos.

As Asbestos Reporting is outside the scope of this report, we advise that you consider a separate Asbestos Inspection and Condition Audit, which can include the taking of samples for definitive confirmation of the presence of Asbestos.

In the interim, the client is advised to act with caution, especially when considering any damage to building materials general wear and tear renovations extensions demolition and general maintenance activities due to the suspected presence of Asbestos.
