Building and Timber Pest Inspection Report

Inspection Date: Tue, 10 Mar 2026

Property Address: 5/38 McLean St, Liverpool NSW 2170,
Australia

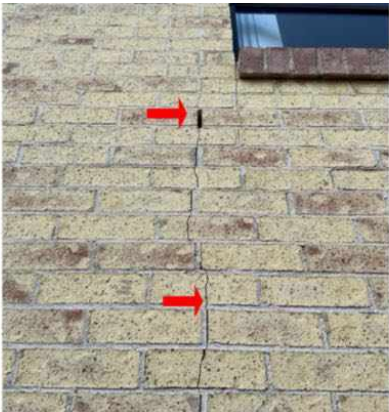
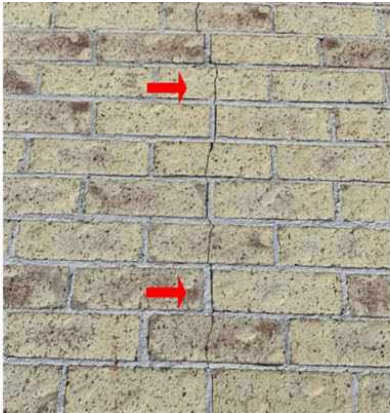
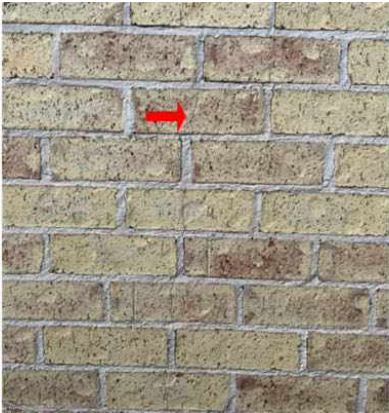
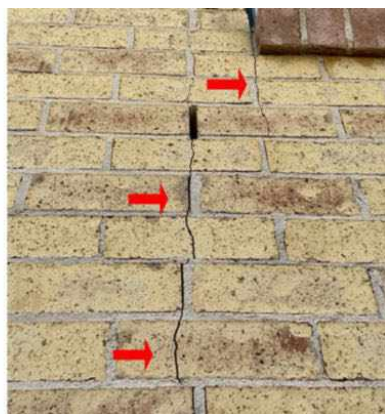
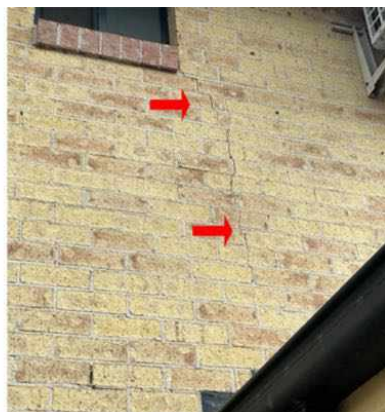
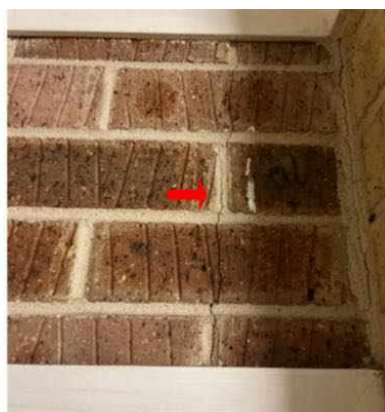
Finding 2.01

Building: Main Building
Location: All External Areas - Right , Left
Finding: Brickwork - Cracking noticeable
Information: Vertical cracking was observed within the external brickwork extending through multiple brick courses. The crack width is moderate and indicative of structural movement within the masonry. The condition may be associated with foundation movement or inadequate articulation within the wall system. Assessment by a suitably qualified structural engineer is recommended to determine the cause and appropriate remedial measures.

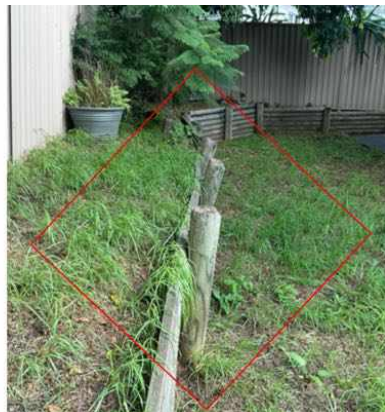
Finding 2.02

| Finding: | Retaining wall - Defective - Bulging, misaligned , wood rot |
| Information: | The retaining wall in this area was found to be defective at the time of inspection. Generally, defective retaining walls are caused by poor original design or material use. However, deteriorated retaining walls may also be a result of substandard construction, poor site drainage or unmanaged stormwater flows. |

If left unmanaged, the retaining wall may become a safety hazard if it continues to destabilise. Where retaining walls further rot and decay, an environment is created that is conducive to termite and pest infestation.

Significant repair and replacement should be expected. Where retaining walls are considered structural walls, a structural engineer / surveyor should be consulted regarding required remedial works. Otherwise, a landscaper or retaining wall installer may be appointed to repair or replace the wall, at the discretion of the client.

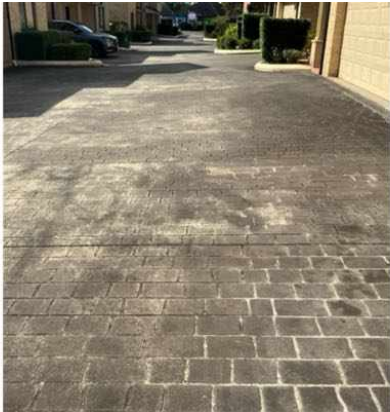
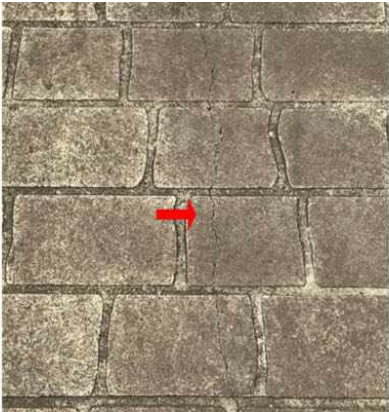
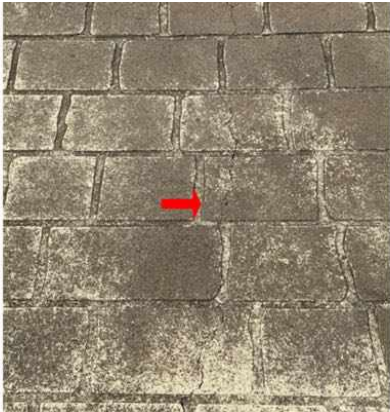
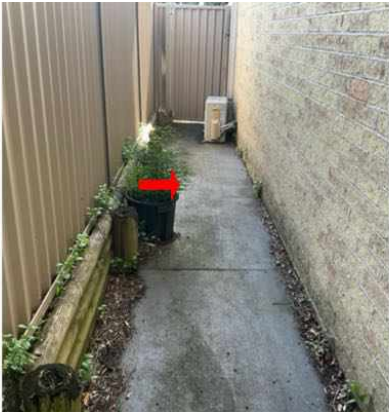
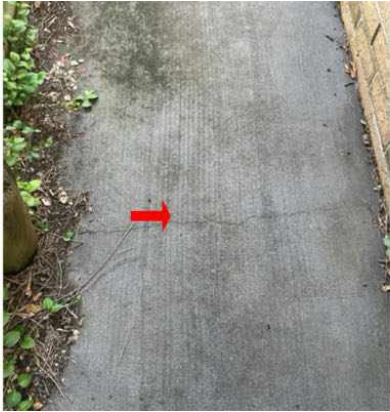
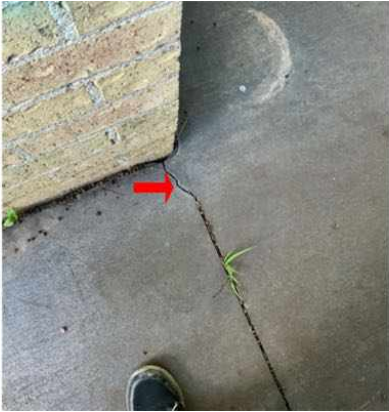
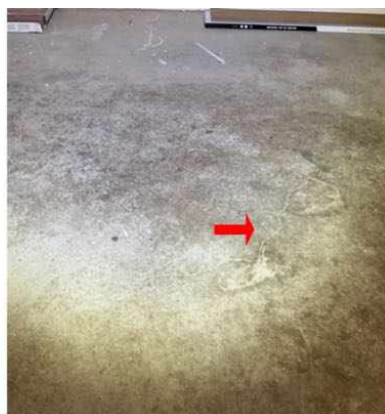
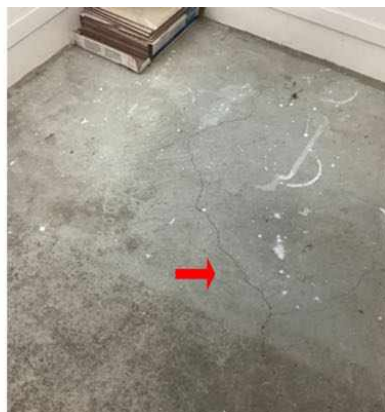
Finding 3.01

| Finding: | Cracking - External Concrete Paving Damage Category 2 - Distinct (less than 3mm) |
| Information: | Distinct cracks were identified in external concrete paving. Distinct cracks are generally found in older concrete paving, and may also present as a trip hazard as consequence of an uneven or curved surface. |

General age and expected deterioration of the paved areas is a common cause of this type of cracking. However, expansion and contraction of the slab may also have occurred due to environmental factors. Such factors include variable moisture and weather conditions, the presence of trees and their roots having a settling or lifting affect on the soil, or the effect of load bearing, e.g. heavy vehicles over a sustained

Cracking to this degree may also be due to poor original installation of the concrete. Factors such as poor compaction of the sub surface and/or inadequate reinforcing of the slab may create cracking and other secondary defects.

Repairs are likely to be required to prevent further cracking and to reduce hazards associated with cracking, such as tripping. Monitoring of all cracking should be conducted frequently. Always contact a building inspector should cracks widen, lengthen, or become more numerous.

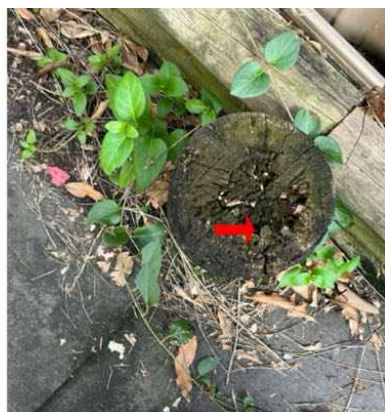
Finding 3.02

| Finding: | Wood rot to some areas |
| Information: | This building element shows evidence of wood rot. Wood rot, also known as Fungal Decay, occurs when timbers and other cellulose building materials are exposed to damp conditions on an ongoing basis. This could be the result of exposure to weathering over a prolonged period of time, or the attraction of excessive moisture from other abutting building materials. Contributing factors also include poor air ventilation in the area. |

registered builder may also be required to replace affected building materials.

An invasive inspection its also recommended by a licensed timber pest technician

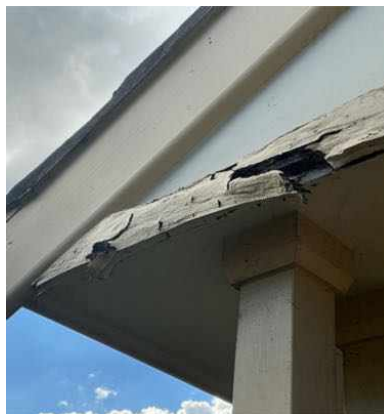
Finding 3.03

barges may then be a necessary step in protecting surrounding building elements from such deterioration.

A qualified plumber may be appointed to assess the cause of excessive moisture and to provide advice on any remedial works as required. A qualified carpenter or registered builder may also be required to replace affected building materials.

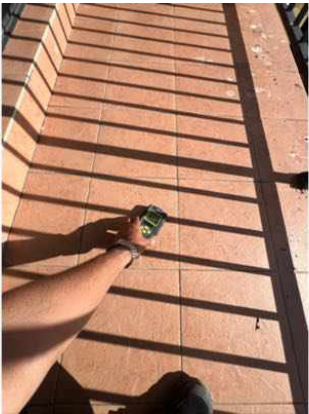
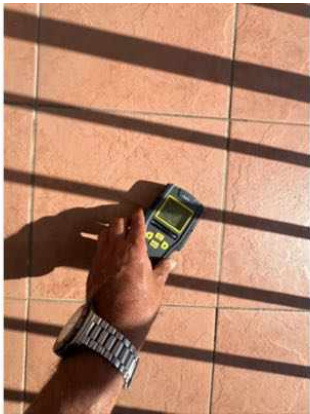
Finding 3.06

Building: Main Building
 Location: Balcony
 Finding: Elevated moisture - No visible deterioration
 Information: Elevated moisture meter readings were recorded to the tiled floor surfaces and adjacent wall bases when tested using a non-invasive (pinless) moisture meter. No visual evidence of moisture ingress, tile debonding, grout deterioration, staining, mould growth, or related moisture damage was observed at the time of inspection. Ongoing monitoring is recommended, and further investigation may be warranted should visible signs of moisture-related distress become evident.

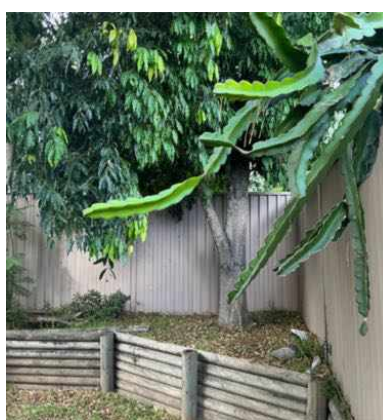
Finding 3.07

| Finding: | Observation – Vegetation/Tree Proximity to Dwelling |
| Information: | A large tree is located adjacent to the dwelling , this proximity poses risks including potential damage to footings and/or underground services from root activity, increased moisture retention conducive to timber pest activity, and ongoing maintenance issues from falling fronds and debris blocking gutters or drains, while the lean of the tree may also present a future safety risk if it becomes unstable, and further assessment by an arborist is recommended to determine stability and potential impacts, with consideration for trimming, monitoring, or removal if necessary. |

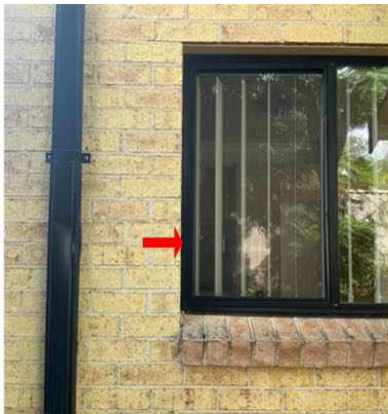
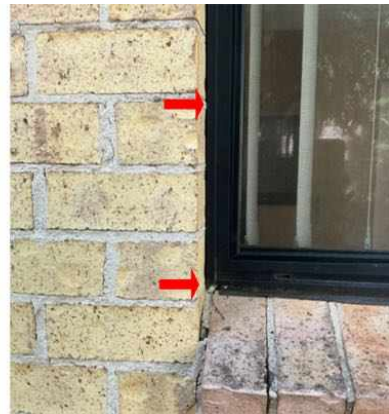
Finding 3.08

| Information: | A visible gap is present between the external window frame and the adjacent masonry wall. This gap may allow water ingress, air infiltration, and potential pest entry if not adequately sealed. Over time, such exposure can contribute to frame deterioration, internal water damage, or reduced thermal performance. Sealing or filling the gap with |

a suitable weatherproof compound is recommended to maintain the integrity of the building envelope, in accordance with good building practice and AS 4349.1

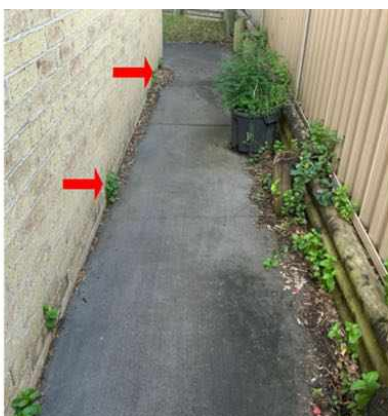
Finding 3.09

This separation may permit water ingress and contribute to concealed moisture-related damage, pest ingress, or slab movement if left unsealed.

The defect appears consistent with common differential settlement or poor sealant detailing at the slab-to-wall junction. Recommend a licensed contractor seal the gap with an appropriate flexible, UV-stable exterior-grade sealant to prevent moisture entry and pest intrusion.

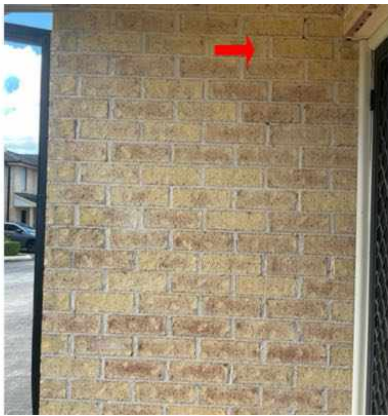
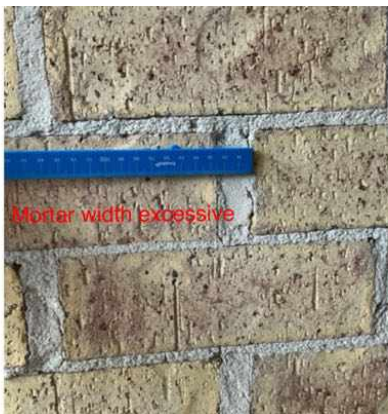
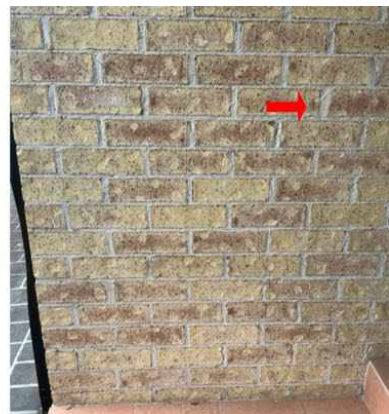
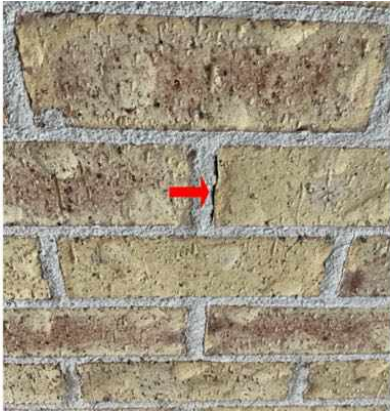
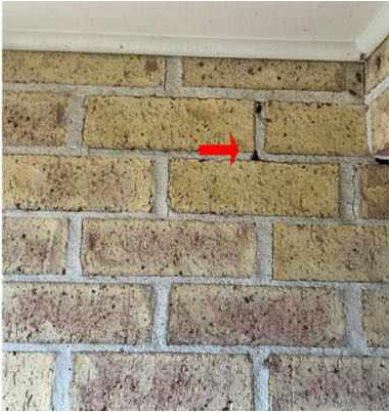
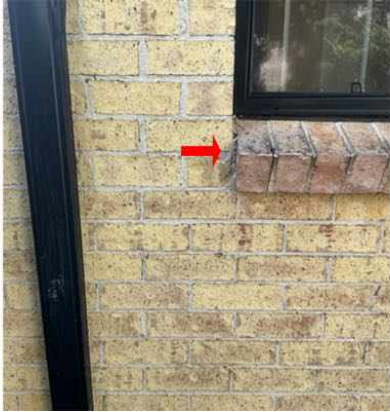
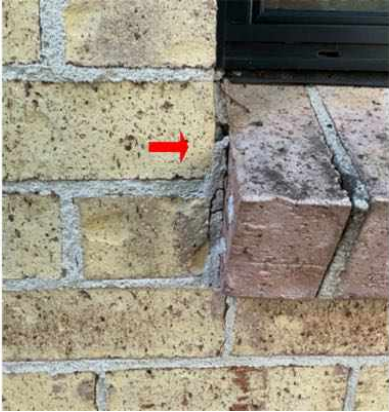
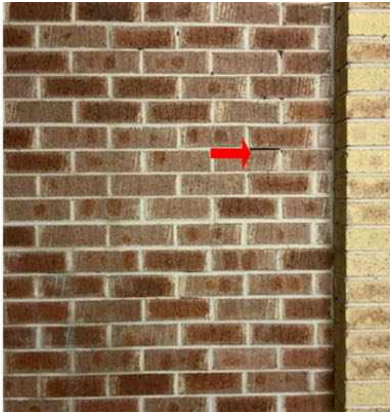
Finding: Brickwork - Deteriorated mortar to some areas
Information: Mortar, or 'bedding', is the material which fills joins and intersections between bricks in masonry walls and structures. Sections of mortar in this brickwork were identified as having deteriorated, which is generally expected for a property of this age and condition.

Mortar may deteriorate as a result of age of building materials, minor movement of bricks, or frequent exposure to weathering. Mortar should be replaced to ensure that bricks remain in their intended location and to prevent gaps, which would allow water or moisture ingress and secondary damage as a result.

Mortar deterioration can be addressed by a bricklayer where areas of deterioration are localised and easily accessible. Alternatively, appointment of a registered builder is advised, to repoint large areas of decaying mortar. Where secondary structural defects have become evident, consultation with a structural engineer may be required.

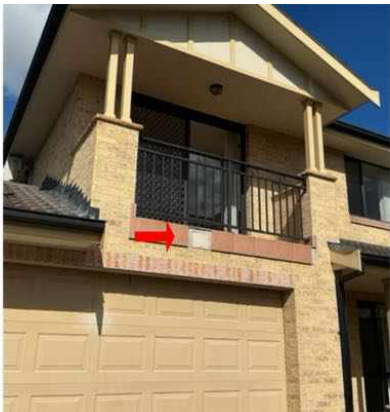
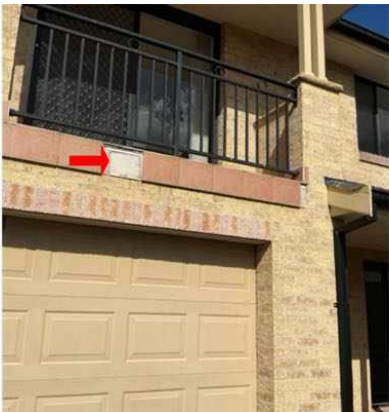
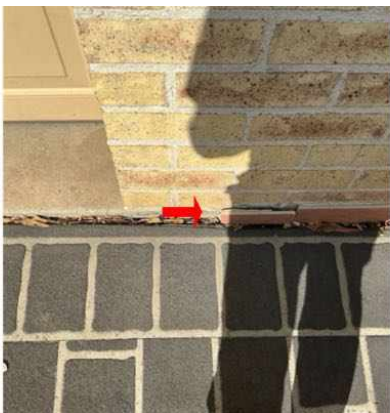
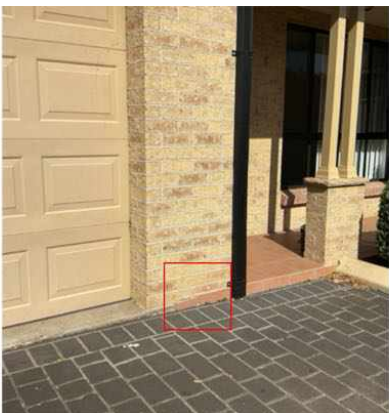
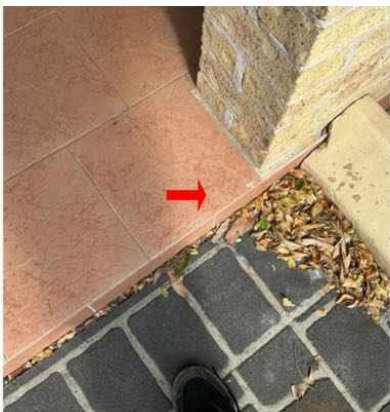
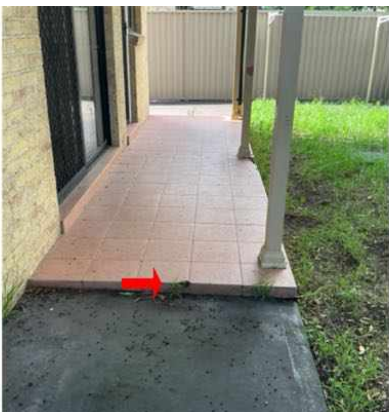
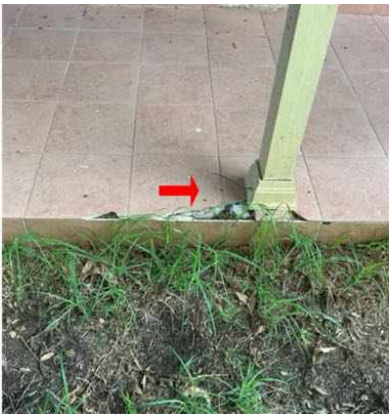
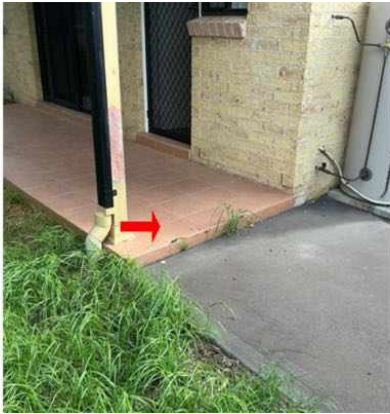
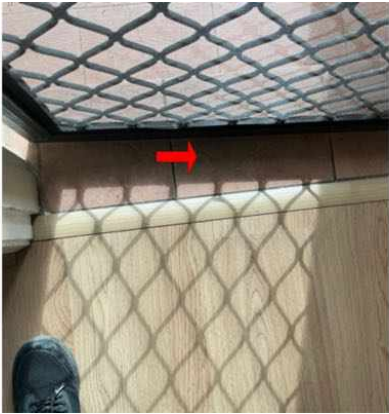
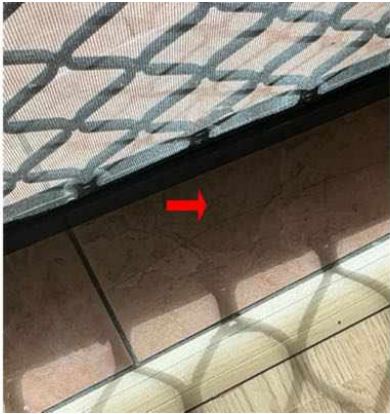
Finding 3.11

Building: Main Building
Location: All External Areas - Front, Rear
Finding: Building element - Missing - Tiles missing and drummy
Information: Although some building elements may seem irrelevant or unnecessary, all building elements play a key role in the operation and function of the overall structure and its performance.

Replacement of any missing building element should be conducted as soon as possible to ensure that no damage or functional issues occur to associated building materials.

The appropriate tradesperson should be appointed as soon as possible to replace the missing building element.

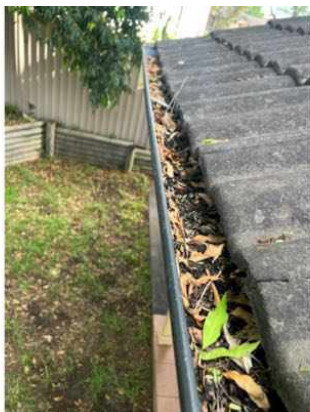
Finding 3.12

Building: Main Building
Location: All External Areas - Rear
Finding: Gutters - Blocked
Information: Roof plumbing structures, such as guttering and downpipes, should be free of all debris to prevent blockages. Blockages of the guttering and downpipes will lead to pooling and accumulated water overflows, which is likely to subsequently flood eaves and exterior walls.

Blocked gutters are likely to lead to high levels of moisture in the affected areas. Such moisture will not only cause rust and decay of the associated building materials, but can also provide conditions that are conducive to termite and timber pest activity. Blockages in gutters should therefore be removed immediately to ensure dry conditions are maintained.

Consult a Licensed Plumber for further specific advice on remedial works that may be required. In the interim, it is highly advised that blocked gutters be removed by the homeowner or a general handyperson as a matter of urgency.

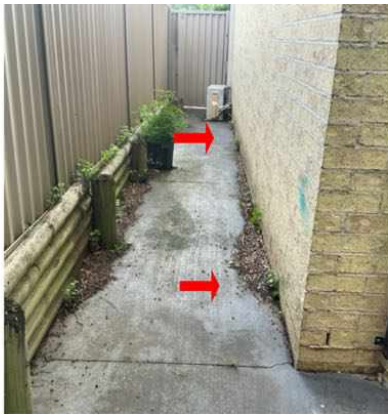
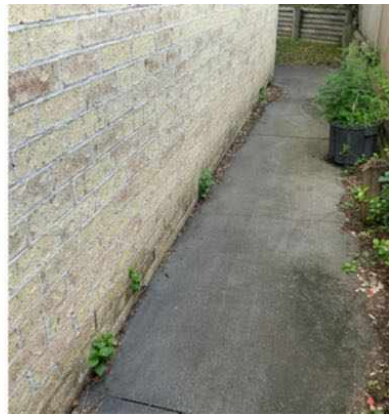
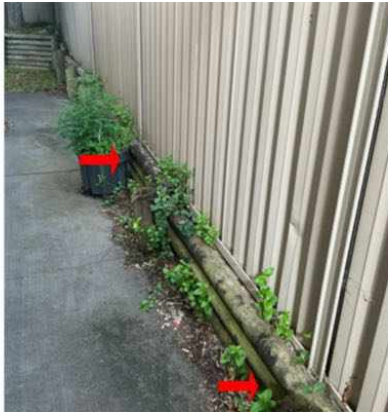
Finding 3.13

| Finding: | Site drainage - Inadequate |
| Information: | The site drainage in this area was found to be inadequate at the time of inspection, creating potential for subsequent water damage to associated building elements. |

It is important that water does not lie against the base of walls; surrounding paths and ground levels should be sloped to drain water away from walls. Downpipes should not discharge stormwater onto lower walls or plinths. Stormwater should be carried away by large, regularly cleaned drains. Ground levels may need to be lowered to expose a buried DPC.

A qualified plumber should be appointed to further inspect the property and perform any remedial works as necessary. Water damage and secondary defects are likely to occur if left unmanaged.

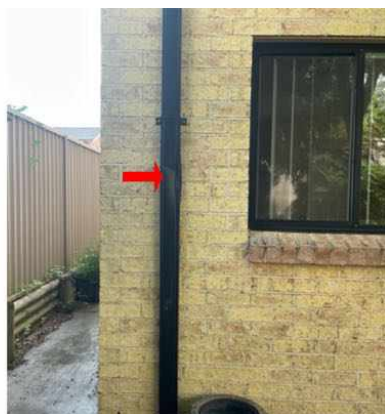
Finding 3.14

| Finding: | Building element - Damaged - Side gate damaged & binding , downpipe damaged rear |
| Information: | Breakage occurs generally when the building materials have either aged and decayed, or as a result of damage (accidental or deliberate). |

Repair and/or replacement of broken elements is advised to ensure that additional secondary defects do not arise as a consequence. Such works are necessary, as all building elements play a key role in the operation and function of the overall structure and its performance.

A relevant tradesperson should be appointed to repair or replace the affected building element prior to any subsequent damage being caused.

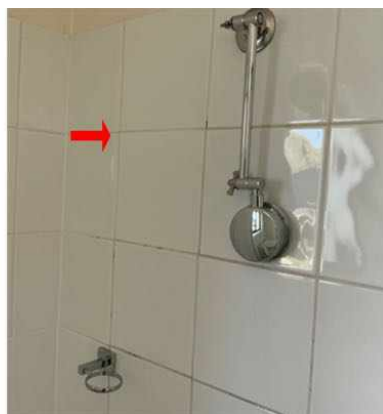
Finding 3.15

| Information: | Drummy tiled areas were identified at the time of inspection. The term 'drummy' refers to tiles that have become detached from their fixing, despite otherwise being in relatively good condition. Such defects are generally caused by physical or moisture damage to the area. Drummy tiled areas may also be a direct result of poor workmanship during the construction process. |

Tiled areas may swell and shrink with changes in air humidity if the area has sustained moisture damage. Any exposure to moisture is capable of causing tiled areas to become drummy and/or cracked over a prolonged period of time. Drummy tiled areas generally require removal and replacement of affected tiles, with adequate sealant and grouting.

Specialist trades are available for these types of services. A registered builder may be required to undertake works if damage is extensive or if secondary building defects have resulted. Otherwise, it is advised that a tiling contractor be appointed to perform works as necessary. Immediate action is recommended to ensure that no further damage is sustained in the affected area.

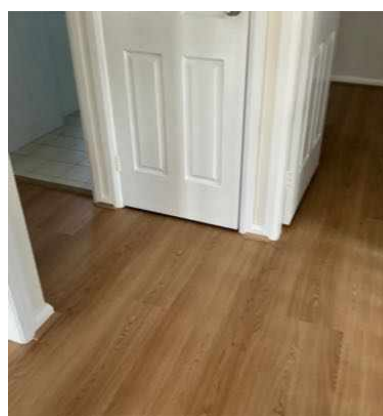
Finding 3.16

Bouncy floors generally indicate that the floorboards or the subfloor structures are coming loose from the joists that they are installed on. Bouncy flooring may also be the result of gaps between flooring and stumps or joist structures, which require packing.

The client is advised to seek quotations for required repairs from a Registered Builder specialising in re-stumping. The potential resolution may range from packing gaps in subfloor structures through to replacement of subfloors stumps and refixing of flooring.

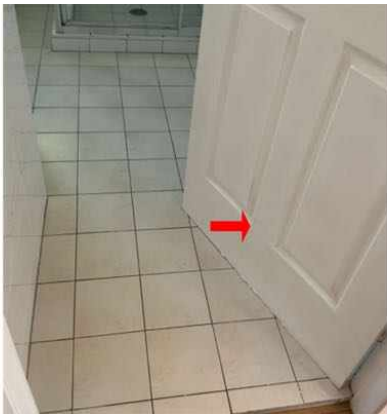
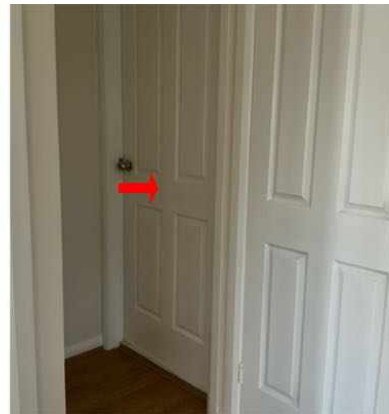
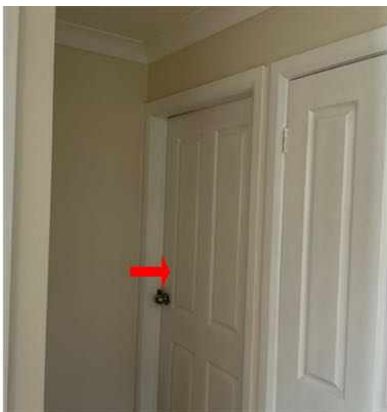
Finding 3.17

Finding: Doors - Binding/Jamming
Information: Binding and/or jamming of several doors throughout the property were evident during standard operation. This defect inhibits the functionality of affected doors as well as creating potential for secondary defects to associated building elements, such as damage to the floor covering.

A door that binds to flooring or to the associated door frame may have several causes, ranging from minor defects, such as poor installation of the door or deteriorated hinges, through to major structural issues, such as damage to subfloor structures.

Where door binding/jamming appears to indicate major structural issues, a registered builder specialising in re-stumping should be appointed to provide an estimate on the cost of rectification.

For minor causes, a qualified carpenter or general handyperson should be appointed to perform minor rectification works at client discretion.

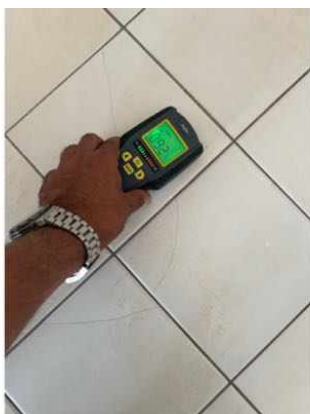
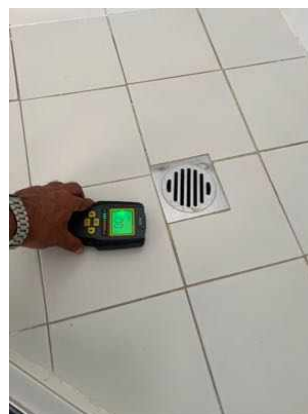
Finding 3.18

Building: Main Building
Location: Bathrooms
Finding: Elevated Moisture Bathroom (No visible deterioration noted)

Information: Elevated moisture levels were detected to tiled surfaces in bathroom/shower areas. Persistent moisture ingress can lead to concealed damage, including timber rot and mould growth.

Elevated moisture readings in tiled wet areas can occur from normal shower use, age/deterioration of waterproofing membranes, plumbing leaks or moisture absorption through grout lines. While no damage was visible, elevated readings may indicate moisture retention behind tiles, which can be a conducive condition for future deterioration if not monitored.

No immediate action required. Monitor the area over time for signs of drumming, efflorescence, tile movement, or grout deterioration. If concerns arise, a licensed waterproofing specialist can perform further investigation (e.g., pressure testing, membrane assessment).

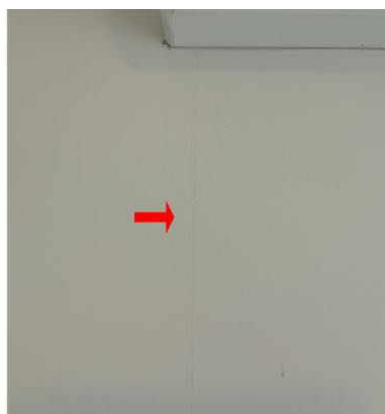
Finding 3.19

Building: Main Building
 Location: All Internal Areas
 Finding: Water staining (Possible aircon)
 Information: Water staining was evident in this area at the time of inspection. Water staining indicates that surfaces have been exposed to excessive moisture over time. The minerals and other elements in the water lead to staining, which may graduate to

corrosion and deterioration if left unmanaged.

While mostly an appearance defect, water staining can be indicative of more serious defects, which may be currently concealed by other building elements.

Where water staining is active, a licensed plumber must be consulted to identify the cause of the staining and to provide advice on any reparation works that may be required. Replacement of any broken or damaged structures is advised.

Conversely, where water staining is old and inactive, affected building materials may be repaired or replaced at client discretion. A qualified carpenter or registered builder may be appointed to perform these works.

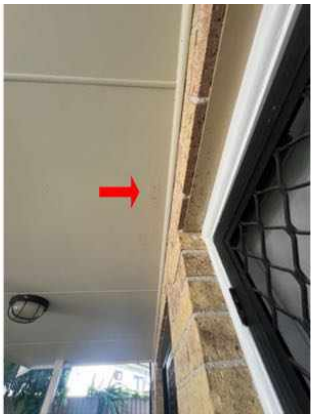
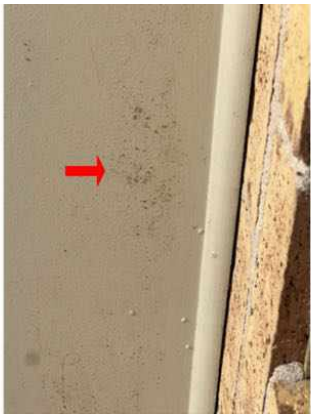
Finding 3.20

| Finding: | Minor Mould Growth and elevated moisture |
| Information: | Minor mould growth was noted at the time of inspection. No visible material deterioration was observed. The exact cause could not be confirmed due to the non-invasive nature of the inspection. Cleaning and ongoing monitoring are recommended, with further investigation advised if the condition persists. |

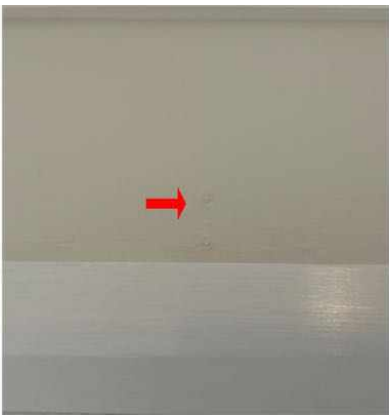
Finding 3.21

Building: Main Building
 Location: All Internal Areas
 Finding: Wall nails - Popping to some areas
 Information: Numerous popped nails were identified in the wall sheets at the time of inspection. Nails and screws are held by the friction between them and the surface that they are applied to. Over time, the nails and screws can back out, which is often a result of general ageing and deterioration of the building structure.

If left unmanaged, the wall sheets may become loose and unstable, increasing the rate of deterioration of the wall sheeting and creating potential for the development of secondary defects.

Re-fastening of popped nails will help to maintain the stability of the internal walls and associated building elements. Such minor works will also help to improve the appearance of the affected area and secure the wall sheets. These works should be performed by a qualified carpenter or plasterer at client discretion.

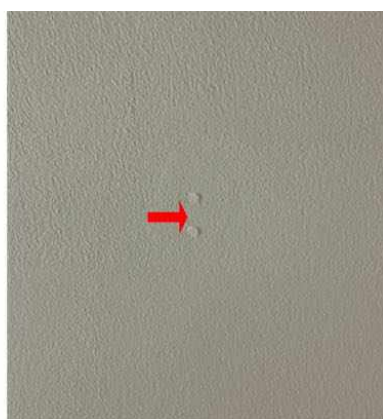
Finding 3.22

Building: Main Building
 Location: All Internal Areas

Finding: Ceiling nails - Popping To some areas
Information: Numerous popped nails were identified in the internal ceiling at the time of inspection. Nails and screws hold simply by the friction between them and the surface they are applied to. Over time, the nails and screws can back out, which is often a result of general ageing and deterioration of the building structure.

If left unmanaged, the ceiling sheets may become loose and unstable, increasing the rate of deterioration of the internal ceiling and creating potential for the development of secondary defects.

Re-fastening of popped nails will help to maintain the stability of the internal ceiling and associated building elements. Such minor works will also help to improve the appearance of the affected area and secure the ceiling sheets, so as to prevent the onset of ceiling sagging. These works should be performed by a qualified carpenter or plasterer at client discretion.

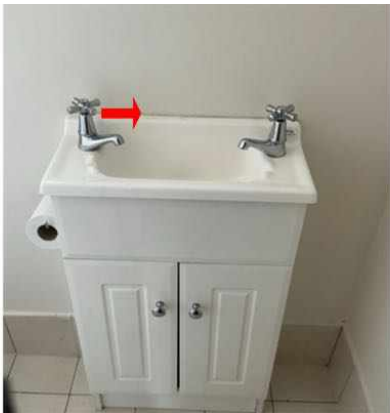
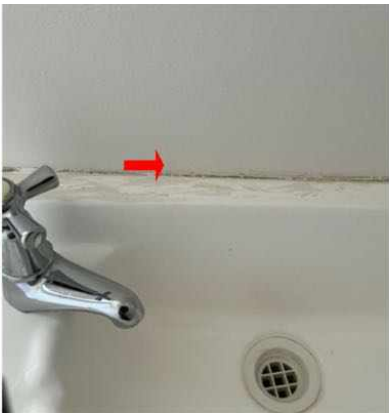
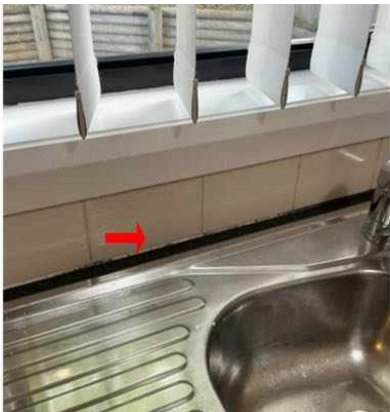
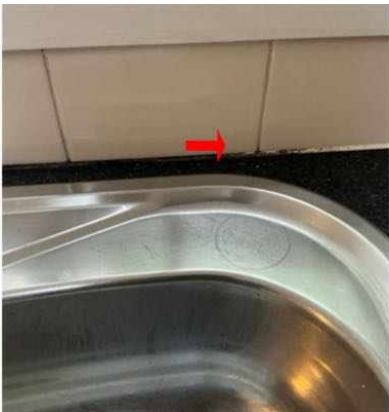
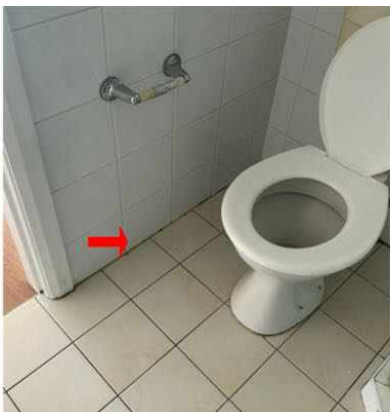
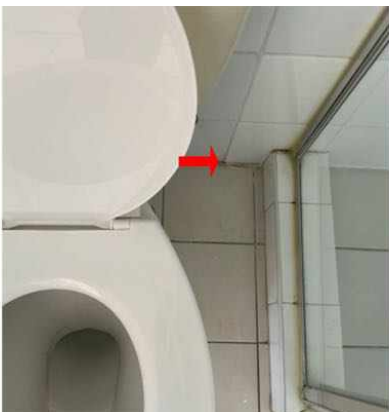
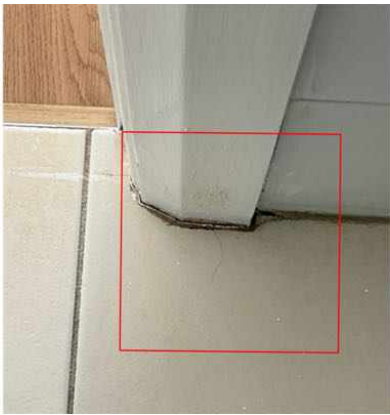
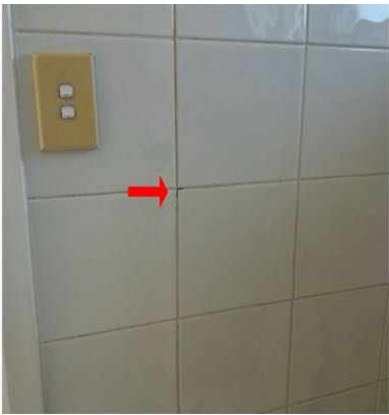
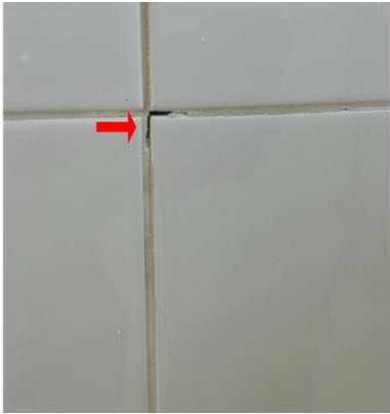
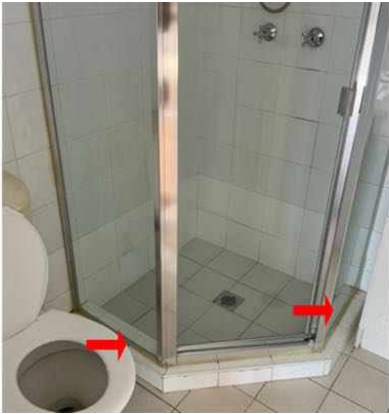
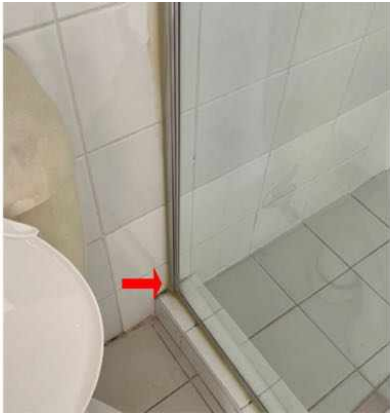
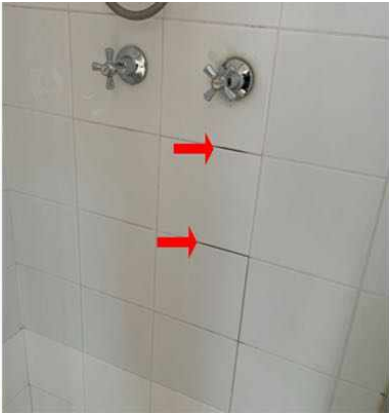
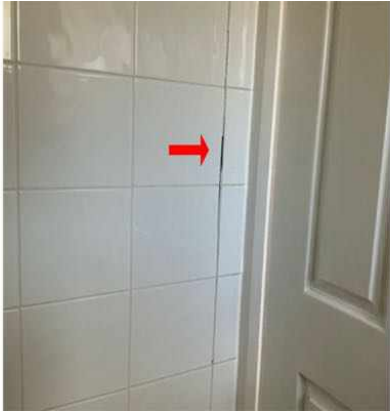
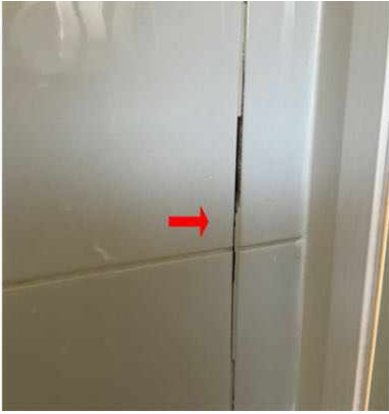
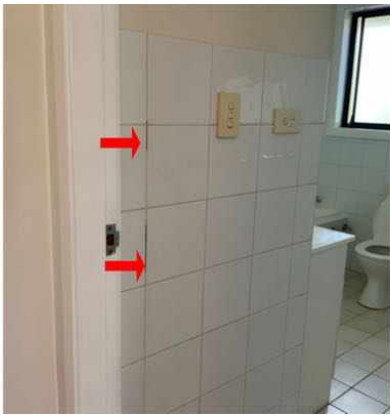
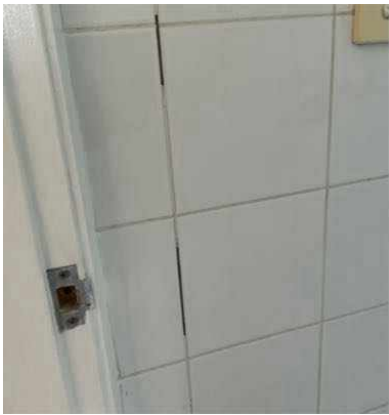
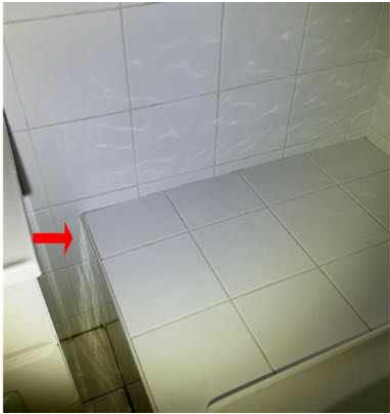
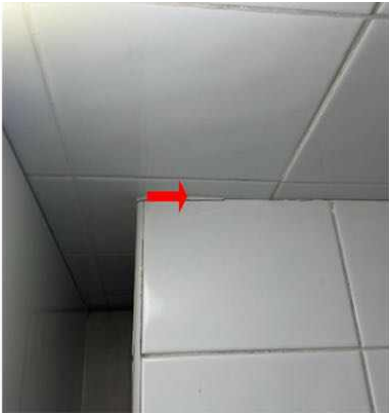
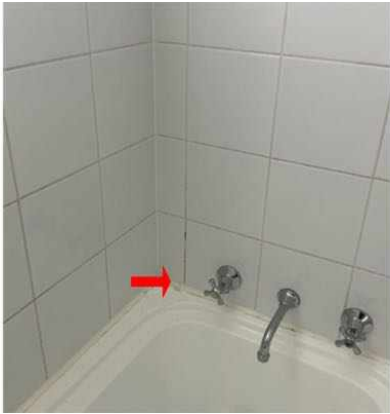
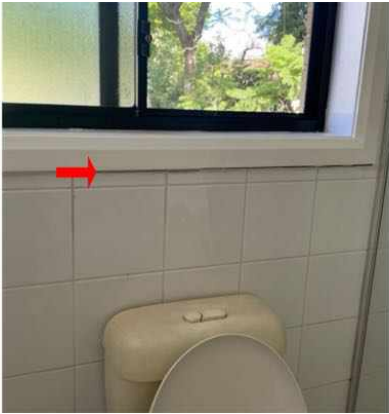
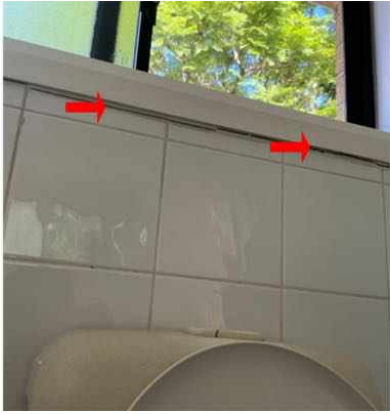
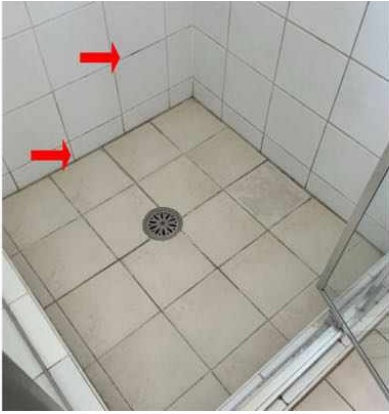
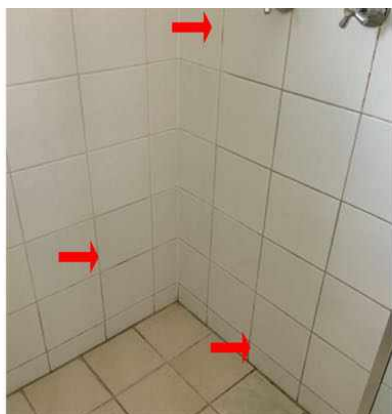
Building: Main Building
Location: All Internal Areas
Finding: Sealant and grouting - Missing or degraded to some areas
Information: It was noted on inspection that sealant or grout is degraded.

Different materials and floor areas move at different rates, generally causing cracking to grout or sealant at this point. A flexible sealant is required to allow for expected expansion and contraction, while keeping the joint water tight and protective of all associated building materials.

Excessive mould to the sealant and grout may require scraping out and replacement.

Flexible and mould resistant materials should be applied to affected areas to prevent any subsequent water damage that is likely to occur. Regular maintenance and replacement of damage or missing or damaged sealant and grout is highly recommended to the wet areas, as this is a regular wear and tear defect. Sealant and grouting in areas that come into regular contact with water should be maintained for

the long term care of your property.

A sealant specialist or tiling contractor should be appointed to complete these works as soon as possible

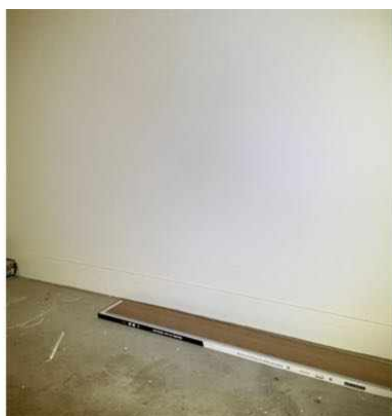
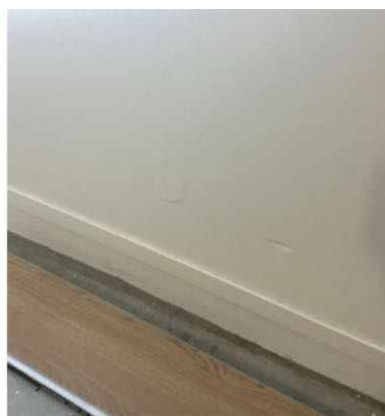
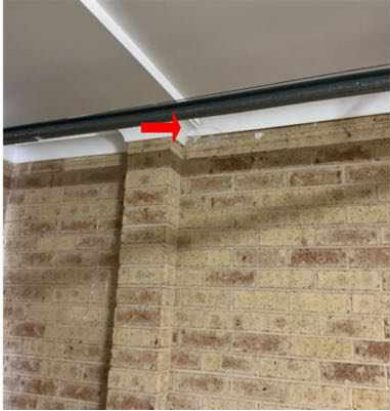
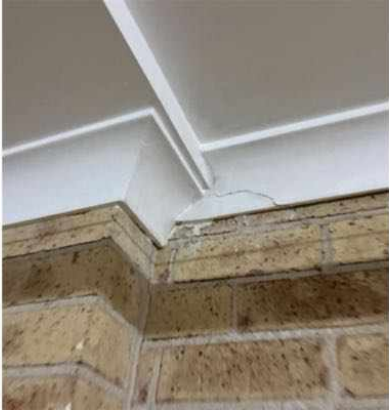
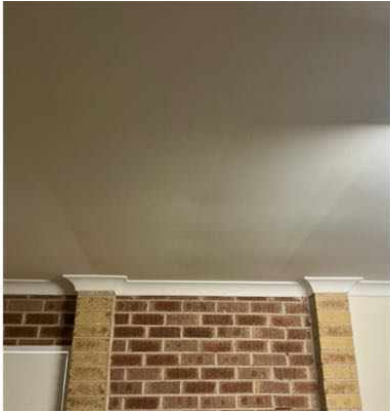
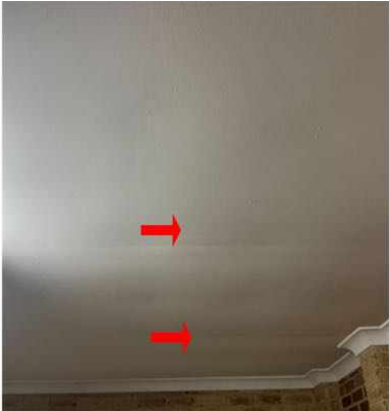
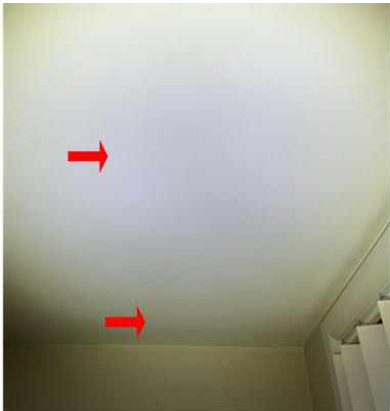
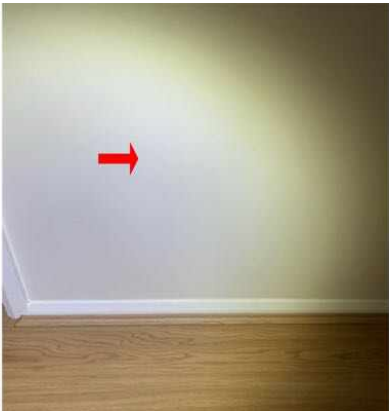
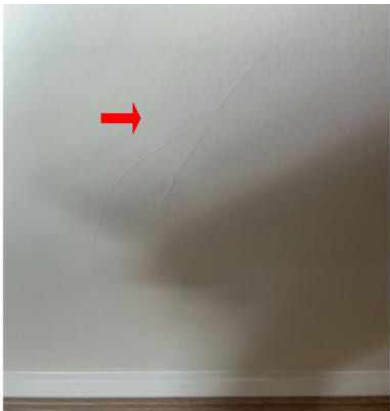
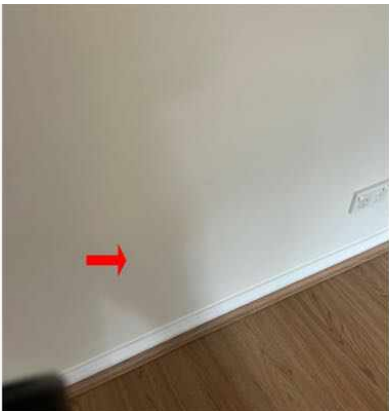
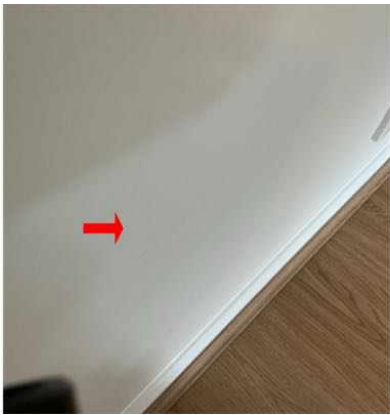
Finding 3.24

| Finding: | Paint Finish & Hairline Cracking - To some areas |
| Information: | The paint finish in this area was identified as being incomplete or substandard at the time of inspection including some hairline minor cracking/separation. Monitoring is recommended where cracking and separation is evident. |

Whilst incomplete or missing paint finish is generally an appearance defect, it can also lead to the development of secondary building defects over time. Incomplete areas of paint finish expose the area to moisture, potentially accelerating the deterioration of underlying building materials.

Incomplete paint finishes should be sanded back, filled, leveled and painted, as applicable. Where inadequate or missing paint protection has led to the deterioration of the associated building element, repair and/or replacement of this building element may be required.

A painting contractor should be appointed as soon as possible to perform necessary works to aid the appearance of the affected area and to ensure the area is protected against further deterioration. Alternatively, the homeowner following manufacturer instructions may perform these works.

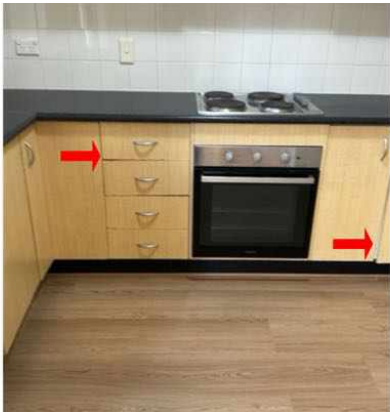
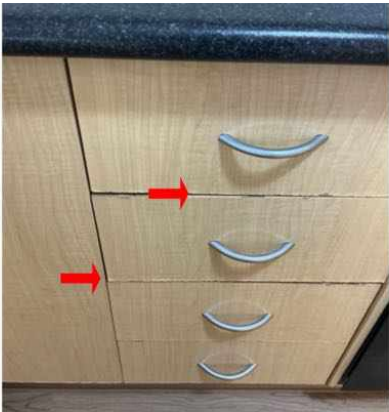
Finding 3.25

Building: Main Building
Location: All Internal Areas
Finding: Building element - Damaged - Kitchen cabinets delaminating , loose hinges kitchen , BIR still to slide
Information: Breakage occurs generally when the building materials have either aged and decayed, or as a result of damage (accidental or deliberate).

Repair and/or replacement of broken elements is advised to ensure that additional secondary defects do not arise as a consequence. Such works are necessary, as all building elements play a key role in the operation and function of the overall structure and its performance.

A relevant tradesperson should be appointed to repair or replace the affected building element prior to any subsequent damage being caused.

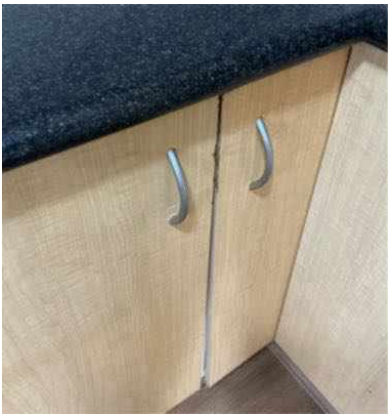
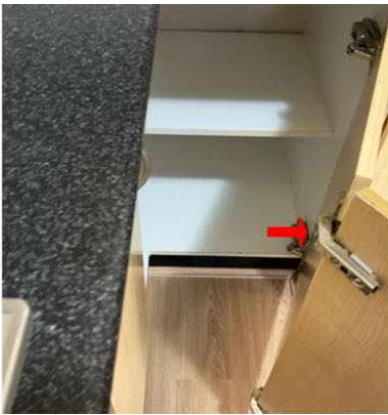
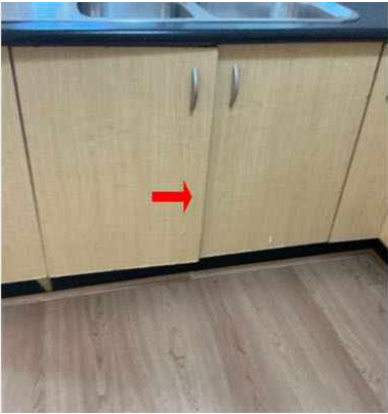
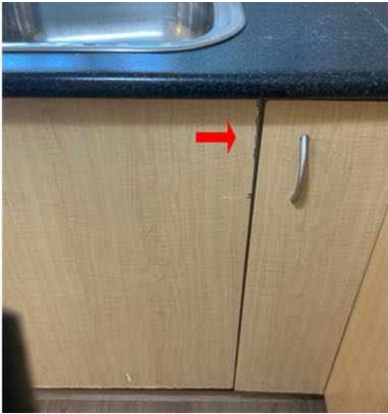
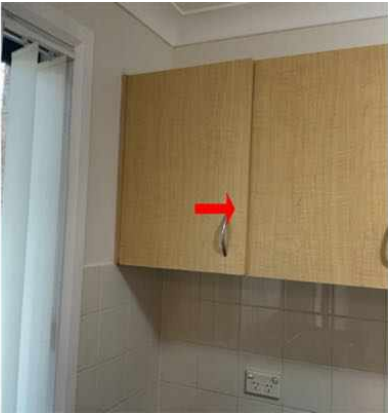
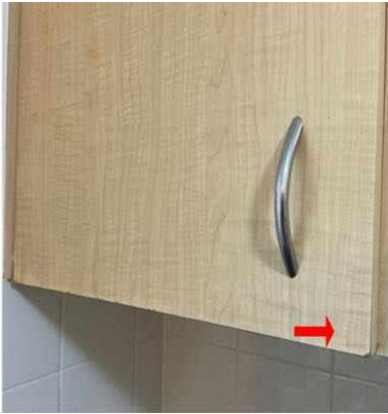
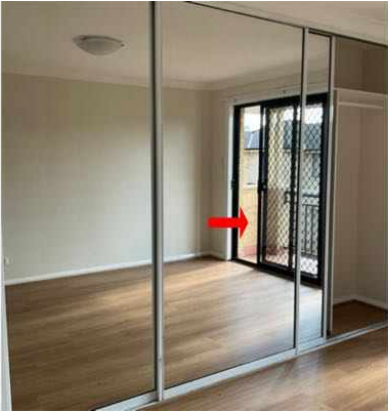
Finding 3.26

| Finding: | Building element - Missing - No ventilation |

Replacement of any missing building element should be conducted as soon as possible to ensure that no damage or functional issues occur to associated building materials.

The appropriate tradesperson should be appointed as soon as possible to replace the missing building element.
