Building and Timber Pest Inspection Report

Inspection Date: Tue, 10 Mar 2026

Property Address: 5/38 McLean St, Liverpool NSW 2170,
Australia

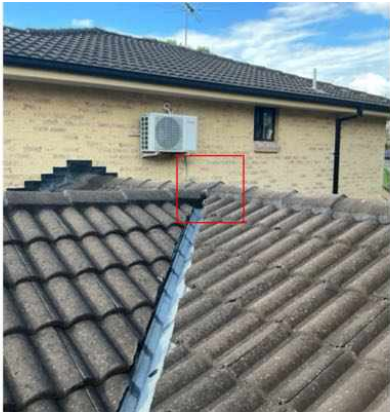
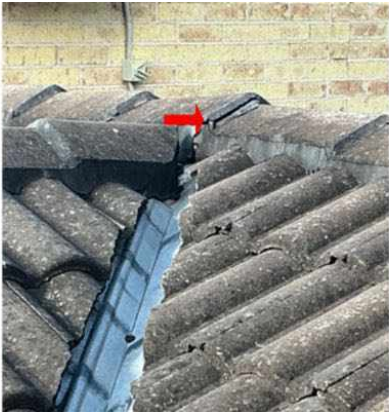
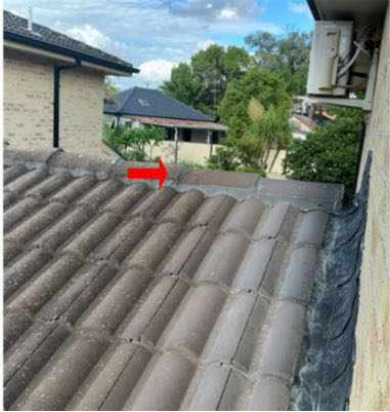
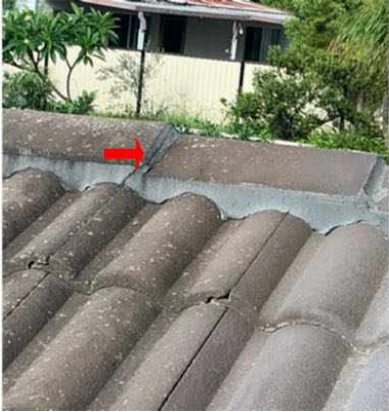
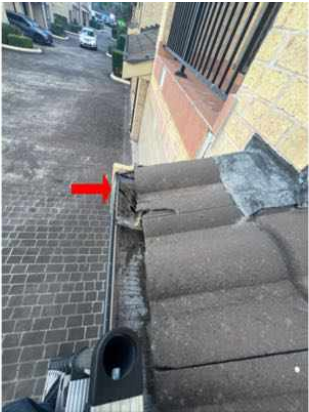
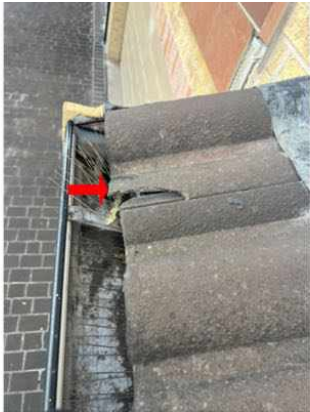
Finding 3.31

| Finding: | Flashing defective -poor installation |
| Information: | The metal flashing at the wall junction appears inadequately installed, with visible gaps and lifting and reliance on surface sealant rather than a properly chased and continuous detail. The junction does not appear fully weather-tight, increasing the risk of moisture ingress into the wall cavity or roof structure over time. Defective flashing installation can lead to concealed deterioration if not addressed. Recommend assessment and rectification by a qualified roofing contractor to ensure compliant and effective weatherproofing. |

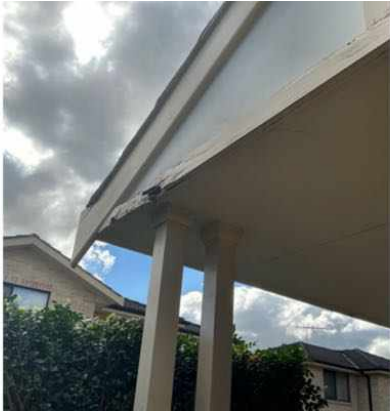
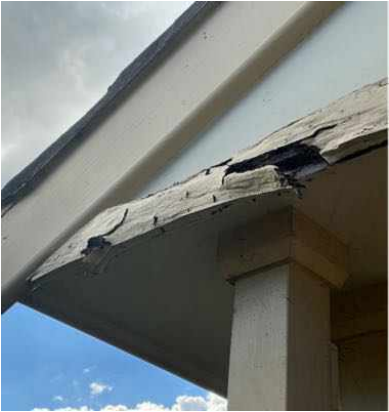
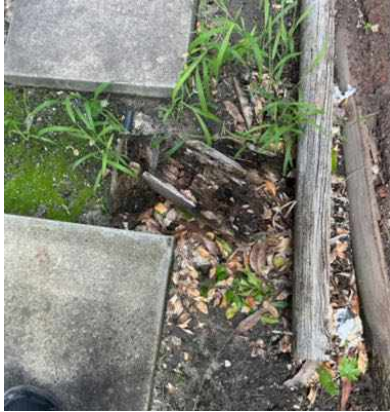
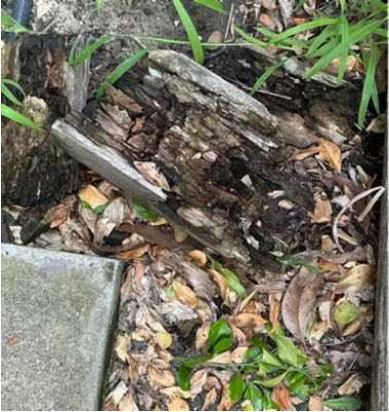
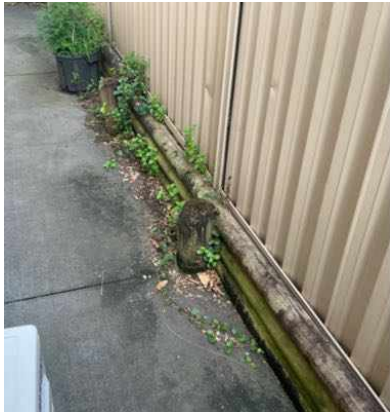
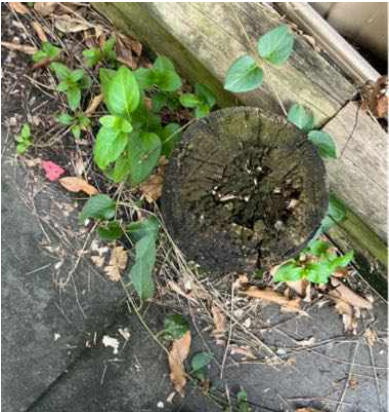
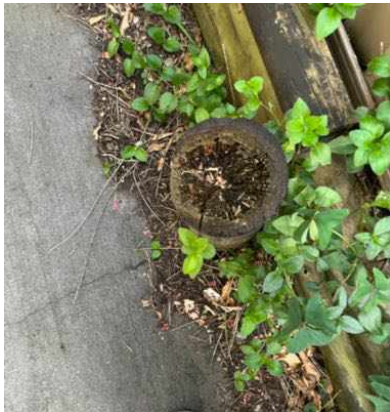
| Finding: | Fungal decay - present |
| Information: | Fungal decay also known as wood decay or wood rot generally refers to the deterioration of timber elements when in contact with excessive levels of moisture for a prolonged period of time. |

The development of fungal decay is accelerated by temperatures in the range of 5degreeC to 40degreeC as well as the presence of oxygen. Generally fungal decay develops on timber elements that are in use in an external environment which are exposed to rain penetration.

In this case although the affected timber element is in a decaying state the extent of any visible damage appears to be localised to a specific area and is yet to spread to other parts of the building element or affect adjoining structures. The fungal decay is therefore likely to be of a relatively superficial nature with minimal impact on the structural integrity or tensile strength of the timber element.

A further invasive inspection by a licensed timber pest technician is highly recommended to check for concealed activity.

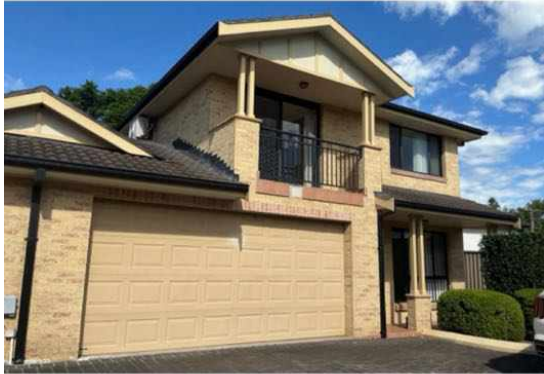
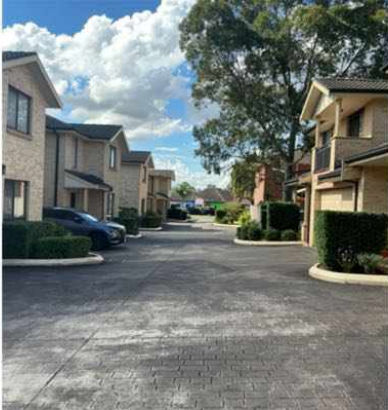
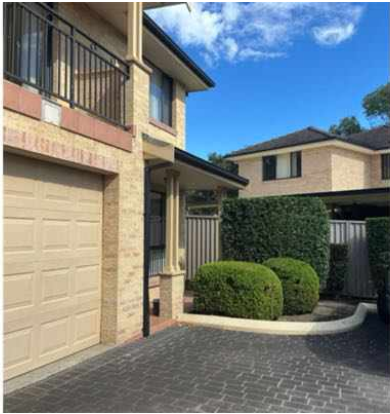
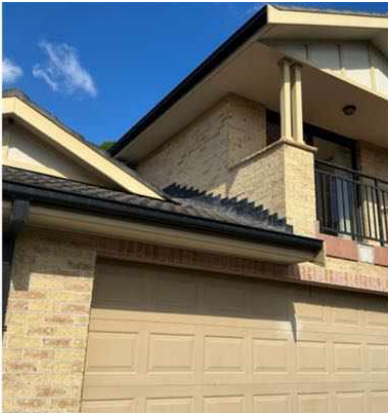
Building: Main Building
Location: All External Areas
Finding: Additional Photos - Obstructions and Limitations
Information: These photographs are an indication of the obstructions and limitations which impeded full inspection of the property at the time of inspection. These obstructions can hide an array of defects and should be removed to allow full inspection to be carried out. A re-inspection is recommended once the areas are made accessible.

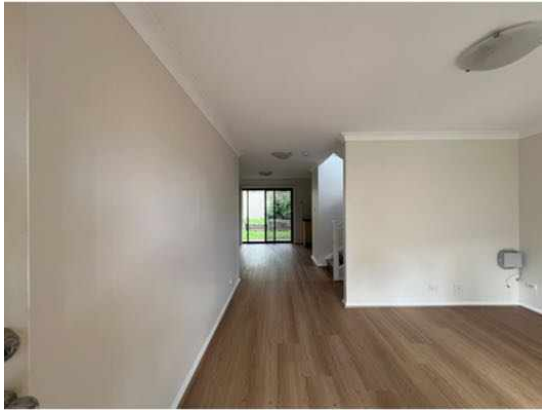
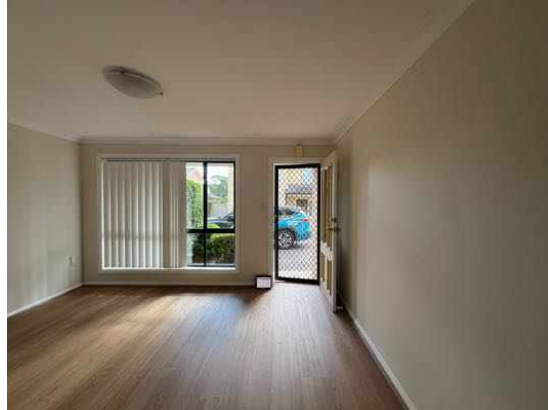
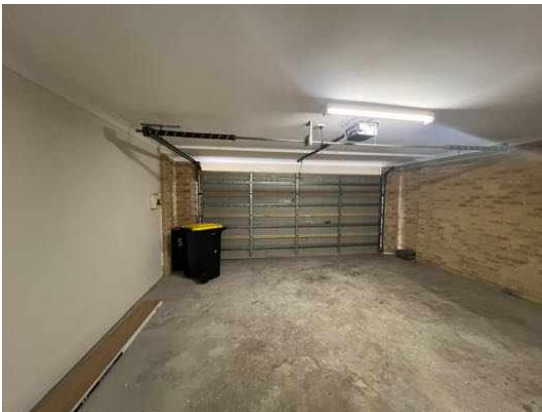
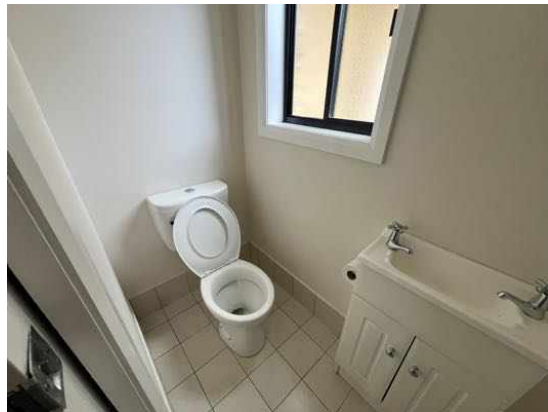
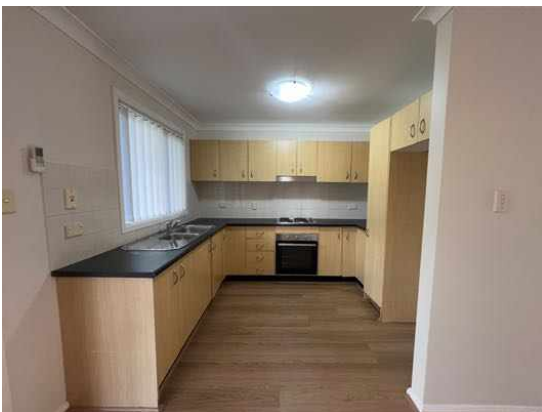
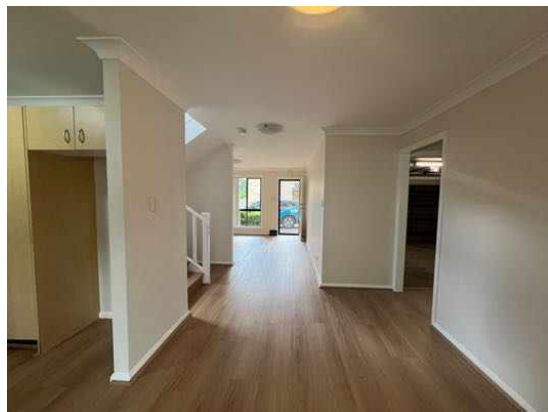
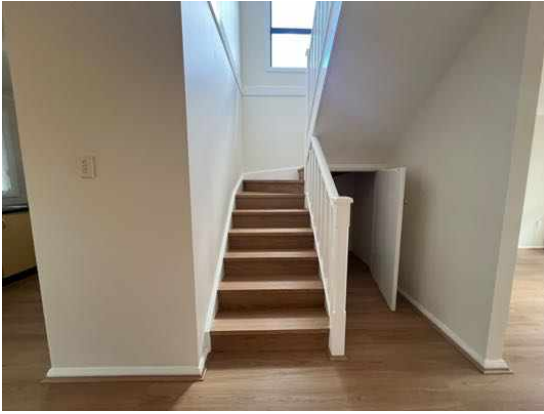
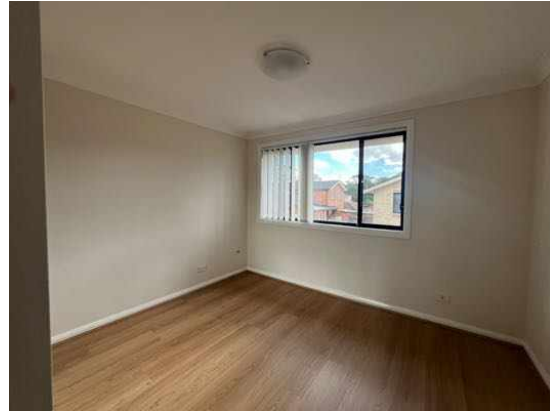
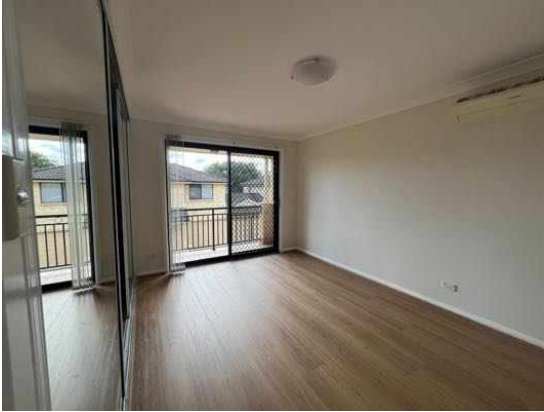
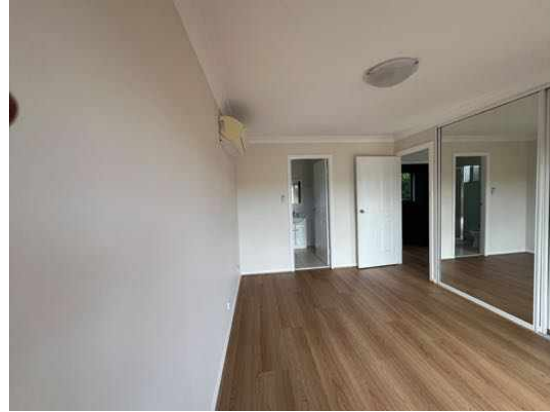
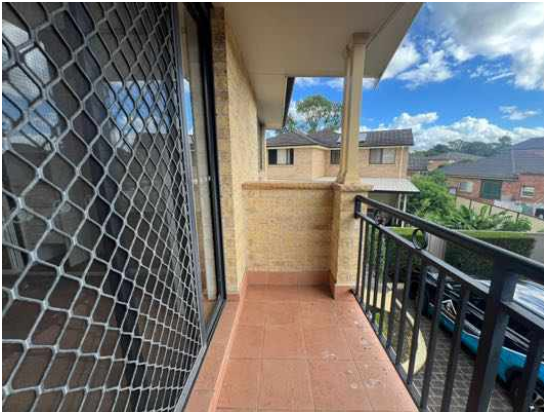
Building: Main Building
Location: All Internal Areas
Finding: Additional Photos - Obstructions and Limitations
Information: These photographs are an indication of the obstructions and limitations which impeded full inspection of the property at the time of inspection. These obstructions can hide an array of defects and should be removed to allow full inspection to be carried out. A re-inspection is recommended once the areas are made accessible.

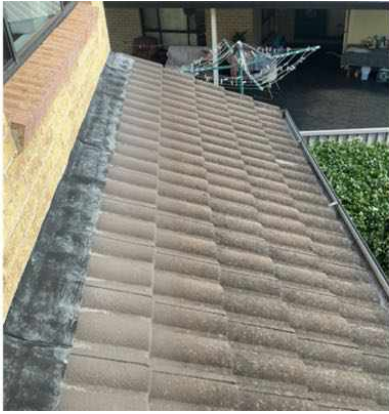
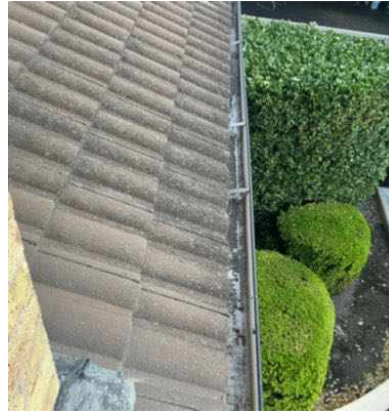
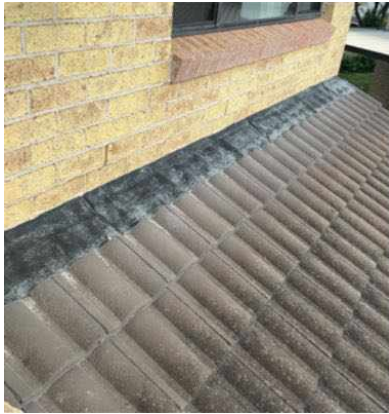
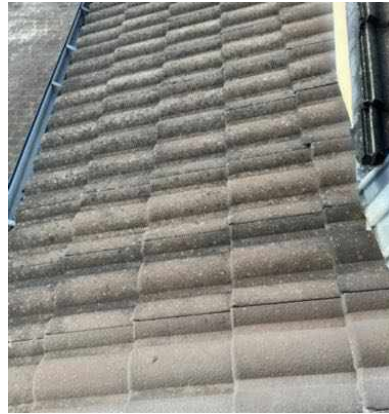
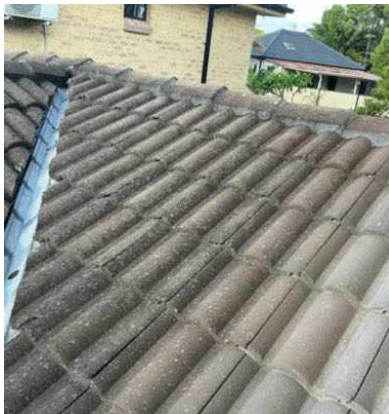
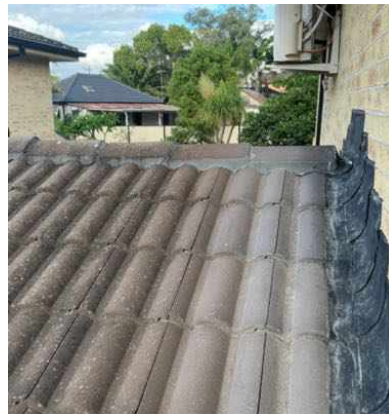
| Finding: | Additional Photos - Obstructions and Limitations |
| Information: | These photographs are an indication of the obstructions and limitations which impeded full inspection of the property at the time of inspection. These obstructions can hide an array of defects and should be removed to allow full inspection to be carried out. A re-inspection is recommended once the areas are made accessible. |

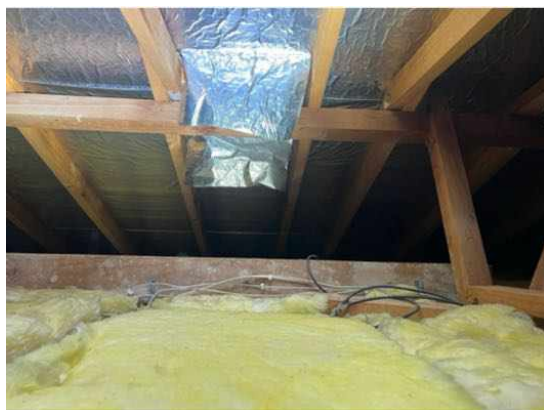
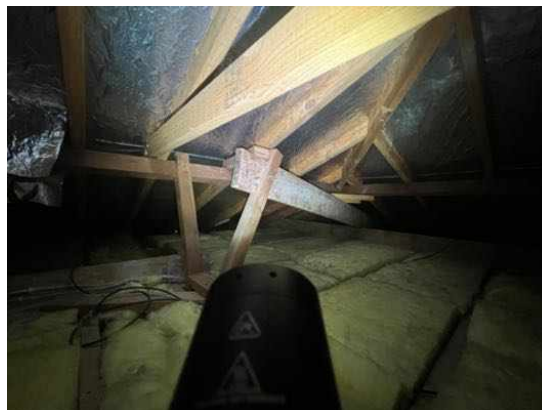
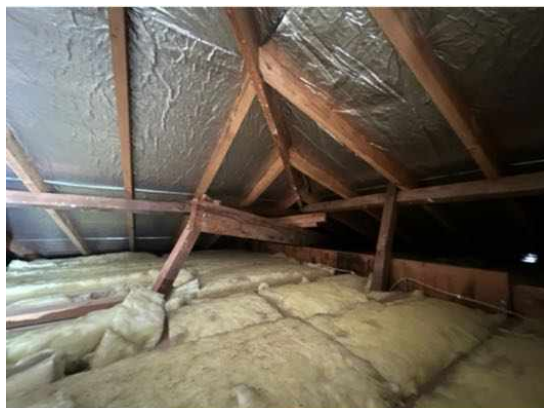
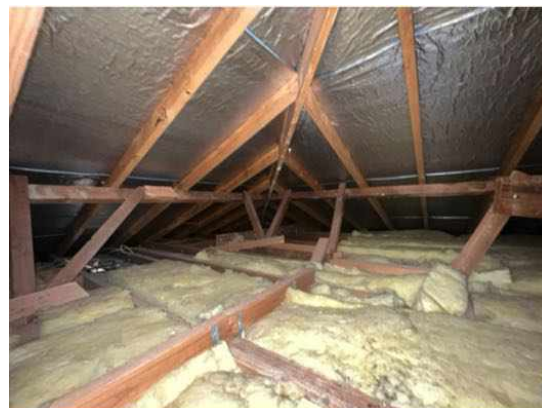
| Finding: | Additional Photos - Obstructions and Limitations |
| Information: | These photographs are an indication of the obstructions and limitations which impeded full inspection of the property at the time of inspection. These obstructions can hide an array of defects and should be removed to allow full inspection to be carried out. A re-inspection is recommended once the areas are made accessible. |

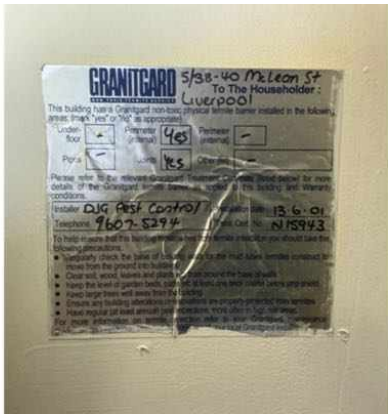
The following items were noted as - Evidence of a previous termite management program

Where a Termite Management System has been identified you should refer to the type of barrier date of installation warranty conditions and any documentation provided by a builder or past owner. Consult the company who installed the barrier to confirm whether the system is still under warranty.

Most chemical termite management systems expire and require replenishment and all physical systems are primarily designed to prevent concealed entry.
