Building and Timber Pest Inspection Report

Inspection Date: Thu, 12 Feb 2026

Property Address: 18 Old Bamarang Rd, Mundamia NSW
2540, Australia

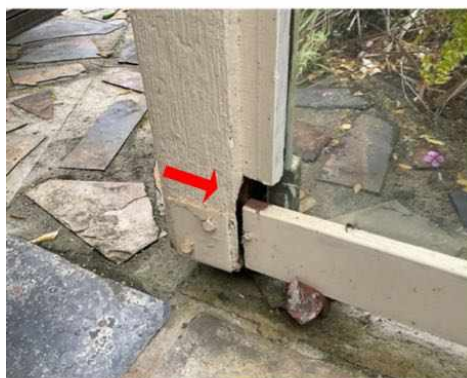
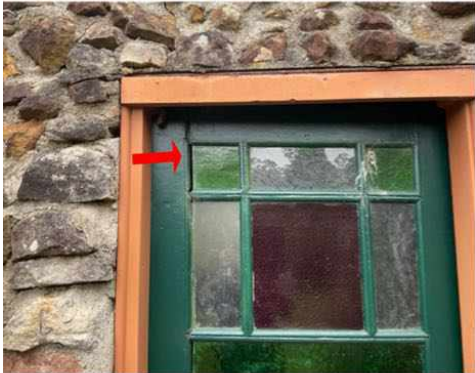
Building:	Building 1
Location:	Pictured pergola and shed areas
Finding:	Wood rot to posts etc and loose glass panes.
Information:	The attached pergola shows evidence of wood rot to some timbers including supportive posts. Two glass panes are now loose due to wood rot.

The shed also has a damaged door and cracked window. These areas of damaged and loose glass need urgent repair to stop potential injury.

Wood rot, also known as Fungal Decay, occurs when timbers and other cellulose building materials are exposed to damp conditions on an ongoing basis. This could be the result of exposure to weathering over a prolonged period of time, or the attraction of excessive moisture from other abutting building materials. Contributing factors also include poor air ventilation in the area.

Early intervention and regular maintenance, particularly of exterior timbers, will prolong the useful life of these building elements. Prior to any works being performed, the cause of the moisture that has created the visible wood rot should be identified and addressed in a suitable manner. Replacement of affected timbers may then be a necessary step in protecting surrounding building elements from such deterioration.

A qualified carpenter or registered builder will be required to make safe the loose and damaged glass urgently.

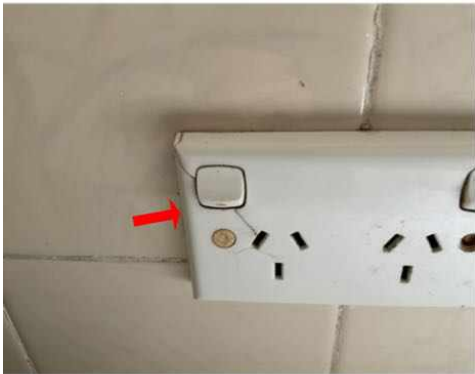
Finding 1.02

Building: Building 1
 Location: Kitchen, bathroom
 Finding: Broken light switches
 Information: The light switches in these areas was found to be cracked at the time of inspection. Breakage occurs generally when the building materials have aged and decayed, but may also be indicative of impact damage to the building element (accidental or deliberate).

Repair and/or replacement of this light switch is advised. A Licensed electrician should be appointed to repair or replace the fitting immediately.

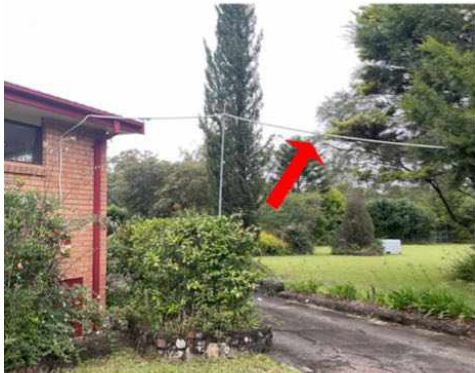
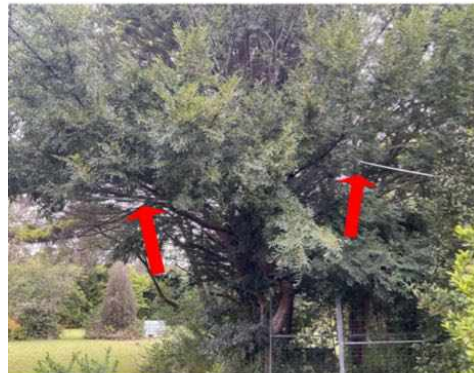
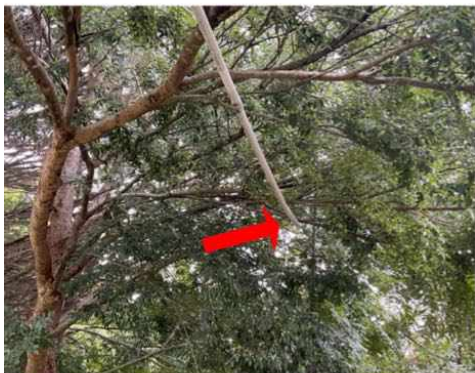
Finding 1.03

Building: Building 1
Location: Left driveway
Finding: Overhead Electrical wires unsafe
Information: The overhead electrical wiring to the shed should be placed underground as the tree branches are impacting it. Contact a licensed electrician for rectification.

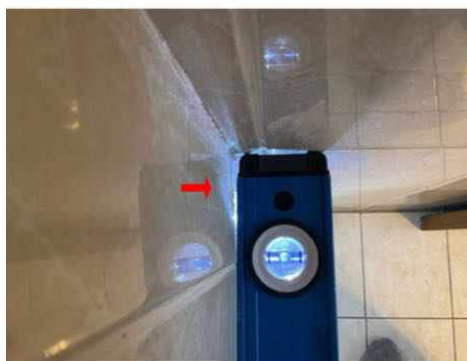
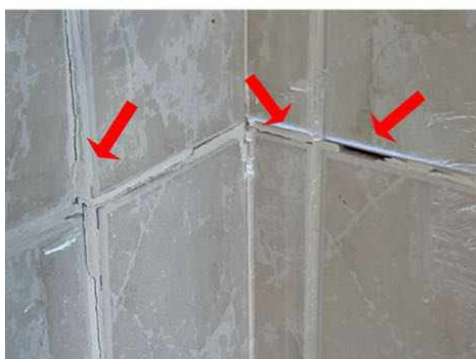
Building: Building 1
 Location: Bathroom behind door
 Finding: Tiles loose
 Information: The tiles behind the bathroom door were found to be loose at the time of inspection. These tiles need to be removed and refixed to the wall to prevent the breakages.

A tiling contractor is required to perform these works.

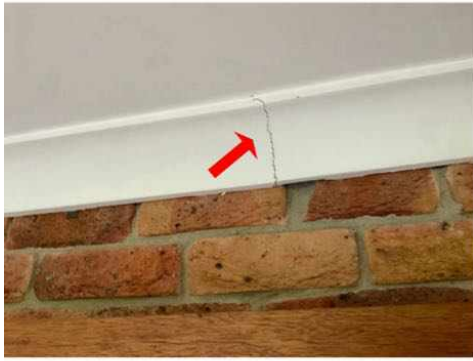
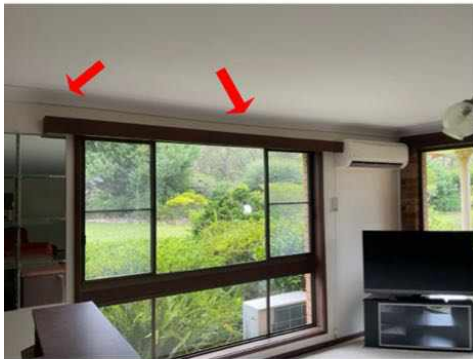
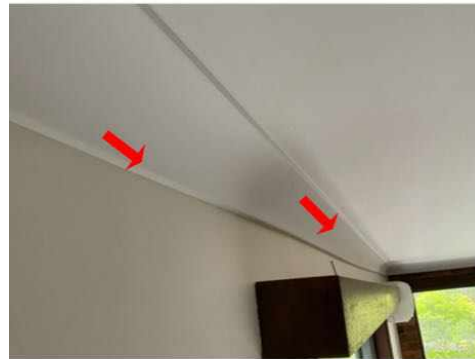
Building: Building 1
 Location: Dining and loungerooms
 Finding: Ceilings - Sagging and minor cracks to cornice
 Information: Sections of these ceilings were found to be sagging at the time of inspection. Sagging to the fixed ceiling structure generally indicates that the building materials have swollen, due to contact with water, or that fixings (e.g. nails or glue) have become loose and require reattachment. No moisture was found in these areas.

In some rare cases, sagging ceiling linings may also indicate that there are structural issues, causing surfaces to warp, twist or sag or there can be deflection in roof timbers from termite damage causing sagging. In these cases, removing roof tiles to inspect these areas of external walls is required to rule out these issues.

In most cases, repair works may be performed by relevant tradespeople, such as plasterers and carpenters.

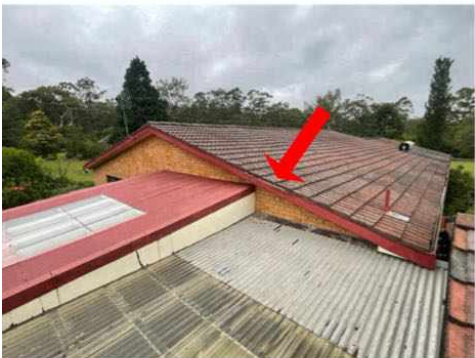
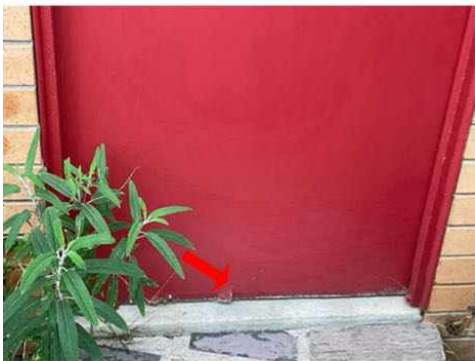
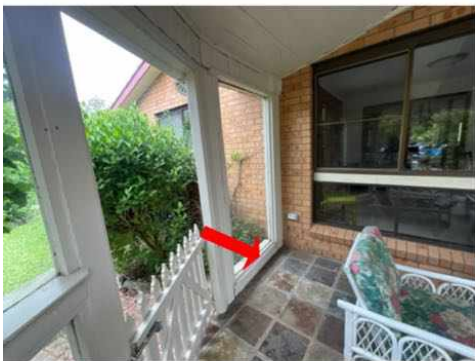
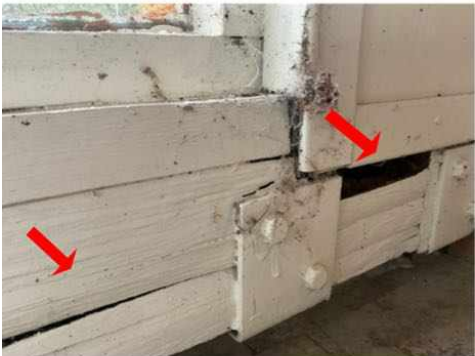
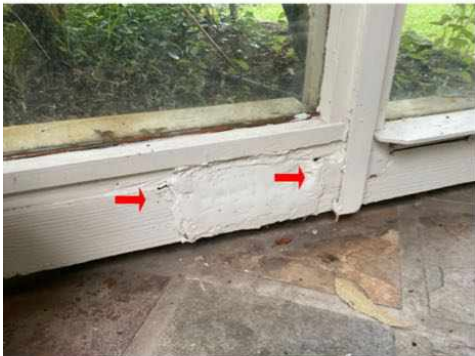
Finding 3.04

Building:	Building 1
Location:	Mostly pergola areas
Finding:	Wood rot
Information:	The pergola and above barge boards show evidence of wood rot. Some right pergola timbers and the above fascia require urgent replacement.

A qualified carpenter or registered builder may also be required to replace affected building materials. This area is the same area as described in the safety defect in the start of this report.

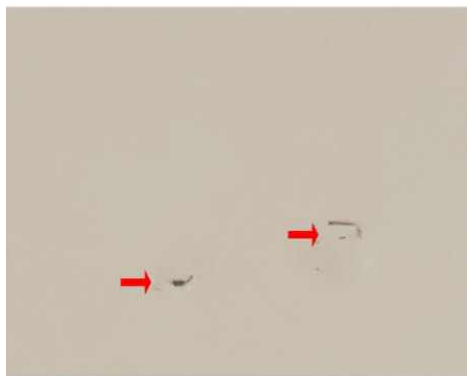
Building:	Building 1
Location:	Hall
Finding:	Cracking - Damage Category 1 - Fine (up to 1mm)
Information:	Although fine cracks are quite noticeable, they are often only considered to be an appearance defect, and usually do not indicate any structural damage. Generally, the cause of a fine crack is indicative of a separation between building materials and finishes (e.g. paint, plaster, etc.) along joints. A few ceiling nails also showed minor movement..

Cracking of this nature can generally be repaired with minor sanding, filling and/or repainting. Such works should be performed by a qualified painter or a general handyman.

Monitoring of all cracking should be conducted frequently. See also cracks in the ceiling sagging defect.

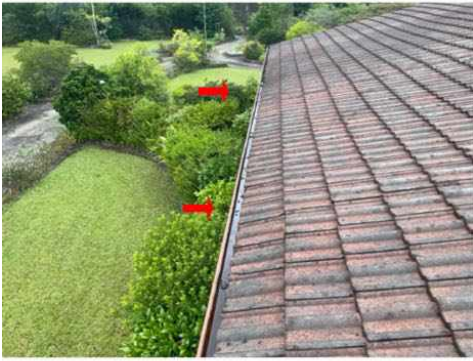
Finding 3.07

Building: Building 1
 Location: Roof exterior
 Finding: Gutters - Full and blocked
 Information: The guttering on around the roof was found to be blocked at the time of the inspection. Roof plumbing structures, such as guttering and downpipes, should be free of all debris to prevent blockages. Blockages of the guttering and downpipes will lead to pooling and accumulated water overflows, which is likely to subsequently flood eaves and exterior walls.

Blocked gutters are likely to lead to high levels of moisture in the affected areas which can cause rust and decay of the gutters and downpipes and wood rot to adjoining timber areas. Blockages in gutters should therefore be removed immediately to ensure dry conditions are maintained.

It is highly advised that gutters be cleaned by the homeowner or a general handyperson as a matter of urgency.

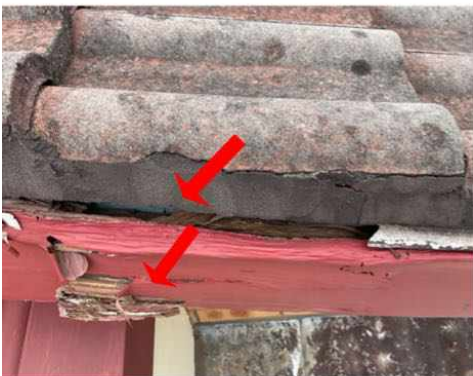
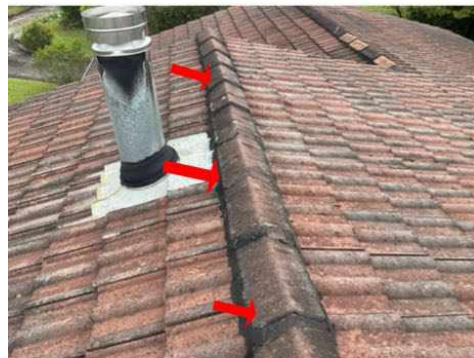
Finding 3.08

Building:	Building 1
Location:	Roof Exterior
Finding:	Roofing areas - Weathered
Information:	Upon inspection of the exterior roofing, the majority of the roof areas were considered to be in a good condition. While weathering of these pictured areas is consistent with the age of the property, maintenance works are required.

Re-sealing and replacing small areas of gaps, damage or rust that may be considered as an interim solution by the client to help preserve and extend the life span of these roofing areas. Where left unmanaged, deteriorating roofing materials are likely to lead to a number of secondary defects, including minor water leaks and weather exposure to internal roofing structures.

Consultation with a roofing contractor is highly advised to gain advice on cost of remedial works that may be required in the short to medium term.

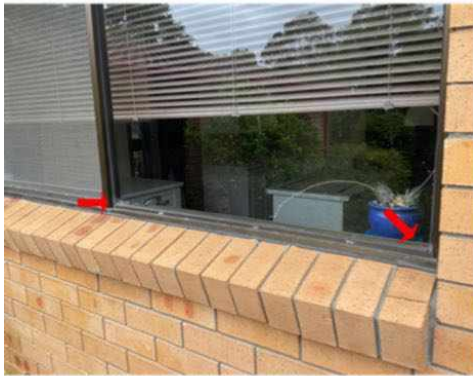
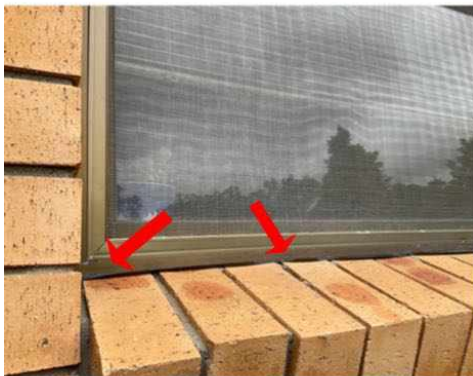
Finding 3.09

Building:	Building 1
Location:	Many window areas
Finding:	Window seals - deteriorated
Information:	Some window seals have deteriorated and are in a generally poor condition. Due to frequent exposure to weather conditions and subsequent moisture, deterioration of window seals is expected in a property of this condition and age.

Where window seals have deteriorated, the window is no longer weather-tight; rain penetration and subsequent water damage is therefore likely to ensue. Insulation of the area against external weather conditions will also be compromised.

It is recommended that all deteriorated window seals be replaced by a general handyman or sealant expert to prevent any further damage and to restore the window to a fully functional level.

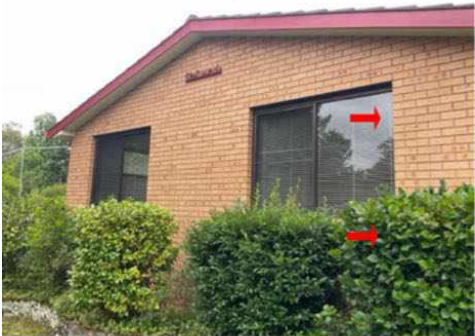
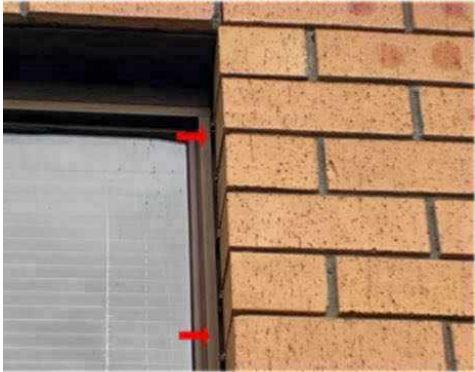
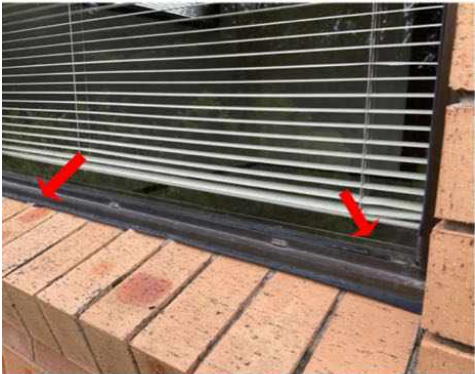
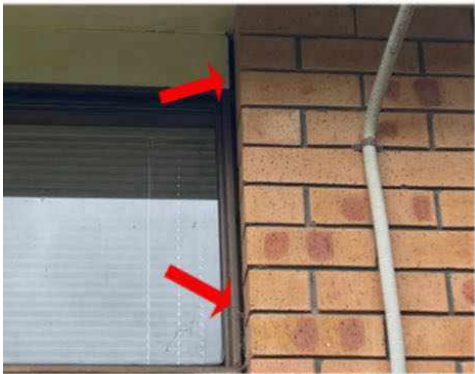
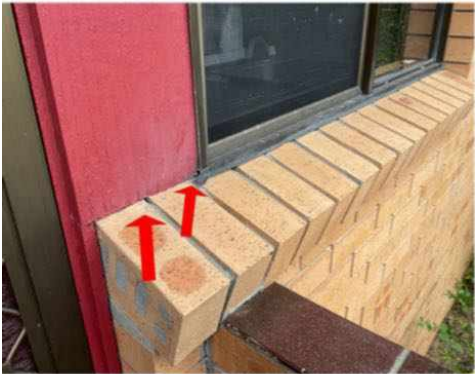
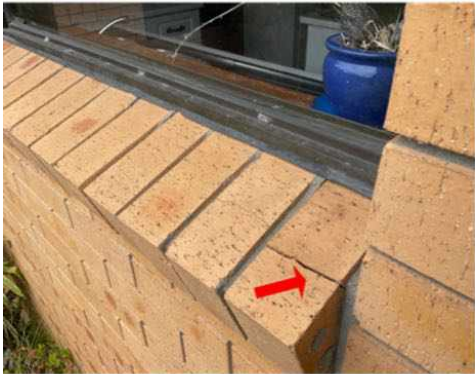
Finding 3.10

Building:	Building 1
Location:	Pictured Areas
Finding:	Sealant (external) - Missing.
Information:	It was noted on inspection that areas of external sealant was missing to small areas of the external walls.

Flexible sealants should be applied to these affected areas to prevent any subsequent water damage that is likely to occur.

A sealant specialist or skilled handy person should be appointed to complete these works as soon as possible

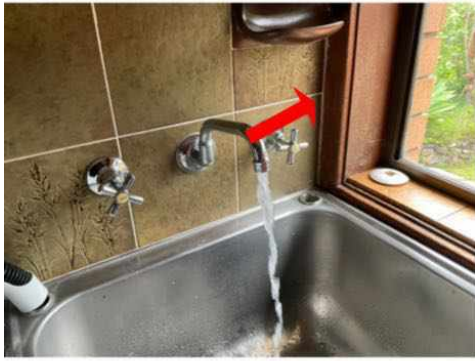
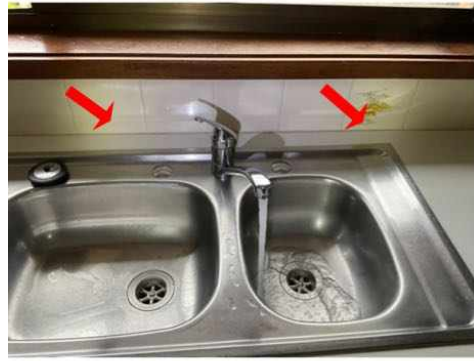
Finding 3.11

Building: Building 1
Location: Kitchen, laundry and bathroom
Finding: Sealant and grouting - Missing or damaged
Information: It was noted on inspection that sealant or grout is degraded to these pictured wet areas.

Different materials and floor areas move at different rates, generally causing cracking

Flexible and mould resistant materials should be applied to affected areas to prevent any subsequent water damage that is likely to occur. Regular maintenance and replacement of damage or missing or damaged sealant and grout is highly recommended to the wet areas, as this is a regular wear and tear defect. Sealant and grouting in areas that come into regular contact with water should be maintained for the long term care of your property.

A sealant specialist or tiling contractor should be appointed to complete these works as soon as possible

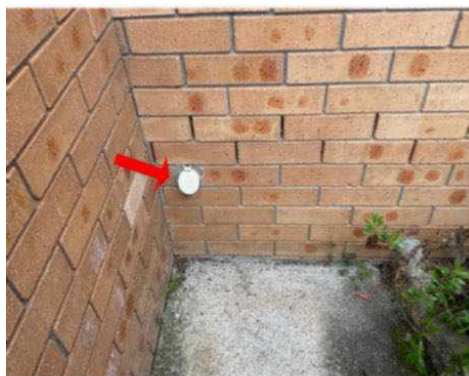
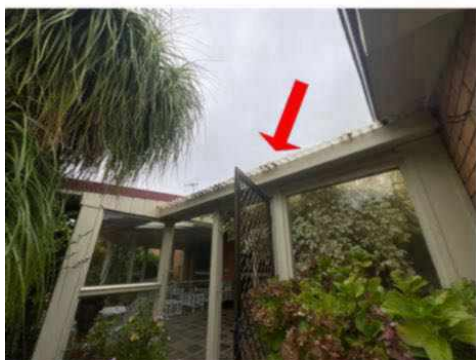
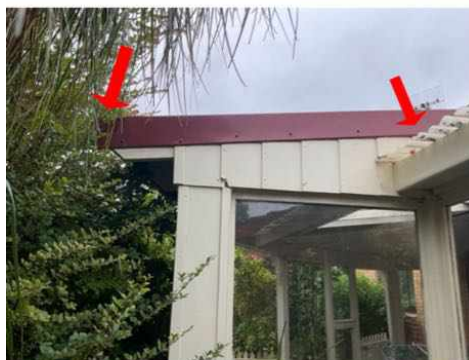
Finding 3.12

Building:	Building 1
Location:	Exterior Walls
Finding:	Site drainage - Inadequate
Information:	The site drainage in this area was found to be inadequate at the time of inspection, creating potential for subsequent water damage to associated building elements.

Three floor wastes empties onto the rear wall. Some pergola areas have no gutters. The Air Conditioner overflows appears to run against the front external wall.

Where site drainage is inadequate, installation of an Agricultural (Aggie) Drain may be required. A qualified plumber should be appointed to further inspect the property and perform any remedial works as necessary. Secondary defects are likely to occur if left unmanaged.

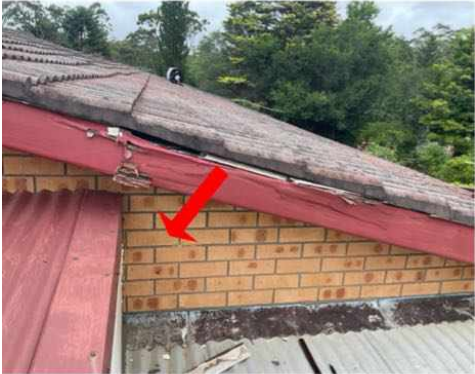
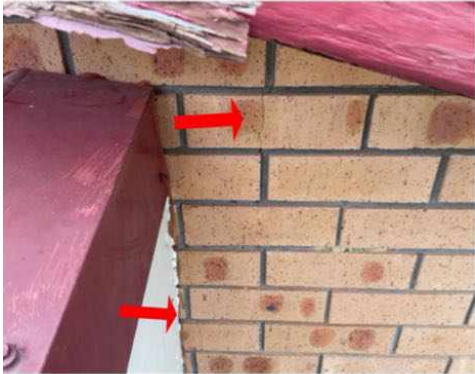
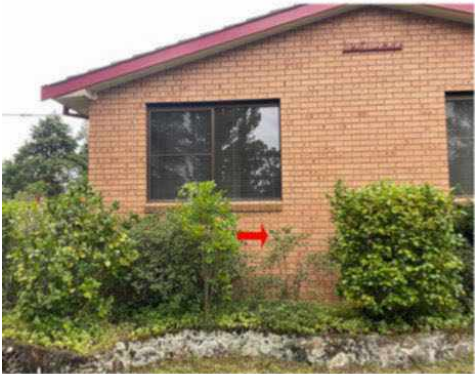
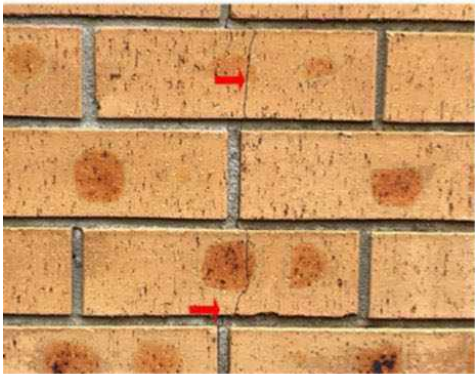
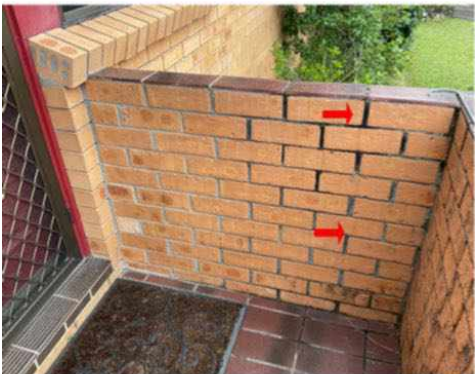
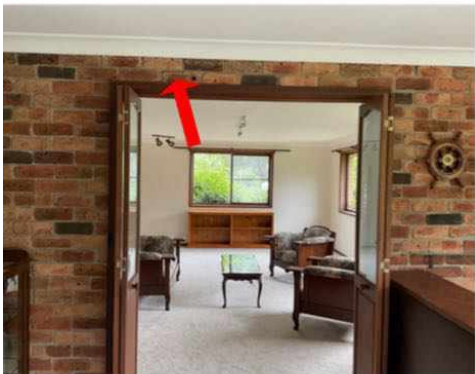
Building:	Building 1
Location:	Exterior wall areas
Finding:	Step cracking to brickwork (minor - most under 1mm)
Information:	Step cracking was identified to the brickwork in these pictures areas at the time of inspection. Step cracking, which is similar to other forms of cracking, has a variety of possible causes. However, the most common is the subsidence of adjacent footings.

Step cracking is a relatively common defect, and is most likely to occur adjacent to windows, doors and other openings. Mortar failure in the gaps between affected bricks indicates the stresses and tensions affecting the wall.

Where step cracking is extensive or severe, the client is advised to consult a structural engineer. Minor step cracking can be used as a warning sign to address factors causing stress to the wall, which can include the effect of surrounding trees, water leaks, soil erosion, or even the presence of reactive soils in the surrounding area.

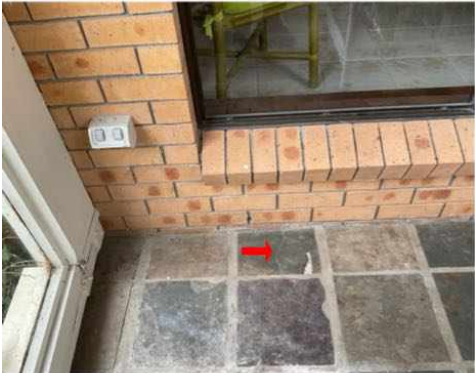
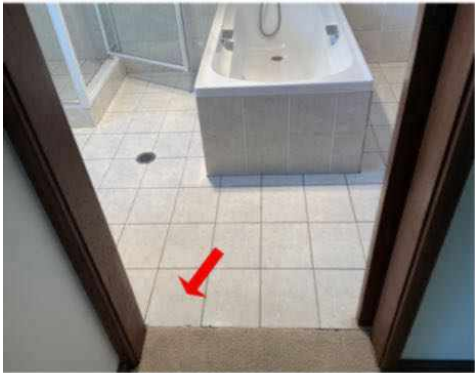
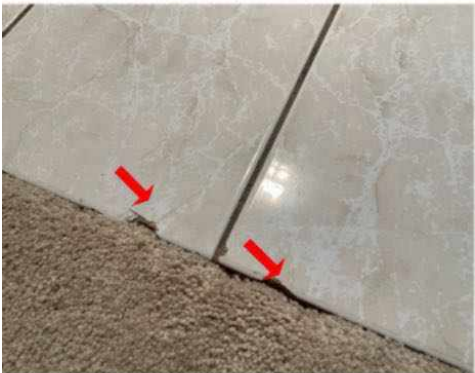
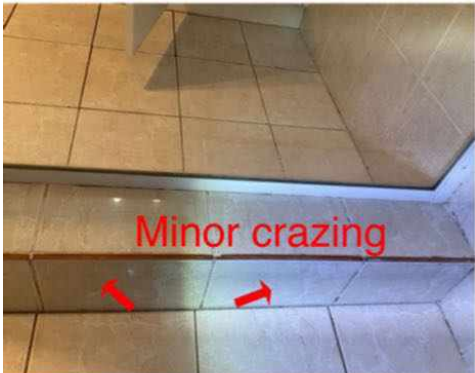
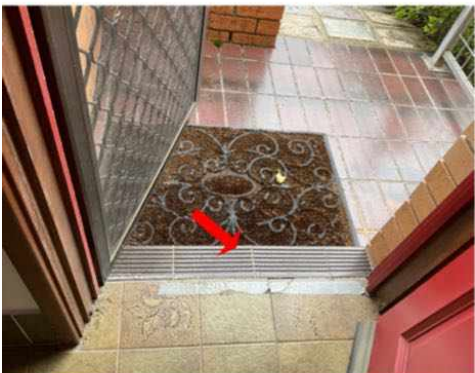
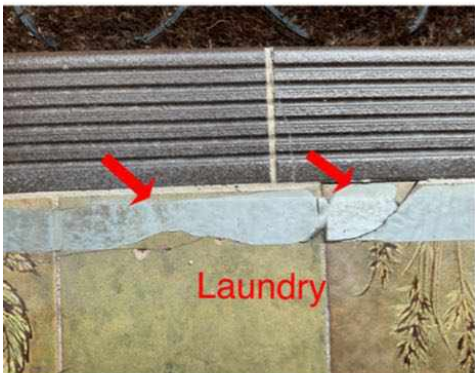
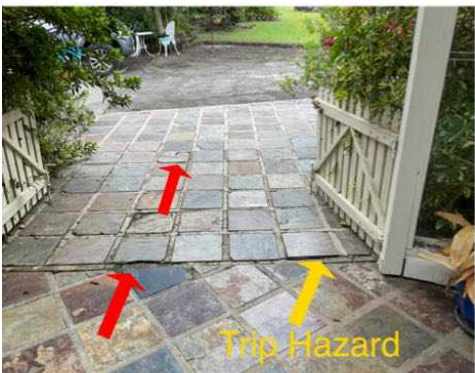
Finding 3.14

Building:	Building 1
Location:	Verandas, bathroom, pergola area
Finding:	Tiles / pavers cracked
Information:	Cracked tiles and pavers were evident in these pictured areas at the time of inspection. It is suspected that this cracking has occurred as a result of minor settlement or impact damage.

Cracked tiles throughout the household detract from the overall appearance of the affected areas. In wet areas of kitchens and bathrooms, it can lead to water damage of adjoining walls and floors.

Replacement of cracked tiles is recommended as soon as possible. A tiling contractor may be appointed to perform these works. Where cracks become more numerous, contact a licensed building inspector for further investigation.

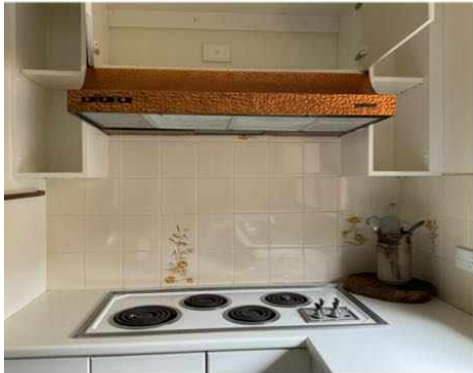
Finding 3.15

Building: Building 1
 Location: Kitchen
 Finding: Rangehood - Light not working
 Information: While the range hood appears to be working at a satisfactory level, the light to the appliance was not working at the time of inspection.

A licensed electrician should be appointed to replace the light on the range hood to restore it to a fully operational state.

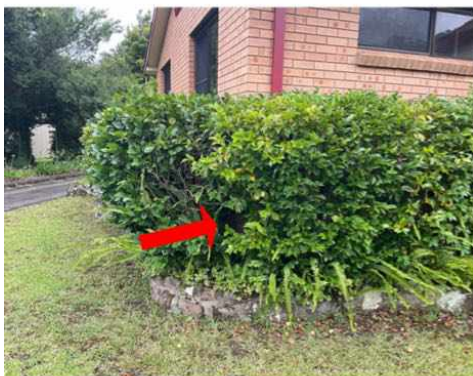
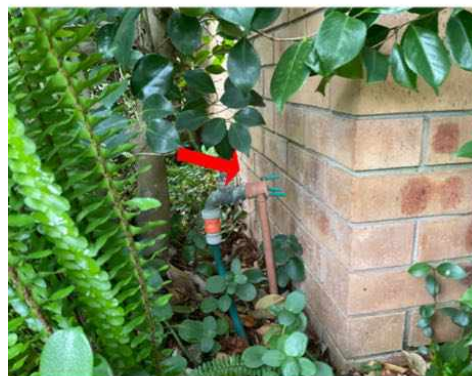
Finding 3.16

Building: Building 1
 Location: Yard - front
 Finding: Additional fixings to tap required
 Information: Evidence of insufficient fixings were evident on the front tap. A carpenter or handy person would be able to add additional fixings to these areas.

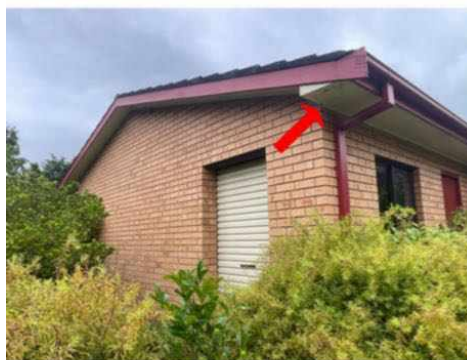
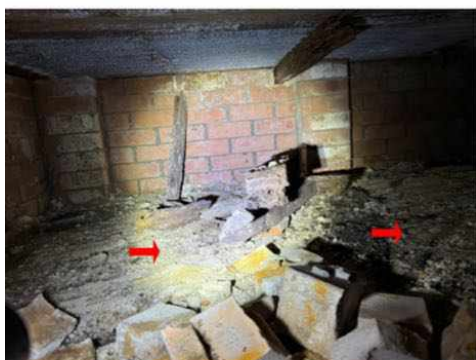
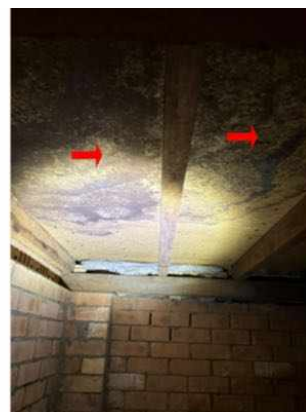
Finding 3.17

Building: Building 1
 Location: Subfloor and eave corners
 Finding: Mould - Present in subfloor

Information: Mould growth was noted in the subfloor and small eave areas. Subfloor mould is generally caused by moisture ingress, lack of external drainage, lack of adequate ventilation and subfloor debris present. These issues need rectification. In this case, it is thought the large amount of vegetation around the house perimeter is restricting ventilation and often keeping the lower brick walls damp.

It is highly recommended to remove much of the perimeter vegetation (or move away from walls) and install more ventilation to reduce the subfloor mould.

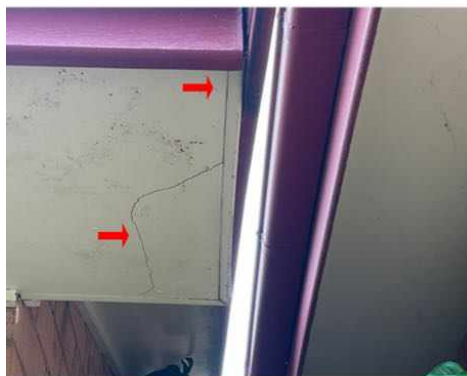
Finding 3.18

Building: Building 1
 Location: Garage
 Finding: Eaves - Sagging & cracking (minor)
 Information: Sagging to the eaves was evident in this area at the time of inspection. This type of defect is generally consistent with older properties, where the eave sheeting has worn over time.

Sagging eaves are susceptible to the attraction of excessive moisture, and are therefore considered non-functional. This defect also detracts from the overall appearance and condition of the roofing structure and any associated structures.

A roofing plumber or general handyman is recommended to perform rectification works.

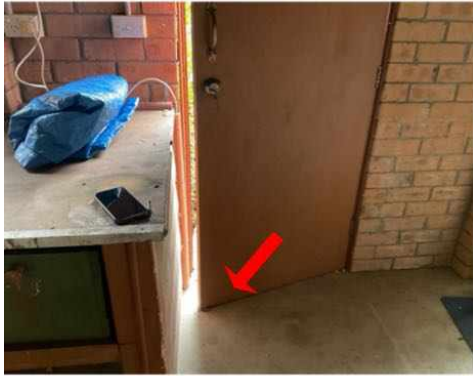
Finding 3.19

Building:	Building 1
Location:	Garage & front doors
Finding:	Doors - Binding/jamming
Information:	Binding and/or jamming of these 2 doors was evident during standard operation. This defect inhibits the functionality of the affected doors as well as creating potential for secondary defects to associated building elements, such as damage to the floor covering.

A door that binds to flooring or to the associated door frame may have several causes, ranging from minor defects, such as poor installation of the door or deteriorated hinges, through to major structural issues, such as damage to subfloor structures.

Where door binding/jamming appears to indicate major structural issues, a registered builder specialising in re-stumping should be appointed to provide an estimate on the cost of rectification.

For minor causes, a qualified carpenter or general handyperson should be appointed to perform minor rectification works at client discretion.

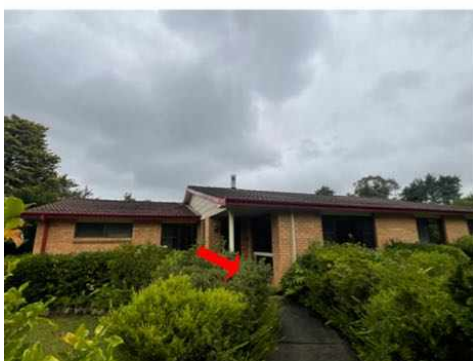
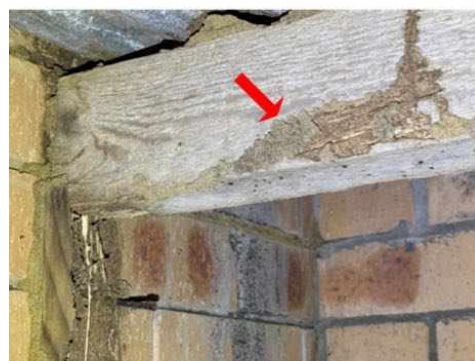
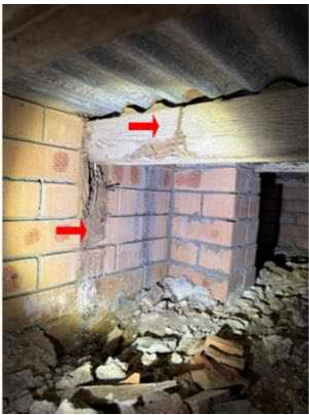
Building:	Building 1
Location:	Subfloor formwork under front entry
Finding:	Evidence of termite damage - minor
Information:	Despite no live termite or timber pest activity being indicated, previous termite damage was found to have affected the old formwork in this porch area. This damage is considered to be inactive and is minor in nature.

At the time of inspection, damage is not structural and is only considered to be superficial. All subfloor loose timber and formwork should be removed from the property as this is very attractive to termites.

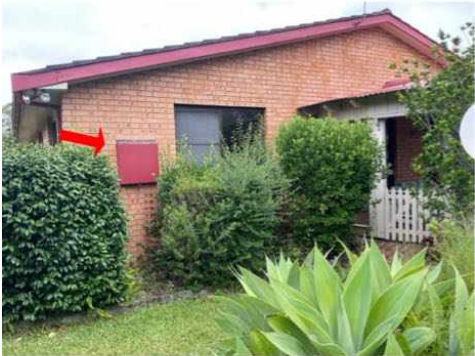
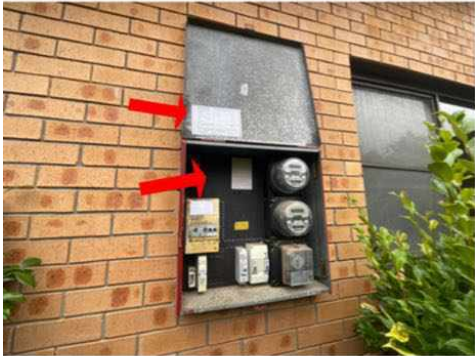
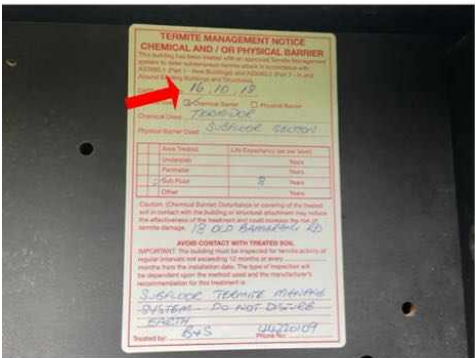
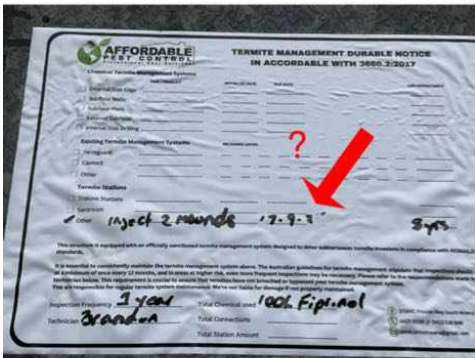
Finding 6.01

Building: Building 1
Location: Meter Box
Finding: Termite Management System advice
Information: The application of a post-construction chemical termite barrier is highly recommended for all properties. Such barriers are highly effective in preventing termite attack on any timber building elements throughout the property.

A durable notice should be placed in the switchboard unit to indicate current termite barriers. At the time of inspection, two durable notices were evident and it appeared as though a chemical termite management was used last year and further work in 2018.

The client must consider gaining further advice from a pest controller as to the costs and procedures involved with further 'chemical' applications due to the large number of conducive conditions found close to the house. It is recommended that obtaining such advice be a short-term priority.

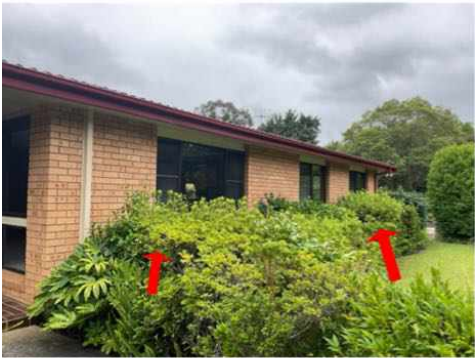
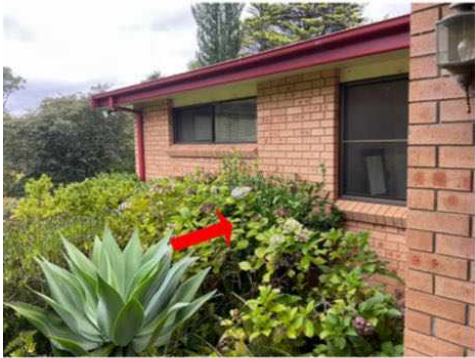
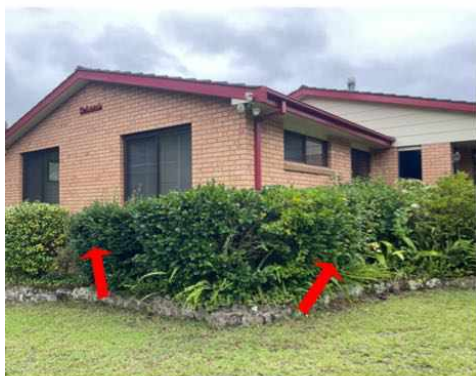
Finding 6.02

Building: Building 1
 Location: All walls
 Finding: Bridging - Vegetation on every external wall
 Information: Where vegetation obstructs inspection of building elements, also known as bridging as it provides a bridging point for the access of termites, full inspection can not be achieved. Consequently moisture or dampness may be present and the areas becomes conducive to termite activity. Plants against or very close to buildings provide cover, shade and can provide an environment that is attractive to termite infestation.

The removal and replanting of species that do not provide "cover" or cutting back of existing vegetation will assist greatly in preventing Bridging from occurring.

The removal of any such materials that may be conducive to termite activity should be carried out as soon as possible and arrange re inspection to minimize the risk of termite attack.

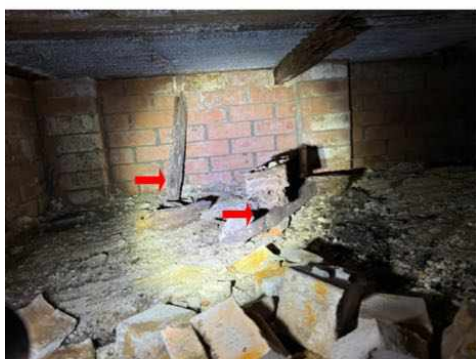
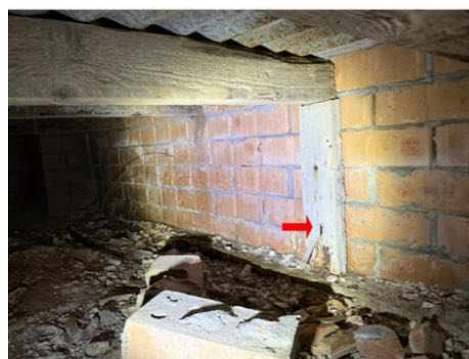
Finding: Timber in contact with the ground
 Information: Any timbers in direct ground contact provide opportunity for concealed termite entry and are likely to be subject to premature rot and decay as the soil retains moisture or damp conditions against the timbers.

Removal of all waste timber that is in direct contact with ground is highly advised. This timber is promoting mould and wood rot and is very attractive to termites.

Frequent pest inspections are advised to readily identify any termite activity in these areas.

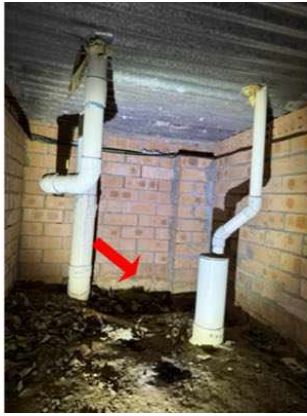
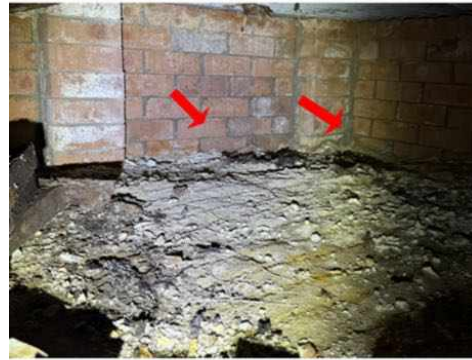
Finding 6.05

Building: Building 1
 Location: Subfloor
 Finding: Damp - Rising
 Information: A few areas of rising damp was found in the subfloor. This describes the upward movement of water in low sections of building elements (e.g. walls) by capillary action - the movement of water through porous materials such as bricks, sandstone or mortar.

As described in other areas of this report, the extensive perimeter vegetation is thought to be one of the causes of this rising damp.

The first step in addressing rising damp is to diagnose the cause. The identified cause should be addressed first before addressing the appearance and other defects which have resulted from the rising damp. If the original cause is not resolved, further cases of damp are likely to ensue, resulting in secondary defects.

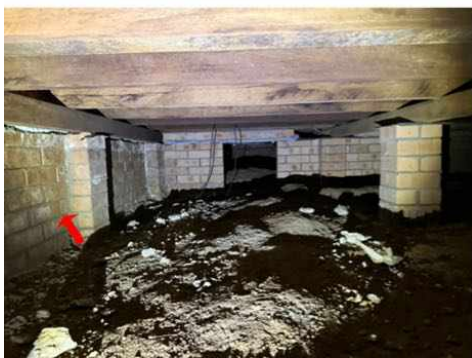
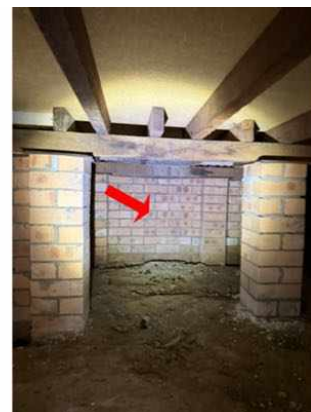
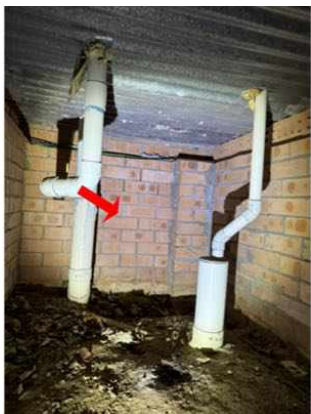
Finding 6.06

Building:	Building 1
Location:	Subfloor
Finding:	Subfloor ventilation - Inadequate
Information:	Adequate subfloor ventilation aids in preventing excessive moisture wood rot and termite activity by ensuring a dry subfloor environment.

Where ventilation is substandard or blocked, it is usually caused by factors such as failure to install adequate vents during construction, or earth and vegetation here covering vents. Low subfloor clearance and stored items or debris in the subfloor also restricting airflow.

Subfloor ventilation can be improved in most cases by addressing the causes such as exposing subfloor vents, installing additional vents, installing mechanical ventilation and removing debris from the subfloor.

A registered builder should be appointed as soon as possible to perform these works as necessary.

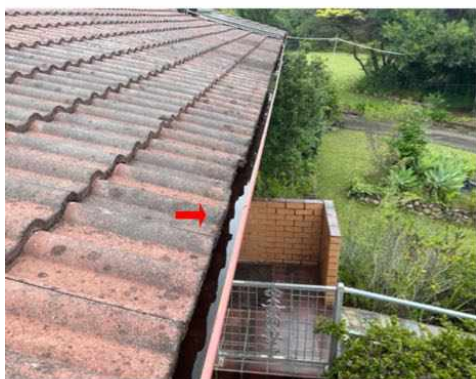
Finding 6.07

Building:	Building 1
Location:	Roof exterior
Finding:	Gutters - Full and blocked
Information:	The guttering on around the roof was found to be blocked at the time of the inspection. Roof plumbing structures, such as guttering and downpipes, should be free of all debris to prevent blockages. Blockages of the guttering and downpipes will lead to pooling and accumulated water overflows, which is likely to subsequently flood eaves and exterior walls.

Blocked gutters are likely to lead to high levels of moisture in the affected areas. Such moisture will not only cause rust and decay of the associated building materials, but can also provide conditions that are conducive to termite and timber pest activity. Blockages in gutters should therefore be removed immediately to ensure dry conditions are maintained.

It is highly advised that gutters be cleaned by the homeowner or a general handyperson as a matter of urgency.

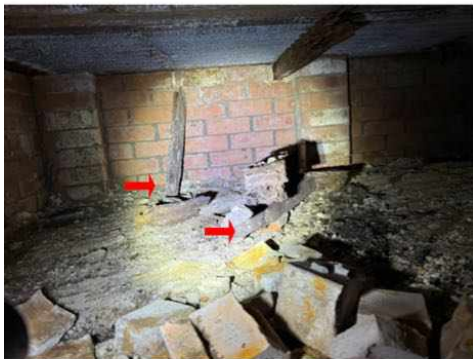
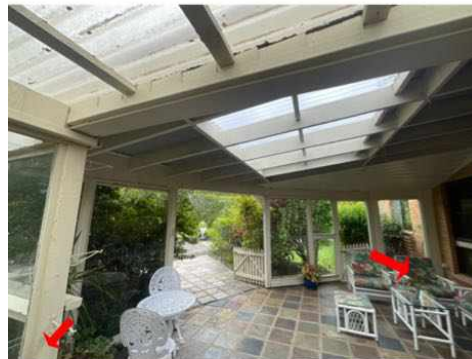
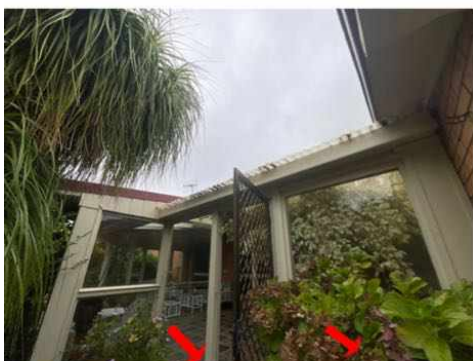
Building:	Building 1
Location:	Pergola
Finding:	Fungal decay - present (localised)
Information:	Fungal decay also known as wood decay or wood rot generally refers to the deterioration of timber elements when in contact with excessive levels of moisture for a prolonged period of time.

The development of fungal decay is accelerated by temperatures from 5degreeC to 40degreeC as well as the presence of oxygen. Generally fungal decay develops on timber elements that are in use in an external environment which are exposed to rain penetration.

Note - See ALL wood rot photos, all these show fungal decay.

In this case, some of the affected timber elements are in a decaying state and will need replacement by a carpenter or licensed builder.

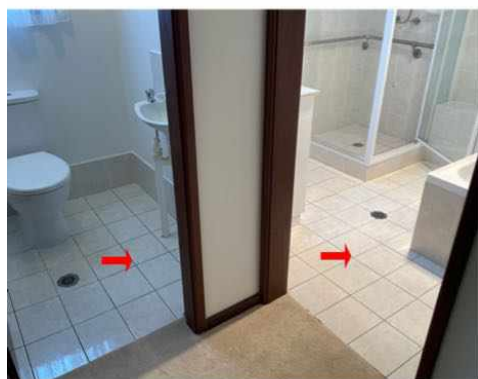
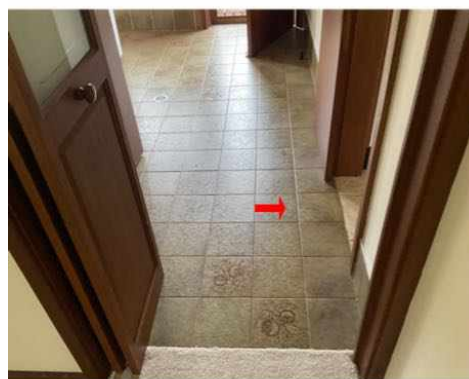
With older property's where this information is unavailable all wet areas should be monitored. If any leaks, water staining, peeling or bubbling of the paint become evident to any adjacent walls or ceilings below a licensed builder or waterproofing specialist is recommended to investigate further.

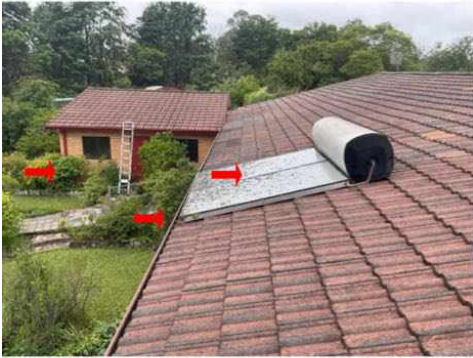
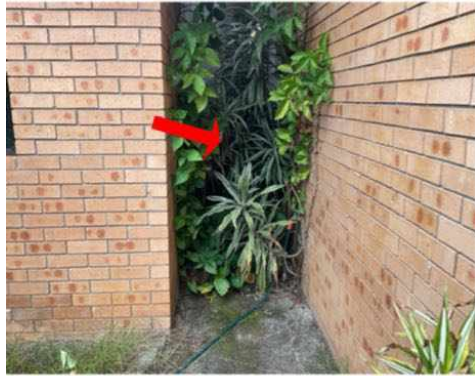
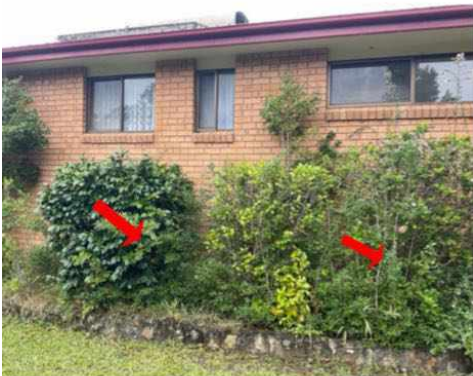
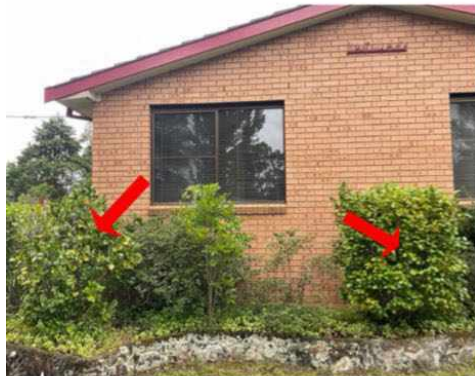
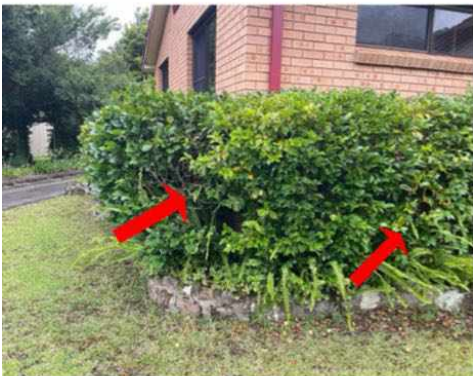
Building: Building 1
 Location: All External Areas
 Finding: Additional Photos - Obstructions and Limitations of EXTERNAL AREAS
 Information: These photographs are an indication of the obstructions and limitations which impeded full inspection of external areas at the time of inspection. These obstructions can hide an array of defects and should be removed to allow full inspection to be carried out. A re-inspection is recommended once the areas are made accessible.

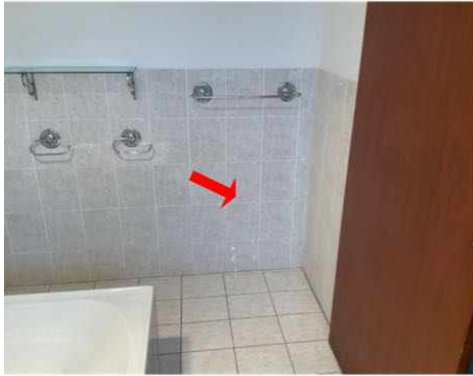
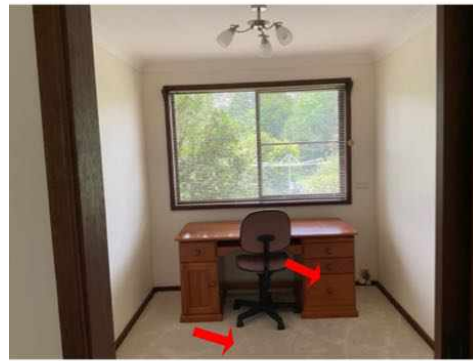
Building: Building 1
Location: All Internal Areas
Finding: Additional Photos - Obstructions and Limitations of INTERNAL AREAS
Information: These photographs are an indication of the obstructions and limitations which impeded full inspection of Internal areas at the time of inspection. These obstructions can hide an array of defects and should be removed to allow full inspection to be carried out. A re-inspection is recommended once the areas are made accessible.

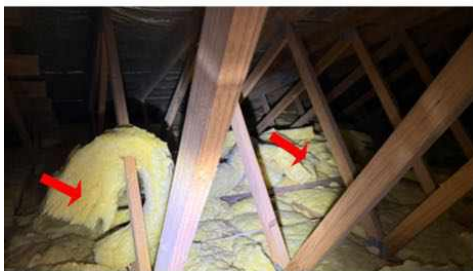
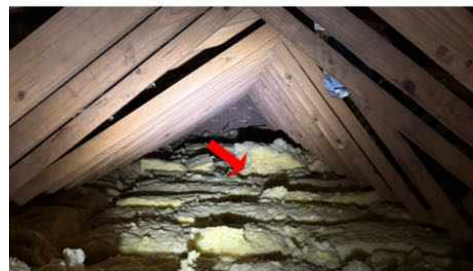
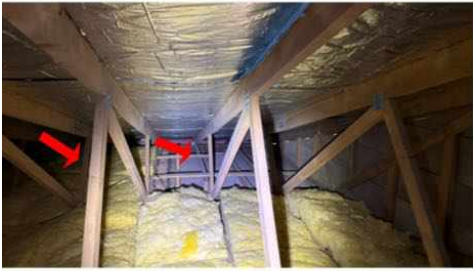
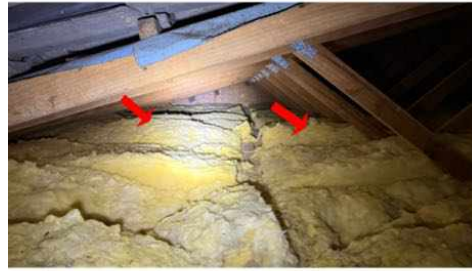
Building: Building 1
 Location: All Roof cavity areas
 Finding: Additional Photos - Obstructions and Limitations of the ROOF CAVITY
 Information: These photographs are an indication of the obstructions and limitations which impeded full inspection of roof cavity areas at the time of inspection. These obstructions can hide an array of defects and should be removed to allow full inspection to be carried out if applicable. A re-inspection is recommended once the areas are made accessible.

The inspection was also limited to areas with an allowable crawl space of 600mm x 600mm, in particular towards the external walls where the roof line diminishes, these areas were not accessible.

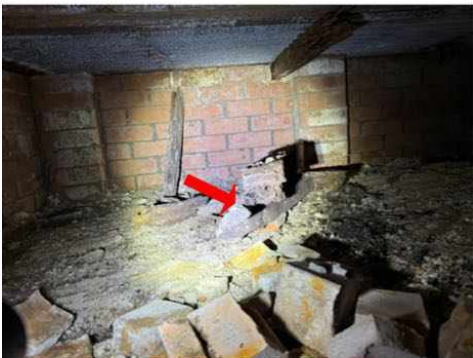
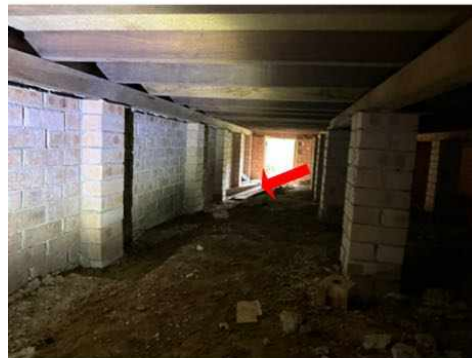
Building: Building 1
 Location: All Subfloor Areas
 Finding: Additional Photos - Obstructions and Limitations of SUBFLOOR AREAS
 Information: These photographs are an indication of the obstructions and limitations which impeded full inspection of subfloor areas at the time of inspection. These obstructions can hide an array of defects and should be removed to allow full inspection to be carried out. A re-inspection is recommended once the areas are made accessible.

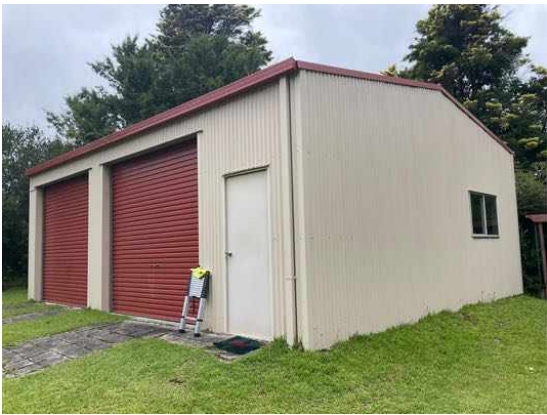
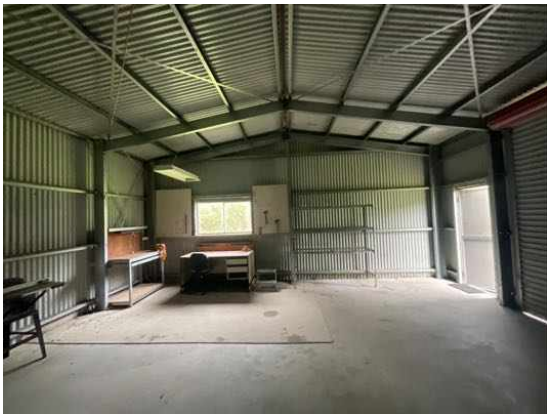
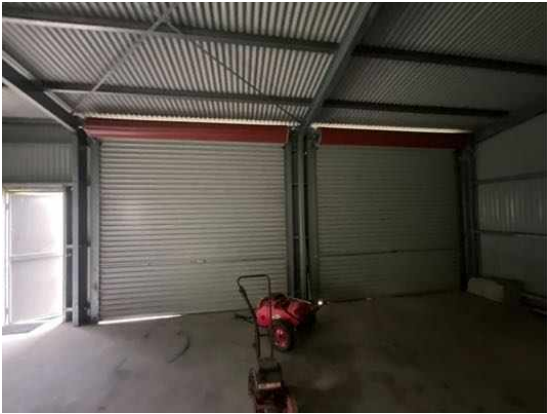
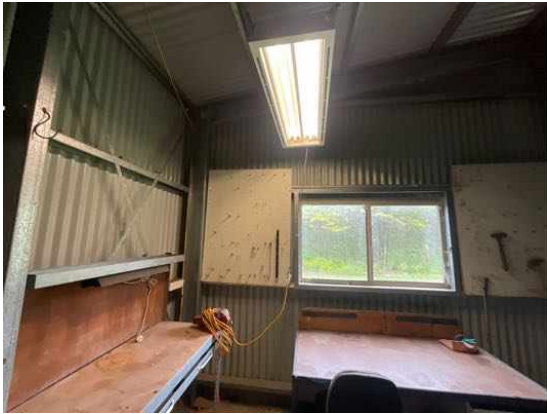
Building: Building 1
Location: All Internal Areas
Finding: Additional Photos
Information: Additional photos are provided for your general reference
